AN EVALUATION OF PCC PAVEMENT TINE
TEXTURING PATTERNS

Study Made by Pavement Branch
Study Supervised by R. A. Forsyth, P.E.
and R. N. Doty, P.E.
Principal Investigators J. H. Woodstrom, P.E.
and L. R. Ferroni, P.E.
Co-Investigator B. F. Neal, P.E.
Report Prepared by B. F. Neal, P.E.

1. REPORT NO. FHWA/CA/TL-85/05		2. GOVERNMENT ACCESSION NO.		3. RECIPIENT'S CATALOG NO.	
4. TITLE AND SUBTITLE AN EVALUATION OF PCC PAVEMENT TINE TEXTURING PATTERNS				5. REPORT DATE November, 1985

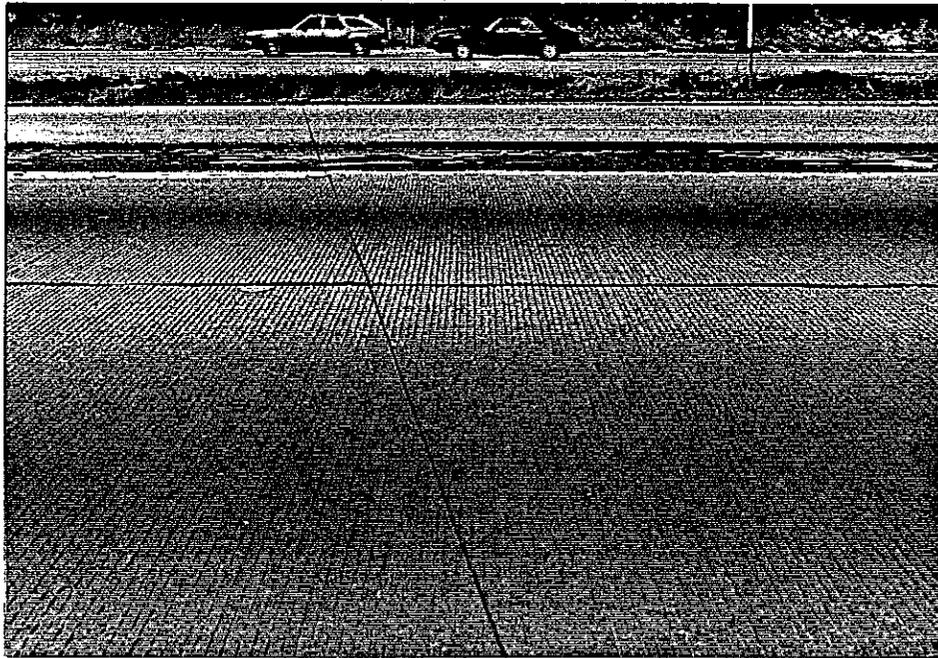
Photo 1. Transverse tine texture, 3/4 inch c-c.

Photographs taken in April, 1985 show typical conditions of the transverse (1 and 2) and longitudinal (3, 4, and 5) texturing on the I-580 project. The tine devices had the metal tines spaced at $\frac{3}{4}$ inch on centers. Photo 6 is of longitudinal texturing on an earlier project where the tines were spaced at $\frac{1}{2}$ inch on centers. This was considered to form land areas too narrow, many of which were sharp edges. After this construction project, the $\frac{3}{4}$ inch c-c spacing was adopted as standard.

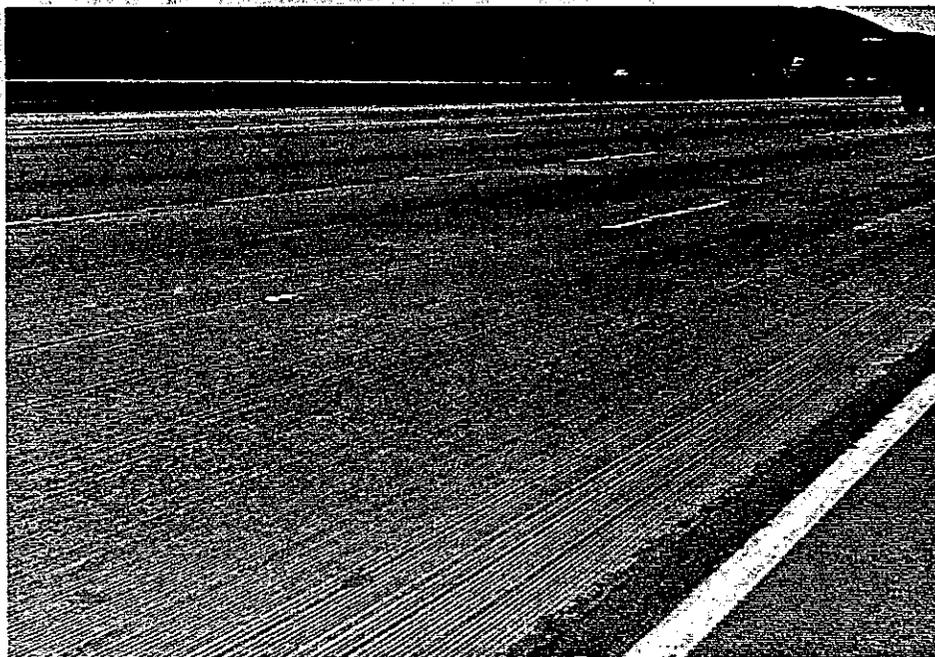
Photo 3. Longitudinal tine texture, 3/4 inch c-c.

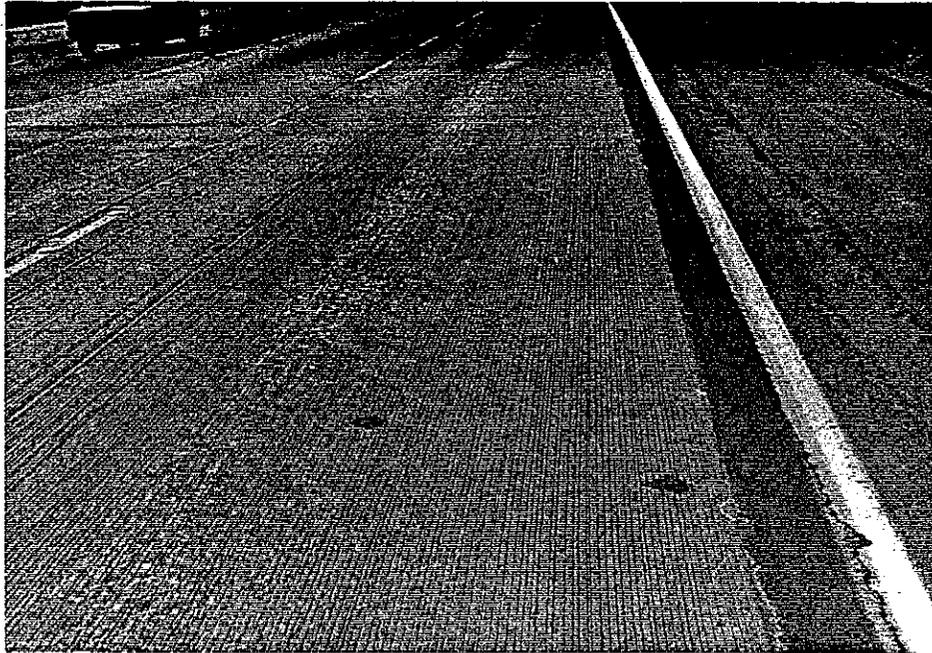
Photo 5. Longitudinal tine texture, 3/4 inch c-c.

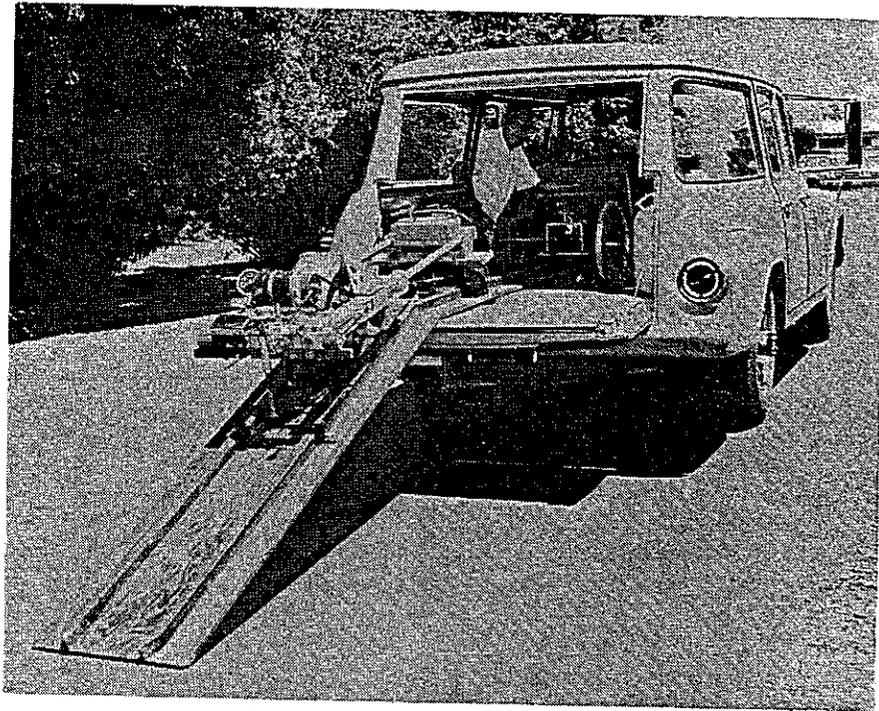
FIGURE 8
APPARATUS BEING PLACED IN VEHICLE
NOTE CABLE AND WINCH FOR MOVING SKID TESTER

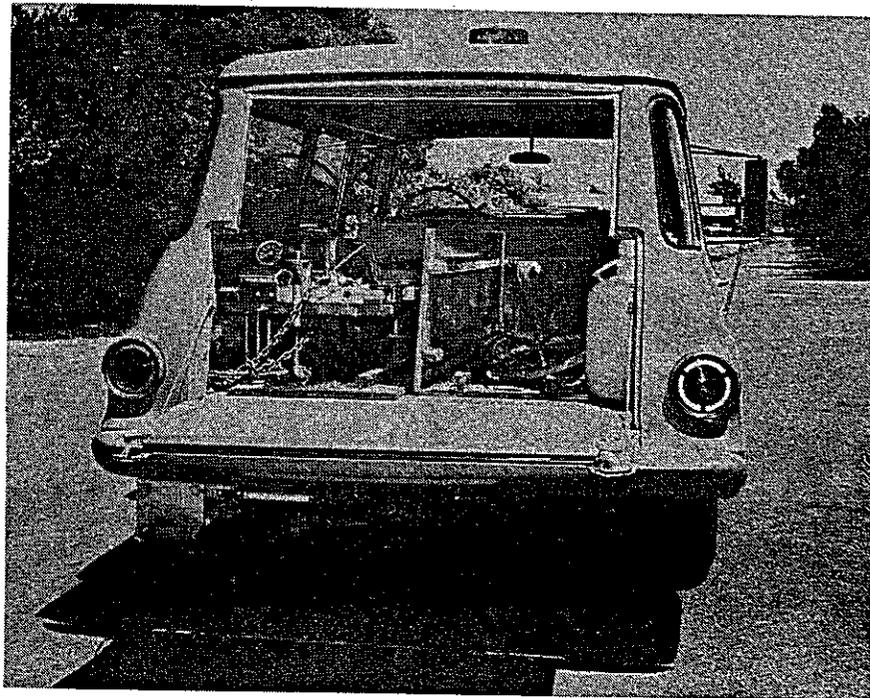
FIGURE 9
APPARATUS IN POSITION FOR TRANSPORTATION

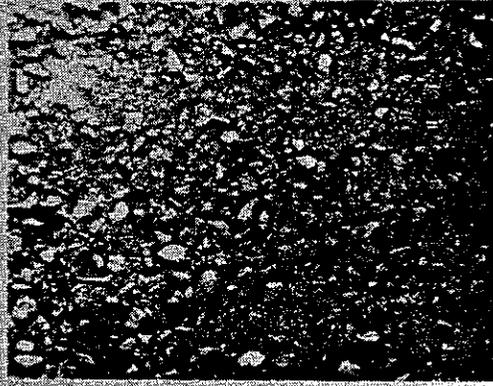
CHIP SEAL WITH SOME
CHIPS IMBEDDED OR MISSING
0.37

COEFFICIENT OF FRICTION VALUES FOR
VARIOUS ASPHALT CONCRETE SURFACES
