## FHWA-WY-06/03F

State of Wyoming  
Department of Transportation

# TIME DOMAIN REFLECTOMETRY FOR MONITORING SLOPE MOVEMENTS

August 2006

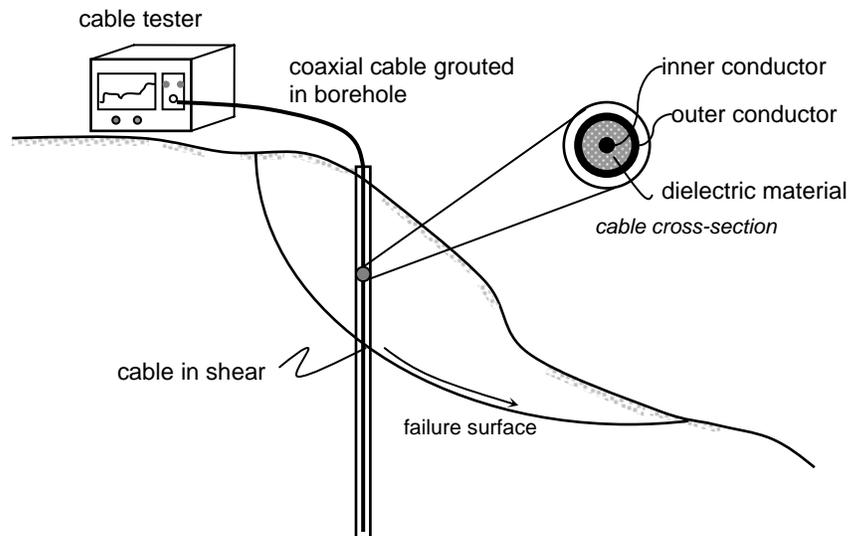
Figure 1. Components of TDR system for monitoring slope movements.

A TDR testing system consists of the components shown in Figure 1. A coaxial cable is installed in a borehole and backfilled with cement grout. The borehole can be drilled using standard soil exploration or water well drilling equipment. To obtain readings, the top of the cable is connected via a standard UHF connector to a portable, battery operated cable tester. A widely used cable tester and the type used for this project is the Tektronix Model 1502C. The cable tester has a built-in monitor for viewing the cable signature. The cable tester can be connected through a serial port to a notebook computer, allowing an operator to transfer the cable signature to the computer in digital form. The cable signature can then be stored, analyzed, and re-plotted using a variety of software packages for data processing.

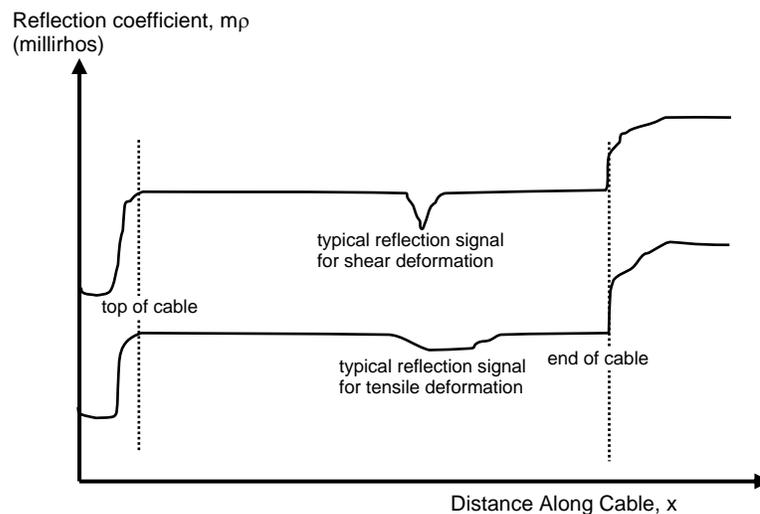
Figure 2. Examples of cable signatures for shear and tensile deformation.

where  $Z_1$  = characteristic impedance of the deformed section of cable and  $Z_0$  = characteristic impedance of the undeformed cable. Changes in  $\rho$  caused by tensile deformation appear as a subtle, trough-like depression in the cable signature (Figure 2) and are more difficult to detect than the signal caused by shearing.

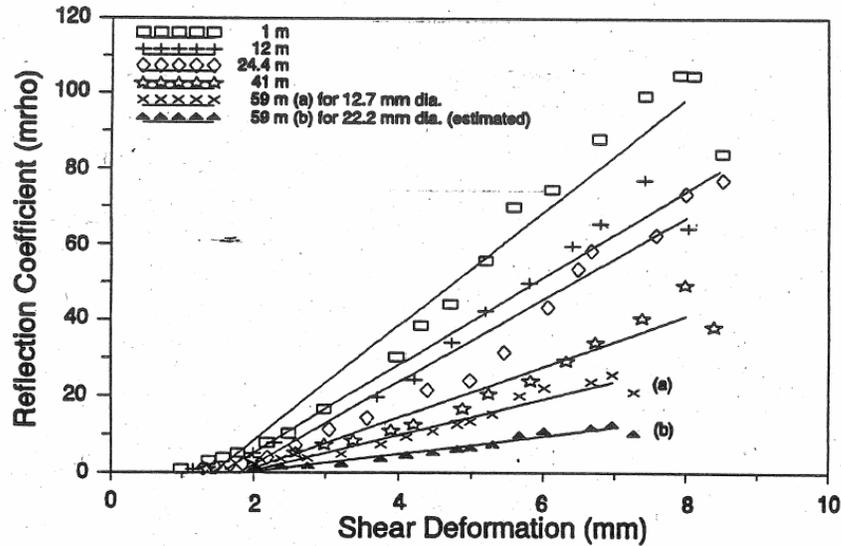
Figure 5. Reflection coefficient versus shear deformation for varying distances (Kim 1989).

Effects of distance between the cable tester and shear zone in the cable are described by Kim (1989). It was found that the slope of the reflection coefficient versus shear deformation curve decreases with increasing distance from the tester, as shown in Figure 5. Although this makes it more difficult to interpret field measurements, with proper calibration this effect can be measured, quantified mathematically, and its effect

accounted for in field measurements. From a practical standpoint, the effect is insignificant for distances less than 100 meters (305 ft), which would be the case for most slope monitoring applications.

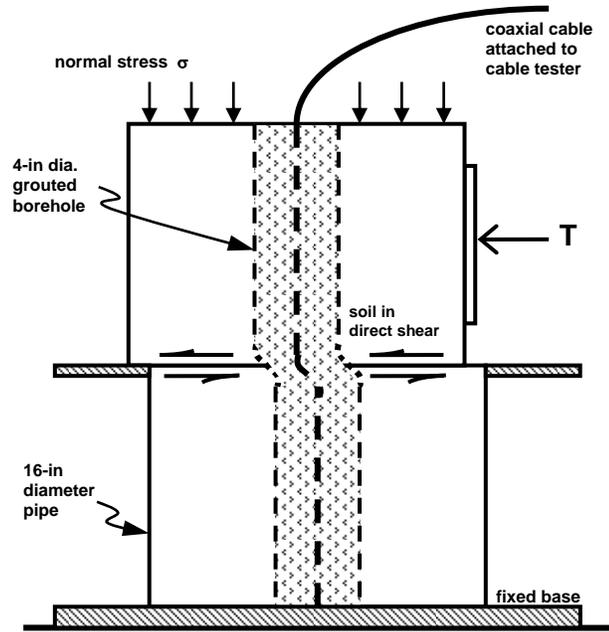
Figure 6. Schematic of direct shear cable testing device.

To facilitate direct shear tests, a concrete base was fabricated to accommodate the bottom halves of three sections of 16-inch diameter pipe. The 15-inch thick concrete base, with the plastic pipe, is shown in Figure 7. In the photo, the base is placed on edge. Direct shear specimens were fabricated as follows. With the concrete base lying flush on the concrete floor, the top half of each pipe was placed into position. Sand was then placed into each of the three chambers, using a 4-inch diameter PVC pipe as a blockout into which the cable and grout would be cast. This part of the procedure is shown in Figure 8. The coaxial cable was fixed by stapling it to a piece of timber placed at the bottom of the chamber. During grout placement, the cable was held straight up in tension and centered as best as possible in the grout tube. Following grout placement, the 4-inch grout tube was removed. Grout was allowed to cure for at least two weeks prior to shear testing.

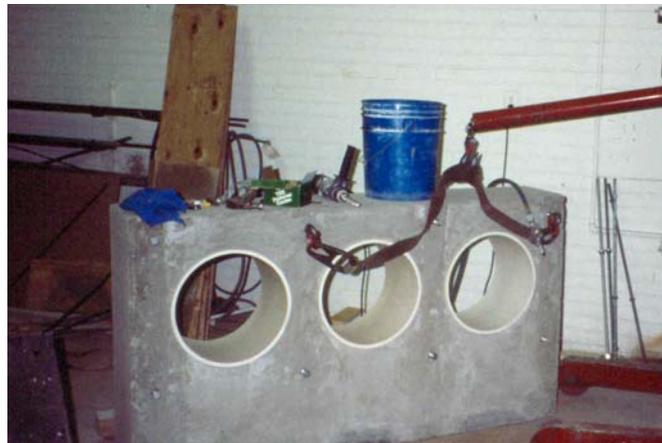
Figure 7. Concrete base with three direct shear testing chambers.

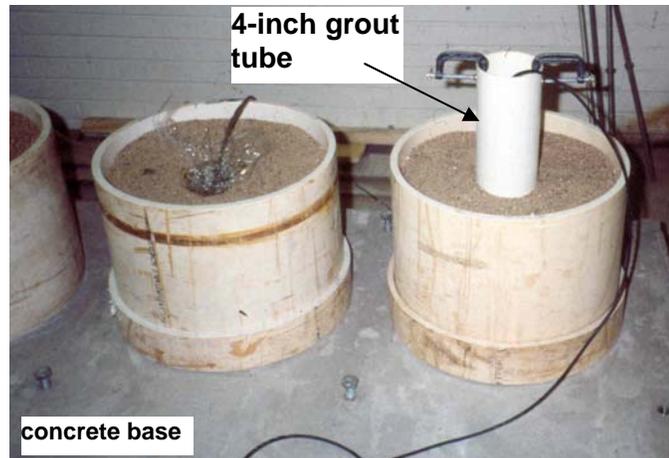
Figure 8. Placement of sand and grout tubes for direct shear specimens.

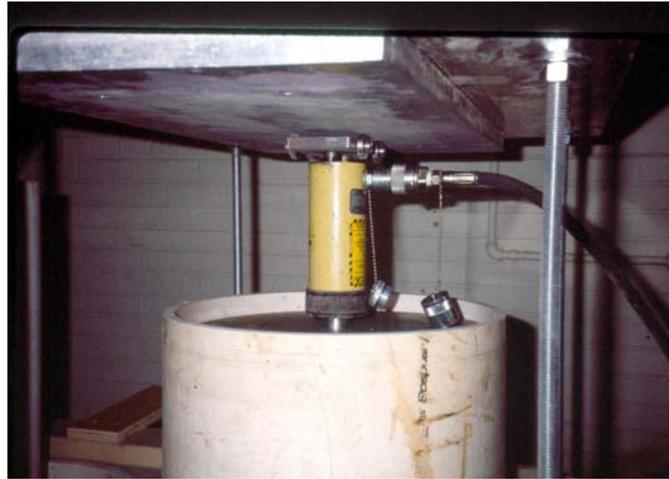
Figure 9. Assembly used to apply a vertical normal stress to the soil deposit.

Normal (vertical) stress was simulated to approximate the overburden stress that would exist in the ground. This was accomplished by applying a vertical compressive force against a steel plate bearing on the top surface of the soil deposit. The force was provided by a hydraulic jack. To provide the necessary reaction, a steel plate was fixed above the testing chamber. The plate was held in place by  $\frac{1}{2}$  inch diameter threaded rods that were anchored in the concrete base. This arrangement is shown in Figure 9. Roller bearings were placed between the jack and the reaction plate to accommodate the horizontal displacement during direct shear testing. A constant normal stress of  $\sigma = 20$  psi was used for all tests. The shear (horizontal) force was applied to the top half of the chamber through a nylon strap wrapped around the top half of the pipe. The strap was fastened to a section of steel channel. A center hole hydraulic jack was then used to apply a tensile load to a steel rod fastened to the channel section, thus pulling the top half of the pipe horizontally. A bearing plate was used between the jack and the concrete. The entire testing arrangement is shown in Figure 10. Load in the jack applying the vertical load was determined using the pressure gage on the hydraulic pump, while load in the jack applying the shear load was measured by a calibrated load cell placed at the top end of the jack. Horizontal shear displacement of the upper half of the chamber was measured using a linear variable displacement transducer (LVDT).

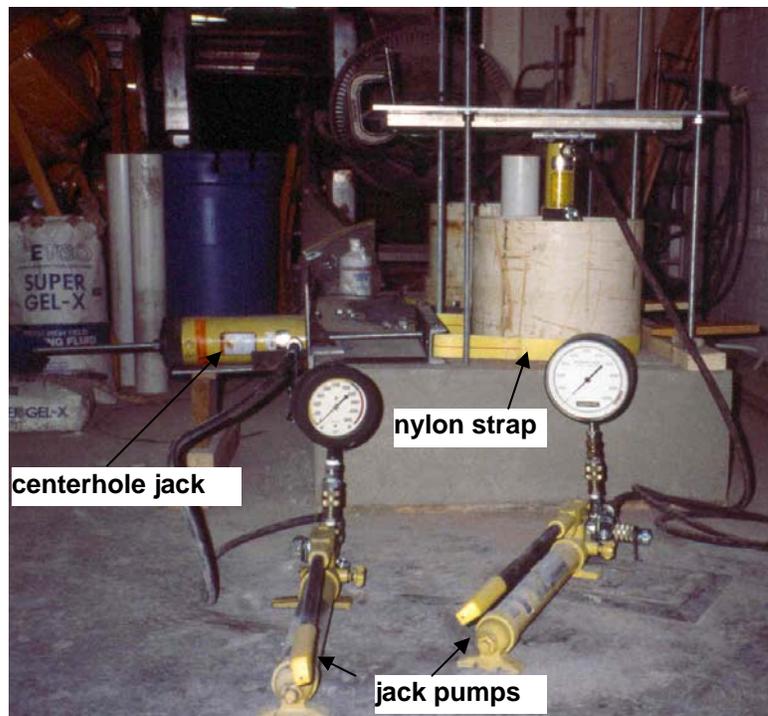
Figure 10. Direct shear test apparatus.

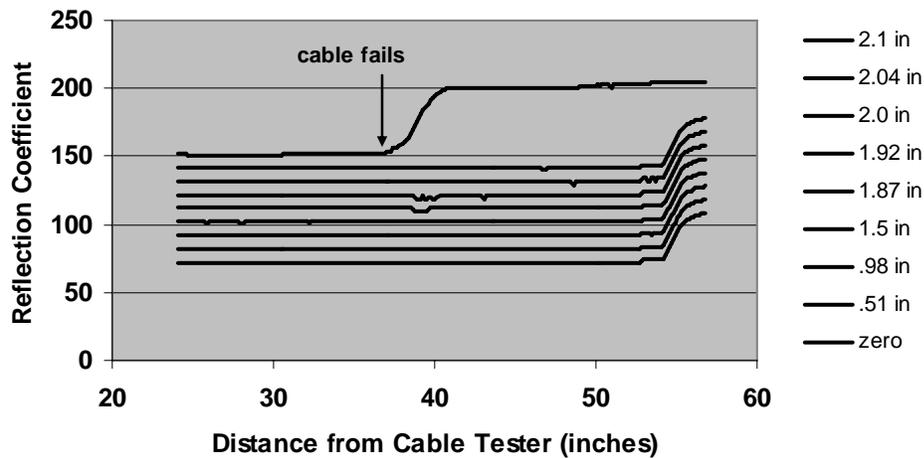
Figure 11. Results of Direct Shear Test No. 13.

Figure 11 shows the results of Test No. 13, which exhibits the type of response described above. No evidence of cable shearing is apparent through a shear displacement of 1.5 inches. At a displacement of 1.87 inches, a trough in the cable signature appears at a distance of approximately 39 inches from the cable tester. The top of the grout column is at 24 inches from the tester, so 39 inches corresponds approximately to the shear plane of the test apparatus. At a displacement of 1.92 inches the trough is still apparent. However, with further displacement the trough disappears as indicated in the cable signatures for displacements of 2.00 and 2.04 inches. At a displacement of 2.1 inches,

the cable fails abruptly at a distance of 38 inches from the tester, or 14 inches from the top of the grout column.

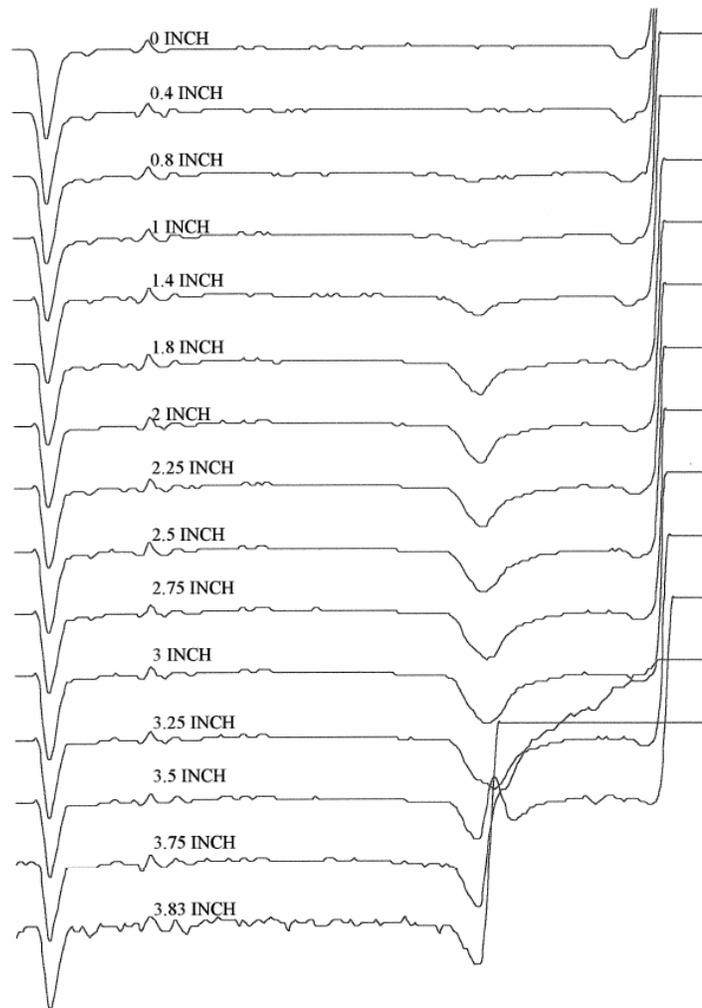
Figure 12. TDR signals for varying shear displacement levels, Sample 1A.

Twelve additional tests (4 sets of three tests per set) were conducted with this mix and procedure. Three sets of tests were conducted with RG 59/U coaxial cable and one set of tests with ½ inch diameter Flexwell hollow cable. These twelve tests are considered to be our best attempt at developing a correlation between shear displacement and cable TDR signatures. The test sets are identified by numbers 1 through 4. Within each set, the three test specimens are labeled A, B, and C. The type of behavior observed in all of the tests can be illustrated by considering the results of Test Set 1, as described in the following. Figure 12 shows the cable signatures measured during shearing of specimen 1A. With increasing shear displacement, a spike appears and increases in magnitude (Note: the spike at the left side of each signature is due to a cable connector). At a displacement between 3.75 in and 3.83 in, the cable fails in shear. A graph was prepared showing the magnitude of the spike in the cable signature versus shear displacement (Figure 13). The data can be approximated using a best-fit straight line by regression analysis, as shown. The value  $R$  = coefficient of correlation and a value of  $R^2 = 0.96$  indicates a strong correlation between the cable signal and shear displacement of the soil deposit.

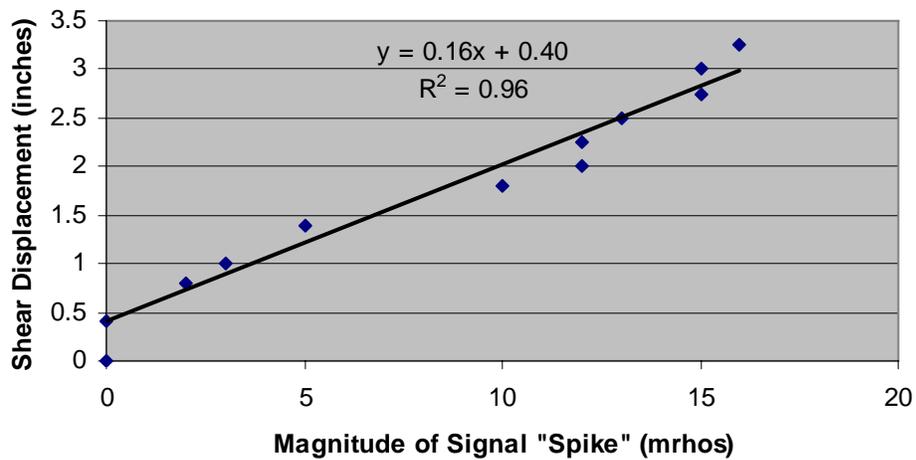
Figure 13. Cable signature "spike" versus shear displacement.

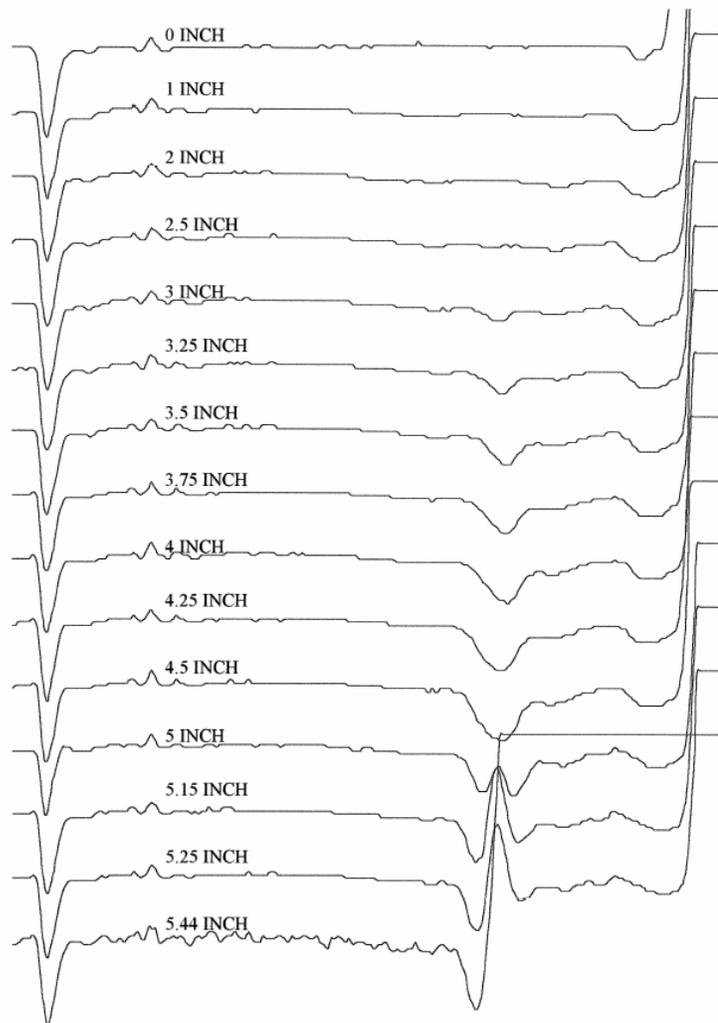
Figure 14. TDR signals for varying shear displacement levels, Sample 1B.

Samples 1B and 1C were prepared and tested identically to Specimen 1A. The measured cable signatures for varying levels of shear displacement are shown in Figures 14 and 15. In Figure 16, results of all three tests (1A, 1B, and 1C) are shown, in terms of the magnitude of the cable signature spike versus shear displacement. Figure 16 shows that the regression lines are different for each specimen, despite an effort to replicate the test conditions as closely as possible. The slopes of the lines for Specimens 1A and 1B are similar, but the intercept, *i.e.*, the displacement at which a spike first appears, is significantly different, in this case more than 1 inch. Specimen 1C exhibits a zero intercept but the slope is much different than for the other two specimens. Results of Test Sets 2 and 3 gave similar results. Individual tests yielded strong correlations, but the intercepts and slopes varied between tests and no consistent, repeatable correlation equation could be established.

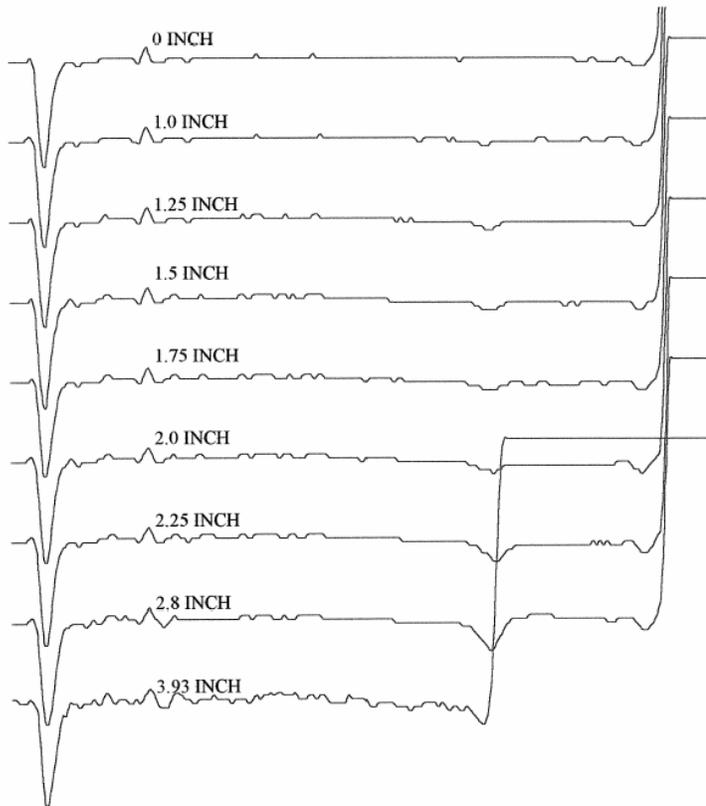
Figure 15. TDR signals for varying shear displacement levels, Sample 1C.

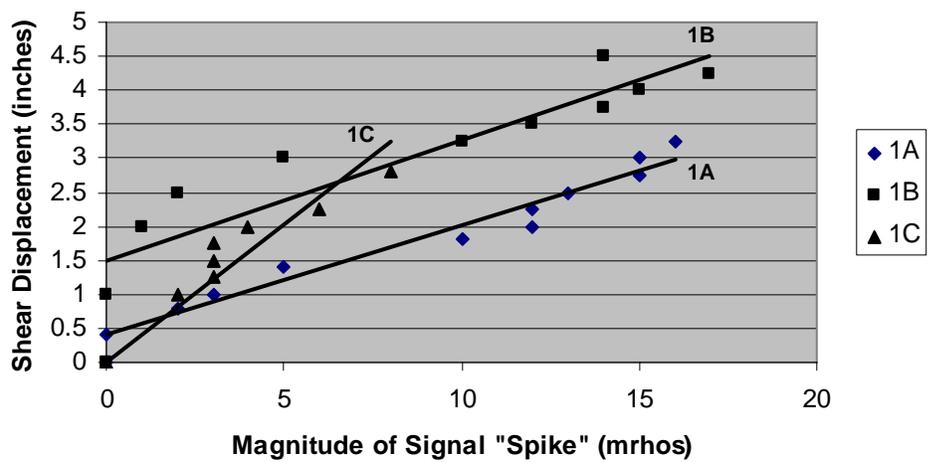
Figure 16. Regression lines for Specimens 1A, 1B, and 1C.

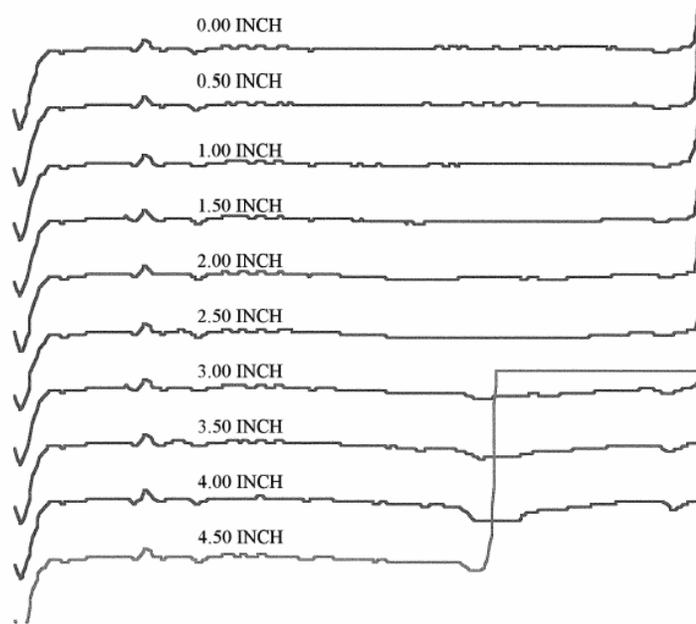
Figure 17. TDR signals for varying shear displacement levels, Sample 4A.

In Test Set 4, half-inch diameter Flexwell air dielectric cable was tested. This type of cable can be used to detect groundwater and was tested for that purpose as described in the next section of this report. The cable is stiffer than RG 59/U because the outer conductor consists of a heavier gage of copper. Figure 17 shows the cable signature obtained from Specimen 4A. With increasing shear displacement, very little change is observed in the cable signal, until the deformation reaches 4.0 inches and then the cable fails suddenly at a displacement of 4.5 inches. For the three specimens, cable failure occurred at displacements of 1.58, 3.76, and 4.5 inches. It was concluded that no consistent, repeatable correlation equation could be developed.

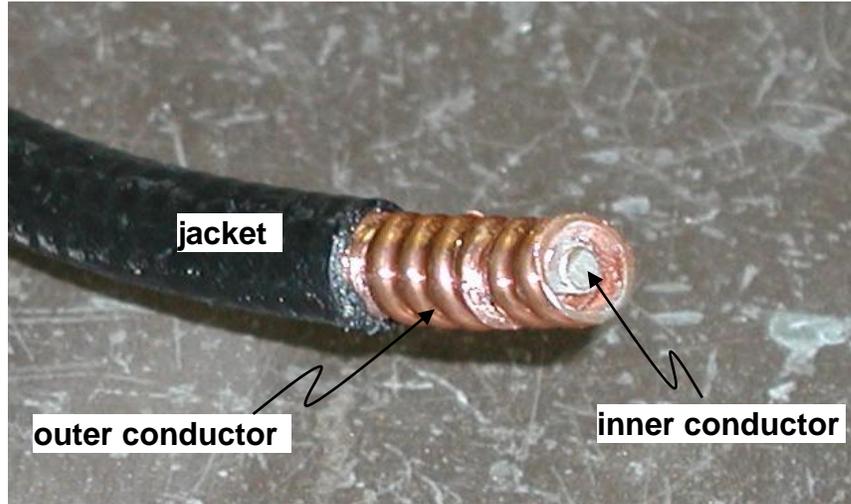
Figure 18. Flexwell hollow coaxial cable.

All tests were conducted using ½-inch diameter hollow cable manufactured by Cablewave Systems, Inc. The cable is shown in Figure 18 and consists of copper clad aluminum inner conductor, helical corrugated copper outer conductor, a spiral polyethylene separator between the conductors, and a black polyethylene jacket. The product is identified as Flexwell Air HCC12-50J (1/2") and the purchased cost in 1999 was \$3.37 per ft. Tests were focused on addressing two questions: (1) whether the water elevation could be detected reliably from the TDR signal and (2) whether shearing of the cable below the water elevation could be detected reliably. Two sets of tests were carried out. The first set involved placing the cable in a clear, vertical Plexiglas tube and monitoring the TDR signal while the water elevation in the tube was varied. The second set of tests involved the creation of “crimps” at known locations in the cable, to simulate shearing of the cable. The signal produced by the crimps was then measured under both

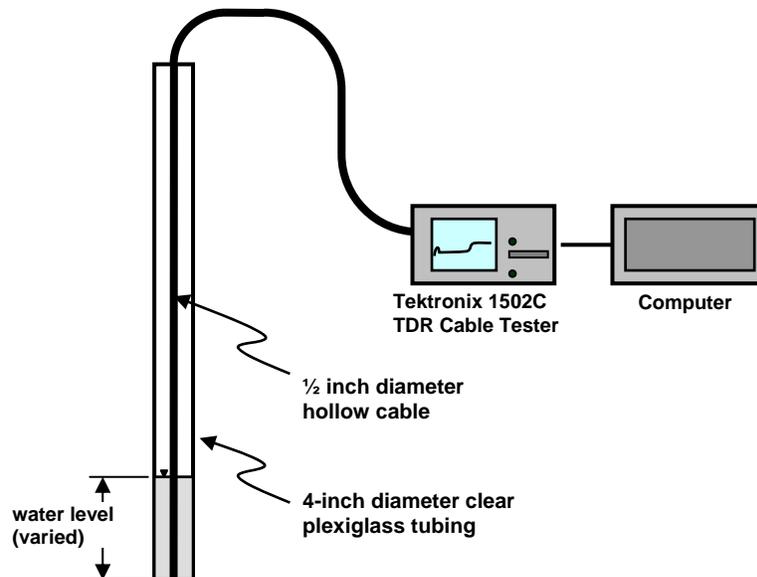
Figure 19. Schematic of test setup (not to scale).

dry and submerged conditions in order to determine the effects of submergence on the strength of the signal. Figure 19 is a schematic of the test setup, which was conducted in the Hydraulics Engineering Lab at the University of Wyoming. The Plexiglas tube is 4 inches in diameter and 17 ft in length. The hollow cable has a total length of 25 ft (17 ft in the tube and 8 ft from the top of the tube to the cable tester). Water was able to enter the cable through the submerged lower end, left open. Holes were drilled near the top of the cable to allow for air to escape during water entry. The Tektronix 1052C cable tester was used to measure the cable signal, which was then downloaded to a notebook computer for processing.

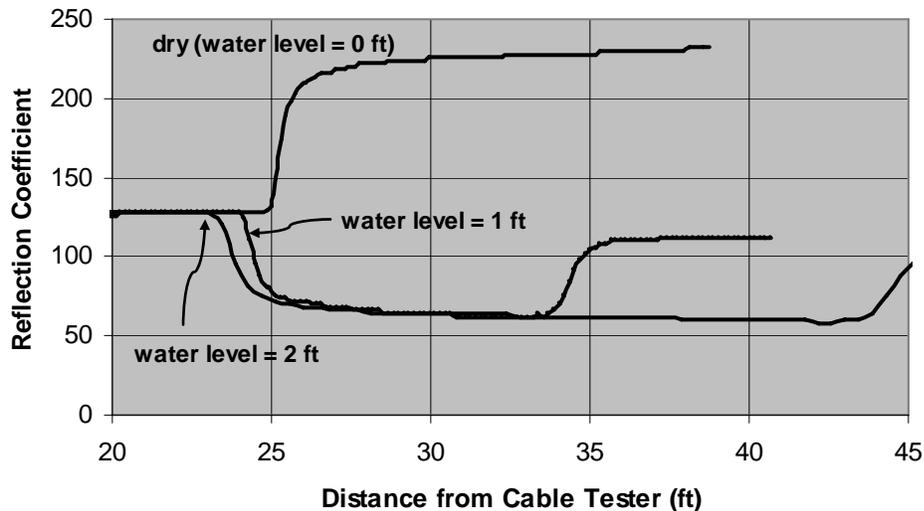
Figure 20. TDR signals showing water levels in Plexiglas tube.

An important observation made from these tests is that the TDR signal for portions of the cable below the water level is changed in a way that alters the apparent cable length. This occurs because the propagation velocity of the cable is changed when water replaces air as the dielectric material. For the particular cable used in these tests, portions of the cable that are submerged appear longer by a factor of 10 (*i.e.*, each 1 ft of cable appears to be 10 ft). If distances below the water table are needed, it is a simple matter to apply a correction factor to account for this attenuation.

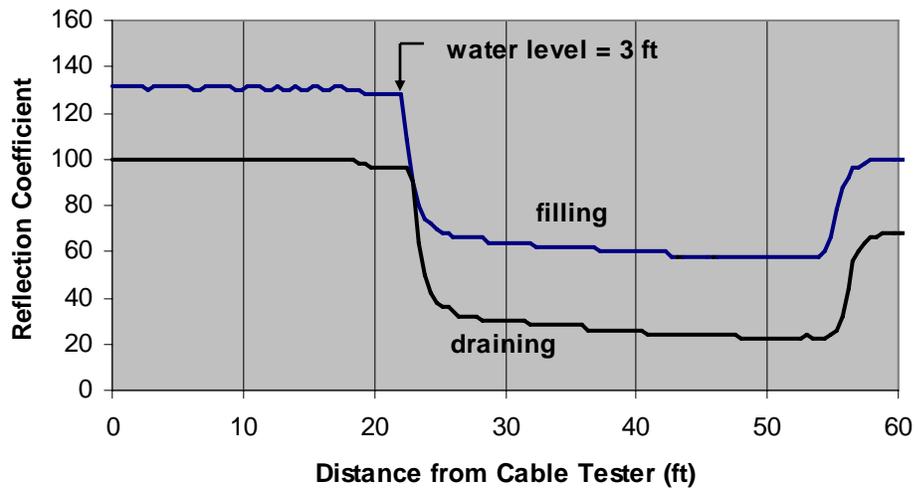
Figure 21. TDR signals with water level at 3 ft for filling and draining (note: curves are offset vertically for clarity).

During draining of the tube, results were essentially identical to those obtained during filling. For example, Figure 21 shows a direct comparison of TDR signals when the water level was at 3 ft, one during filling and the other during draining. These results indicate that water enters and exits the hollow cable freely in response to rising or lowering water levels outside of the cable. This suggests that the Flexwell ½-inch diameter hollow cable is capable of monitoring fluctuating water table elevations in field applications.

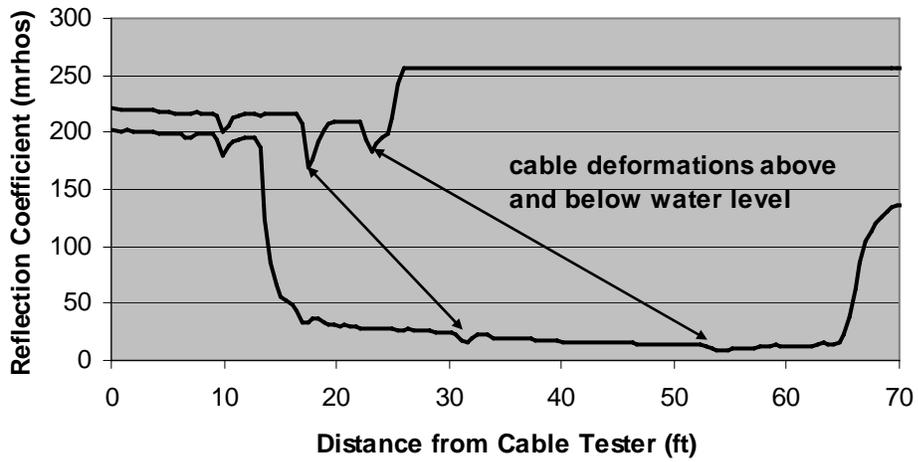
Figure 22. TDR signals from crimped cable.

- (3) Shearing of the hollow cable below the water level is detectable but the signal is not as pronounced as the signal induced by the same magnitude of shearing above the water level. Hollow cable can therefore be used to monitor both slope movements and groundwater elevations, but detection of slope movement below groundwater is more difficult.

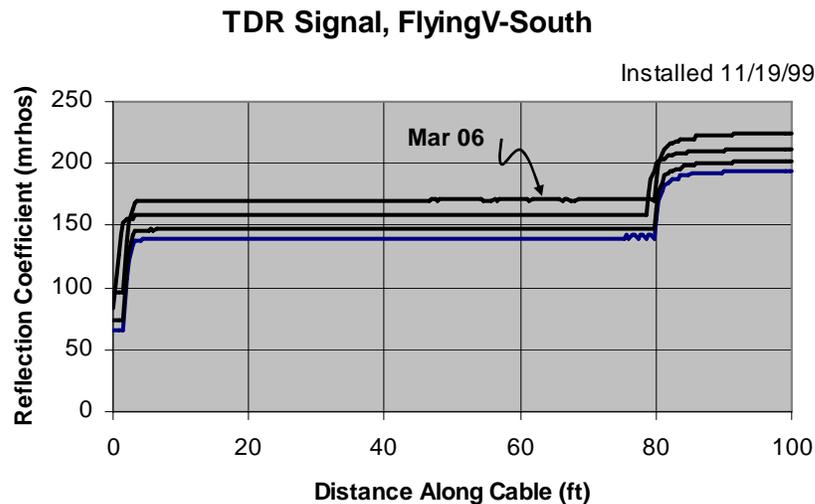
Figure 23. TDR cable signatures through March 06, Flying V South.

Figure 23 shows TDR signals from the Flying V South installation. The cable has been in place for over 6 years and has not exhibited any signal. Slope inclinometer readings have shown movements at this location, suggesting that the TDR has not performed as expected. Readings from FV-8 are shown in Figure 24 for a period between 2004 and 2006. The inclinometer readings show a distinct slide plane over a depth interval between 31 ft and 34 ft, with a cumulative displacement of over 1.4 inches during this period.

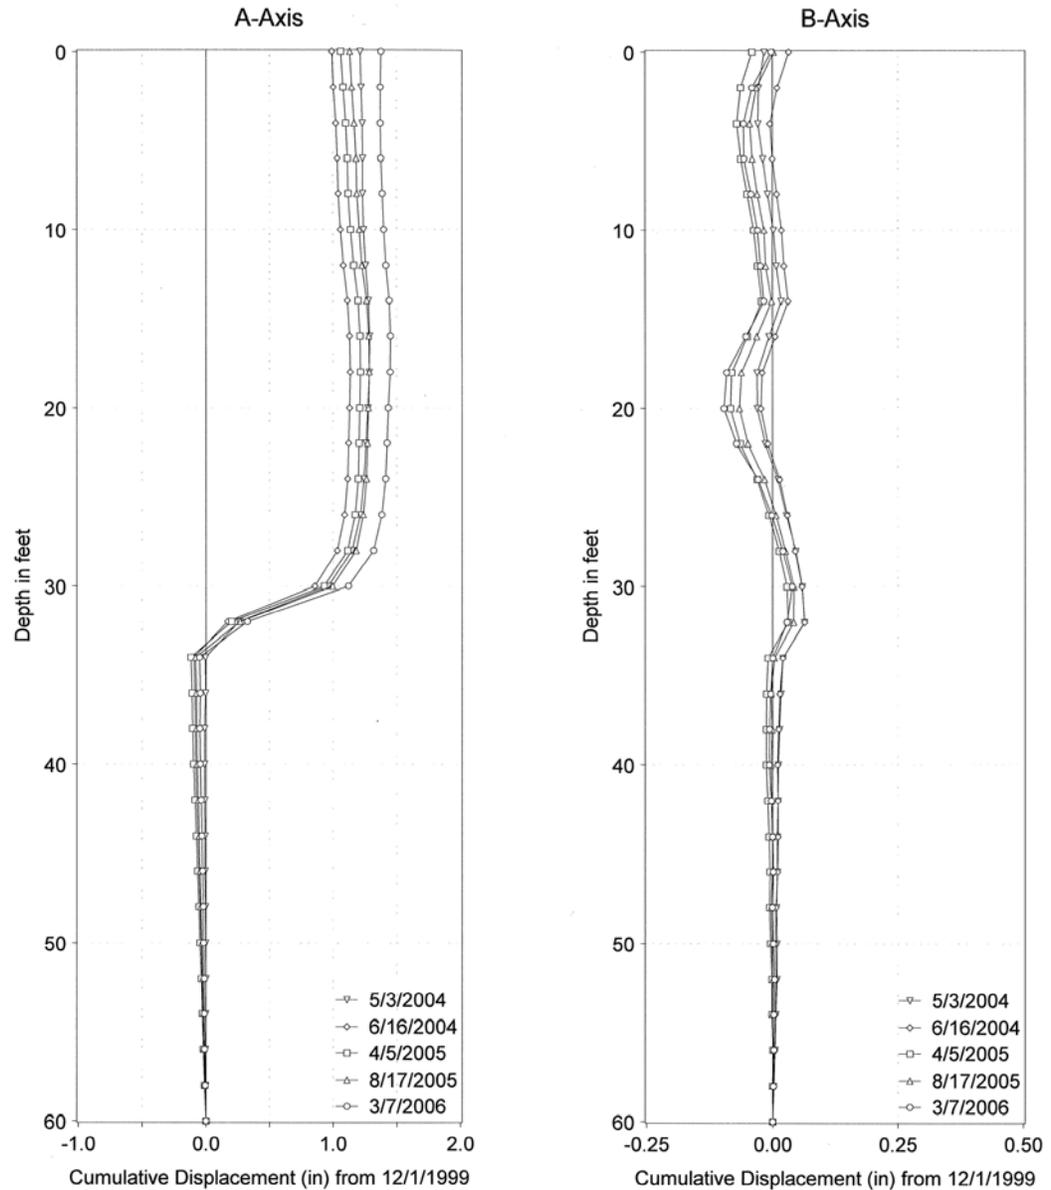
Figure 24. Slope inclinometer readings, FV-8, Flying V South.

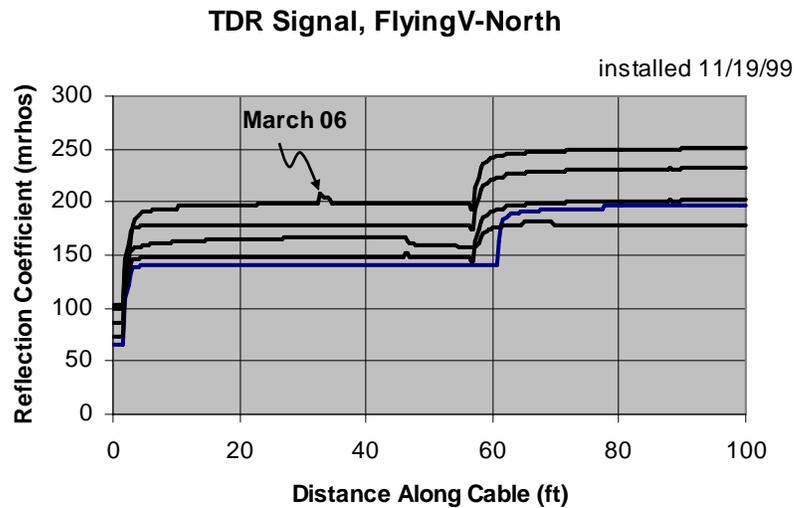
Figure 25. TDR cable signatures through March 06, Flying V North.

Figures 25 and 26 show TDR and inclinometer readings from Flying V North and FV-7, respectively. Since being installed, this cable has shown evidence of distress, but there has not been a distinctive spike indicating a well-defined failure plane. In contrast, the inclinometer readings show a well-defined shear zone at a depth of 40 ft with deformation exceeding 2 inches. Since April 2005 it has not been possible to monitor FV-7 because the inclinometer casing has sheared. In the most recent monitoring (March 06), there is a recognizable spike in the TDR signal at around 33 ft (depth of approximately 28 ft). Without inclinometer readings for verification, it is not known whether a new shear plane has developed at this depth, but the TDR signal suggests the

possibility. In view of the inclinometer readings and lack of corresponding TDR signals, it has to be concluded that this installation did not perform its intended function.

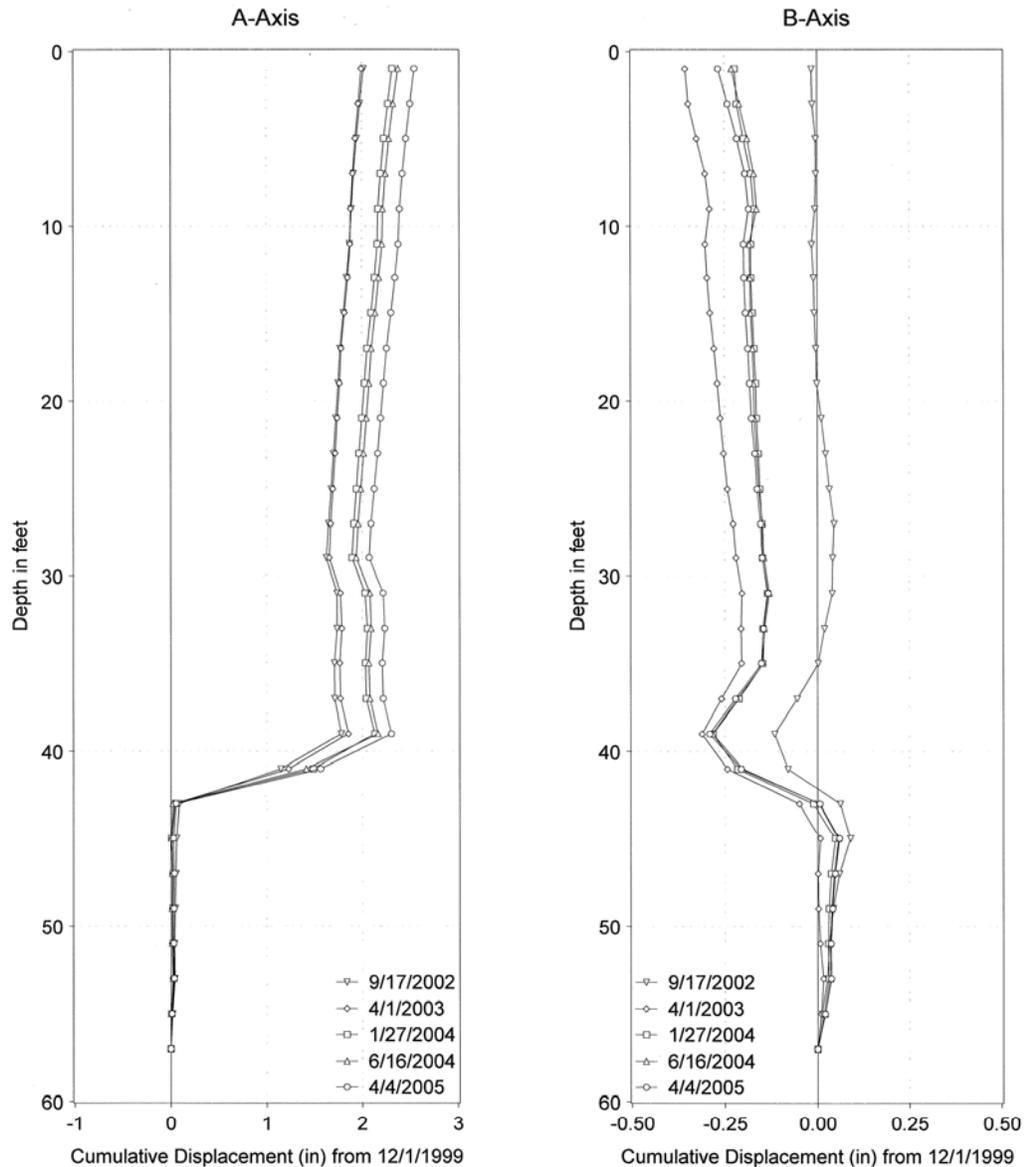
Figure 26. Slope inclinometer readings, FV-7, Flying V North.

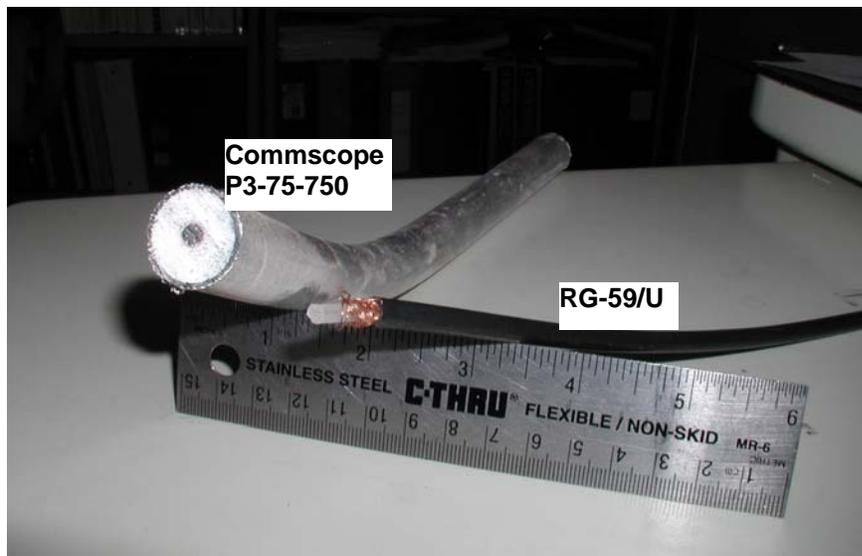
Figure 27. Photo showing Commscope cable and RG-59/U cable.

The cables used at this site are Commscope P3-75-750. This type of cable is 19 mm in diameter (about  $\frac{3}{4}$  inch) and has a relatively stiff outer aluminum jacket. This outer jacket is also the outer conductor. The dielectric material is expanded polyethylene foam, which is why this type of cable is sometimes referred to as foam-dielectric. The inner conductor is copper-clad aluminum. This cable was recommended by researchers at Northwestern University, who report good results at sites where movement has occurred in both soil and rock. Figure 27 is a photo of the Commscope cable, with the RG-59/U for comparison.

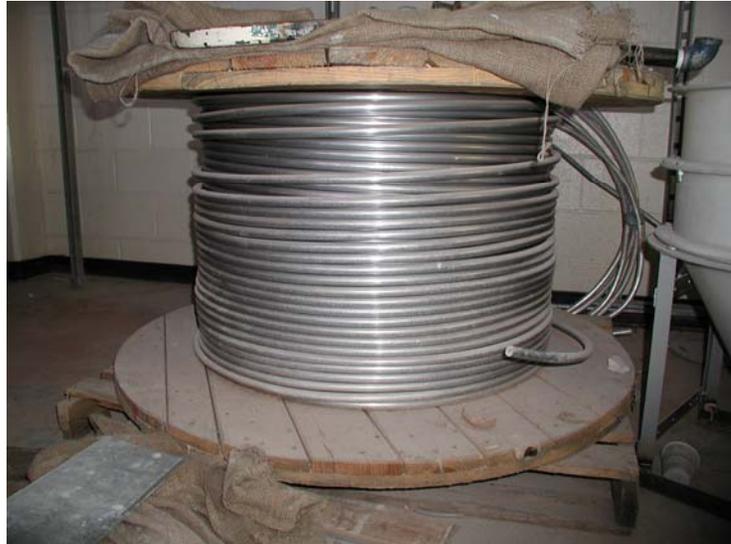
Figure 28. Commscope P3-75-750 coaxial cable spool.

it is necessary to lay it out on the ground. It is quite difficult and unwieldy to lay the cable out to a straight length and to install it into the ground. Center-hole spacers were used to center the cable in the hole. A piece of cable with a spacer and the female BNC connector required for attachment to the cable tester are shown in Figure 29. Dowding (personal communication, 2002) describes a unit that can be attached to the front of a drill rig or truck on which the cable spool can be mounted, allowing the cable to be placed directly into the hole from the spool. If this type of cable were to be used regularly, this type of equipment is highly recommended.

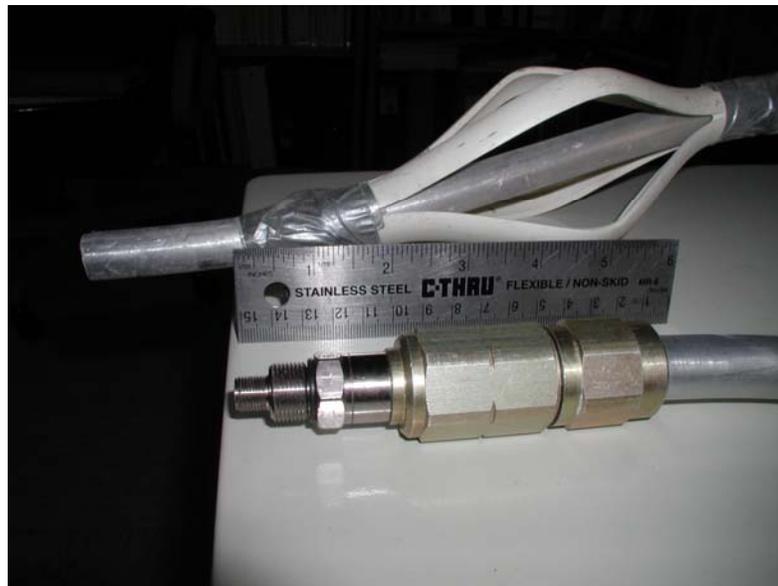
Figure 29. Commscope cable with center-hole spacer and BNC connector.

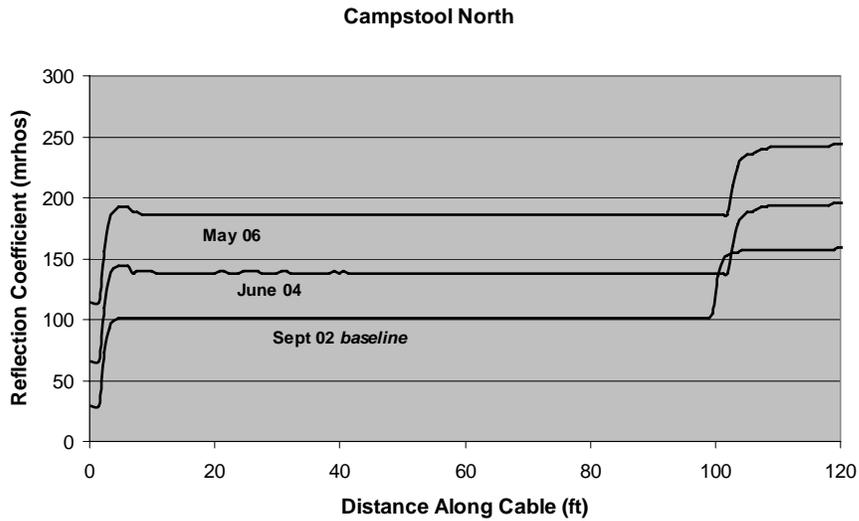
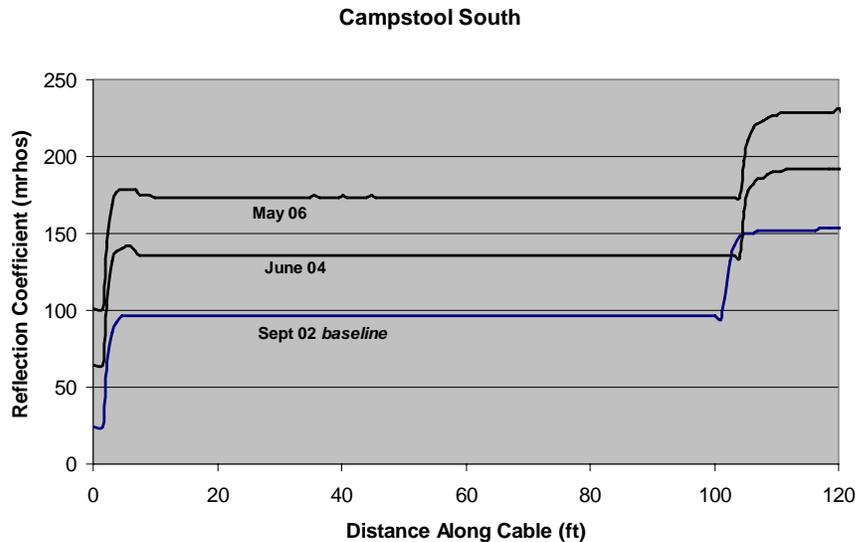
Figures 30 and 31 show TDR signals at Campstool North and Campstool South, respectively, for a period of nearly four years. The cables show no sign of shearing. Figures 32 and 33 show corresponding inclinometer readings for Campstool North and South, respectively. The inclinometer readings also show no measurable deformation, in agreement with the TDR measurements. No conclusions can be made about the performance of the cables at Campstool because deformation has not been sufficient to shear or otherwise damage the cables. This site should be considered for further monitoring by both TDR and slope inclinometer. If sliding occurs in a weak shale layer, it will be possible to evaluate performance of the TDR system.

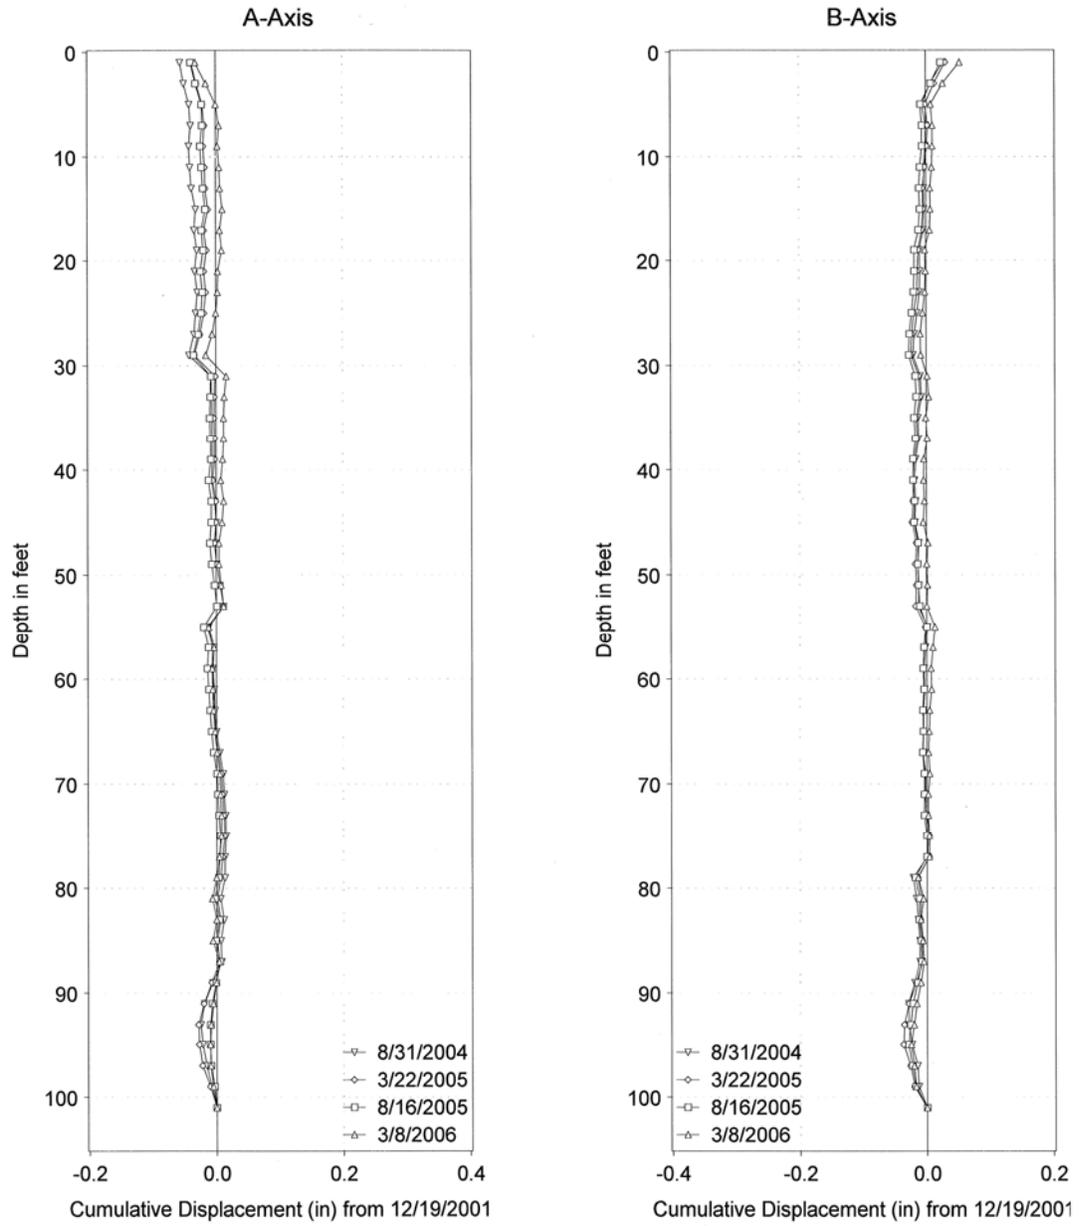
Figure 32. Slope inclinometer readings, Campstool North.

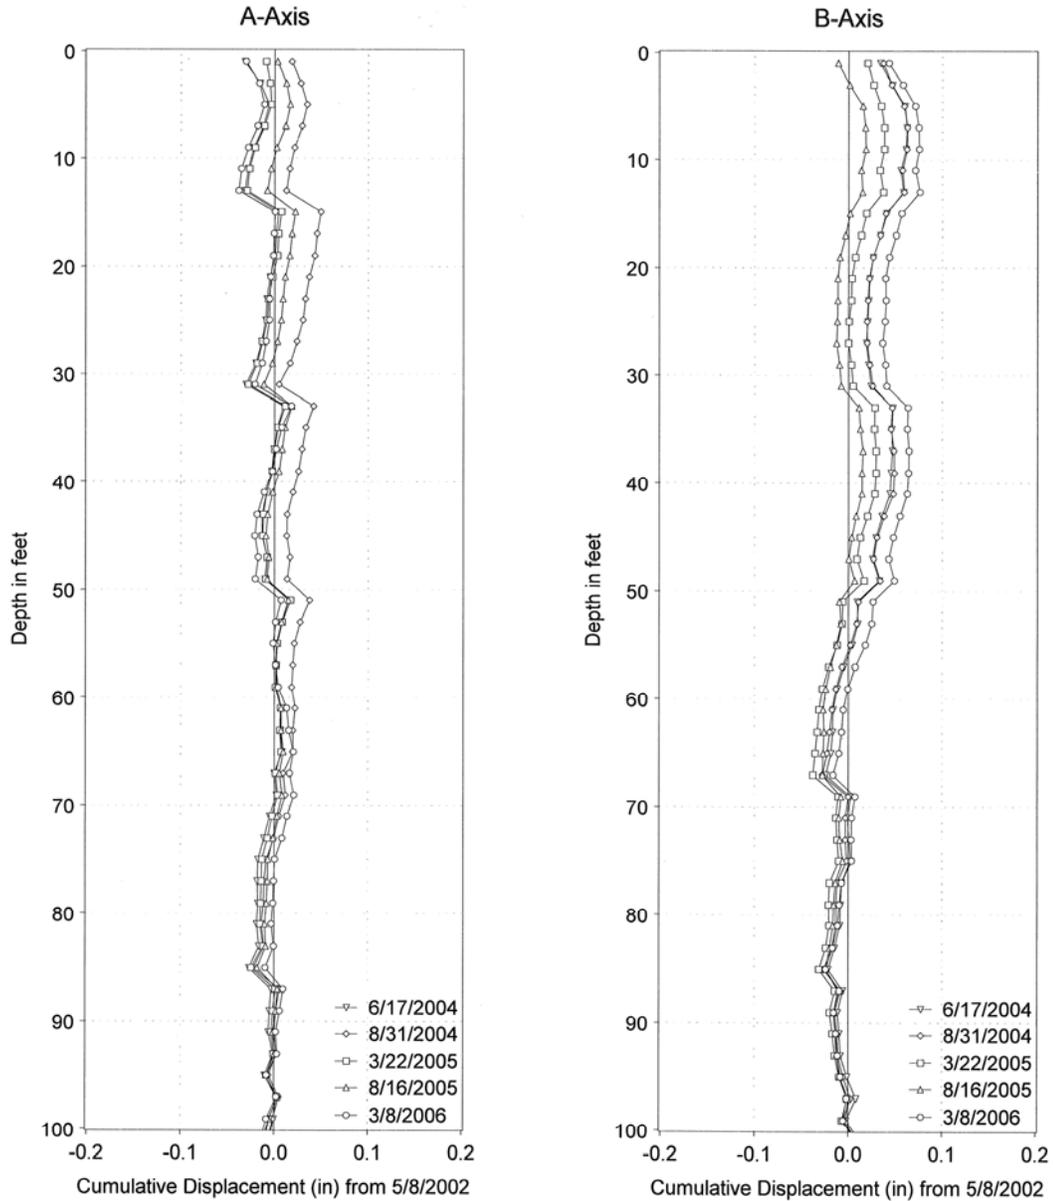
Figure 33. Slope inclinometer readings, Campstool South.

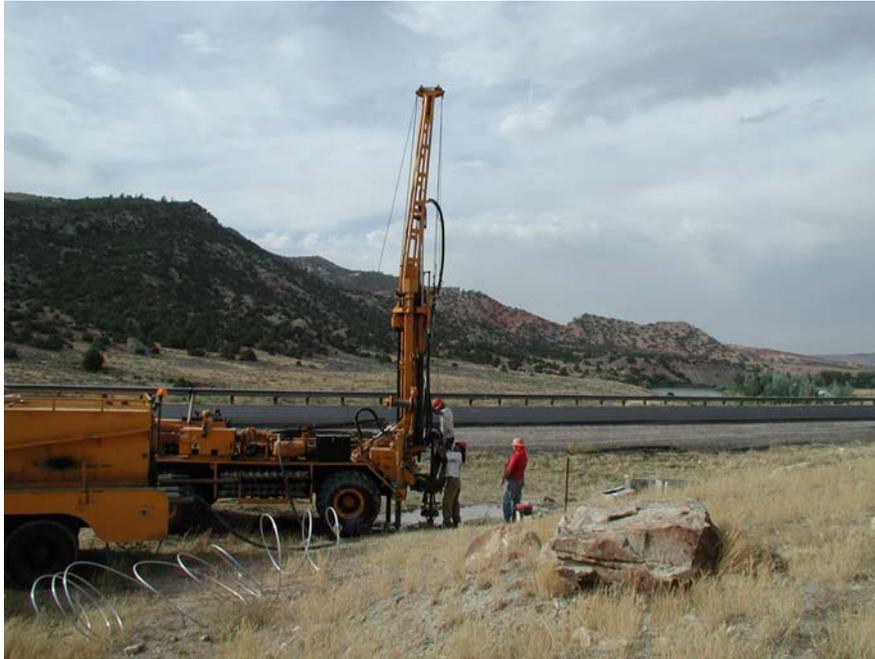
Figure 34. Drilling for cable installation, Narrows South.

Two cables were installed in October of 2002 at the Narrows slide along WYO 220 west of Casper. Both cables are Commscope P3-75-750. Figure 34 shows the drilling operation for the cable installation on the south side of the roadway. In this photo, the Commscope cable is shown on the ground prior to placement in the hole. The stiffness of the uncoiled cable that makes it difficult to install manually is apparent.
