## FHWA-WY-06/03F

State of Wyoming  
Department of Transportation

# TIME DOMAIN REFLECTOMETRY FOR MONITORING SLOPE MOVEMENTS

August 2006

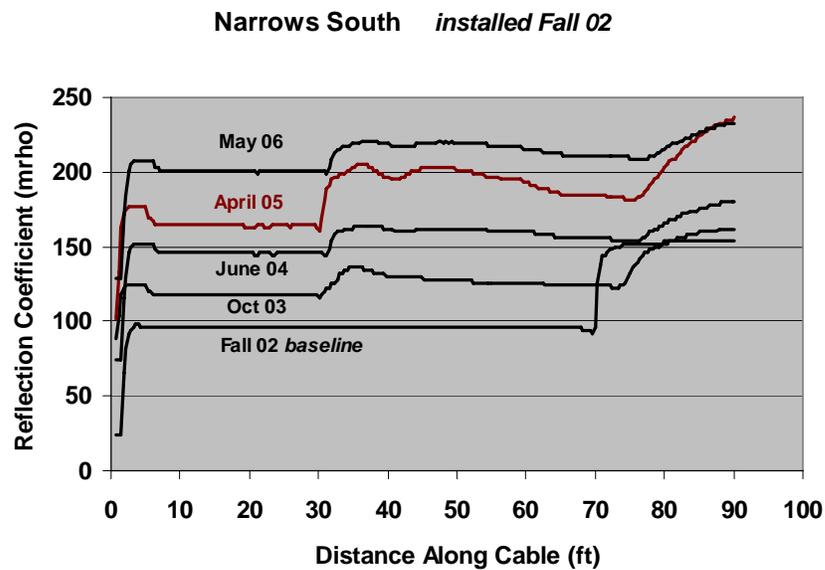
Figure 35. TDR signals, Narrows South.

ft from the cable tester (approximate depth of 26 ft). The magnitude of signal change at this depth has generally increased with each subsequent reading and corresponds to increased movement at this depth, as indicated by inclinometer readings that show a clear slide plane at a depth of 26 ft. (Figure 36). However, the most recent reading (May 06) exhibits a small decrease in the magnitude of the signal at the slide depth. The behavior

of RG/59-U cable in laboratory tests showed that the cable signature decreases slightly right before cable rupture. It is not known whether this is the case at Narrows South, but further monitoring might provide additional information. Also, the signal does not exhibit a well-defined spike, but rather increases at the shear depth and then gradually decreases until the bottom of the cable is reached. Interpretation of this signal is not entirely clear, but it could be caused by some combination of shear and tension. Despite some uncertainties, Narrows South represents the most encouraging performance of a TDR field installation to date. The TDR clearly shows evidence of sliding that correlates well with slope inclinometer readings.

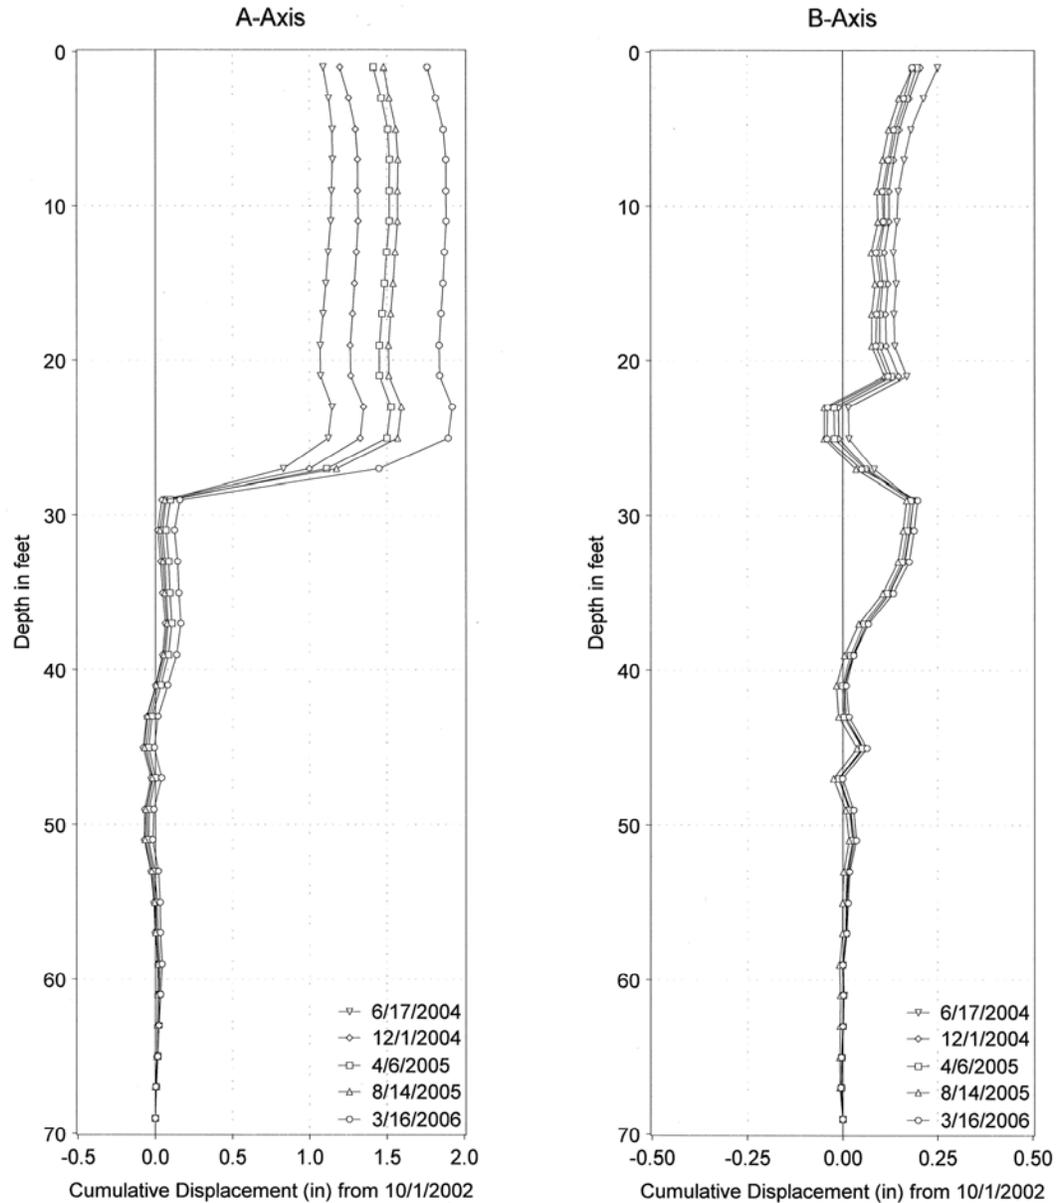
Figure 36. Slope inclinometer readings, Narrows South.

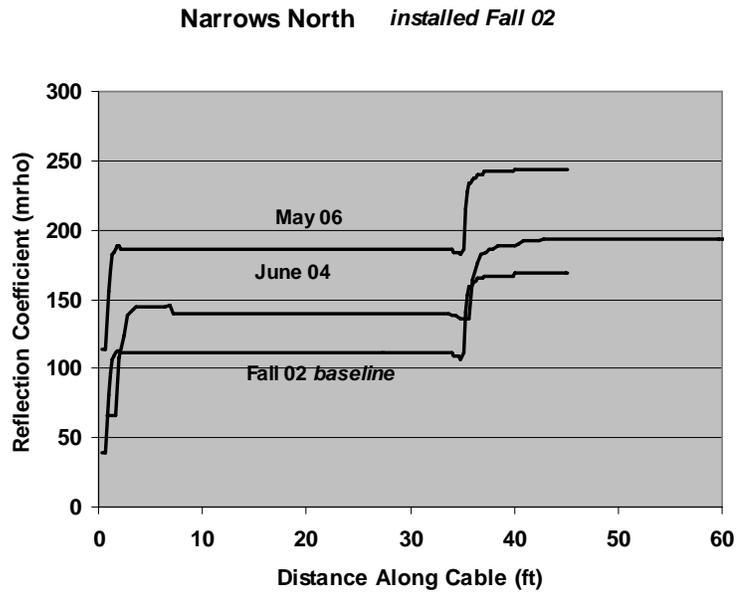
Figure 37. TDR signals, Narrows North.

Narrows South was initially the only TDR installation planned at the Narrows slide. After setting up the installation, approximately 35 ft of Commscope cable was left over. It was decided to install this available length of cable at a second installation on the north (downslope) side of the road. Figures 37 and 38 show the TDR and inclinometer readings for Narrows North. The inclinometer readings clearly show a shear zone at approximately 52 ft. Unfortunately the cable installation does not reach this depth. A second shear zone may be developing at a depth of approximately 24 ft, but the cable does not show any signal to date.

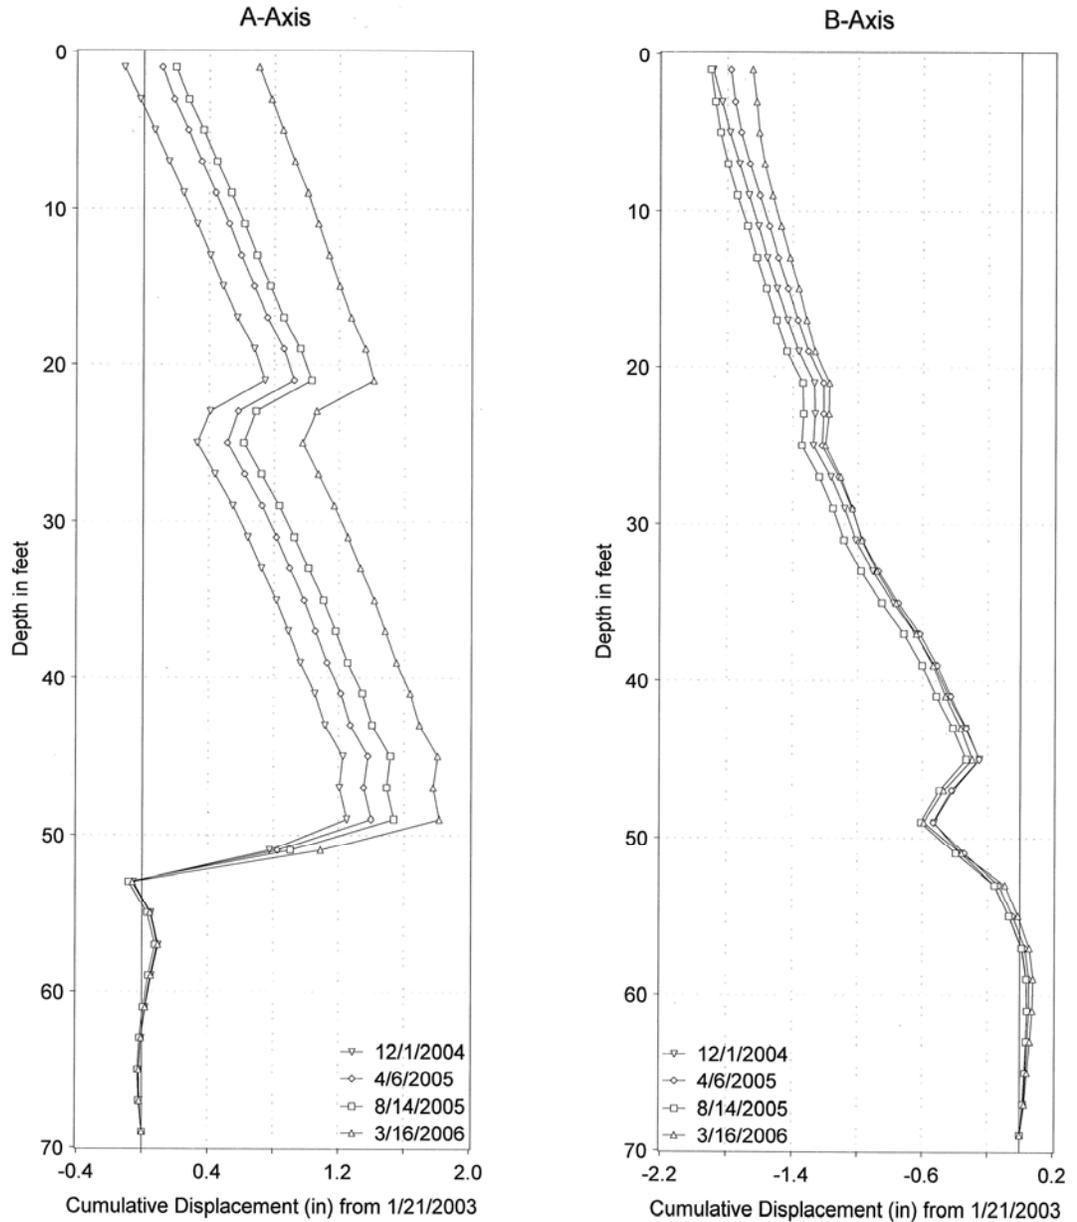
Figure 38. Slope inclinometer readings, Narrows North.

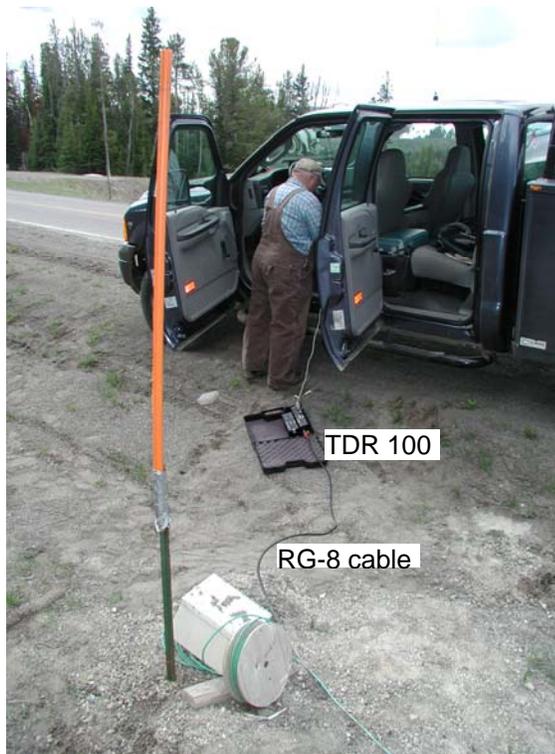
Figure 39. TDR readings at County Line using the TDR 100.

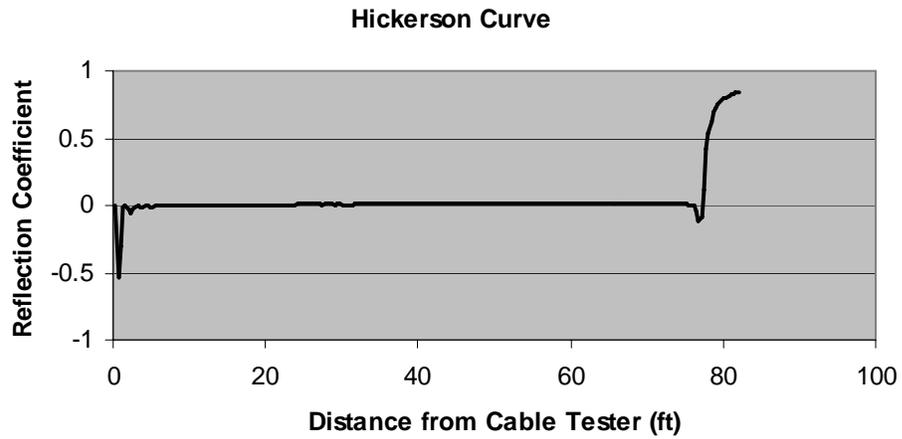
Figure 40. TDR signals, Hickerson Curve site.

A reading obtained recently using the TDR 100 for Hickerson Curve is shown in Figure 40. The closest inclinometer reading on the downhill side of the roadway is shown in Figure 41 and shows a slide plane at approximately 8 ft deep with movement exceeding 1.4 inches. The cable signature does not show any clear signal, although there is a slight signal change which may represent initiation of cable damage over this depth interval. Additional inclinometer readings above the roadway show zero movement, so it is not entirely clear whether there is movement at the cable installation.

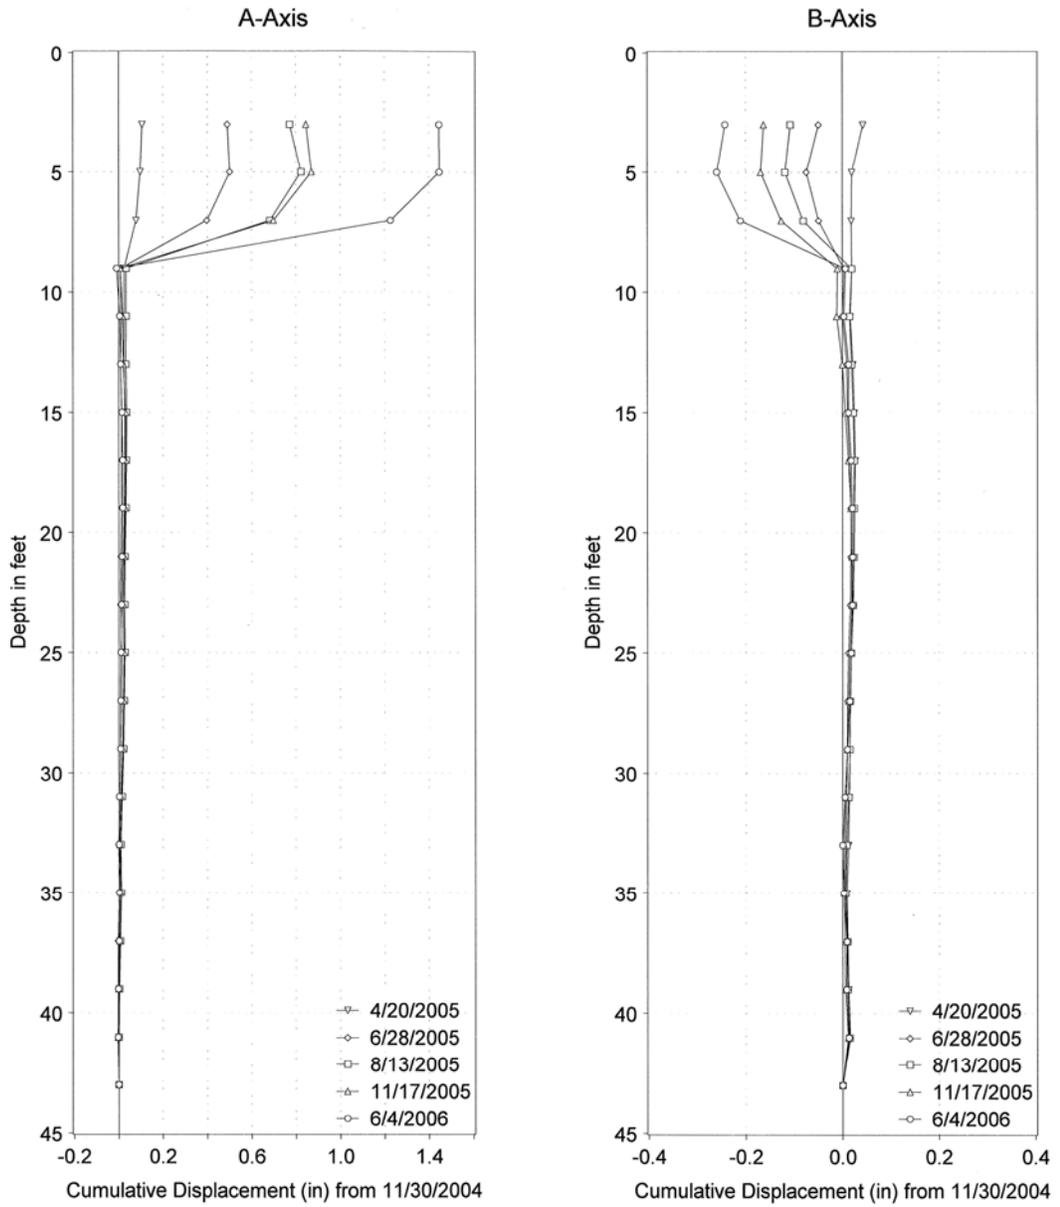
Figure 41. Slope inclinometer readings, Hickerson Curve, below the roadway.

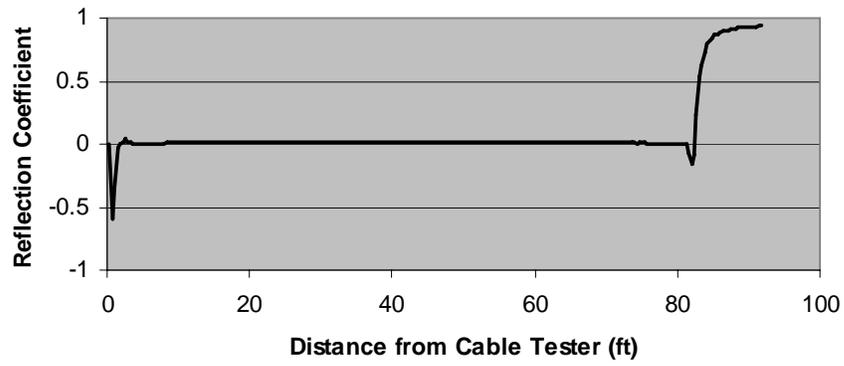
Figure 42. TDR signals, County Line site.

Figure 42 shows the TDR reading obtained during June 2006 at the County Line site. This cable is located on the upslope shoulder of the roadway and shows no clear sign of shearing or other damage. There are three inclinometer installations at this site, all of which are located below the roadway (downslope slide). The inclinometer casings do not

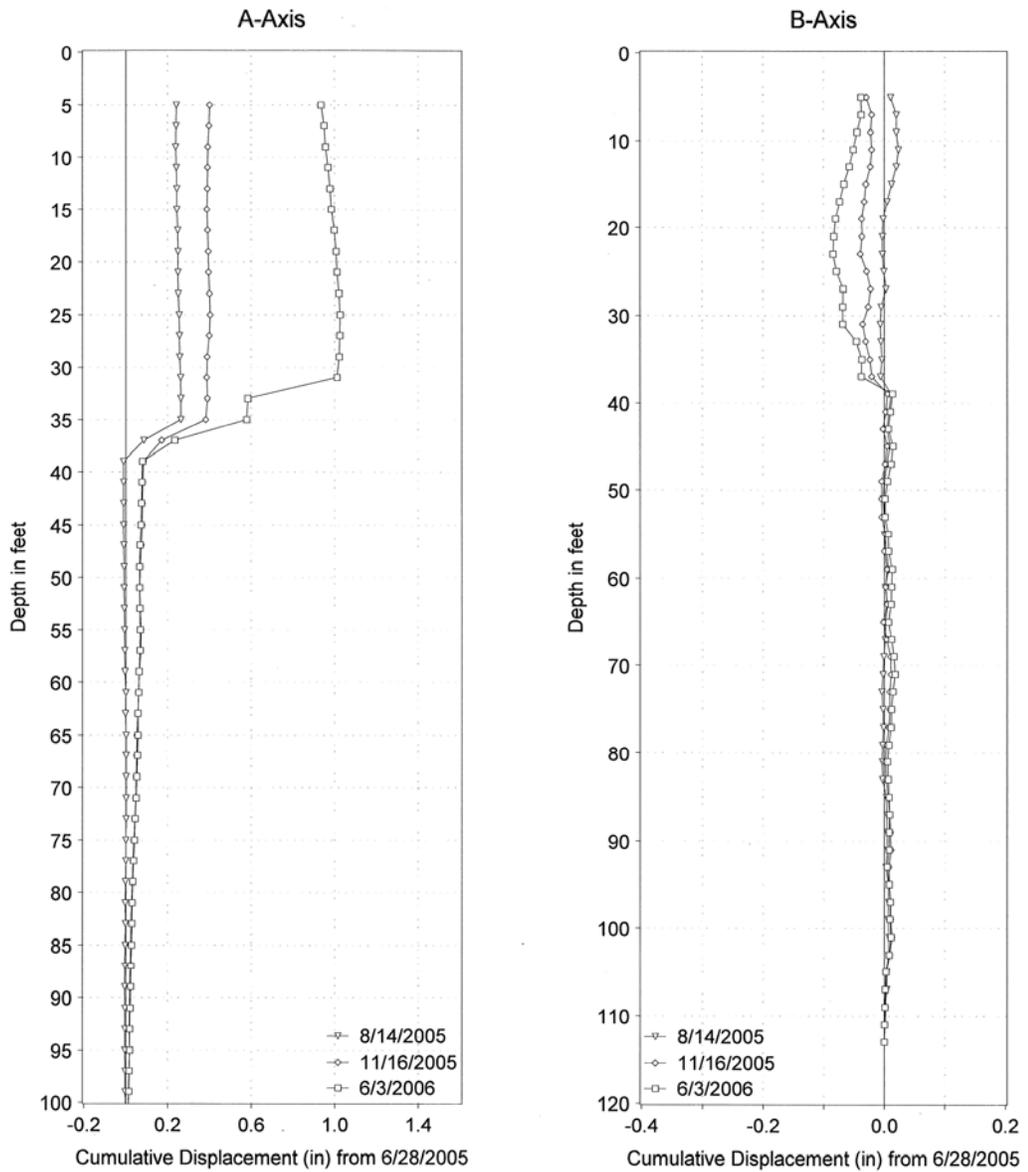
Figure 43. Slope inclinometer readings, County Line, below the roadway.

correspond to the cable location. Figure 43 shows inclinometer readings for the casing that is closest to the roadway. A slide plane is evident at a depth of approximately 35 ft. The other two inclinometers show slide plane depths of 60 ft and 52 ft. It is apparent that the slide plane depth varies with location and it is not known whether the slide plane extends through the cable location or at what depth. Nevertheless, the cable does not show any signs of movement to date.
