Dynamic Full Scale Tests of Bridge Rails

December 1960

State of California  
Department of Public Works  
Division of Highways  
Materials and Research Department

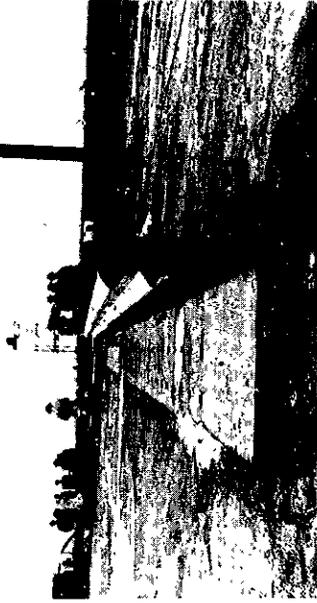
### METAL BEAM BRIDGE RAIL - DESIGN III

Only one design of this type was submitted by the Bridge Department for evaluation. This design (Exhibit 4) consisted of 6" - 15.5 lb. H-Beam posts mounted on the side of the bridge deck at 6' 3" centers (using two 1 1/4" and two 3/4" bolts for each post) with a 12 gage corrugated metal beam type guard rail mounted on the posts at a height of 27" above the deck.

Upon vehicle impact with this design the connecting device between the bridge deck and the post failed, allowing excessive deflection of the rail, thus forming a pocket which entrapped the automobile. Had this occurred on an actual bridge, the vehicle would probably have gone through the rail because of lack of support beyond the edge of a bridge. The vehicle was retained during this test only because of the earth fill behind the simulated structure.

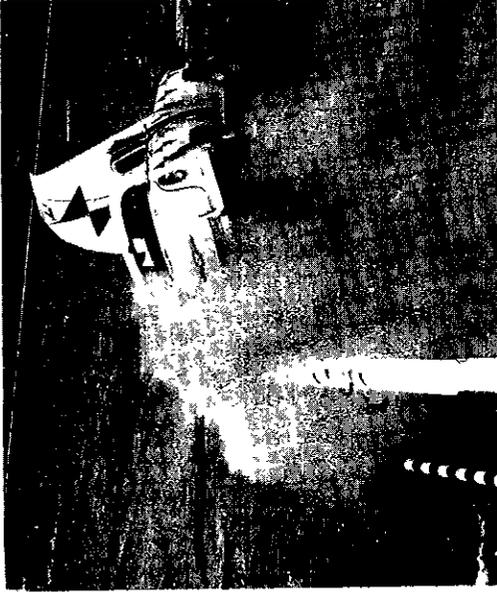
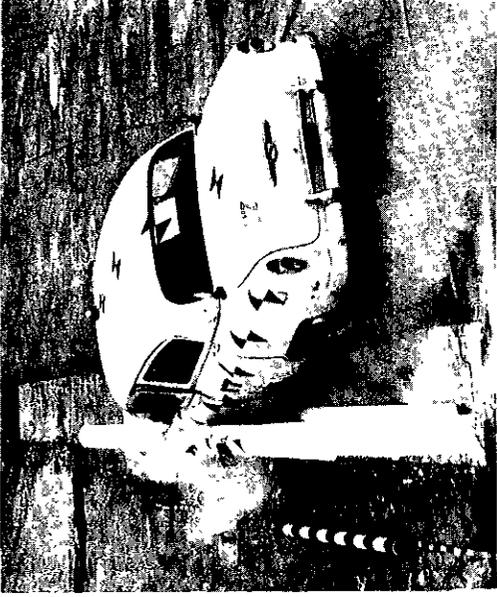
POST IMPACT

IMPACT + 425 M SEC.

IMPACT + 75 M SEC.

BRIDGE RAIL . . . . . Reinforced P.C.C. DUMMY INJURY . . . . . Severe left shoulder & side injuries.  
 LENGTH OF INSTALLATION . . . 36' (Possible Fatality)  
 GROUND CONDITION . . . . . Med. Wet BRIDGE RAIL DAMAGE . . . . . Minor chipping & scratching.  
 VEHICLE DAMAGE . . . . . Total Loss  
 DUMMY DECELERATION (PEAK) . . . . Long . 26G . . . Transv. 35G

TEST NO. . . . . 17  
 DATE . . . . . 1-22-59  
 VEHICLE . . . . . Chev. 53 Sedan  
 SPEED . . . . . 57 MPH  
 IMPACT ANGLE . . . . 29°  
 VEHICLE WEIGHT . . . 3700  
 (W/DUMMY & INSTRUMENTATION)

Design II (Exhibit 3) met all the requirements for a rigid rail when tested with passenger cars as shown in Exhibits 6 and 7. However, due to structural failure it did not retain the 17,000 pound bus at an impact velocity of 40 mph (Exhibit 9).

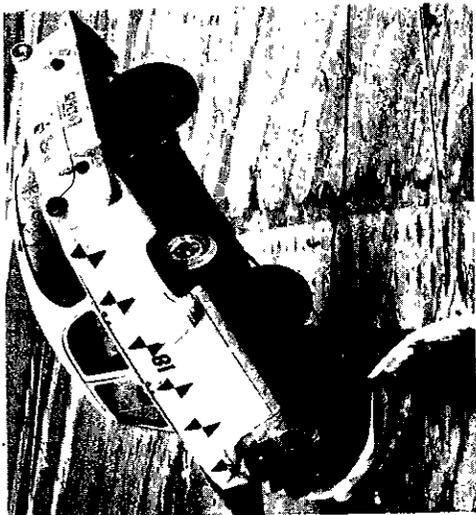
POST IMPACT

IMPACT + 500 M SEC.

IMPACT + 100 M SEC.

BRIDGE RAIL ..... Single W Section  
 BRACKET ..... None  
 POST ..... 6" W/ 15.5 #  
 POST SPACING ..... 6'-3" O.C.  
 LENGTH OF INSTALLATION ... 62.5'  
 GROUND CONDITION ..... Wet

BRIDGE RAIL DAMAGE ..... Severe head & shoulder injuries.  
 POST DAMAGE ..... 3 Sections damaged beyond repair  
 VEHICLE DAMAGE ..... 5 Posts damaged beyond repair  
 MAX. DYNAMIC DEFLECTION OF RAIL ... 60"  
 DUMMY DECELERATION (PEAK) ..... Long. 196 ... Transv. 7.1 G

TEST NO. .... 18  
 DATE ..... 2-11-59  
 VEHICLE ..... Ford 52 Sedan  
 SPEED ..... 55 MPH  
 IMPACT ANGLE ..... 30°  
 VEHICLE WEIGHT ... 4000  
 (W/DUMMY & INSTRUMENTATION)

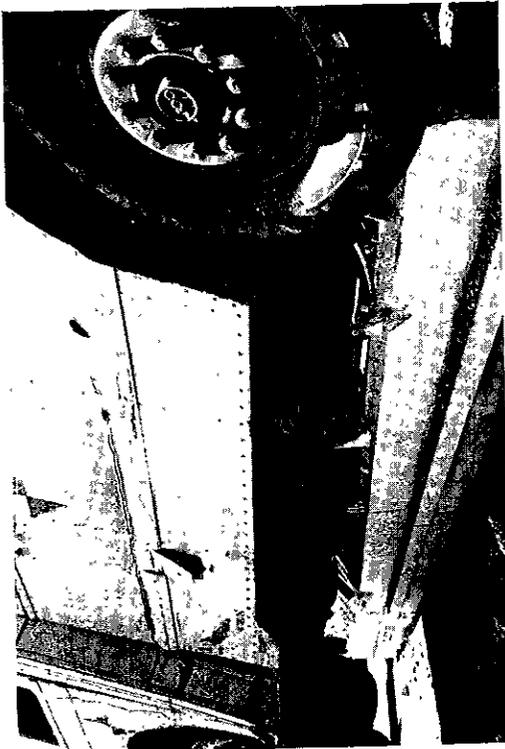
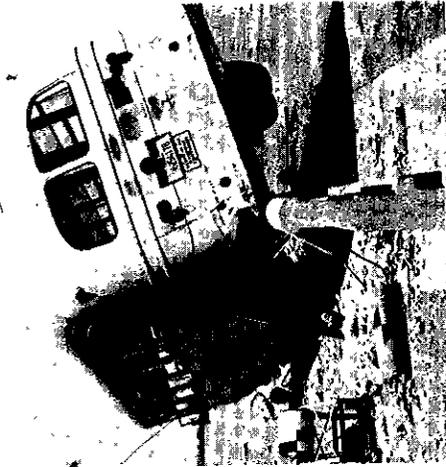
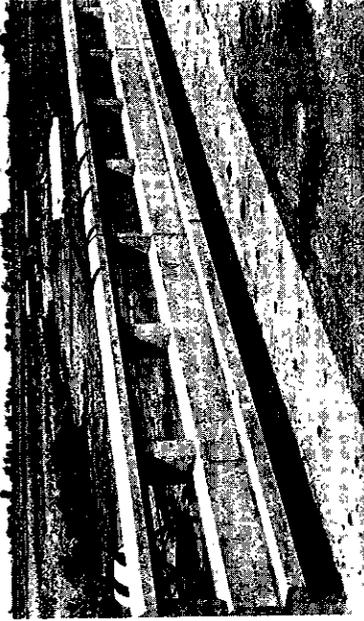
BRIDGE RAIL & BUS (FRONT VIEW)

POST IMPACT

BRIDGE RAIL INSTALLATION

BRIDGE RAIL ..... Reinforced P.C.C.  
 LENGTH OF INSTALLATION ... 36'  
 GROUND CONDITION ..... Dry

Severe head, left shoulder & side injuries.  
 BRIDGE RAIL DAMAGE ..... 32' demolished  
 VEHICLE DAMAGE ..... Total loss

TEST NO. .... 25  
 DATE ..... 7-30-59  
 VEHICLE ..... ACF 34 Pass. Bus  
 SPEED ..... 31 MPH  
 IMPACT ANGLE .... 28°  
 VEHICLE WEIGHT ... 17500

Analysis of this latter failure indicates that the position of the horizontal openings in this rail were the primary contributors to failure. These openings permitted the framing members of the bus to contact the balusters so that the full collision force was accepted by one post. The post failed, permitting further baluster failures and "topping of the rail" by the vehicle. There were no failures of the lower solid portion of this railing. It is our opinion (based on previous test results) that, had this solid wall portion been at least 27" high, the railing would have functioned as desired.

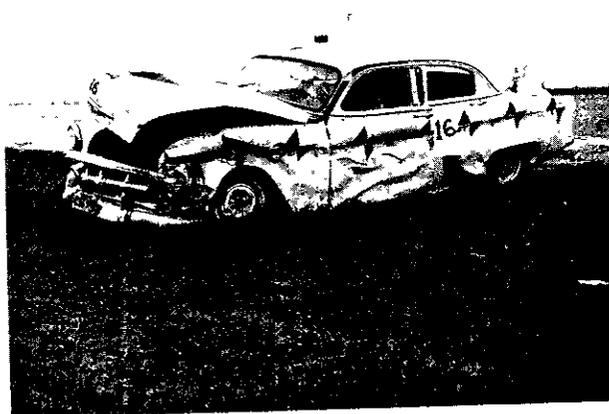
View showing damage to vehicle.

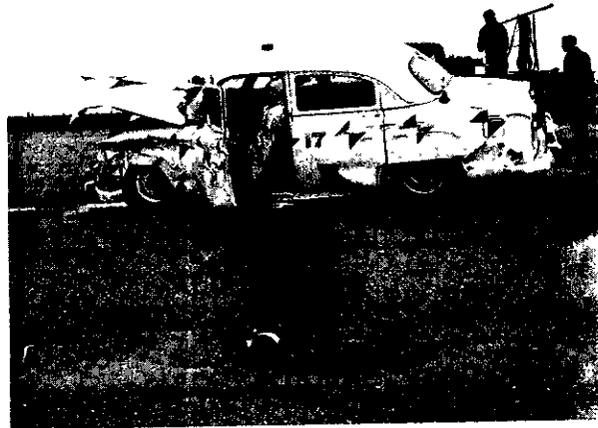
View showing vehicle damage.

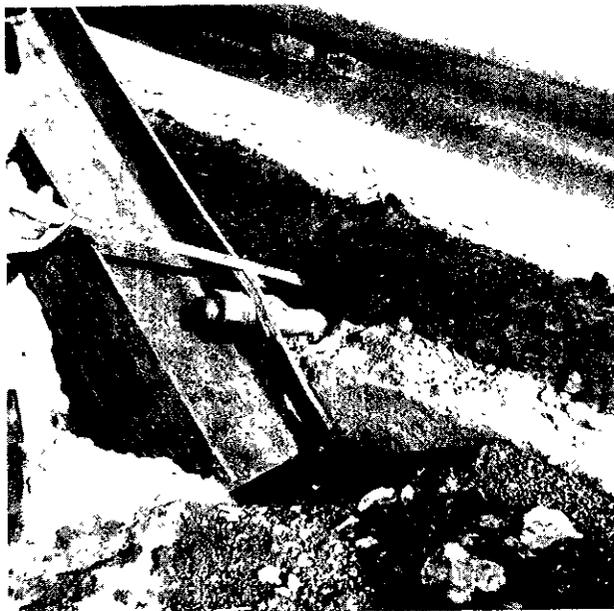
Post impact view showing spalling of  
bridge deck around anchor bolts.

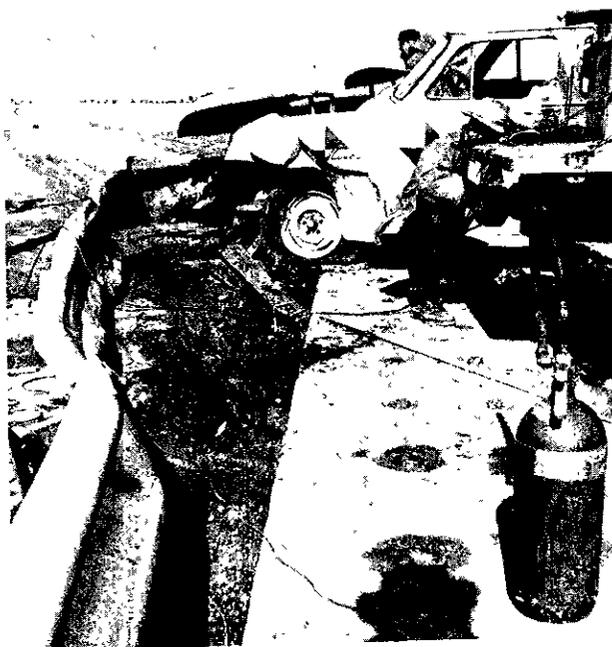
View showing damage to bridge  
rail, posts, and vehicle.

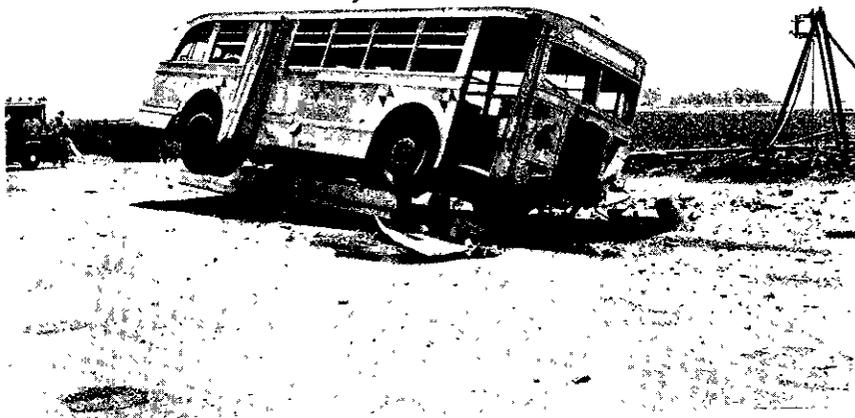
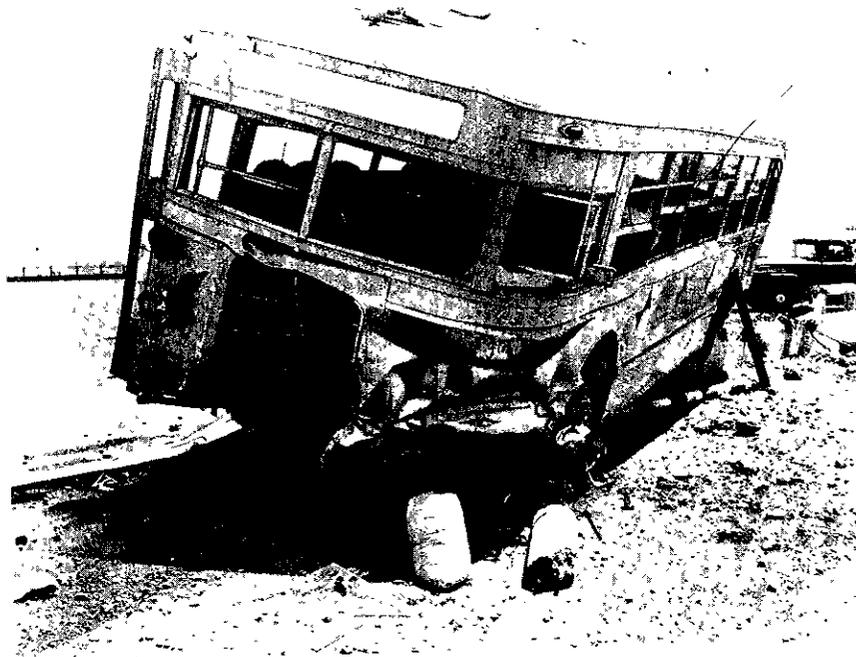
Two views showing bridge rail and bus damage.
