1. REPORT NUMBER CA13-2380	2. GOVERNMENT ASSOCIATION NUMBER	3. RECIPIENT'S CATALOG NUMBER
4. TITLE AND SUBTITLE Implementation of New Quieter Pavement Research: Accelerated Pavement Testing and Laboratory Evaluation of Different Open-Graded Hot-Mix Asphalt Materials	5. REPORT DATE 10/22/2013

6. PERFORMING ORGANIZATION CODE	
7. AUTHOR R. Wu, I. Guada, E. Coleri, A. Rezaei, M. Kayhanian, and J.T. Harvey	8. PERFORMING ORGANIZATION REPORT NO. UCPRC-RR-2013-04

9. PERFORMING ORGANIZATION NAME AND ADDRESS University of California Pavement Research Center UC Davis, UC Berkeley One Shields Avenue Davis, CA 95616	10. WORK UNIT NUMBER

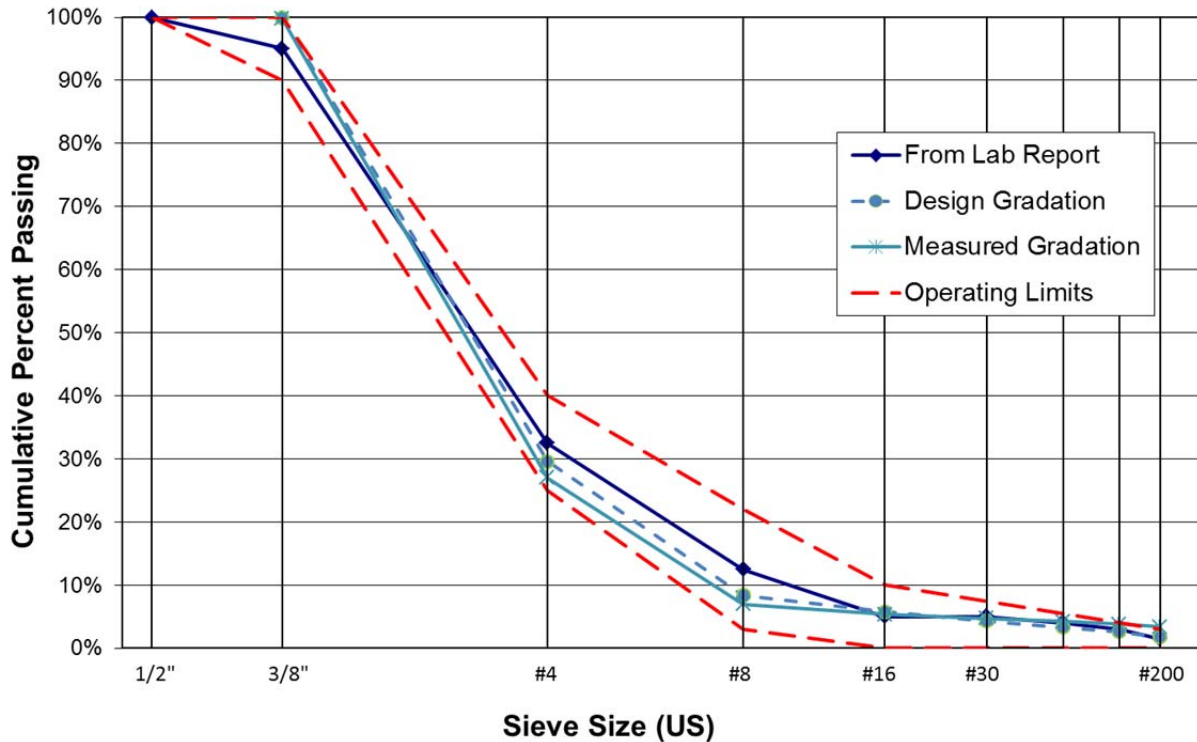
Figure 2.2: Summary of design (“lab report”), as-built (“measured”), and specification (“operating limits”) gradations for the 3/8 in. (9.5 mm) aggregate gradation, Mix A.

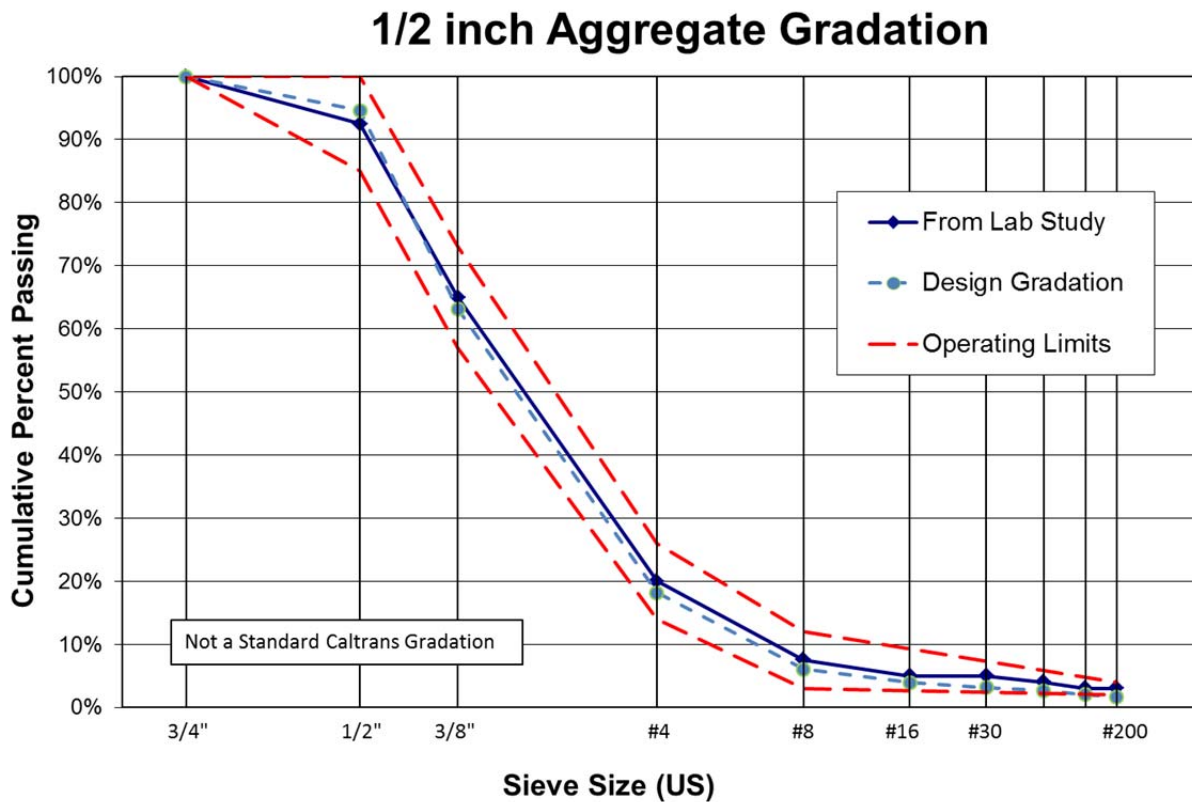
Figure 2.4: Summary of design (“lab report”), revised (“design”), and specification (“operating limits”) gradations for the 1/2 in. (12.5 mm) mix, Mix D.

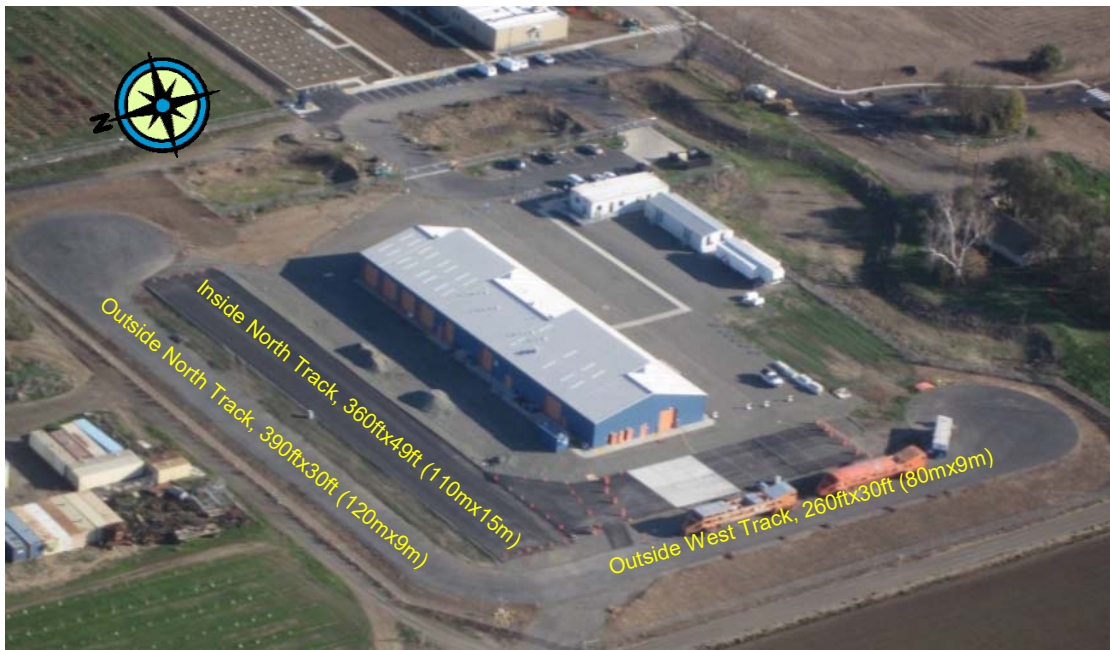
Figure 2.5: Aerial photo of the UC Davis ATIRC facility showing the test track locations and rough dimensions. The Outside North Track, Outside West Track, and a 360 ft long-by-16.4 ft wide area at the south part of Inside North Track were used for OGFC testing.

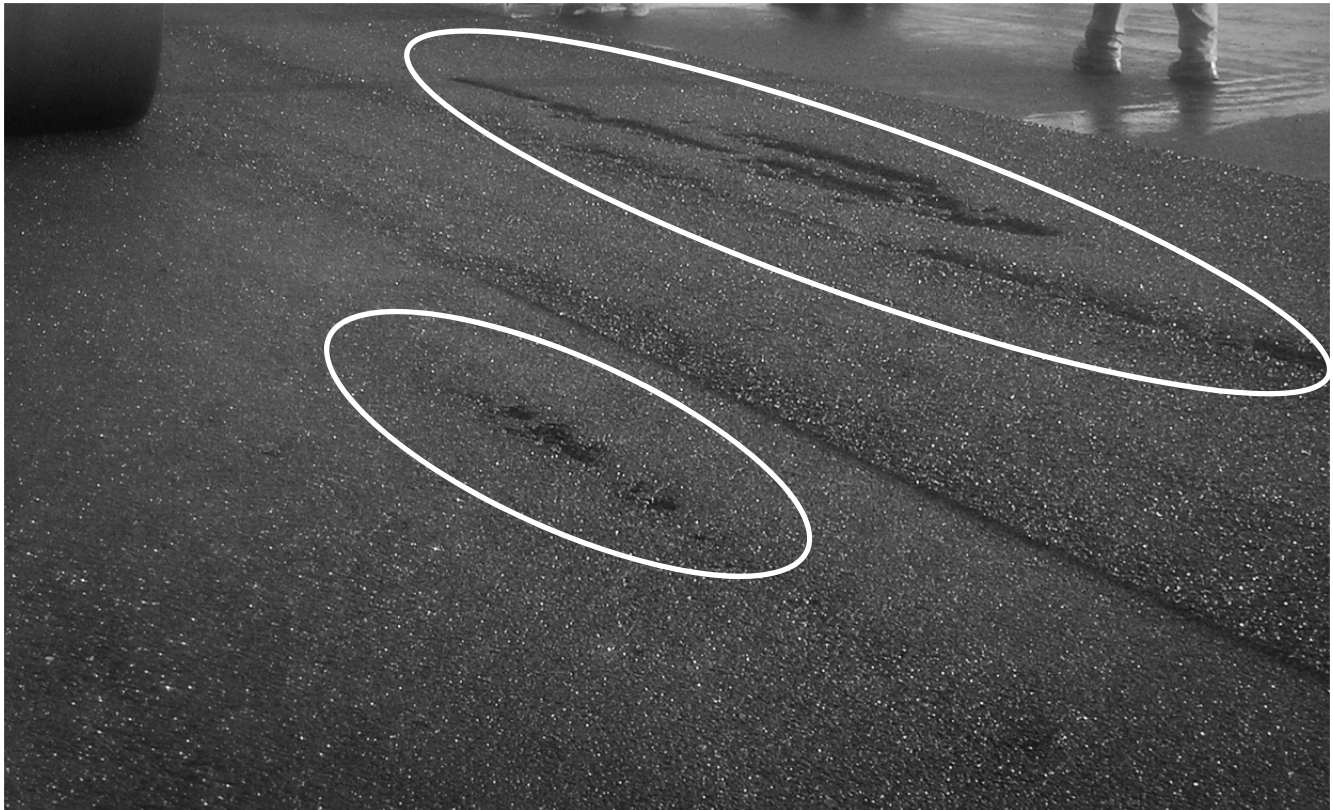
Figure 2.6: Scarring caused by crusted mix (Cell B1, #4P mix with PG 76-22PM).

As seen in Figure 2.6, there were difficulties with spreading and compacting the two mixes, due to the crusting of the mix in the truck and the cooling of the thin lift. The scarred mat was caused by chunks of crusted material being dragged by the paver. The mixing temperature for the mixes (i.e., the Caltrans 3/8 inch mix and the two #4P mixes) with the warm mix additive was approximately 295°F (146°C), as reported by the plant operator. Initial mix temperatures taken from the paver hopper measured between 248°F (120°C) and 302°F (150°C). As with Mix D, these mixes cooled quickly after laydown. The mat temperature dropped more than 54°F (30°C) in five minutes.

As seen in Figure 2.6, there were difficulties with spreading and compacting the two mixes, due to the crusting of the mix in the truck and the cooling of the thin lift. The scarred mat was caused by chunks of crusted material being dragged by the paver.

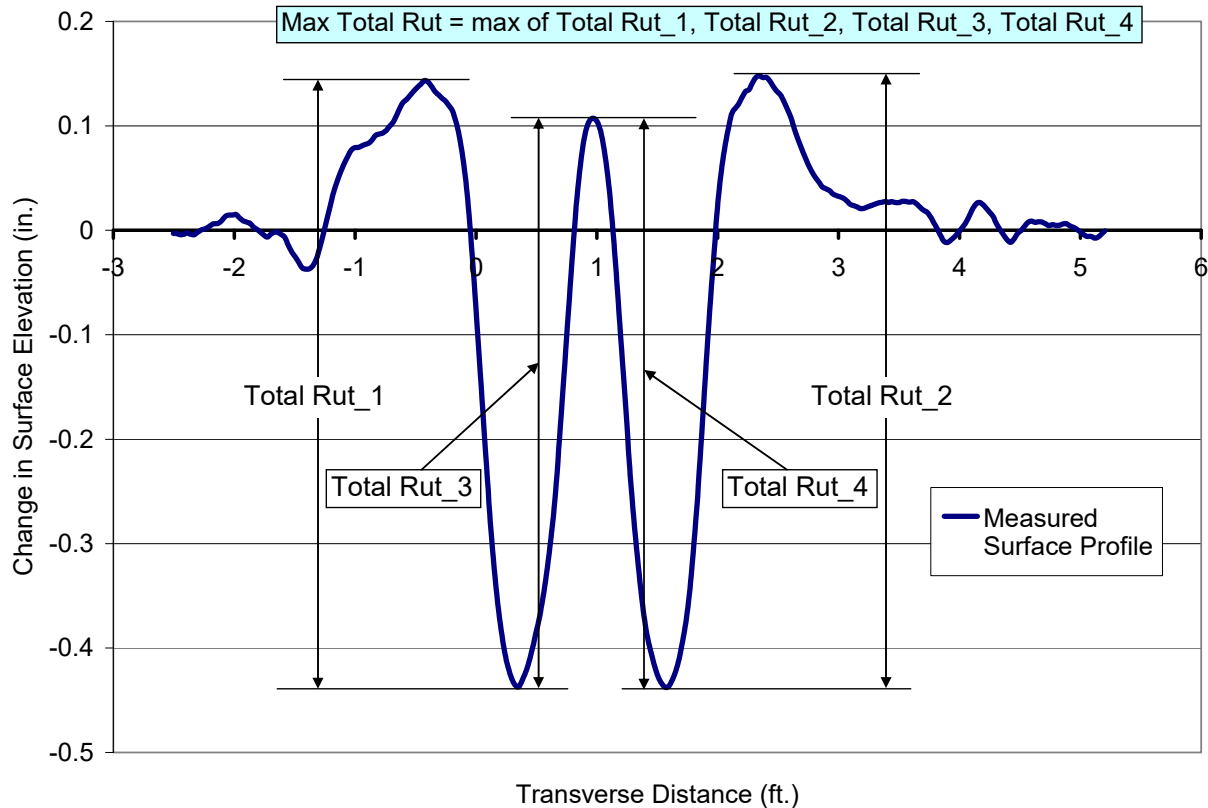
Figure 3.3: Definition of maximum total rut (MTR).

The rutting test failure criterion was determined to be when the *average maximum total rut* (AMTR) measured between Stations 3 and 13 reached 0.5 in. (12.5 mm). The definition of *maximum total rut* (MTR) is shown in Figure 3.3. When a pavement reached rutting failure, HVS trafficking was stopped.

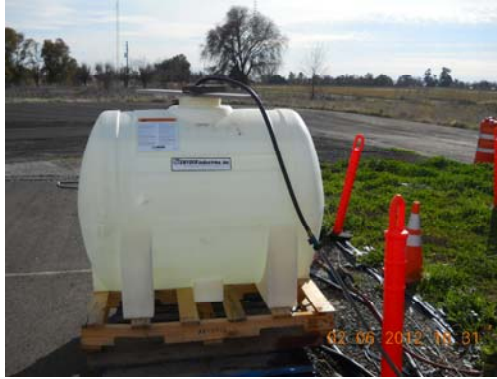
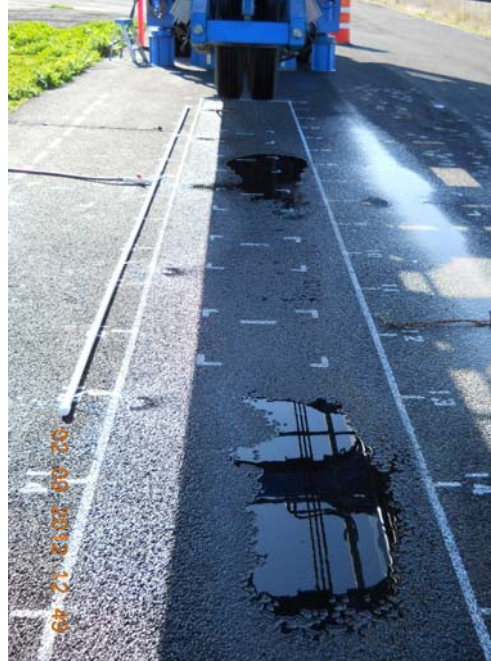
(a) Water tank

(b) Auto shut-off device to maintain constant water head

(c) Water sprayed onto pavement with perforated PVC pipe

Figure 3.4: Flooding method for the first HVS moisture damage test (Section 652HC).

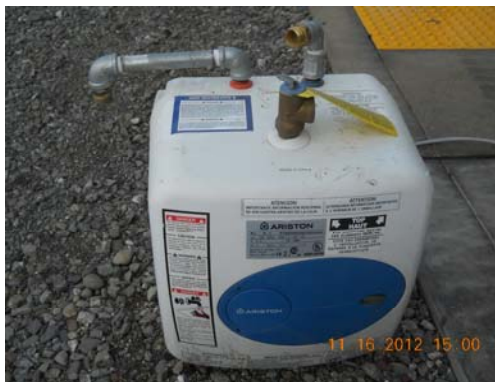
(a) Water heater

Figure 3.5: Heater used for heating water and the wax dam used to pond the water for Section 662HC.

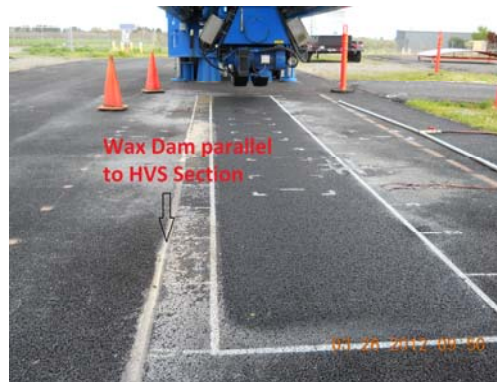
(b) Ponding of water with a wax dam parallel to the test section at the down slope side

At the conclusion of the first moisture test, it was discovered that the test section showed extensive unbound layer rutting and HMA layer cracking but no signs of moisture damage in the OGFC layer. A decision was then made to continue the testing program with a reduced load and more aggressive flooding. For the next test, the HVS load was reduced to 4.5 kips (20 kN) from 9 kips (40 kN), and the water from the tank was heated to approximately 77°F (25°C)—using two Ariston GL 4 heaters connected in serial—before it flowed into the spraying pipe (see Figure 3.5a). The heated water was also ponded by using a wax dam parallel to the HVS test section (see Figure 3.5b). The wax dam was built by sawing a shallow one inch wide trench down to the top of the underlying HMA layer and filling the trench with melted wax.

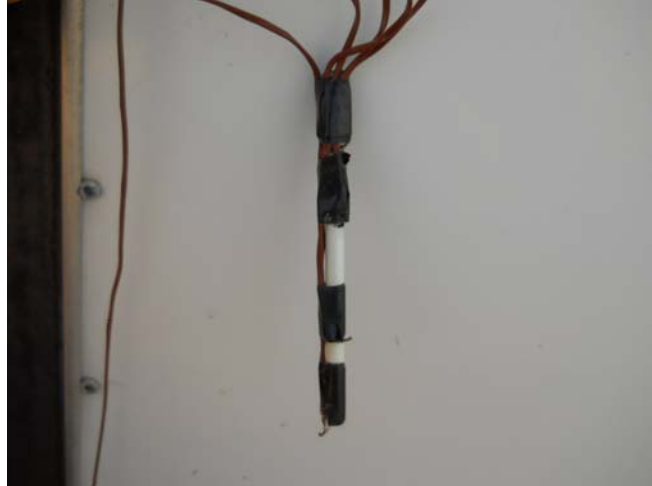
Figure 3.6: A “thermocouple tree” consisting of five Type-K thermocouples wrapped on a plastic dowel.

In this project, pavement and air temperatures (both inside and outside the temperature chamber) were measured with Type-K thermocouples. Individual thermocouples measured the air temperature, and five bundled thermocouples, forming a “thermocouple tree” (Figure 3.6), measured pavement temperatures at multiple depths at each location. The locations of thermocouple trees are shown in Figure 3.2. Note that two sets of thermocouples were used: one for manual measurements using a thermometer and the other for automatic measurements using the HVS data acquisition (DAQ) system.

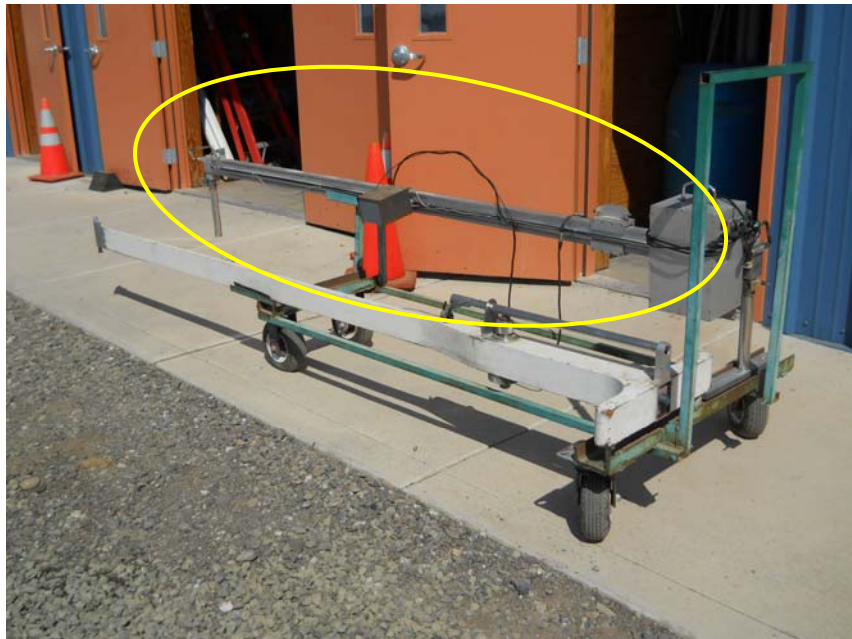
Figure 3.7: The laser profilometer.

A laser profilometer (Figure 3.7) was used to measure the transverse surface profile of the test section at every station, i.e., from Station 0 to Station 16. The permanent change in surface profile is defined as the difference between the initial surface profile and the surface profile after HVS trafficking. Therefore, using the change in surface profile at each station, the maximum total rut was determined for each station, as illustrated in Figure 3.3. Laser profilometer measurements were taken at the following load repetitions: 0, 250, 500, 1,000, 2,000, 5,000, 10,000, and once a day afterward.

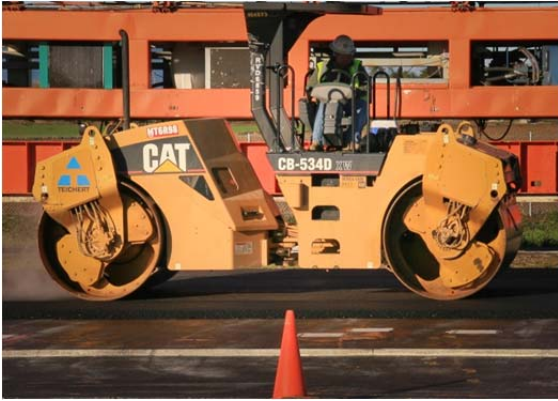
(a) Construction of OGFC

Figure 3.8: The general procedure followed for x-ray CT image data collection.

In this study, the procedure developed by Coleri et al. [8] was used to evaluate microstructure changes using x-ray CT imaging. The steps outlined below correspond with the photographs displayed in Figure 3.8.

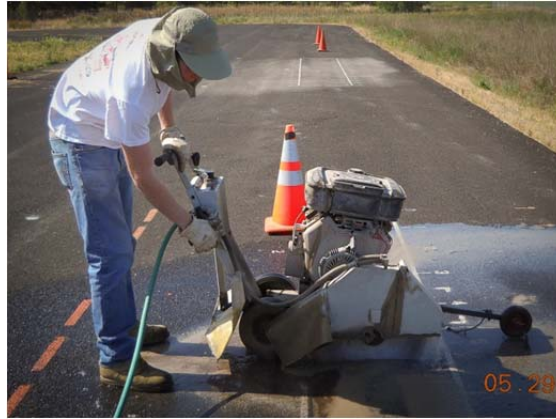
(b) Sawing of blocks

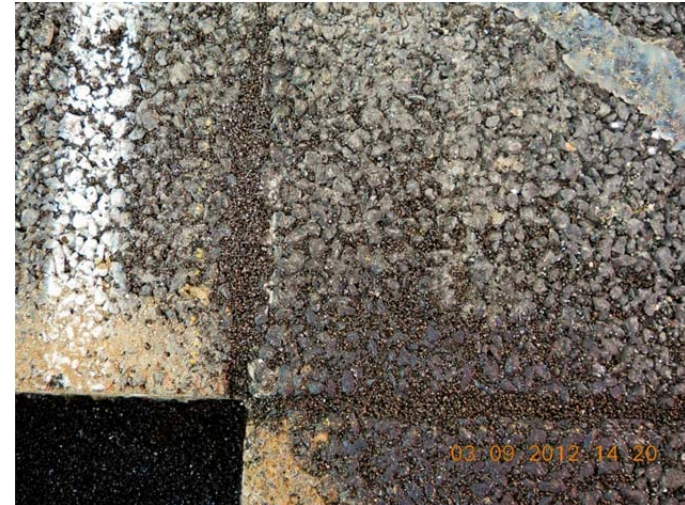
(e) Extended cuts in test sections refilled with emulsion-sand mixture

4. Extended cuts created during sawing of the blocks, due to the circular shape of the concrete saw, were filled with an emulsion-sand mixture to avoid localized failures (Figure 3.8e).

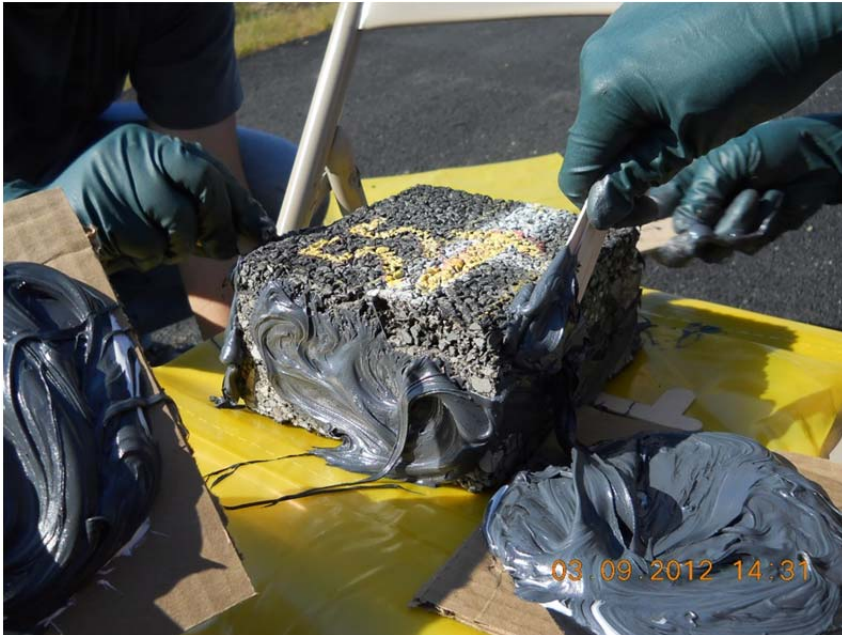
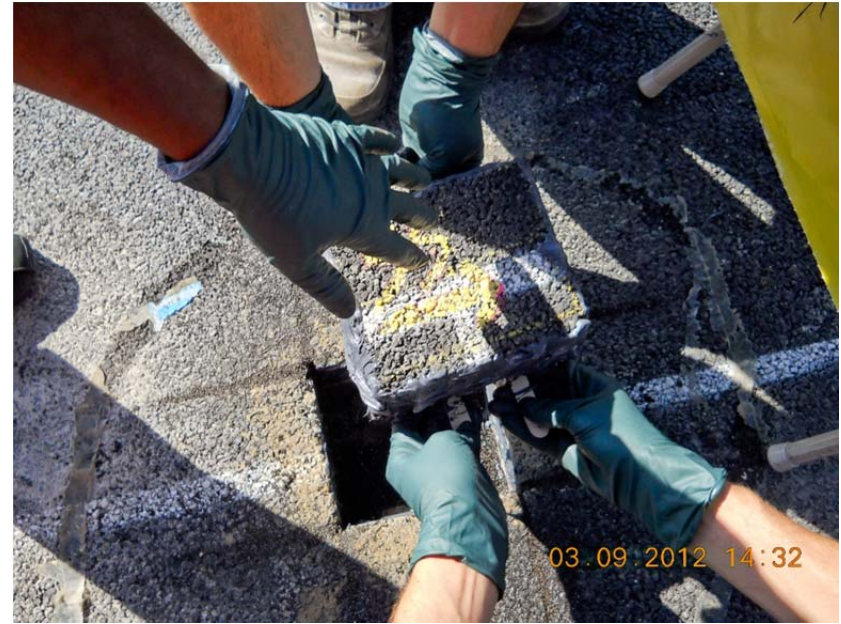
Replacement of blocks in the HVS test section

5. The scanned blocks were re-installed into their original positions with fast-setting epoxy (Figure 3.8f and Figure 3.8g).

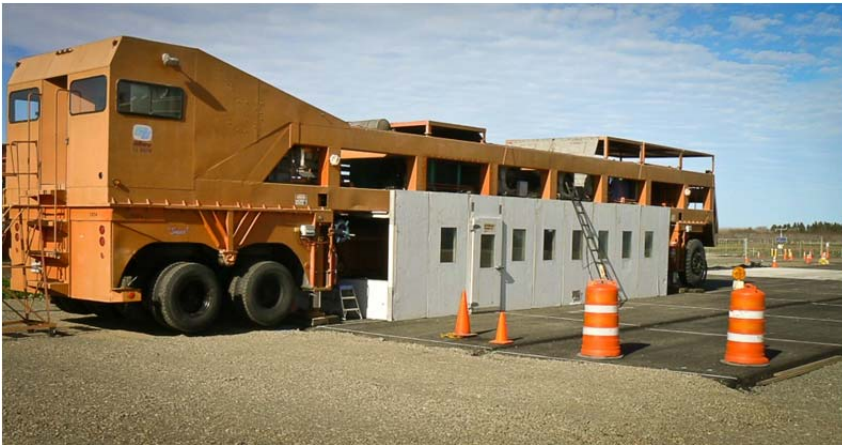
(h) HVS testing of sections containing scanned blocks

6. After HVS testing was completed on the test sections containing the blocks (Figure 3.8h), the blocks, now with accumulated permanent deformation, were again removed and returned to UCDMD to obtain post-testing images (Figure 3.8i).
7. The post-testing images were then processed to determine the post-testing distributions of the aggregate, mastic, and air-void phases.
8. By comparing the before and after test images, it was possible to determine changes in air-void distributions and permanent particle movement attributable to HVS trafficking. These results were used to evaluate the rutting failure mechanisms of the study's multilayered asphalt pavement systems.

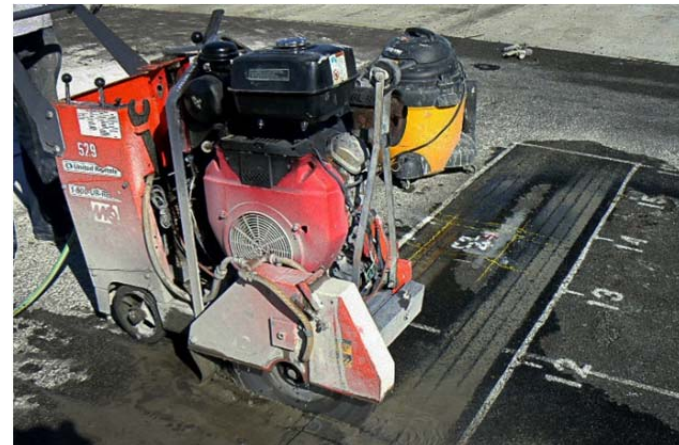
(i) Removal of scanned blocks for post-test scanning

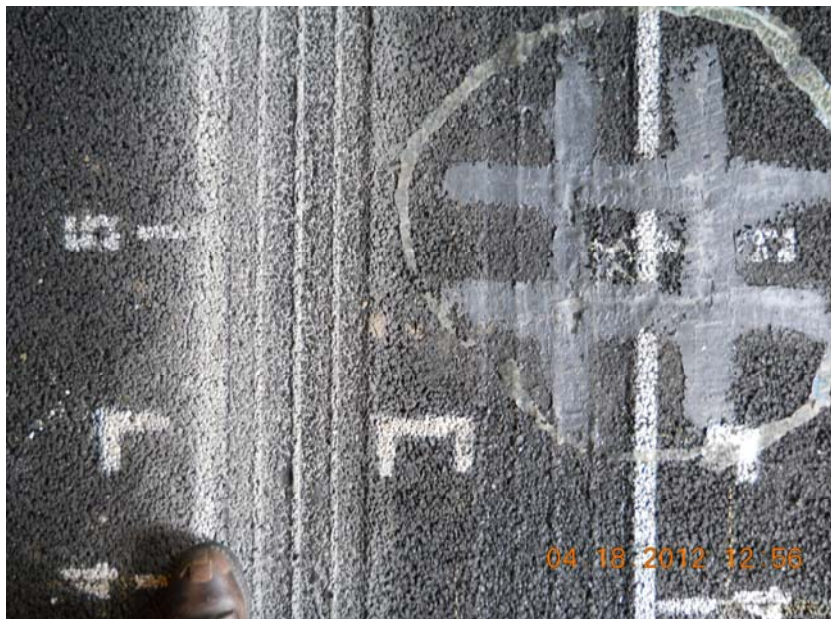
Figure 3.14: Section 653HB after 2,000 load repetitions with the asphalt concrete block at Station 5.

One asphalt concrete block was obtained for each of the three selected HVS sections at the upslope side of the section (see Figure 3.14).

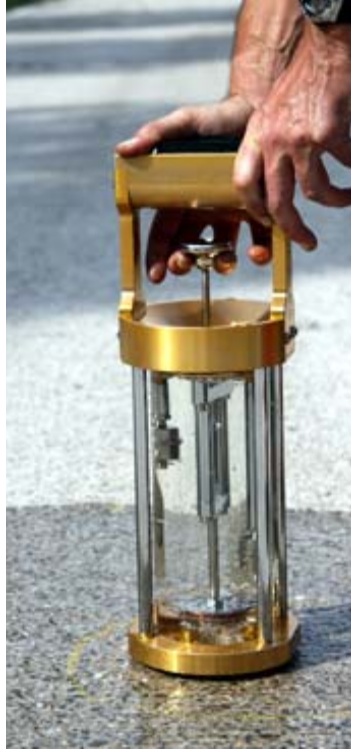
Figure 3.20: Outflow Meter.
(Courtesy of KLARUW Systems.)

The Outflow Meter (OTF) (see Figure 3.20:) is a device that measures the rate at which a known quantity of water, under gravitational pull, escapes through voids in the pavement texture of the structure being tested. The time required for this to complete is referred to as *outflow time*. Use of the OTF provides a measure of a pavement's ability to relieve pressure from the face of vehicular tires, and thus an indication the potential for hydroplaning under wet conditions [14]. The reciprocal of the outflow time is highly correlated with MPD except when a surface is highly porous. The OTF can also be used to detect surface wear and predict correction measures [22].

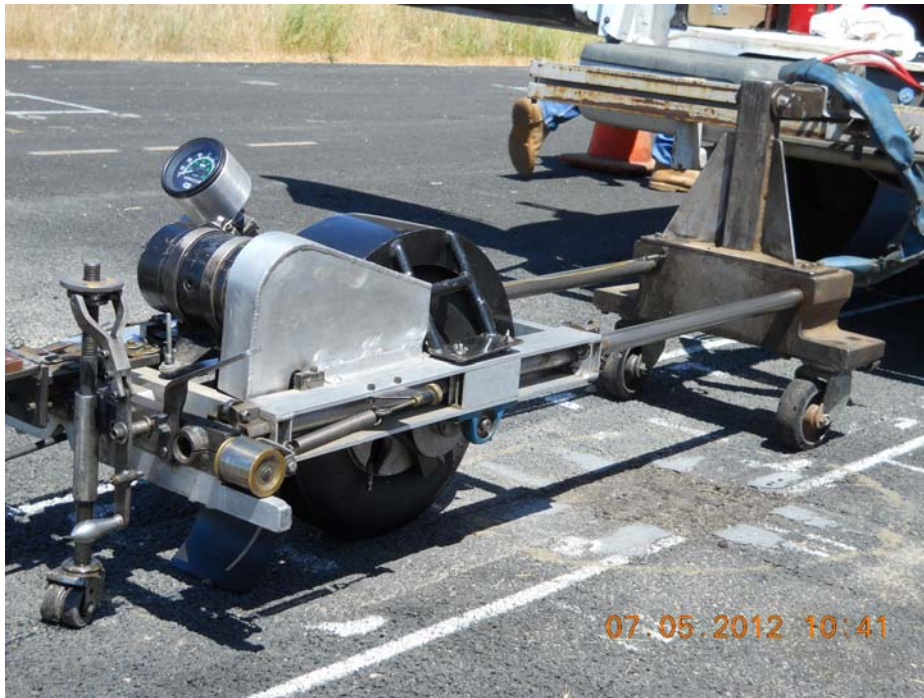
Figure 3.21: California Portable Skid Tester (CST) used to measured surface skid resistance following California Test (CT) 342.

Operation of the California Portable Skid Tester (CST) (Figure 3.21) involves spinning a rubber-tired wheel to a speed of 80 km/h (50 mph) while it is off the ground, then lowering it to the pavement and noting the distance the wheel travels against the resistance of a spring before stopping. The device measures the coefficient of friction values of bituminous and portland cement concrete pavements and bridge decks. During testing the device is attached to the rear of a suitable stationary vehicle. Glycerin is used to wet the full circumference of the test tire before each test. The CST operates initially with a slip ratio of one since the test wheel is rotating but the test carriage is not moving relative to the pavement. Once the wheel is in contact with the pavement the slip ratio changes to zero since there is no braking effort applied to the wheel. In addition, the test is not conducted at a constant speed as there is no further energy applied to the wheel once it touches the ground [23].

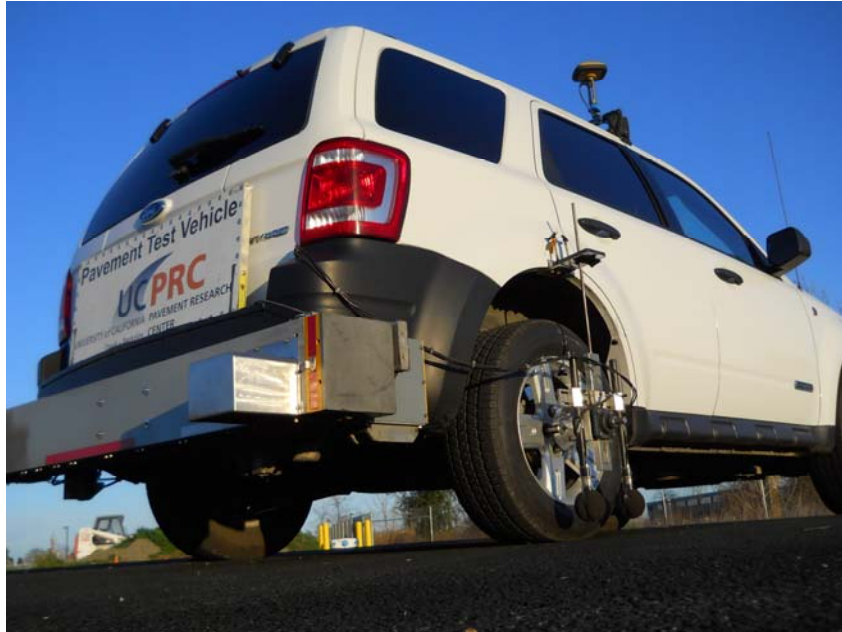
Figure 3.22: The UCPRC On-board Sound Intensity (OBSI) measurement vehicle.

Tire/pavement noise measurements were performed using the UCPRC's OBSI measurement vehicle (Figure 3.22). The vehicle is a Ford Escape with a rear-mounted laser profilometer and the OBSI measurement device installed on the right rear wheel. In the figure, the steel box on the back of the vehicle is the inertial laser profilometer, which measures the pavement elevation profiles on both wheel tracks. The surface texture, expressed as MPD, is also measured in the right wheel track. The OBSI measurement equipment was developed in California by Paul Donovan of Illingworth & Rodkin, Inc.

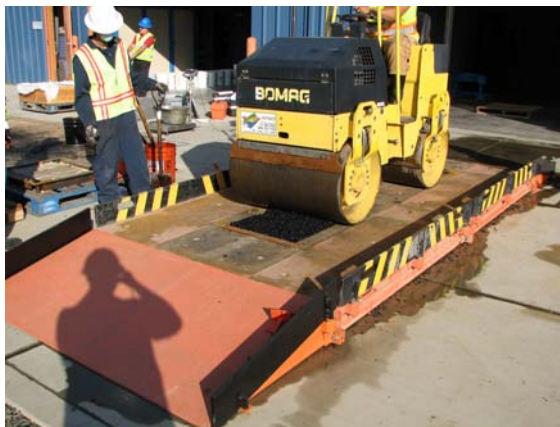
(a) Compaction using rolling wheel

Figure 3.25: Preparation of ingot mold specimens for laboratory evaluation, including surface texture measurements and shear stiffness testing.

Ingot specimens were prepared on the day of construction. The ingots were 1.5 inches (38 mm) thick, 20 inches (505 mm) wide, and 23 inches (575 mm) long. Figure 3.25 shows the compaction using rolling wheel compactor and the finished ingot specimen with the mold still attached. Once surface texture measurements were obtained, 6 inch (150 mm) diameter cores were taken from the ingot specimens and used for determining shear stiffness at 131°F (55°C). The amount of loose mix used and the number of rolling passes were the same for each ingot. The target was to obtain approximately 20 percent air-void content.

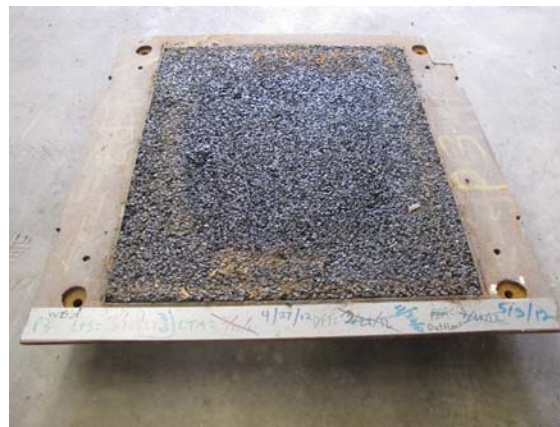
(b) Finished ingot specimen in the mold

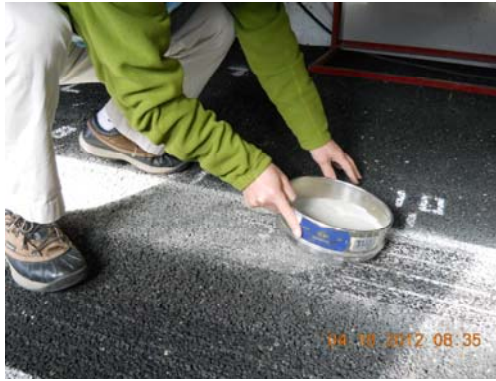
(a) Spreading the dust using a #200 sieve

Figure 3.27: Spreading of passing #400 dust on the downslope wheelpath using a #200 sieve.

In order to study the effect of dry dust on clogging of the OGFC layer, dry dust particles were applied over three of the HVS test sections that were trafficked with dual wheels. For this experiment, 100 grams of particles passing the #400 sieve (sieve opening 1.5×10^{-6} in. [38 micron]) were applied on the downslope wheelpath at two different times: once at the beginning of HVS testing and again after the development of about 0.25 in. (6.3 mm) of average maximum total rut. The estimated 200 gram mass was calculated based on the HVS wheelpath surface area and an assumed average rainfall of 15 inches per year for 15 years. In addition, it was assumed that the total suspended solid (TSS) concentration of highway runoff is equal to 140 mg/L and that only 10 percent of the particles found in the TSS can pass the #400 sieve [24]. This 200 gram mass was applied uniformly using a #200 sieve.

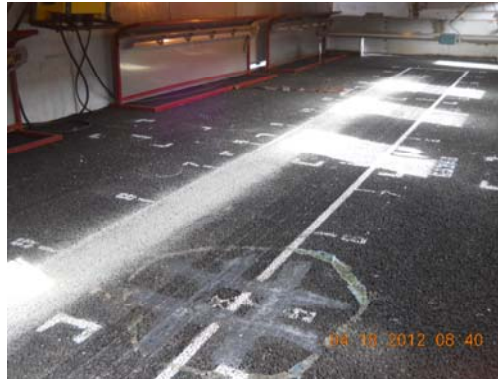
(b) Test section with dust spread on the down-slope wheelpath

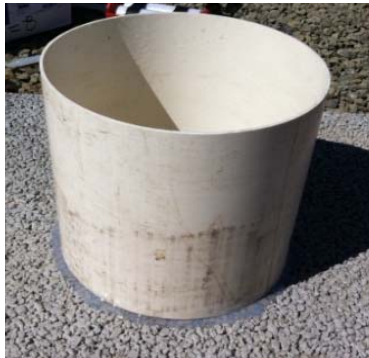
(a). Standard-sized (12 in.) cylinder

Figure 3.29: Permeameters used with the ASTM C1701 test method in this study. Photos show sealing of the base using Ecoflex 5 silicone rubber.

The ASTM C1701 test method requires the use of a hollow cylinder with a 12 in. (300 mm) inner diameter that is at least 2.0 in. (50 mm) tall. However, the standard-sized cylinder was too large to fit inside the individual wheelpaths created by the dual wheels. The cylinder diameter was therefore reduced to 6 in. (150 mm). The two cylinders with different diameters used in this study are shown in Figure 3.29. The ASTM 1701C permeability test was performed based on the constant head method.

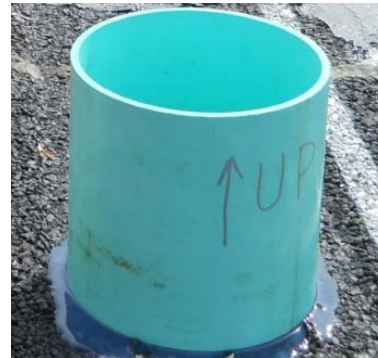
(b) Modified (6 in.) cylinder

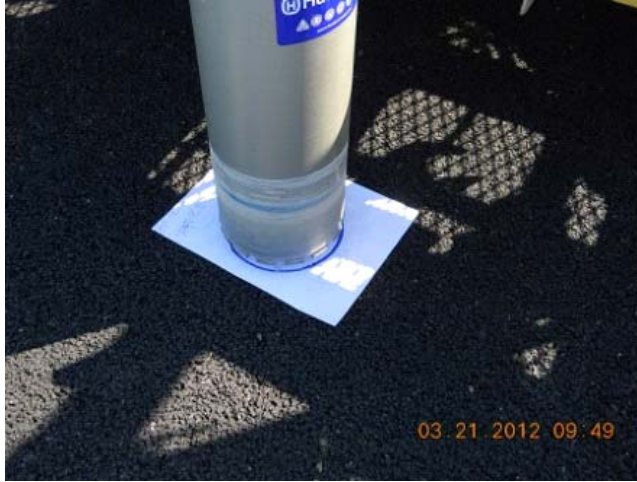
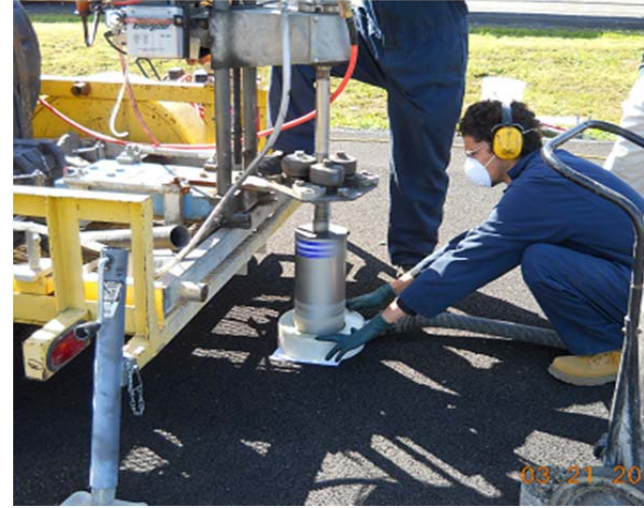
Air-cooled coring

1. Using epoxy, seal impermeable paper over the core specimen area in order to prevent air from penetrating the core samples (Figure 3.30a).
2. Initiate air-cooled coring while vacuuming dust (Figure 3.30b).

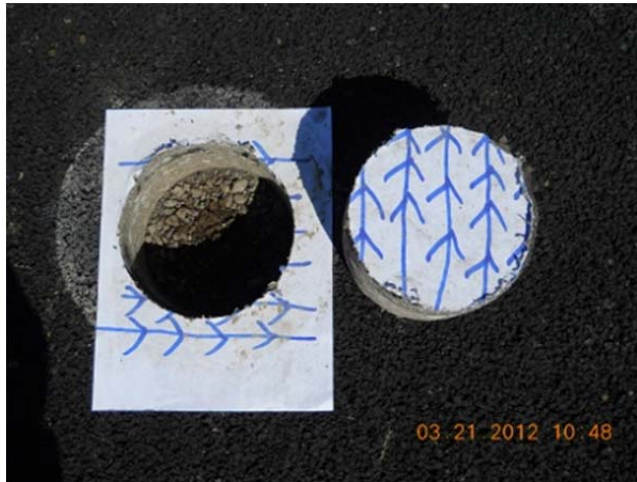
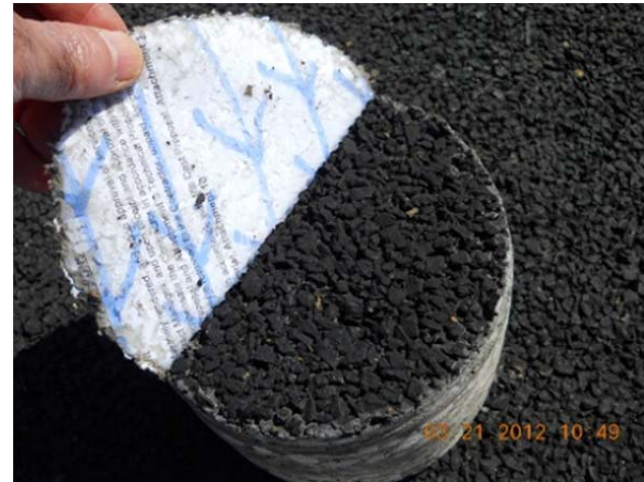
Extracted core and removal of impermeable paper

3. Remove the cored sample along with the impermeable paper (Figure 3.30c). (Attachment of the paper is noted in “Obtaining Pavement Core Samples” on page 58.)

4. Peel off the impermeable paper (Figure 3.30d) and conduct x-ray CT imaging (Figure 3.30e).
5. Process x-ray CT images to determine the distributions of air-voids in the asphalt cores (Figure 3.30f).

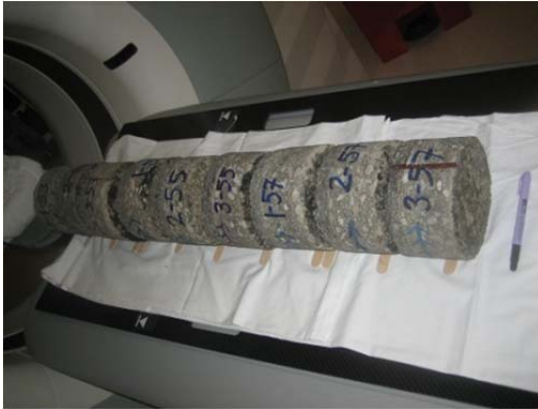
(e) X-ray CT imaging

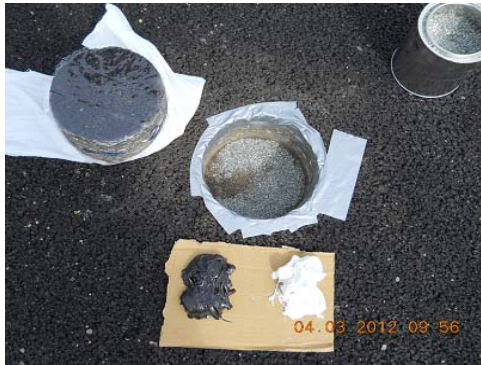
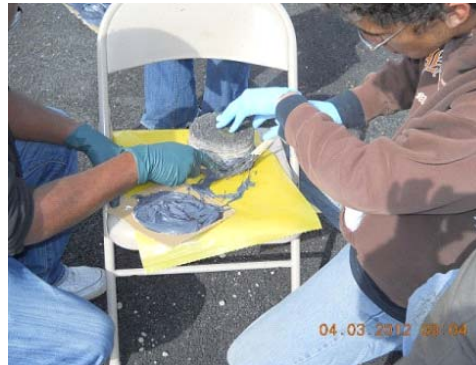
Replacement of core in the HVS test section

6. Put the core back into the pavement for rainfall simulation:
 - a. Tape the top part of the core hole to avoid any exposure to fast-setting epoxy before putting the core back (Figure 3.30g).

- b. Apply epoxy to the bottom half of the core (Figure 3.30h).
 - c. Replace the core in its original location and fill the upper portion of the open-graded pavement with large sand particles (Figure 3.30i).

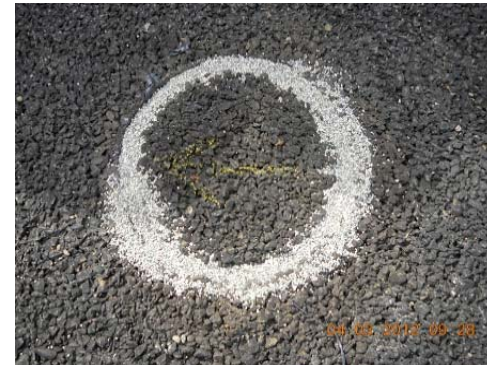
(i)

Figure 3.30: Photos of steps for evaluation of clogging susceptibility due to drainage of run-off using simulated rainfall.

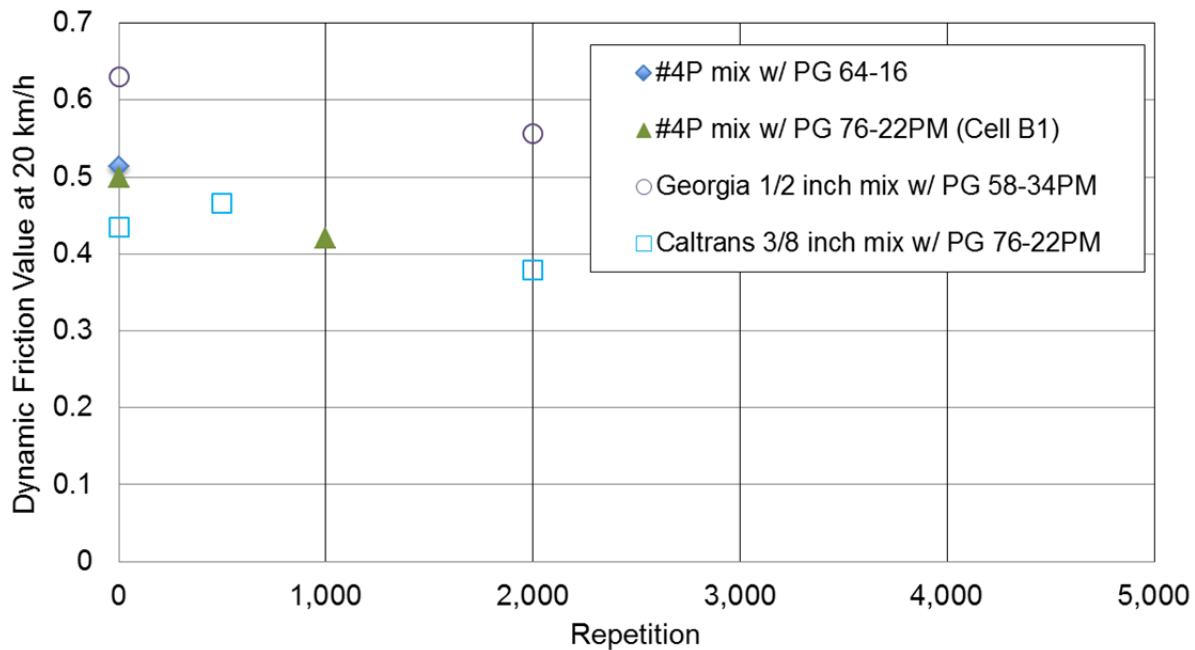
Figure 4.2: Progression of dynamic friction measured with the DFT versus load repetitions for the different mixes at the beginning of HVS trafficking.

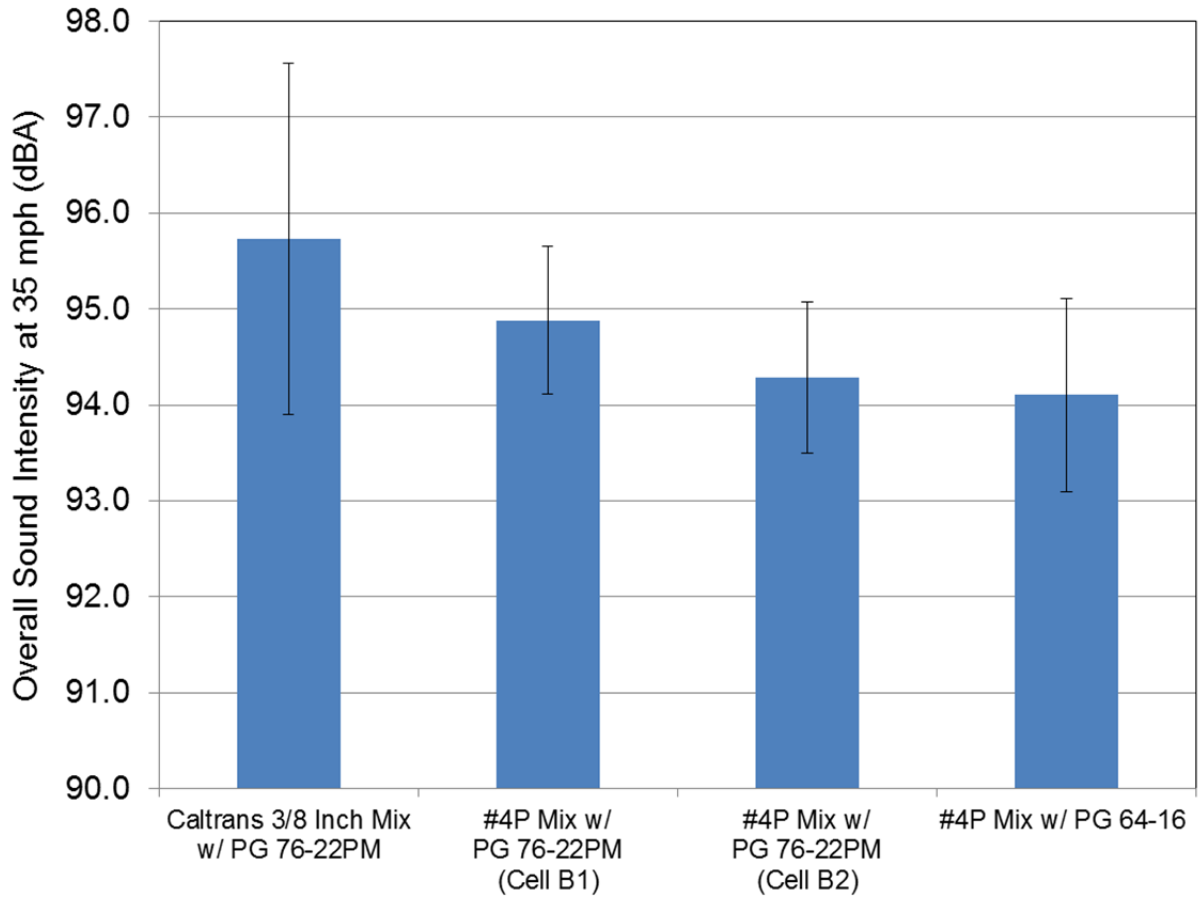
Figure 4.11: Overall sound intensities measured at 35 mph for the different mixes.

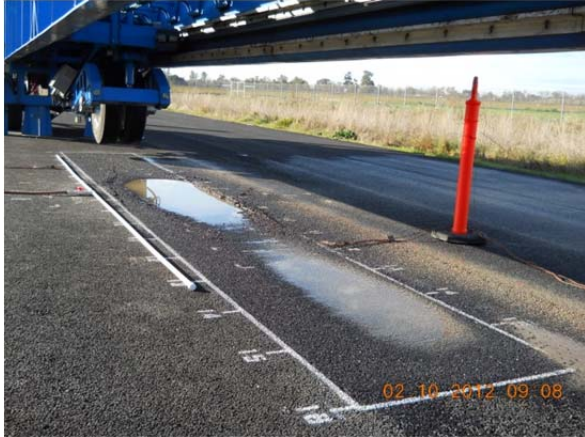
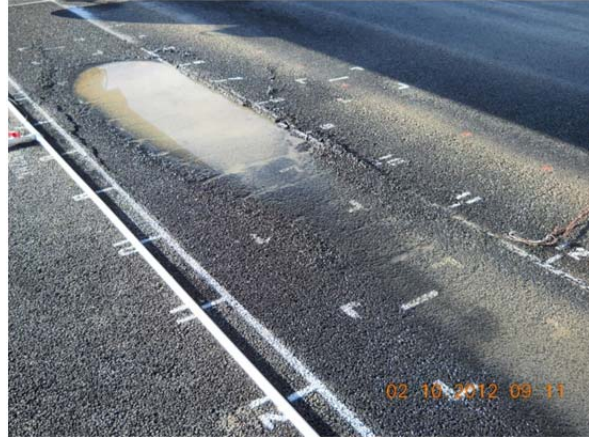
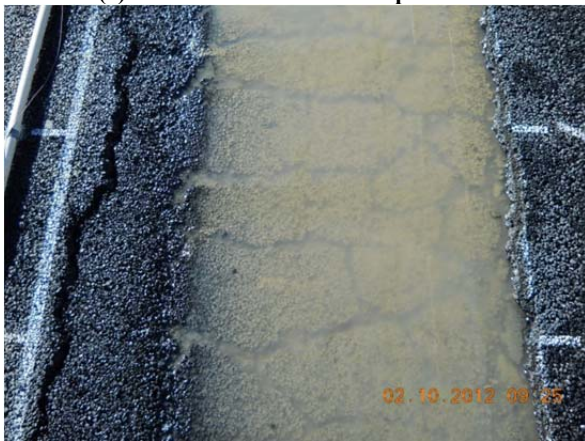
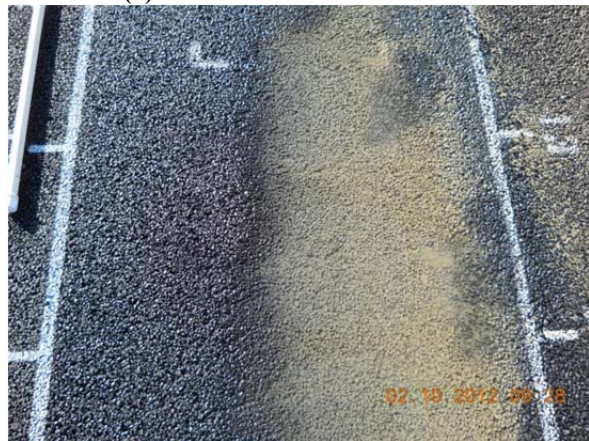
(a) Overall view of the failed pavement

(b) A closer look at the test section

(c) Severe cracking and punch down near Station 7

(d) Signs of subgrade rutting and crack initiation near Station 13 but no moisture damage in the asphalt

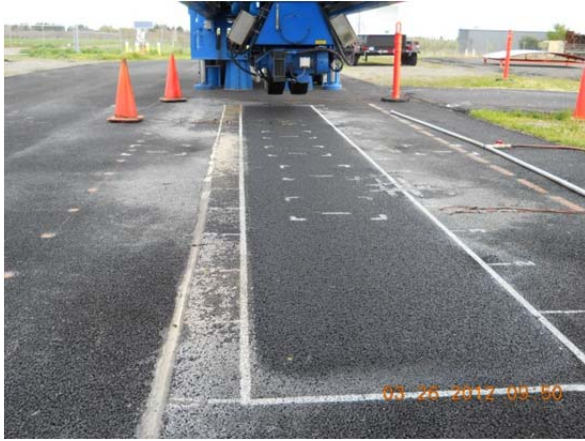
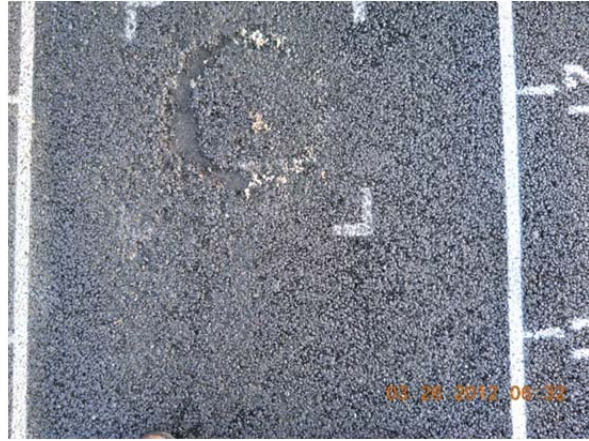
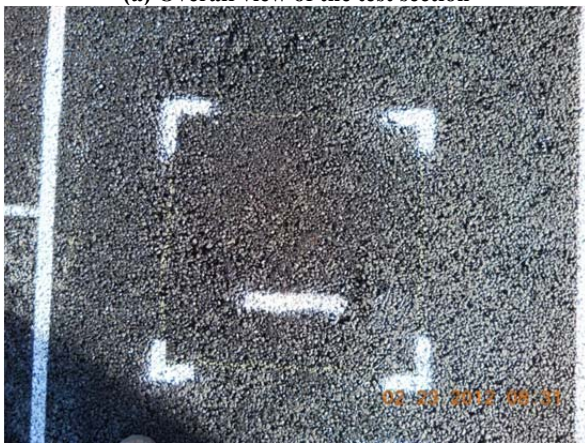
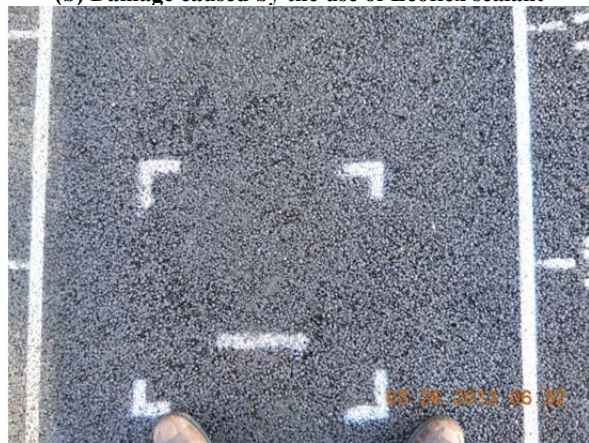
(a) Overall view of the test section

(b) Damage caused by the use of Ecoflex sealant

(c) Picture at Station 10 before HVS Trafficking

(d) Picture at Station 10 after HVS trafficking

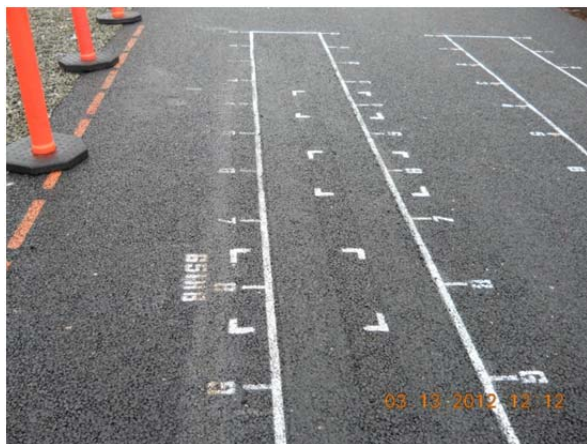
(a) 651HB: Georgia 1/2 inch mix with PG 58-34PM binder, OGFC thickness = 0.15 ft

Figure 6.3: Surface photos of two sections previously tested with the HVS showing different residual permeability during a 0.17 in. (4.3 mm) rain.

It is expected that rutting caused by HVS trafficking will affect pavement permeability. In this study, this phenomenon is referred to as *rutting-related clogging*. A 0.17 in. (4.3 mm) rain event on March 13, 2012, at Davis, California, led to a clear visual indication of rutting-related clogging. Figure 6.3 shows photos of two HVS test sections during the rain. Both sections had been tested with the HVS and had about 0.5 inches of total rut. The rutted portion of Section 651HB (0.15 ft of Georgia 1/2 inch mix with PG 58-34PM binder [Figure 6.3a]) drained well and showed no signs of standing water on its surface. On the other hand, the rutted area in the wheelpath created by the NGWBT on Section 669HB (0.07 ft of #4P mix with PG 76-22PM binder) drained poorly and filled with standing water. The fact that the unrutted area of Section 669HB (Figure 6.3b) still drained properly indicates that the clogging was due to rutting.
