1. REPORT NUMBER CA13-2380	2. GOVERNMENT ASSOCIATION NUMBER	3. RECIPIENT'S CATALOG NUMBER
4. TITLE AND SUBTITLE Implementation of New Quieter Pavement Research: Accelerated Pavement Testing and Laboratory Evaluation of Different Open-Graded Hot-Mix Asphalt Materials	5. REPORT DATE 10/22/2013

6. PERFORMING ORGANIZATION CODE	
7. AUTHOR R. Wu, I. Guada, E. Coleri, A. Rezaei, M. Kayhanian, and J.T. Harvey	8. PERFORMING ORGANIZATION REPORT NO. UCPRC-RR-2013-04

9. PERFORMING ORGANIZATION NAME AND ADDRESS University of California Pavement Research Center UC Davis, UC Berkeley One Shields Avenue Davis, CA 95616	10. WORK UNIT NUMBER

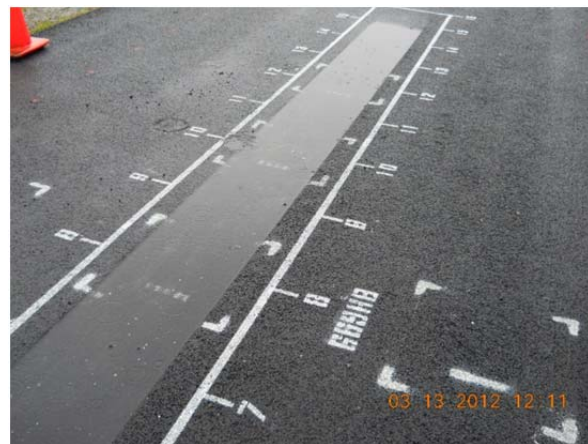
(b) Section 669HB: #4P mix with PG 76-22PM binder, OGFC thickness = 0.07 ft

Figure 6.3: Surface photos of two sections previously tested with the HVS showing different residual permeability during a 0.17 in. (4.3 mm) rain.

It is expected that rutting caused by HVS trafficking will affect pavement permeability. In this study, this phenomenon is referred to as *rutting-related clogging*. A 0.17 in. (4.3 mm) rain event on March 13, 2012, at Davis, California, led to a clear visual indication of rutting-related clogging. Figure 6.3 shows photos of two HVS test sections during the rain. Both sections had been tested with the HVS and had about 0.5 inches of total rut. The rutted portion of Section 651HB (0.15 ft of Georgia 1/2 inch mix with PG 58-34PM binder [Figure 6.3a]) drained well and showed no signs of standing water on its surface. On the other hand, the rutted area in the wheelpath created by the NGWBT on Section 669HB (0.07 ft of #4P mix with PG 76-22PM binder) drained poorly and filled with standing water. The fact that the unrutted area of Section 669HB (Figure 6.3b) still drained properly indicates that the clogging was due to rutting.

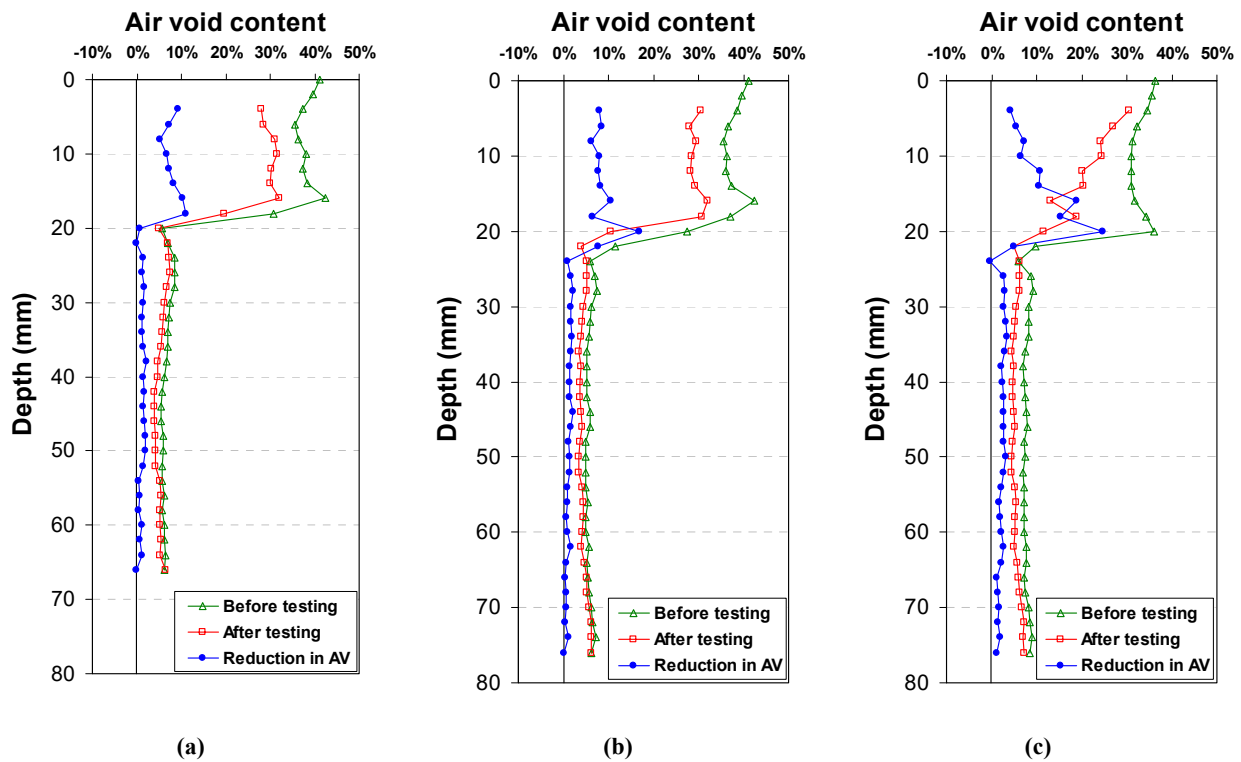
Figure 6.8: Air-void content distributions of three asphalt cores before and after rutting tests, depth = 0 for the OGFC surface.
(a) Section 653HB: Caltrans 3/8 inch mix with PG 76-22PM binder; (b) Section 655HB: #4P mix with PG 76-22PM binder; and (c) Section 657HB: #4P mix with PG 64-16 binder.

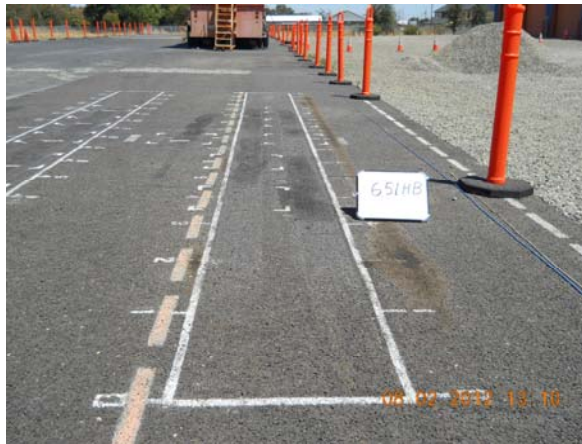
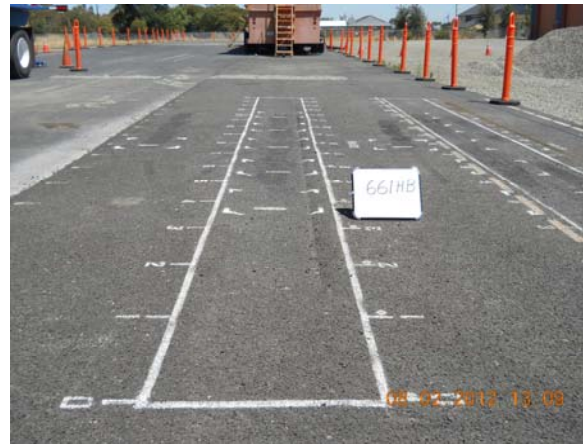
Figure 7.2: Surface photos of Sections 651HB and 661HB (Georgia 1/2 inch mix with PG 58-34PM binder, Cell D) after HVS trafficking.

Surface photos of all the HVS rutting test sections after trafficking are shown in Figure 7.2 to Figure 7.6. All the photos show visible surface ruts that were mostly caused by permanent deformation in the asphalt-bound layers. The treads and grooves on the HVS tires left ridges in the wheelpaths because of the channelized traffic pattern on all the test sections, but the ridges were especially pronounced on the sections tested with dual wheels. These ridges affected surface texture measurements and had to be accounted for during data analyses.

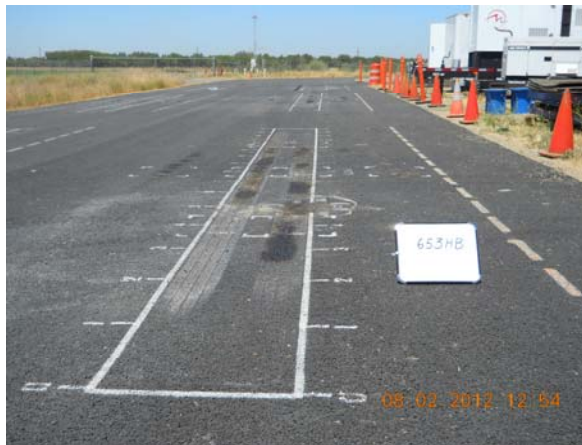
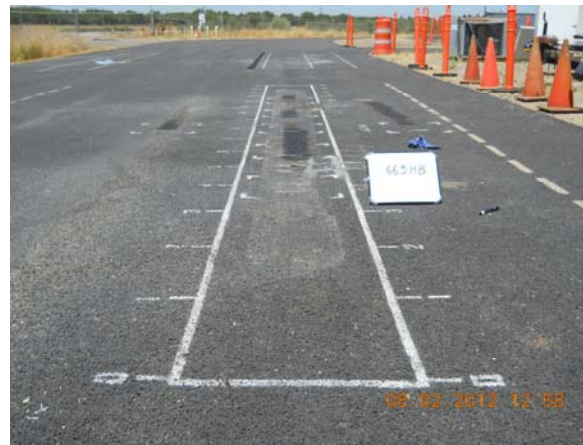
Figure 7.3: Surface photos of Sections 653HB and 663HB (Caltrans 3/8 inch mix with PG 76-22PM binder, Cell A) after HVS trafficking.

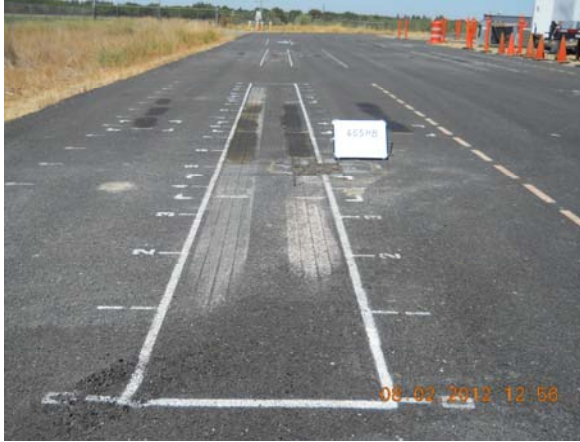
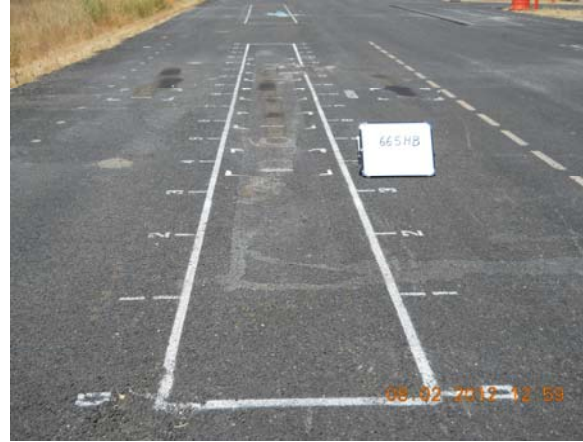
Figure 7.4: Surface photos of Sections 655HB and 665HB (#4P mix with PG 76-22PM binder, Cell B1) after HVS trafficking.

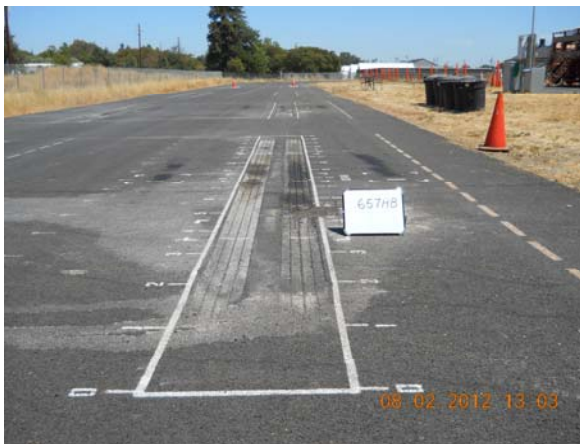
(a) Section 657HB, tested with dual wheels

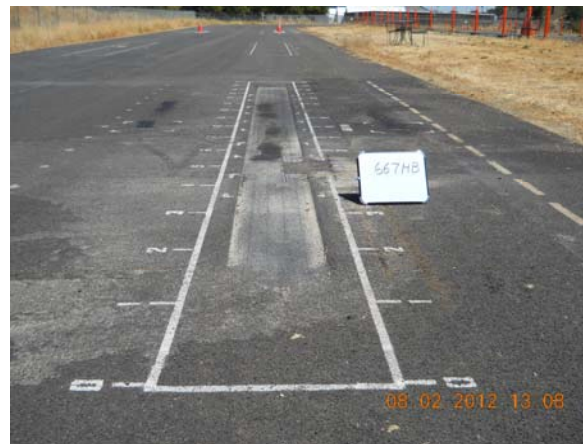
Figure 7.5: Surface photos of Sections 657HB and 667HB (#4P mix with PG 76-22PM binder, Cell B2) after HVS trafficking.

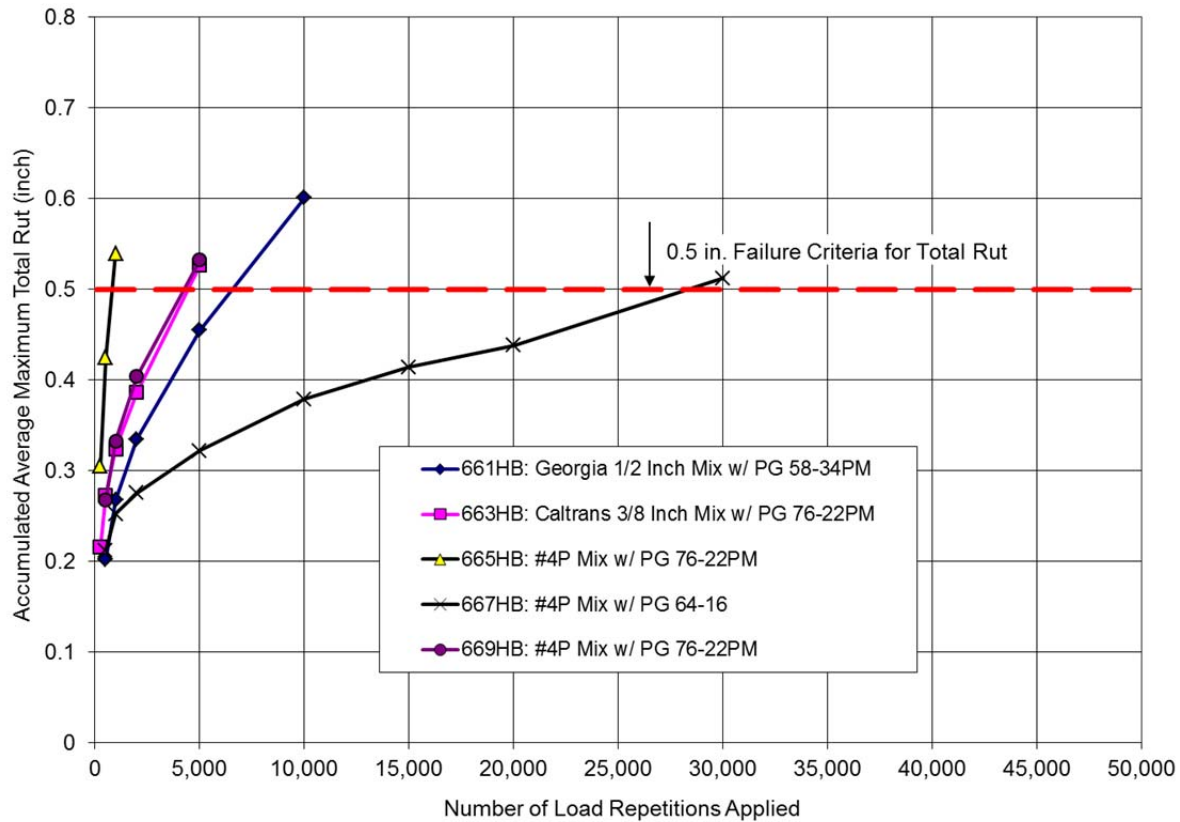
Figure 7.8: Accumulation of total rut for the HVS sections tested under next generation wide base tire (NGWBT) traffic.

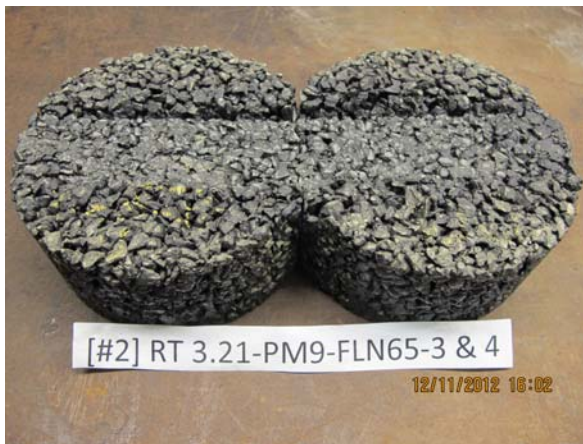
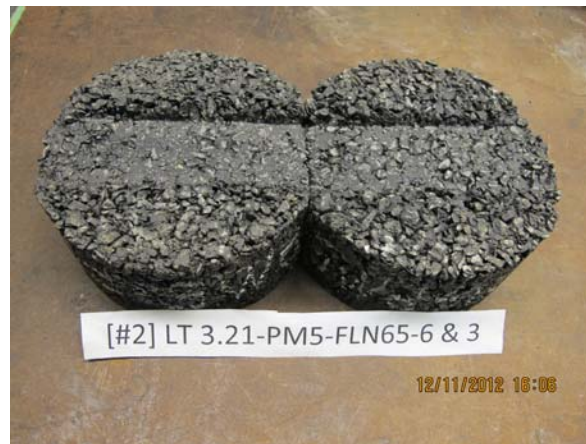
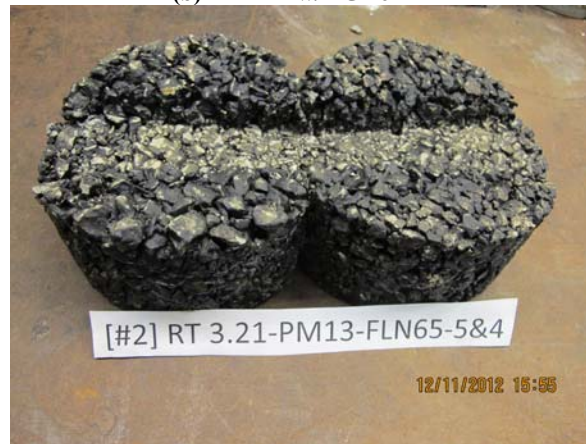
Figure 7.9 shows example specimens of each OGFC mix after HWTT was completed. The pictures show (a) relatively small rut depths in specimens of the two mixes with PG 76-22PM binder compared to specimens with the other two mixes and (b) that in addition to large rut depth, the specimens with #4P mix with PG 64-16 binder exhibited signs of crumbling, which indicates moisture damage in the specimen.

Figure 7.9: Examples of specimens of each OGFC mix after HWTT testing.

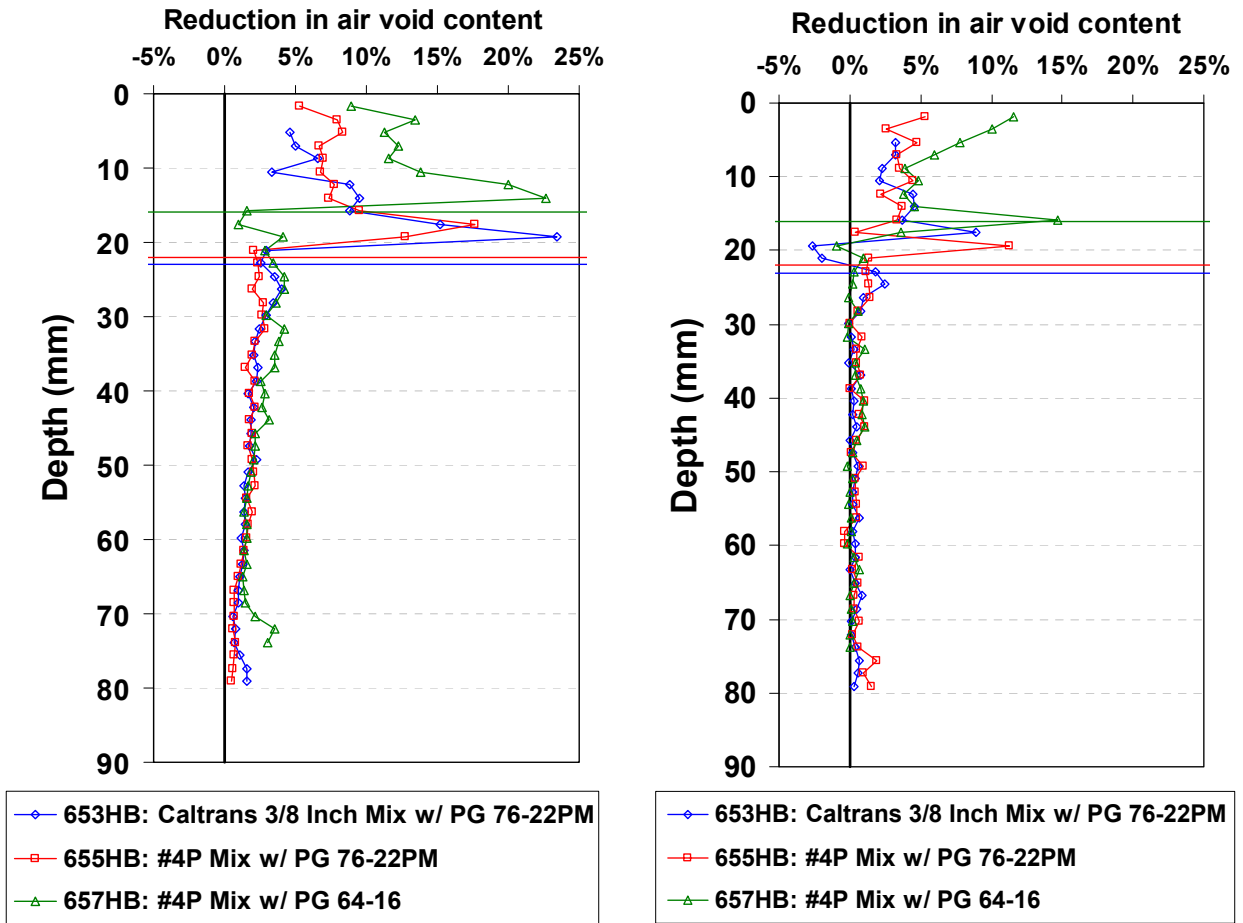
Figure 8.1: Reductions in air-void content caused by HVS trafficking (a) in the wheelpath area and (b) in the hump area (b).
