1. REPORT NUMBER CA09-1974	2. GOVERNMENT ASSOCIATION NUMBER	3. RECIPIENT'S CATALOG NUMBER
4. TITLE AND SUBTITLE Experimental and Computational Evaluation of Current and Innovative In-Span Hinge Details in Reinforced Concrete Box-Girder Bridges Part 1: Experimental Findings and Pre-Test Analysis		5. REPORT DATE January 2009

7. AUTHOR(S) Matias A. Hube & Khalid M. Mosalam		6. PERFORMING ORGANIZATION CODE
9. PERFORMING ORGANIZATION NAME AND ADDRESS Department of Civil and Environmental Engineering Pacific Earthquake Engineering Research Center College of Engineering University of California, Berkeley		8. PERFORMING ORGANIZATION REPORT NO. PEER 2008/103

## **Experimental and Computational Evaluation of Current and Innovative In-Span Hinge Details in Reinforced Concrete Box-Girder Bridges**

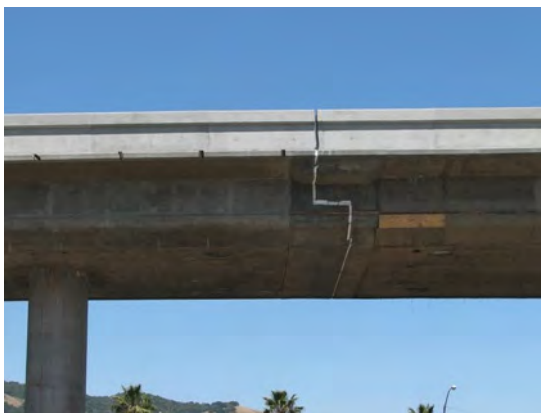
(a) Interstate 580 connector, San Rafael

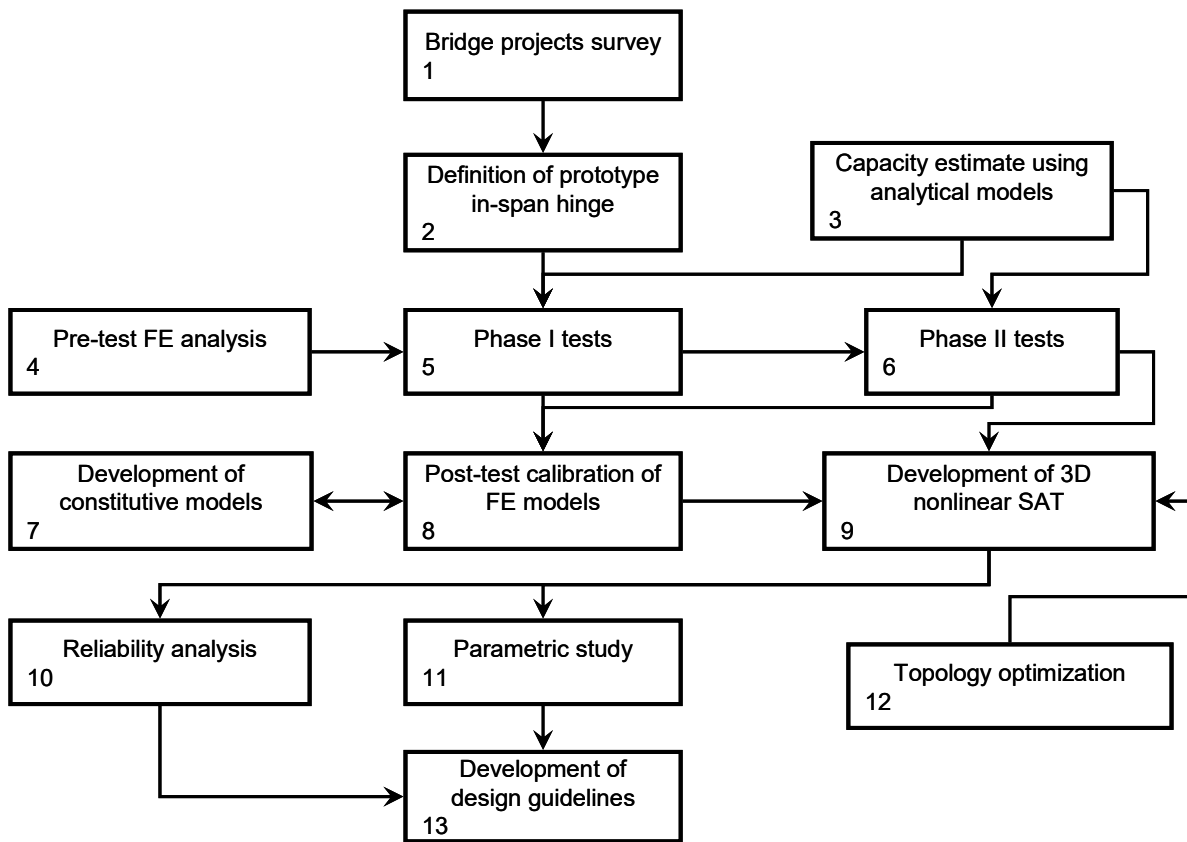
**Fig. 1.2 Overview of study program.**

The overall study program of in-span hinges is shown in Figure 1.2. This report focuses on the tasks shown in boxes 1 to 6. Other tasks in boxes 7 to 13 will be addressed in a future report. The study presented in this report aims at understanding the load path, the failure modes, and the strength of typical in-span hinges designed and constructed in California. This objective is achieved using a combined approach of computational and experimental research. The typical in-span hinge characteristics of California RC box-girder bridges are determined based on a survey of eight projects (box 1, Fig. 1.2). Findings from the experimental results revealed that in-span hinges fail with a combination of three failure modes: (1) one-dimensional (1D) shear, (2) 2D SAT, and (3) punching shear. Based on the experimental and computational results of two typical in-span hinges (phase I), three other specimens are designed and tested in phase II. The design of these specimens in phase II is aimed to reduce the steel congestion and improve the performance of in-span hinges. Another objective of the presented study is to determine the

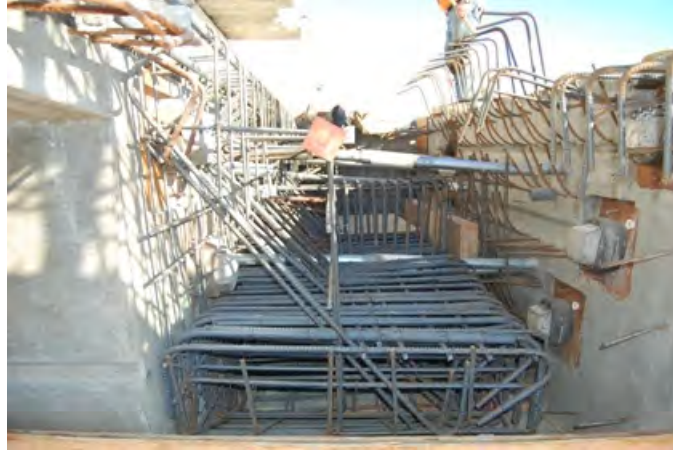
**Fig. 2.5 Reinforcement congestion of in-span hinge of prestressed box-girder bridge.**

Because in-span hinges of prestressed box girders are more critical, this study is focused on those types of hinges. Two examples of reinforcing steel details of in-span hinges are shown in Figure 2.6. The figure shows the details of projects 3 and 4 from Table 2.1, both having prestressed box girders, which are characterized by a construction joint in the diaphragm. The left side of the hinge of project 3 does not have prestressed box girders in this case because the hinge is located at the vicinity of the bridge bent.

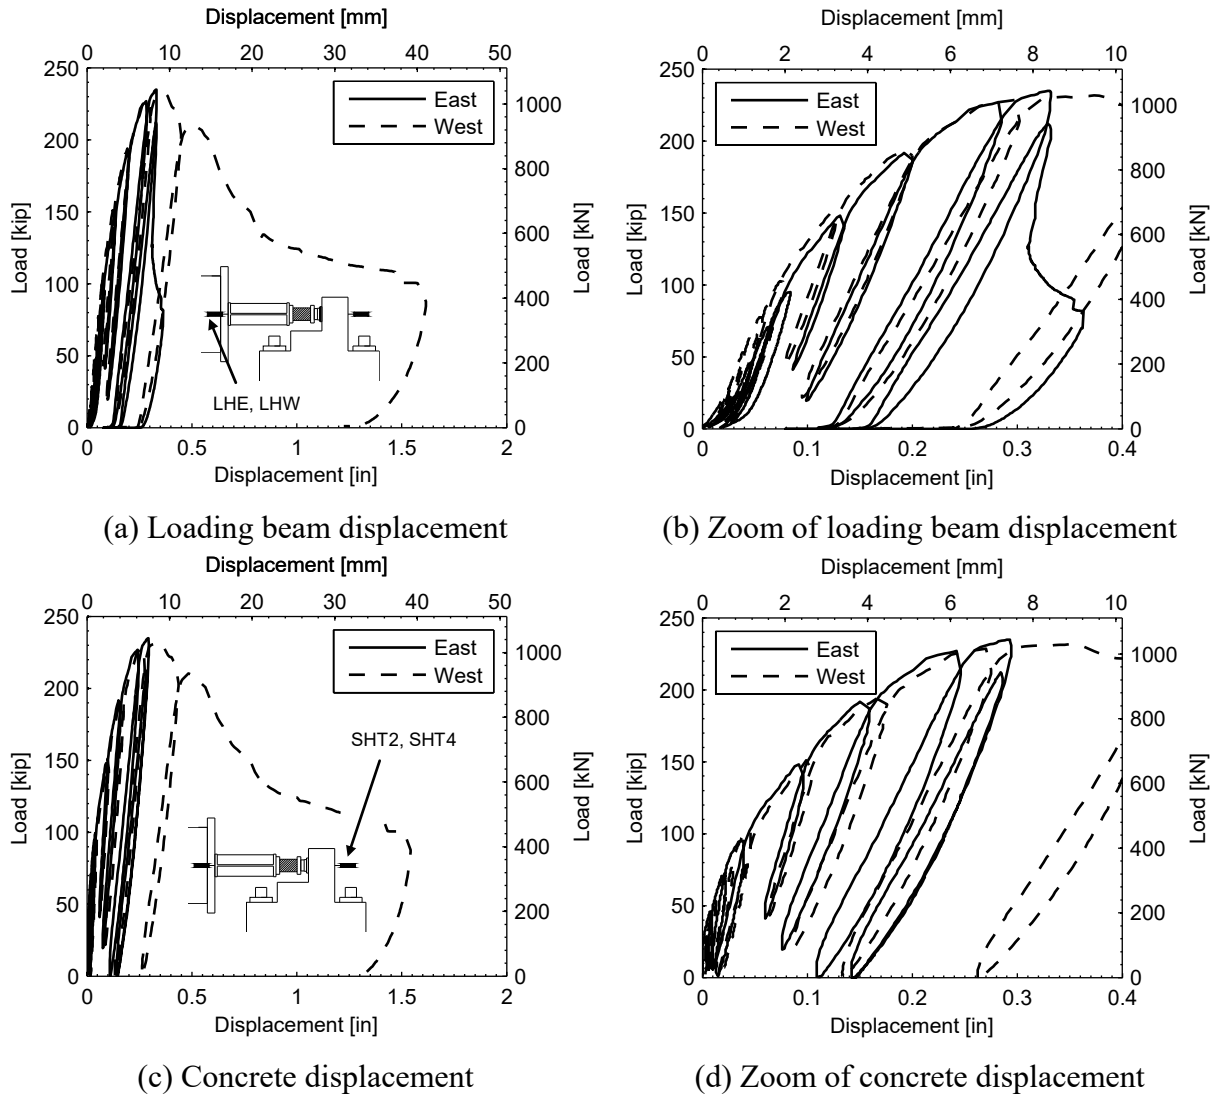
**Fig. 5.11 Load-displacement at bearings for two displacement measurements of specimen S1.**

The load-displacement relationships at both bearings are shown in Figure 5.11. The figure shows these relationships using two different displacements: the displacement of the loading steel beam (Figs. 5.11a–b) and the displacement of the concrete seat (Figs. 5.11c–d). During the test, the displacements of the loading beam and the concrete seat were measured with the instruments (LHE, LHW) and (SHT2, SHT4), respectively. From Figure 5.11, it can be observed that the initial stiffness is lower when the displacement is measured from the loading steel beam than from the concrete seat. This lower stiffness is attributed to the flexibility of the steel beam and the loading system. The relationships show that the east bearing did not fail during the test, since the east deformation decreased when the west bearing started to fail. The decrease of the east deformation is due to the lower load that was applied by the system caused by the punching shear failure observed on the west side.

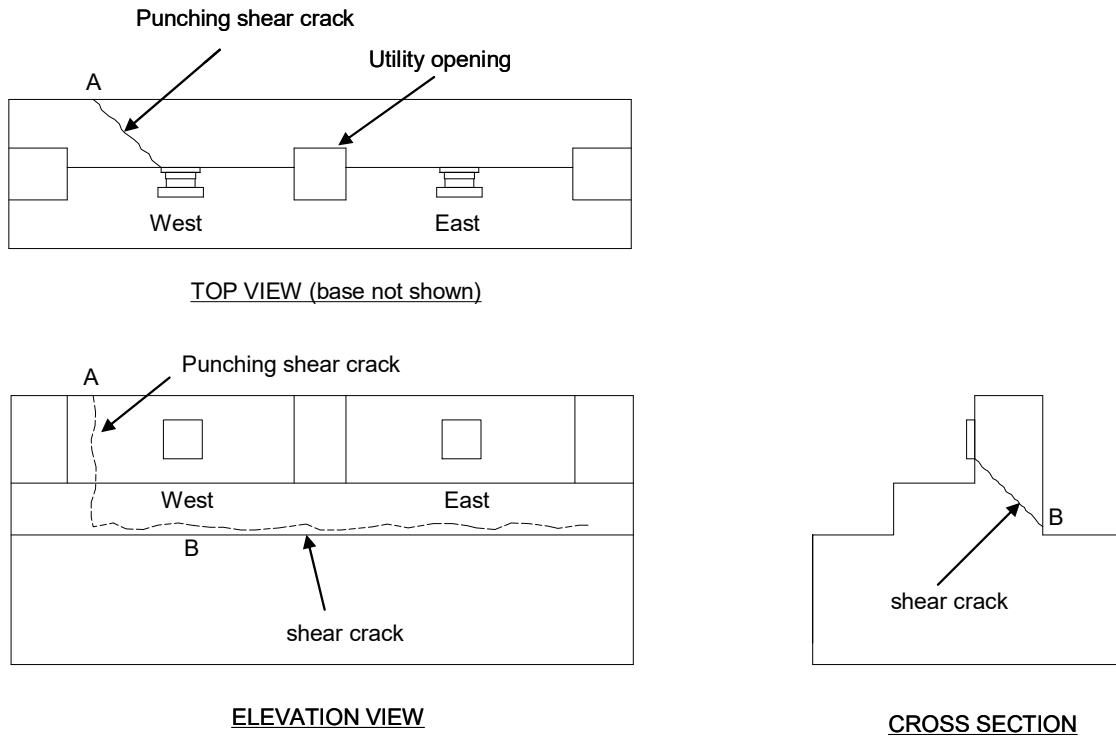
**Fig. 5.28 Failure mode of specimen S2.**

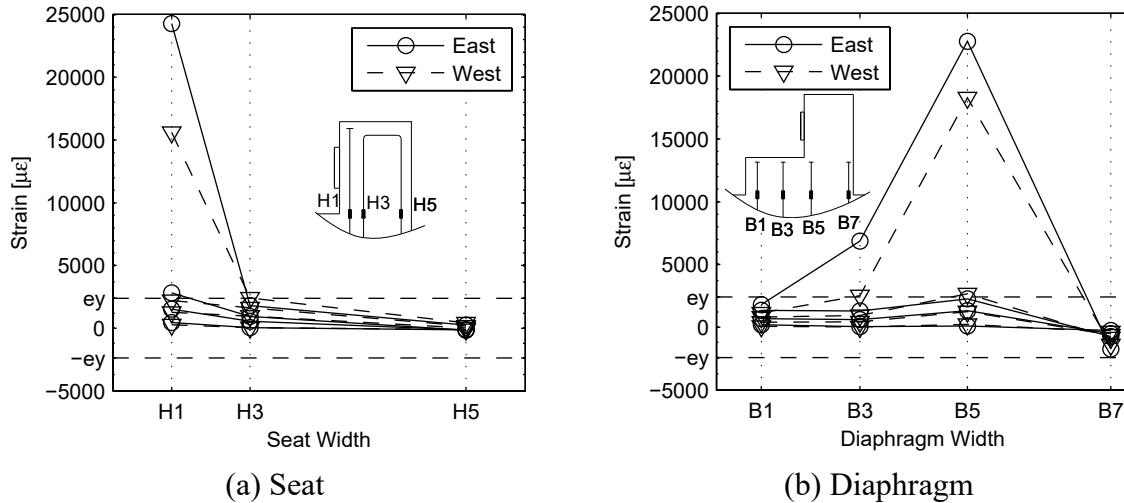
**Fig. 6.16 Horizontal (vertical in test orientation) strain distribution along seat and diaphragm width at 25%, 50%, 75%, and 100% of peak load of specimen S3.**

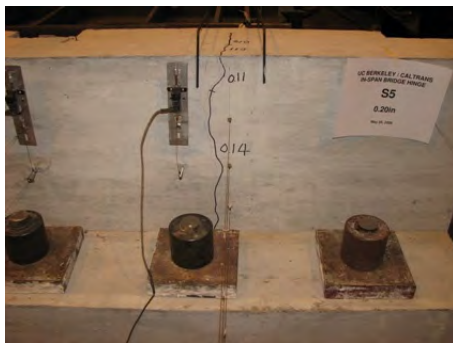
(c) 0.2" (5.1 mm) displacement, west side

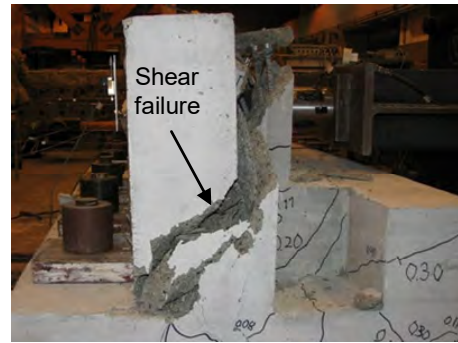
(f) At failure, west side

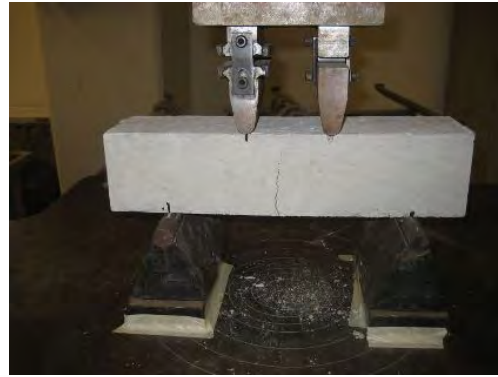
(b) Modulus of rupture test setup

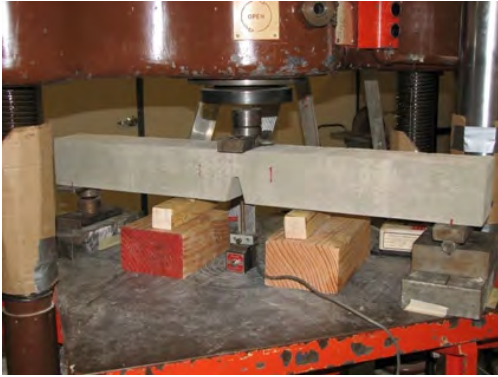
(a) Test setup

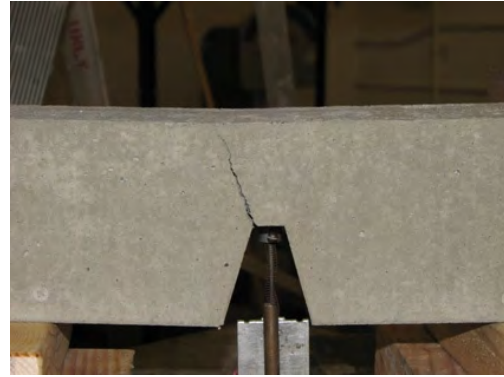
(b) Detail of failed specimen
