1. Report No. CA09-1645		2. Government Accession No.		3. Recipient's Catalog No.	
4. Title and Subtitle Investigation of Ground-Penetrating Radar (GPR) Technology for the Health of Bridge Decks: Phase I – Feasibility Testing				5. Report Date September 30, 2009

6. Performing Organization Code	
7. Author(s): R. Heikkilä, K. Yen, B. Ravani, and T. Lasky				8. Performing Organization Report No. UCD-ARR-09-09-30-05

9. Performing Organization Name and Address AHMCT Research Center UCD Dept. of Mechanical & Aerospace Engineering Davis, California 95616-5294				10. Work Unit No. (TRAIS)

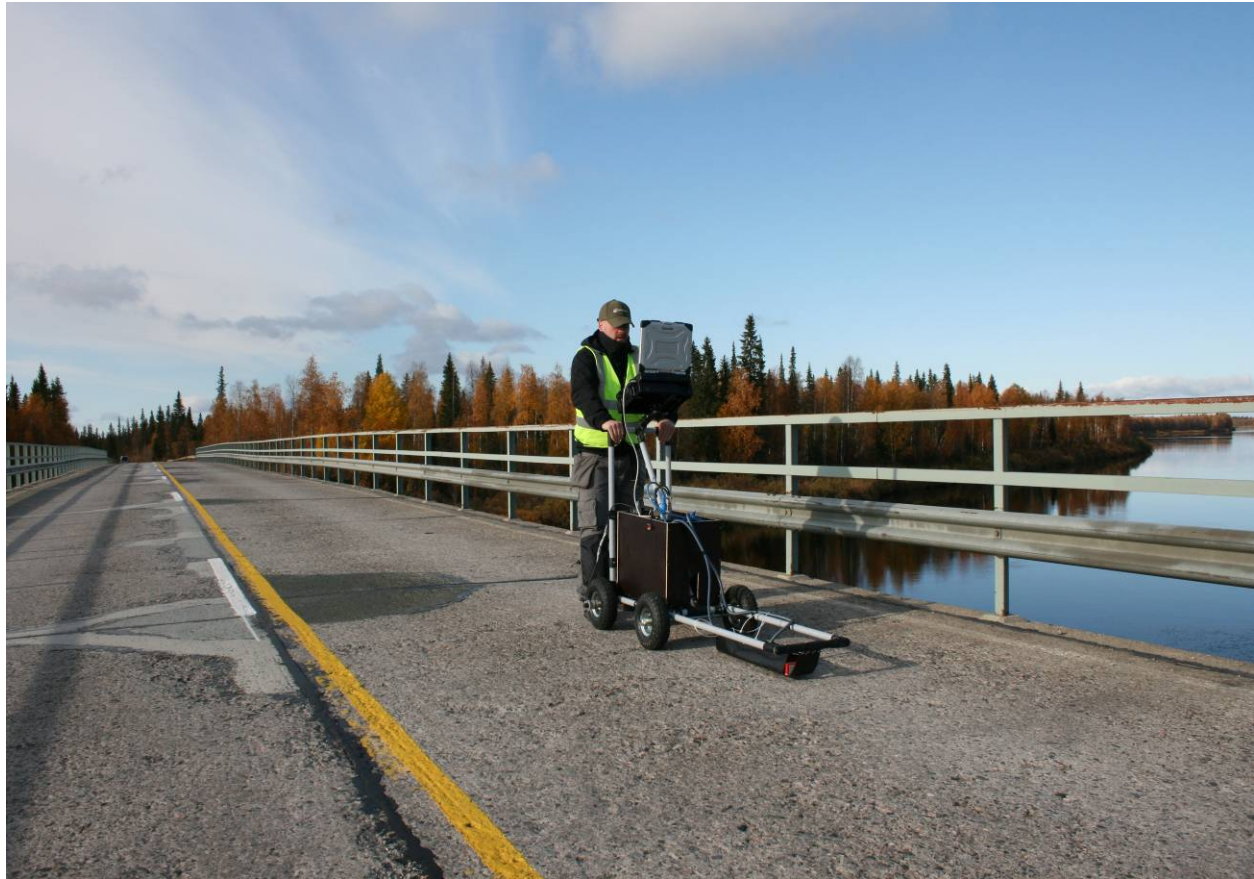
**Figure 1: An example of Bridge GPR deck measurement executed in Finland 2008
(courtesy of Roadscanners Oy)**

According to Saarenketo [20] both high-frequency ground-coupled and air-coupled antennas can be used in bridge deck surveys. Ground-coupled systems can provide very detailed information about the bridge deck's structures and reinforcement bars; however, current systems must be used at slow speed for data collection so that bridge lanes have to be closed during the operation. As such, the use of air-coupled antenna systems, which can perform data collection without causing major traffic problems, is highly recommended especially on high traffic volume roads.

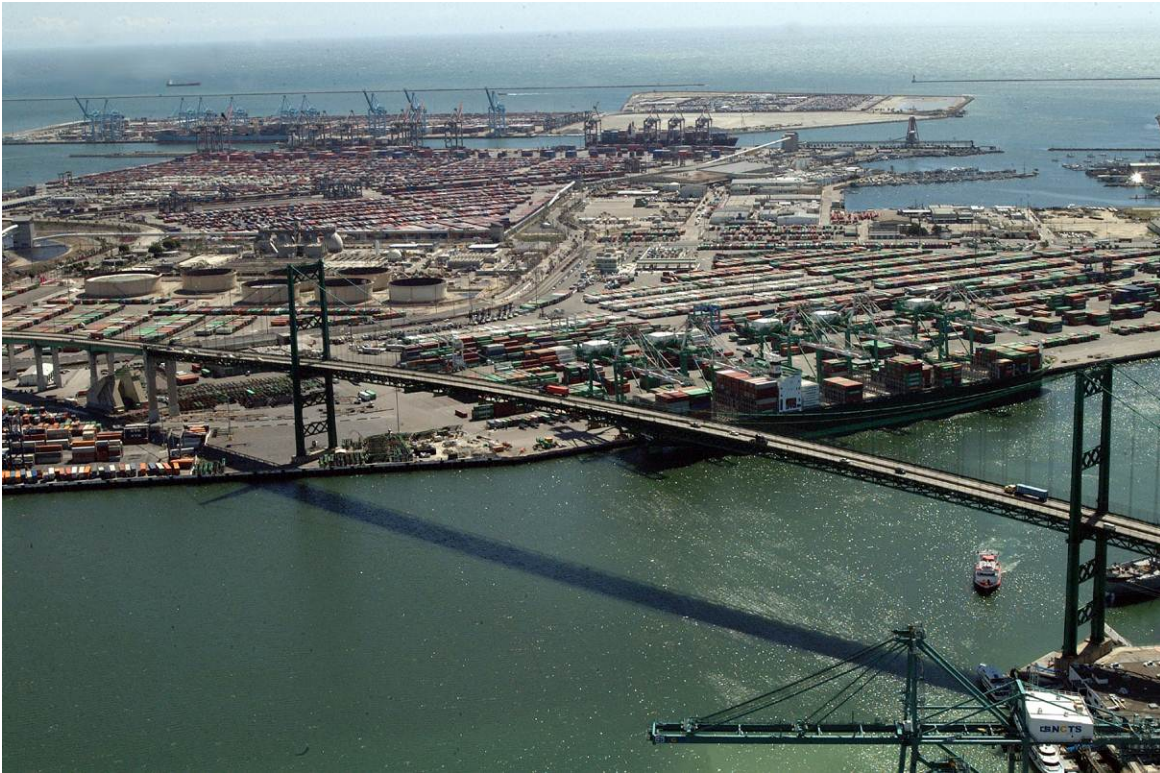
Figure 5: Vincent Thomas Bridge, Los Angeles, California

In California, a test of GPR measurement was executed by Resource International Inc. in 2006 [15] for Caltrans on the Vincent Thomas Bridge, shown in Figure 5. The test focused on the corrosion mechanism of the reinforcing steel. GPR was successful in identifying amount and locations of impending or advanced corrosion conditions that would cause corrosion of reinforcement, change in concrete integrity and chemistry, and damage (such as cracking, delamination, or spalling) to concrete. GPR data was collected at 30 MPH.

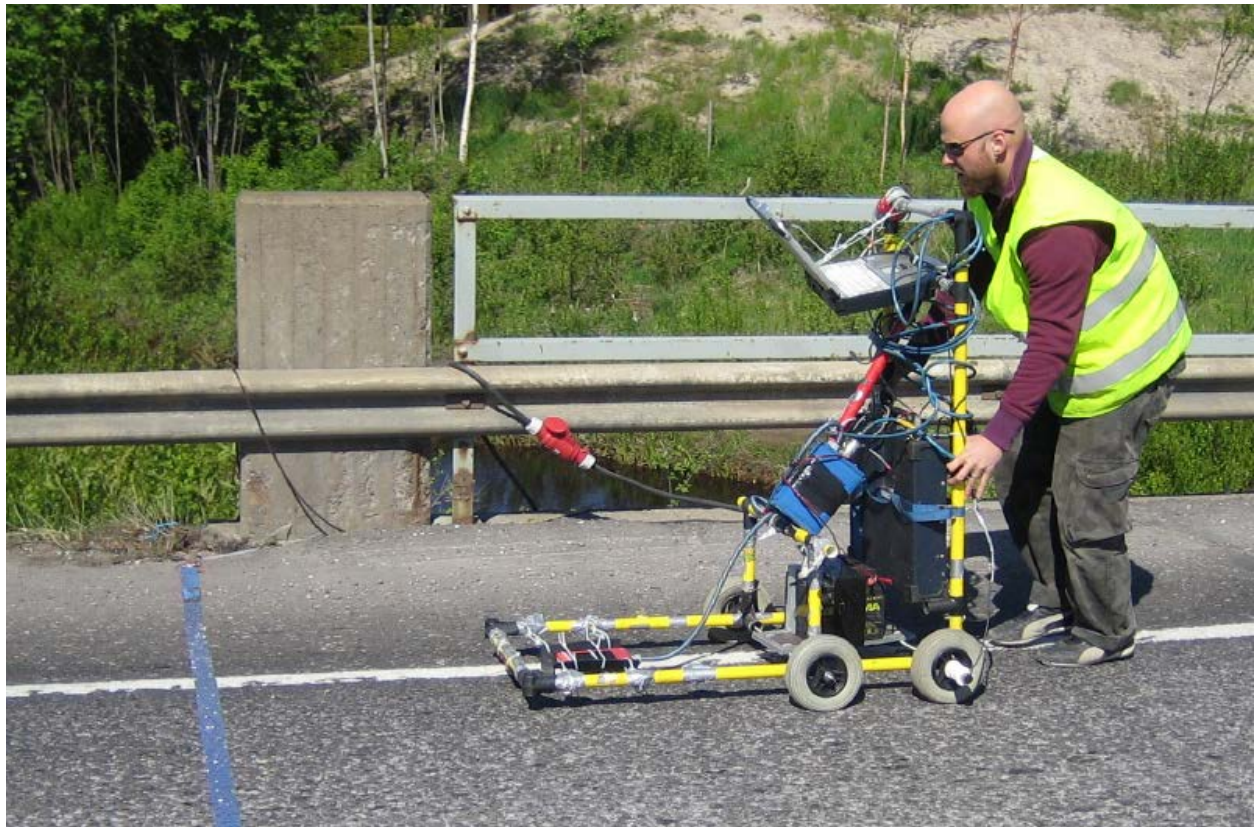
Figure 6: 2D GPR on the Sipoonlahti Bridge, Finland (Courtesy of Roadscanners Oy)

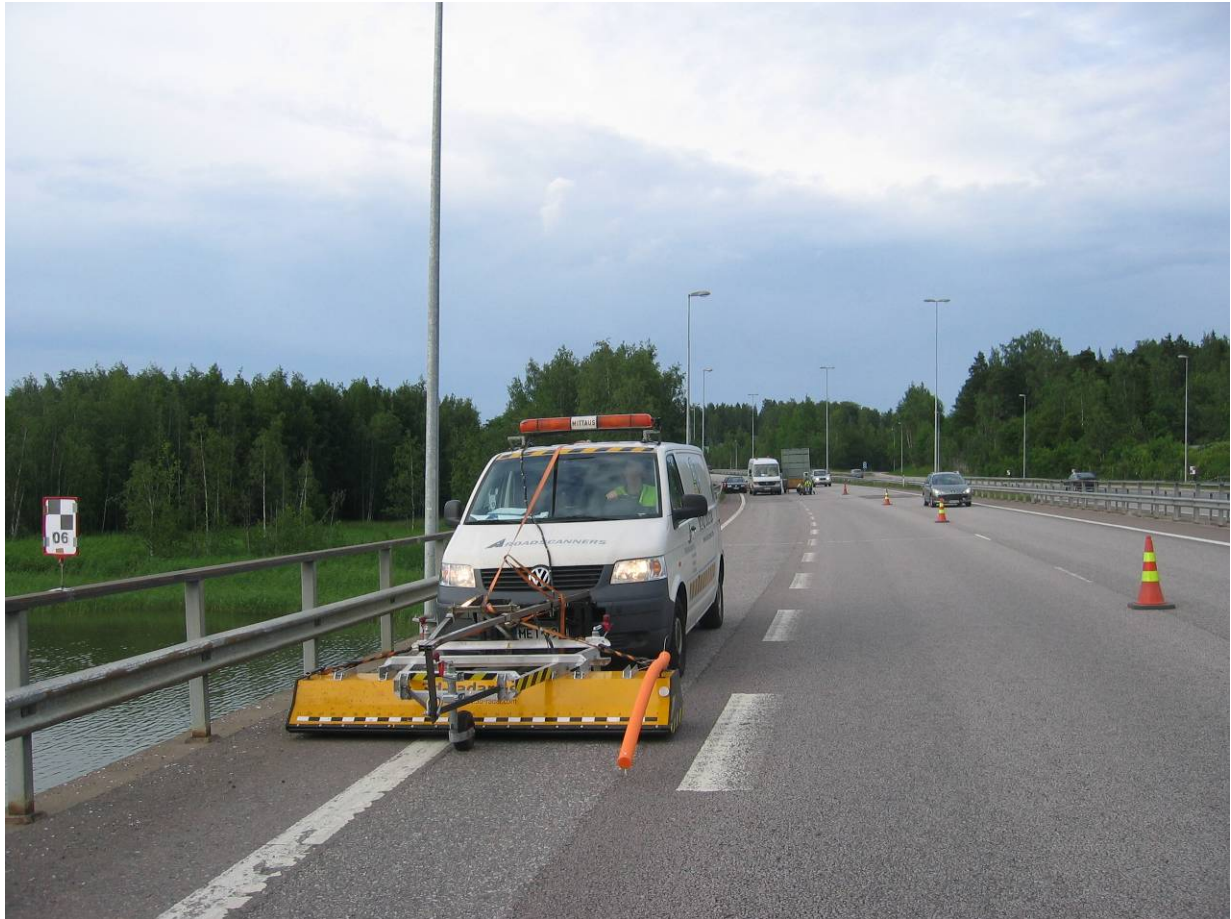
Figure 7: 3D GPR on the Sipoonlahti Bridge, Finland (Courtesy of Roadscanners Oy)

During the GPR measurements, weaknesses were observed in the 3D GPR measurements (Antenna Technology of 3D Radar AS, Norway, 16 antennas with the interval of 15 cm, 100 measurement/m, frequency range 150 MHz–2 GHz) and interpretation of the observations. Therefore also 2D GPR (GSSI Inc. SIR-20 Antenna, 1.5 GHz, frequency range 250 MHz - 3.75 GHz) measurement method was used in the research. All of the seven bridges, except one (Sipoonlahti U-1250 N), were measured by using both 3D and 2D GPR method. Compared to the aims, the following conclusions were made based on the experiences achieved in the research:

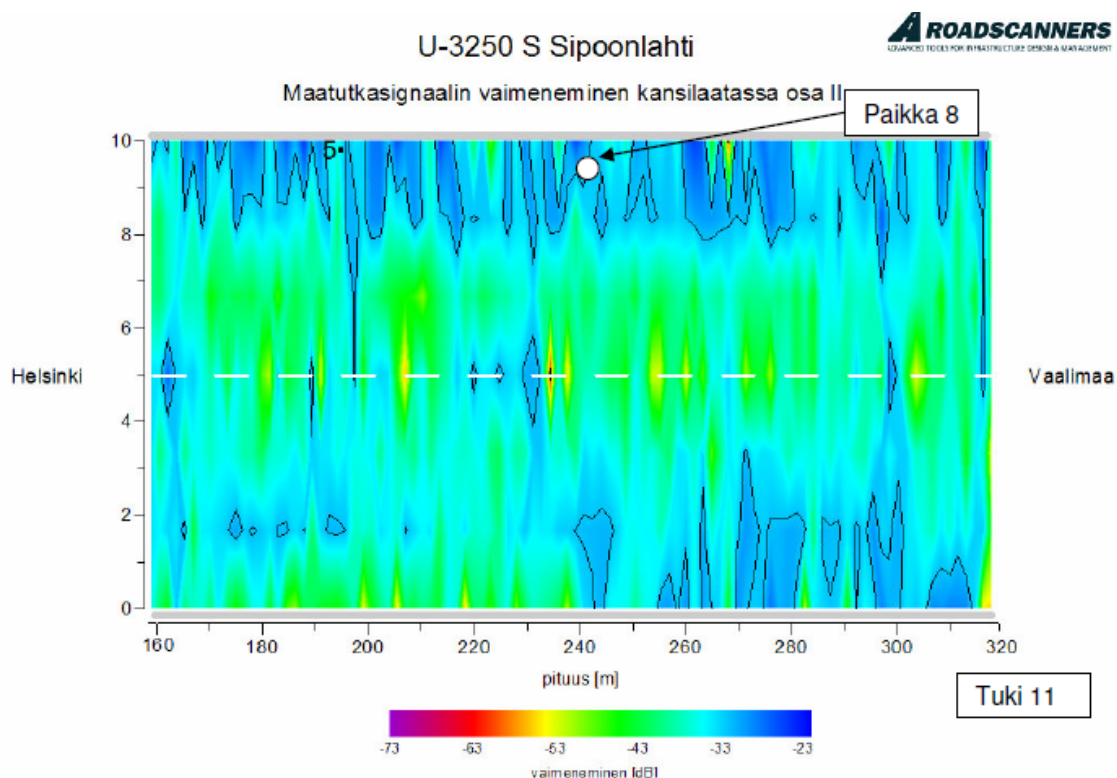
Figure 8: An example of the moisture content in the area of the concrete deck of U-3250 Bridge, measured by 2D GPR method, Finland 2007 (Courtesy of Roadscanners Oy)

3) *The variety of moisture content in different areas and parts of the concrete deck.* This was found to be very difficult without the use of GPR measurement. Based on the thin-section research some individual and partial estimates can be made indicating also increased water moisture in that area. The use of 2D GPR was evaluated to produce reliable results.

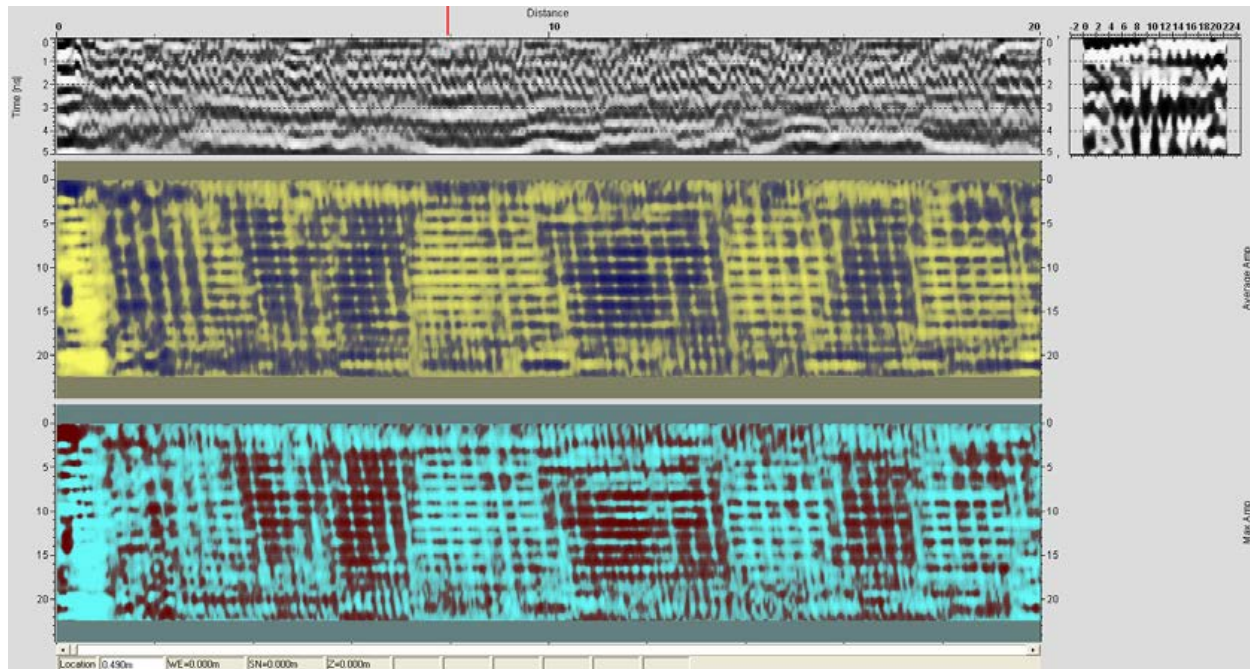
Figure 9: View of 3D bridge data. (Courtesy of Roadscanners Oy).

Figure 9 shows a view of 3D bridge data. The topmost bar is the 3D GPR data from one antenna. On the right is a cross-section profile of the bridge. The two colored bars underneath the 3D GPR data are plane views of reinforcement in the concrete deck slab. Figure 10 provides data for pavement thickness of a bridge in Finland. The deterioration map of the concrete deck slab of

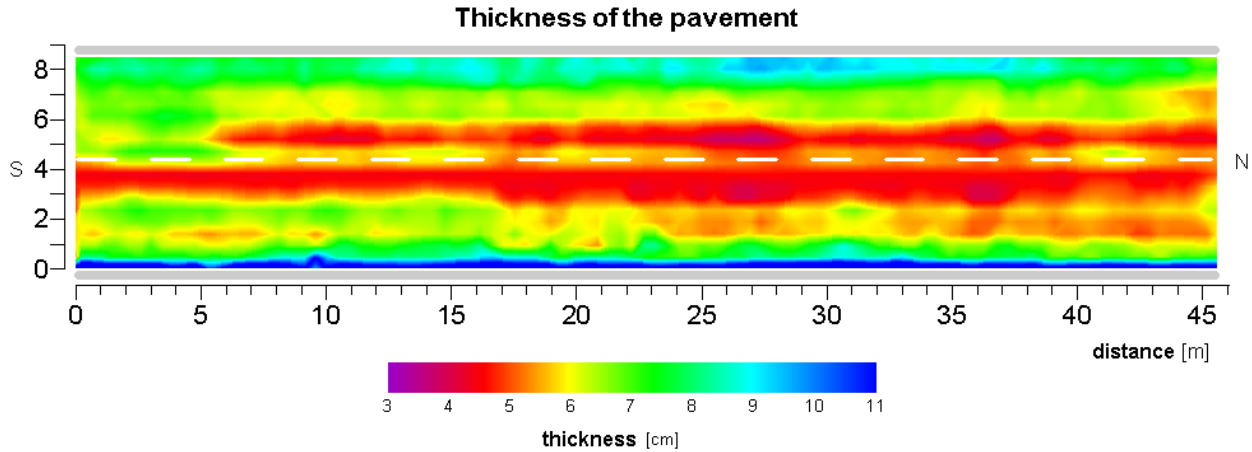
Figure 10: Pavement thickness of a bridge in Finland. (Courtesy of Roadscanners Oy).

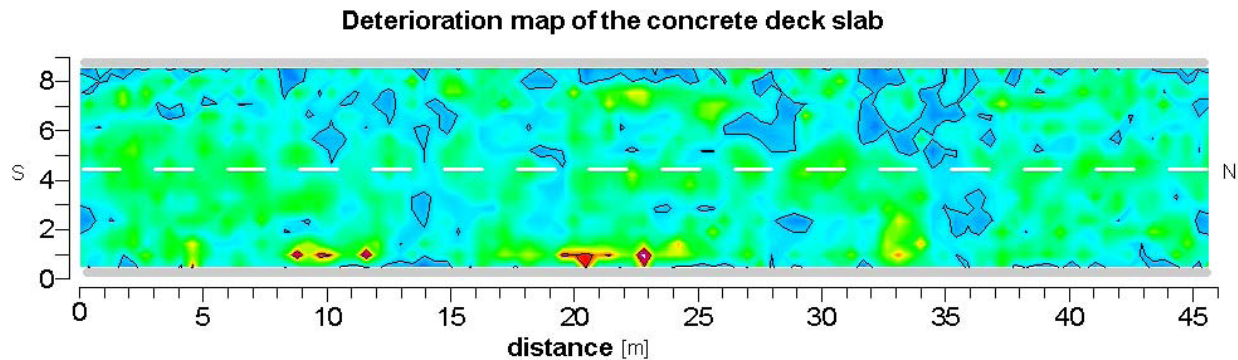
Figure 11: Deterioration map of the bridge deck slab. (Courtesy of Roadscanners Oy).

this bridge is shown in Figure 11. The pavement layer of the bridge is clearly worn out mostly in the left wheel paths. This is because the right wheel path is patched. Blue areas in the deterioration map of the bridge deck slab indicate possible moisture in concrete. The red areas indicate possible other damage like corrosion in the reinforcement. The green areas are found good. Moisture can be detected from both edges of the bridge and from both construction joints and from the abutments at 14 m and 35 m.

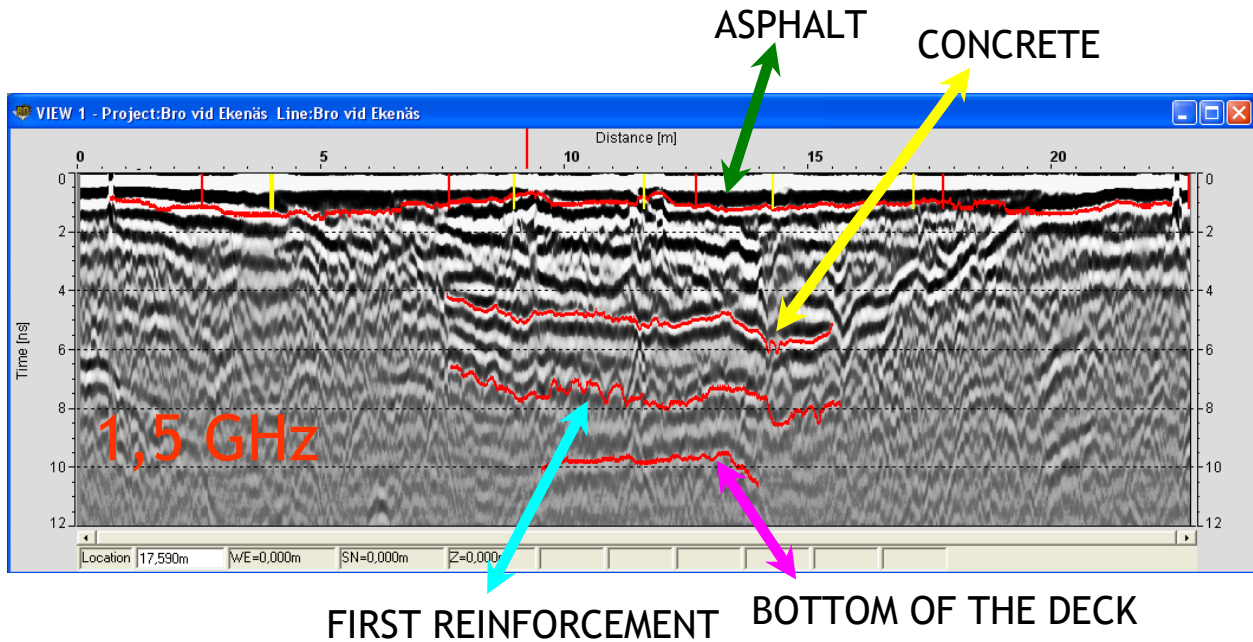
Figure 12: BRO vid Ekenäs bridge: interpretation of the fundamental GPR quantities (Courtesy of Roadscanners Oy)

Examples of GPR imagery and deliverables from the BRO vid Ekenäs bridge measured in Sweden in 2008 by Roadscanners Oy are presented in Figures 12 – 14.

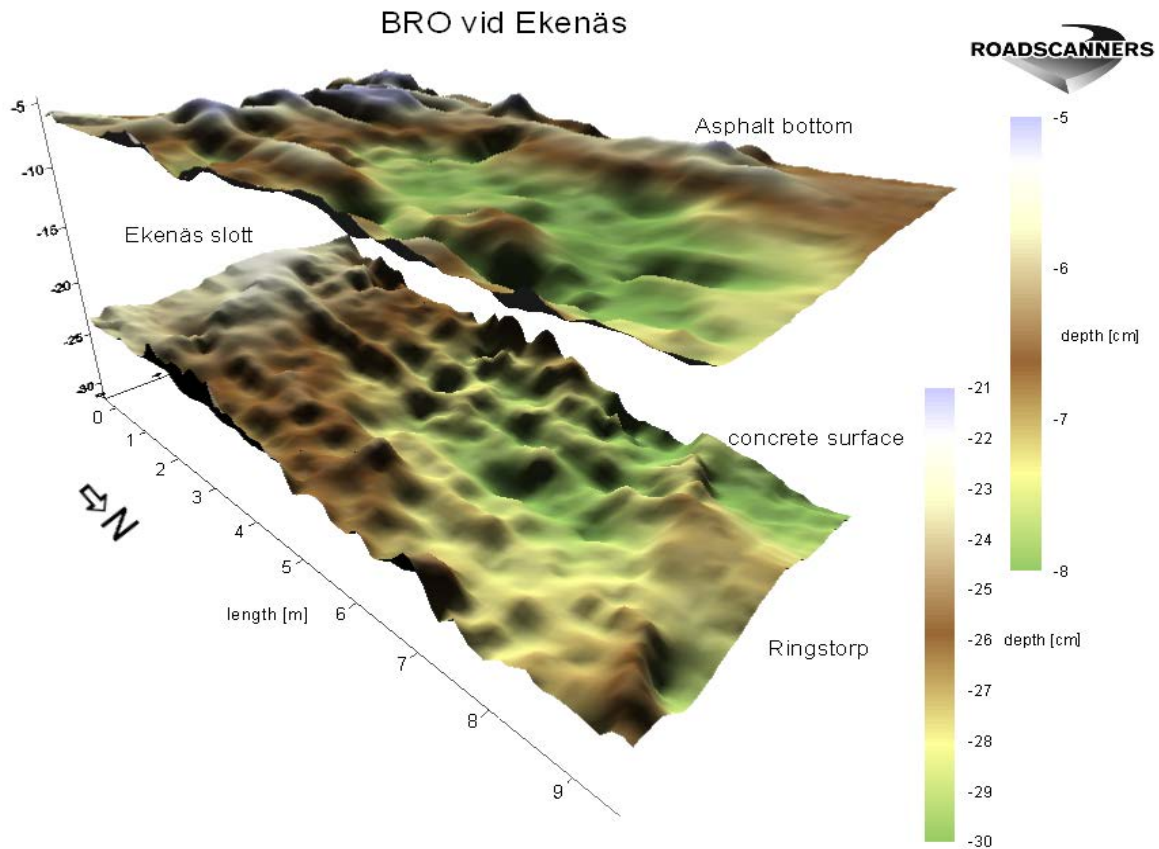
Figure 13: BRO vid Ekenäs bridge: derivative quantities of the surfaces of asphalt bottom and upper concrete layers. (Courtesy of Roadscanners Oy)

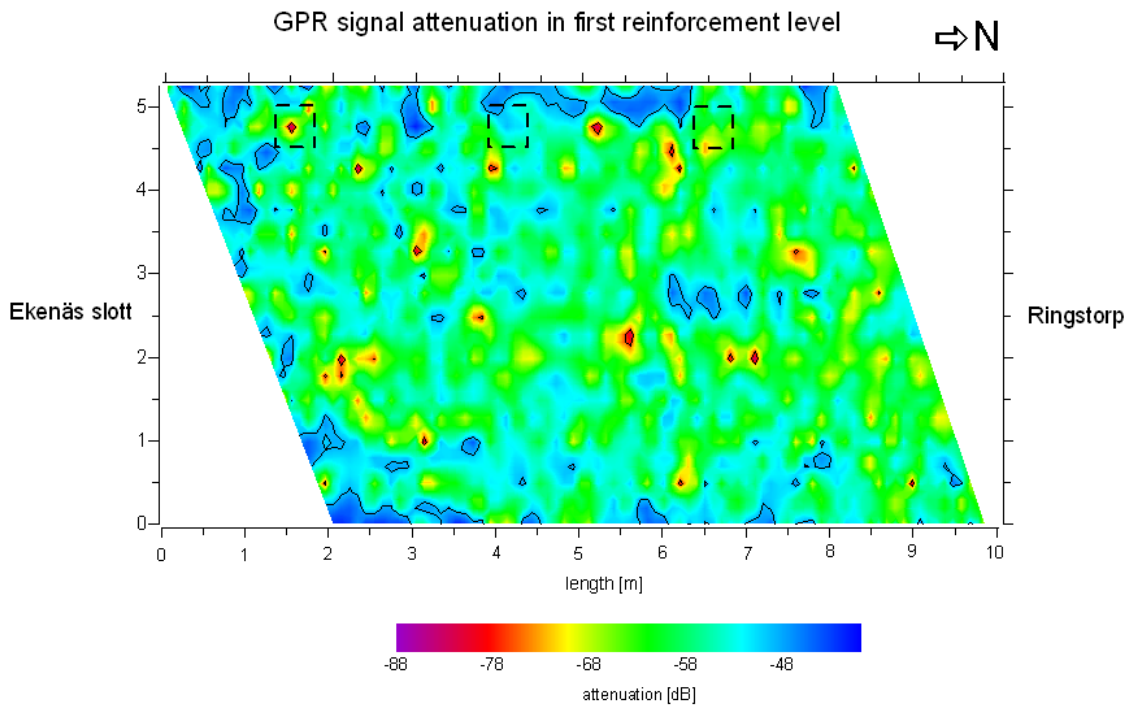
Figure 14: BRO vid Ekenäs bridge: signal attenuation in the first reinforcement level. (Courtesy of Roadscanners Oy)

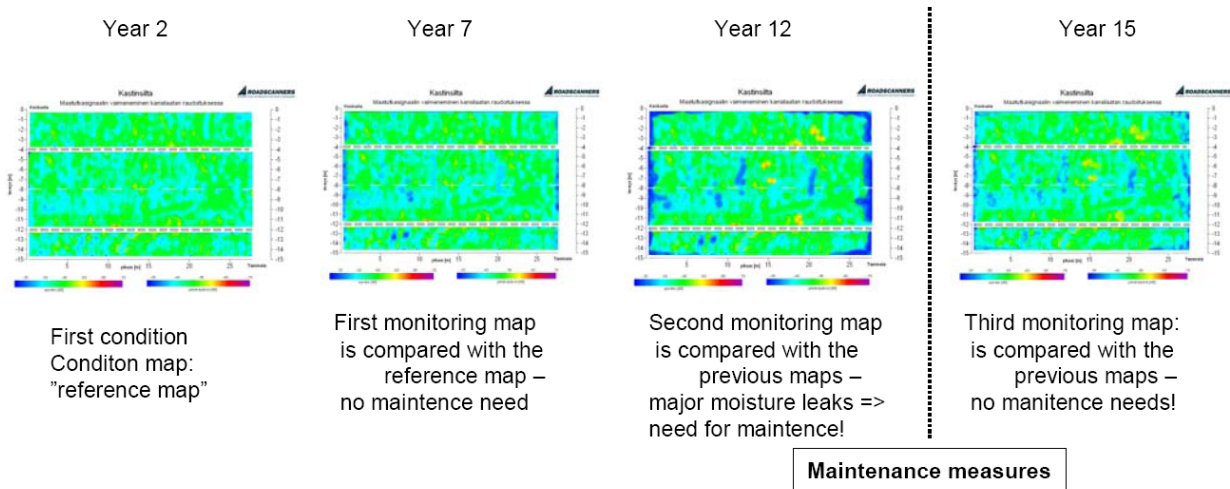
Figure 15: Concept for long-term health monitoring with GPR (Saarenketo, Roadscanners Oy)

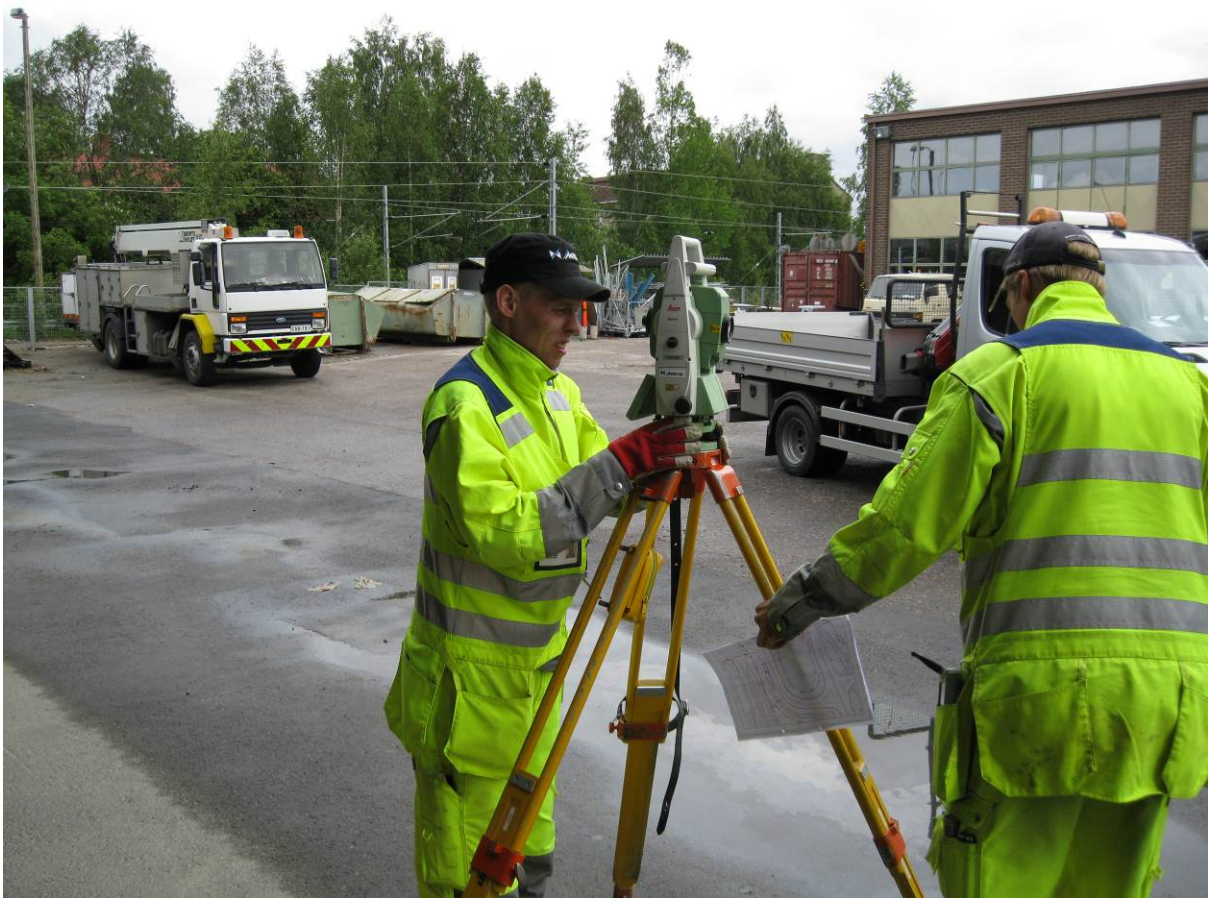
Figure 18: Leica TCRP 1200 total station

The coordinate transformation to the site coordination system was determined by measuring the three fixed points using Leica TCRP 1200 total station (Figure 18). The same points were also measured by the Trimble R8 RTK-GNSS system to determine the same transformation to the GPR measurement system.

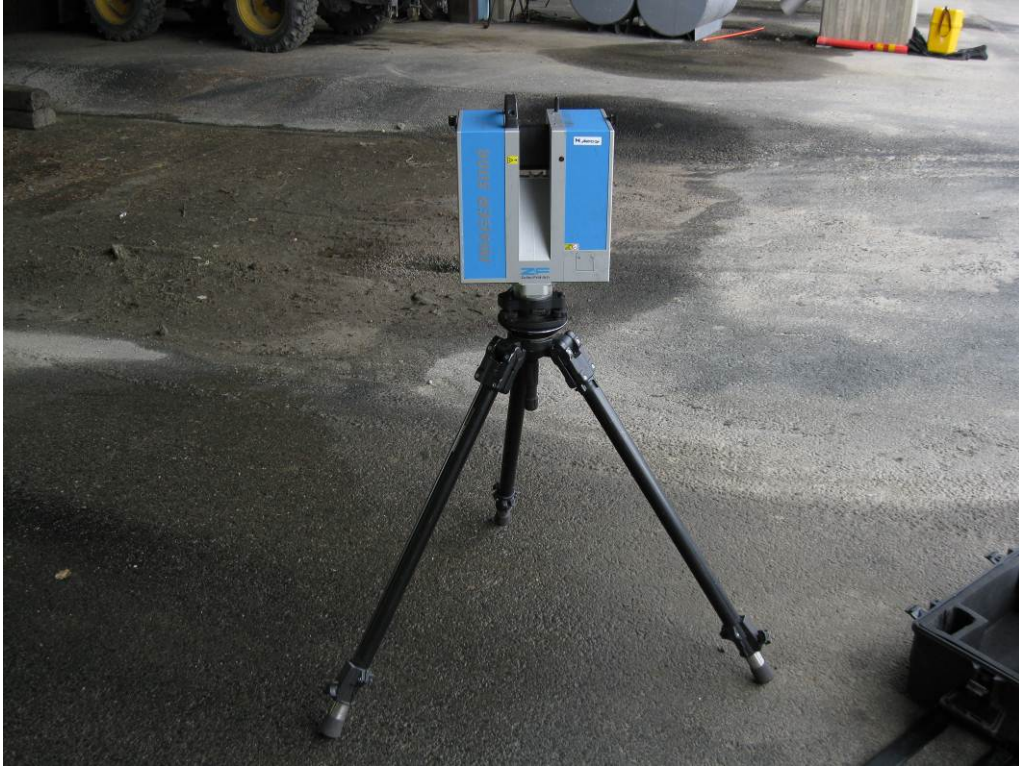
Figure 19: The laser scanning was executed using the Zöller & Fröhlich Imager 5006 system by a measurement consultant (Mitta Oy)

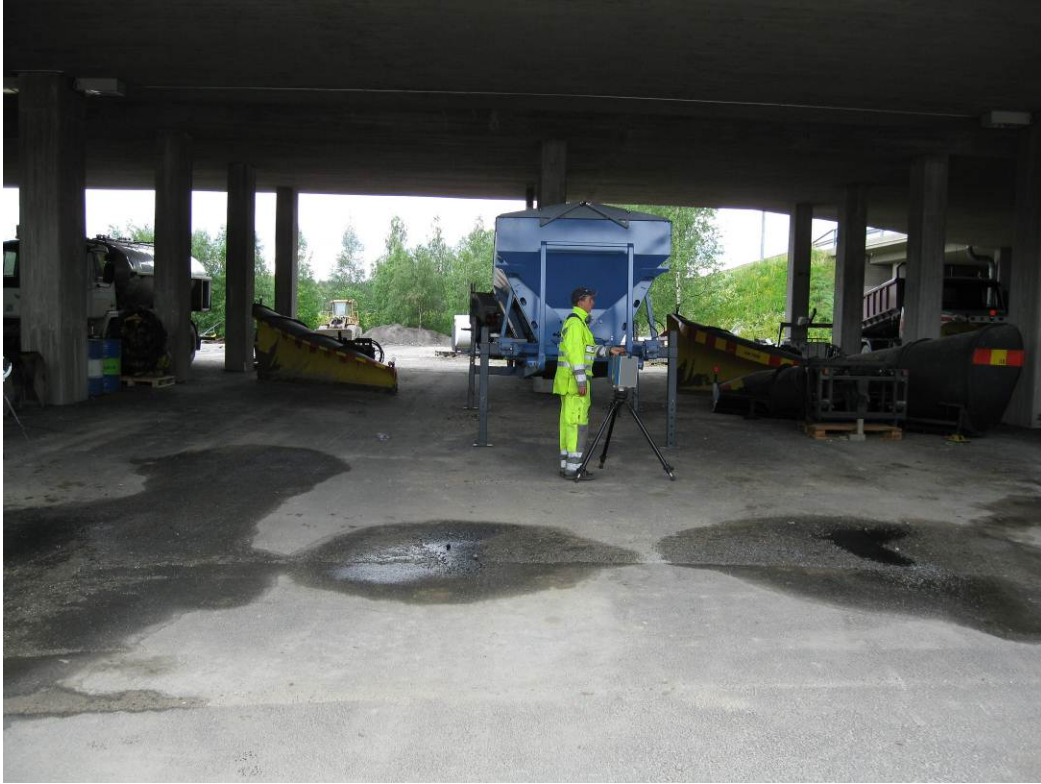
Figure 20: Measuring under the bridge deck

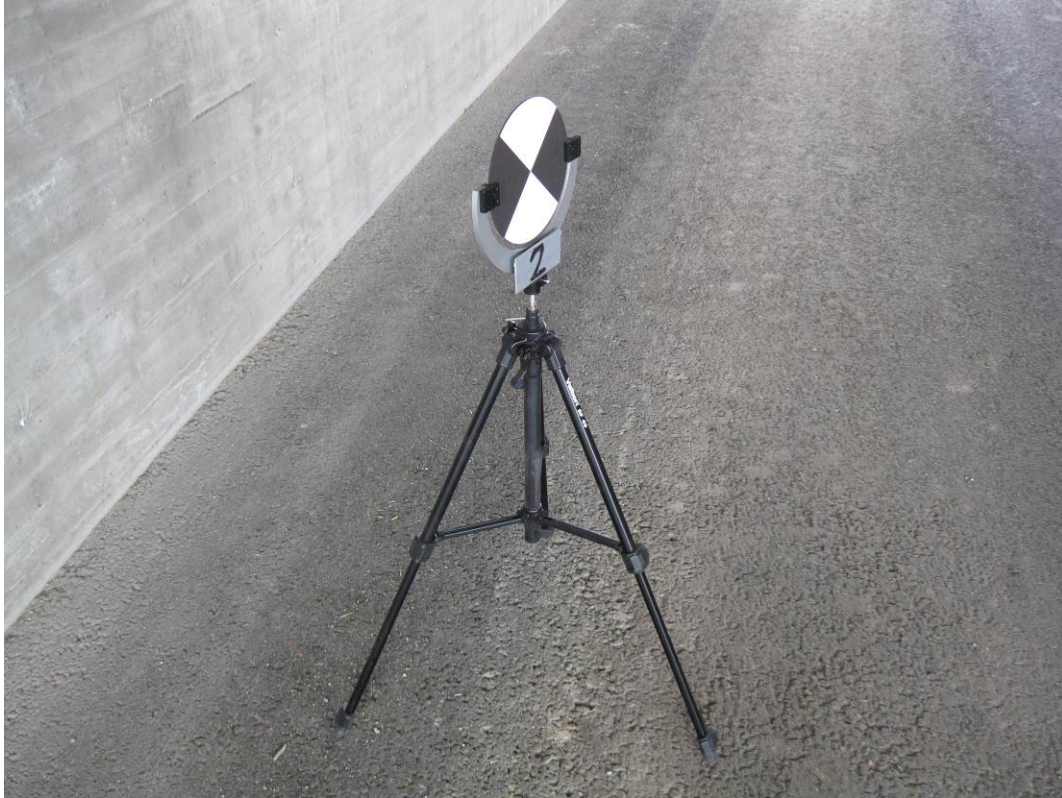
Figure 21: One of the target points of the laser scanning system

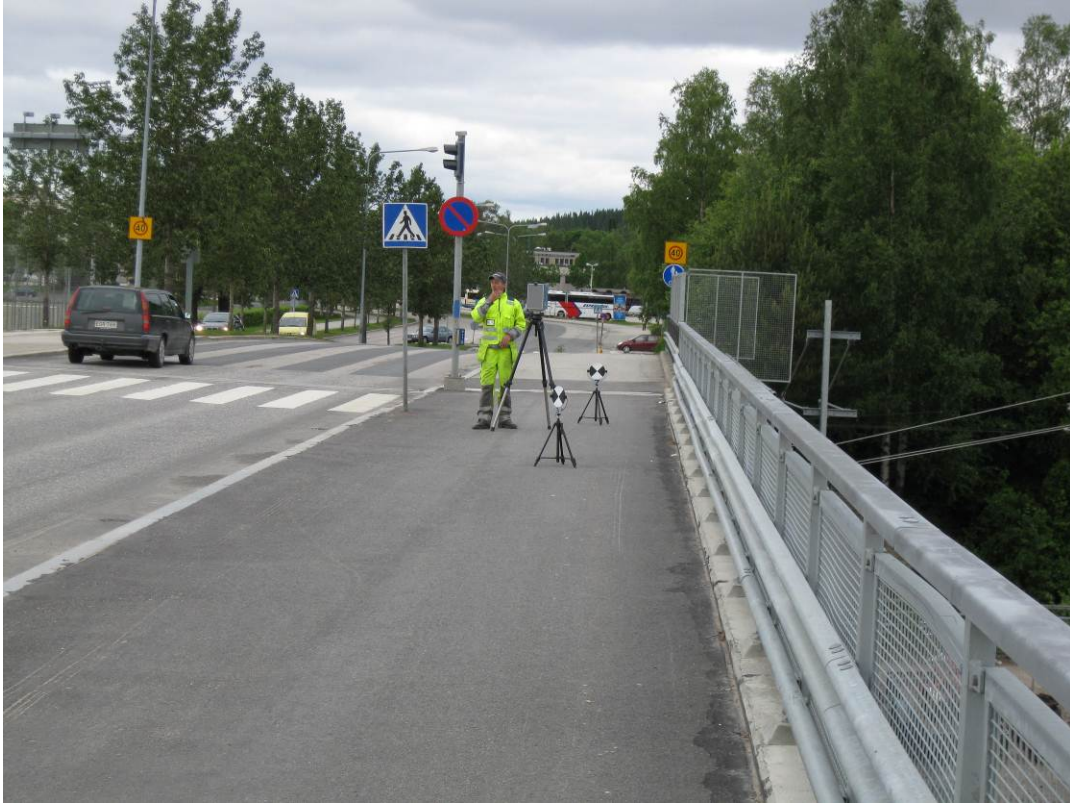
Figure 22: Laser scanning on the bridge deck

The geometry of the bridge was measured by laser scanning the visible surfaces by a Zöller & Fröhlich Imager 5006 laser scanning system (see Figure 19) (measurement speed 500,000 points/s, maximum range 79 m, accuracy of single point measurement varies typically $\pm 2... \pm 7.5$ mm depending the distance as well as color of the object). Nineteen (19) different scans were executed up and down the bridge deck. The point clouds measured were transformed to the coordinate system of the bridge using target points. The registration was made by Laser Control software of the Zöller & Fröhlich system. The results were compared to the earlier laser scans made in 2007 during the construction phase of the bridge.

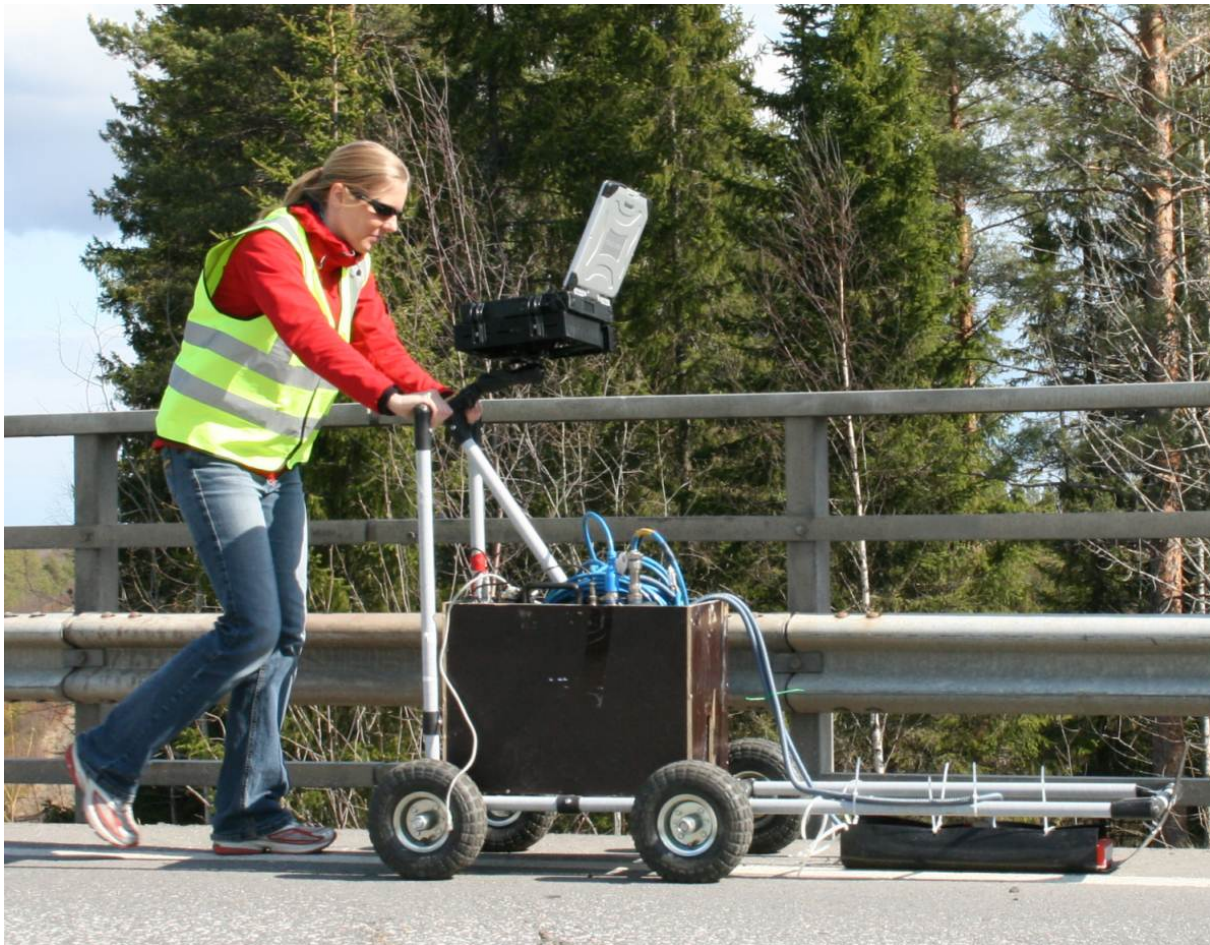
Figure 23: The GPR measurement was made using the GPR system of GSSI (this photo is from a different bridge, Courtesy of Roadscanners Oy)

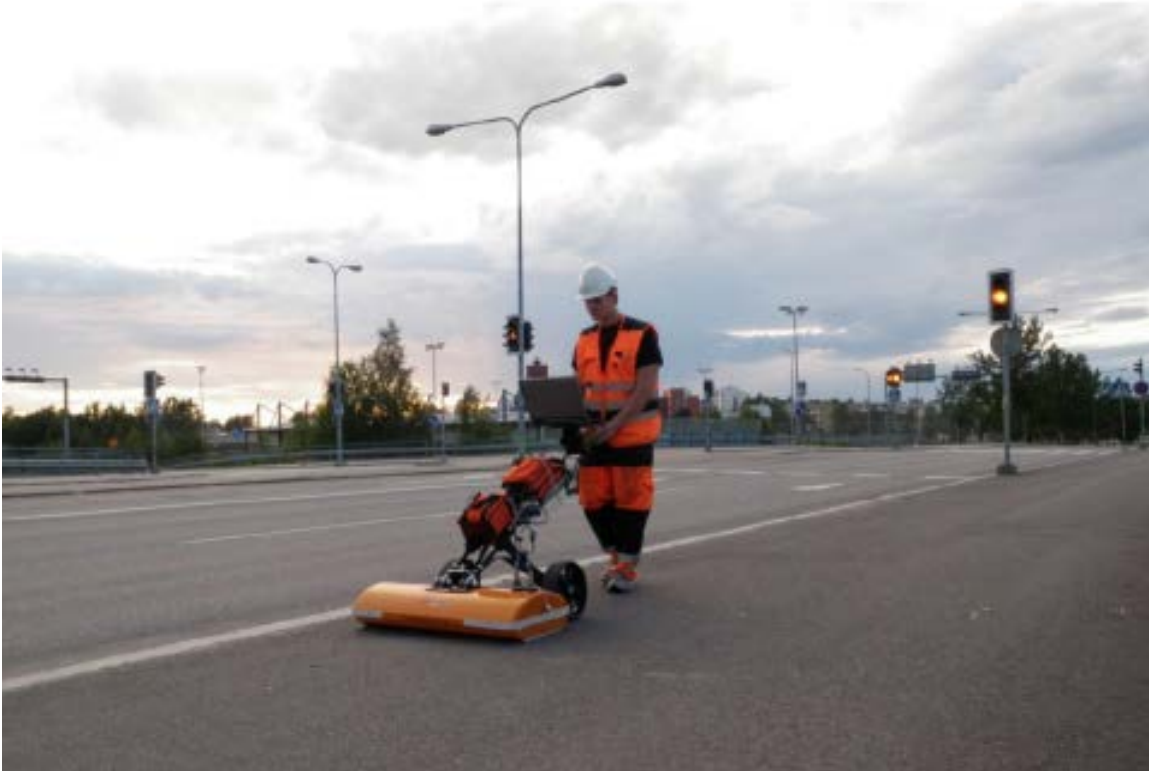
Figure 24: The deck was also measured using the new system of IDS (Ingegneria dei Sistemia Inc., Roadscanners)

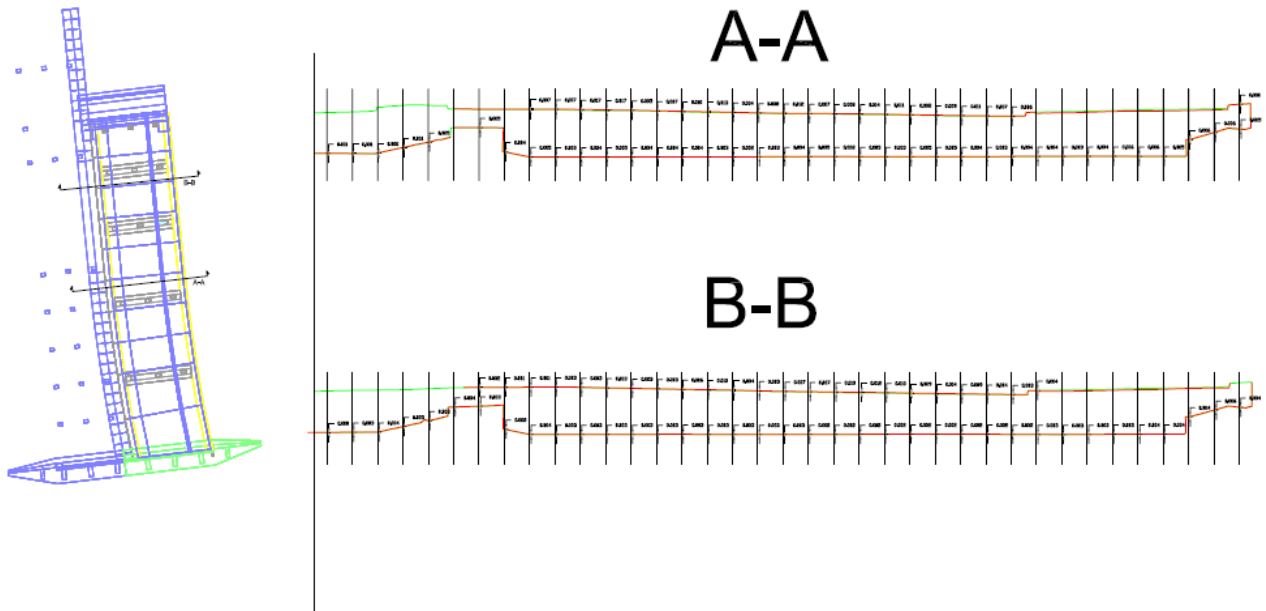
Figure 25: The comparison of the laser scanned results (cross sections A and B) measured in 2009 and 2007

According to the laser scanning results, the deck of the bridge has settled when comparing to the results made in 2007. The deformation and tracking due to the traffic can be observed from the laser scanned point cloud.

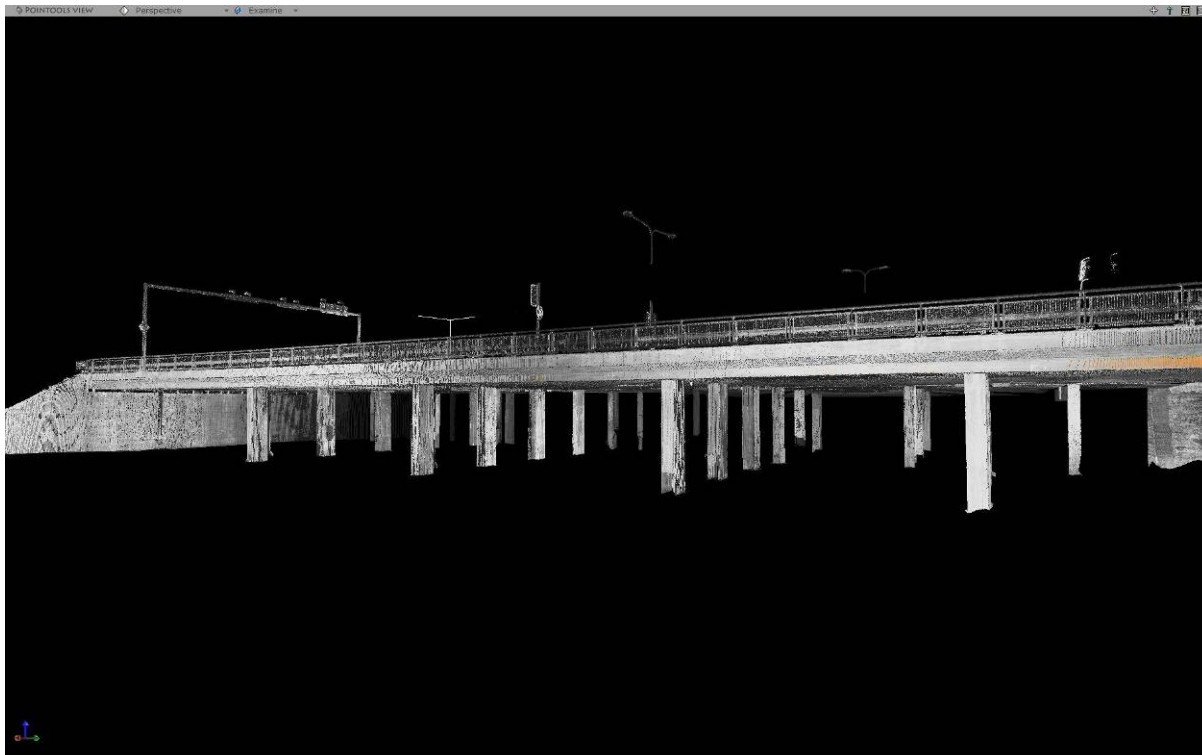
Figure 30: The final point cloud of the new 2009 measurement

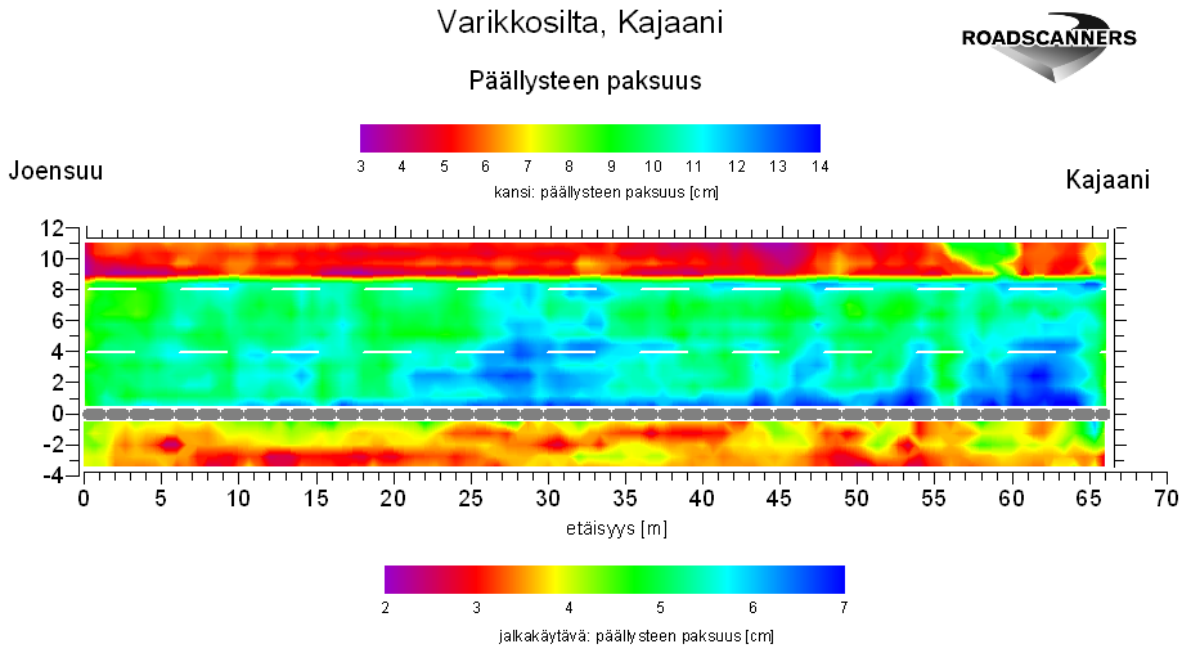
According the results, the thickness of the asphalt layer was 9-11 cm. The thickness of the west lane was only 5-6 cm. The most thickness was observed from the East lane, where it was 12-14 cm. On the sidewalks the thickness was only 3-4 cm.

Figure 31: The thickness of the pavement measured by the GPR method (Courtesy of Roadscanners Oy).

From the raw data the thickness of the asphalt layer and the upper reflexes of reinforcement were analyzed. The signal absorption of the reflexes of reinforcement were calculated and illustrated onto the map picture below so that possible damaged areas can be positioned. The results are calculated from the results of 1.5 GHz and 2.6 GHz observations. For the interpretation the laser scanning report and some extra pictures were utilized.

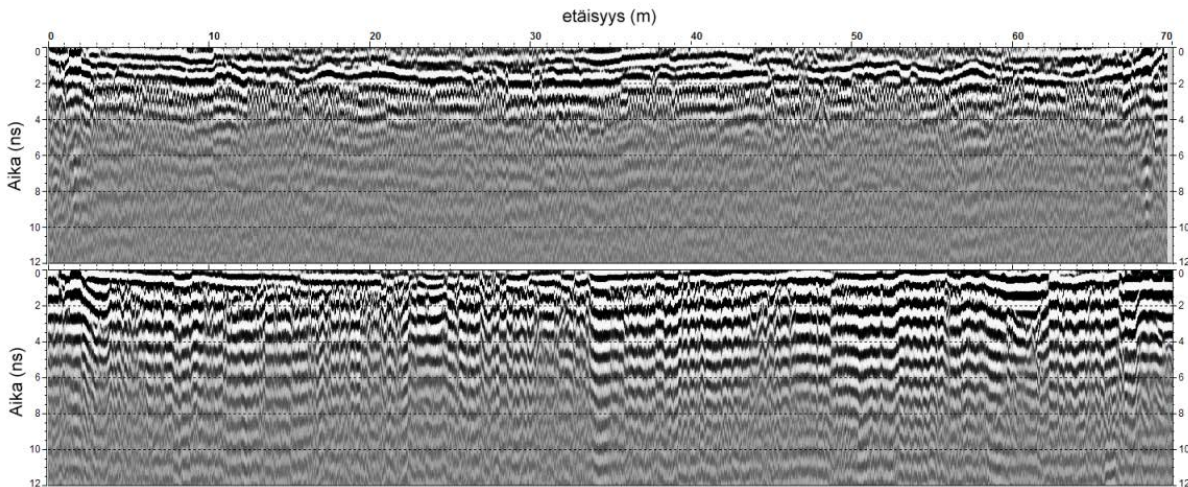
Figure 32: Two slitting from the GPR observations (frequency 1,5 GHz). The upper picture is from the right lane of the bridge (when driving towards Kajaani), and lower picture from the left lane including also larger noise among the observations making it difficult to observe different structures (Roadscanners Oy).

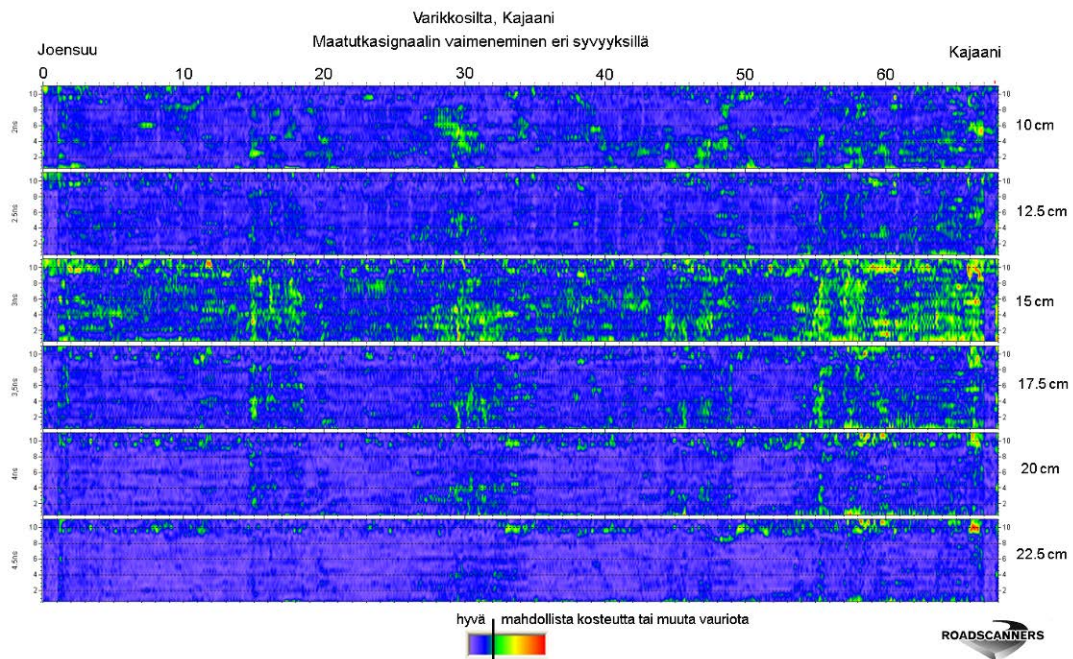
The absorption (degradation) of GPR signals were calculated using Road Doctor software. The first reinforcement was located 15 cm from the upper surface of the deck. The positions of the main foundations can be seen from the observations. In the left side of the left there was observed clear anomaly due to moisture or some other structure.

Figure 34: Absorption of the GPR signal at different depths in the deck below driving lanes (Courtesy of Roadscanners Oy).
