1. Report No. CA09-1645		2. Government Accession No.		3. Recipient's Catalog No.	
4. Title and Subtitle Investigation of Ground-Penetrating Radar (GPR) Technology for the Health of Bridge Decks: Phase I – Feasibility Testing				5. Report Date September 30, 2009

6. Performing Organization Code	
7. Author(s): R. Heikkilä, K. Yen, B. Ravani, and T. Lasky				8. Performing Organization Report No. UCD-ARR-09-09-30-05

9. Performing Organization Name and Address AHMCT Research Center UCD Dept. of Mechanical & Aerospace Engineering Davis, California 95616-5294				10. Work Unit No. (TRAIS)

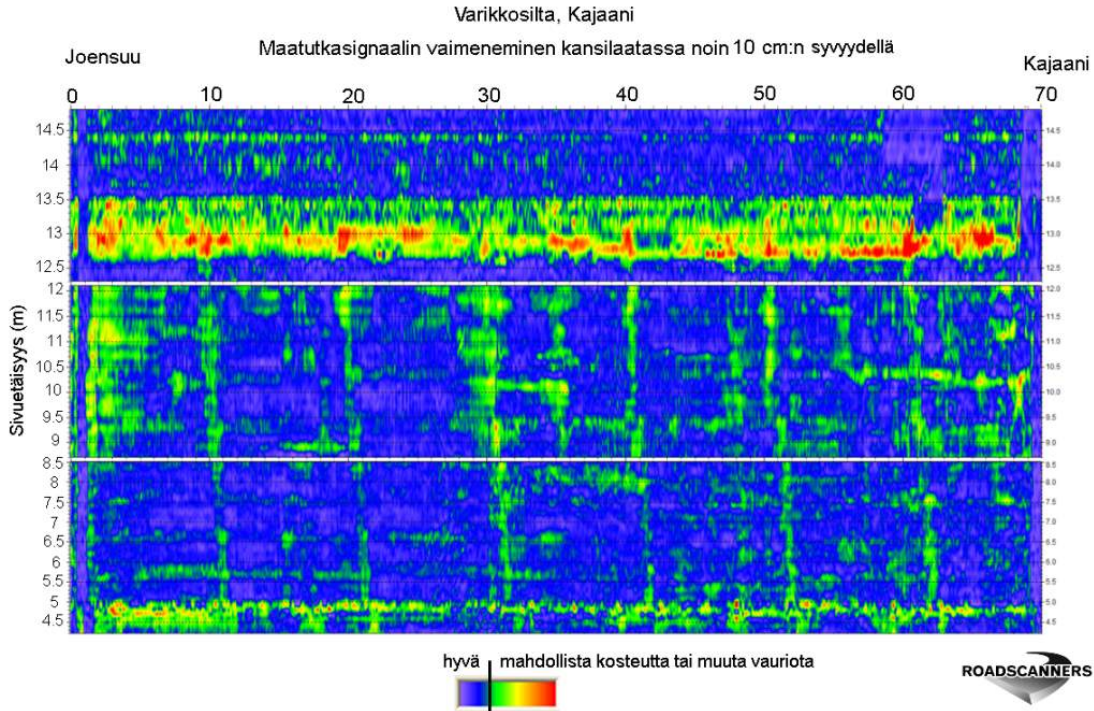
The complete analysis of the IDS measurement results is not included in this report. The absorption (degradation) of some GPR signals by IDS was calculated by the Road Doctor software. According to the Roadscanners the results seemed to be very good and correlated also with GSSI results, but were even more accurate.

Figure 35: Absorption of IDS device GPR signal at different depths in the deck below driving lanes (Courtesy of Roadscanners Oy).
