1. Report No. CA15-1648 FHWA-TPF-5(166)		2. Government Accession No.		3. Recipient's Catalog No.	
4. Title and Subtitle  Application of Three-Dimensional Laser Scanning for the Identification, Evaluation, and Management of Unstable Highway Slopes				5. Report Date March 2015

# **Application of Three-Dimensional Laser Scanning for the Identification, Evaluation, and Management of Unstable Highway Slopes**

**Pooled Fund Study  
Final Report TPF-5(166)  
March 2015**

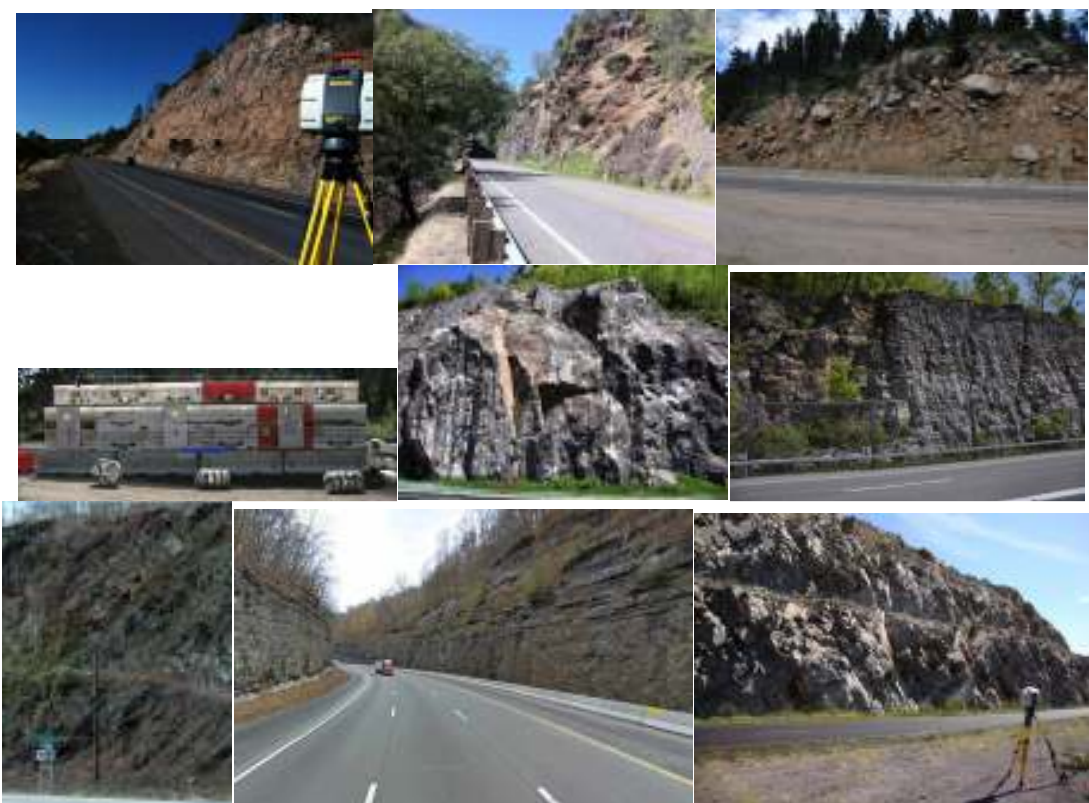
**Figure 5. Nine sites were selected for the LIDAR pooled fund study. Top row, left to right: Arizona, California, and Colorado Site 1. Middle row: Colorado Site 2 (an artificial rock surface), New Hampshire, and New York. Bottom row: Pennsylvania, Tennessee, and Texas.**

Table 3 and Figure 5 show that eight of the nine sites are highway rock slopes, and one site is an artificial “slope” consisting of jersey and plastic barriers. The eight rock slopes cover a wide variety of rock types and slope conditions. In general, the rock slopes were selected because of geotechnical issues. Some of these issues are apparent in the photos in Figure 5. For example, the New Hampshire site shows wedge and plane failures that have occurred, and the Tennessee site shows overhanging sandstone slabs posing a hazard to the interstate highway below. The Colorado site is an ancient landslide deposit and the large boulders are prone to toppling, as shown in Figure 6a.

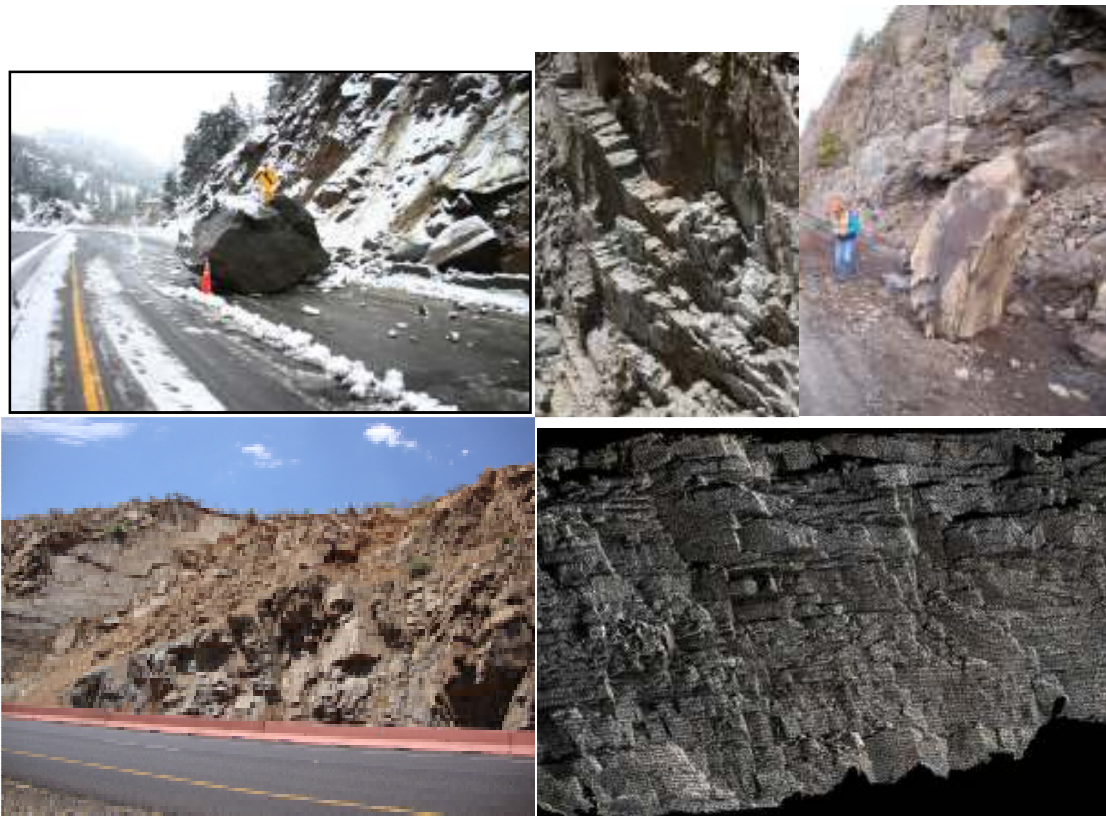
**Figure 6. Images showing geotechnical issues associated with some of the pooled fund sites: top row, left to right, rockfall at one Colorado site, toppling at the California site, and rockfall at the Arizona site. Bottom left shows wedge failure at the Texas site, and bottom right shows overhangs at the New York site (Photos courtesy of CDOT).**

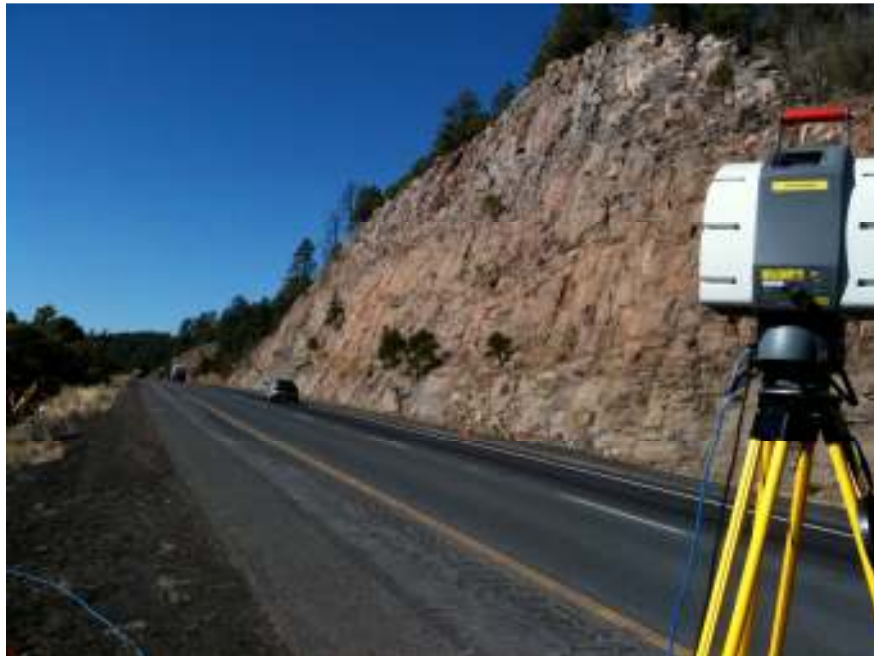
**Figure 7. The Arizona site, showing the Leica scanner used to conduct scans.**

The Arizona site is a rock slope next to the westbound lane of Interstate 40 at milepost 180.1. The site is about 11 miles west of Flagstaff, Arizona, and about 18 miles east of Williams, Arizona. A picture of the site is shown in Figure 7.

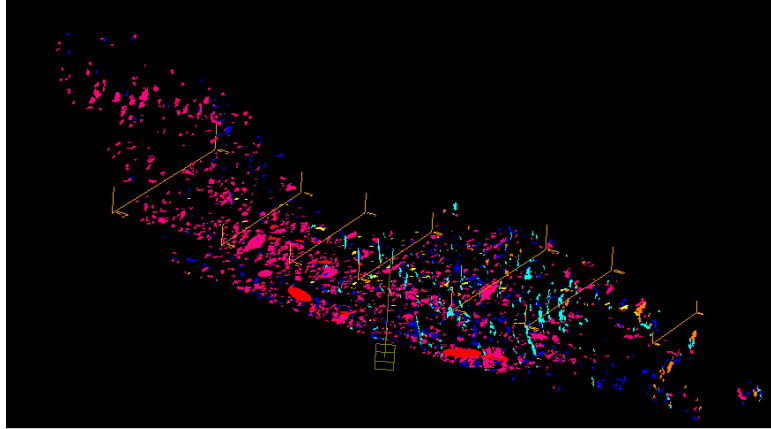
**Figure 8c. The delineated fractures in Scan 2.**

For example, the approximate location of Scan 2 is shown in Figure 8a, and the color point cloud of Scan 2 is shown in Figure 8b. The length of this point cloud is about 503 ft, the height ranges from 60 to over 100 ft, and the point cloud contains about 4 million points. The average dip of the rock slope in Scan 2 is 65.5 degrees and the average dip direction is 208.1 degrees. The delineated fracture surfaces and traces from this point cloud are shown in Figure 8c.

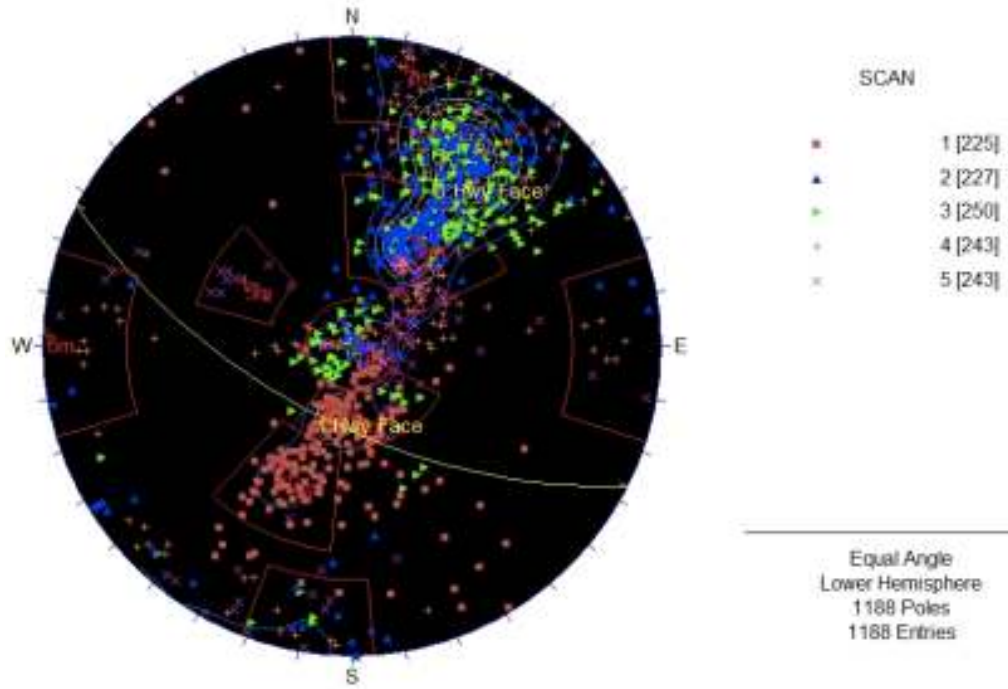
Figure 9a. Combined fractures from Scans 1-5, separated by scan.

The stereonet results from Scans 1-5 have been combined into a single stereonet and are shown in Figures 9a and 9b. In Figure 9a, the icons in the stereonet are differentiated by scan number (1-5). It shows that some of the geologic structure shows up only in one or two of the scans, while other structure shows up across the entire slope. In Figure 9b, the icons in the stereonet are differentiated by set number (1-8). Eight primary joint sets have been determined from the combined data, and the mean orientation and the Fisher constant for each set are given in Table 6. In addition to these eight sets, there are a number of fractures that are not assigned to any set (gray triangles in Figure 9b). Most of these are blasting fractures that are sub-parallel to the slope. The average orientation of the highway is also shown in Figures 9a and 9b. Figure 10 shows how the blasting fractures emanate from the blast hole half-casts, and also how the blasting fractures interact with natural fractures in the rock mass. The results in Figure 9 show that the geologic structure is complex and contains several sets of subvertical cooling joints, as well as subhorizontal discontinuities and several sets of discontinuities that dip adversely and may be prone to plane and wedge sliding. This is discussed further in the section on slope stability.

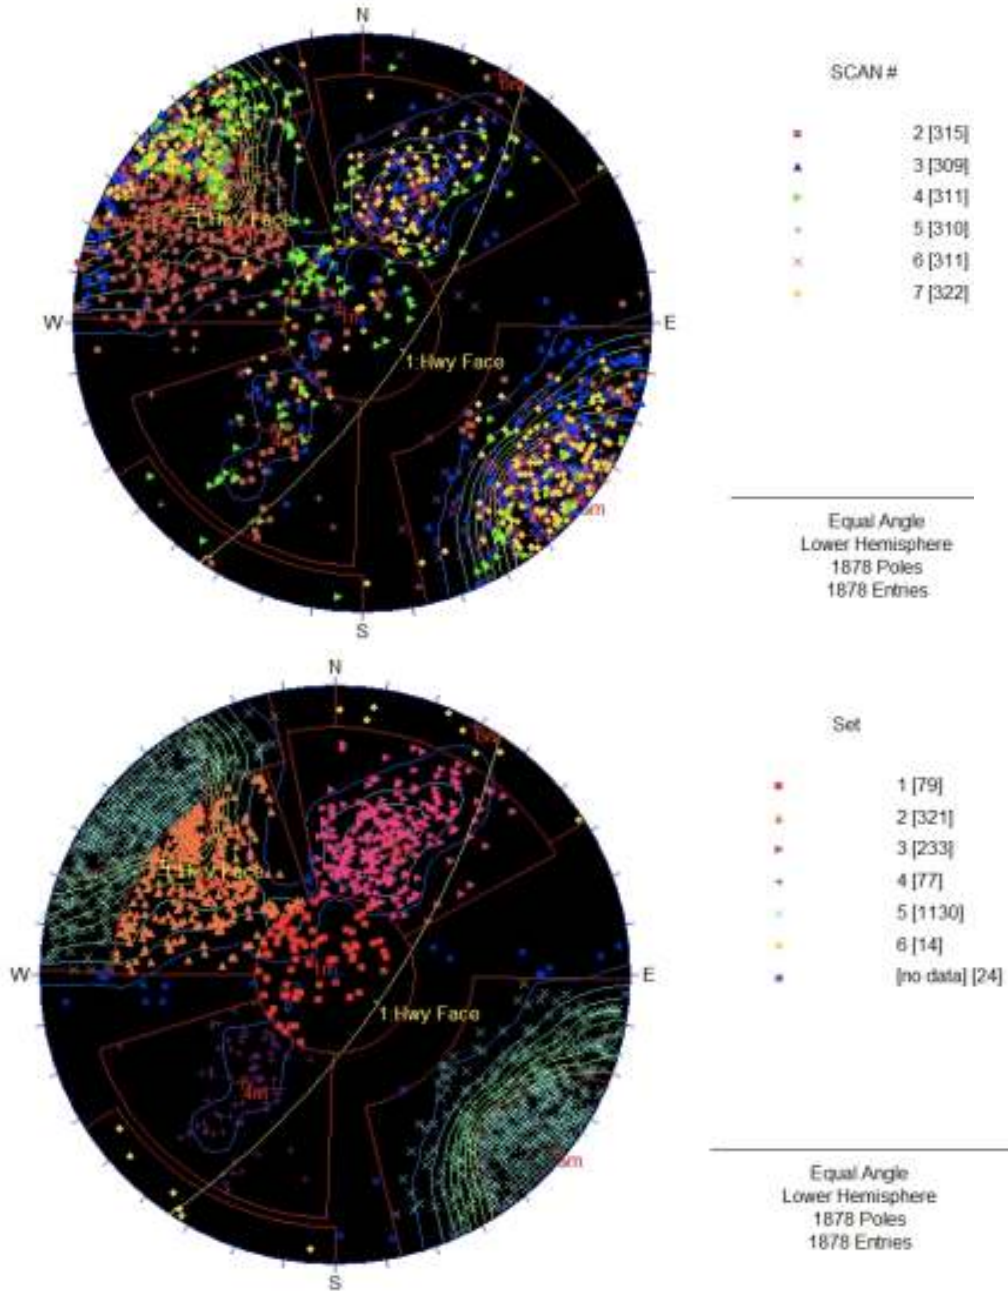
Figure 18g-h. Top to bottom, images are (g) lower hemisphere stereonet plot for the combined discontinuity orientations extracted from LIDAR NFCurve2 through NFCurve7, separated by scan, and (h) combined results of NFCurve2-NFCurve7, separated by set.

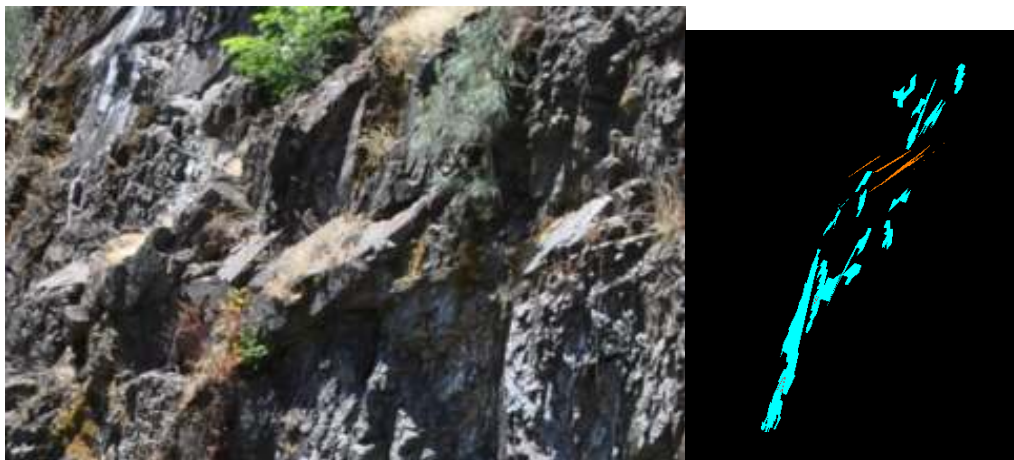
Figure 22. Left is an image of possible planar failure surfaces of approximately 50-degree dipping Joint Set 2 (light orange) with respect to the general rock face, while right shows a side view of Split-FX image of Joint Set 2 (orange) as compared to the main slope surface (teal).

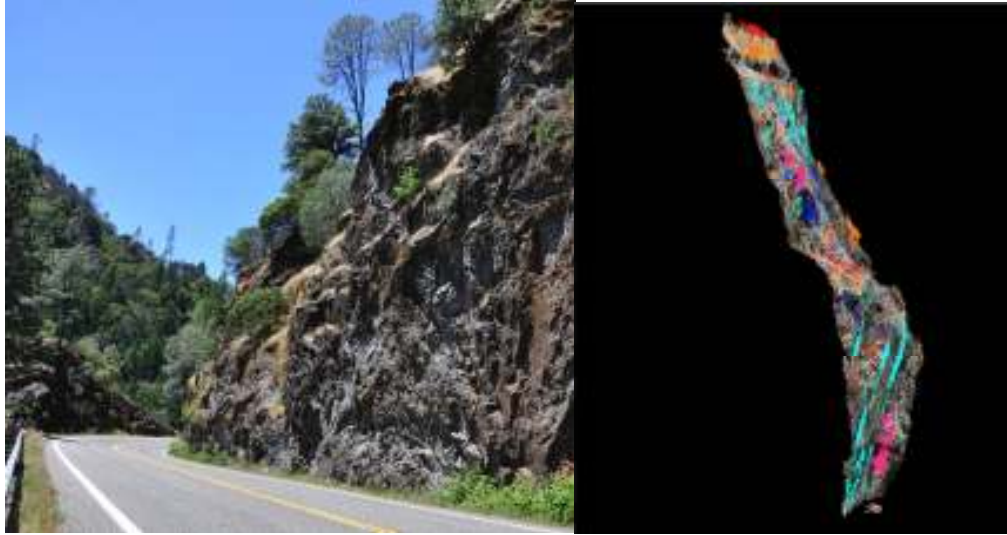
**Figure 24. Left to right, a digital image of overhanging fractures of Joint Set 5 (teal) with minimal ditch width, and an image of color point cloud showing overhanging fractures of Joint Set 5 (teal).**

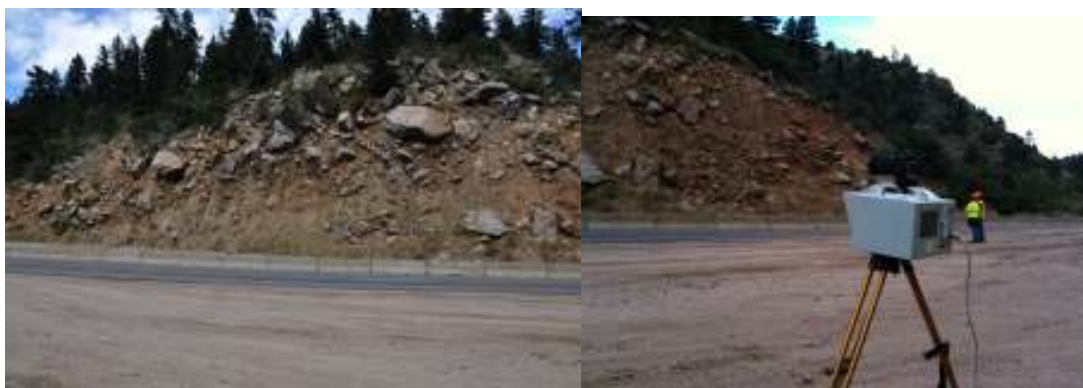
**Figure 25. Colorado Site 1 along with the scanner used, an Optech ILRIS3D.**

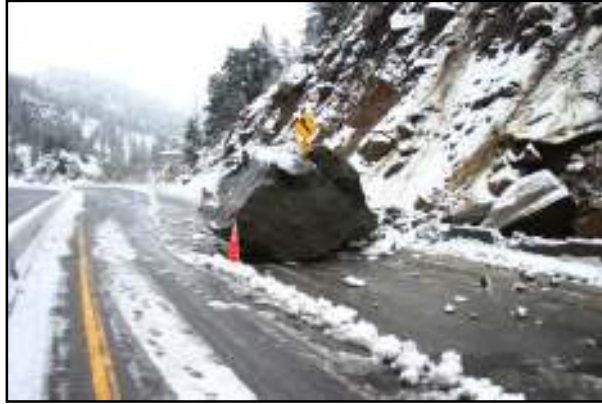
**Figure 26. Large rockfall along U.S. 285 in Colorado that occurred in April 2007 (Photo courtesy of CDOT).**

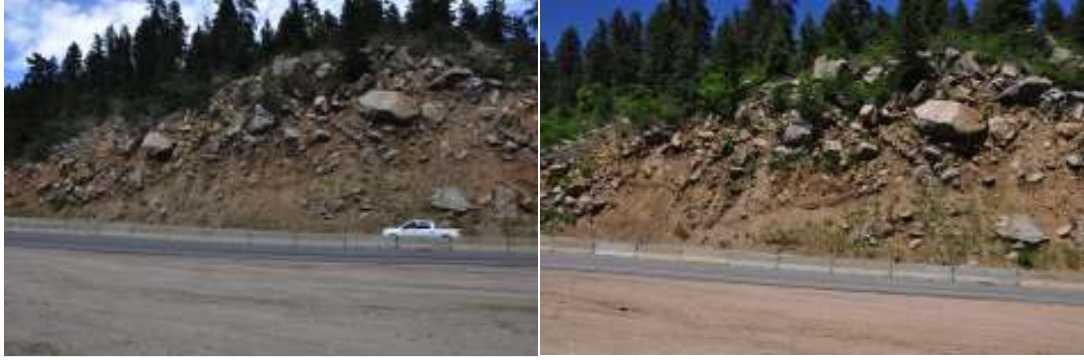
**Figure 30. At Colorado Site 1 along U.S. Route 285, upper photos show, left to right, the conditions before (September 2009) and after (June 2010). The bottom image is a difference cloud for the site.**

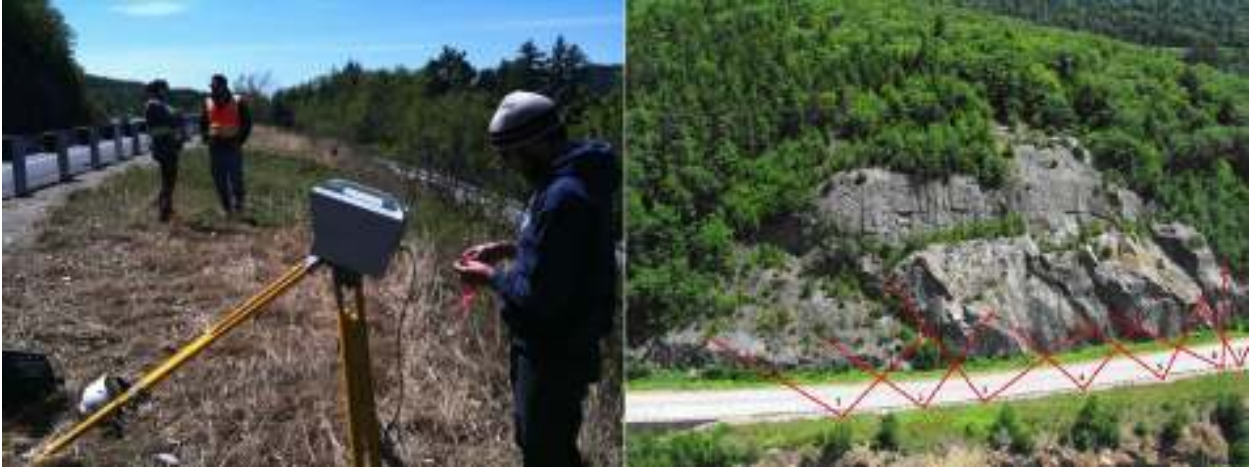
**Figure 32. Left to right, an example of scanning at the site using an Optech ILRIS 3D scanner, and the approximate locations of scans Woodstock1 to Woodstock7.**

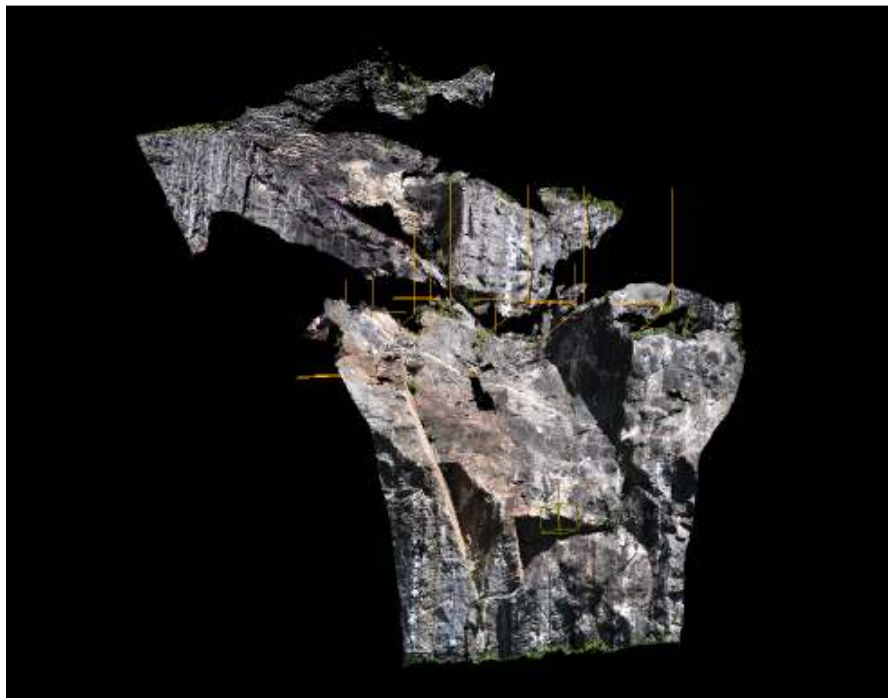
**Figure 33. Color point cloud of the Woodstock6 LIDAR scan.**

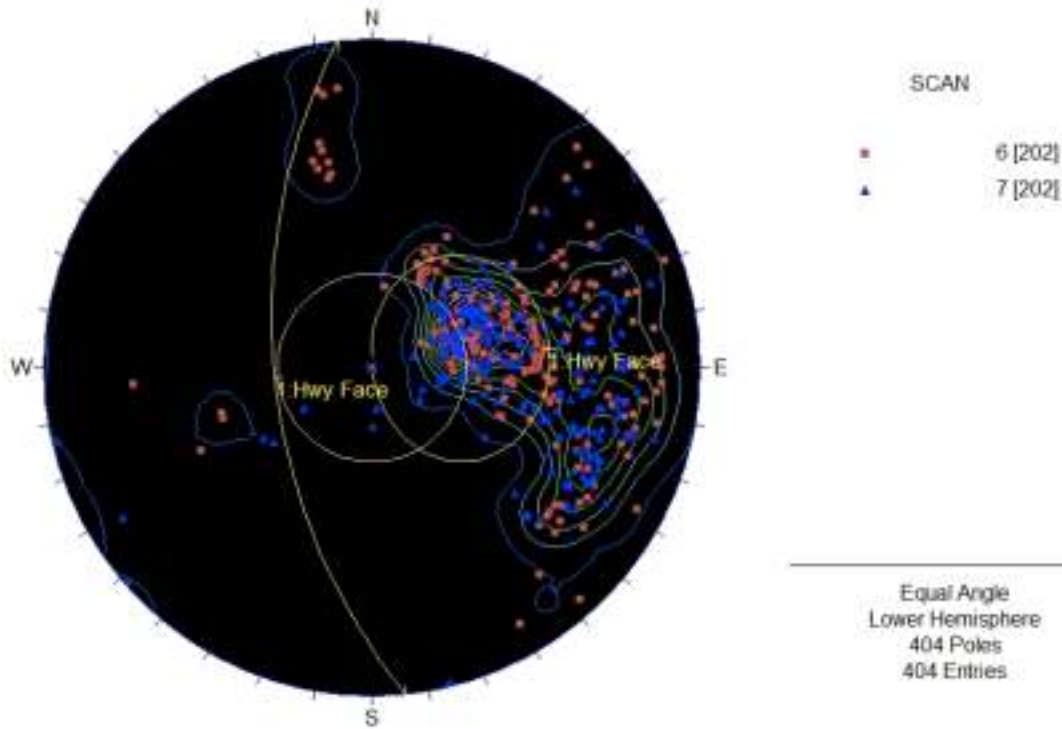
**Figure 35c. Analysis of plane sliding at the New Hampshire site, Woodstock6-Woodstock7 combined.**

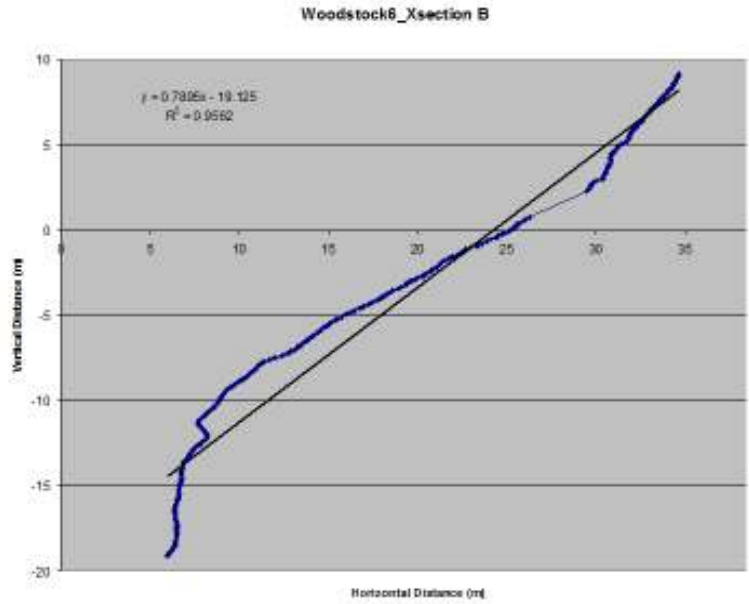
**Figure 36. Left to right, a photograph of the Woodstock6 portion of the New Hampshire site, and a slope profile generated from the Woodstock6 scan.**

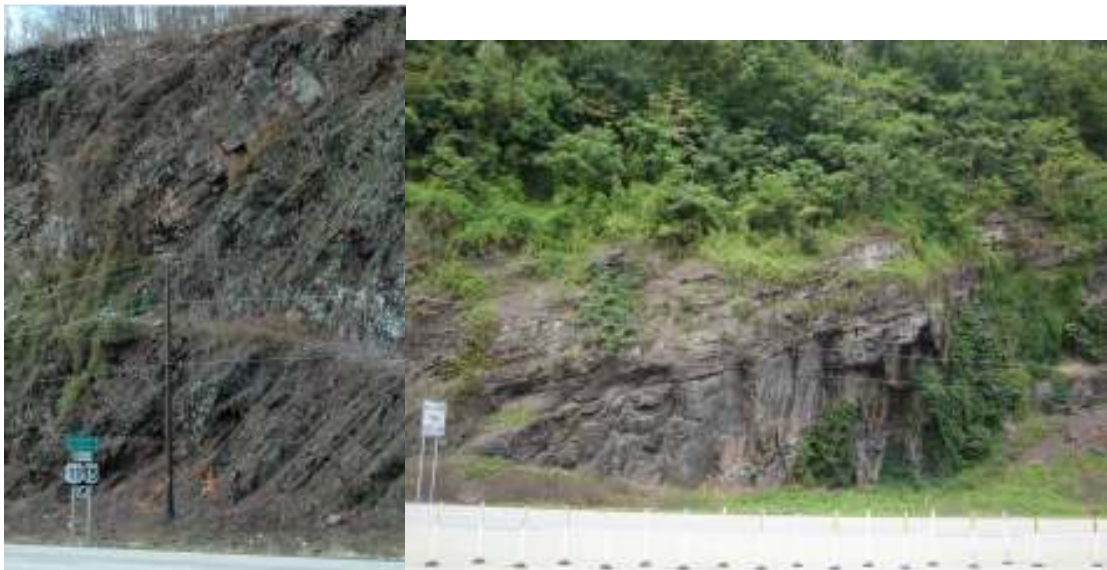
**Figure 48. Left, a portion of the South Area scan, and at right, a portion of the North Area scan.**

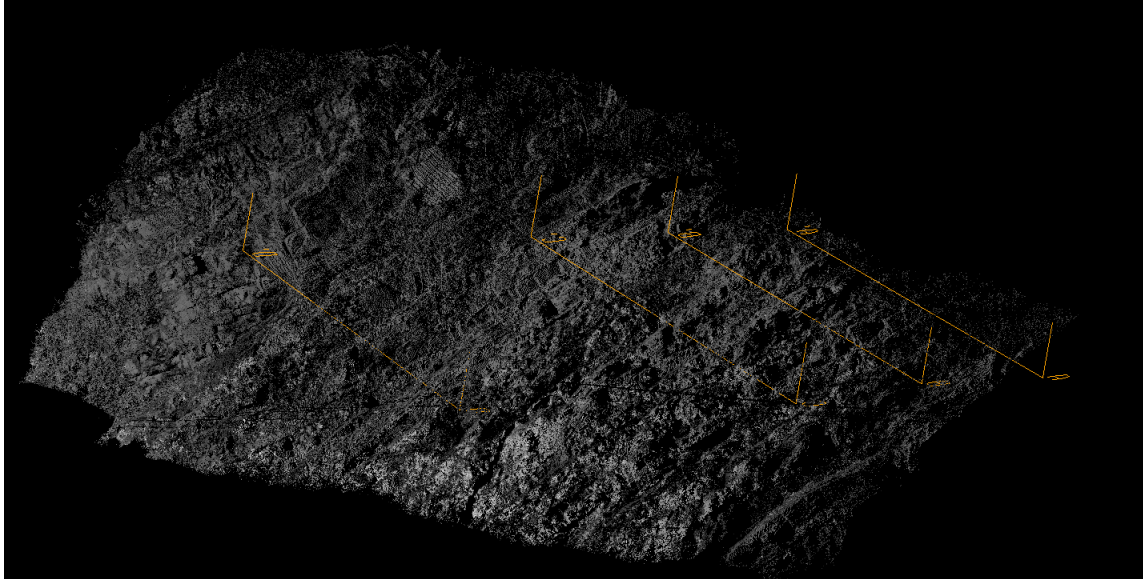
**Figure 49. Point cloud of SAtr.**

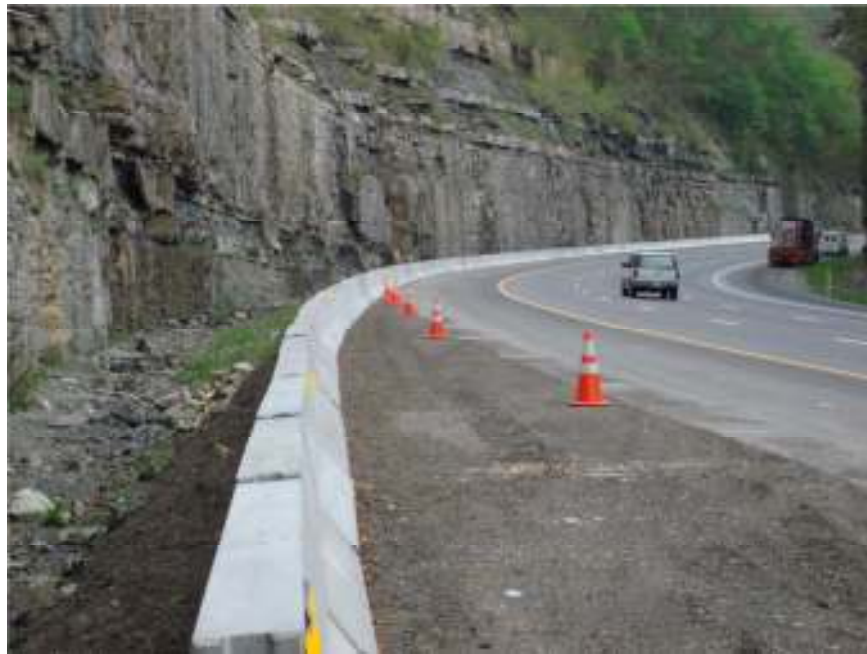
**Figure 55. Location of I-24 scans showing ditch and highway (upper slopes not visible) (Photo courtesy of TDOT).**

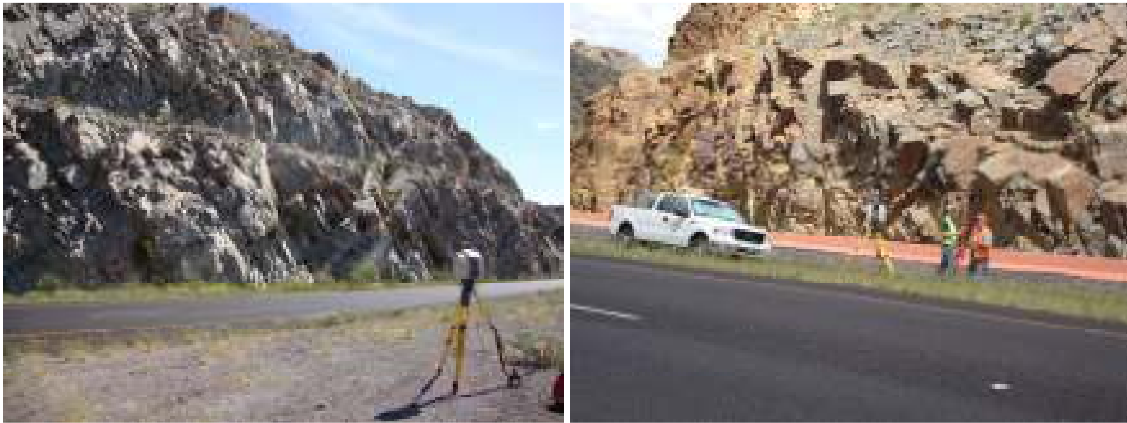
**Figure 63. Pictures of Texas site, along with the Leica Scanstation 2 scanner.**

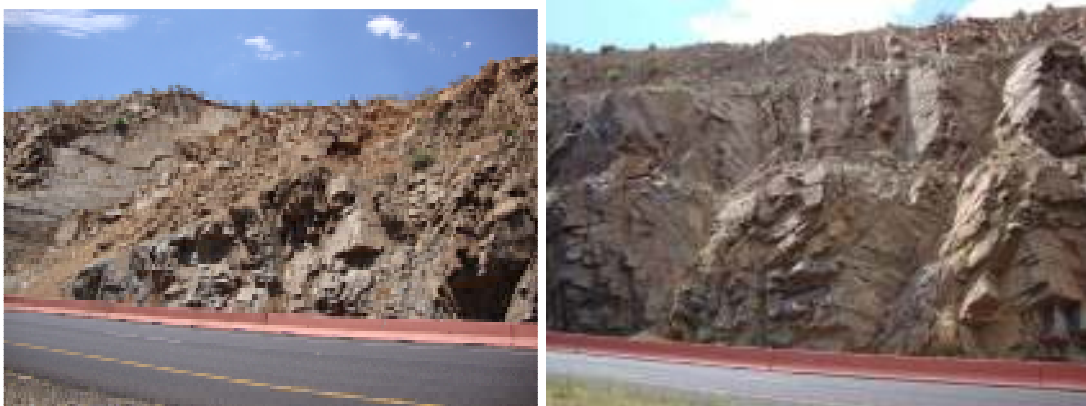
**Figure 68. Wedge failures at the Texas site formed by discontinuity Sets 1 and 4 (see Figure 66b and Table 34).**

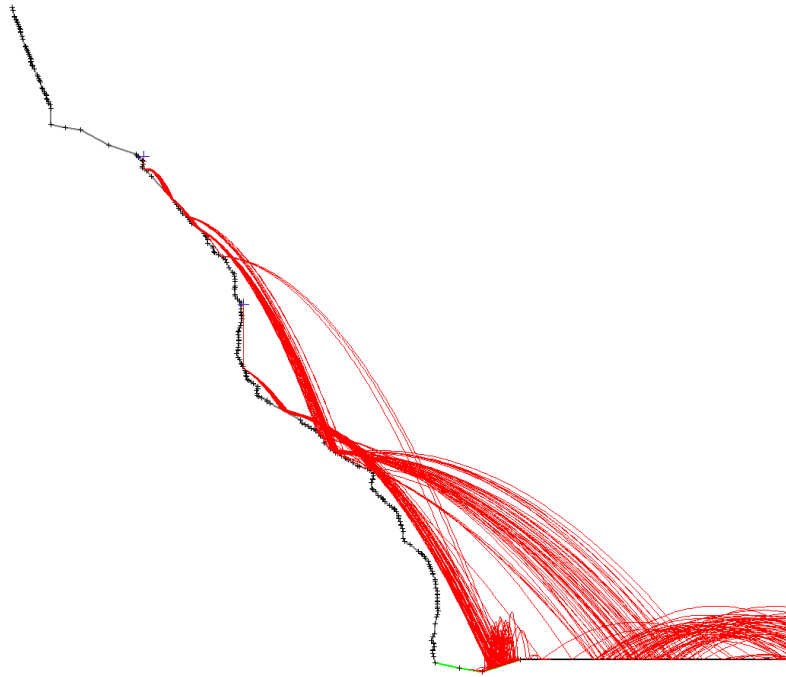
**Figure 70. Trajectories from Cross Section C from Scan 2, analyzed with the RocFall program.**
