Pavement

Results from Visual Inspection and Laboratory Testing for ASR in Existing Concrete cores from Bridges and Pavements in California

**Task Number:** 2702

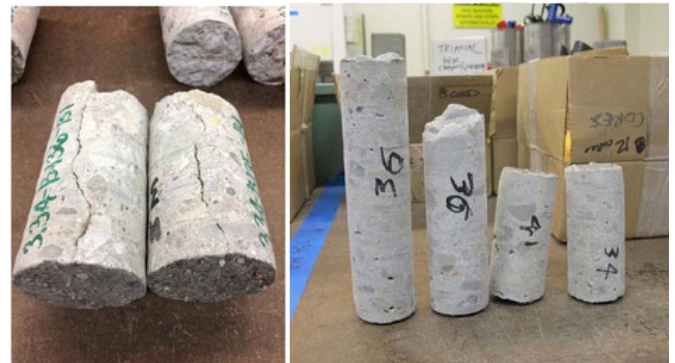
FIGURE 1: Bridge cores; cores equal to or longer than 3 inches were used for ASR visual inspection

We used existing concrete cores collected by three earlier Caltrans studies to initiate an ASR survey study on the cores. From these previous studies there were a total of 265 pavement samples and 311 Bridge samples. No new cores were taken for this study. The report summarizes the results of the inventory and testing of the cores.

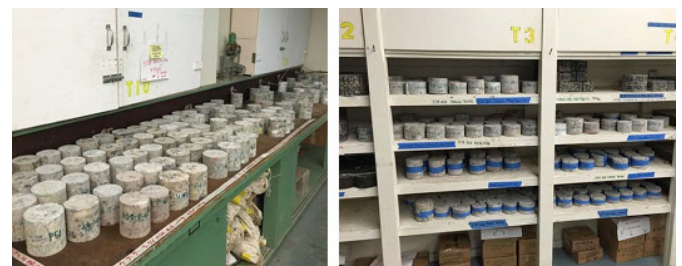
FIGURE 2: Pavement and bridge cores after cutting for visual inspection
