# Richardson Grove Operational Improvement Project

HUMBOLDT COUNTY, CALIFORNIA DISTRICT 1 – HUM – 101, PM 1.1/2.2  
464800

## Supplement to the Final Environmental Assessment

September 2013

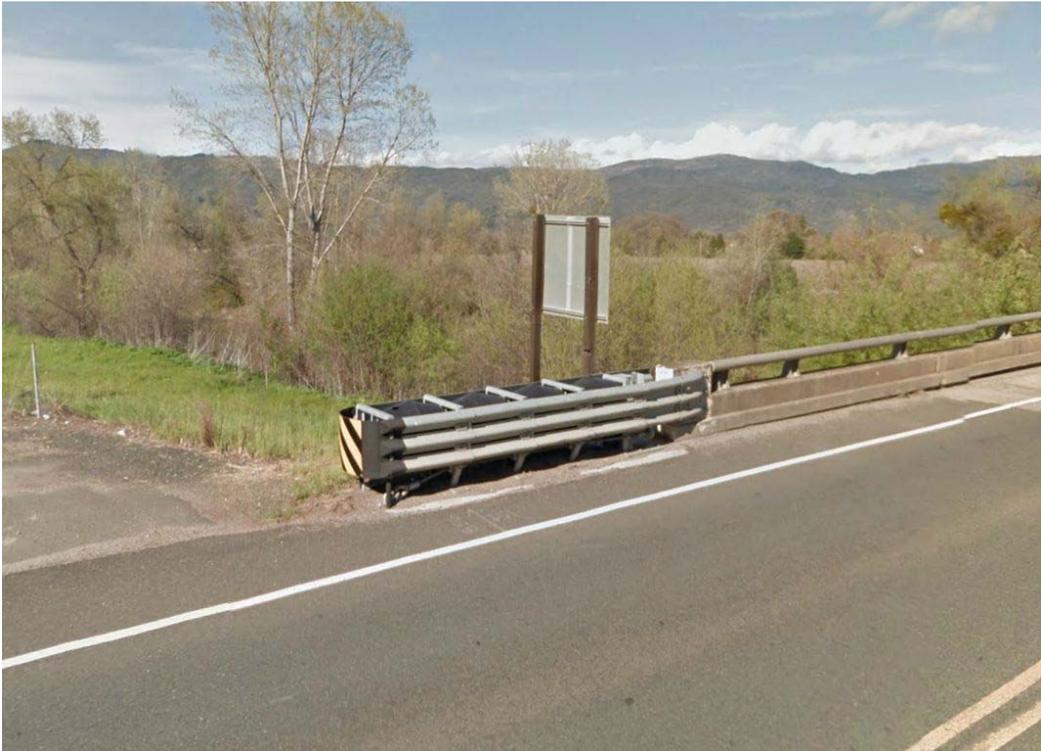
**Metal Beam Guardrail Crash Cushion**

The proposed barrier rail modifications at the bridge entail removing the obsolete metal beam guardrail (MBGR), constructing a barrier transition piece to retrofit this older style of bridge rail, and installing a crash cushion system at the end of the new barrier transition. The crash cushion was chosen to minimize the size and length of the terminal end. Installation of the transition barrier requires a footing four feet deep, 5.5 feet wide, and 20 feet long. The crash cushion would be a maximum of 15 feet in length, requiring a foundation one foot deep, four feet wide and the same length as the cushion. At the north end of the proposed retaining wall, the barrier would be extended ten feet and angled away from traffic. It would be placed on top of the proposed gabion wall, and would be attached directly to the retaining wall without a concrete transition section. Examples of a crash cushion and transition barrier are shown in Figure 3.

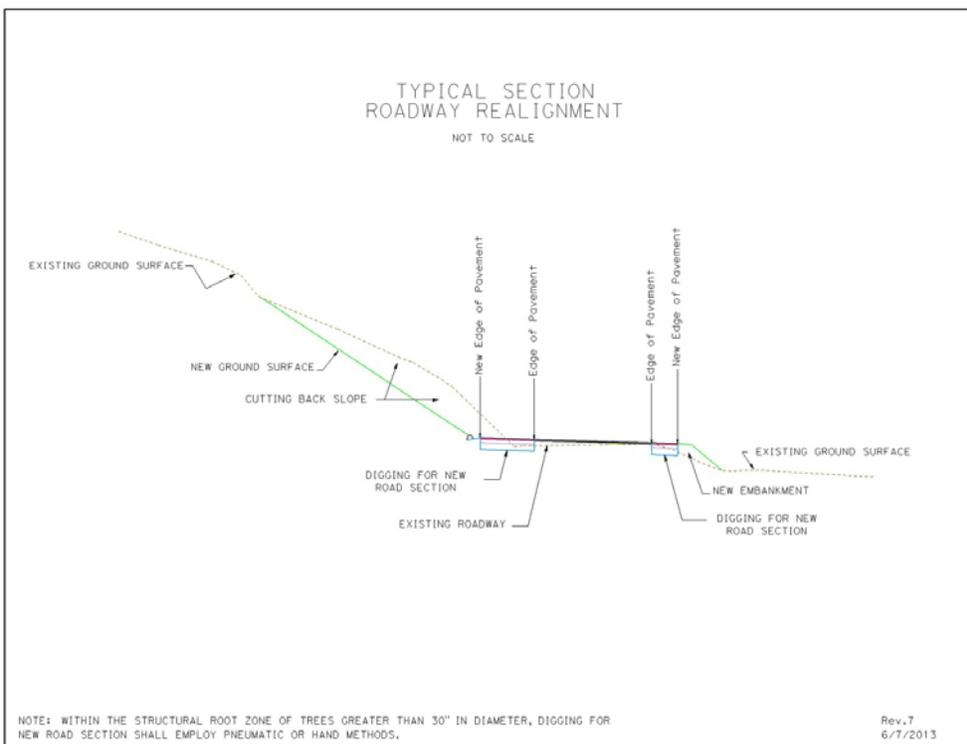
**Figure 4 A Typical Cross Section of Ground Disturbing Activities in Road Improvement**

Placing impervious material and embankment over the roots can cause compaction of soils that breaks down soil aggregates, potentially resulting in poor aeration, reduced drainage, impaired root growth, increased erosion and greater susceptibility to root rots (Harris 2004). The proposed construction would add less than 5% of hardened surface (roadbed) to the existing hardened surface within the structural root zone. Because of the limited extent of embankment

The Department designed the proposed project to maintain as much sheet flow of rain runoff from the highway as possible, to utilize the exceptional filtering properties of the forest duff layer. At PM 1.78 and PM 2.10, the proposed project includes redirecting drainage, which is currently inadequately controlled and causing erosion, to existing culverts. Because of this design feature, the Department included the trees at these locations in the impact analysis. Other than these minor improvements, the proposed project would not change existing drainage patterns.
