**Natural Environment Study  
(Minimal Impacts)**

County of Orange, California  
Cities of San Juan Capistrano and Unincorporated San Juan Capistrano, California  
12-ORA-SR74 – PM 0.0-11.5  
EA 0R990  
1219000072

**November 2025**

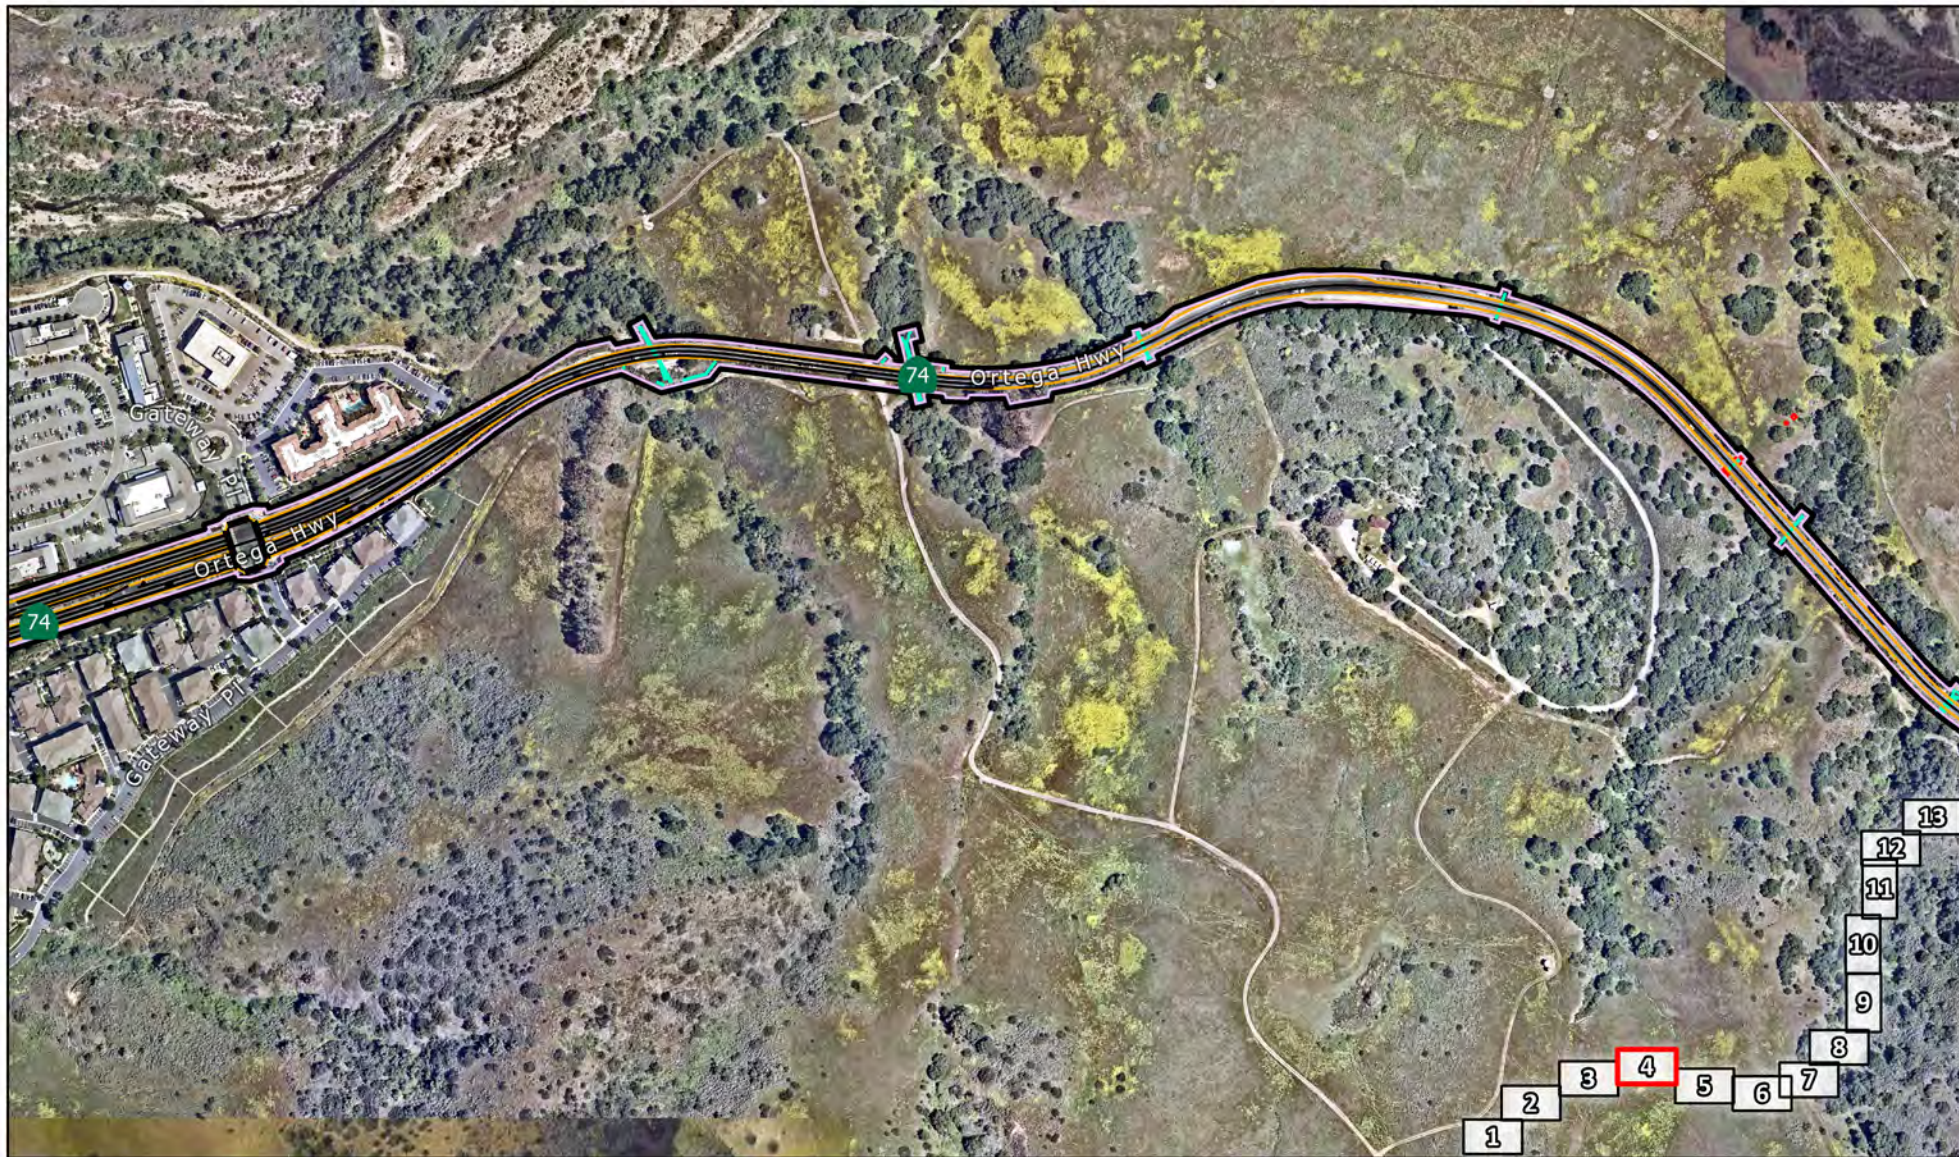
- Project Site**
- Proposed Project Components**
- Proposed Drainage Repair
  - Proposed Culvert and Associated Work Area
  - Edge of Pavement
  - Existing Right of Way
  - Existing Roadway

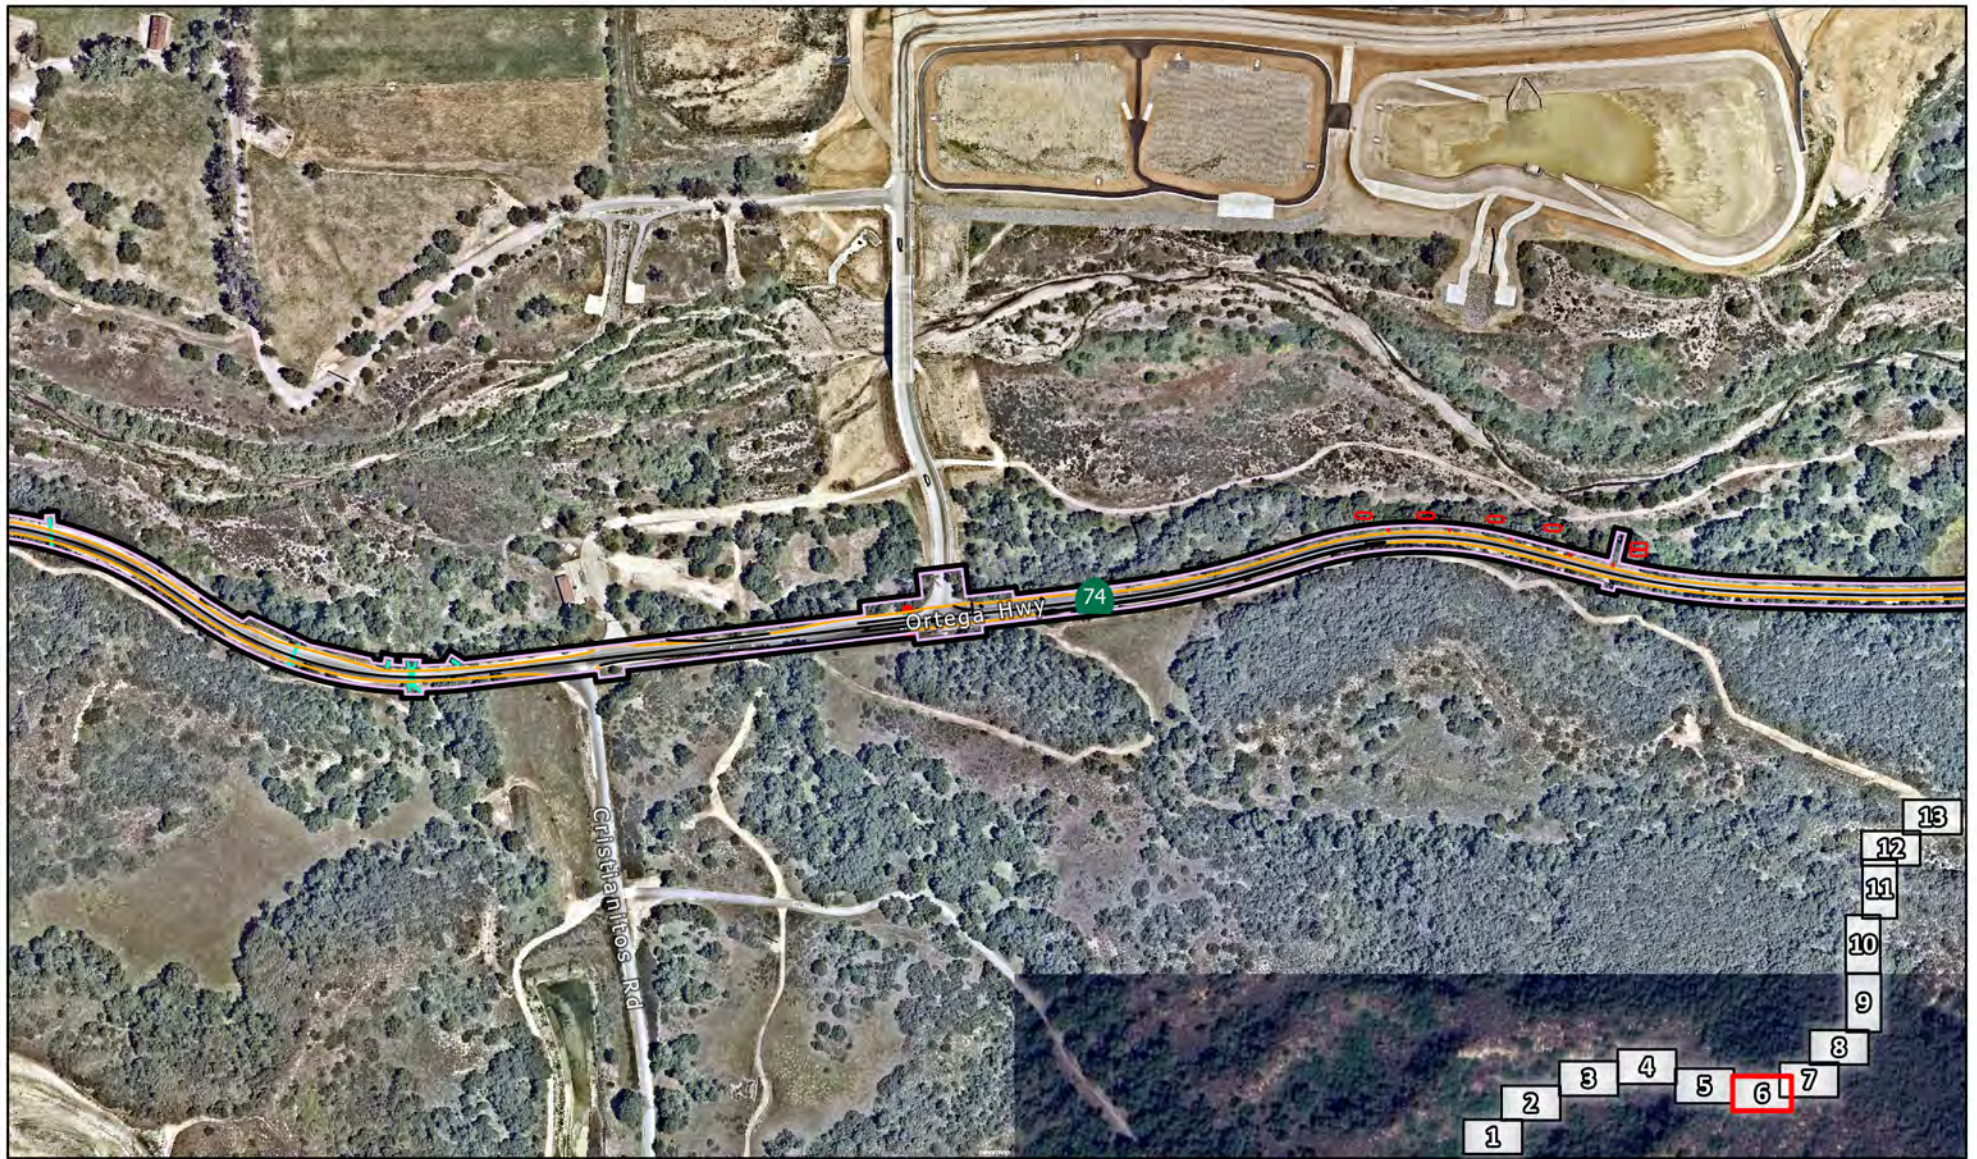
FIGURE 2  
Sheet 6 of 13

- Project Site**
- Proposed Project Components**
- Proposed Drainage Repair
  - Proposed Culvert and Associated Work Area
  - Edge of Pavement
  - Existing Right of Way
  - Existing Roadway

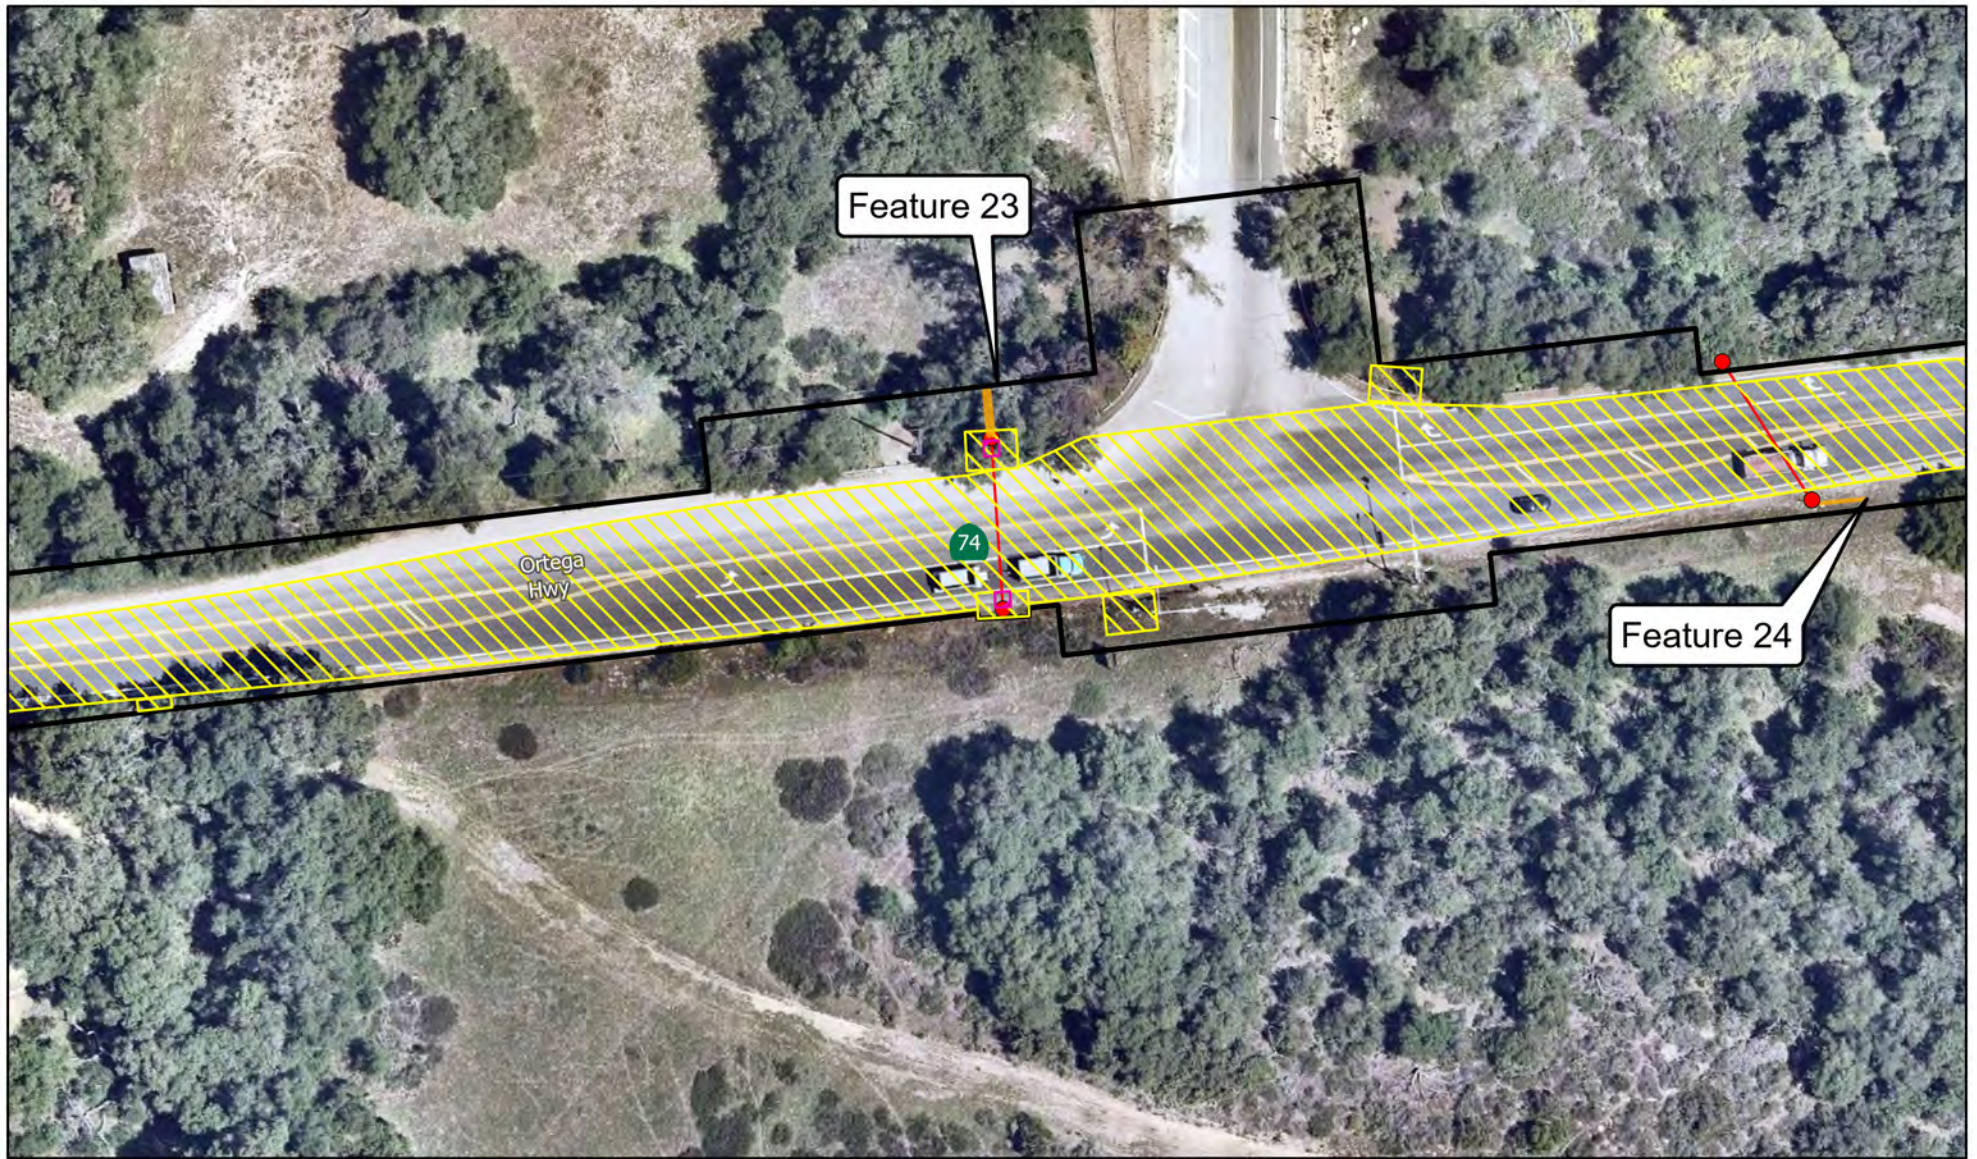
- Project Site
- Permanent Impact
- Temporary Impact
- Non-jurisdictional Underground Feature
- Culvert

- Jurisdictional Features
- CDFW Streambed/USACE Non-jurisdictional Waters/RWQCB Nonwetland Waters

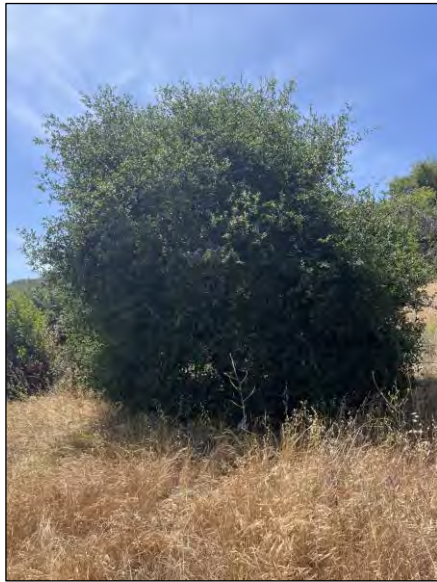
**Tree 1: Coast live oak in good condition.**

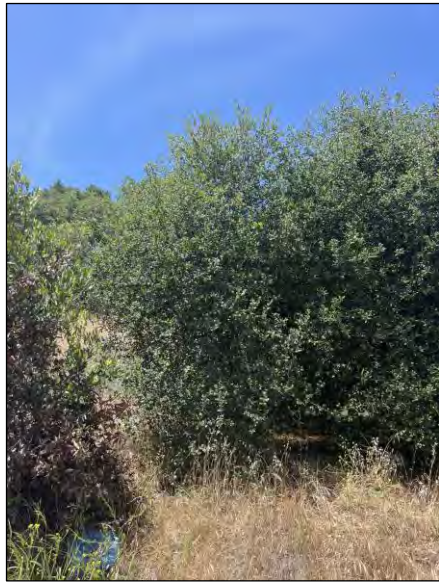
**Tree 2: Coast live oak in poor condition.**

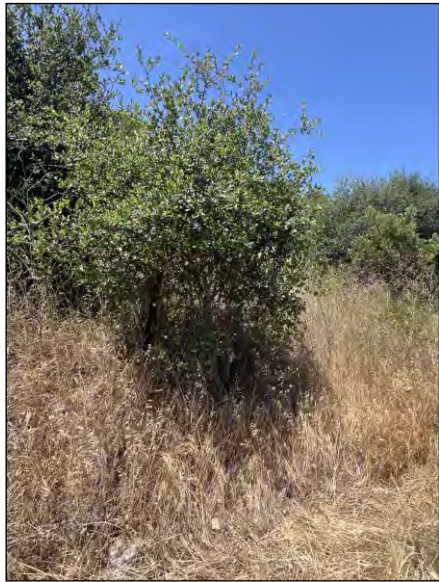
**Tree 3: Coast live oak in poor condition.**

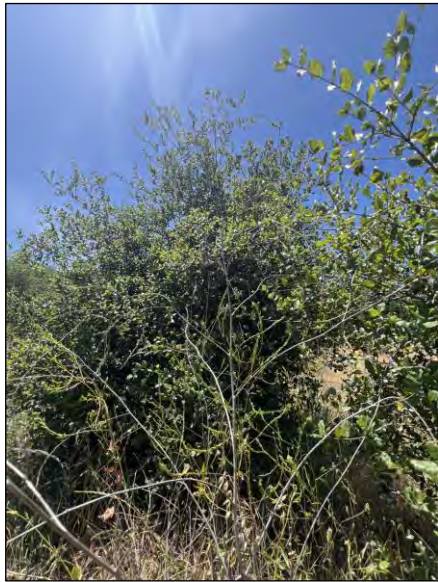
**Tree 4: Coast live oak in good condition.**

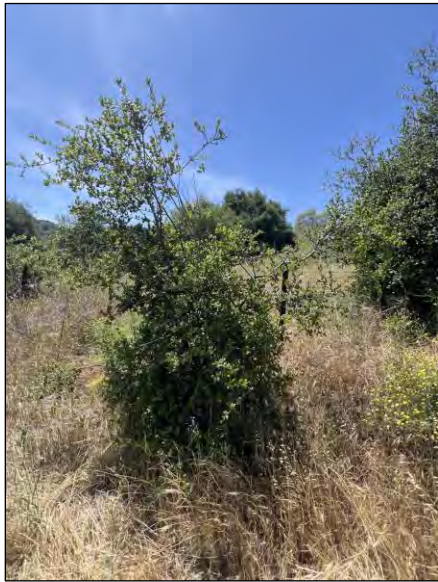
**Tree 5: Coast live oak in good condition.**

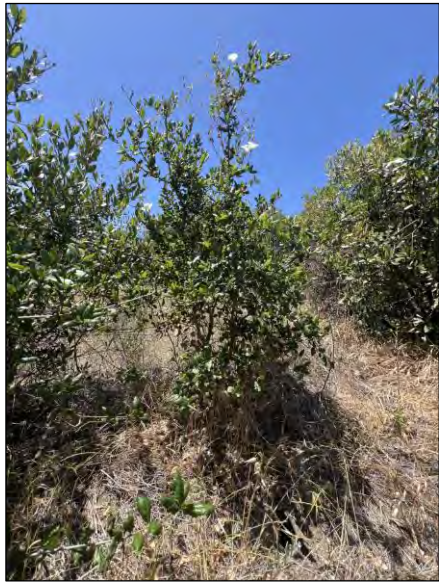
**Tree 6: Coast live oak in good condition.**

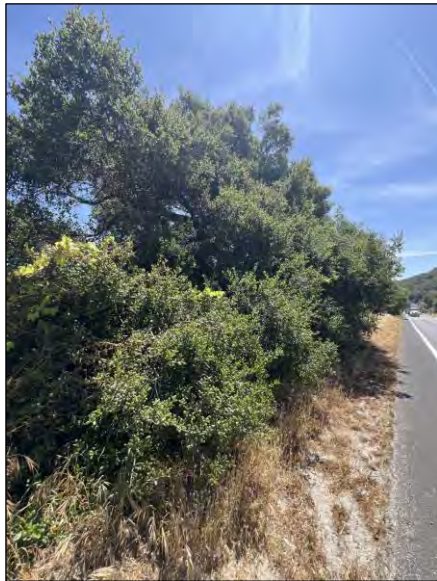
**Tree 7: Coast live oak in good condition.**

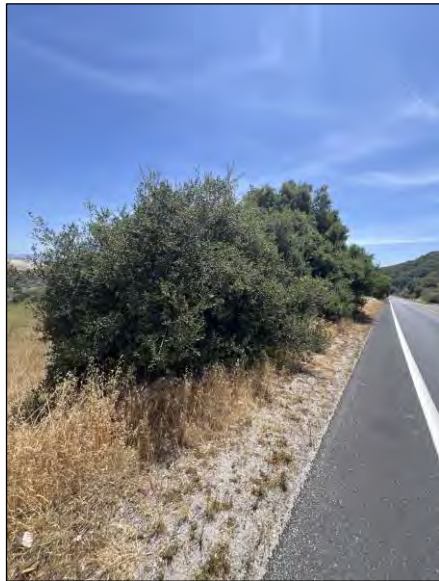
**Tree 8: Coast live oak in good condition.**

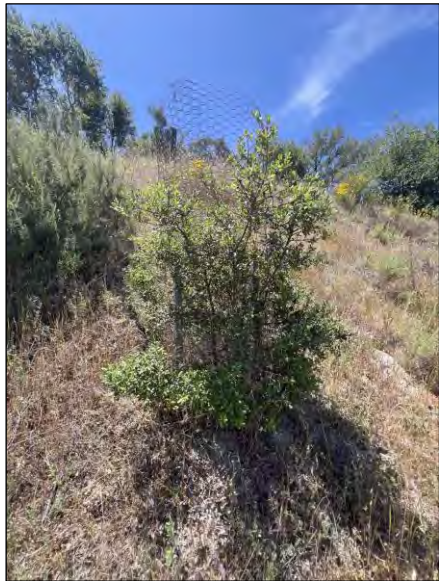
**Tree 9: Coast live oak in good condition.**

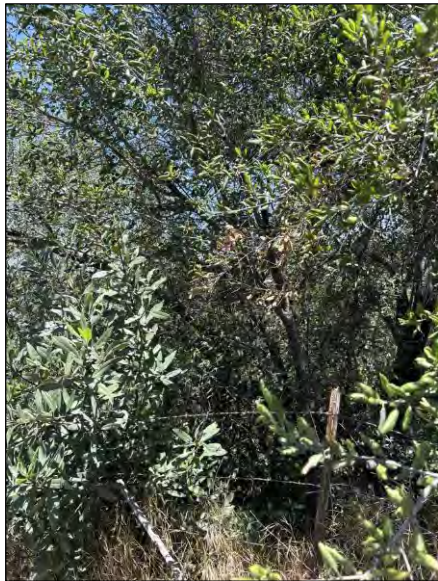
**Tree 10: Coast live oak in fair condition.**

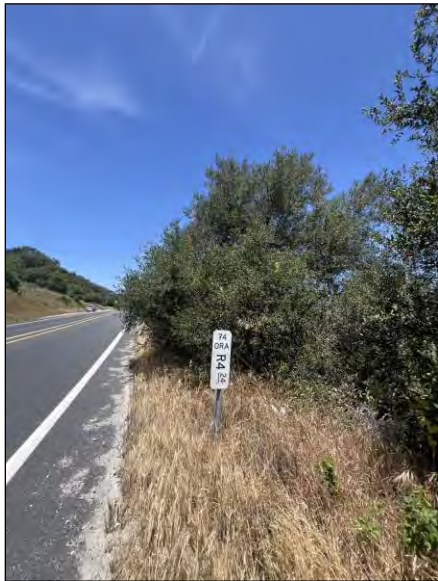
**Tree 11: Coast live oak in good condition.**

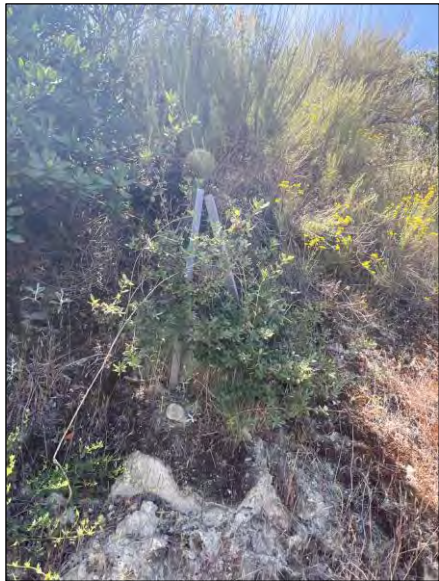
**Tree 12: Coast live oak in good condition.**

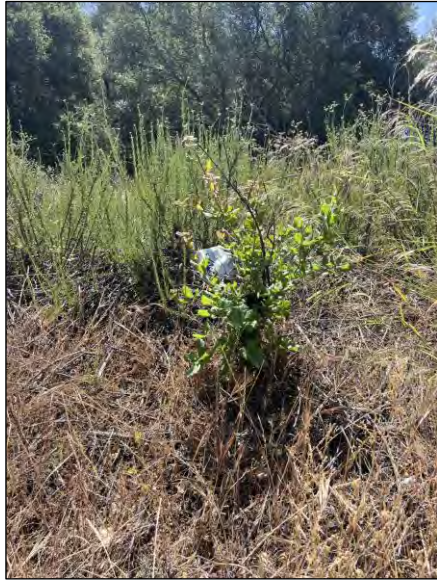
**Tree 13: Coast live oak in good condition.**

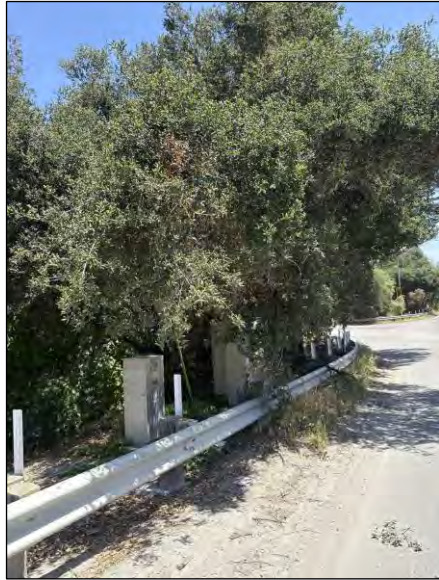
**Tree 14: Coast live oak in good condition.**

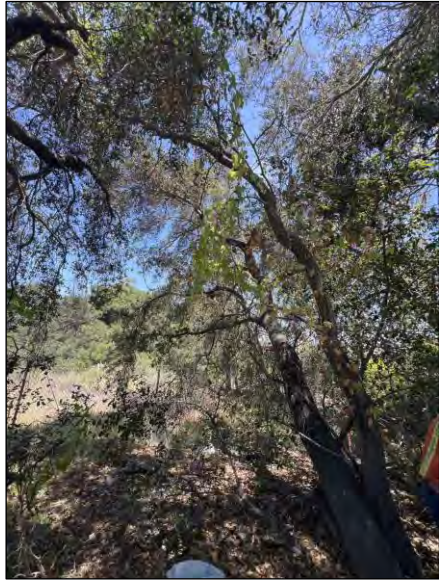
**Tree 15: Coast live oak in fair condition.**

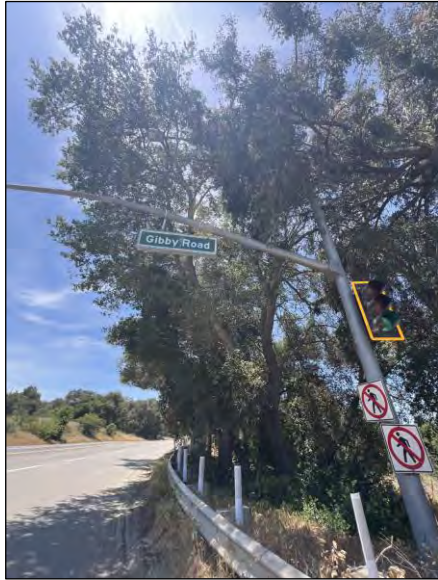
**Tree 16: Coast live oak in good condition.**

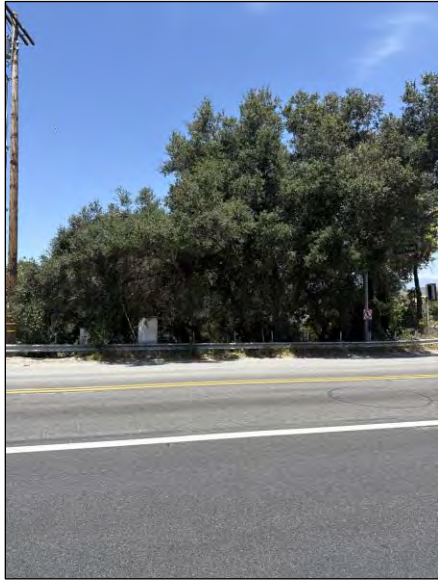
**Tree 17: Coast live oak in fair condition.**

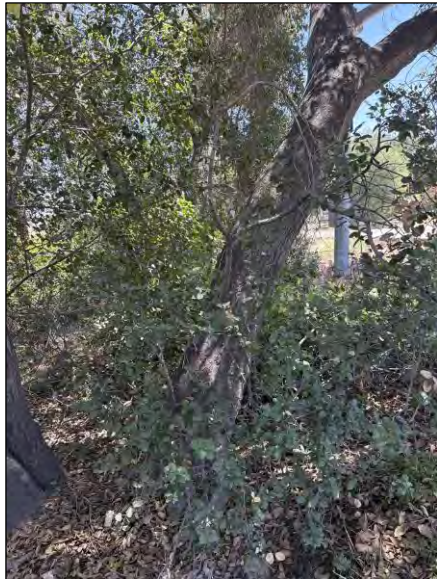
**Tree 19: Coast live oak in poor condition.**

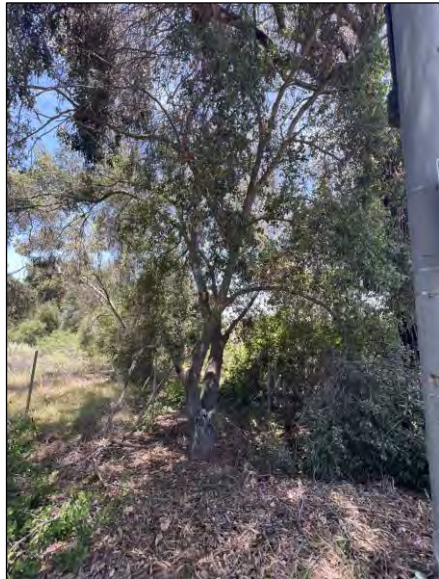
**Tree 20: Coast live oak in fair condition.**

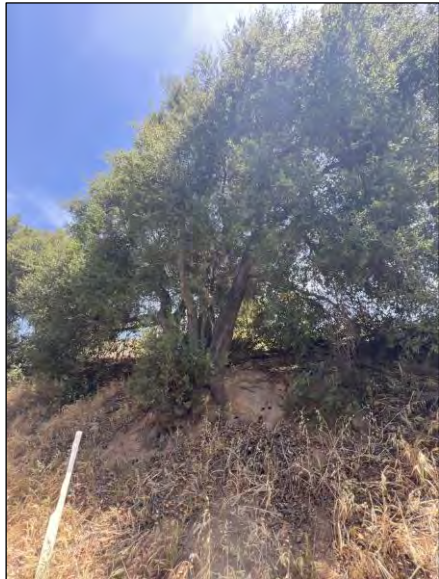
**Tree 21: Coast live oak in good condition.**

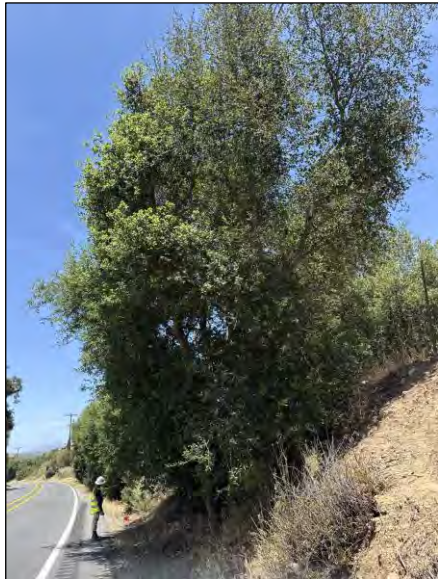
**Tree 22: Coast live oak in fair condition.**

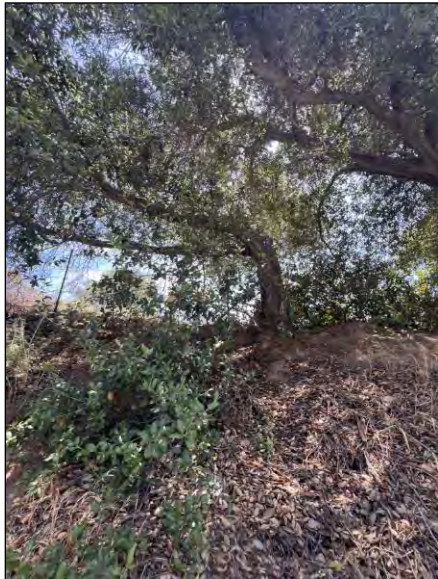
**Tree 23: Coast live oak in good condition.**

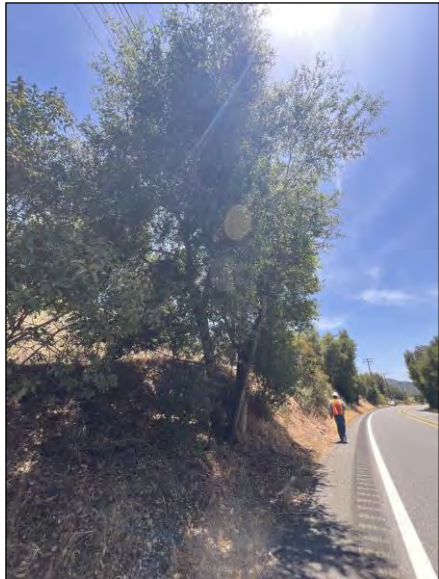
**Tree 24: Coast live oak in good condition.**

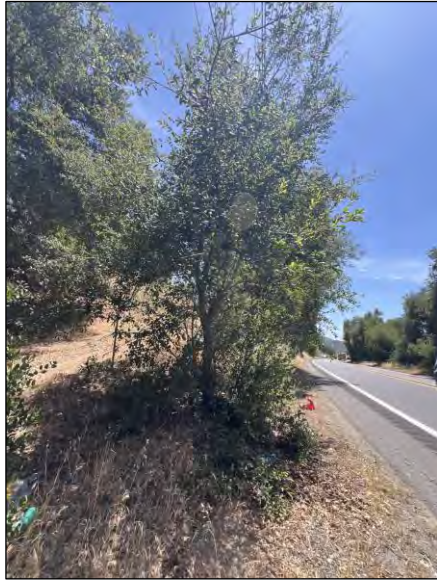
**Tree 25: Coast live oak in fair condition.**

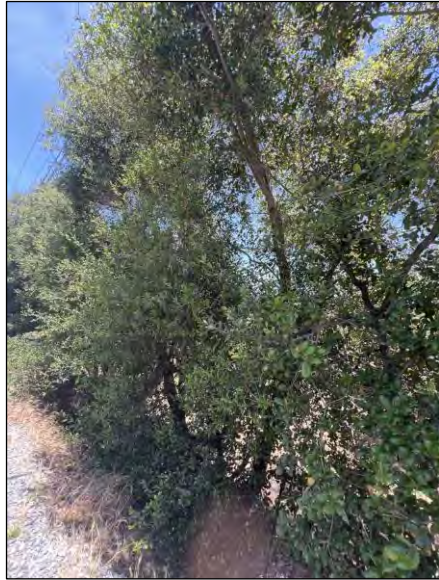
**Tree 26: Coast live oak in good condition.**

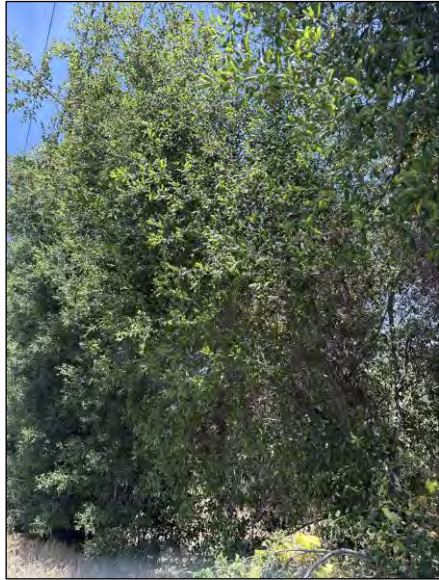
**Tree 27: Coast live oak in fair condition.**

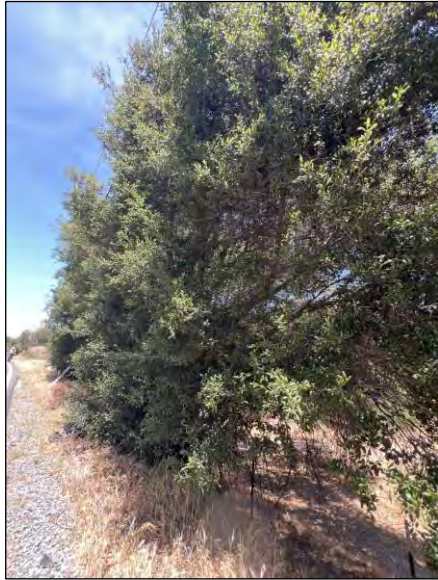
**Tree 28: Coast live oak in fair condition.**

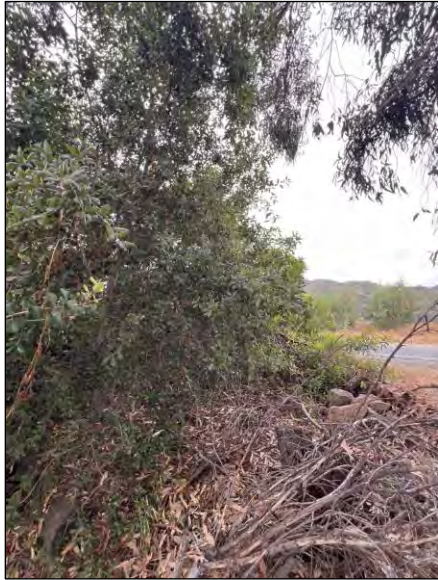
**Tree 29: Coast live oak in fair condition.**

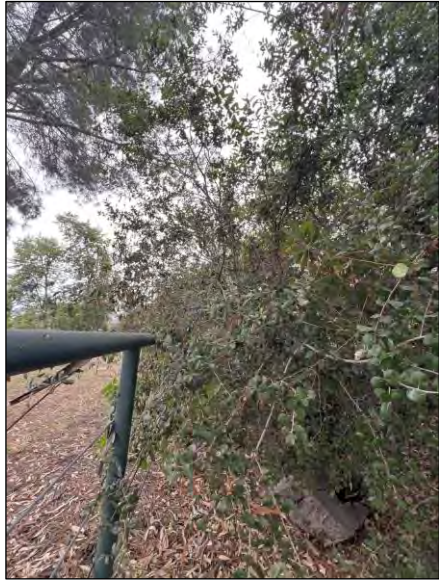
**Tree 30: Coast live oak in fair condition.**

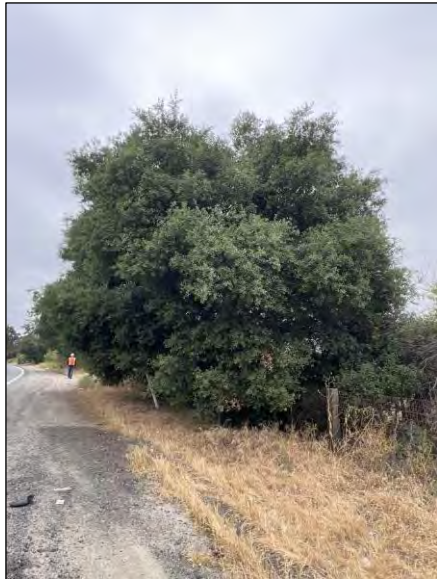
**Tree 31: Coast live oak in fair condition.**

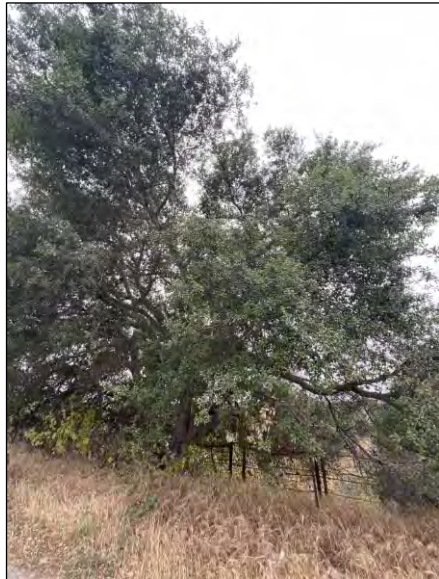
**Tree 32: Coast live oak in fair condition.**

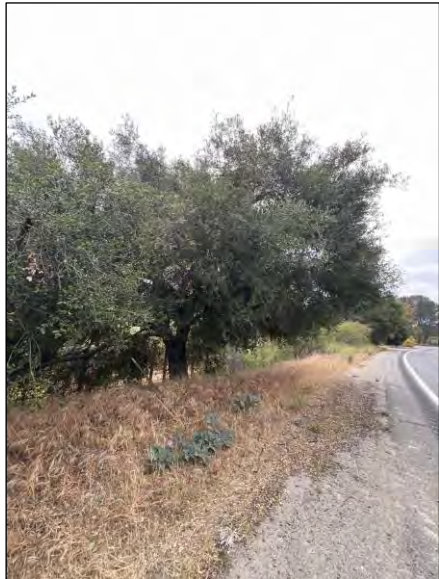
**Tree 33: Coast live oak in fair condition.**

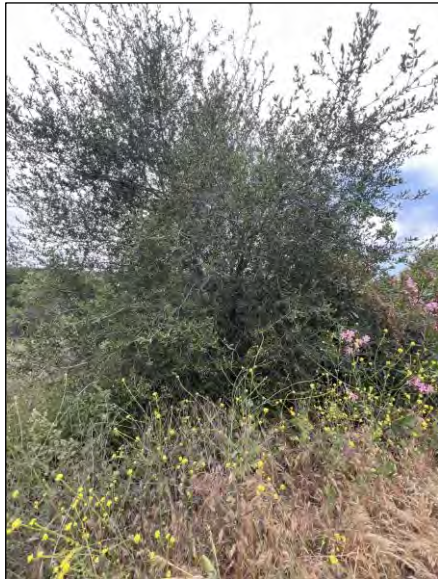
**Tree 34: Coast live oak in fair condition.**

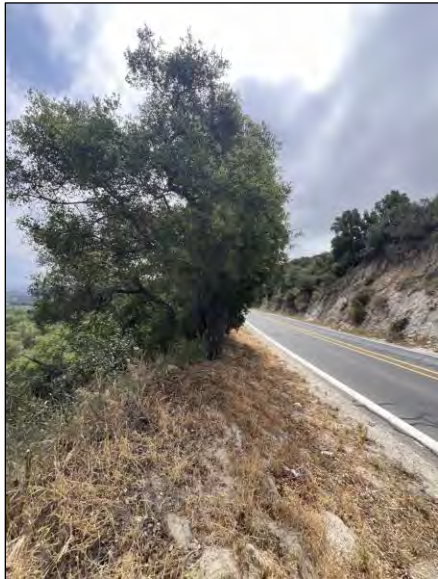
**Tree 35: Coast live oak in poor condition.**

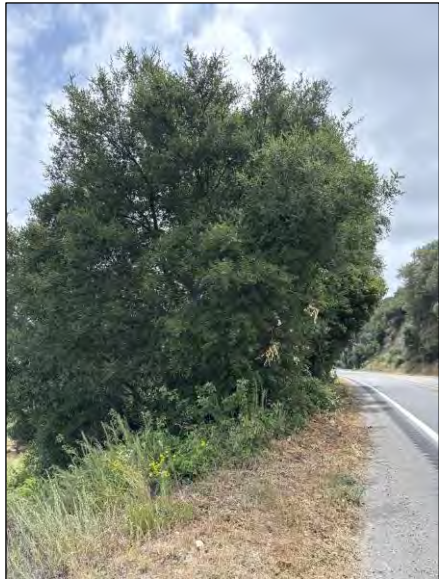
**Tree 36: Coast live oak in fair condition.**

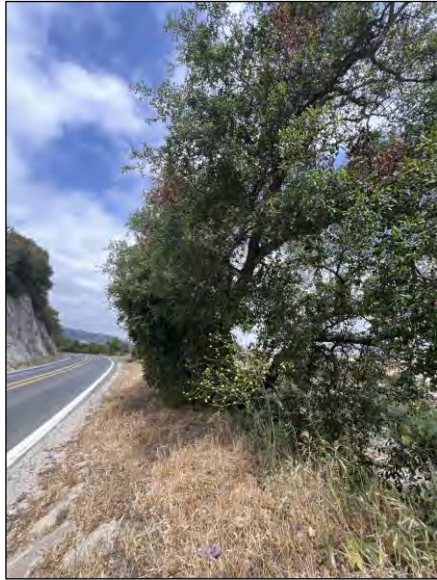
**Tree 37: Coast live oak in poor condition.**

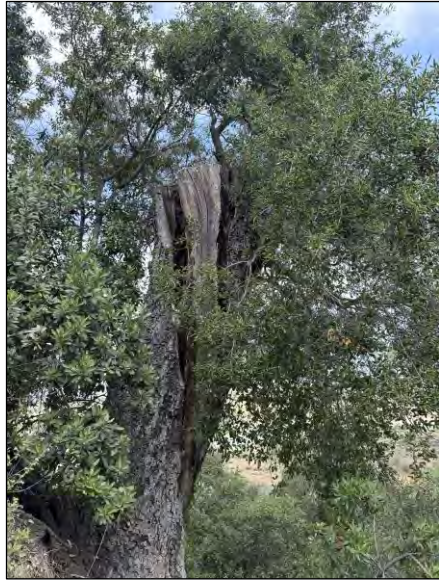
**Tree 38: Coast live oak in very poor condition.**

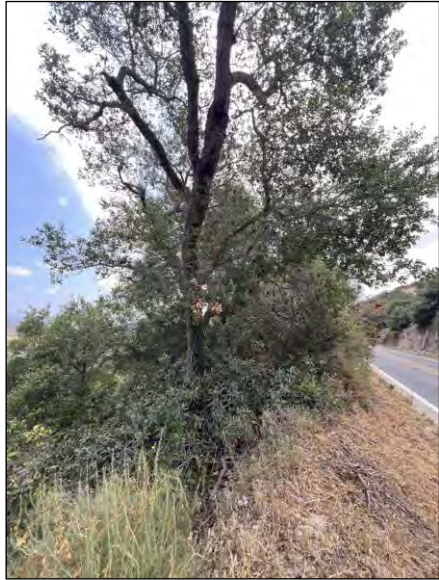
**Tree 39: Coast live oak in poor condition.**

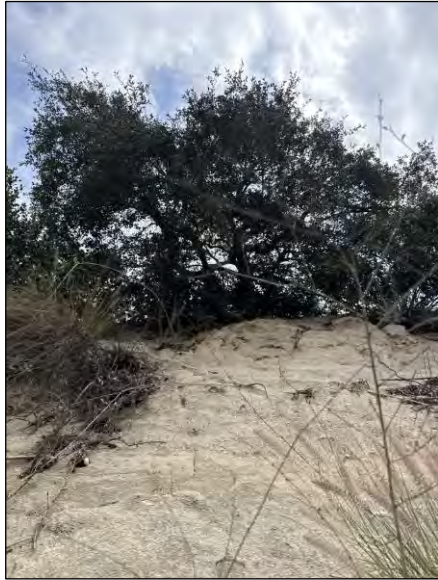
**Tree 40: Coast live oak in fair condition.**

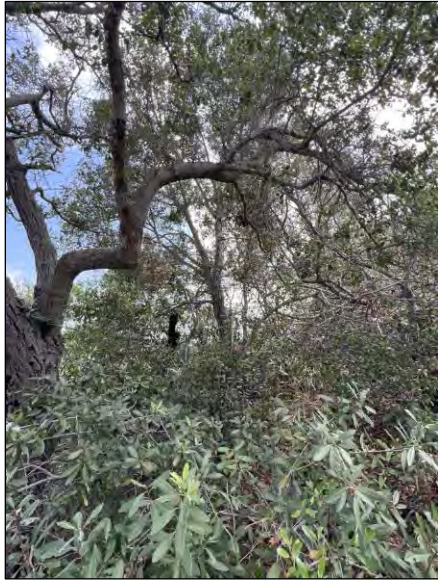
**Tree 41: Coast live oak in fair condition.**

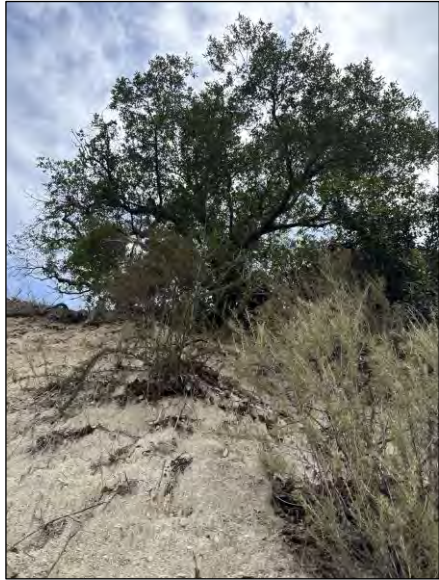
**Tree 42: Coast live oak in fair condition.**

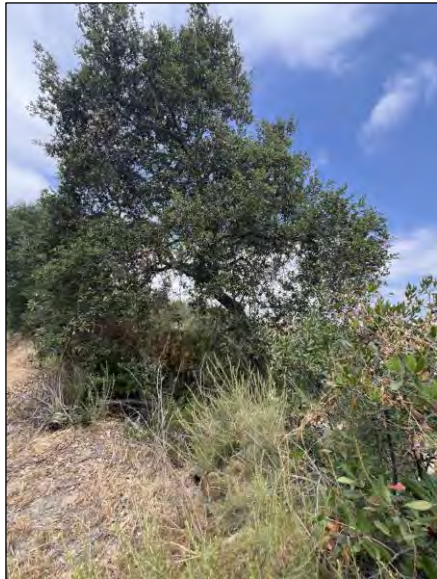
**Tree 43: Coast live oak in fair condition.**

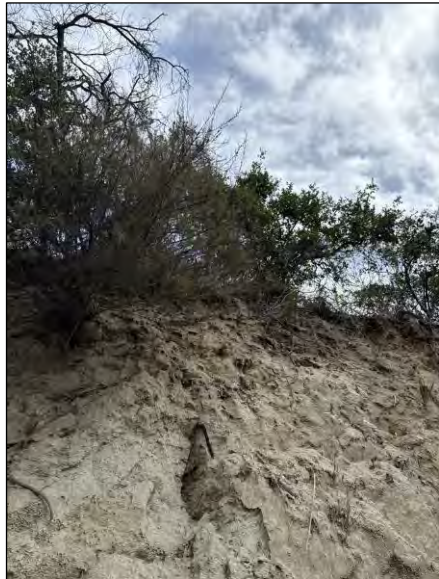
**Tree 44: Coast live oak in fair condition.**

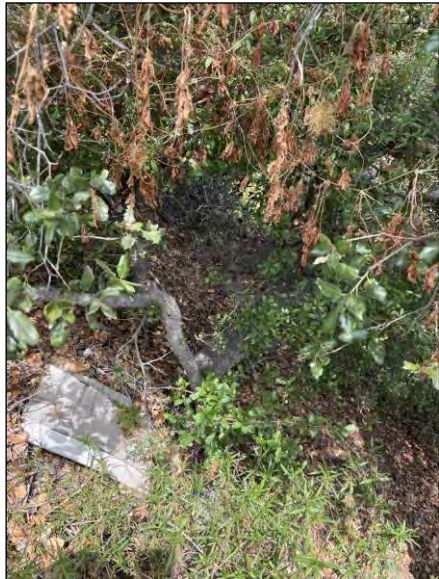
**Tree 45: Coast live oak in fair condition.**

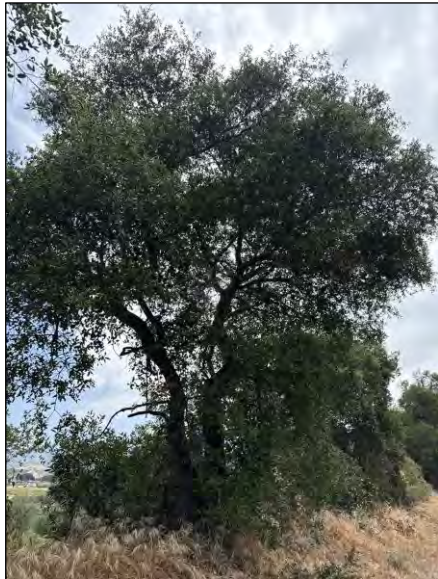
**Tree 46: Coast live oak in fair condition.**

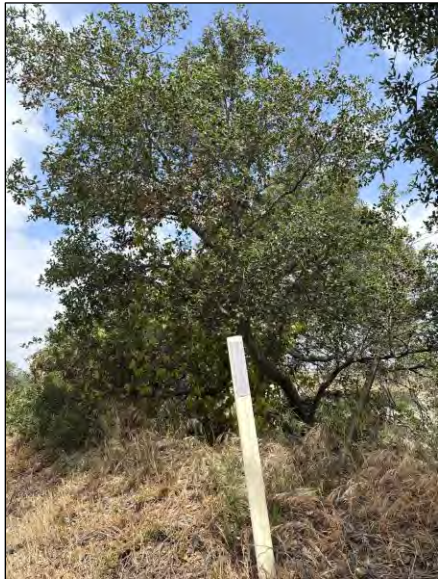
**Tree 47: Coast live oak in fair condition.**
