PROJECT AREA

EL CAMINO REAL ROADWAY RENEWAL

PROJECT OVERVIEW

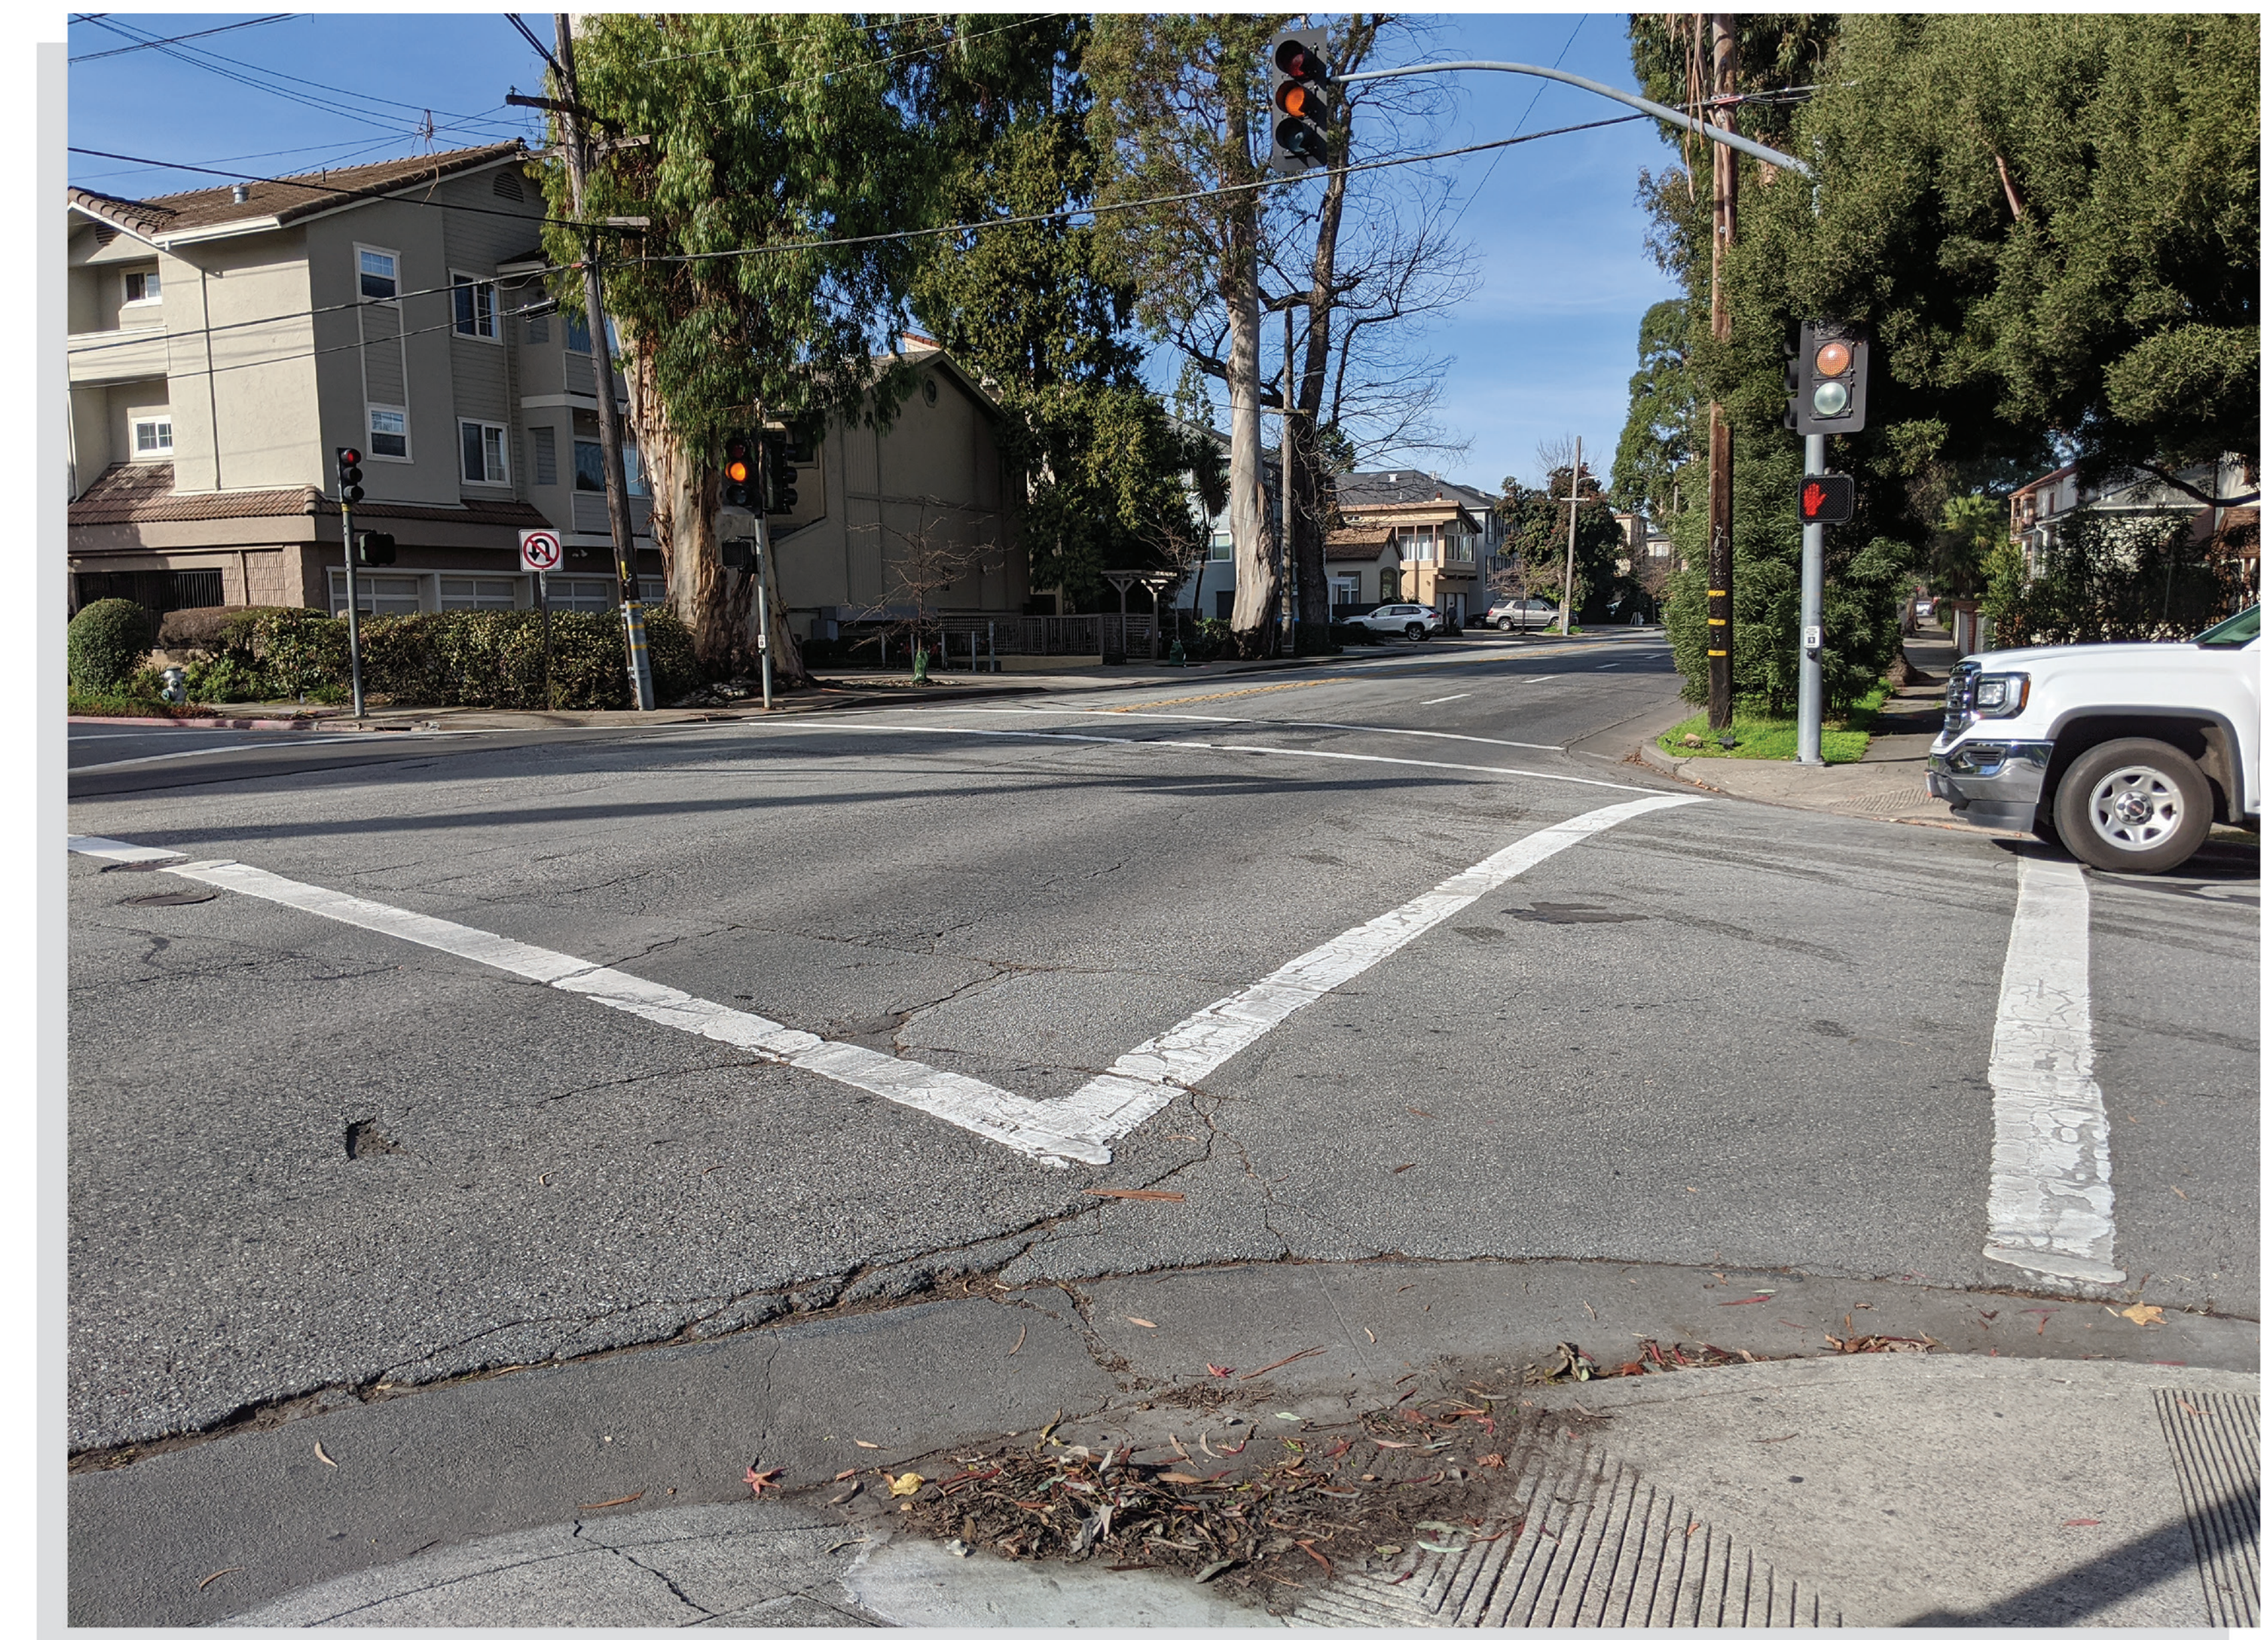
Crosswalks, like the one shown in this image from the 1500 block of Carmelita, have worn or absent crosswalk markings and no signage.

A total of 16 intersections in the project area of El Camino Real need pedestrian crossing improvements. Typical crosswalks should have highly visible pavement markings and yield signage.

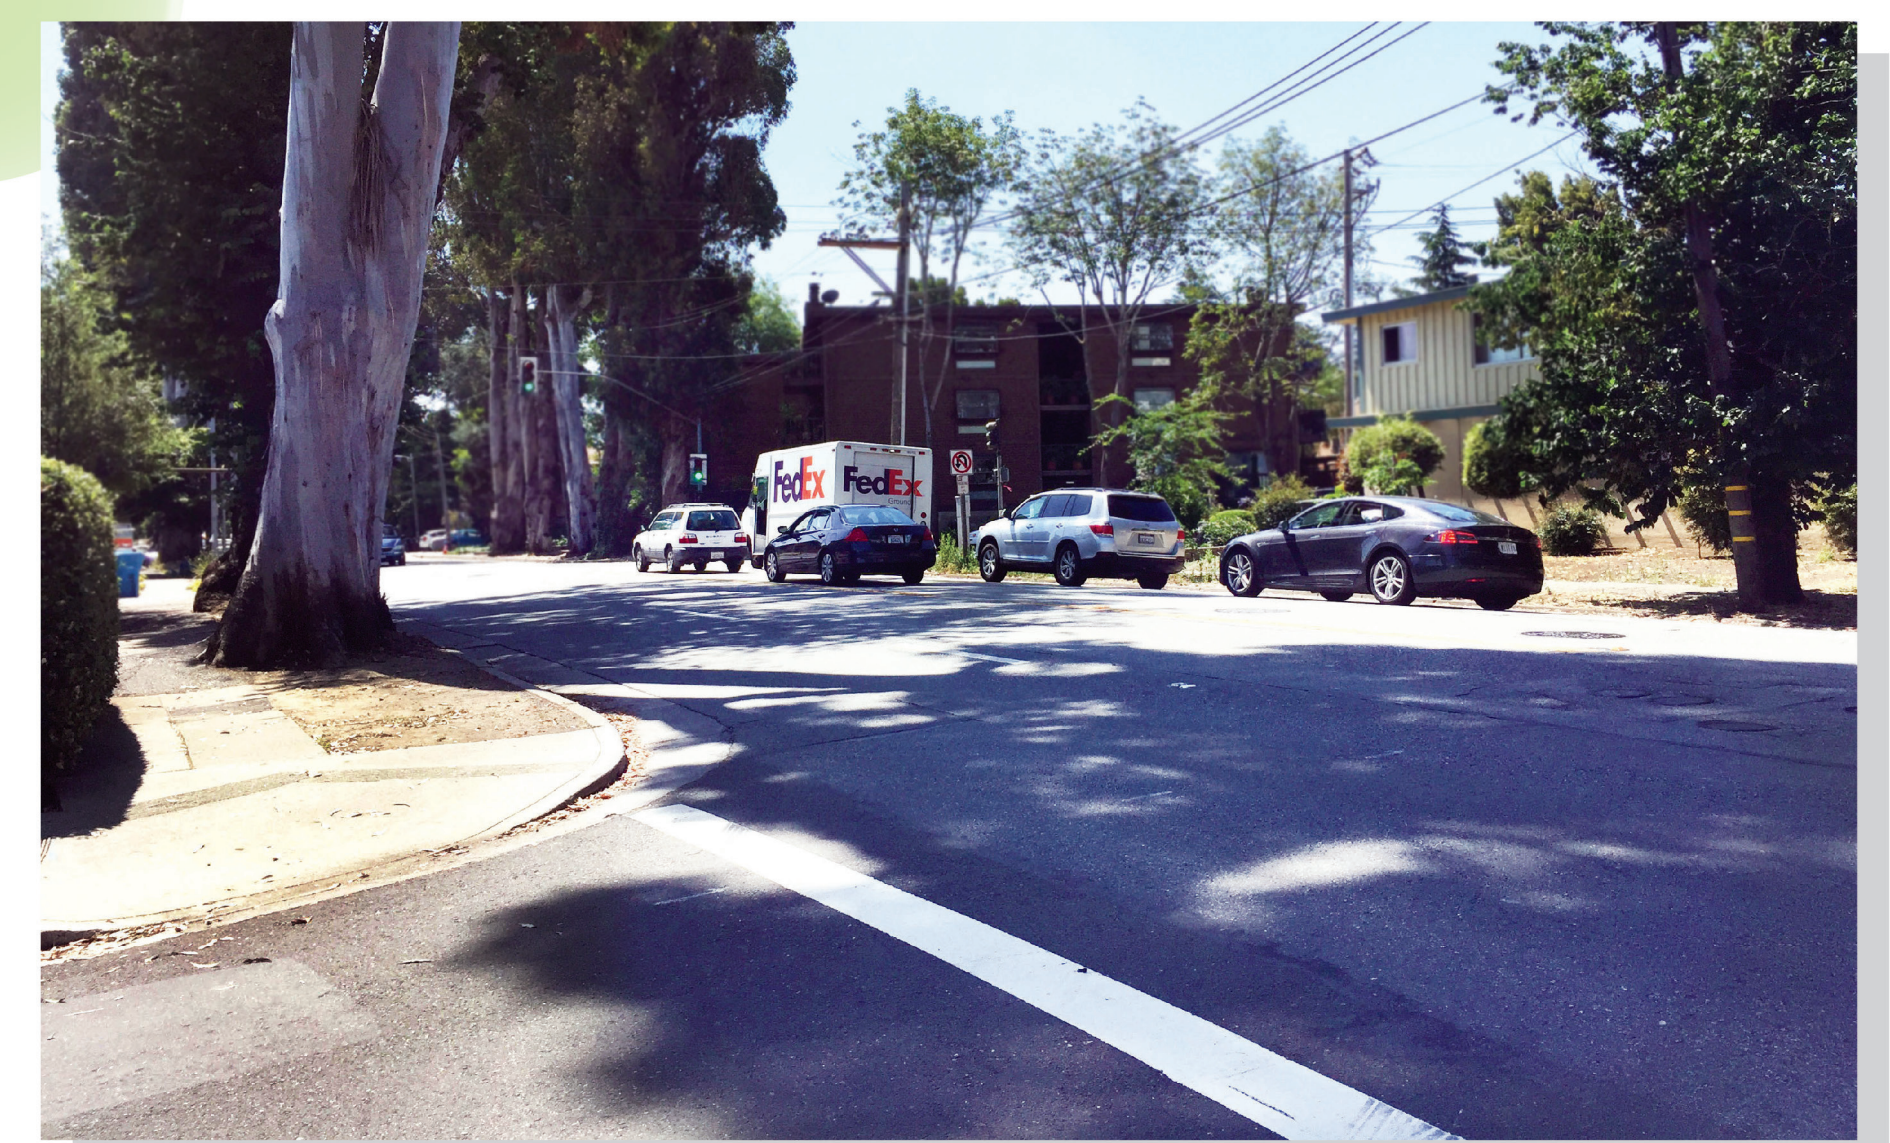
A large tree trunk obscures oncoming traffic

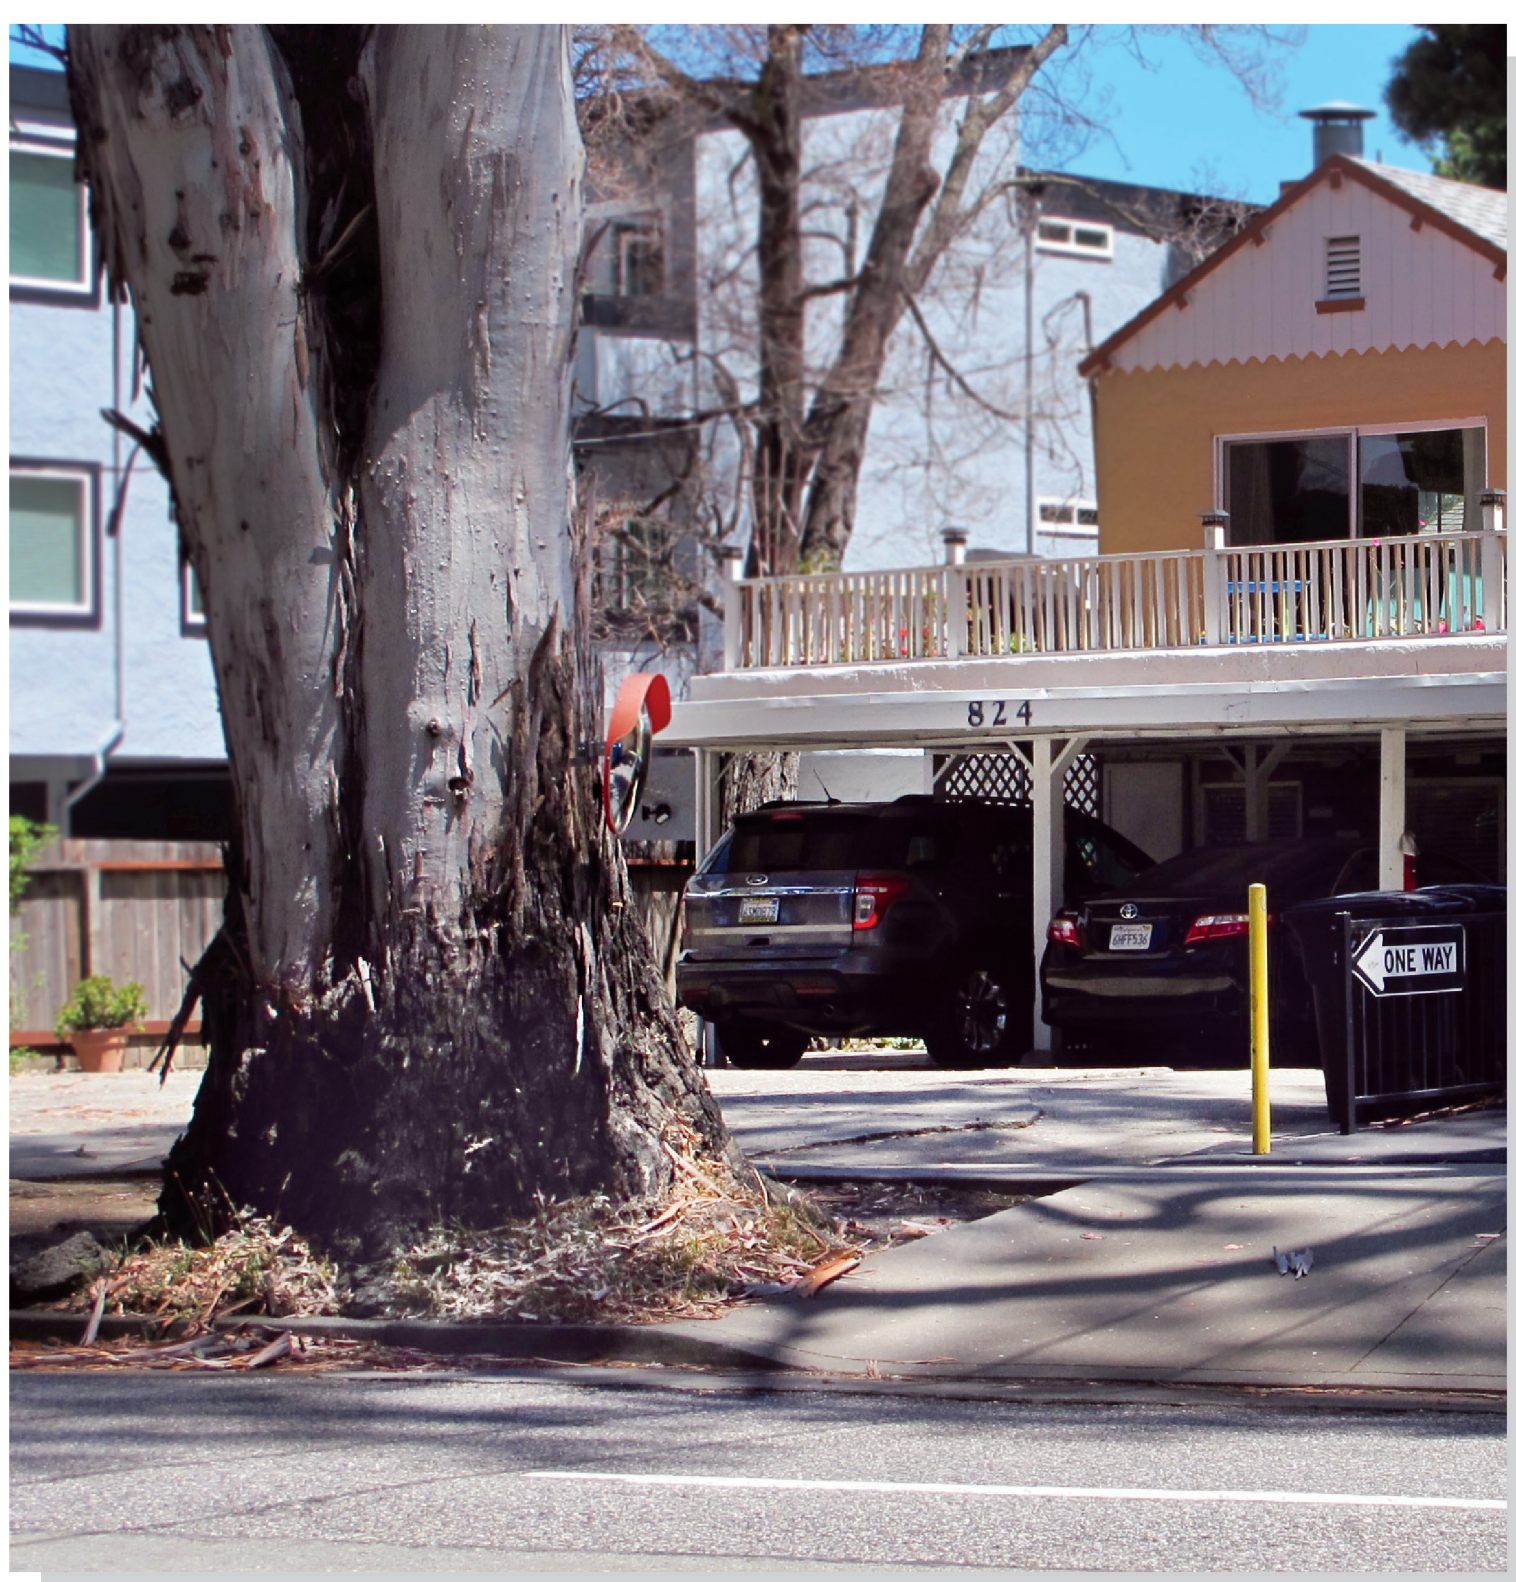
Residents have mounted a mirror to compensate for poor visibility at a driveway

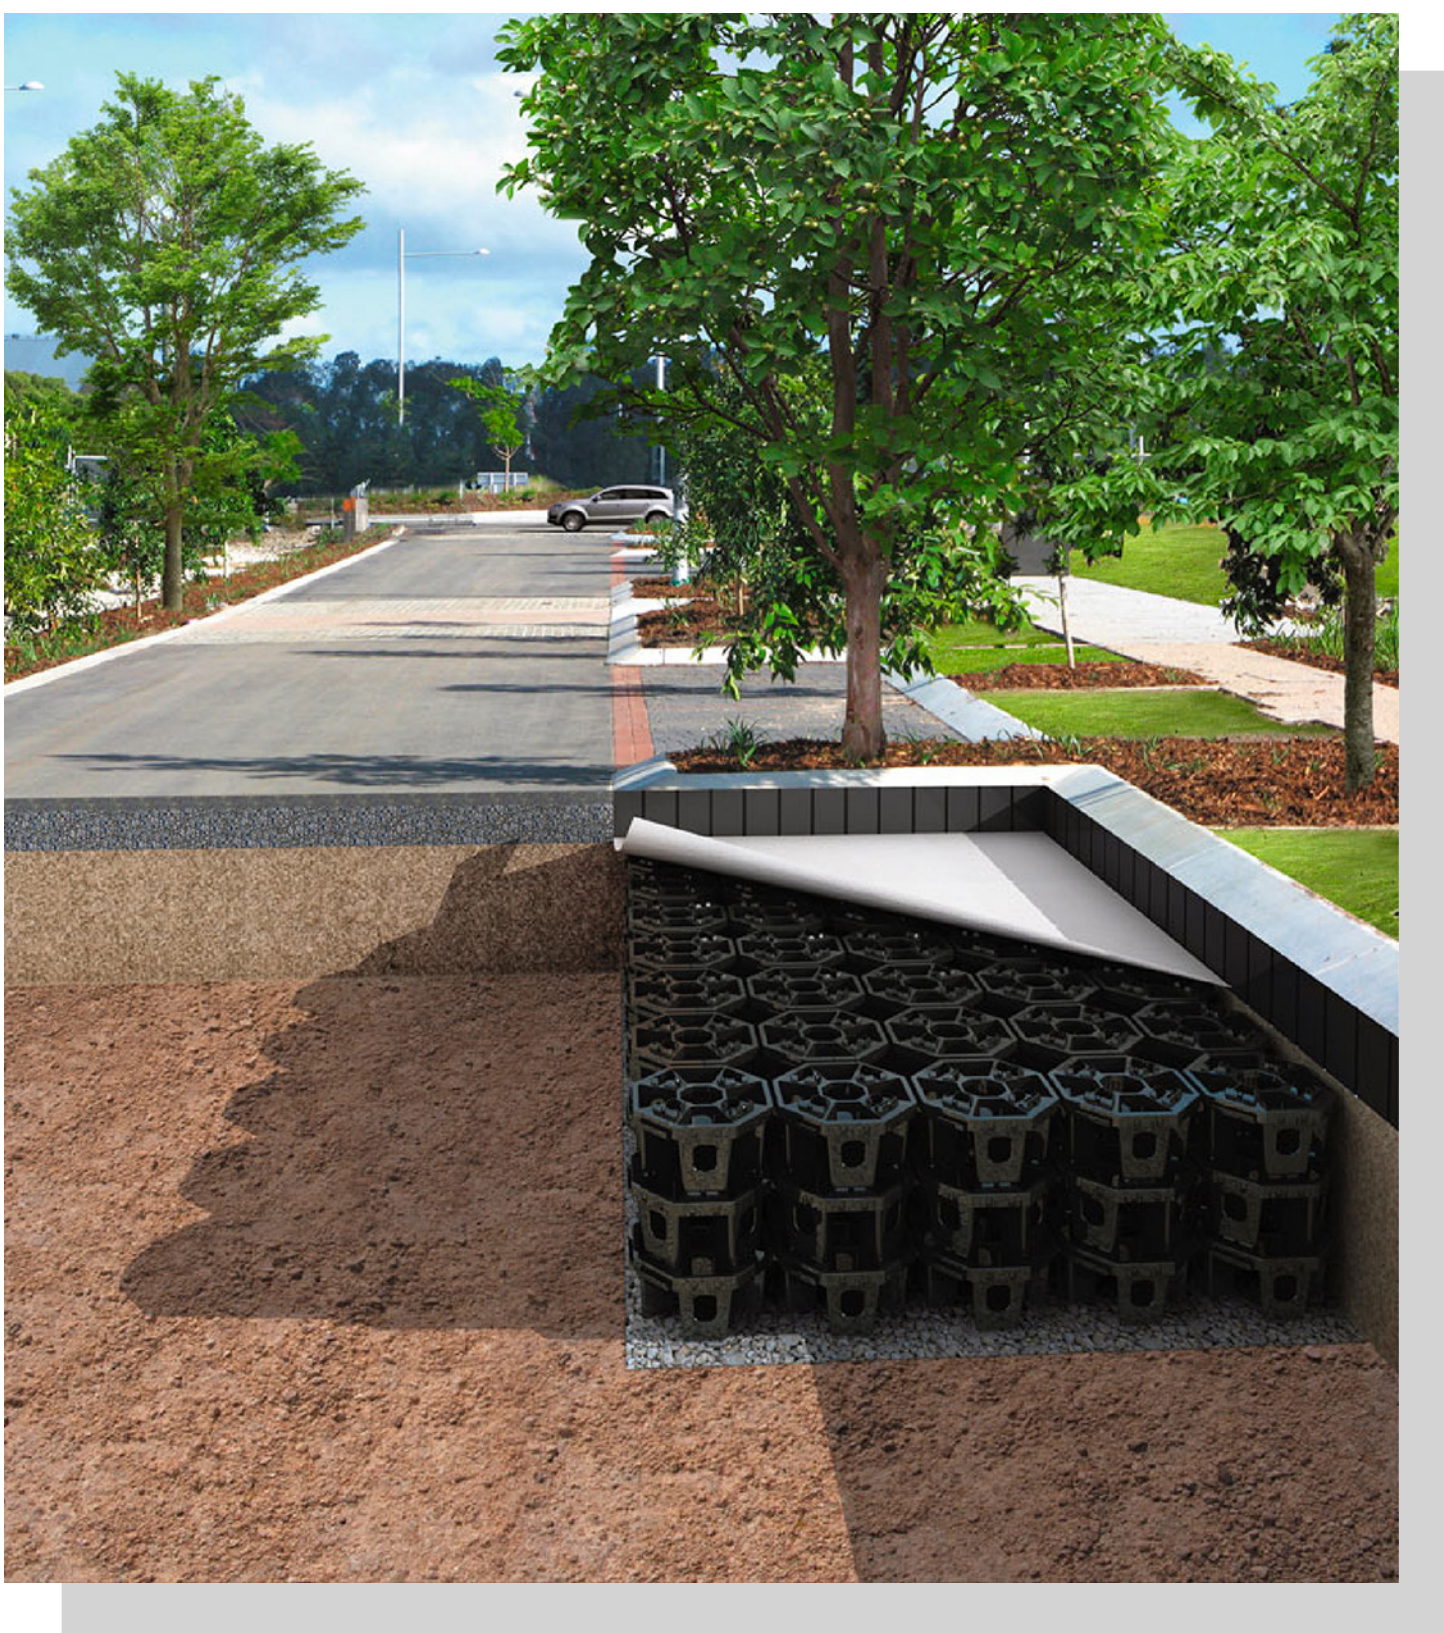
Suspended pavement is supported by a modular cagelike structure underground. This keeps the pavement from settling, but lets roots move through uncompacted soil.

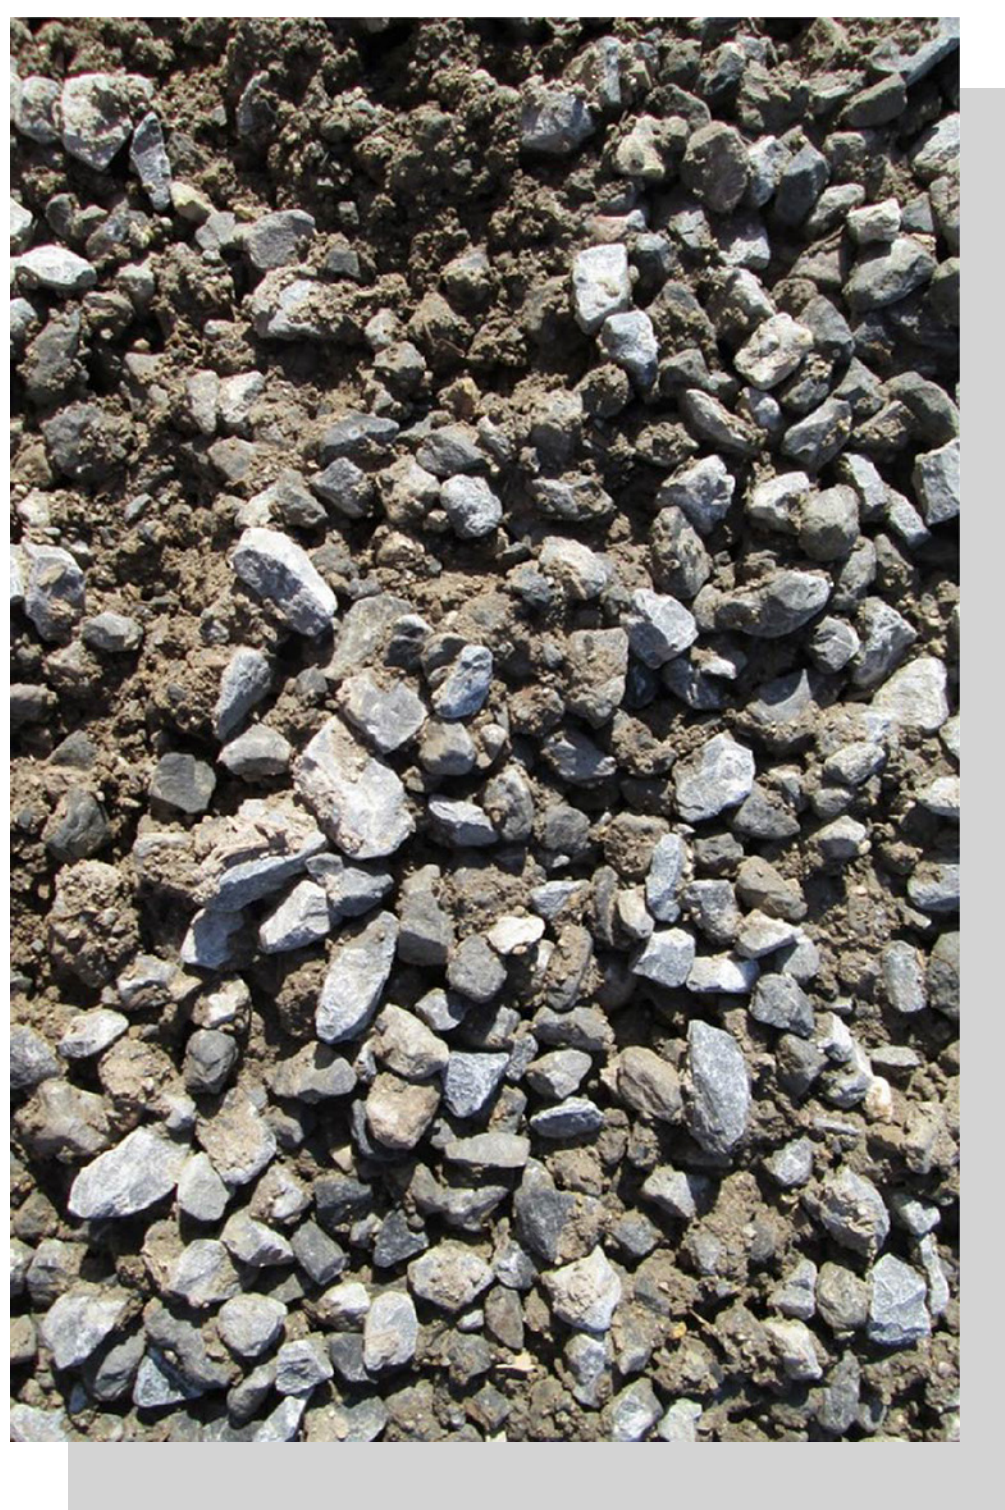
Coarse structural soils can be compacted to support pavement, while still retaining the oxygen roots need in the pore spaces between the aggregate.

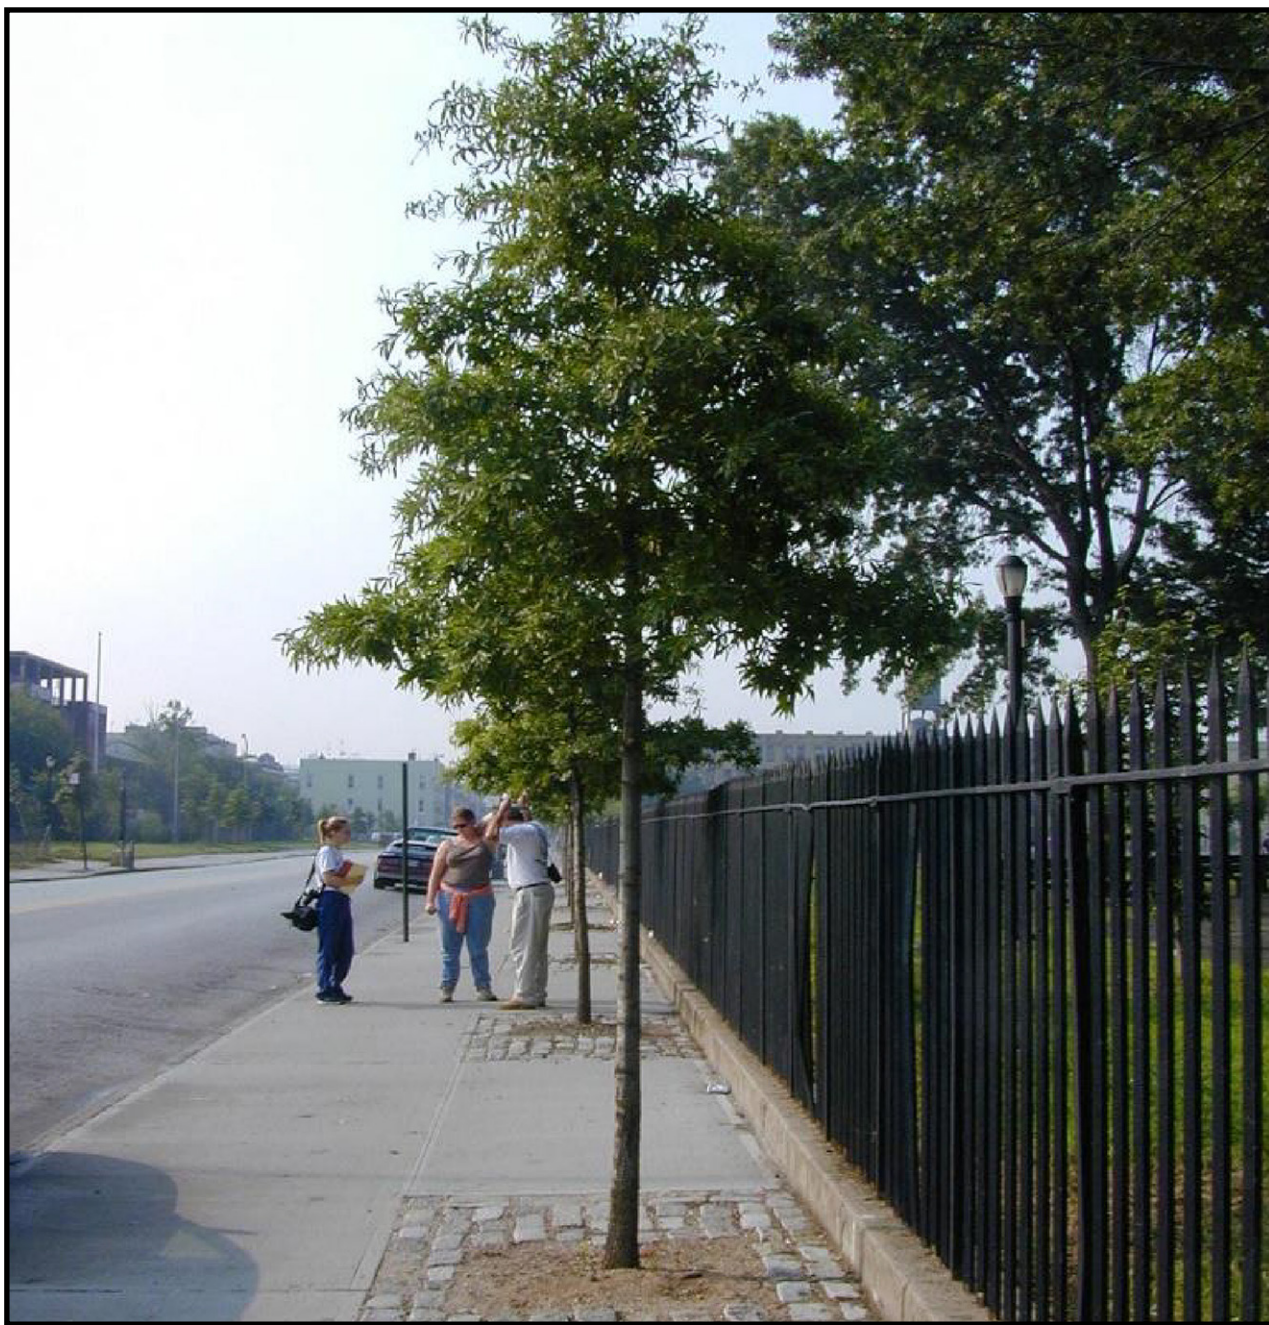
Street trees planted in structural soil in Brooklyn, New York in 1997.

3 years after planting

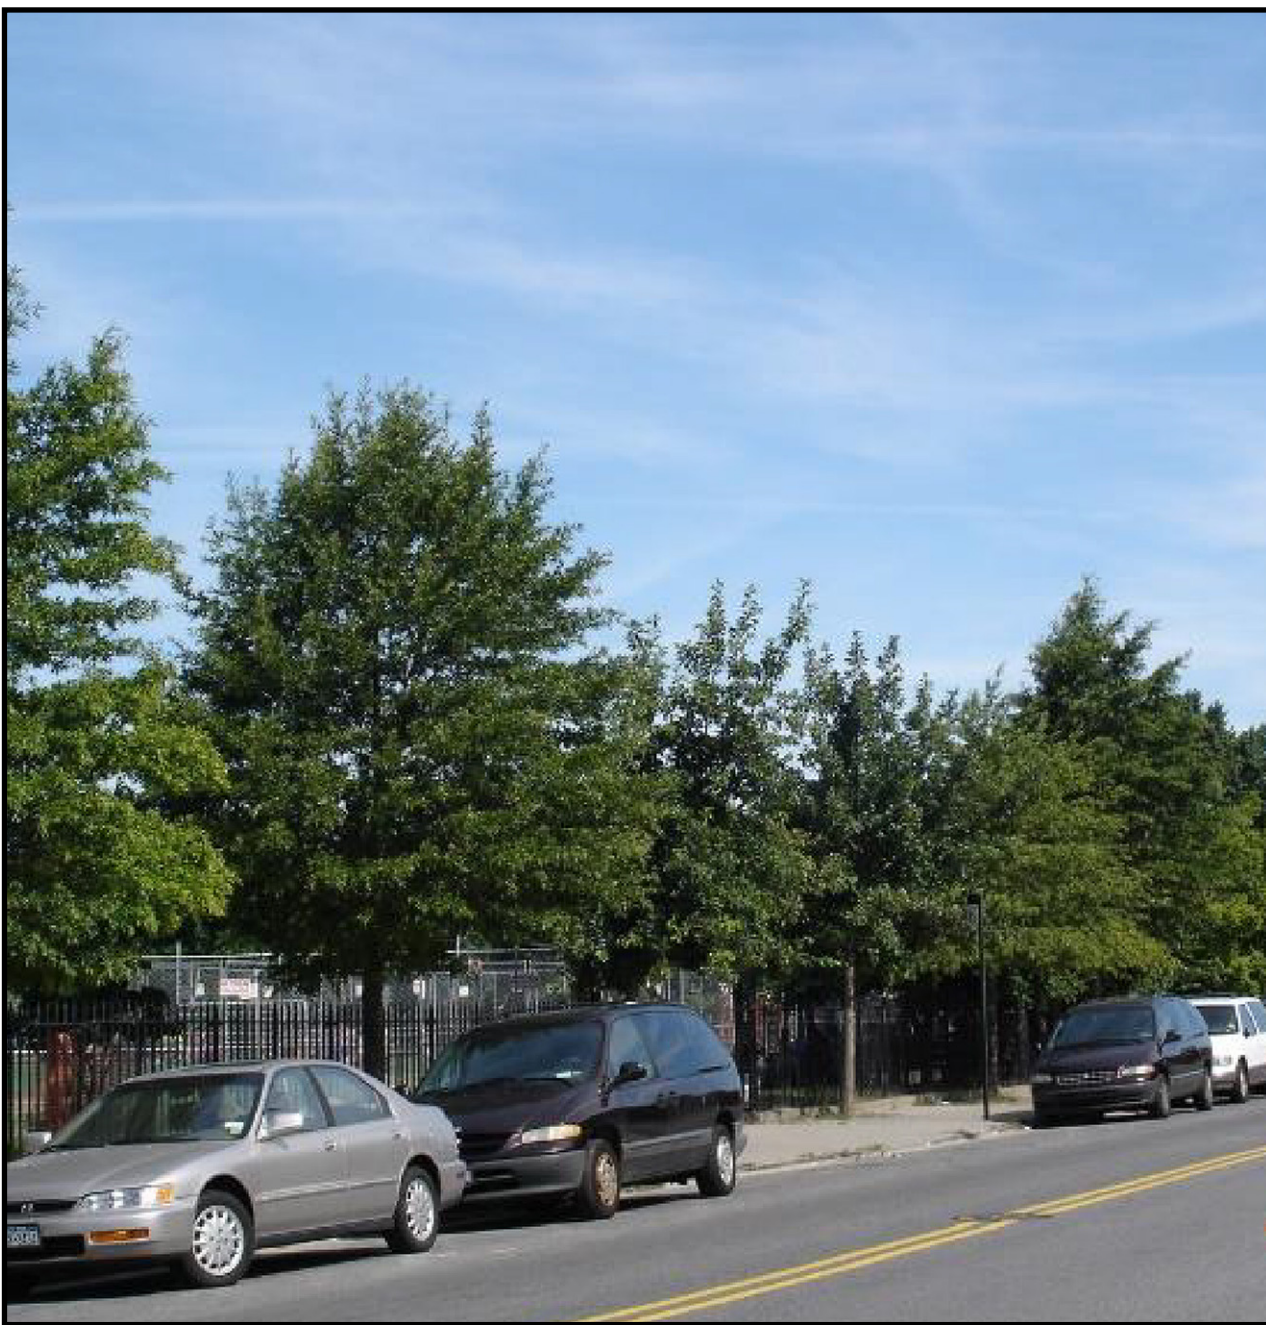
10 years after planting

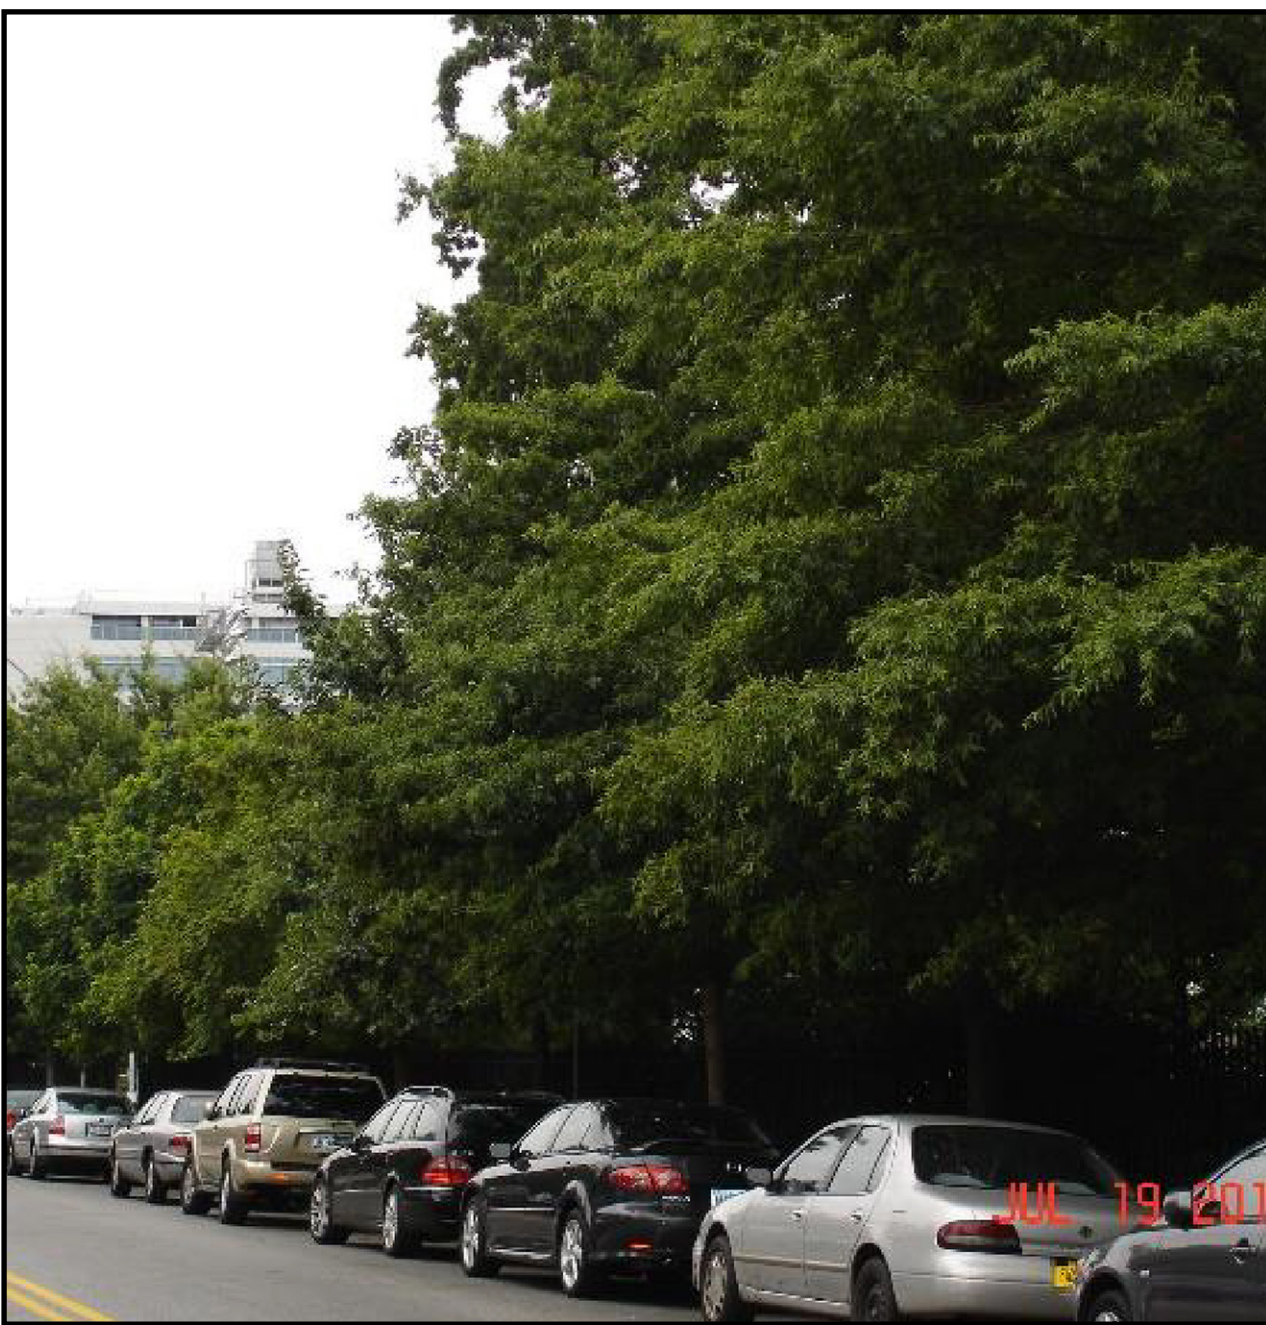
15 years after planting
