Project Title: Aesthetic, Low-Maintenance Guardrail Systems for Rural Areas

Development of Aesthetic, Low-Maintenance Guardrail System Alternatives

Crash testing of a bridge rail mounted onto a new concrete foundation design in an effort to provide aesthetic, low-maintenance guardrail alternatives.

# DEVELOPMENT OF AESTHETIC, LOW-MAINTENANCE GUARDRAIL SYSTEM ALTERNATIVES

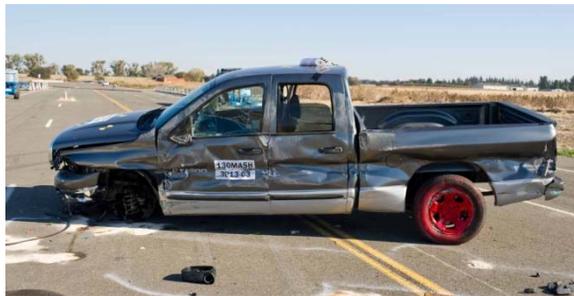
**Figure 3 - Vehicle on Side**

The combination of the ST-10 bridge rail and trench footing successfully redirected the vehicle but the vehicle rolled onto its side after it lost contact with the barrier. Although this combination failed MASH's evaluation criteria, the trench footing functioned as intended. Therefore, this trench footing is recommended for use with any bridge rail designs that have met either NCHRP Report 350's or MASH's Test Level 3 or Test Level 4 criteria. These rail/footing combinations may be considered for use on California's roadways as TL-3 guardrail.

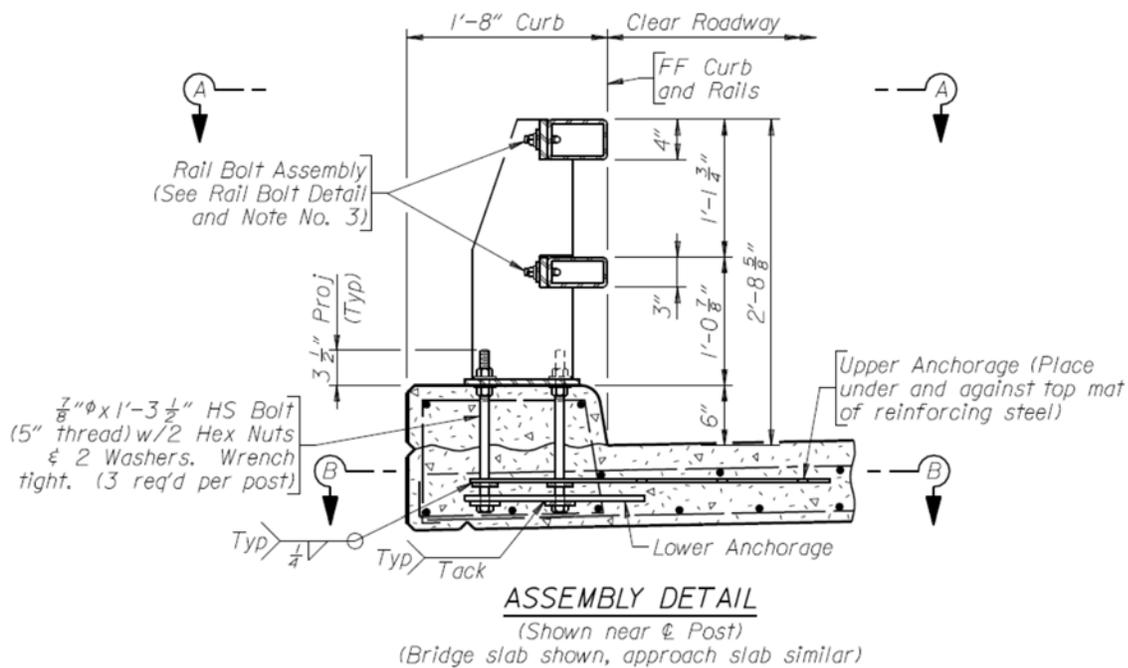
Figure 1-1 Profile of Wyoming TL-4 Bridge Rail (Excerpt from Wyoming DOT TL4 Bridge Railing Sheets)

The ST-10 Bridge Rail used for the test conducted in this report is a modified version of the Wyoming TL-4 Bridge Rail<sup>3</sup>. The two rails have similar profiles but the Wyoming Rail's lower rail is 3 inches (76 mm) tall and the ST-10 Rail's lower rail is 4 inches (102 mm) tall. The change was made so that the ST-10 parts would be uniform and would require less stock in maintenance yards. Since the difference in profile between the ST-10 and Wyoming Rail is minor, it was deemed that the ST-10 would not need to be crash tested and the change was accepted by the FHWA.

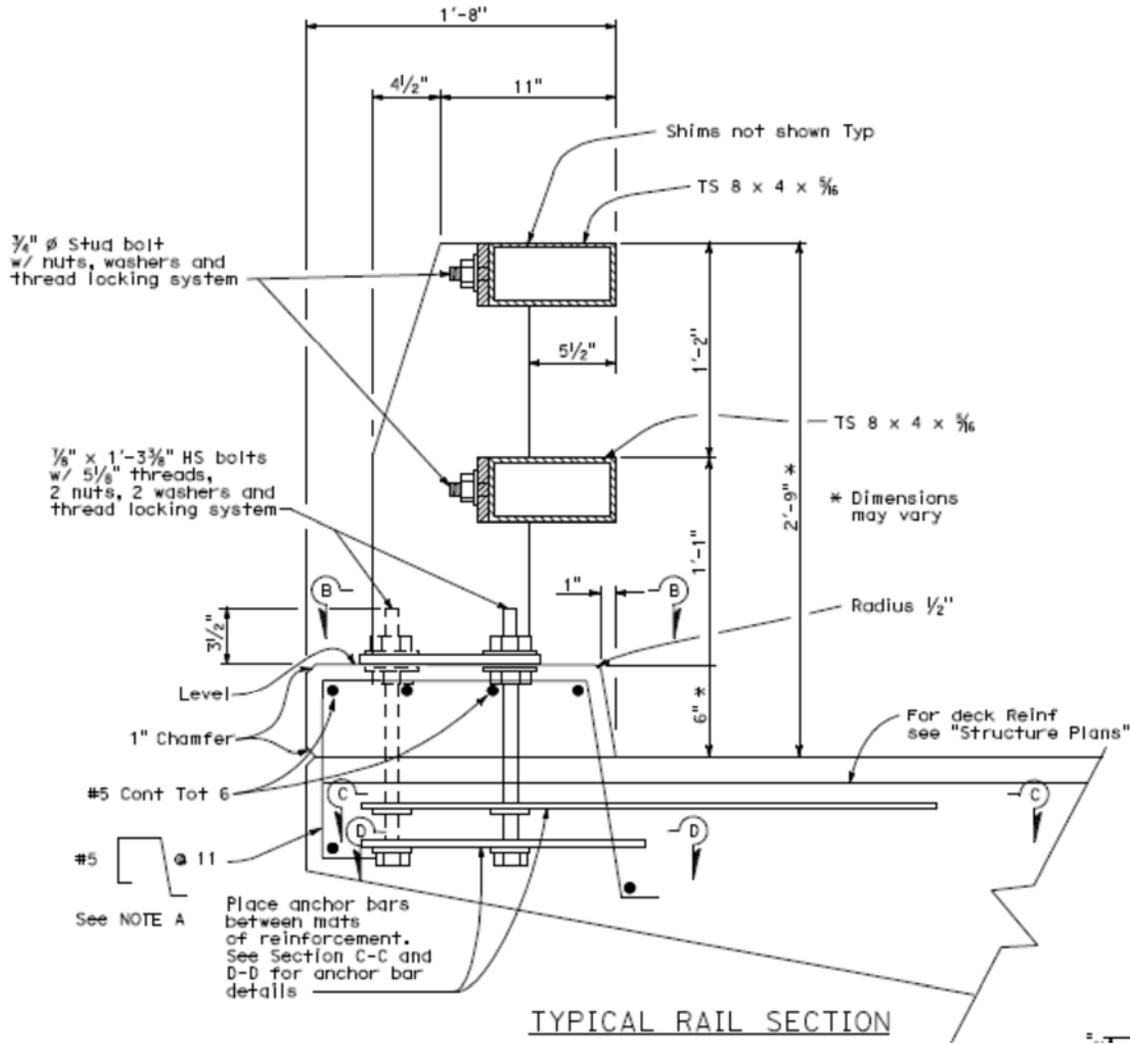
Figure 1-2 Profile of Caltrans ST-10 Bridge Rail (Excerpt from 2006 California Standard Plan B11-68)

The ST-10 Bridge Rail is a 33-inch (838-mm) high steel barrier that consists of two 8-inch (203-mm) by 4-inch (102-mm) steel rails (designated TS 8x4x5/16 inch) and a 6-inch (152-mm) concrete curb. See Figure 10-1 through Figure 10-3 for Caltrans' 2006 Standard Plans for the ST-10 Bridge Rail. The bridge rail was modified by mounting the rail on a 30-inch (762-mm) by 20-inch (508-mm) concrete trench footing foundation in place of a bridge deck. The length of the test article was 112.6 feet (34.34 m). See Figure 10-4 through Figure 10-8 for details on the test article. The ST-10 Bridge Rail was chosen for this project because it is very rigid and has the least mass of other Caltrans bridge rails. Therefore it would impart the greatest load to the footing.

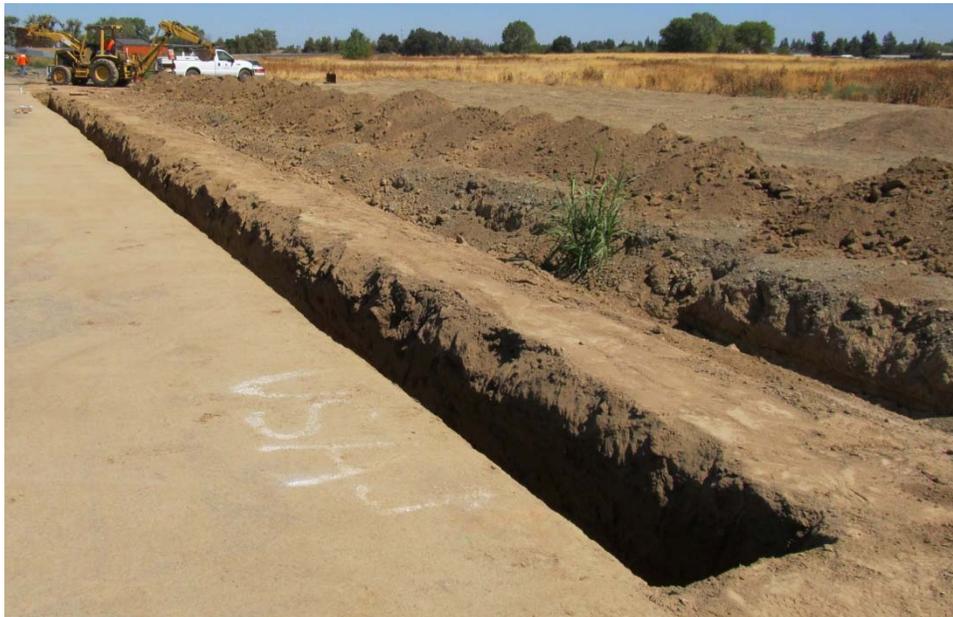
Figure 2-1 Excavation

During the installation of the foundation's rebar the back of the barrier's upper edge of the trench footing had some erosion. The erosion was due to the workers having to move around in the trench to assemble the rebar cage for the concrete foundation. The erosion caused the top of the trench to be larger than the bottom by an average of 11 inches (279 mm). This wear on the edges is typical of a field installation for a foundation of this type.

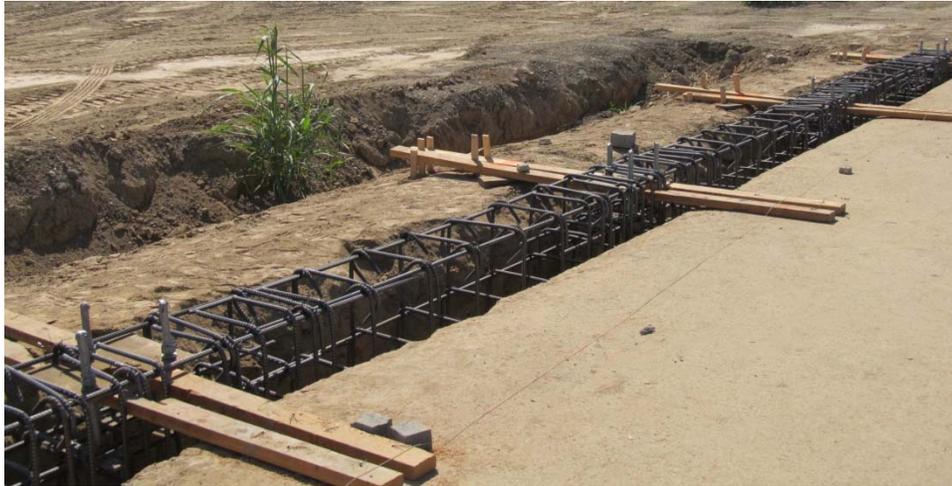
Figure 2-2 Rebar for Barrier

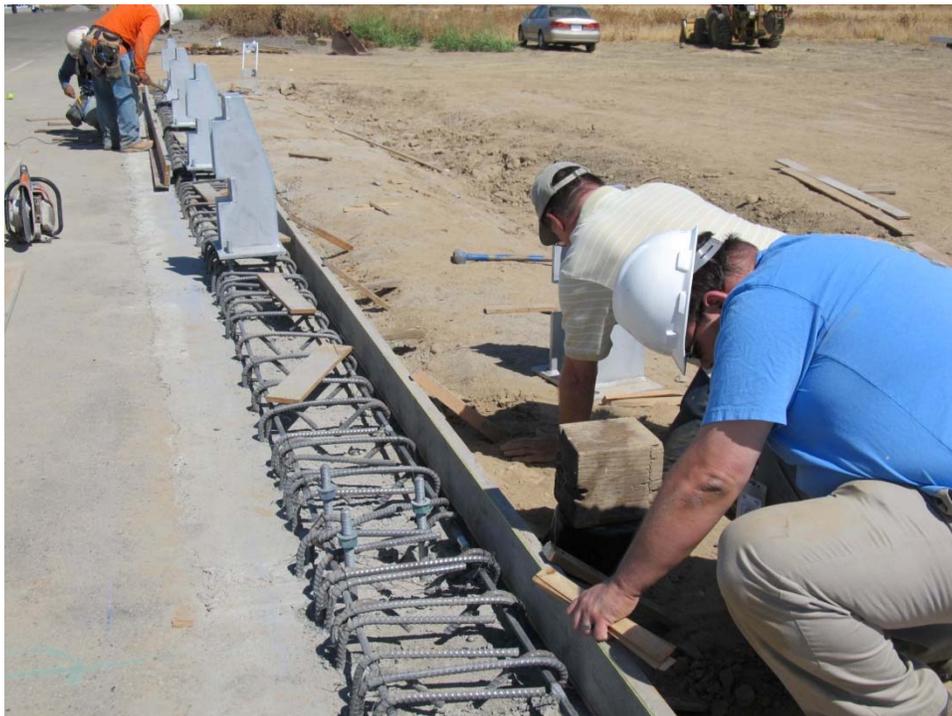
Figure 2-3 After the First Concrete Placement

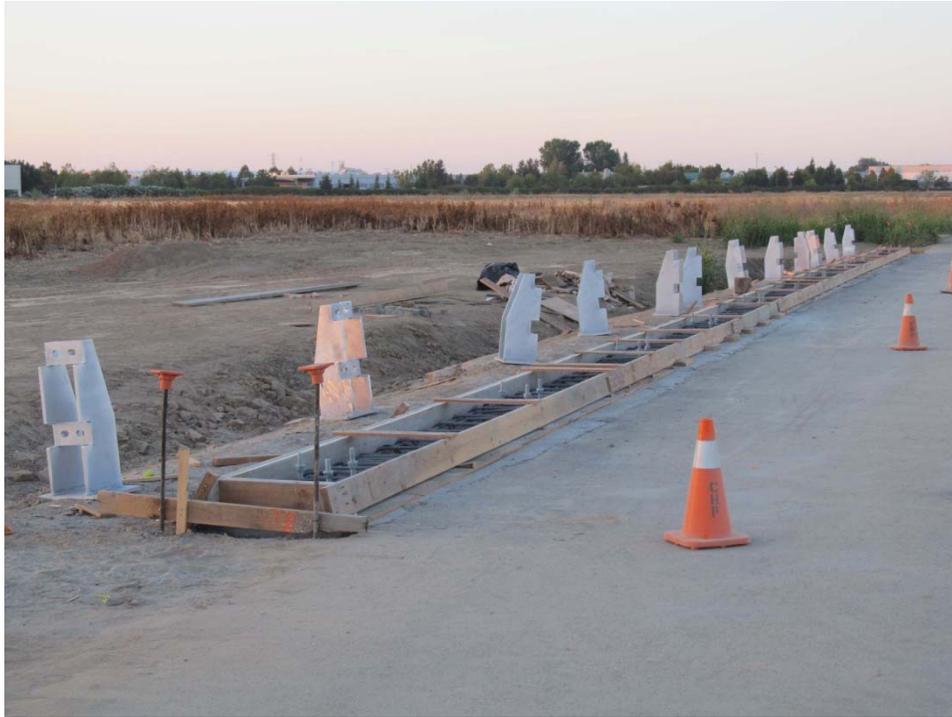
Figure 2-4 Before the Second Concrete Placement For Curb

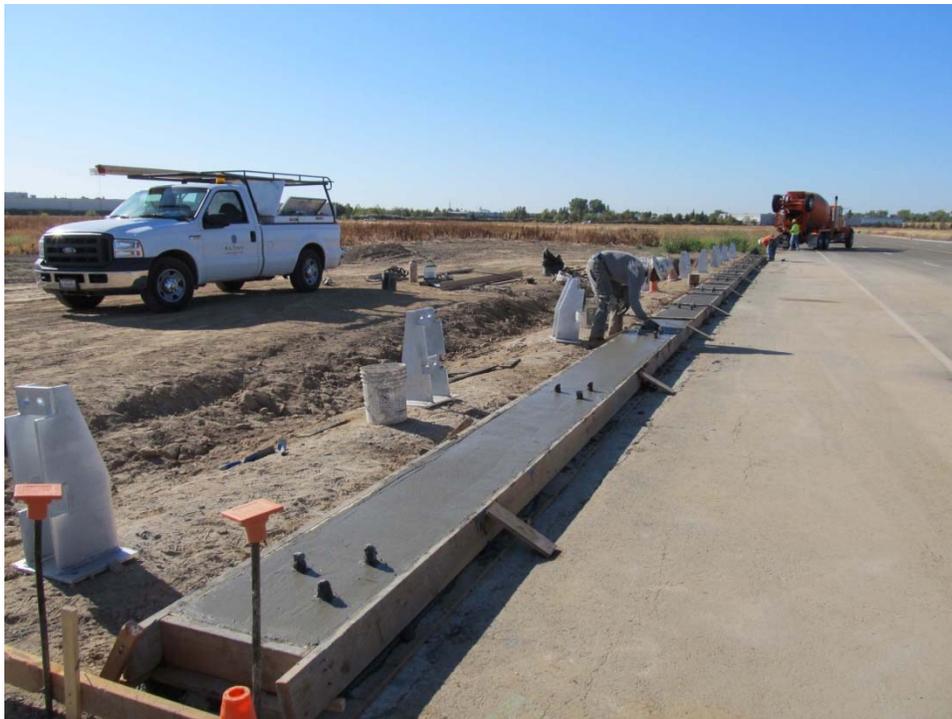
Figure 2-5 After the Second Concrete Placement

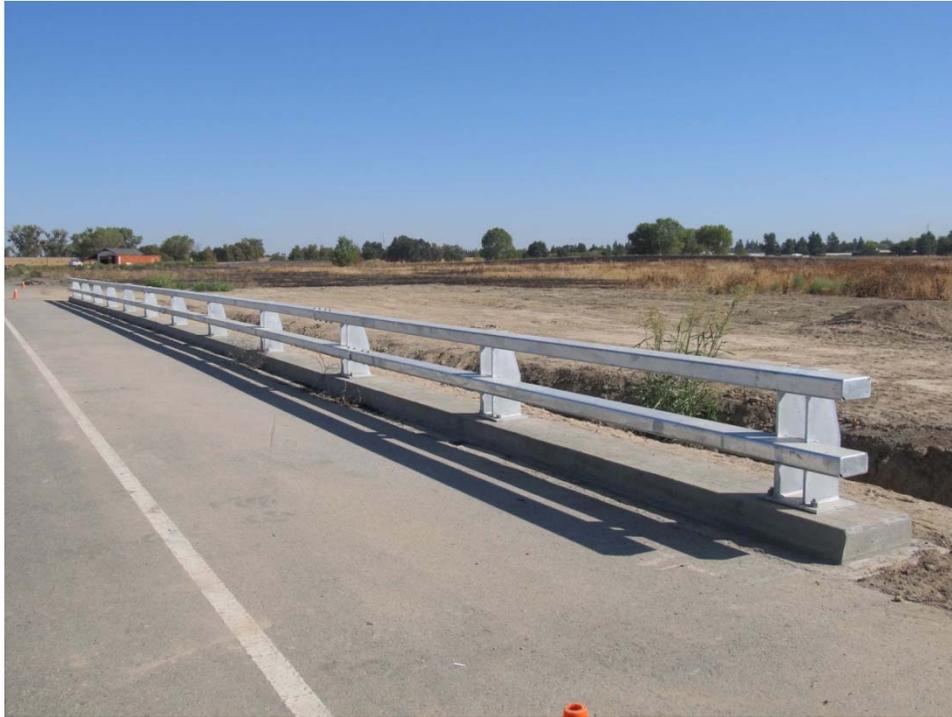
Figure 2-6 Completed Barrier Construction Front

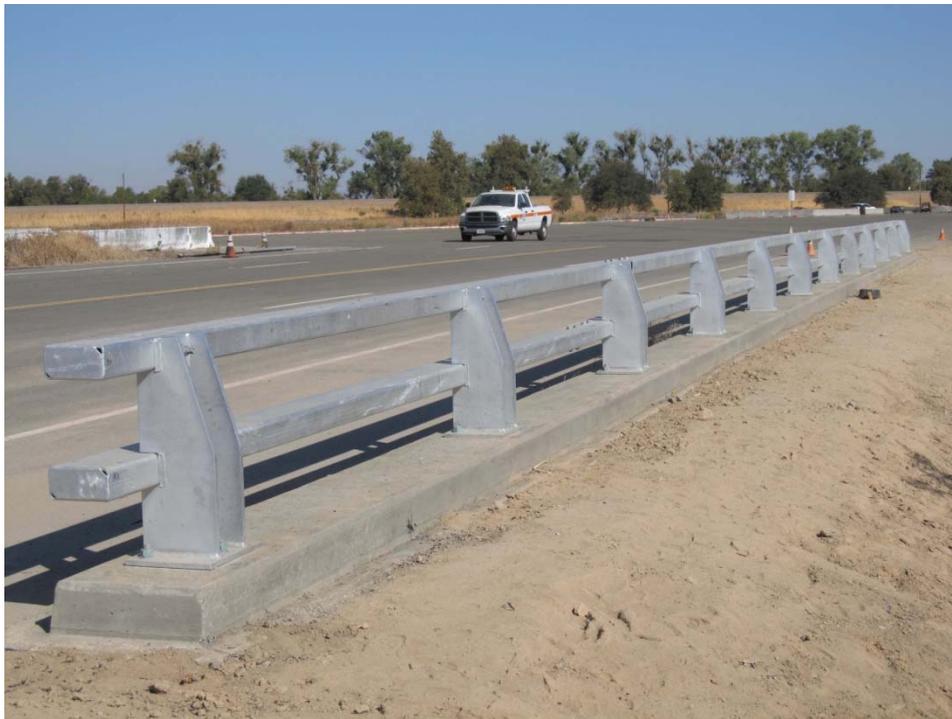
Figure 2-7 Completed Barrier Construction Back

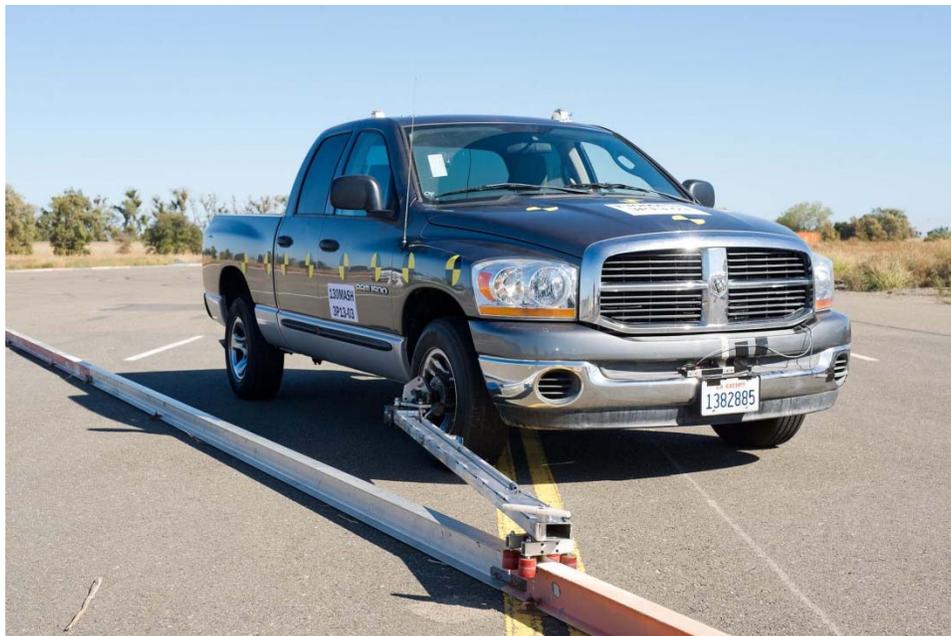
A rail guidance system directed the vehicle into the barrier. The guidance rail, anchored at 12.5-ft (3.8-m) intervals along its length, was used to guide a mechanical arm that is attached to the front passenger side wheel of the vehicle (Figure 4-1). A high density polyethylene arm on the front end of the guidance arm was used to trigger the release mechanism on the guidance arm, thereby releasing the vehicle from the guidance system before impact. A 0.375-in (10-mm) nylon rope was used to pull the guidance arm away from the vehicle after the release was triggered.

Figure 4-1 Test Vehicle Guidance System

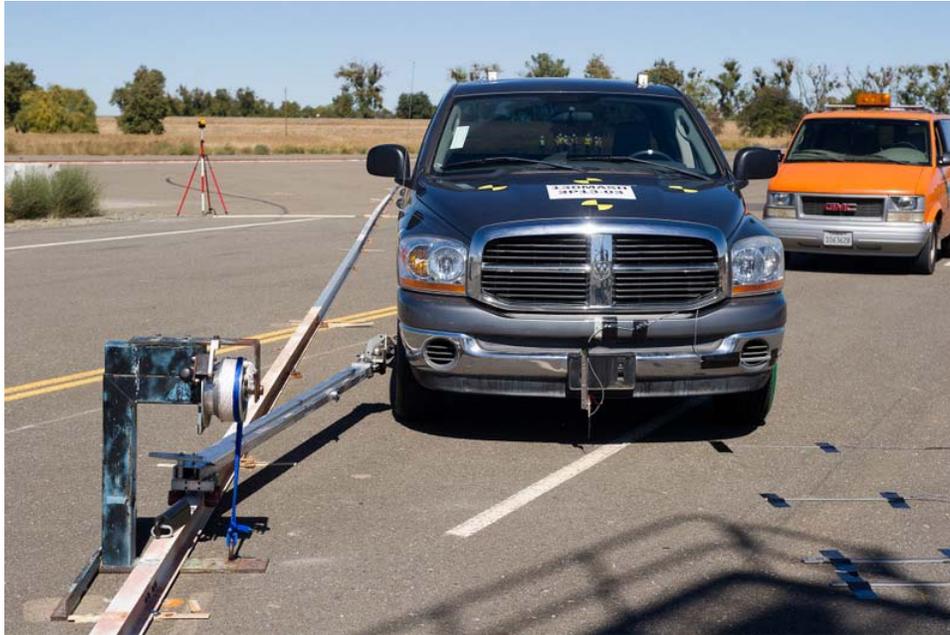
Figure 4-2 Guidance Arm Release Mechanism

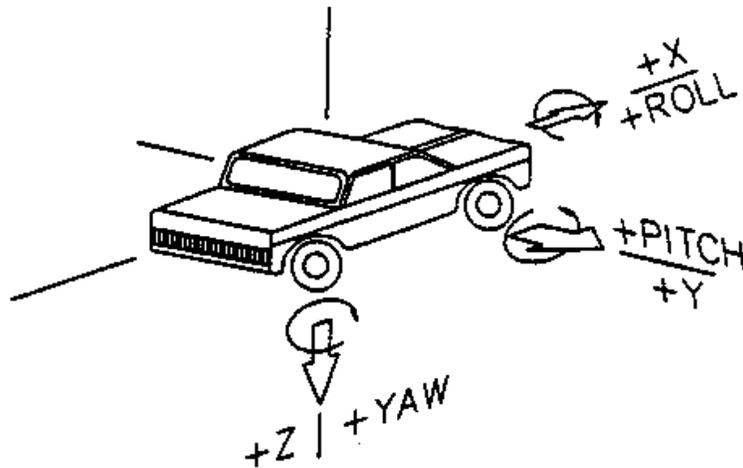
Figure 4-3 Vehicle Coordinate Sign Convention

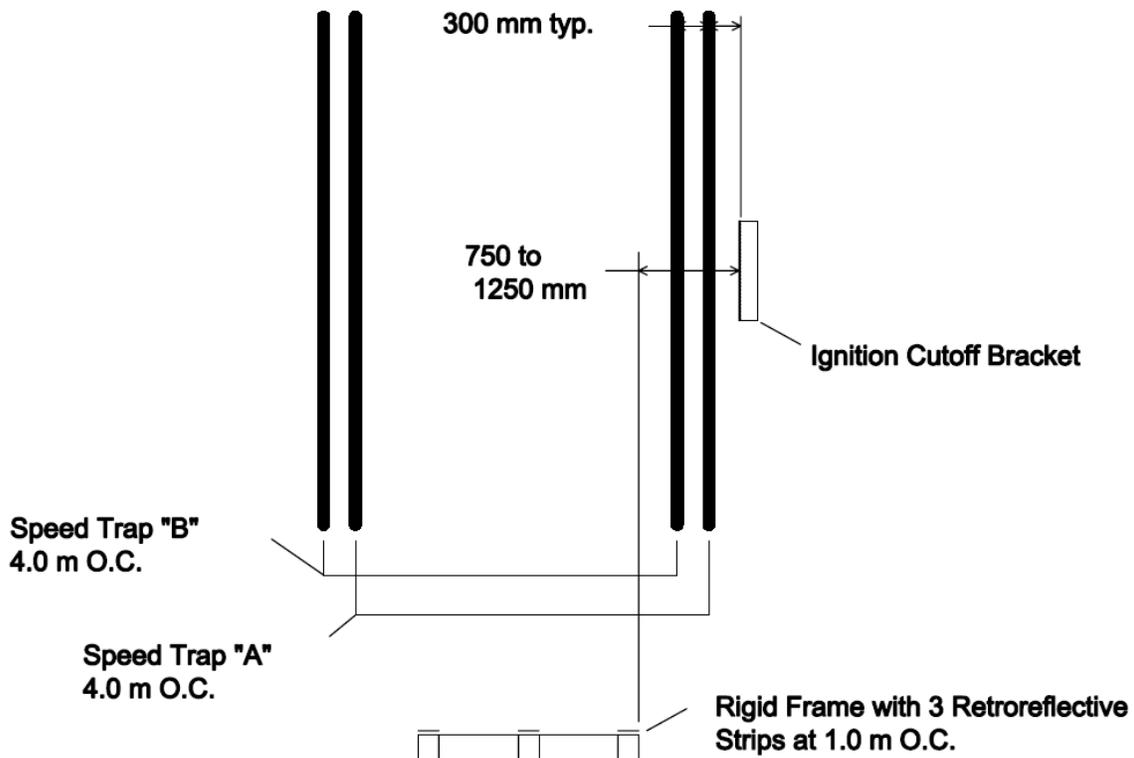
A rigid stand with three retro-reflective 90° polarizing tape strips was placed on the ground near the test article and alongside the path of the test vehicle. The strips were spaced at carefully measured intervals of 3.28-ft (1.0-m). The test vehicle had an onboard optical sensor that produced sequential impulses or "event blips" as the vehicle passed the reflective tape strips. The event blips were recorded concurrently with the accelerometer signals on the TDR, serving

as "event markers". The impact velocity of the vehicle could be determined from these sensor impulses, the data record time, and the known distance between the tape strips. A pressure sensitive tape switch on the front bumper of the vehicle closed at the instant of impact and triggered two events: 1) an "event marker" was added to the recorded data, and 2) a flashbulb mounted on the top of the vehicle was activated. Two sets of pressure activated tape switches, connected to a speed trap, were placed 13.1 ft (4.0 m) apart just upstream of the test article specifically to establish the informal impact speed of the test vehicle. The layout for all of the pressure sensitive tape switches and reflective tape is shown in Figure 4-4.

Figure 4-4 Event Switch Layout

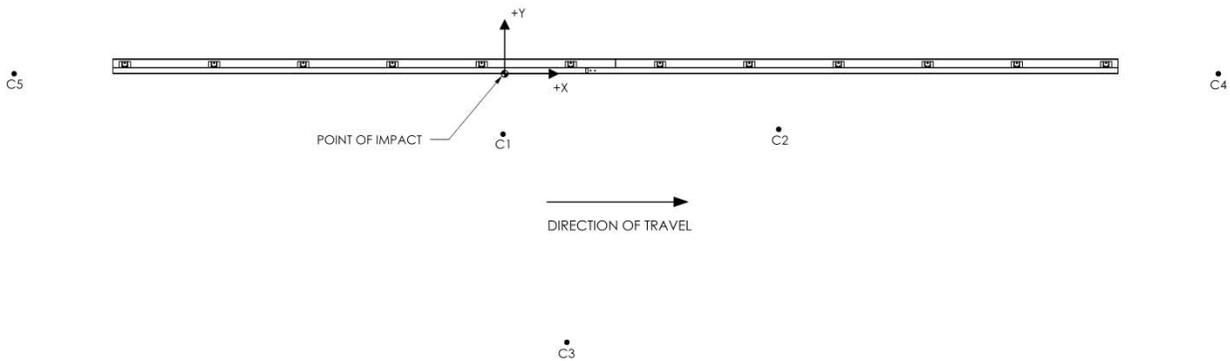
Camera Location	Camera Type	Figure 4-5 Labels	Coordinates in Feet (m)		
			X*	Y*	Z*
Overhead 1	Phantom Miro 110	C1	-0.19 (-0.06)	-6.75 (-2.06)	31.18 (9.50)
Overhead 2	Phantom Miro 110	C2	30.12 (9.36)	-6.21 (-1.89)	39.80 (12.13)
Across	Phantom v642 Broadcast	C3	6.97 (2.13)	-60.75 (-18.52)	3.60 (1.10)
Downstream	Phantom v642 Broadcast	C4	205.70 (62.69)	-1.35 (-0.41)	4.55 (1.39)
Upstream	Phantom v642 Broadcast	C5	-175.65 (-53.54)	0.90 (0.27)	5.07 (1.54)
Note: *X, Y, and Z distances are relative to the impact point.

Figure 4-5 Camera Locations (Not to Scale)

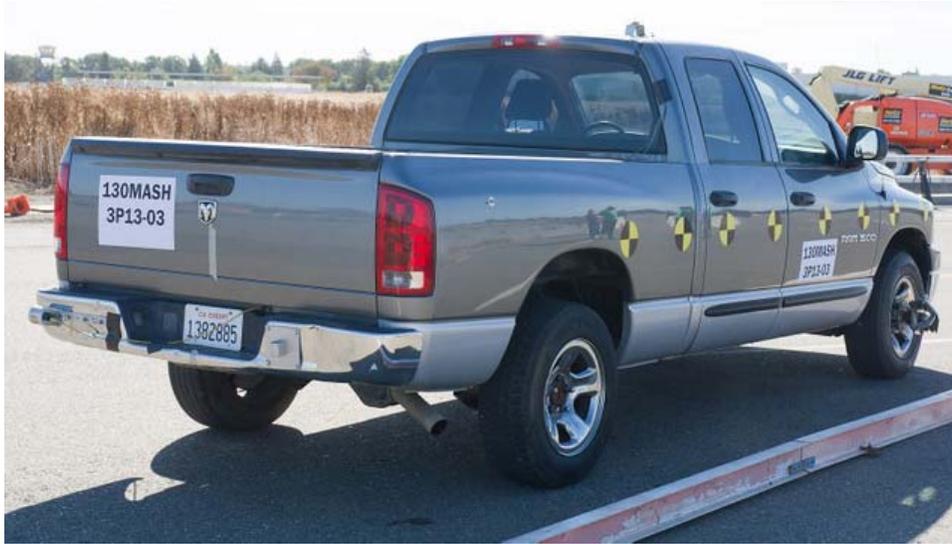
The test vehicle was a 2006 Dodge Ram 1500 Quad Cab pickup truck. The vehicle was in good condition and complied with MASH criteria. The test inertial weight of the vehicle was 5017.3 lbs (2275.8 kg). Dimensions and information on the test vehicle are reported in Section 10.2. The vehicle was self-powered. The engine was modified to include a speed-control device, which limited acceleration once the impact speed had been reached. To meet the 28-inch (710-mm) minimum vertical center of gravity height, 104 lbs (47.3 kg) of ballast was added to the front center of the truck bed. Additional modifications included a remote braking system, a modification to the front right wheel for the guidance system, and the addition of various sensors and electronics. A detailed description of the test vehicle equipment and guidance system is contained in Section 4.2 and 4.3.

Figure 5-2 Test 130MASH3P13-03 Test Vehicle Pretest 1

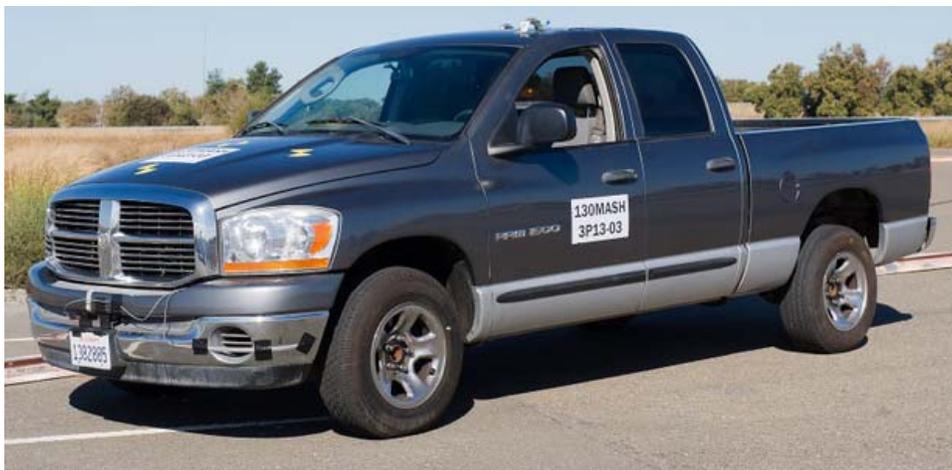
Figure 5-3 Test 130MASH3P13-03 Test Vehicle Pretest 2

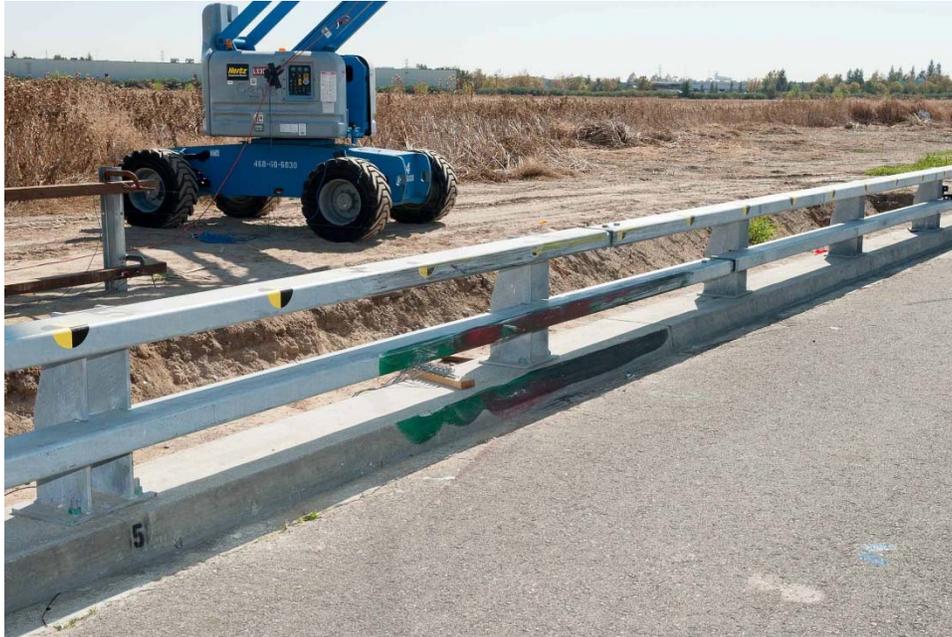
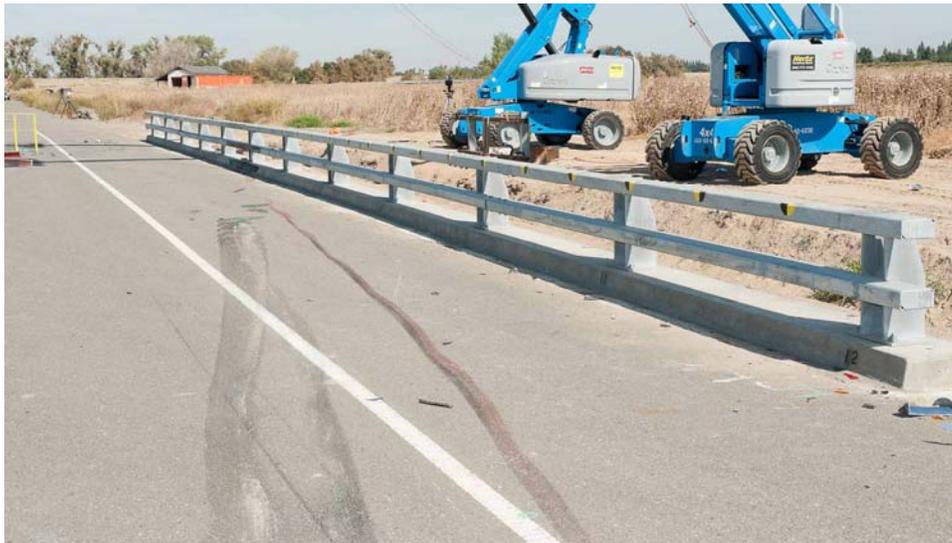
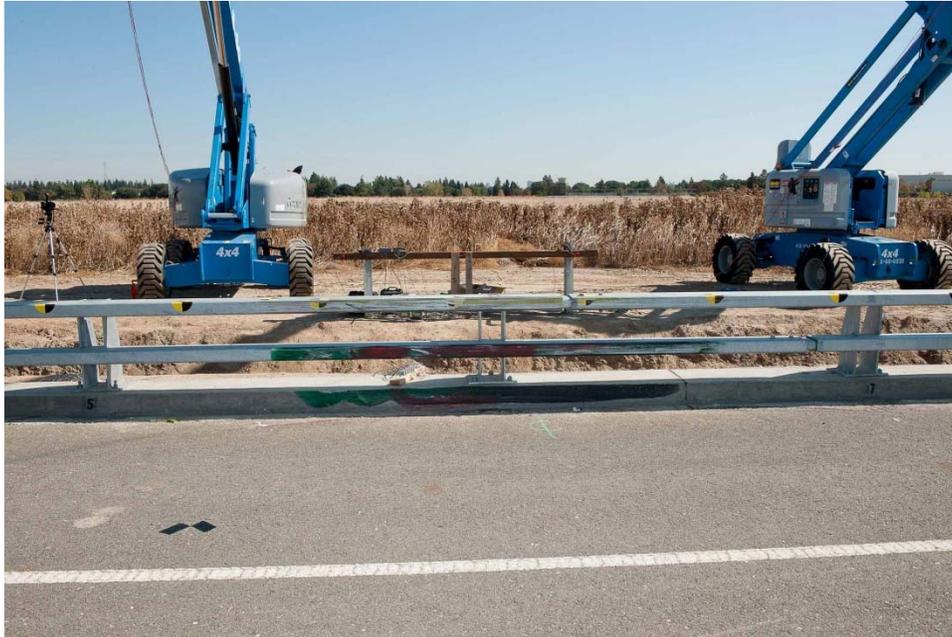
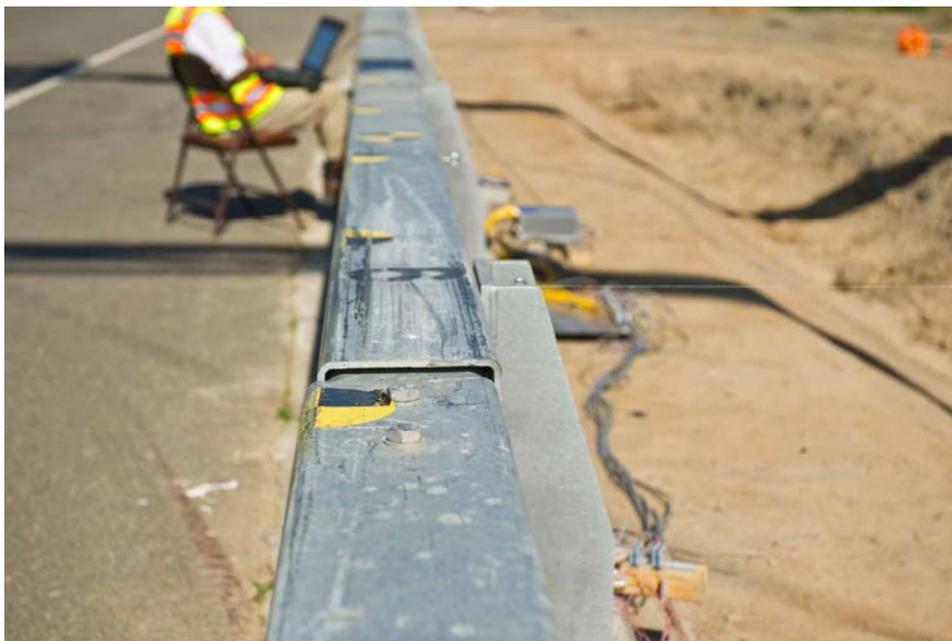
There was only cosmetic damage to the test article. The only maintenance that might be done is to use paint to cover over the marks left by the vehicle's tires.

Figure 5-4 Test Article After Test 130MASH3P13-03 Looking Downstream

Figure 5-5 Test Article After Test 130MASH3P13-03 Looking Upstream

Figure 5-6 Test Article After Test 130AMSH3P13-03 Looking Across

Figure 5-7 Test Article After Test 130MASH3P13-03 Close Up

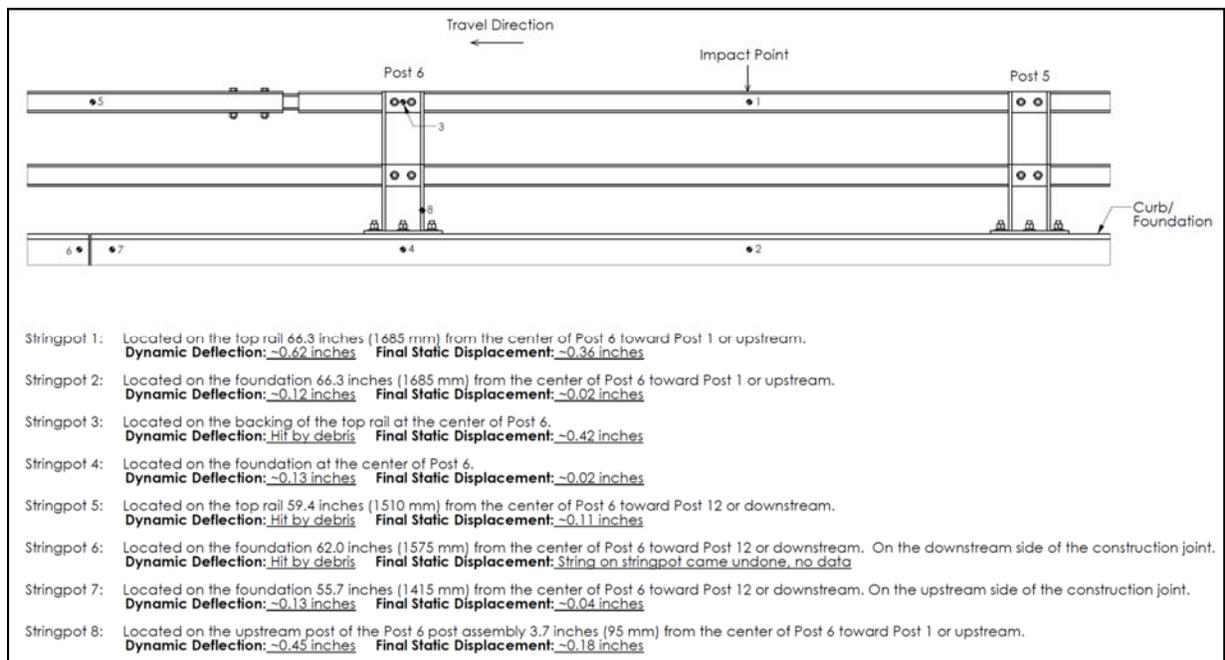
Eight string potentiometers (stringpots) were used on the top rail and on the back of the curb in the area of the impact to record the barrier's lateral movement, see Figure 5-8 for location and summary details. The stringpots on the curb recorded a maximum dynamic deflection of 0.13 inches (3 mm) and maximum static displacement of 0.04 inches (1 mm). All but one of the stringpots on the top rail were hit by debris and were not able to provide dynamic deflection measurements. The one top rail stringpot that was not hit by debris was located at the point of impact and recorded a maximum of 0.62 inches (16 mm) of dynamic deflection. Although most of the top rail stringpots were not able to provide dynamic deflection measurements they were able to provide static displacement measurements. The maximum static displacement of the top rail was measured as 0.42 inches (11 mm).

Figure 5-8 Locations and Summary of Stringpot Data\*

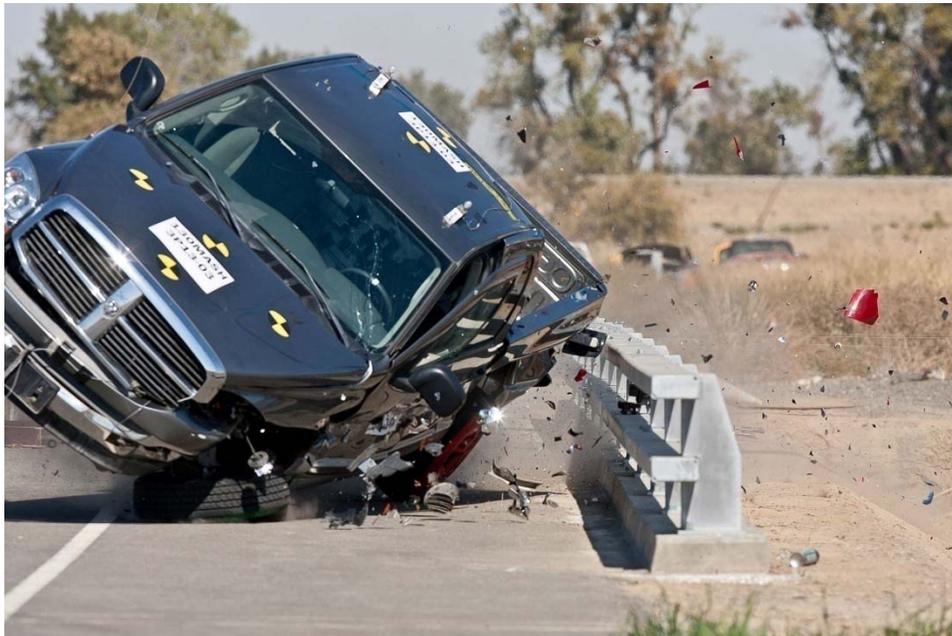
Figure 5-9 Vehicle Riding on Drive Side Front Tire

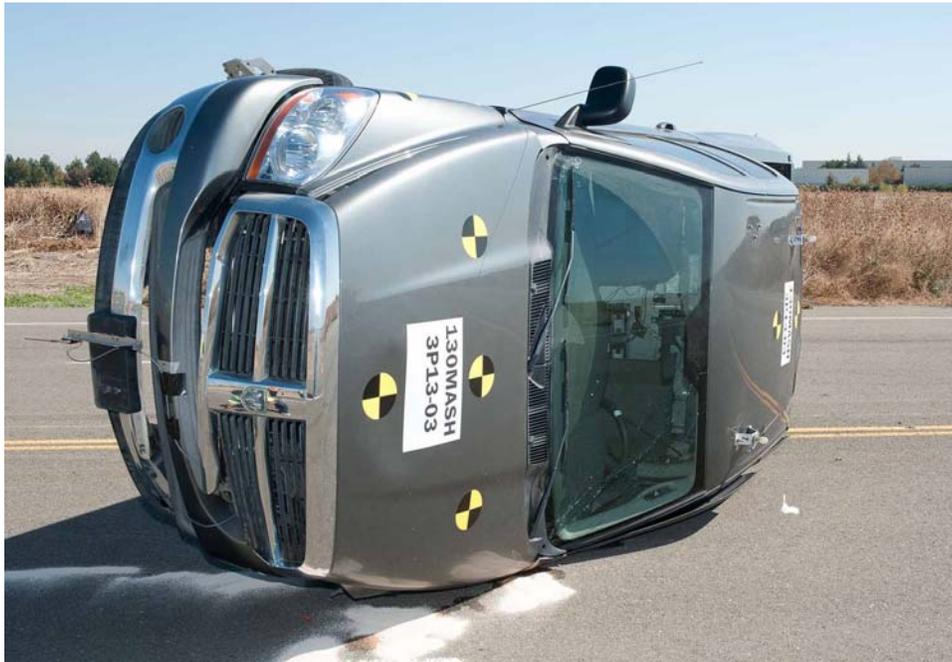
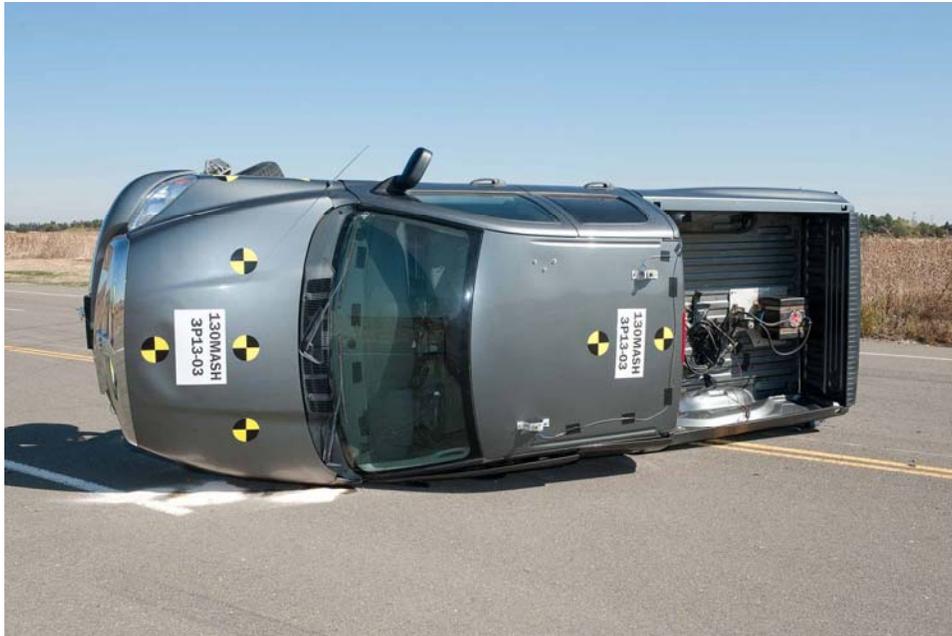
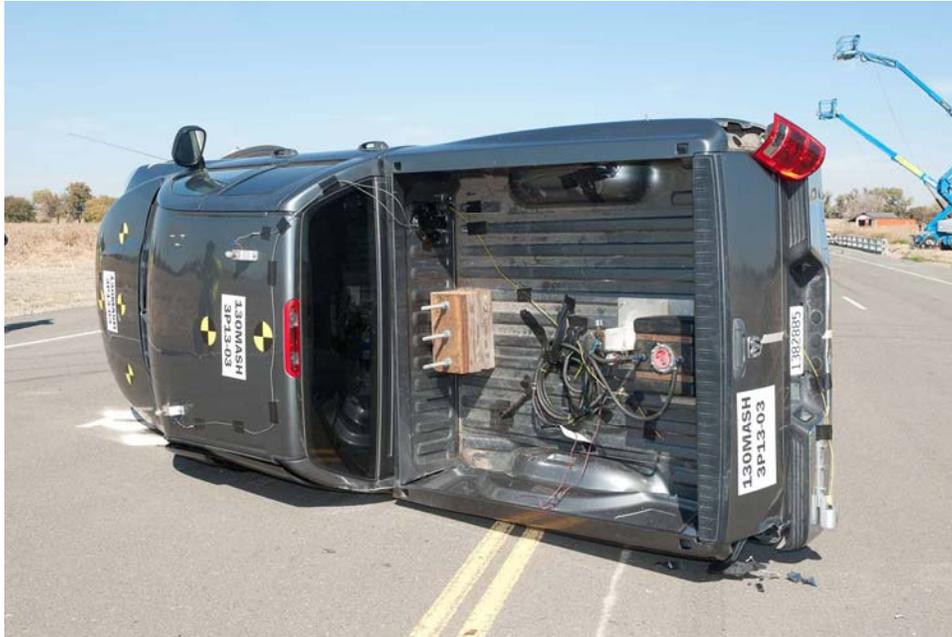
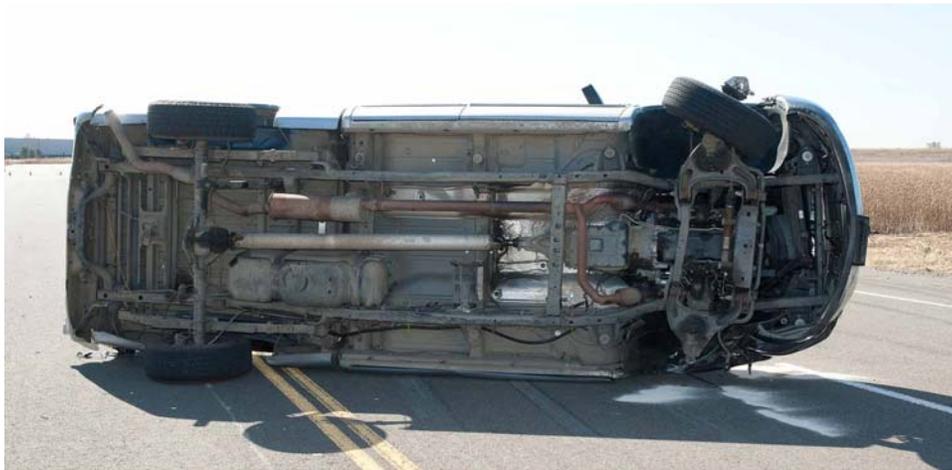
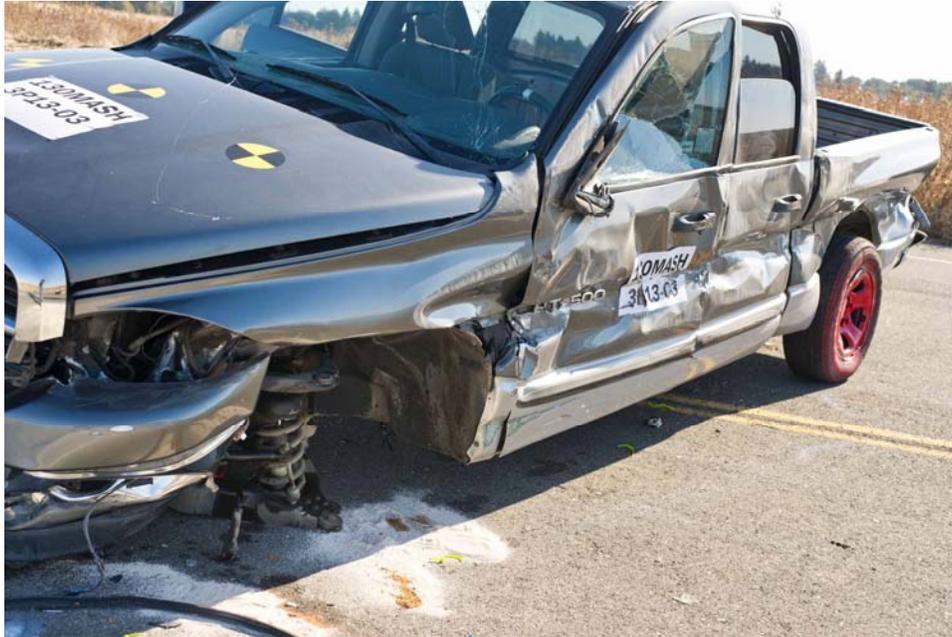
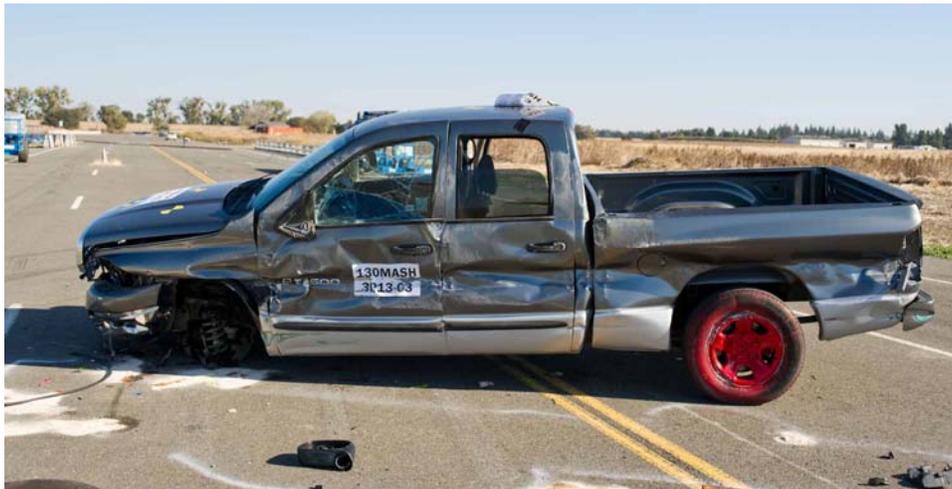
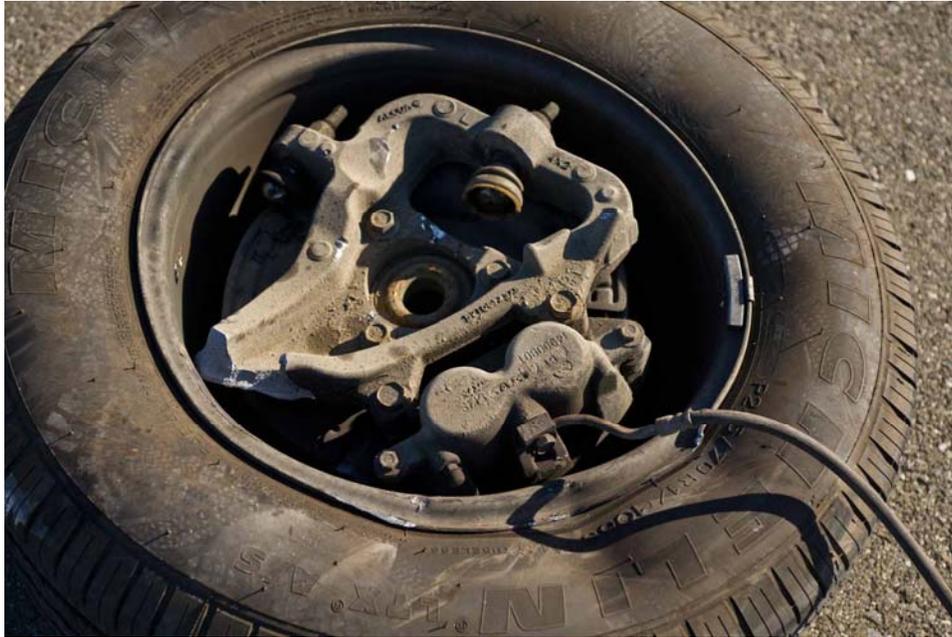
Damage to the vehicle is shown in Figure 5-10 through Figure 5-16. Impact with the test article caused the driver side front tire and hub assembly to break off of the vehicle. The left side of the vehicle sustained the majority of the damage, with the left front corner of the vehicle being pushed back into the vehicle from the impact with the barrier. The left side of the vehicle was damaged as the vehicle was redirected parallel to the barrier and the vehicle's momentum pushed the vehicle into the barrier. Additional scraping damage to the paint and door handles on the vehicle's left side was caused by the vehicle rolling onto its side. The driver side window was shattered when the side mirror broke off during the vehicle's roll onto its side; the shattered window was not caused by the impact with the barrier.

Figure 5-10 Front of Vehicle on Its Side After Test 130MASH3P13-03

Figure 5-11 Top of Vehicle on Its Side After Test 130MASH3P13-03

Figure 5-12 Back of Vehicle on Its Side After Test 130MASH3P13-03

Figure 5-13 Bottom of Vehicle on Its Side After Test 130MASH3P13-03

Figure 5-14 Front Corner of Upright Vehicle After Test 130MASH3P13-03

Figure 5-15 Side of Upright Vehicle After Test 130MASH3P13-03

Figure 5-16 Driver Side Tire and Hub Assembly

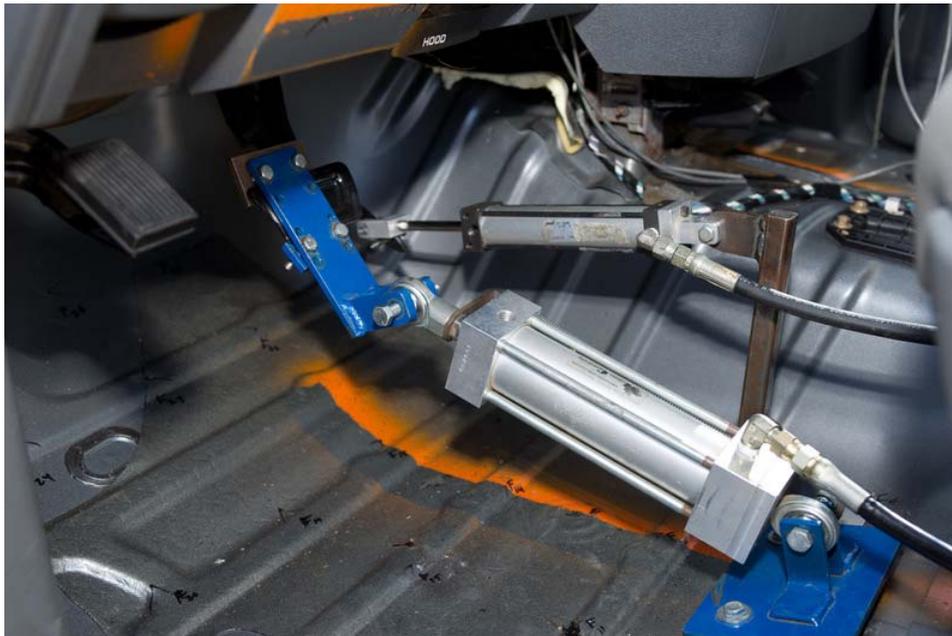
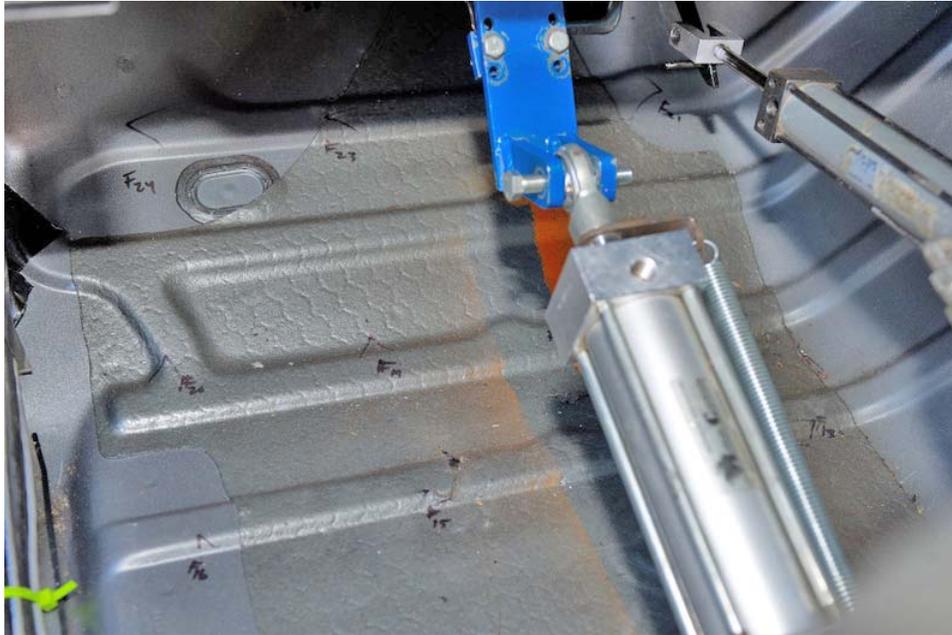
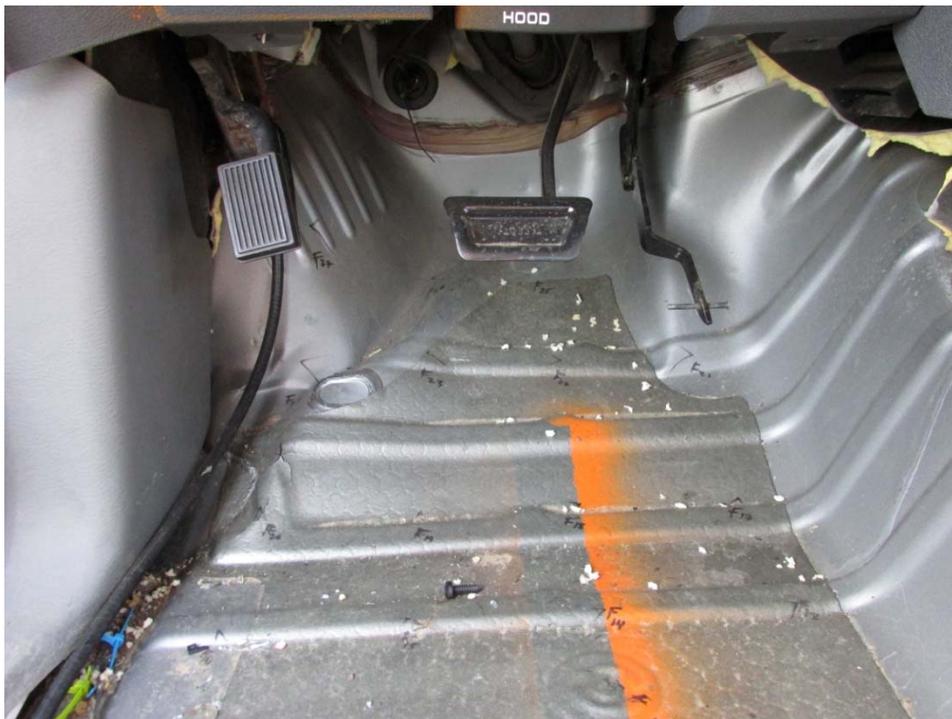
Figure 5-17 through Figure 5-19 shows the floorboard of the vehicle before and after impact with the test article. Table 10-3 shows the measurements of the occupant compartment before and after impact with the test article. The maximum deformation measured in the occupant compartment was 2.8 inches (70 mm) in the longitudinal direction on the wall of the floorboard near the engine compartment firewall, see Figure 5-19.

Figure 5-17 Vehicle Floorboard Pretest 1

Figure 5-18 Vehicle Floorboard Pretest 2

Figure 5-19 Vehicle Floorboard Post Test
