Project Title: Aesthetic, Low-Maintenance Guardrail Systems for Rural Areas

Development of Aesthetic, Low-Maintenance Guardrail System Alternatives

Crash testing of a bridge rail mounted onto a new concrete foundation design in an effort to provide aesthetic, low-maintenance guardrail alternatives.

# DEVELOPMENT OF AESTHETIC, LOW-MAINTENANCE GUARDRAIL SYSTEM ALTERNATIVES

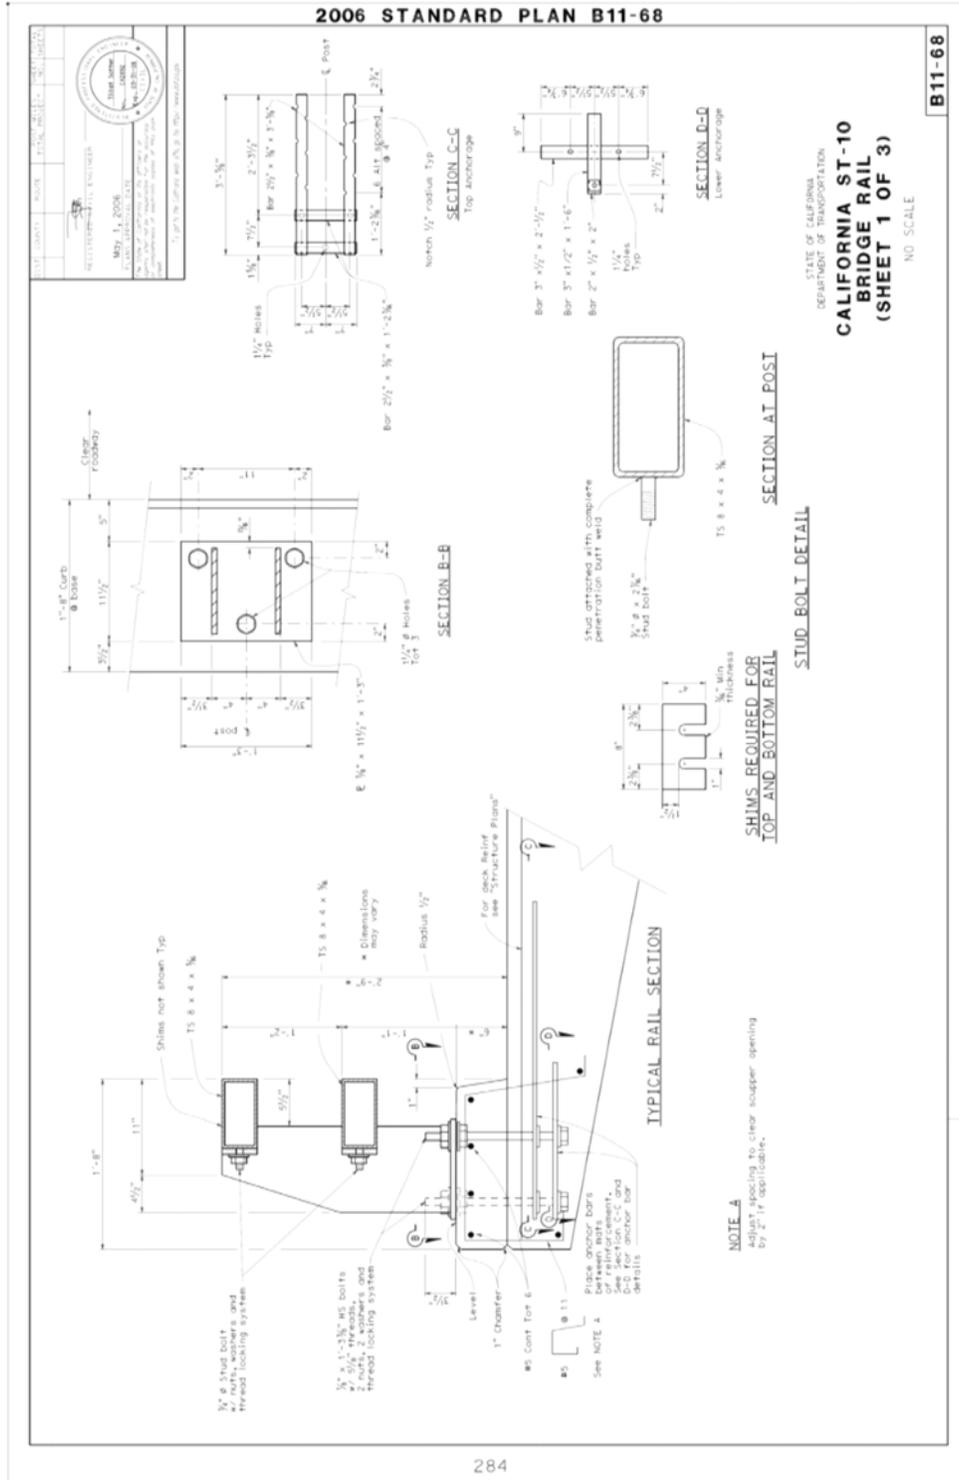
The ST-10 Bridge Rail is a 33-inch (838-mm) high steel barrier that consists of two 8-inch (203-mm) by 4-inch (102-mm) steel rails (designated TS 8x4x5/16 inch) and a 6-inch (152-mm) concrete curb. See Figure 10-1 through Figure 10-3 for Caltrans' 2006 Standard Plans for the ST-10 Bridge Rail. The bridge rail was modified by mounting the rail on a 30-inch (762-mm) by 20-inch (508-mm) concrete trench footing foundation in place of a bridge deck. The length of the test article was 112.6 feet (34.34 m). See Figure 10-4 through Figure 10-8 for details on the test article. The ST-10 Bridge Rail was chosen for this project because it is very rigid and has the least mass of other Caltrans bridge rails. Therefore it would impart the greatest load to the footing.

Figure 10-1: California Standard Plan for the ST-10 Bridge Rail Sheet 1 of 3

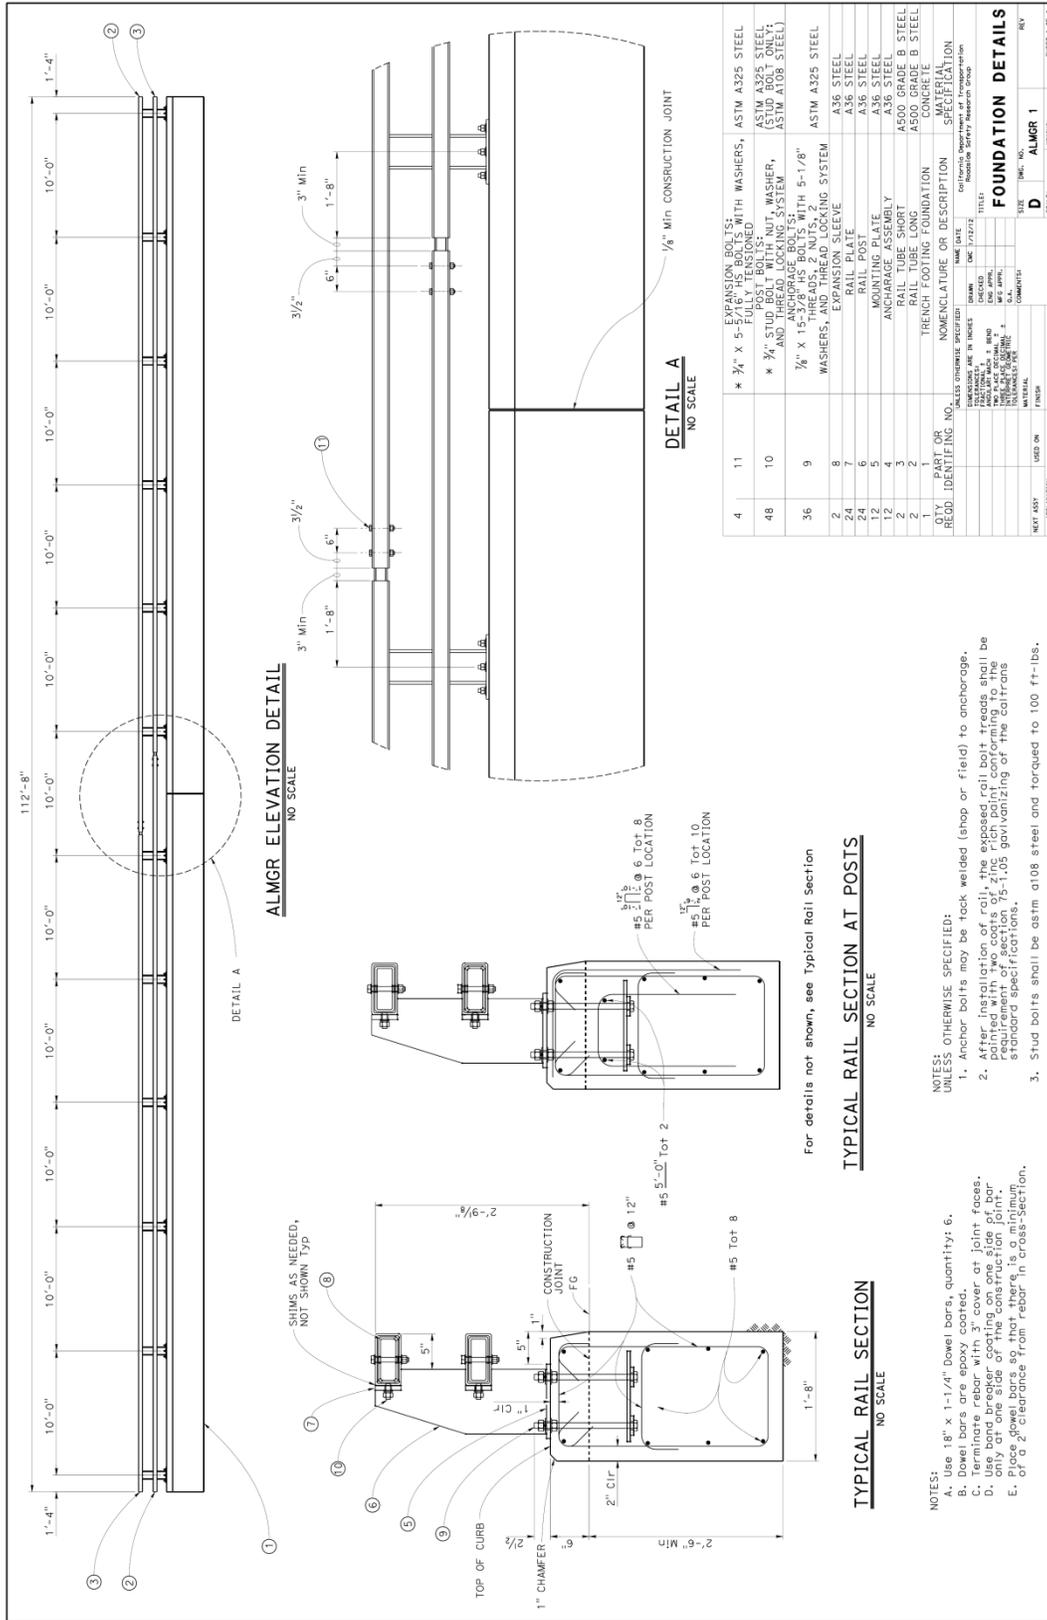
Figure 10-4 Trench Foundation Detail

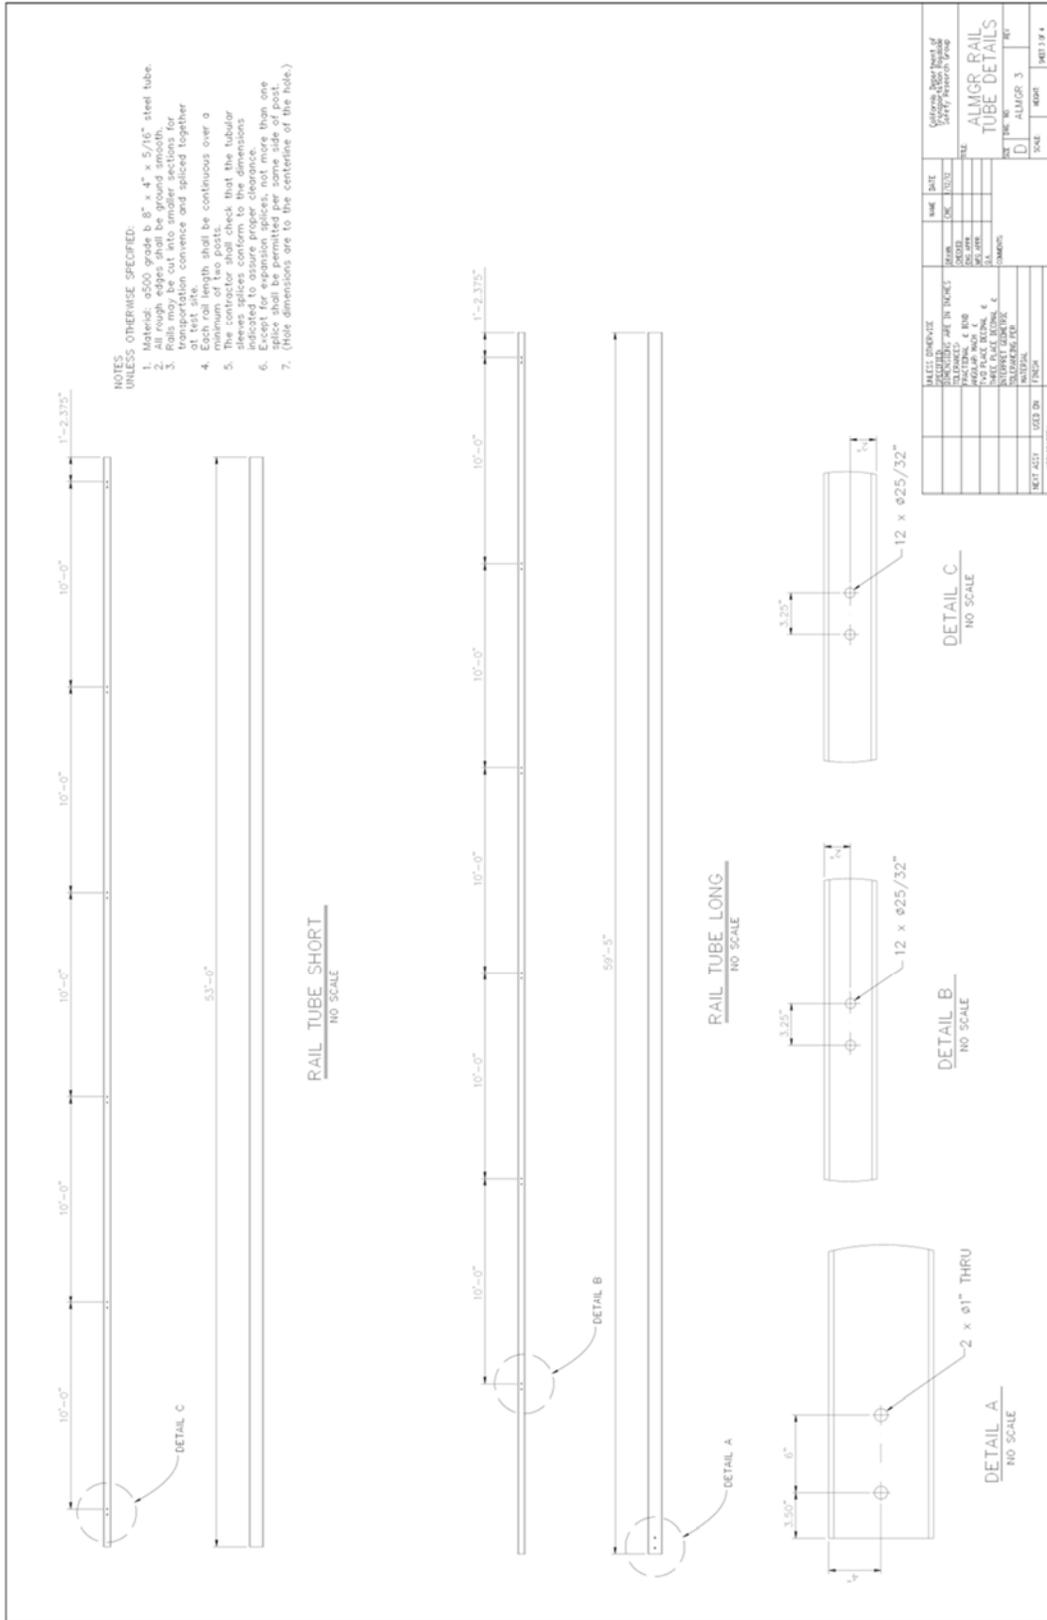
Figure 10-7 ALMGR Test Article Tube Details

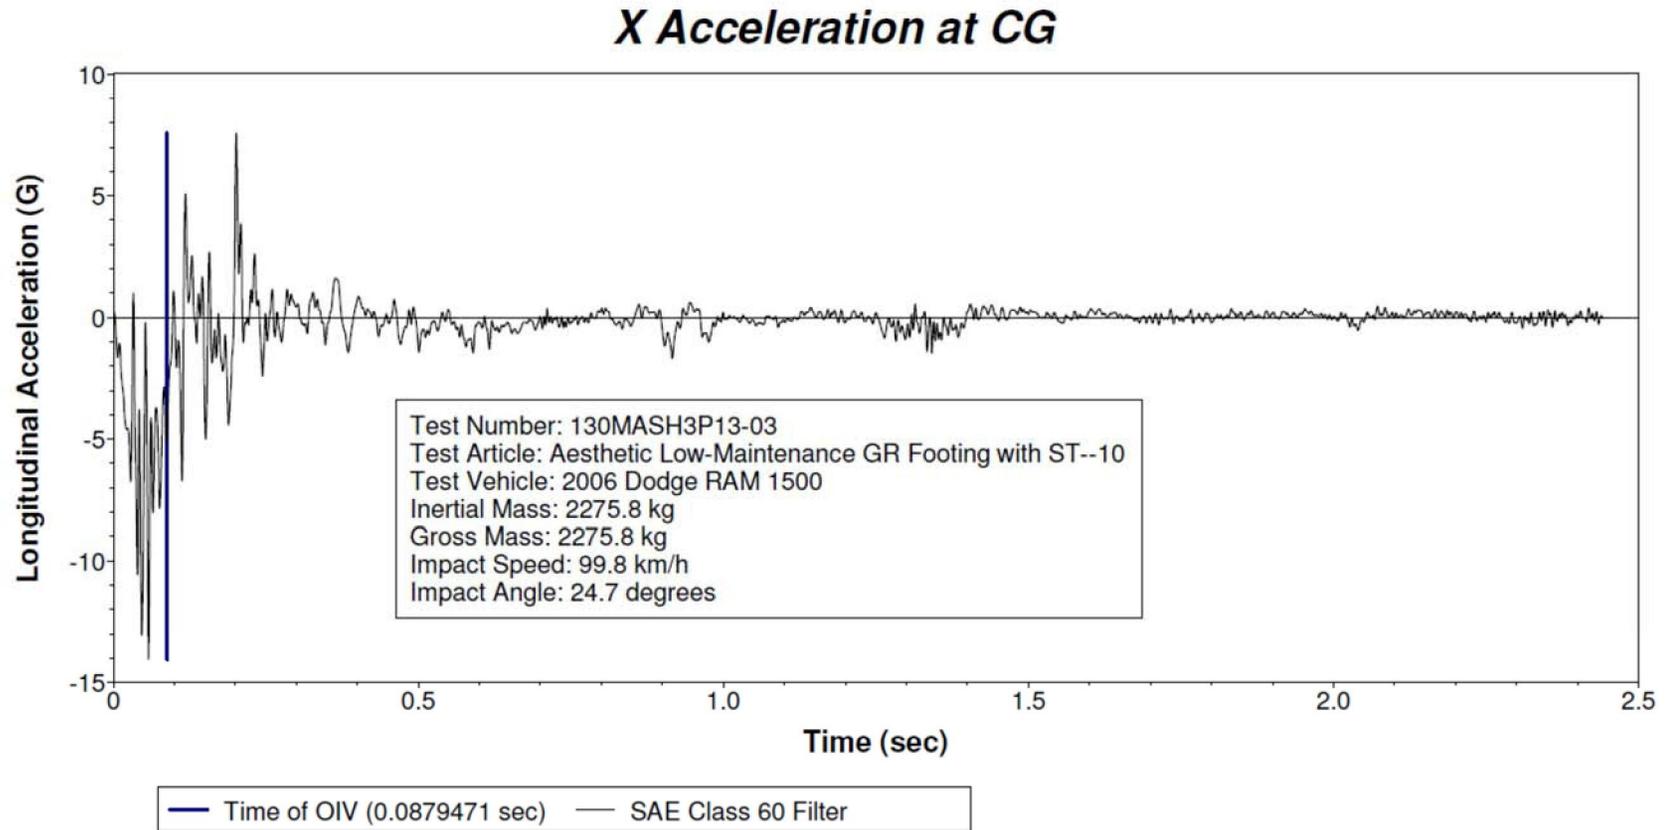
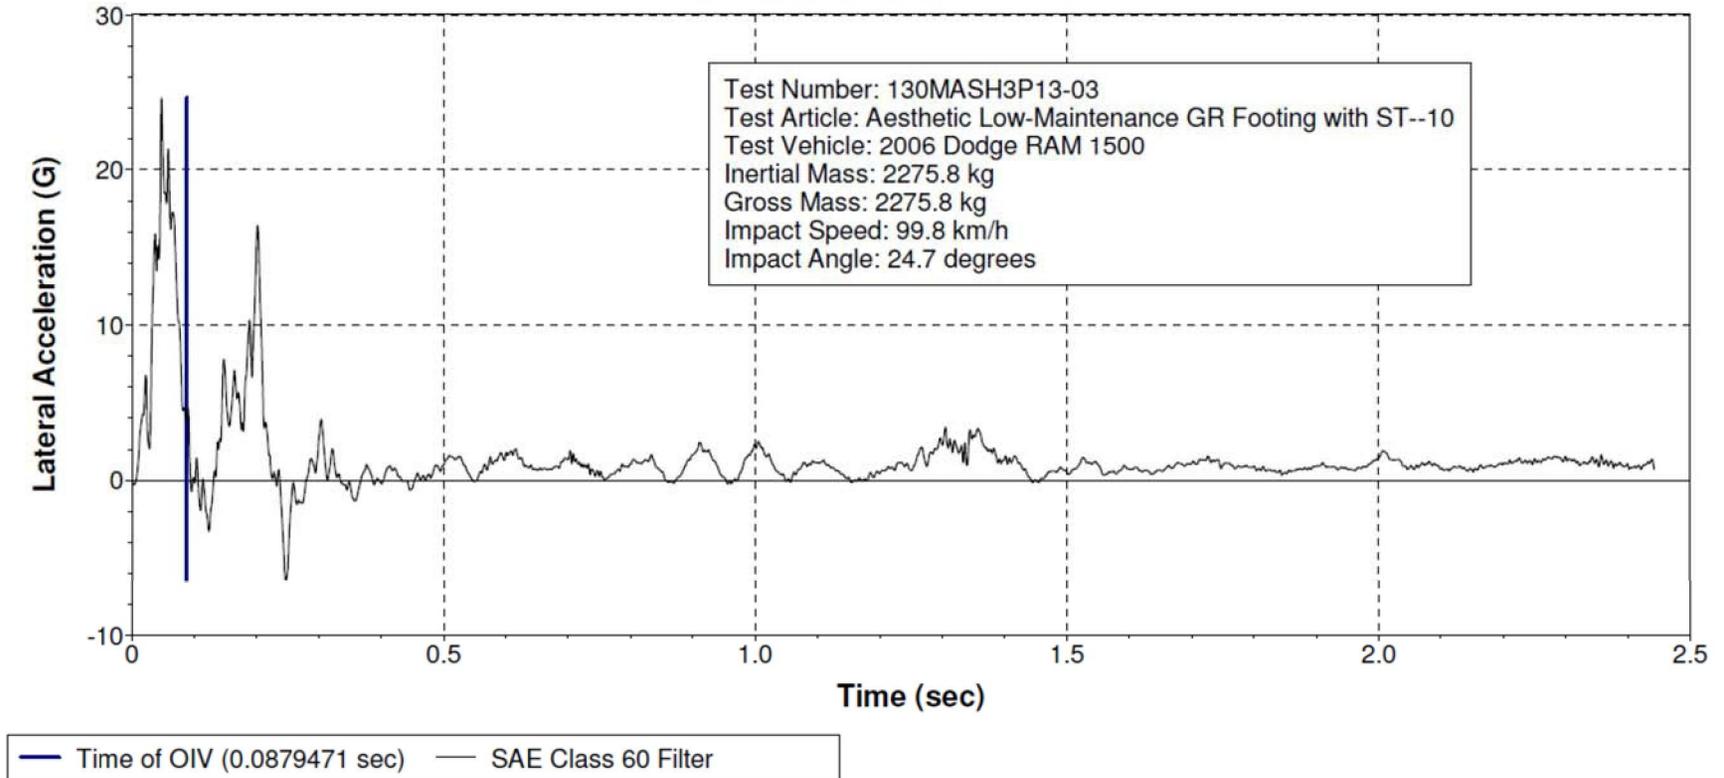
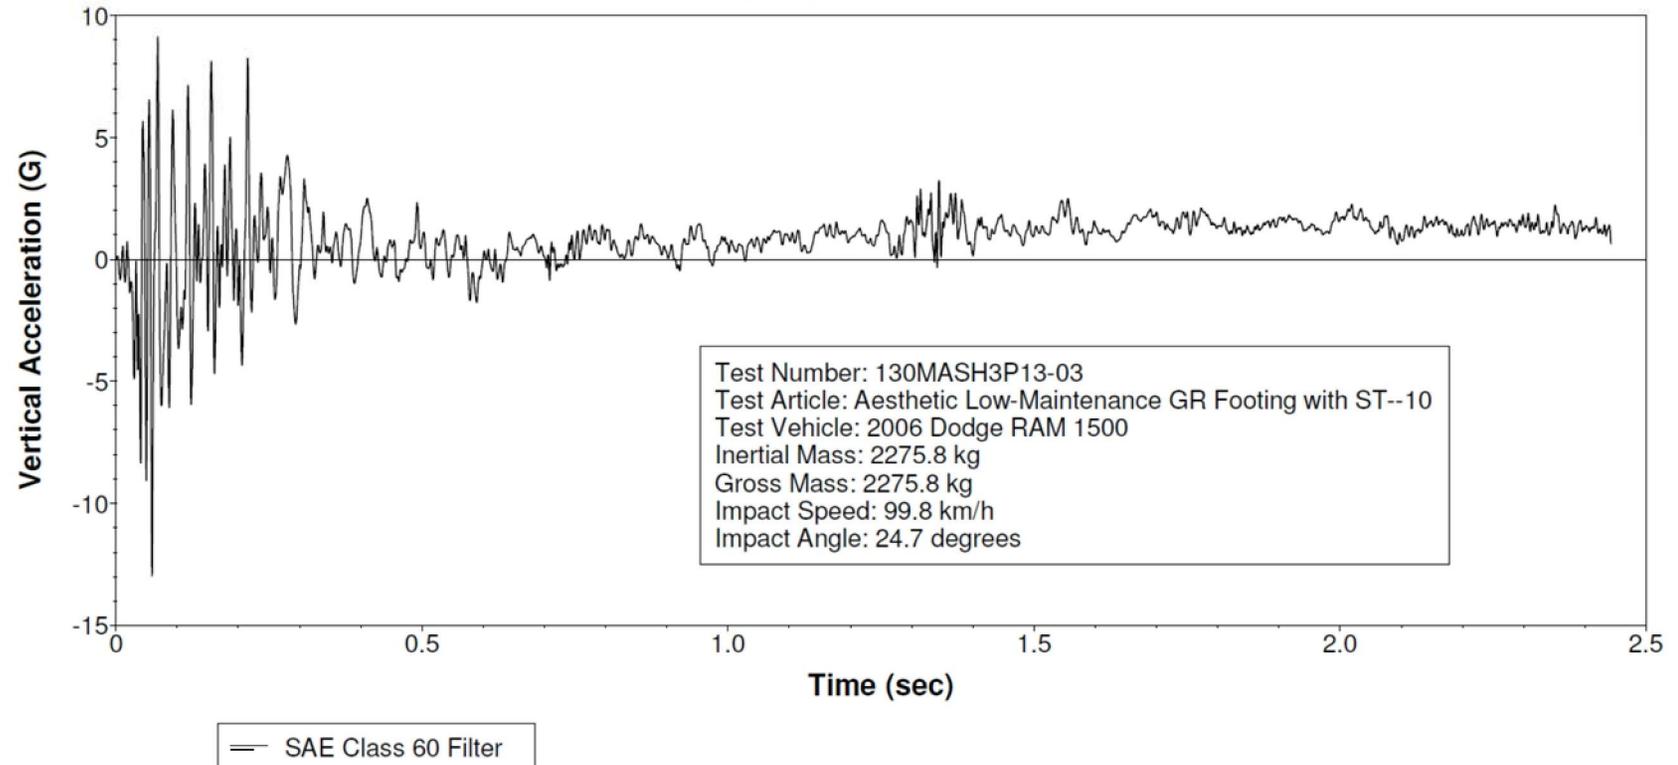
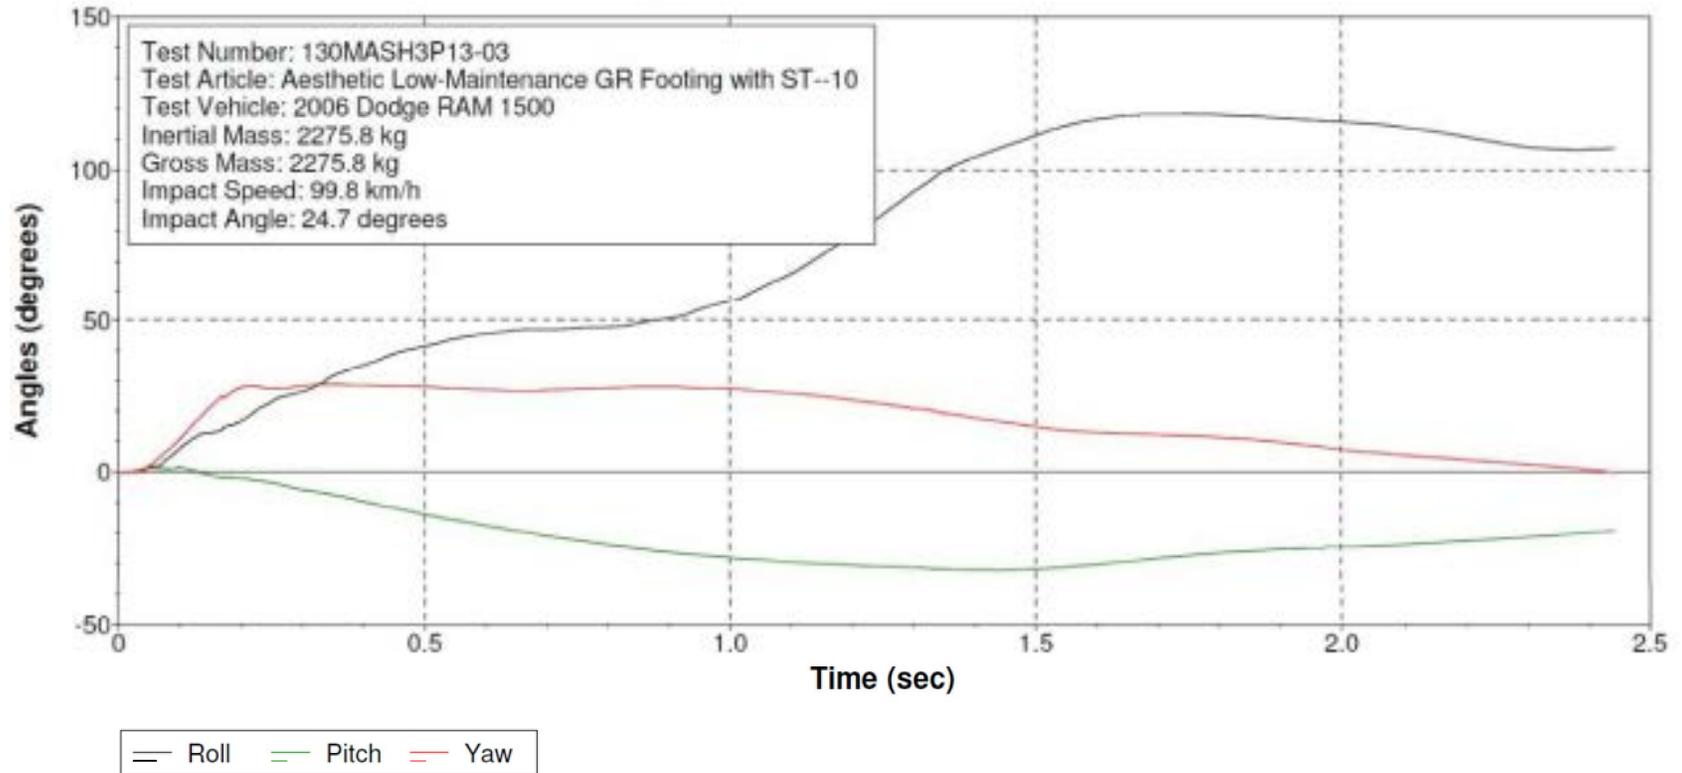
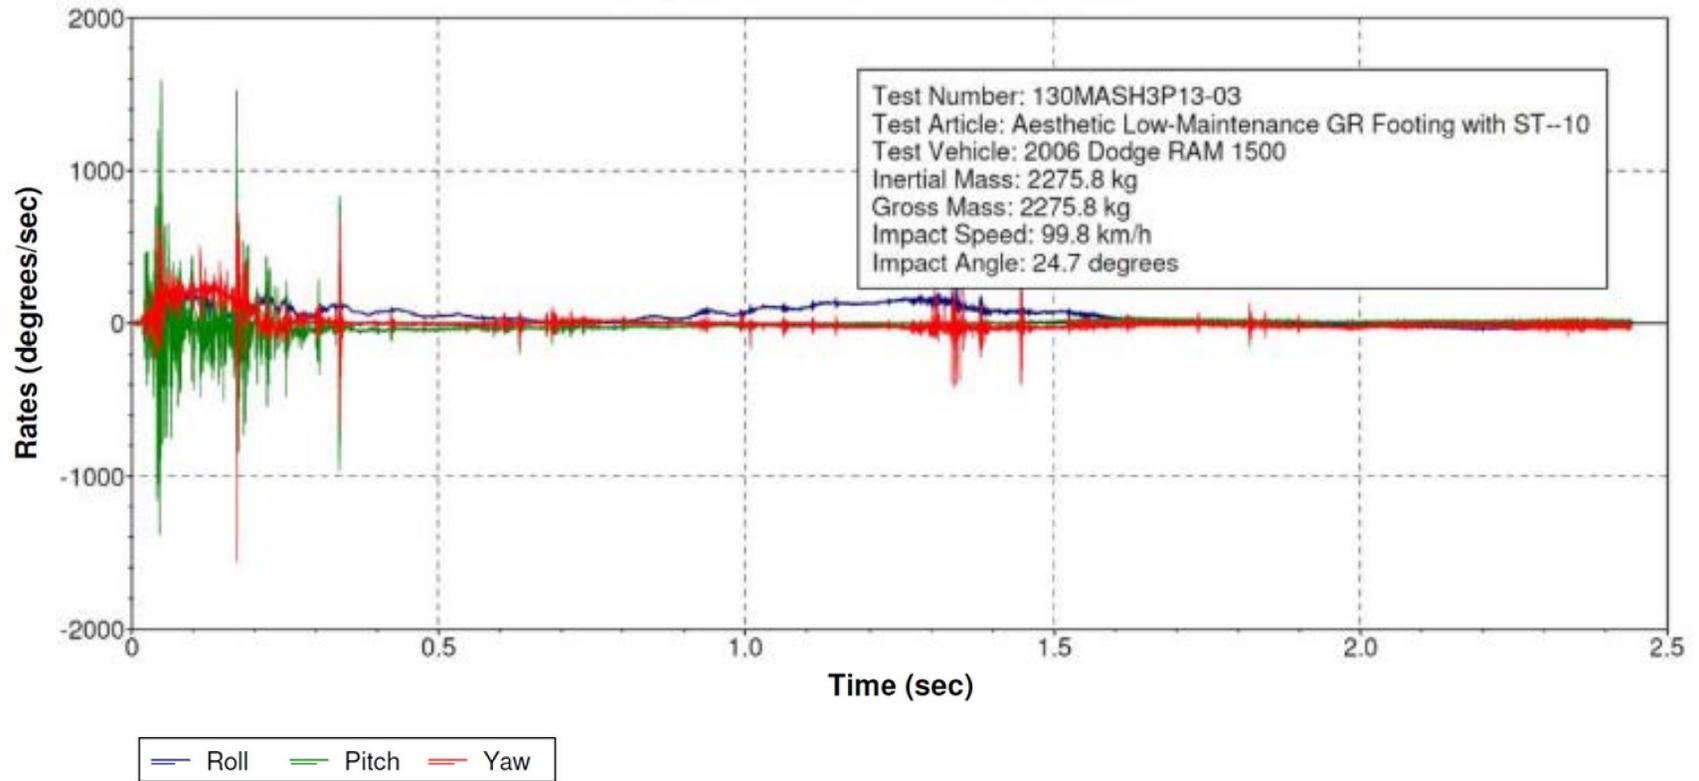
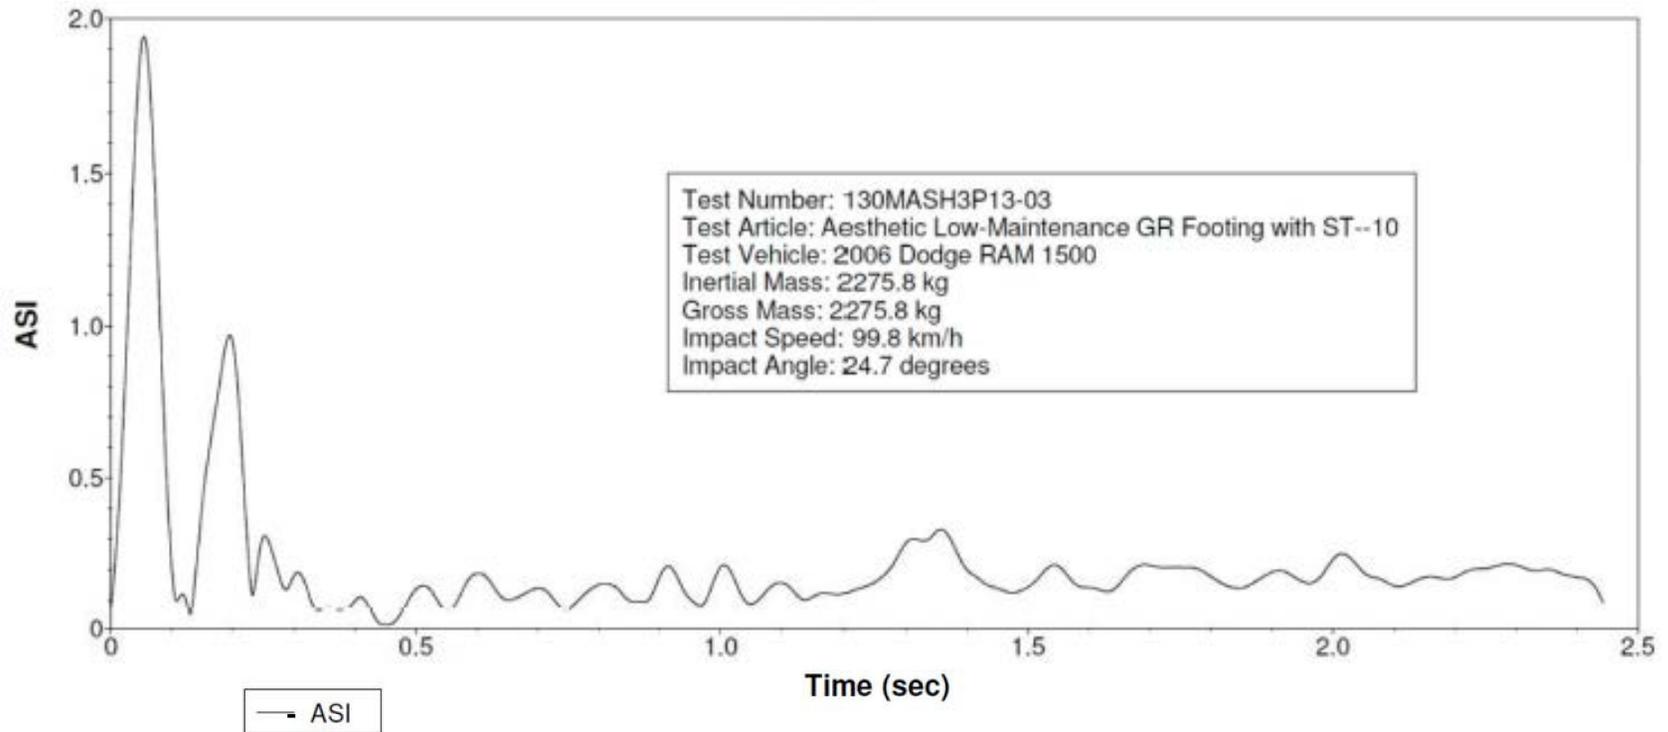
The data curves are shown in Figure 10-9 through Figure 10-14 include the accelerometer and angular rate sensor records from the test vehicle. They also show the velocity and displacement curves for the longitudinal and lateral components. These plots are required to calculate the occupant impact velocity defined in MASH. All data were analyzed using TRAP.

Figure 10-9 Vehicle Longitudinal Accelerometer trace for Test 130MASH3P13-03

Figure 10-10 Vehicle Lateral Accelerometer trace for Test 130MASH3P13-03

Figure 10-11 Vehicle Vertical Accelerometer Trace for Test 130MASH3P13-03

Figure 10-12 Vehicle Angular Displacements for Test 130MASH3P13-03

Figure 10-13 Vehicle Angular Rate of Change for Test 130MASH3P13-03

Figure 10-14 Acceleration Severity Index for Test 130MASH3P13-03

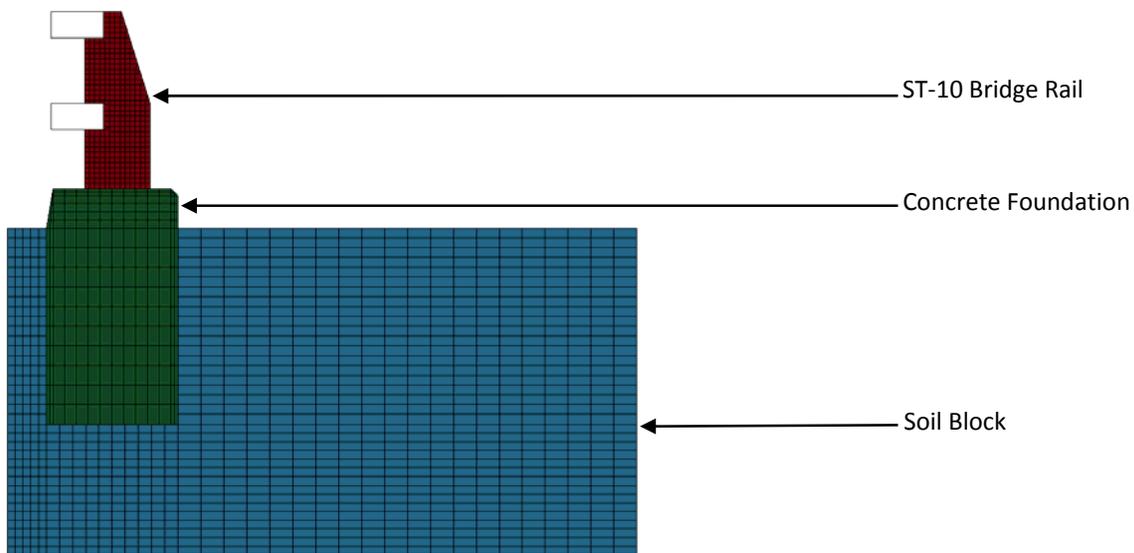
The 30-inch (762-mm) by 20-inch (508-mm) wide concrete trench foundation was imbedded in a loose sand model that had a density of 90 pcf (1442 kg/m<sup>3</sup>). The sand model extended behind the barrier by 70 inches (1778 mm) and 20 inches (508 mm) below the barrier. There is no rebar in the concrete trench foundation model. The ST-10 bridge rail was mounted on top of the trench foundation. The purpose of this model was to represent the real world crash test as closely as possible.

Figure 10-16 Test Article in Soil Block Model

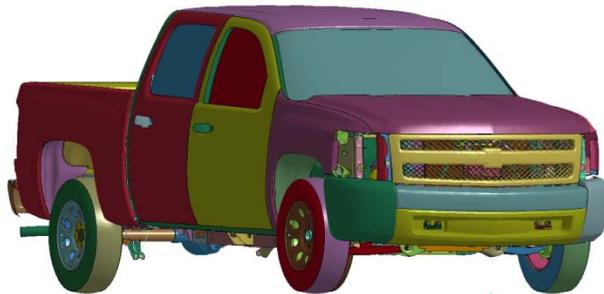
Figure 10-17 MASH 2270P Test Vehicle

The vehicle model used in the virtual tests was a 2270-kg 2007 Chevy Silverado version 2. This model is free to use and was developed by the National Crash Analysis Center (NCAC). This vehicle model and more are available at [www.ncac.gwu.edu/vml/models.html](http://www.ncac.gwu.edu/vml/models.html). The only change to the vehicle model was to increase the velocity of the model to match the required speed for a MASH Test Level 3.

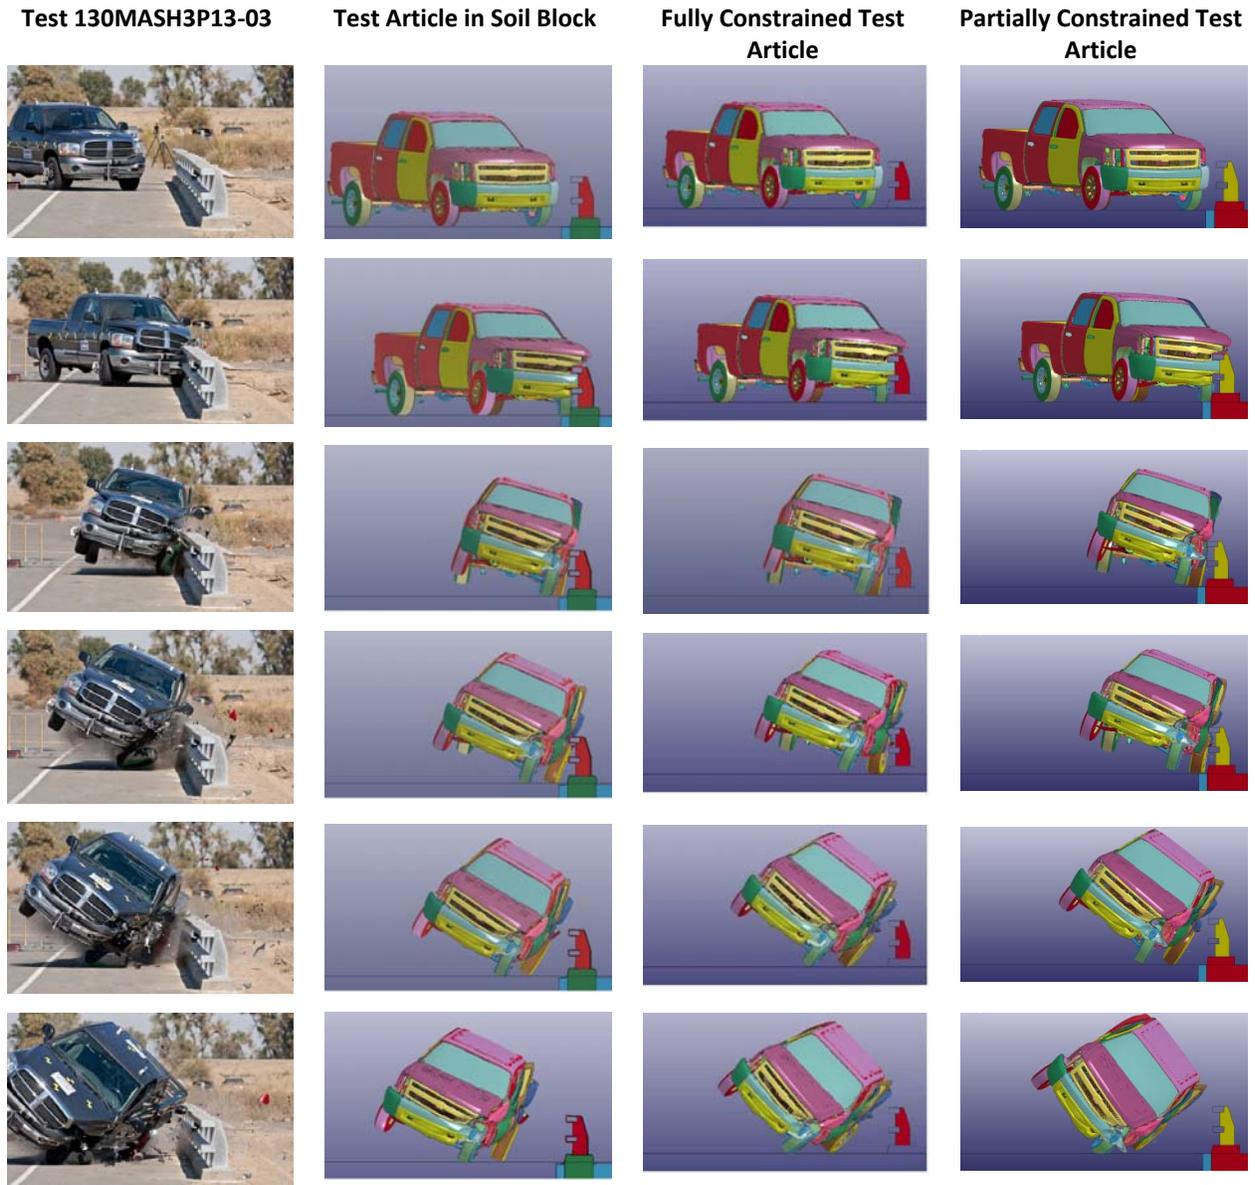
Figure 10-21 shows a comparison of the full scale crash test and the FE model simulations. In the simulations and the actual test, the vehicle appears to have similar interactions with the barrier until the vehicle begins to lose contact with the barrier and is redirected. The full scale crash test, the Fully Constrained Test Article model, and the Partially Constrained model visually have the same reactions to the barrier and ultimately have the vehicle roll on its side. The vehicle in the Test Article in Soil Block model stays upright after it loses contact with the barrier. From these visual results it appears that the Fully Constrained Test Article model and the Partially Constrained model best represent the actual crash test.

Figure 10-21 Visual Comparison of Actual Crash Test to Simulation Crash Tests

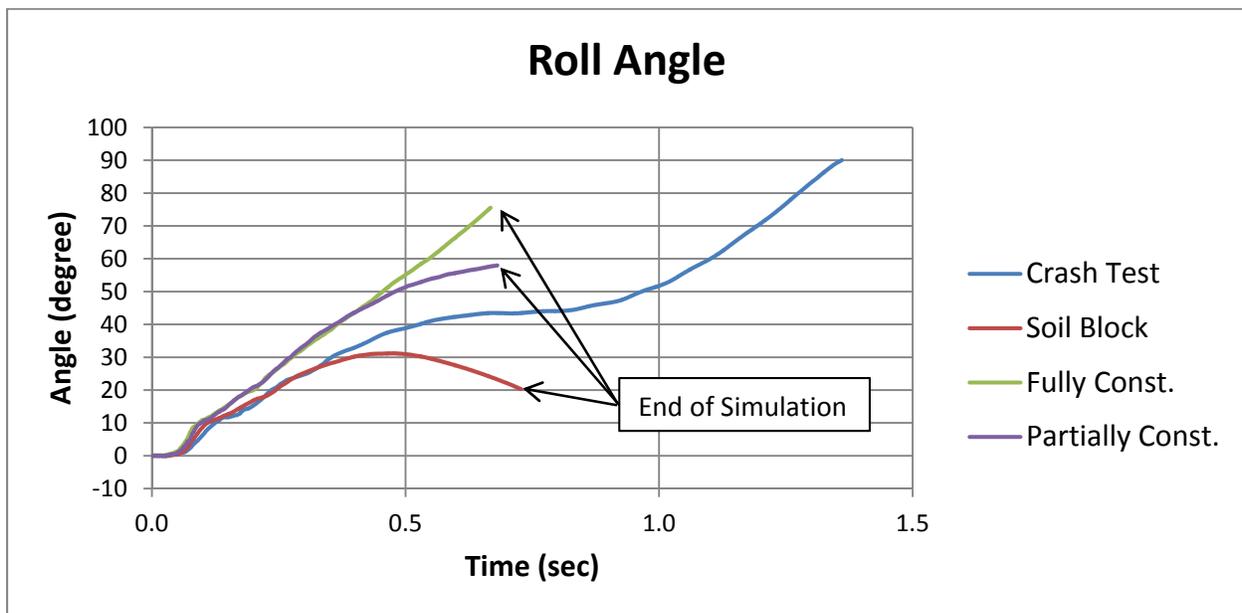
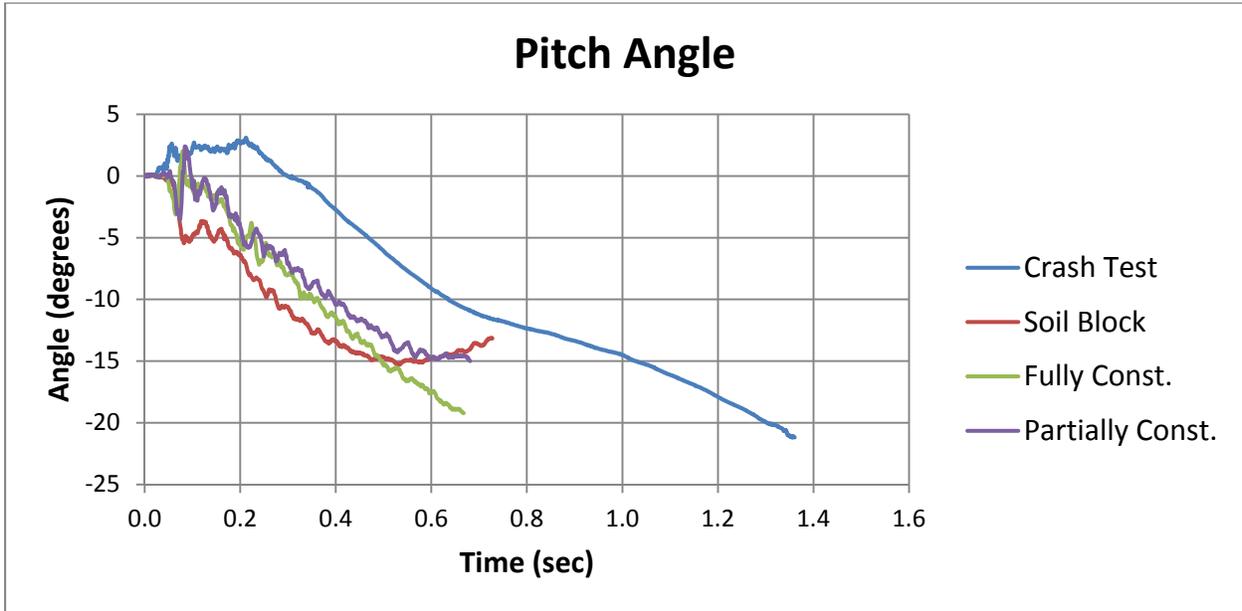
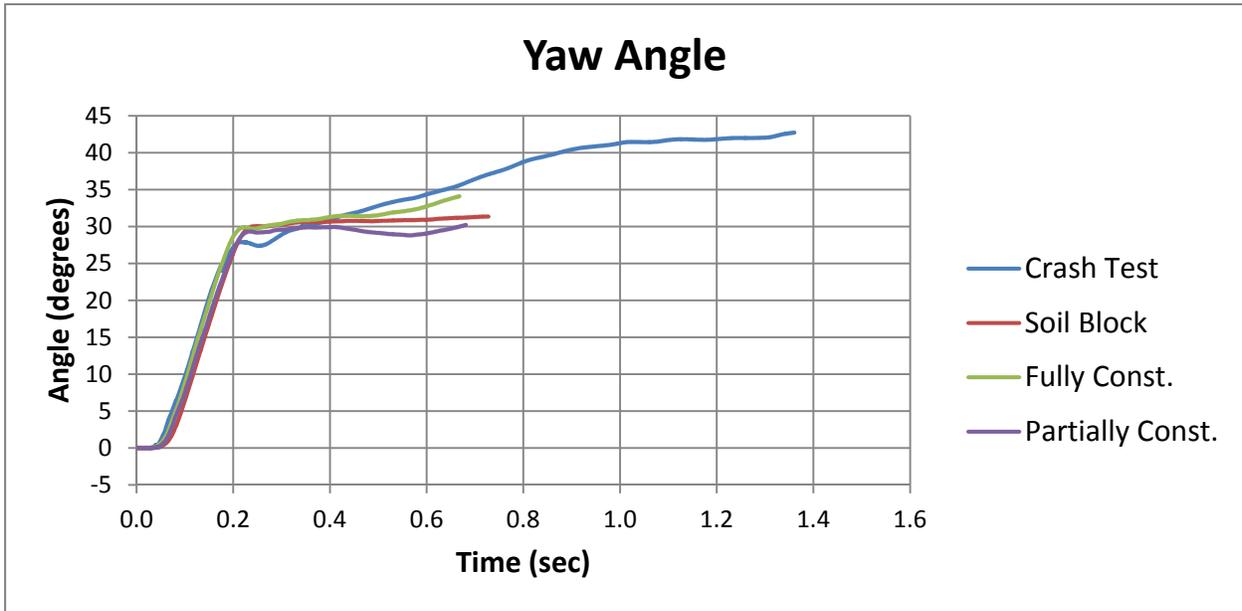
The vehicle pitch angles for the crash test, the Fully Constrained model, and the Partially Constrained model have similar linear slopes once their angles start to decrease. The Soil Block model's vehicle pitch angle has a more parabolic shape compared to the crash test and the other two models. The yaw angles are very similar for the crash test and the simulation models.

Figure 10-22 Comparing Crash Test and Simulation Roll Angles

Figure 10-23 Comparing Crash Test and Simulation Pitch Angles

Figure 10-24 Comparing Crash Test and Simulation Yaw Angles

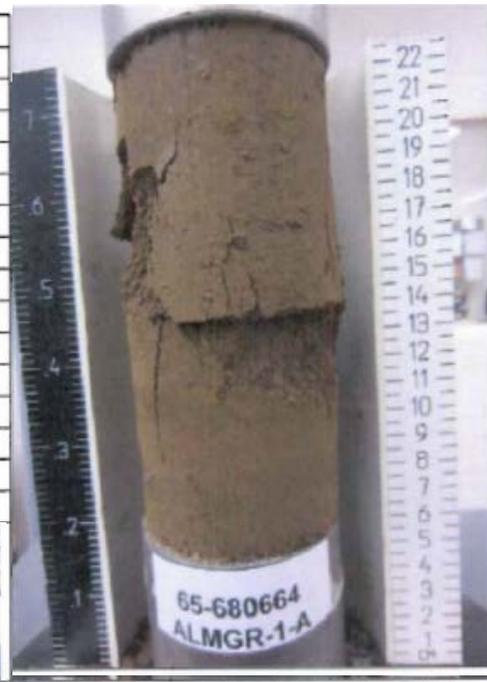
Symbol	⊙	
Test No.	Q12-011	
Initial	Diameter, in	2.8
	Height, in	6
	Water Content, %	9.70
	Dry Density, pcf	110.6
	Saturation, %	
	Void Ratio	
Unconfined Compressive Strength, psi	16.64	
Undrained Shear Strength, psi		
Time to Failure, min		
Strain Rate, %/min	1	
Implied Specific Gravity		
Liquid Limit	---	
Plastic Limit	---	
Plasticity Index	---	
Failure Sketch

Project: AESTHETIC LOW-MAINT.
	Location:
	Project No.: 65-680664
	Boring No.: ALMGR
	Sample No.: 1-A
	Description: MOIST, BROWN SILTY CLAY
	Remarks: ASTM D 2166. REMOLDED

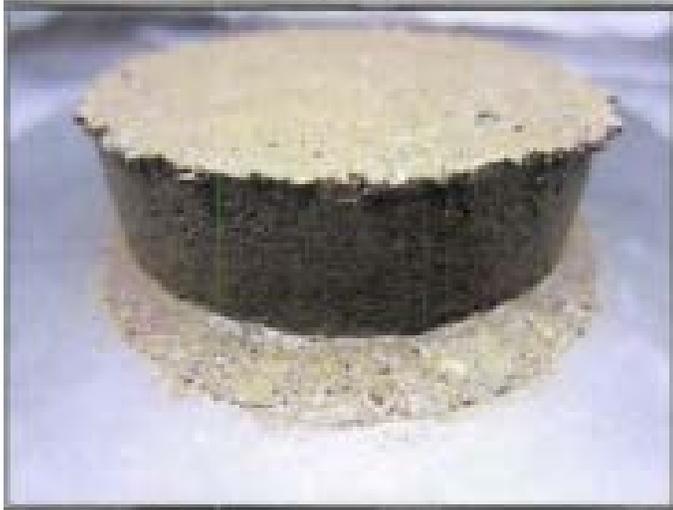
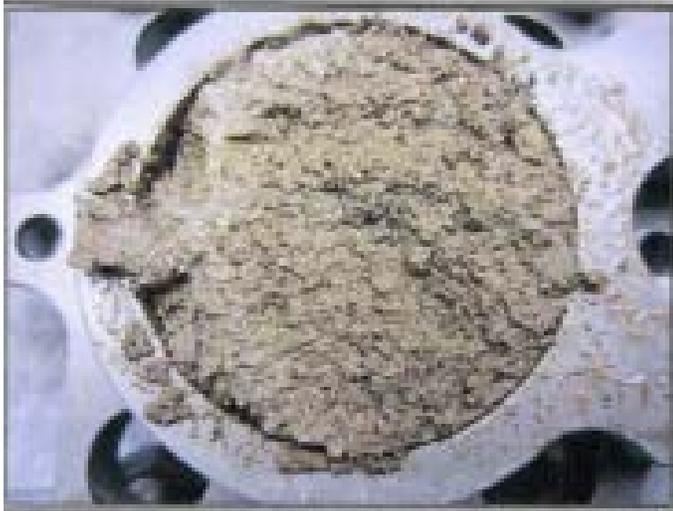
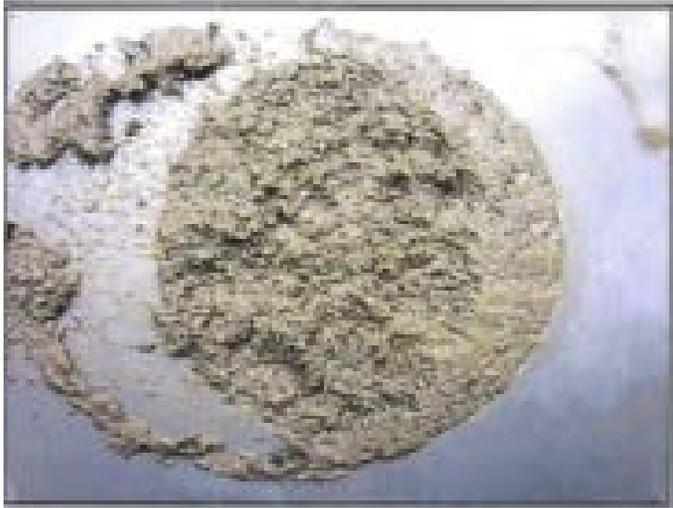
**DIRECT SHEAR**  
**JOB : 65-680664**  
**SAMPLE : ALMGR\_1-B**  
Test Specimen A

Project: Aesthetic Low-Maint GR	Description: Damp, Firm, Brown, Silty Soil with Clay. Remolded to 90% RC @ Optimum MC
Location:	Remarks: ASTM D 3080.
Project No.: 65-680664	
Boring No.: ALMGR	
Sample Type: REMOLD
