H Ground Anchors & Soil Nails

Case Study- Soldier Pile Wall with Tieback Anchors

Contract No. 04-1S2724 04 - SM - Rte 84 - PM 10.2
Soldier Pile Wall with Tieback Anchors (7.7 km west of Rte 35).
Completed in June 2004. \$850,000.00.

Case Study - Soil Nail Wall

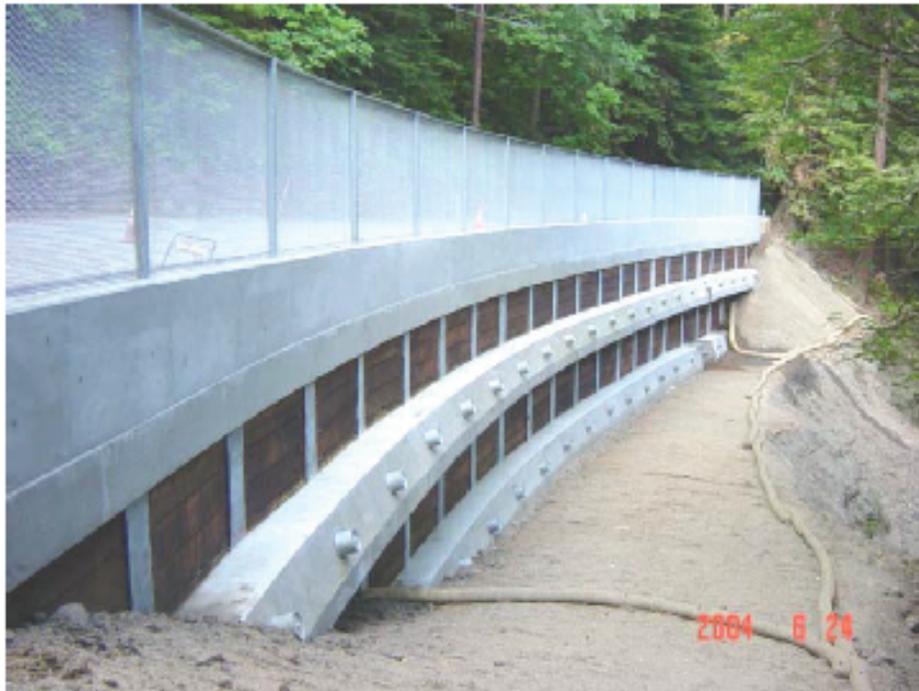
Figure H-1. Completed Soldier Pile Wall

Soldier Pile Wall with Tieback Anchors within two concrete walers. Date: June 2004.
Fiber rolls placed along slope for erosion control. Photo by D. Dait, P.E., Sr Br Engr

Project 04-1S2724 specified a soldier pile wall with *tieback anchors*. The wall prevents further erosion of the slope adjacent to a creek. The design specified 44 soldier piles with timber lagging. Two rows of tieback anchors are connected to concrete walers. A concrete barrier slab and concrete barrier with chain link fence is on top of the wall.

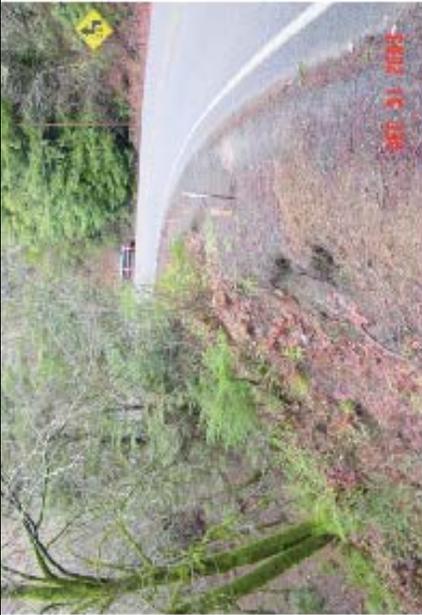
<p style="color: red; font-size: small; text-align: right;">2003 11 20 03</p> <p>“Before”, Facing east. Survey stakes placed. Slope is eroding (on the left). 12/31/03</p>

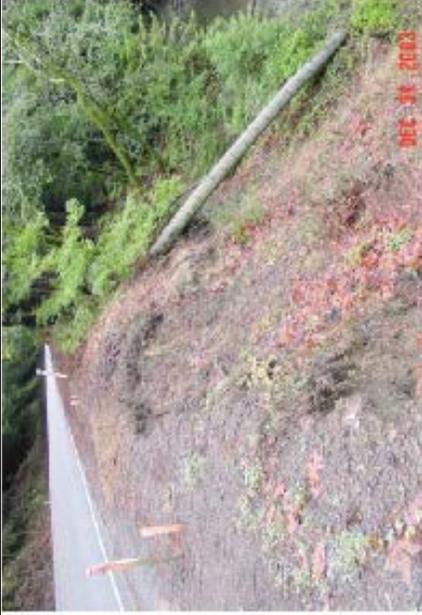
<p style="color: red; font-size: small; text-align: right;">2003 11 20 03</p> <p>“Before”, Facing west. Survey stakes placed. Slope is eroding. Existing drainage pipe and creek on right.</p>

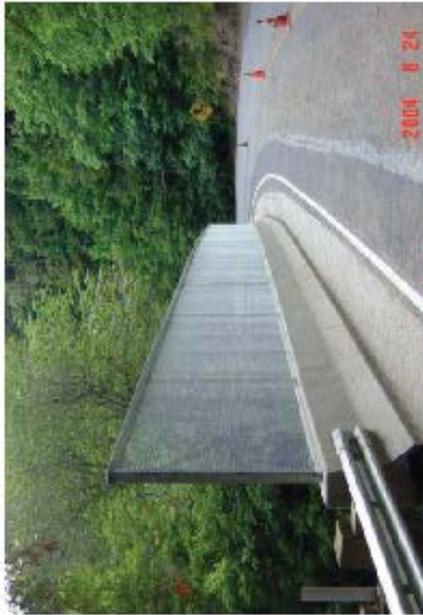
<p style="color: red; font-size: small; text-align: right;">2004 6 24</p> <p>“After”, Facing east. Type 7 chain link fence. Type 27 modified concrete barrier on top of barrier slab. 6/24/04</p>

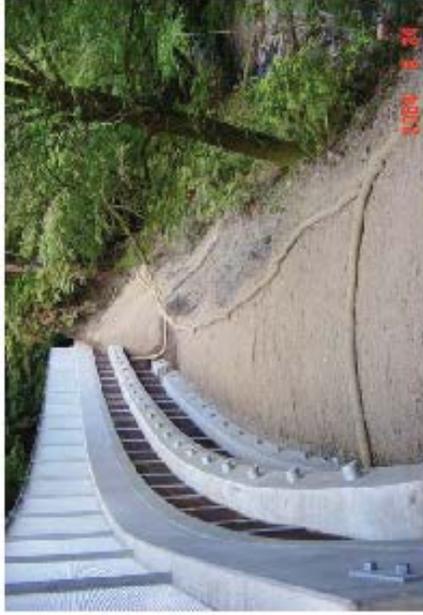
Figure H-2. Soldier Pile Wall – Before and After.

<p style="color: red; font-size: small; text-align: right;">2004 6 24</p> <p>“After”, Facing west. Wall is complete. Two rows of concrete walers (with tieback anchors). Creek on the right. 6/24/04</p>
<p>PROJ/RTE/PM: 04-SM-Rte 84-PM 10.2 Soldier Pile Wall with Tieback Anchors PROJECT NO. 04-1S2724 Photos by Dan Dait, P.E., Sr Br Engr</p>

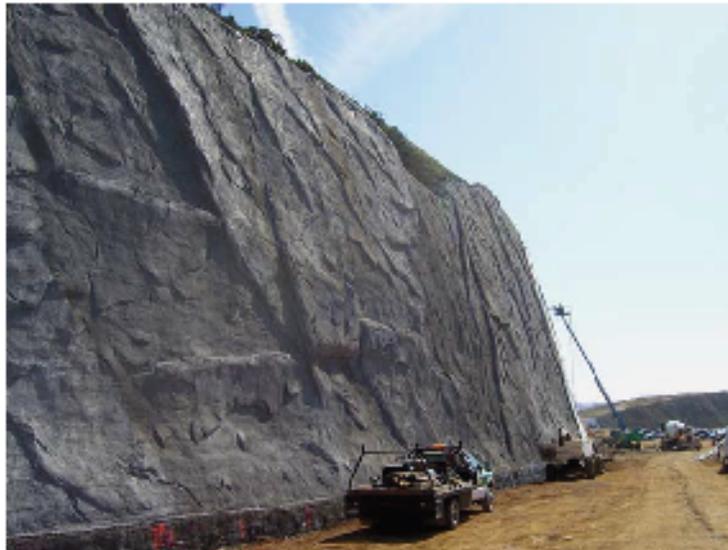
Figure H-3. Soil Nail Wall – Sculpted Facing.

Retaining Wall #2. Shotcrete sculpting at northern end of wall.

The South Rock Cut wall consists of a *soil nail wall*. The soil nail wall is composed of two walls separated by a 25m concrete barrier. Total length of walls is 281m (RW No. 2 is 190m long, RW No. 1 is 91m long). The soil nail assembly pay item equals 18, 860 meters.

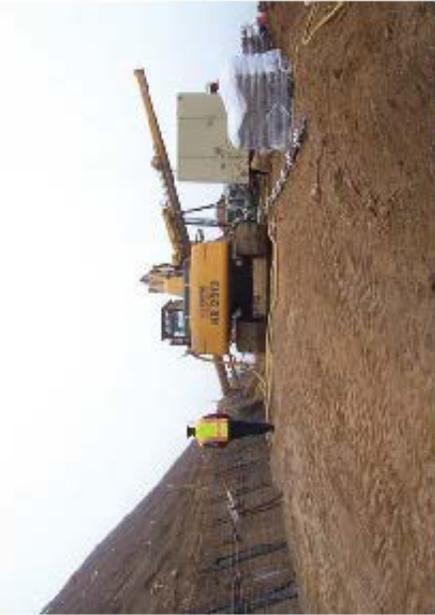
<p>Drilltech drilling top row of nails at Wall #2. Test nail installed between two nails. 8/09/05</p>

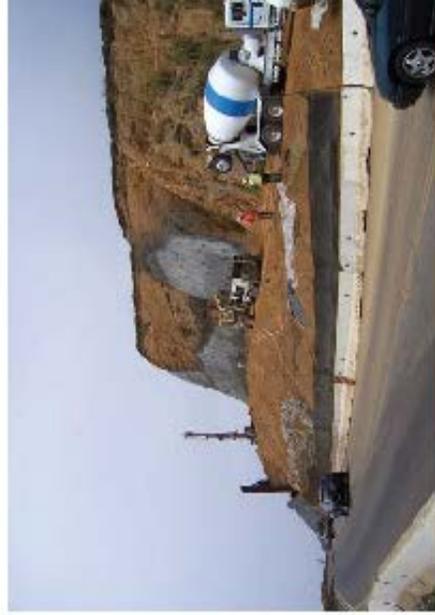
<p>Drilltech shooting next section of initial shotcrete at Wall #1. 8/11/05</p>

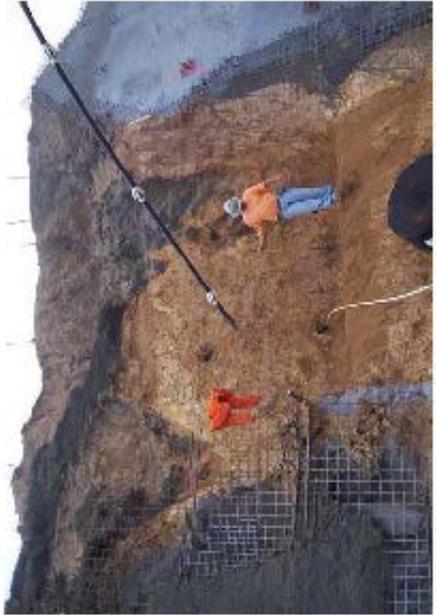
<p>Soil nail getting ready to be installed in a drilled hole. Grouting lower nail w/1" PVC grout tube. 8/04/05</p>

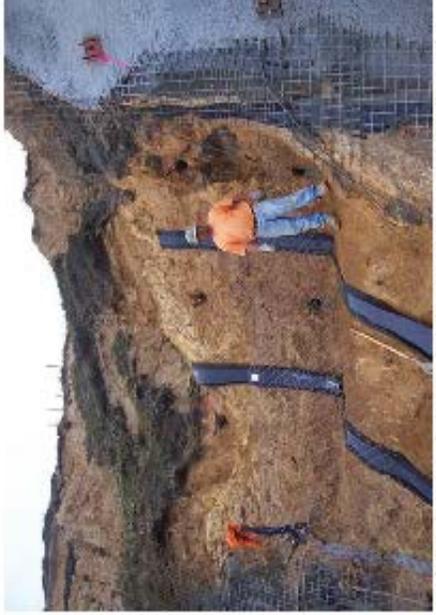
Figure H-4. Soil Nail Wall Construction 1.

<p>Drilltech crew installed 12" geocomposite drain strips between nail columns.</p>
<p>PROJ/RTE/PM: 04-SM-Rte1-KP 61.2/62/2 South Rock Cut Soil Nail Wall Date: 2005/2006 PROJECT NO. 04-1123C4 Photos by Ann Meyer, P.E., Structure Representative Photo Page 1</p>
