APPENDIX

J Micropiles

Specification Example - Micropiles for Earth Retention

Contract No. 04-1S2804
04 - SON - Rte116, PM 3.2
Duncan’s Mills Retaining Wall
Construction completed in 2007.

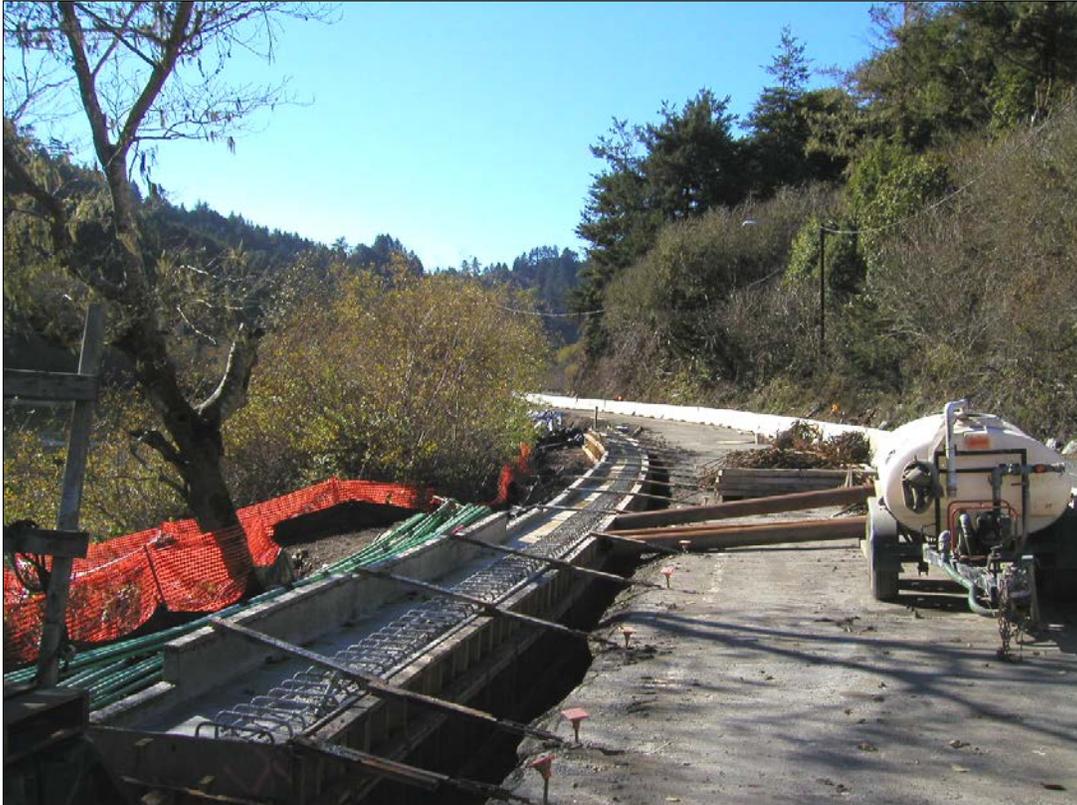
Figure J-2. Duncan's Mills Retaining Wall – Cap Beam Construction.
Photo from Jim Cook, Sr Br Engr

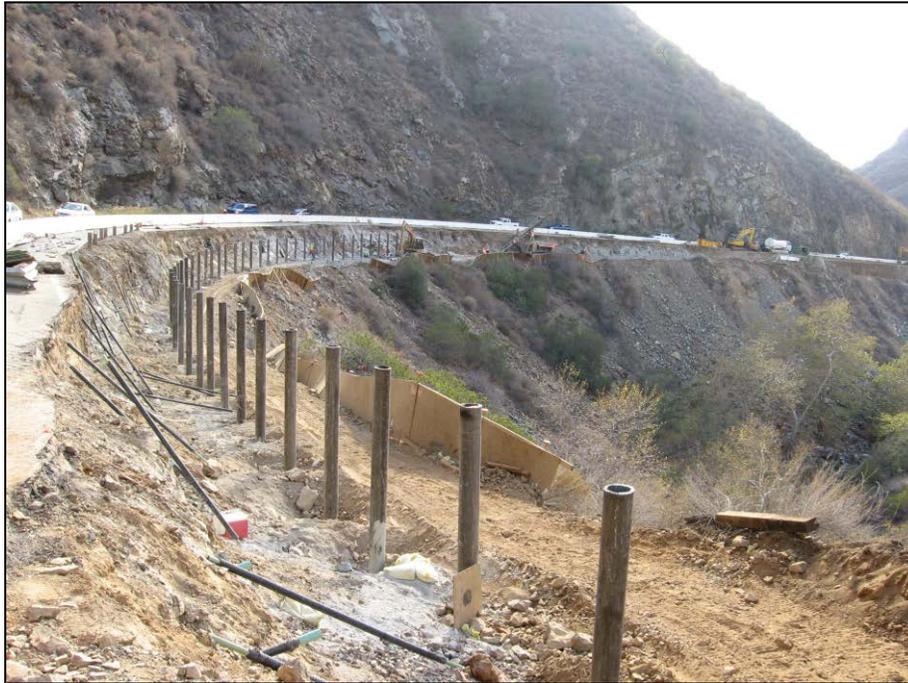
Figure J-6. Ortega Highway Micropile Construction Photo 1.

Micropile (NPS 8-XX Strong Steel Pipe) in a 300-mm dia drilled hole. On the ground –Sections of Rock Anchors to be installed later. Date: 2007.

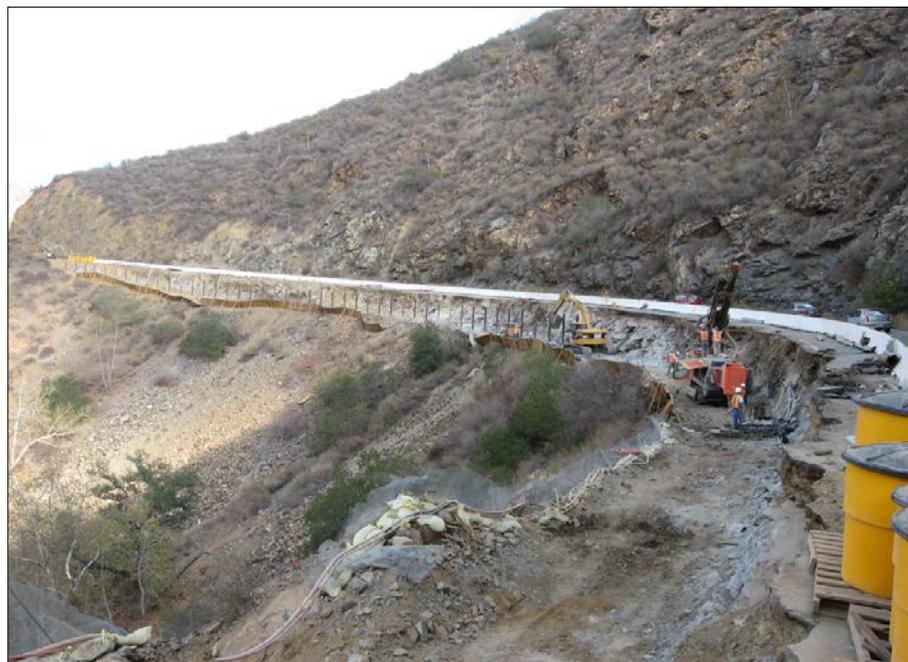
Figure J-7. Ortega Highway Micropile Construction Photo 2.

Total wall length = 753 ft. The area is mostly comprised of very hard rock croppings. The road, Rte 74, is open to traffic. Date: 2007.

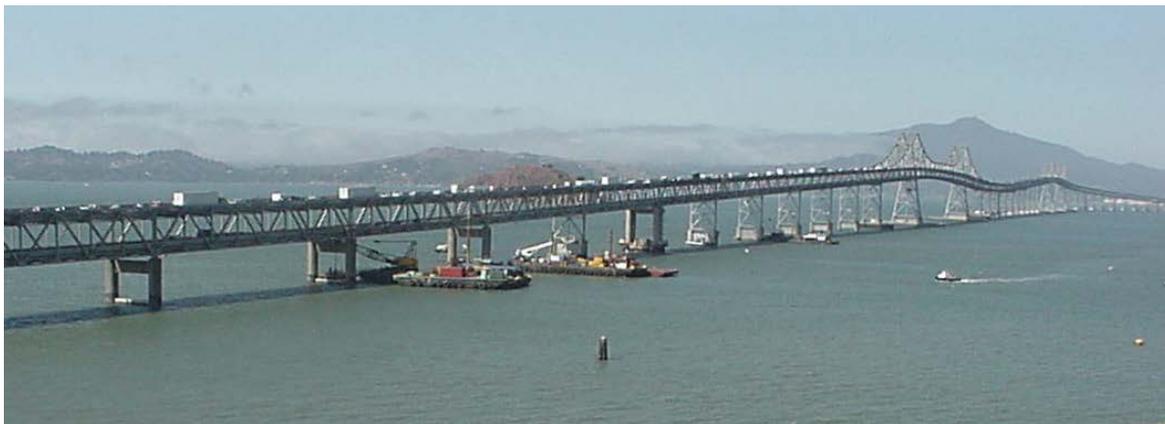
Figure J-8. Richmond-San Rafael Bridge (Photo from Caltrans Office of Geotechnical West Photo Gallery).

The bridge work on this project consisted of the replacement of the concrete trestle portion and the seismic retrofit on the rest of the structure. ***The seismic retrofit included constructing 481 micropiles in the substructure.*** The micropiles were installed underwater.

Per the special provisions, micropiles (substructure) were specified to consist of small diameter steel pipe reinforcement grouted in place and conforming to the design requirements and layout shown on the contract plans and the special provisions.

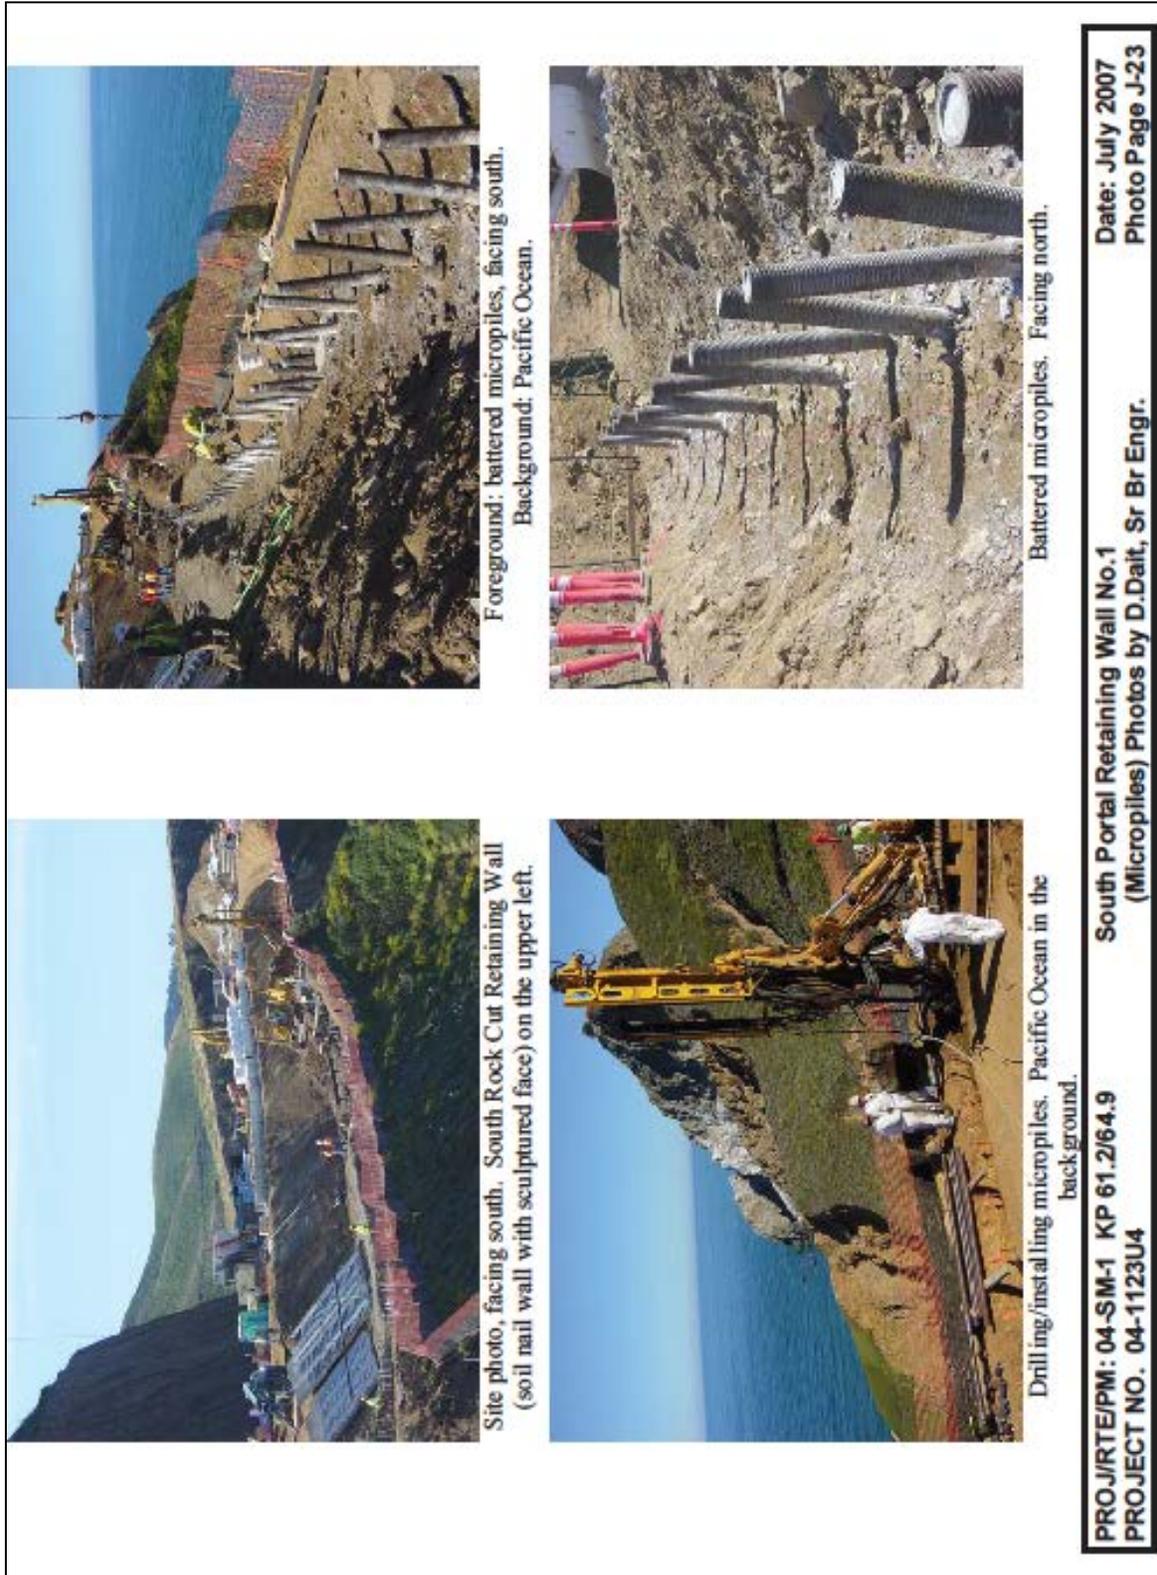
Figure J-12. Devil's Slide Micropile Construction Photos 1.

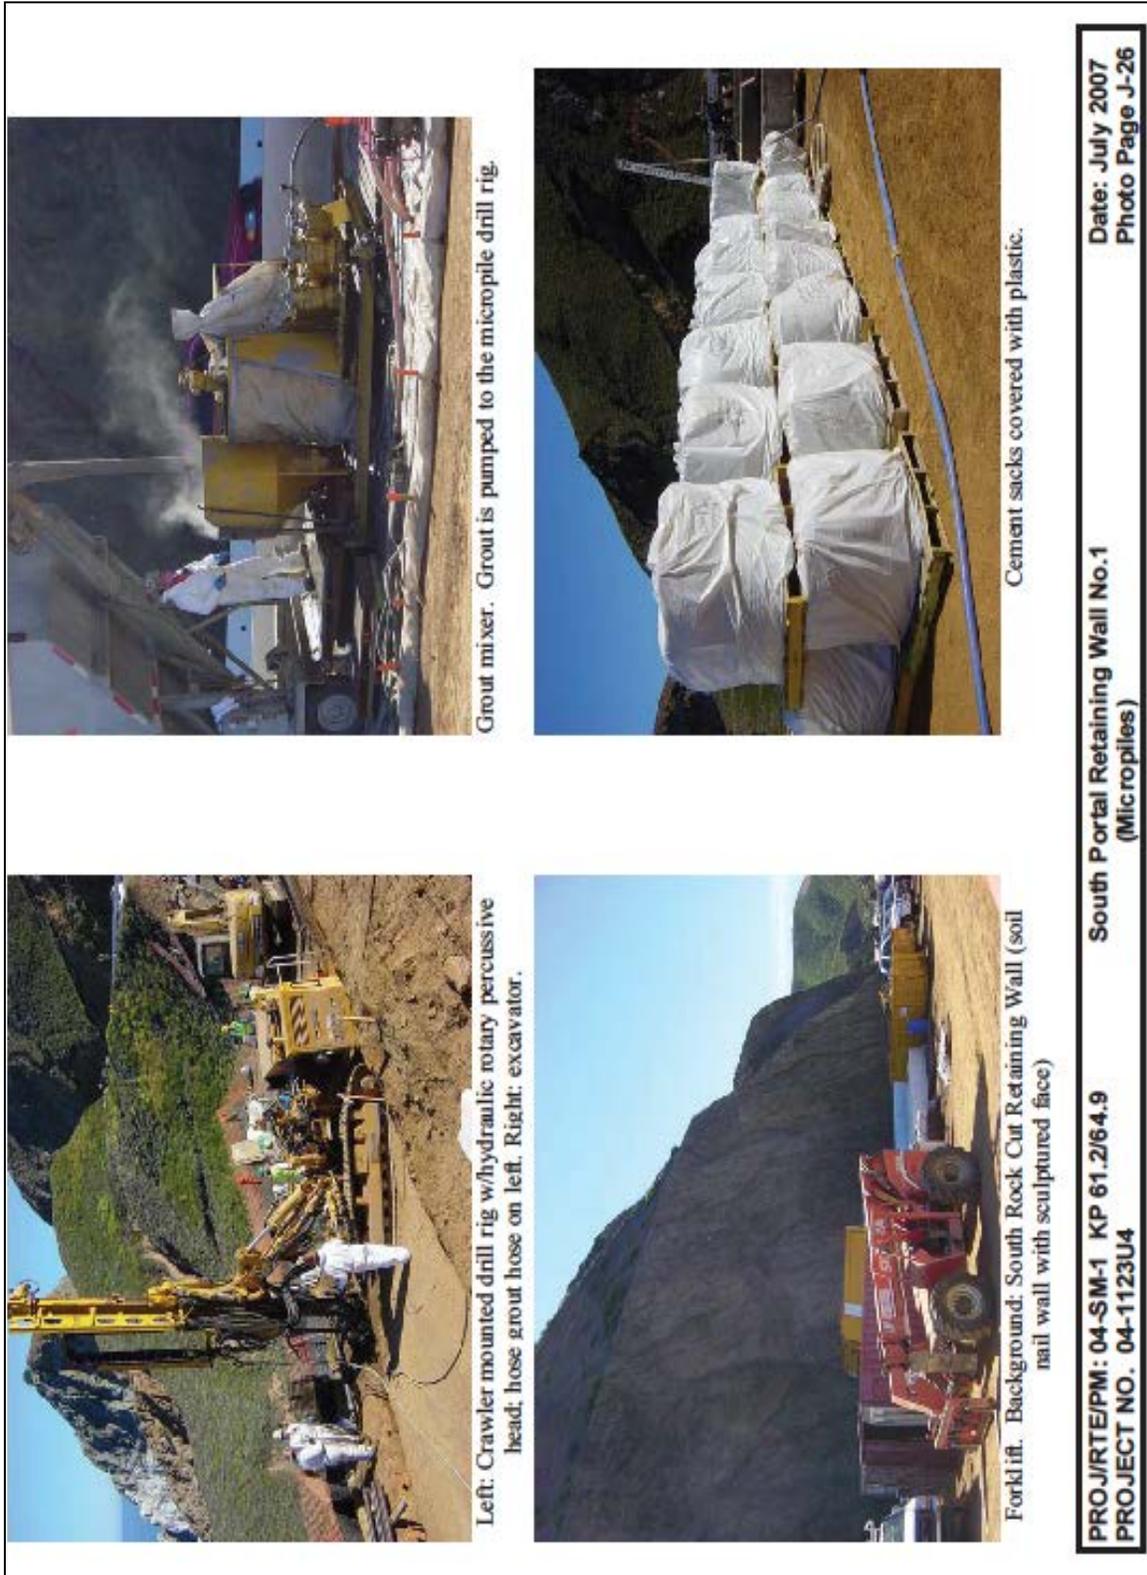
Figure J-14. Devil's Slide Micropile Construction Photos 3.

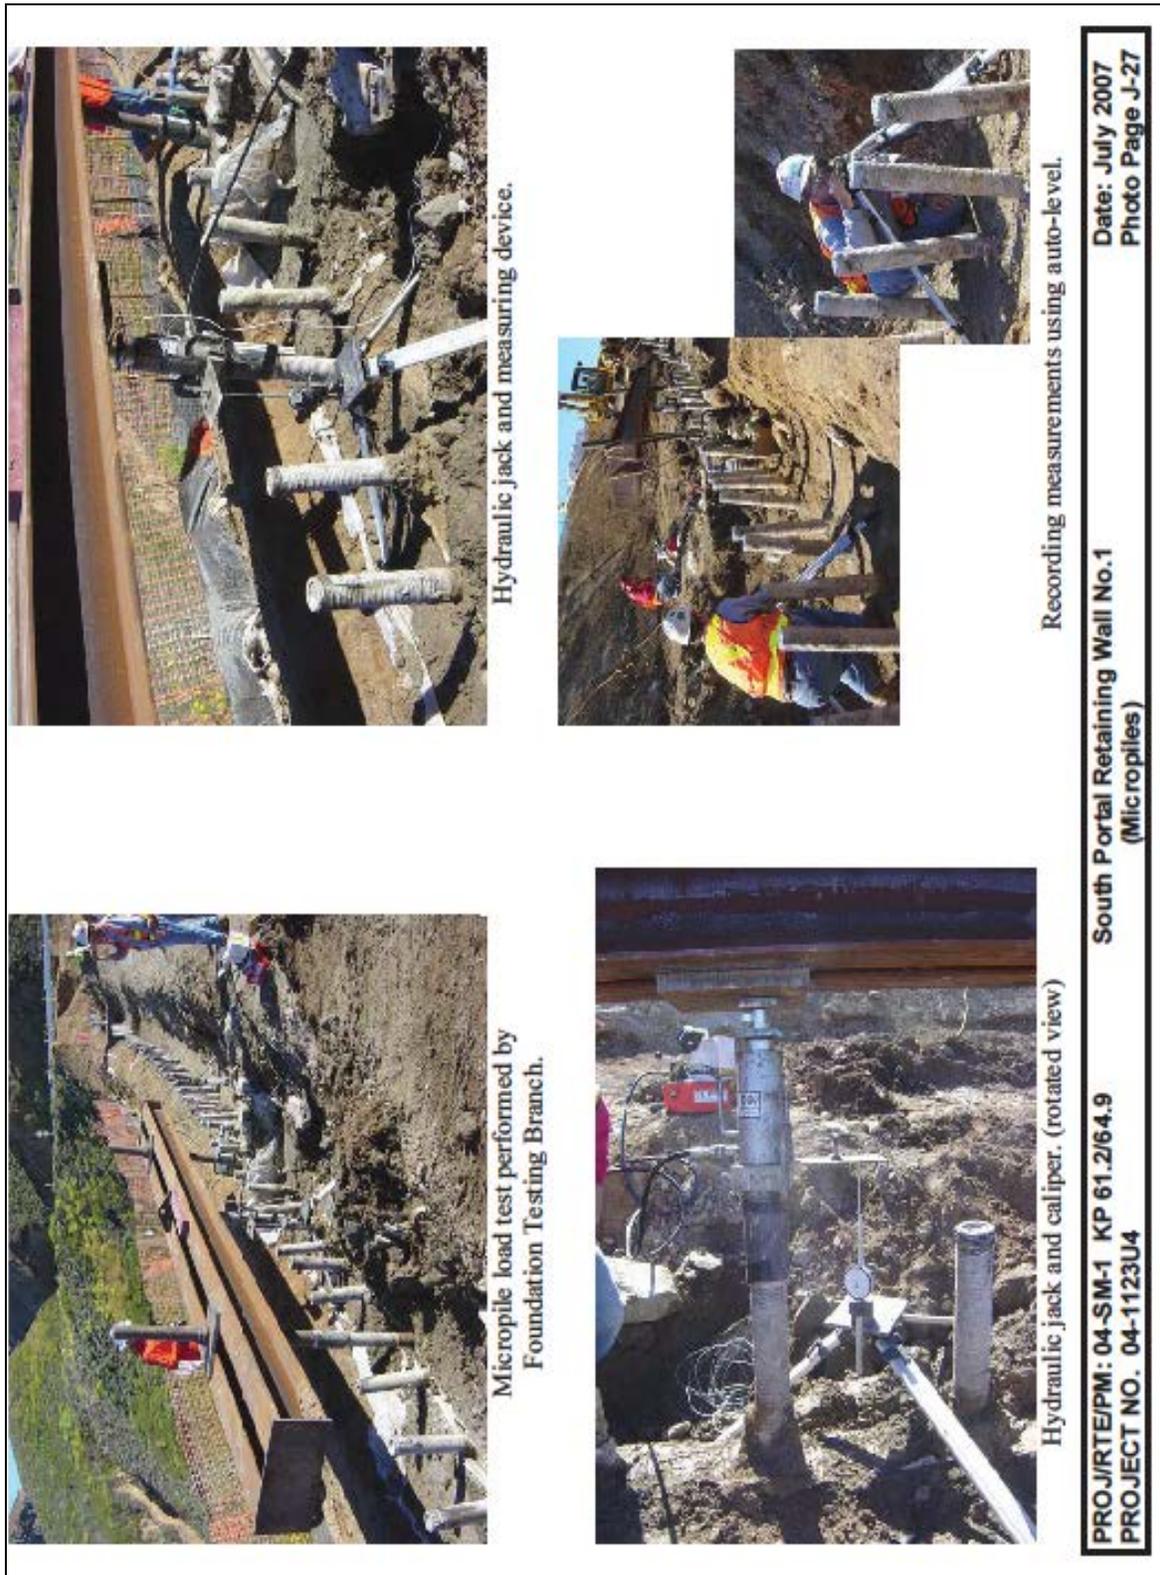
Figure J-15. Devil's Slide Micropile Testing Photos.

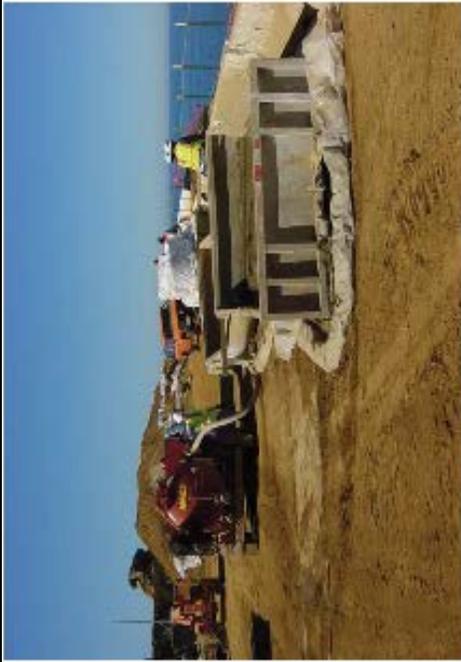
<p>Storm Water Pollution Prevention Plan (SWPPP). Right: grout settlement container. Left: mobile tank and pump.</p>

- In some areas, soft soil caused grout bubbling through adjacent piles; the excess grout probably formed a grout curtain.
- Micropile operation is very messy operation; proper SWPPP measures are needed.
- Pile production/installation was approximately 1 pile per 30 to 40 minutes

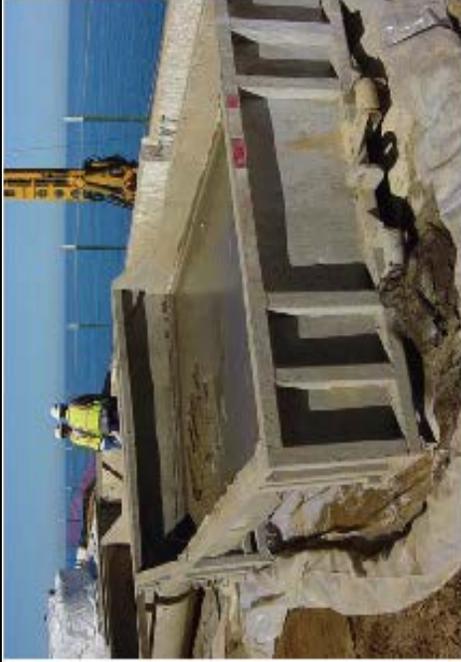
<p>SWPPP: grout settlement container / concrete washout container.</p>

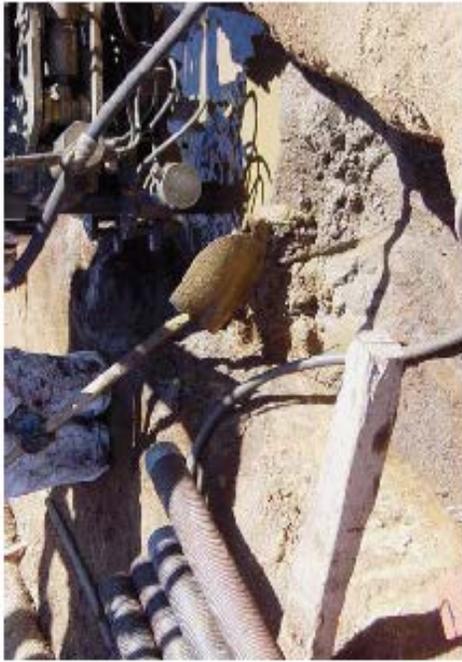
<p>SWPPP: laborer is creating a check dam at each drill location to prevent grout and drill cuttings from covering next pile location.</p>

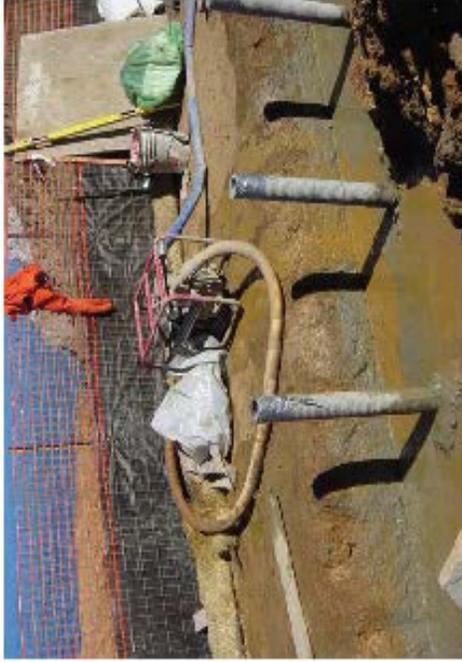
<p>Portable pump used to pump excess grout and drill cuttings into settlement containers. Behind pump is silt fence and rolled straw.</p>
<p>PROJ/RTE/PM: 04-SM-1 KP 61.2/64.9 South Portal Retaining Wall No.1 PROJECT NO. 04-1123U4 (Micropiles)</p> <p>Date: July 2007 Photo Page J-28</p>

Figure J-16. Devil's Slide Micropile Construction – SWPP Measures.

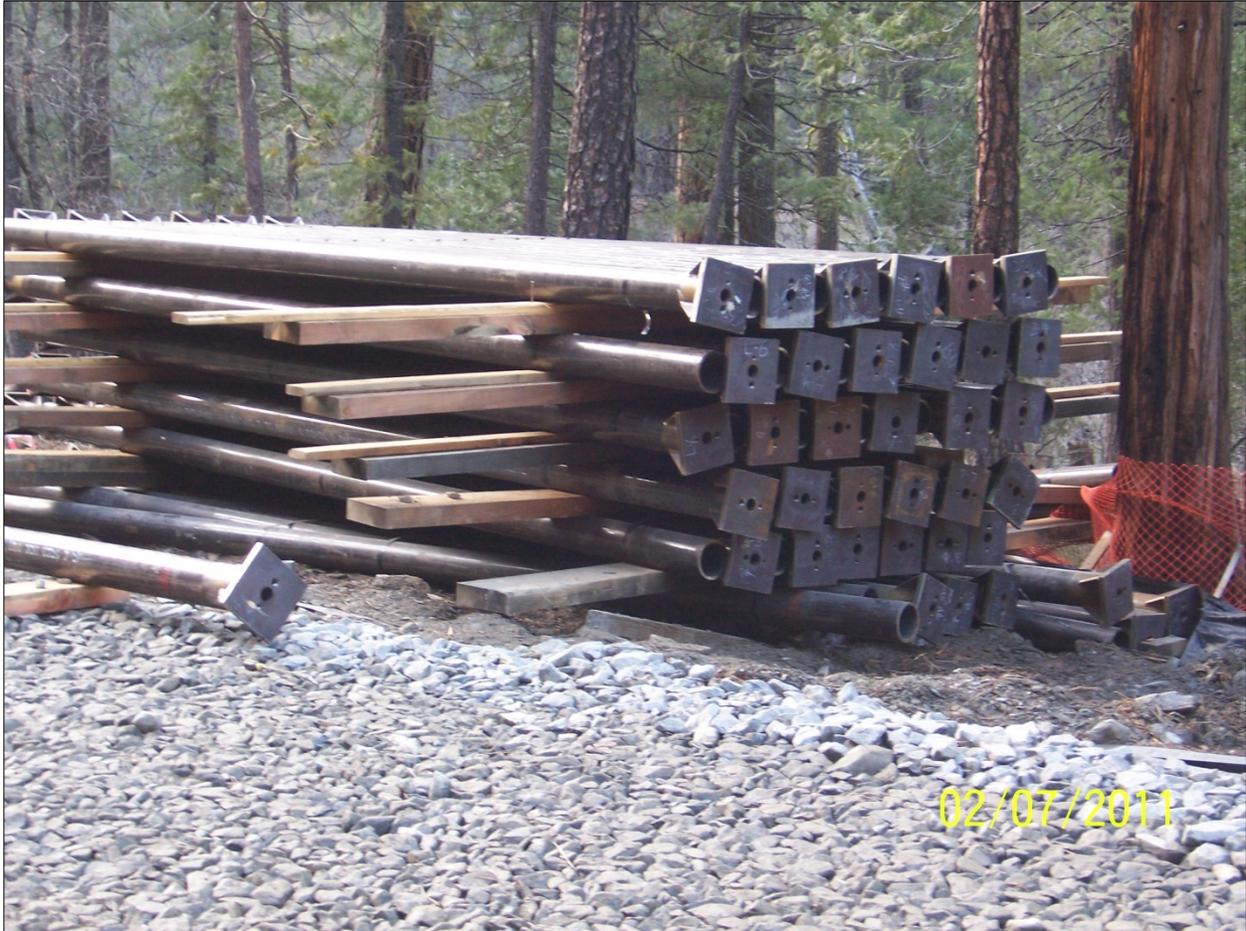
Figure J-24. API N80 Casing Prior to Threaded Rod Installation. Photo taken by Jeff Rothgery

The specifications require the use of 7-inch outside diameter API (American Petroleum Institute) N80 casing with a marked API monogram. Additionally, “Buy America” provisions were required due to the contract being funded with Federal funds. The FHWA micropile manual substantiates their recommendation for using API casing due to the wide availability of secondary material thereby reducing installation costs. Secondary casing is cut-off surplus material from oil field work. Once the secondary casing material is deemed secondary, the heat numbers are typically ground off and mill certification reports are no longer available. Proving domestic origin becomes impossible once heat numbers are removed. On this project, the Contractor was required to order a mill run of the API N80 material due to the need for 3500 linear feet. This increased the contractor’s anticipated material costs. Project costs could be reduced if an alternative casing material was specified.

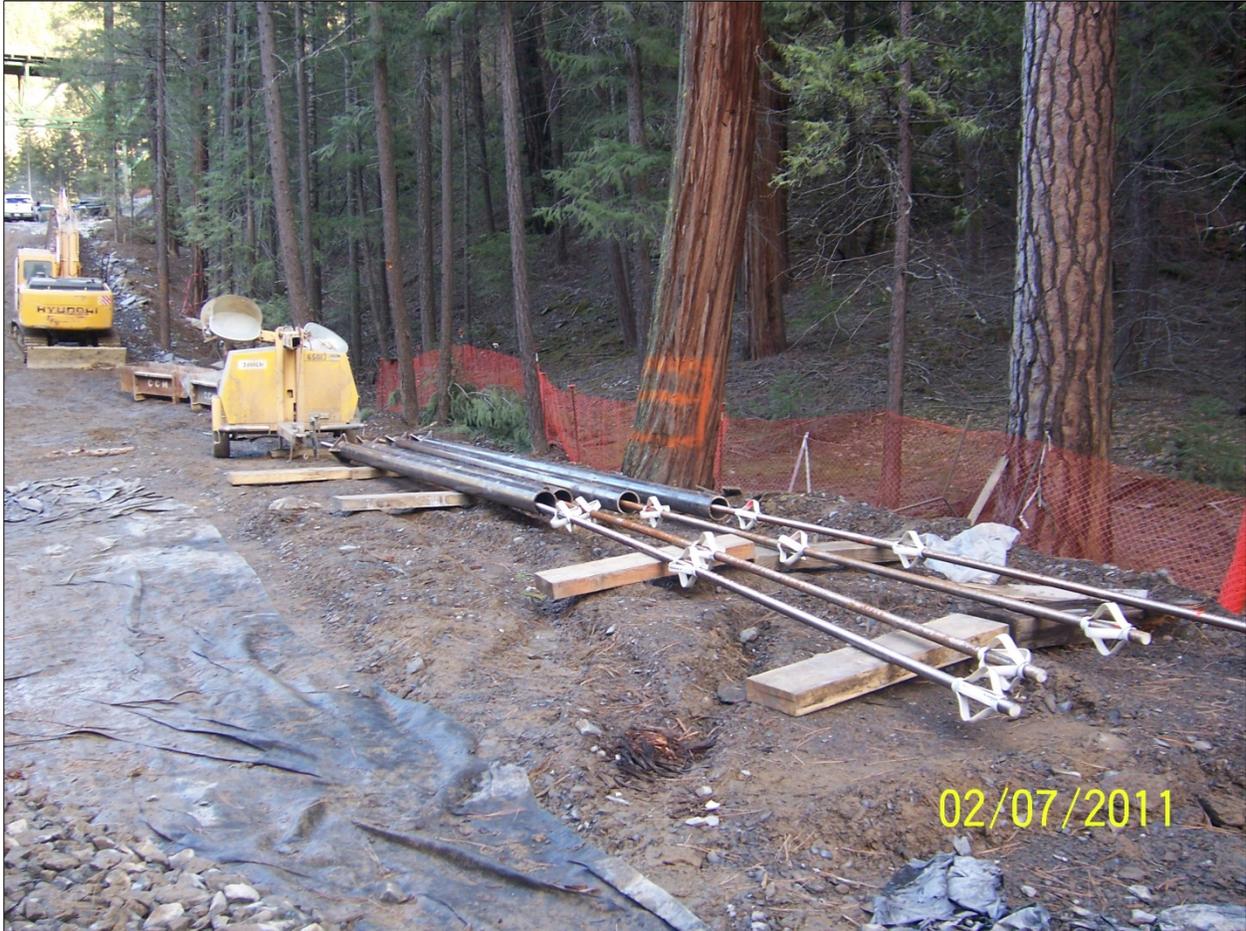
Figure J-25. Micropile Assemblies Ready for Installation.

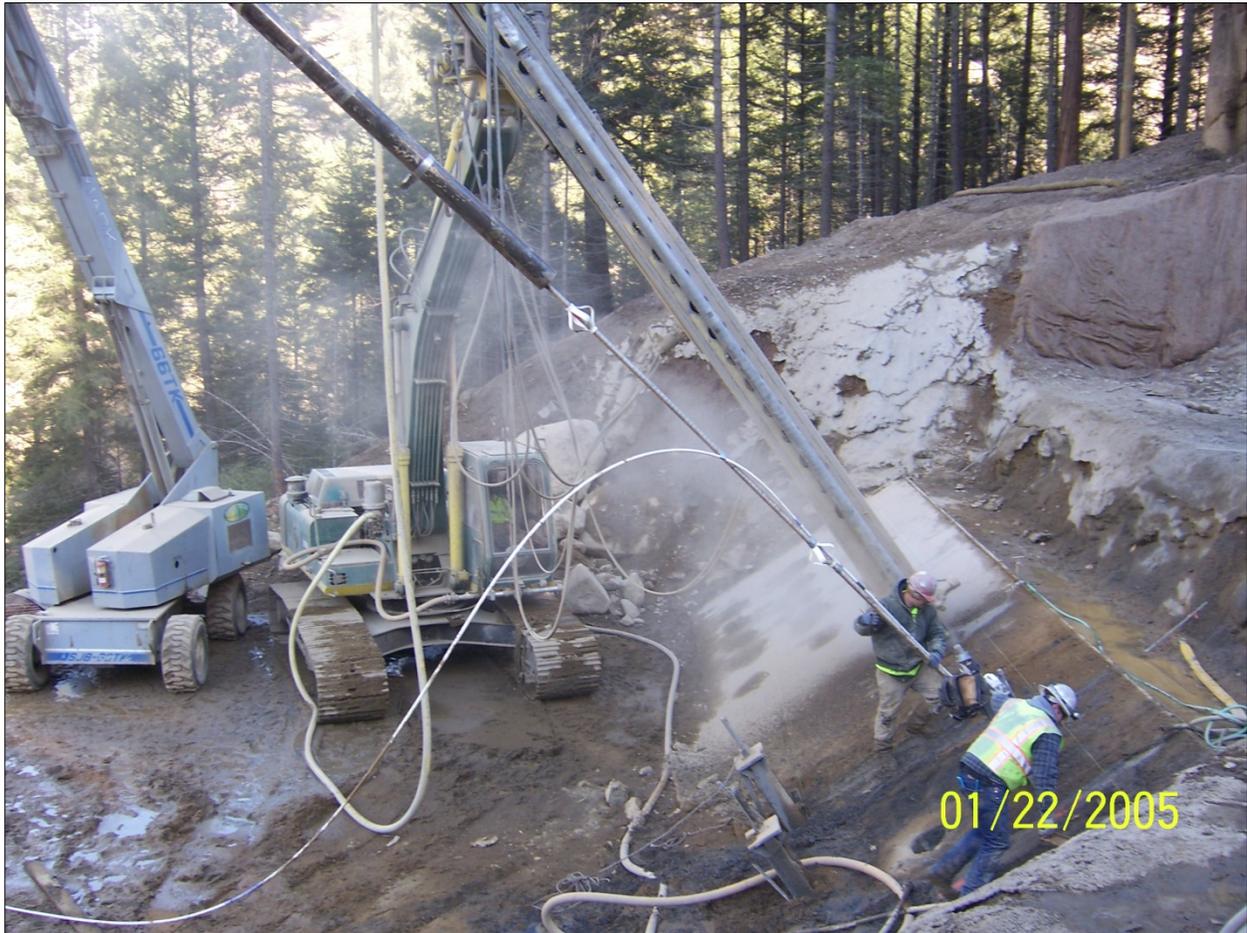
**Figure J-26. Foreground – Micropile Assembly Installation Underway with Post Grouting Tube.
Background – Pier 6 Micropile Drilling with Articulated Down-hole Percussive Rotary Method.
Photo taken by Jeff Rothgery**

Drilling of the micropiles was performed by an excavator mounted articulated down hole rotary percussive hammer. Some drifting of the borings were noted, occasionally causing binding of the 20-foot long casing during installation breaking the plastic centralizers. The use of steel centralizers would alleviate the centralizer issue. The requirement for an alignment check after drilling with a follower device would be useful in identifying boring alignment deviations.

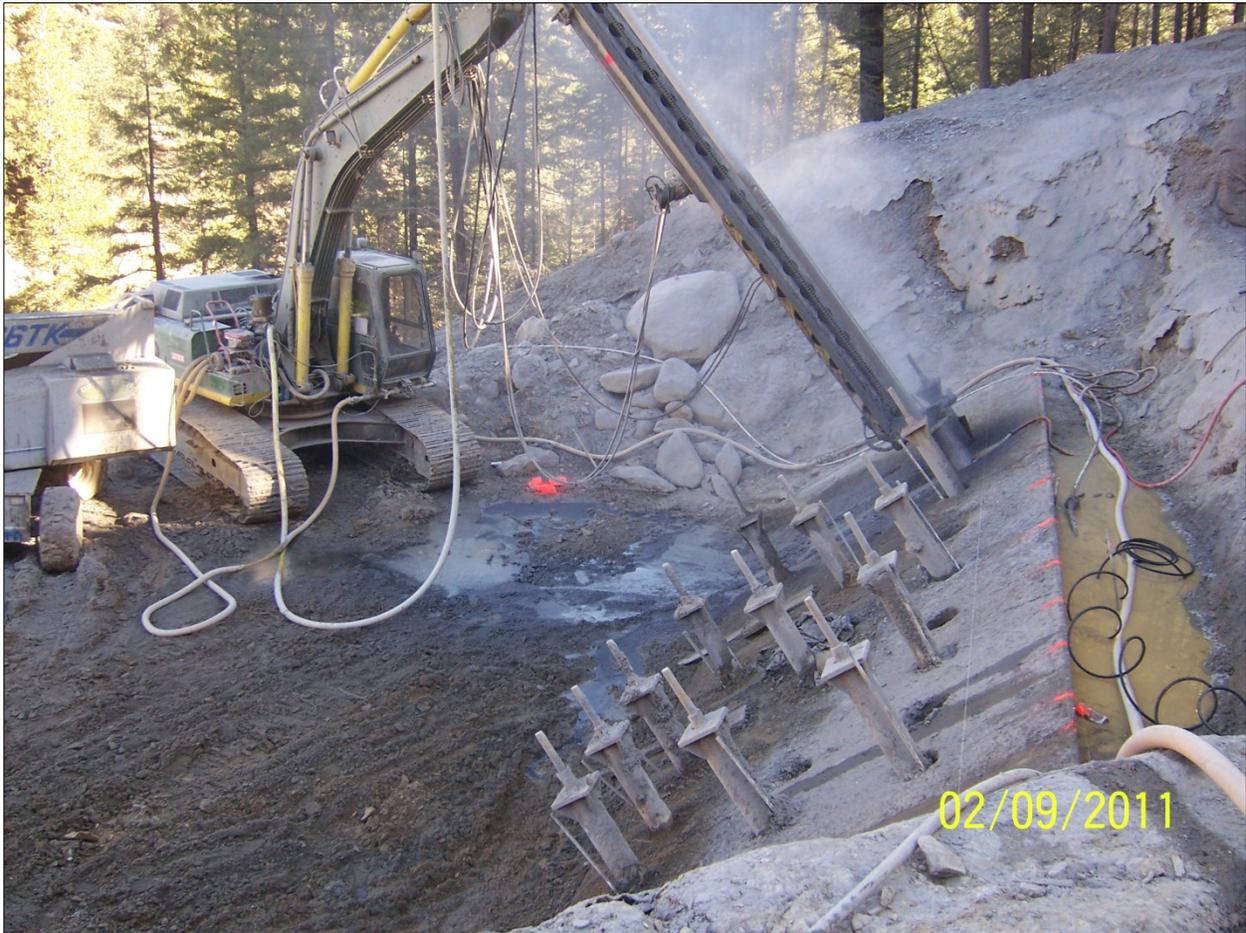
Figure J-27. Pier 6 Micropile Installation.

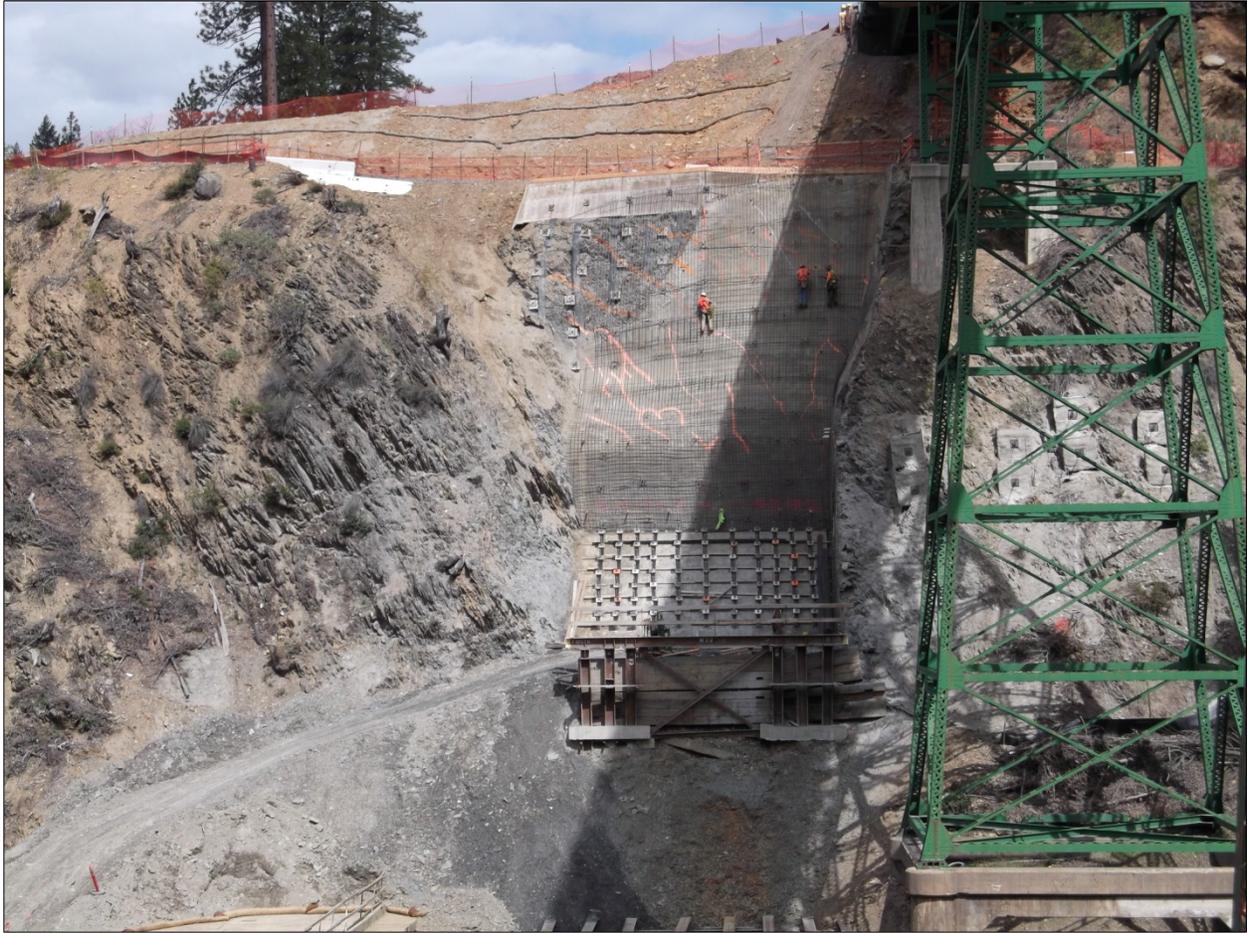
Figure J-28. Pier 2 Installed Micropiles.

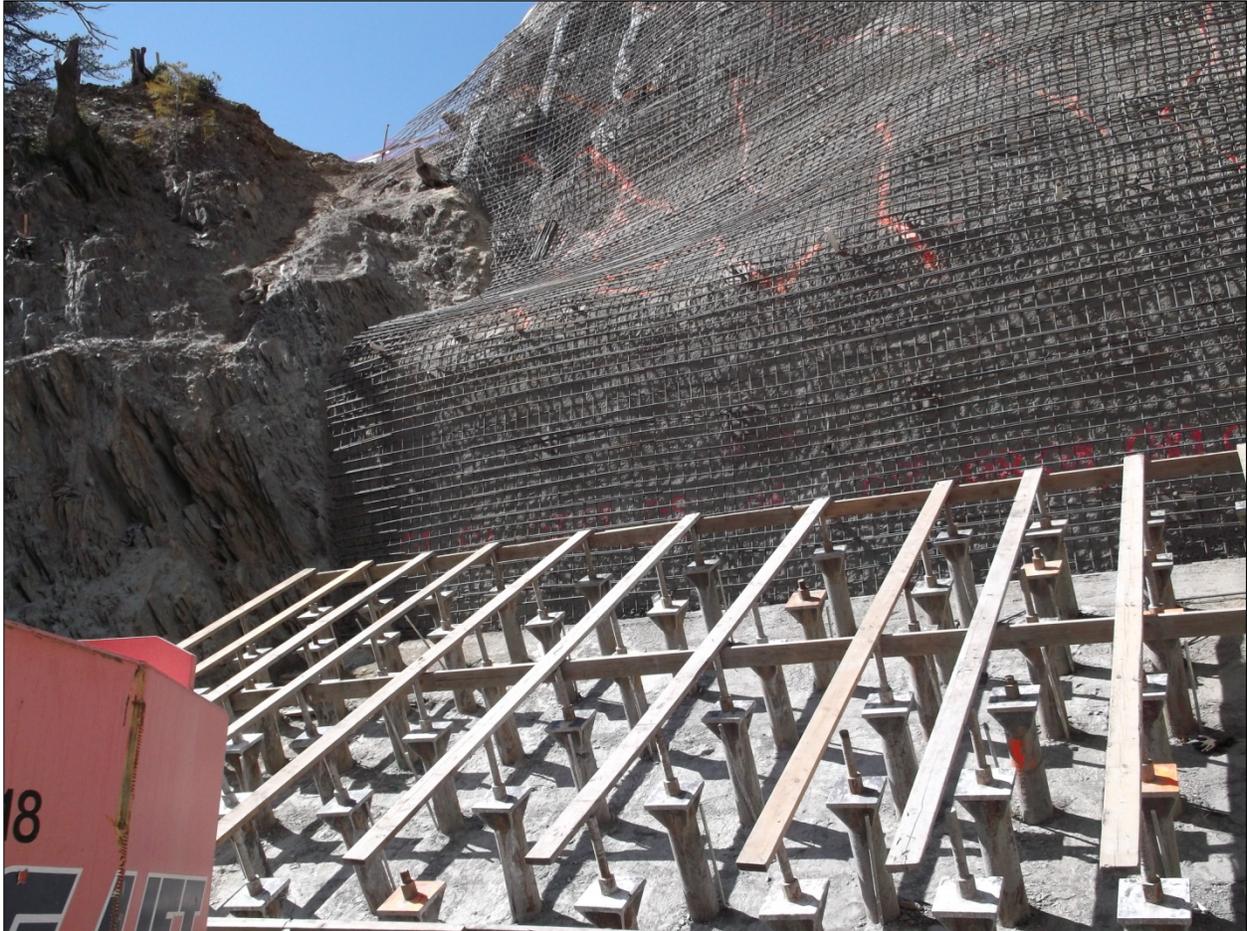
Figure J-29. Pier 2 Installed Micropiles, Preparing for Load Testing.

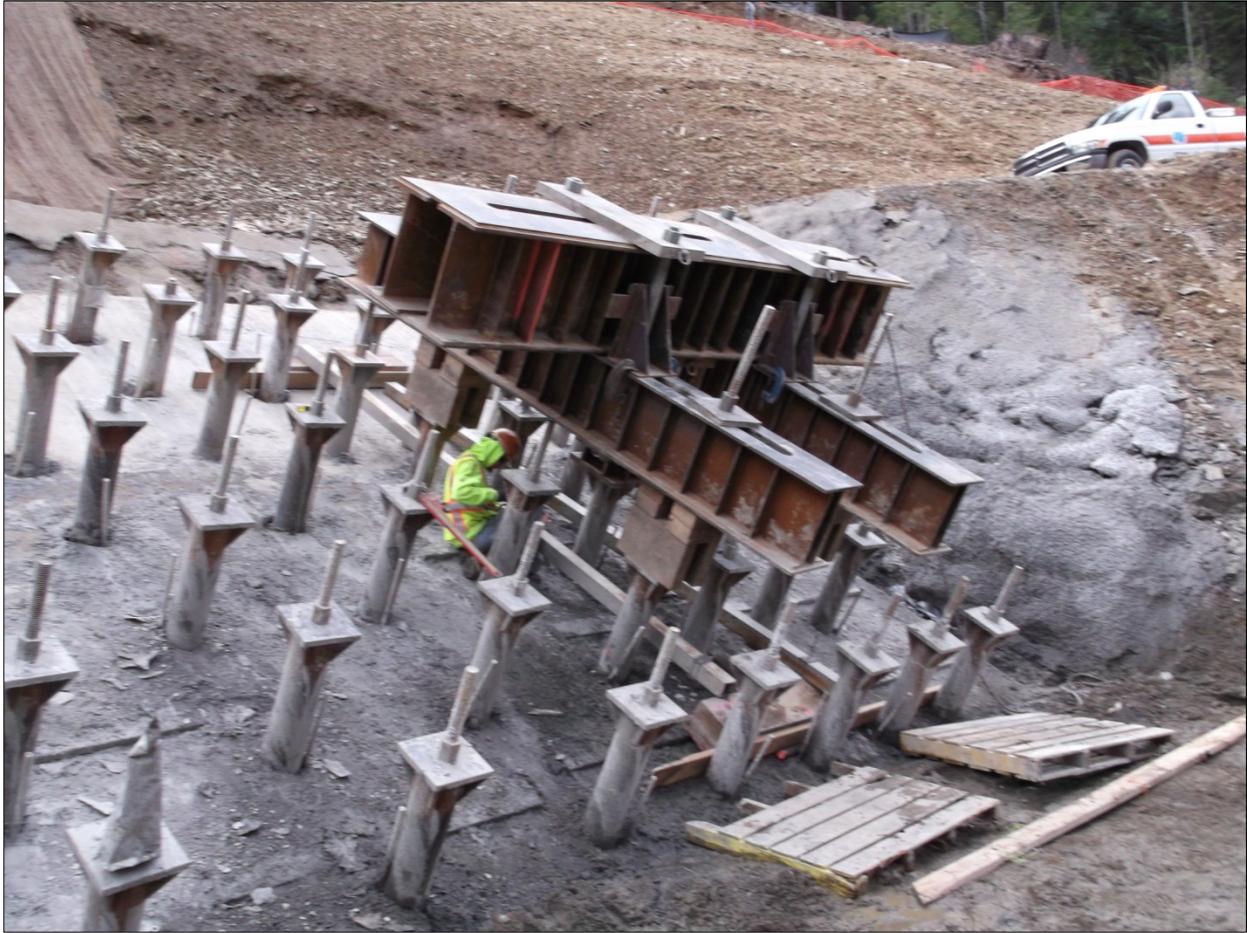
Figure J-30. Pier 6 Micropiles with Load Test Frame.

Proof testing of 10 percent of the production piling was performed to 75% of the axial nominal resistance in compression. This was a good verification of the capacity of the micropiling. Due to the micropile test frame utilizing neighboring piles as reaction piles, perimeter pilings were unable to be tested due to the lack of reaction piles for test frame mounting.
