### Federal Highway Administration 01/10/2017 California Division Nine Proven Safety Countermeasures

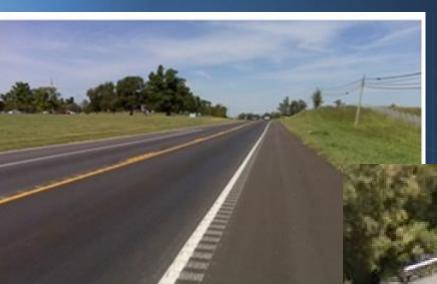
SR 84 in bay area Courtesy of Google

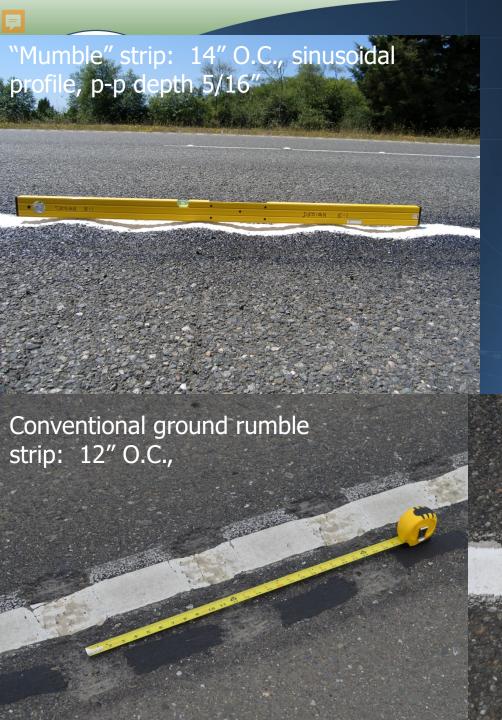
# Caltrans (patent pending) Mumble Strip Evaluation

4" Dia Dots: 12" O.C.,

- Rumble strips can help reduce sideswipe, head-on collisions, and run-off-road crashes
- Caltrans mumble strips achieved goals
  - Lower exterior dB A-weighted levels
  - Provide sufficient driver warning input
- Interior noise & vibration response varied with vehicle type

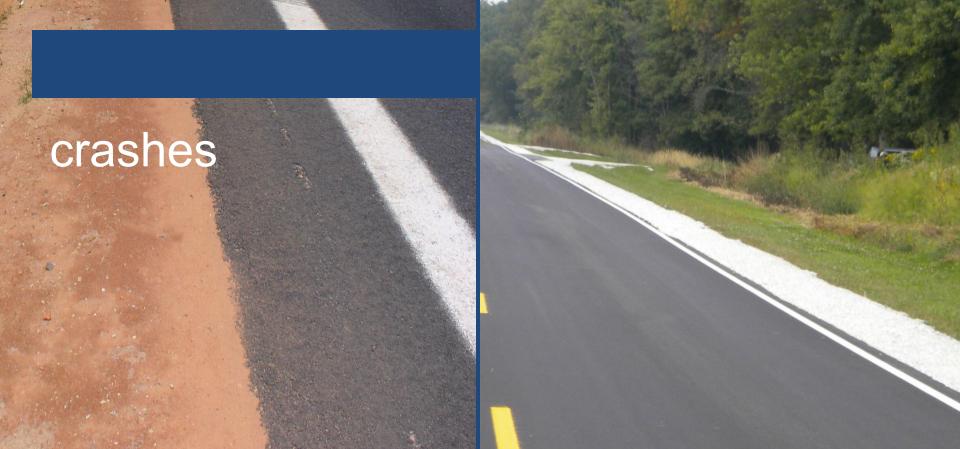
### What Is the Safety Edge?

When used on asphalt navement the

- Saves Lives
  - Allows vehicles to safely return to the travel lane
- Improves Durability
  - Reduces edge raveling
- Low Cost
  - Minor change to paving operations

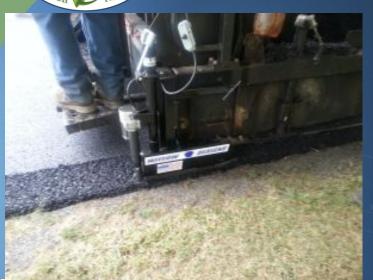
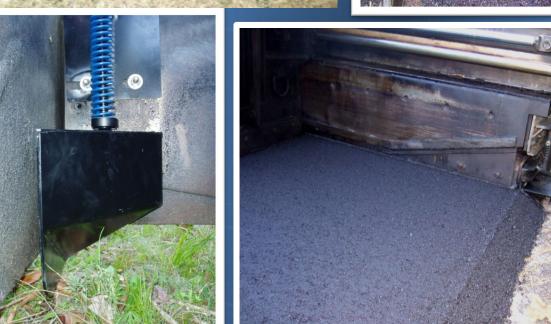
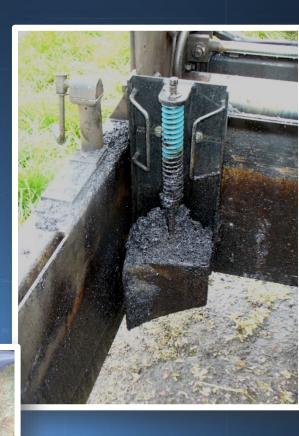
### The Hardware

- Hardware
  - Approximately \$1400-\$4500 per device
  - Reusable
- Material
  - Minor additional asphalt(depends on shoulder condition)

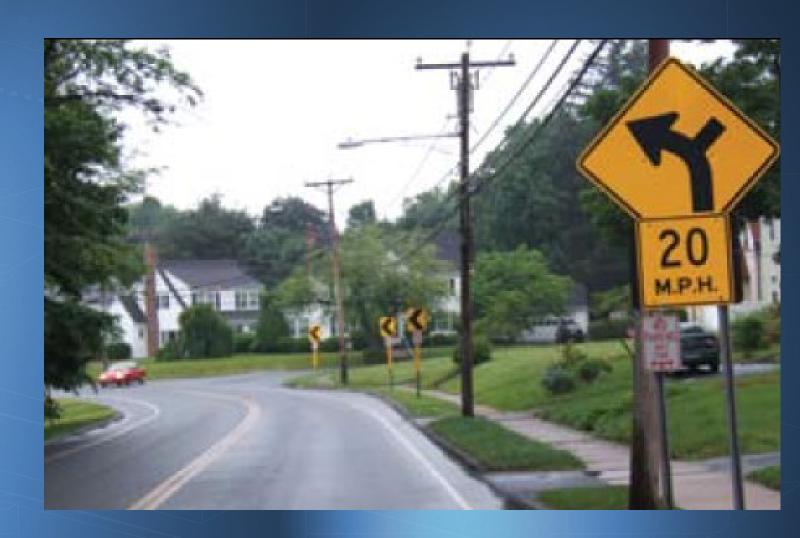
### Example of Enhanced Delineation

- Data collected from states of Connecticut and Washington
- Delineation improvements for horizontal curves on two-lane rural roads
- 117 mile/years of before and after data (228 sites total)
- Chevron, curve ahead, horizontal or suggested speed limit signs
- Fluorescent sheeting, increased size or additional signs

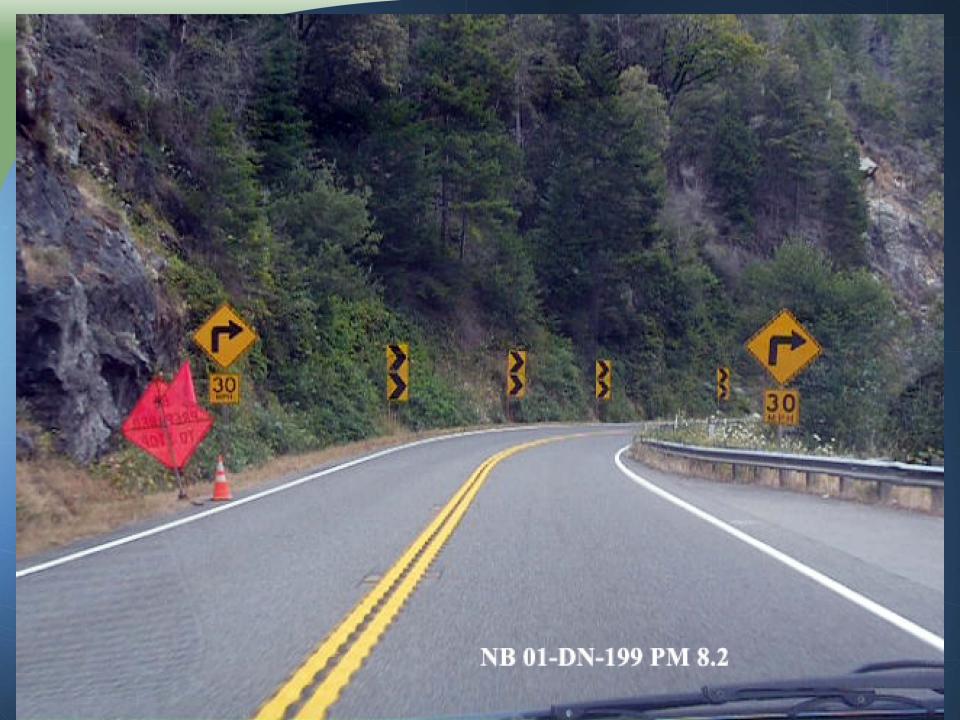
### Case Study: DN-199

- All 28 collisions in 3 years occurred under wet pavement conditions.
- District had used many low cost countermeasures with little change in collision pattern.
- District proposed curve realignment.

- Initial proposed project was to realign curve
  - \$14 M project; approx. 5 years for environmental, design and construction
- Realignment project put on hold to install HFST
  - \$250 K project; approx. 6 months for environmental, design and construction
- No crashes since installation (Summer 2012)
