#### Federal Highway Administration 2/1/2018

California Division

Nine Proven Safety Countermeasures

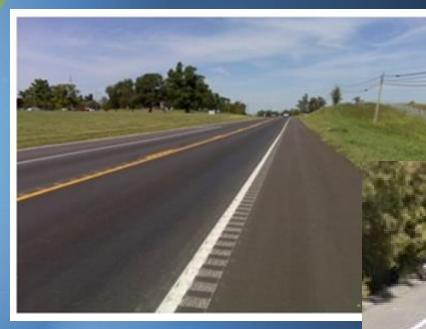
**Shoulder Rumble Stripe**

SR 84 in bay area Courtesy of Google

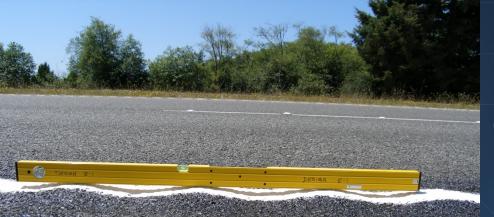
"Mumble strip: 14" O.C., sinusoidal profile, p-p depth 5/16"

Conventional ground rumble strip: 12" O.C.,

## Caltrans Sinusoidal Rumble Strip (aka mumble strip)

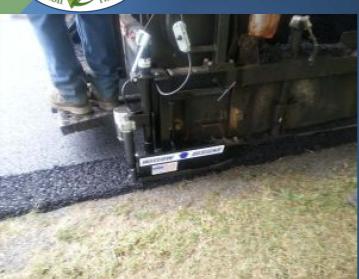
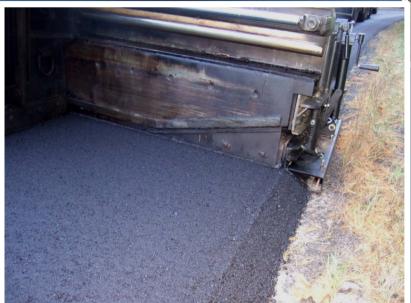
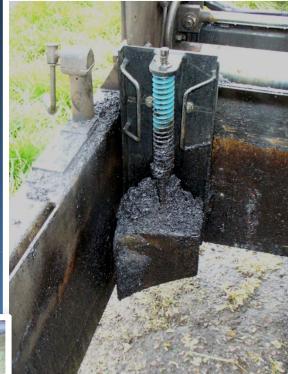
#### The Hardware

- Approximately \$1400-\$4500 per device
- Reusable

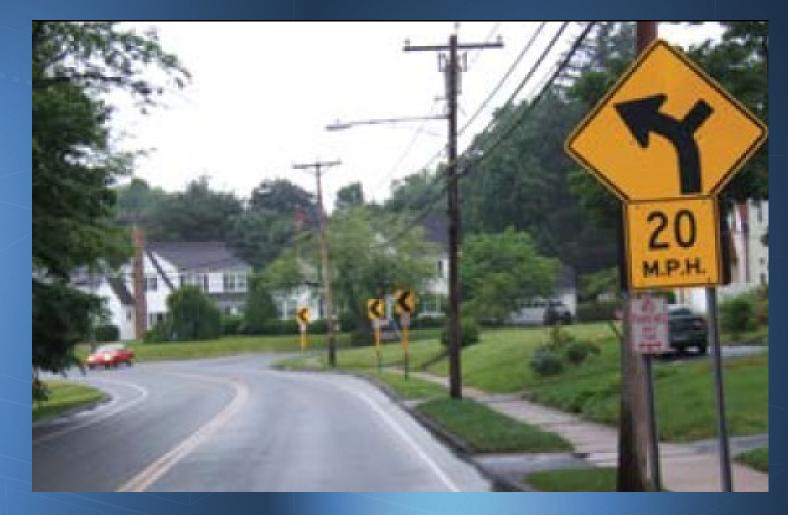
# Example of Enhanced Delineation

- Data collected from states of Connecticut and Washington
- Delineation improvements for horizontal curves on two-lane rural roads
- 117 mile/years of before and after data (228 sites total)
- Chevron, curve ahead, horizontal or suggested speed limit signs
- Fluorescent sheeting, increased size or additional signs
