Nine Proven Safety Countermeasures

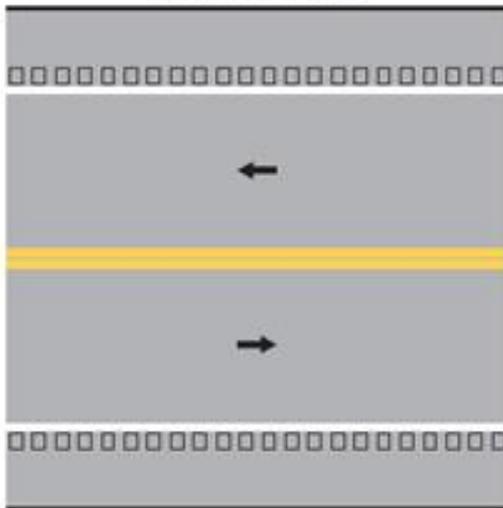
A - Edge line not on rumble strip

Figure 3J-1. Examples of Longitudinal Rumble Strip Markings

Note: Edge line may be located alongside the rumble strip (Option A) or on the rumble strip (Option B). Center line markings may also be located on a center line rumble strip (Option C).

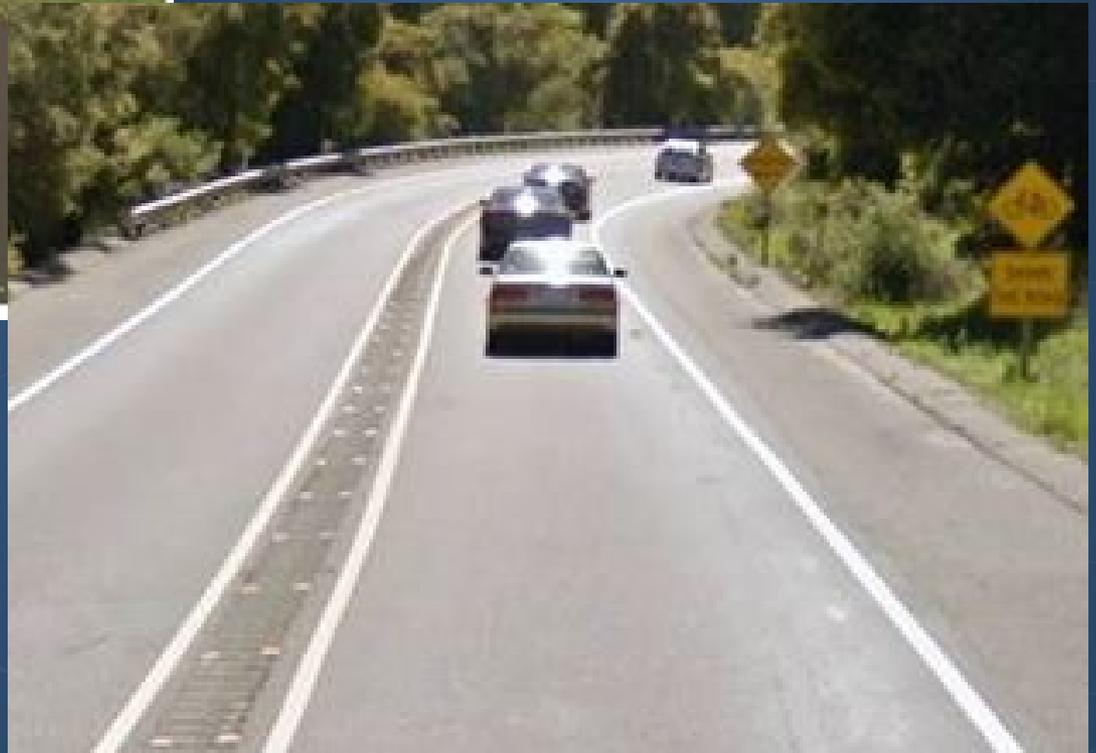
Shoulder Rumble Stripe

SR 84 in bay area
Courtesy of Google

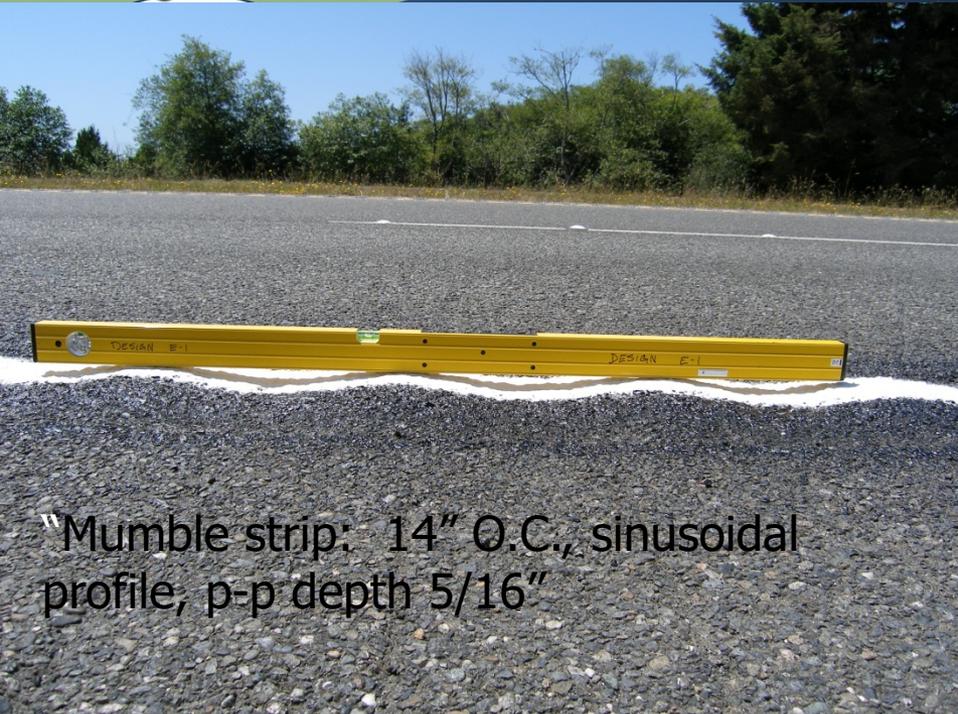
"Mumble strip: 14" O.C., sinusoidal profile, p-p depth 5/16"

Caltrans Sinusoidal Rumble Strip (aka mumble strip)

- Rumble strips can help reduce sideswipe, head-on collisions, and run-off-road crashes
- Caltrans mumble strips achieved goals
 - Lower exterior dB A-weighted levels
 - Provide sufficient driver warning input
- Interior noise & vibration response varied with vehicle type

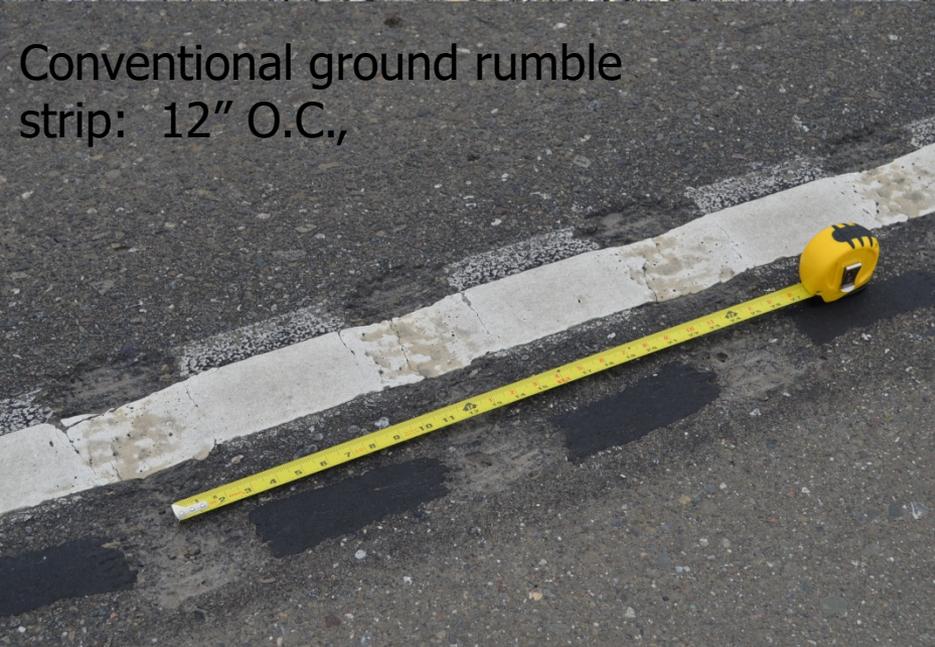
Conventional ground rumble strip: 12" O.C.,

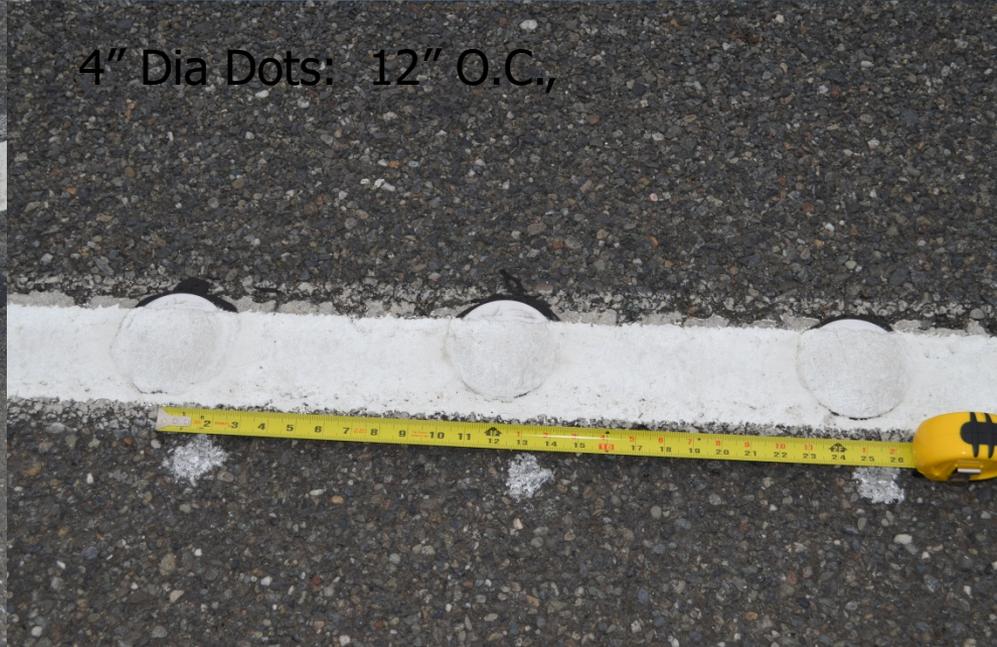
4" Dia Dots: 12" O.C.,

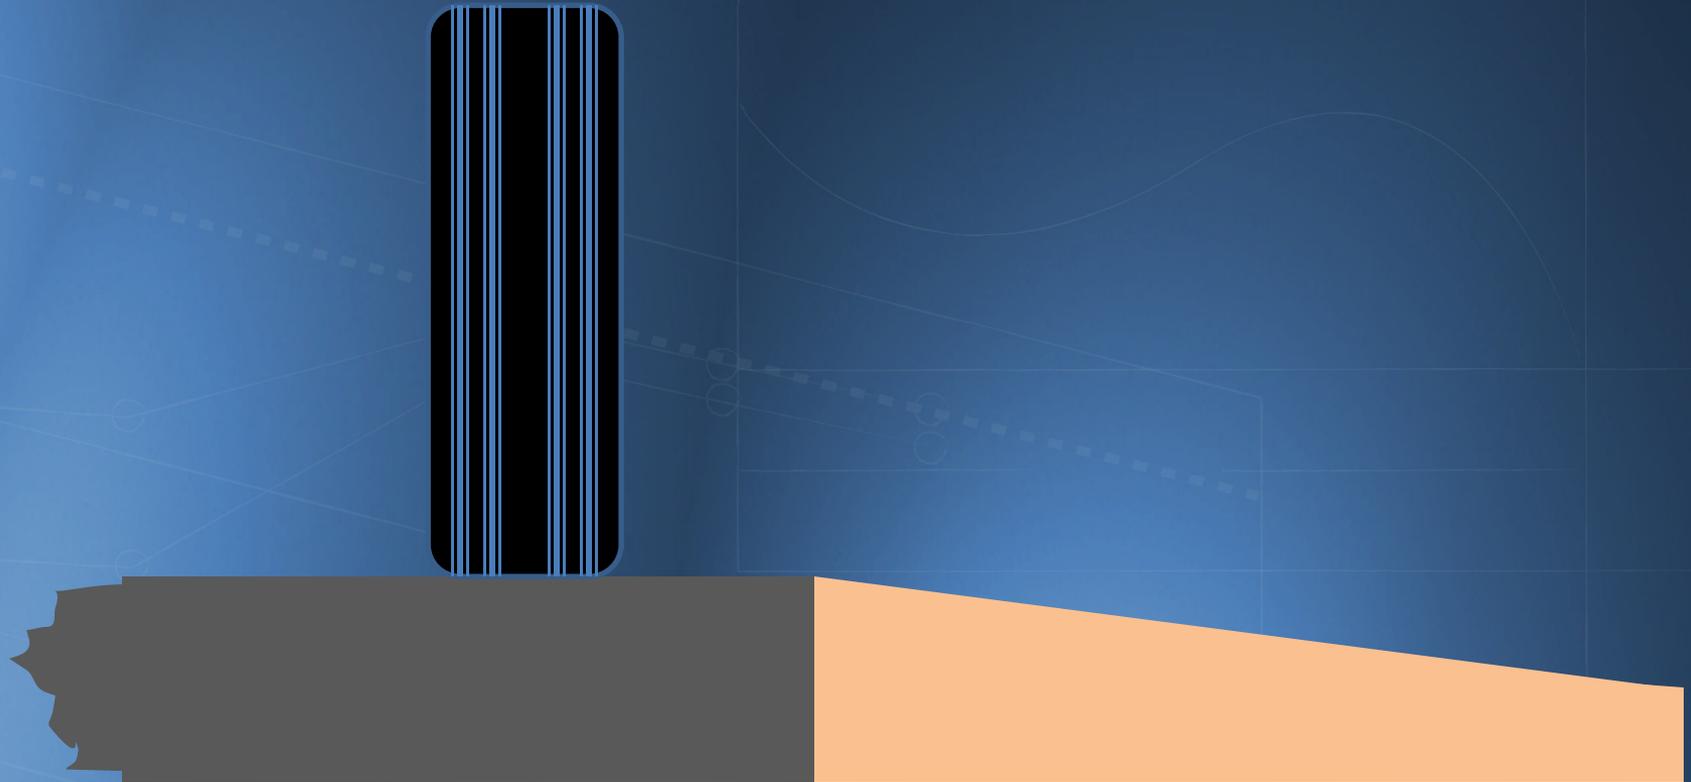
Basic Principle

Without a Safety Edge

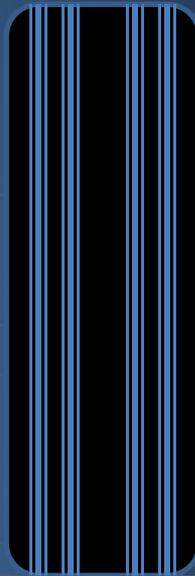
Basic Principle

With Safety Edge

- **Saves Lives**
 - Allows vehicles to safely return to the travel lane
 - CMF for Drop-Off related crashes is 0.655
- **Improves Durability**
 - Reduces edge raveling
- **Low Cost**
 - Minor change to paving operations

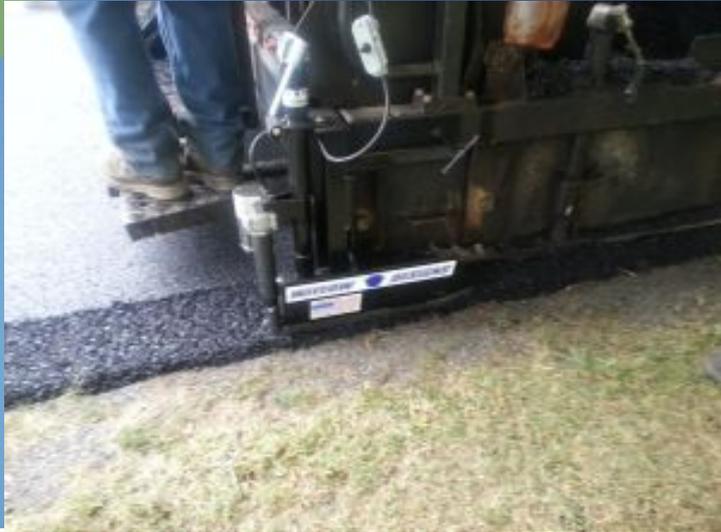
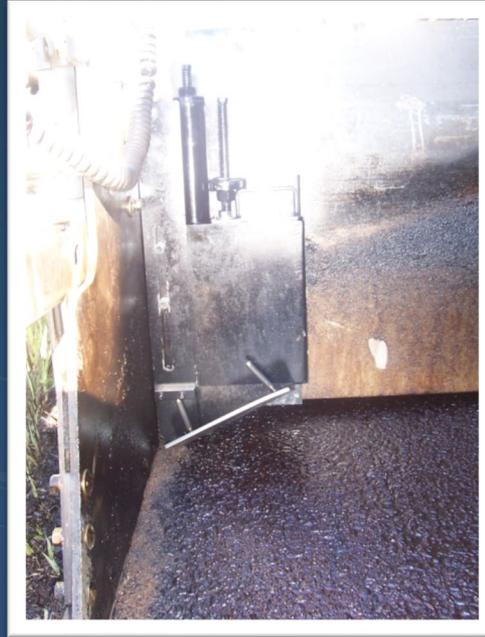
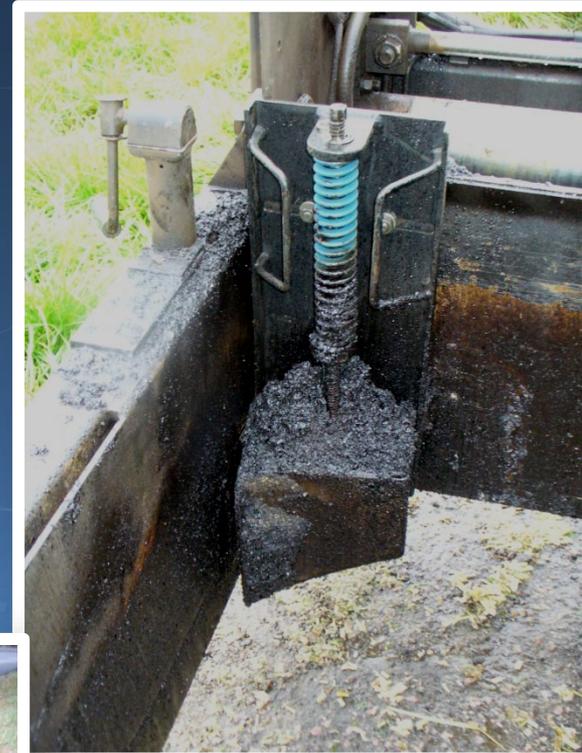
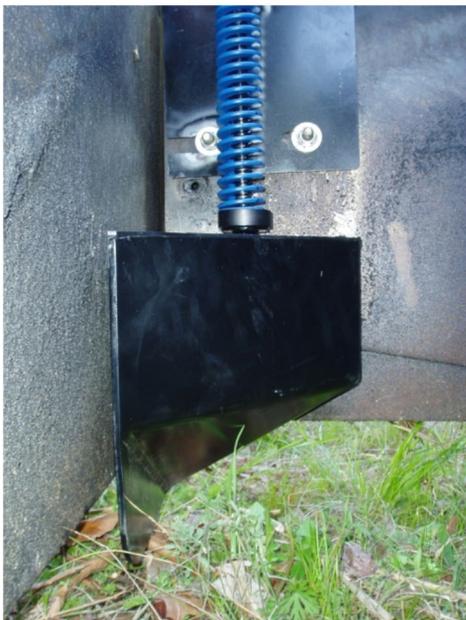
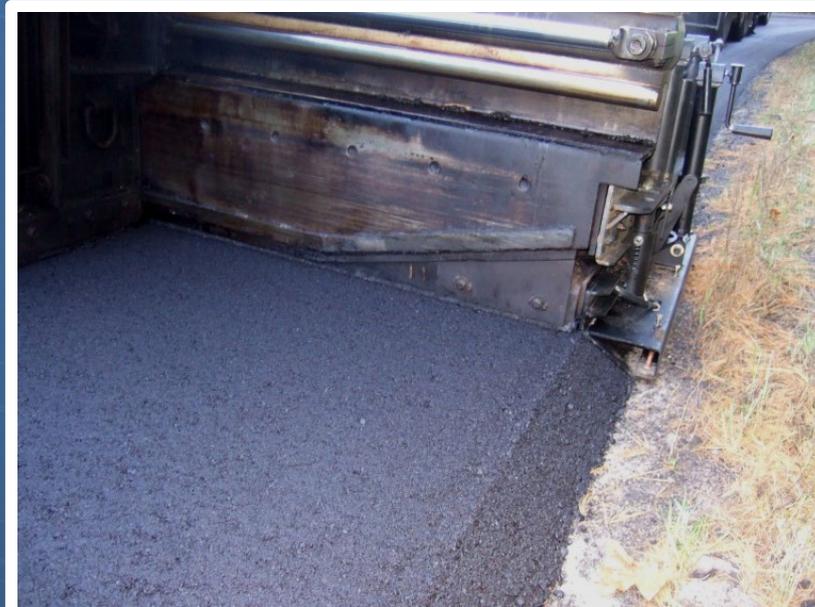
The Hardware

- Hardware
 - Approximately \$1400-\$4500 per device
 - Reusable
- Material
 - Minor additional asphalt (depends on shoulder condition)
- Paving Process
 - No change in paving speed or rolling patterns
 - No additional operation
 - Minimal monitoring
- Surface Details
 - No change in smoothness/ride quality

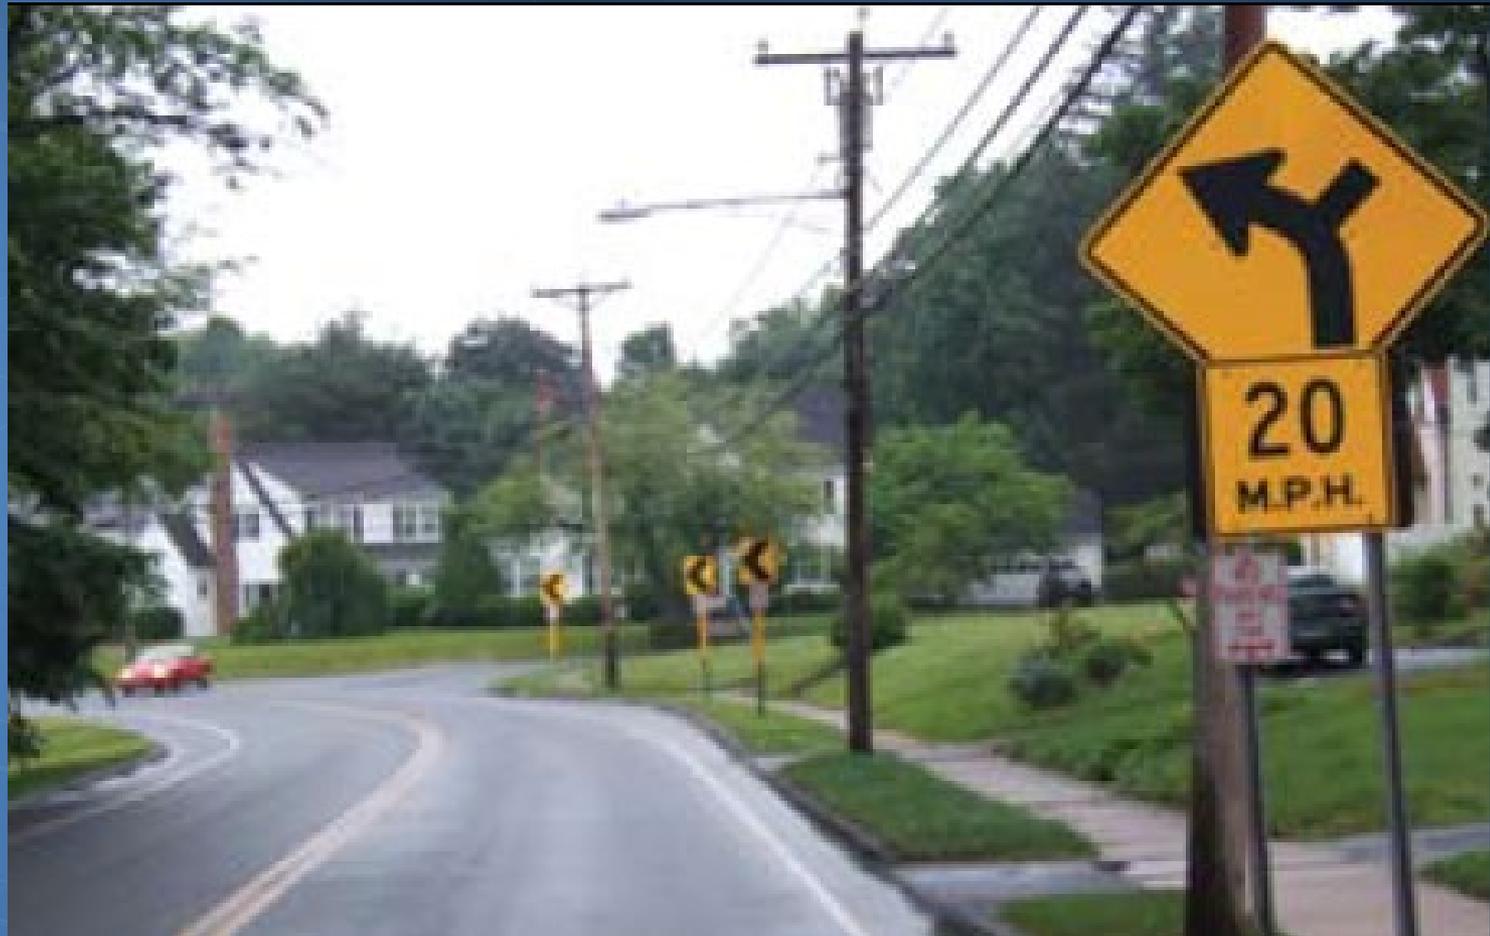
Example of Enhanced Delineation

- Data collected from states of Connecticut and Washington
- Delineation improvements for horizontal curves on two-lane rural roads
- 117 mile/years of before and after data (228 sites total)
- Chevron, curve ahead, horizontal or suggested speed limit signs
- Fluorescent sheeting, increased size or additional signs

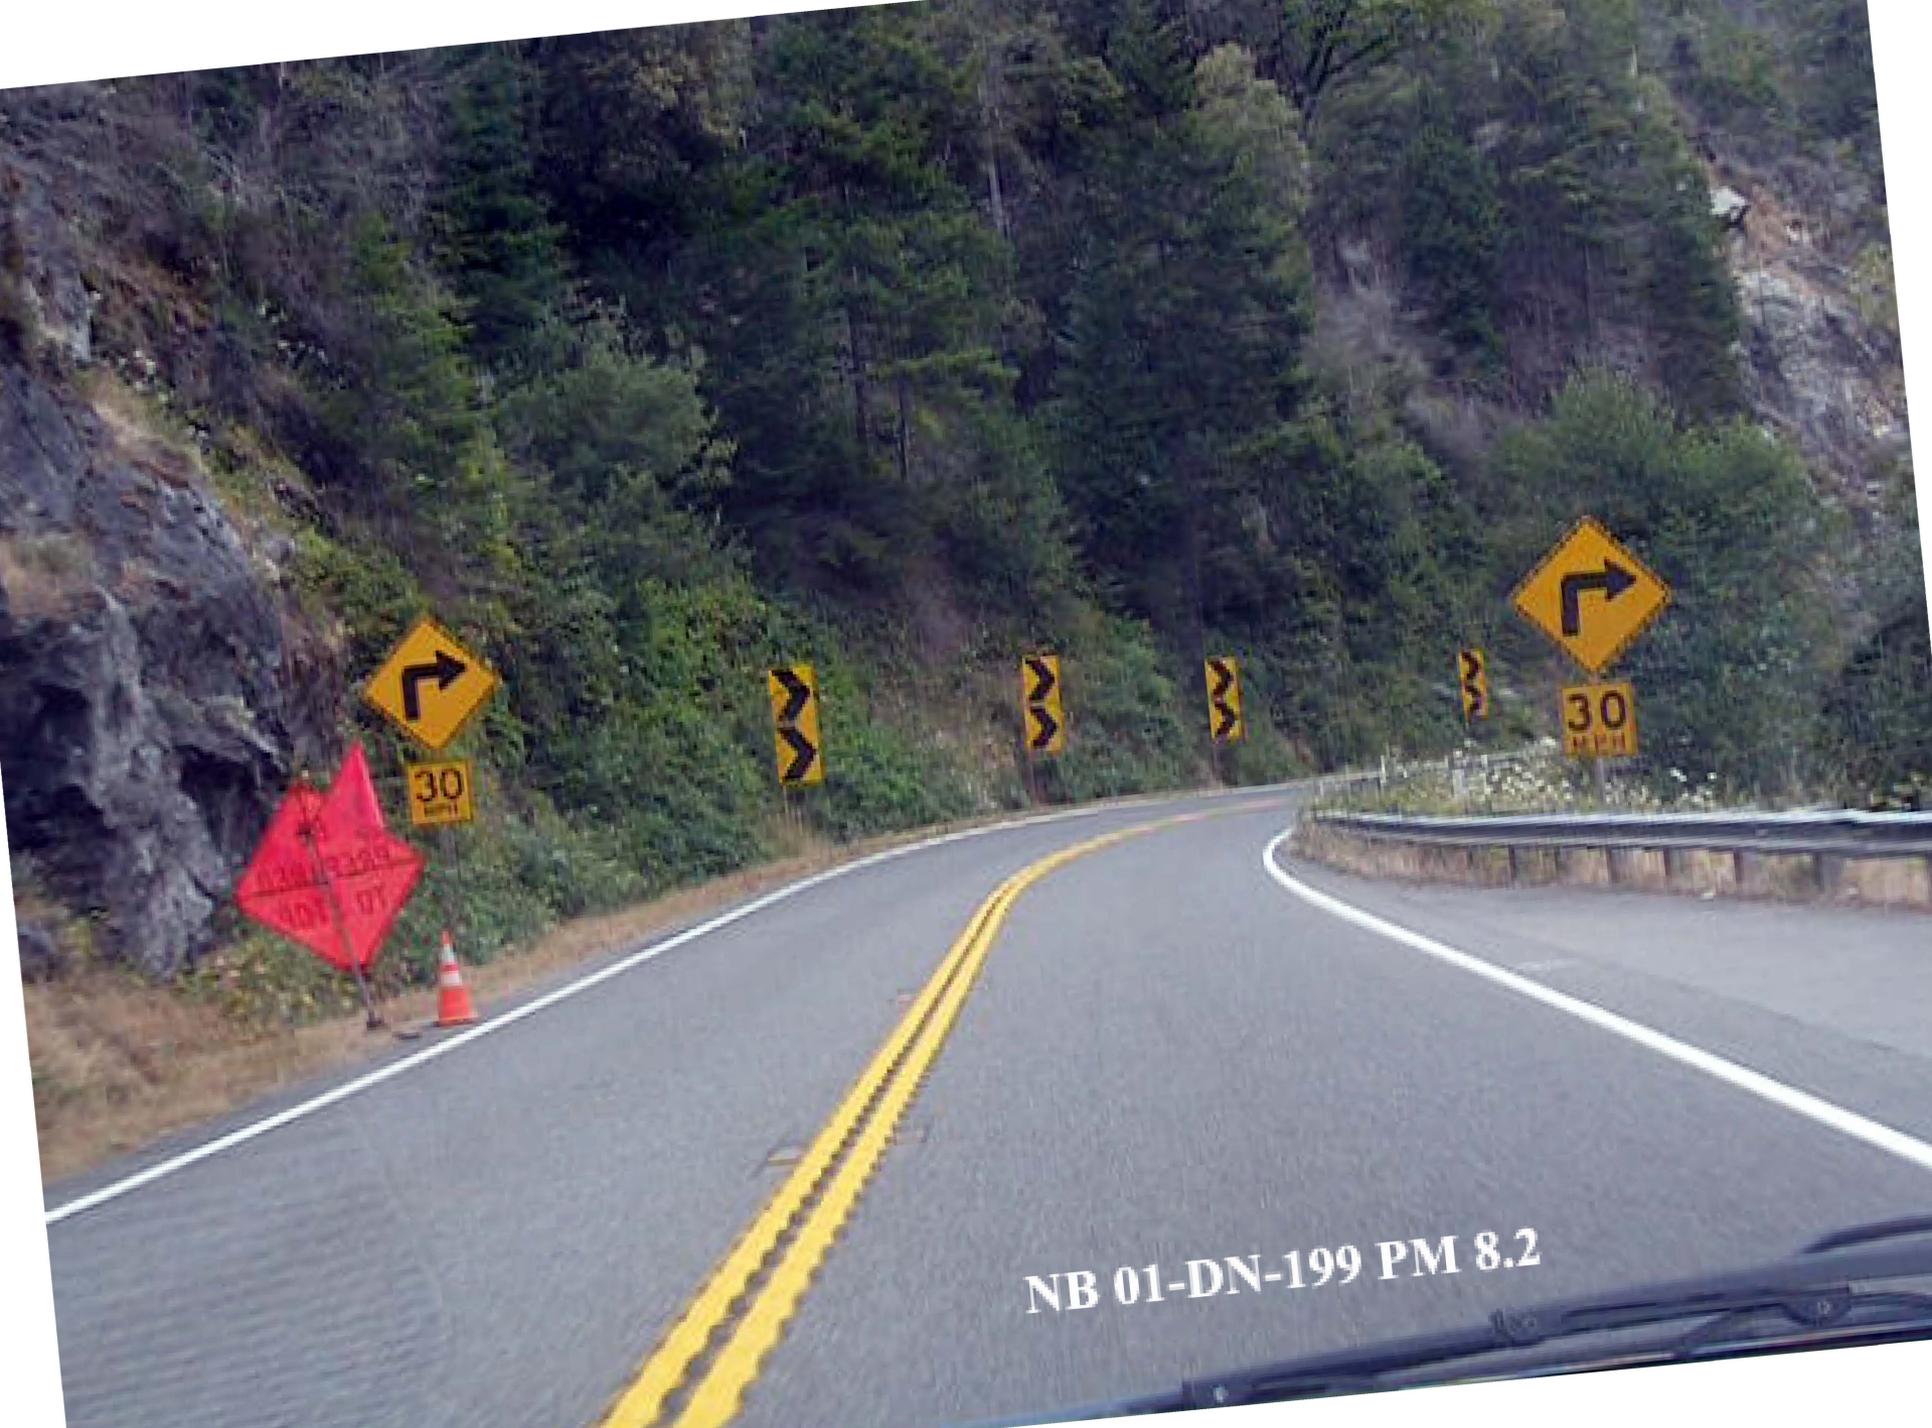
NB 01-DN-199 PM 8.2

- All 28 collisions in 3 years occurred under wet pavement conditions.
- District had used many low cost countermeasures with little change in collision pattern.
- District proposed curve realignment.

- Initial proposed project was to realign curve
 - \$14 M project; approx. 5 years for environmental, design and construction
- Realignment project put on hold to install HFST
 - \$250 K project; approx. 6 months for environmental, design and construction
- No crashes since installation (Summer 2012)

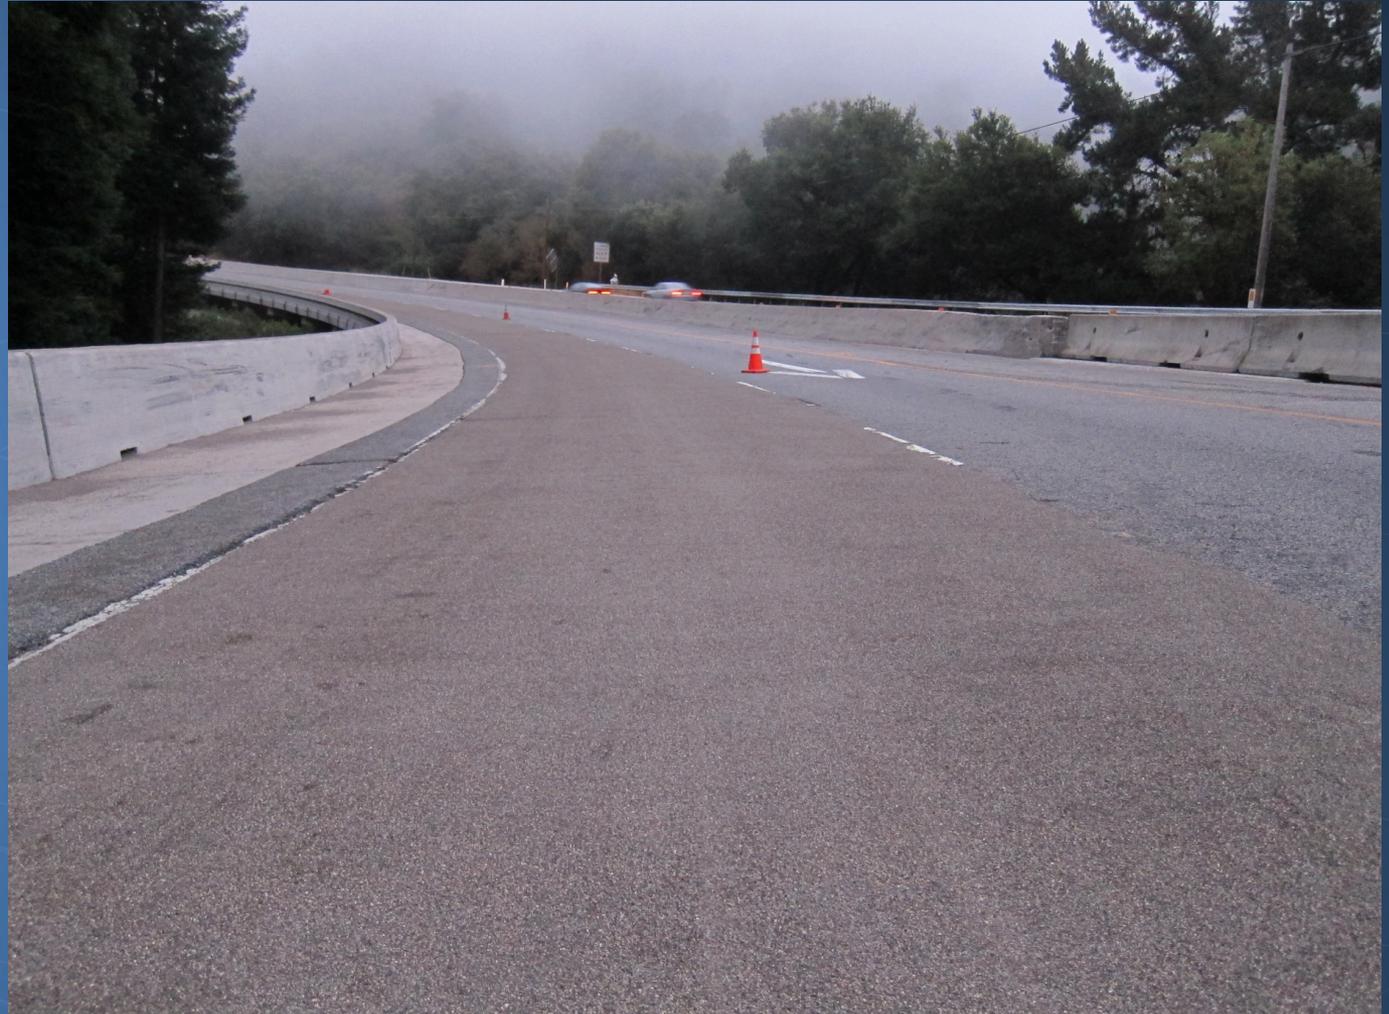
SR-17, Laurel Curve near Santa Cruz (July 2012)

Case Study: Hwy. 17 at Laurel Canyon

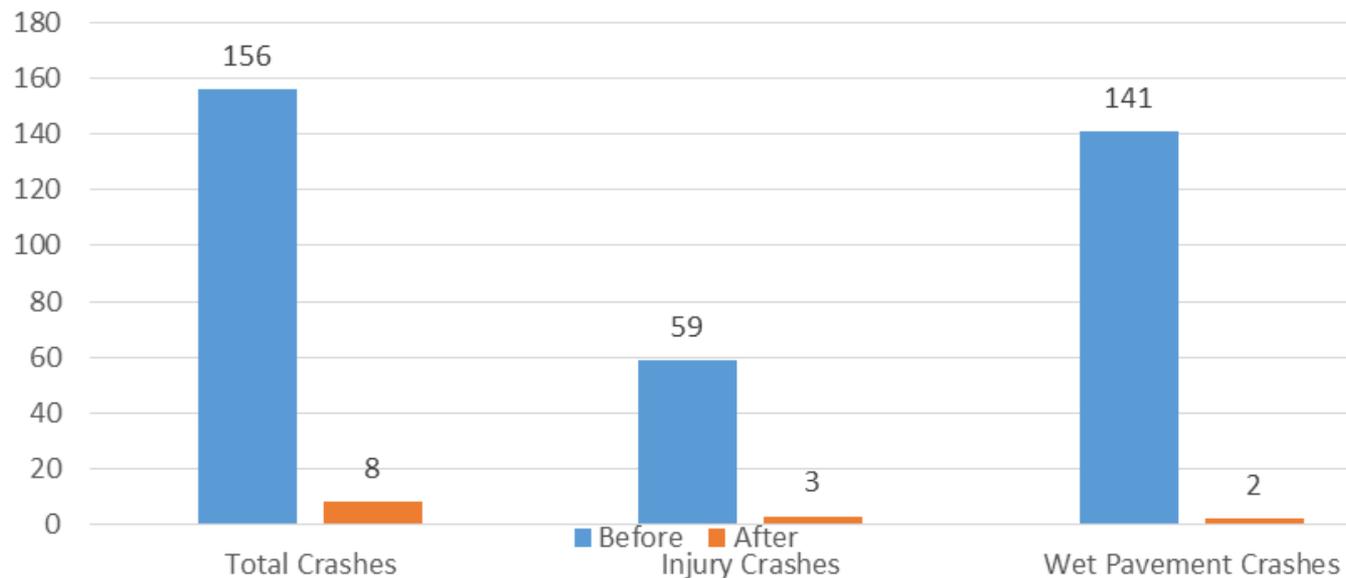
Southbound SR 17 - Laurel Curve 36 months Before / After

94.8% collision reduction!!
B/C – 183 to 1
