Report No.
SSRP-14/08

**Influence of the Spacing of Longitudinal
Reinforcement on the Performance of Laterally
Loaded CIDH Piles – Experimental
Investigation**

October 2014

Final Report Submitted to the California Department of Transportation under
Contract No. 65A0369

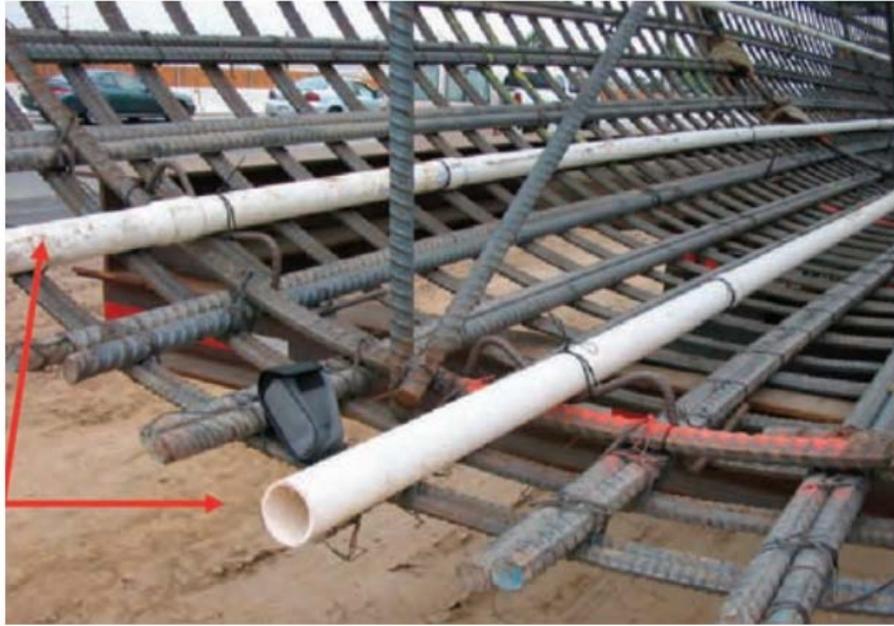
Figure 1.1 – Typical drilled shaft reinforcing cage with PVC inspection tubes (Alter 2011)

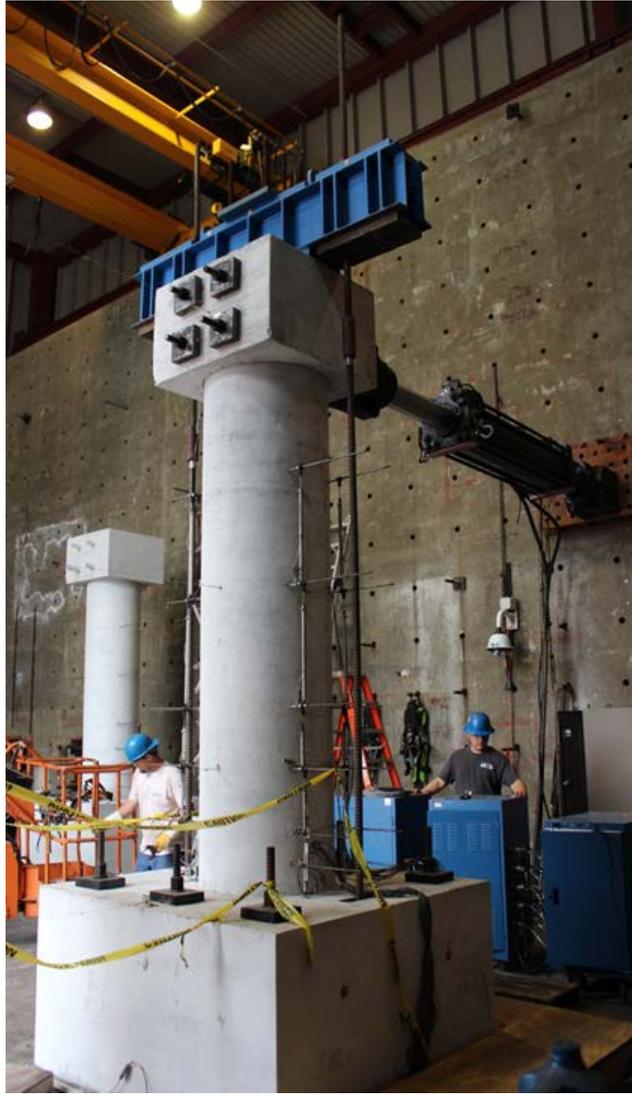
Figure 2.9 Picture of Specimen #1 test setup

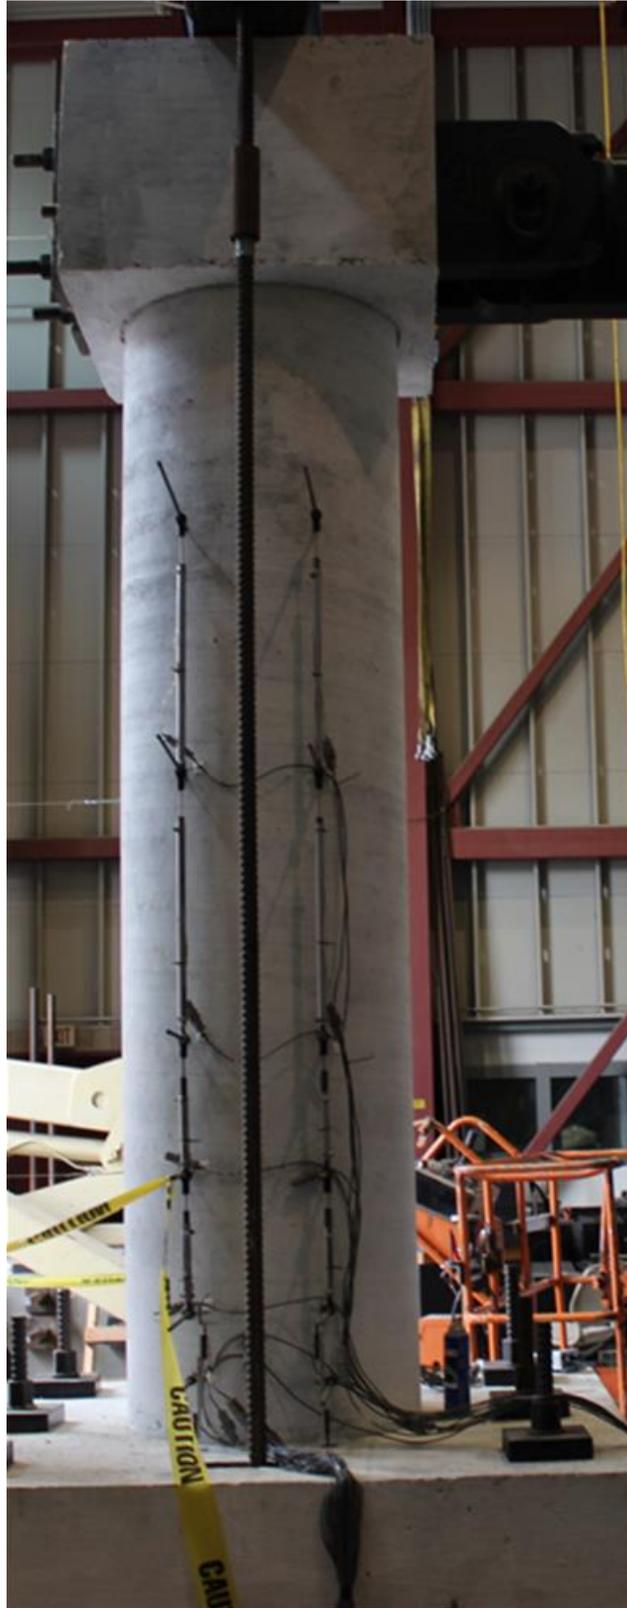
Figure 2.13 - Picture of displacement transducers mounted on west face of Specimen #1

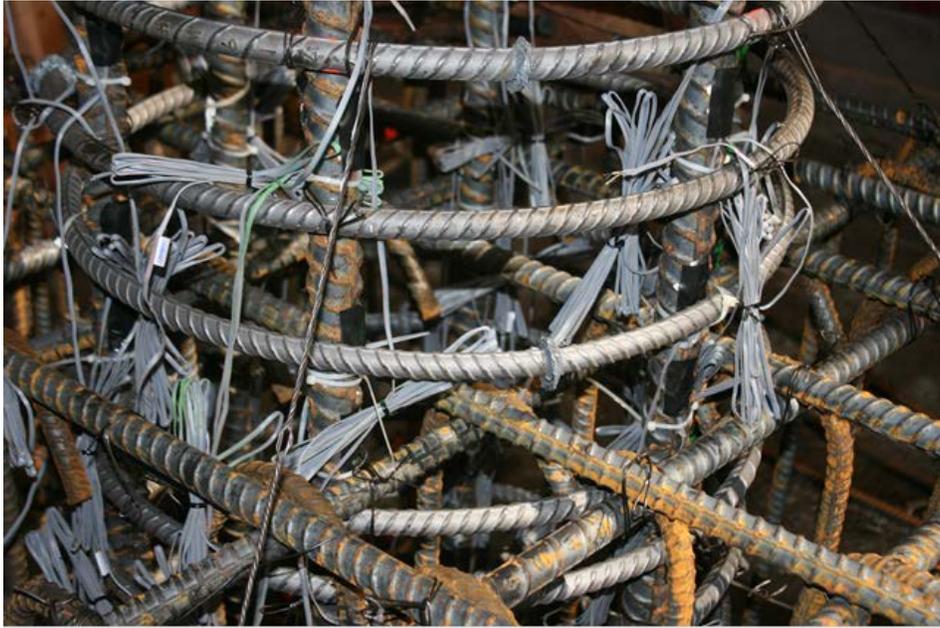
Figure 2.17 – Picture of strain gages on reinforcing bars of Specimen #1

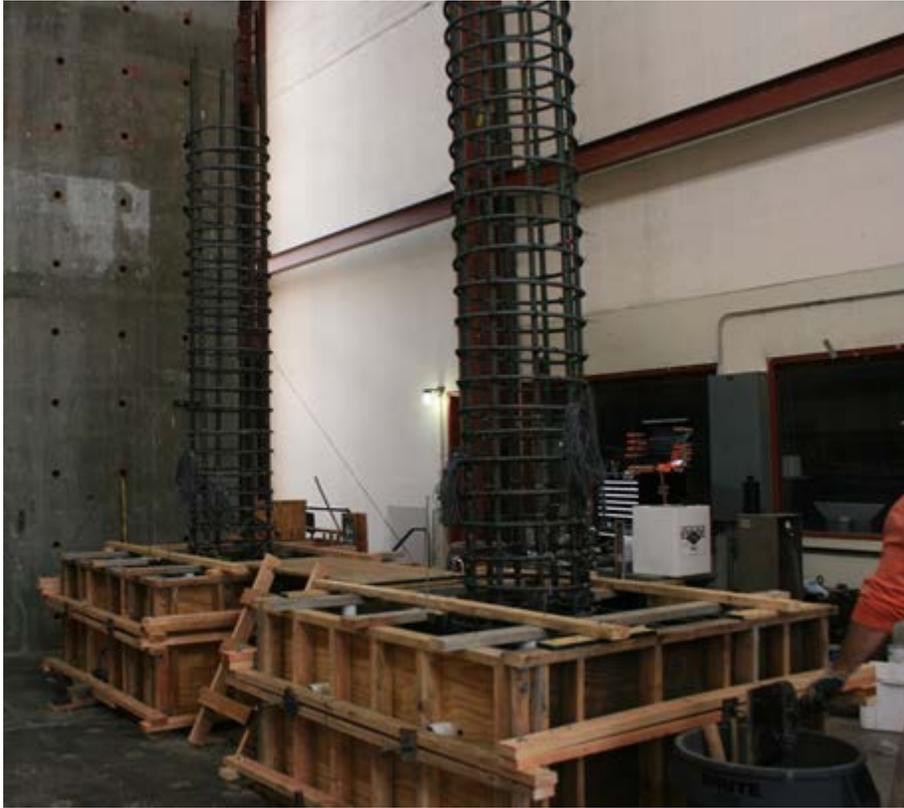
Figure 2.19 - Assembled forms for casting of footings

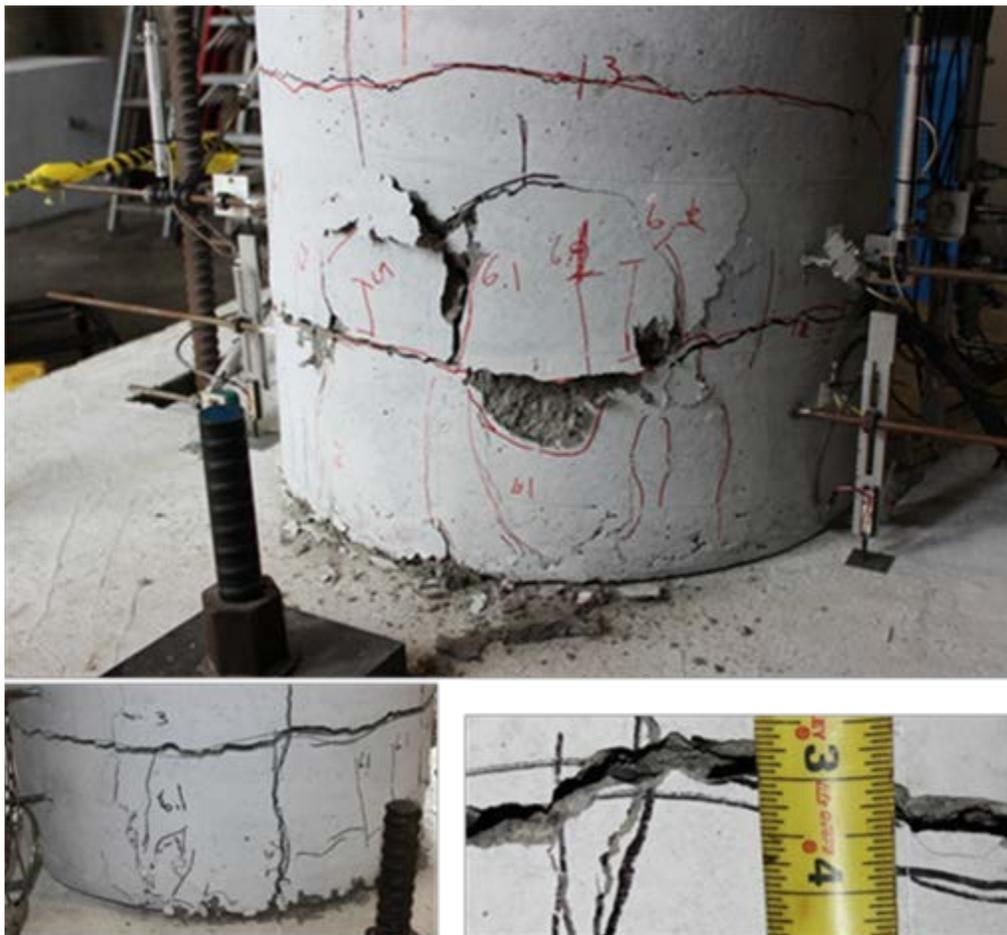
Figure 3.6 - Specimen #1 at 3% drift

Flexural cracking in concrete initiated in the 1st force-controlled cycle. The horizontal cracks around the circumference of the pile propagated from cycle to cycle quite rapidly. At 1% drift, corresponding to a ductility demand of 1.22, flexural cracks developed over a height of 5 ft. with more or less uniform spacing of 9 to 12 in. as shown in Figure 3.4. At a drift of 2%, concrete cover near the base of the pile started to show compressive damage with visible vertical cracks, as shown in Figure 3.5. At this drift level, widely opened flexural cracks were observed. Figure 3.6 shows the spalling of the concrete cover near the base of the pile specimen at 3% drift. In this cycle, a peak load of 10 kips was reached, which is lower than that in the previous cycle of 2% drift as shown in Figure 3.1. This was probably caused by the spalling of the concrete as noted above. At this drift level, the width of the flexural cracks was more than $\frac{1}{4}$ in. as shown in Figure 3.6.

The tests have shown a clear influence of the spacing and the size of the longitudinal reinforcement on the spacing and the width of the horizontal flexural cracks, which is a well-known fact. As shown in Figure 3.4 and Figure 3.16, flexural cracks were more widely spaced in Specimen #1 than in Specimen #2. Distances of flexural cracks in Specimen #1 were 6 to 9 in., while those in Specimen #2 were 9 to 12 in. Moreover, the width of the flexural cracks in Specimen #1 was also larger as shown in Figure 3.6 and Figure 3.18.

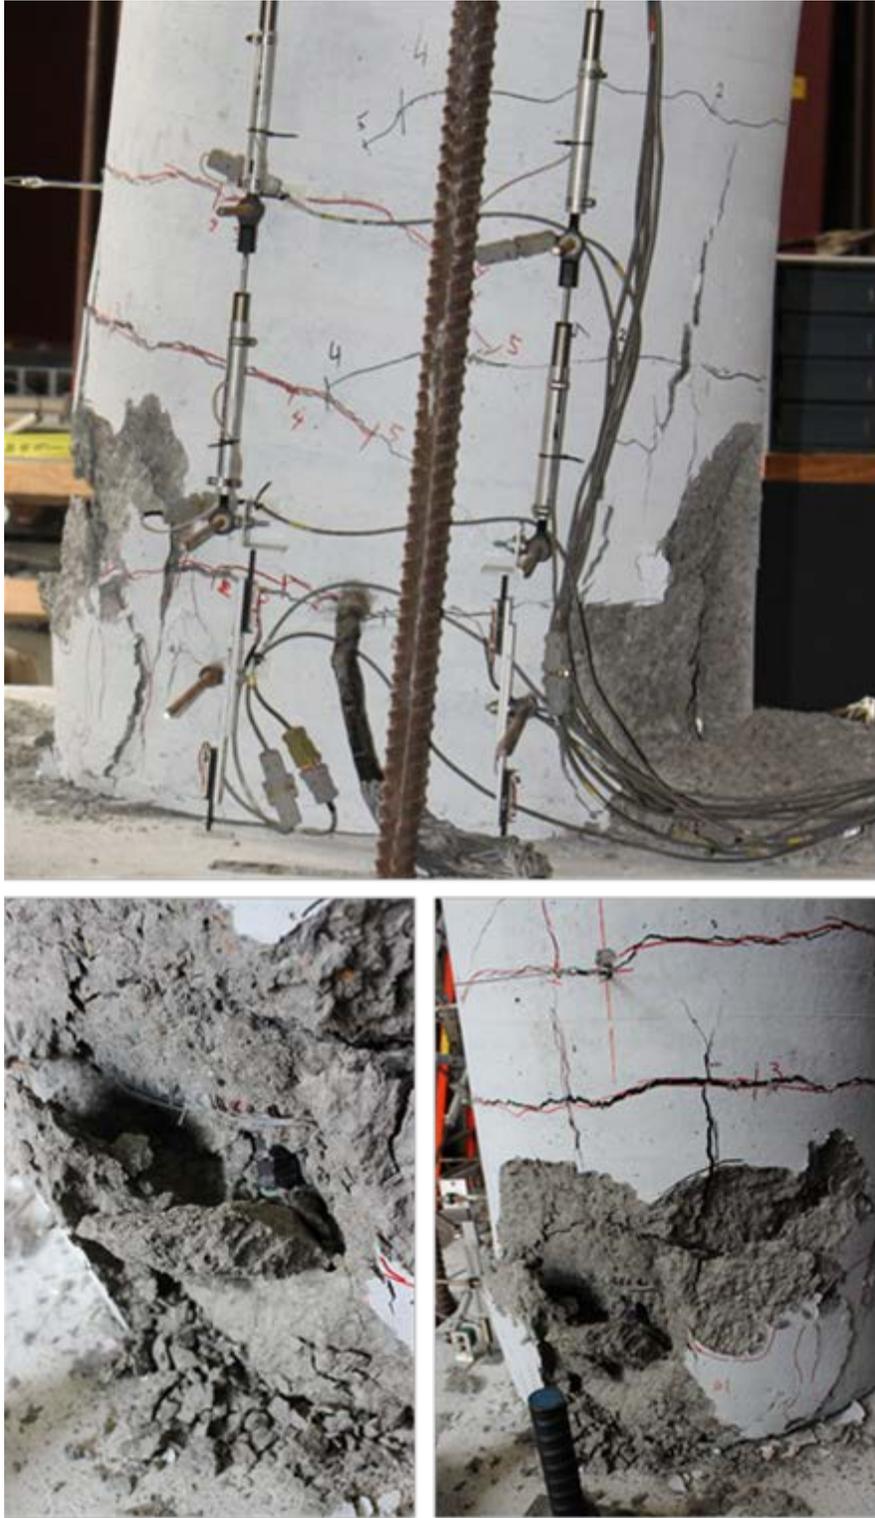
Figure 3.7 – Specimen #1 at 6% drift

As shown in Figure 3.7, at 6% drift, concrete spalling was deeper into the pile and extended from the base of the pile up to a height of 1.5 ft. Moreover, a longitudinal reinforcing bar and part of the horizontal hoops were exposed due to the concrete spalling. In the 2nd cycle of -8% drift, corresponding to a ductility demand of 9.8, bar #1 at the south face buckled, as shown in Figure 3.8. During the 1st cycle of -10% drift, the buckling of bar #1 became quite severe, as shown in Figure 3.9a. Figure 3.9b shows the bending deformation observed in bar #4 at the north face during the 1st cycle of +10% drift. Both bars bent outward between two adjacent hoops. Concrete spalling extended up to a height of 2 ft. from the base of the specimen exposing the longitudinal bars and the hoops. Parts of the confined core was crushed as shown in Figure 3.9.

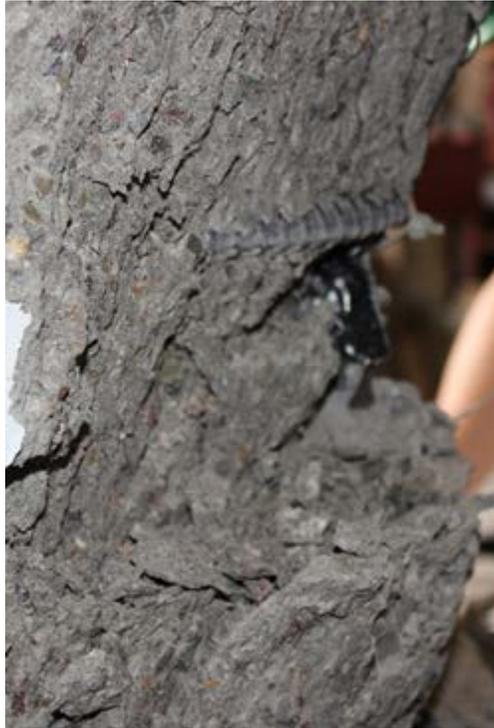
Figure 3.8 – Buckled bar #1 at south face of Specimen #1 during 2nd cycle of -8% drift

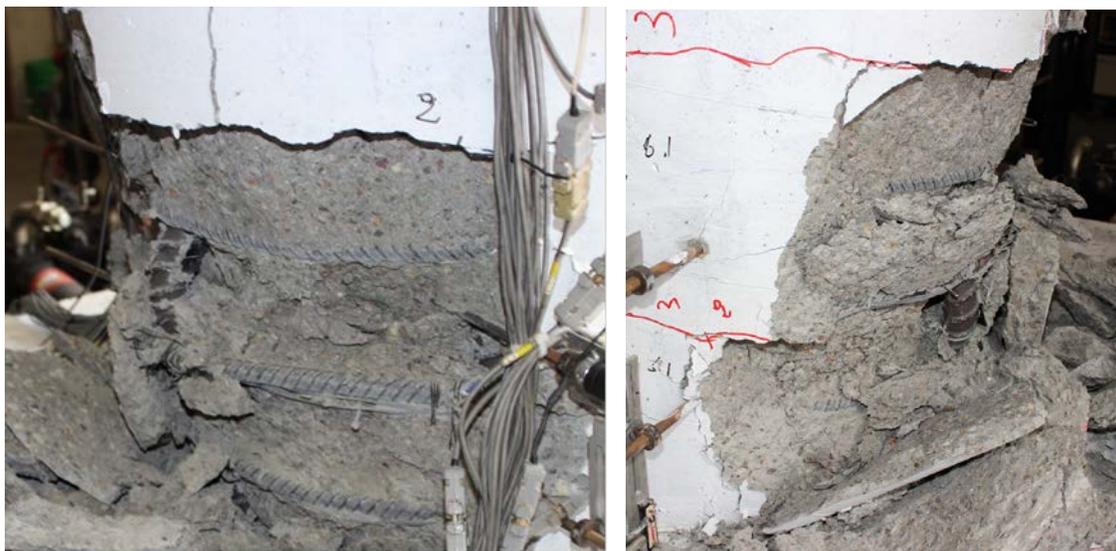
Figure 3.9 – Crushing in Specimen #1 during 1st cycle of 10% drift

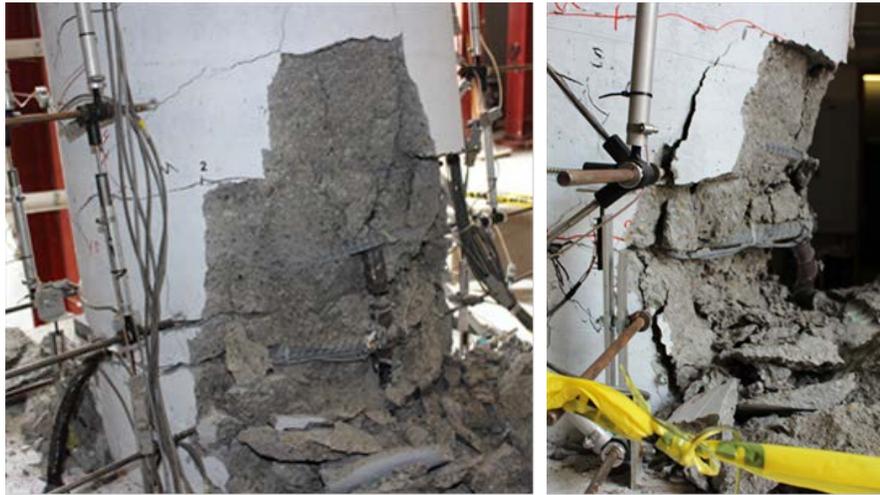
Figure 3.10 – Crushing in Specimen #1 during 2nd cycle of +10% drift

During the 2nd cycle of +10% drift, buckled bar #1 at the south face fractured in tension (Figure 3.10a), while bar #4 at the north face had severe buckling (Figure 3.10b). During the load reversal, buckled bar #4 at the north face also fractured in tension as shown in Figure 3.11. At that point, the test was

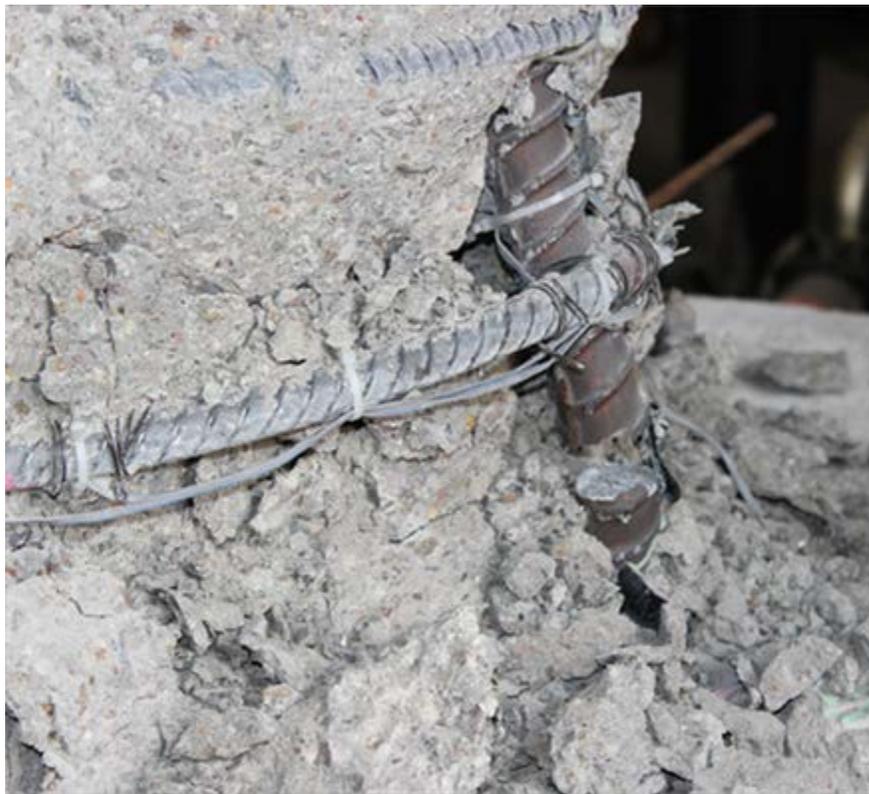
Figure 3.11 – Fractured bar #4 at north face of Specimen #1 during 2nd cycle of -10% drift

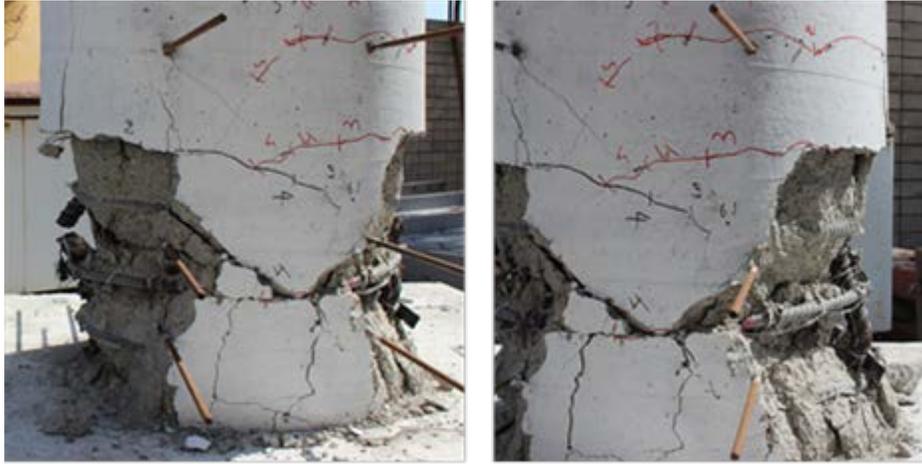
Figure 3.12 – Specimen #1 at the end of testing

terminated and the top of the specimen was brought back to zero lateral displacement. A drift of 10% corresponds to a lateral displacement of 12 in. Figure 3.12 shows pictures of Specimen #1 at the end of the test, zooming-in on the two bars that fractured, with one at each face of the pile, and the severe crushing of the concrete. The section at 10 in. above the base of the pile had the most severe damage.

Specimen #1 had its concrete cover spalling occurring over a distance of 2 ft. from the base as shown in Figure 3.12, while Specimen #2 had the concrete spalling occurring over a distance of 3 ft. as shown in

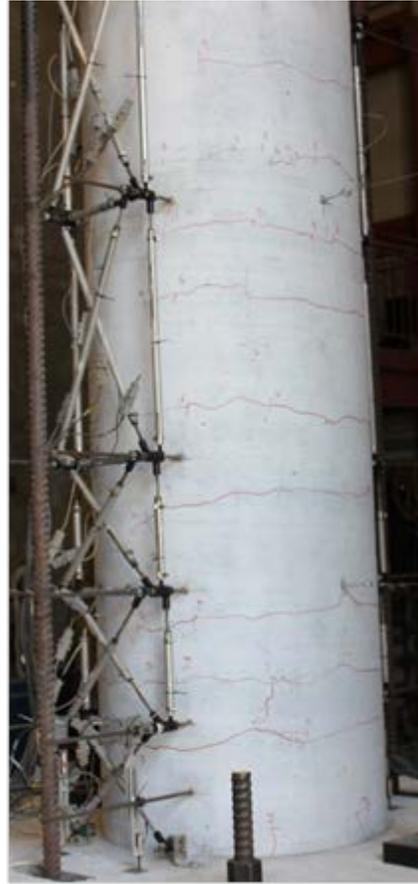
Figure 3.16 – Specimen #2 at 1% drift

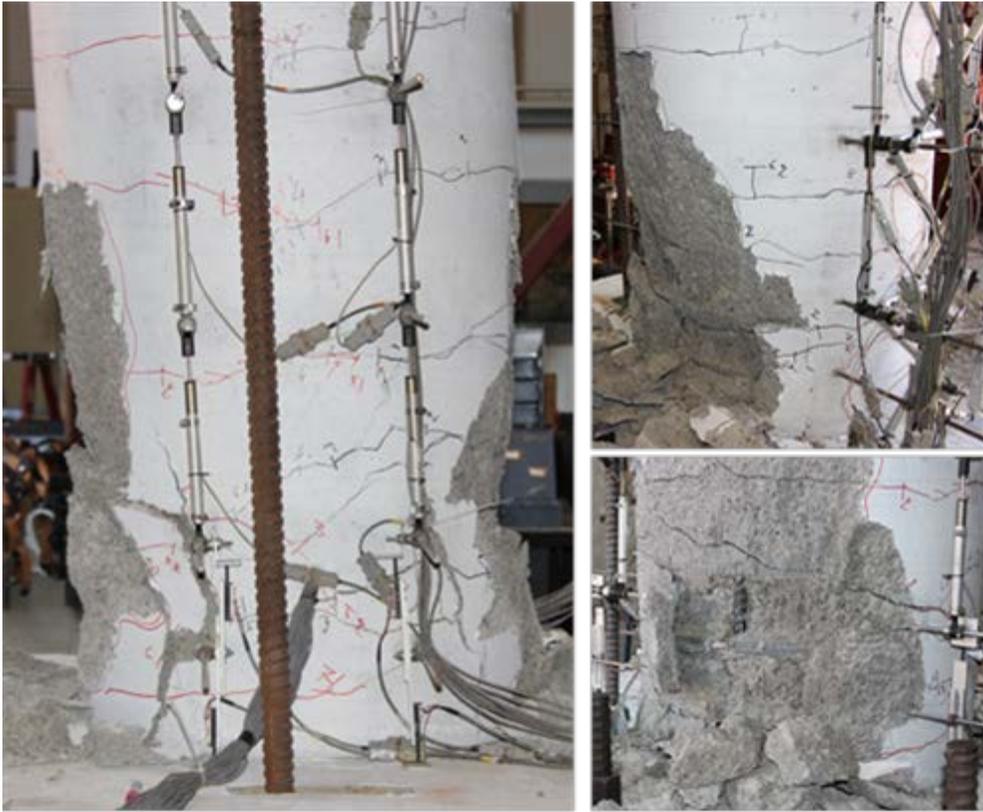
Figure 3.20 - Specimen #2 at 6% drift

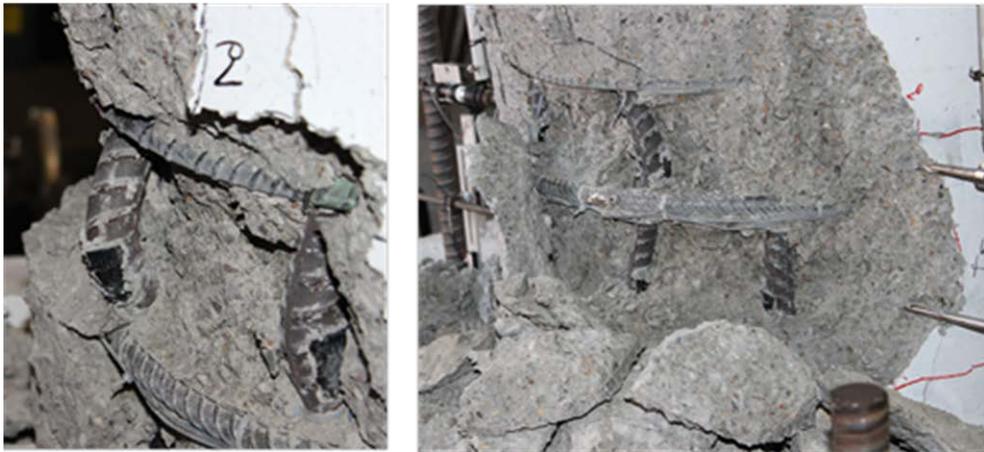
Figure 3.22 – Crushing in Specimen #2 at 2nd cycle of 8% drift

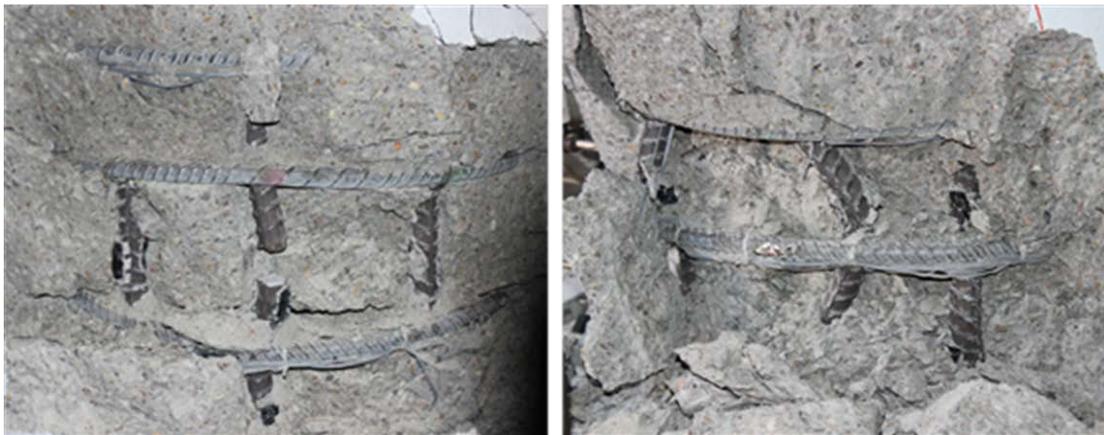
Figure 3.23 – Fracture of bar #1 in Specimen #2 during 1st cycle of +10% drift

At the beginning of the 1st cycle of +10% drift, buckled bar #1 at the south face fractured in tension, while bars #4 and #5 at the north face, which were in compression, had severe buckling, as shown in Figure 3.23. In the following displacement reversal at -10% drift, buckled bars #4 and #5 at the north face fractured in tension as shown in Figure 3.24. At that point, with the fracture of bars #1, #4, #5, and the buckling of bars #2 and #6, the test was terminated. The maximum drift of 8% reached before the fracture of the longitudinal bars corresponds to a lateral displacement of 9.3 in. Figure 3.25 shows pictures of Specimen #2 at the end of the test. The section at 12 in. above the base of Specimen #2 had the most severe crushing of the concrete core.

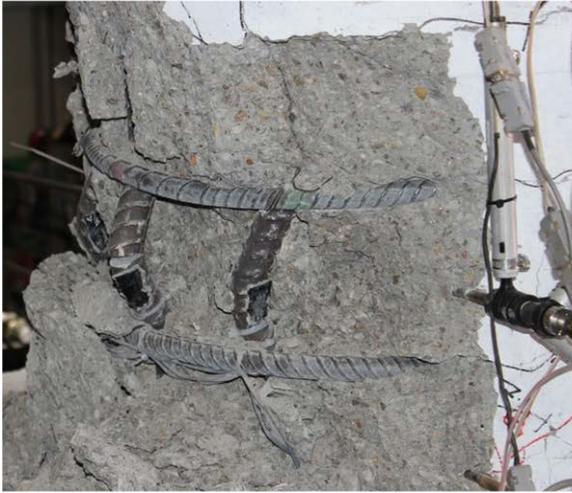
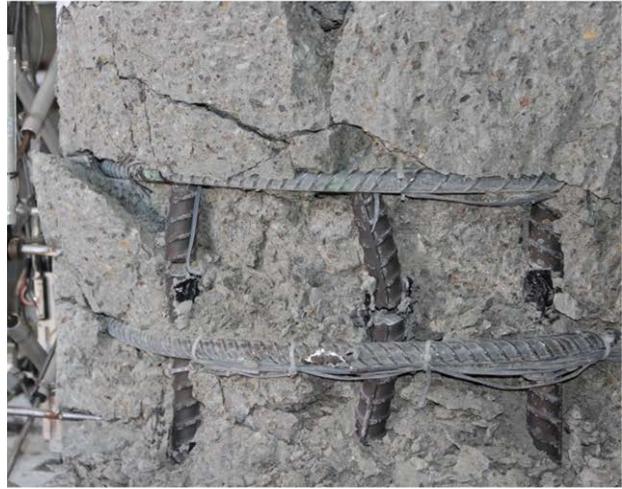
Figure 3.24 – Fractured bars in Specimen #2 during 1st cycle of -10% drift

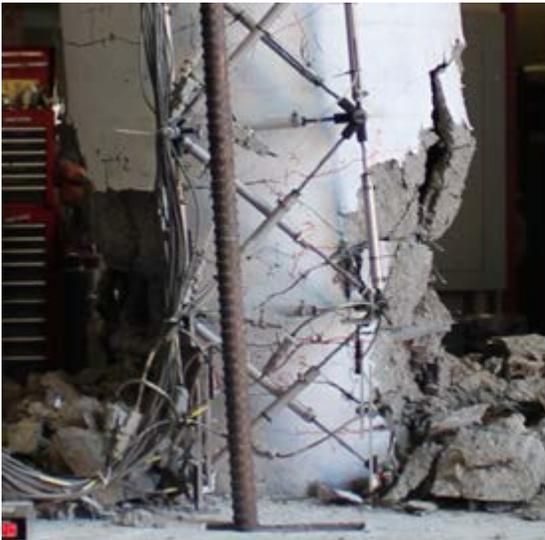
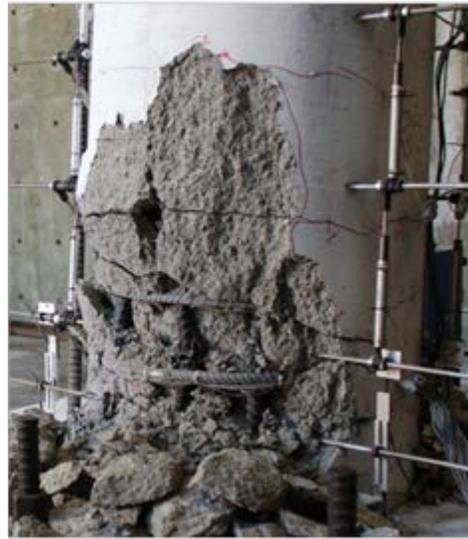
Figure 3.25 – Specimen #2 at the end of testing
