1. Report No. CA15-2560		2. Government Accession No.		3. Recipient's Catalog No.	
4. Title and Subtitle Development Length for Headed Bars in Slab-Column Joints of RC Slab Bridges				5. Report Date 12/4/2015

Report No.
SSRP-15/10

**Development Length for Headed Bars in
Slab-Column Joints of RC Slab Bridges**

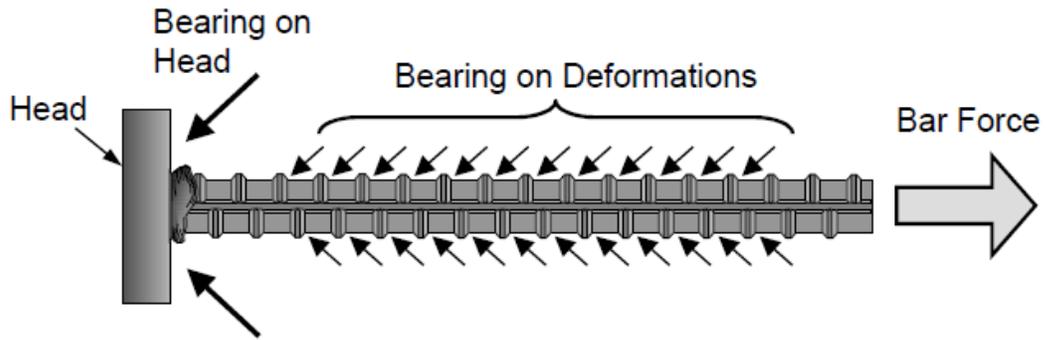
Figure 2.1 – Anchorage of a headed bar (Thompson et al. 2002)

The anchorage capacity of a headed bar is contributed by the bearing of the head against the concrete and the bond between the bar and the surrounding concrete, as shown in Figure 2.1. Past research has shown that the anchorage failure of a headed bar is governed by three main mechanisms: (1) side-face blowout failure of concrete when the bar is close to the edge of a concrete slab or block; (2)

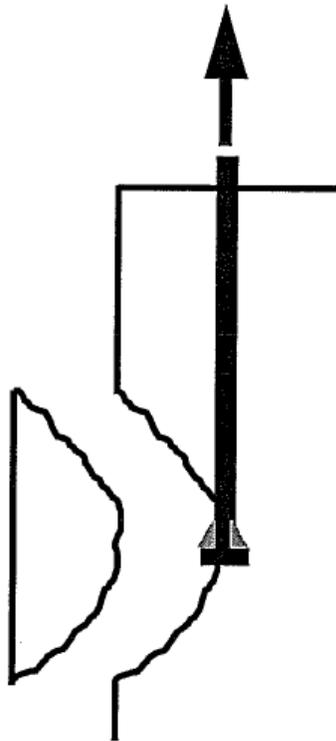
Figure 2.2 – Side-blowout failure (De Vries et al. 1996)

concrete breakout failure when the embedment length is shallow; and (3) bearing failure at the anchor head. A side-blowout failure is characterized by the spalling of the concrete cover on the surface parallel and adjacent to the bar, as shown in Figure 2.2. This type of failure can occur in beams and columns, and has been observed in tests on bars with deep embedment lengths (as compared to the side cover) and in beam-column joint tests. Breakout failures are characterized by the formation of a pullout cone failure on the concrete surface perpendicular to the bar, as shown in Figure 2.3. A bar with a short embedment length, compared to the lateral concrete cover, such as a bar embedded in the central portion of a slab, may experience this type of failure. Bearing failure at the anchor head can be characterized by the lateral splitting and/or crushing of the concrete in front of the head, as shown in Figure 2.4. This type of failure has been observed in the anchorage region of longitudinal bars at the end of a beam.

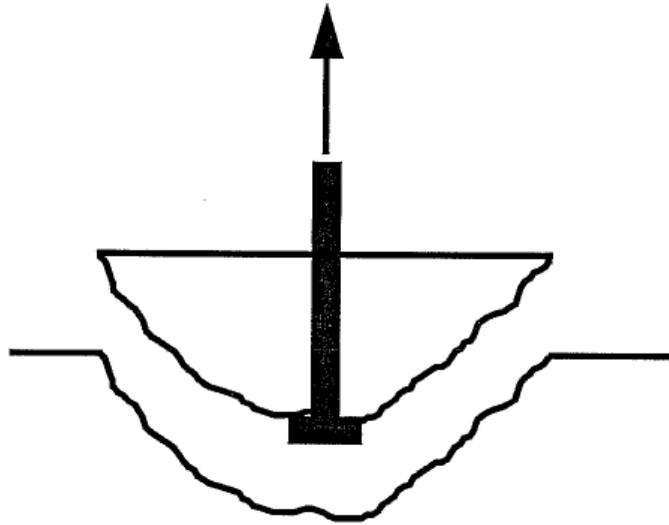
Figure 2.3 – Concrete breakout failure (De Vries et al. 1996)

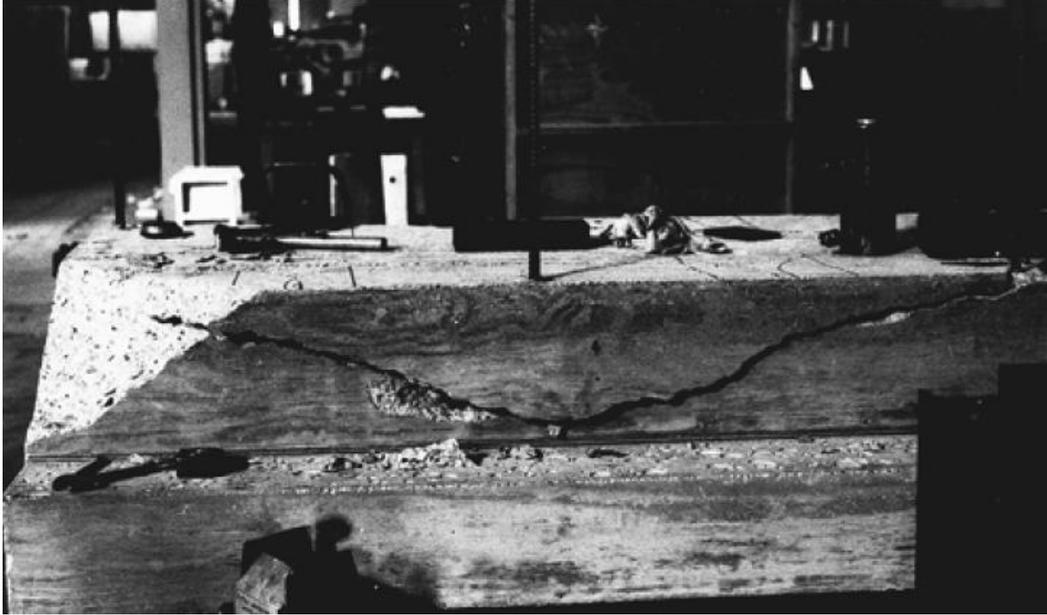
Figure 2.5 – Concrete Breakout failure in a shallow embedment test (De Vries et al. 1999)

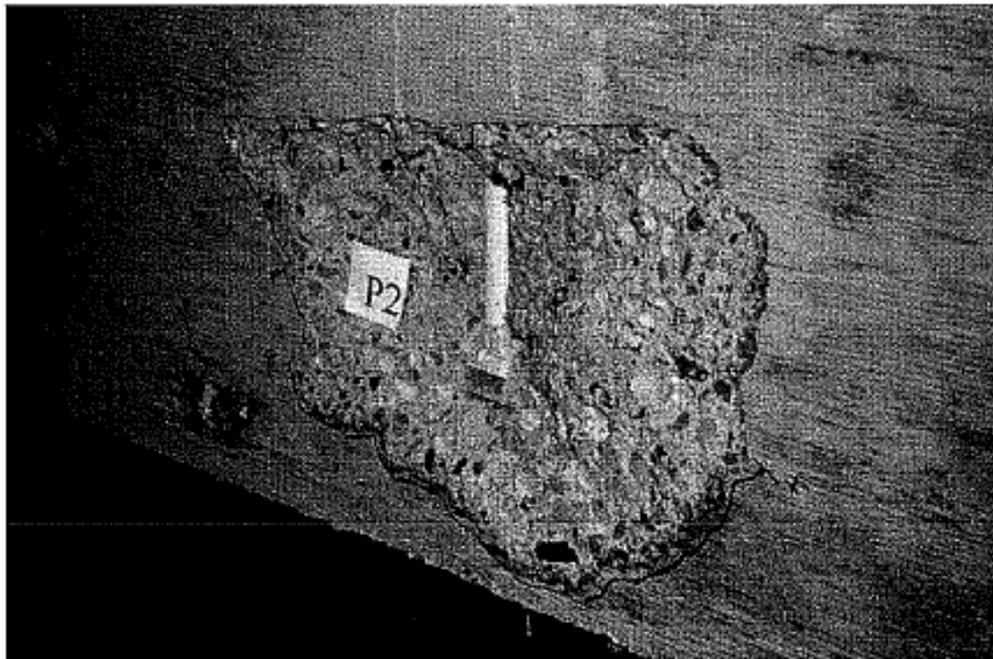
Figure 2.6 – Side-blowout failure in a beam-column joint test (Bashandy 1996)

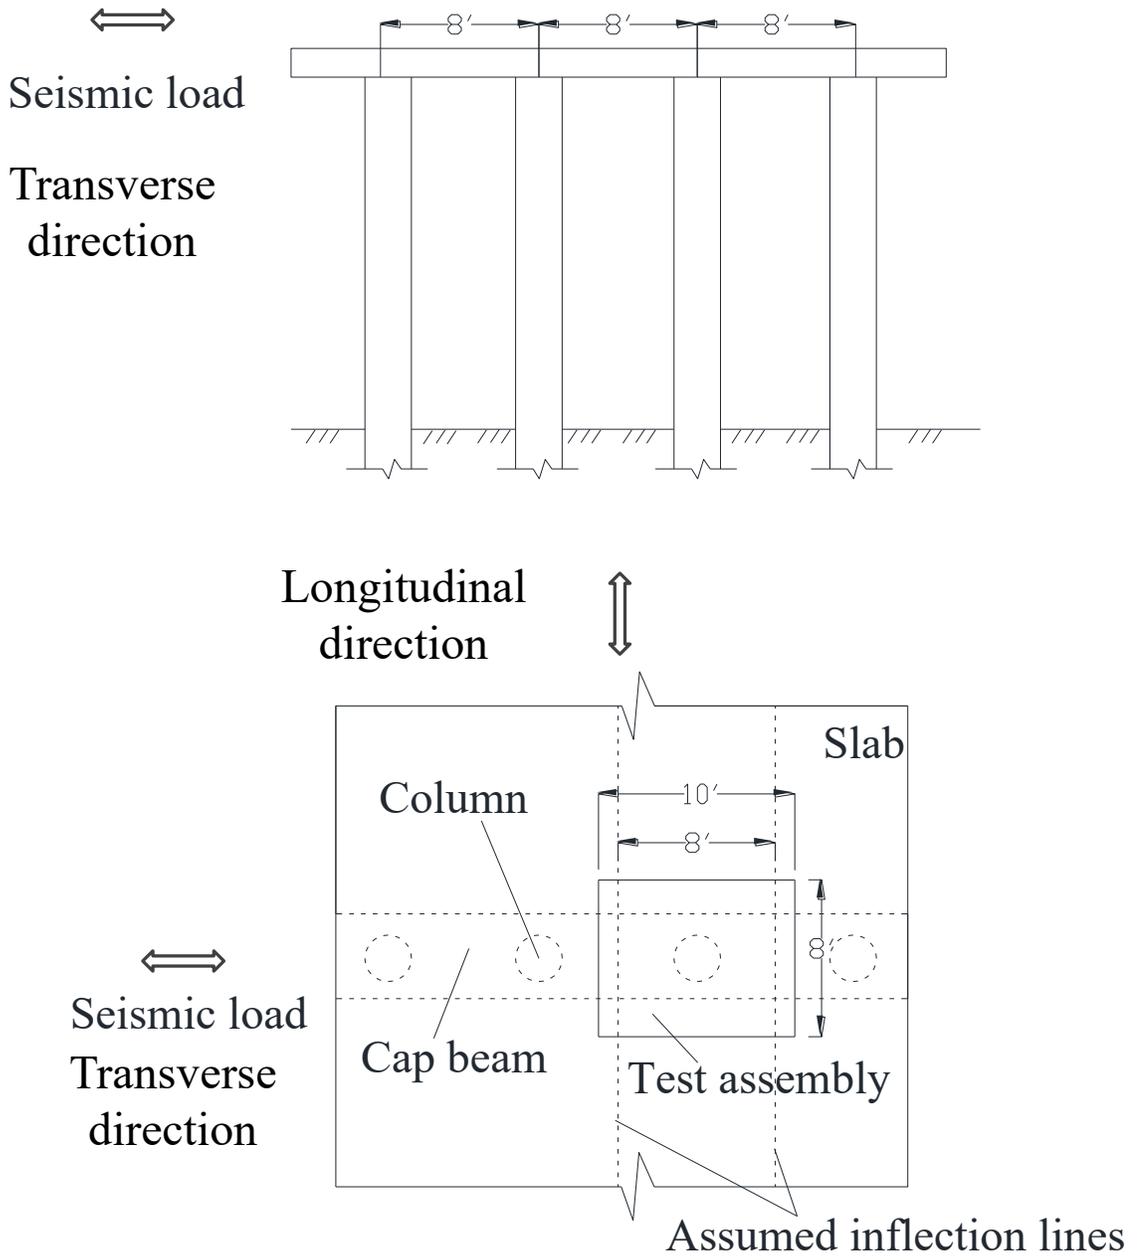
Figure 3.1 – Slab-column assembly of a slab bridge

The test setup mimicked the loading condition for a slab bridge when it is subjected to a lateral seismic force in the transverse direction, as shown in Figure 3.1. As shown in the figure, the test assembly represented a portion of the bridge. The configuration of a test specimen and the test setup are shown in Figure 3.2. The slab-column assemblies were tested in an upside-down position with two edges of the slab hinge-supported. Each specimen was subjected to quasi-static cyclic lateral displacements in the north-south direction using a 220-kip load capacity, 48-in. stroke, actuator attached to the hammerhead of the column on the south side of the specimen. The other end of the actuator was attached to a strong wall. The hinge supports for the slab were based on the assumption that inflection points developed during the bending of the cap beam were located midway between two adjacent columns when the superstructure was subjected to the lateral seismic force. The point of horizontal application represented the inflection point of column bending. Figure 3.3 shows a picture of the test setup. The total axial compressive stress applied to the base section of the column was 3.5% of the targeted compression strength of the concrete.

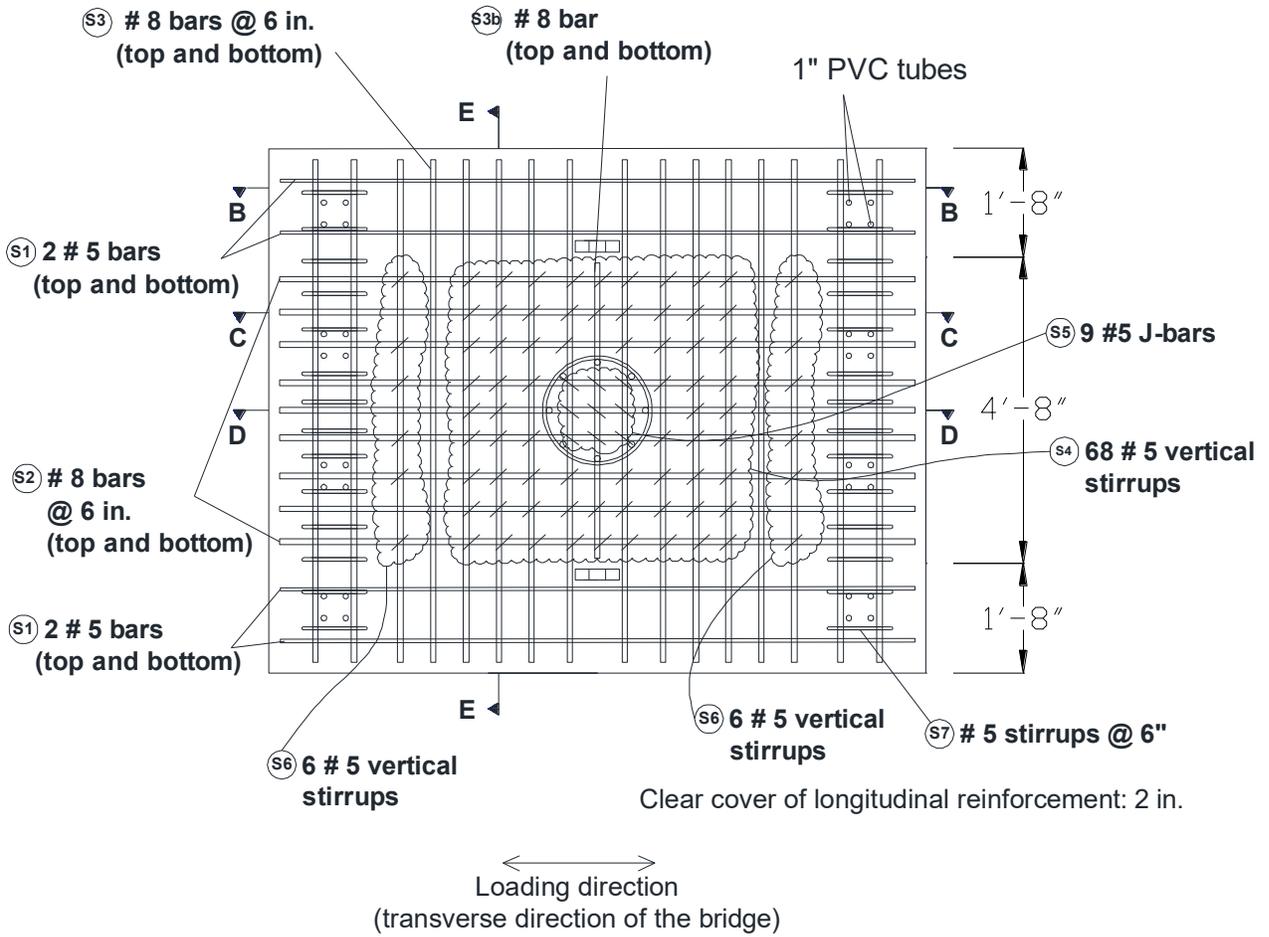
Figure 3.6 – Plan view of slab reinforcement for Specimen #1

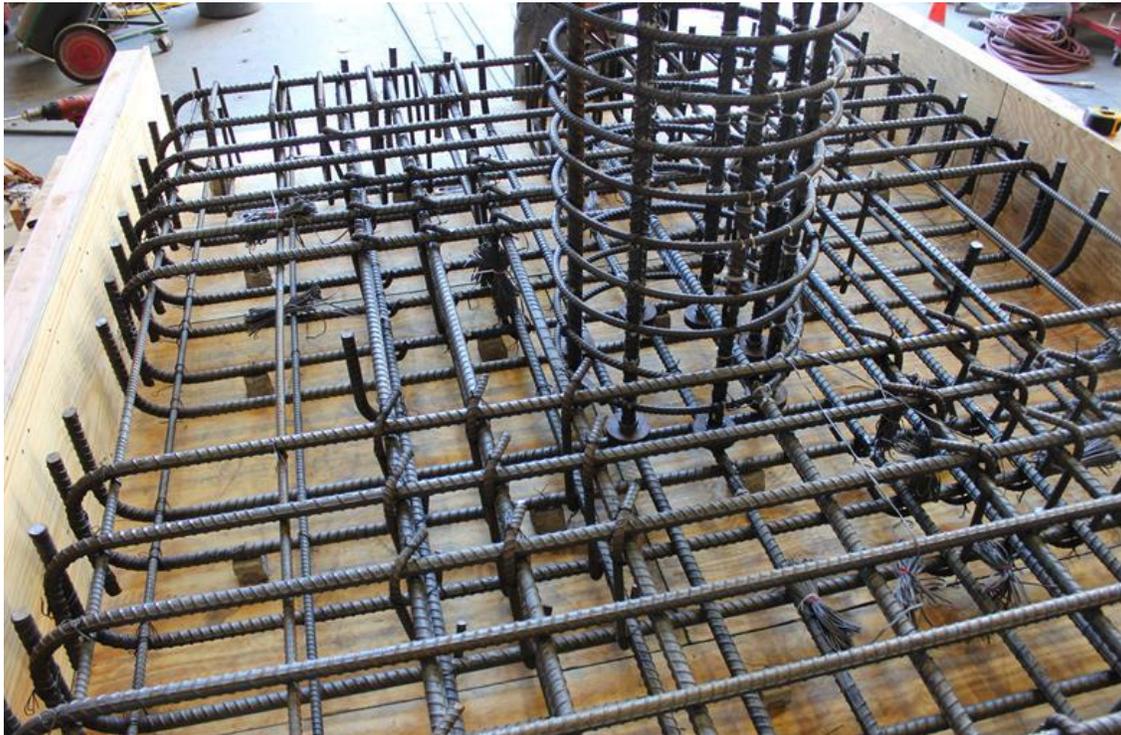
Figure 3.8 – Picture of the slab and column reinforcement of Specimen #1 during construction

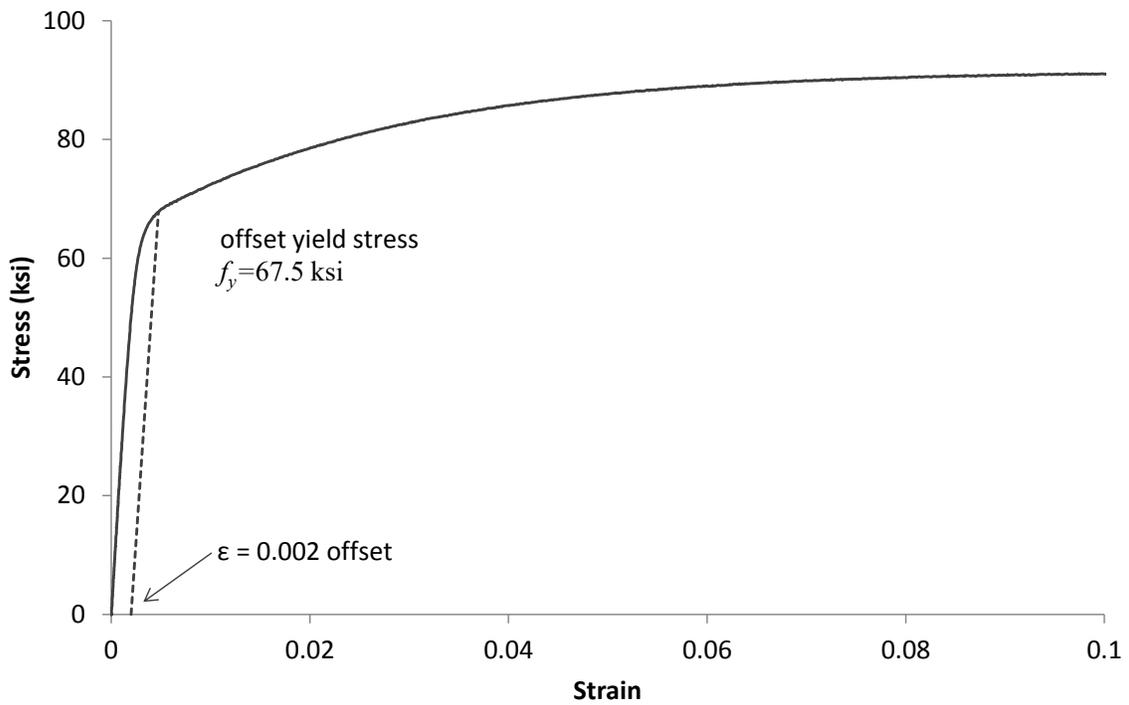
Figure 3.10 – Stress-strain curve for material sample of column hoops in Specimen #1

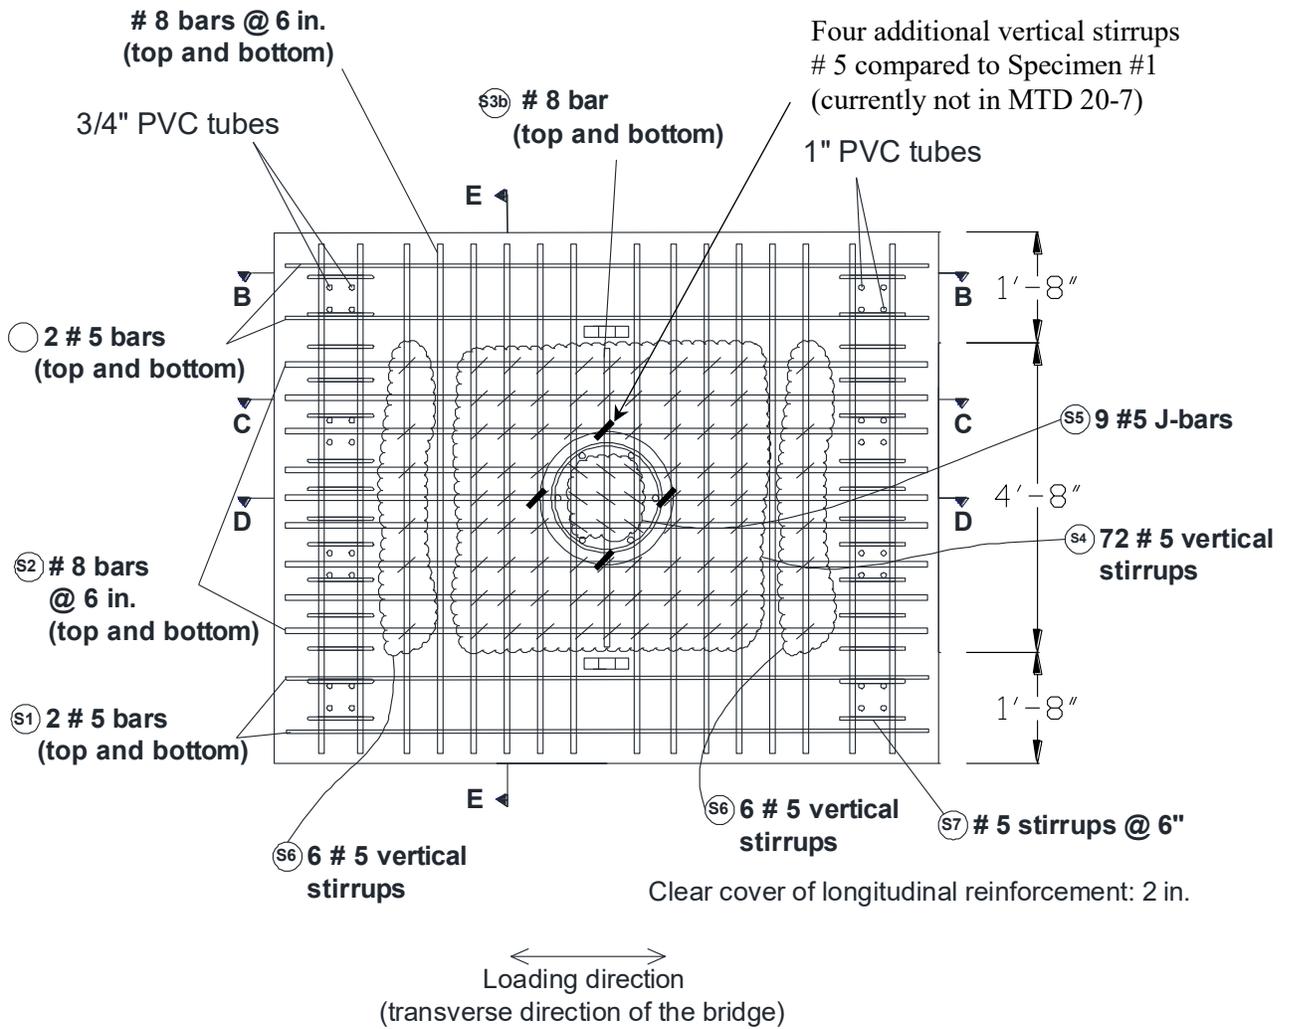
Figure 3.12 – Plan view of slab reinforcement for Specimen #2

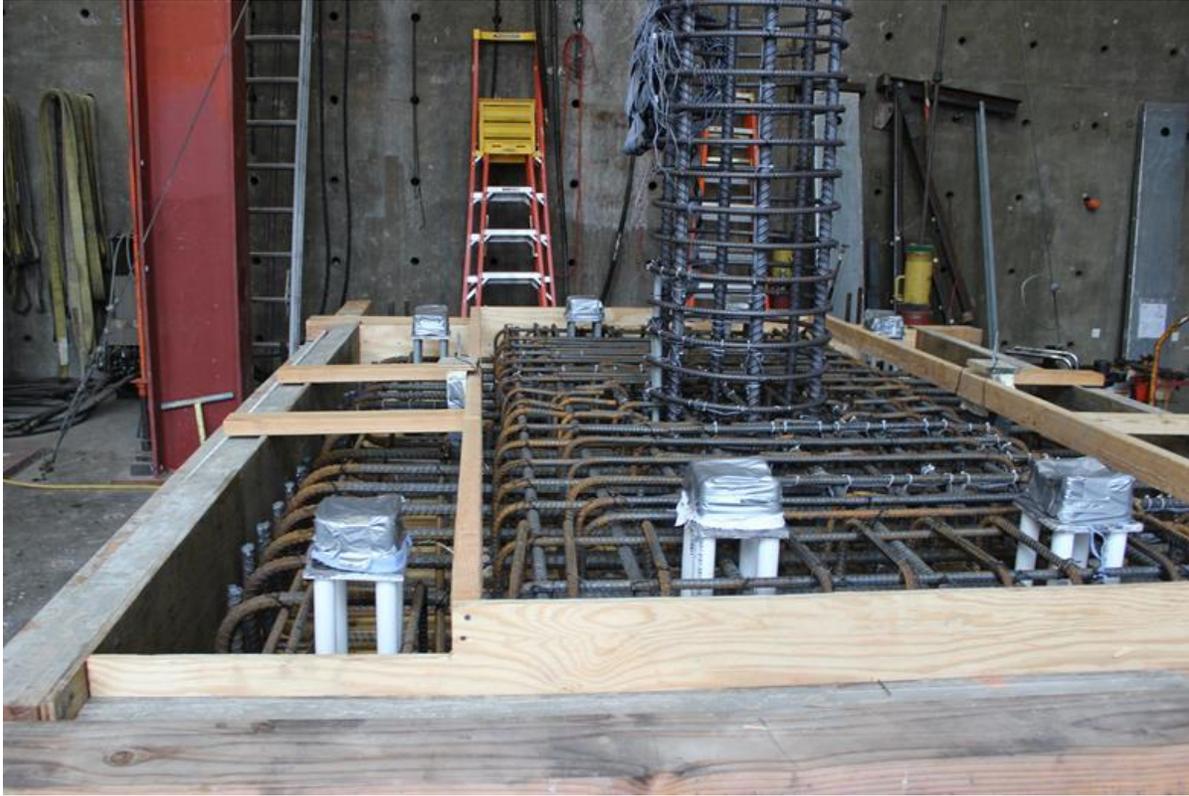
Figure 3.15 – Picture of slab and column reinforcement of Specimen #3 prior to casting

Specimen #3 also had six No. 10 headed bars for the longitudinal reinforcement of the column. However, as shown in Figure 3.4, a 3-in. deep drop cap was added to the 16-in. thick slab, providing an embedment length of $11d_b$ for the headed bars. This specimen was intended to check if structural performance could be improved, in terms of the severity of punching cracks in the slab, with the increase of the development length.

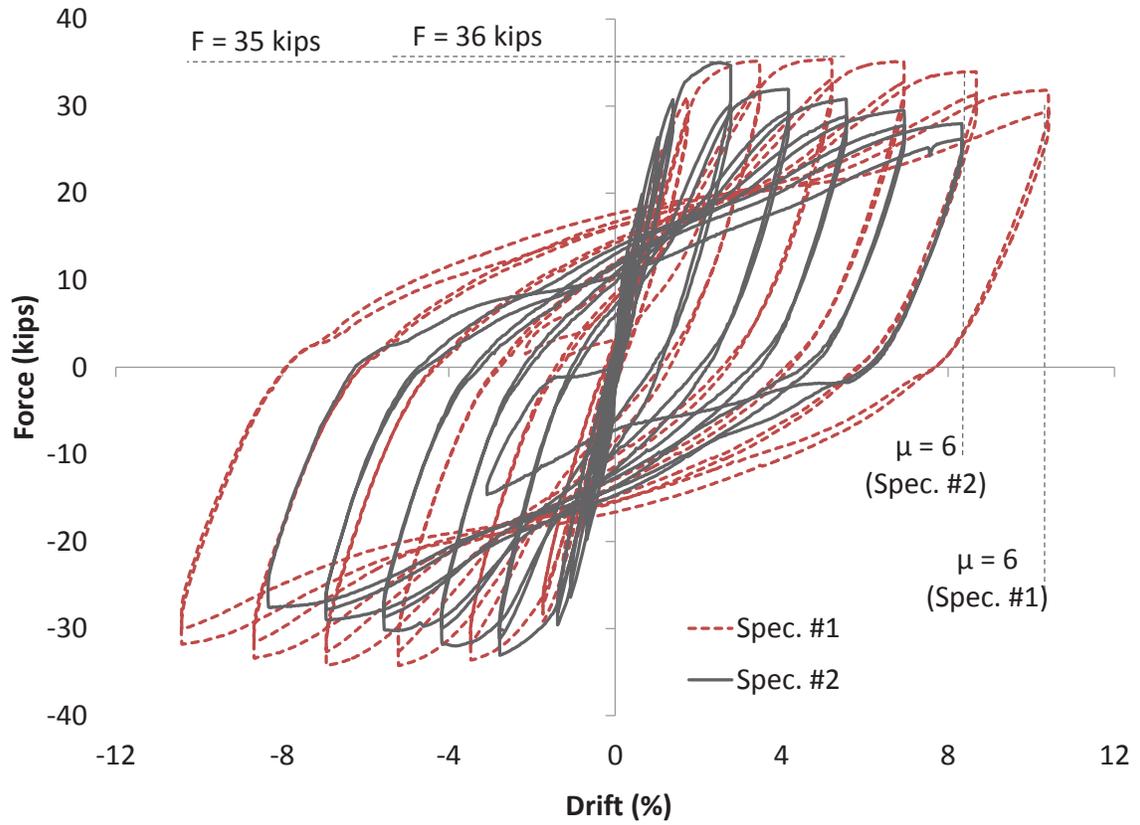
Figure 4.1 – Lateral force-vs.-drift ratio for Specimens #1 and #2

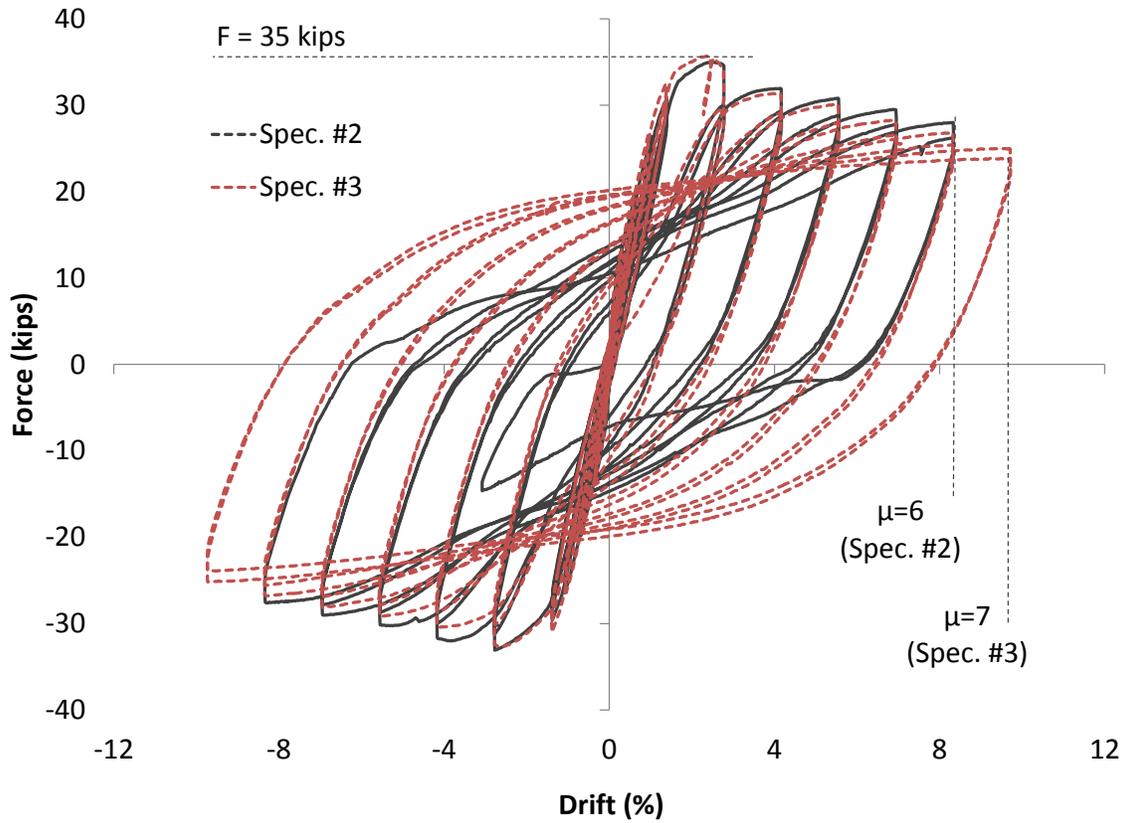
Figure 4.3 – Lateral force-vs.-drift ratio for Specimens #2 and #3

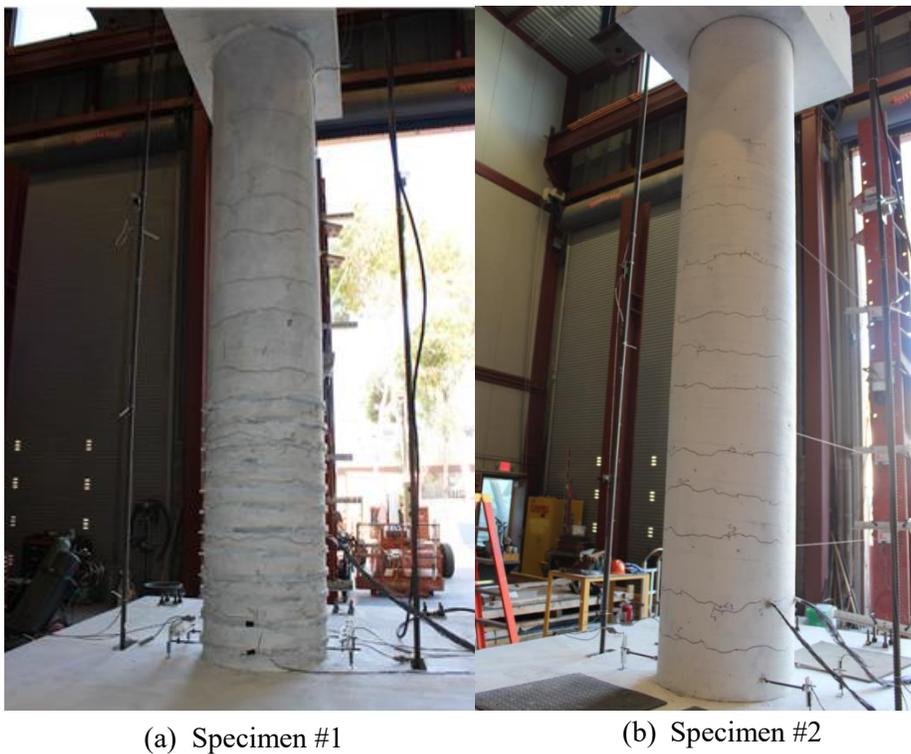
Figure 4.4 – Flexural cracks at the south face of the columns of Specimens #1 and #2 at Cycle 4 (1st yield)

For all three specimens, flexural cracks started to be visible in the lower half of the columns, in the test configuration, during Cycle 2, at a lateral load that was about 50% of the force predicted by analysis to cause the first yield of the longitudinal bars. At Cycle 4, when the load approached the theoretical first yield, flexural cracks were formed almost along the whole height of the columns, as shown in Figure 4.4 for Specimens #1 and #2. The same observations also stand for Specimen #3. Up to Cycle 4, no cracks were observed in the slabs. Observations obtained in latter cycles are presented below. For all three specimens, plastic hinges eventually developed at the bottom of columns in the test configuration, which had the slab-column assembly in the upside-down position.

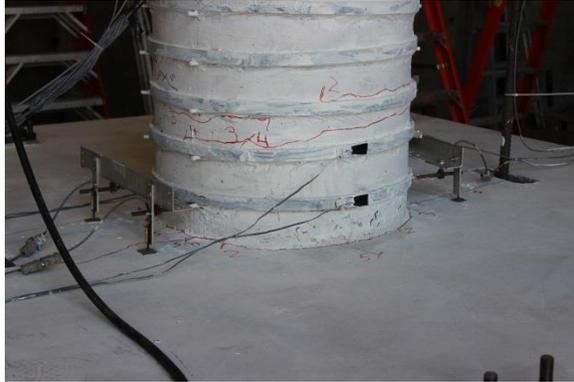
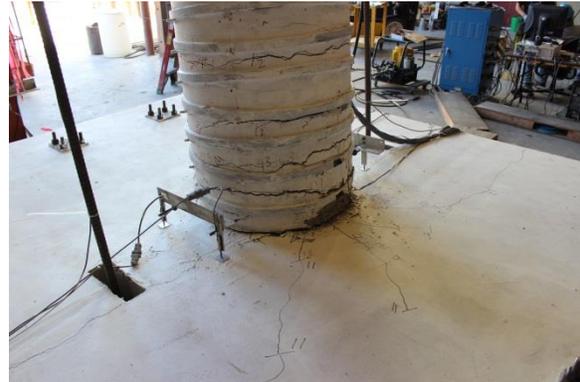
(a) north face at Cycle 6a ($\mu = 2$)

(d) south face at Cycle 9a ($\mu = 5$)

Figure 4.5 – Evolution of damage at the bottom of the column of Specimen #1

Figure 4.5 shows the evolution of damage near the bottom of the column in Specimen #1. Crushing of the concrete cover started in Cycle 6(a), which was the 1st cycle of ductility 2, as shown in Figure 4.5(a) and Figure 4.5(b). Concrete cover spalling and large flexural cracks were observed in the 1st cycle of ductility 5, as shown in Figure 4.5(c) and Figure 4.5(d). However, the spalling of concrete was not severe because of the external steel confinement. This is reflected in the small load degradation exhibited by the lateral load-vs.-drift ratio curve presented in Figure 4.1. Figure 4.6 shows the hoop strains in the two steel straps closest to the base of the column. The straps were located 4 in. and 8 in. away from the column base. As shown, the straps yielded in tension, with the lowest one experiencing larger strains. This shows that they were fully engaged in the confinement action.

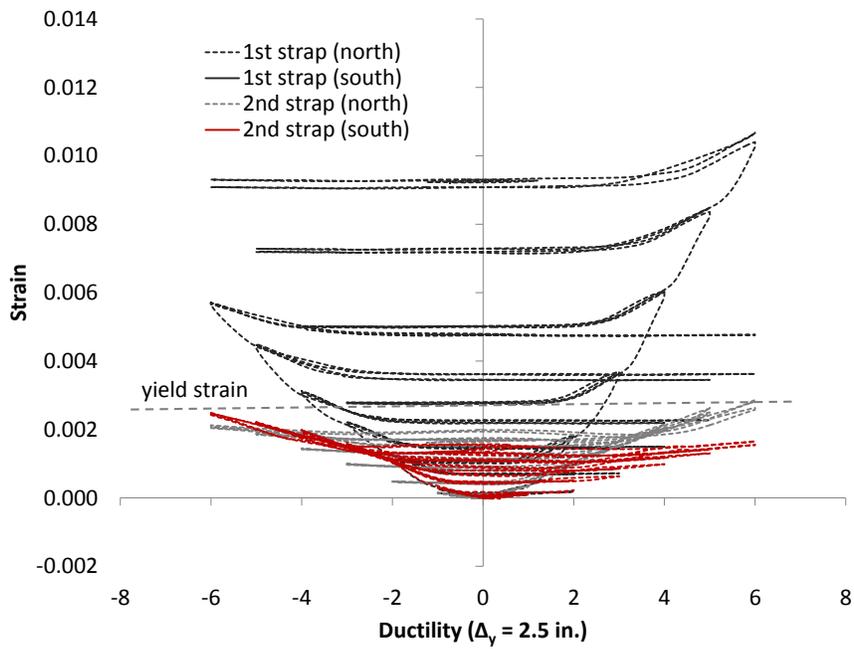
Figure 4.6 – Strains in confining steel straps around the column of Specimen #1

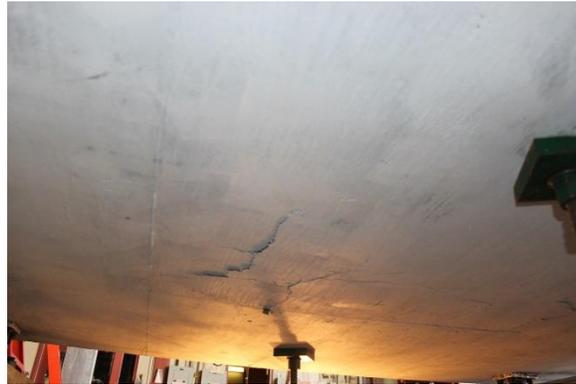
(d) Cycle 10a ($\mu = 6$)

Figure 4.7 – Evolution of damage in the slab of Specimen #1

Figure 4.7 shows the evolution of damage in the slab of Specimen #1. Flexural cracks were observed at the bottom face of the slab (top face in the specimen) in the 1st cycle of ductility 1. In Cycle 7a, corresponding to a ductility demand of 3, additional cracks, radiating from the column, appeared at the bottom face of the slab (top face in the specimen). These cracks extended towards the east and west edges of the slab, as the displacement applied to the column increased. The crack pattern at the bottom face of the slab (top face in the specimen), at the end of the test, is shown in Figure 4.8. At the top face of the slab (bottom face in the specimen), punching cracks could be observed in the 2nd cycle of ductility 3, as shown in Figure 4.7(c). The punching cracks were formed as the heads of the bars under compression pushed against concrete. The punching cracks were marked and measured after the end of the test. Relative vertical displacements were observed across punching cracks. After the end of the test, the residual punching crack displacements in the north and south region were 0.12 in. and 0.2 in., respectively. The punching crack displacement is defined as the differential vertical displacement of the slab surface across a punching crack measured with a micrometer. Figure 4.9 shows the crack pattern at the end of the test, with the locations of the column and the heads of the longitudinal bars marked. As shown in the figure, two large punching cracks were formed outside the column perimeter, at a maximum distance of 10 in. Cracks crossing the footprints of the column and the bar heads were also observed. After the test, concrete pieces between large punching cracks were removed with the use of mechanical tools, and some fracture surface was exposed, as shown in Figure 4.10. The average inclination of the fracture surface radiating from a bar head varies between 20° and 40°.

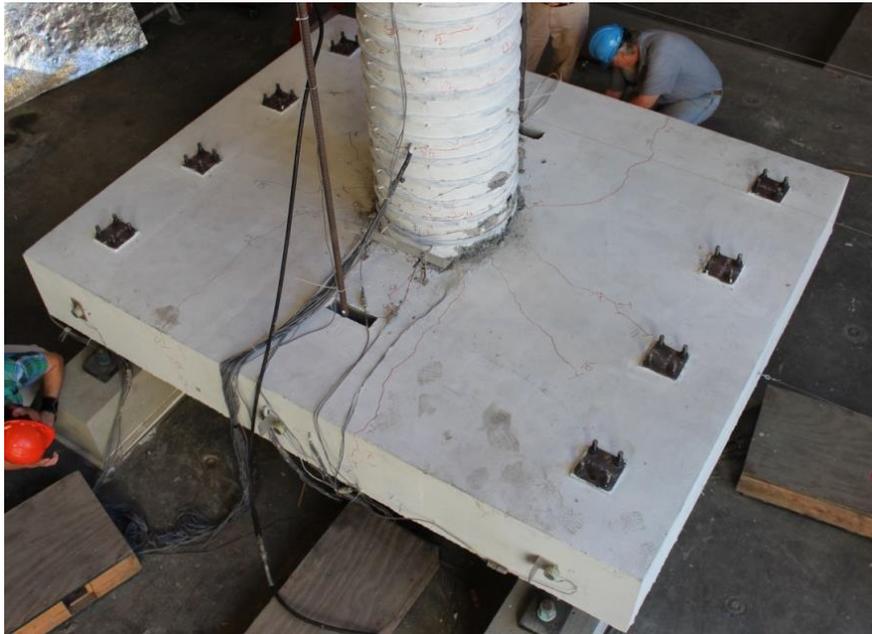
Figure 4.8 – Damage at the bottom face of the slab (top face in the specimen) of Specimen #1 at the end of testing

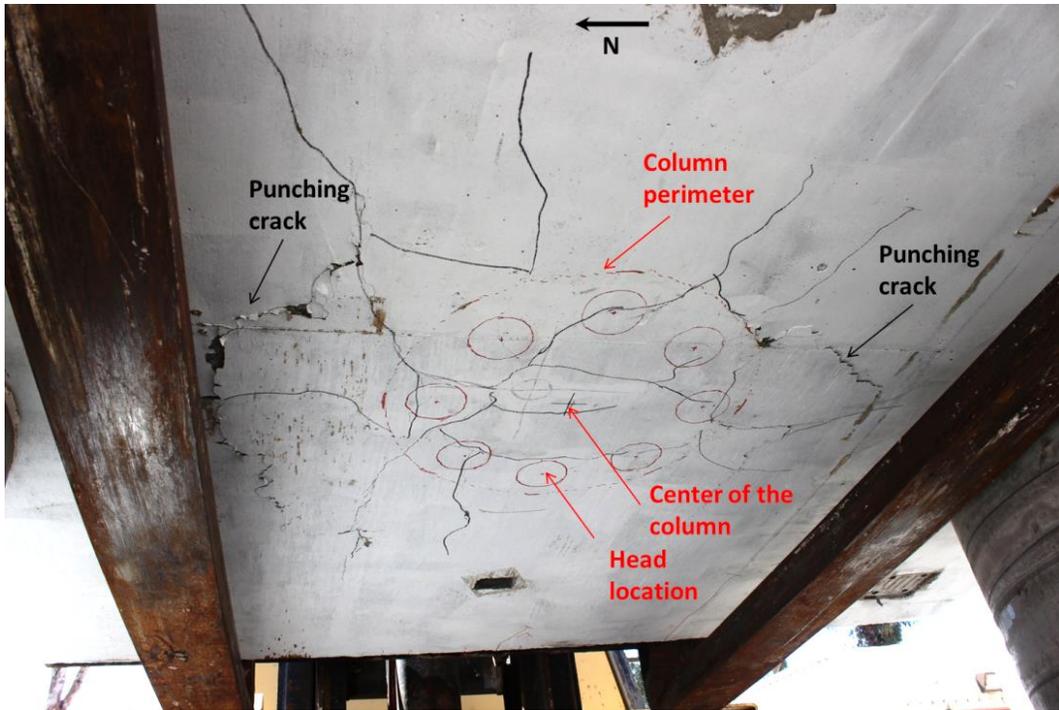
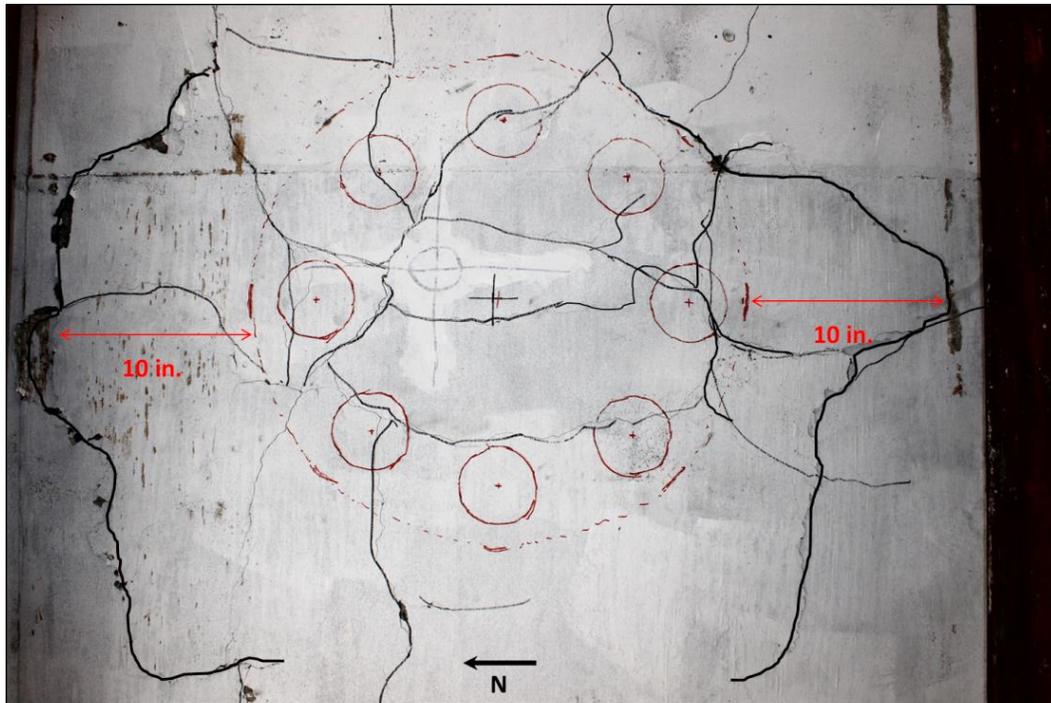
Figure 4.9 – Crack pattern at the top face of the slab (bottom face in the specimen) after the testing of Specimen #1

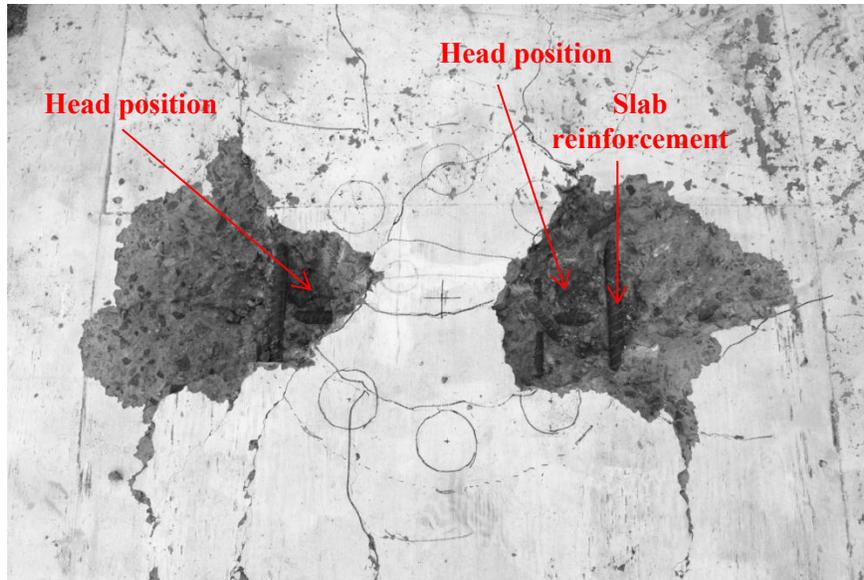
Figure 4.10 – Exposure of fracture surface at the top face of the slab (bottom face in the specimen) of Specimen #1

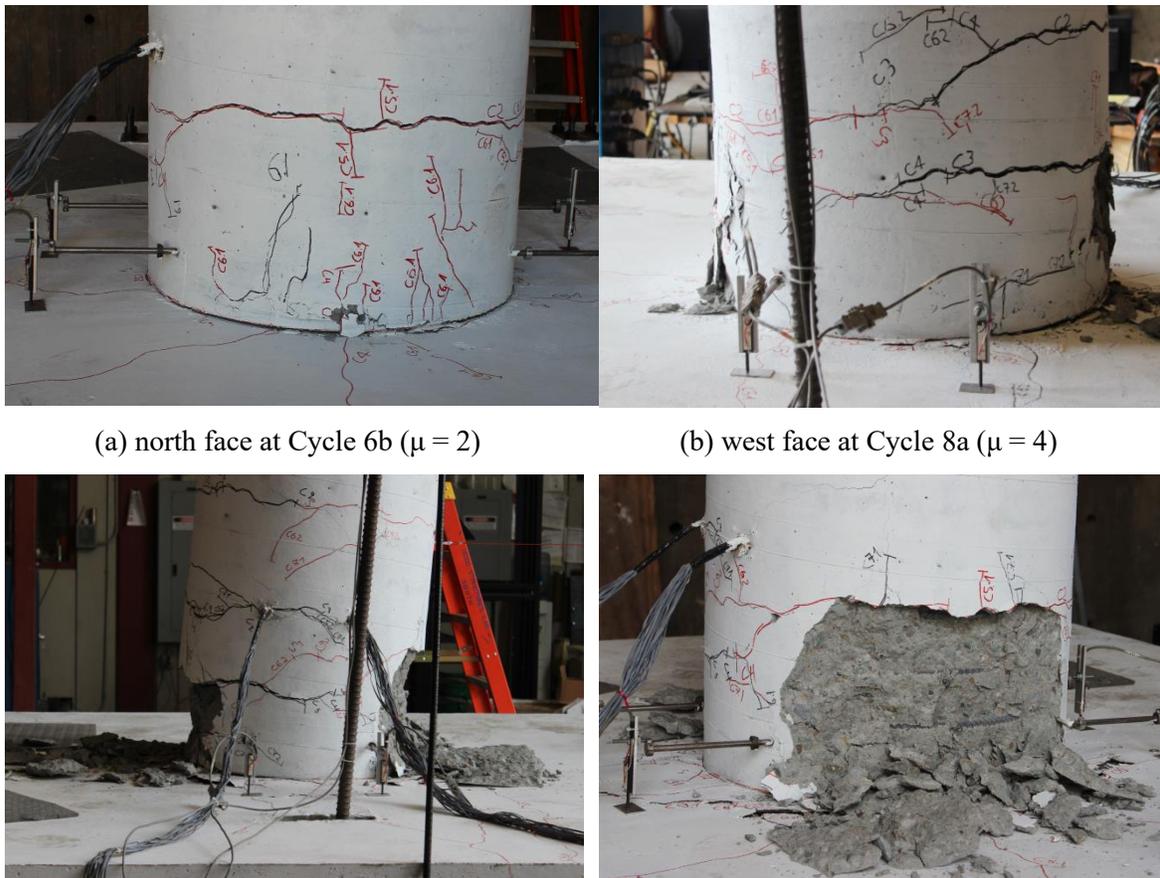
(a) north face at Cycle 6b ($\mu = 2$)

(b) west face at Cycle 8a ($\mu = 4$)

(d) north face at Cycle 10a ($\mu = 6$)

Figure 4.11 – Evolution of damage at the bottom of the column of Specimen #2

Crushing of concrete started near the base of the column of Specimen #2 in the 2nd cycle of ductility 2, as shown in Figure 4.11(a). This was followed by a noticeable drop of the lateral resistance of the column as shown in the lateral load-vs.-drift ratio curve in Figure 4.1. Figure 4.11(b) through Figure 4.11(d) show the evolution of damage near the base of the column, where severe concrete cover spalling

was observed. In the last cycle at ductility 6, the transverse reinforcement was exposed due to the cover spalling, as shown in Figure 4.11(d).

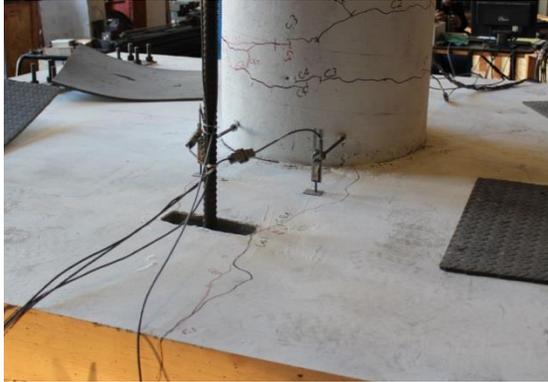
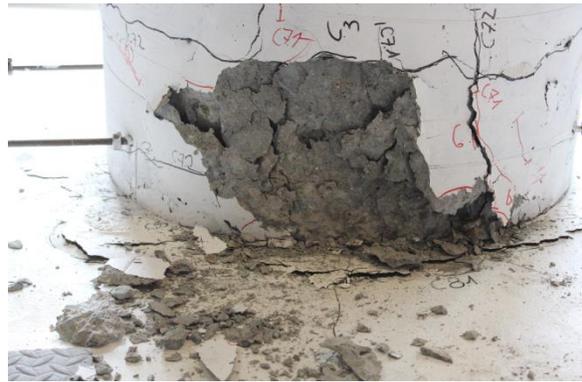
(a) west face at Cycle 6a ($\mu = 2$)

(c) east face at Cycle 9a ($\mu = 5$)

(d) north face at Cycle 9a ($\mu = 5$)

Figure 4.12 – Evolution of damage at the bottom face of the slab (top face in the specimen) of Specimen #2

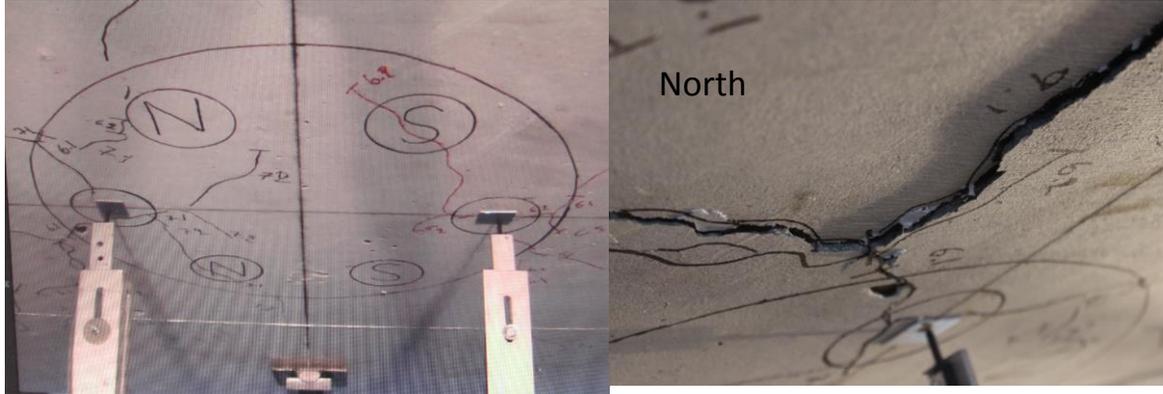
(a) Cycle 7b ($\mu = 3$)

(b) Cycle 9b ($\mu = 5$)

Figure 4.13 – Evolution of damage at the top face of the slab (bottom face in the specimen) of Specimen

For Specimen #2, the effective yield displacement calculated is $\Delta_y = 2.0$ in. During the 2nd cycle of positive drift at ductility 6, concrete spalling was observed at the top surface of the slab (bottom surface in the specimen), with big concrete pieces coming off. The spalling was limited to the cover concrete and was caused by the punching action of the headed bars when they were in compression. The test was stopped at that point, due to the significant drop of the lateral load resistance in the following load reversal, as it can be seen in Figure 4.1. The maximum drift ratio attained was 8.3 %. The smaller embedment length ($8.7d_b$) of the headed bars in Specimen #2, as compared to $9.8d_b$ in Specimen #1, resulted in more severe deterioration of the bar anchorage and the more significant load drop in the later cycles due to bar slip. It can also be noted from Figure 4.1 that the hysteresis curves for Specimen #2 are more pinched because of the more significant slip of the headed bars within the slab.

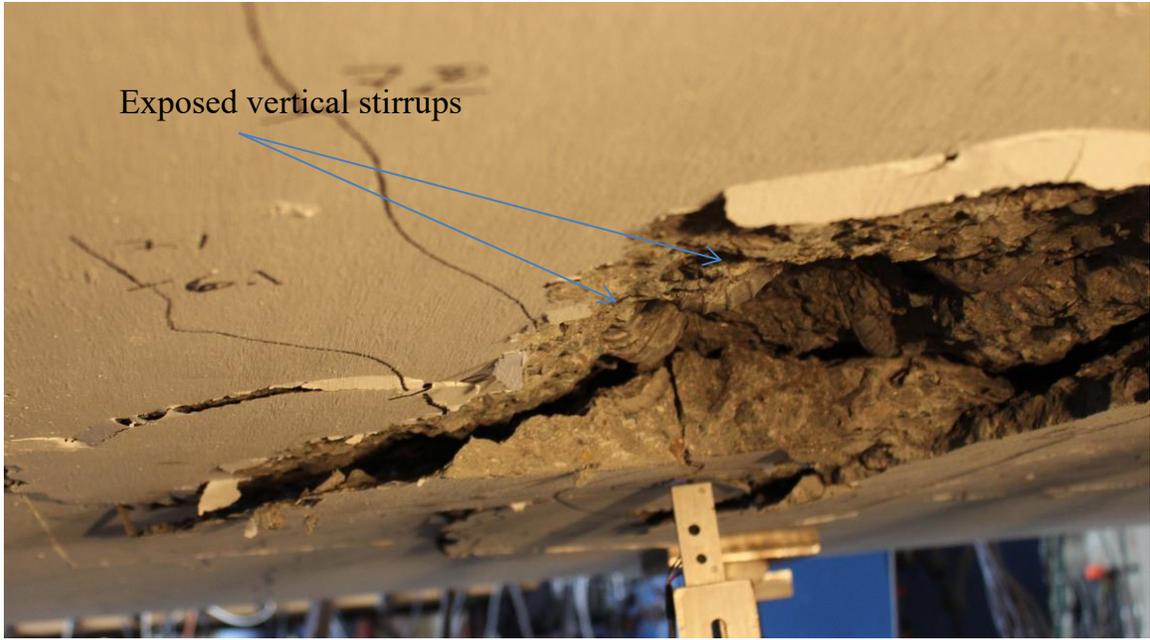
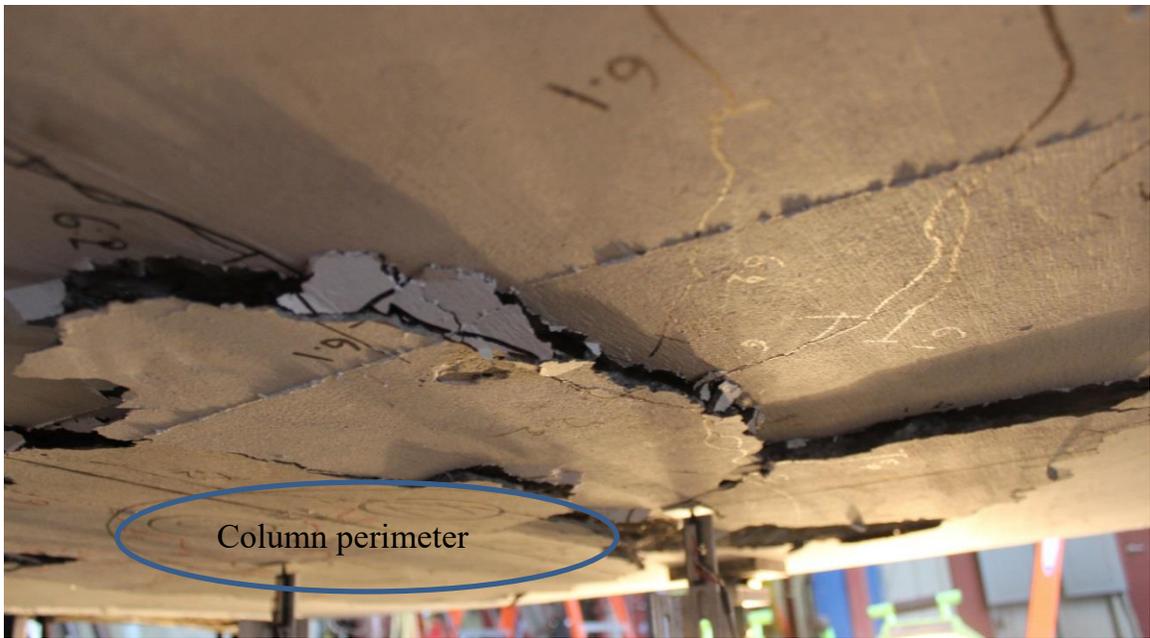
Figure 4.14 – Damage at the top face of the slab (bottom face in the specimen) of Specimen #2 at the end of testing
