1. Report No. CA15-2560		2. Government Accession No.		3. Recipient's Catalog No.	
4. Title and Subtitle Development Length for Headed Bars in Slab-Column Joints of RC Slab Bridges				5. Report Date 12/4/2015

Report No.
SSRP-15/10

**Development Length for Headed Bars in
Slab-Column Joints of RC Slab Bridges**

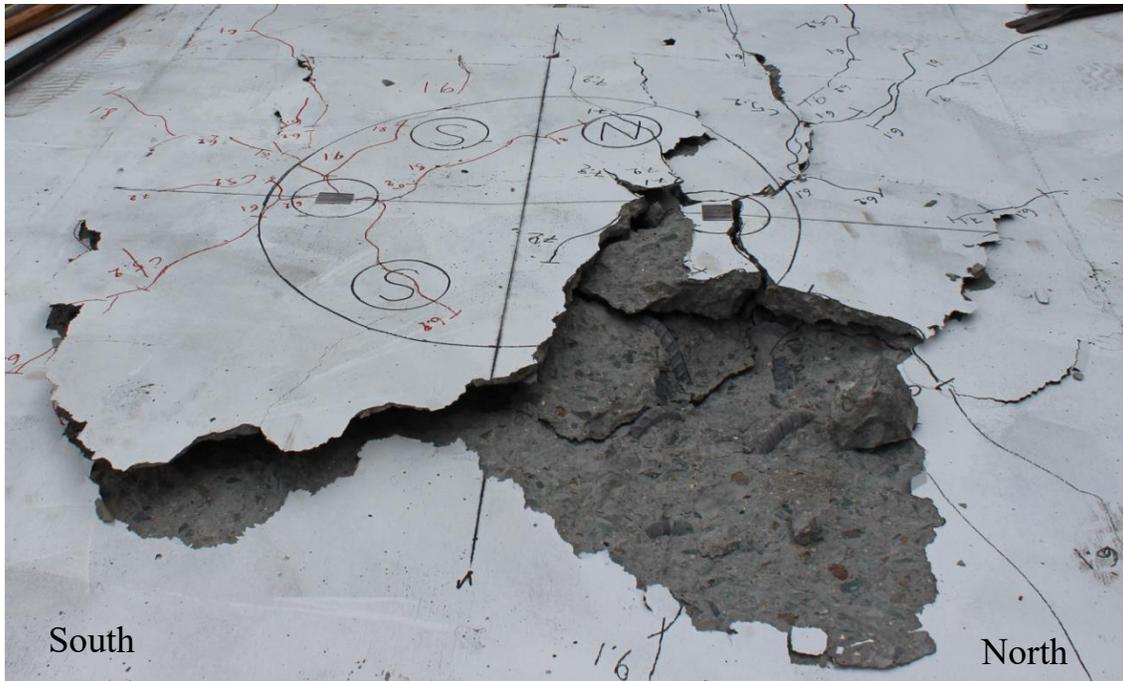
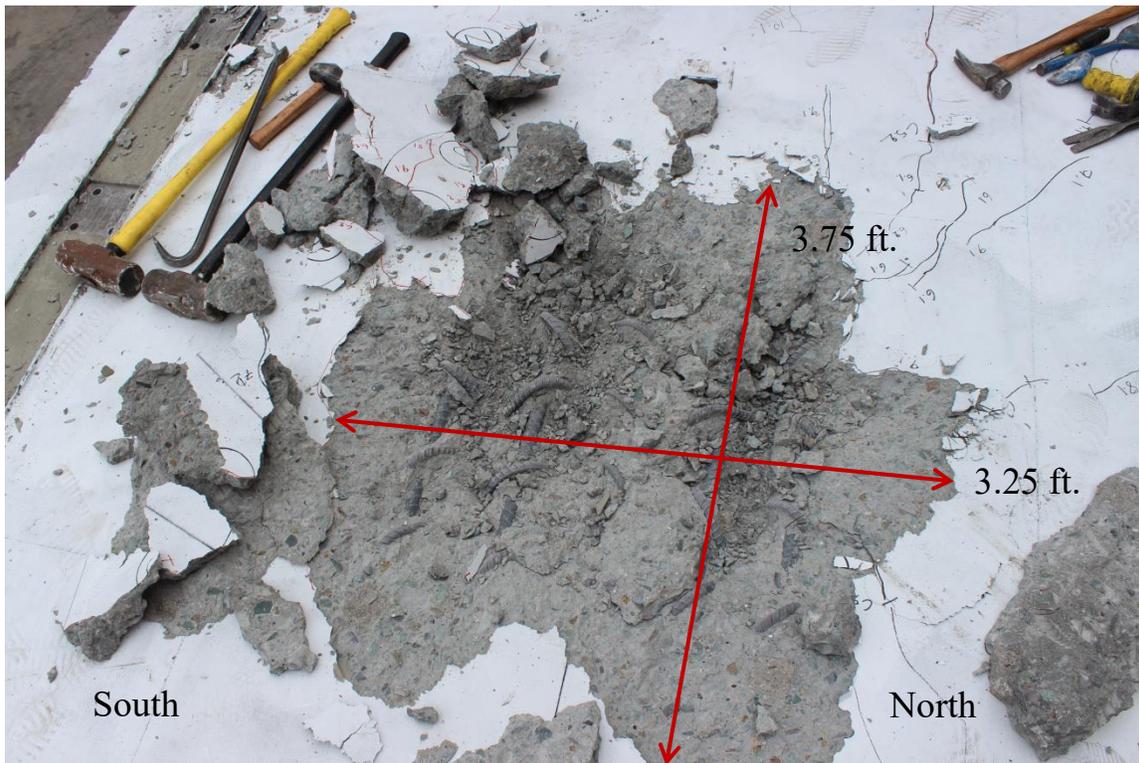
(a) Before removing loose concrete pieces

(b) After removing loose concrete pieces

Figure 4.15 – Exposure of fracture surface at the top face of the slab (bottom face in the specimen) of Specimen #2

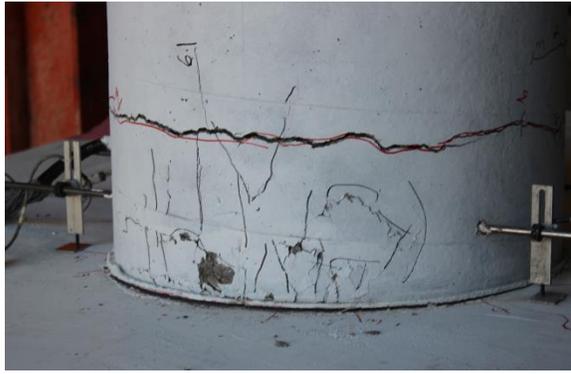
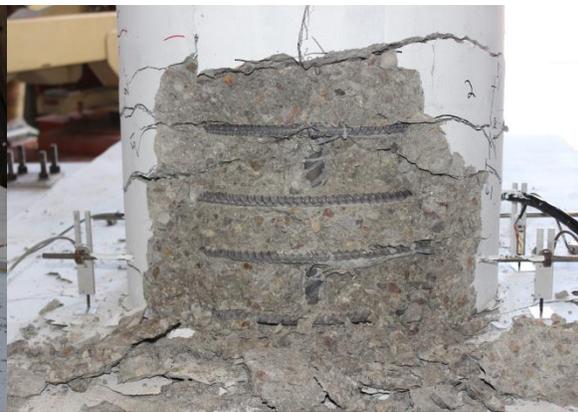
Figure 4.16 – Evolution of damage at the base of the column of Specimen #3

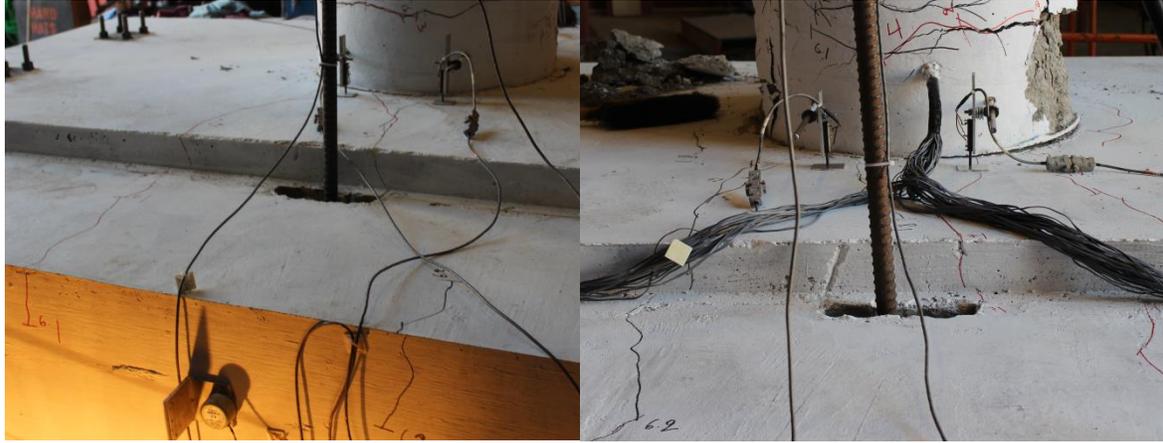
Figure 4.17 – Evolution of damage at the bottom face of the slab (top face in the specimen) of Specimen #3

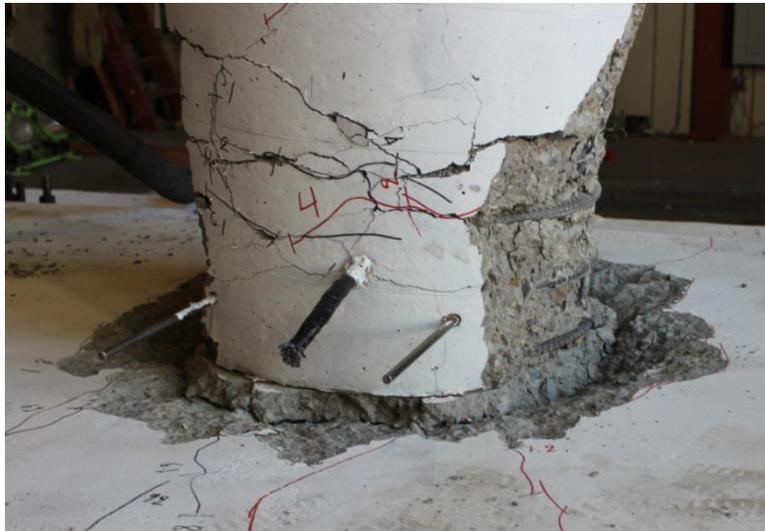
Figure 4.18 – Damage at the slab-column interface after the testing of Specimen #3

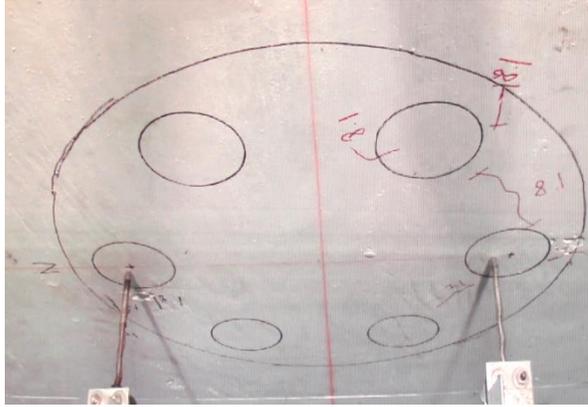
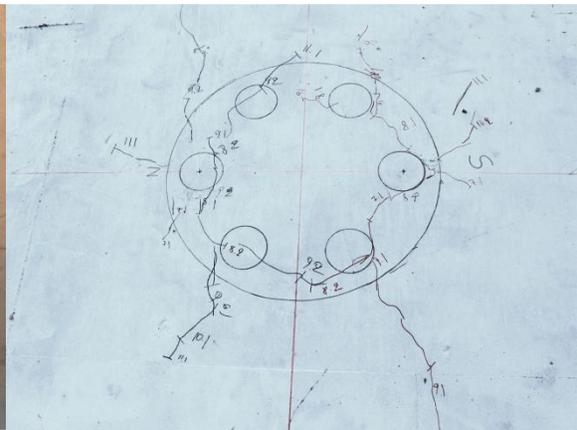
(d) After the end of the test

Figure 4.19 – Evolution of damage at the top face of the slab (bottom face in the specimen) of Specimen #3

at ductility 7. At that point, the test was ended to avoid possible damage to the vertical post-tensioning rods. The damage at the top surface of the slab (bottom surface in the specimen) of Specimen #3 was very mild, compared to that observed in Specimen #2.

the specimen) after the test is shown in Figure 4.19(d). The damage due to the punching of the headed bars was very minor.

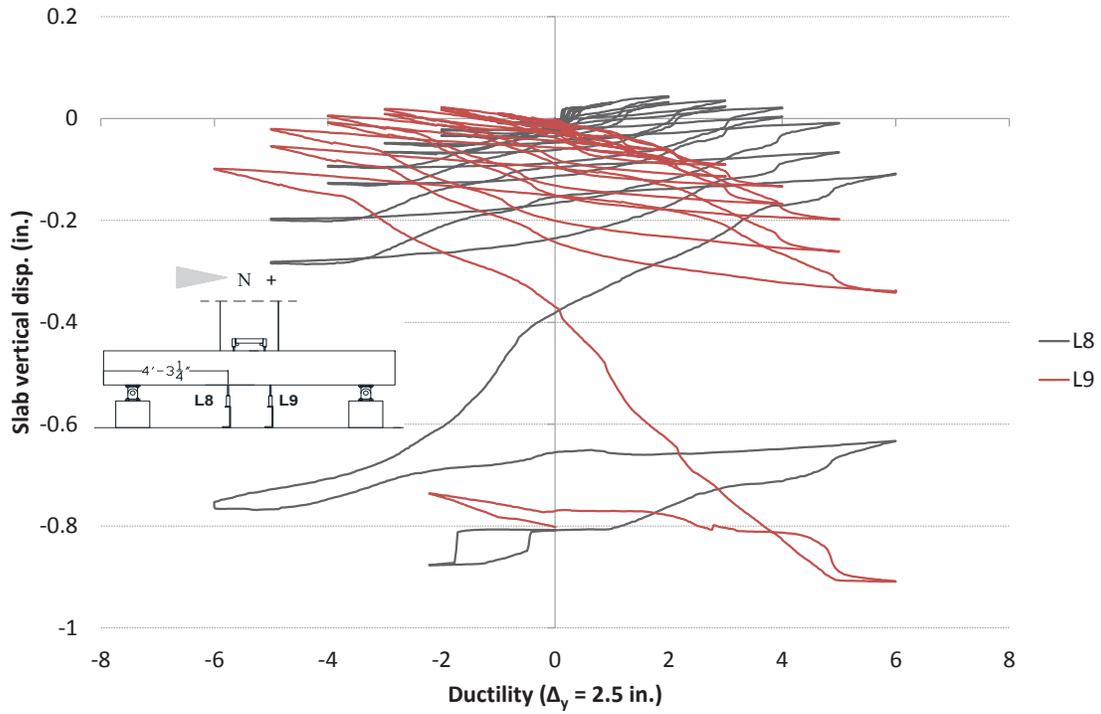
Figure 4.20 – Vertical displacement of the top face of the slab (bottom face in the specimen) of Specimen #2

For Specimens #2 and #3, two vertical transducers were placed underneath the slab to measure the vertical displacements of the top surface of the slab (bottom surface face in the specimen) at the positions of the two extreme longitudinal bars at the north and south faces of the column. These displacements were caused by the punching force of the headed bars as the rotation of the slab was extremely small. Detailed instrumentation plans for the specimens are provided in Appendix A.

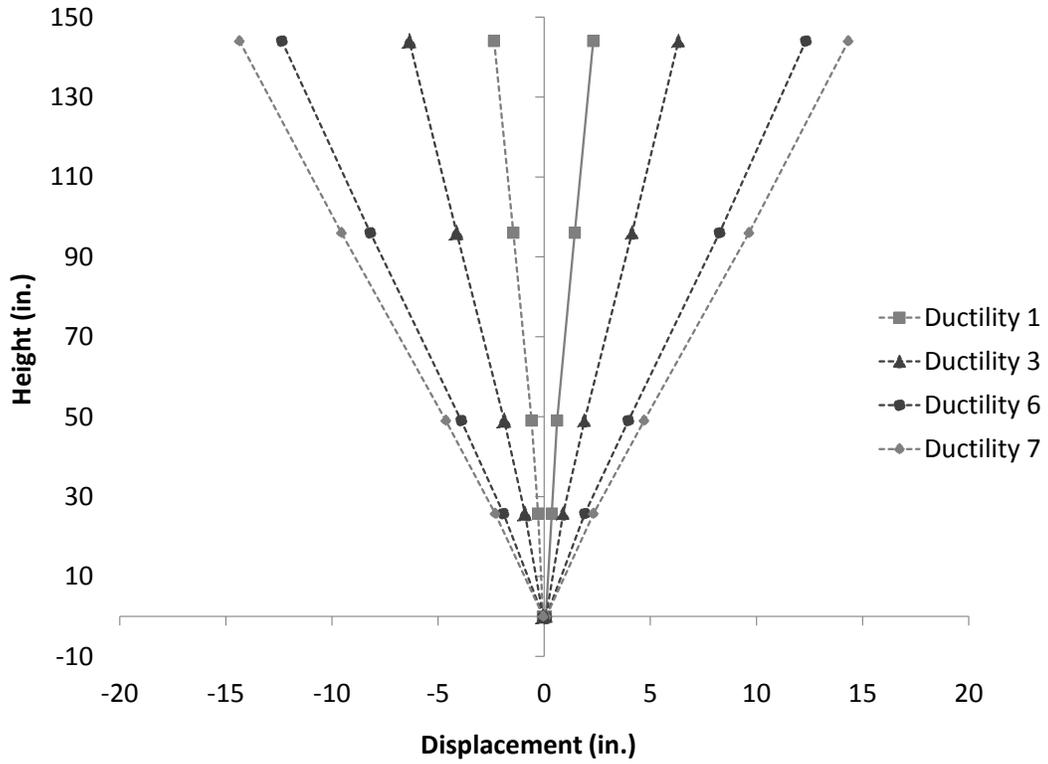
Figure 4.24 – Lateral displacement of the column of Specimen #3

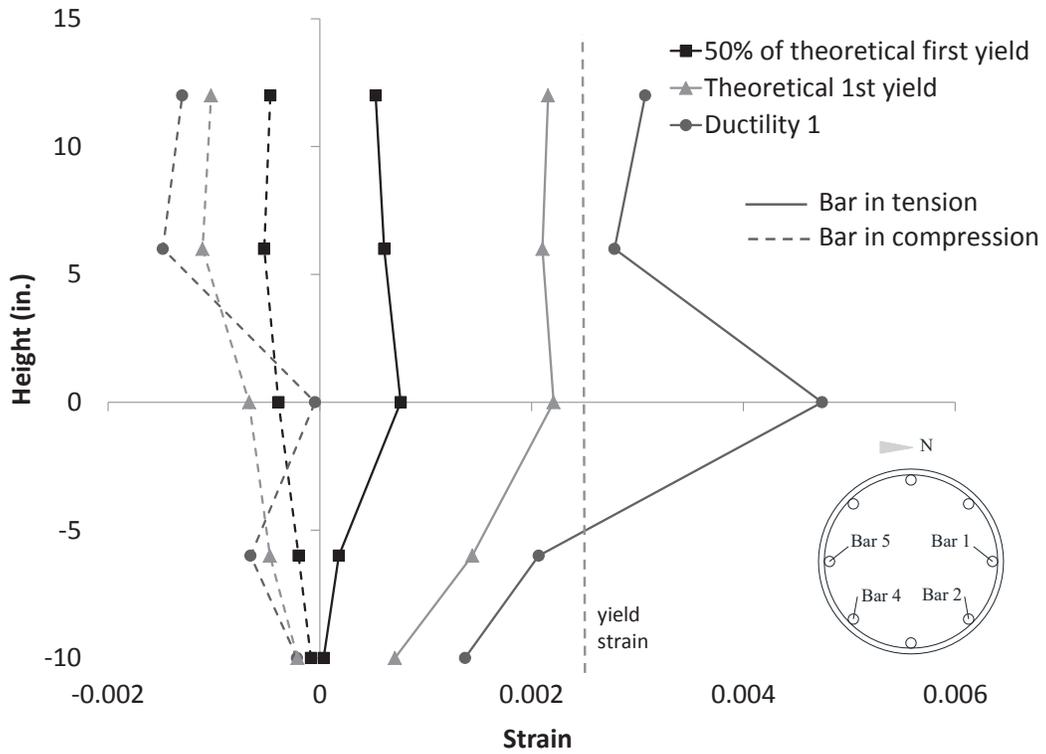
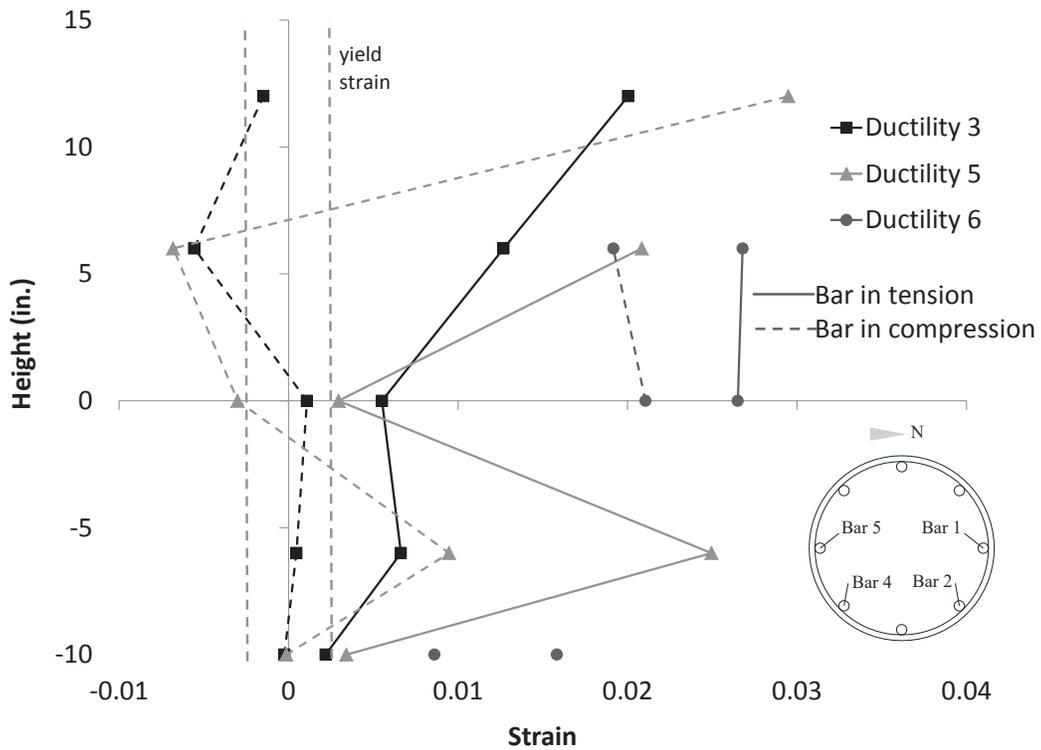
Figure 4.29 – Stains along Bar 5 in Specimen #1

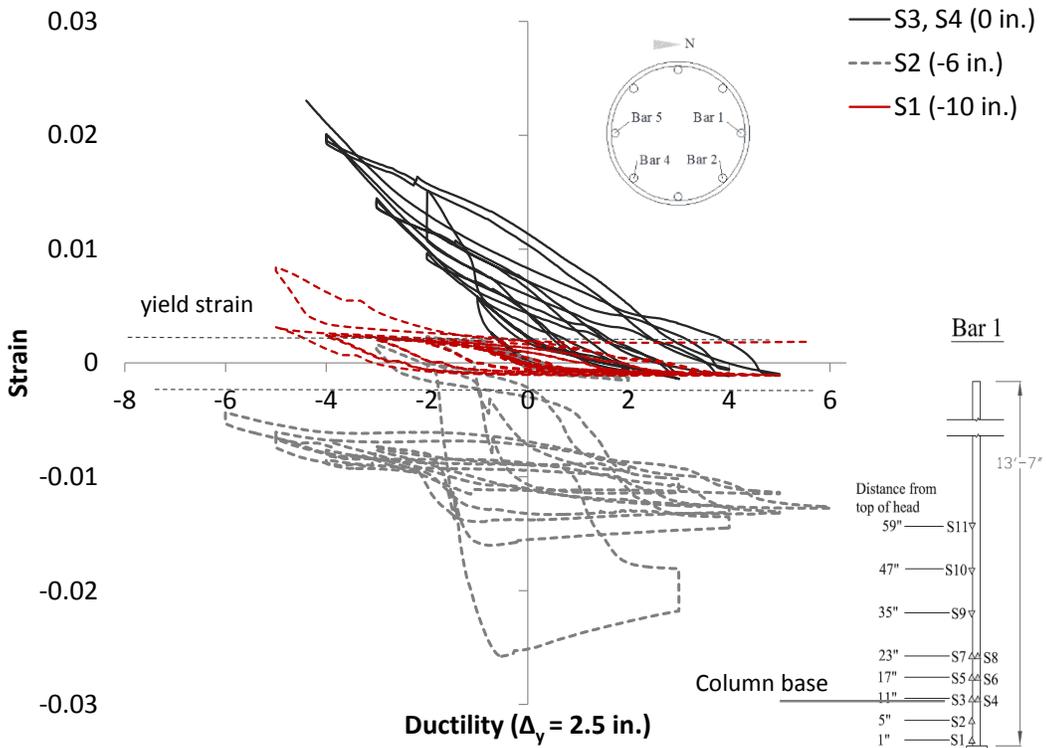
Figure 4.30 – Strain-vs.-ductility curves for Bar 1 in the slab-column joint of Specimen #1

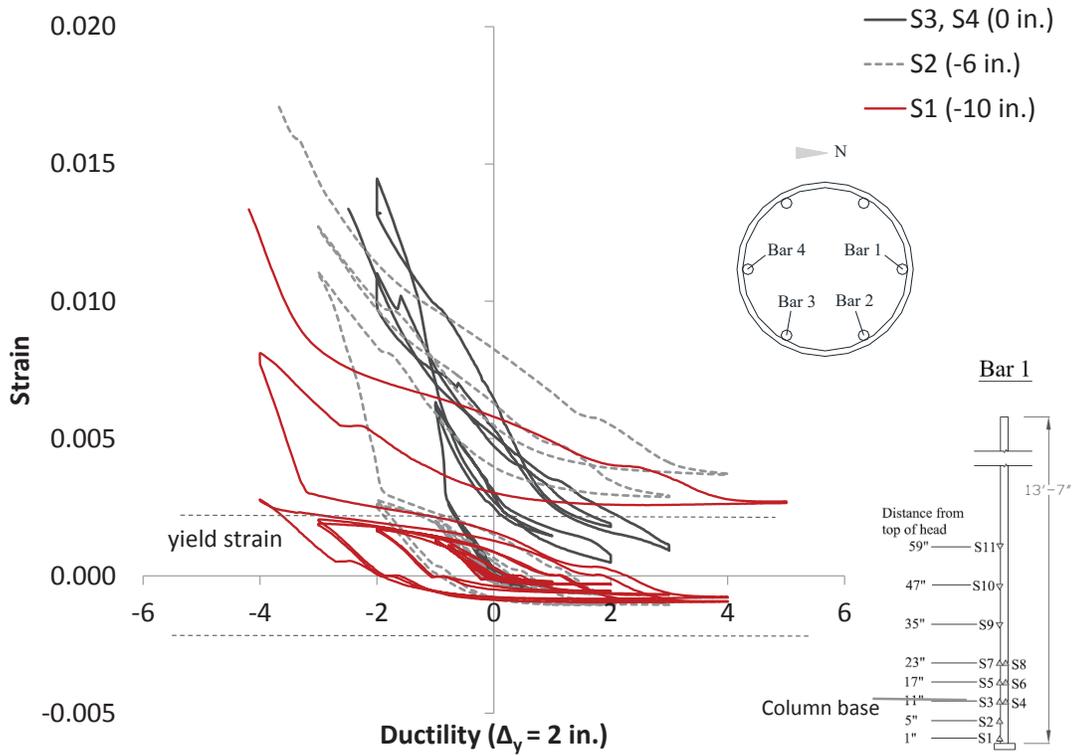
Figure 4.34 – Strain-vs.-ductility curves for Bar 1 in the slab-column joint of Specimen #2

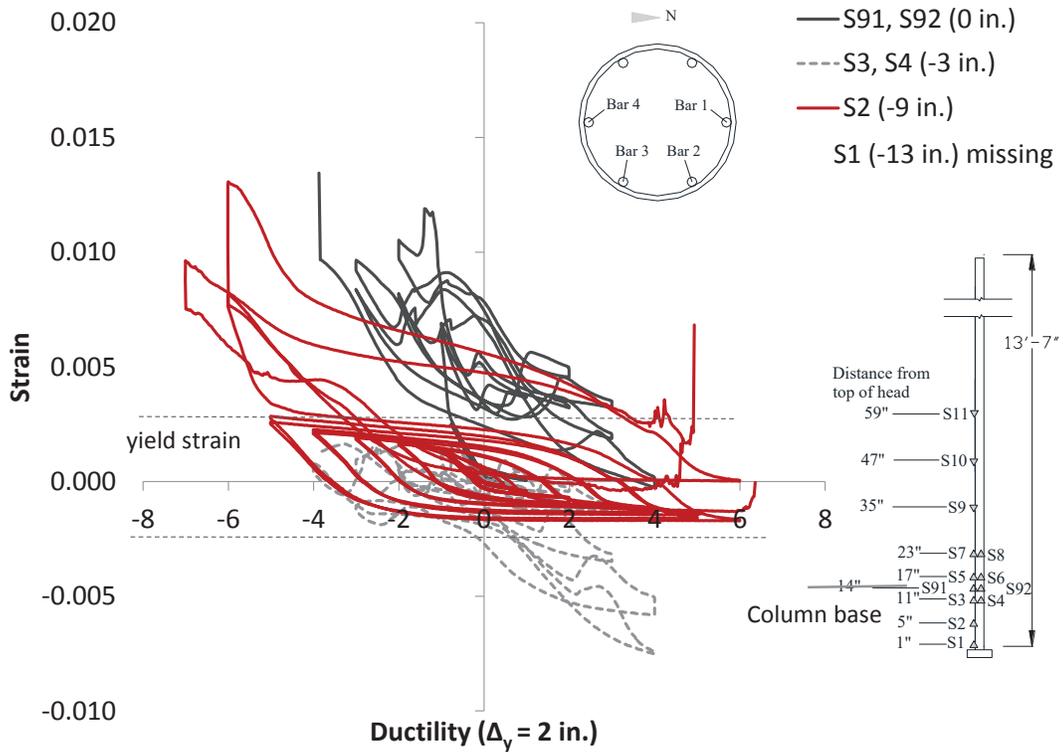
Figure 4.38 – Strain-vs.-ductility curves for Bar 1 in the slab-column joint of Specimen #3

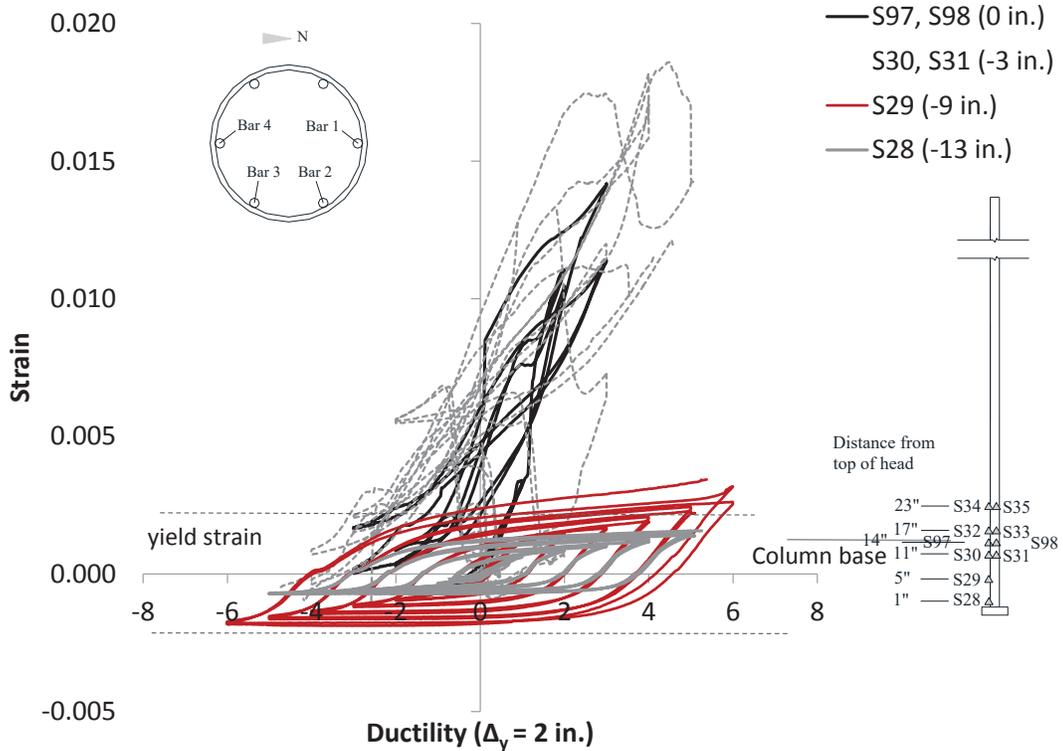
Figure 4.39 – Strain-vs.-ductility curves for Bar 4 in the slab-column joint of Specimen #3

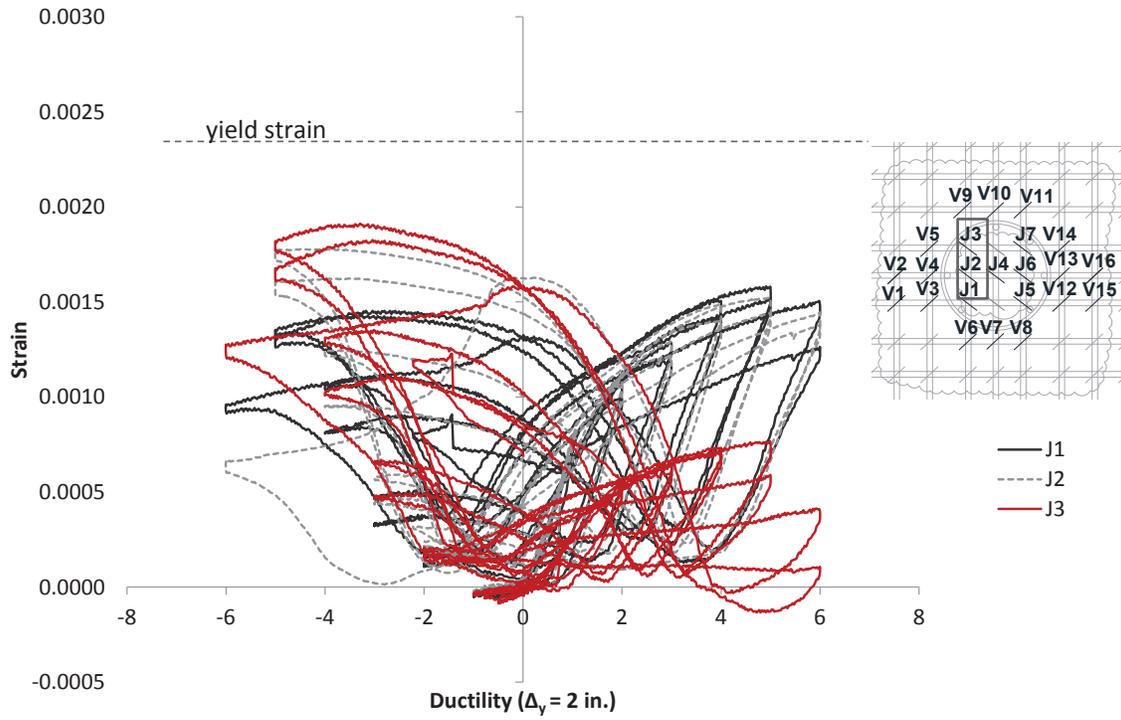
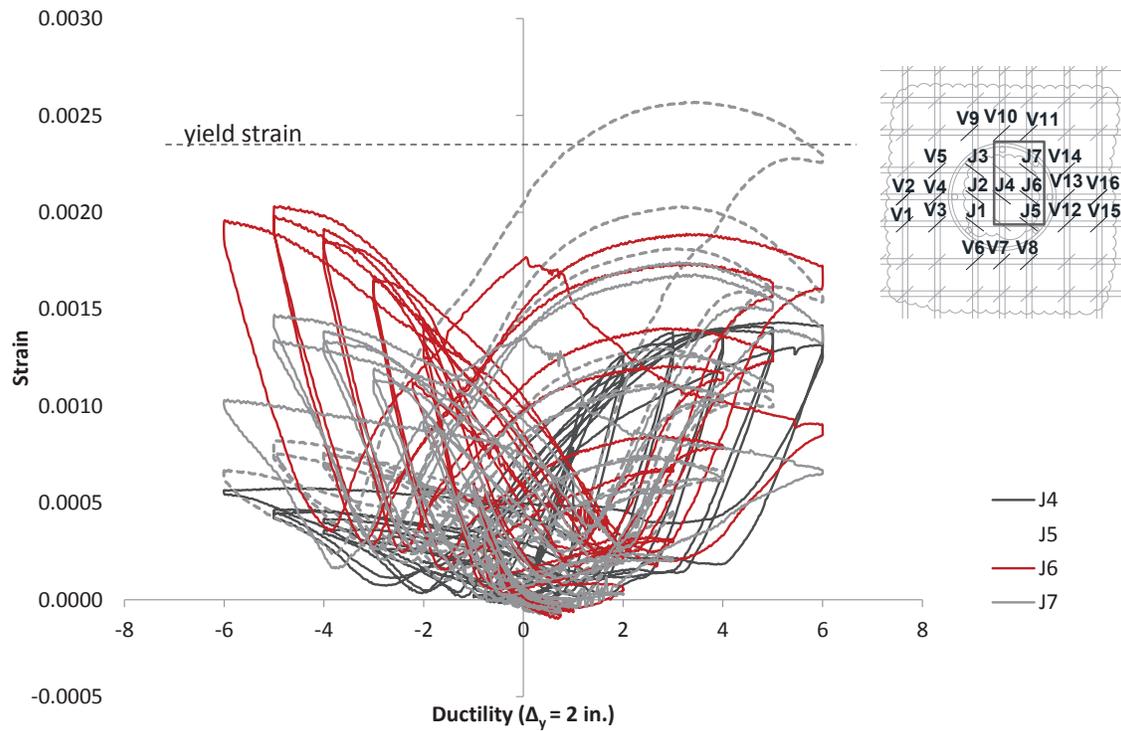
Figure 4.41 – Strains in J-bars of Specimen #2

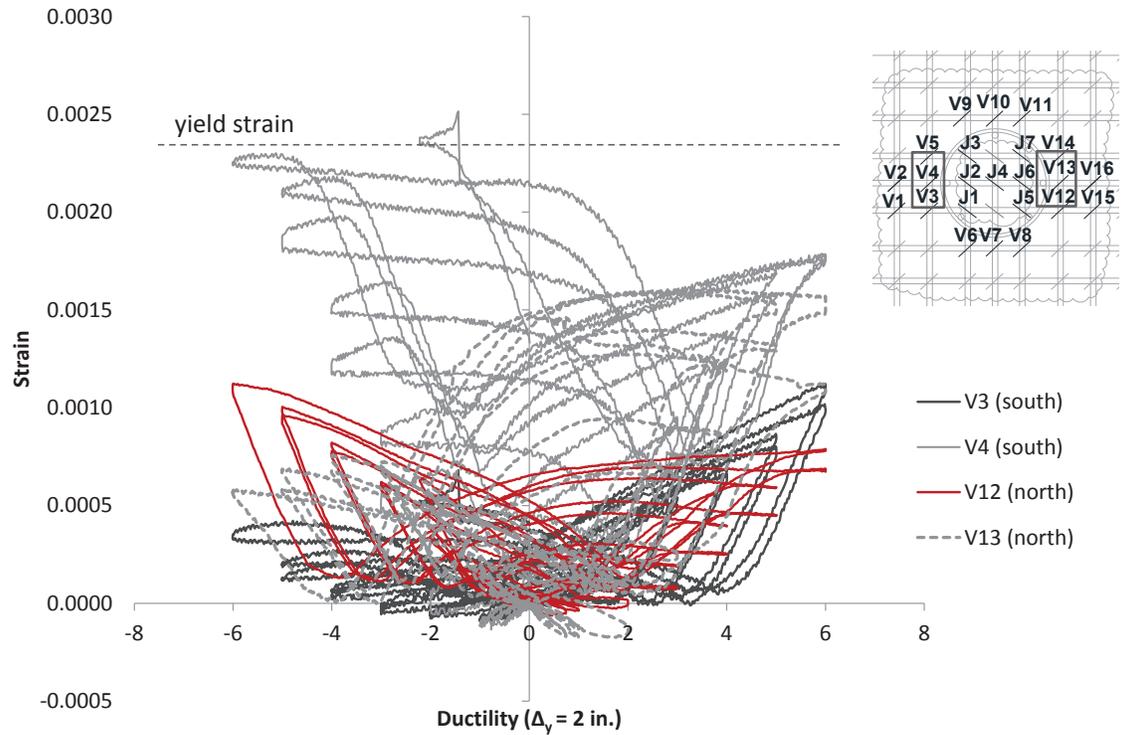
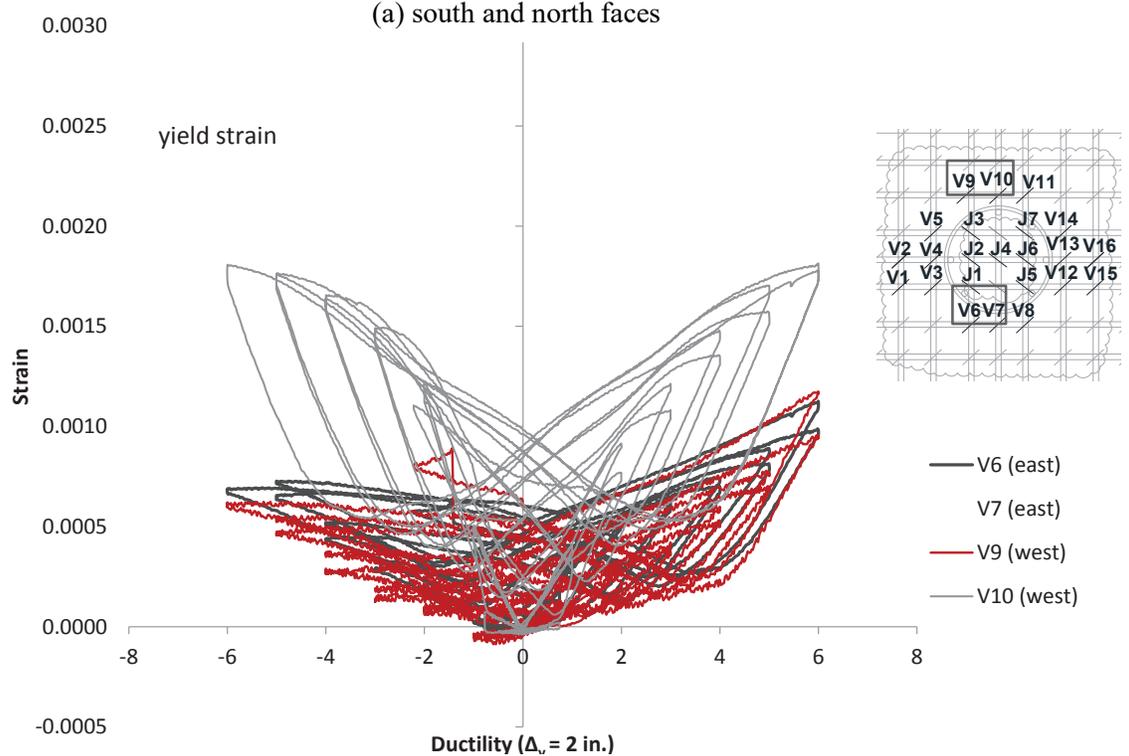
Figure 4.44 – Strains in the 1st row of vertical stirrups of Specimen #2

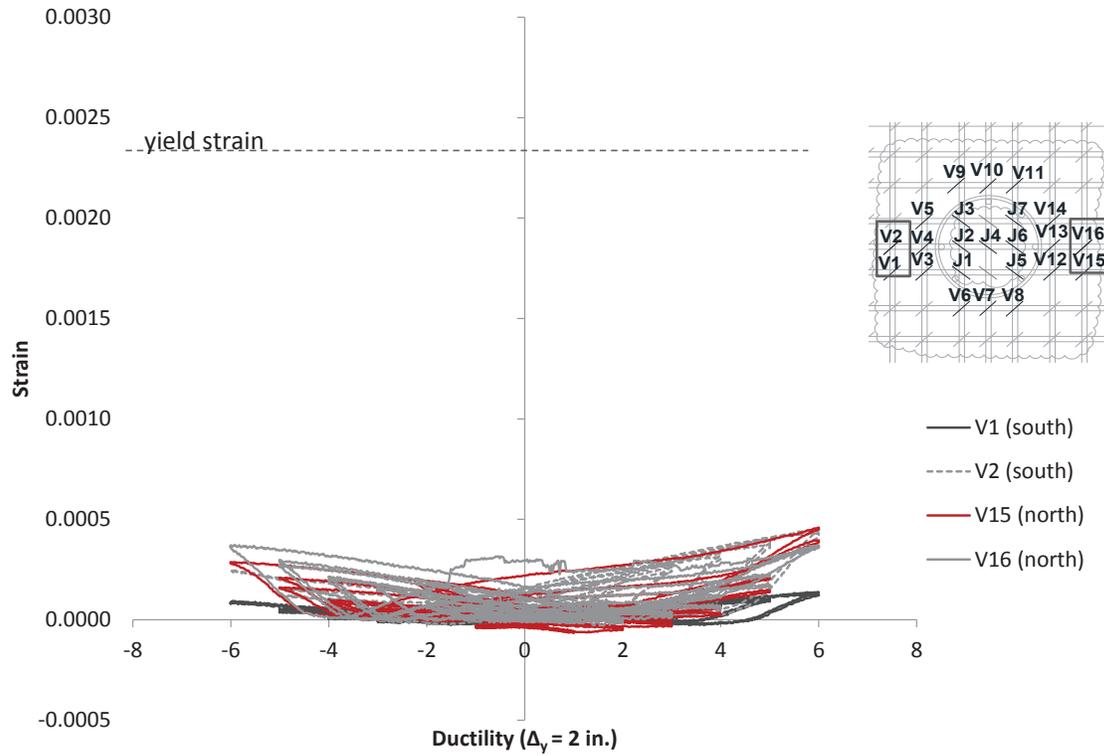
Figure 4.47 – Strains in the 2nd row of vertical stirrups of Specimen #2

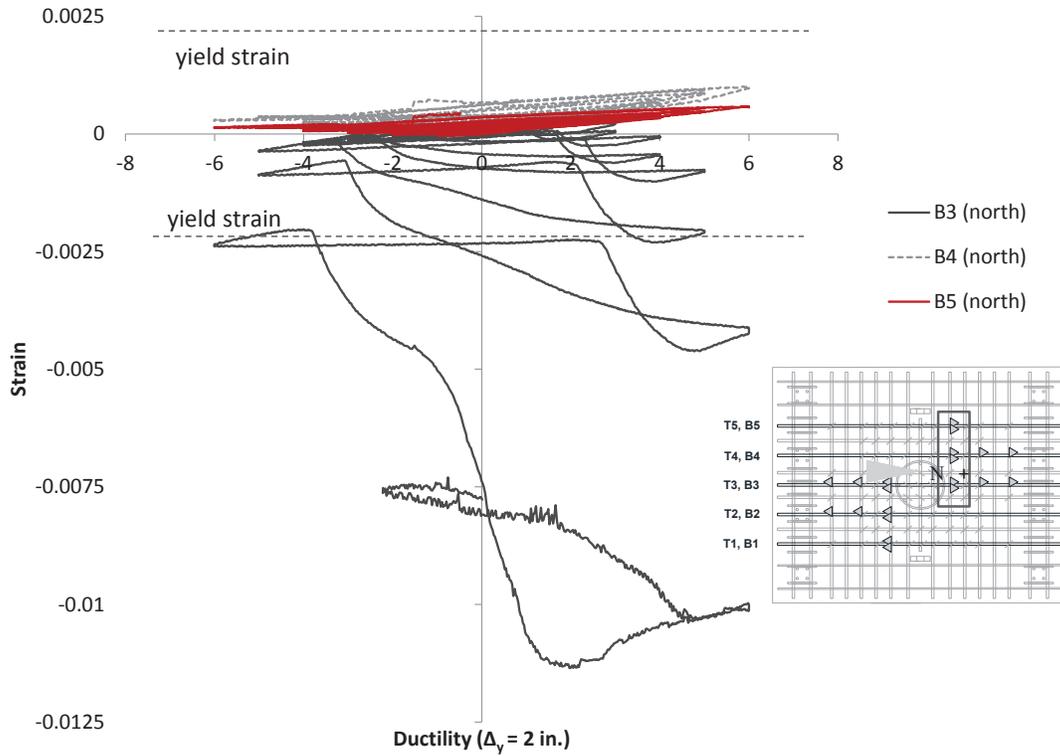
Figure 4.53 – Strains in longitudinal bars at the top face of the slab (bottom face in the specimen) of Specimen #2

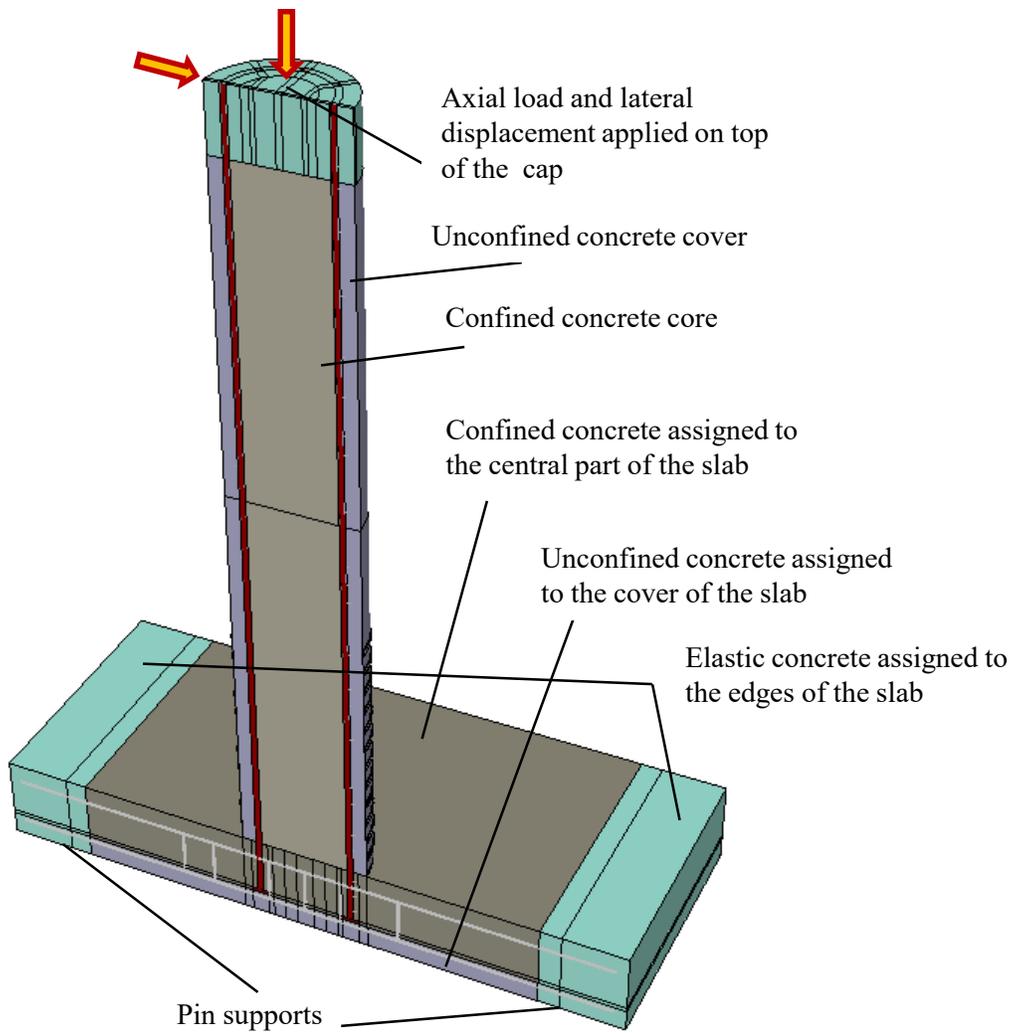
Figure 5.6 – FE model of slab-column Specimen #1

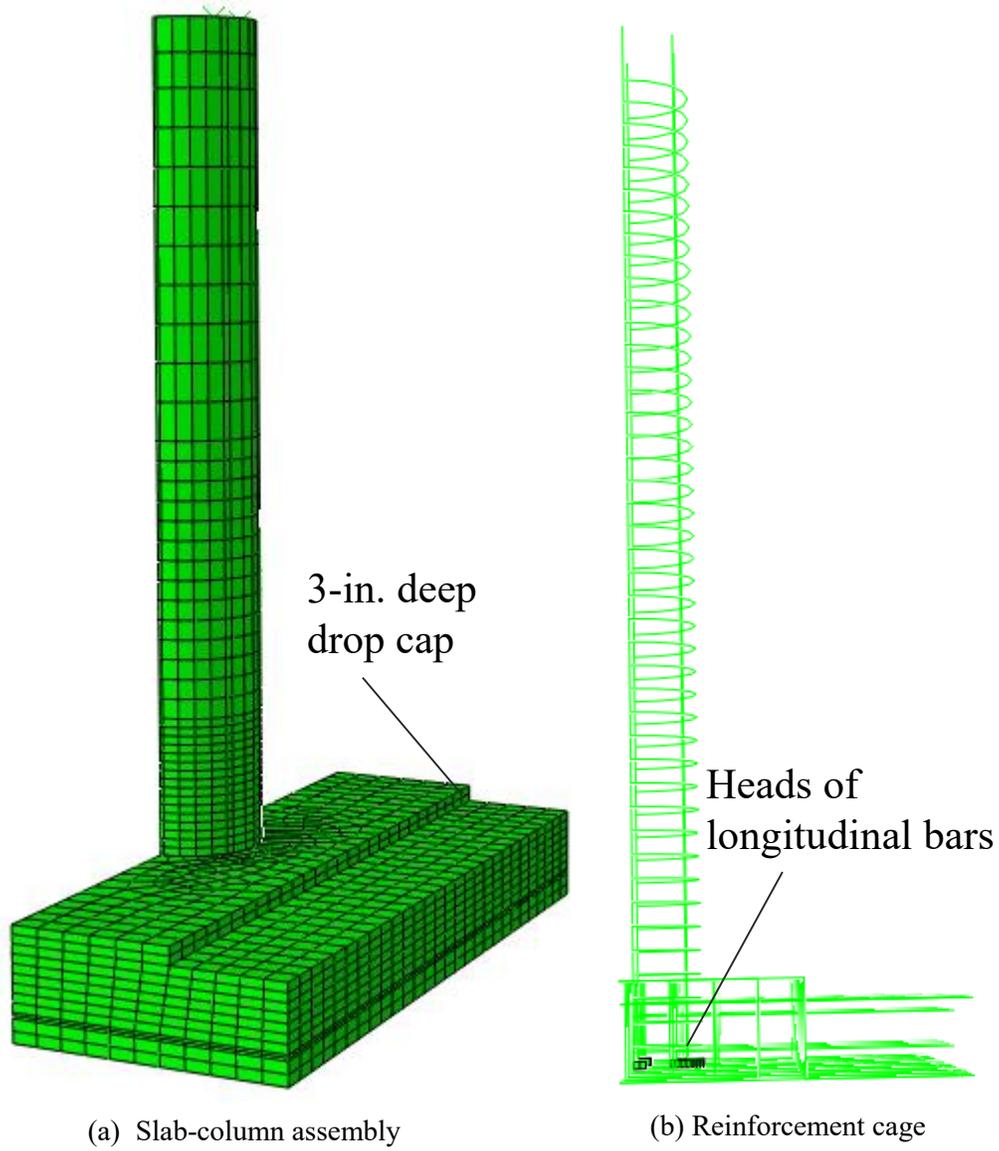
Figure 5.9 – FE model of Specimen #3

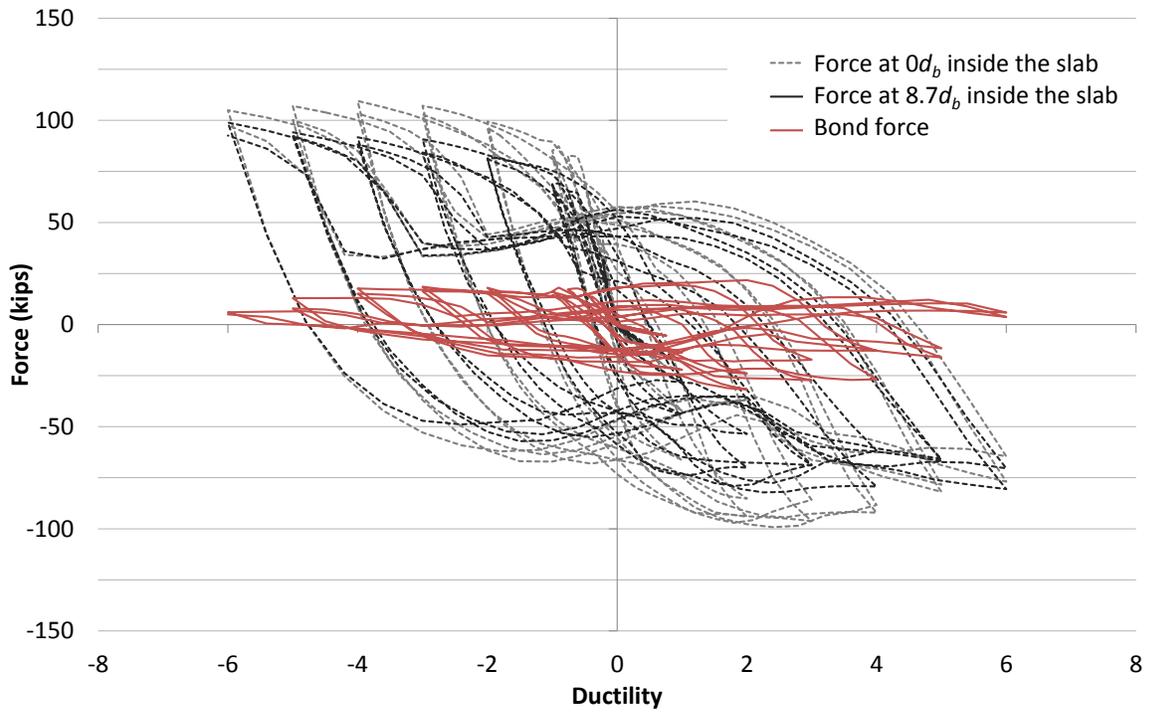
Figure 5.22 – Forces in longitudinal Bar 1 from FEA (microplane) of Specimen #2

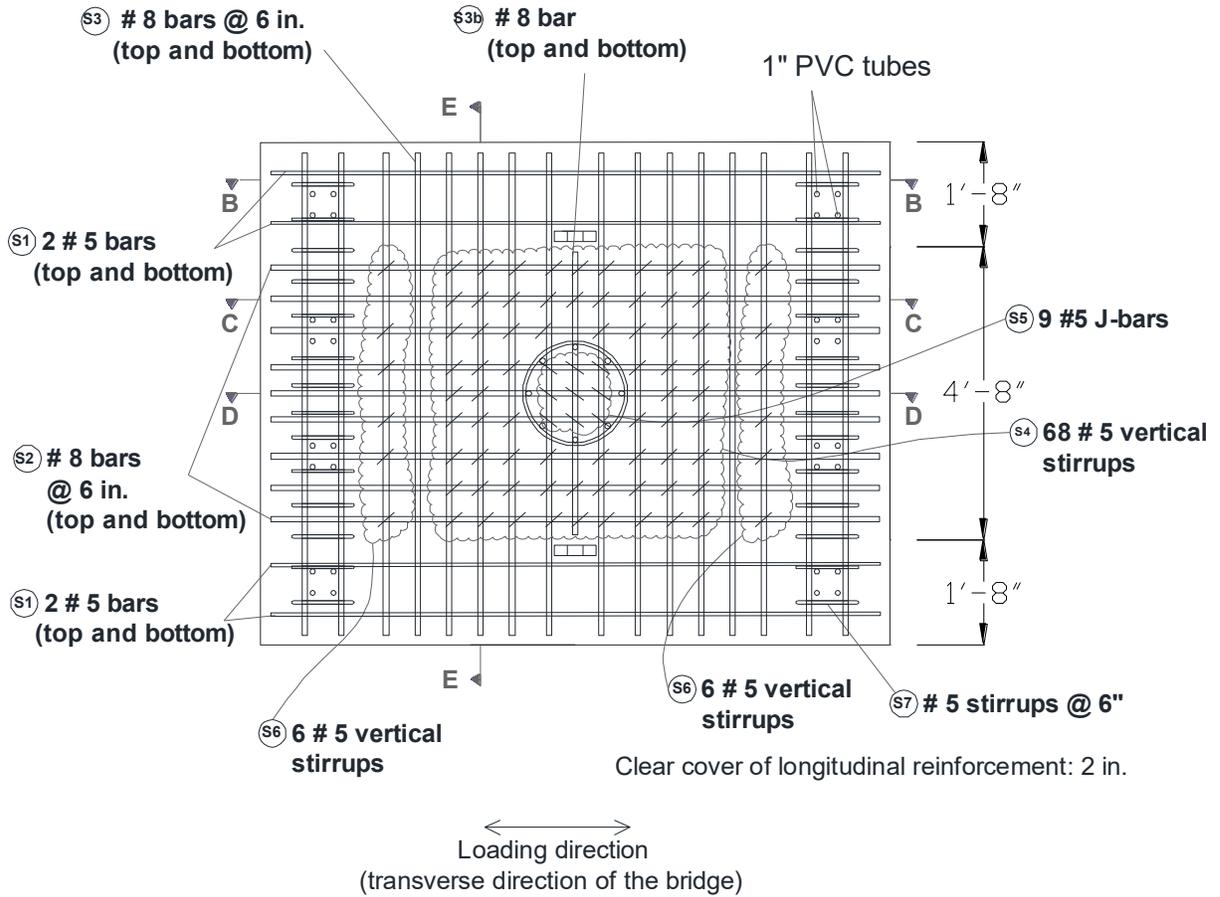
Figure A.2 – Plan view of slab reinforcement for Specimen #1

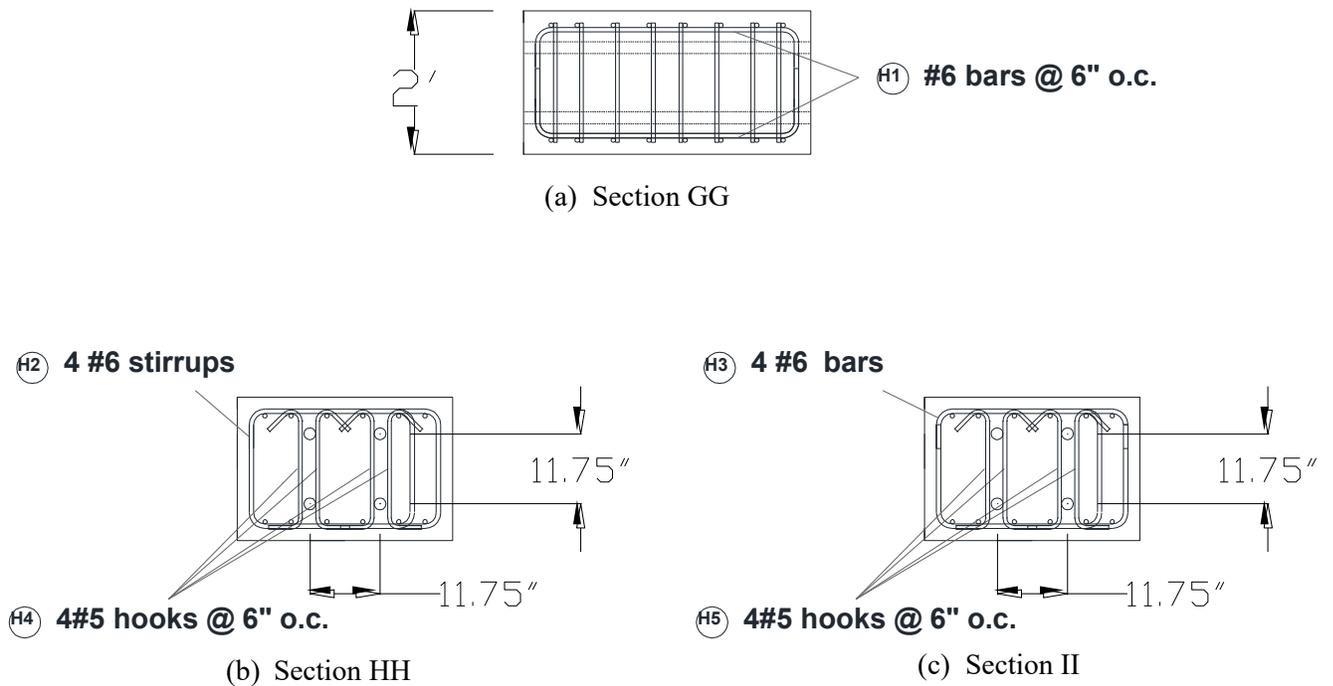
Figure A.8 – Elevation views of head reinforcement at different sections for Specimen #1 (same for Specimens #2 and #3)

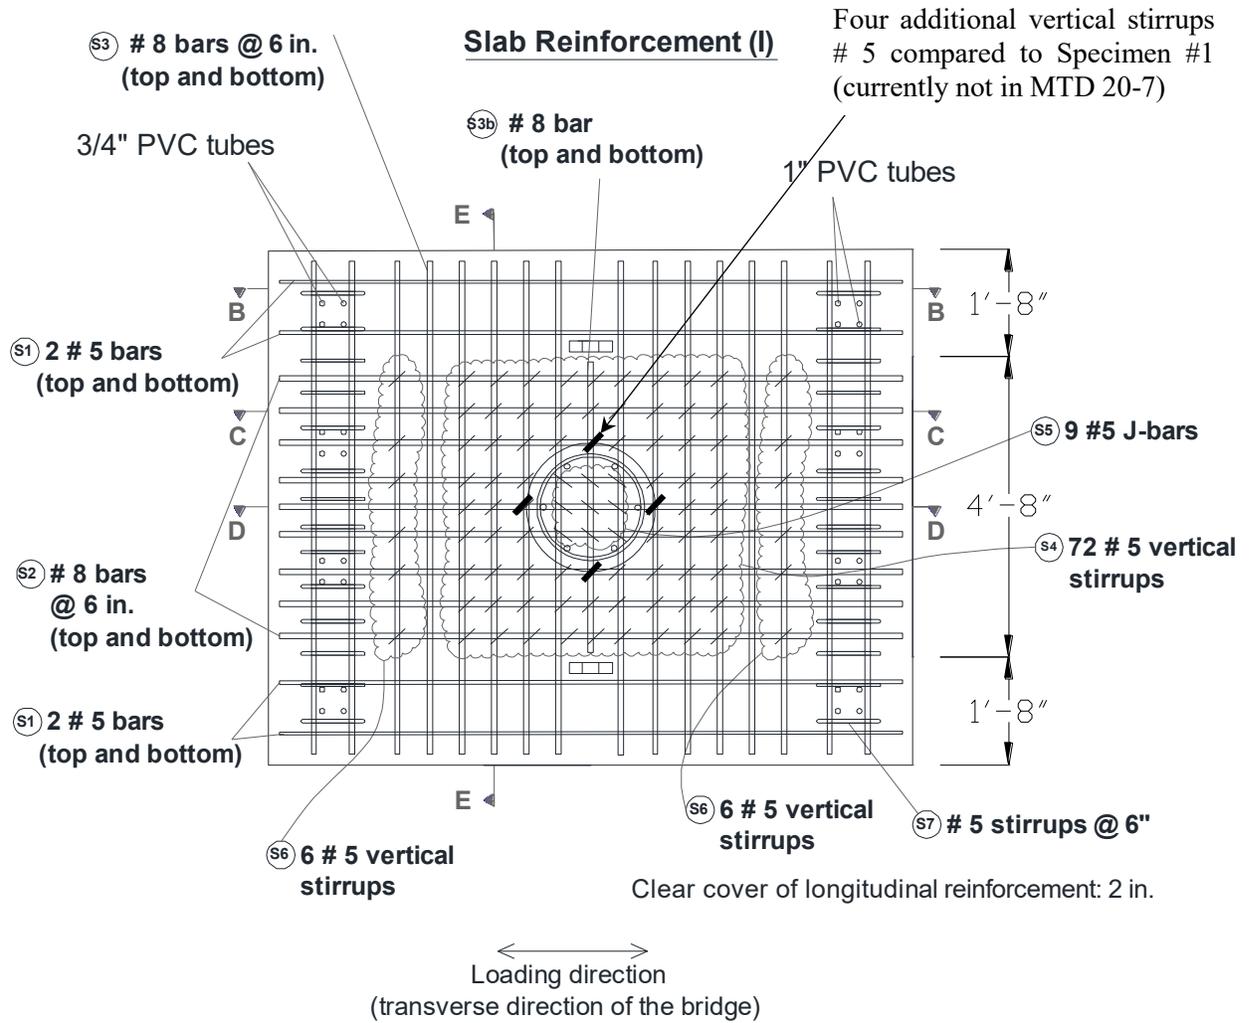
Figure A.10 – Plan view of slab reinforcement for Specimen #2

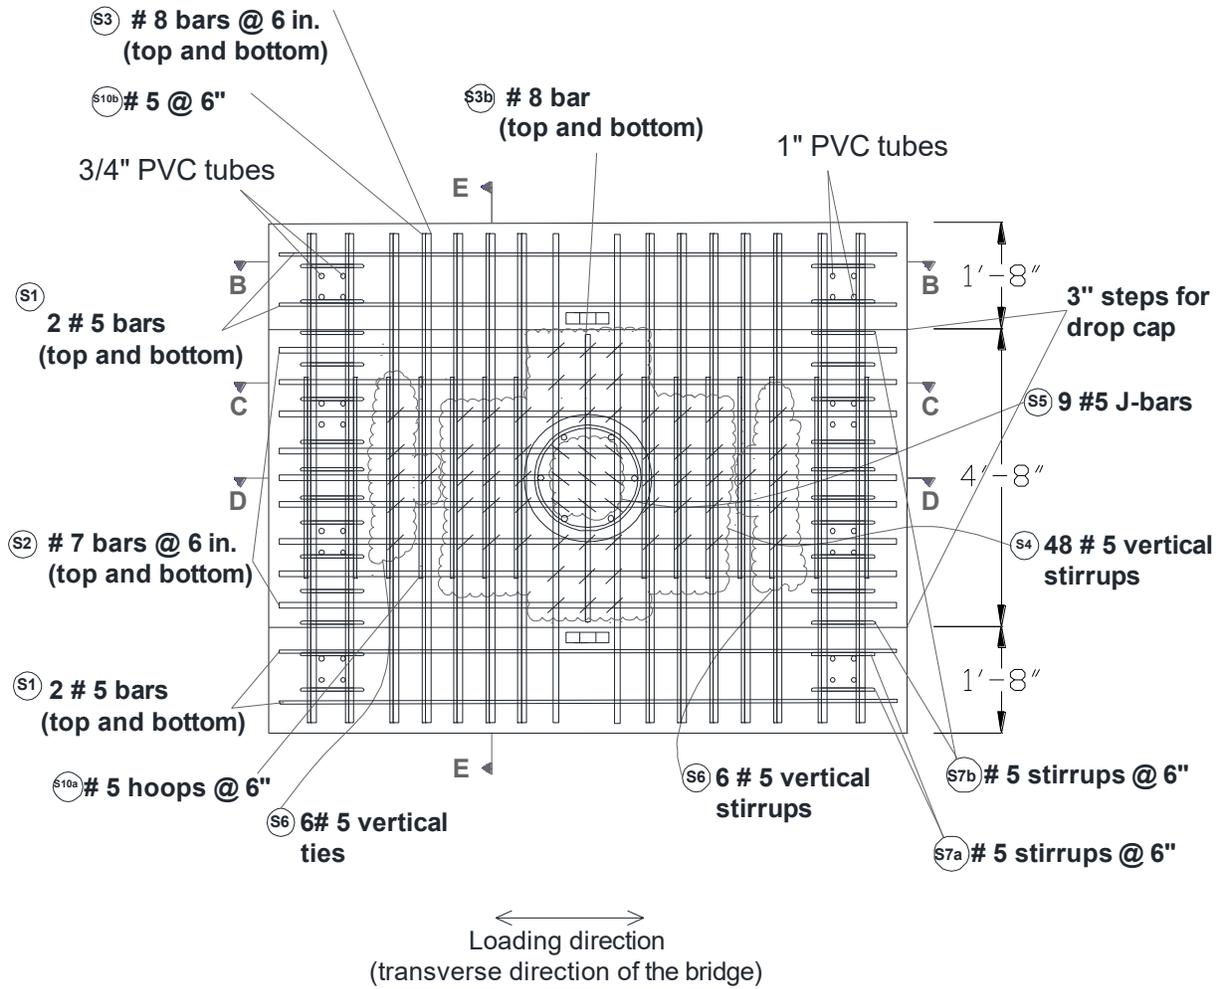
Clear cover of longitudinal reinforcement: 2 in.

Figure A.17 – Plan view of slab reinforcement for Specimen #3
