1. Report No. CA15-2560		2. Government Accession No.		3. Recipient's Catalog No.	
4. Title and Subtitle Development Length for Headed Bars in Slab-Column Joints of RC Slab Bridges				5. Report Date 12/4/2015

Report No.
SSRP-15/10

**Development Length for Headed Bars in
Slab-Column Joints of RC Slab Bridges**

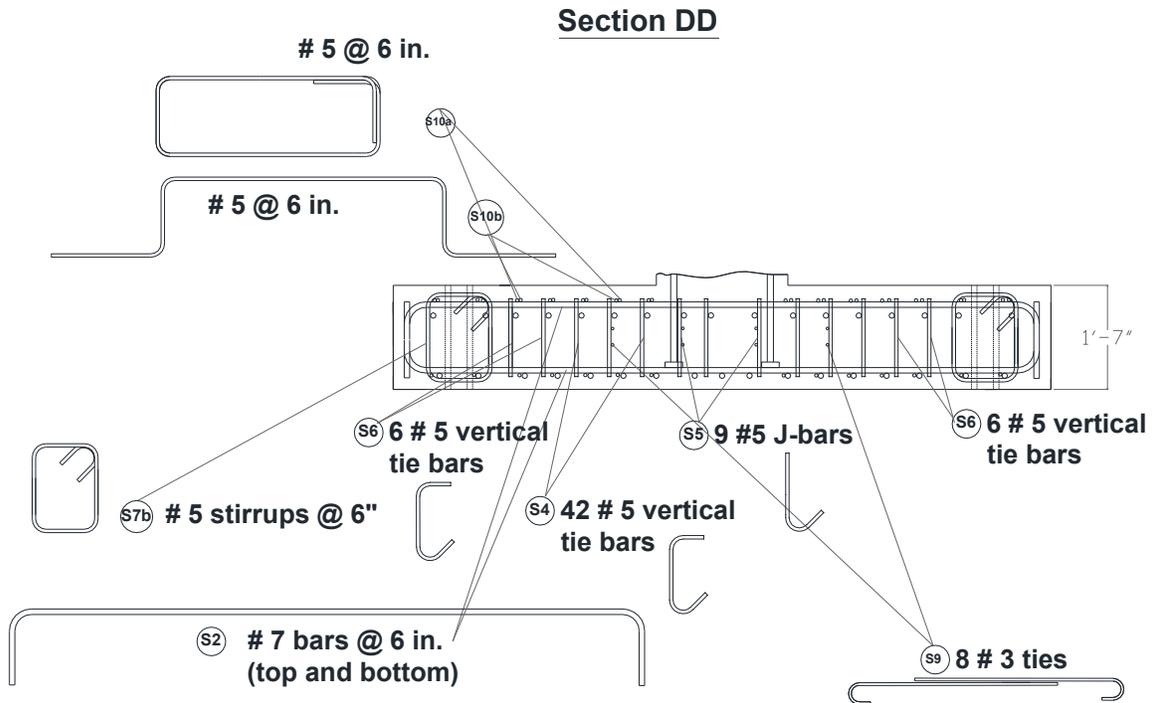
Figure A.20 – Elevation view of slab reinforcement at Section DD for Specimen #3

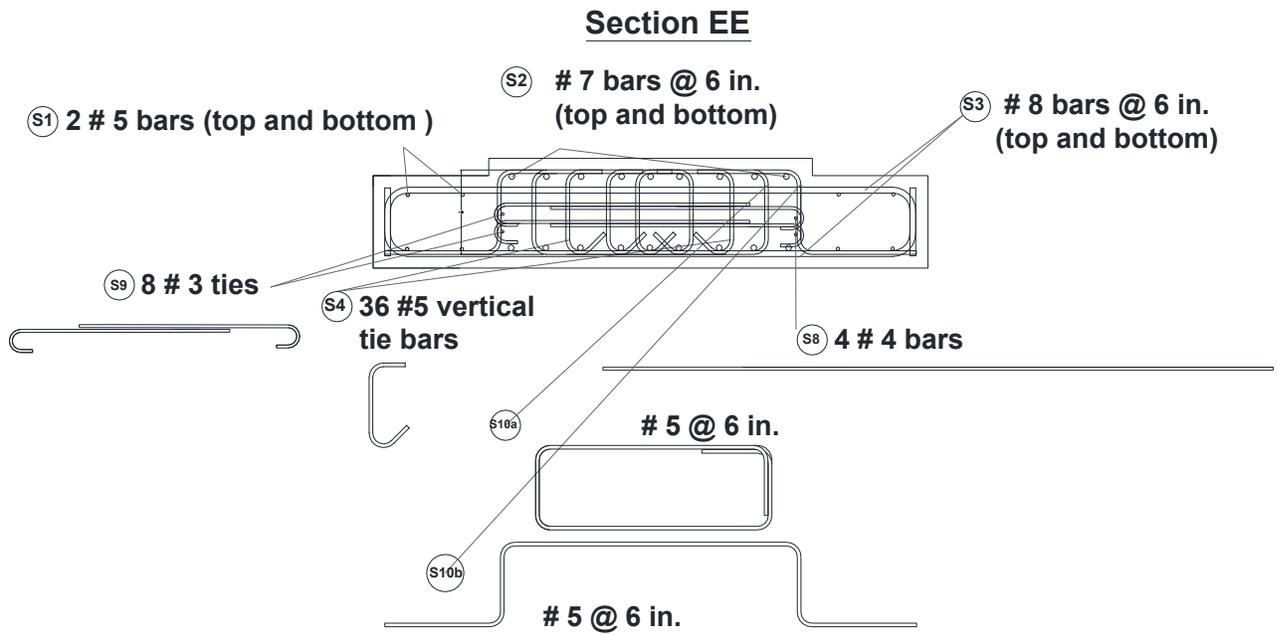
Figure A.21 – Elevation view of slab reinforcement at Section EE for Specimen #3

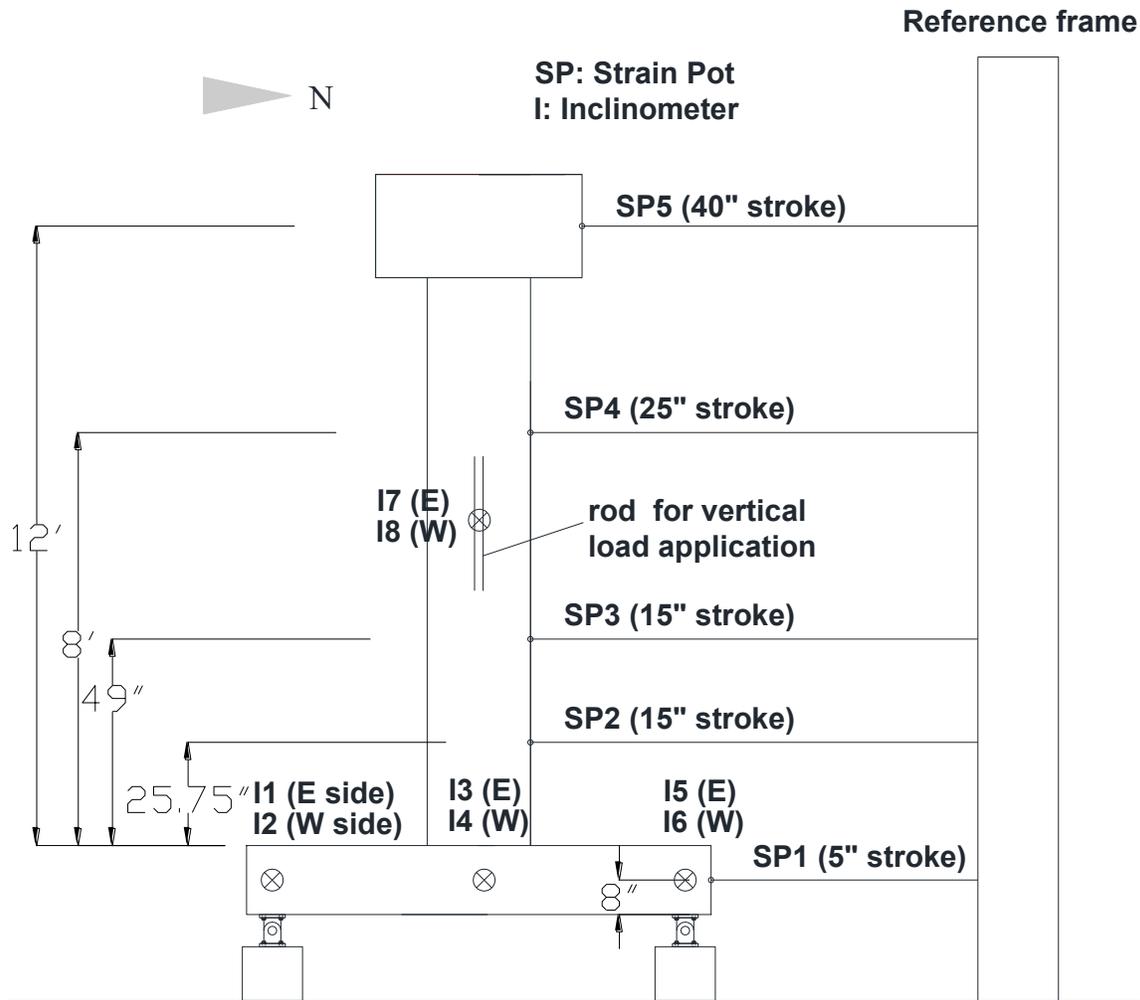
Figure A.25 – Strain pots and inclinometers mounted on Specimens #1

Displacement and rotation transducers were used to measure the lateral displacement of the column and the rotations of the slab. Vertical displacement transducers were mounted near the base of the column to measure the rotation of the column base with respect to the slab caused by bar slip.

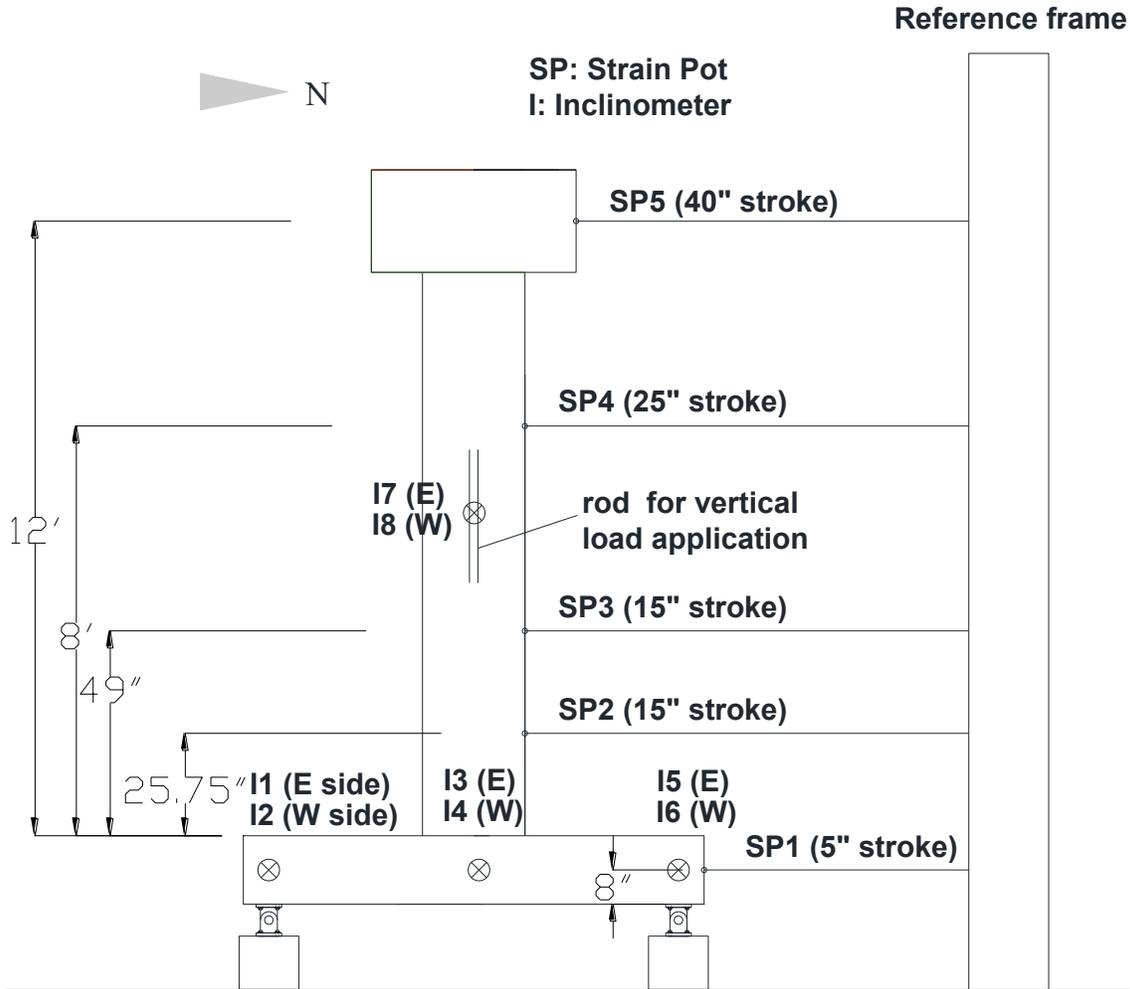
Figure A.30 – Strain pots and inclinometers mounted on Specimens #2

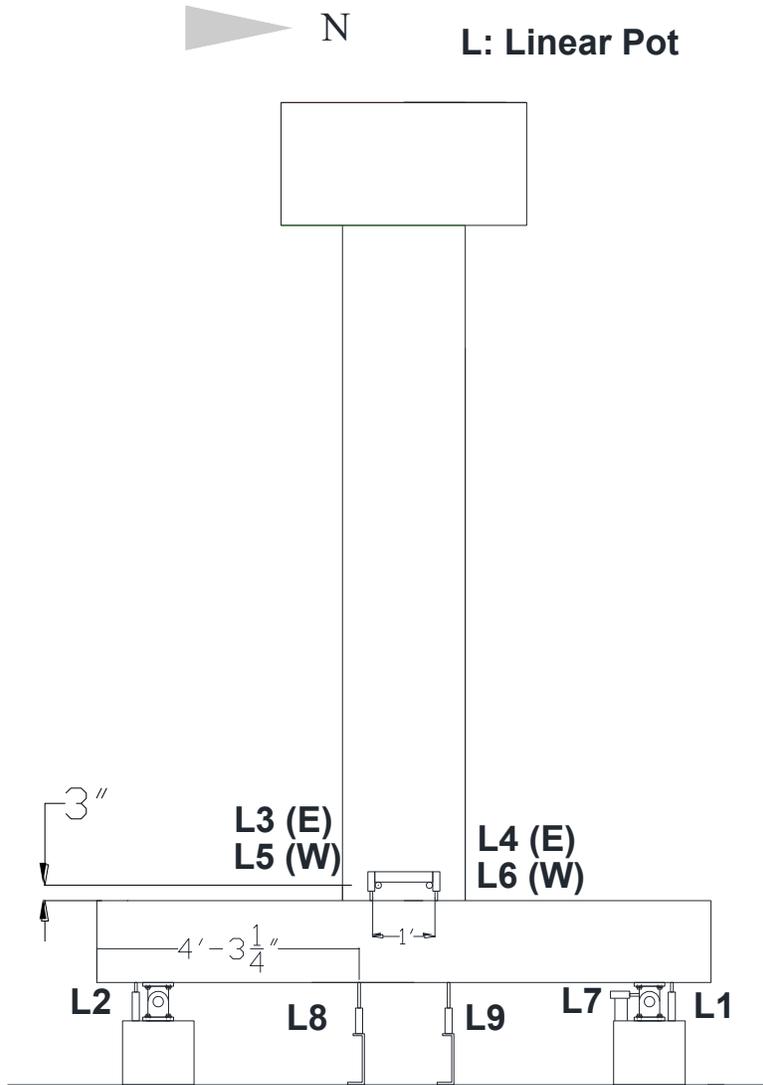
Figure A.31 – Linear pots mounted on Specimen #2

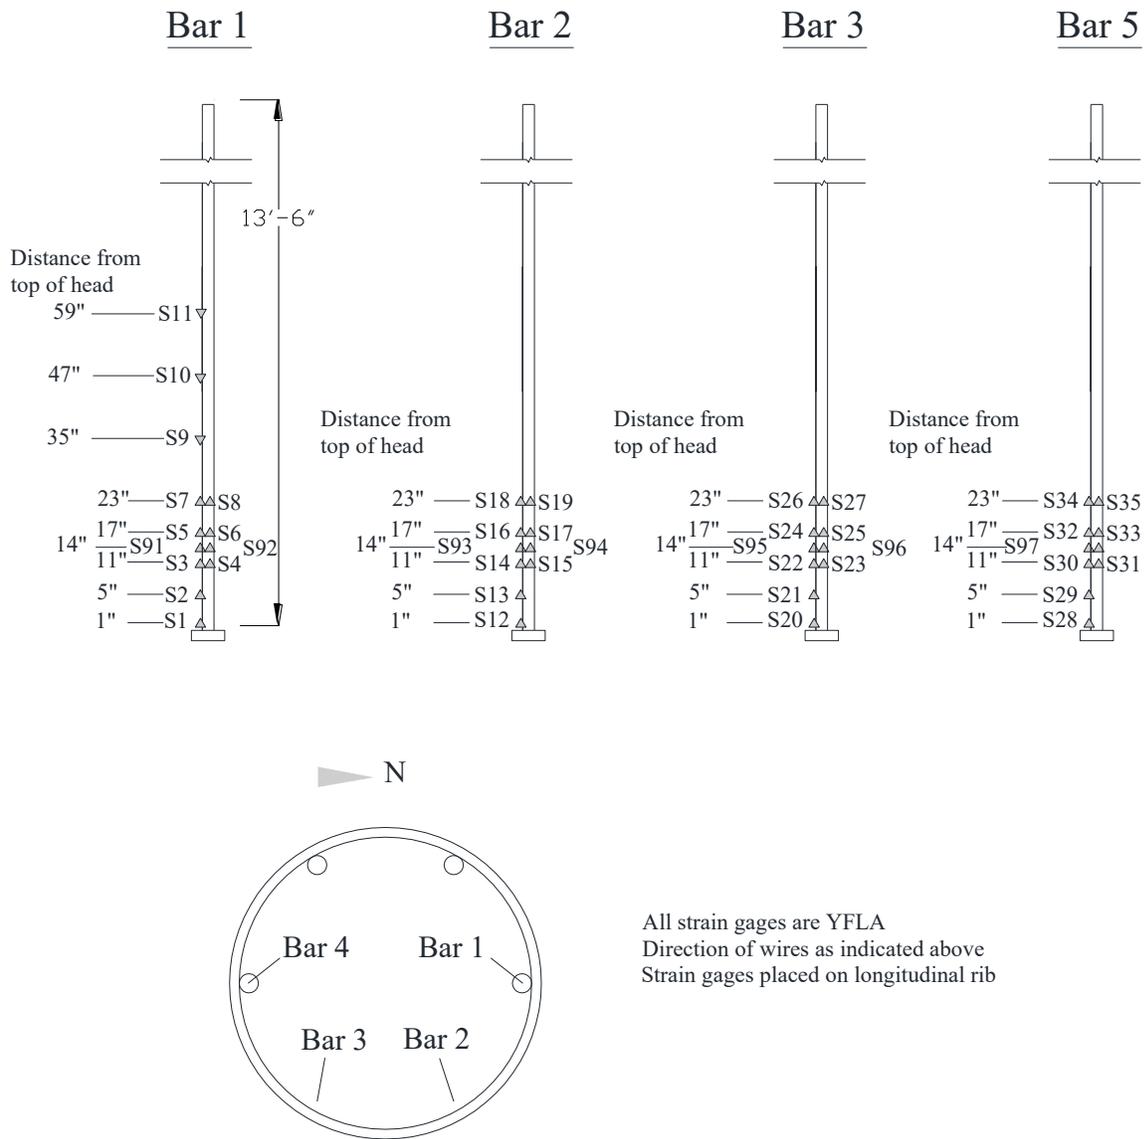
Figure A.33 – Strain gages on longitudinal bars in the column of Specimen #3

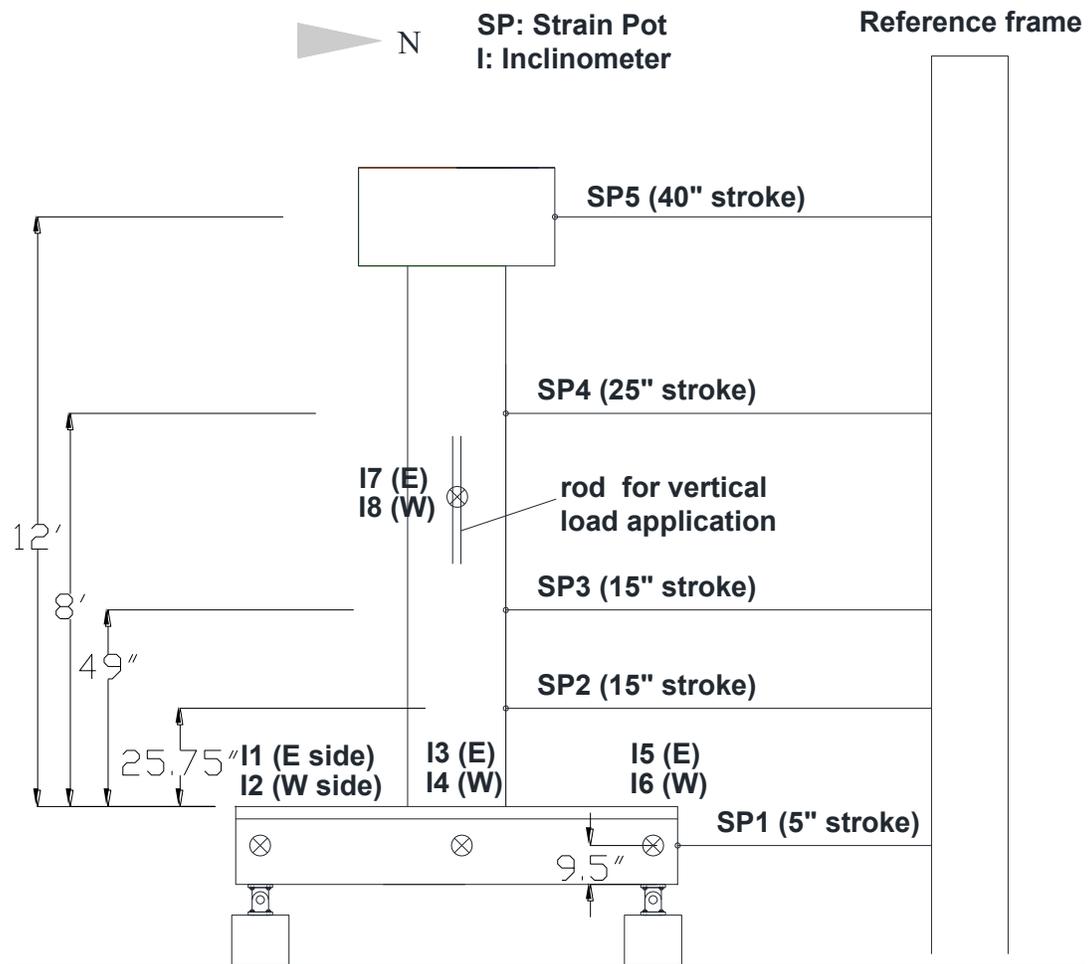
Figure A.35 – Strain pots and inclinometers mounted on Specimen #3

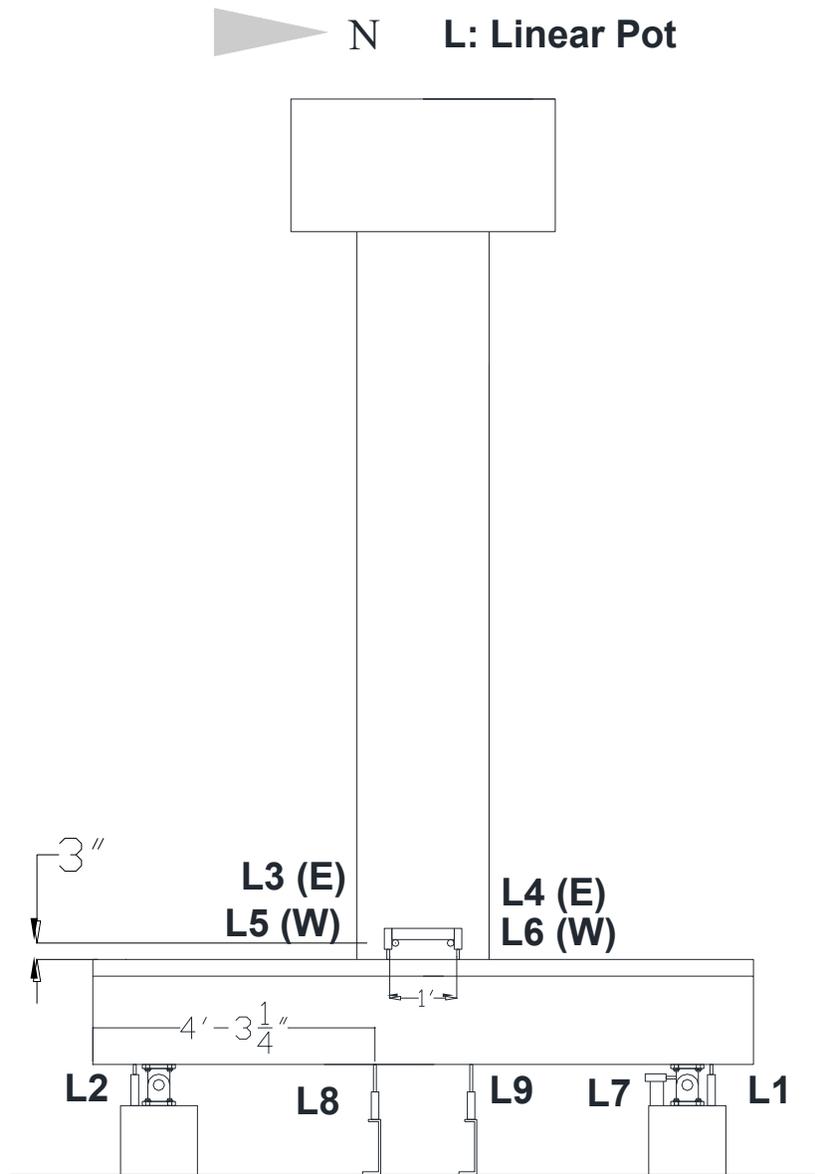
Figure A.36 – Linear pots mounted on Specimen #3.
