1. REPORT NUMBER FHWA/TX-11/9-1526-1	2. GOVERNMENT ASSOCIATION NUMBER	3. RECIPIENT'S CATALOG NUMBER
4. TITLE AND SUBTITLE Fatigue Life of Steel Base Plate to Pole Connections for Traffic Structures	5. REPORT DATE January 2011; Revised July 2011

Fatigue Life of Steel Base Plate to Pole Connections for Traffic Structures

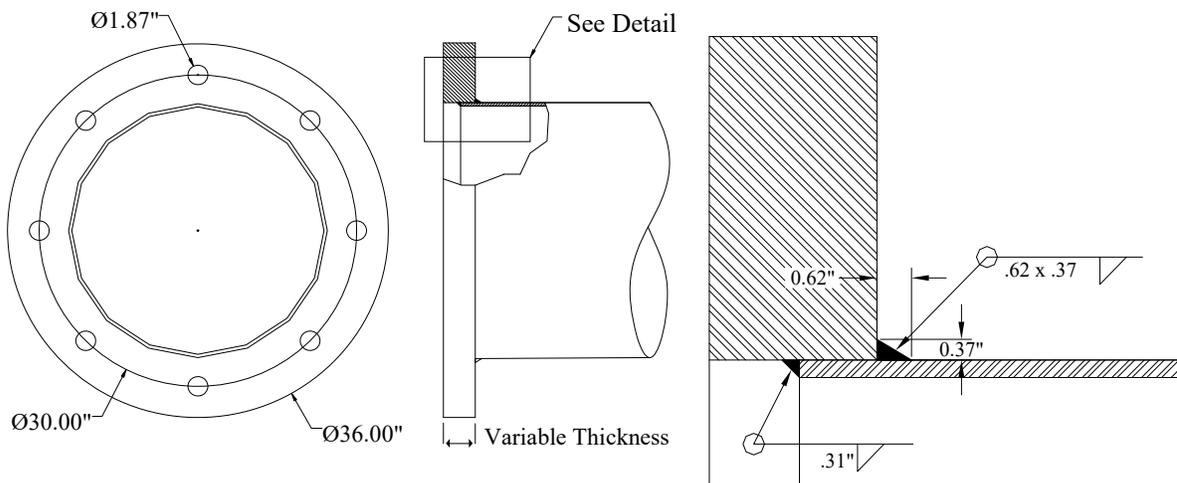
The socket connection, shown in Figure 1.1, is made using fillet welds at the top and bottom of the base plate. Experimental and analytical evaluations have shown that the fillet weld on the outside of the shaft where the shaft enters the hole or socket in the base plate transmits most of the load into the base plate. The interior fillet weld at the end of the shaft seals the interface of the shaft and base plate from corrosion. The socket connection is widely used in the industry for both high-mast and mast arm base plate connections.

Figure 1.1: Socket Connection

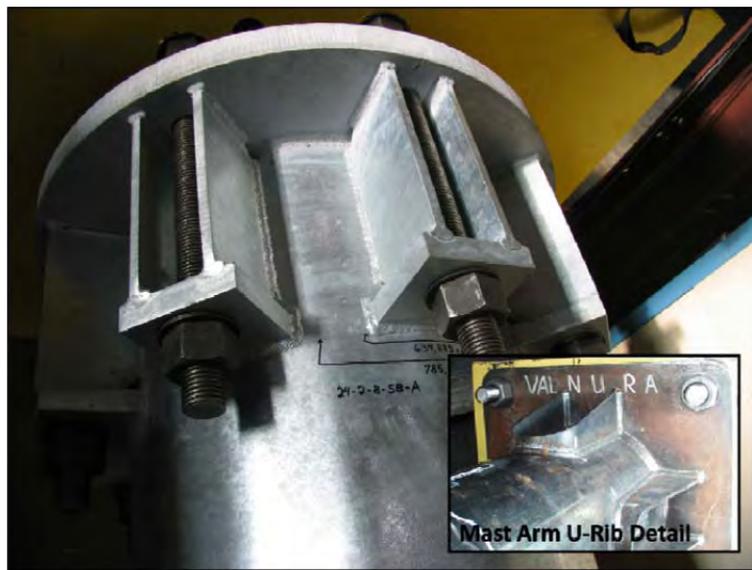
Variations on the socket connection are shown below. External stiffeners have been used to stiffen the connection. Both plain tapered stiffeners and U-shaped stiffeners have been employed. The U-shaped stiffener, shown in the inset of Figure 1.2, provides improved fatigue performance. The stool base connection in Figure 1.2 stiffens the connection similar to the U-shaped stiffener and reduces the concentration of forces at the anchor bolt locations. External collars or ground sleeves are used to provide a uniform increase in stiffness around the shaft.

Figure 1.2: U Rib Stiffener and Stool Base Details

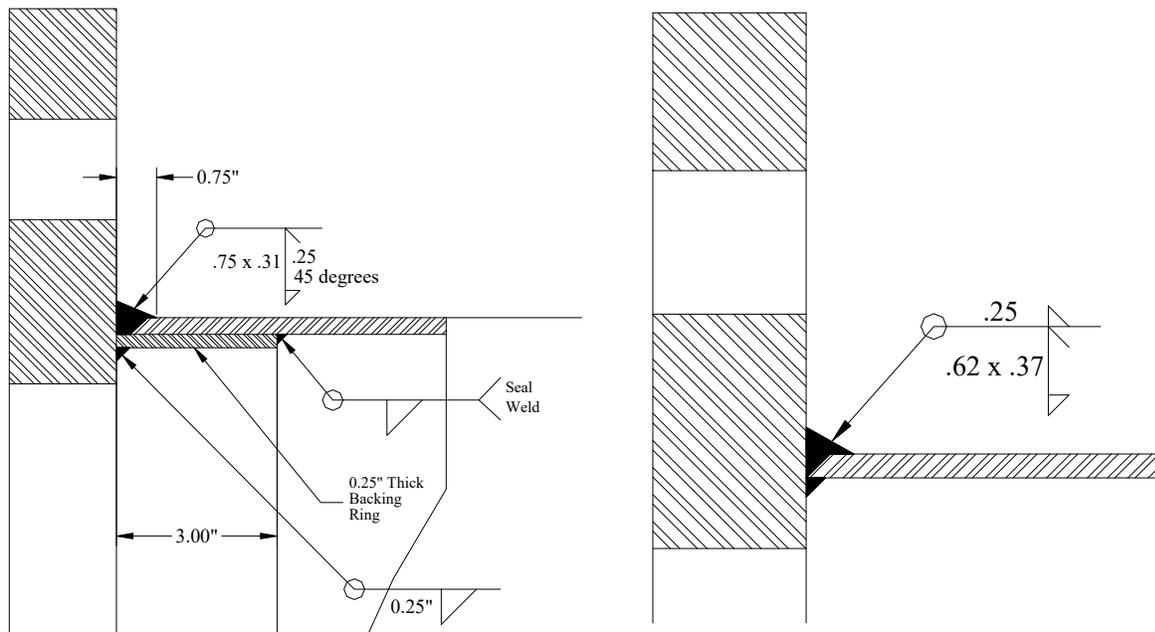
Full penetration welds have also been specified for the connection of the base plate. Several full penetration weld details are shown in Figures 1.3 and 1.4. The hole in the base plate can be made smaller than the shaft diameter, increasing the stiffness of the base plate. The minimum diameter of the internal hole in Figure 1.3 is governed by the access required to weld the internal backing welds. A minimum diameter of 16 in. was recommended by the fabricators participating in the project. The maximum diameter of the hole is typically 4 in. less than the diameter of the shaft. Two types of full penetration weld details have been used and were tested in this project. The first, which is used by Texas and labeled as the “Texas connection” in this report, uses an internal fillet weld as backing for the external full penetration weld. This detail can only be used on the large diameter high-mast poles. The smaller diameter mast arms are not large enough to provide access to make the backing weld. Wyoming uses a backing ring to provide backup to the external full penetration weld. In the smaller mast arms, the top of the backing ring is specified to be sealed with silicone caulking after galvanizing. In the larger high-mast arms, the backing bar can be fillet welded at the top and bottom to seal the space between the backing bar and shaft wall. When a backing bar is welded at the top and bottom, it becomes a load-carrying element and acts like an internal collar. The fillet weld at the top of the backing bar becomes a structural weld, not just a seal weld. A further variation of the full penetration weld is to use a full penetration weld in conjunction with an external collar.

Figure 1.3: Full Penetration Weld Detail—Texas on Right, Wyoming on Left

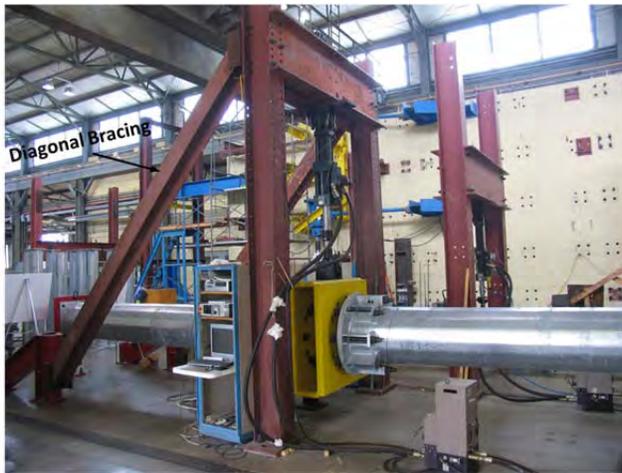
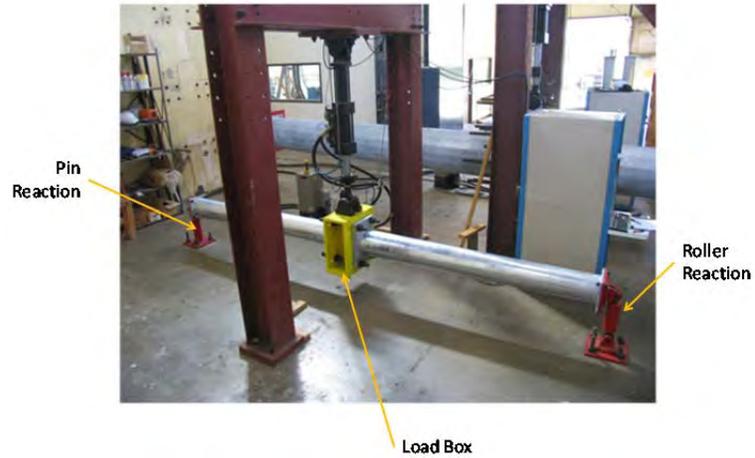
When the ram applied a compressive (downward) force into the coupled masts, the rotational and translational freedoms permitted by these joints would cause the masts to rotate about their long axis rather than forcing them into the desired positive curvature. As the masts rotated, the inclination of the ram created a lateral force, only worsening the instability. As a result, the ram was used only to apply tensile forces, and all fatigue stresses at the top fibers of the masts were tensile.

Figure 2.3: Portal Loading Frame High-mast and Mast Arm Tests

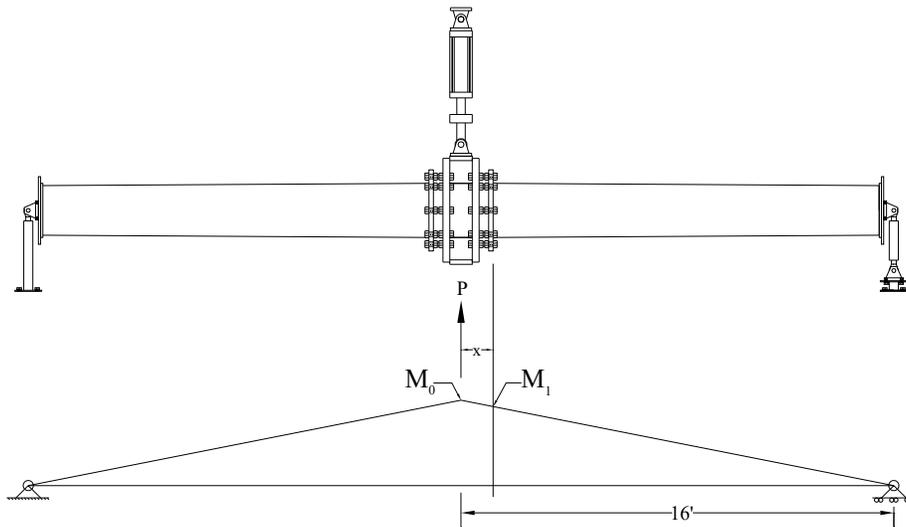
The simple elastic bending formula of $\sigma = Mc/I$ was used to correlate top fiber nominal stresses and bending moments. In this formula, M is the bending moment at the location of the weld, I is the section's second area moment (moment of inertia or MOI) at that location, and c is the distance separating the section's top fiber and centroid. Moment ranges were calculated for the prescribed maximum and minimum nominal stresses and converted to loading ranges using the horizontal distance separating the loading location and weld toe. The moment M_1 , shown in Figure 2.7, is the nominal moment used to calculate the desired load range.

Figure 2.7: Moment Diagram for Calculating Testing Loads (Rios, 2007)

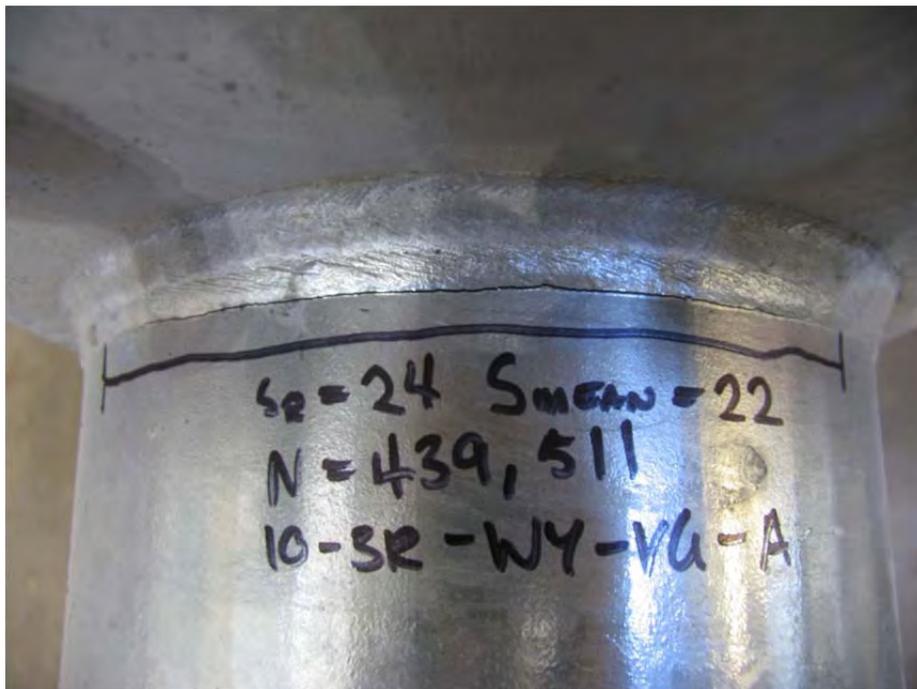
Full penetration details typically failed at the weld toe. A typical failure is given in Figure 3.1. The crack initiated at the top of the tension region and propagated down either side of the mast arm, perpendicular to the maximum principal tension.

Figure 3.1: Typical Weld Toe Failure of a Full Penetration Connection

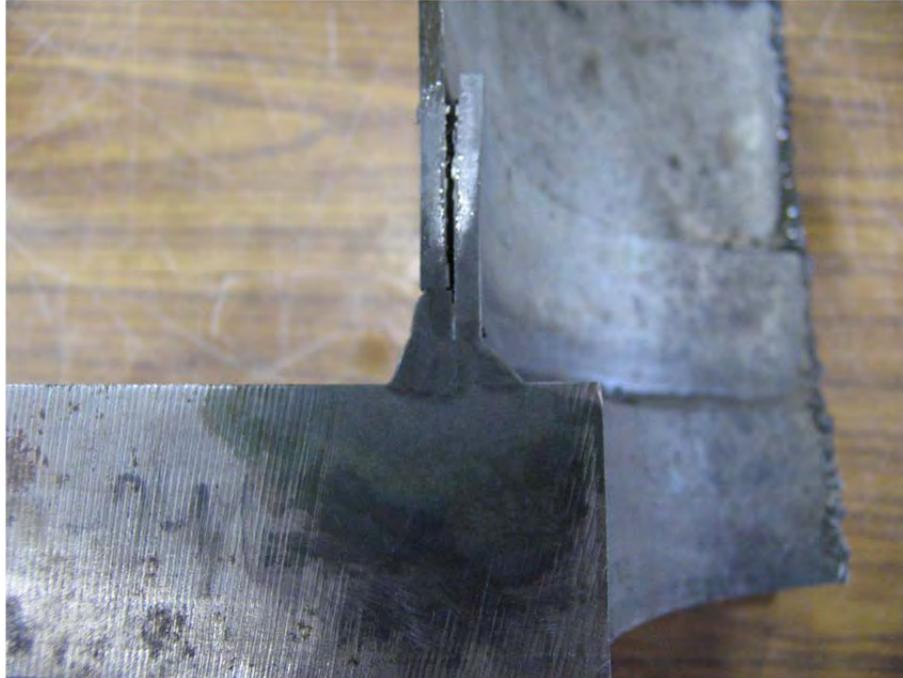
An etched cross section of a typical full penetration detail is given in Figure 3.2.

Figure 3.2: Cross Section of a Typical Full Penetration Connection

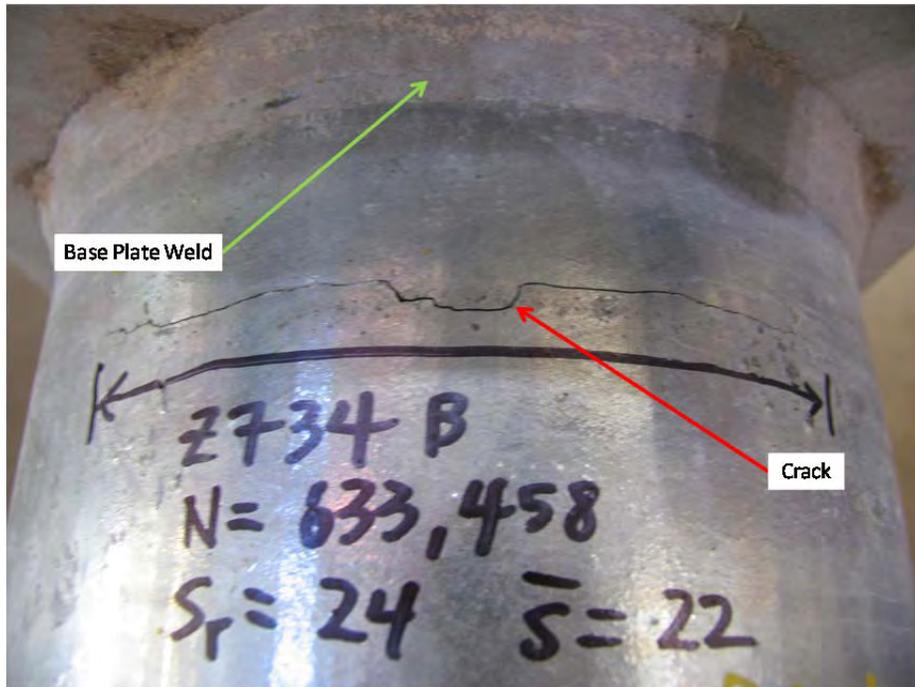
Several specimens had fillet welds at the top of the backing bar. All specimens with fillet welds at the top of the backing ring failed at the toe of the fillet weld. A typical failure is seen in Figure 3.3.

Figure 3.3: Typical Failure at a Backing Ring Fillet Weld

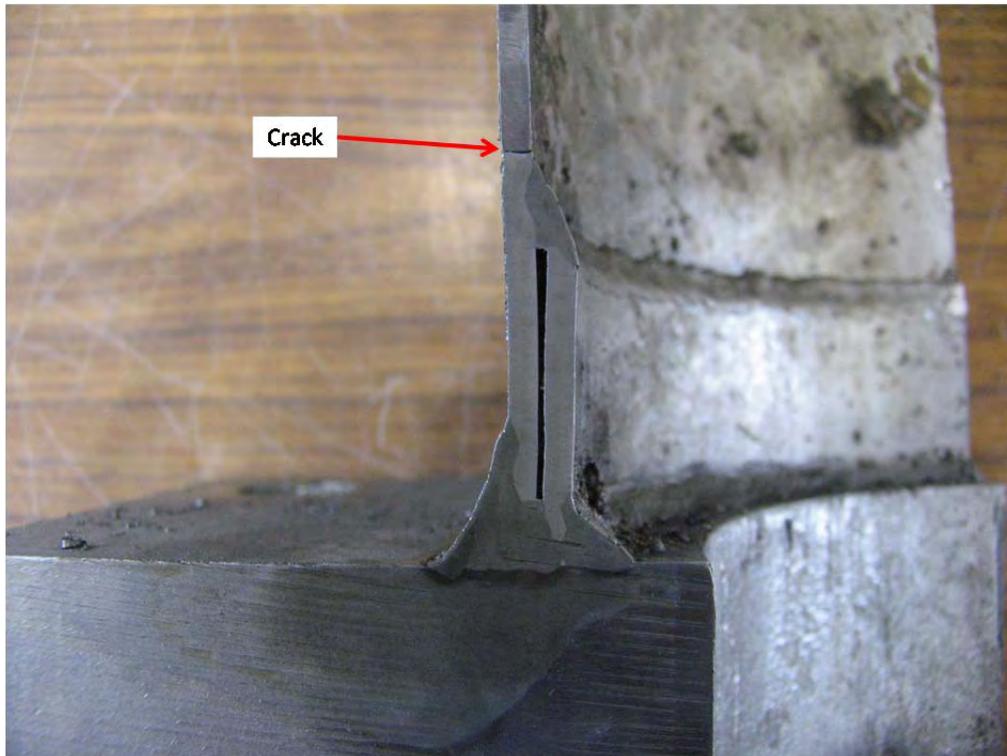
An etched cross section of a failed full penetration specimen with a fillet weld at the top of the backing ring is shown in Figure 3.4.

Figure 3.4: An Etched Cross Section of a Full Penetration Connection with a Backing Ring Fillet Weld

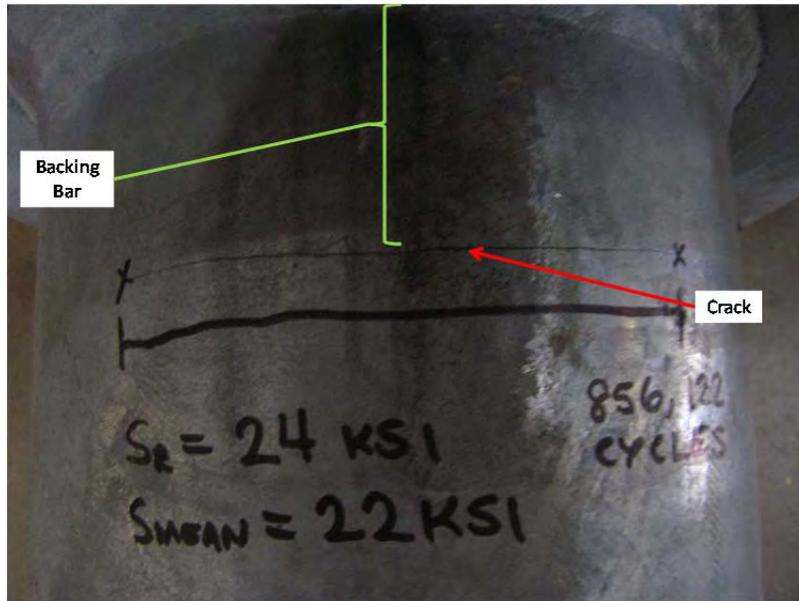
Some specimens had a tack weld connecting the top of the backing ring to the inside of the mast arm wall. Some of these tack welded specimens failed at the toe of the tack weld, while others failed at the base plate weld. A typical failure is shown in Figure 3.5 and a cross section through the crack is shown in Figure 3.6.

Figure 3.5: Typical Failure at a Backing Ring Tack Weld

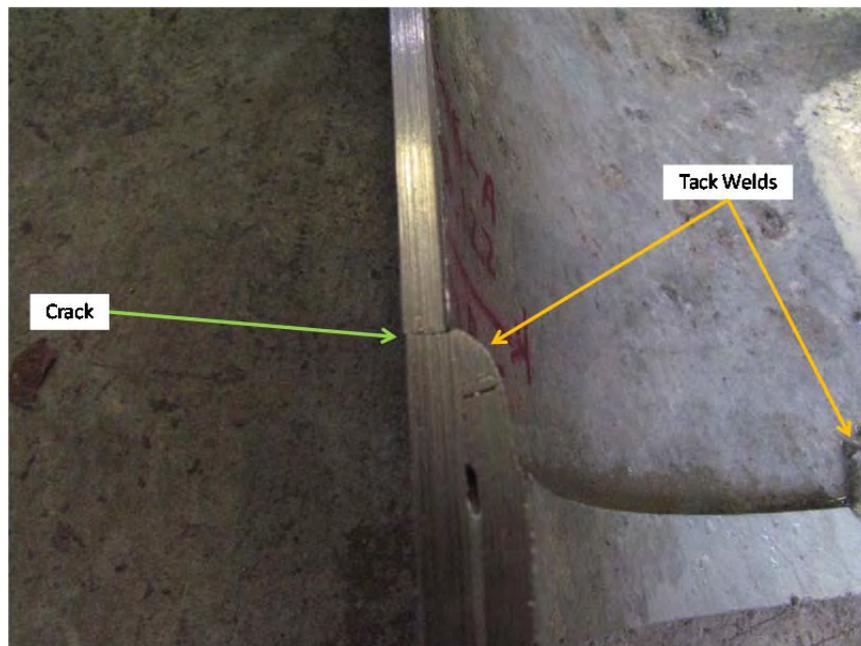
Figure 3.6: Cross Section of a Tack Weld Failure

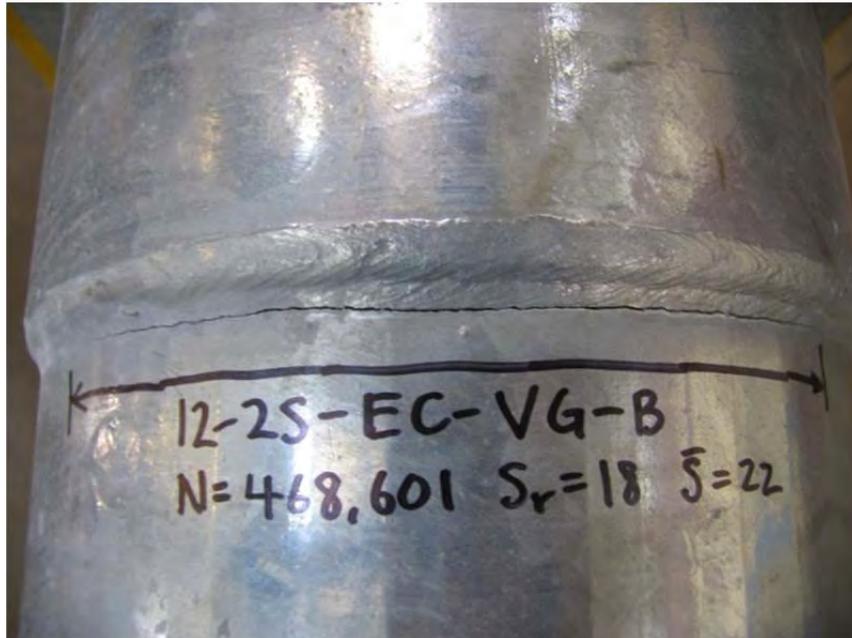
full penetration failure, the crack initiates at the extreme tension fiber and propagates down both sides, perpendicular to the maximum principle tension.

Figure 3.7: Typical External Collar Failure

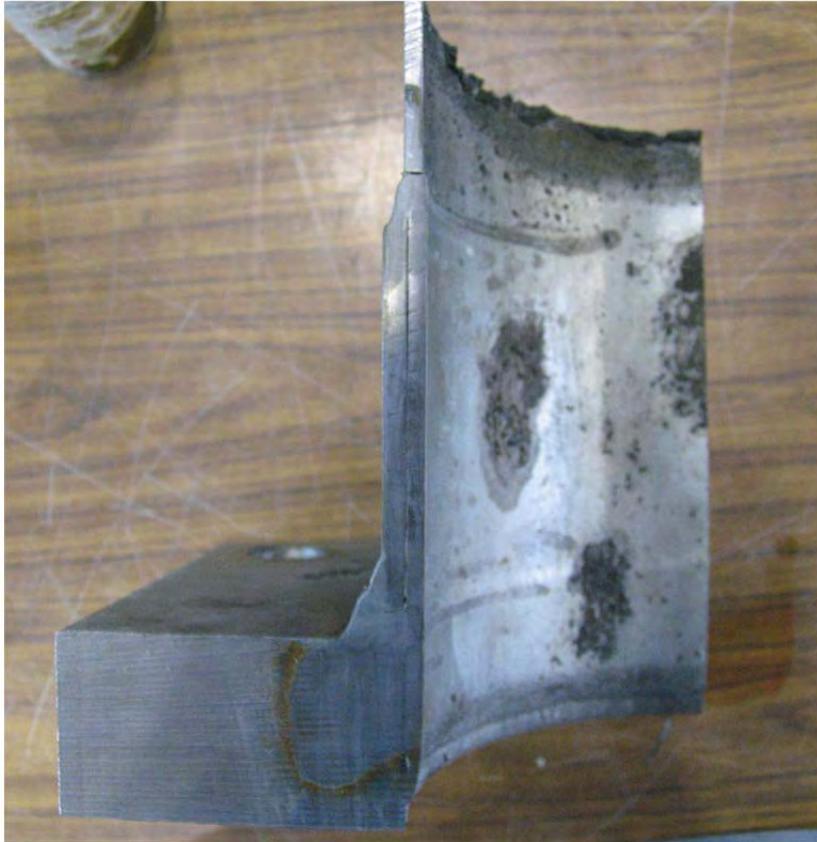
Etched cross sections of a typical external collar detail are given in Figures 3.8 and 3.9.

Figure 3.8: A Cross Section of a Typical External Collar Detail

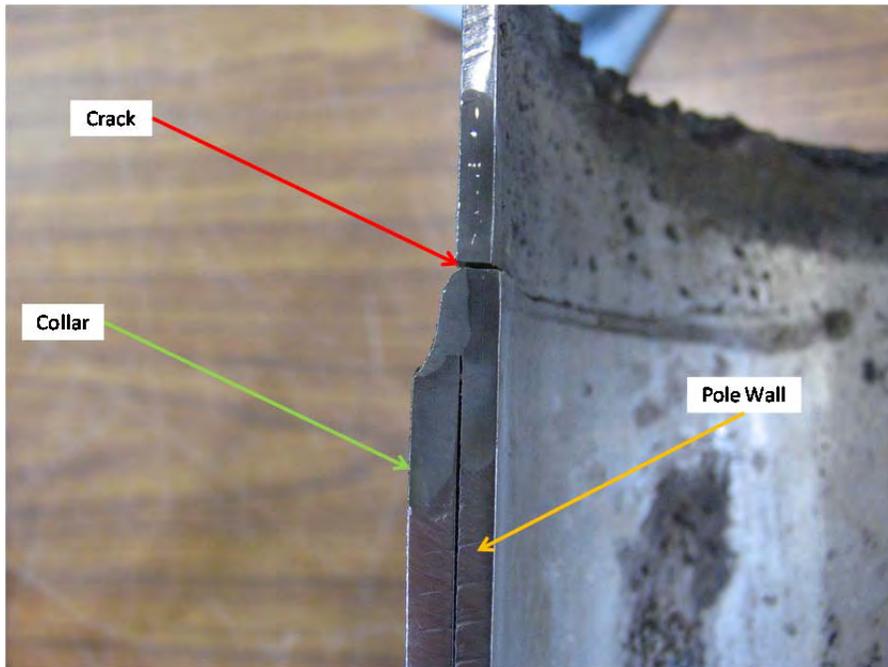
Figure 3.9: Close-up of the Collar Weld (Etched)

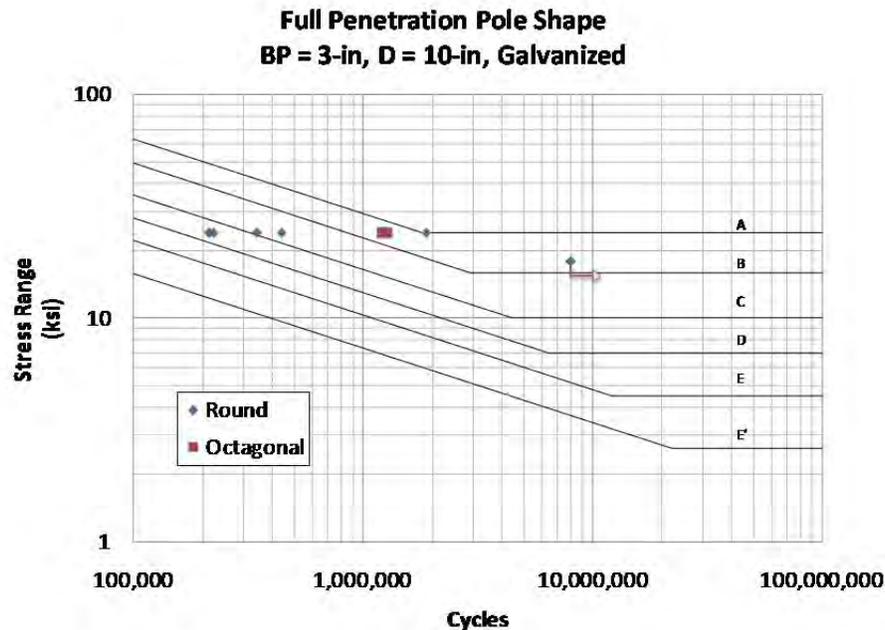
Round and octagonal mast arms with 3-in. base plates and 10-in. diameter mast arms (10-3R-WY) were studied with both full penetration details and external collar details. The influence of mast arm shape can be seen in Figure 3.10. The round full penetration detail contains data from three manufacturers. The two pairs of round specimens that performed between a Category B and a Category A were 10-3R-WY-UG (Union Metal) and 10-3R-WY-VG (Valmont). The Union Metal specimen was tested at 24 ksi to 1,873,499 cycles before failing and the two Valmont specimens experienced 8,037,420 cycles at a stress range of 18 ksi and did not fail (the two data points lie on top of each other on the graph and appear as one point). The two round data points that performed between a Category C and a Category B were the second tests of the 10-3R-WY-VG specimens, when the stress range was increased to 24 ksi. The stress range and cycle count reported for these specimens does not account for any fatigue damage that occurred during the first test at the 18-ksi stress range. This seems to be the case, because in the second test, the specimens did not perform in the same fatigue category as they did in the first test. The two round data points that performed between a Category D and a Category C were 10-3R-WY-AG (Ameron).

Figure 3.10: Comparison of Round and Octagonal Full Penetration Details

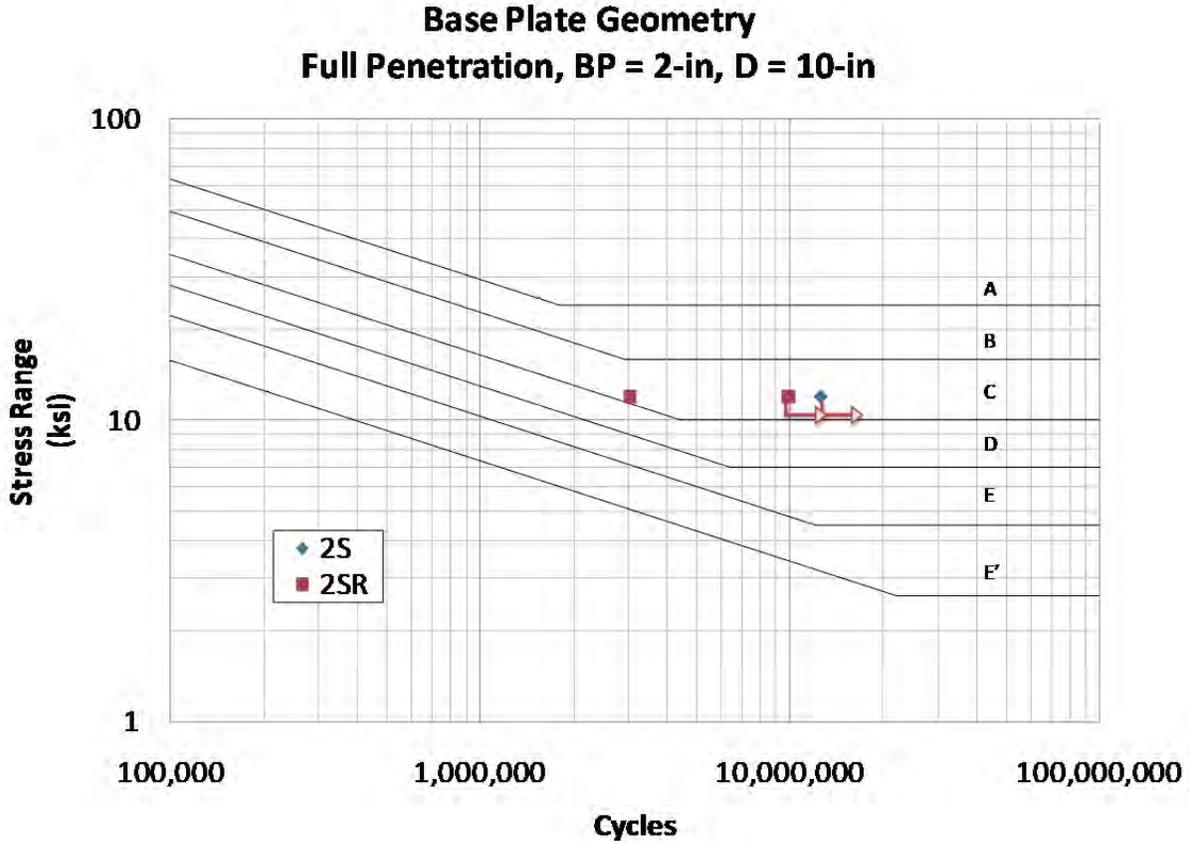
A comparison of *S* and *SR* geometries for full penetration details with 2-in. base plates and 10-in. diameter mast arms is shown in Figure 3.11.

Figure 3.11: Comparison of *S* and *SR* Full Penetration Details

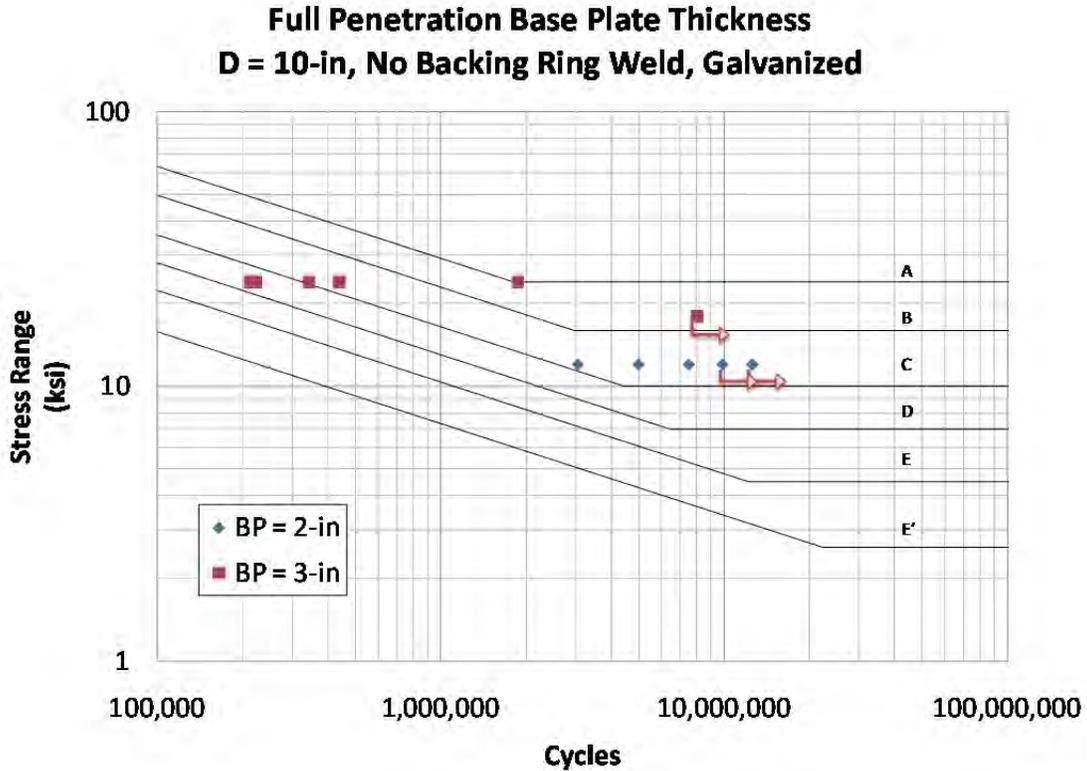
Of the 26 full penetration details, 10 had a base plate thickness of 2 in. and 16 had a base plate thickness of 3 in. The effect of base plate thickness in full penetration details is shown by the data plotted in Figure 3.14.

Figure 3.14: Comparison of 2-in. and 3-in. Full Penetration Details

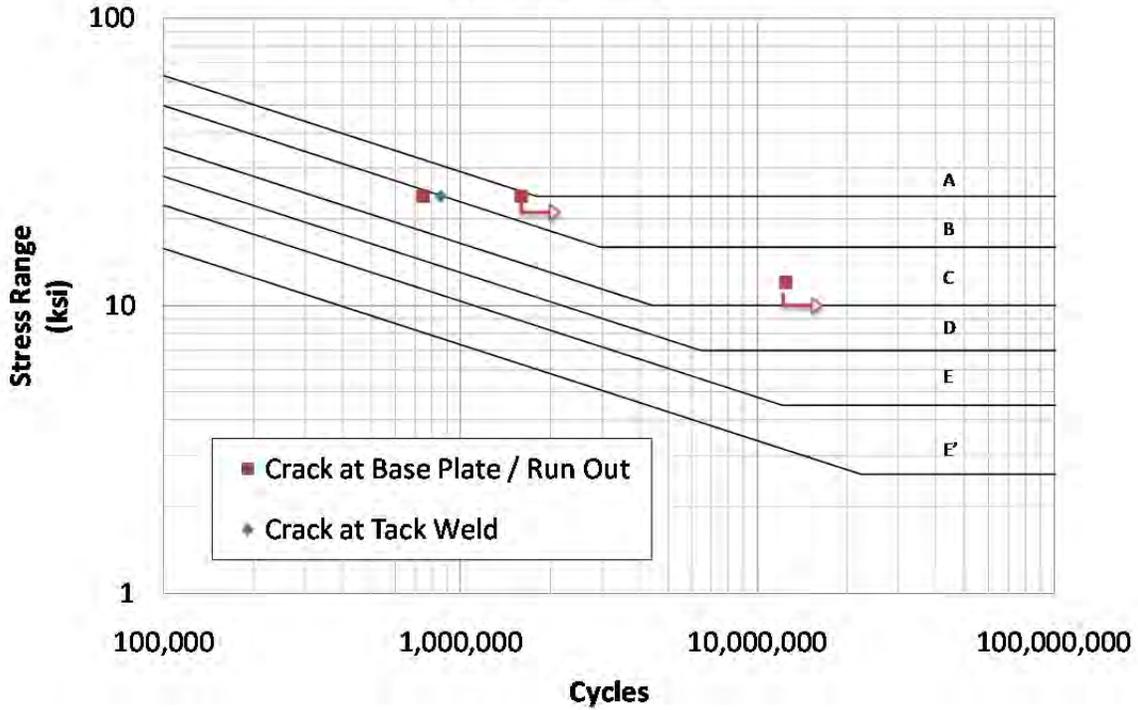
Figure 3.19: Variation of Backing Ring Welds, 8-2S-WY

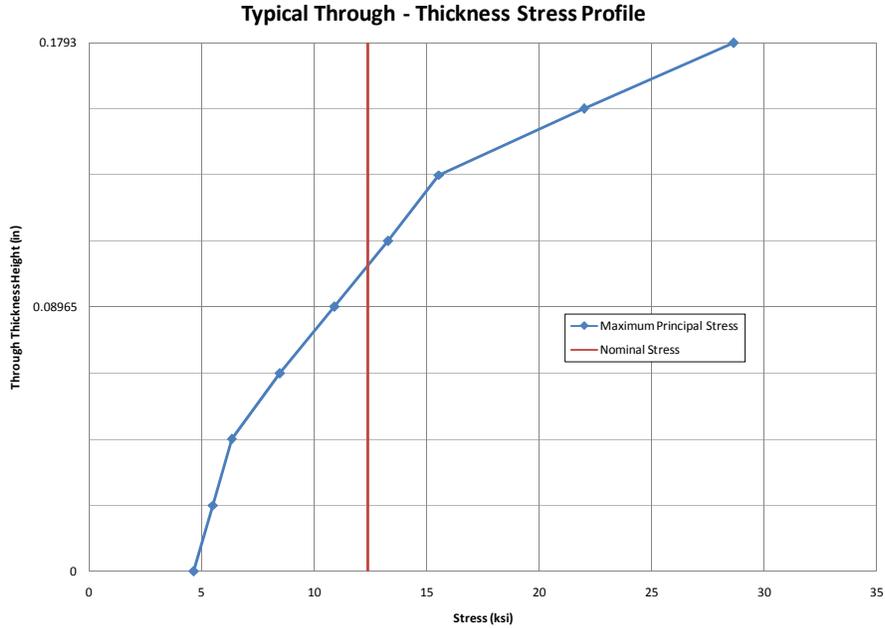
stresses at any given point will be approximately constant through the thickness. Localized curvature in the mast arm wall will induce local bending stresses in the wall, increasing the tension stresses at one edge of the mast arm wall and decreasing the tension stresses (making them more compressive) on the other side, as shown in Figure 4.1.

Figure 4.1: Typical Through Thickness Stress Profile

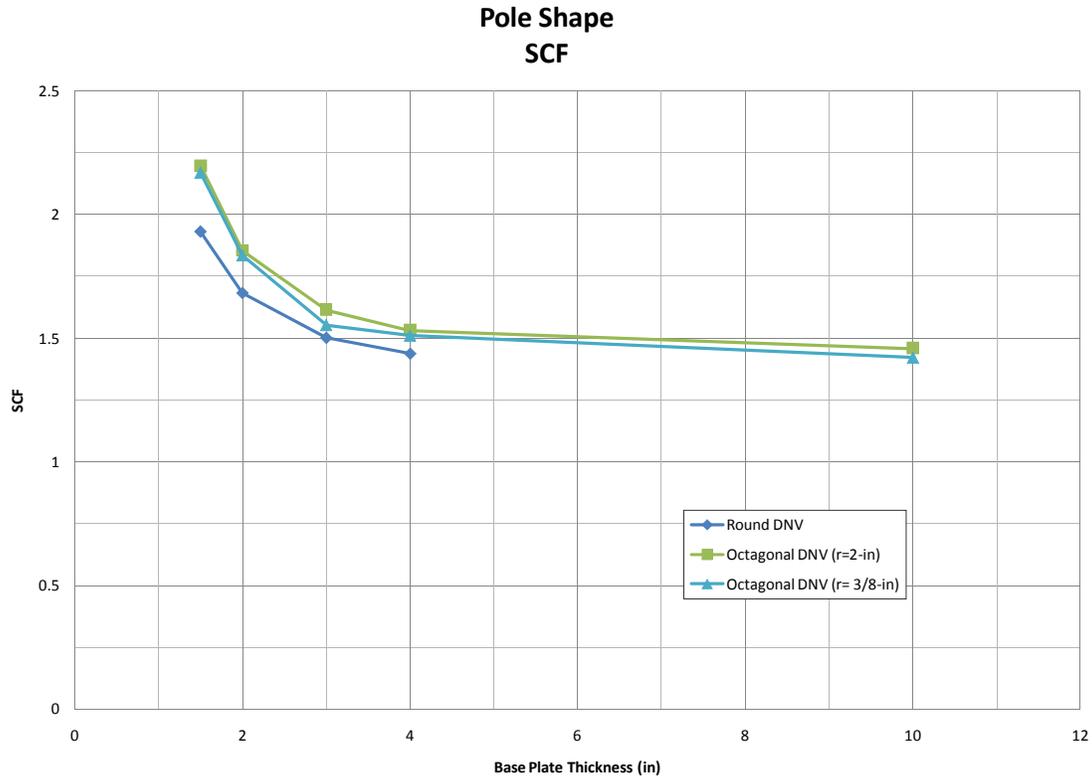
Figure 4.9: Mast arm Shape Evaluation (SCF versus Base Plate Thickness)

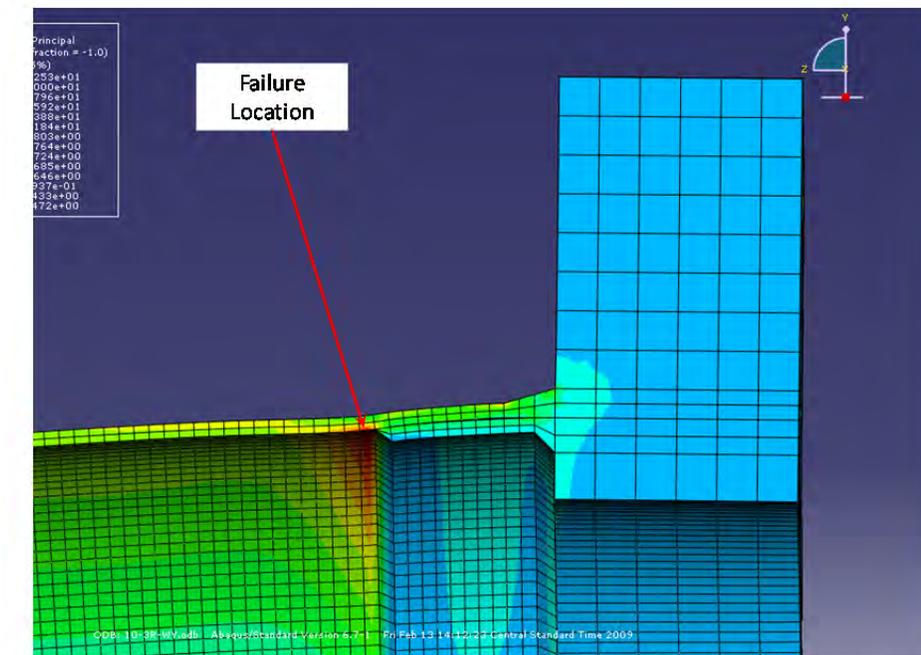
The presence of a fillet weld connecting the top of the backing ring to the inside of the mast arm wall moved the failure location away from the base plate to the toe of that fillet weld in the experimental tests. The backing ring reduces the local bending near the weld toe and provides an extra path for stress to flow through the connection. The connection is shown in Figure 4.17.

Figure 4.17: 10-3R-WY-FILLET Stress Distribution

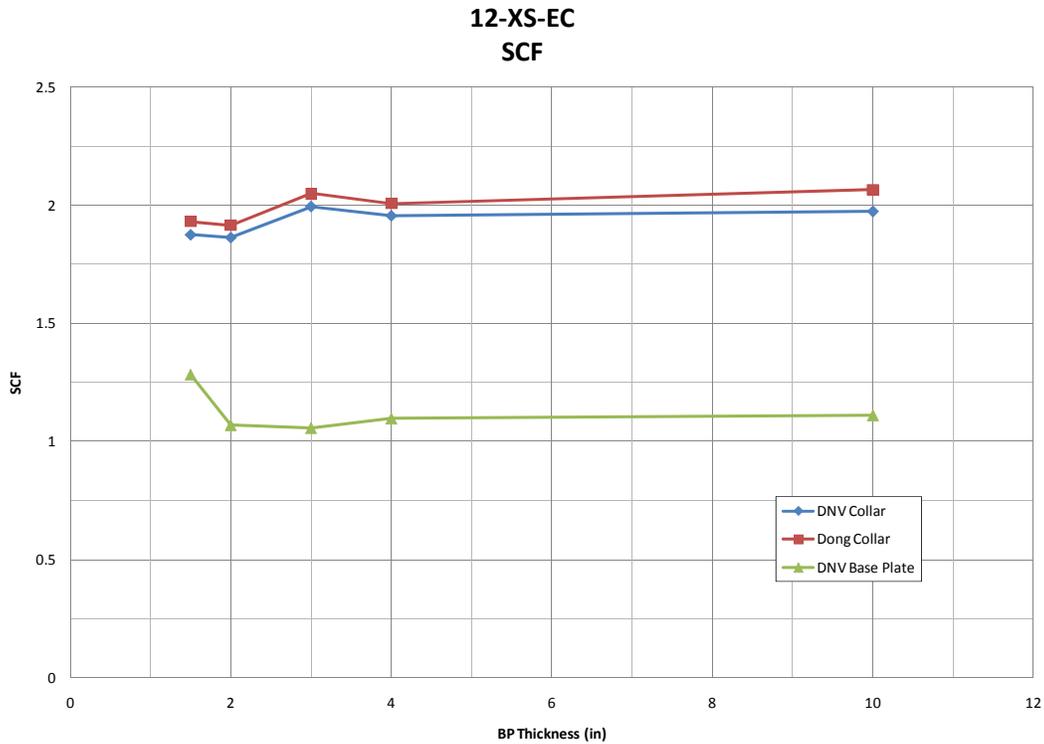
A 12-XS-EC detail was studied and results are shown in Figure 4.19.

Figure 4.19: 12-XS-EC (SCF versus Base Plate Thickness)

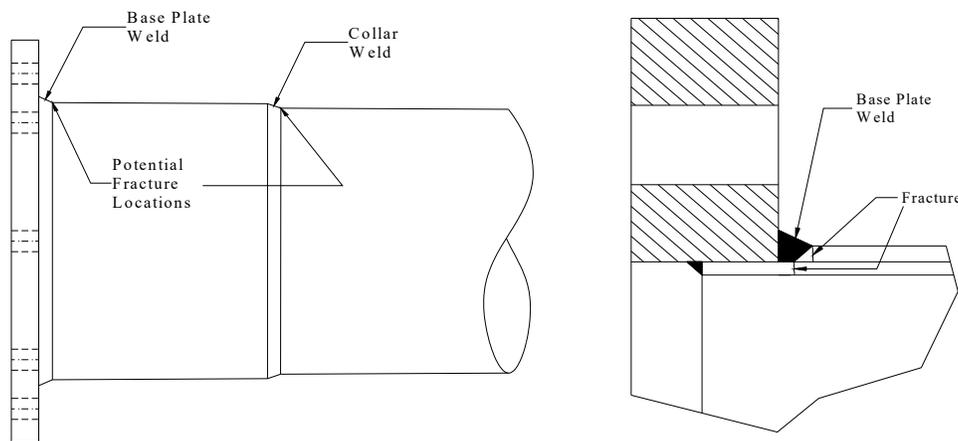
The manner in which all fractures initiated and grew was consistent, though the fracture locations varied depending on the detail (see Section 5.2). All fractures initiated at the top of the poles at a weld toe adjacent to the pole shaft (for example, in Figure 5.1, toes of either the base plate weld or collar weld), then propagated down through the shaft wall (and collar, if present). Crack growth was in the characteristic radial pattern, so once extending fully through the shaft wall, the fracture would grow along the weld toe, propagating circumferentially from either side of the initiation point. See Figure 5.1 for a schematic illustrating potential fracture locations and the weld detail for a fractured socket external collar connection.

Figure 5.1: Potential Fracture Locations and Weld Detail for Socket External Collar Connection

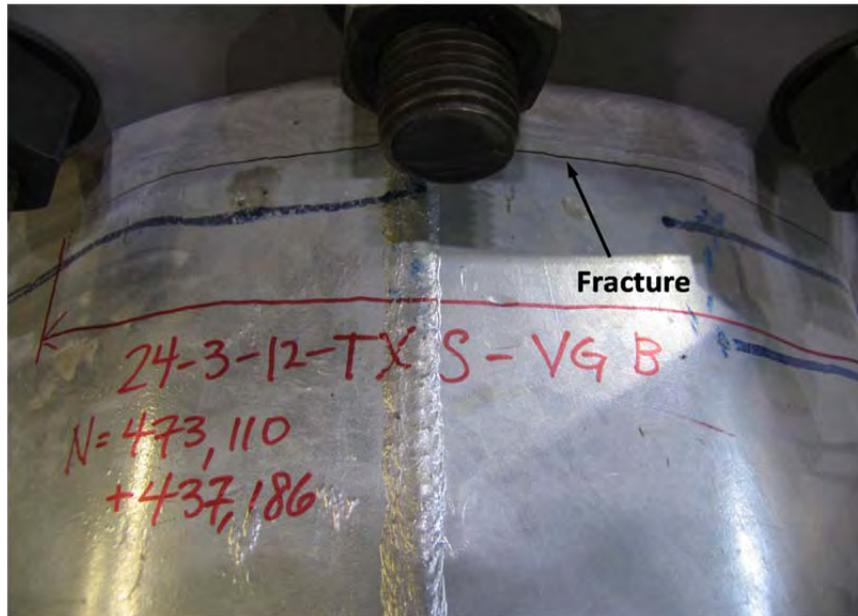
Among unstiffened specimens (no external collars or stools), the invariable location of cracking was the toe of the fillet weld that connected the base plate and pole shaft (called the “base plate weld”). Figure 5.2 shows a typical fracture of this type. Phase II unstiffened details included Wyoming (WY), Texas (TX), and Wyoming Thick Wall (WTh).

Figure 5.2: Base Plate Weld Fracture

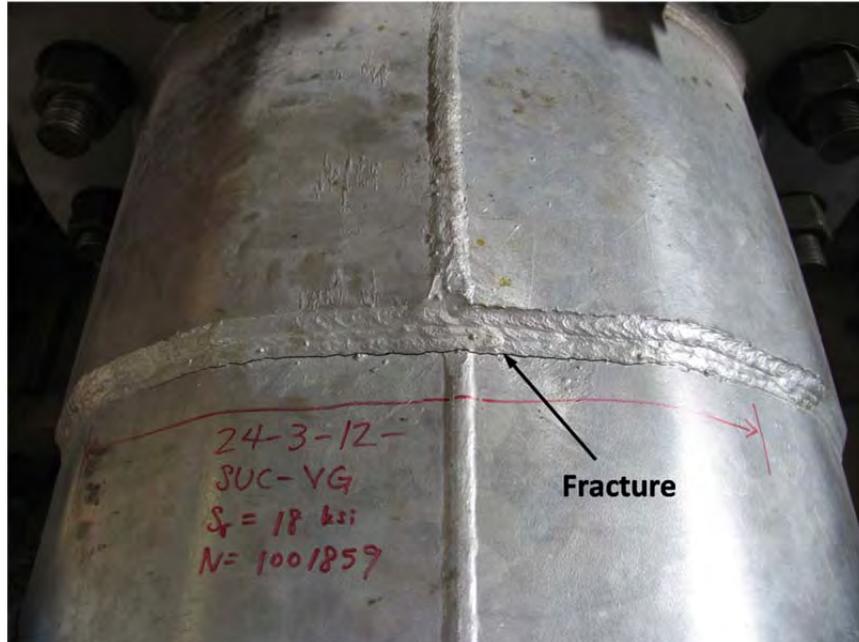
Both Wyoming External Collar (WEC) specimens developed fractures at their collar welds. This connection detail is inherently stiffer than the SEC and TXEC details due to its backing ring and reduced base plate inner diameter. This high level of stiffness moves the critical hot spot from the base plate weld to the top of the collar. See Figure 5.3 for an image of this crack location.

Figure 5.3: Collar Weld Fracture

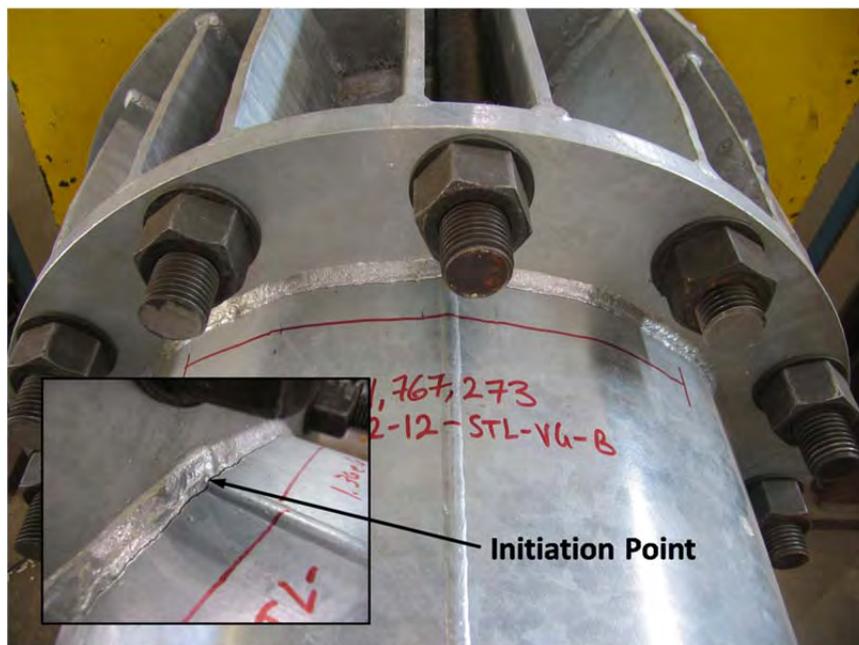
All stool-stiffened specimens developed fractures at the fillet weld toe along the top of the stool (see Figure 5.4). Similar to the WEC detail's collar effect, the presence of the stool in these details increases the rotational stiffness of the connection and shifts the hot spot, and hence crack, away from the base plate.

Figure 5.4: Stool Detail Fracture

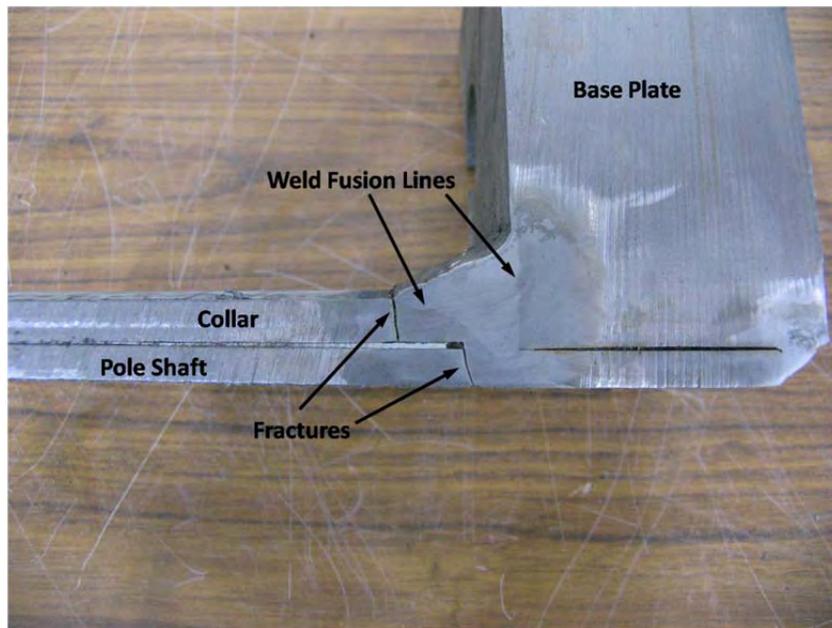
Figure 5.5: Section of Valmont Socket External Collar Connection

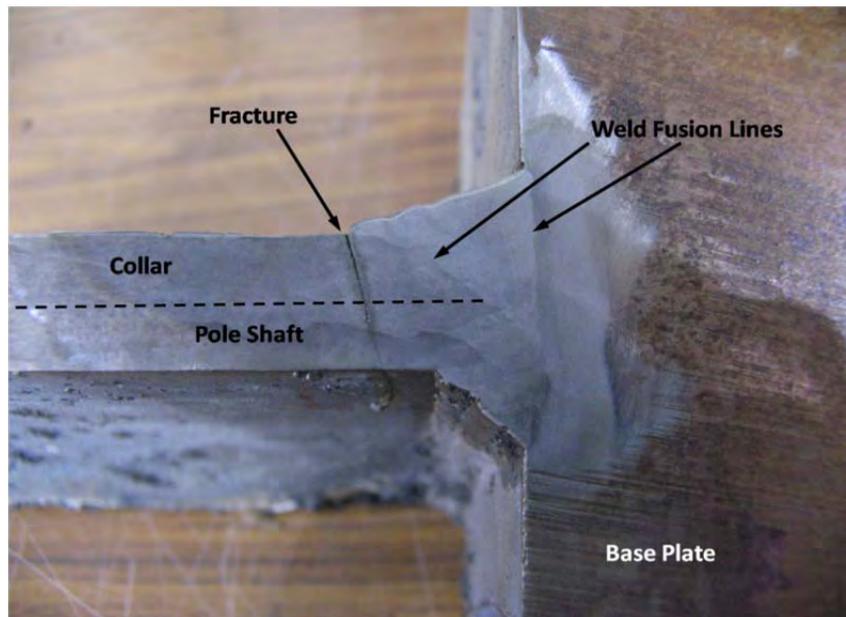
The Valmont TXEC specimens, the first specimens of the testing program, were cycled at a stress range of 12 ksi. This turned out to be a relatively low stress range for the stiffer details of Phase II, so the first specimen (B) did not begin cracking until about 4.0 million cycles, which at 1.5 Hz represented 30 days of continuous testing. In the interest of program completion, specimen A was not tested further and was declared a runout specimen. Cracking in specimen 24-3-12-TXEC-VG-B initiated at the base plate weld toe and propagated through both the collar and shaft wall before growing circumferentially along the weld toe. See Figure 5.6 for a polished and etched section of this specimen's weld. Note that the inner surfaces of both the pole shaft and collar were fused by the heat of the band saw, and their interface is not visible. It is therefore marked with a dashed line.

Figure 5.6: Section of Texas External Collar Connection

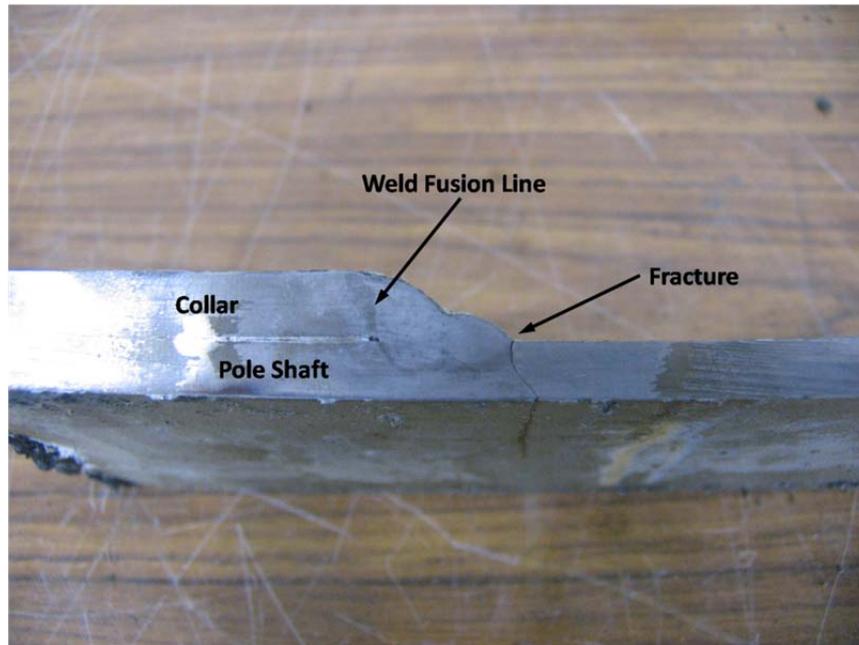
Following the testing of TXEC details, the nominal stress range was raised to 18 ksi for specimens of comparable rotational stiffness. Specimens with the WEC detail were tested at this elevated stress range, and both developed cracks within about 1.5 million cycles. Cracking initiated not at the base plate weld, but at the top of the collar weld for both specimens (as shown in Figure 5.3). Figure 5.7 shows a polished and etched section at the collar weld, the location of cracking. Notice that this weld is indeed an unequal leg fillet.

Figure 5.7: Section of Collar Weld in Wyoming External Collar Connection

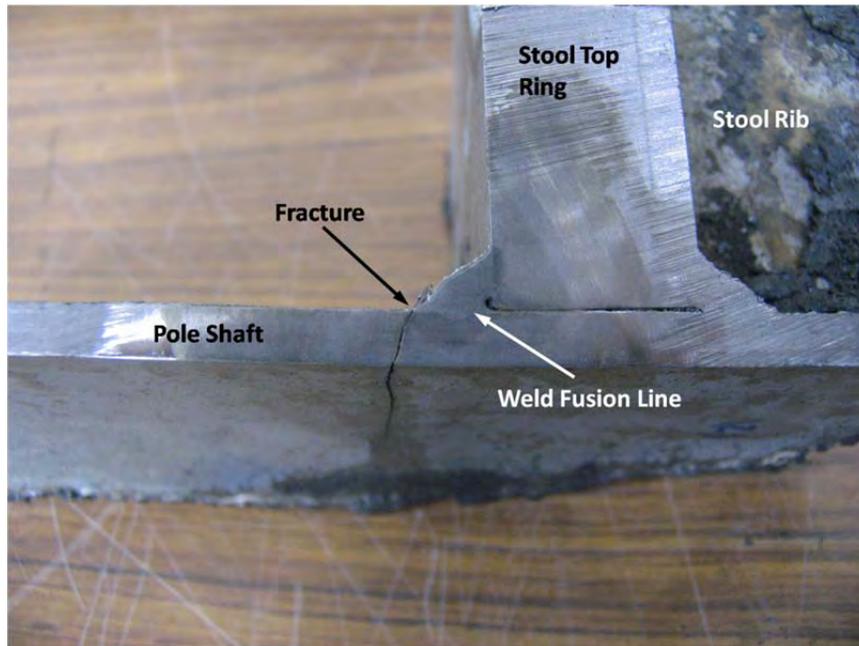
All specimens for the three stool-stiffened details were tested at a nominal stress range of 12 ksi. Fatigue lives for all six specimens ranged from about 1 to 2 million cycles. Cracking for each specimen initiated at the fillet weld above the stool and propagated circumferentially along the weld toe (as in Figure 5.4). Figure 5.8 shows a polished and etched section at the crack location of one of the six specimens. See Table 5.4 for a summary of results for all stool-stiffened specimens.

Figure 5.8: Section of Stool Detail Fillet Weld
