1. REPORT NUMBER FHWA/TX-11/9-1526-1	2. GOVERNMENT ASSOCIATION NUMBER	3. RECIPIENT'S CATALOG NUMBER
4. TITLE AND SUBTITLE Fatigue Life of Steel Base Plate to Pole Connections for Traffic Structures	5. REPORT DATE January 2011; Revised July 2011

Fatigue Life of Steel Base Plate to Pole Connections for Traffic Structures

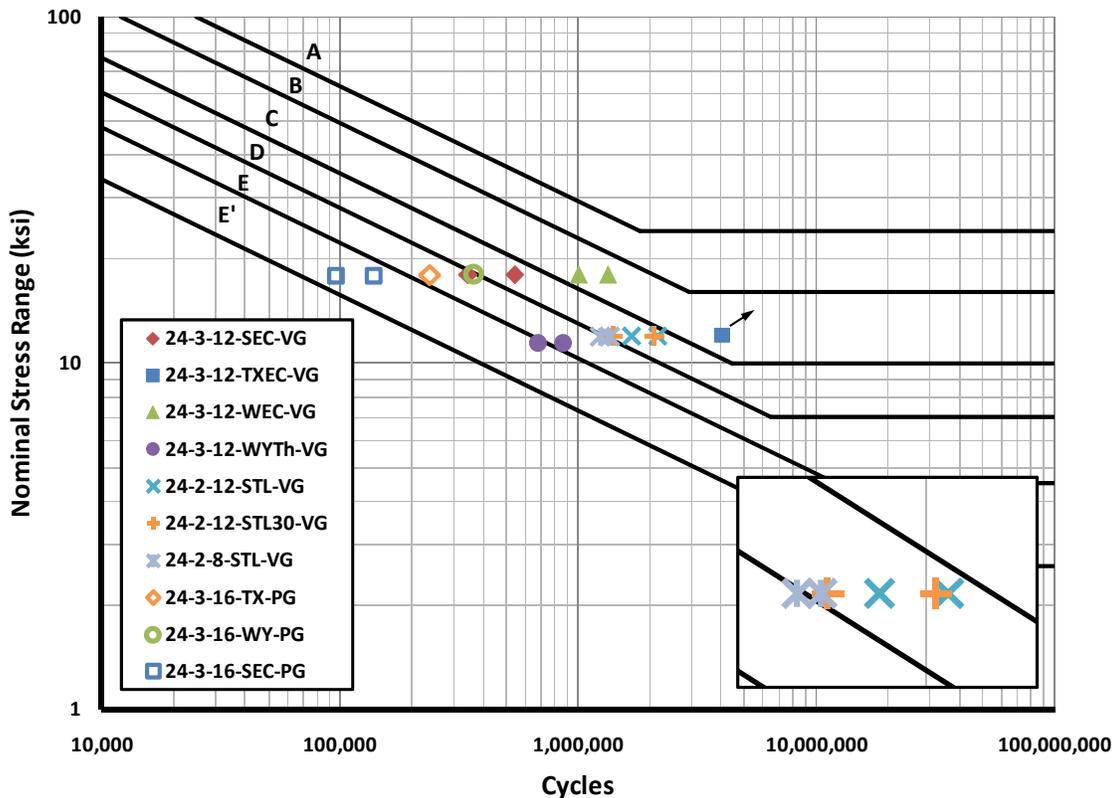
The S-N chart in Figure 5.9 summarizes all Phase II fatigue data for specimens from both manufacturers. The single TXEC runout specimen is marked with a small arrow, which indicates that it would have plotted with greater life, had it been tested to failure.

Figure 5.9: Phase II Fatigue Test Results

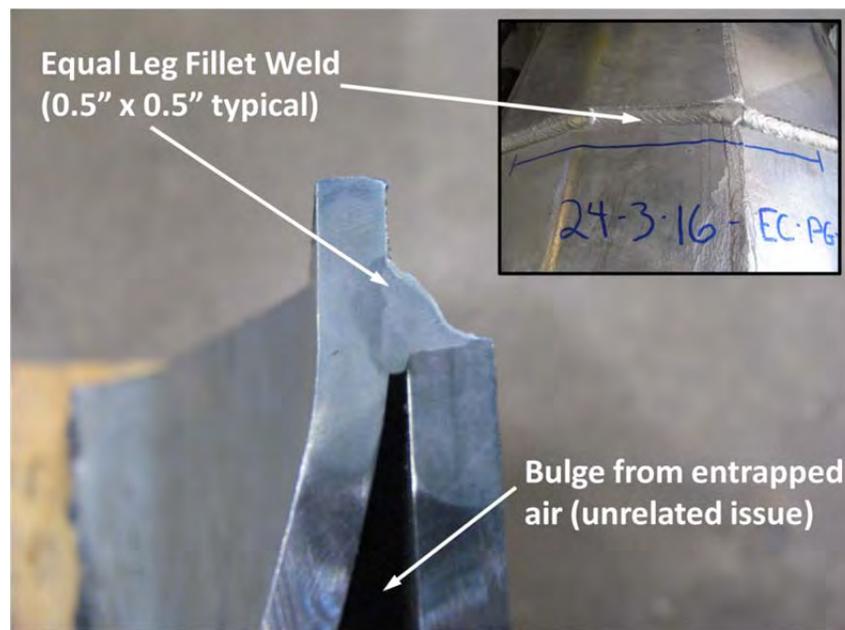
Figure 5.10: Typical Collar Weld in Pelco SEC Connection

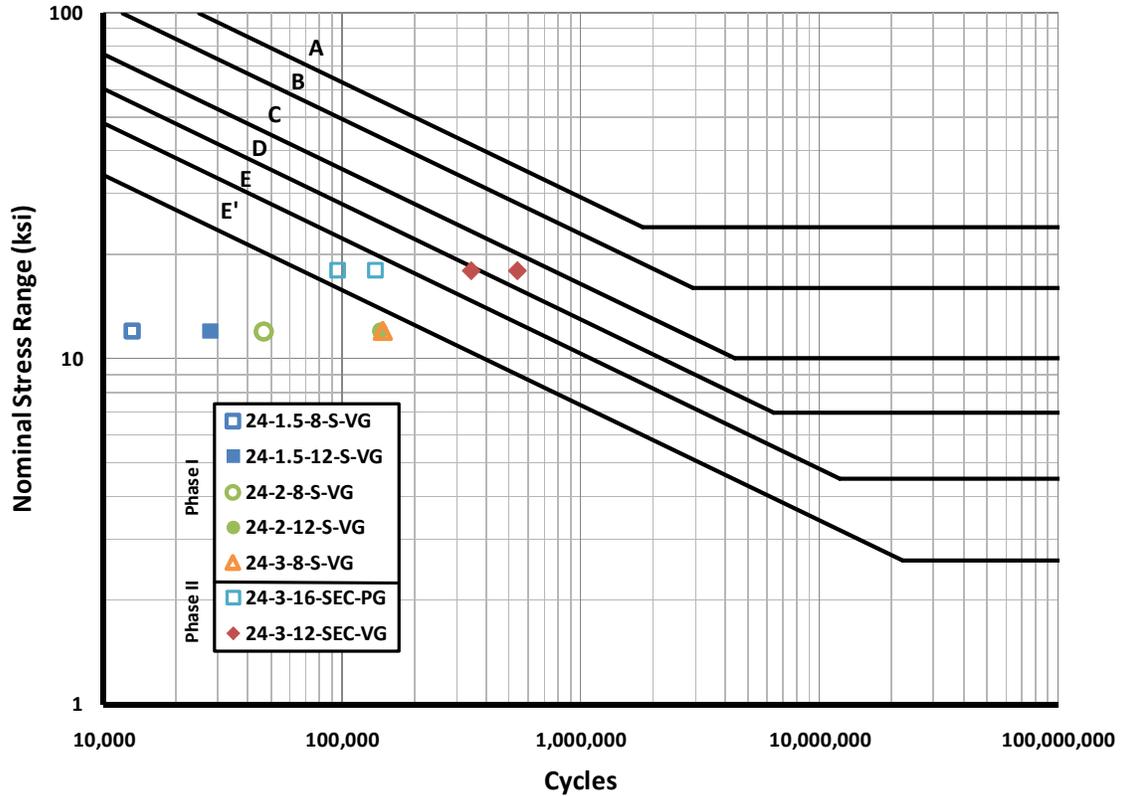
The inclusion of Phase I data in Figure 5.11 reiterates the chief findings for Phase I socket details: fatigue performance is strongly tied to both the number of anchor rods and the base plate thickness. Increasing either will clearly improve performance. However, the Phase I simple sockets still performed very poorly, not even reaching a Category E' level, which is their AASHTO classification.

Figure 5.11: Socket Results for Phases I and II

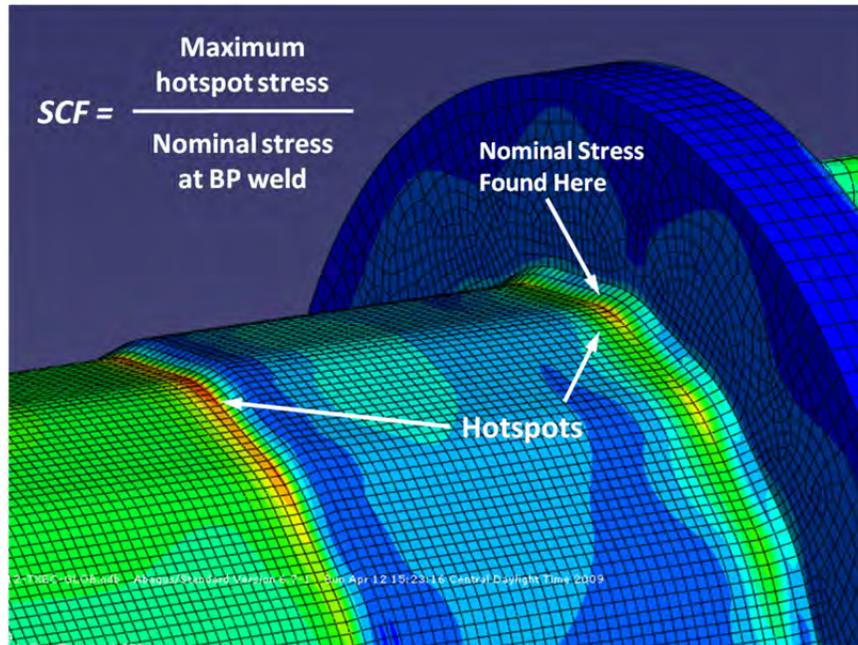
For stiffened models, such as those with collars, multiple hot spot locations could exist (see Figure 6.1). For these models, the stress concentration factor was defined by the largest of the hot spots (also called the “critical hot spot”), but was still normalized by the nominal stress at the base plate weld. Note that the calculations for section modulus at the base plate weld ignored the presence of collars and backing rings and considered only the pole's section.

Figure 6.1: Analytical Model with Multiple Hot Spot Locations

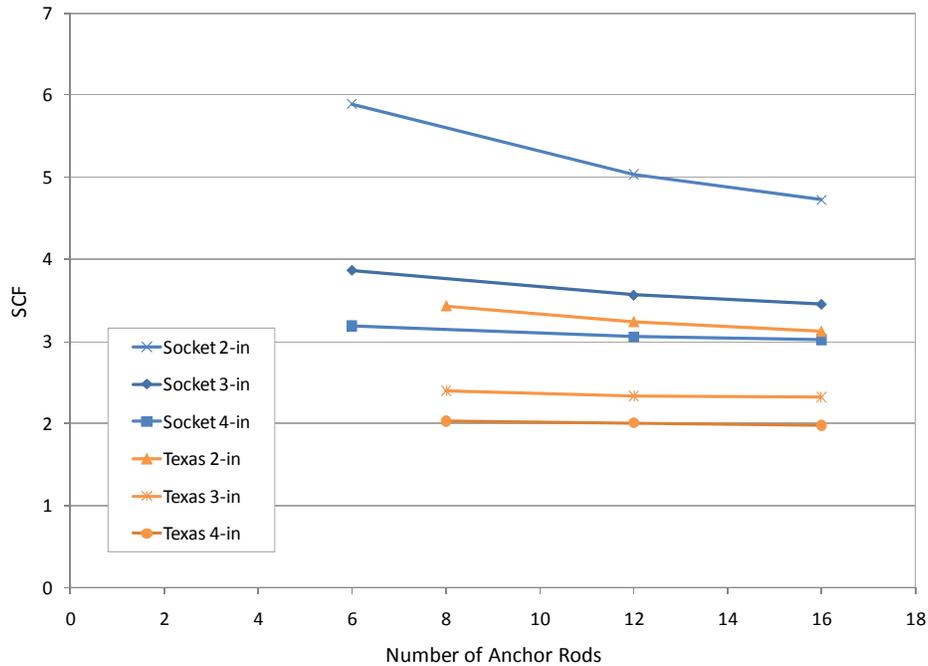
Figure 6.6: Results of Anchor Rod Parametric Evaluation

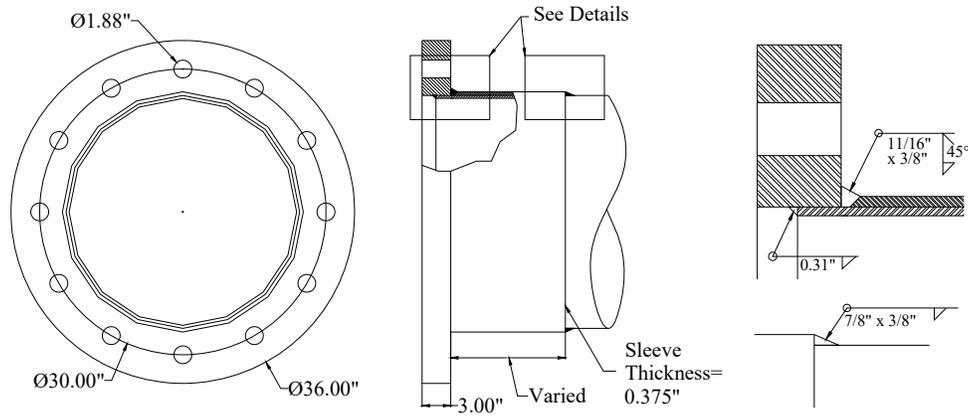
This parametric examination considered the SEC connection and sought to investigate whether the stress concentration factor was dependent on the length of the collar. See Figure 6.9 for a detail of this connection.

Figure 6.9: Socket External Collar Connection Detail

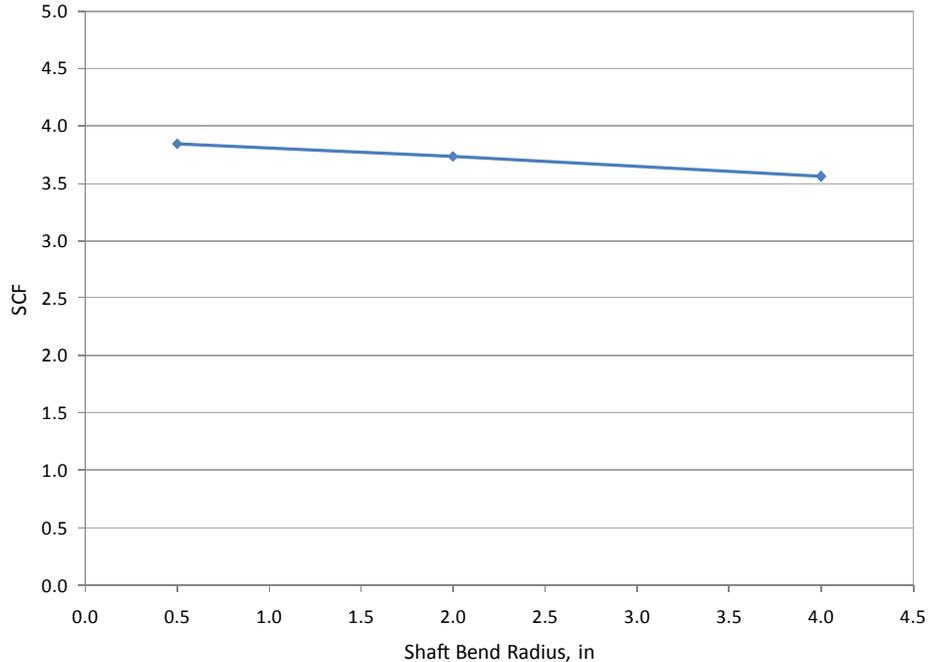
Figure 6.11: Results of Bend Radius Evaluation

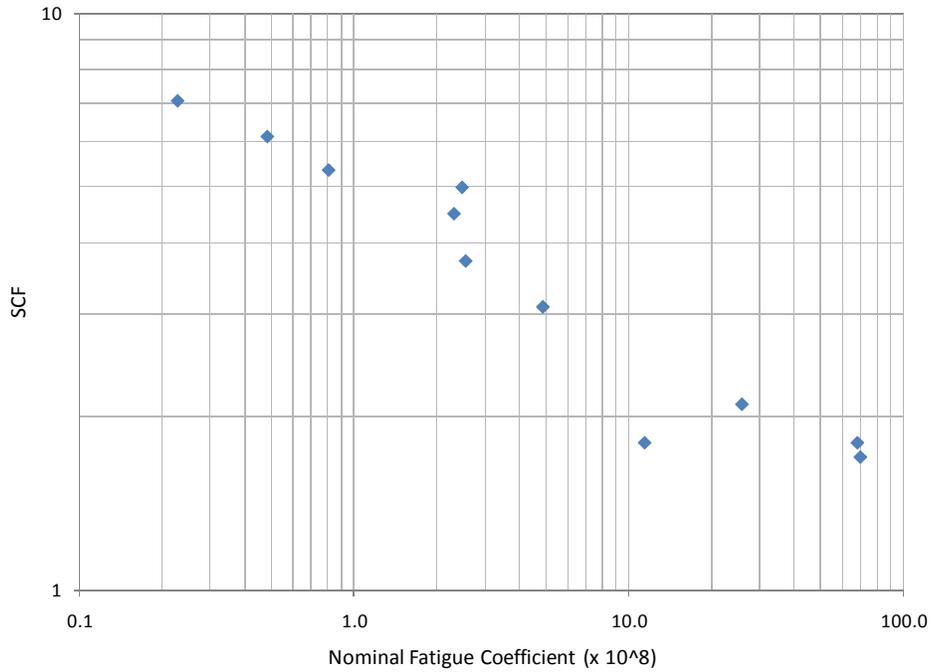
Figure 6.12: Experimental Fatigue Performance vs. Analytical SCF

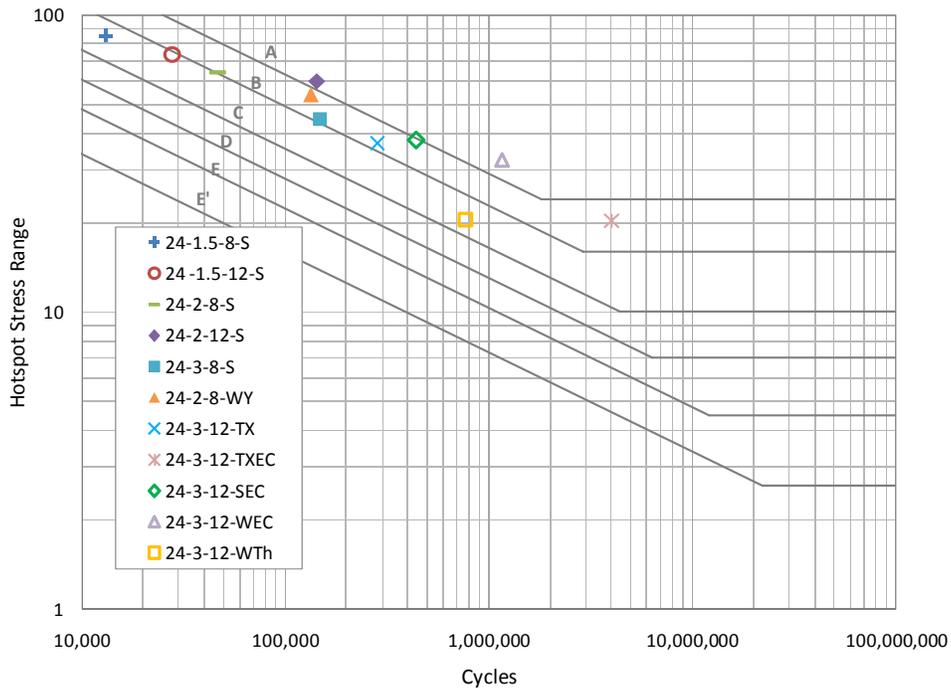
Figure 6.13: Experimental Fatigue Life vs. Hot spot Stress

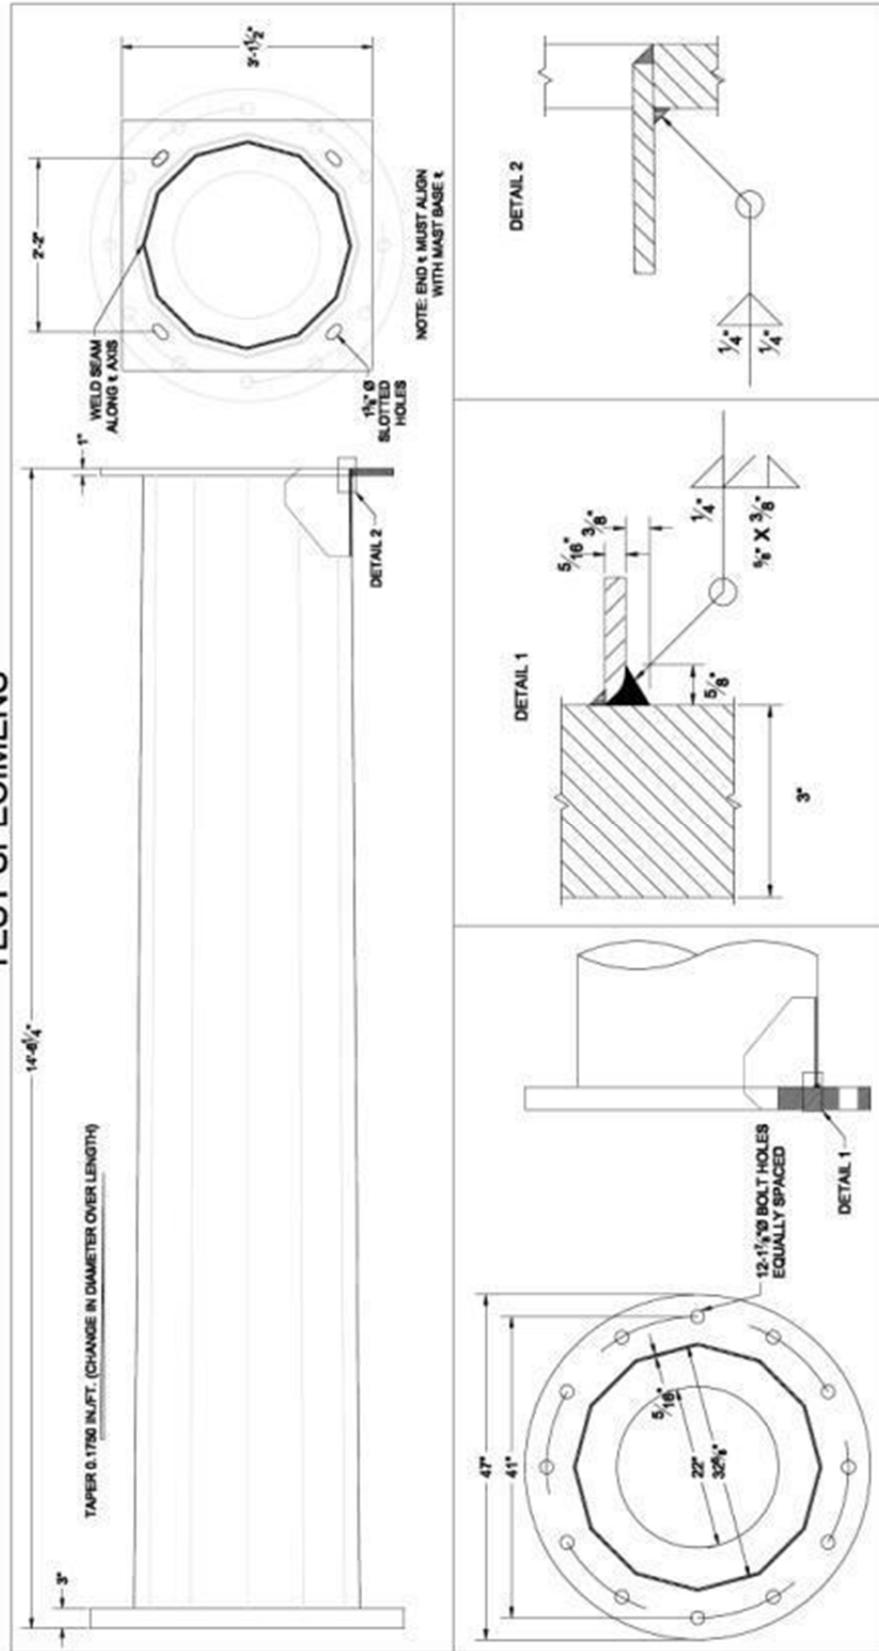
CONFORMS TO TxDOT STANDARDS FOR 150',
12 SIDED HMP DESIGNED FOR 80 MPH WINDS

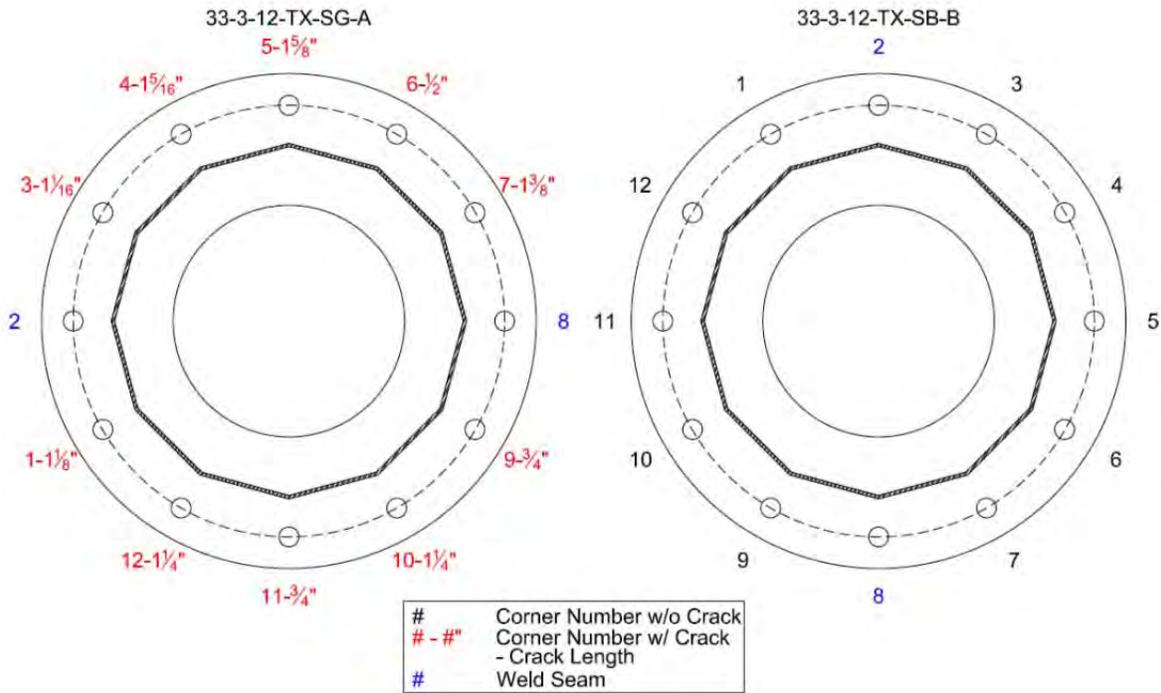
Figure 7.2: Initial Crack Locations and Lengths in Specimens 33-3-12-TX-SG-A and 33-3-12-TX-SB-B

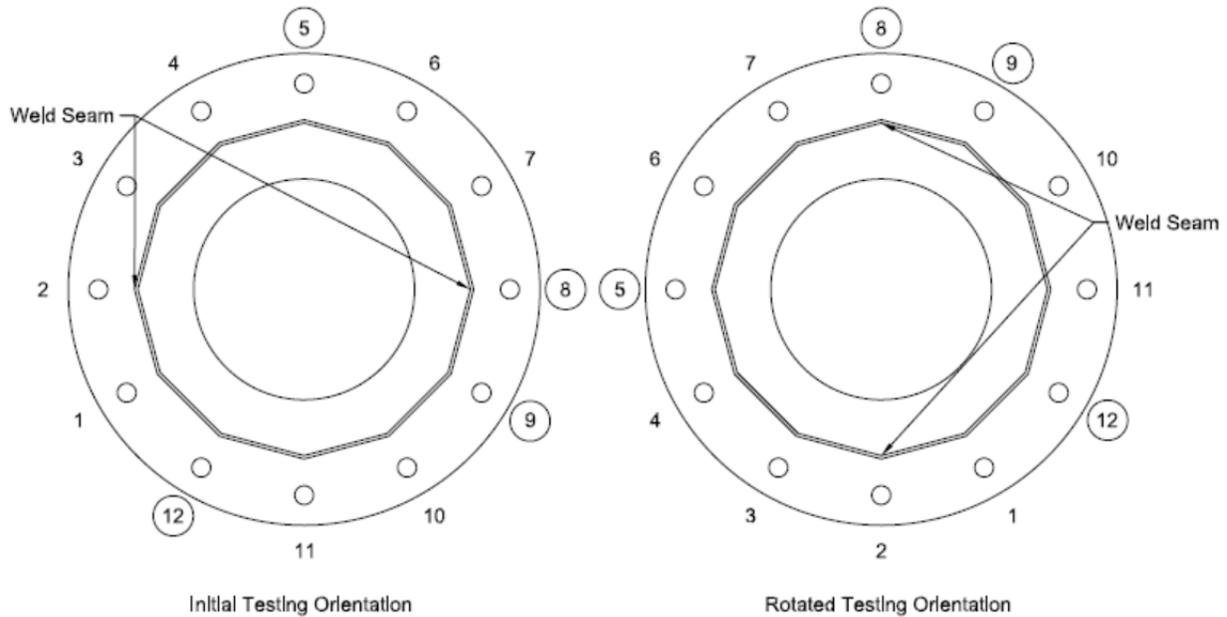
Figure 7.3: Initial and Rotated Orientation of 33-3-12-TX-SG-A with Circled Bends Further Investigated

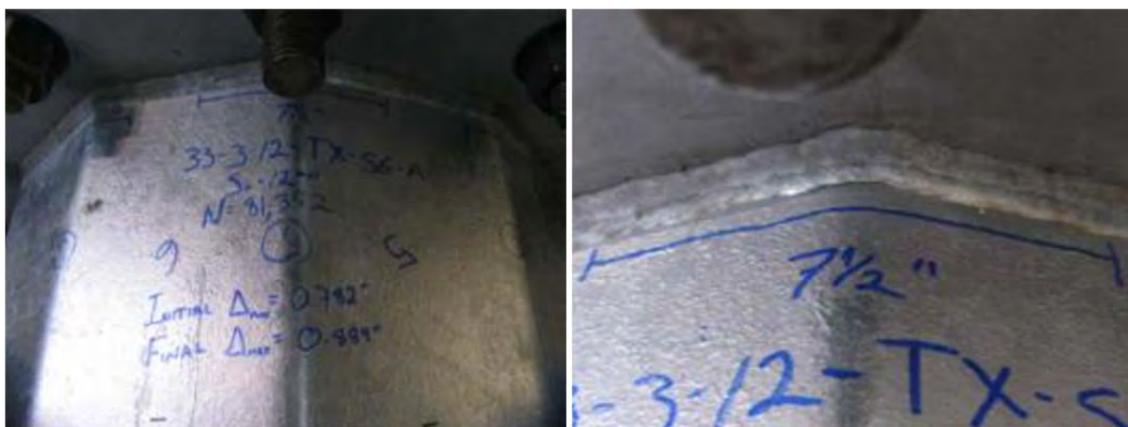
Figure 7.4: Crack Length at Bend 5 on the Galvanized Specimen after 81,326 Cycles

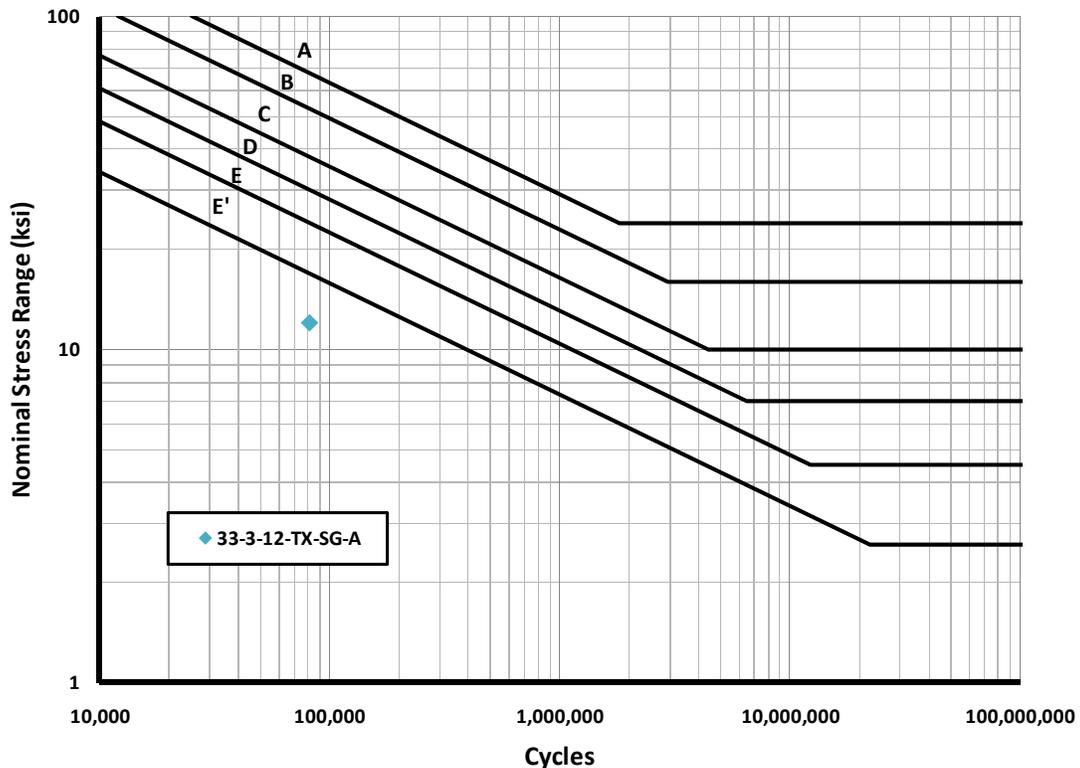
Figure 7.5: Fatigue Life of Galvanized Specimen Compared to AASHTO Fatigue Categories

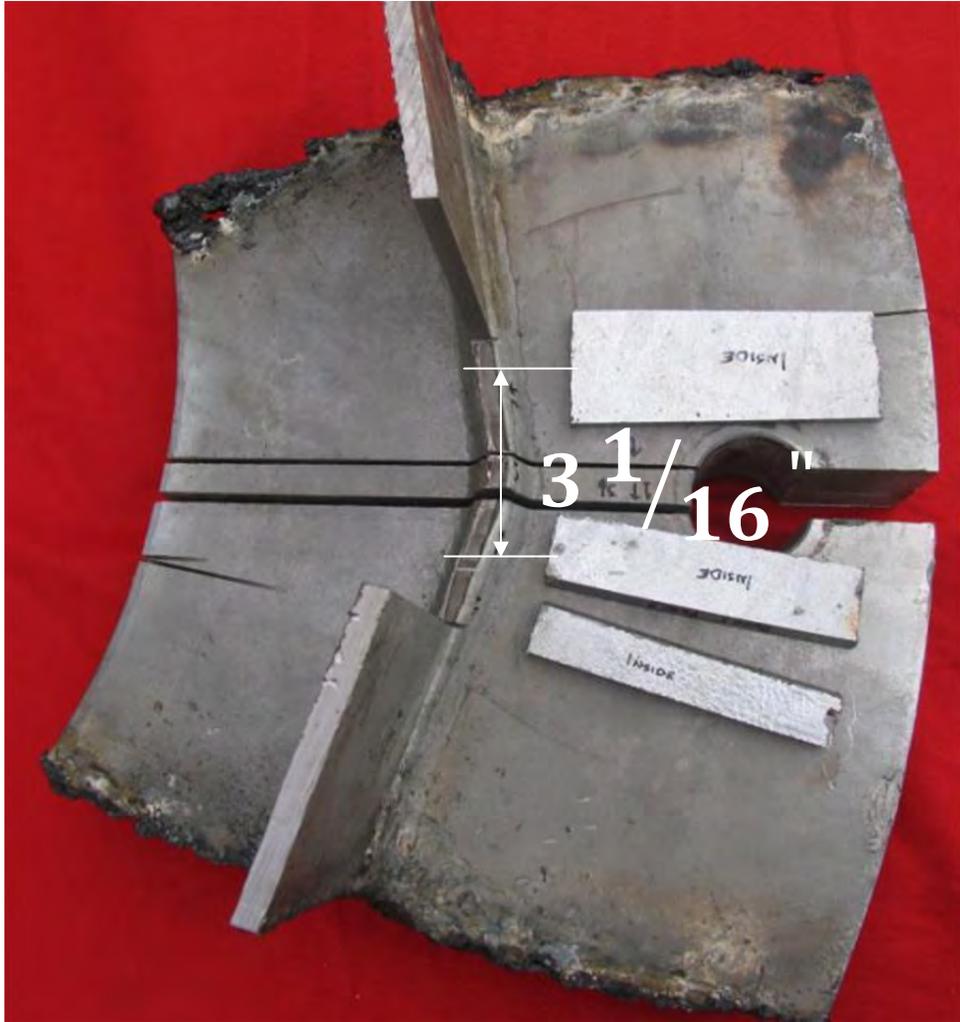
Figure 7.6: View of Bend 5 after Sectioning. Length of Observed Initial Crack is Labeled

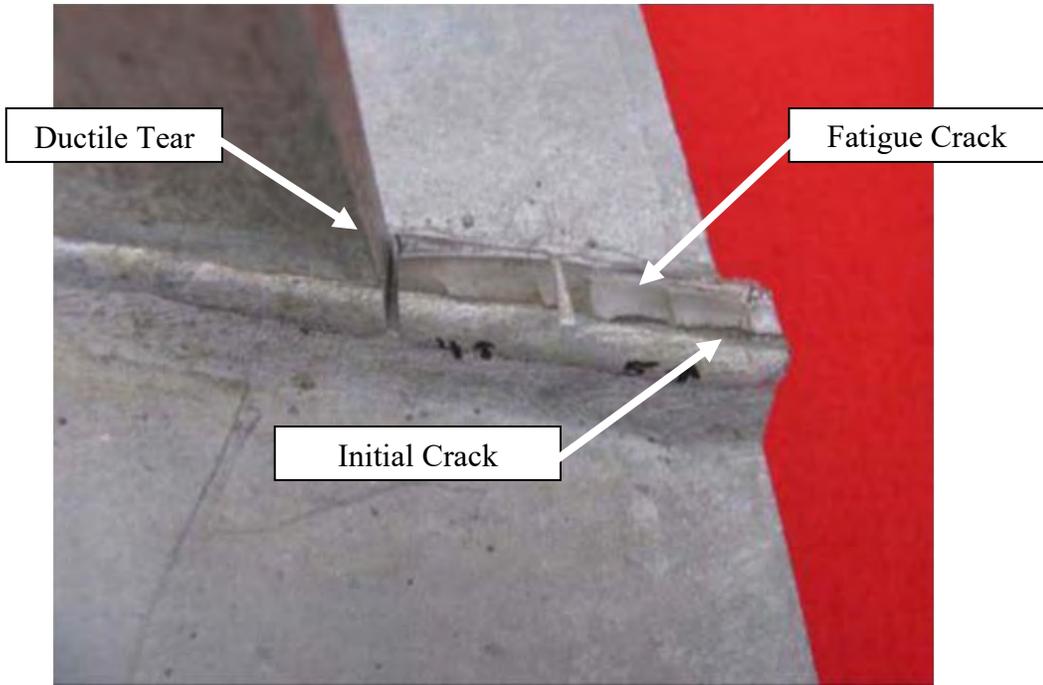
Figure 7.7: Close-up of Fracture Surface at Bend 5

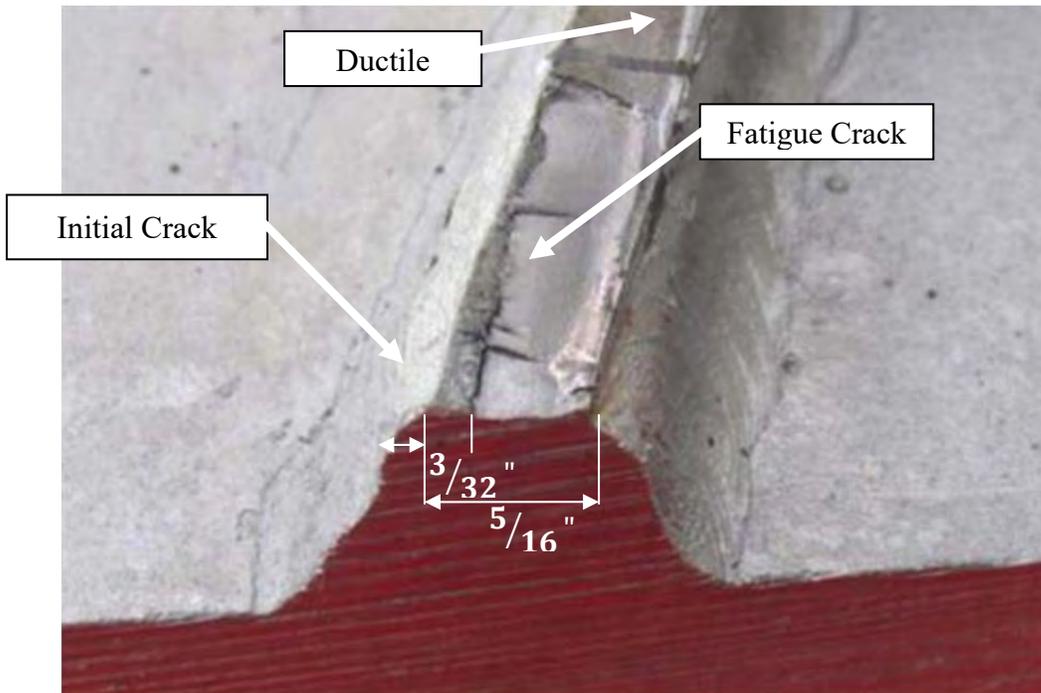
Figure 7.8: Depth of Initial Crack at Weld Toe

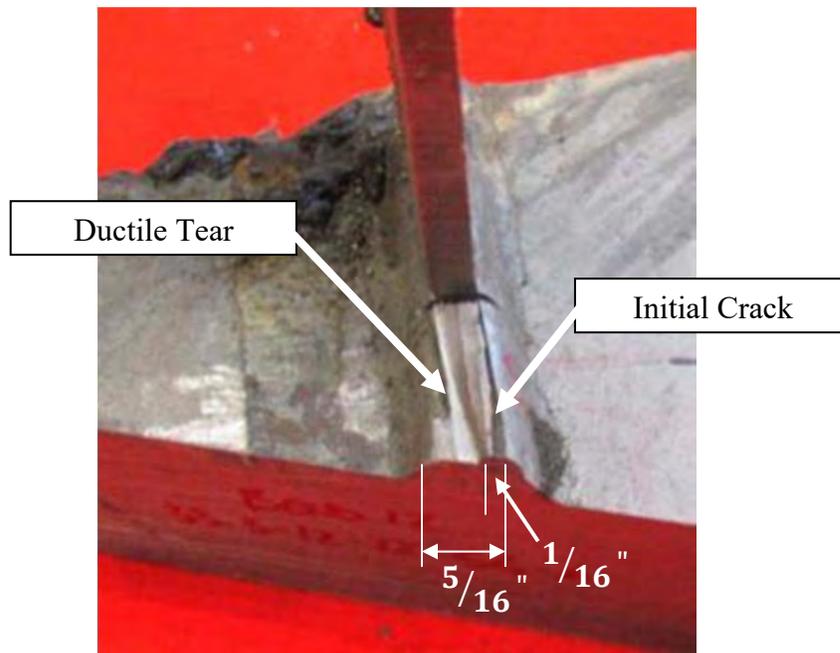
Figure 7.9: Fracture Surface at Bend 12

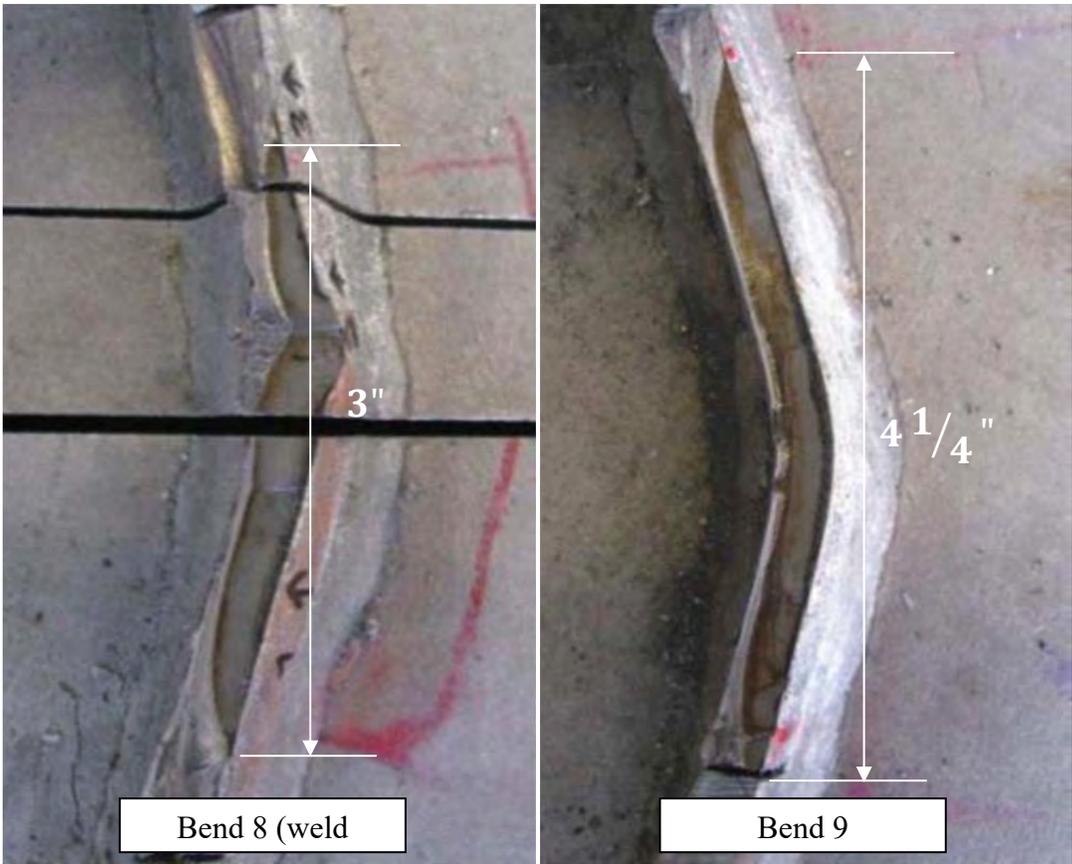
Figure 7.10: Fatigue Cracks at Bends 8 and 9

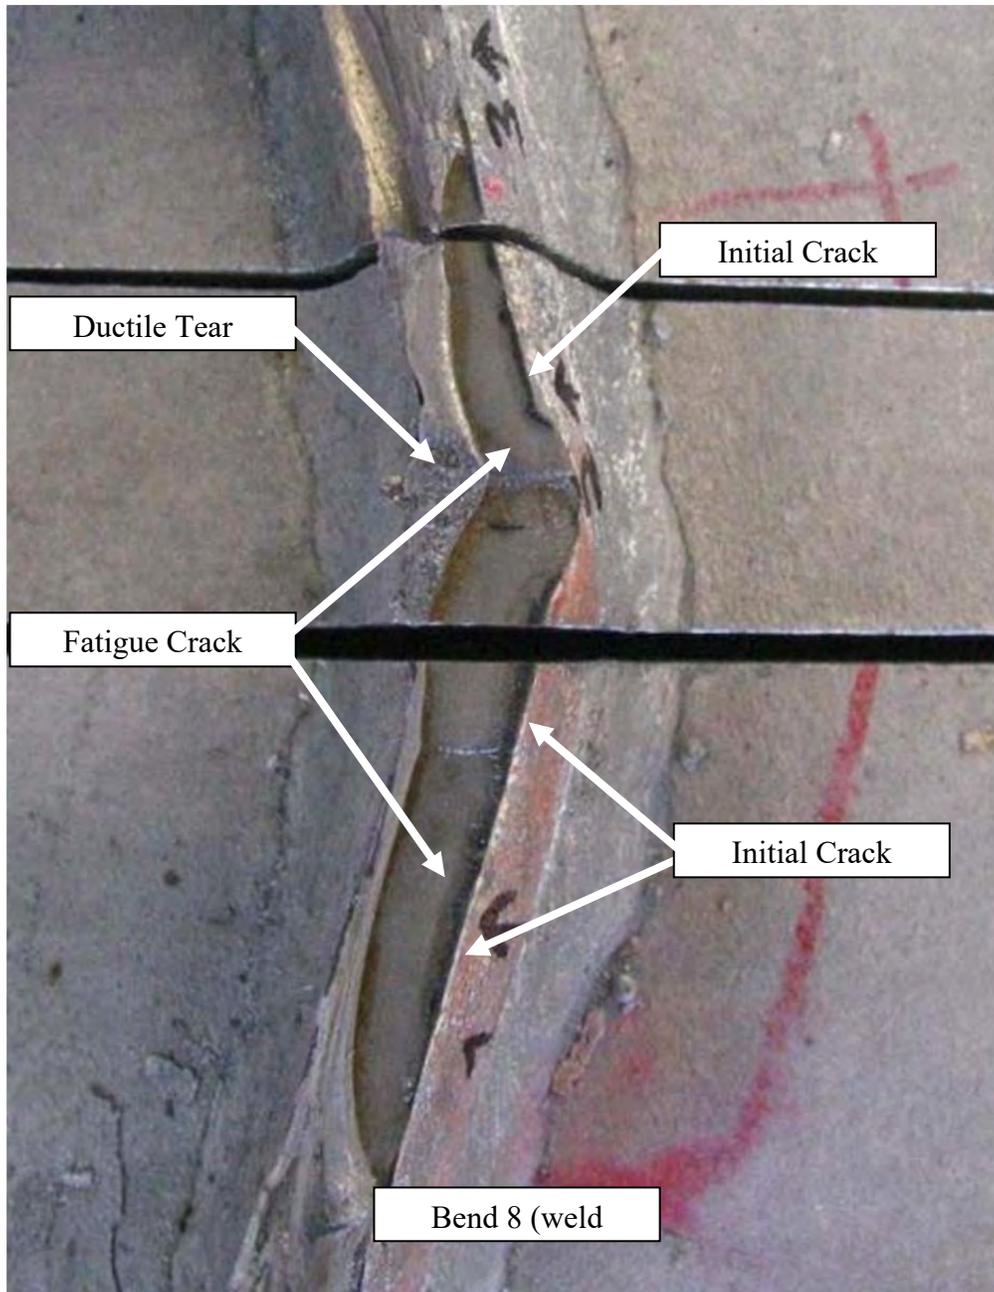
Figure 7.11: Fracture Surface of Bend 8

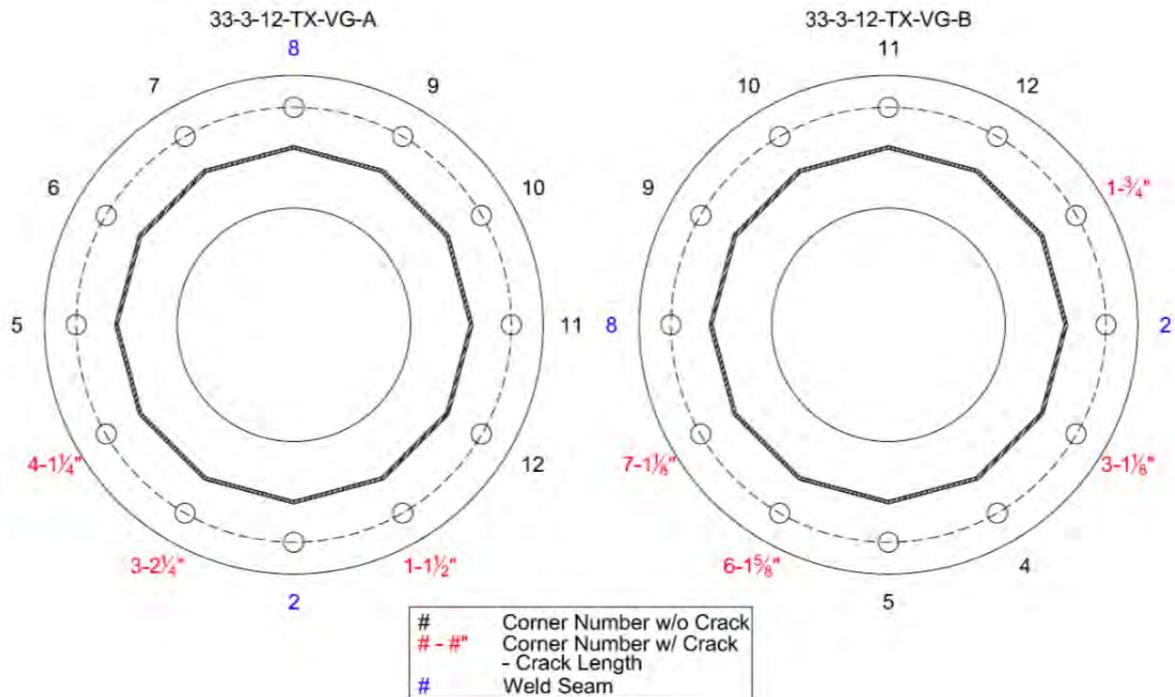
Figure 7.12: Ultrasonic Results and Initial Orientation of 33-3-12-TX-VG-A and 33-3-12-TX-VG-B

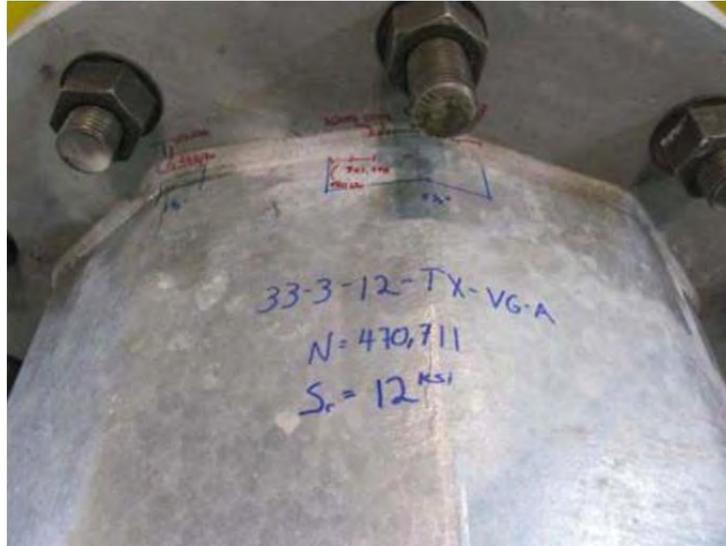
Figure 7.13: Specimen 33-3-12-TX-VG-A after Fatigue Testing

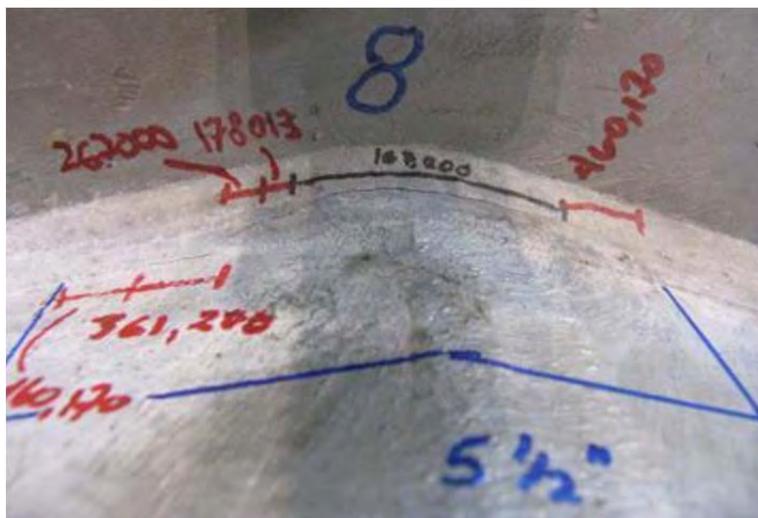
Figure 7.14: Fatigue Crack at Bend 8

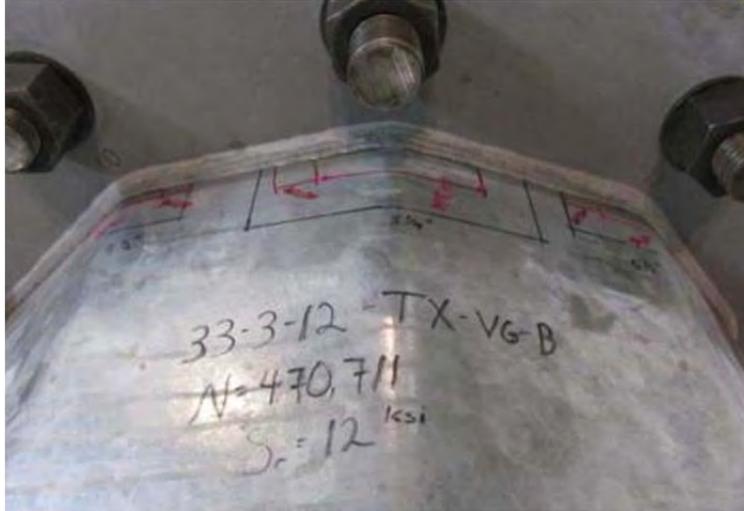
Figure 7.15: Specimen 33-3-12-TX-VG-B after Fatigue Testing

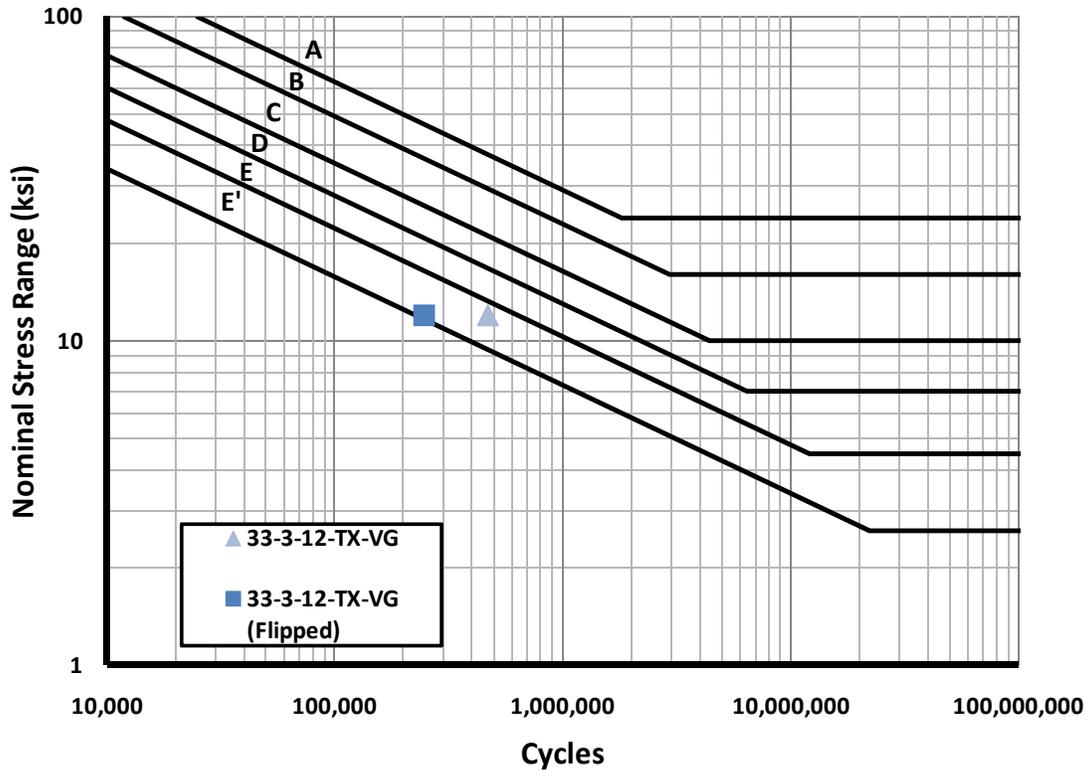
Figure 7.16: S-N Plot for Samples in Initial Orientation and Flipped Orientation

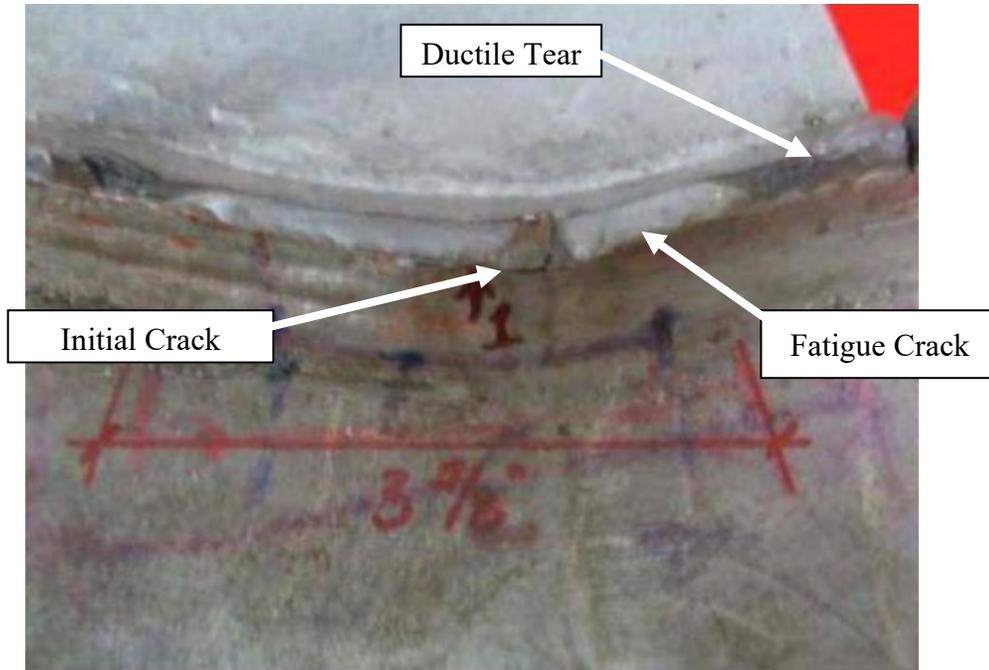
Figure 7.17: Bend 3 of Specimen 33-3-12-TX-VG-A

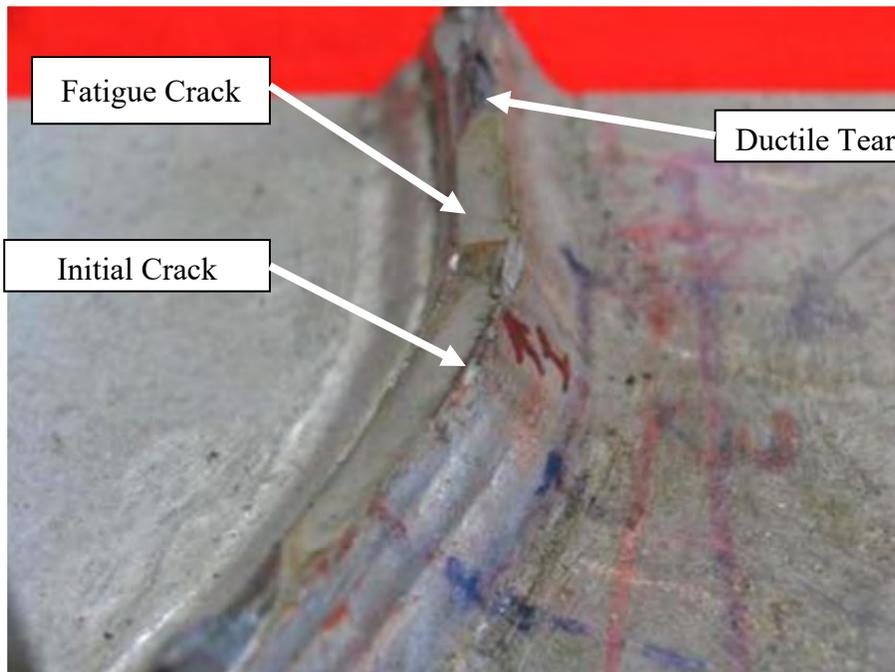
Figure 7.18: Bend 3 of Specimen 33-3-12-TX-VG-A

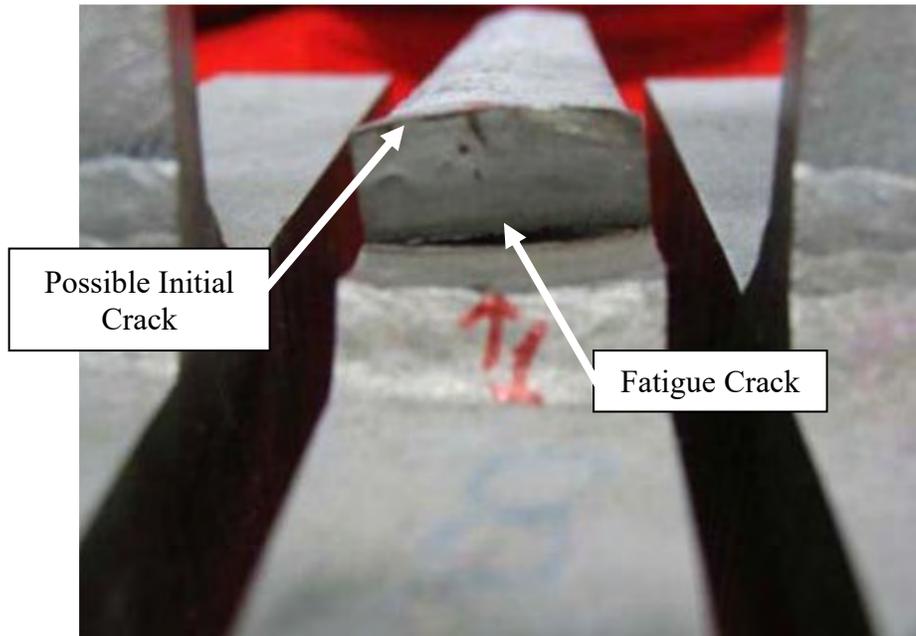
Figure 7.19: Bend 8 of Specimen 33-3-12-TX-VG-A with Fatigue Failure through Weld

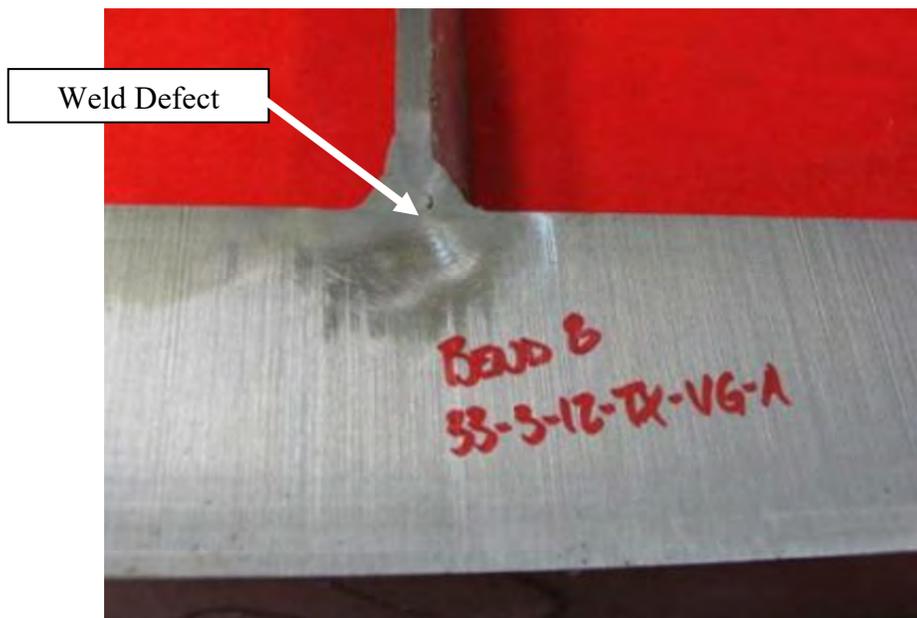
Figure 7.20: Cross Section of Bend 8 of Specimen 33-3-12-TX-VG-A Showing Apparent Weld Defect

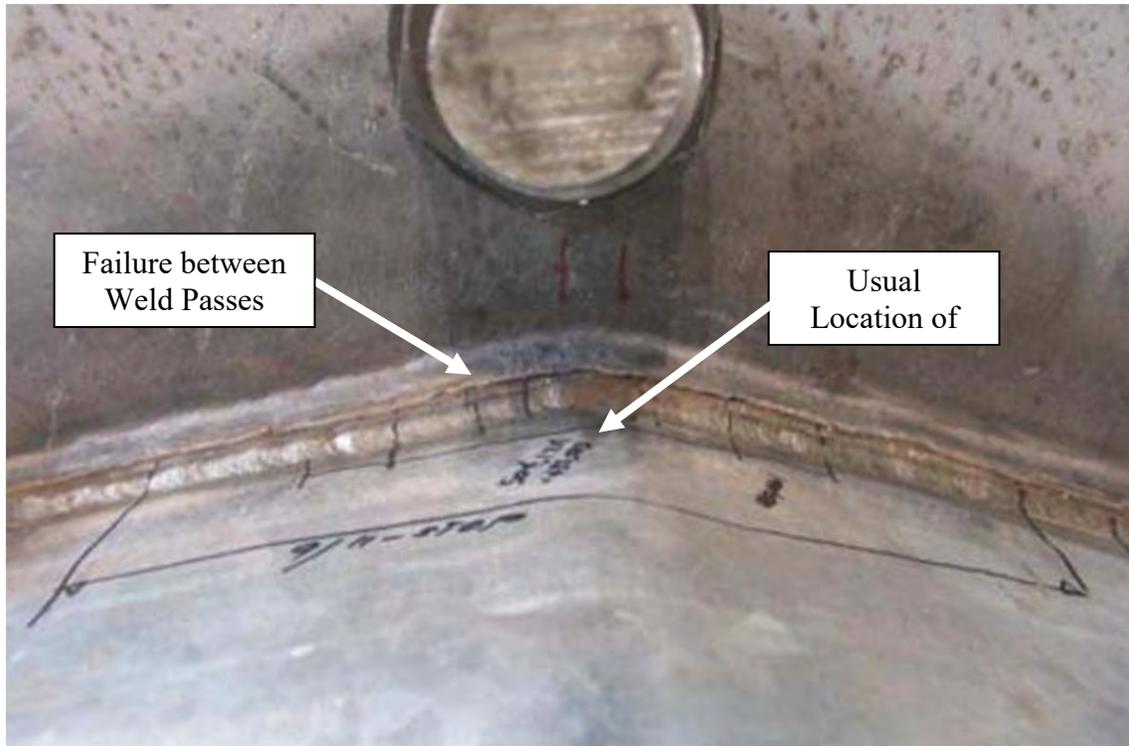
Figure 7.21: Bend 11 of Specimen Field Repair with Failure through Weld
