1. REPORT NUMBER FHWA/TX-11/9-1526-1	2. GOVERNMENT ASSOCIATION NUMBER	3. RECIPIENT'S CATALOG NUMBER
4. TITLE AND SUBTITLE Fatigue Life of Steel Base Plate to Pole Connections for Traffic Structures	5. REPORT DATE January 2011; Revised July 2011

Fatigue Life of Steel Base Plate to Pole Connections for Traffic Structures

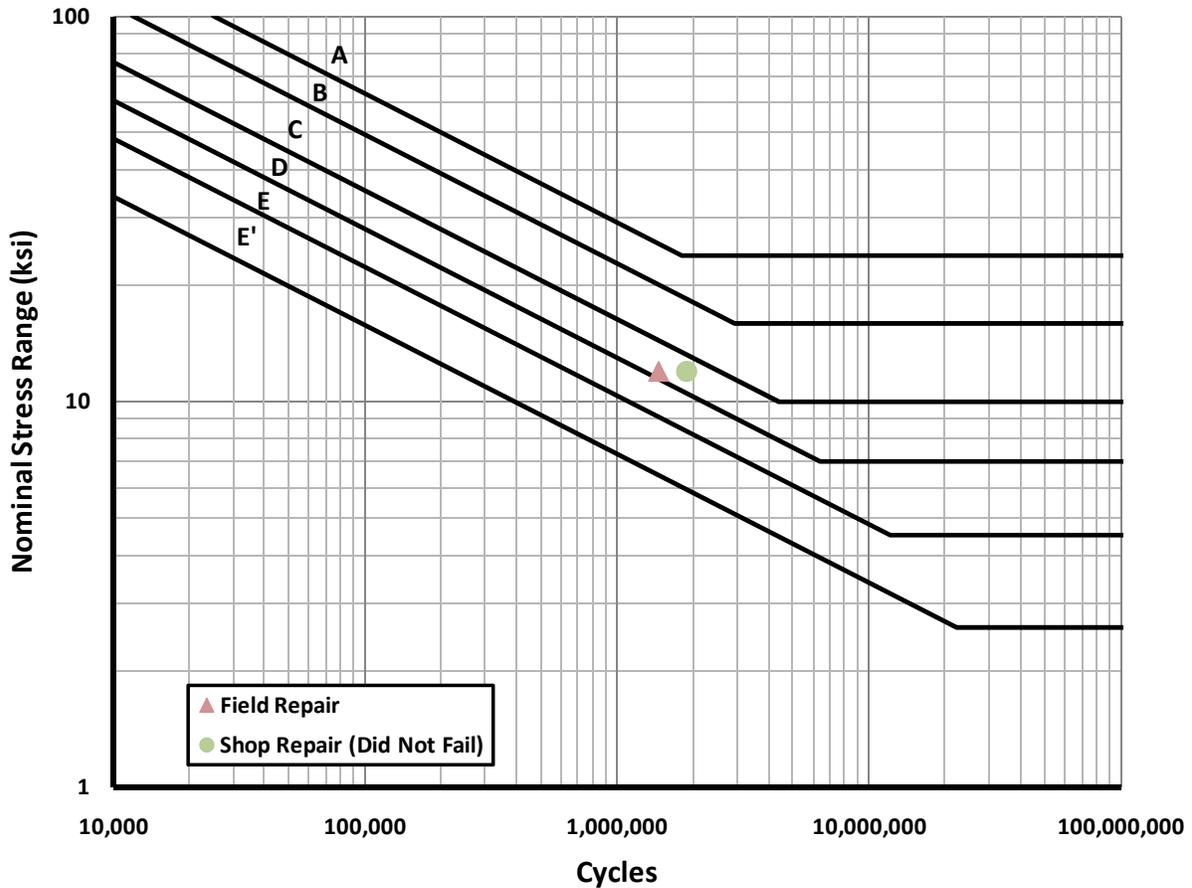
Figure 7.22: S-N Plot of Weld Repair Specimens

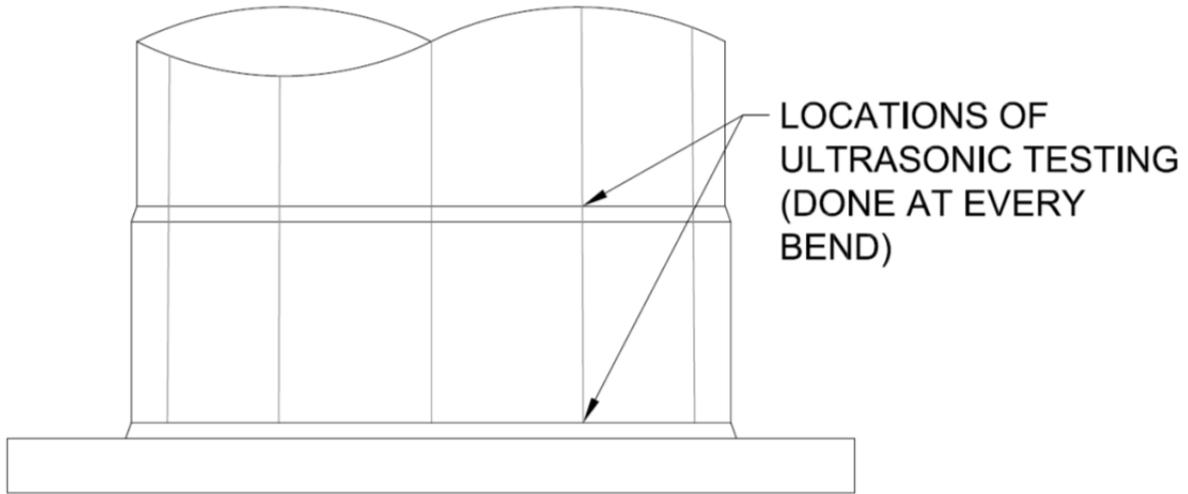
Figure 7.23: Locations Inspected Using Ultrasonic Testing on External Collar Samples

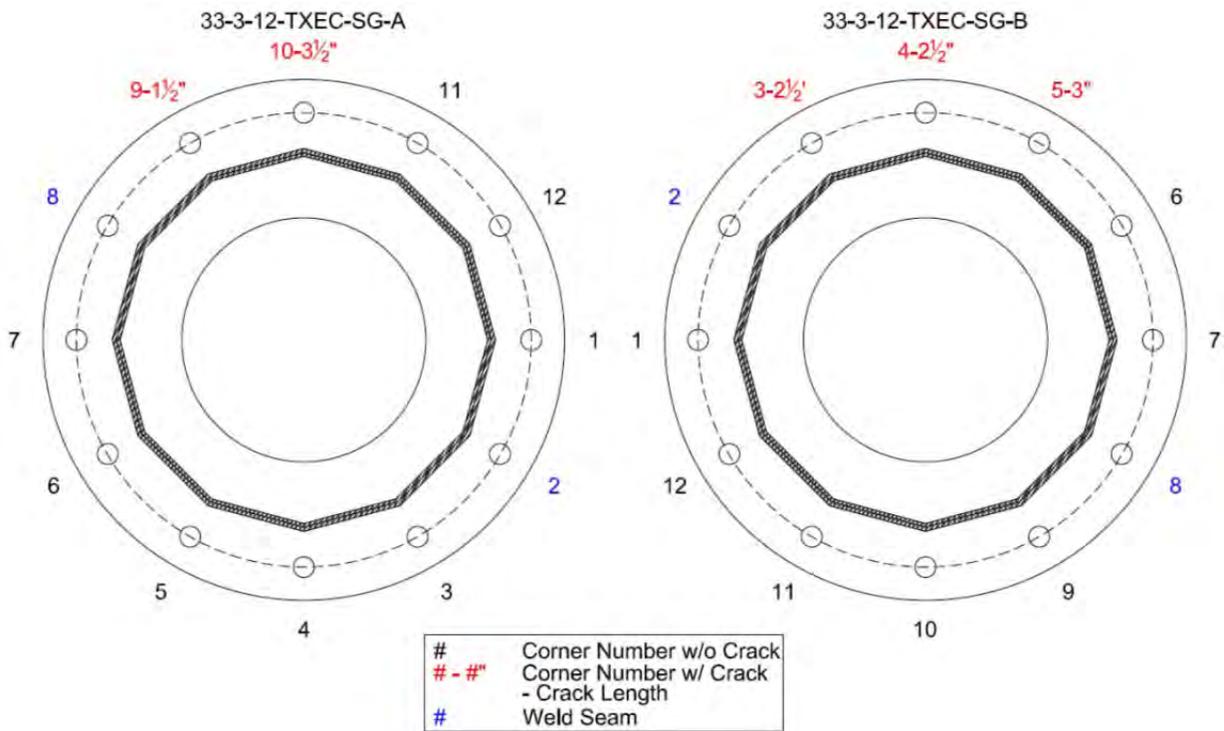
Figure 7.24: Crack Indications, Lengths, and Initial Orientation of External Collar Samples

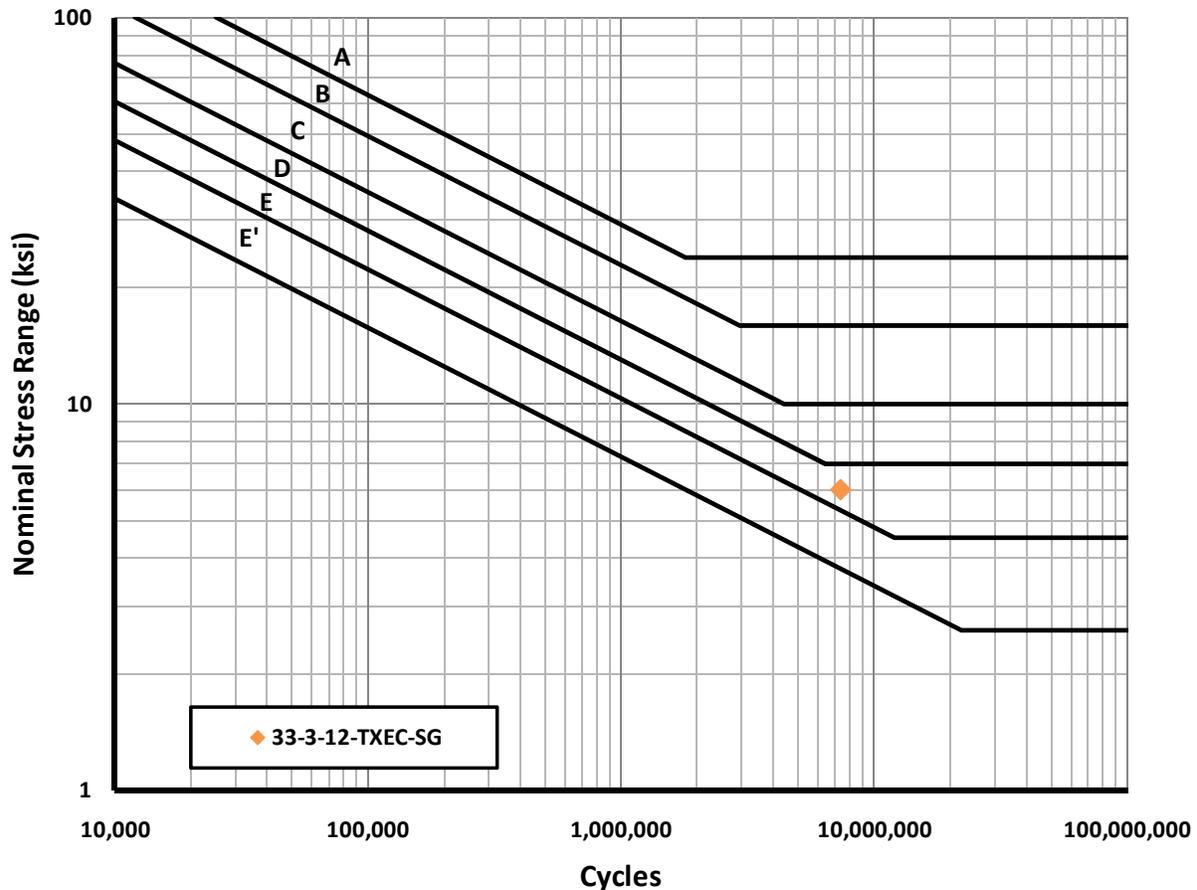
Figure 7.25: S-N Plot of External Collar Samples

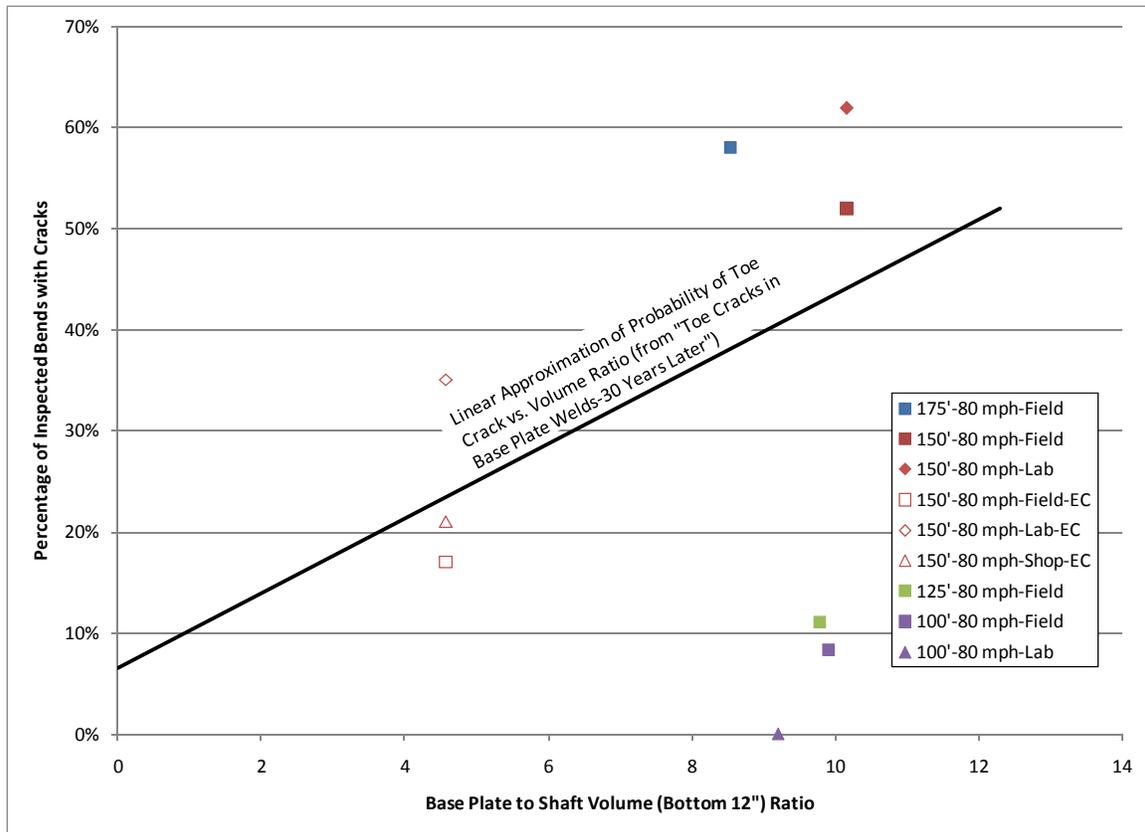
Figure 7.26: Percentage of Cracks Found Compared to Ratio of the Volume of the Base Plate to the Volume of the Shaft

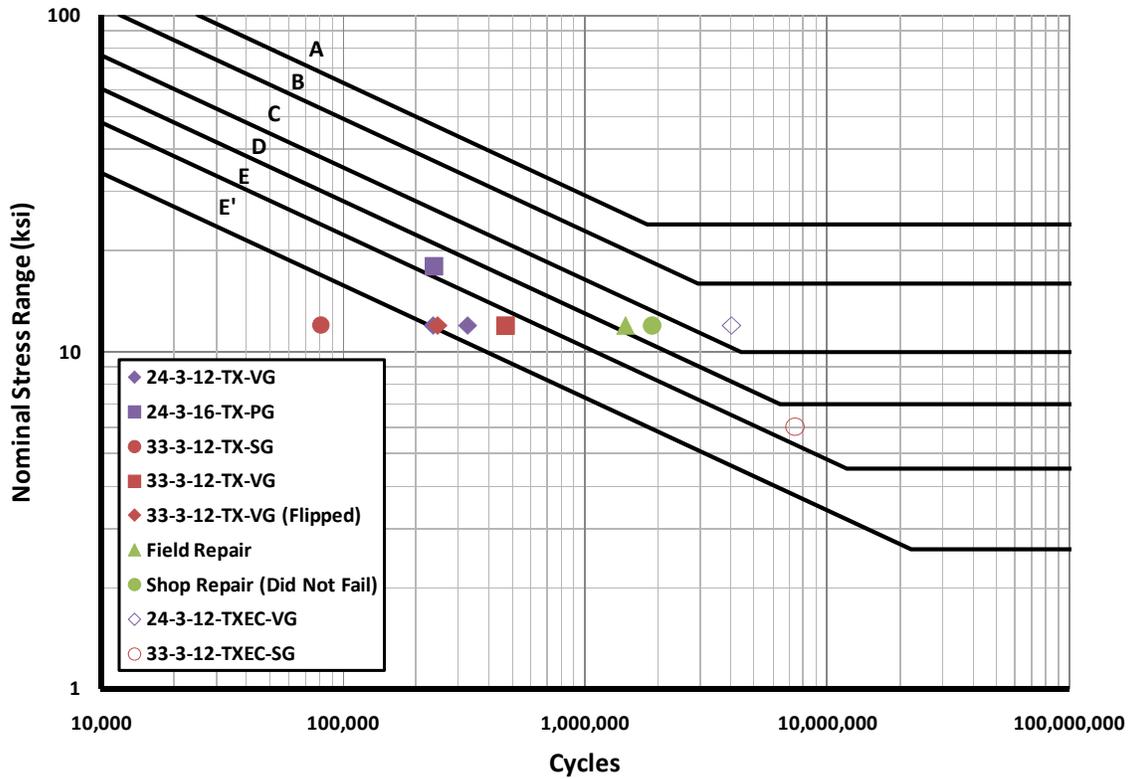
Figure 7.27: S-N Plot of All Specimens

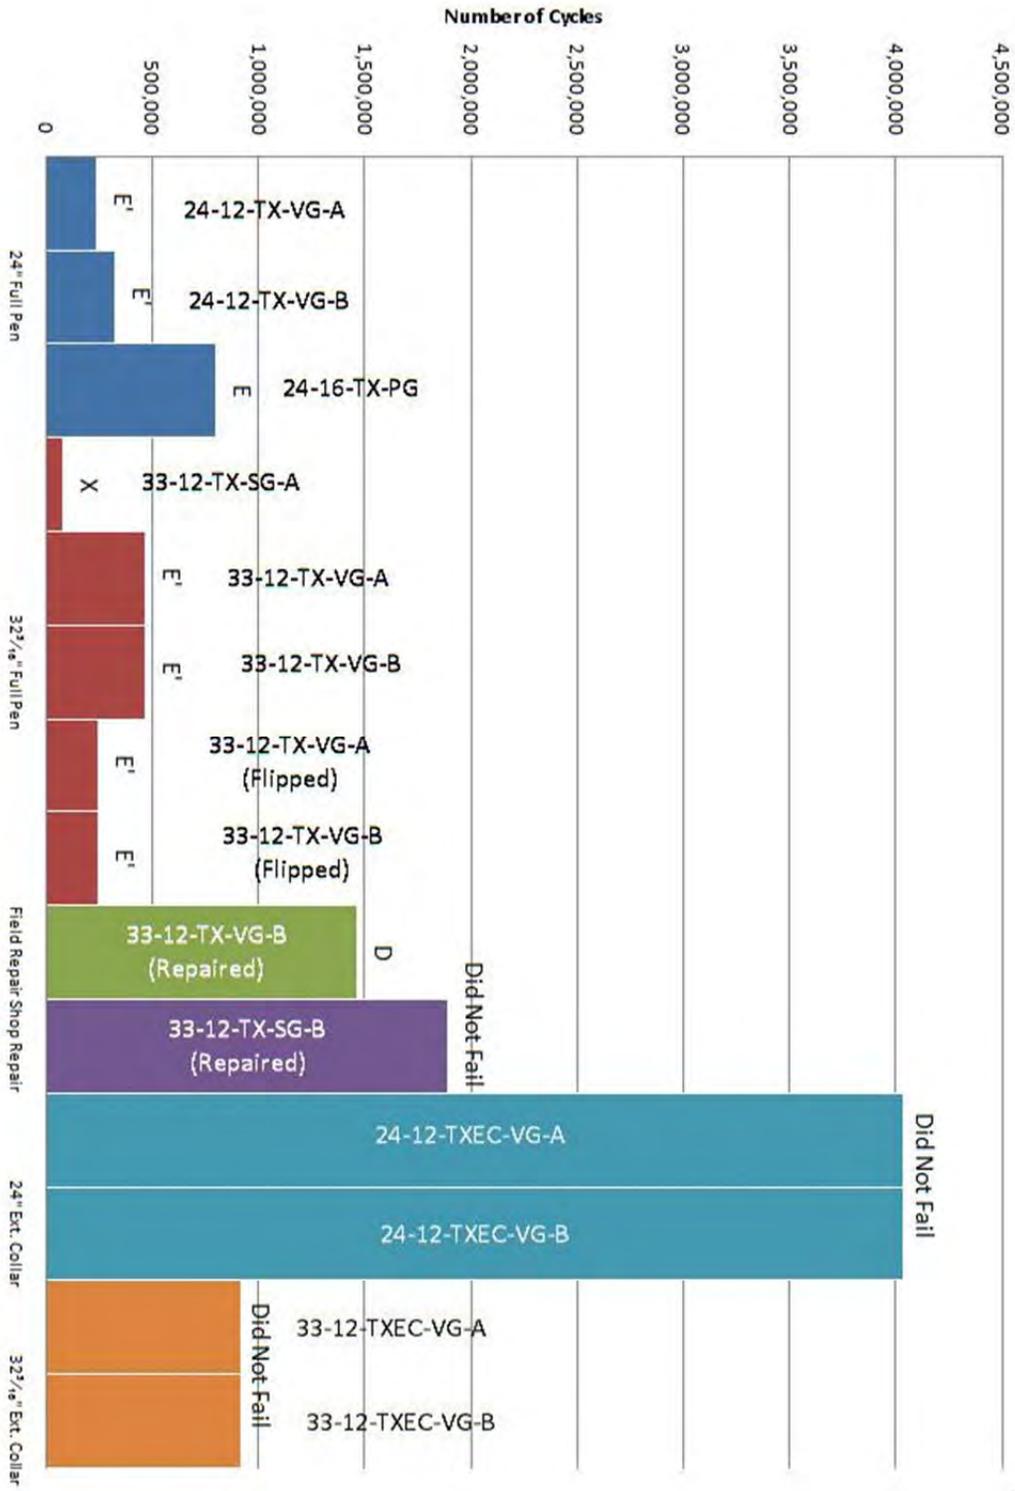
Figure 7.28: Fatigue Results by Specimen Normalized for 12-ksi Stress Range

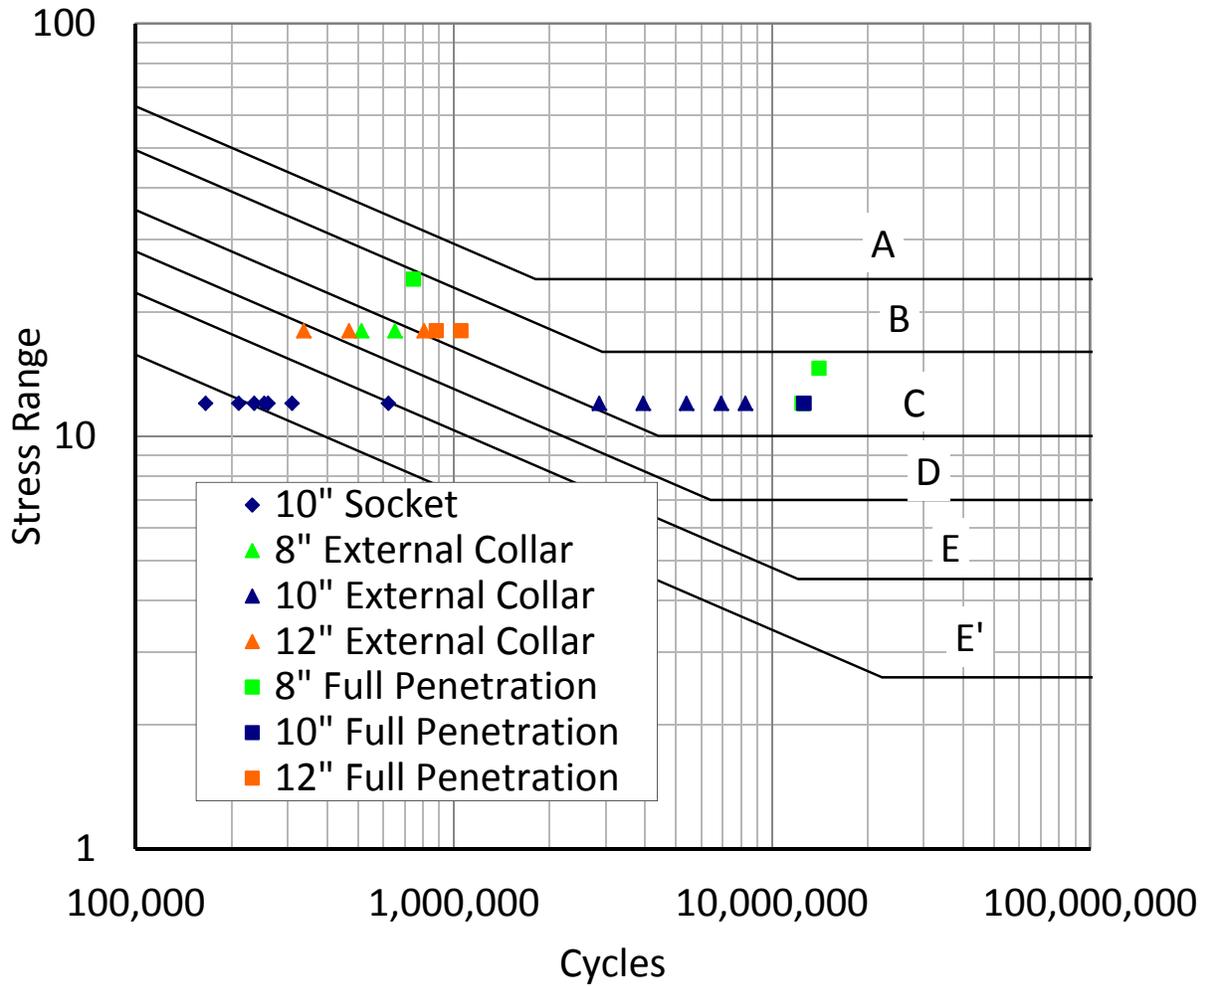
Figure 8.1: Mast Arm Fatigue Test Results—2-in. End Plates
