1. REPORT NUMBER CA11-1562 A	2. GOVERNMENT ASSOCIATION NUMBER	3. RECIPIENT'S CATALOG NUMBER
4. TITLE AND SUBTITLE Warm-Mix Asphalt Study: First-Level Analysis of Phase 2 HVS and Laboratory Testing, and Phase 1 and Phase 2 Forensic Assessments		5. REPORT DATE 07/30/2009
		6. PERFORMING ORGANIZATION CODE
7. AUTHOR David Jones, Rongzong Wu, Bor-Wen Tsai, and John T. Harvey		8. PERFORMING ORGANIZATION REPORT NO. UCPRC-RR-2009-02
9. PERFORMING ORGANIZATION NAME AND ADDRESS University of California, Davis & Berkeley Partnered Pavement Research Center 1353 S. 46th Street, Bldg. 452 Richmond, CA 94804		10. WORK UNIT NUMBER
		11. CONTRACT OR GRANT NUMBER 65A0272 Task ID 1562
12. SPONSORING AGENCY AND ADDRESS California Department of Transportation Division of Research and Innovation, MS-83 1227 O Street Sacramento CA 95814		13. TYPE OF REPORT AND PERIOD COVERED Final
		14. SPONSORING AGENCY CODE

TECHNICAL REPORT DOCUMENTATION PAGE

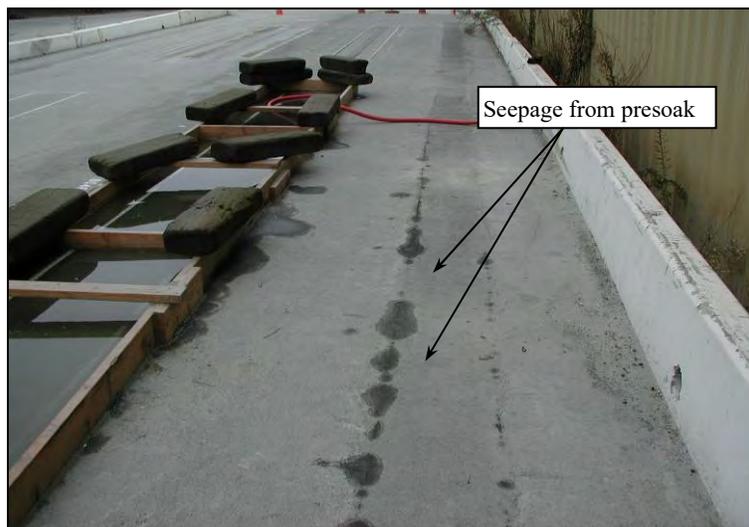
Figure 4.3: Seepage during presoaking.

During presoaking of the section some seepage through the pavement (patched area from earlier sampling after construction of the test track) was observed adjacent to the test section (Figure 4.3) implying that water was possibly seeping between the top and bottom lifts of asphalt.

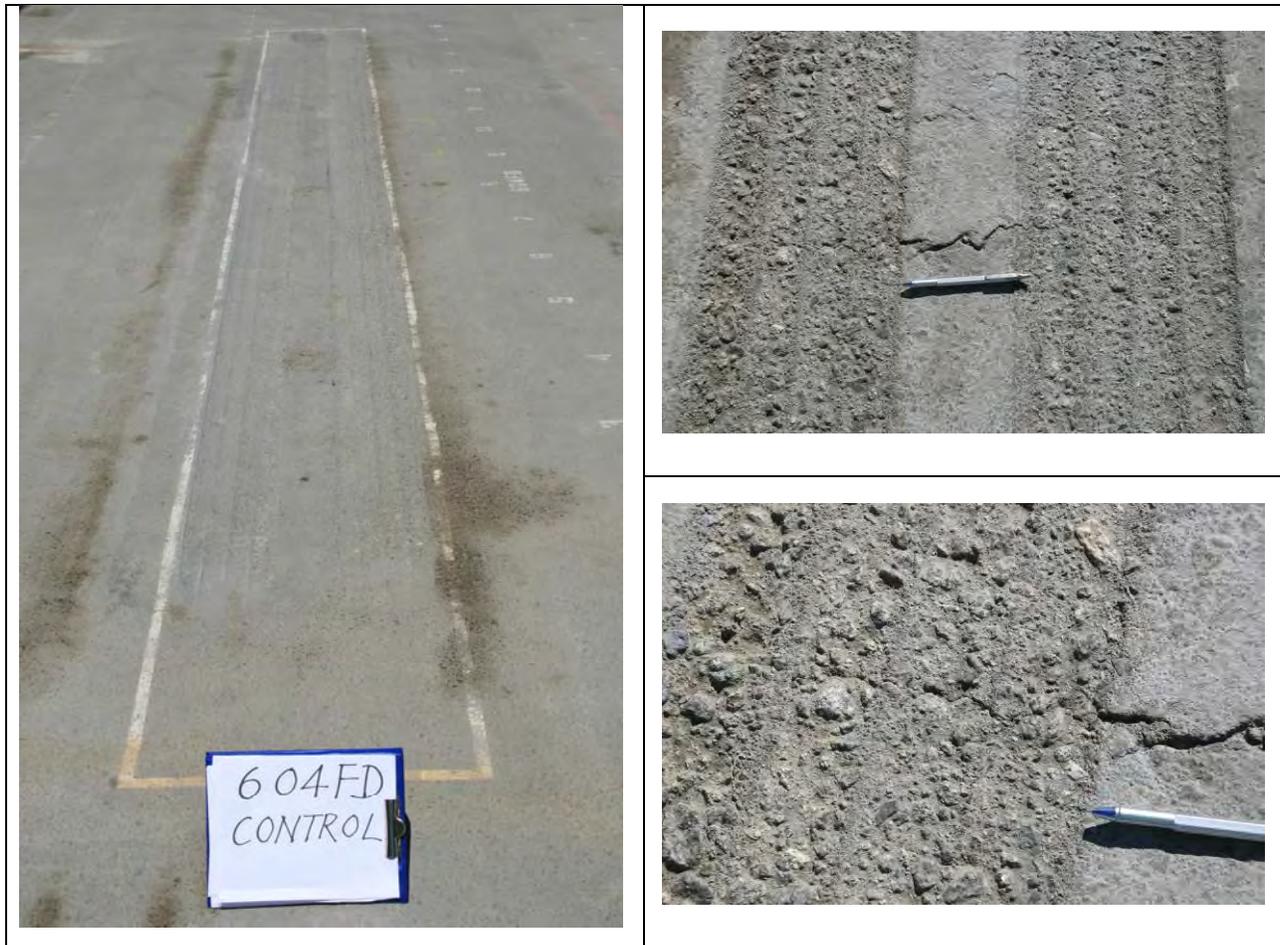
Figure 4.18: 604FD: Section photographs at test completion.

- Although some “wear” (attributed to the channelized traffic and constant water flow) was noted on the surface (Figure 4.18), no aggregate stripping, ravelling or other evidence of moisture damage was noted during or after the test.

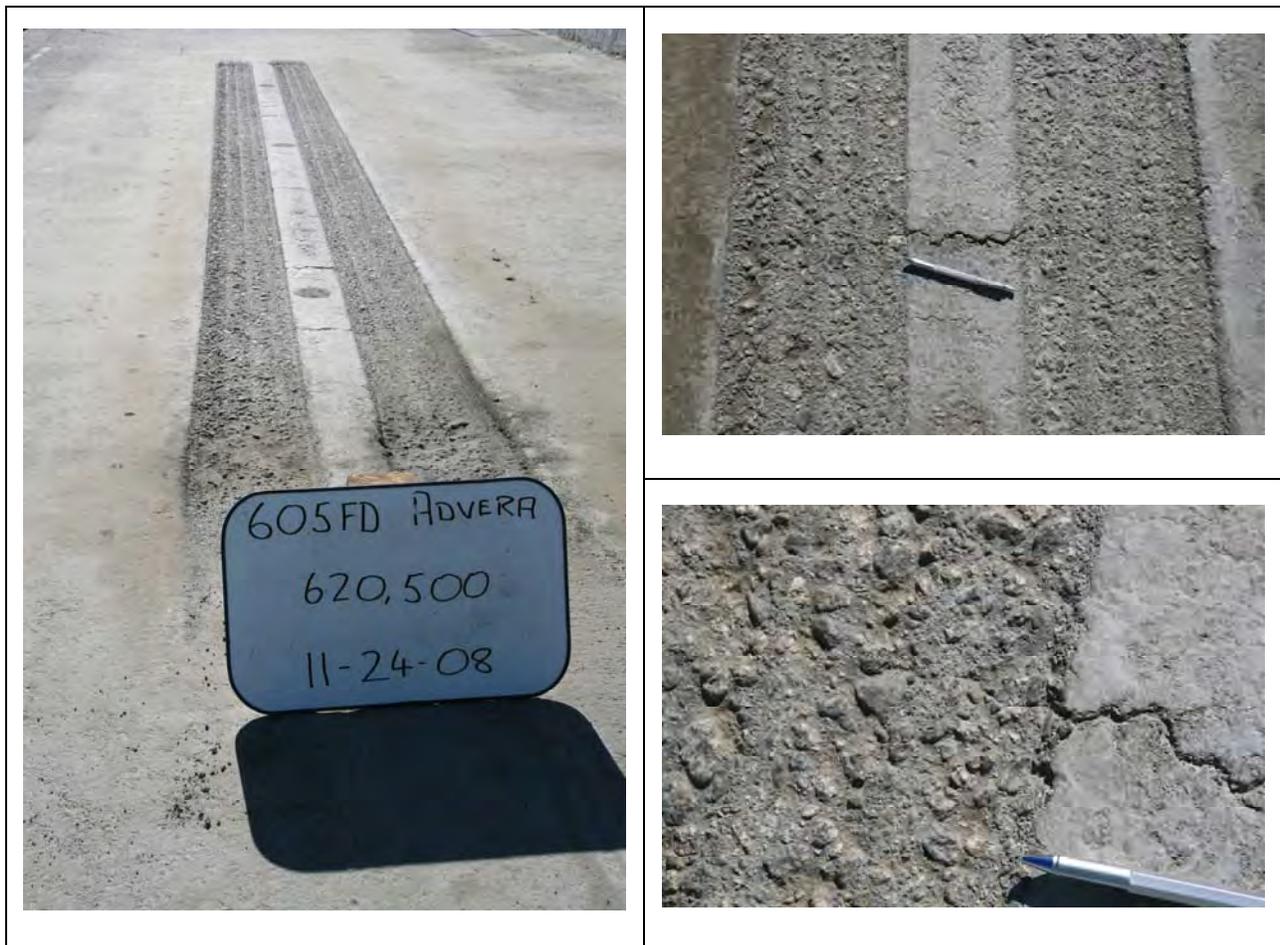
Figure 4.32: 605FD: Section photographs at test completion.

- The rutting pattern after completion of the test was typical of HVS rutting tests (Figure 4.32) and similar to that observed on the Control.
- Although some “wear” was noted on the surface (Figure 4.32), no aggregate stripping, ravelling or other evidence of moisture damage was noted during or after the test.

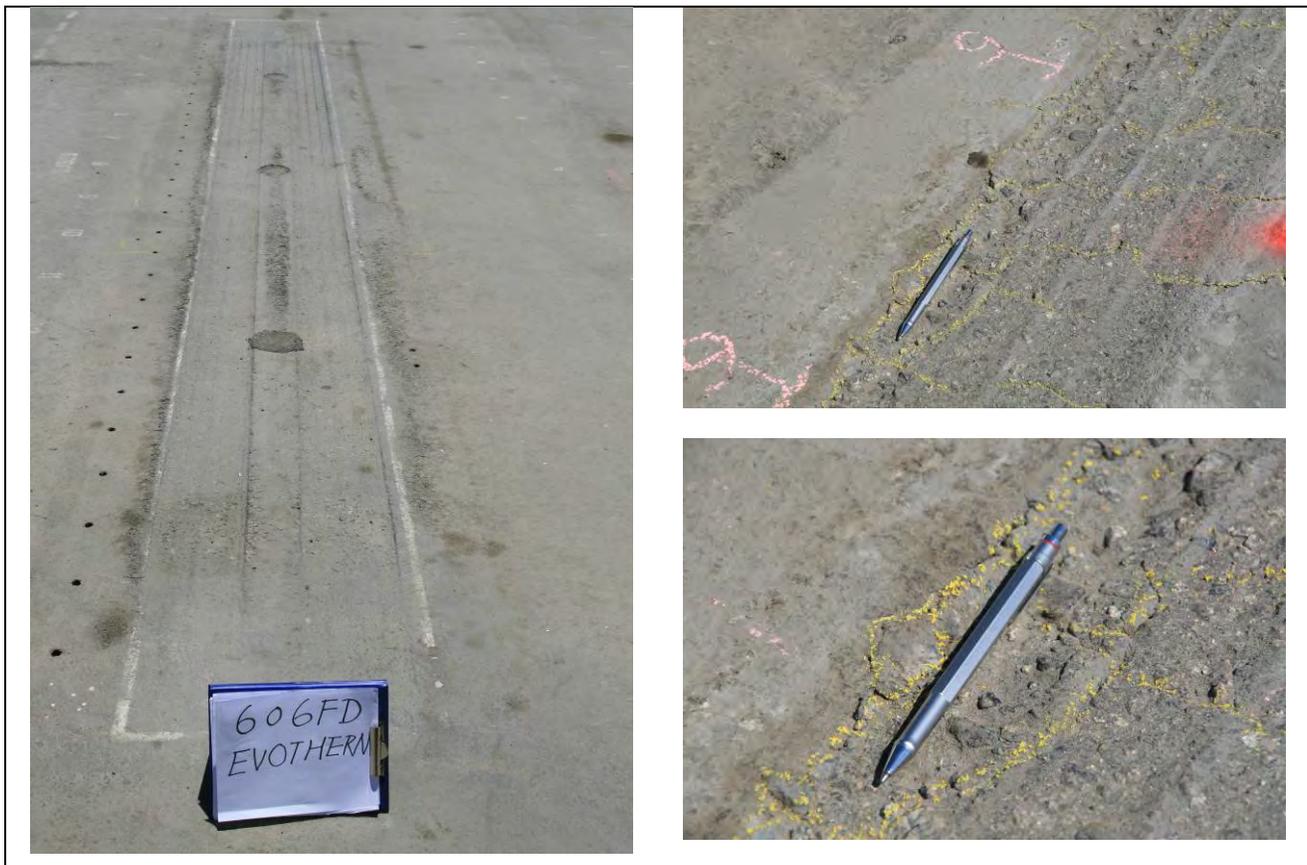
Figure 4.43: 606FD: Section photographs at test completion.

- The rutting pattern after completion of the test was typical of HVS rutting tests (Figure 4.43) and similar to that observed on the Control.
- Although some “wear” was noted on the surface (Figure 4.43), no aggregate stripping, ravelling or other evidence of moisture damage was noted during or after the test.

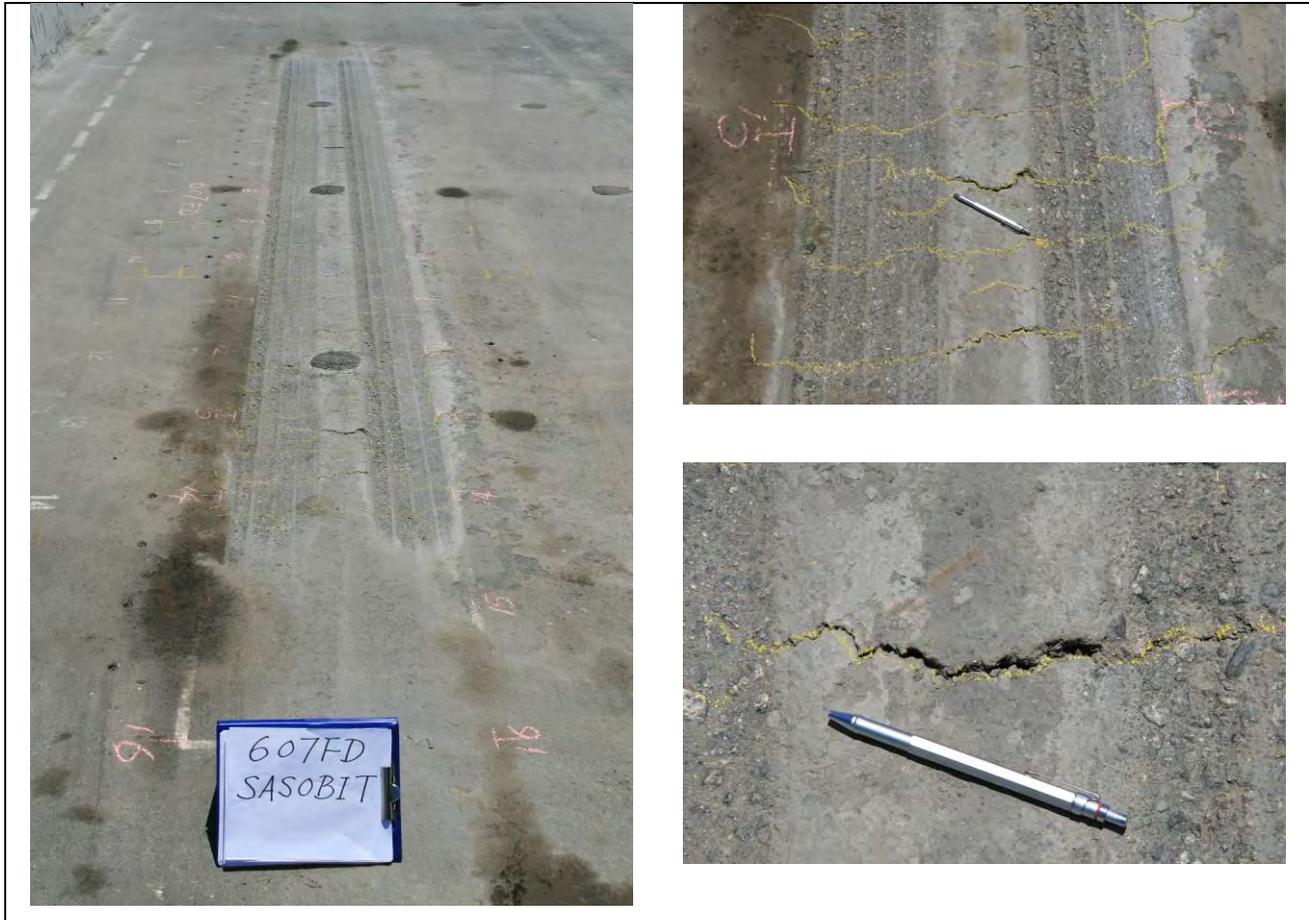
Figure 4.54: 607FD: Section photographs at test completion.

- The rutting pattern after completion of the test was typical of HVS rutting tests (Figure 4.54) and similar to that observed on the Control.
- Although some “wear” was noted on the surface (Figure 4.54), no aggregate stripping, ravelling or other evidence of moisture damage was noted during or after the test.
