Oregon State University  
School of Civil and Construction Engineering

**BENCHMARKING RECENTLY DEVELOPED PROCEDURES FOR  
DESIGNING PILE FOUNDATIONS IN LATERALLY SPREADING  
GROUND**

Final Report on a Research Project Funded by  
Caltrans under Facilities Contract No. 65A0453

18 July 2014

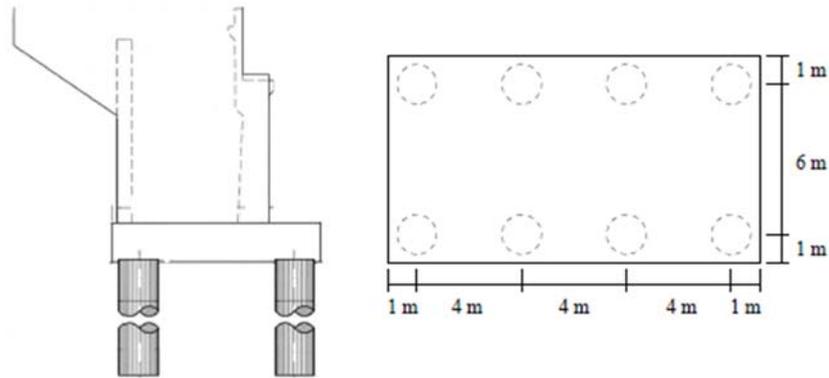
**Figure 2.1 Elevation and plan views of typical abutment for Puente Mataquito (courtesy Ministerio de Obras P'ublicas, Chile) (McGann et al. 2012)**

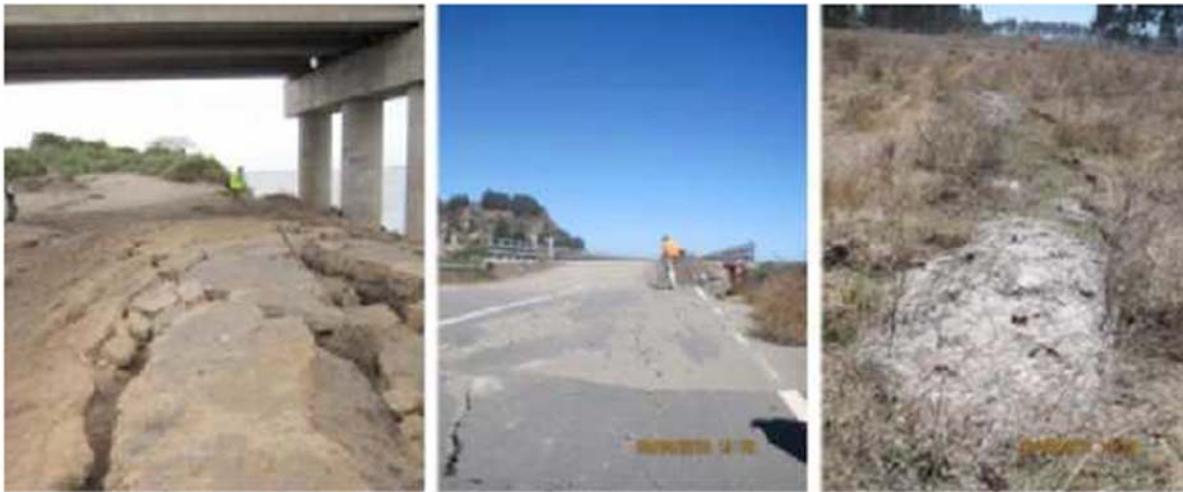
**Figure 2.4 Mataquito bridge: (a) Lateral spreading on the south end of the bridge, S35.050712° W72.162258°; (b) approach fill settlement at the north abutment of the bridge (70 cm offset at the bridge deck), S35.050712° W72.162258°; (c) sand boils at the north end, S35.051961° W72.163217° (Ledezma et al. 2012)**

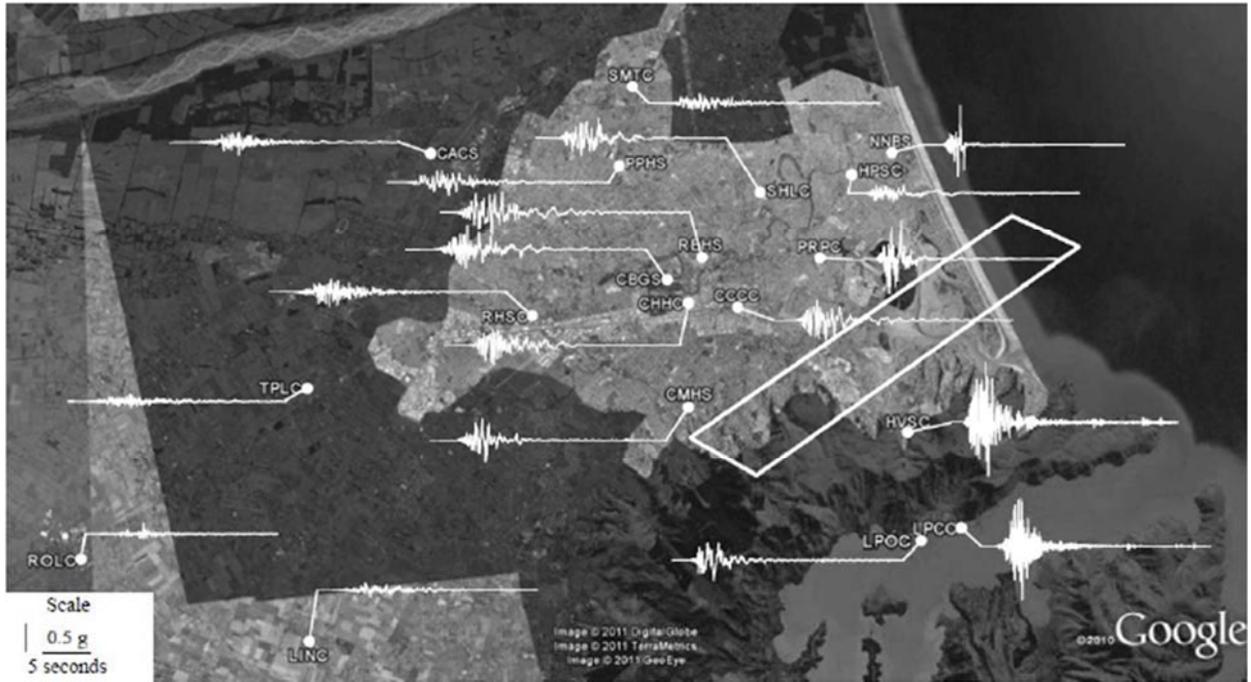
**Figure 2.5 Observed fault-normal horizontal acceleration time histories at various locations in the Christchurch region from the 22 February earthquake with reference to the inferred surface projection of the causative fault which dips to the south-east (Cubrinovski et al. 2011)**

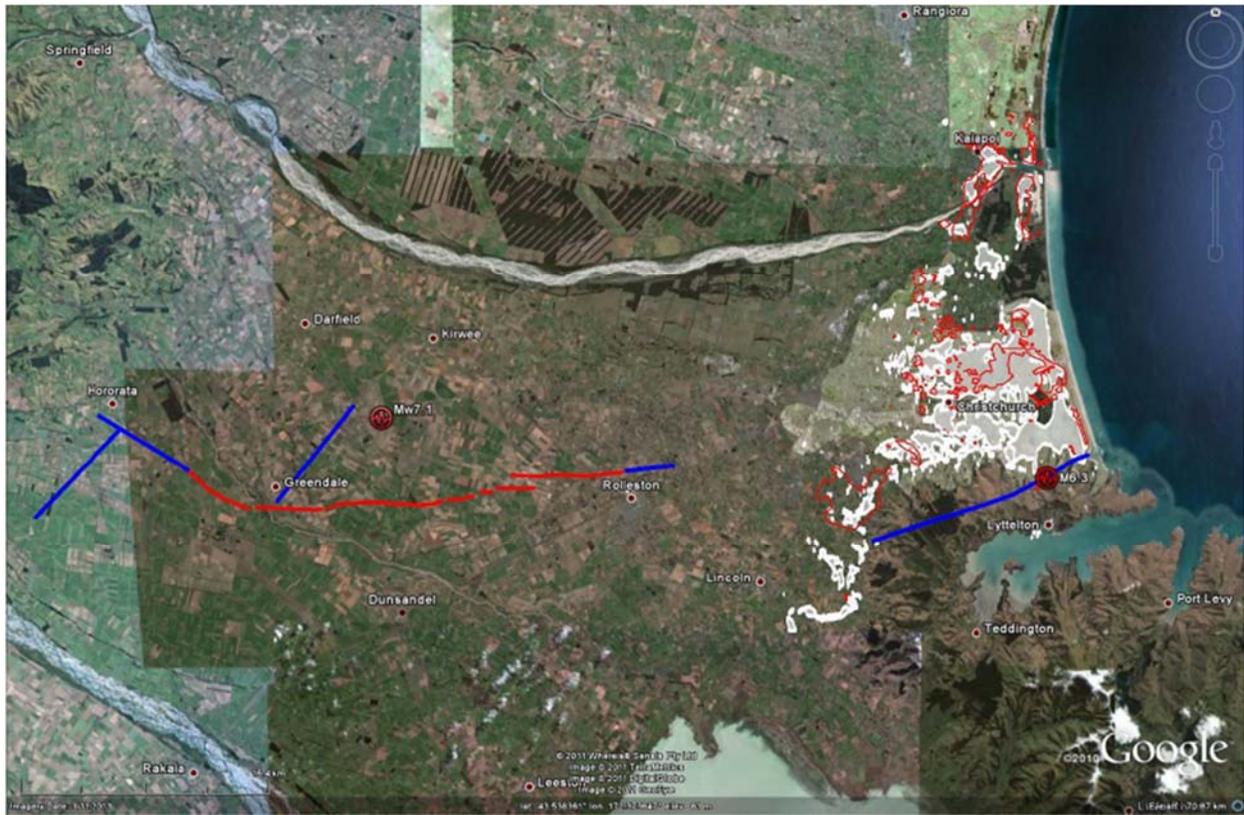
**Figure 2.6 Areas of induced liquefaction by the 4 September 2010 (red bordered areas) and 22 February 2011 (white shaded areas) earthquakes and associated fault ruptures (red – fault rupture with surface trace; blue – fault rupture with no surface trace) (NZ-GEER 2011)**

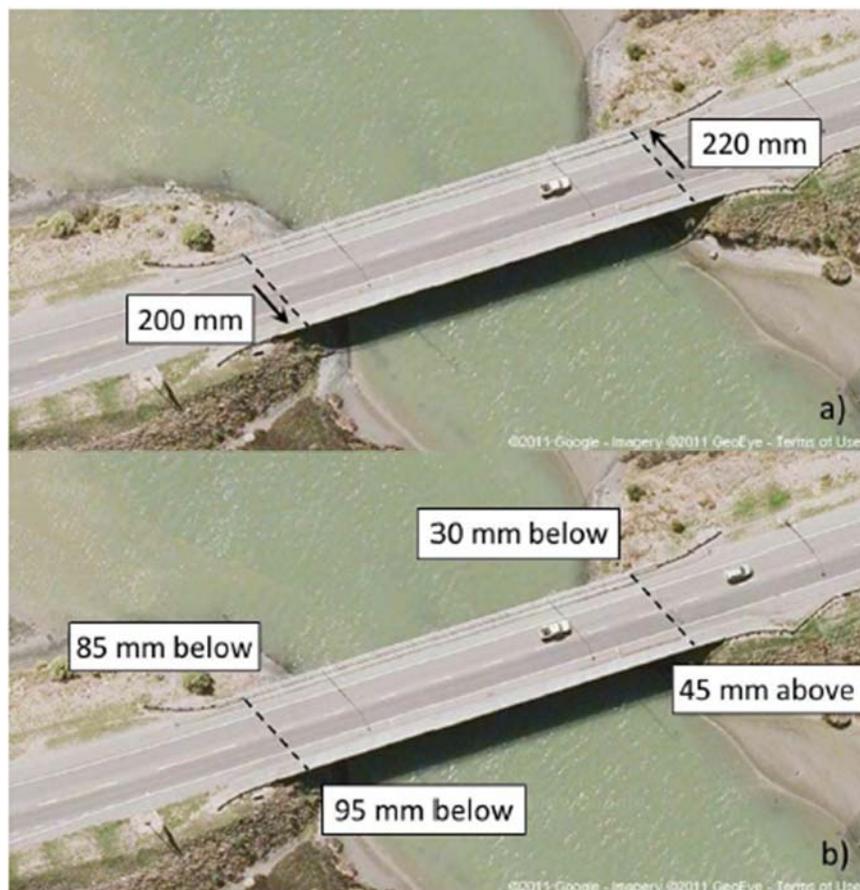
**Figure 2.9 South Brighton bridge; a) horizontal movement of abutments compared to bridge deck; b) vertical position of abutment compared to bridge deck (NZ-GEER 2011)**

Both abutments moved relative to the bridge deck. The east abutment moved about 0.22m, settled 0.030 m at north side, and lifted 0.045 m at south side, respectively. The west abutment moved 0.2 m, and settled 0.085 m at north side and 0.095 m at south side (in Figure 2.9). These displacements were measured after the Christchurch earthquake. The east abutment rotated about 7 degrees and the underlying soils spread laterally, which exposed the battered octagonal precast, prestressed concrete piles. Plastic hinges in the front and rear piles of the abutments were observed (in Figure 2.10). The west abutment rotated approximately 8 degrees following the Christchurch earthquake. Significant settlements of the soil beneath the west abutment occurred, which exposed the supporting piles. Note that there is fine sand underneath the abutment at this site. Figure 2.11 shows a comparison to the post-Darfield conditions. Significant settlement and ground spreading were observed (NZ-GEER 2011).

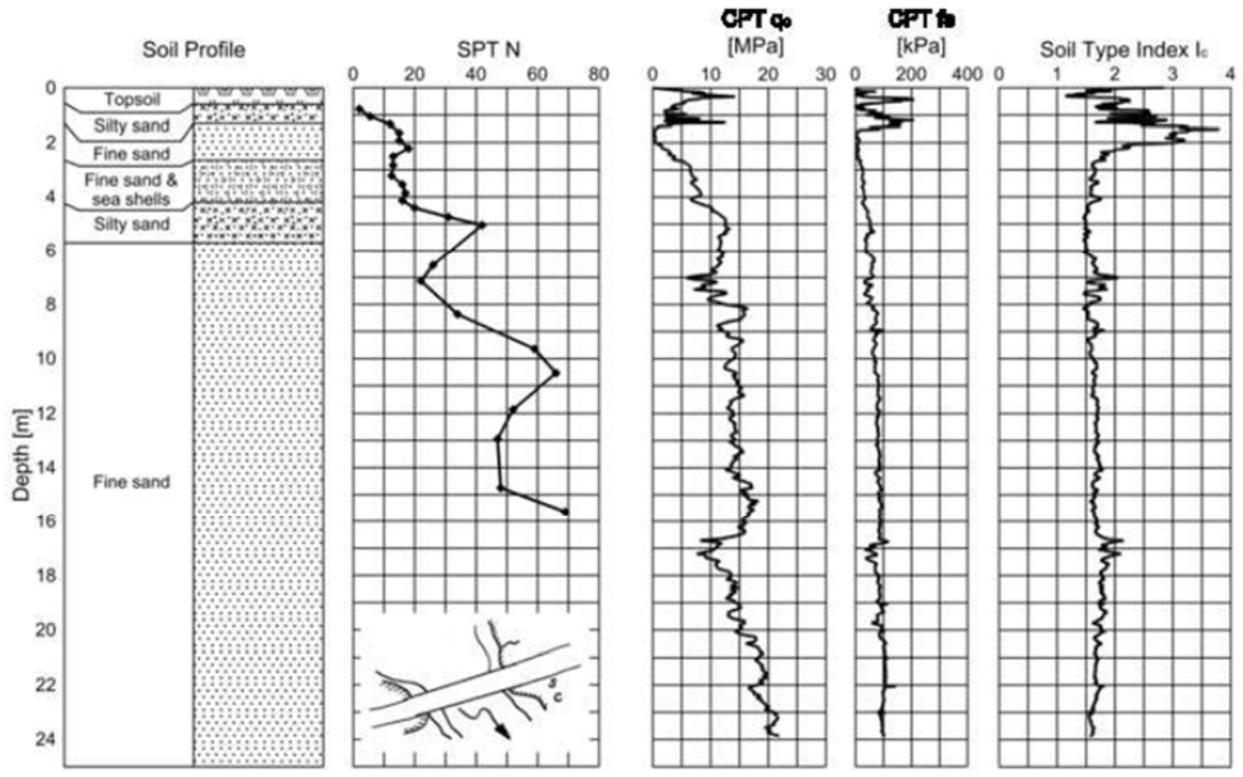
Figure 2.12 Soil profile, SPT and CPT data of South Brighton Bridge (Cubrinovski et al. 2013)

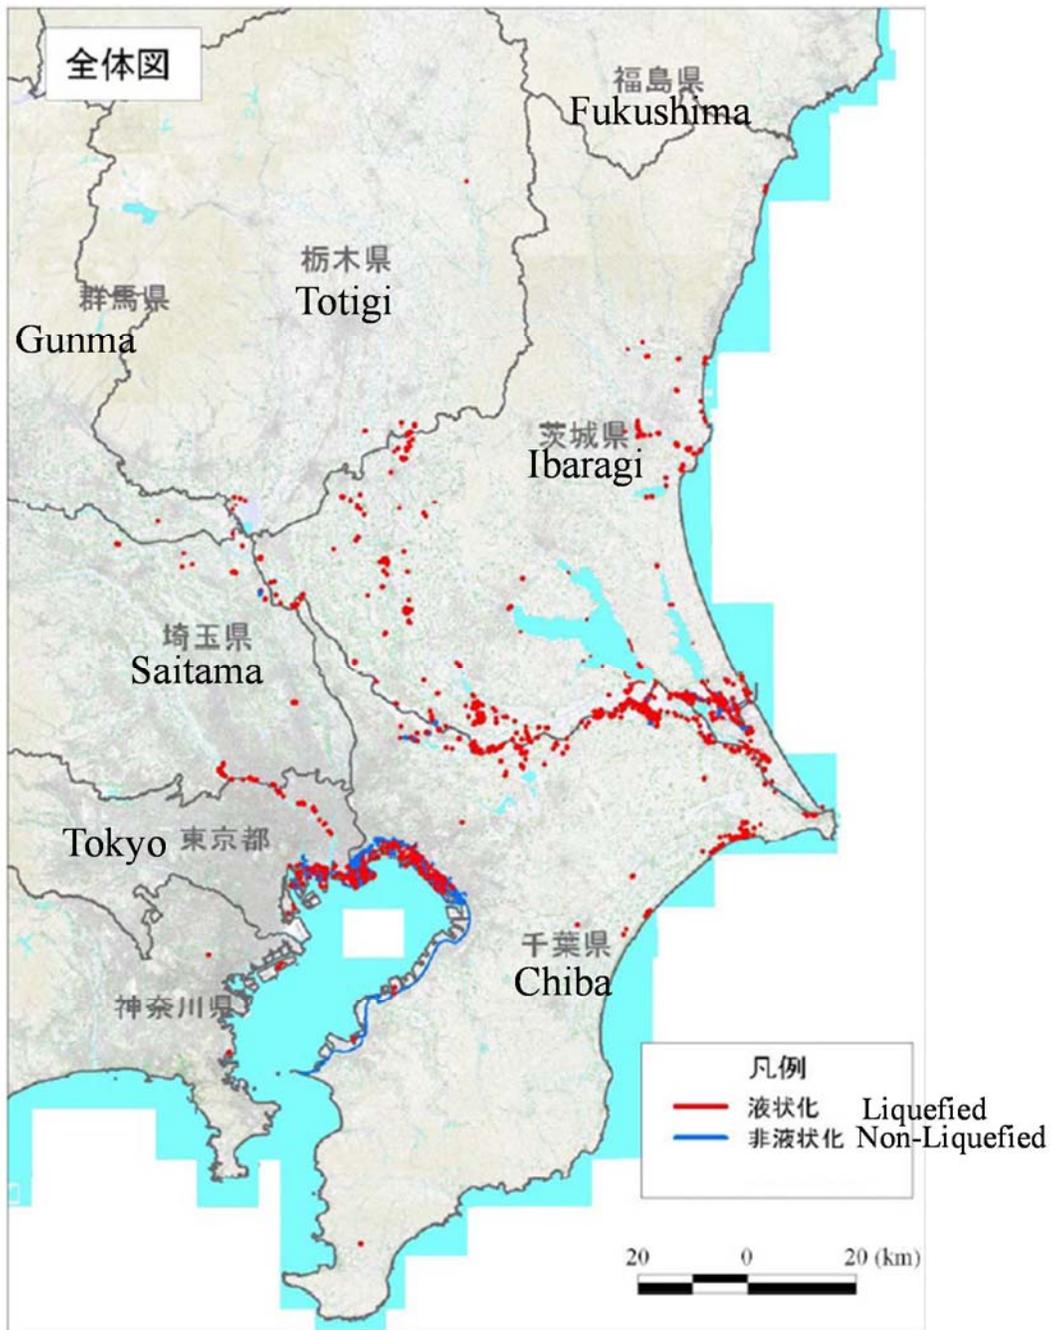
Figure 2.13 The map that liquefaction observed in Kanto area (JGS 2011)

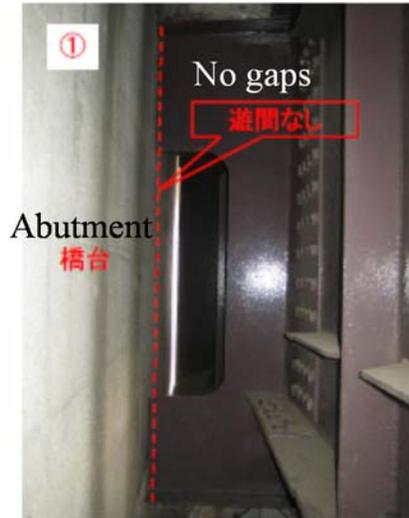
Figure 2.16 No gaps between the deck and A2 abutment (Chiba city 2011)

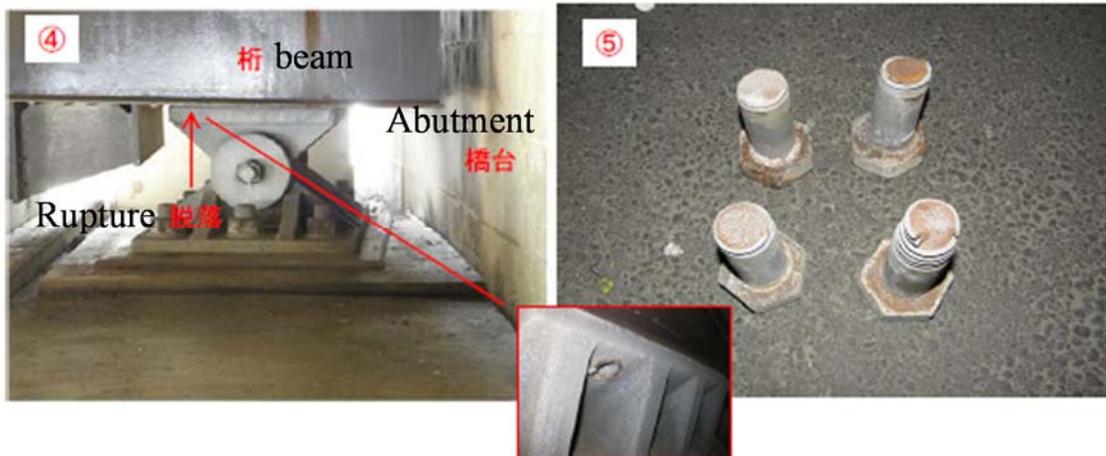
Figure 2.17 Ruptured bolts of A2 abutment (Chiba city 2011)

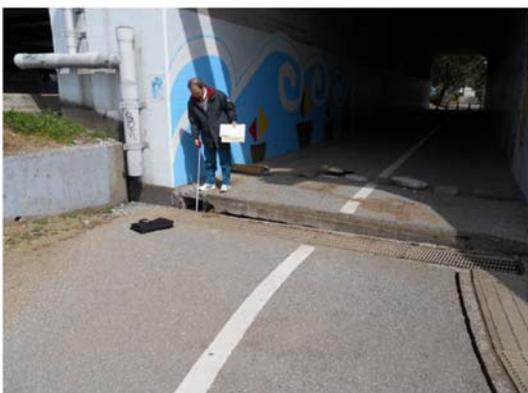
Figure 2.18 Ground settlement at the side of A1 abutment (Chiba city 2011)

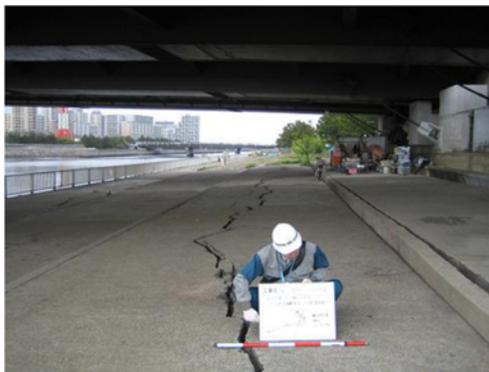
Figure 2.24 Cracks on the sea bank in front of the A1 abutment W=100mm (Chiba city 2011)

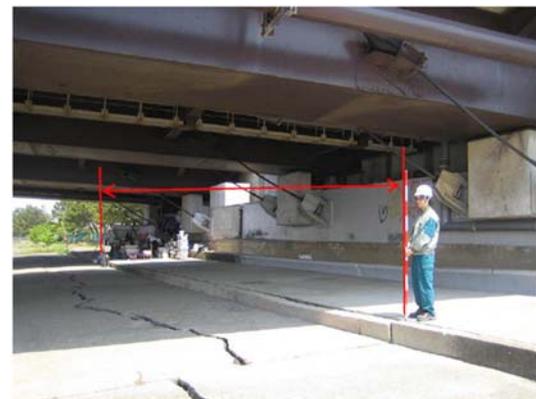
Figure 2.25 Cracks on the sea bank in front of the A1 abutment (Chiba city 2011)

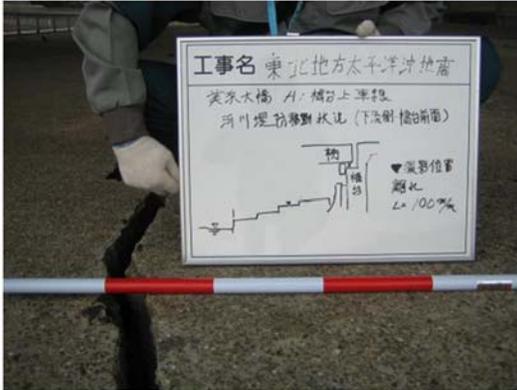
Figure 2.26 Cracks on the sea bank  
W=100mm (Chiba city 2011)

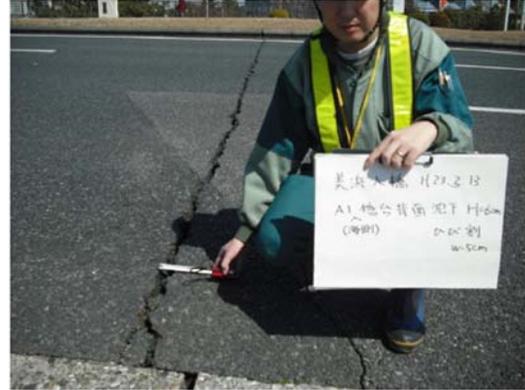
Figure 2.27 Cracks on the A1 abutment  
approaching road W=50mm (Chiba city  
2011)

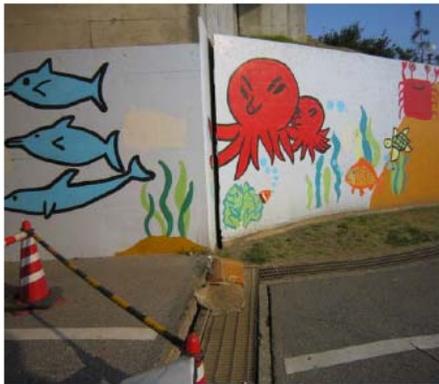
Figure 2.28 Gap between retaining wall and  
A1 abutment (Downstream side) (PWRI  
2011)

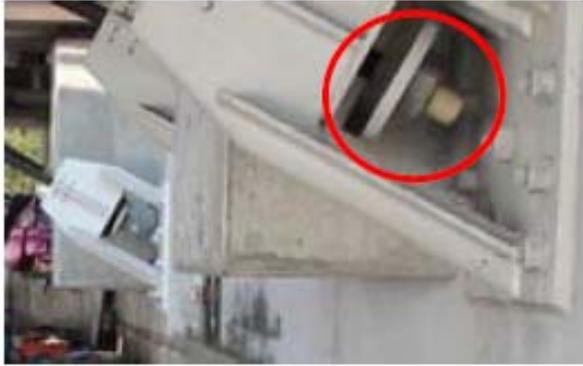
**Figure 2.31 Loosed bridge fall prevention device (PWRI 2011)**

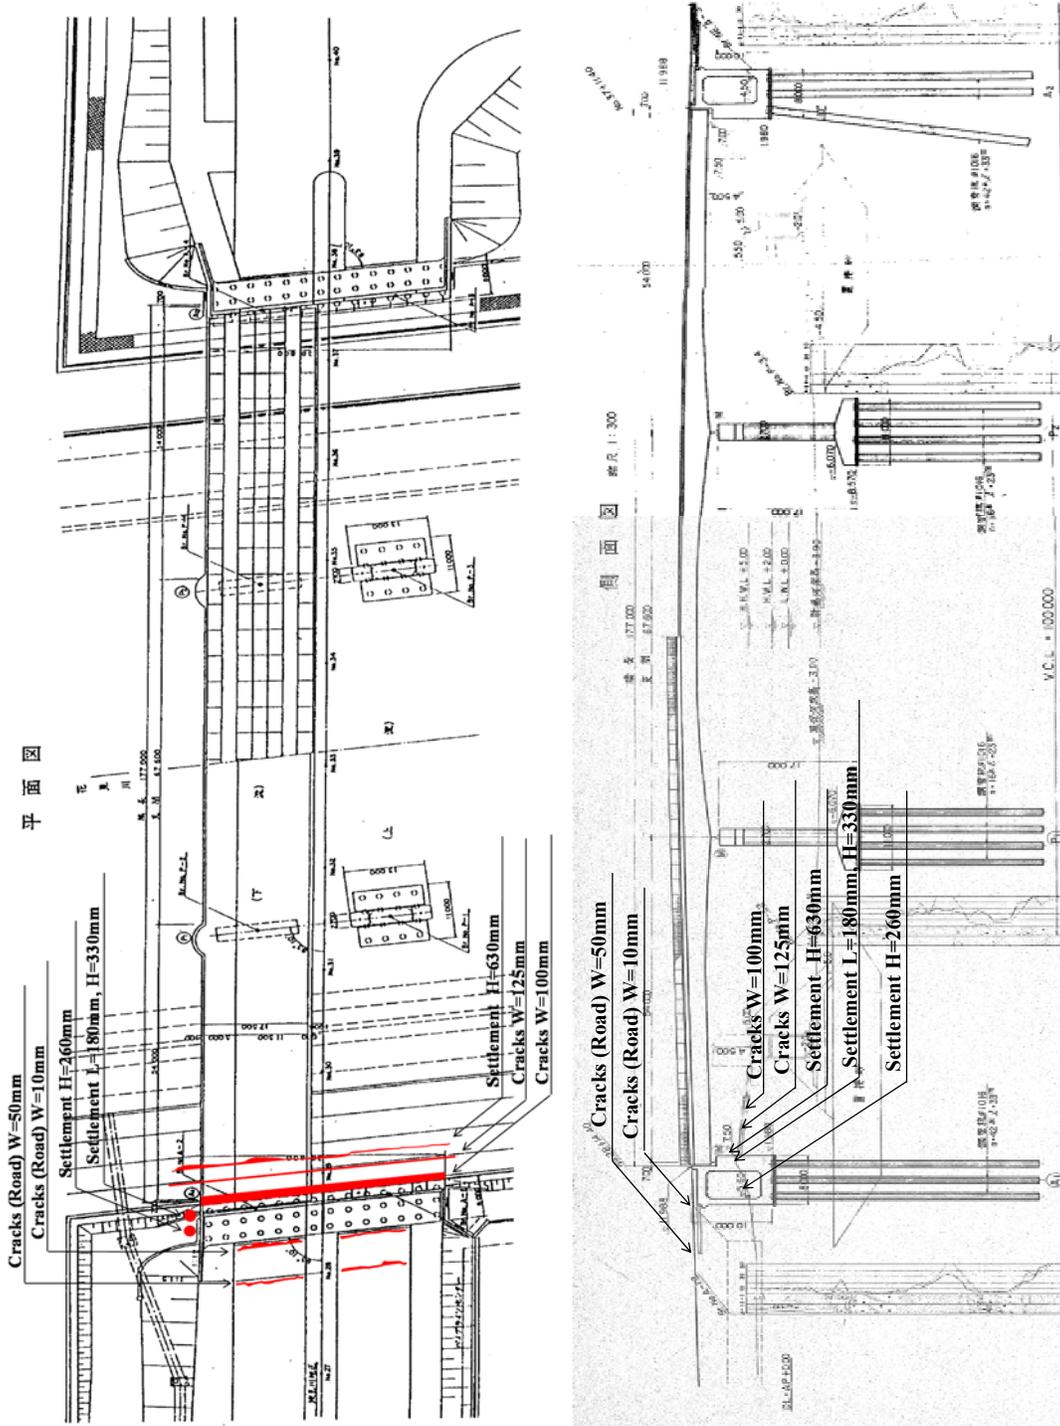
Figure 2.33 Observed cracks near the A1 abutment (Chiba city 2011)

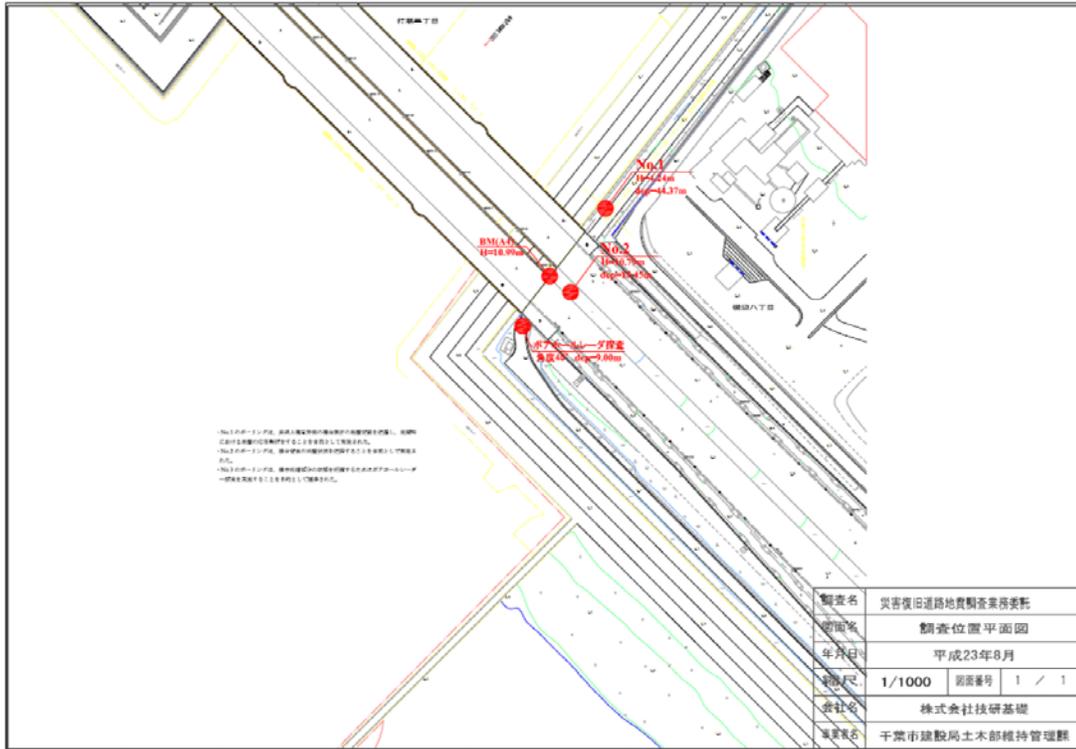
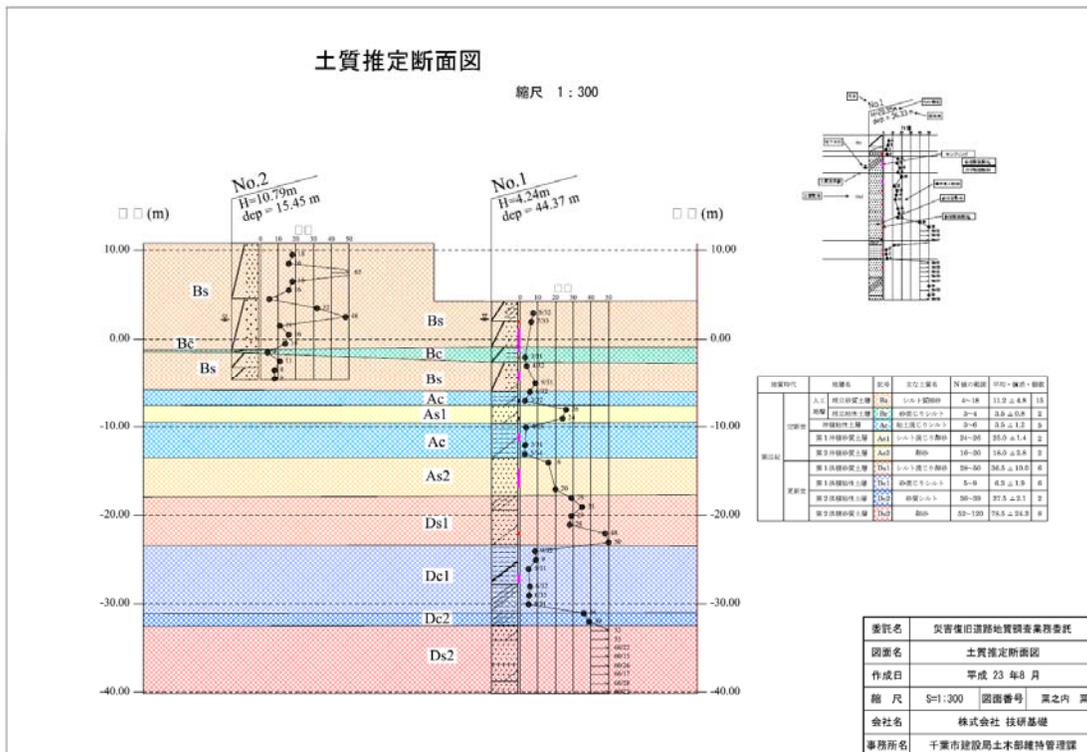
Figure 2.34 Boring data at the liquefied site near the A1 abutment (Investigated during 23-26 April in 2011) (Chiba city 2011)

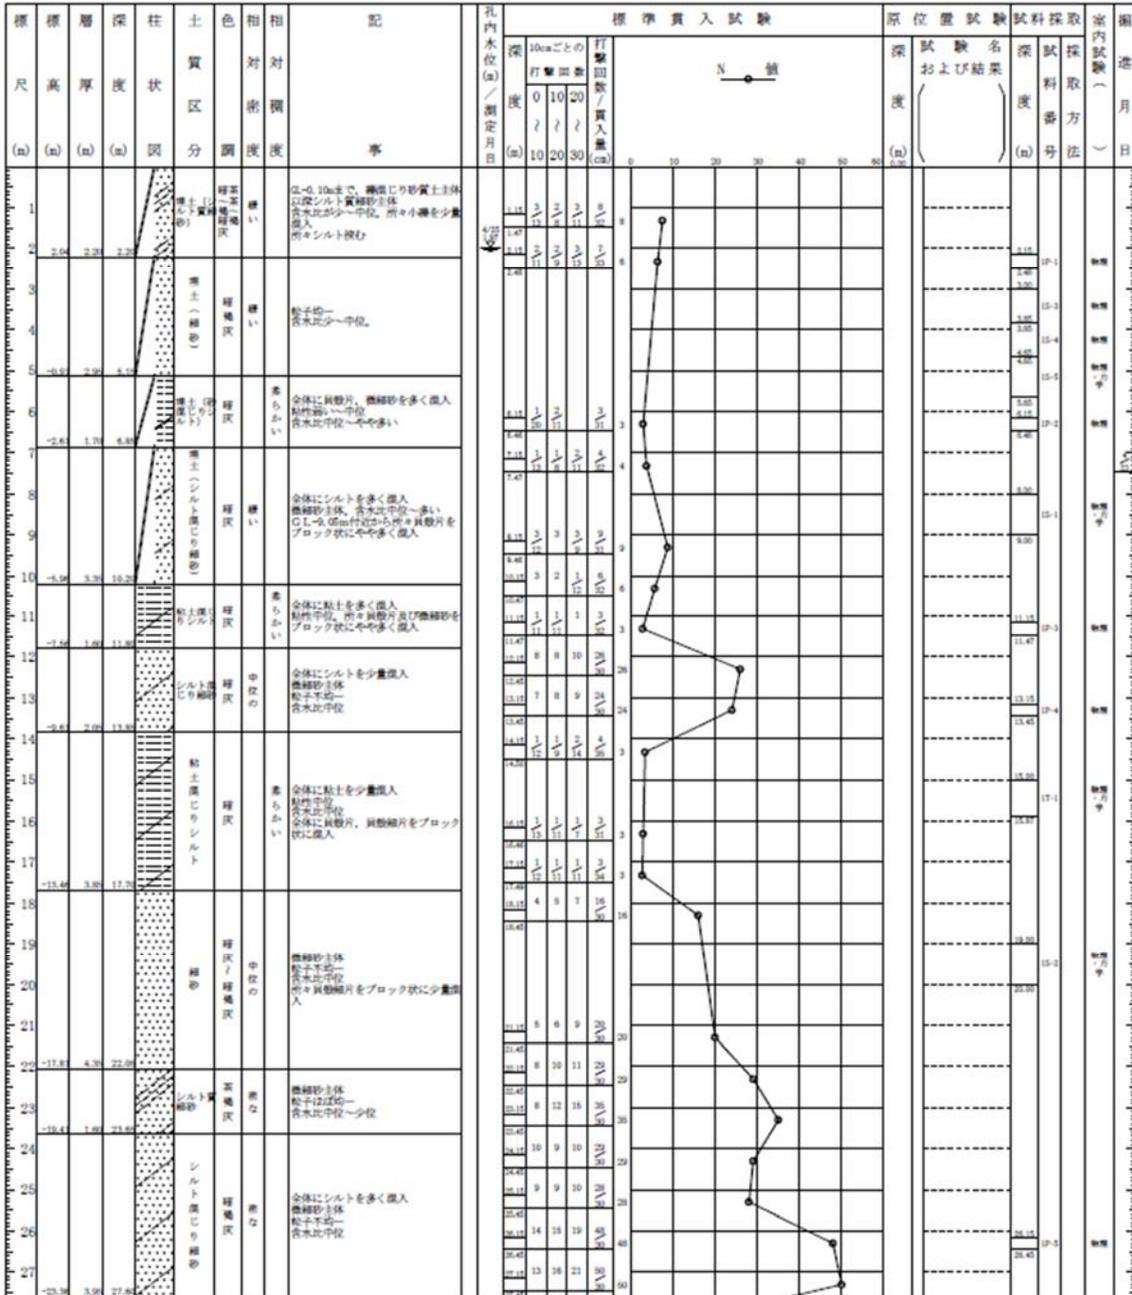
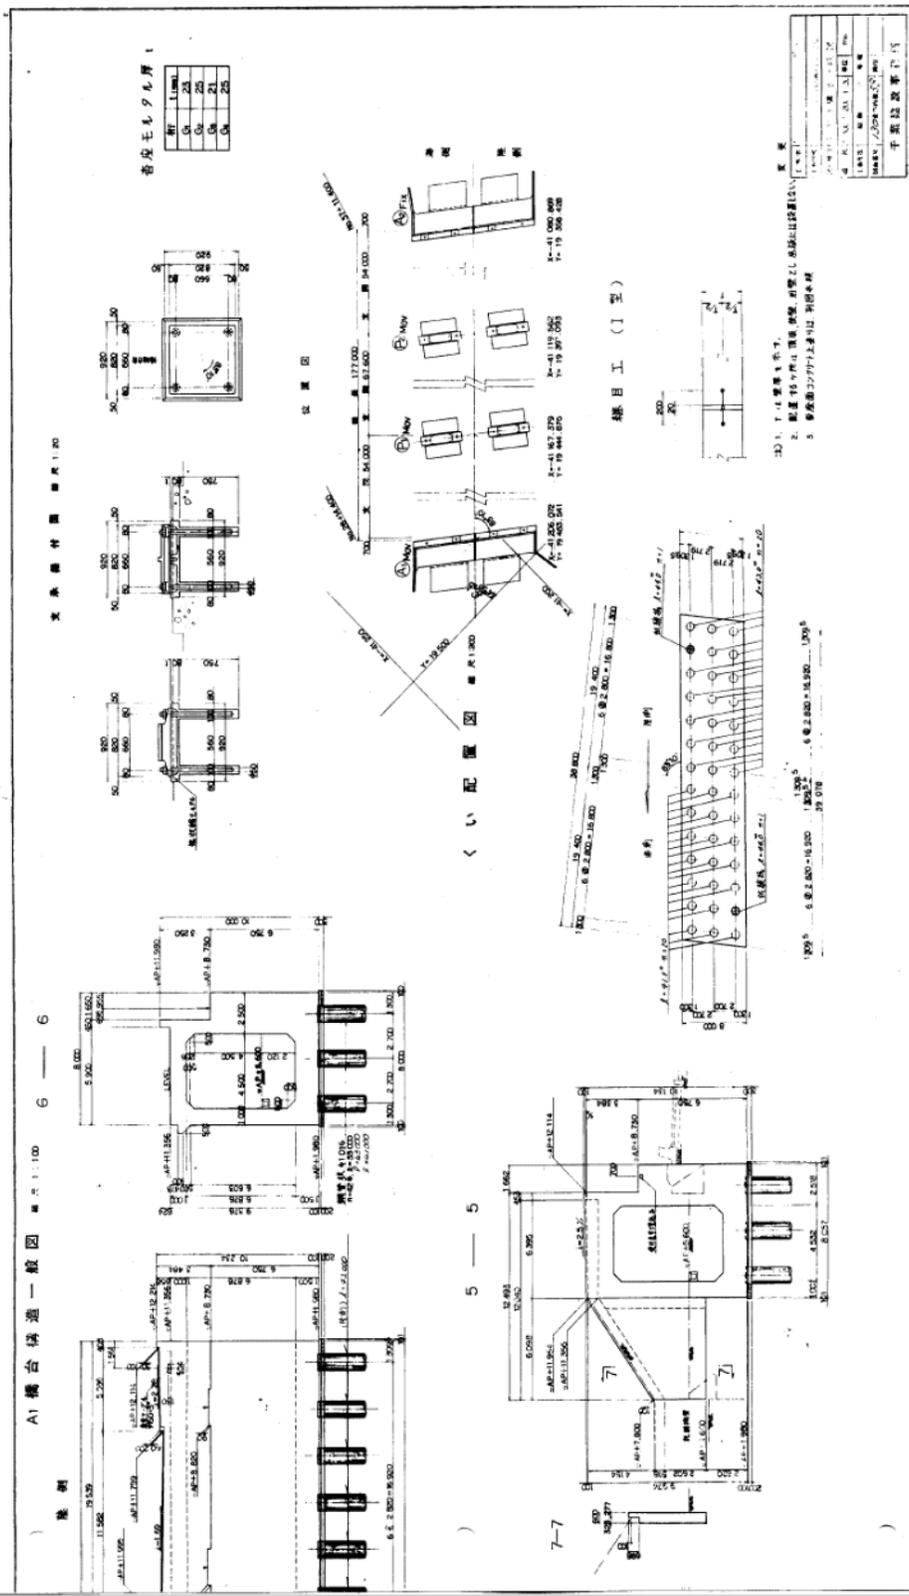
Figure 2.37 The A1 abutment drawings

Figure 2.37 - Figure 2.39 show the piles and both A1 and A2 box culvert type abutment drawings. The A1 abutment is supported by 42 (3×12) steel pipe piles (i.e. not filled with concrete). The A1 steel pipe pile is 33m long that is composed of three 11m long portions. The diameter of each portion is 1,016mm. The thickness of the first portion (just beneath of the A1 abutment) is 14mm, and the second and third portions are 12mm thick. The 42 (3×12) steel pipe pile supporting A2 abutment is 44m long and composed of four 11m portions. The A2 steel pipe pile diameter is 1,016mm. The thickness of the first portion (beneath of the A2 abutment) is 14mm and the other portions are 12mm thickness.

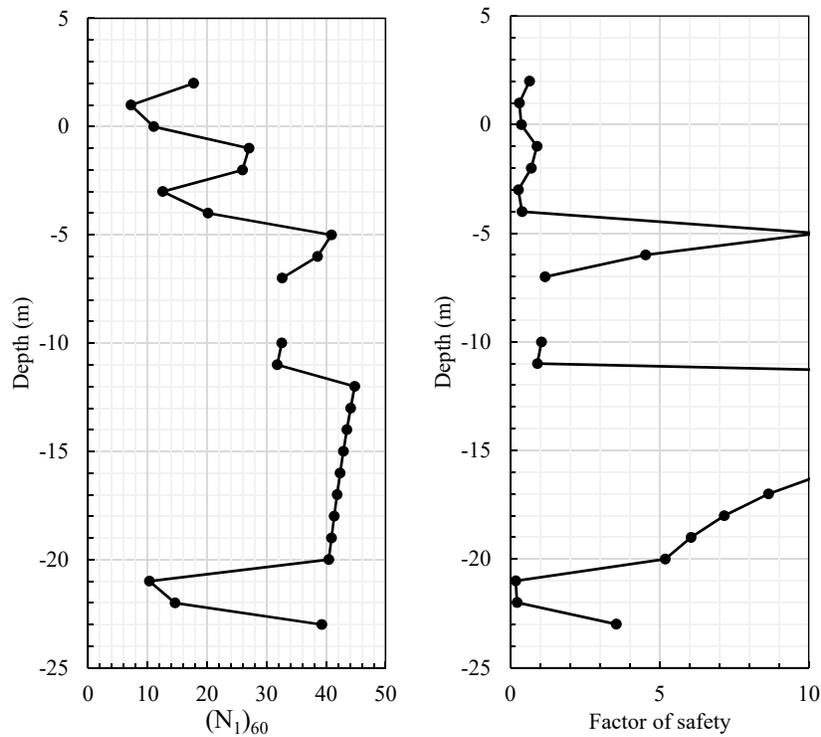
Figure 3.1 shows that the result of liquefaction potential evaluation. Cyclic resistance ratio (CRR) is estimated based on SPT N-value reported by Ledezma et al. (2011). Factor of safety shows that most susceptible liquefiable layer is embedded from 0m to -4.5m. Although the factor of safety at the depth 11m are less than one, the factor of safety is close to one and this layer is thin. Displacement effects against piles are relatively small. Also, the factor of safety at the depth from 21m to 22m is less than one, however, this layer is not expected to liquefy because of high vertical effective stress. Therefore, liquefaction is not expected at this depth. Ledezma et al. (2011) reported that liquefiable fine sand layer, 5m thickness, at north abutment is embedded. Judging from liquefaction potential evaluation and Ledezma et al. (2011), the liquefiable layer at the Mataquito Bridge is embedded from 0m to -4.5m.

Figure 3.1 Results of the liquefaction potential evaluation, the Mataquito Bridge

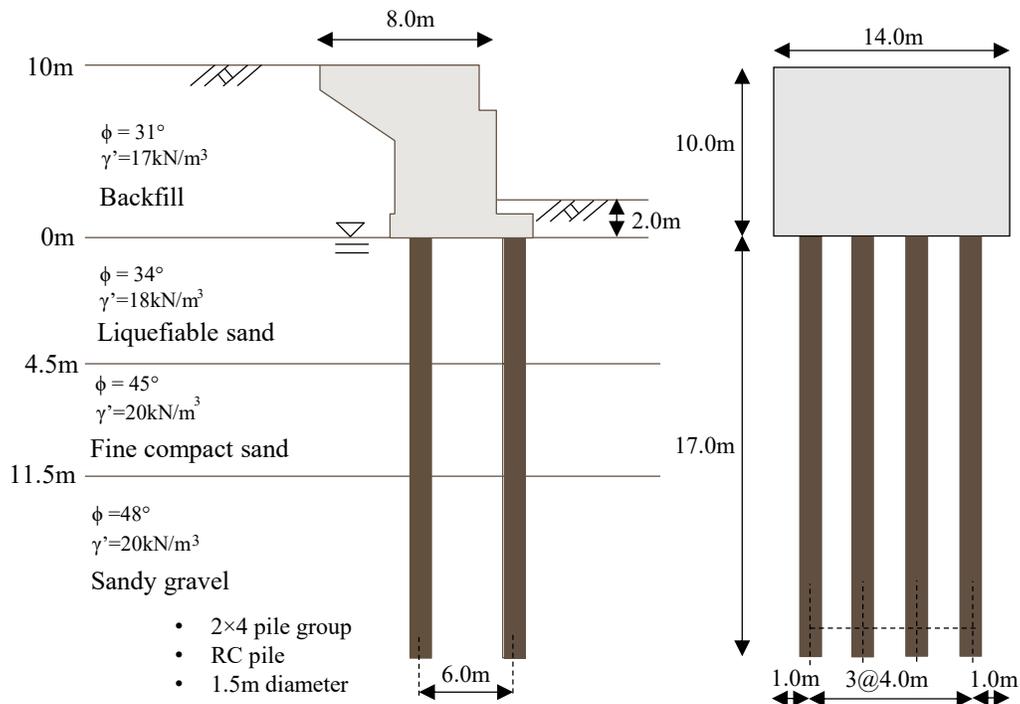
Figure 3.2 Sketch of north abutment foundation of the Mataquito Bridge

Soil unit weight is estimated from Kulhawy and Mayne (1990). Figure 3.2 shows the sketch of the soil layers and the approach embankment of Mataquito Bridge. Figure 3.3 shows the sketch of the embankment.

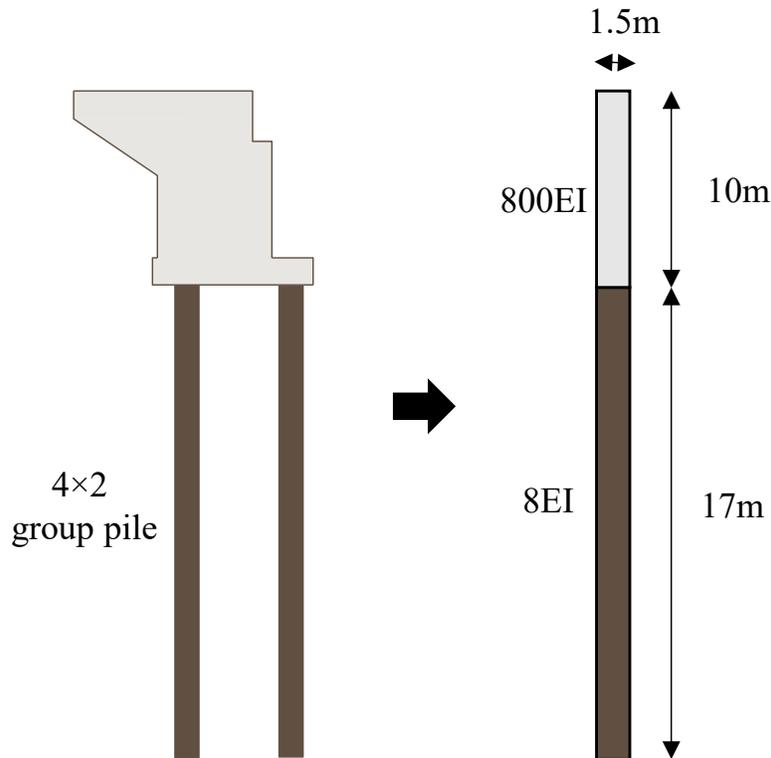
An equivalent non-linear single pile is modeled simply by multiplying bending stiffness by the number of piles. The abutment section is described as very stiff pile, and the bending stiffness is multiplied by a number of piles and one hundred. Figure 3.4 shows the modeling of group pile with an equivalent single pile.

**Figure 3.4 Modeling of an equivalent single pile, the Mataquito Bridge**

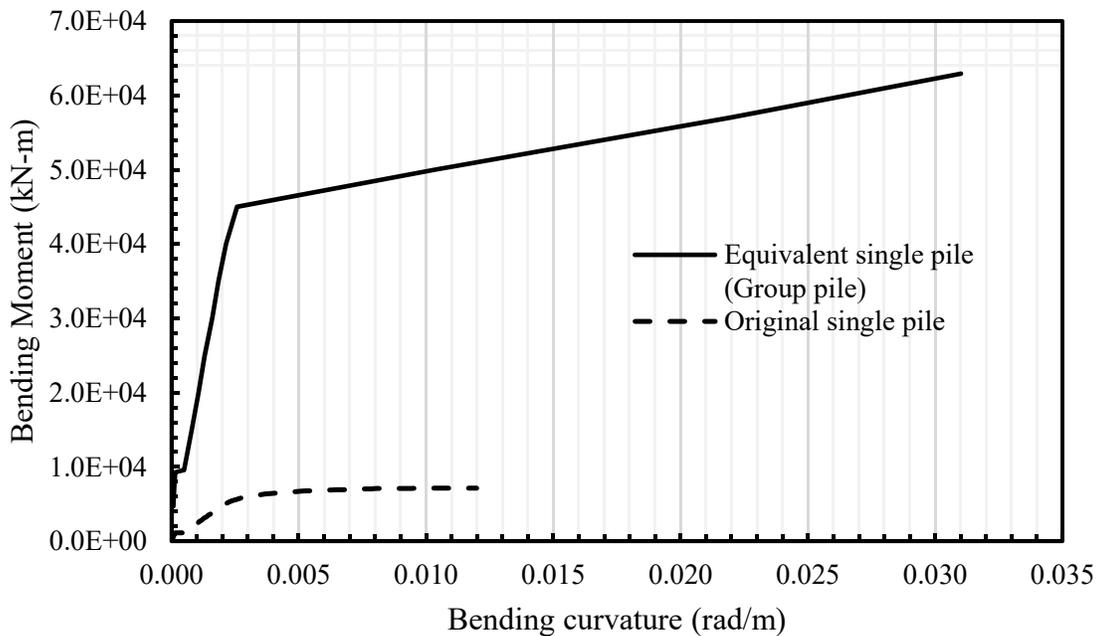
**Figure 3.5 Bending moment – bending curvature of the group pile section, the Mataquito Bridge**

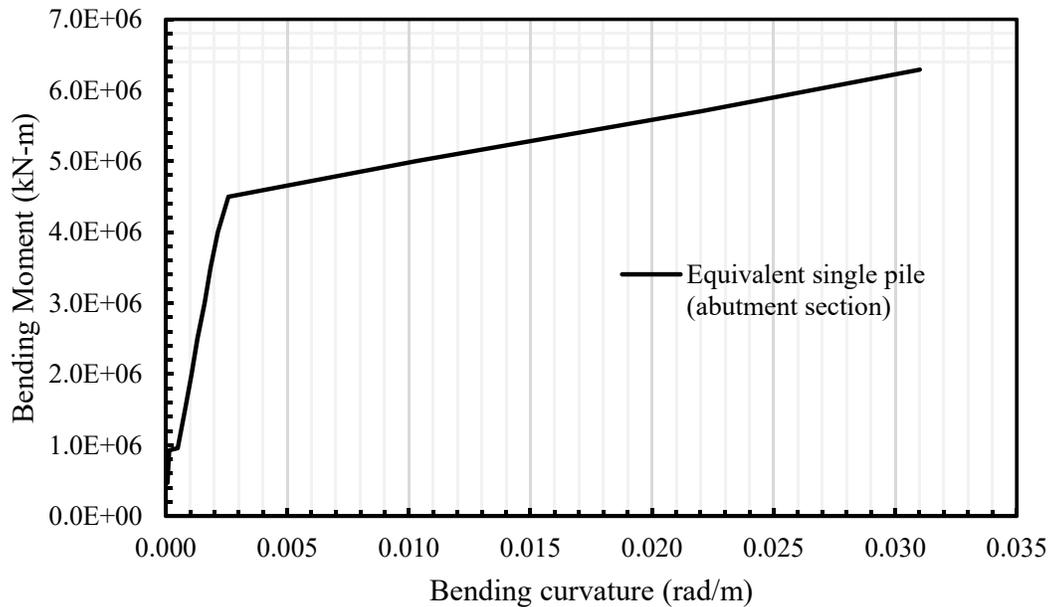
**Figure 3.6 Bending moment – bending curvature of the abutment section, the Mataquito Bridge**

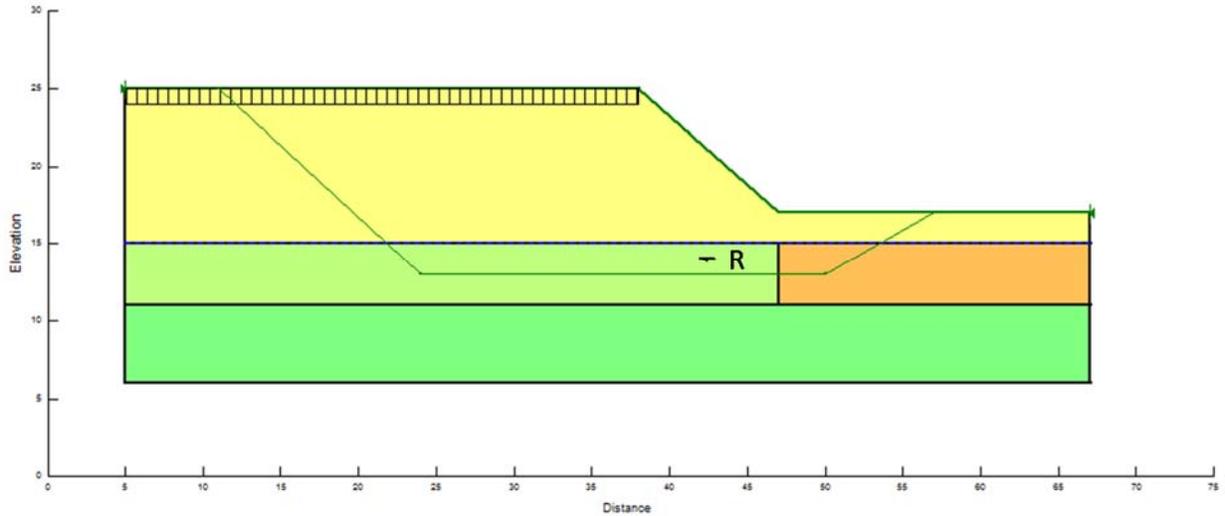
**Figure 3.9 Slope stability analysis model to determine coefficient of horizontal acceleration, the Mataquito Bridge**

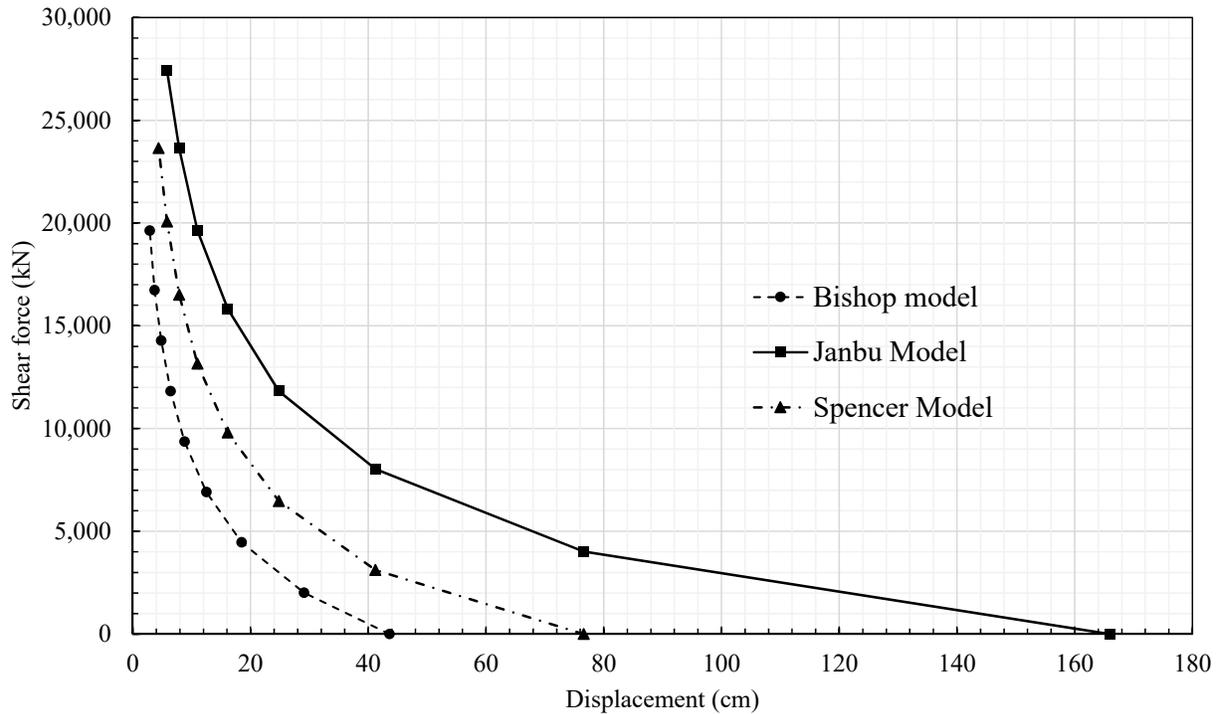
**Figure 3.10 Estimated ground displacement with PGA =0.461g, the Mataquito Bridge**

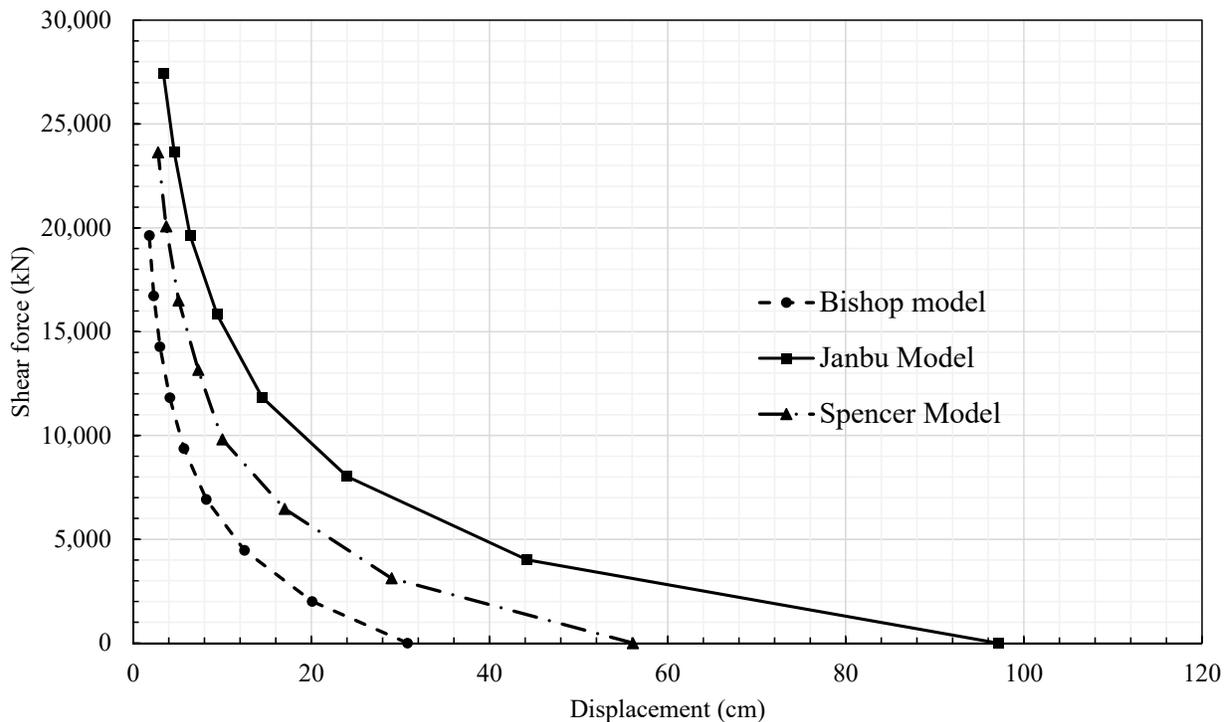
**Figure 3.11 Estimated ground displacement with PGA =0.390g, the Mataquito Bridge**

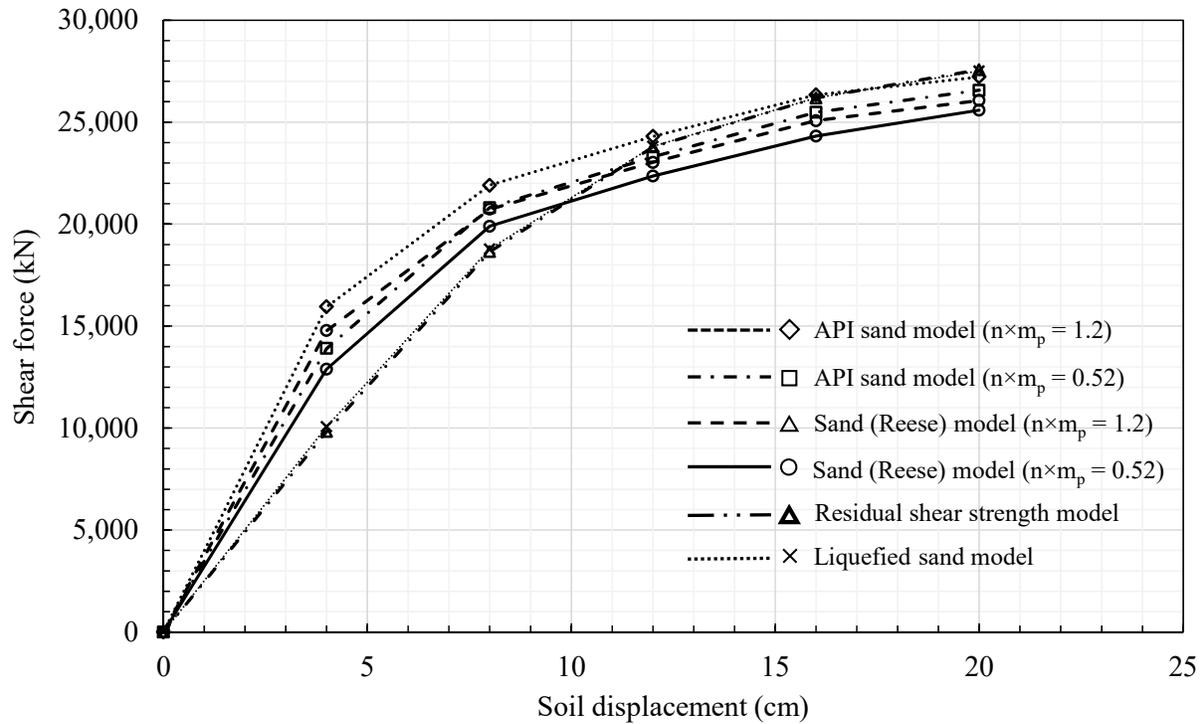
**Figure 3.12 Results of the pushover analysis of the Mataquito Bridge**
