Oregon State University  
School of Civil and Construction Engineering

**BENCHMARKING RECENTLY DEVELOPED PROCEDURES FOR  
DESIGNING PILE FOUNDATIONS IN LATERALLY SPREADING  
GROUND**

Final Report on a Research Project Funded by  
Caltrans under Facilities Contract No. 65A0453

18 July 2014

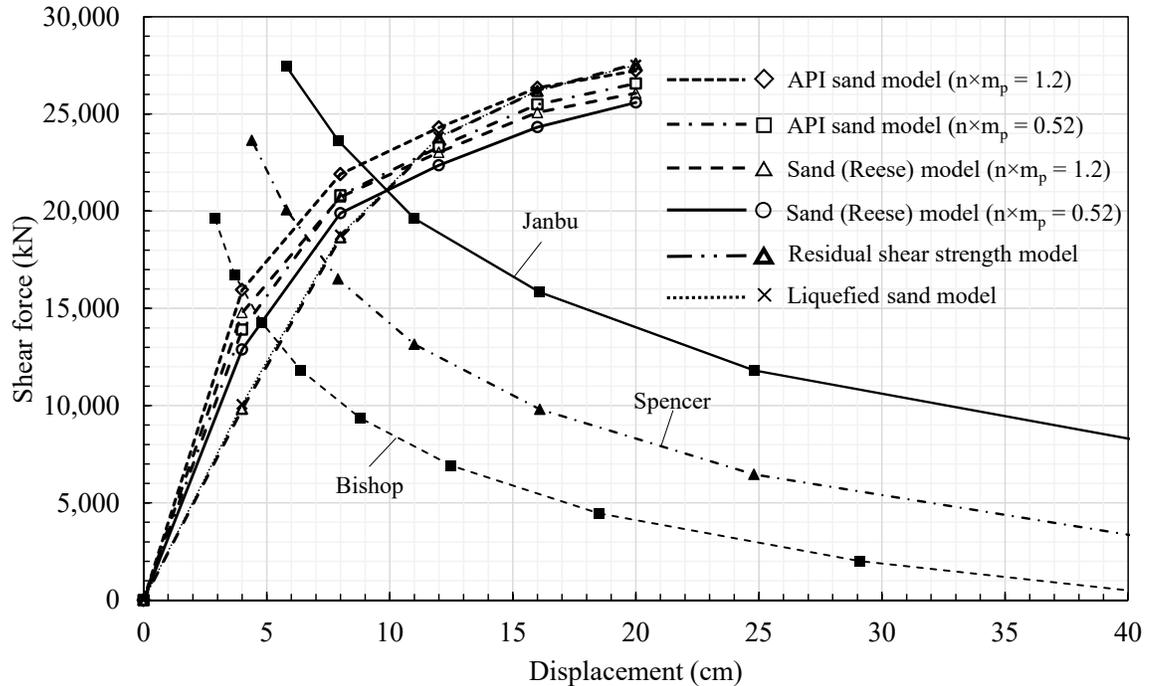
In order to determine the displacement, the intersection points of the pushover analysis and the slope stability analysis are determined. Figure 3.13 and Figure 3.14 show the intersection points of both  $PGA = 0.461g$  and  $0.390g$ . The estimated ground displacements with  $PGA = 0.461$  are from 4cm to 10cm and with  $PGA = 0.390g$  are from 3.5cm to 8cm.

**Figure 3.13 Pushover analysis vs slope stability analysis, the Mataquito Bridge ( $PGA = 0.461g$ )**

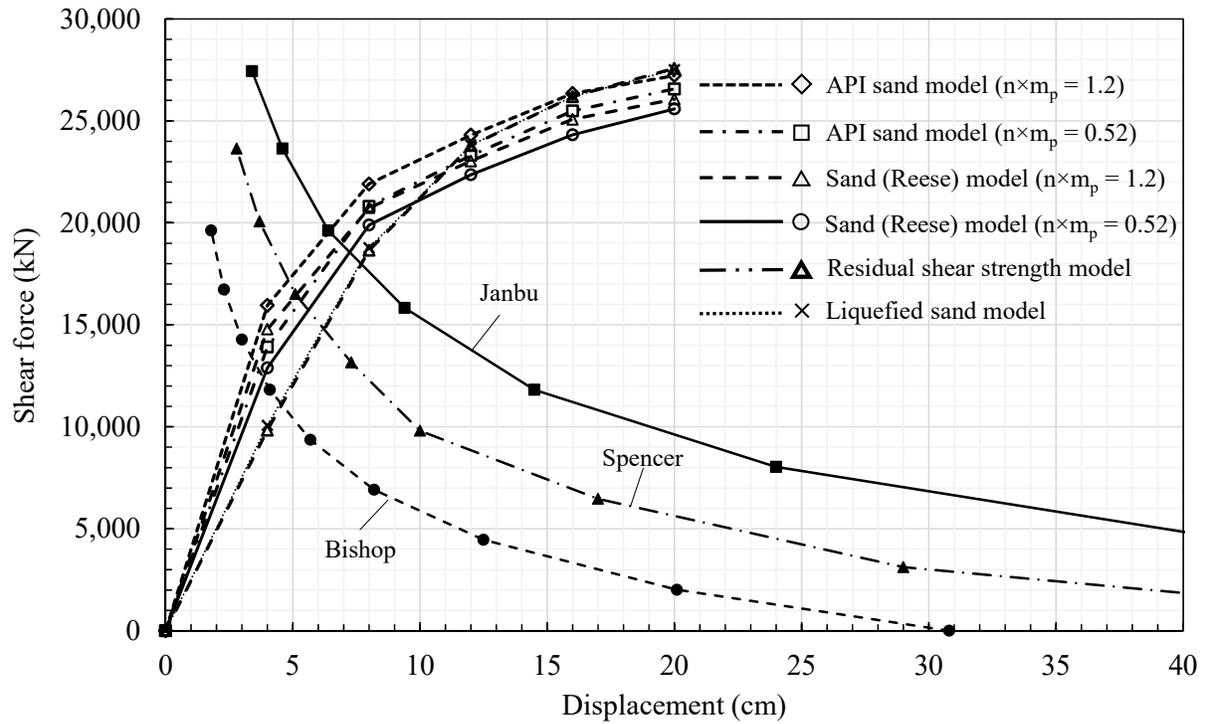
**Figure 3.14 Pushover analysis vs slope stability analysis, the Mataquito Bridge (PGA = 0.390g)**

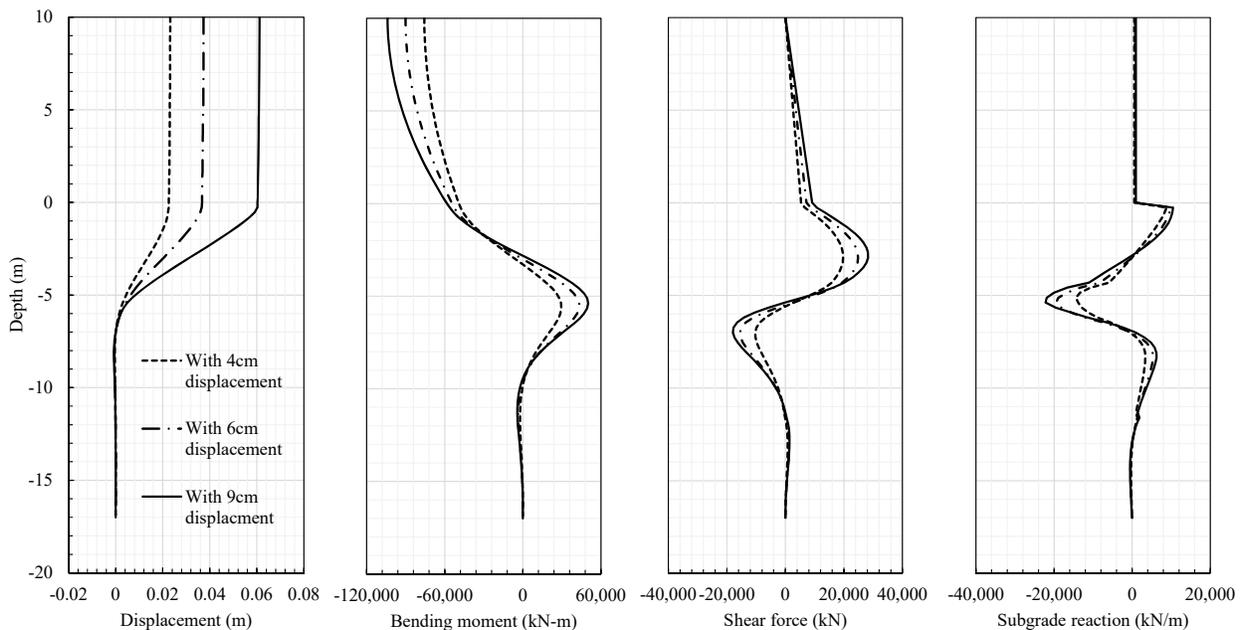
**Figure 3.15 Deflection, estimated bending moment, shear force and subgrade reaction with API sand (O'Neill) model, the Mataquito Bridge**

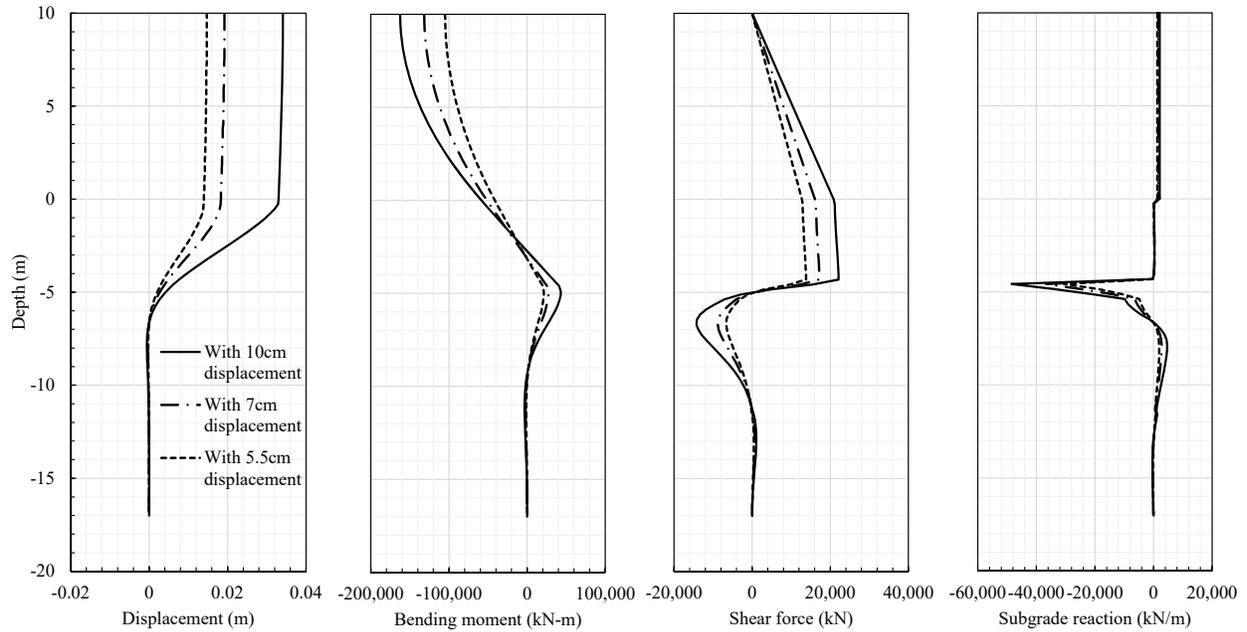
**Figure 3.16 Deflection, estimated bending moment, shear force and subgrade reaction with residual shear strength model, the Mataquito Bridge**

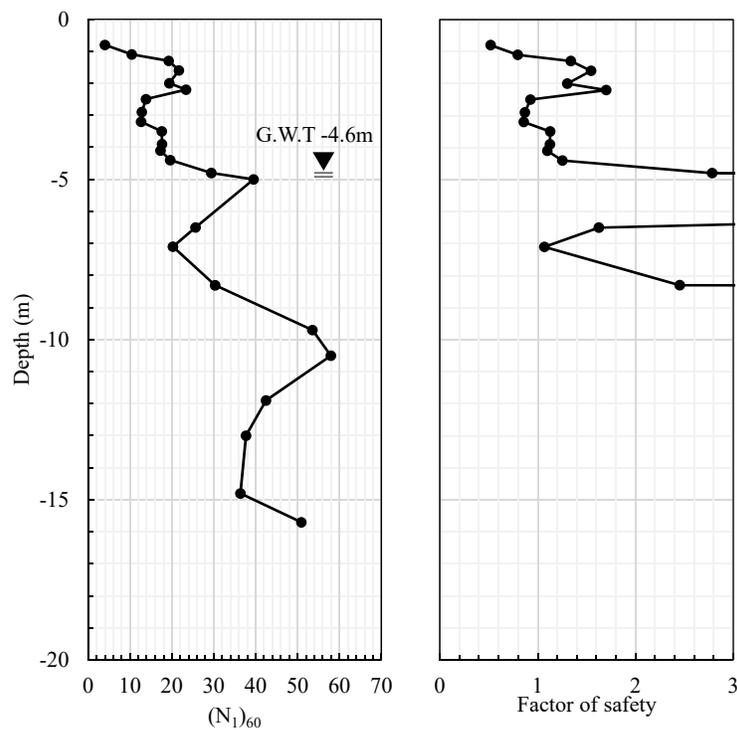
**Figure 3.17 Results of the liquefaction potential evaluation based on SPT, the South Brighton Bridge**

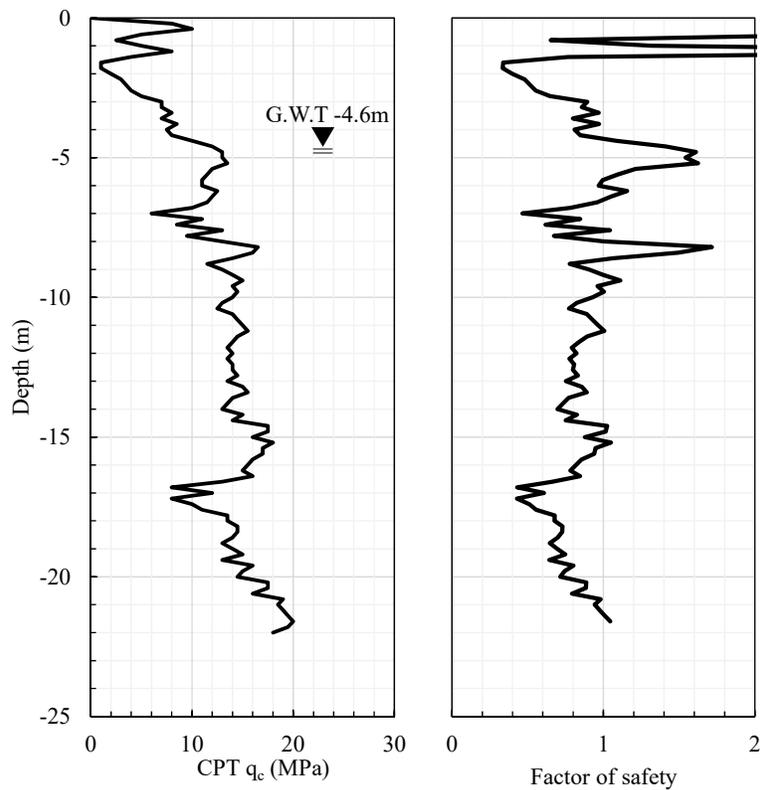
**Figure 3.18 Results of the liquefaction potential evaluation based on CPT, the South Brighton Bridge**

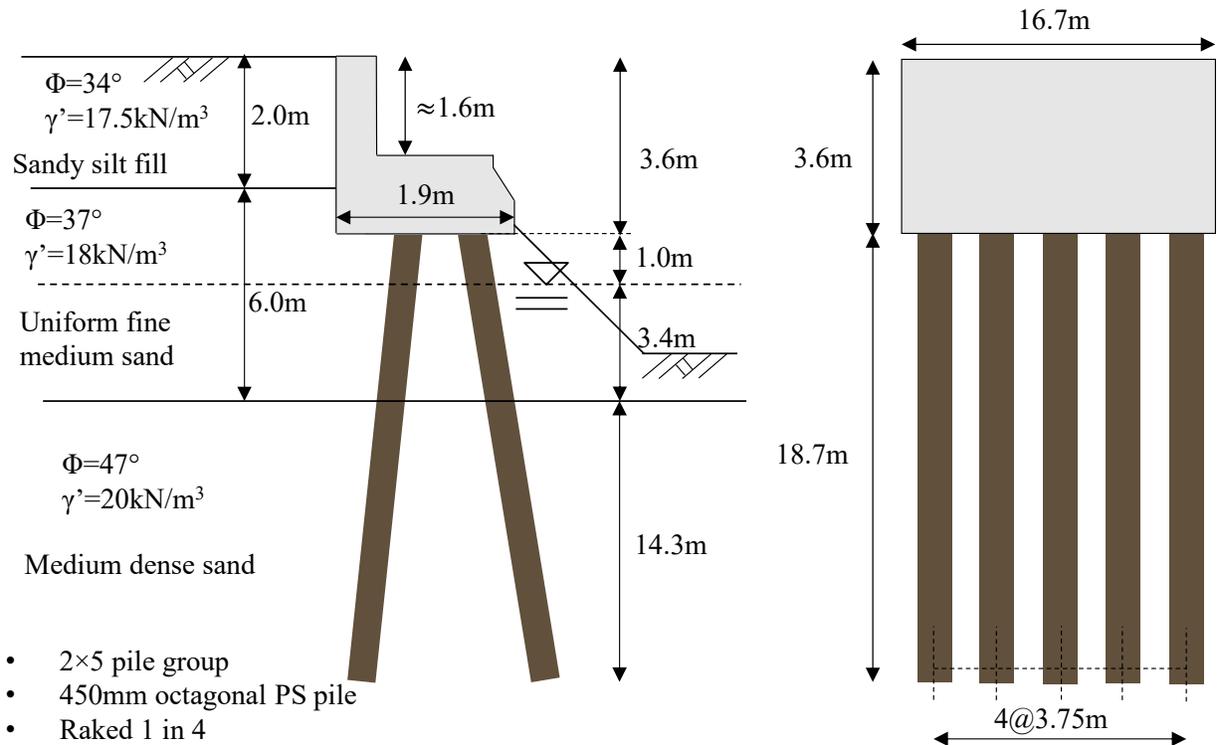
Figure 3.19 Sketch of the South Brighton Bridge

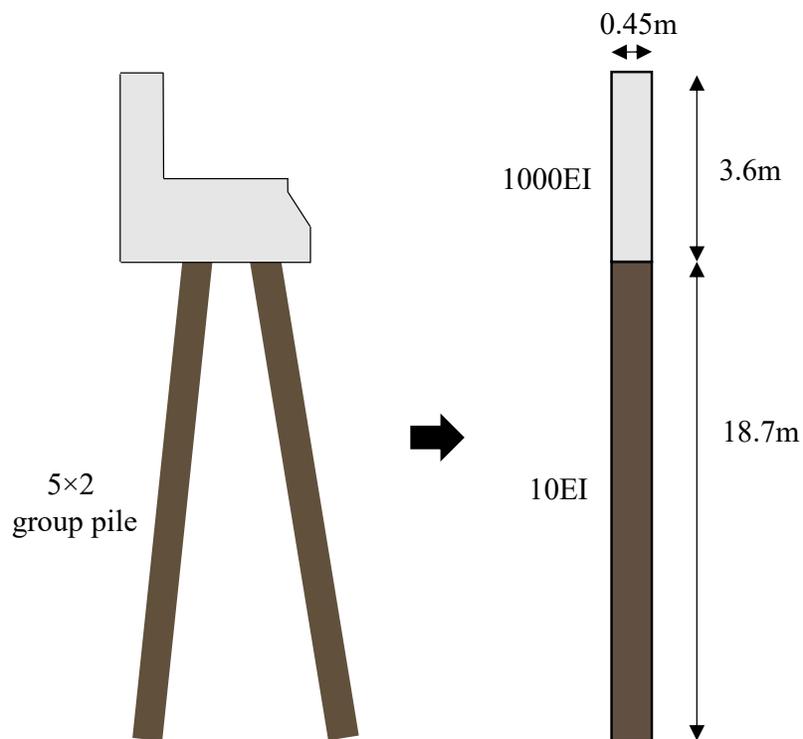
Figure 3.21 Modeling of an equivalent single pile, the South Brighton Bridge

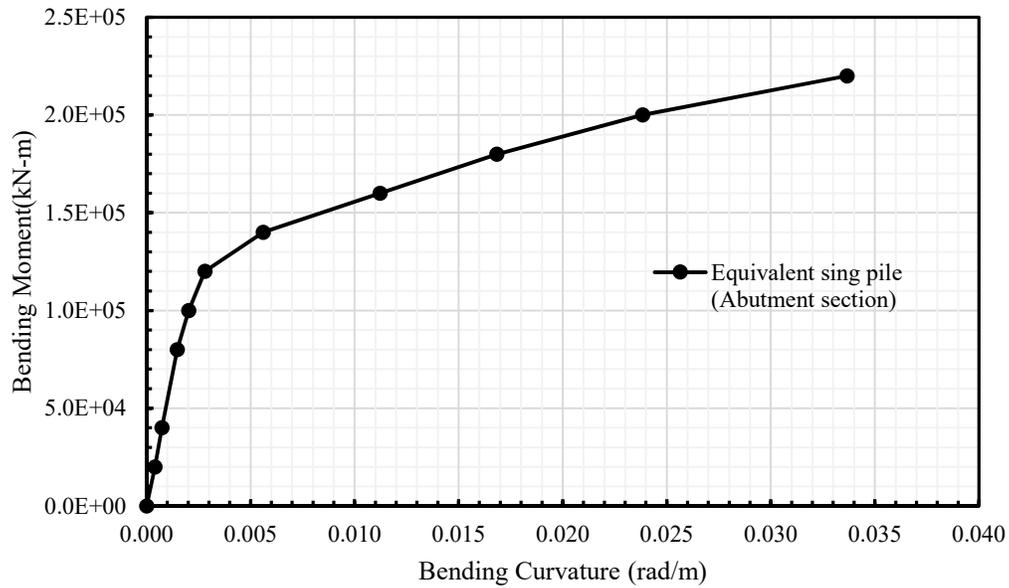
**Figure 3.23 Bending moment – bending curvature of the equivalent single pile for abutment section, the South Brighton Bridge**

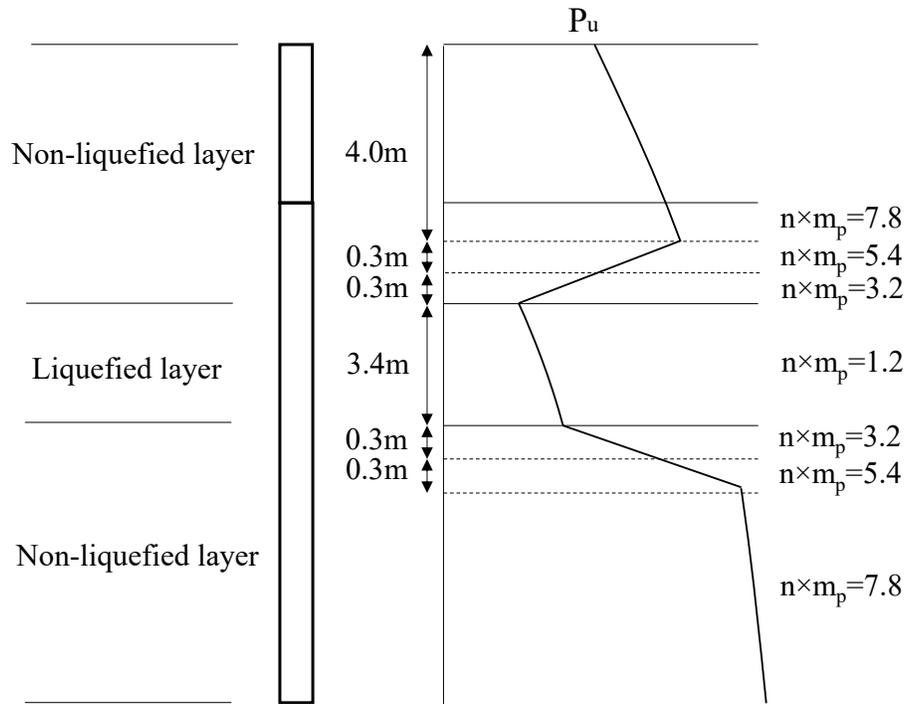
**Figure 3.25 Modification factor near liquefiable layers, the South Brighton Bridge**

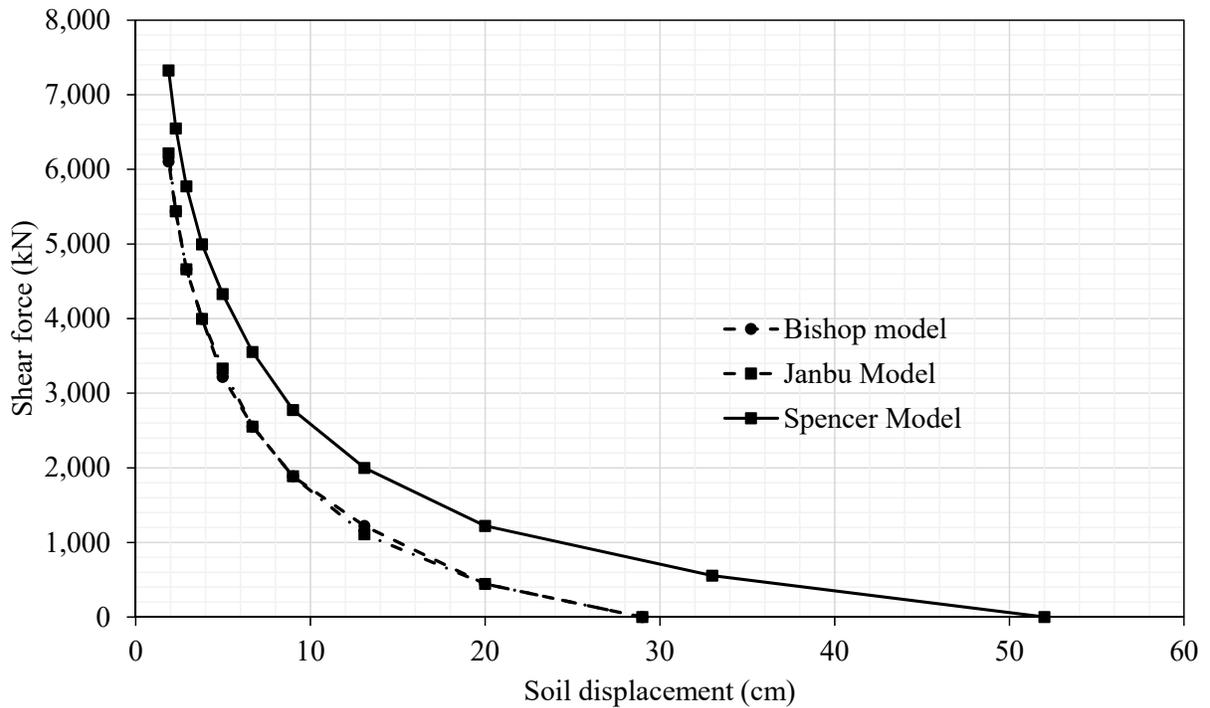
**Figure 3.27 Estimated ground displacement, the South Brighton Bridge**

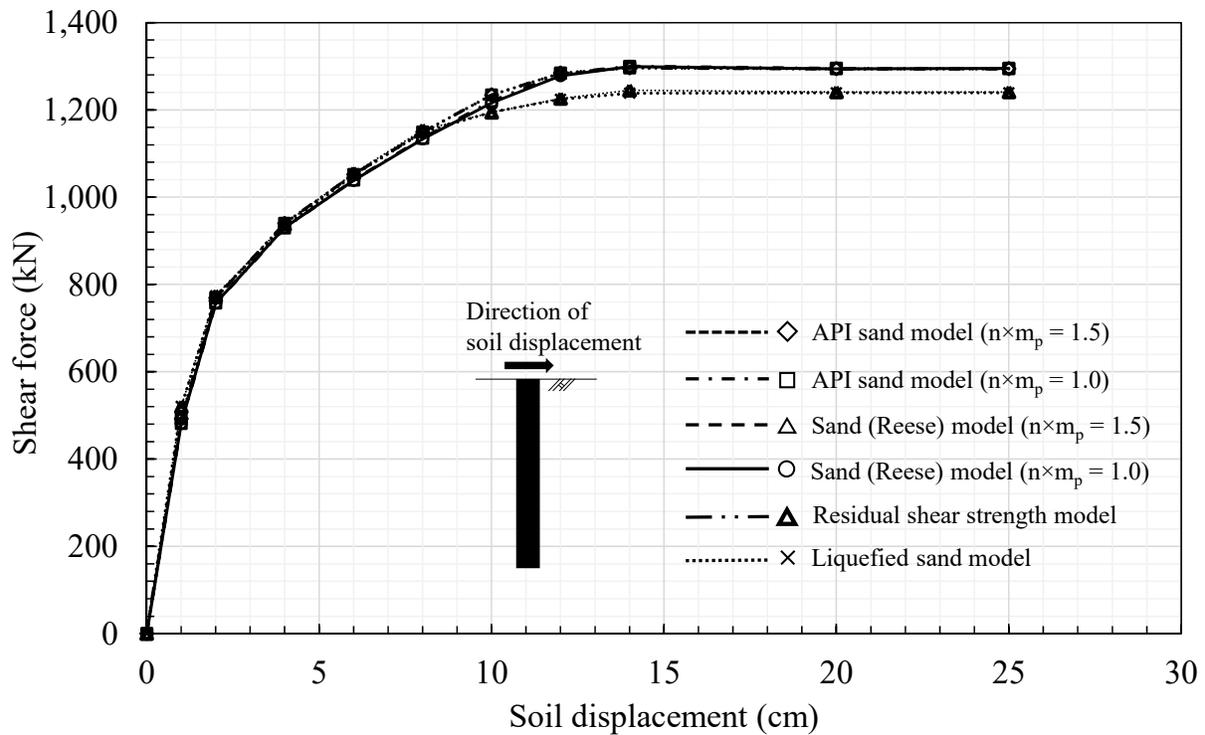
**Figure 3.28 Results of the pushover analysis with 2x5 group piles, the South Brighton Bridge**

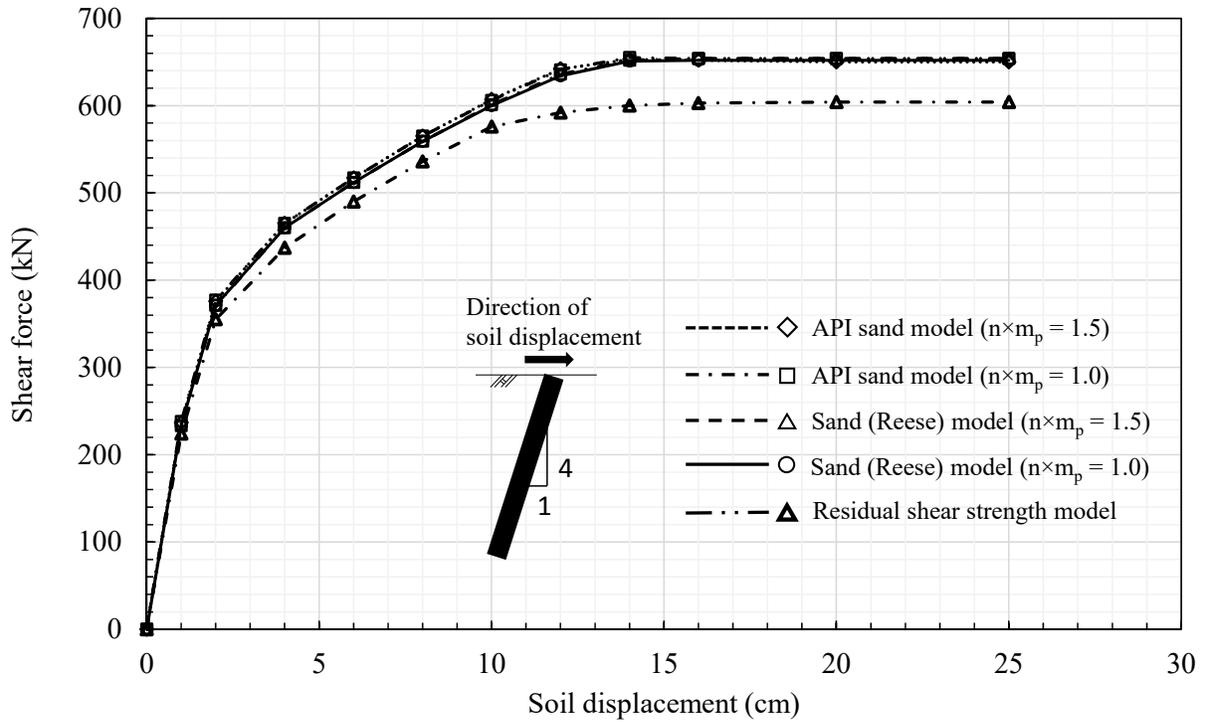
Figure 3.29 Results of the pushover analysis with battered pile (+14 degree), the South Brighton Bridge

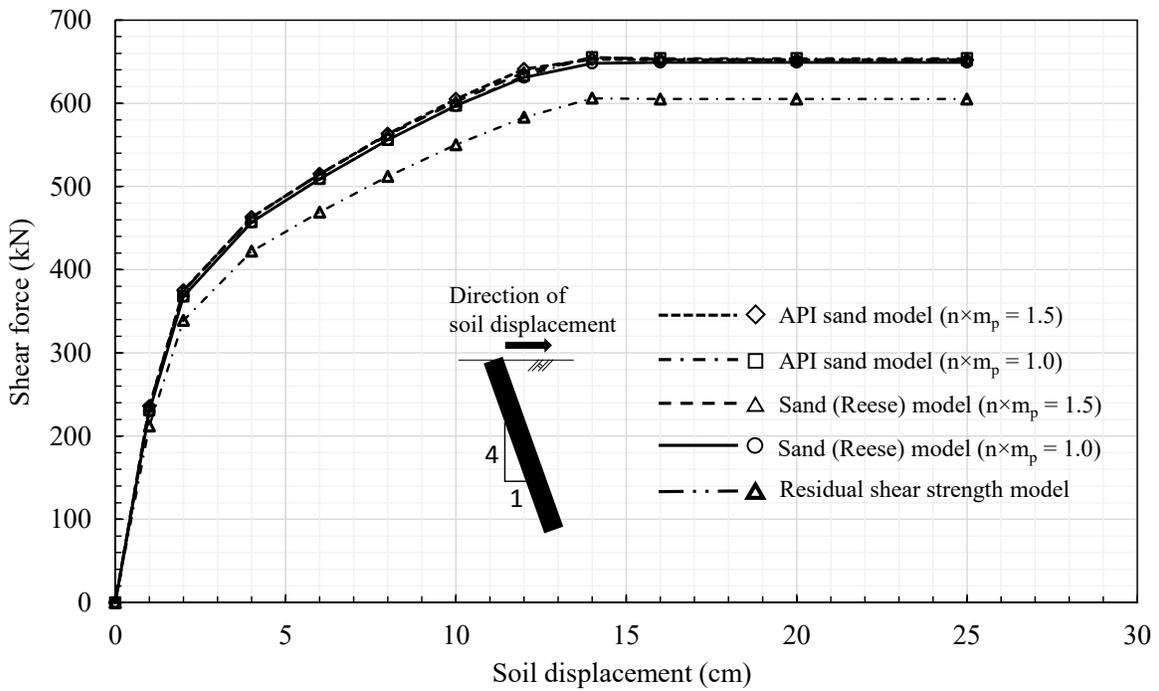
Figure 3.30 Results of the pushover analysis with battered pile (+14 degree), the South Brighton Bridge

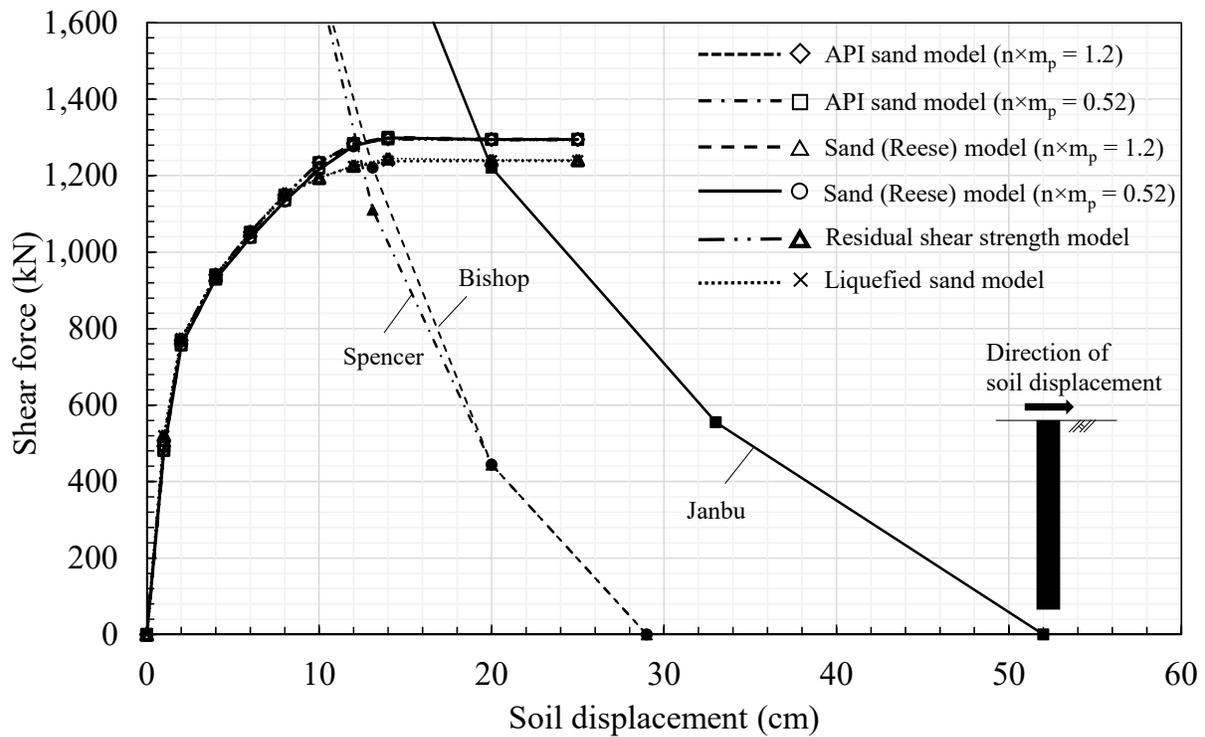
**Figure 3.31 Pushover analysis vs slope stability analysis with 2x5 group piles, the South Brighton Bridge**

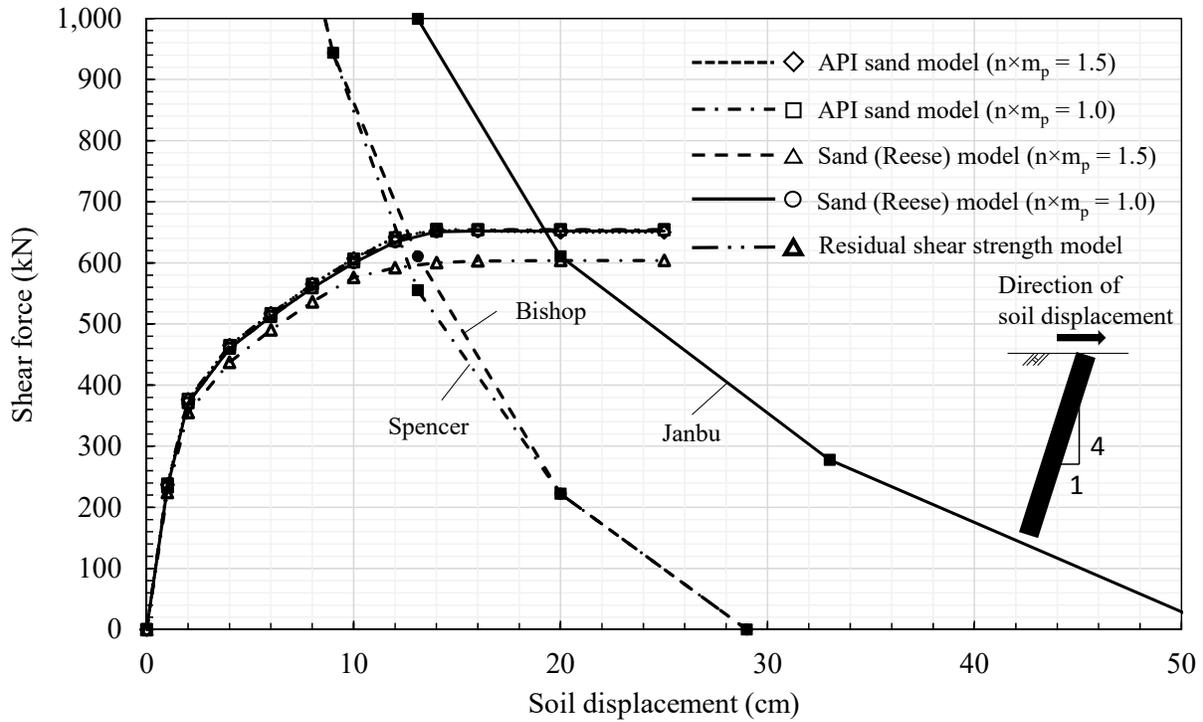
**Figure 3.32 Pushover analysis vs slope stability analysis with battered pile (+14 degree), the South Brighton Bridge**

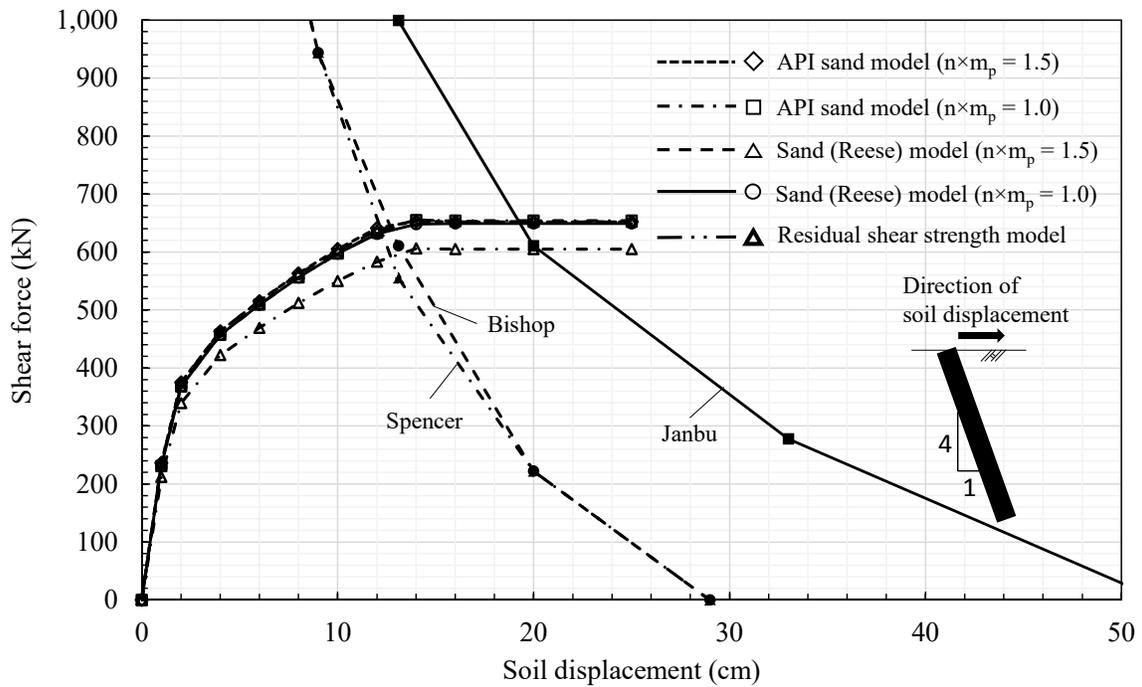
**Figure 3.33 Pushover analysis vs slope stability analysis with battered pile (-14 degree), the South Brighton Bridge**

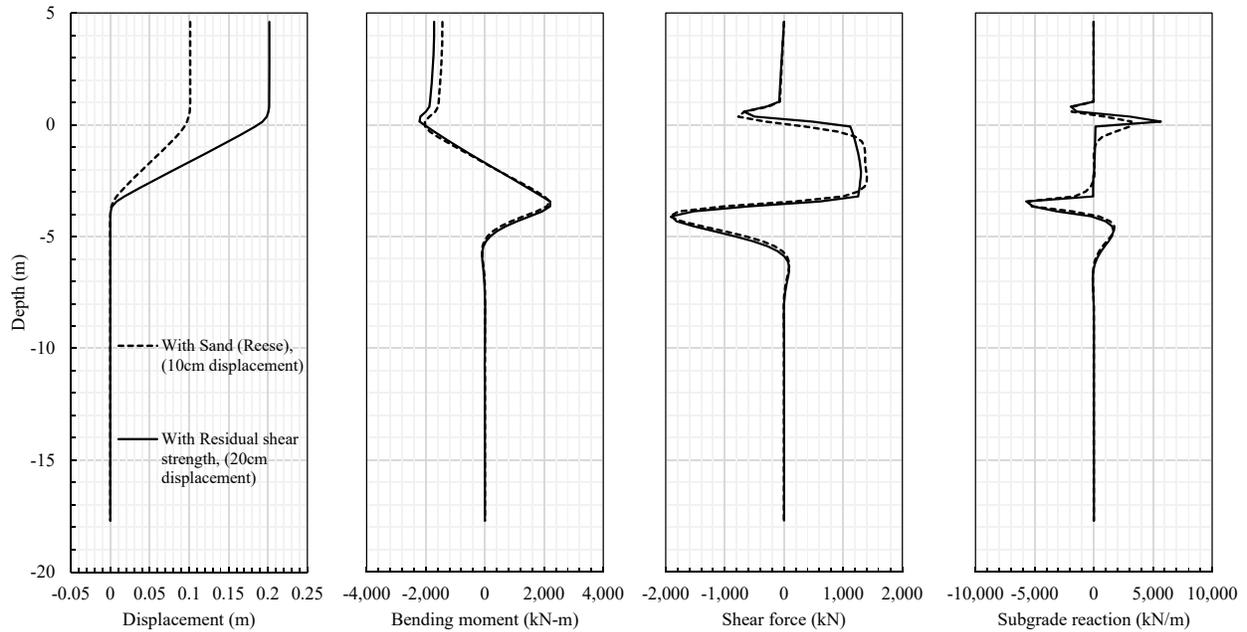
**Figure 3.34 Estimated deflection, bending moment, shear force and subgrade reaction of the abutment foundation, the South Brighton Bridge**

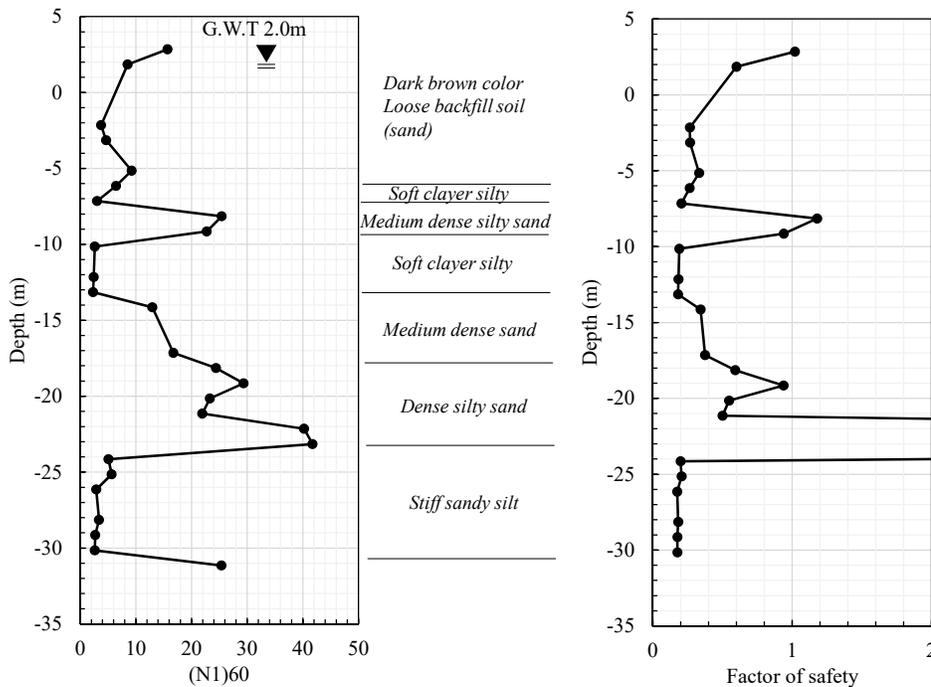
**Figure 3.35 Results of the liquefaction potential evaluation, Mihama Bridge**

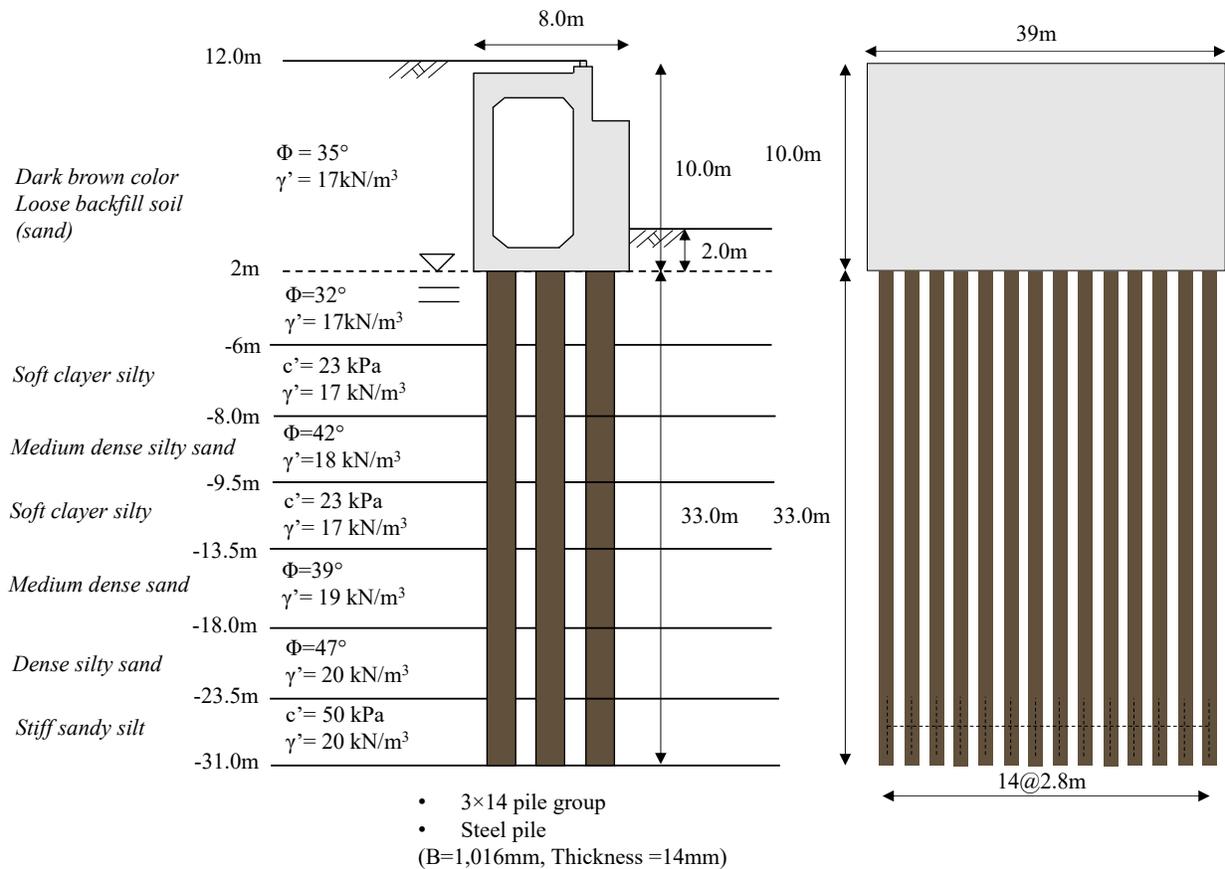
Figure 3.36 Sketch of the Mihama Bridge

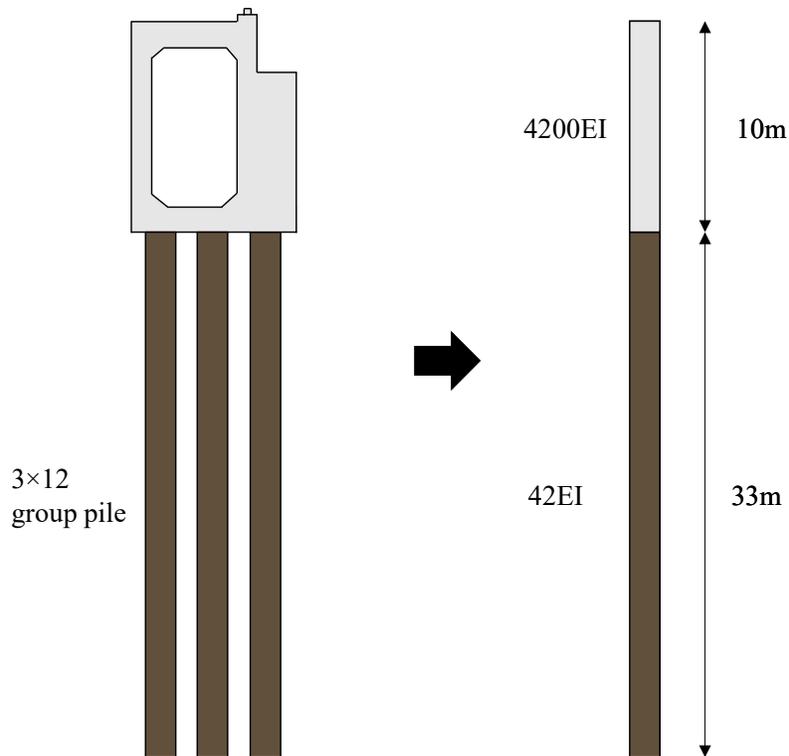
**Figure 3.38 Modeling of an equivalent single pile, the Mihama Bridge**

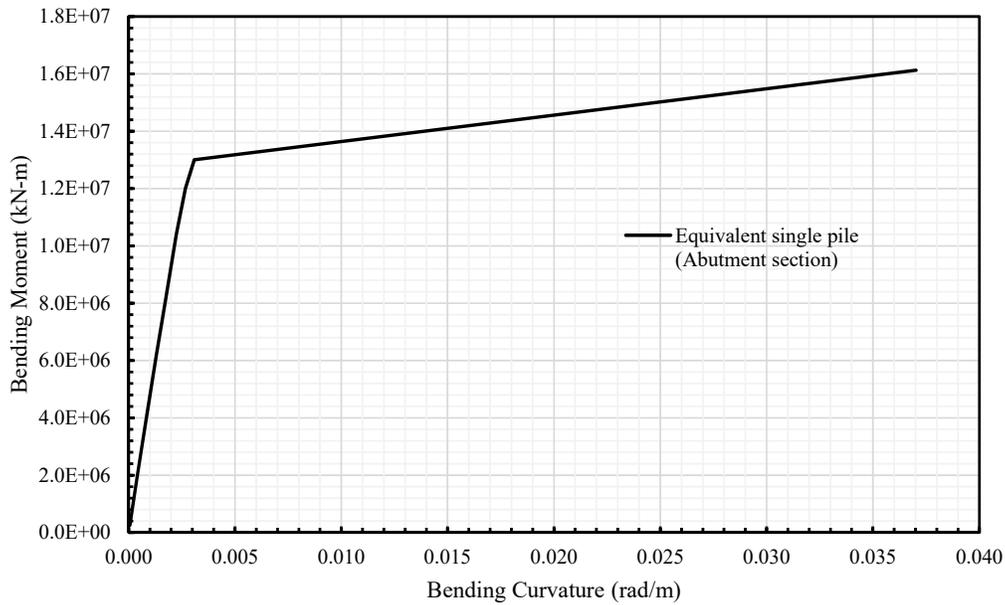
**Figure 3.40 Bending moment – bending curvature of abutment section, the Mihama Bridge**

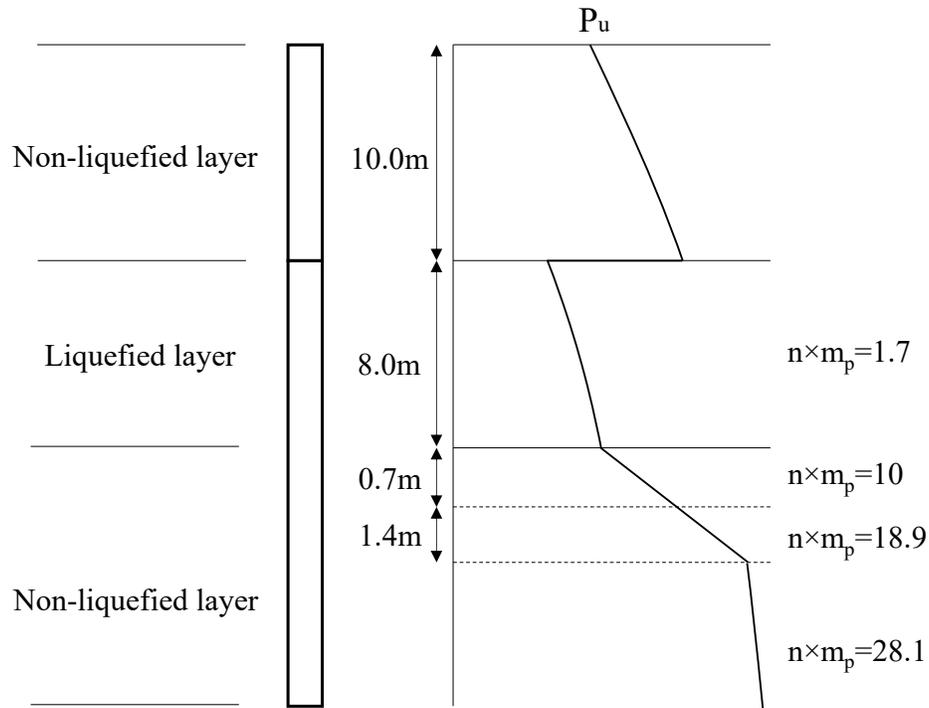
**Figure 3.42 Modification factor near liquefiable layers, the Mihama Bridge**

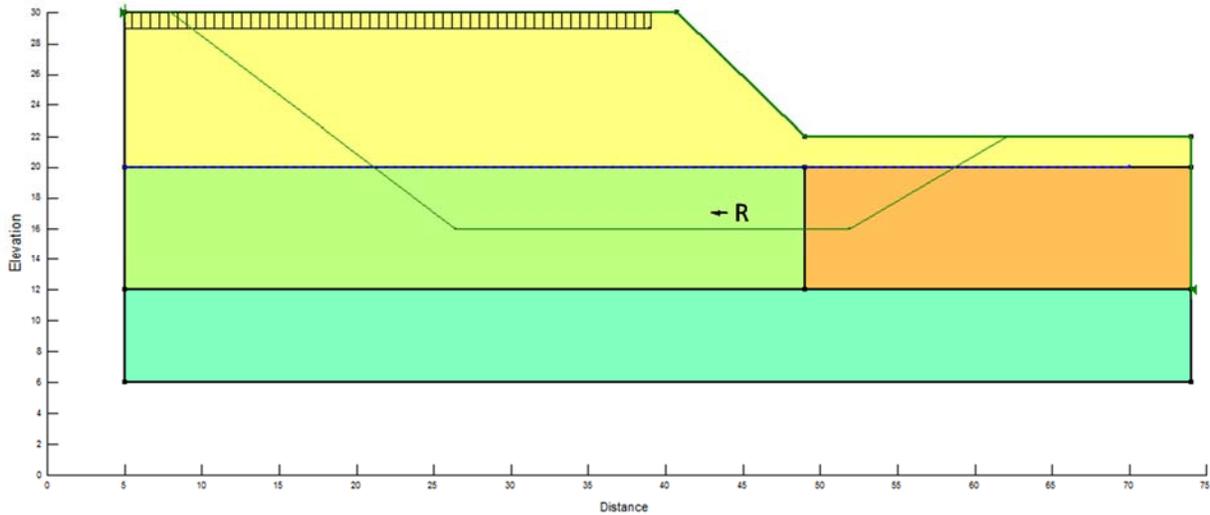
**Figure 3.43 Slope stability analysis model to determine coefficient of horizontal acceleration, the Mihama Bridge**

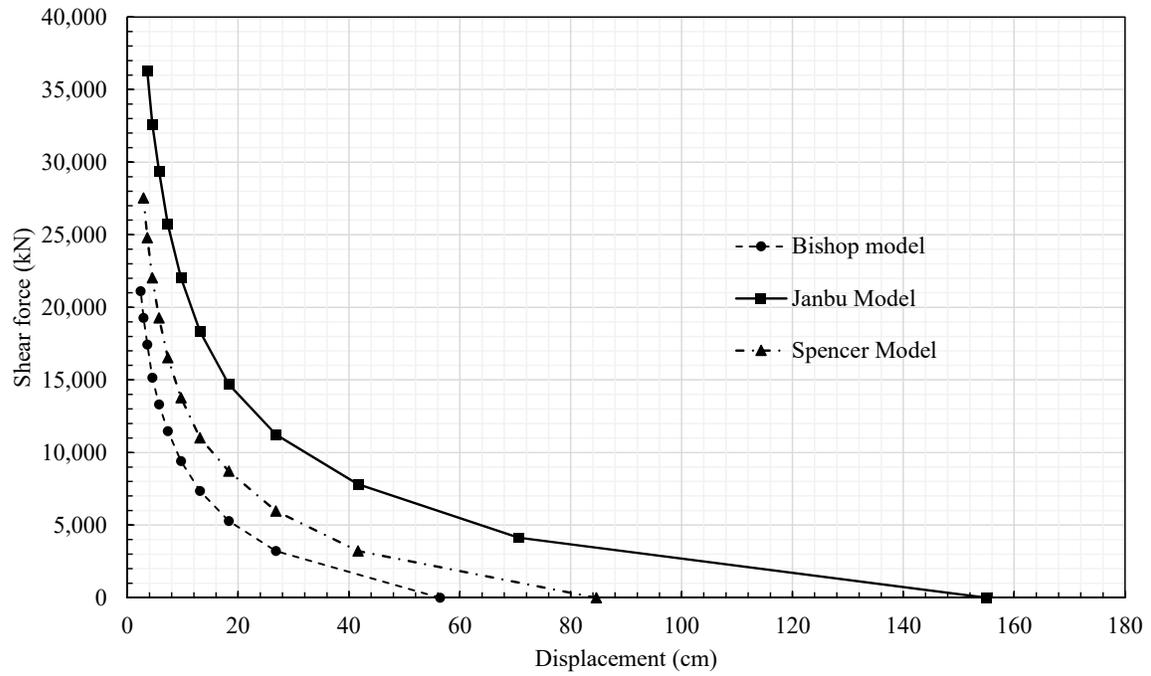
**Figure 3.44 The results of slope stability analysis, the Mihama Bridge**

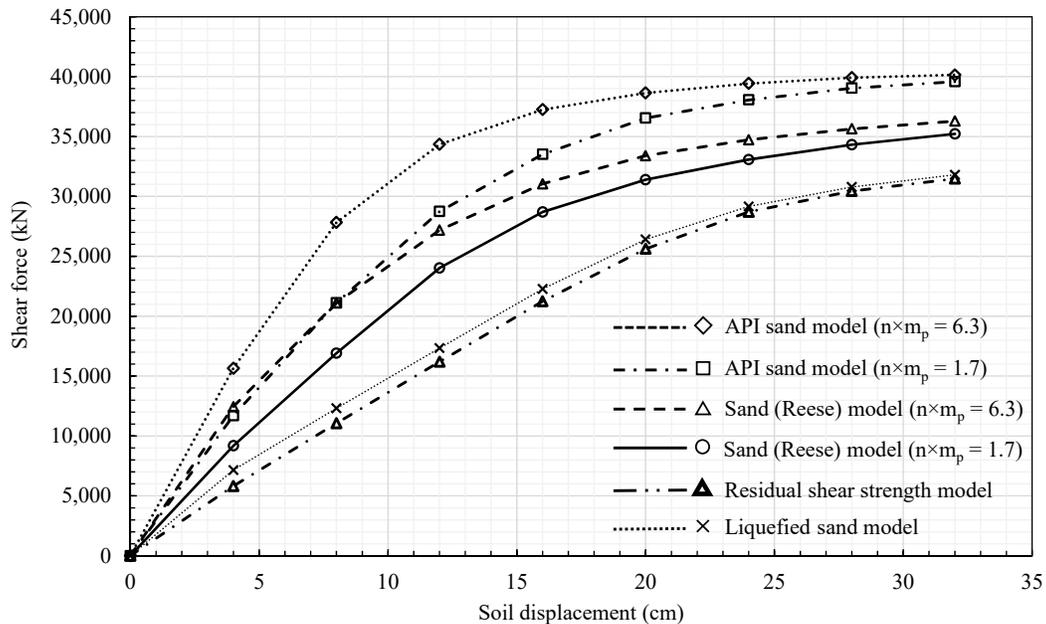
**Figure 3.45 Pushover analysis of the Mihama Bridge**

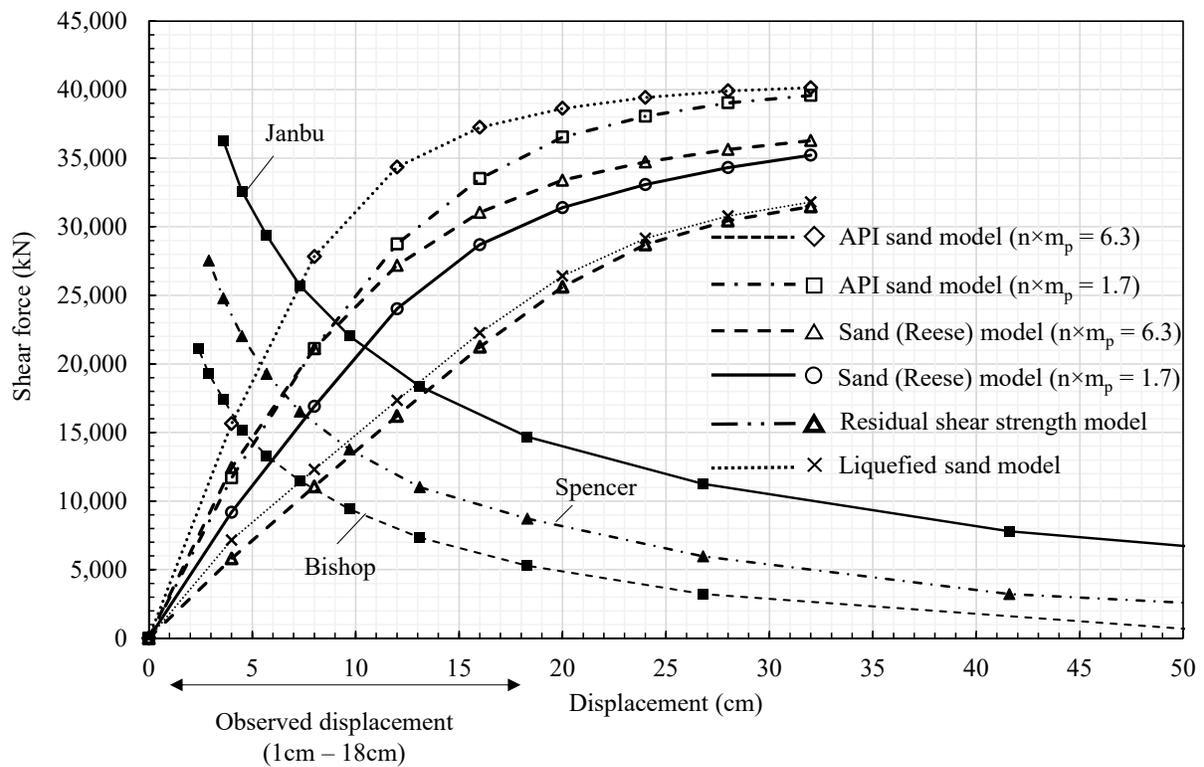
**Figure 3.46 Shear force – Displacement diagram, the Mihama Bridge**

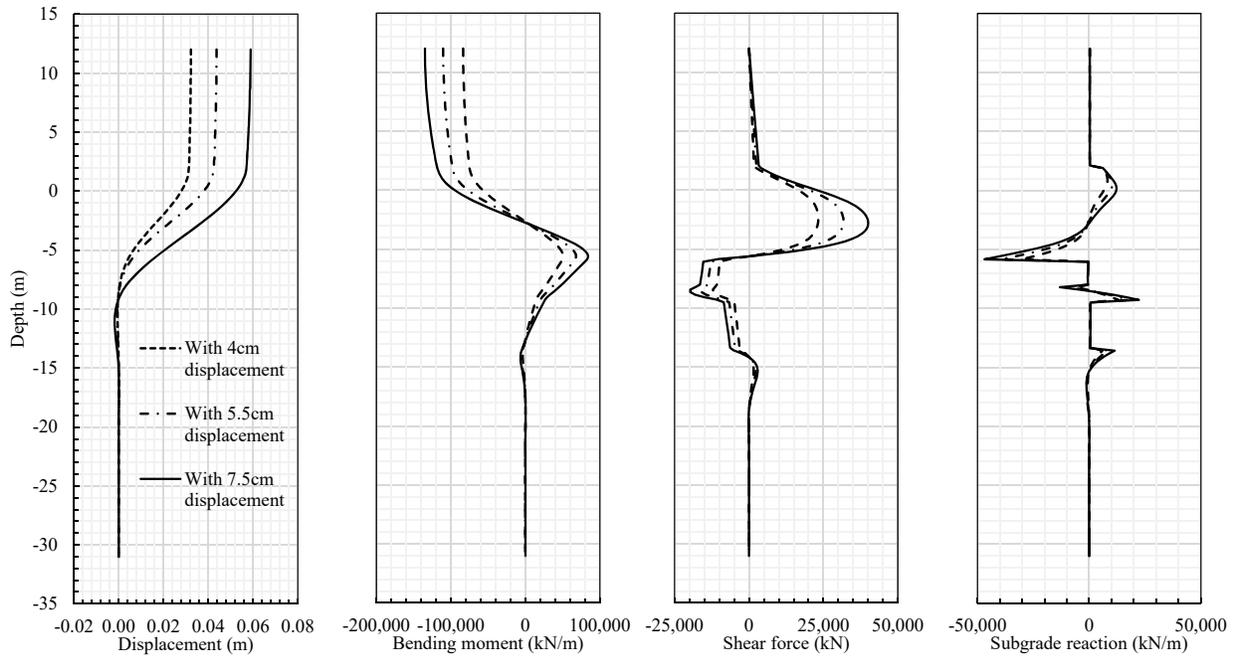
**Figure 3.47 Estimated deflection, bending moment, shear force and subgrade reaction using API sand model ( $n \times m_p = 6.3$ ), Mihama Bridge**

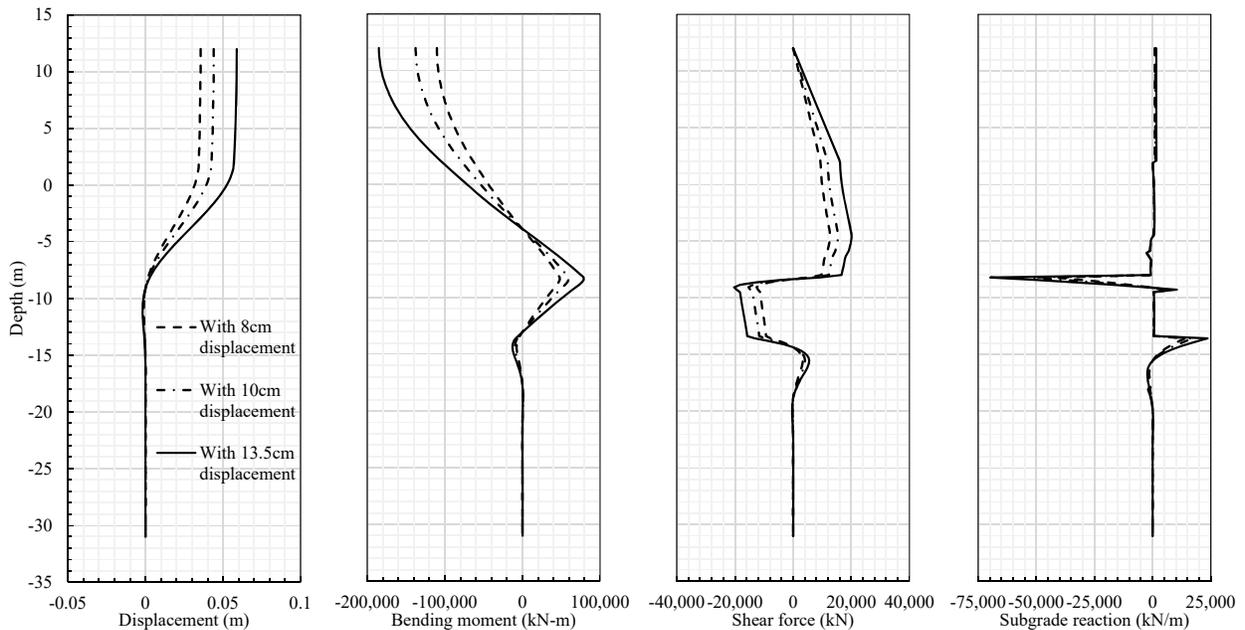
**Figure 3.48 Estimated deflection, bending moment, shear force and subgrade reaction using the residual shear strength, Mihama Bridge**
