Oregon State University  
School of Civil and Construction Engineering

**BENCHMARKING RECENTLY DEVELOPED PROCEDURES FOR  
DESIGNING PILE FOUNDATIONS IN LATERALLY SPREADING  
GROUND**

Final Report on a Research Project Funded by  
Caltrans under Facilities Contract No. 65A0453

18 July 2014

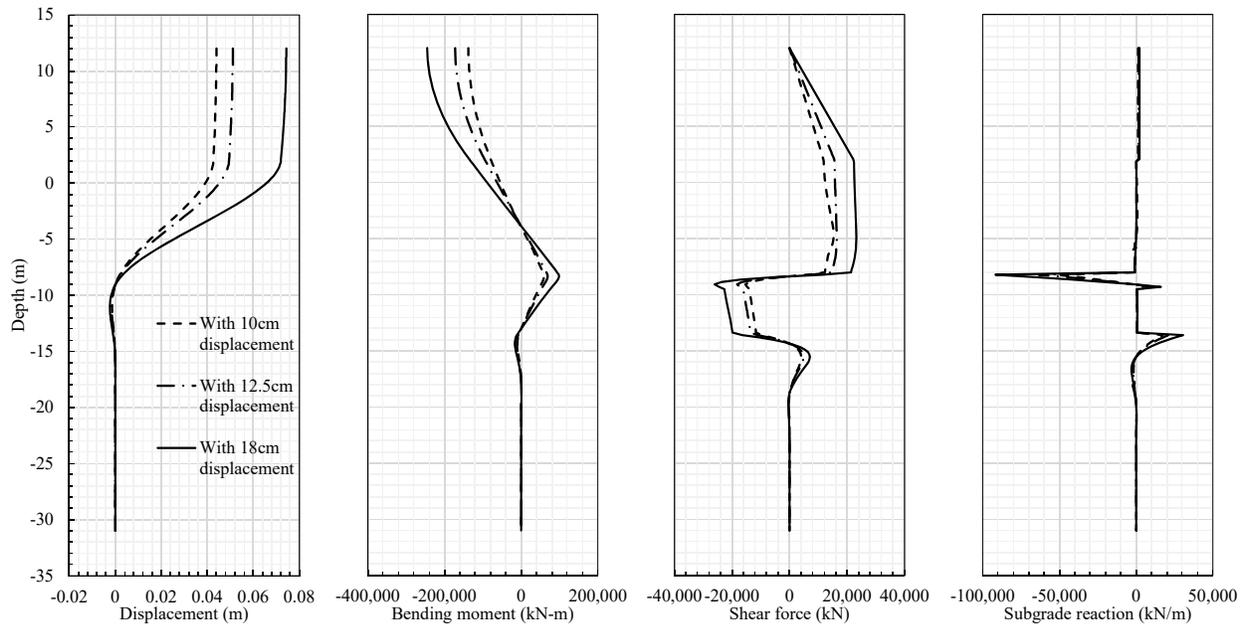
**Figure 3.49 Estimated deflection, bending moment, shear force and subgrade reaction with observed ground displacement, Mihama Bridge**

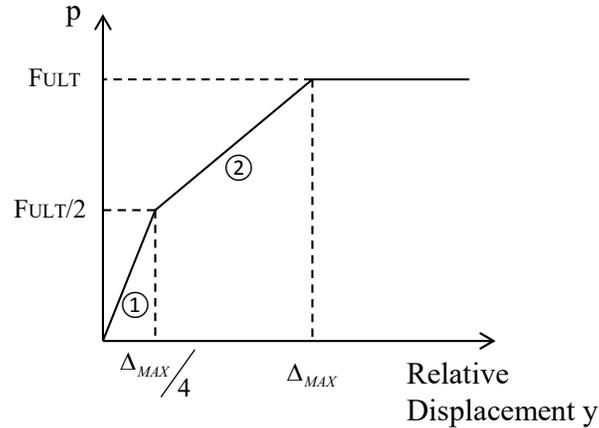
**Figure 4.1 Recommended model of p-y curve for pile cap or abutment**

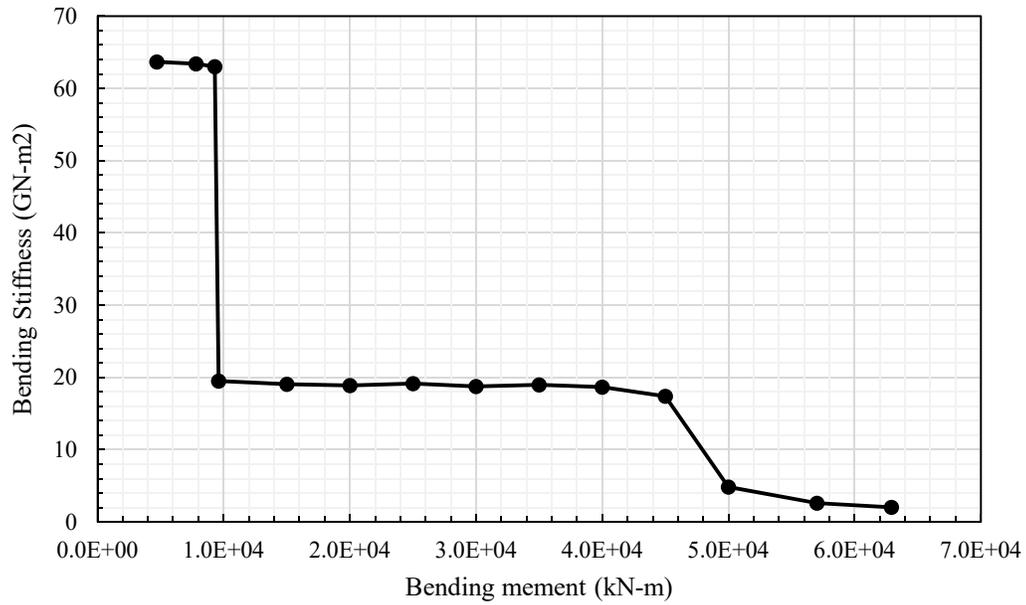
**Figure B-1 Mataquito Bridge, equivalent single pile: Bending stiffness and bending moment diagram of the group pile section**

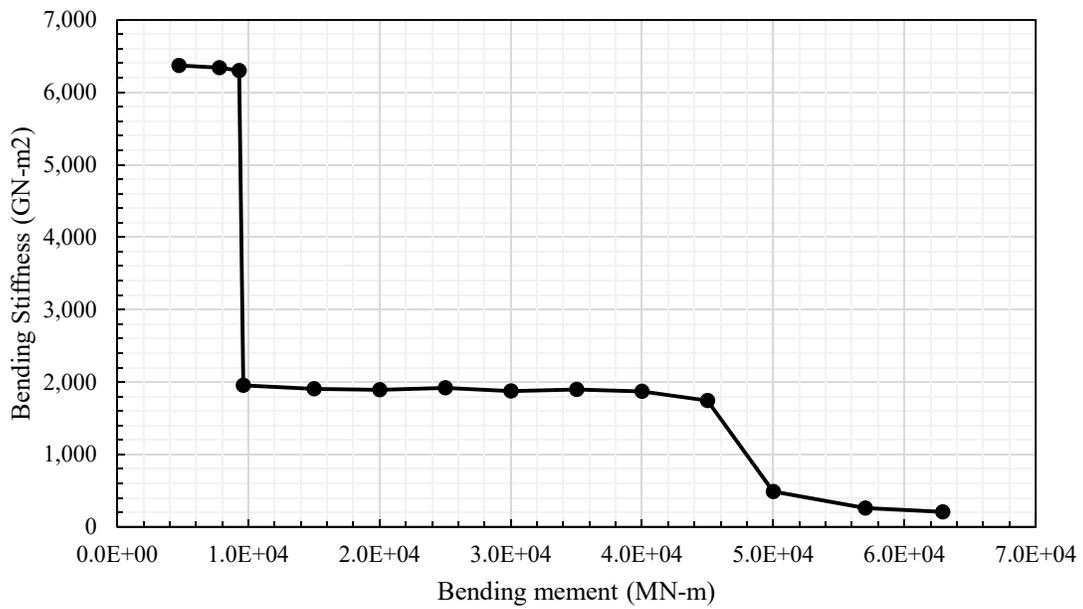
**Figure B-2 Mataquito Bridge, equivalent single pile: Bending stiffness and bending moment diagram of the group pile section**

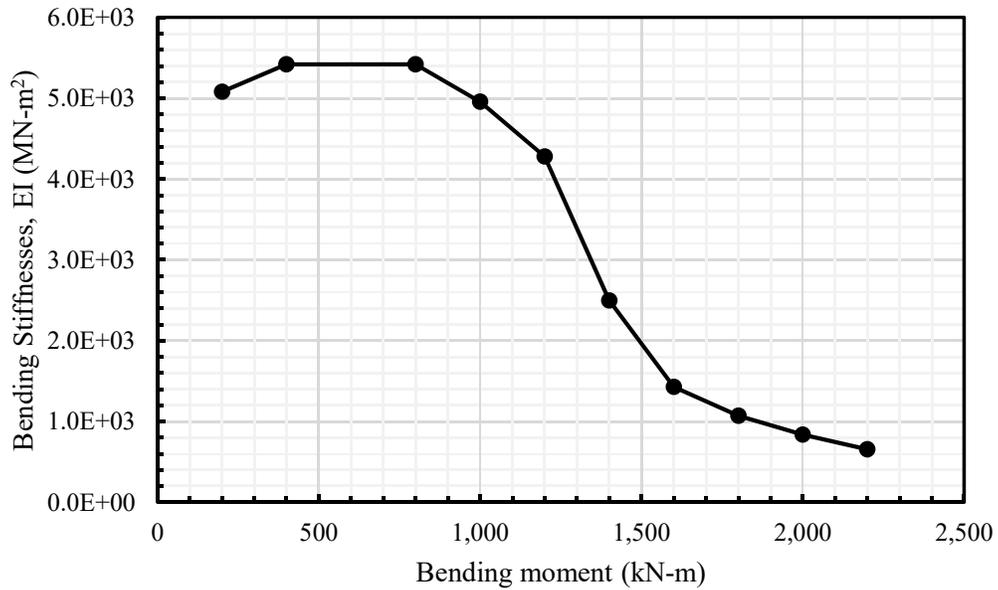
**Figure B-3 South Brighton Bridge, equivalent single pile: Bending stiffness and bending moment diagram of the group pile section**

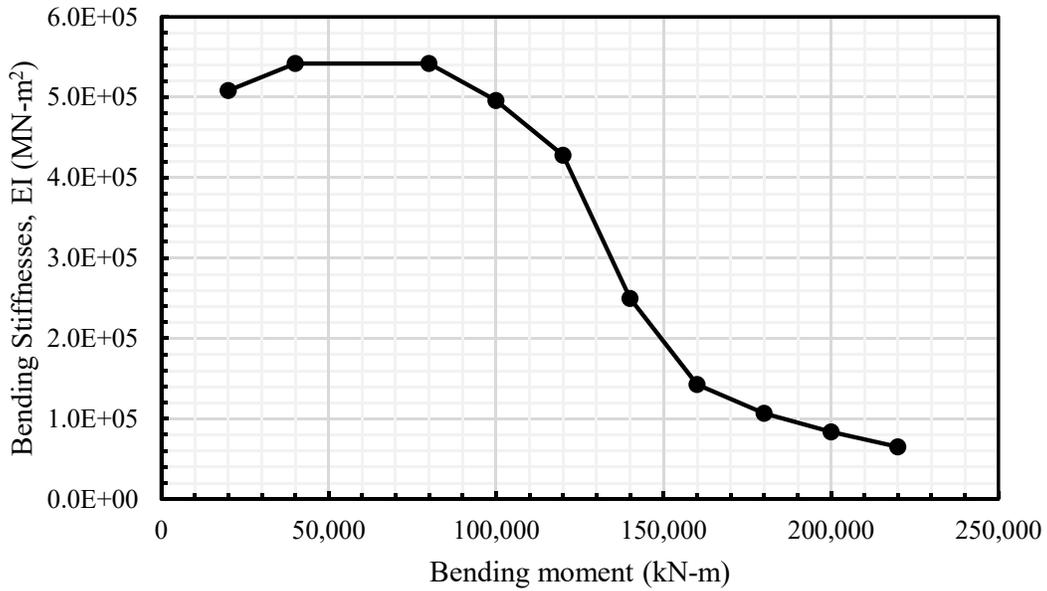
**Figure B-4 South Brighton Bridge, equivalent single pile: Bending stiffness and bending moment diagram of the group pile section**

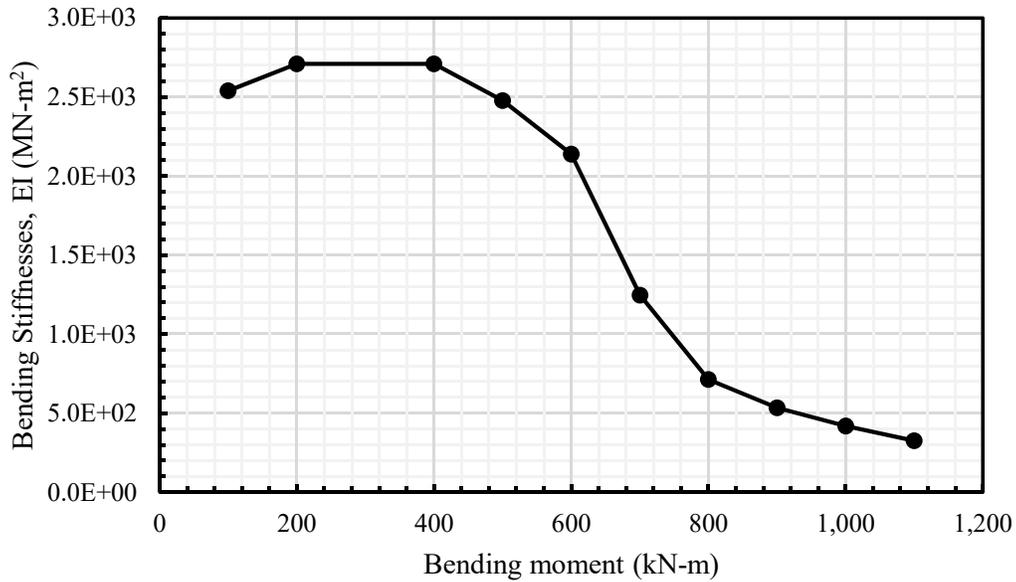
**Figure B-5 South Brighton Bridge, equivalent single pile: Bending stiffness and bending moment diagram of group pile section for the battered pile**

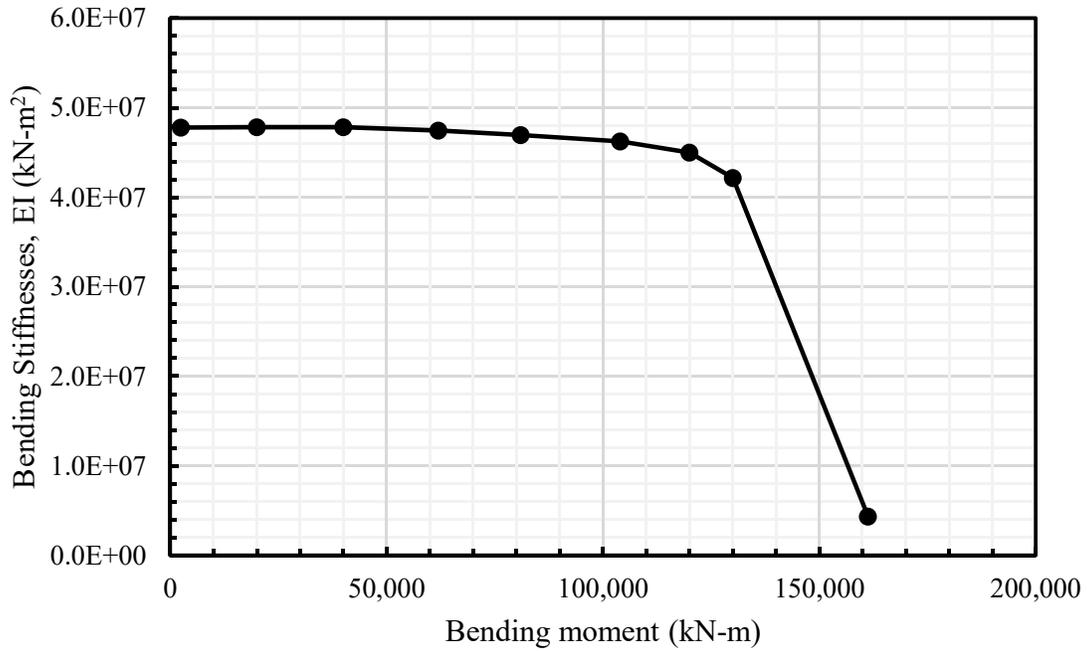
**Figure B- 7 Mihama Bridge, equivalent single pile: Bending stiffness and bending moment diagram of group pile section**

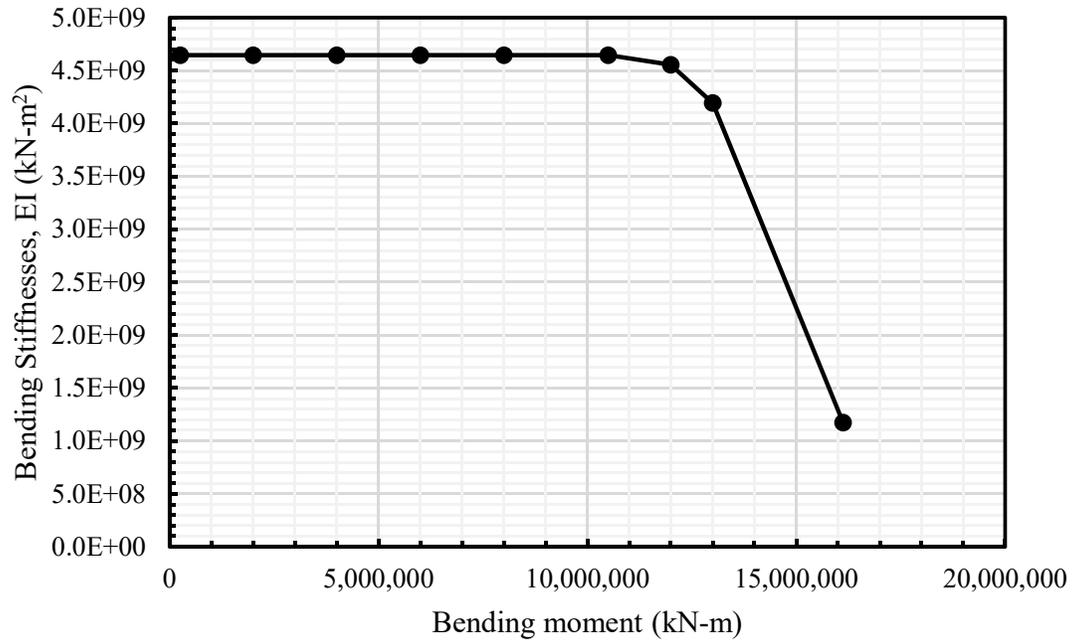
**Figure B-8 Mihama Bridge, equivalent single pile: Bending stiffness and bending moment diagram of abutment section**
