Evaluation of the University of Minnesota GPS Snowplow Driver Assistance System

Report Number: CA16-2167

AHMCT Research Report: UCD-ARR-15-08-30-01

August 30, 2015

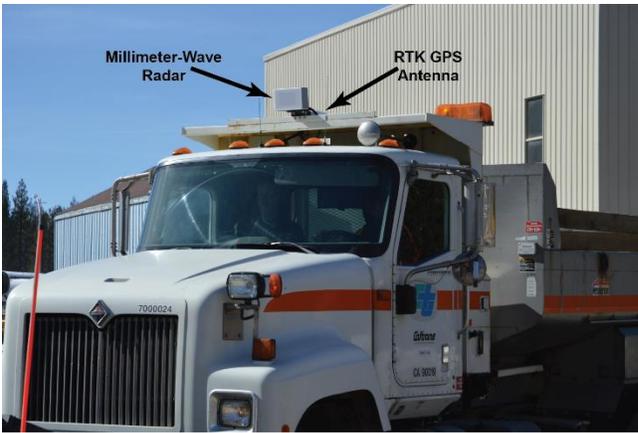
Figure 1.1: University of Minnesota (UM) DAS exterior components

The snowplow DAS functions include lane position indication, lane departure warning, and forward collision warning. The DAS interior and exterior components are shown in Figures 1.1, 1.2, and 1.4. Lane position indication and lane departure warning are displayed on a HUD, as shown in Figures 1.3 (simulated) and 1.5 (actual). The Collision Warning System (CWS) uses a millimeter-wave radar which performs well in the snow environment as it detects vehicles and other inorganic objects. Azimuth angle data allows the system to map detected obstacles to their lateral location, i.e. the system can show the driver what lane the obstacle is located in relative to the snowplow. The system also stores the location of fixed roadside objects in a geospatial database to eliminate false negative collision warnings. Highly accurate vehicle position is provided by the RTK GPS receiver, which can deliver sub-centimeter accuracy under fairly ideal conditions. However, its accuracy is generally recognized to be only centimeter-level under normal operating conditions. Producing a high-accuracy RTK GPS solution requires data from two dual-frequency (L1 and L2) GPS receivers—one stationary base station and one rover—collecting signals from at least five GPS satellites at the same time. The solution can be calculated in real-time by the rover GPS (on the snowplow) when it receives the base station data in real-time through a cellular radio data link.

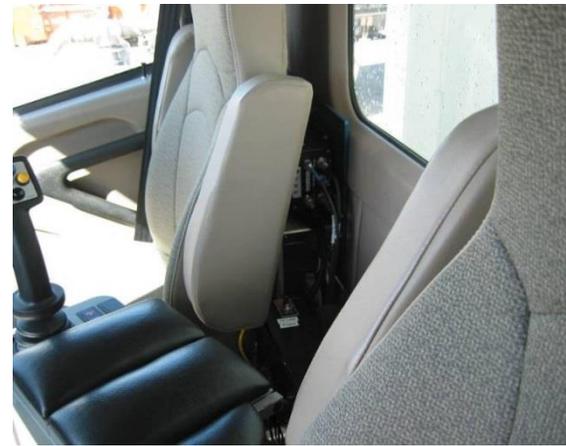
Figure 1.2: UM DAS installed behind passenger seat

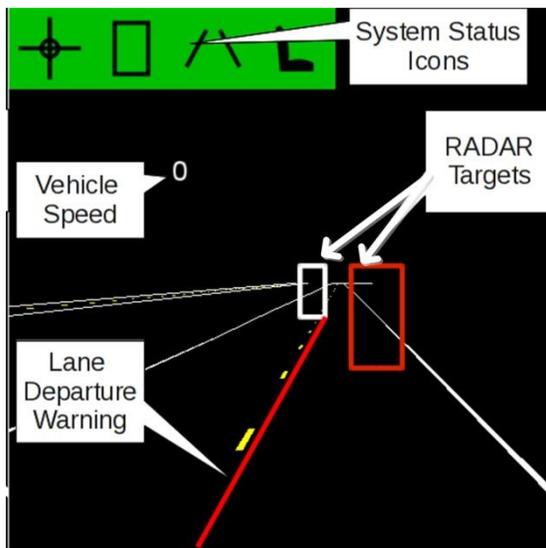
Figure 1.3: UM DAS simulated HUD view

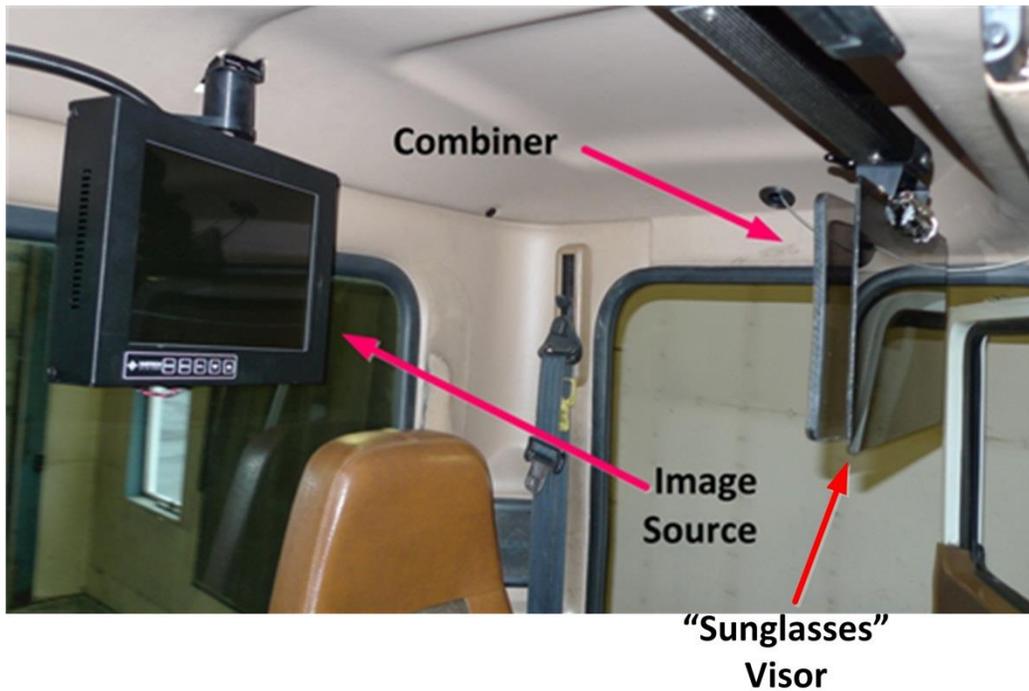
Figure 1.4: UM DAS HUD image source and display combiner

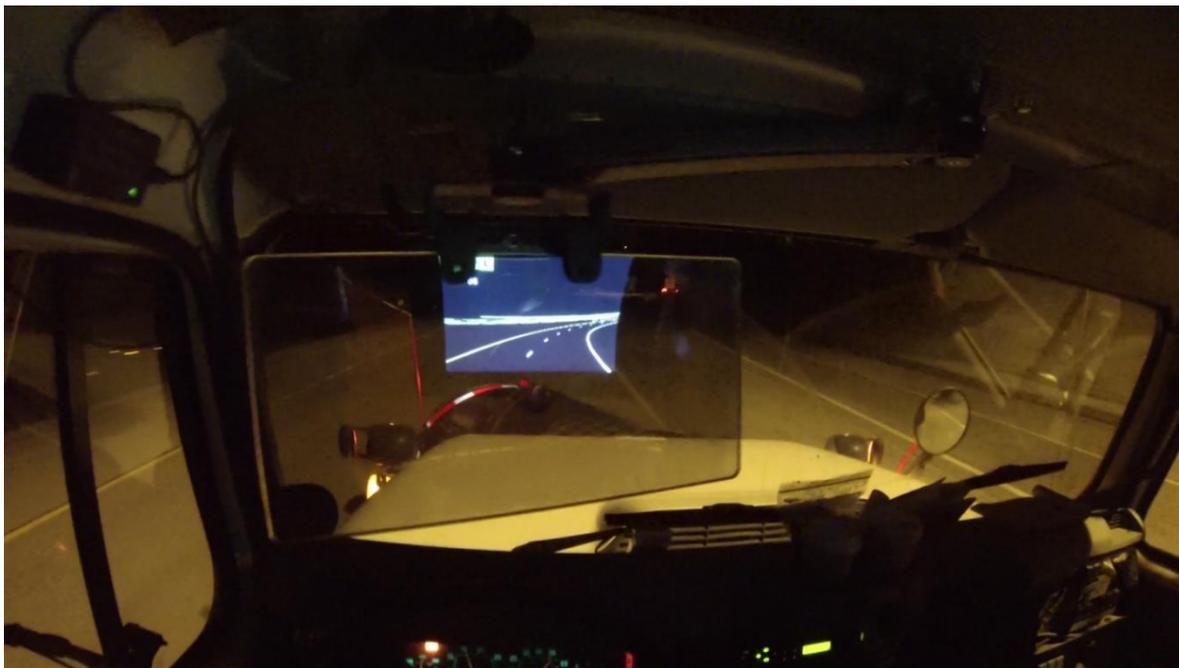
Figure 1.5: DAS viewed from behind driver's seat in a snowplow operating at night. The lane lines and road features are overlaid on the road using the HUD.

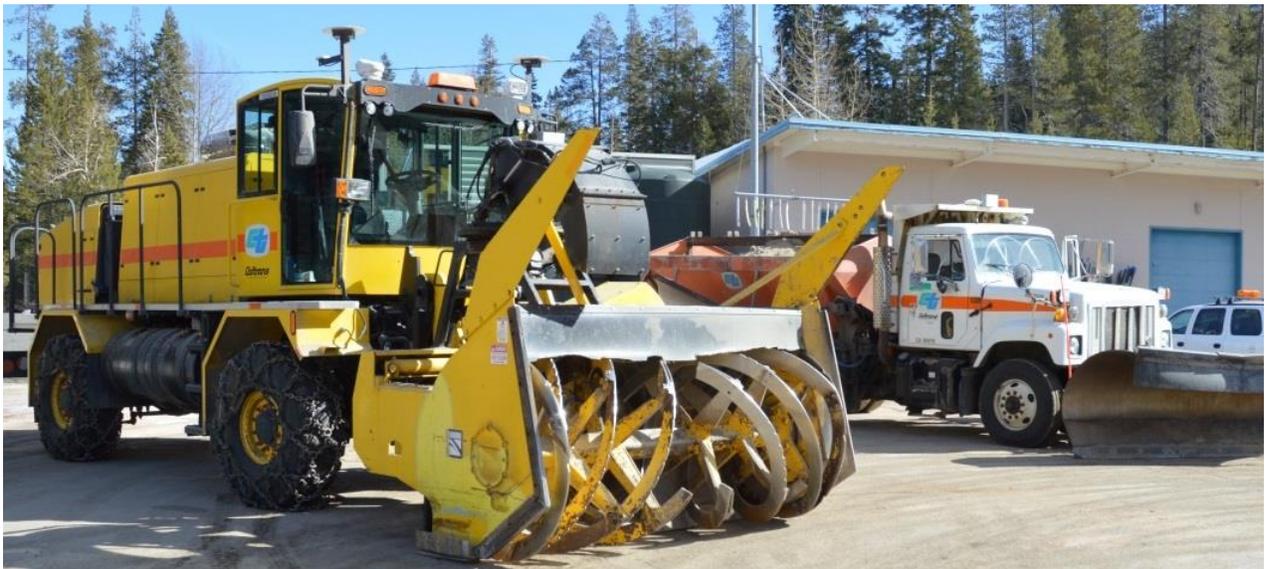
Figure 2.1: Snowplow DAS installed on Caltrans snow blower (left, yellow) and snowplow (right, white)

In 2012, DAS were installed in two snowplows (Caltrans vehicle # 7000506 and 7000024) and one snow blower (Caltrans vehicle # 7005039). Figure 2.1 show the snow blower and one snowplow (7000506) with the DAS installed. All equipment and subsystems were procured by AHMCT so that the system would become AHMCT/Caltrans instrumentation for scientific evaluation and experimentation. When possible, AHMCT tested all components and subsystems to assure they would perform the required operations before installation on the vehicles. The vehicles were provided by Caltrans from their winter maintenance fleet.

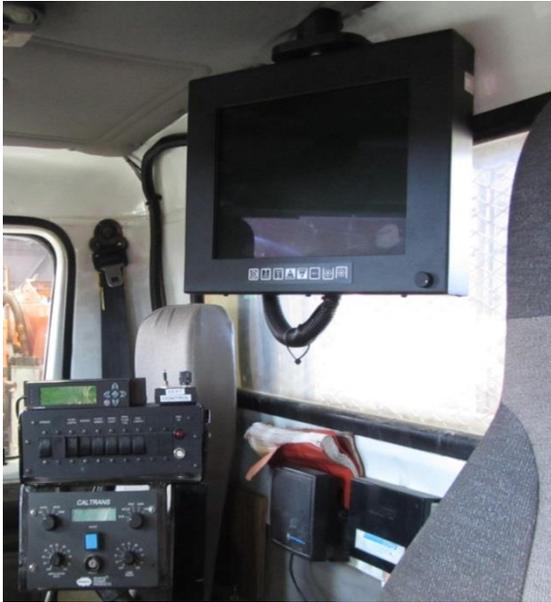
Figure 2.2: DAS user interface and LCD imager display on snowplow

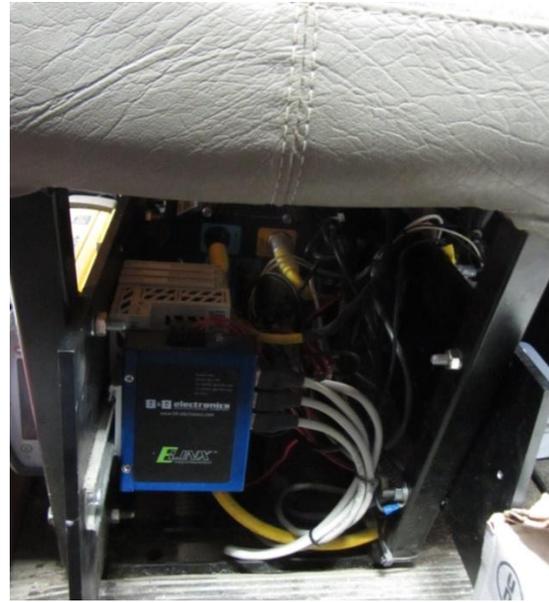
Figure 2.3: DAS installed under the passenger seat on snowplow

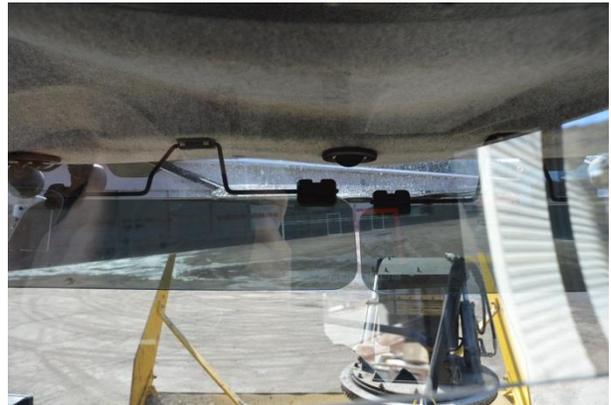
Figure 2.11: Driver's view looking through the combiner in the snow blower

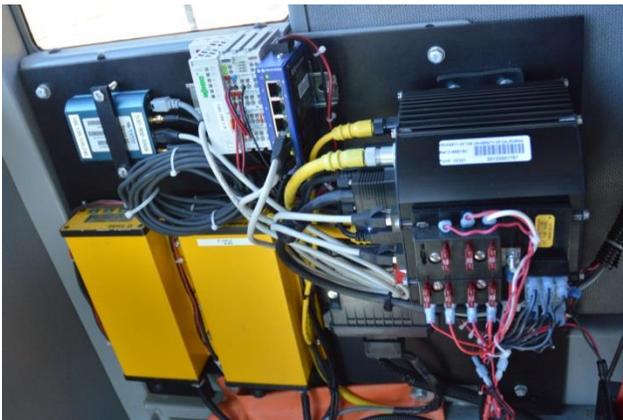
Figure 2.12: DAS equipment mounted next to the operator's seat in the snow blower

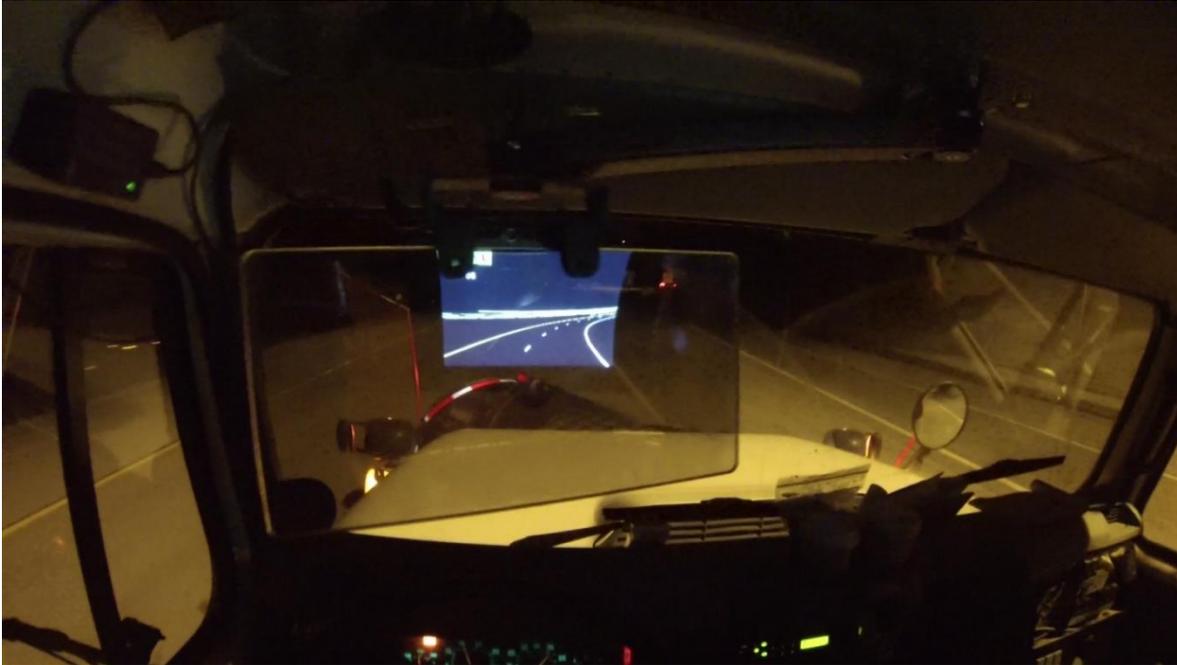
Figure 2.14: DAS viewed from behind driver's seat in a snowplow operating at night. The lane lines and road features are overlaid on the road using the HUD.

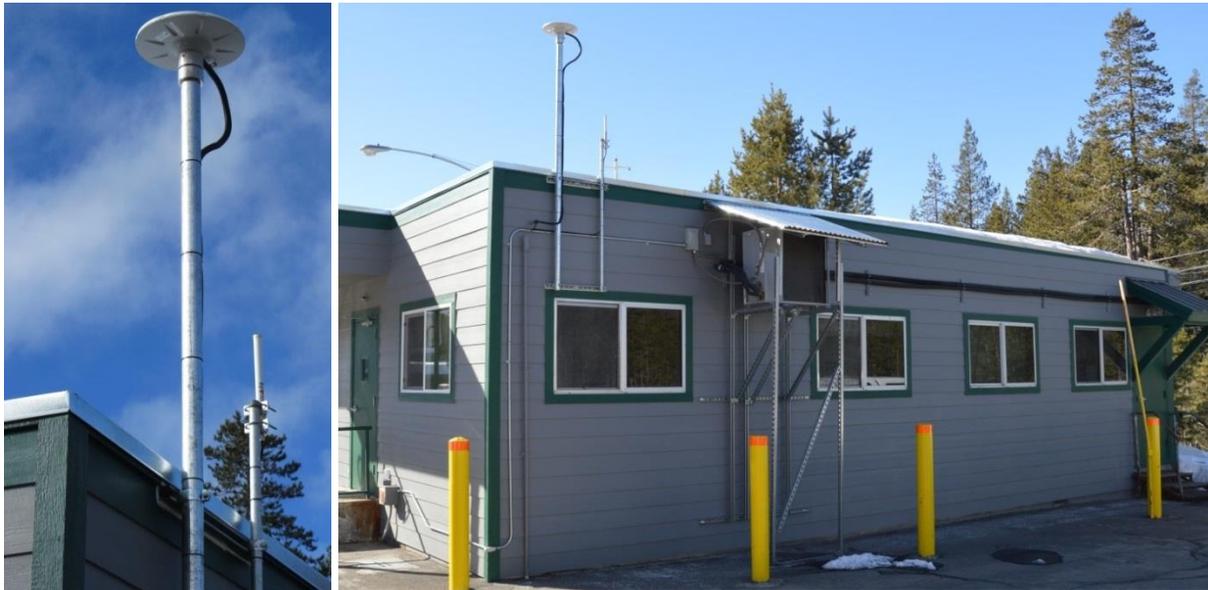
Figure 2.15: GNSS base station antenna and mobile network antenna installation at Kingvale Command Center

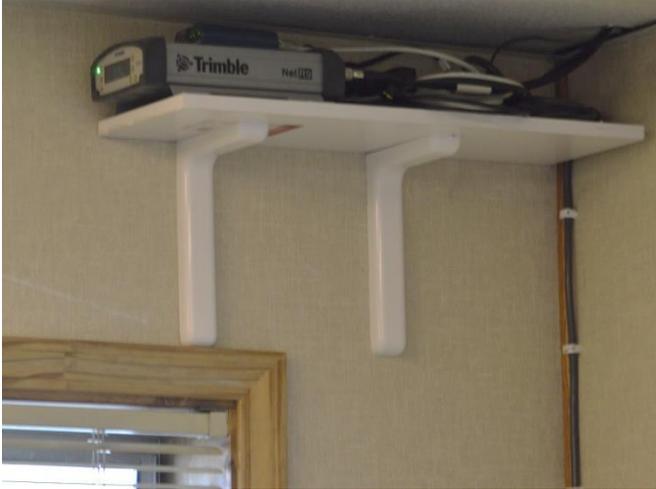
Figure 2.16: GNSS base station receiver and mobile network modem installation at Kingvale Command Center

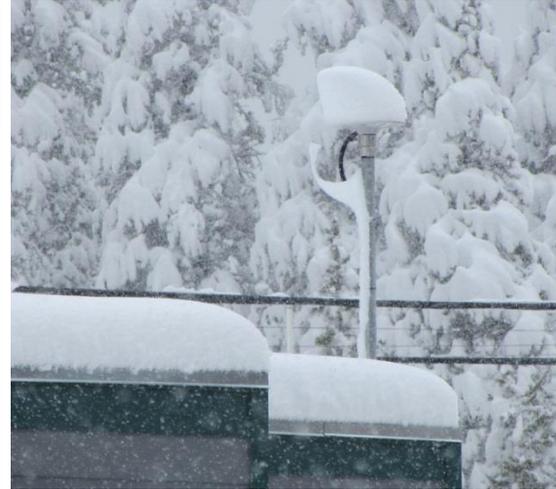
Figure 2.17: GNSS base station antenna functioning under heavy snow cover

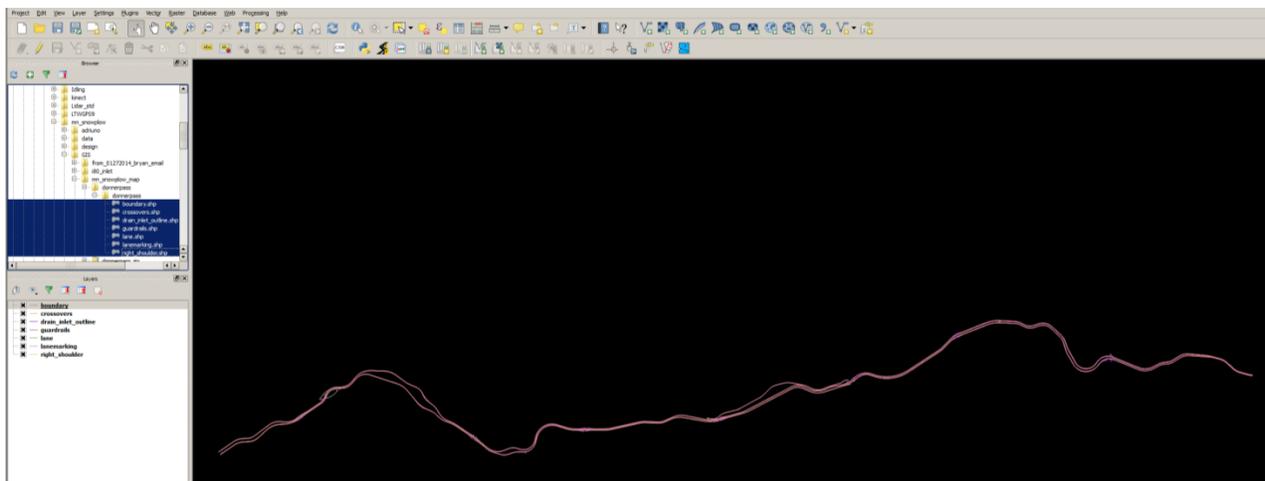
Figure 3.1: All DAS map layers SHP files displayed on QGIS

The project area was later surveyed and mapped using the Caltrans Mobile Terrestrial Laser Scanner (MTLS) [13-16]. The resulting point cloud was used to extract the inlet locations and outlines for the snow blower. The inlet .shp (Shapefile, a popular geospatial vector data format for geographic information system (GIS) software, developed and regulated by Esri²) files were first created in the EPSG:2767, NAD83 (HARN) / California Zone 2 State Plane map projection³. QGIS open-source software was used in the data conversion and post-processing⁴. The inlet .shp files were then sent to MTS for verification and final processing. A donnerpass.zip digital file, which contains all the DAS digital maps files, was returned for unloading onto the snow blower computer. The contents of the donnerpass.zip file are available in Appendix I. Appendix I also illustrates the map updating process for the snow blower.

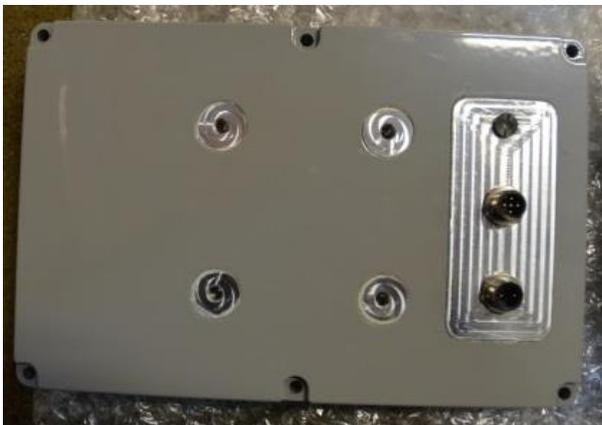
Figure 4.1: Heated enclosure back

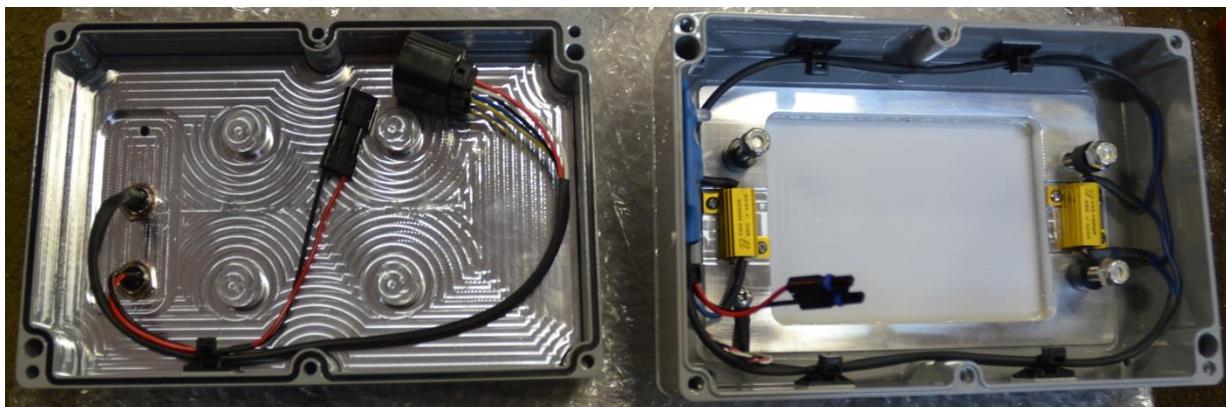
Figure 4.3: Inside of the ESR heated enclosure

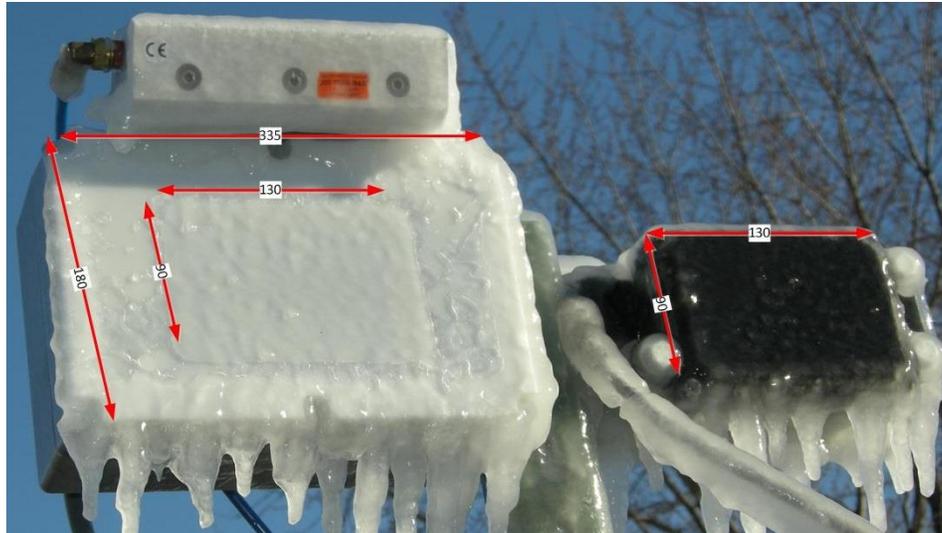
Figure 4.4: AutonomouStuff radar enclosure test setup (photo provide by AutonomouStuff)

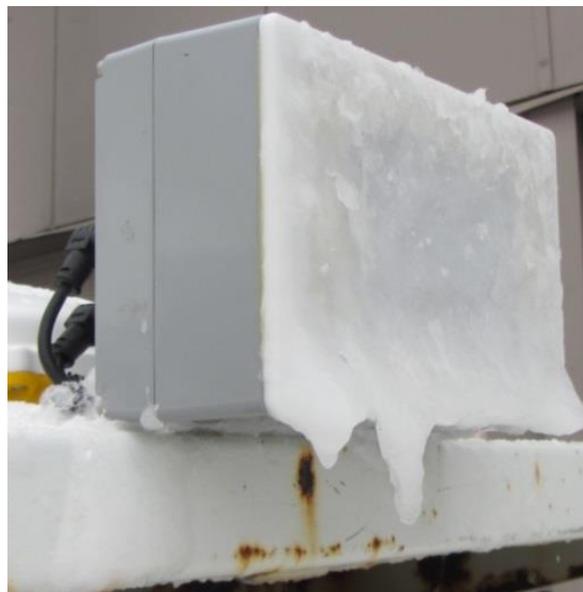
Figure 4.5: Icing on the heated radar enclosure

ESRs were mounted inside the heated enclosures purchased from AutonomouStuff for testing on the snowplow and an AHMCT test vehicle. Subsequent testing showed that the heaters were underpowered to melt and eliminate the wet snow build-up when the vehicle speed is high (~35 mph) and under heavy snowfall. Figure 4.5 shows icing on the heated fascia after driving in a heavy snow storm at about 30 mph. However, the heater was adequate in keeping ice from forming when the vehicle is stationary. Because of the slow speed of the snow blower, the heated radar enclosure should be effective in keeping the wet snow and ice build-up under control on the snow blower; however due to the lack of heavy snow storm, the snow blower was not used in the past few years. This testing showed that the heated enclosure from AutonomouStuff does not solve the radar icing problem for the snowplows.

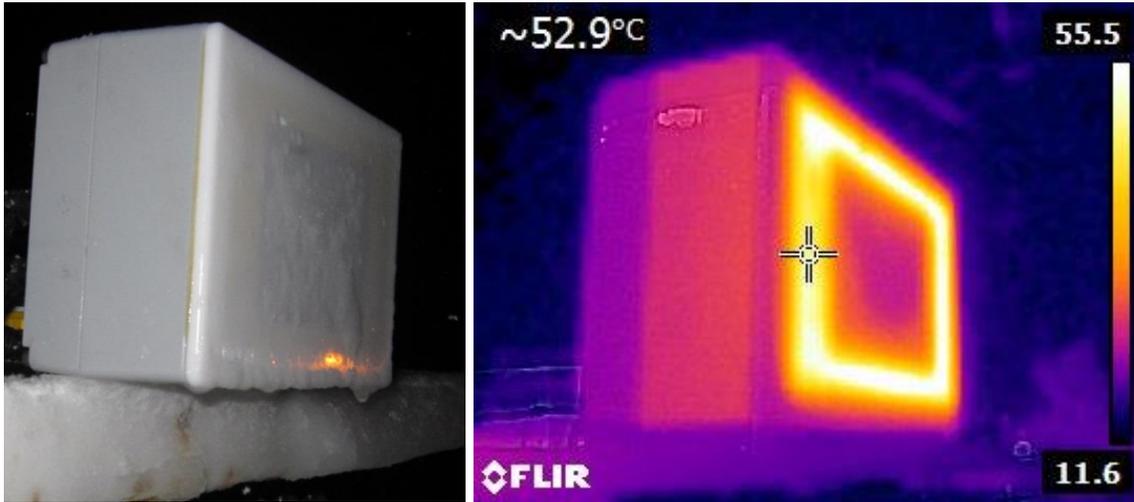
Figure 4.6: Icing on the heated radar enclosure, including thermal image on right

Figure 4.6 showed a thermal image of the heated fascia (on the right) next to a photo of the enclosure. The thermal image illustrates that the center of the fascia is cold (registering at freezing temperature) while the temperature near the heating element is hot. This distribution is due to the poor thermal conductivity of the fascia plastic. The temperature of the aluminum housing side is also higher than that of the fascia plastic front. Therefore, significant heat is lost to the side of the higher thermal conductivity aluminum housing. The heating element should be insulated so that all the heat generated is transferring to the front fascia.

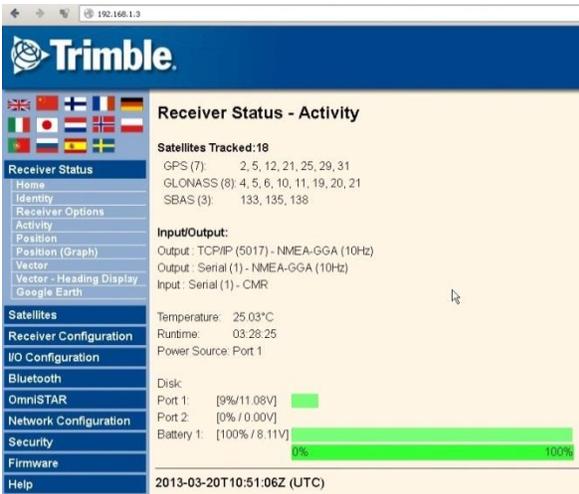
Figure 4.7: Trimble GNSS receiver web user interface showing power supply voltage at 11.08 v when heater is running

Due to additional current draw by the enclosure heater, there was significant voltage drop in the power supply (to about 11 volts), as shown in Figure 4.7. This was caused by undersized wiring. The supply voltage drop caused the GNSS receiver to shut down when the enclosure heater was on for a period of time. The GNSS receiver was programmed to automatically shut down when the power supply voltage drops below 11.4 volts, resulting in system failure. Once this problem was identified, the GNSS receiver was reconfigured to shut down at 10.8 volts. In addition, heavier gauge (10-gauge) wires were used to replace the original, undersized wiring. The GNSS receiver did not shut down after these revisions.

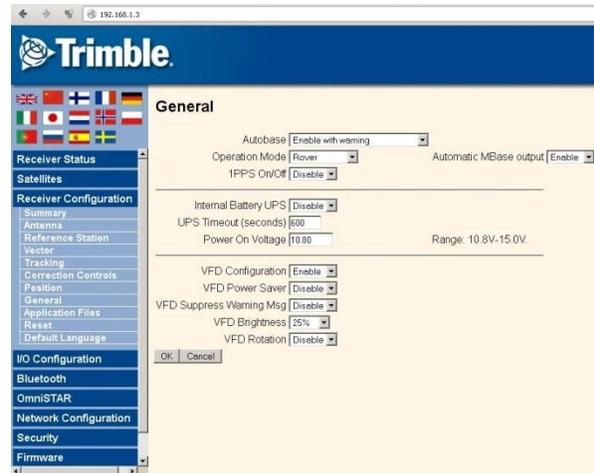
Figure 4.8: Trimble GNSS receiver web user interface showing power on voltage set to 10.8 v

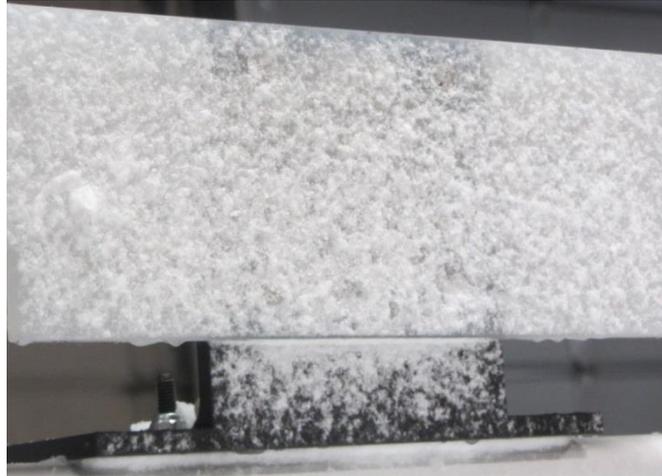
Figure 4.9: Icing on polycarbonate plastic coated with Rust-Oleum NeverWet after driving in a snow storm

AHMCT, MTS, and the radar vendor also explored various hydrophobic coatings as an additional component of addressing the radar freezing problem. Figure 4.9 shows that ice and snow sticks to the polycarbonate plastic coated with Rust-Oleum NeverWet hydrophobic coating. A hydrophobic coating alone may not solve the icing problem.

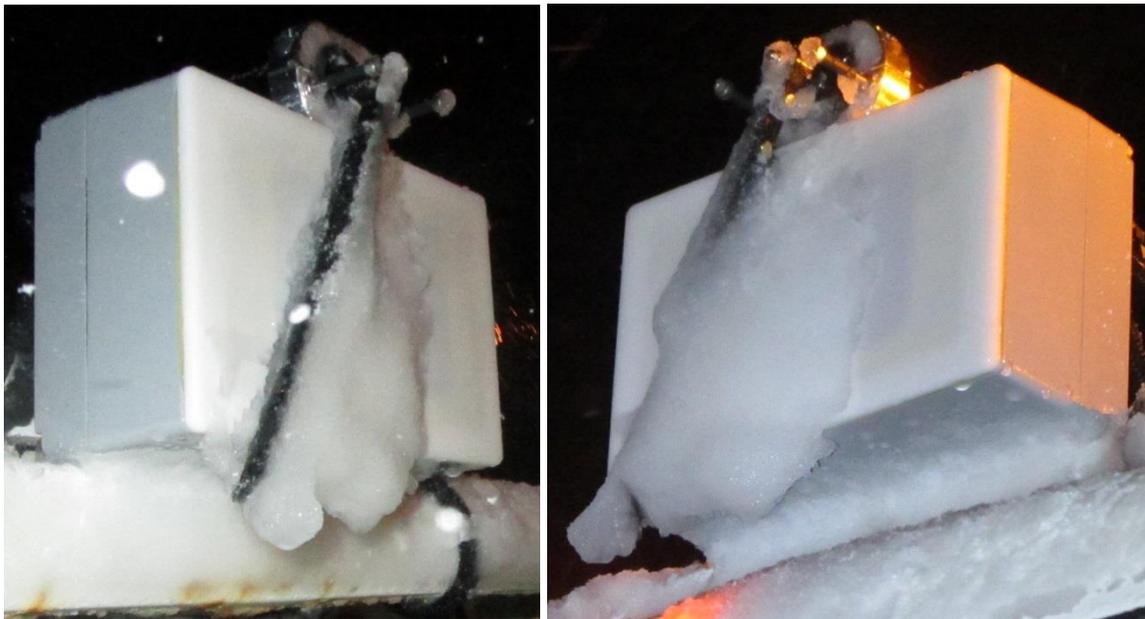
Figure 4.10: First-generation wiper / heated enclosure system

AHMCT, MTS, and the radar vendor explored additional solutions to the icing problem. Delphi Automotive was consulted through AutonomouStuff. A wiper blade was mounted to the heated radar enclosure to determine its effectiveness, as shown in Figure 4.10. The first-generation wiper system failed due to snow and ice sticking to the wiper blade, and the wiper blade did not apply sufficient pressure onto the fascia to push snow away. Furthermore, the wiper motor was a COTS system developed for the military market. It was highly programmable in its range of motion, but very expensive. Nevertheless, the first generation design provided important insight to future wiper design improvement:

- A heated wiper blade is required
- The wiper blade must also move to an open area to allow the wind to blow away the snow on the wiper blade.

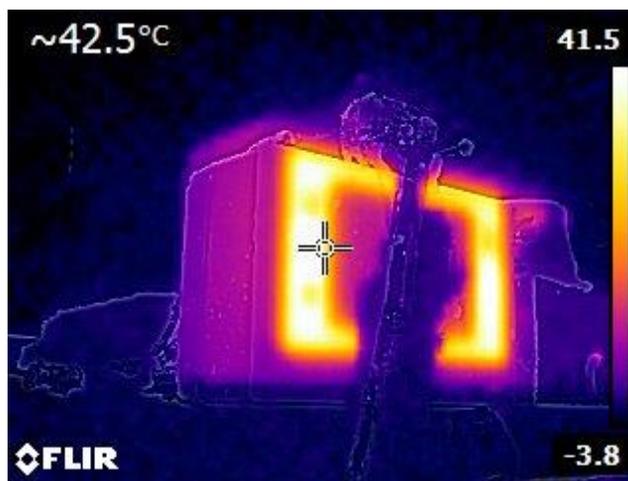
Figure 4.11: Thermal image of the first-generation wiper / heated enclosure system

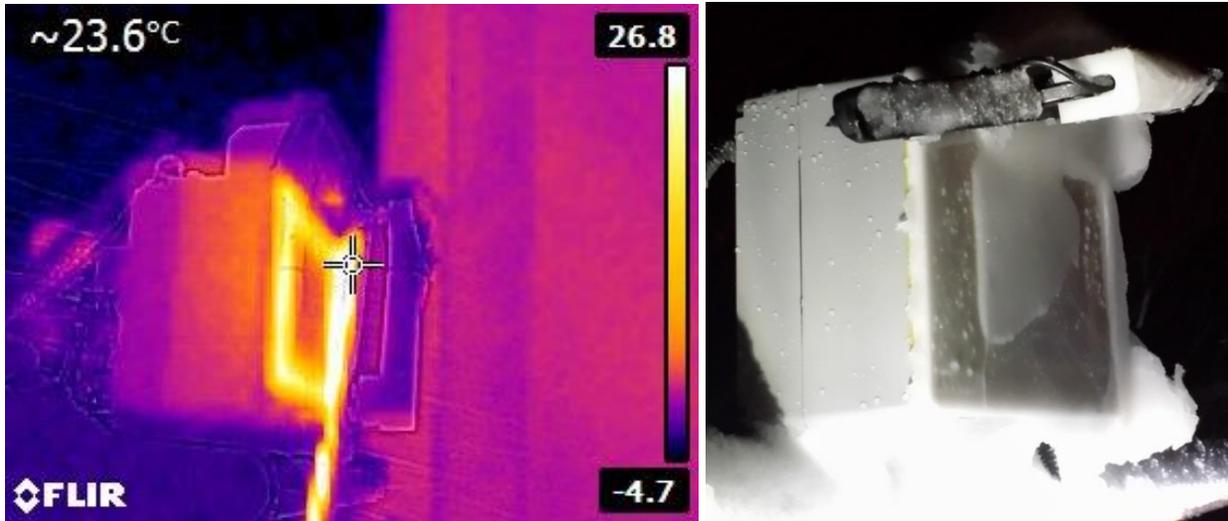
Figure 4.12: Second-generation wiper design (wiper motor mounted on top) with heated wiper blade, including thermal image on left

The second- and third-generation designs failed when the snow fall was heavy for an extended period. The cause of failure is snow accumulation on the side of the fascia by the wiper blade pushing snow to the accumulation area. The snow build-up diminished the ability of the wiper blade to push snow from the center of the fascia.

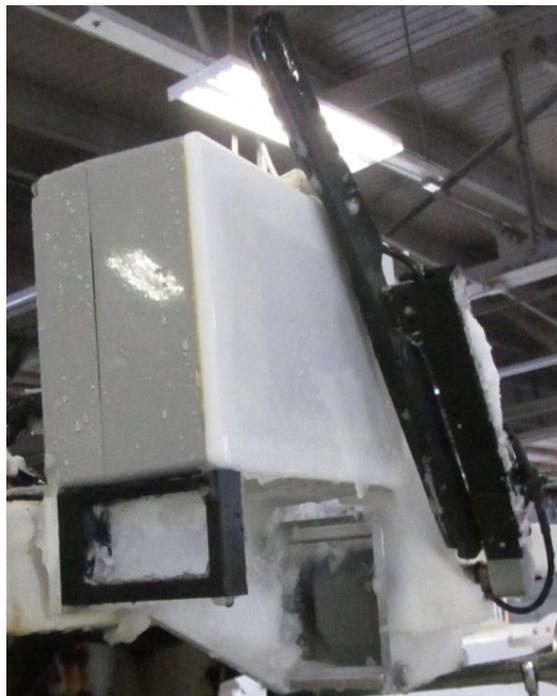
Figure 4.13: Third-generation wiper design (wiper motor mounted on bottom) with heated wiper blade

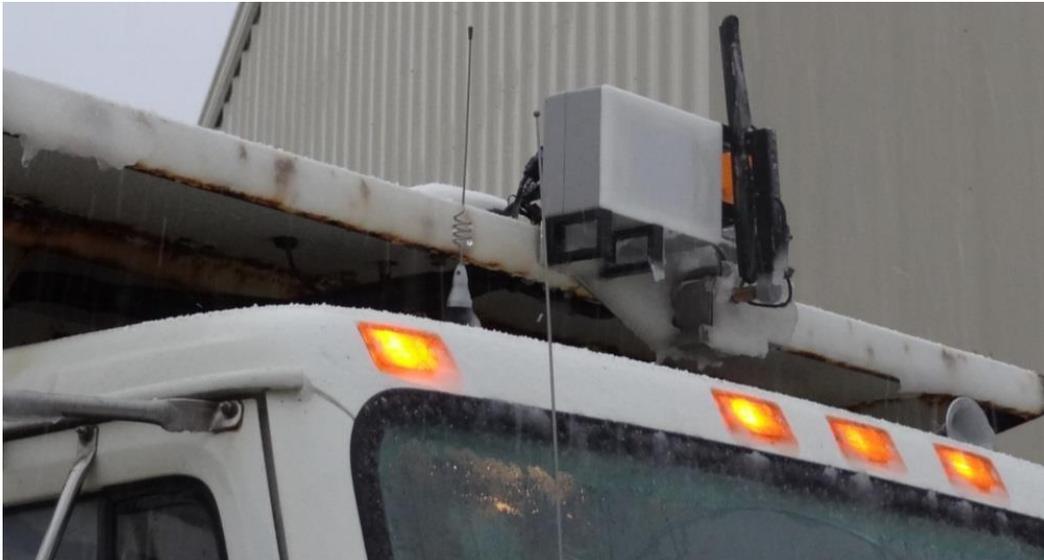
Figure 4.14: Final wiper design with heated wiper blade

ice on the motor face and mount will not hinder the wiper operation. In addition, two black narrow plastic supports were added to the bottom and side of the enclosure. The supports allow wind to blow the snow and ice off the wiper blade and themselves, preventing snow and ice accumulation. Insulation was added behind and to the side of the heating element to focus the heat transfer toward the front fascia. Figure 4.15 shows that the final wiper design with heated wiper blade passed operational tests. Snow accumulated in areas surrounding the radar, but not on the fascia. The final radar wiper system was installed and tested on both 700024 and 700506. The final radar wiper system seems to work well and prevented ice from forming during the testing in the 2014 - 2015 snow season.

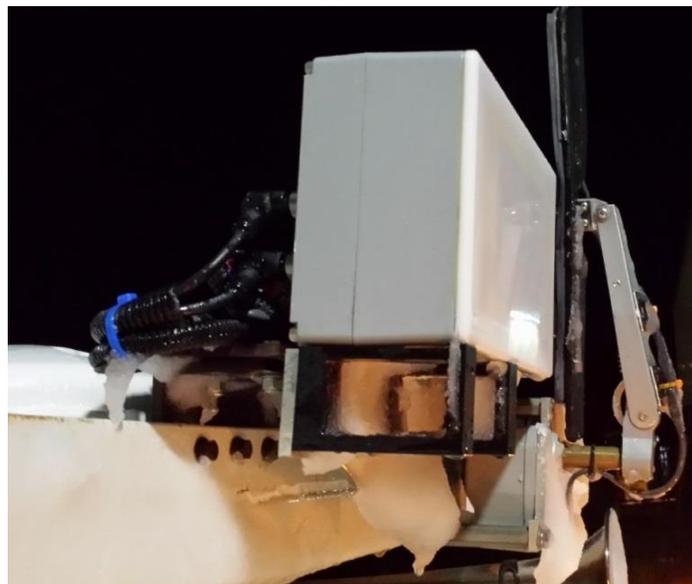
Figure 4.15: Final wiper design with heated wiper blade. This design passed operational testing. Snow accumulated in areas surrounding the radar, but not on the fascia.

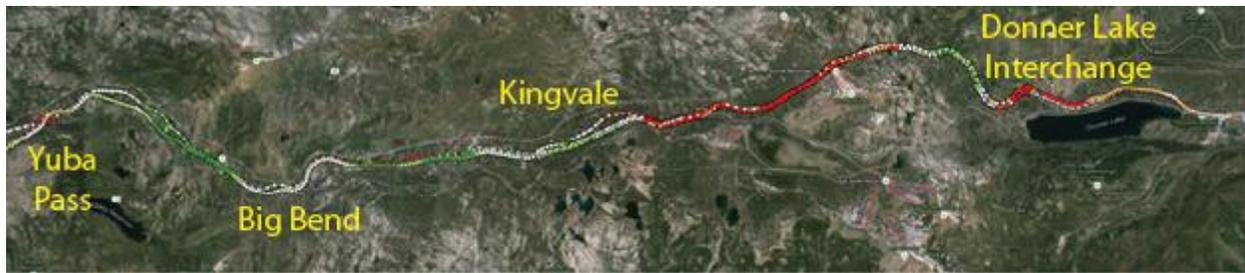
Figure 5.1: RSSI on I-80 from SR 20 to DLI overlaid a Google hybrid map

The received signal strength indicator (RSSI) in dBm was logged in the DAS log file along with the vehicle position. The data were overlaid on a Google hybrid map and analyzed in QGIS. Each color dot represents different RSSI range as listed in Table 5.1. RSSI below -100 dBm is considered poor signal with limited connectivity. Figure 5.1 shows the Verizon mobile network coverage of the entire test area (on I-80 from SR 20 interchange to DLI). The red dotted areas (at, and east of, Soda Spring and DLI) shows poor signal strength.

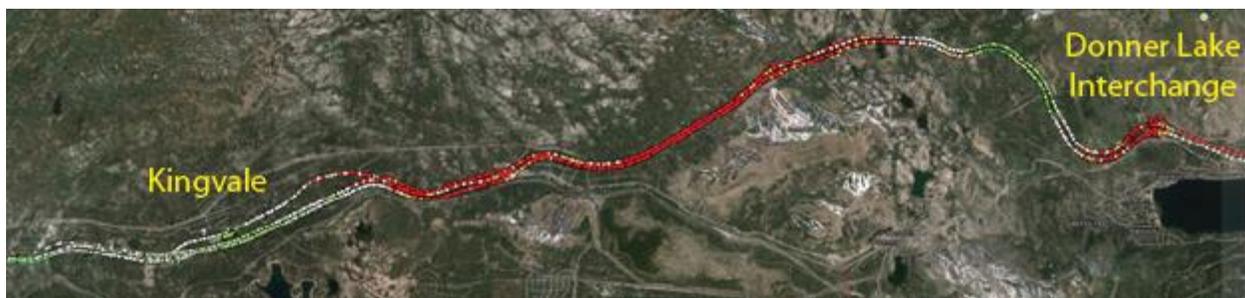
Figure 5.3: RSSI on I-80 from Kingvale to DLI overlaid on a Google hybrid map

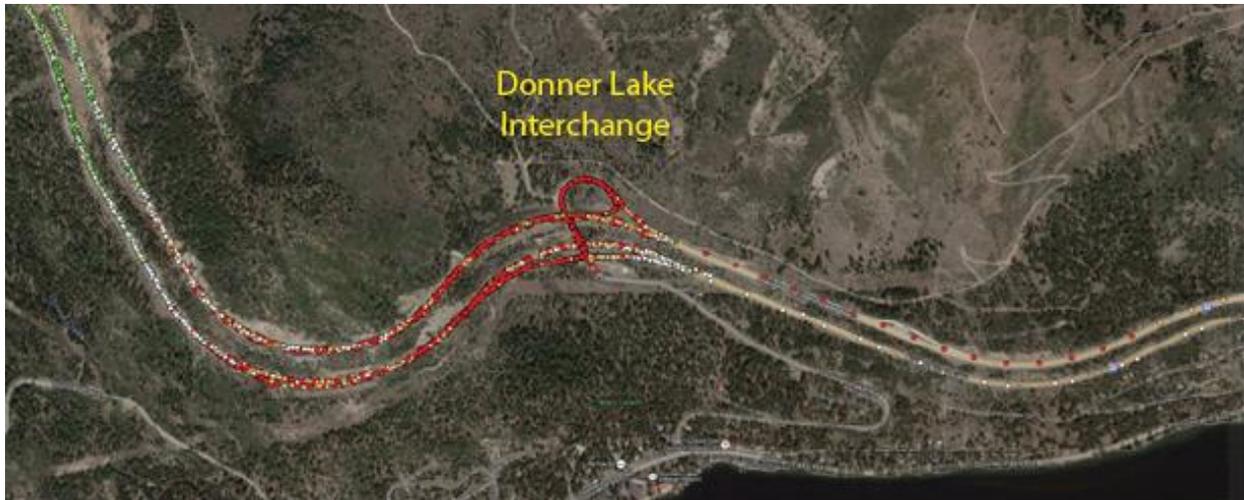
Figure 5.4: RSSI on I-80 at DLI overlaid on a Google hybrid map

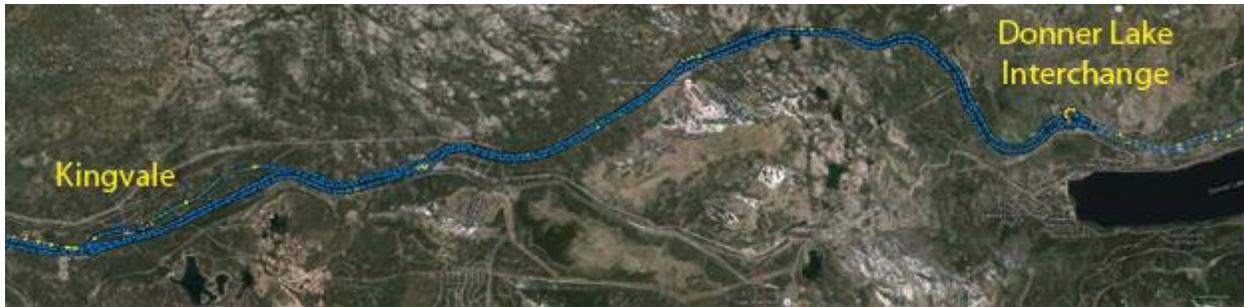
Figure 5.5: GNSS RTK solution status on I-80 from Kingvale to DLI overlaid on a Google hybrid map

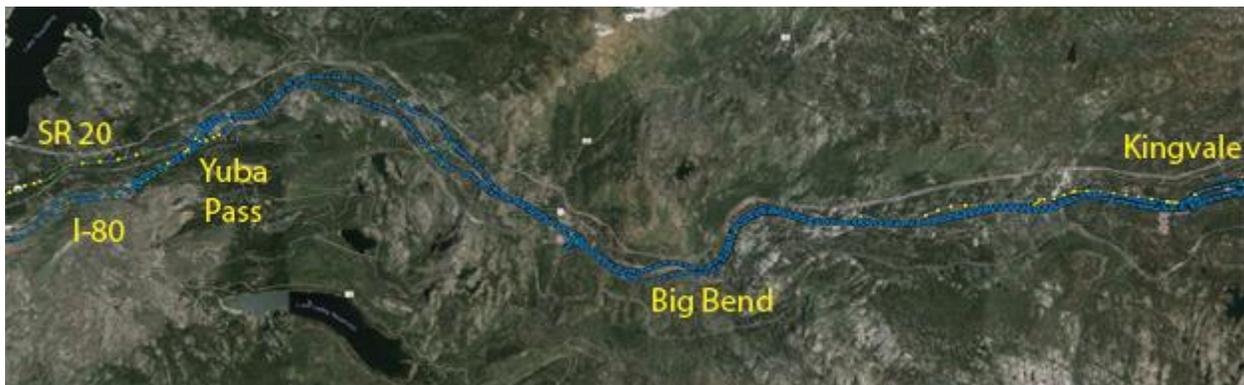
Figure 5.6: GNSS RTK solution status on I-80 from SR 20 intersection to Kingvale overlaid on a Google hybrid map

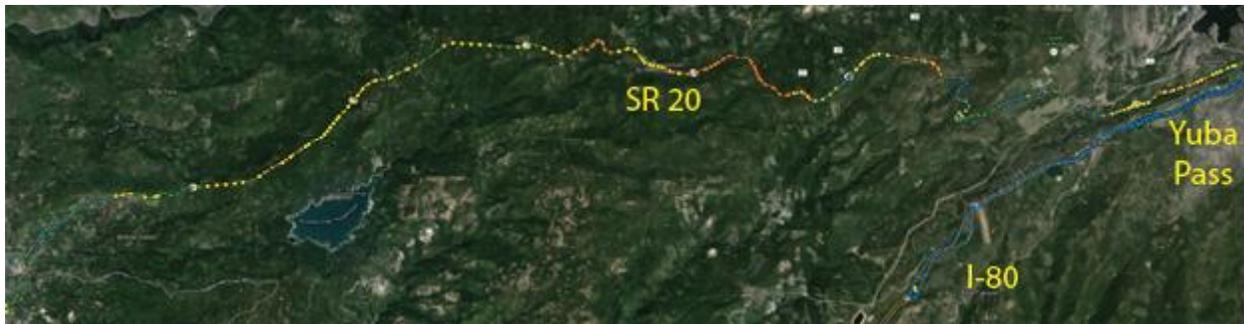
Figure 5.7: GNSS RTK solution status on SR 20 overlaid on Google hybrid map

Figure 5.7 shows that the GNSS receivers were not providing accurate solution on SR 20. Thus, the DAS does not work well on SR 20. However, SR 20 was not an area of interest for the DAS. Figures 5.8-5.10 display small areas where the GNSS solution is not accurate for DAS due to GNSS signal blockage when the snowplow drives under a bridge. This issue is discussed below.

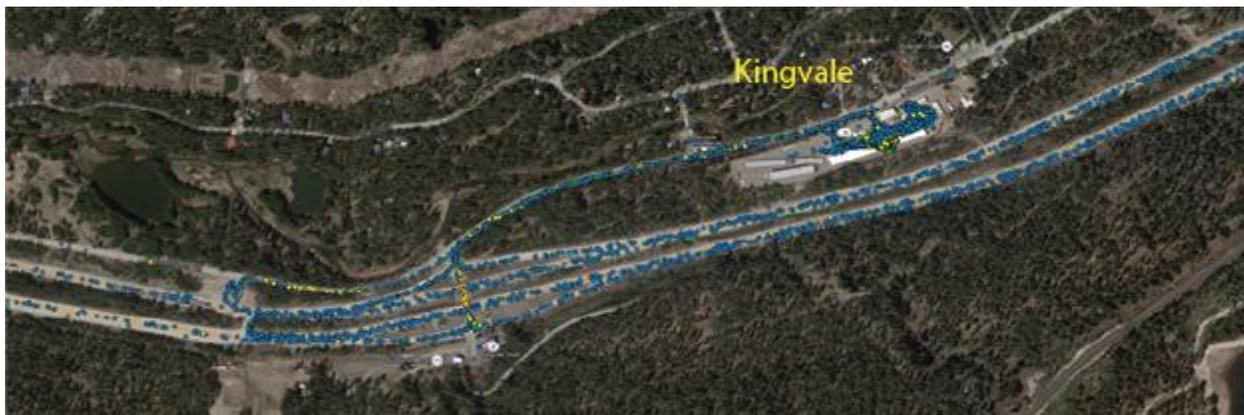
Figure 5.8: GNSS RTK solution status on I-80 at Kingvale area overlaid on a Google hybrid map

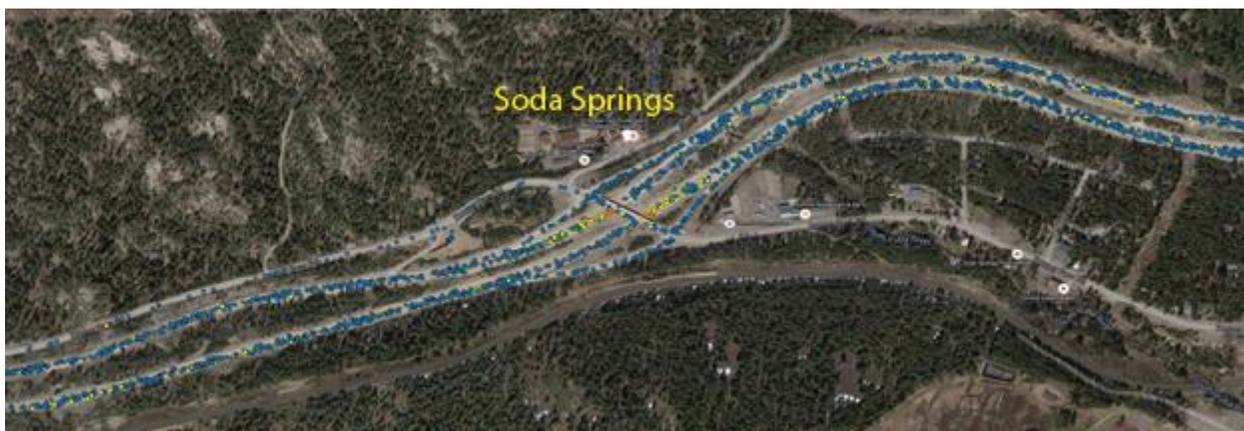
Figure 5.9: GNSS RTK solution status on I-80 at Soda Spring overlaid on a Google hybrid map

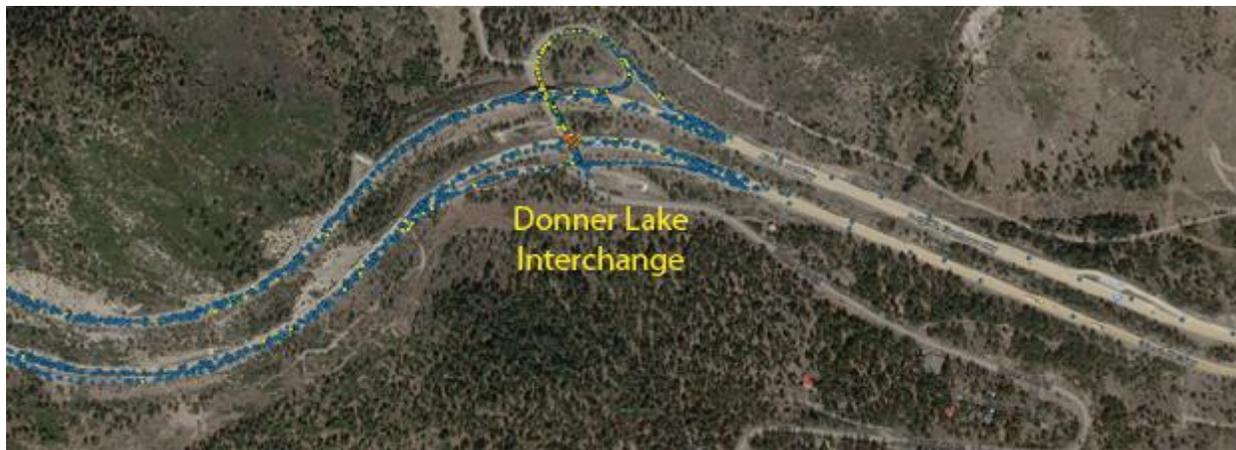
Figure 5.10: GNSS RTK solution status on I-80 at DLI overlaid on a Google hybrid map

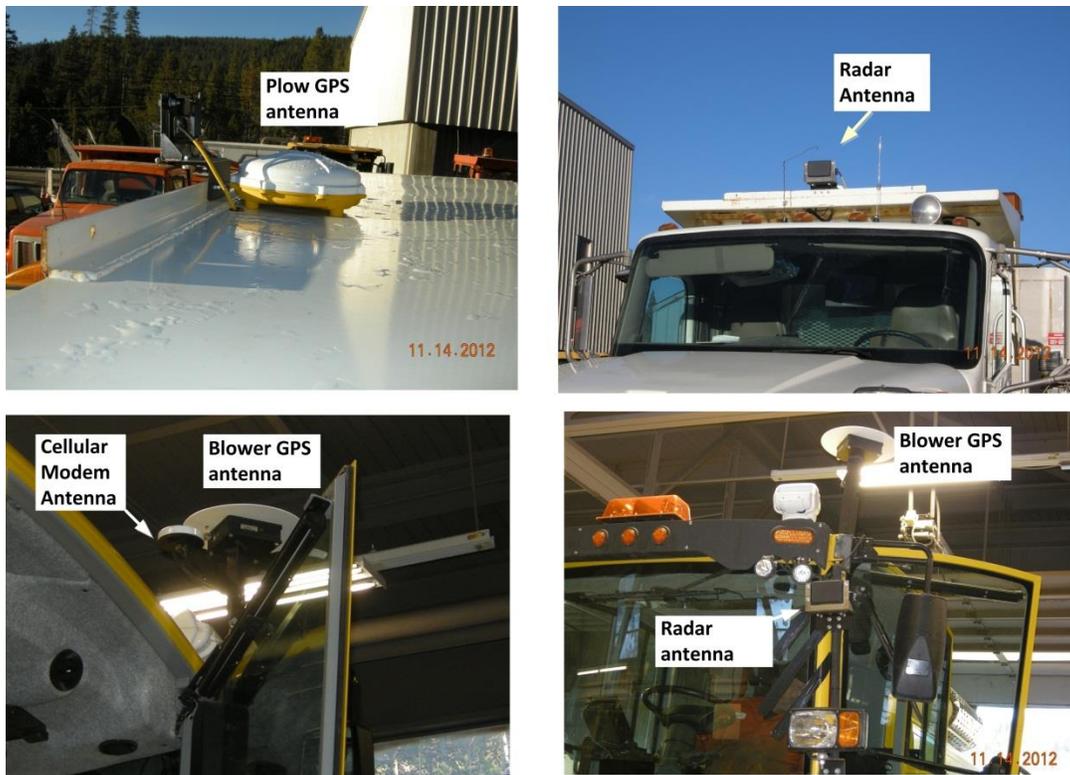
Figure B.1: System components mounted on the outside of the vehicles

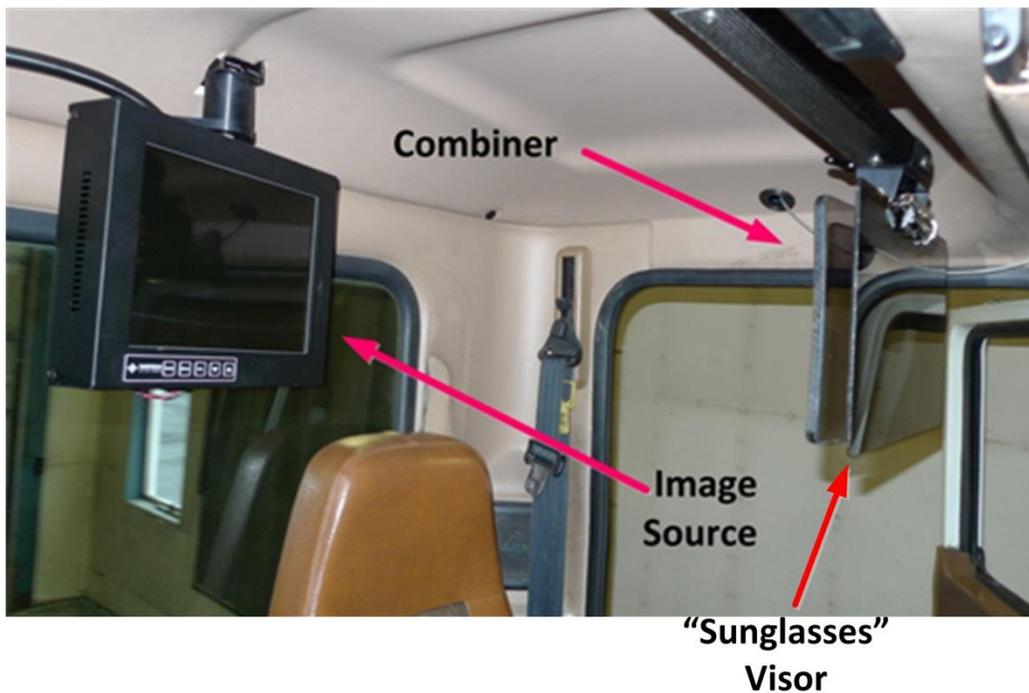
Figure B.2: Head-Up Display components

Combiner - "Combines" the actual road with the computer generated road. The driver can see through the combiner and also see a reflection of the image presented by the image source. The combiner is made from a heat-formed acrylic, and treated with a reflective coating on the concave side, and an anti-reflective coating on the convex side. **It is important to note that these coatings are relatively delicate, and cannot tolerate any sort of chemical cleaner (Windex, Sparkle, etc.) or any sort of rubbing.** The cleaning process is described below.

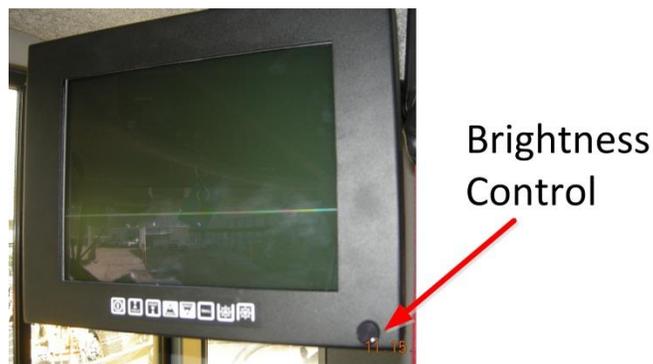
Figure B.3: Brightness control for HUD image source

Image Source: – Generates the image which is seen by the driver when looking through the combiner. The display has a brightness control used to allow the system to be bright during high ambient light conditions, and very dim during nighttime operation when stray light in the cab is undesirable. The brightness control is shown in Figure B.3.

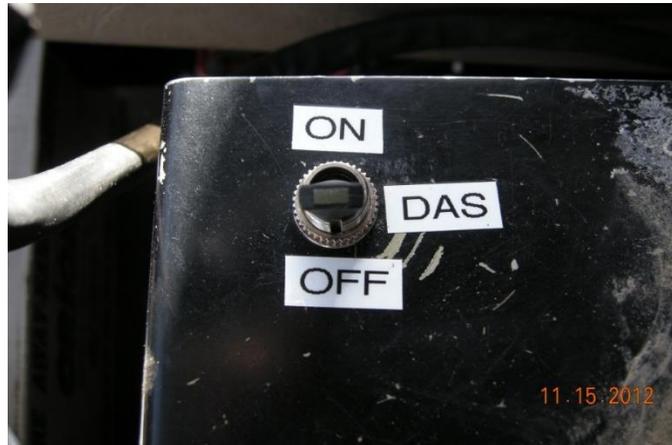
Figure B.4: Driver Assist System (DAS) ON/OFF switch for plow 0530506 located beneath the Muncie spreader controls
