Evaluation of the University of Minnesota GPS Snowplow Driver Assistance System

Report Number: CA16-2167

AHMCT Research Report: UCD-ARR-15-08-30-01

August 30, 2015

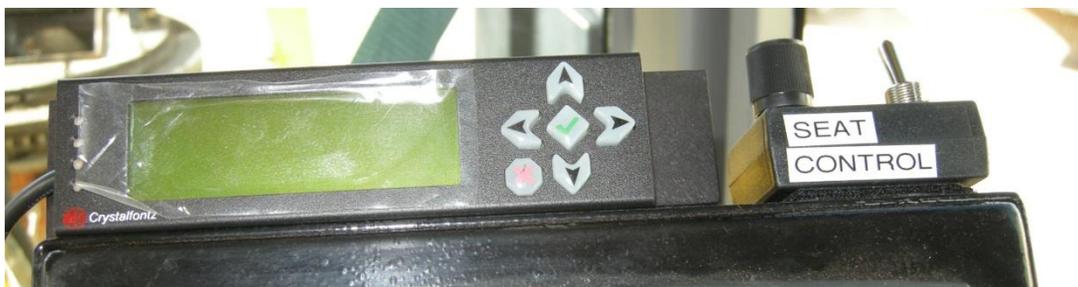
Figure B.5: DAS user interface. The Crystalfontz LCD touchpad is on the left, and the seat controller is on the right.

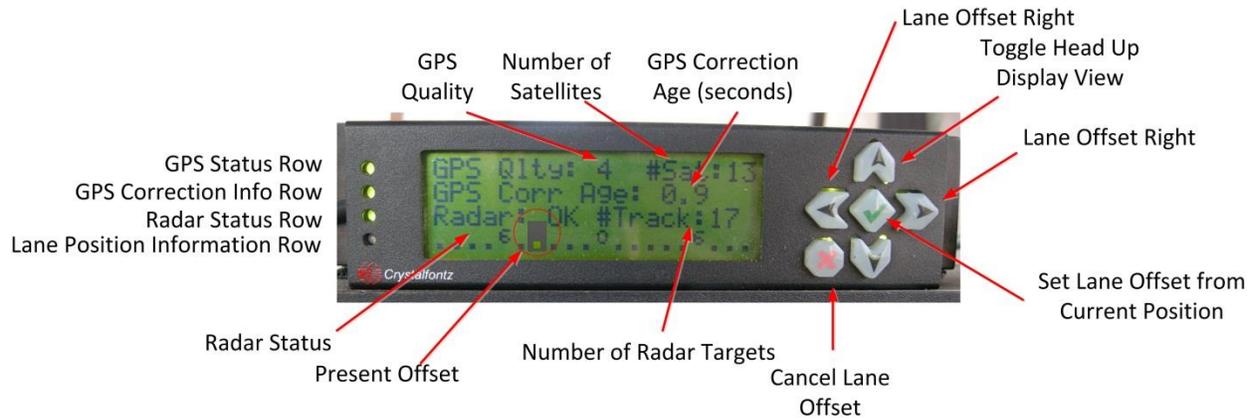
Figure B.6: DAS LCD control panel. Display shows status, and the buttons allow the driver to change the desired location of the virtual lane boundary to facilitate the plowing of shoulders or clearing over the centerline.

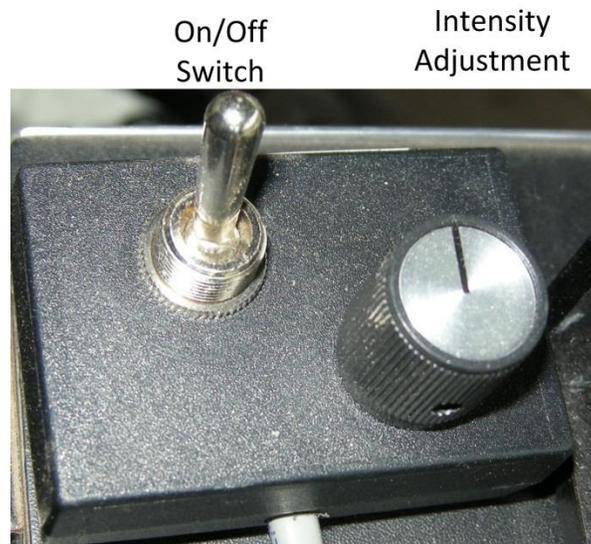
Figure B.7: Seat controller showing seat switch and intensity adjustment

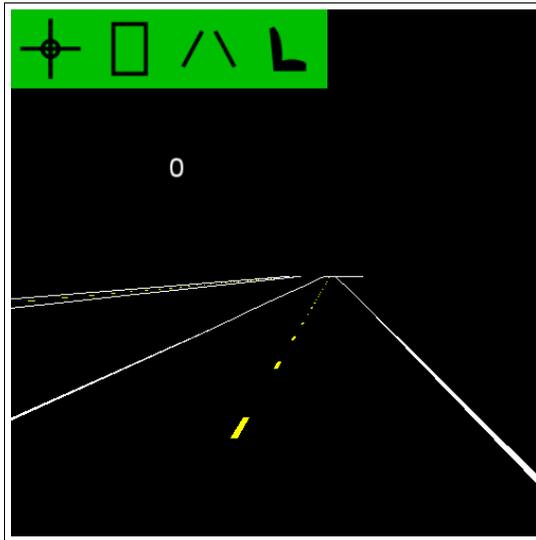
This image represents the typical computer generated view seen through the HUD. In this view the driver can see two lanes of traffic in their direction, separated by a yellow skip line and delineated by white fog lines. More traffic lanes can be seen across the median.

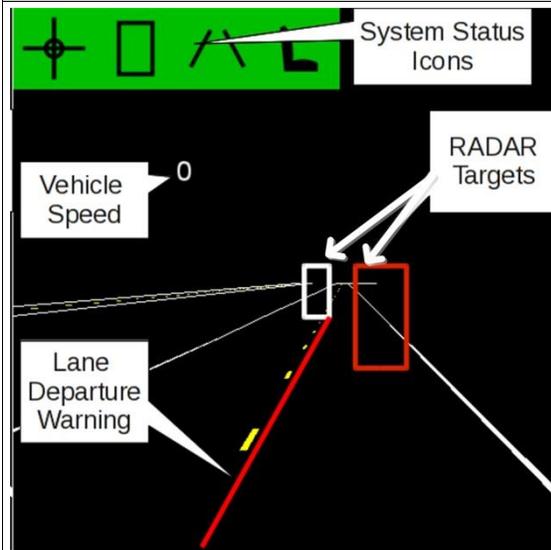
Here the different components of the HUD are highlighted.

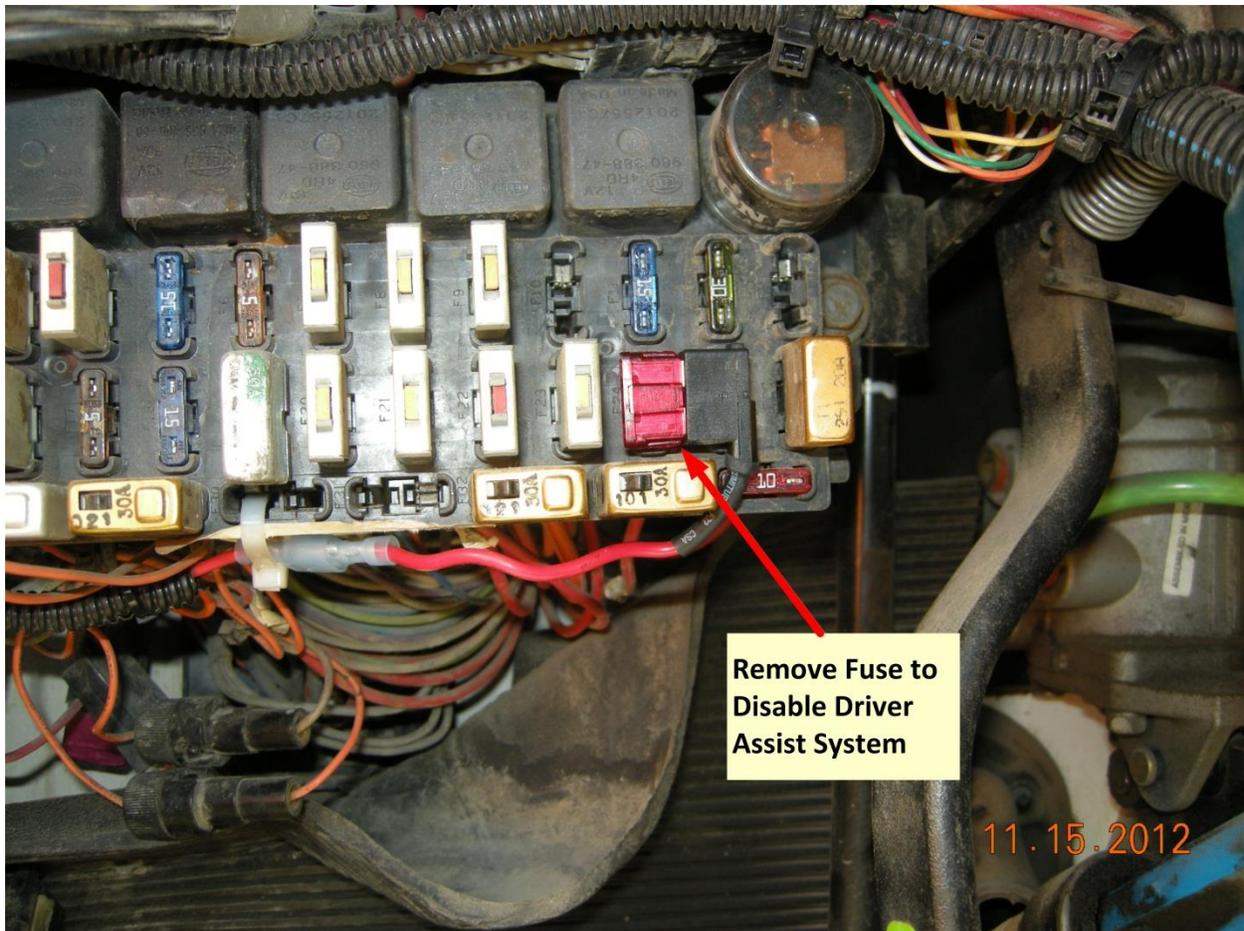
Figure B.8: DAS power connection for plow 0530506. This fuse block is located to the left of the clutch pedal in front of the driver's seat.

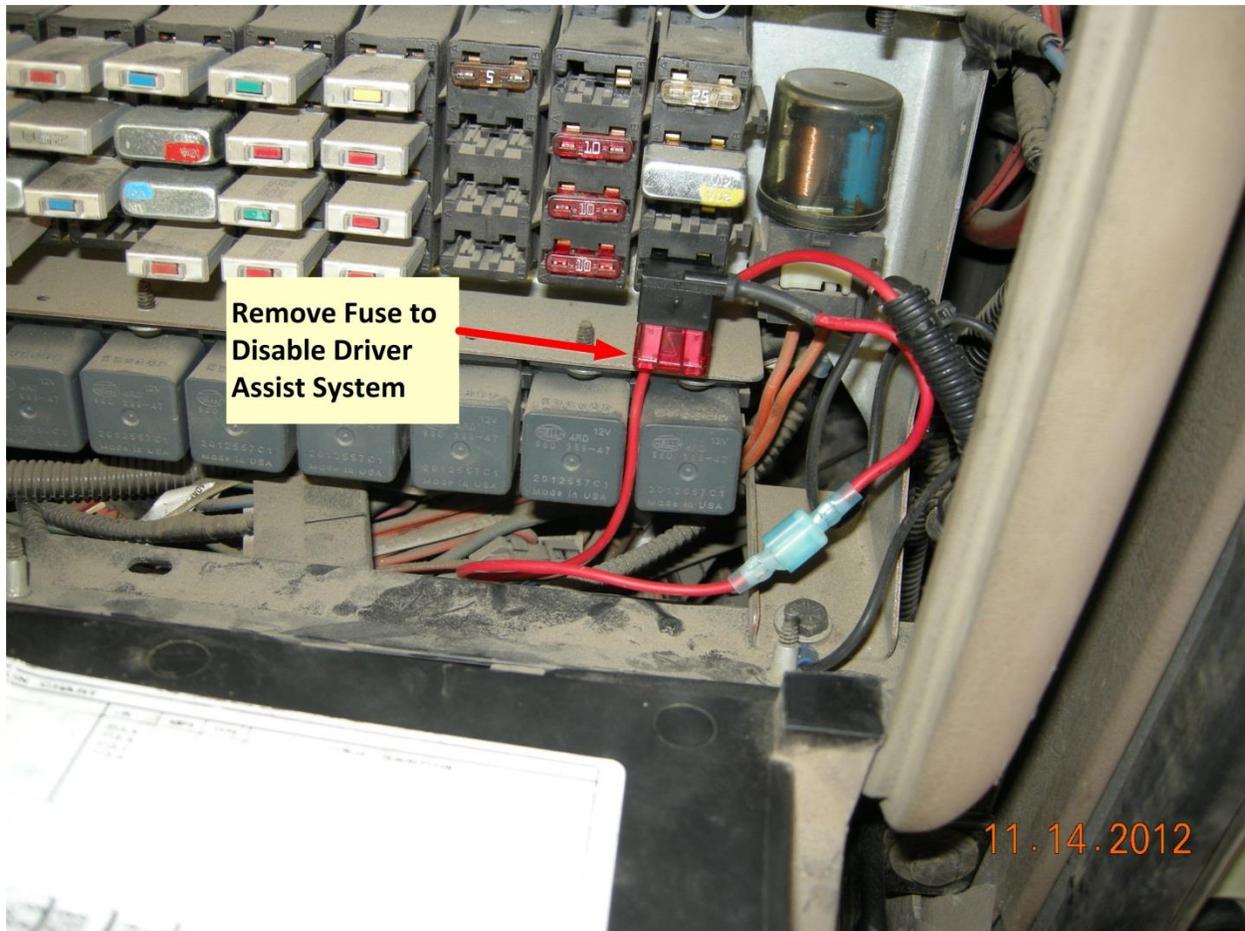
Figure B.9: DAS power connection for plow 7000024. This fuse block is located behind the glove box which is in front of the passenger seat.

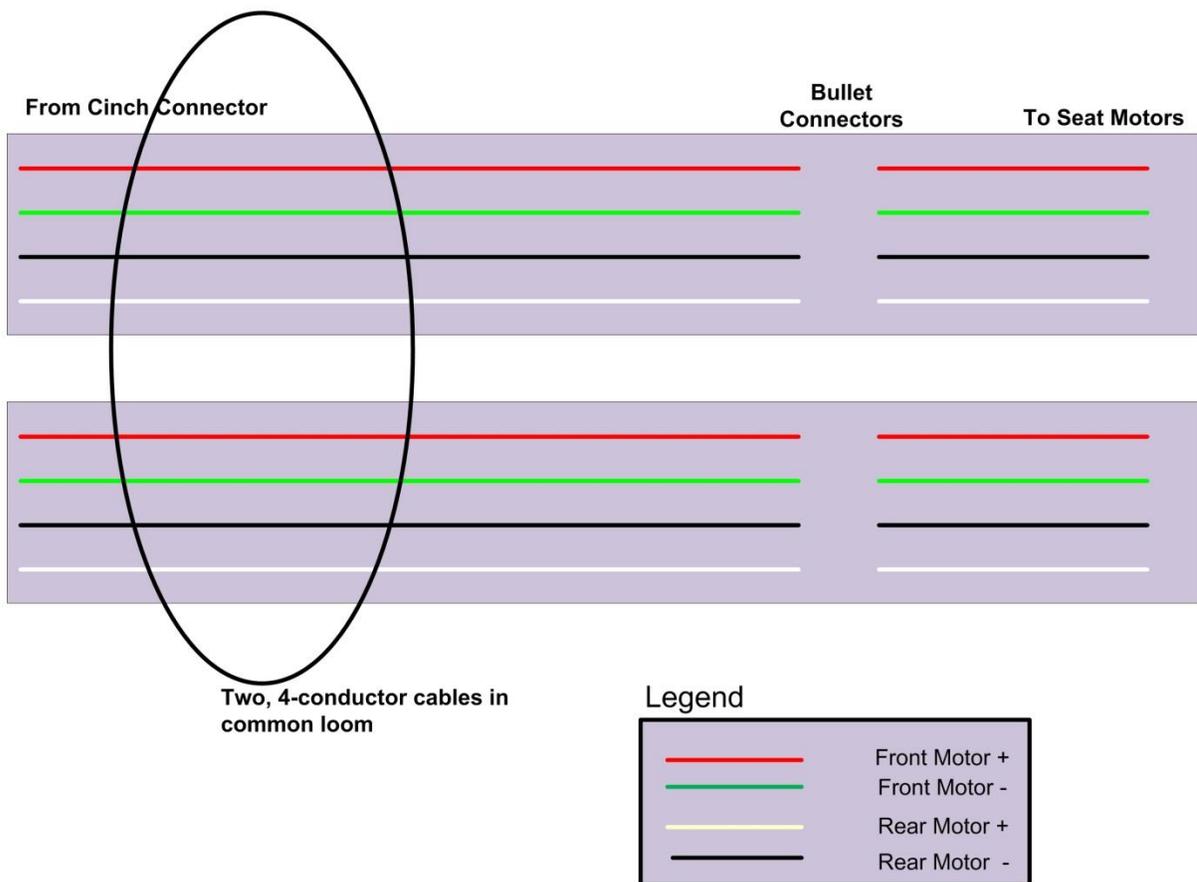
Figure B.11: Wiring between seat actuators and seat controller Cinch connector

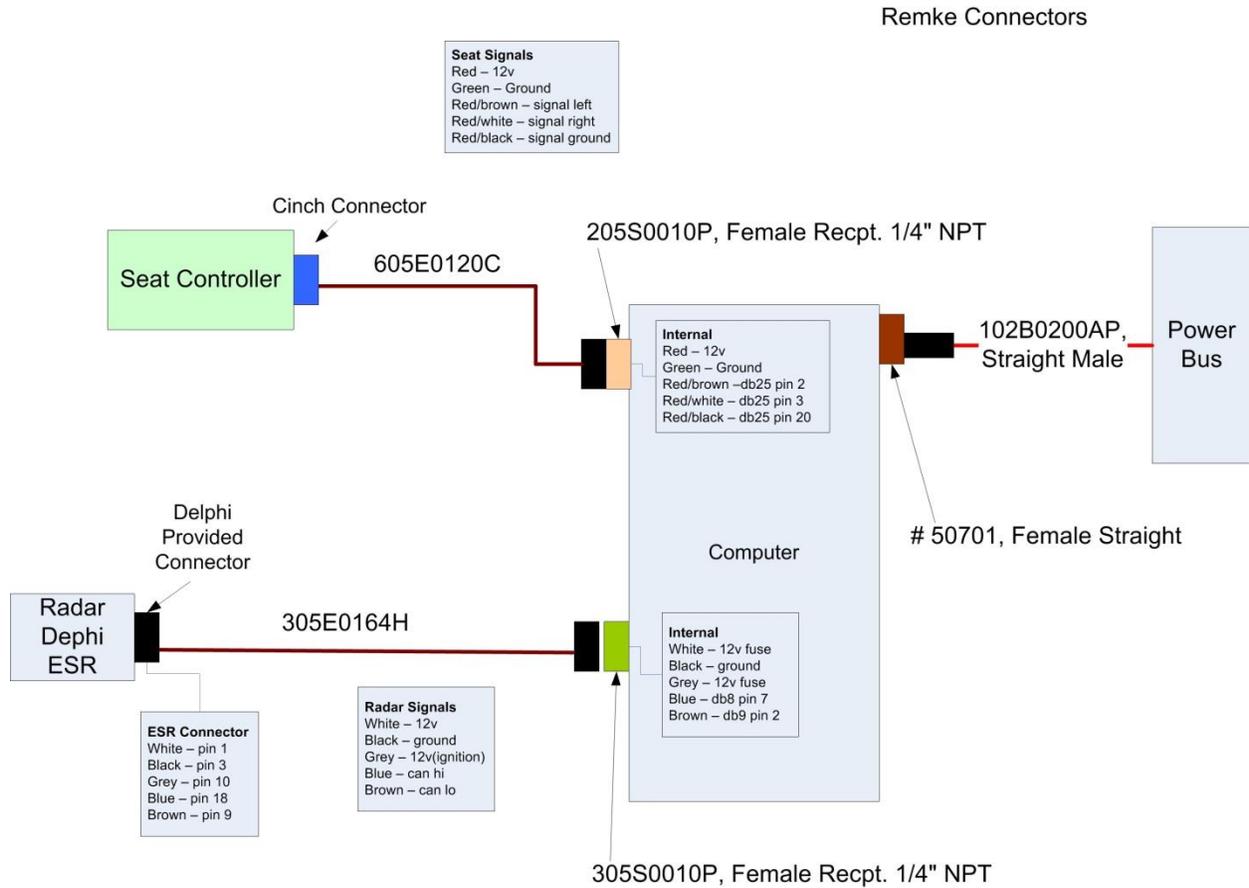
Figure B.12: Remke cabling for radar, seat controller, and computer power for all three vehicles (plows 0530506 and 7000024, and blower 7005039)

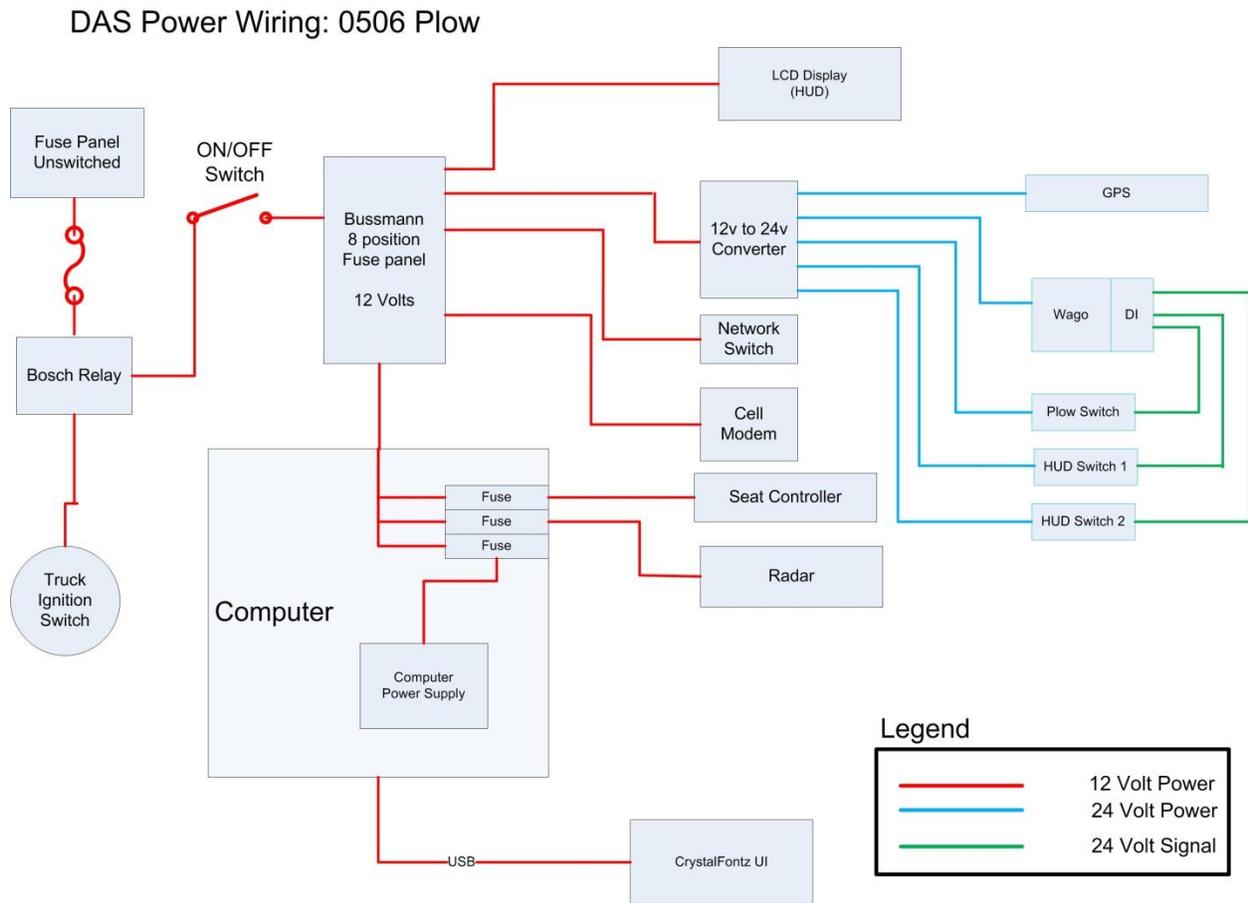
Figure B.13: Power wiring diagram for plow 0530506. The plow switch is used by AHMCT to determine how often the DAS is used while plowing snow.

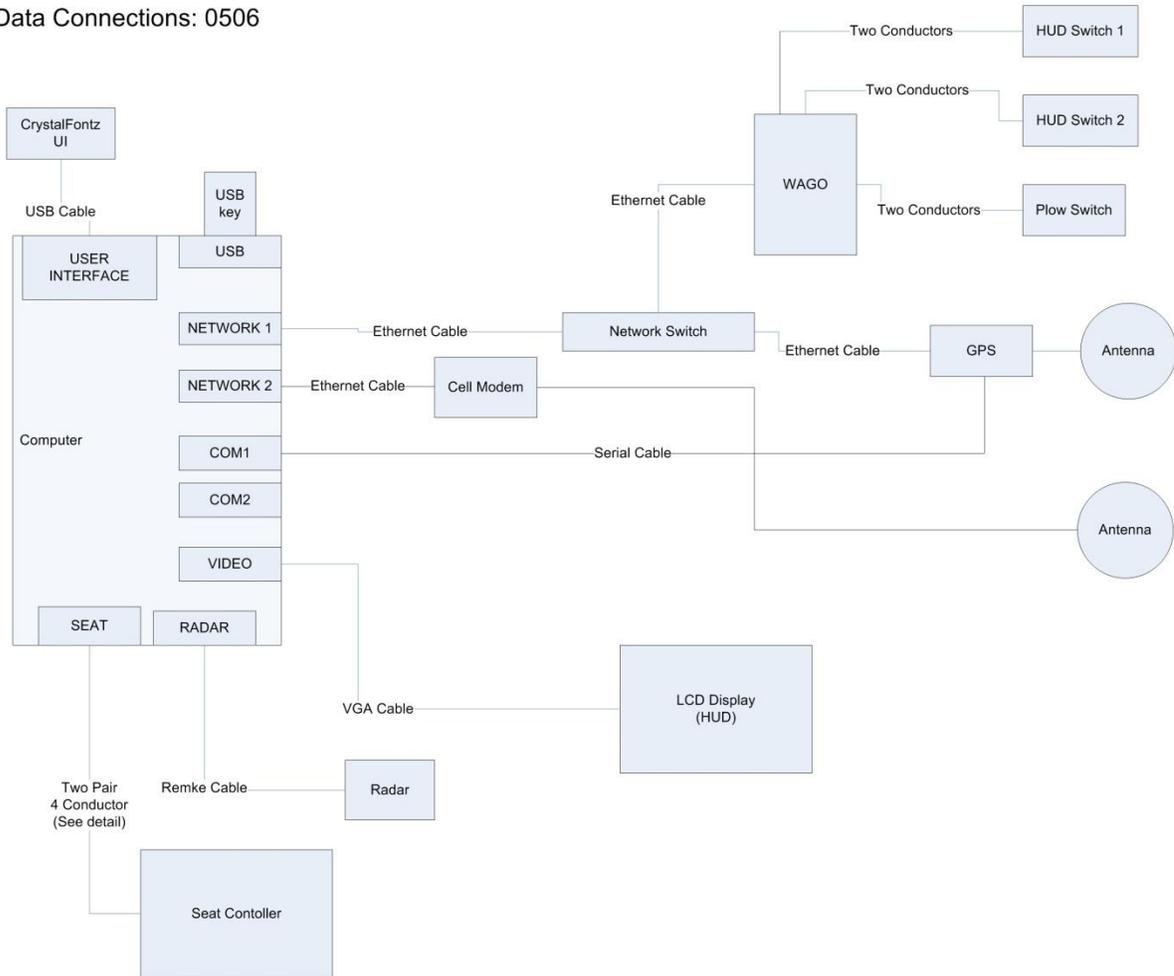
Figure B.14: Data wiring for plow 0530506. This vehicle has two HUD switches. GPS data is transferred via serial communications.

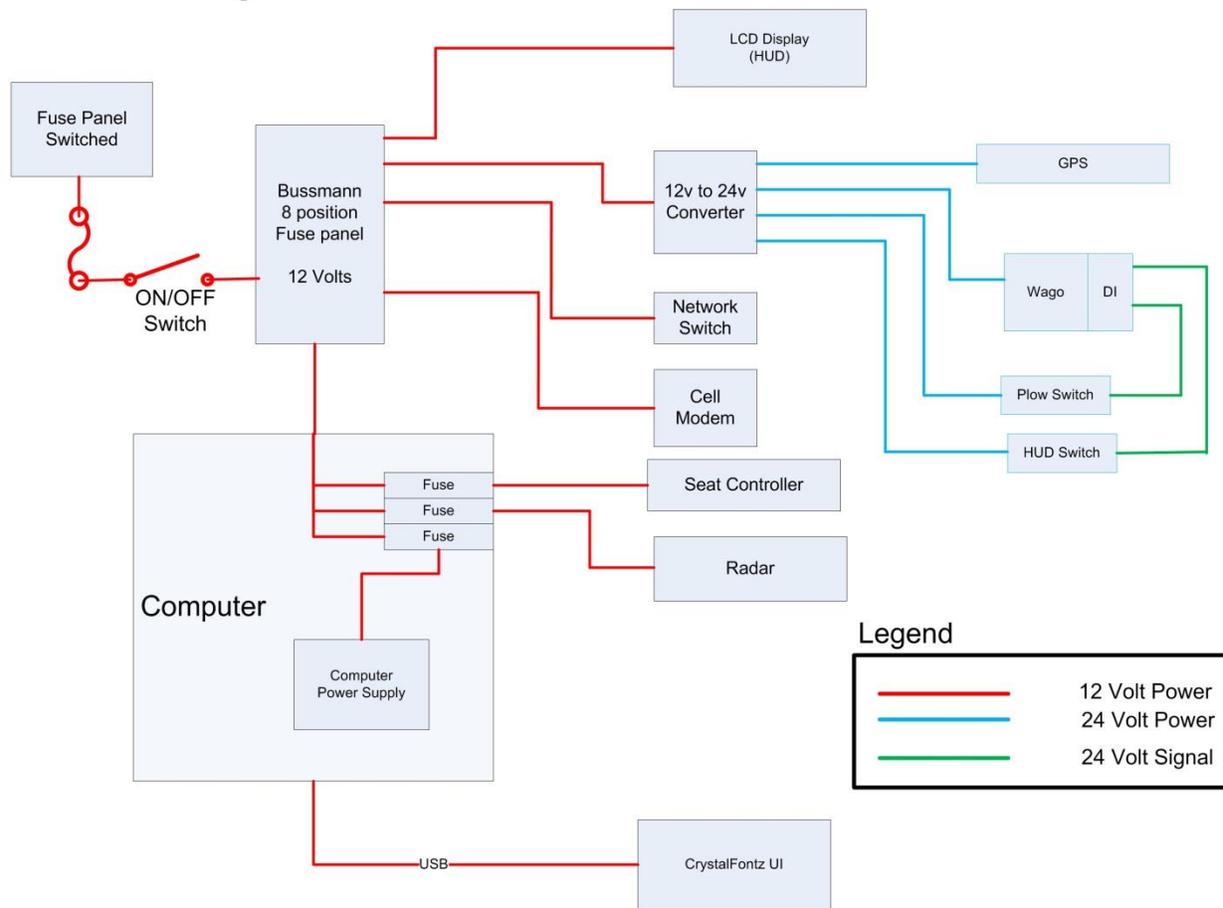
Figure B.15: Power wiring diagram for plow 7000024. The plow switch is used by AHMCT to determine how often the DAS is used while plowing snow.

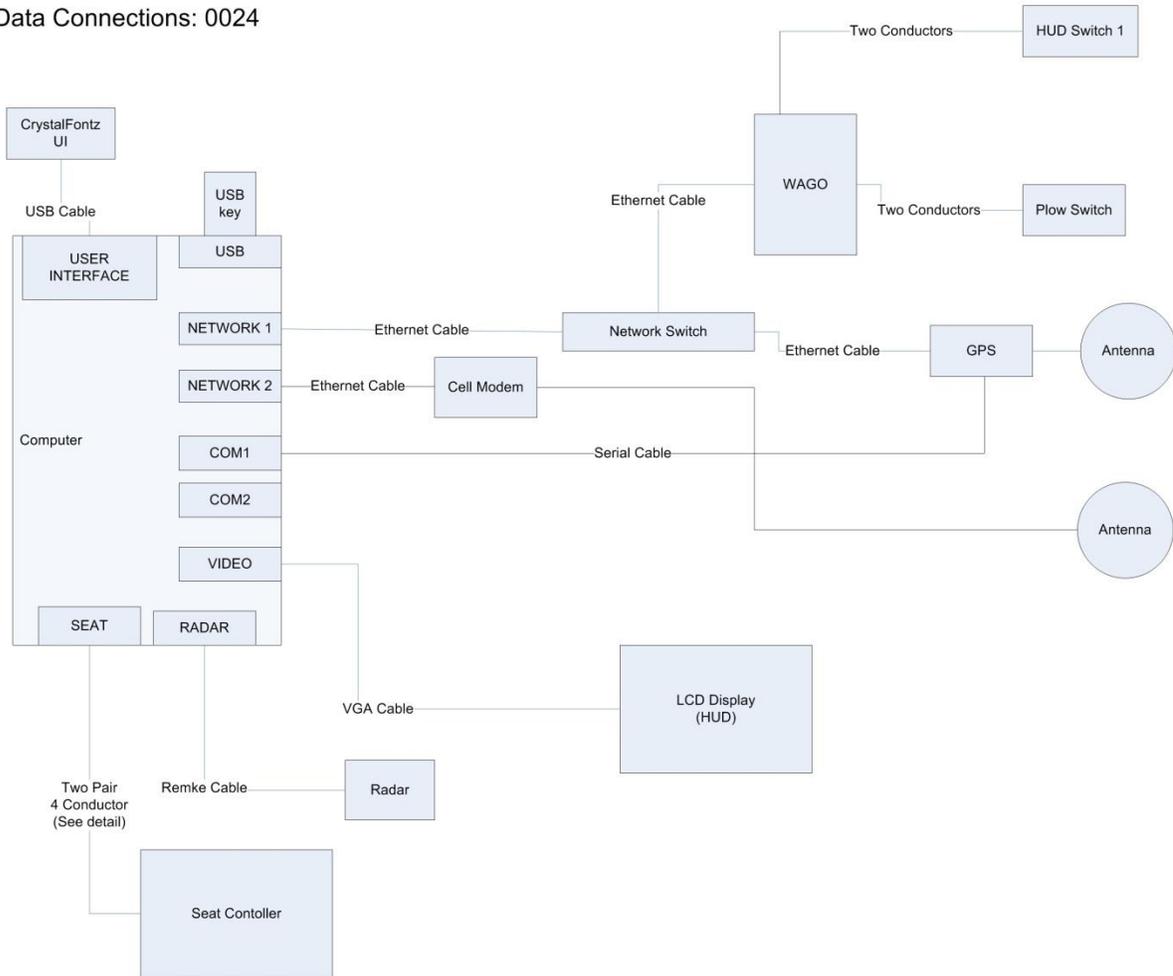
Figure B.16: Data wiring for plow 7000024. This vehicle has one HUD switch. GPS data is transferred via serial communications.

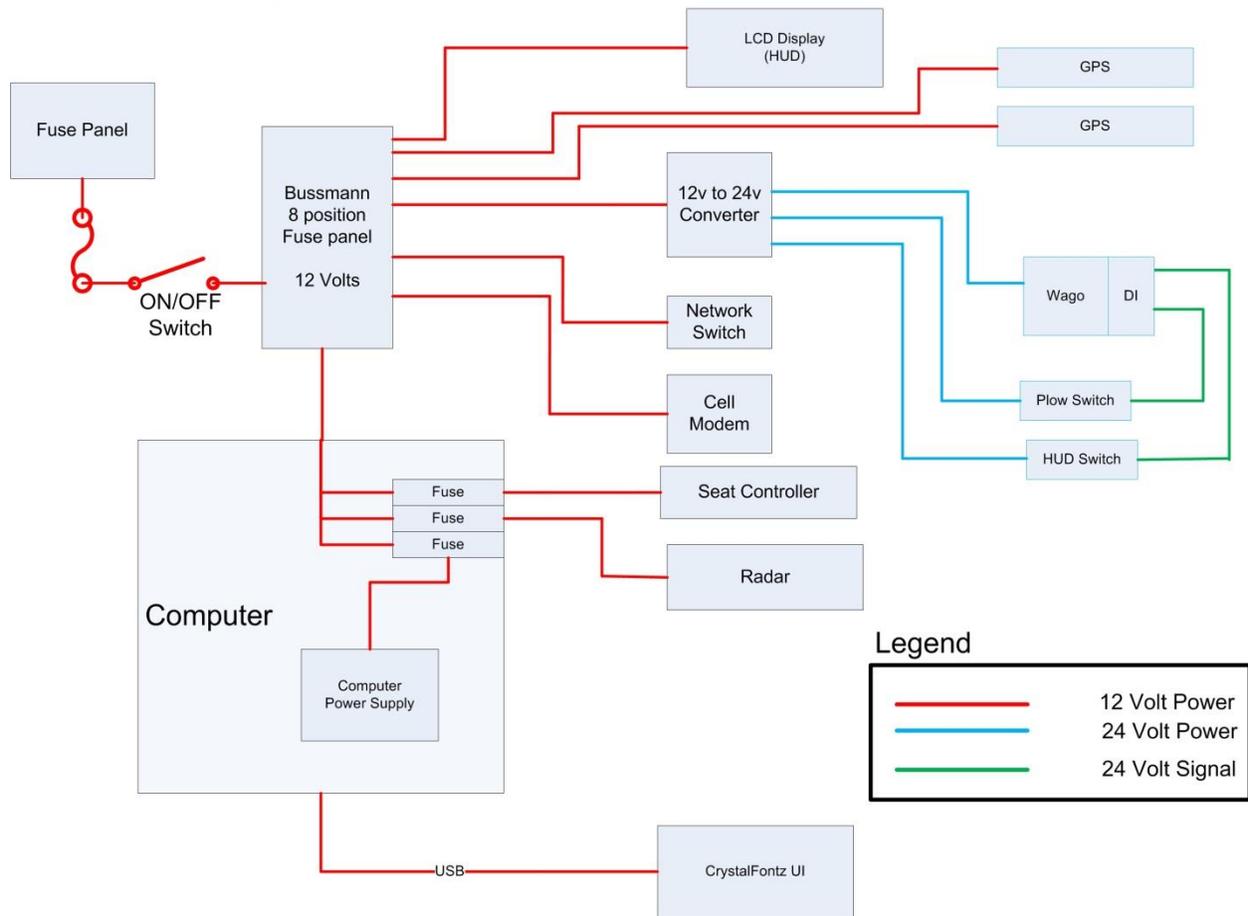
Figure B.17: Power wiring diagram for Wausau blower 7005039

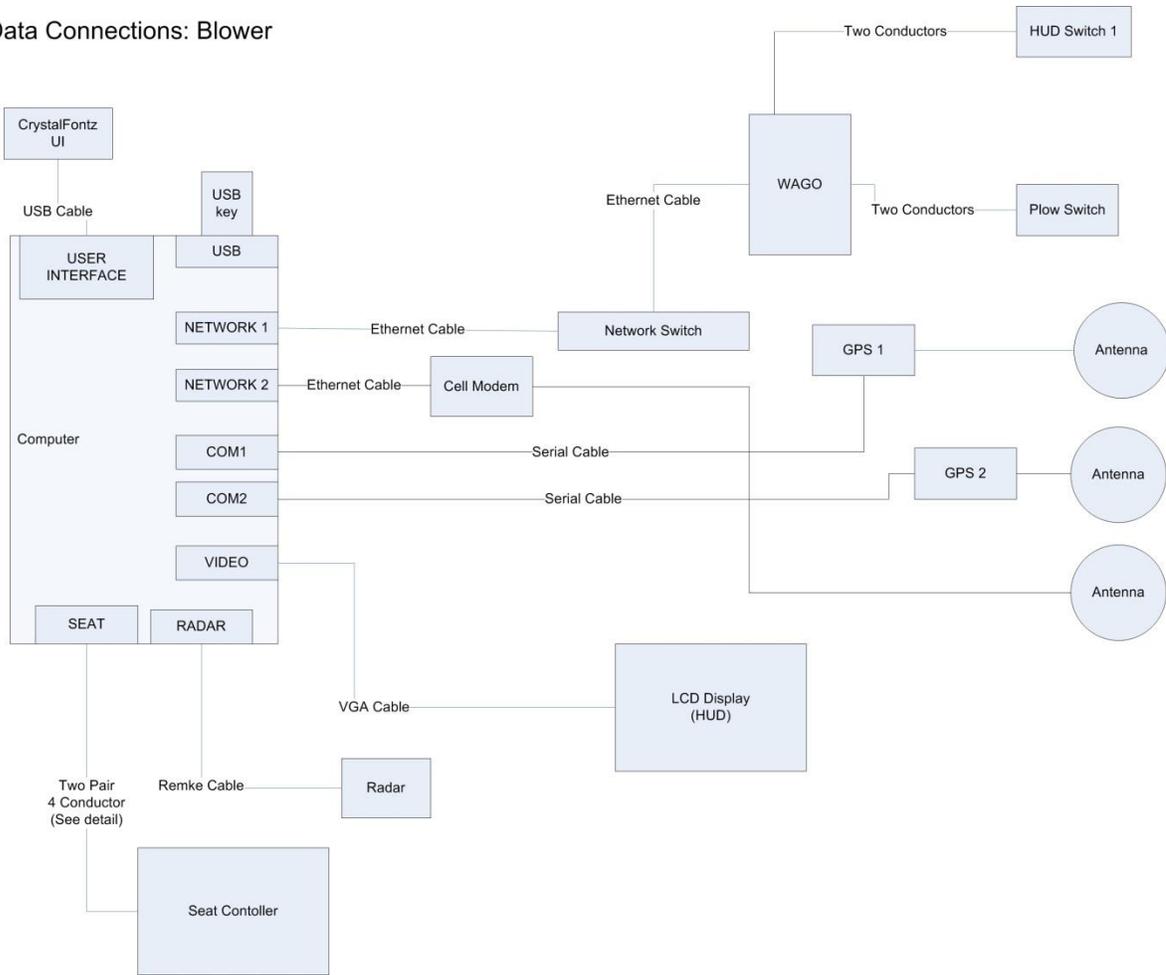
Figure B.18: Data wiring for Wausau blower 7005039. This vehicle has two GPS receivers. GPS data is transferred via serial communications.

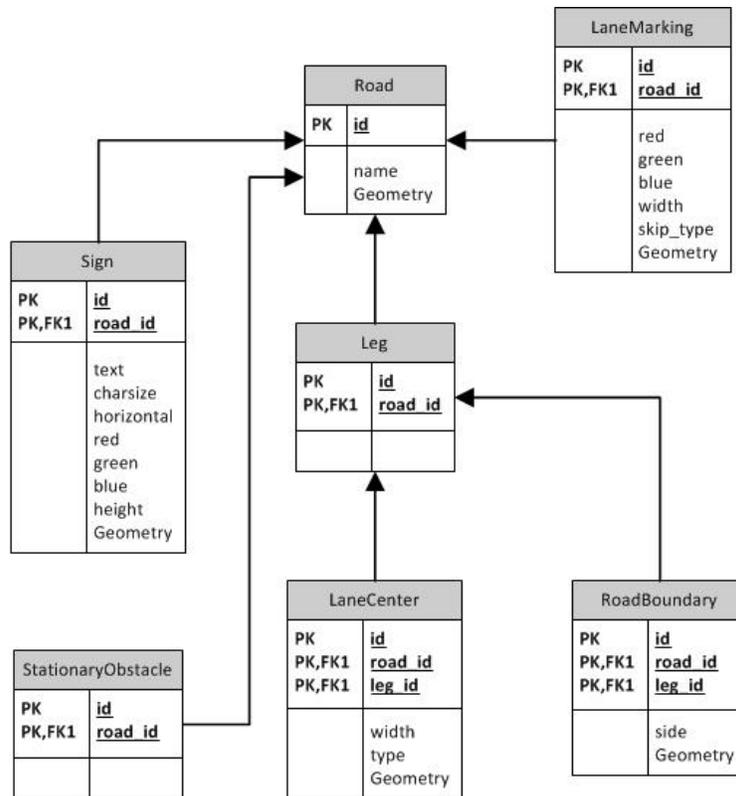
Figure D.2: DAS Data Model with entity relationships and attributes. PK is primary key; FK1 is foreign key (a primary key from another entity). Together the primary key and the foreign keys uniquely identify the object with the database.

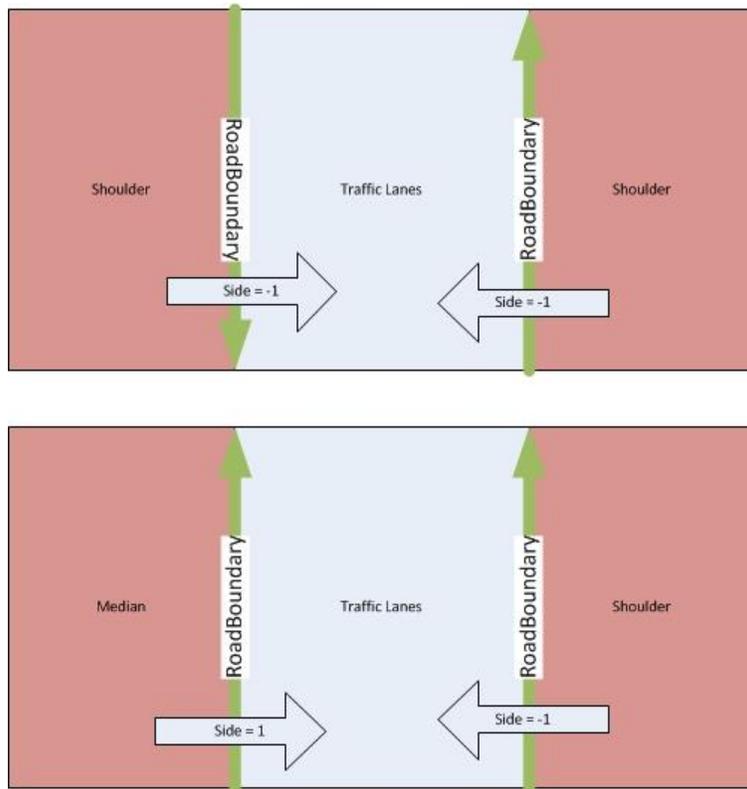
Figure D.3: RoadBoundary Side attribute

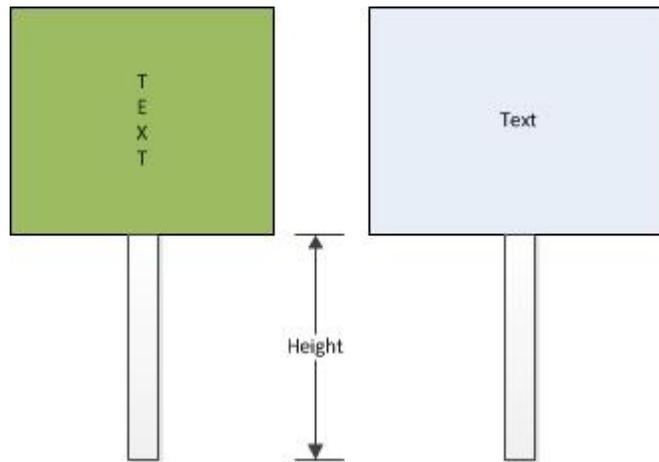
Figure D.4: Two Signs with vertical text (Horizontal = 0) on the left and horizontal text (Horizontal=1) on the right

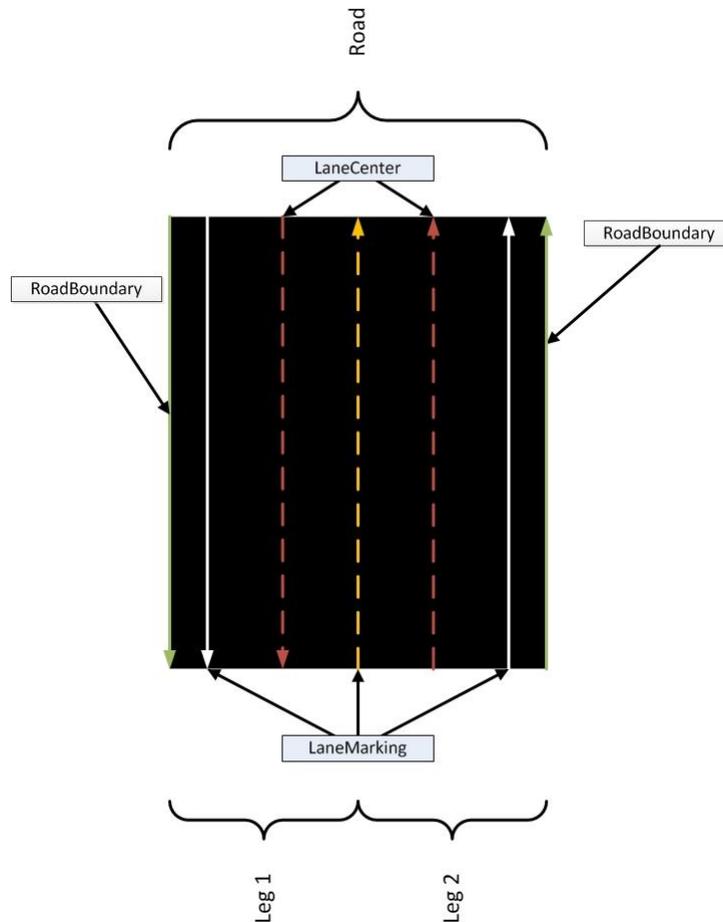
Figure D.5: Two-lane road

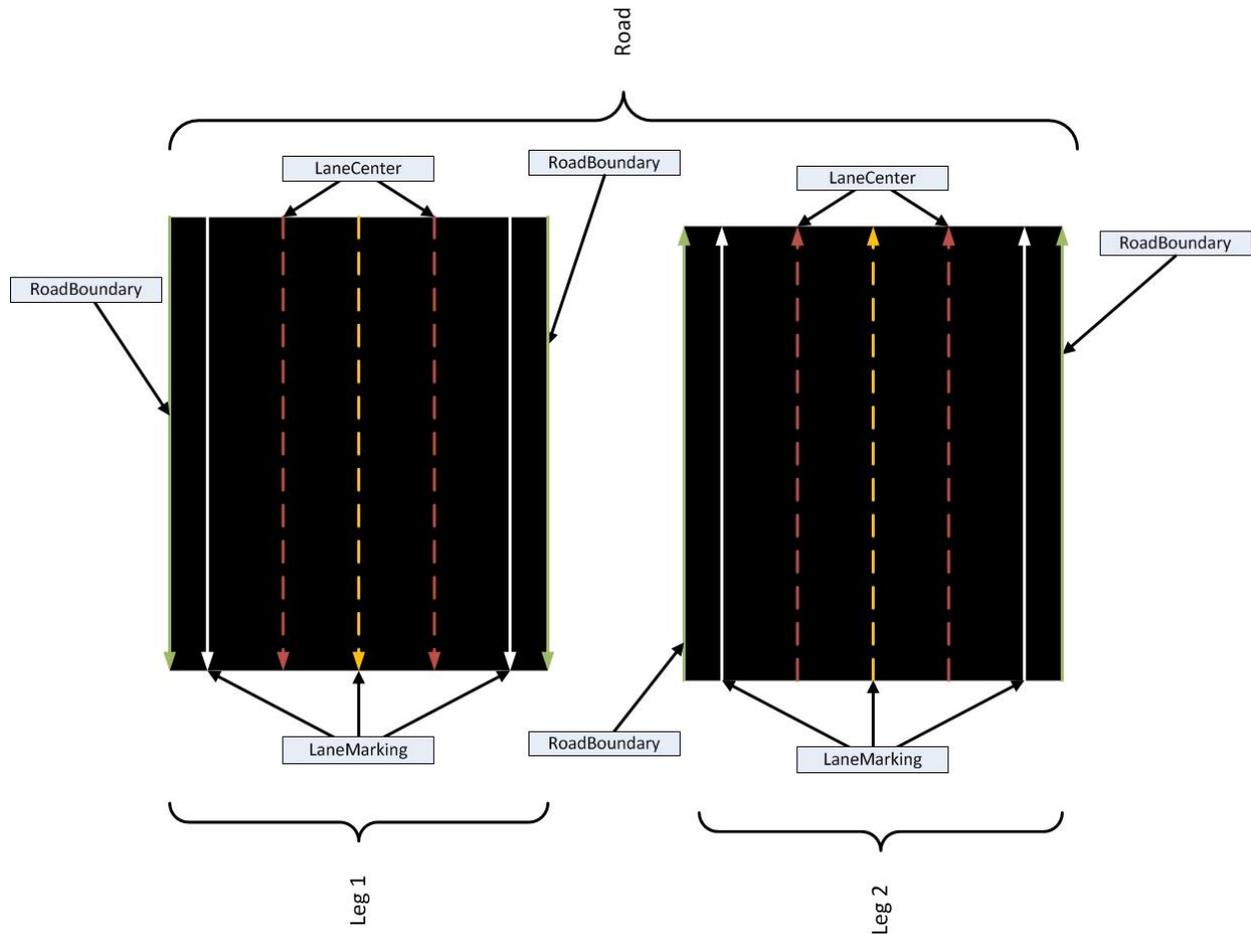
Figure D.6: Four-lane divided road

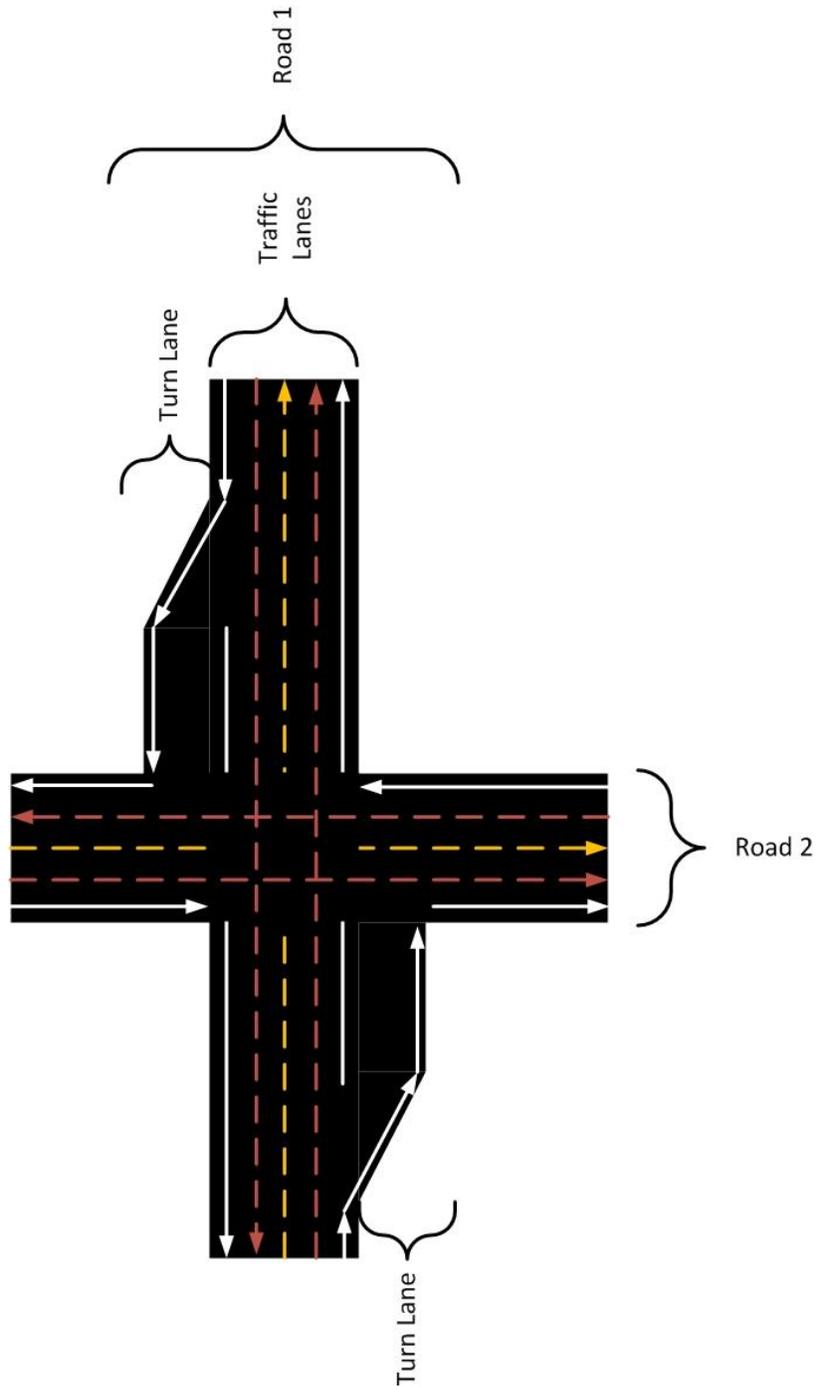
Figure D.7: An intersection of 2 two-lane roads

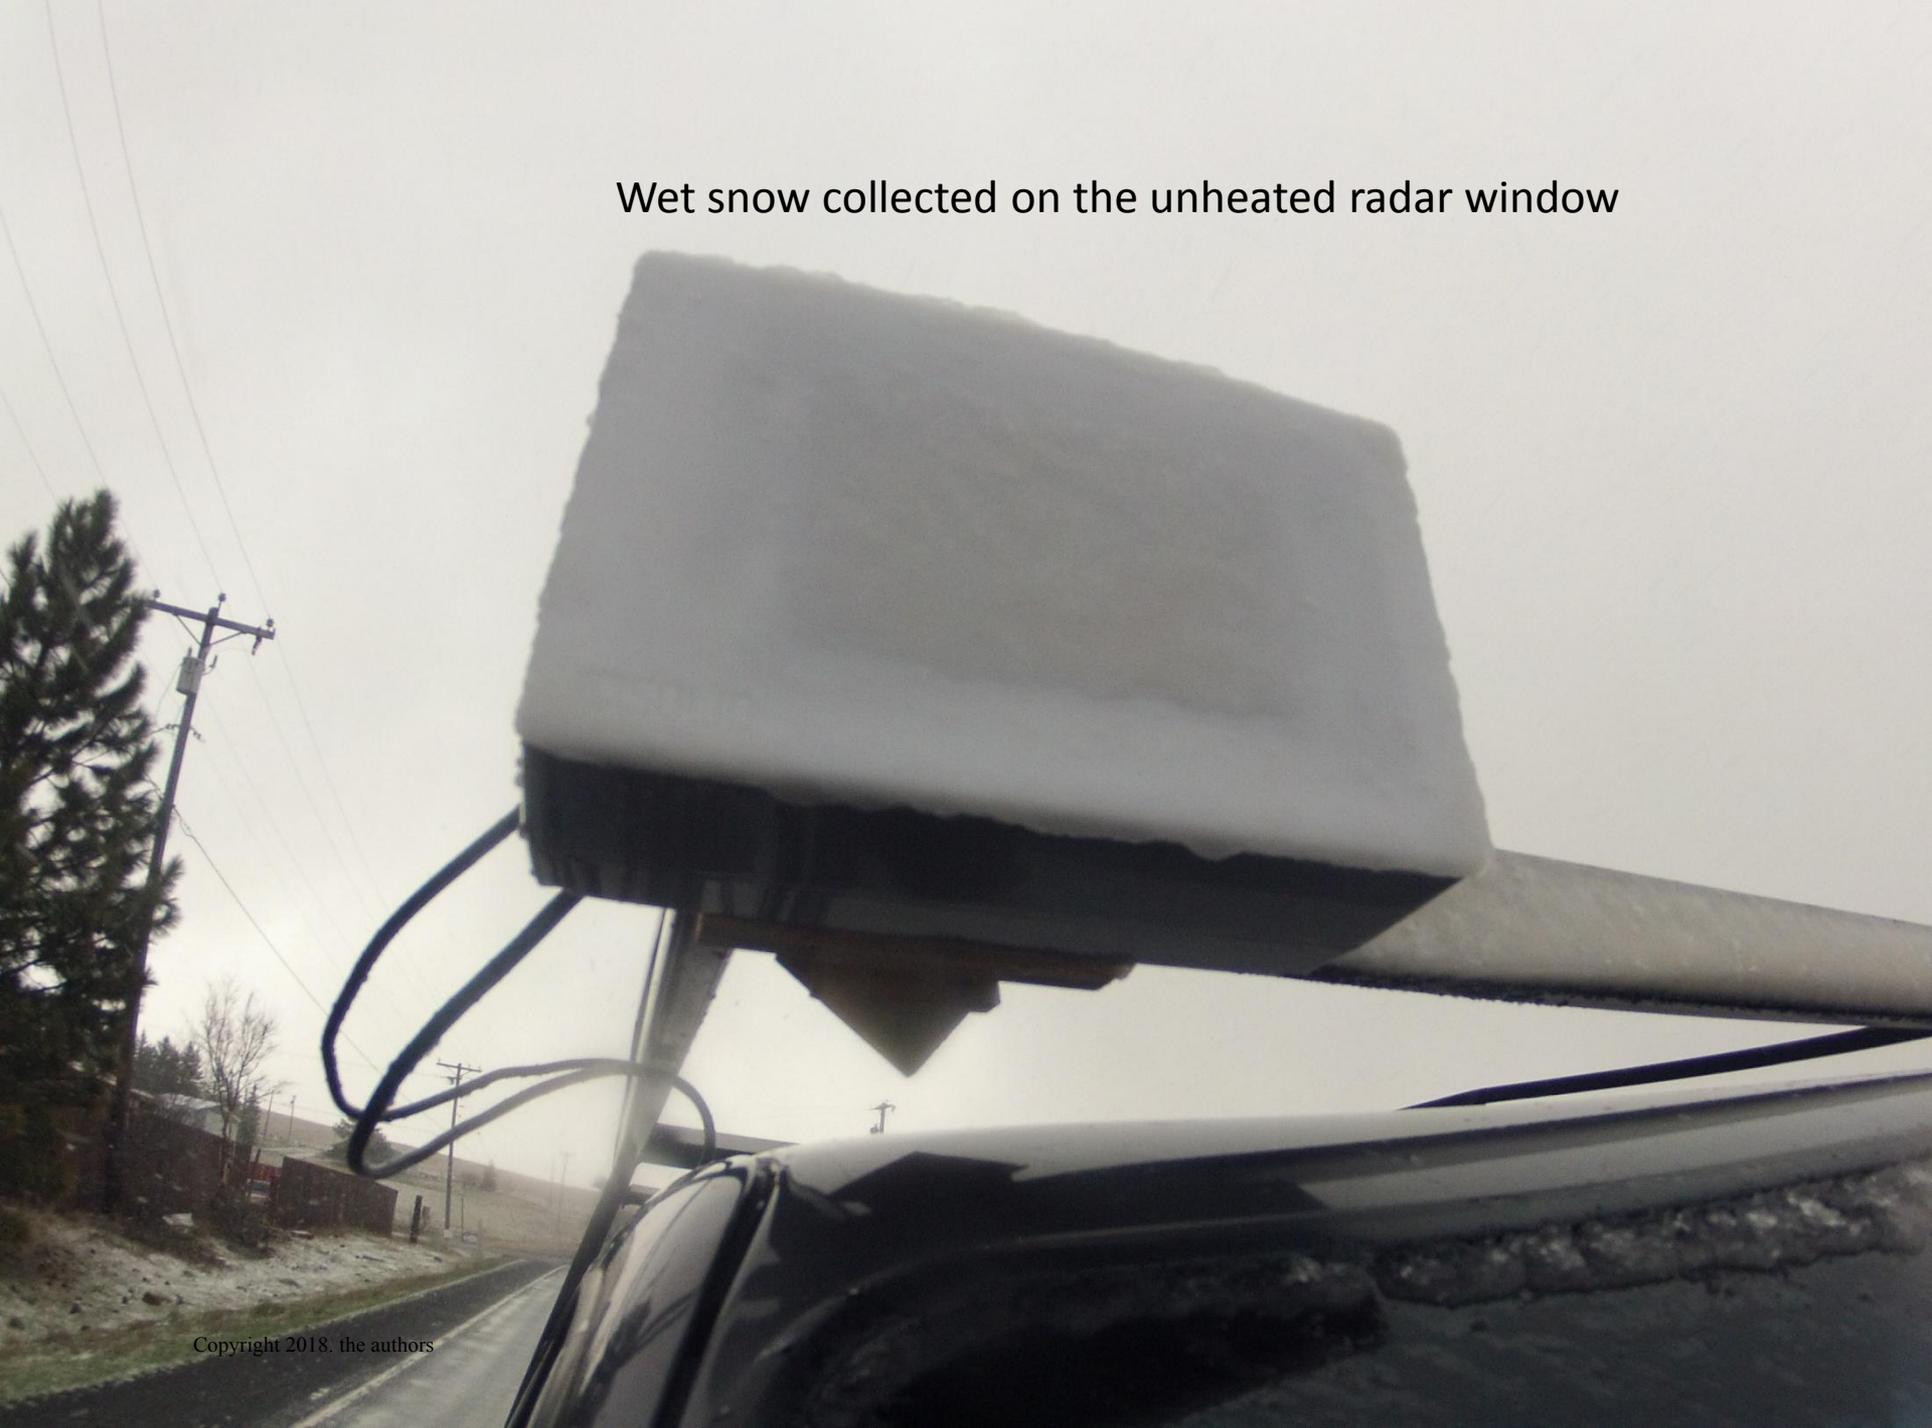
And eventually built up around the perimeter
