Evaluation of the University of Minnesota GPS Snowplow Driver Assistance System

Report Number: CA16-2167

AHMCT Research Report: UCD-ARR-15-08-30-01

August 30, 2015

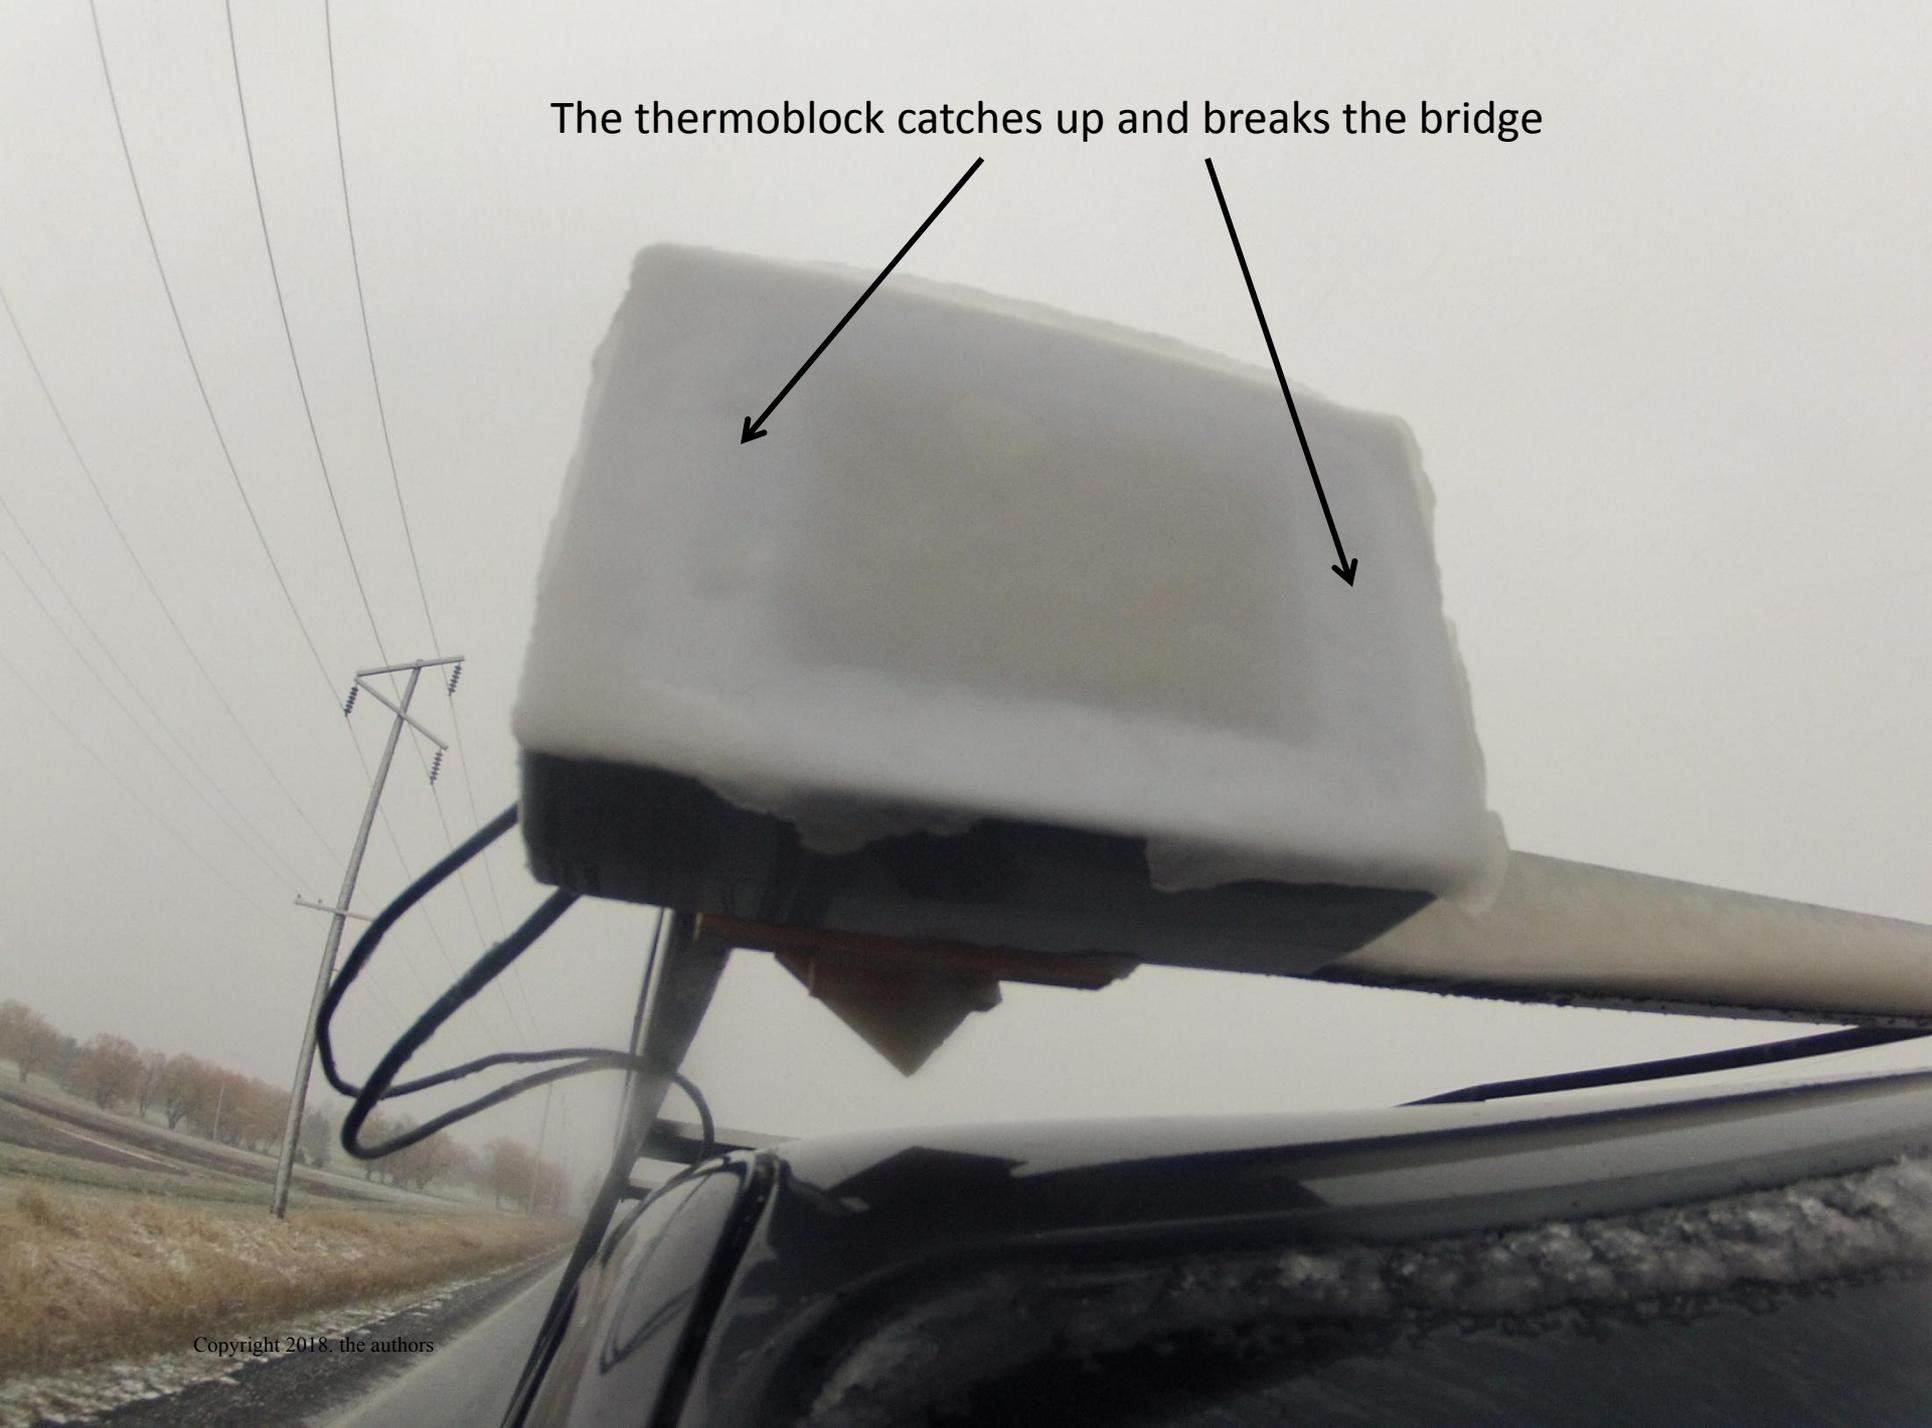
Allowing the perimeter buildup to break away

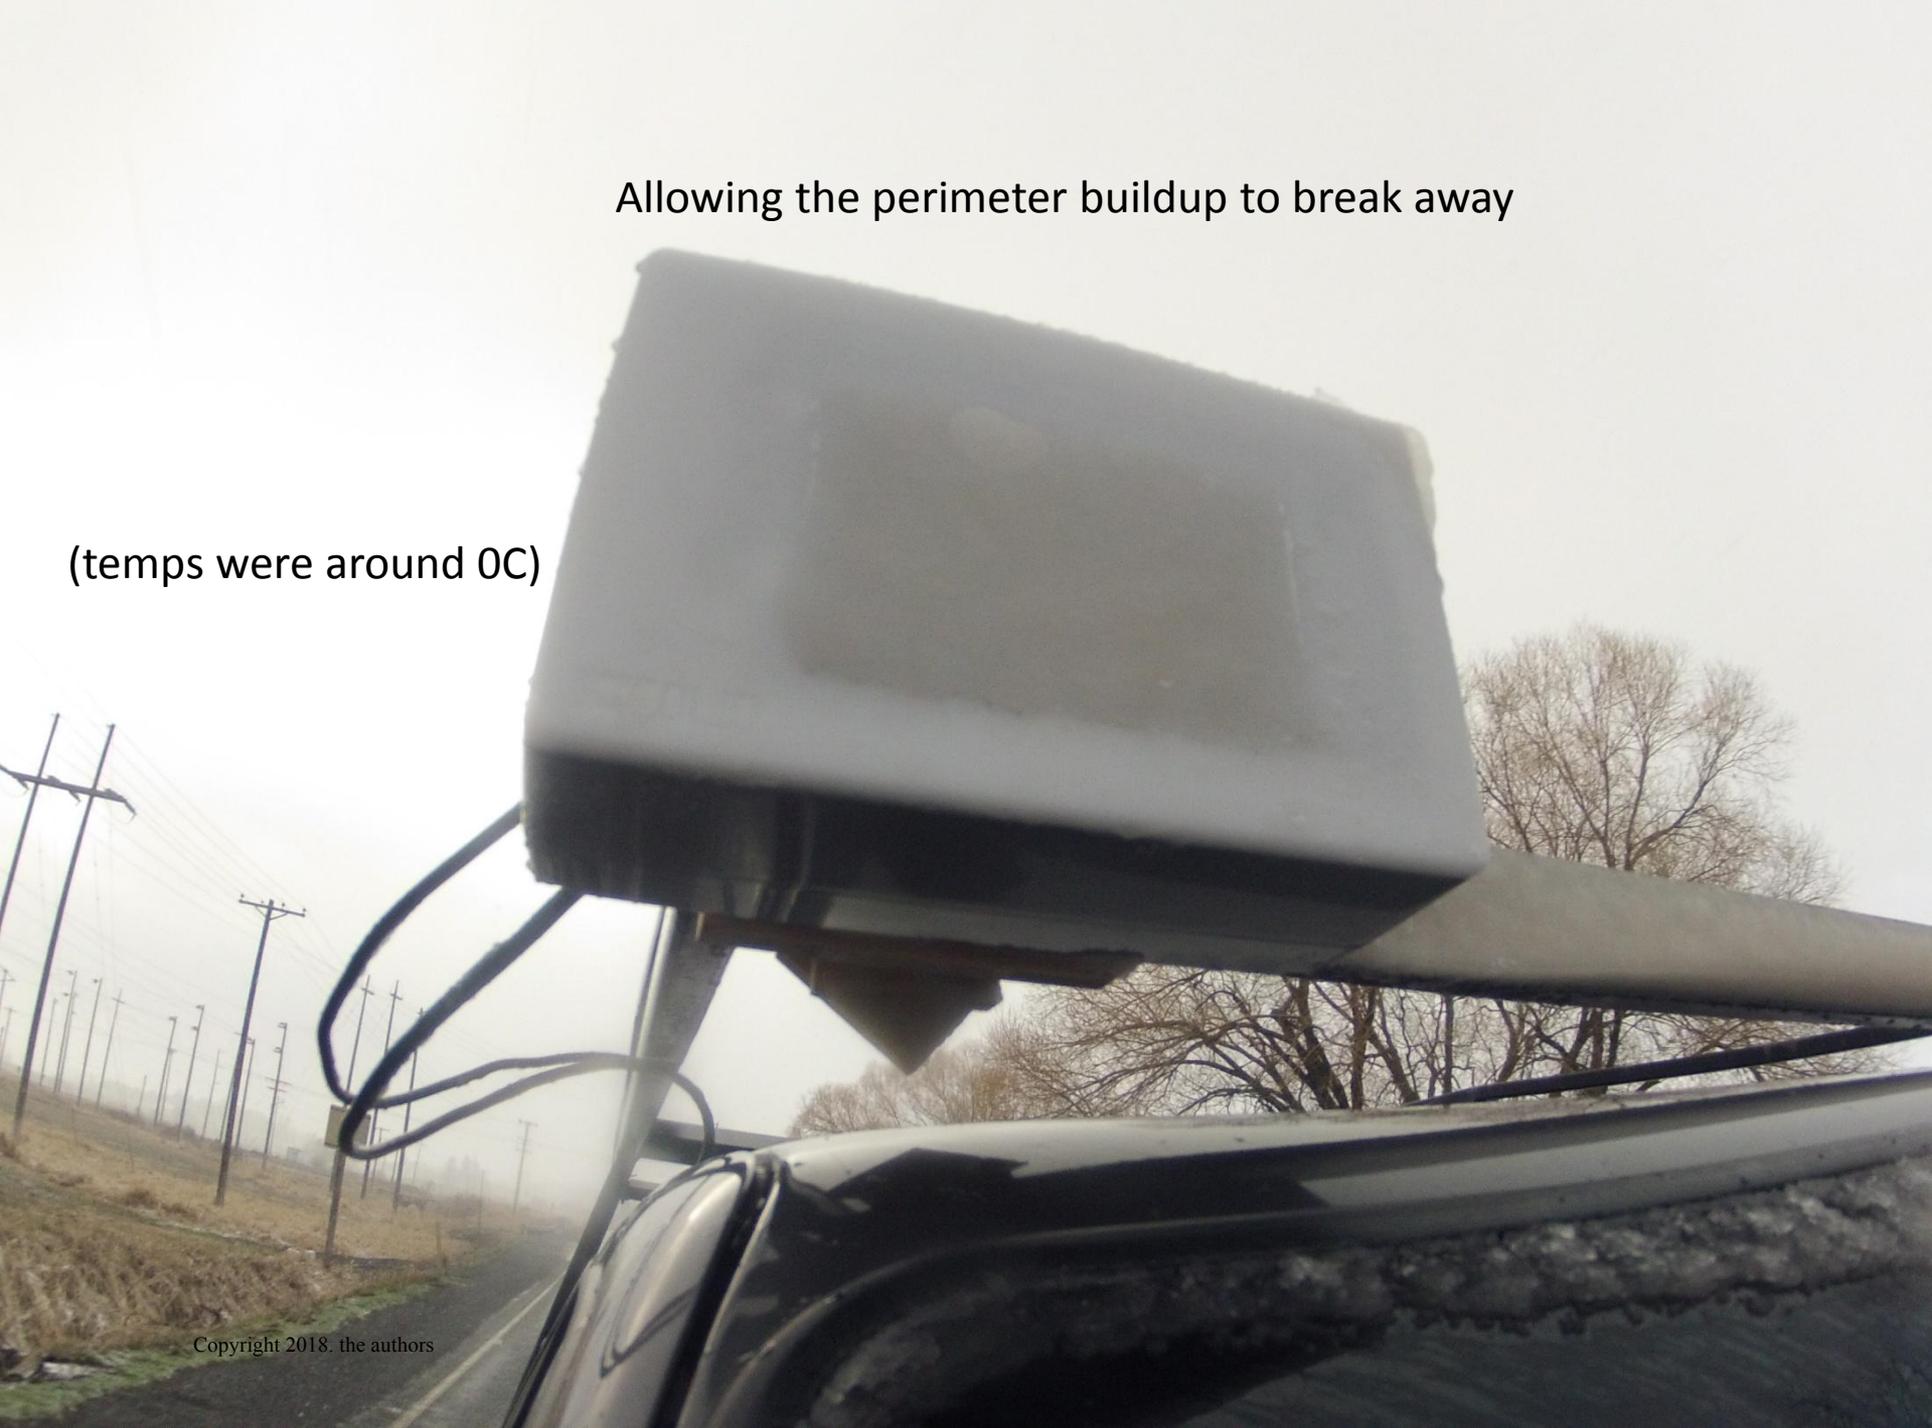
As the internal housing temp builds, the interface liquifies and the snow patch begins to descend

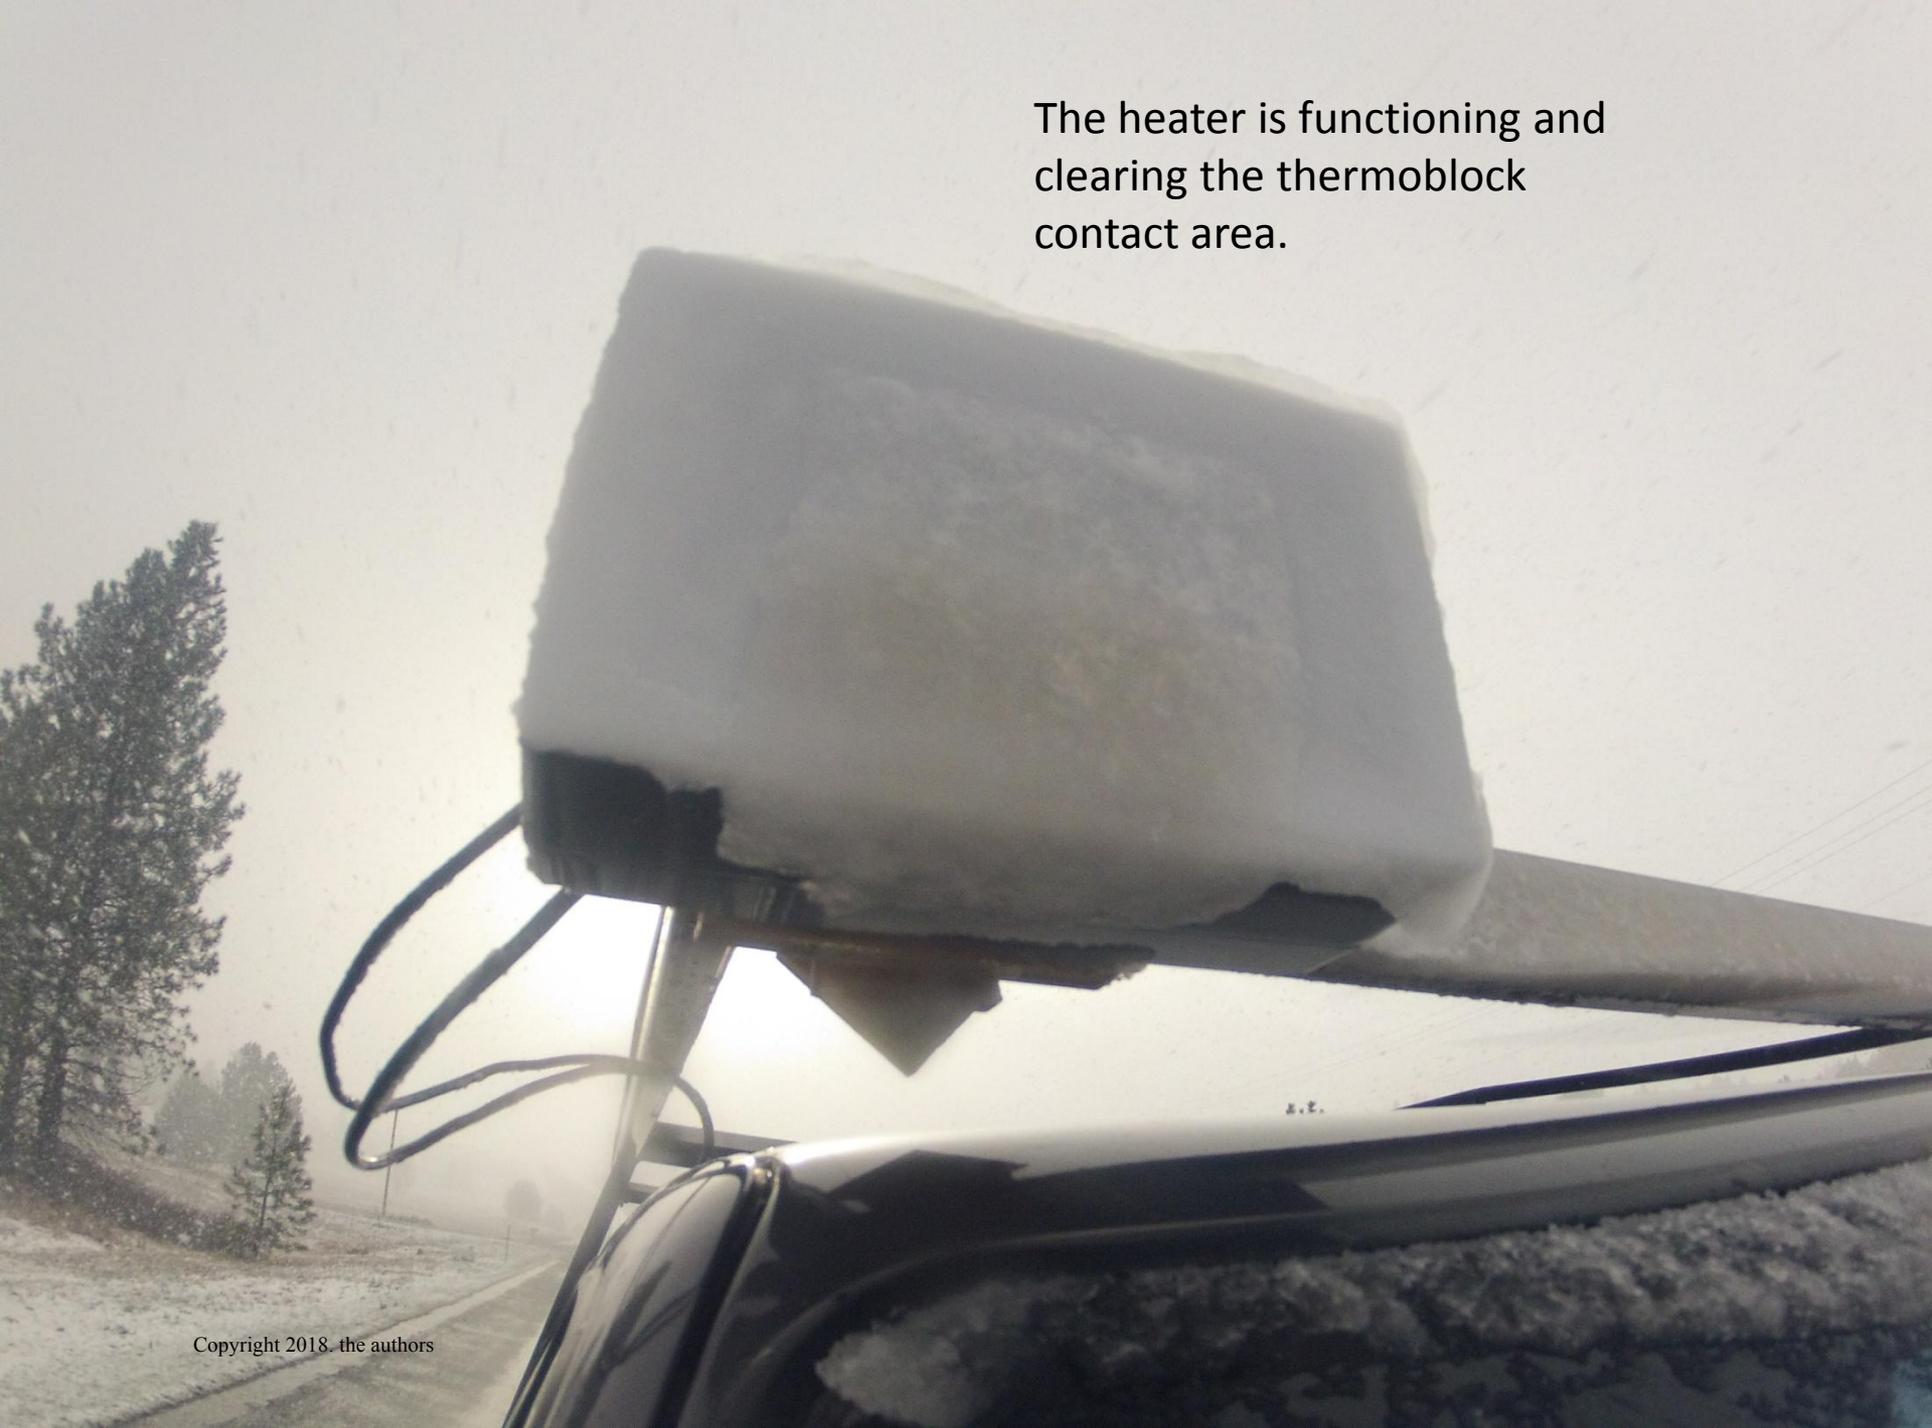
But buildup tends to “hang on” to the face and wants to create bridges.

- High moisture snow has exceptional ability to bridge the heated and unheated areas of the housing.
- Hard to generalize but icing likely starts with a “patch” in front of the radar which starts the bridging process.
- The radome material is exhibiting very low hydrophobicity and does not shed frozen material quickly.
