1. REPORT NUMBER CA13-2215	2. GOVERNMENT ASSOCIATION NUMBER	3. RECIPIENT'S CATALOG NUMBER
4. TITLE AND SUBTITLE Deployment Support and Caltrans' Implementation of the Sealzall Machine		5. REPORT DATE 10/24/2014

6. PERFORMING ORGANIZATION CODE
7. AUTHOR Duane Bennett, Steven A. Velinsky	8. PERFORMING ORGANIZATION REPORT NO. UCD-ARR-13-06-30-03	
9. PERFORMING ORGANIZATION NAME AND ADDRESS Advanced Highway Maintenance and Construction Technology (AHMCT) Research Center Department of Mechanical & Aerospace Engineering University of California, Davis Davis, California 95616-5294		10. WORK UNIT NUMBER

11. CONTRACT OR GRANT NUMBER IA 65A0416, Task ID: 2215
		13. TYPE OF REPORT AND PERIOD COVERED Final Report July 2012 - July 2013
12. SPONSORING AGENCY AND ADDRESS California Department of Transportation PO Box 942873, MS #83 Sacramento, CA 94273-0001		14. SPONSORING AGENCY CODE Caltrans

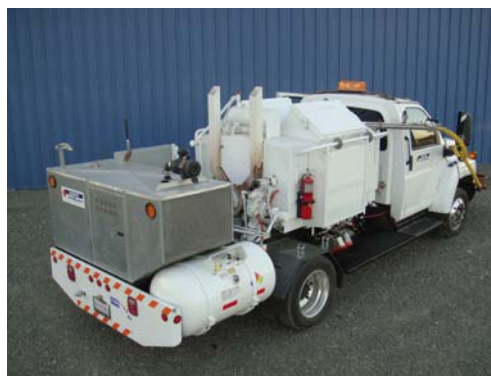
Figure 1. Sealzall Machine Platform

The Sealzall sealant application system prototype (Figure 1) is a completely self-contained automated accessory mounted to a GMC C550 chassis. A rear mounted 2.4L auxiliary gasoline engine is the main power source for the Sealzall system and only shares the fuel tank and battery connection with the truck. The automated machine can be quickly configured to seal both longitudinal cracks and manual in-lane cracks.

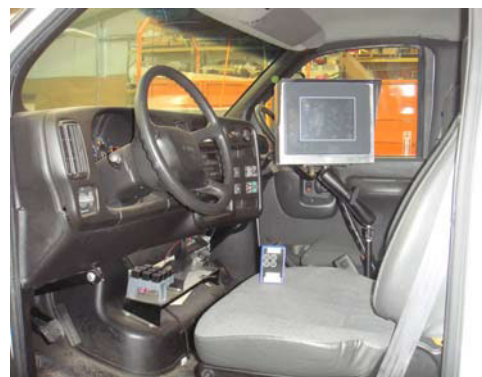
Figure 2. Operator GUI Touchscreen

System operational control is automated to simplify operator training and improve operational efficiency. An in-cab touch screen GUI display (Figure 2) provides a simple operator interface to the PLC unit, which directly and automatically controls all the necessary onboard sealing and support systems. Starting the auxiliary engine starts the Sealzall system and activates the user control GUI screen in the cab. The Sealzall machine has a fully automated heat-up cycle process, which reduces the complex series of steps required to heat the system down to a single a push of a button on the GUI screen. The Sealzall heat up process takes about an hour and a half for all necessary systems and the sealant to reach operational temperature before transitioning

into the recirculation phase. The operator then mounts the sealant wand in the recirculation cradle on either side of the truck and with another push of a button on the GUI, the hot sealant is circulated through the entire sealant passage and back into the kettle. The Sealzall is then ready to be configured and begin sealing. Sealant blocks are loaded into the kettle through 2 hatches on top of the unit. The Sealzall can also be loaded by means of high speed hot sealant transfer from a separate transfer trailer kettle for an extra sealant production boost.

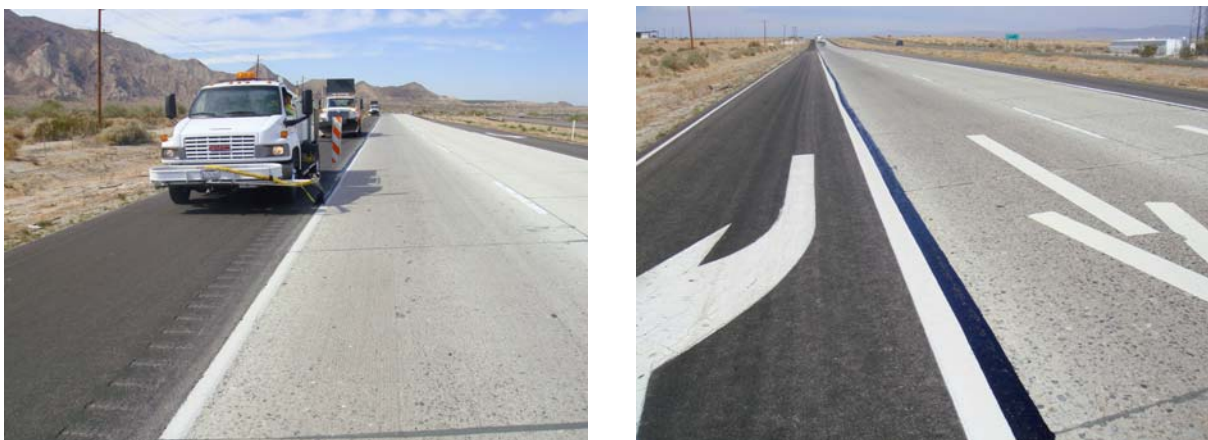
Figure 3. Longitudinal Sealing Highway Shoulder Joint Sealing Operation - Hwy 86

The first Sealzall trial work site was on Highway 86 and is shown in Figures 3, 4 and 5. Sealing occurred on the edge and center cracks northbound (NB) and southbound (SB) in the section south from the Riverside County line post mile 58 to 69, a total of 44 lane miles. The #1 and #2 in-lane PCC cracks and joints were recently sealed with polymer concrete. It was only necessary to seal the joints between the PCC lanes and both shoulders with polymer modified sealant (Crafco). These longitudinal cracks were blown clean when the in-lane cracks were cleaned and sealed. Therefore, longitudinal crack cleaning was not required before sealing.

The operation began March 6, 2013 by sealing the longitudinal crack along the shoulder while running the Sealzall and traffic control with both SB traffic lanes open. The moving closure consisted of two TMA trucks and a signboard truck all spaced apart and moving along the shoulder. Beginning with the Sealzall kettle full and sealing a small crack, the operation was able to seal five miles in about three hours. The Caltrans operator was instructed on-the-fly on how to operate the Sealzall and he performed all the day's sealing.

The Sealzall kettle holds approximately two pallets of sealant. The kettle was 90% full at the start, a pallet was added on the highway, and the day was finished with the kettle completely empty. So, approximately three pallets (or approximately 600 gallons) of sealant were applied the first day. Time on site was about four hours, of which at least half was static consisting of kettle heating time and lunch. Hence, five miles of longitudinal sealing occurred, dispensing 600 gallons of sealant in less than two hours with no traffic impact and no workers being exposed directly to traffic. At the time, this equipment operator had 14 years of highway maintenance experience in this area, and he estimated that their standard sealing operation could have sealed approximately half of a mile at that site. Accordingly, on his first day of training with the Sealzall, he increased his sealing production by ten times.

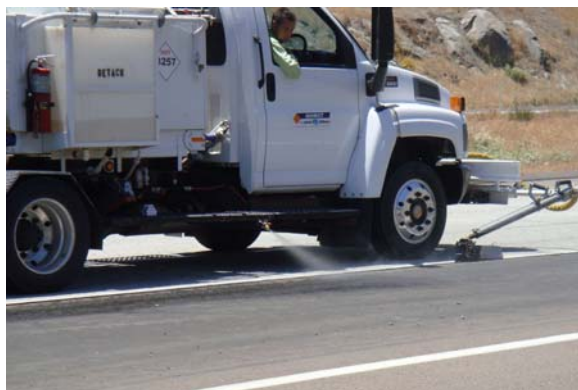
Figure 4. No Tack Spray - Hwy 86

(Notice Foam Covered Sealant Blocks)

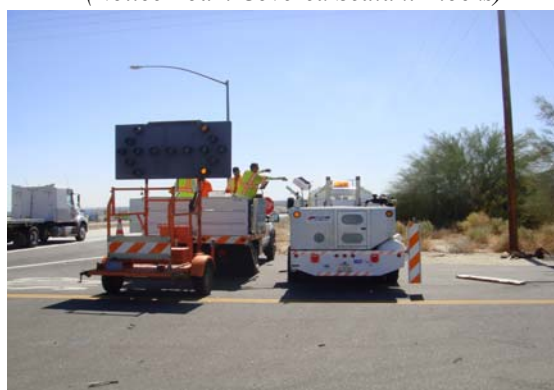
Figure 5. Loading Sealant Blocks - Hwy 86

On the second day (March 7, 2012), the kettle was empty. Since sealant blocks encased in foam were being used (Figure 5), the kettle was unable to be completely refilled this day. Still, 4-1/2 miles were sealed and this involved pouring two pallets of sealant in the same four hour time period. On this occasion, the kettle was half filled in an attempt to improve the next day's melting performance. Foam blocks melt far slower than traditional boxed sealant, clog the loading hatches, and ultimately produce a poorer performing seal. Manufacturers have gotten away from packaging sealant in foam, but District 11 still had a stockpile of foam block sealant that had to be used up before new sealant could be purchased.

the kettle half full to enable the foam blocks to melt quicker. The day's melting production was a full three pallets, but since sections of this part of the crack were up to eight inches wide and three inches deep, the sealing operation covered only two miles of longitudinal crack.

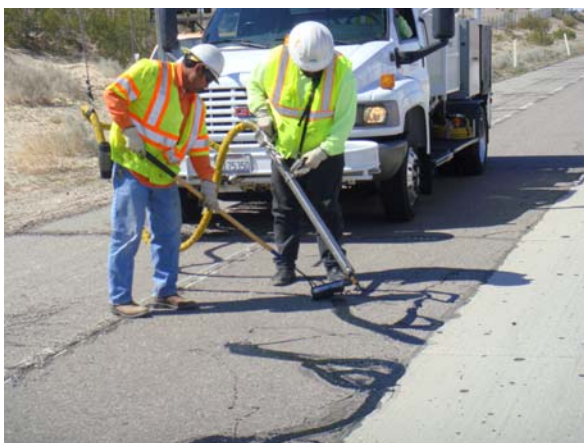
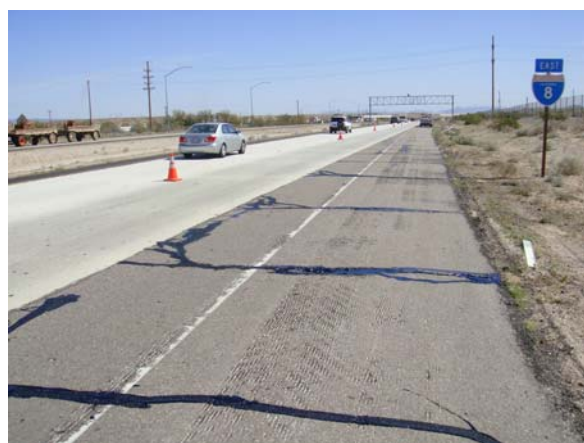
Figure 6. Merge Lane Manual Sealing - Hwy 8

On March 9, 2012, the Sealzall was used to seal random AC cracks on the eastbound (EB) entry ramp at Sidewinder Road post mile 87-88 on Interstate 8 as shown in Figure 6. This was the first Sealzall manual in-lane sealing operation, so AHMCT quickly trained the dedicated operator how to operate the Sealzall in manual sealing mode. Almost a mile of merge lane and

some ramp was sealed with about 1-1/2 pallets of sealant in about 2-3 hours of work time. The Sealzall and crew returned later in March on the 26th, 27th and 29th without AHMCT present to complete the three remaining ramps at this location.

The Sealzall random sealing process and production rates are comparable to traditional sealing operations. The main advantage of the Sealzall manual random sealing operation is that the vehicle operates orientated forward in the same direction as traffic and backs in the lane. This configuration is more favorable than needing to turn the vehicle around and drive in the opposite direction of traffic, which is common for the standard trailered sealant kettle sealing operations.

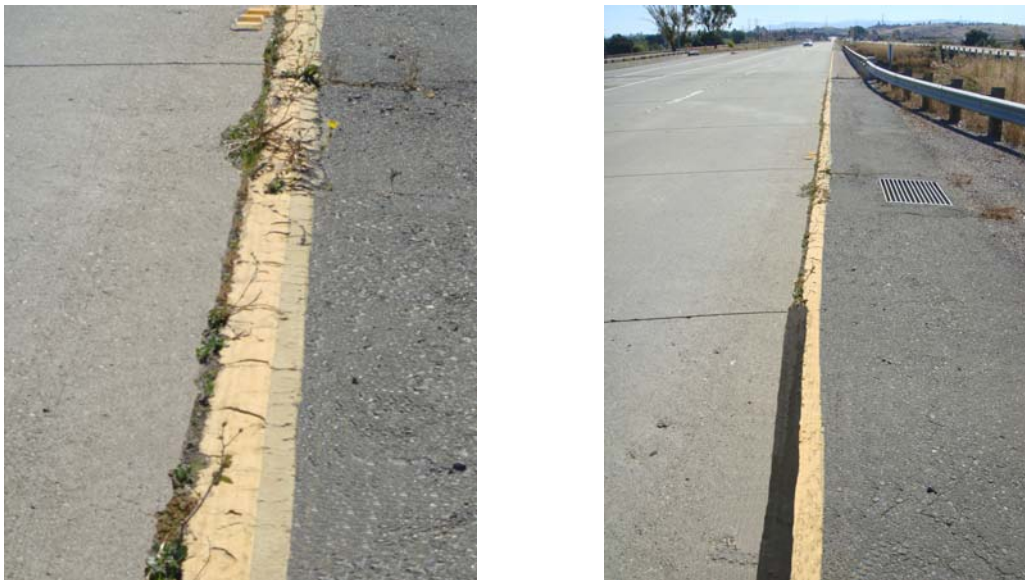
Figure 7. Typical Unsealed Longitudinal Joint and Same Joint Sealed with Proper Cleaning

Crack debris and vegetation has always been a Caltrans maintenance concern. Weeds growing out of longitudinal cracks are as unsightly as they are detrimental to pavement longevity. This vegetation was typically sprayed with herbicide along the roadside. The resulting lack of vegetation roots combined with pavement displacement due to thermal cycles made the debris easier to dislodge with compressed air alone. Currently, with the mandated reduction in herbicide use, crack vegetation is allowed to essentially grow unimpeded. The prospect of instigating a renewed spraying of longitudinal crack vegetation with herbicide is improbable since it would always rank lower in priority than fulfilling the mandated roadside requirements, which are already chronically short on resources.

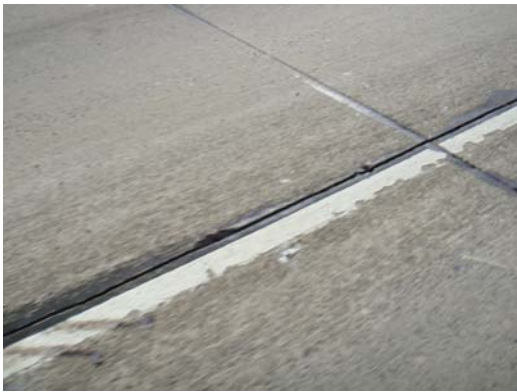
Figure 8. Failed In-lane Seal between Lanes 1-2

loaded with debris and moisture. Vegetation also does not survive well within the traffic lanes but thrives away from traffic along the edge where it has additional moisture and plenty of fresh dirt. Longitudinal crack vegetation even thrives in the State's most desolate desert areas. Since sealing longitudinal edge joints is the best targeted utilization of the Sealzall operations, the problem of highway longitudinal cracks being packed full of debris and vegetation is a major impediment to Sealzall deployment. The images in Figure 8 of failed seals were taken at the same highway pavement section and on the same day "as is" without any cleaning. They clearly illustrate the difference in vegetation and debris built-up between in-lane and longitudinal joints.

Eastbound Interstate 80 near the Northgate exit

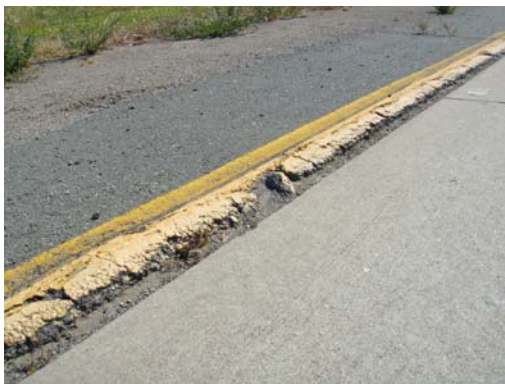
Figure 10. Shoulder Crack Lipping – Hwy 160

Another problem with not cleaning longitudinal cracks is that allowing incompressibles to remain in a working longitudinal PC/AC crack leads to AC shoulder lipping. As the pavement temperature lowers, the cracks fill with dirt and small rocks. Then as the pavement temperature rises daily and seasonally, the crack closes. Since the crack is now full of incompressible debris, large pressures develop in the crack interface. The crack compression force pushes some debris out of the crack toward the surface, but deeper in the crack the pavement must do the displacing. The AC pavement side of the crack is flexible, so it displaces in the only possible direction, upward. This causes a mound to form on the AC side of the crack. When the pavement subsequently cools and the crack widens again, debris refills the crack space and the process repeats. Each successive cycle pushes the AC edge mound or lip higher, and it becomes a fairly common traffic hazard (Figure 10). To mitigate the hazard, a pavement planer is used to grind down the lip and in the process chunks of stressed AC in the shoulder crack wall become dislodged creating a much wider crack.

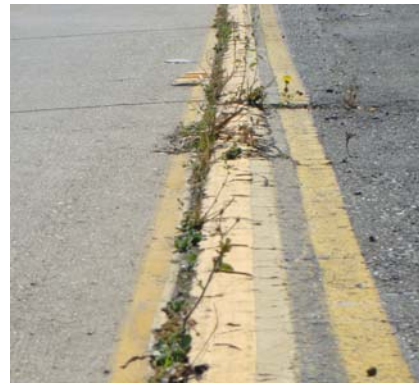
Figure 11. Joint Vegetation - Hwy 160

Removing vegetation from longitudinal cracks usually represents one of the biggest challenges in crack cleaning. The weeds that can thrive in highway cracks are well established and very durable. Their roots reach very deep in the crack and tightly grip the jagged edge of the AC shoulder (Figure 11). High pressure air blasts may dislodge the soil, but the vegetation will remain being held in by sturdy roots. Scraping the vegetation out of the crack is the only practical option, but the jagged AC edge helps protect the roots from being cut efficiently. By utilizing hand scrapers and wire wheels, much of the vegetation can be removed but at substantial cost. Still, the toughest weeds will remain and sealing over them will not always kill them. Vegetation shoots leave pores in the sealant where the weeds can continue to grow and

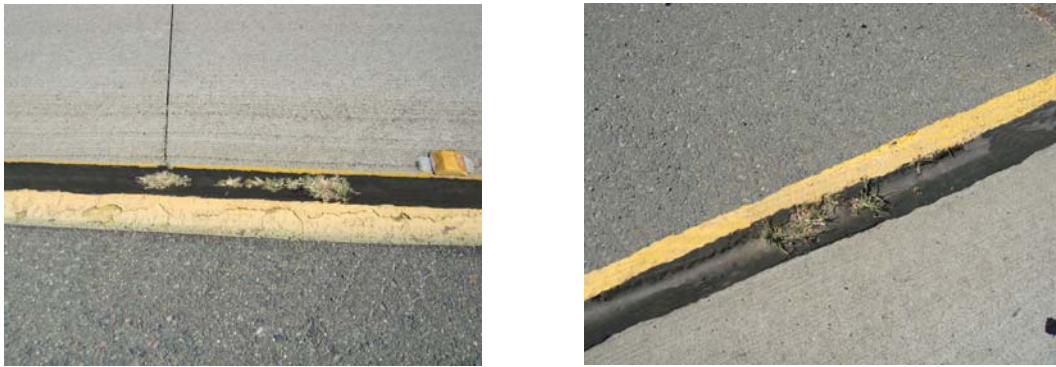
Figure 12. Vegetation in Seal after only 6 Months - Hwy 160

create a pathway for moisture to continue entering the crack. As a test, an excessive amount of time and labor was invested in an effort to eliminate all vegetation from a particular longitudinal joint crack on Hwy 160 prior to sealing. Ultimately, about 95% of the vegetation was completely removed and what remained was very distressed indeed. Still, a small amount of vegetation remained which then survived the hot sealant application and ultimately compromised the seal (Figure 12). The test clearly reveals that sealing over any small amount of vegetation will significantly compromise the longevity of a joint seal.

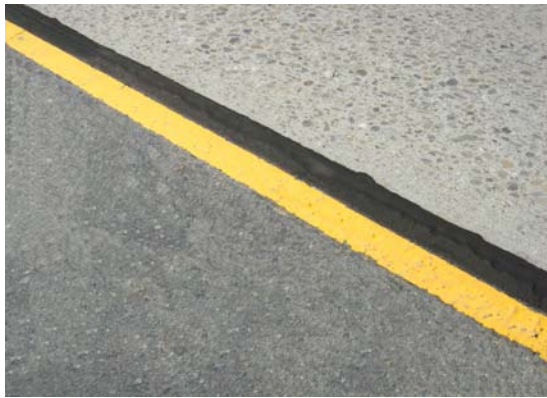
Figure 13. Effective Joint Seal - Hwy 160

depth where their effects on lipping are reduced. The depth of crack cleaning is related to the crack width to create a reservoir for sealant application with a shape factor (depth/width) greater than two.

Longitudinal Joint Seal with Proper Crack Cleaning

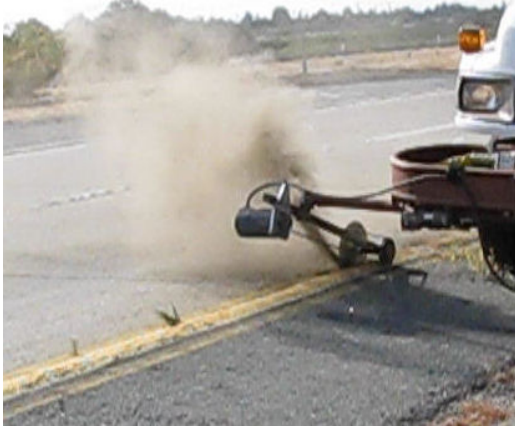
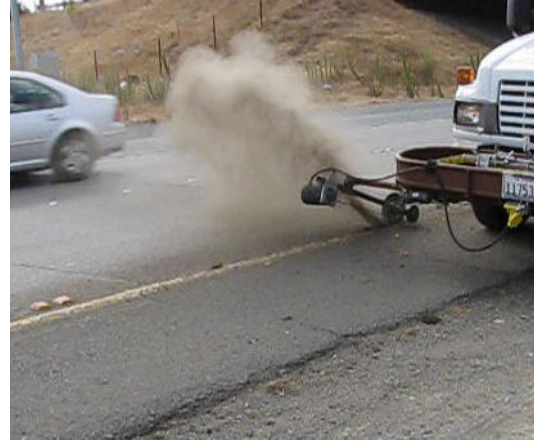
Figure 16. Sealzall Crack Cleaning Attachments – Hwy 160

Two cleaning wheels were fabricated. A thin steel cutting blade with carbide teeth could cut through hard dirt and gravel and a wire wheel was utilized to remove vegetation and loose debris. Highway testing of the cleaning attachment was successful and did produce a relatively clean crack, but the time investment was extreme. Typically, three passes were required to properly clean a crack full of packed debris and vegetation. Even worse, the speed of each cleaning pass was nearly half the speed of longitudinal sealing. Even though sealing wide longitudinal joints can sometimes require two passes, one to fill and the second to recap, the wheel attachment cleaning operation is still about four times more time intensive than the sealing process. When working with Caltrans maintenance crews in District 4 and 11, it became clear that the added time and worker exposure required to clean the crack with these attachments would not be reasonable on a large scale. An efficient method of removing heavy debris and vegetation from longitudinal joint cracks in a single pass would need to be developed to

Cutting Blade Attachment Cleaning

Brush Wheel Attachment Cleaning

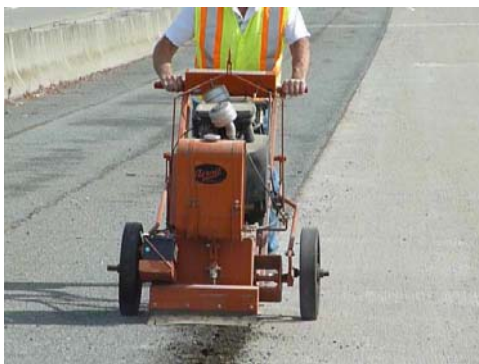
Figure 17. Joint Routing - Interstate 380

To efficiently clean enough longitudinal joint cracks to adequately support Sealzall high production crack sealing capabilities, some type of high speed, single pass crack routing operation needs to be developed. Self-contained impact pavement routers that are manually controlled are readily available (Figure 17). They use consumable carbide tipped star wheel cutters (Figure 18). Pavement planer and wheel saw attachments are also available, which mount on Skid-Steer tractors (Figures 19 & 20). The impact cutting head and wheel saws are appropriate for crack cleaning, while the planer is typically used to cut a flat surface. Since there is often some degree of pavement lipping associated with longitudinal cracks needing to be sealed, including a pavement planer option with a crack cleaner would be a major multi-functional tool bonus.

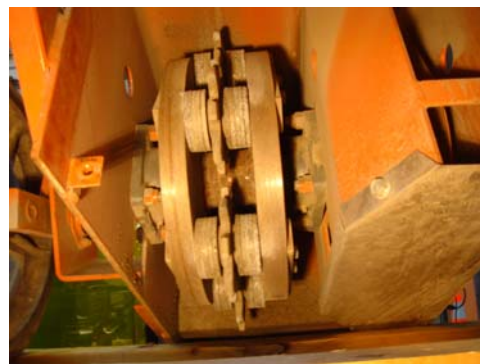
Figure 18. Impact Router Cutter

Neither the impact router, nor the wheel saw are perfectly suited for longitudinal crack cleaning without modifications. Standard impact router cutter star wheels have a shallow depth of cut, and the wheel cutter width cuts too wide for most cracks. Both of these shortcomings can be overcome, but custom modifications to the cutter wheels would necessitate significant redesign. Also, the means to mount the cutters to self-track the longitudinal crack would have to be developed for either device. Ideally, the cutting system could be truck mounted to enable crack routing to be conducted from the shoulder without lane closures to achieve the greatest cost efficiency.

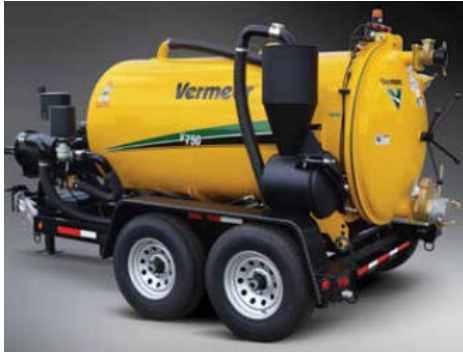
Figure 21. Vortex Vacuum System

valuable feature to include. Potentially, the vacuum system could be strong enough to also clean the crack following the routing. This would eliminate the need for a trailing blast of compressed air to clean the crack which creates its own dust. An ideal candidate for a commercially available vacuum capable of handling the large amount of debris routed from a continuous longitudinal joint crack would be a three-stage cyclonic filtration system (Figure 21).
