INVESTIGATION OF METHACRYLATE REHABILITATION STRATEGY TO EXTEND THE SERVICE LIFE OF CONCRETE BRIDGE DECKS

Final Project Report

Western Transportation Institute, College of Engineering
Montana State University – Bozeman

California Department of Transportation
Department of Research and Innovation

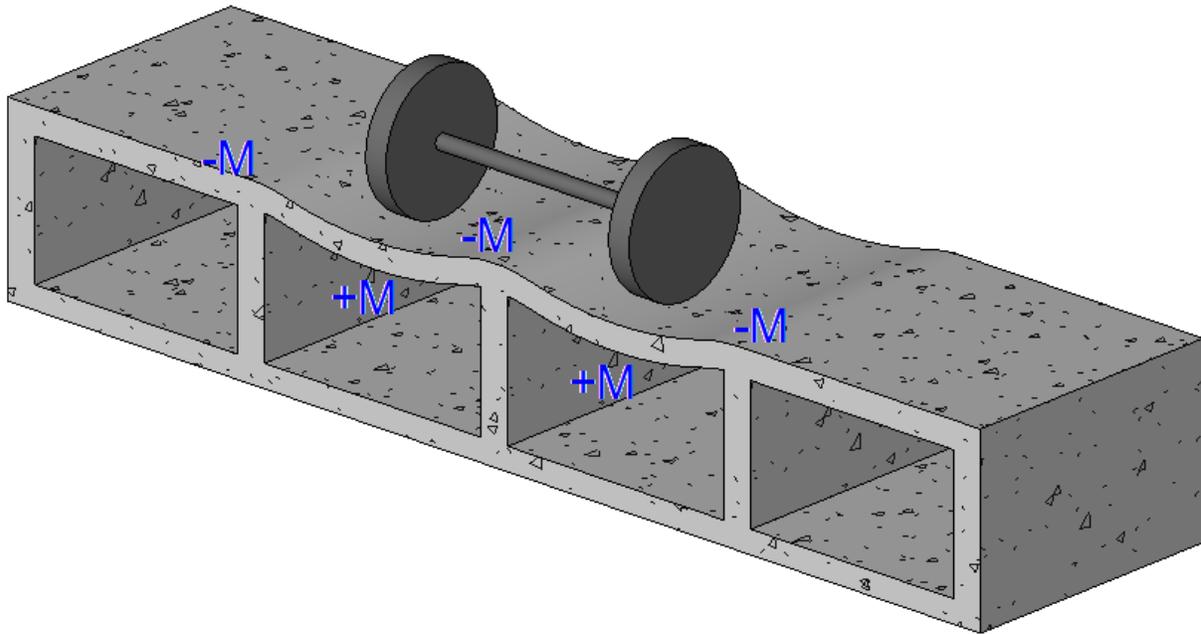
Figure 8: Idealized moment behavior of the deck in the transverse direction.

The plan geometry and support conditions for the test panels were specifically determined based on matching the local transverse flexural stresses in the panel with those experienced in an actual bridge deck. Note that these local stress excursions in the transverse direction under each passing wheel load were judged to be more critical in the fatigue performance of the deck than the global longitudinal stress excursions generated by transmitting vehicle loads longitudinally to the bridge supports. Simply stated, these local transverse stresses consist of tensile stresses in the top of the deck over the webs of the box girders (negative moment) and compressive stresses in the top surface of the deck between webs (positive moment), as shown in Figure 8.

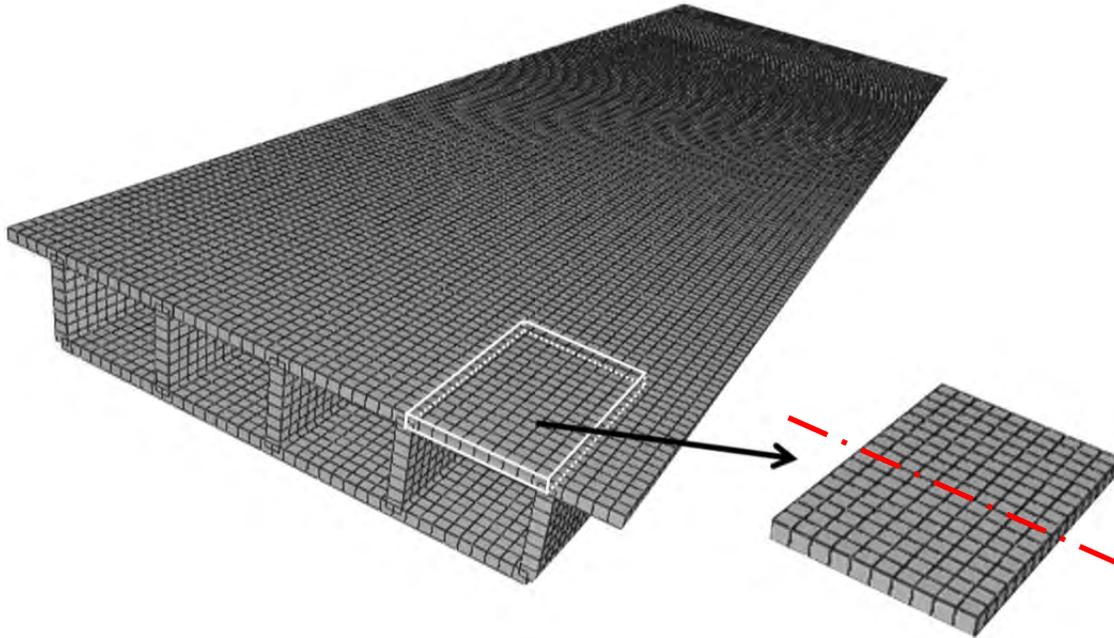
Figure 9: Three-dimensional geometry and VA FEA mesh of the full-scale deck model.

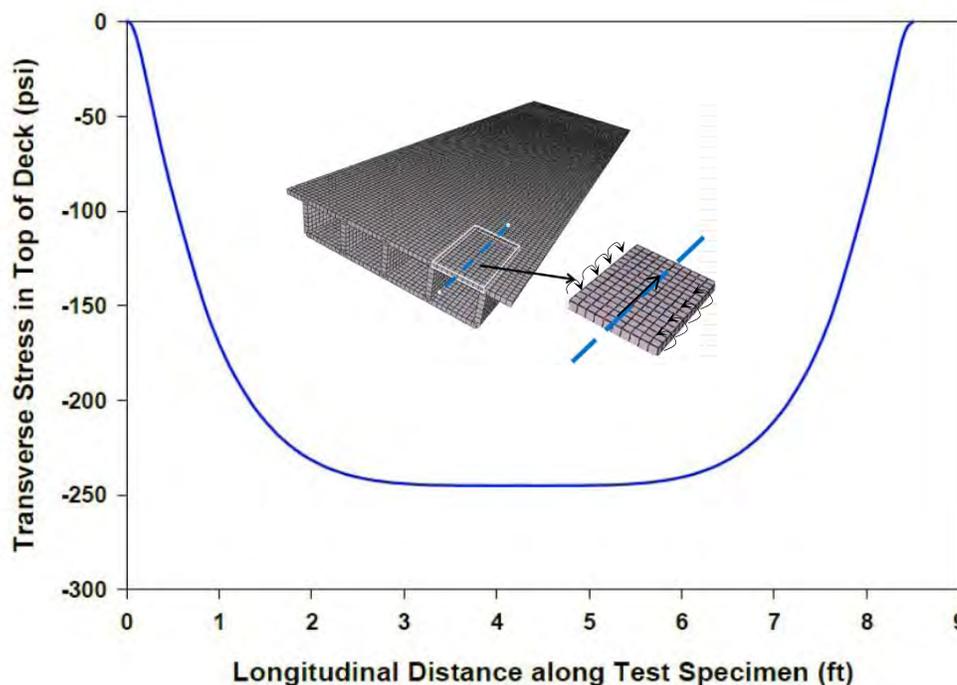
Figure 11: Transverse stresses in the top of the deck under the rolling wheel load as it moves along the specimen.

Finite-element modeling was also used to determine whether the leading and trailing transverse edges of the deck panels should be supported during testing. In the absence of support at these locations, as the wheel starts onto the specimen large deflections and relatively high stresses would be induced at these “free” edges. These relatively large stresses could have initiated cracks that would then propagate to the interior of the specimens, possibly leading to premature failures not representative of actual bridge deck behavior. Supporting these edges eliminated this issue, but did result in significantly lower stresses in these edge zones when compared to an actual bridge. The transverse stress in the deck under the wheel at various longitudinal positions of the load axle for the supported case is shown in Figure 11. Referring to Figure 11, boundary effects from the lead and trailing transverse edges of the models are evident, with approximately 3.5 feet of length in the center of the panel experiencing relatively constant stress response (longitudinal positions 2.5 to 6.0 feet). In the remaining edge affected zones of the panel, the stresses quickly diminish to zero at the panel edge. As a stress deviation in edge affected zones of the panels was inevitable, it seemed more desirable for the stress to be lower in these regions than in the actual case (supported condition) rather than higher than in the actual case (unsupported condition), so that premature damage from this area would not propagate to the interior section. Therefore, the decision was made to simply support the transverse edges of the panels.

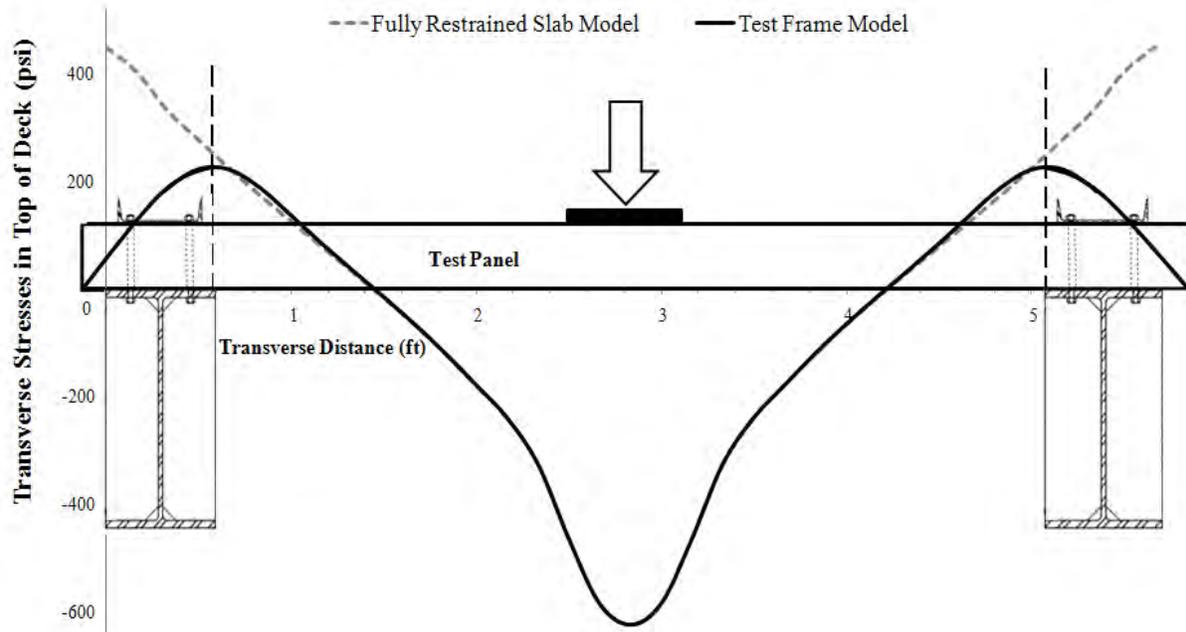
Figure 19: Comparison of transverse stresses in the top of the deck for the fully-restrained slab model and rest frame model.

In designing the reaction frame, multiple finite element analyses were done of the complete test setup (i.e., the reaction frame, clamping system and test panels) to confirm that the stresses generated in the test panels would be consistent with their required fixed edge support condition in the transverse direction (Gilbert, 2011). Linear elastic ANSYS analyses were done using an applied patch load of 15 kips. The initial frame design, for example, did not include web stiffeners for the longitudinal support beams. Subsequent finite element analyses revealed that these beams twisted when load was applied to the test panel, reducing the negative moment at the clamped edges of the panel and increasing the positive moment at the center of the panel. To address this problem, various web stiffener arrangements were analytically investigated iterating on stiffener size and spacing until the observed transverse stresses in the test panel were close in magnitude to those analytically predicted for a panel with perfectly fixed longitudinal edges (see Figure 19).

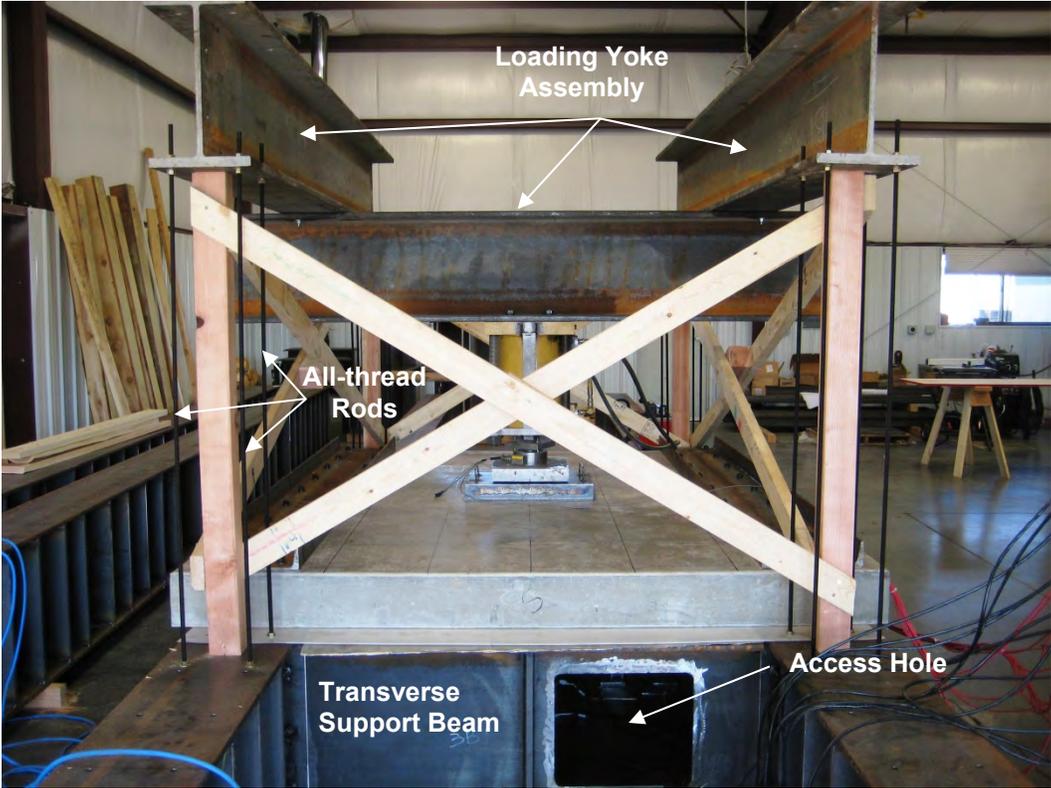
Figure 20: End view of static load test setup.

A further verification of the performance of the reaction frame was conducted by physically loading to failure a single test panel mounted in one of the interior bays of the frame (Figure 20 and Figure 21). The specific specimen used in this test had the same geometry and reinforcing arrangement as the already described fatigue test specimens, with a 28-day concrete strength of 7,618 psi (8,040 psi on the day it was tested). The panel was clamped in the reaction frame using the procedure outlined above. Load was applied using a 2.5-inch thick A-36 steel loading plate with a contact area of 12 x 20 inches (representing a dual truck tire assembly).

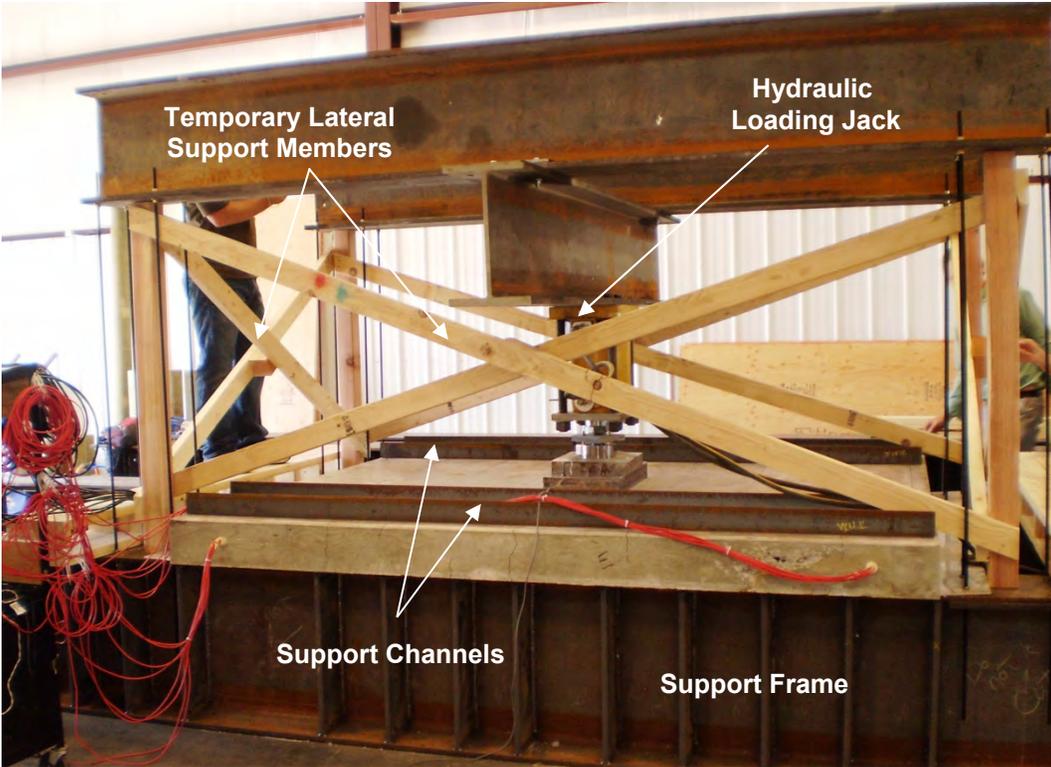
Figure 21: Side view of static load test setup.

Internal strain measurements made in the transverse direction of the panel during this test confirmed that the reaction frame offered a high degree of rotational fixity along the longitudinal edges of the slab (Gilbert, 2011). The strains measured near the clamped edges were tensile in the top of the deck and compressive in the bottom (negative moment) for loads up to 75 kips. Furthermore, the measured strains closely matched those obtained in an FE analysis of the slab in which full rotation and translation restraint was assumed along the longitudinal edges. A tensile strain of 30 microstrain and a compressive strain of 37 microstrain were recorded in the static load test, while the ANSYS model with ideally clamped edges experienced a tensile strain of 35 microstrain, and a compressive strain of 46 micro-strain. These tensile and compressive strains were higher than the experimental results by only 17 and 23 percent, respectively. Finally, the observed crack patterns in the test slab were also consistent with the expected distribution of stresses, that is, all of the top surface cracks initiated in the expected tension zone along the face of the supports, and bottom surface cracks were concentrated in the expected tension zone directly under the applied load.

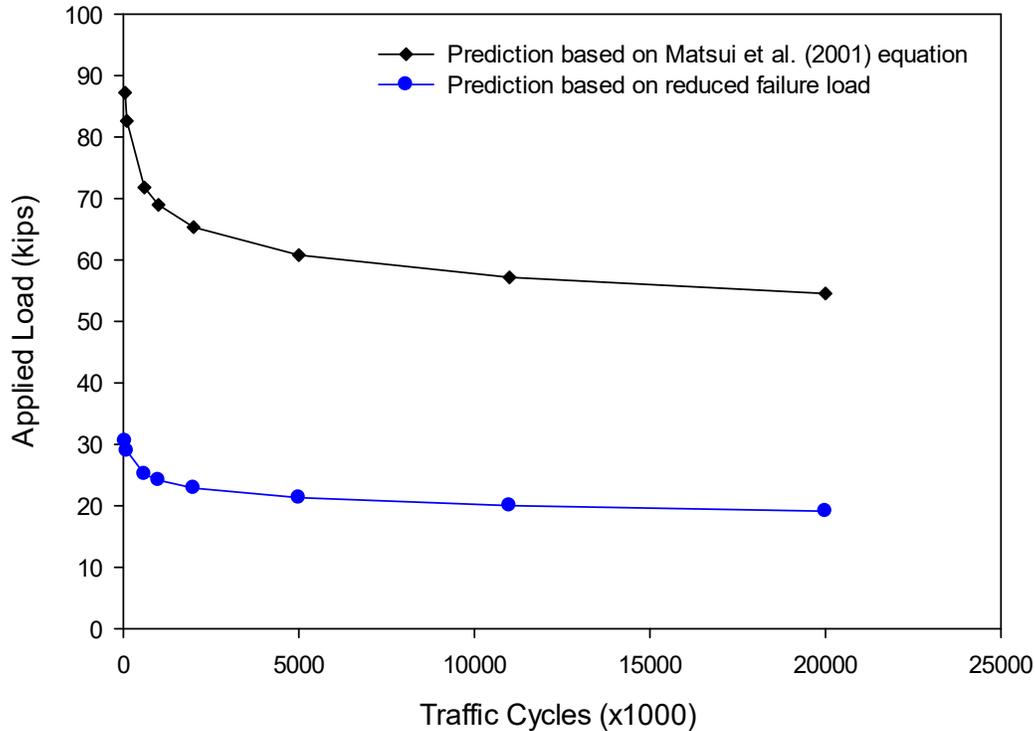
Figure 22: Predicted fatigue life of test panels as a function of applied load.

Another important task prior to initiating the trafficking of the test panels was to estimate the number of traffic cycles that would be needed to produce the degree of deck deterioration needed in this study. This degree of deterioration was defined as the maximum level of distress at which an HMWM treatment would still be used as a rehabilitation treatment. Thus, for the test panel configuration defined above, an effort was made to predict the magnitude and number of load cycles that would be required to reach this deteriorated condition. These predictions were made generally following the form of fatigue life prediction equation previously introduced by Matsui et al. (2001), in which the number of load cycles to failure was expressed as a function of the applied load normalized by the ultimate capacity of the deck slab (Equation 1). This equation was first evaluated with failure being defined as a complete loss of structural load carrying capacity. The failure capacity of a typical slab was established in a previously described test by Gilbert (2011) to be 192 kips (with the failure mechanism being punching shear). This value was adjusted for relative concrete strength (the concrete in the Gilbert slab had an unconfined compression strength of 8,040 psi, compared to a target concrete strength in these test panels of 4,000 psi) and was then used for the normalizing value, P_s , in Equation 1. The resulting fatigue life curve is presented in Figure 22 (upper curve in this figure). Notably, across a range of possibly reasonable magnitudes for the rolling wheel load of 15 to 25 kips, the predicted fatigue life was effectively infinite.

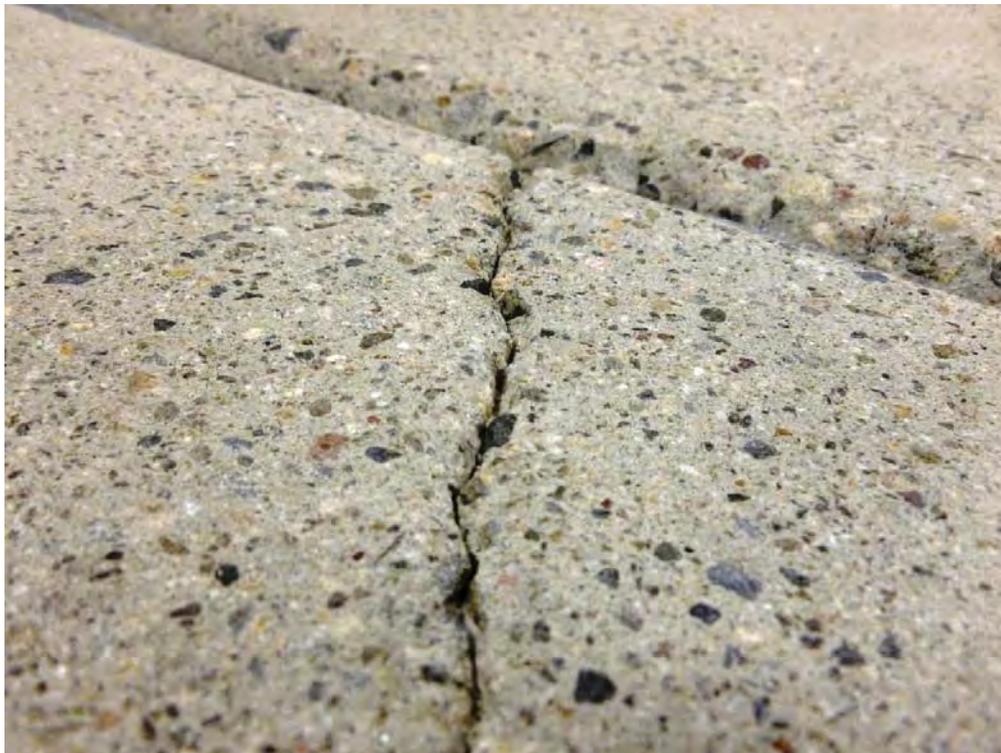
Figure 32: Crack in deck surface after shot blasting.

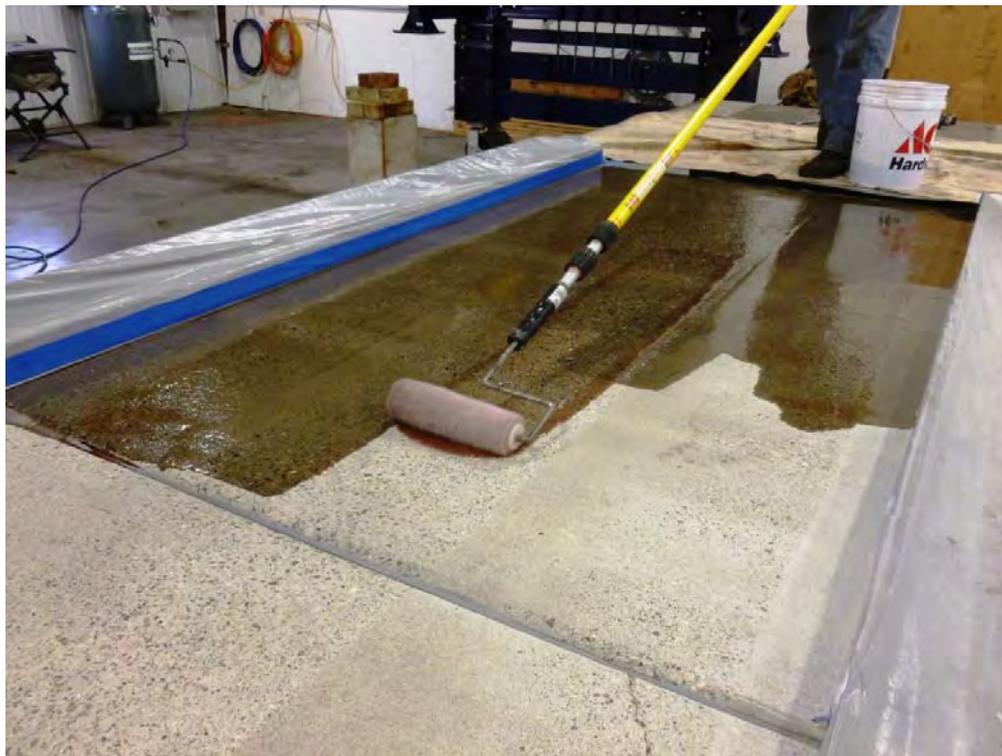
Figure 33: Application of HMWM surface treatment.

Subsequent to surface preparation, the KBP 204 (HMWM) was mixed in accordance with Kwik Bond product specifications and applied with a ½-inch nap paint roller (Figure 33). Excess material was rolled to the end of the slab and soaked up or deposited in a trough formed between adjacent test panels. Because cracked areas tended to soak up more methacrylate, special attention was paid to these areas to ensure adequate HMWM was present to fill the cracks prior to curing. The sealer cured for several days before trafficking was resumed. Friction enhancing sand was not added to the surface prior to curing as additional traction was deemed unnecessary in this application, and it was thought that this sand would obscure detection of surface distresses in the deck. A close-up photo of a crack filled with methacrylate is shown in Figure 34.

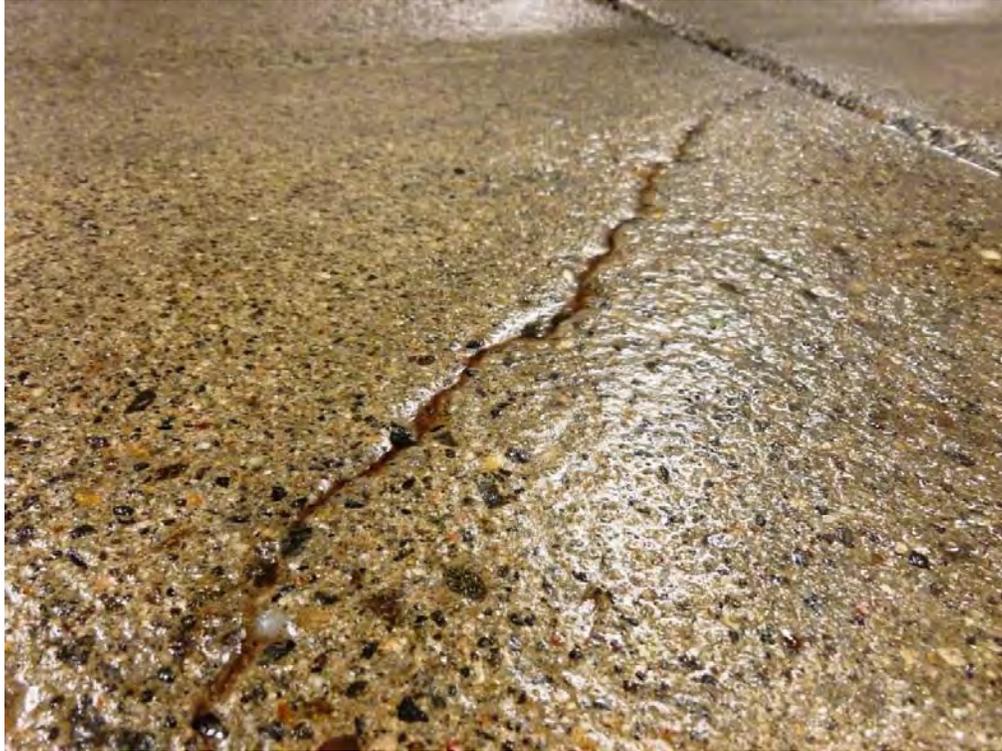
Figure 34: Close-up of methacrylate-filled crack.

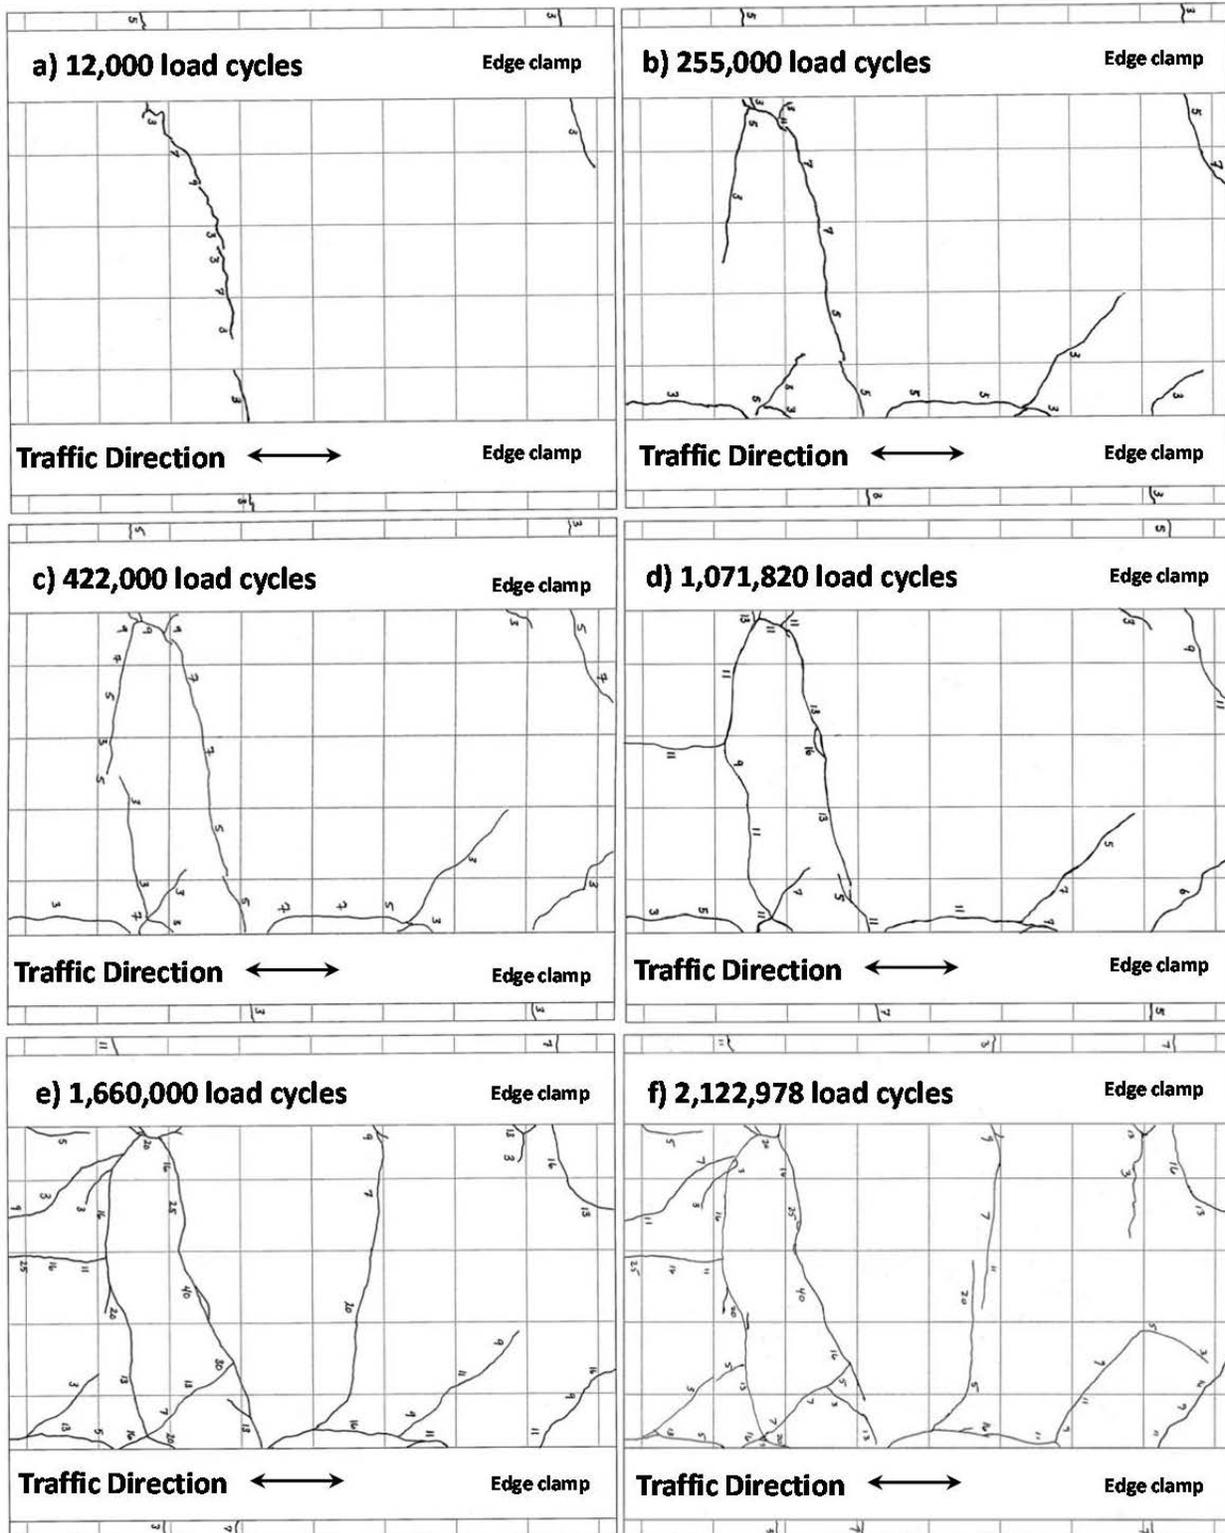
Figure 35: Top cracking in Control_a test panel at various traffic levels.

A typical set of crack maps as a function of cycles of applied load is presented in Figure 35 and Figure 36 for top surface and bottom surface cracking, respectively (test panel Control_a is shown). Cracking in the top surfaces of the panels occurred in many of the specimens by 12,000 to 25,000 load cycles (refer to Figure 35a). This distress often consisted of a single crack along the longitudinal edge of the panel indicative of negative transverse moment, and a few relatively “random” oriented skew and transverse cracks. By the second set of inspections (after 255,000 and 78,000 cycles of applied load, respectively, for panel set one and two), all panels exhibited cracking in their top surfaces. This cracking generally consisted of one or two longitudinal cracks along one or both edges of the panel, and some diagonal cracks across the corners, with occasional skew and transverse cracks. Bottom cracking at these same levels of cyclic load (Figure 36, for test panel Control_a) was confined to the center region of panels. Bottom surface cracking consisted initially of a few longitudinal cracks at or near the center of each panel, consistent with the presence of positive transverse bending moment. Cracking in the bottom surface of the decks definitely reflected the layout of the bars in the bottom mat of reinforcing, and initially, in particular, the longitudinal bars in this mat. Note that the cracking in the top surfaces of the decks did not follow the layout of the top mat of reinforcing steel. The top surfaces of the panels also appeared to generally exhibit less cracking than the bottom surfaces (as is borne out in the quantitative crack analysis presented below). This difference in cracking behavior between the top and bottom surfaces of the decks is believed to be due in part to the relative clear cover on the top and bottom mats of reinforcing steel. The top mat had 2 inches of clear cover, versus 1 inch for the bottom mat.

In general, as cycling progressed, cracks continued to increase in extent and width in the top surface of the decks (Figure 35), with this cracking being almost completely arrested when a panel received HMWM treatment. Early crack widths, i.e., at the time of the second set of crack inspections, were typically in the range of only 0.003 to 0.007 inches. At the conclusion of testing of Panel Set 1, cracks in the top surface of the untreated panels (i.e., test panels Control_a and Control_b) generally were in the range of 0.016 to 0.020 inches wide, with a maximum width of 0.040 inches. A typical longitudinal crack along a clamped edge is shown in Figure 37 (edge of M1000_a test panel at approximately 1,000,000 load cycles). Note the maximum crack width in each panel at the time the HMWM treatment was applied was previously reported in Table 3.

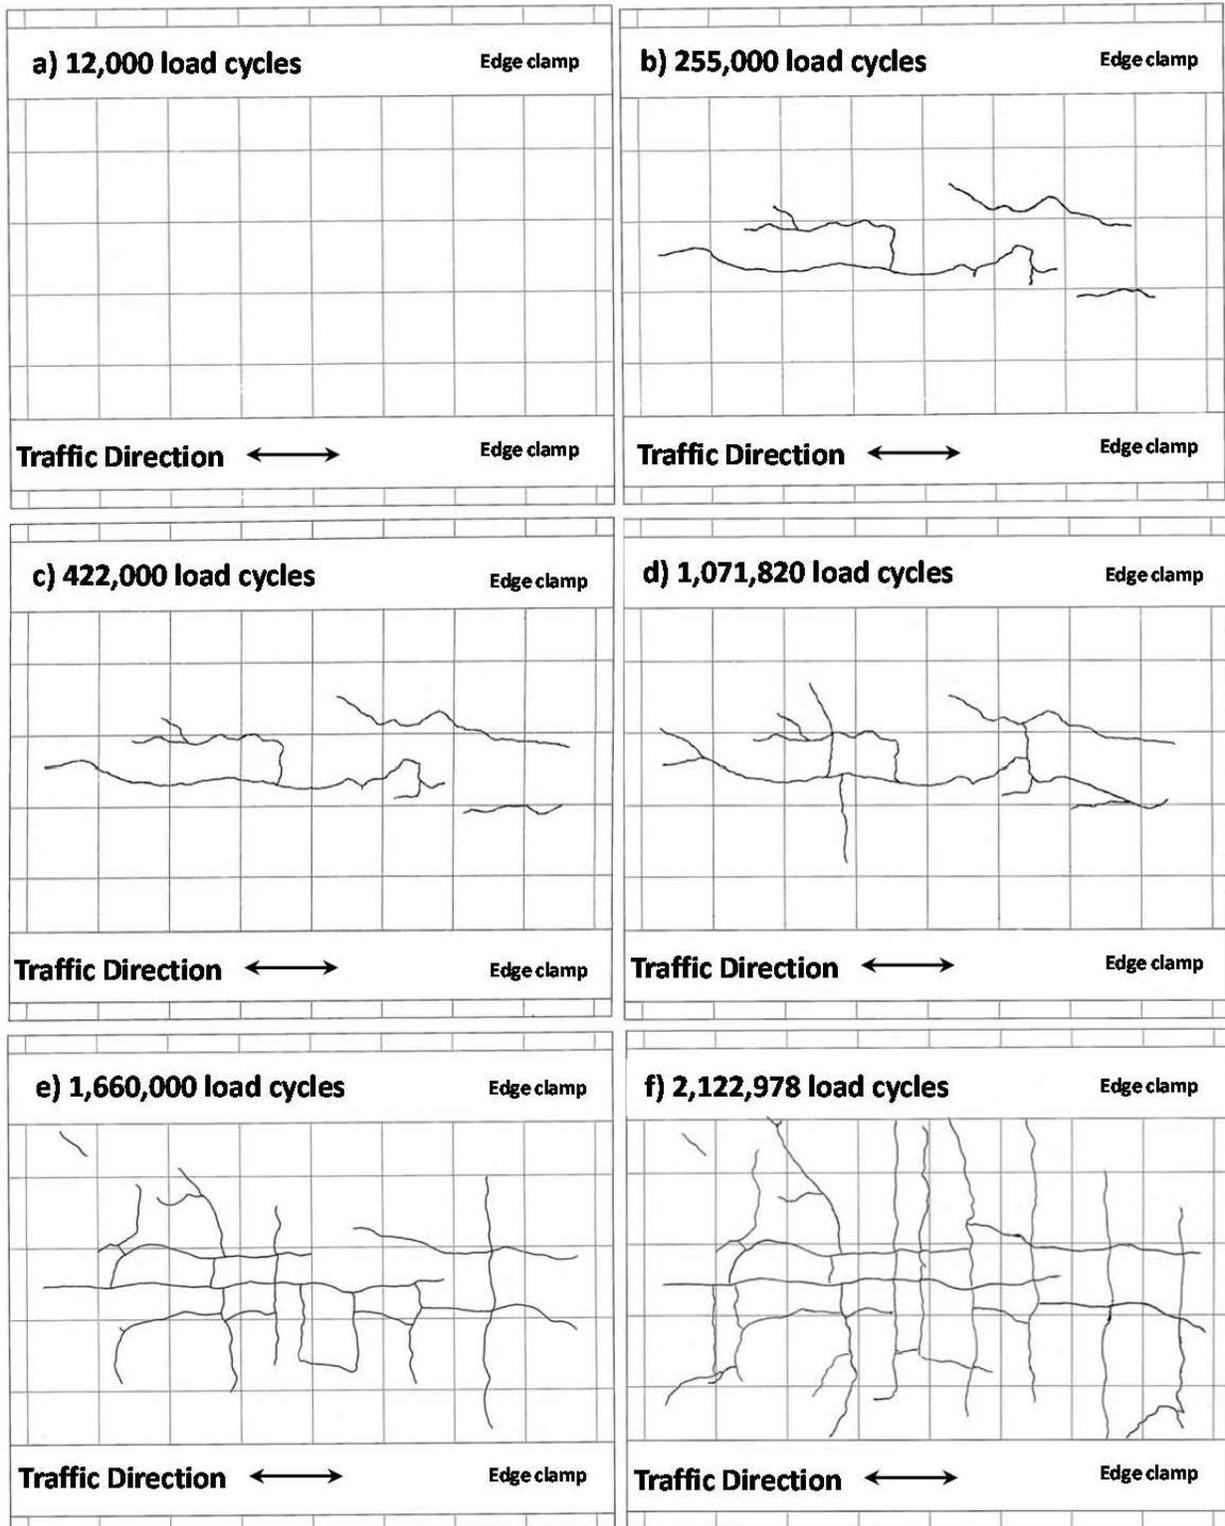
Figure 36: Bottom cracking in Control_a test panel at various traffic levels.

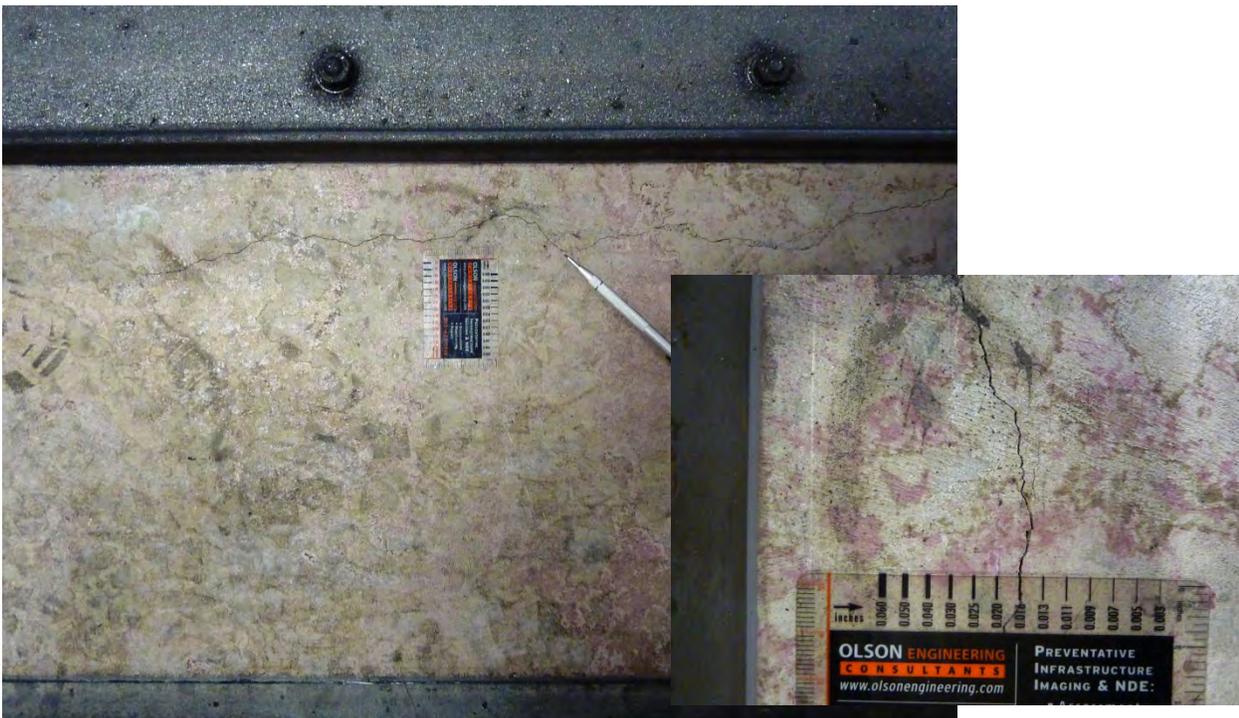
Figure 37: Longitudinal crack in top surface.

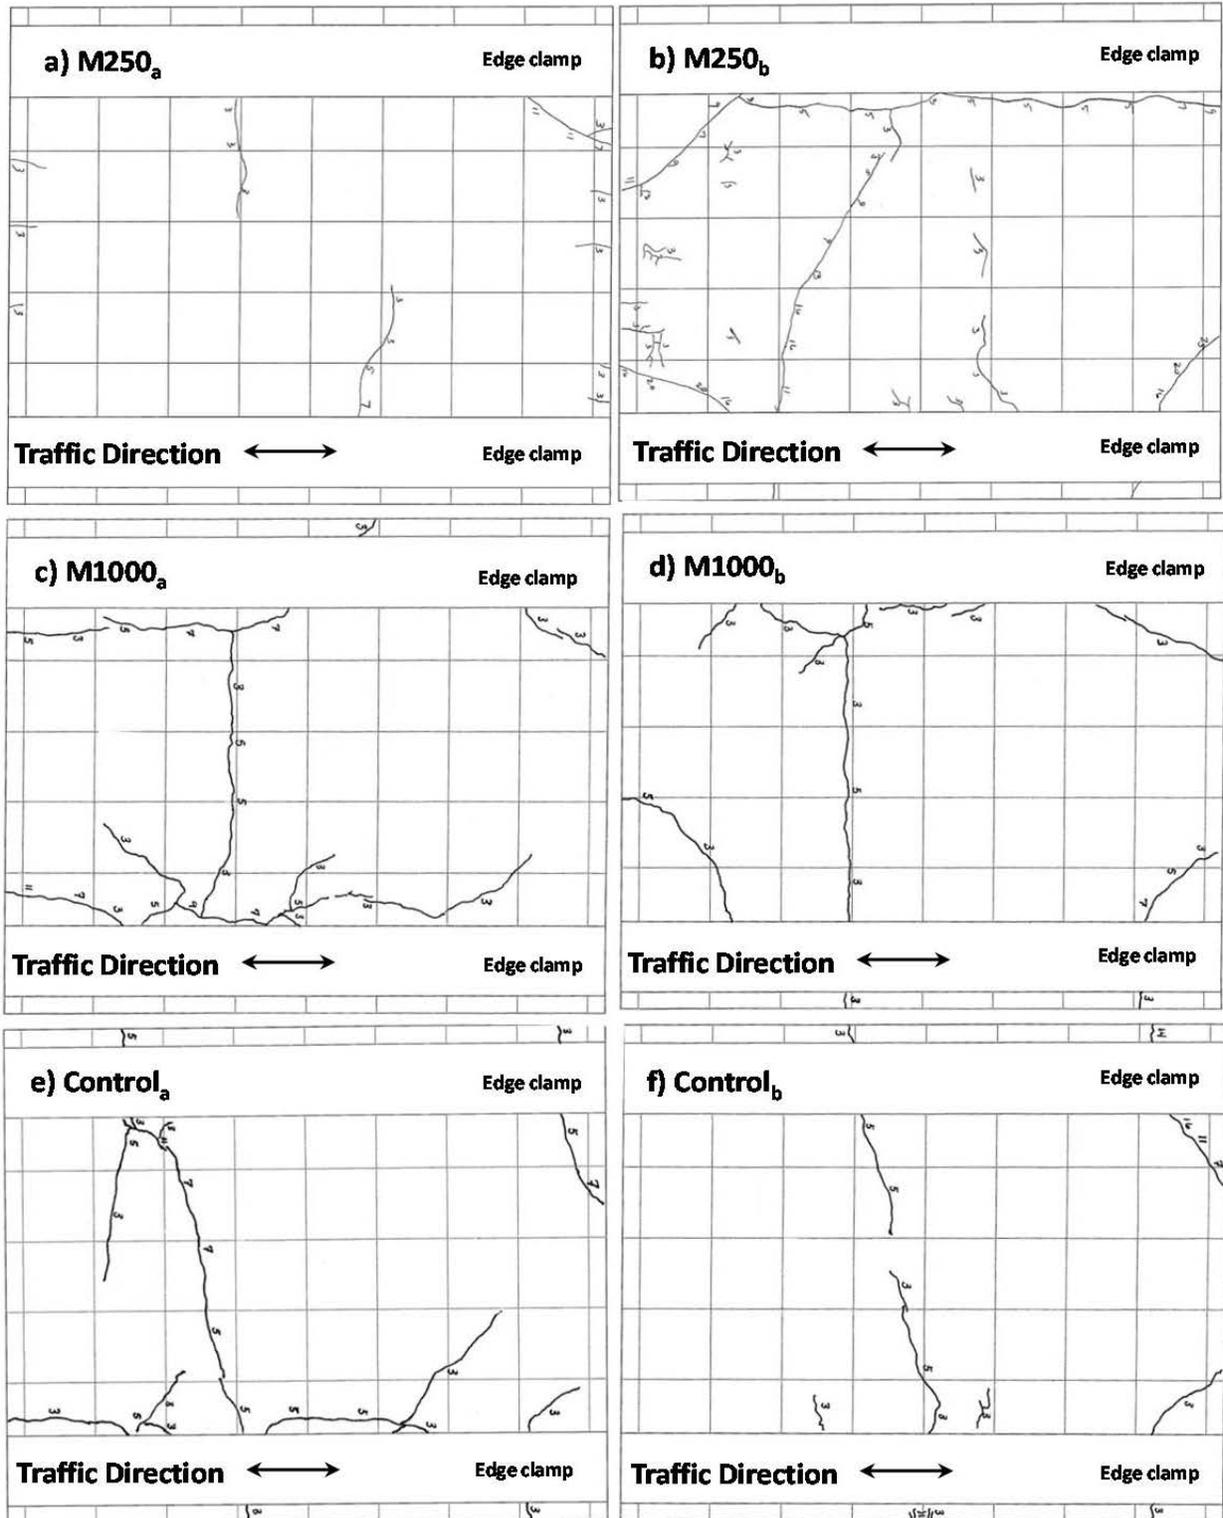
Figure 38: Top cracking in all test panels at about 250,000 traffic passes.

Relative to comparative performance between panels, all panels were expected to exhibit similar top surface distress as cycling proceeded until any given panel received HMWM treatment. An excellent opportunity to make such a comparison was after approximately 250,000 load cycles, as six of the eight panels were still untreated at this point, and crack assessments were done on all panels at about this same level of trafficking. The cracking distress in the top surface of these six panels at approximately 250,000 load cycles is presented in Figure 38. Panels M250_b, M1000_a, M1000_b and Control_a exhibited similar crack patterns, as did panels M250_a and Control_b. The difference in the response between these two groups of panels is the presence of longitudinal cracks in the former panels along at least one clamped edge of the panel, while such cracks are absent in the latter panels. The absence of such cracks in Panels M250_a and Control_b could have resulted from differences in the degree of clamping provided by the support frame for these panels, although an associated decrease in the stiffness of these panels was not observed (see stiffness results presented in the subsequent sections below). In the case of panel M250_a, the HMWM was applied at 250,000 load cycles, arresting any further crack development. In the case of panel Control_b, limited longitudinal cracks did develop along the clamped panel edges after 1,360,000 cycles of applied load.

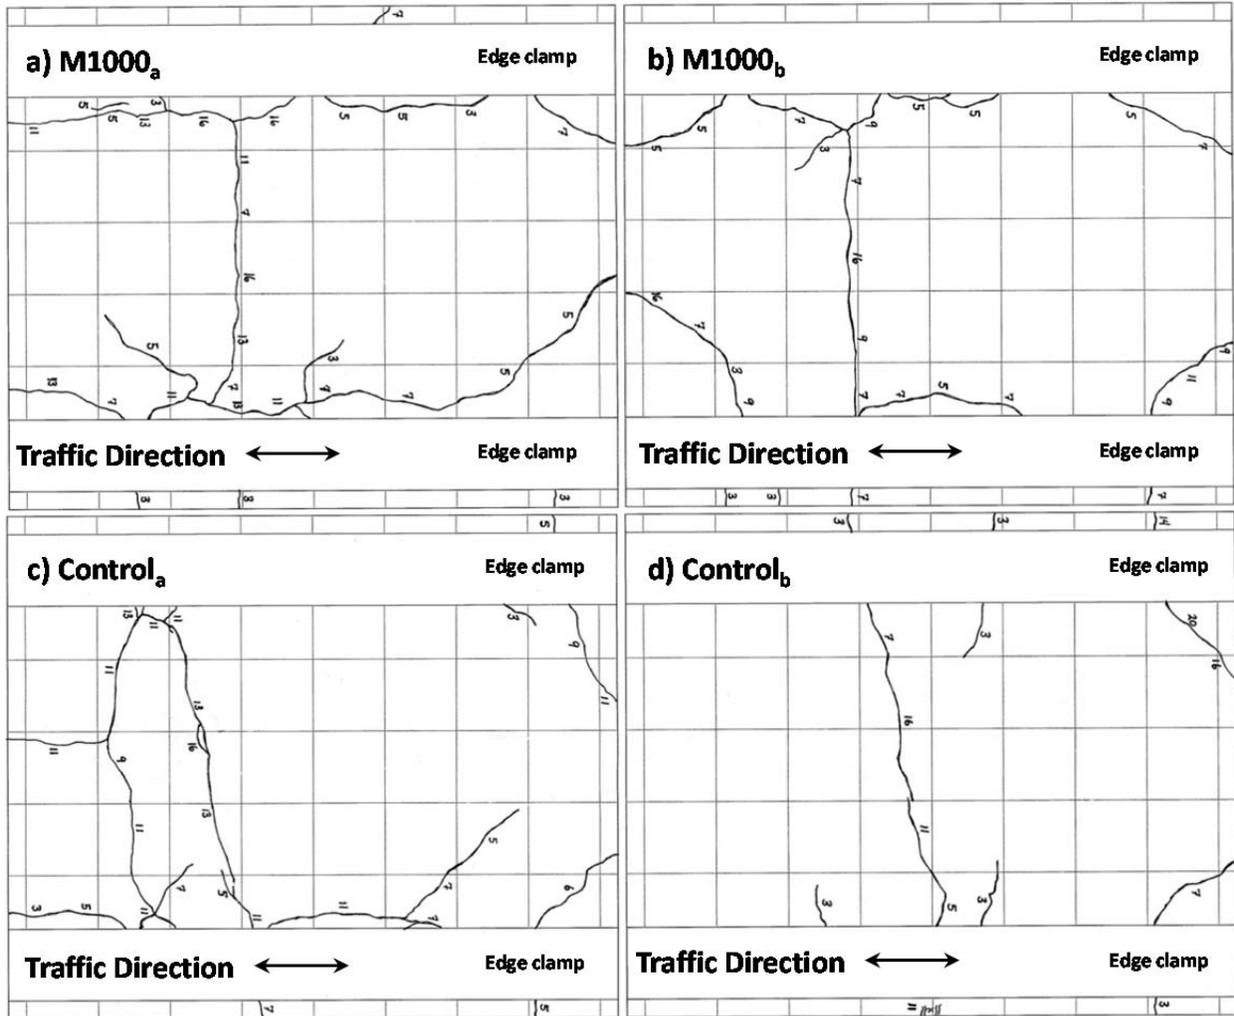
Figure 39: Top cracking in M1000 and Control test panels at 1,071,820 traffic passes.

The expected similarity in the distress generated in similarly configured and loaded test panels could also be evaluated using the condition of the slabs in Panel Set 1 at approximately 1,000,000 load cycles, as no treatments were applied to any of these slabs prior to this point. Crack maps of the top surfaces of the four panels comprising this set of panels at approximately 1,000,000 load cycles are presented in Figure 39. Once again, the crack patterns in slabs Control_a, M1000_a and M1000_b are similar in nature, while panel Control_b continued to manifest no longitudinal cracks.

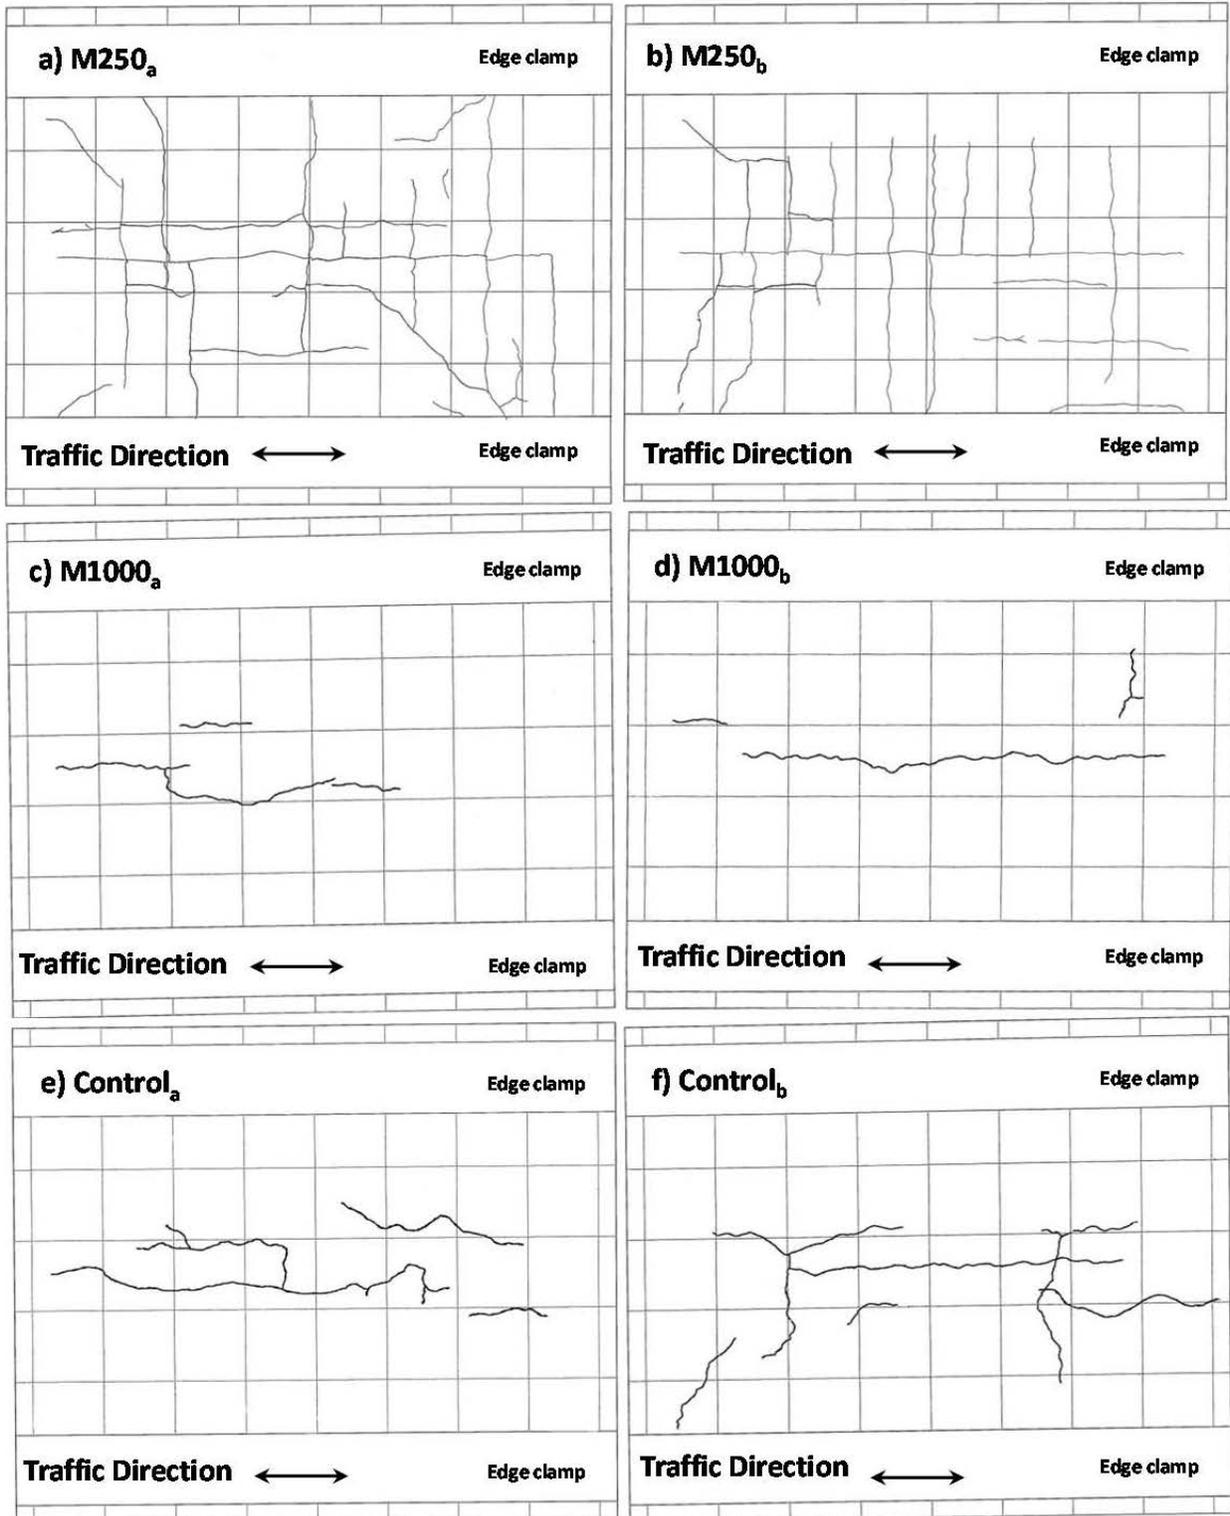
Figure 40: Bottom cracking in M250, M1000 and Control test panels at 250,000 load cycles.

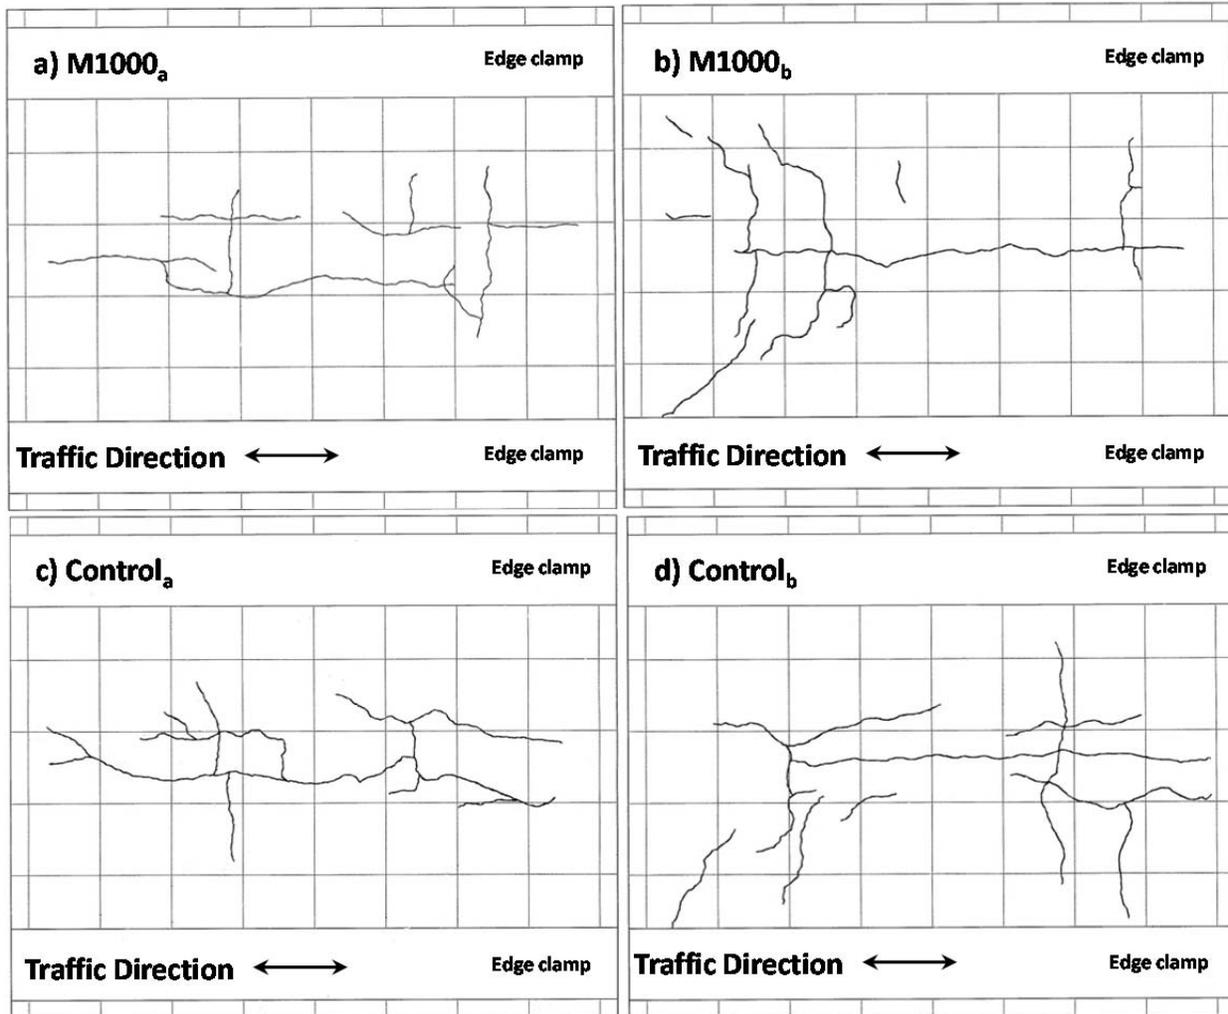
Figure 41: Bottom cracking in M1000 and Control test panels at 1,071,820 traffic passes.

Bottom cracking in the four slabs in Panel Set 1 at 1,071,820 cycles of applied load are shown in Figure 41. At this cycle point the most extensive bottom cracking continued to be seen in panel Control_b, with the least bottom cracking in panel M1000_a (closely followed by Control_a).
