INVESTIGATION OF METHACRYLATE REHABILITATION STRATEGY TO EXTEND THE SERVICE LIFE OF CONCRETE BRIDGE DECKS

Final Project Report

Western Transportation Institute, College of Engineering
Montana State University – Bozeman

California Department of Transportation
Department of Research and Innovation

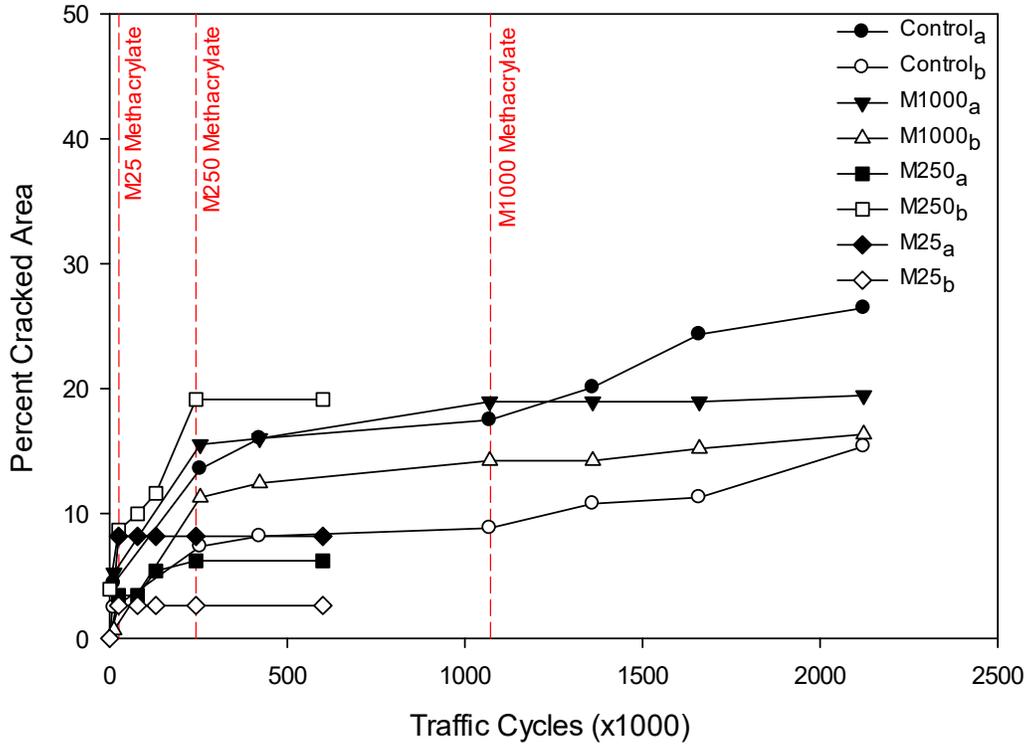
Figure 42: Percent top cracking for both panel sets.

In an effort to more fully and objectively identify distress based differences in slab behavior as a function of applied cycles of load and HMWM treatment, the percent cracked area and total crack length were calculated for each test panel for both the top and bottom surfaces as cycling progressed (using the methodology described in the previous chapter of this report). Progression of cracking in the top and bottom surfaces of the deck panels is presented in Figure 42 and Figure 43, respectively, in terms of percent cracked area and total crack length. Referring to these figures, similarities were immediately evident in the cracking response as quantified by these two parameters. Therefore, the remaining discussion is focused on the percent cracked area results.

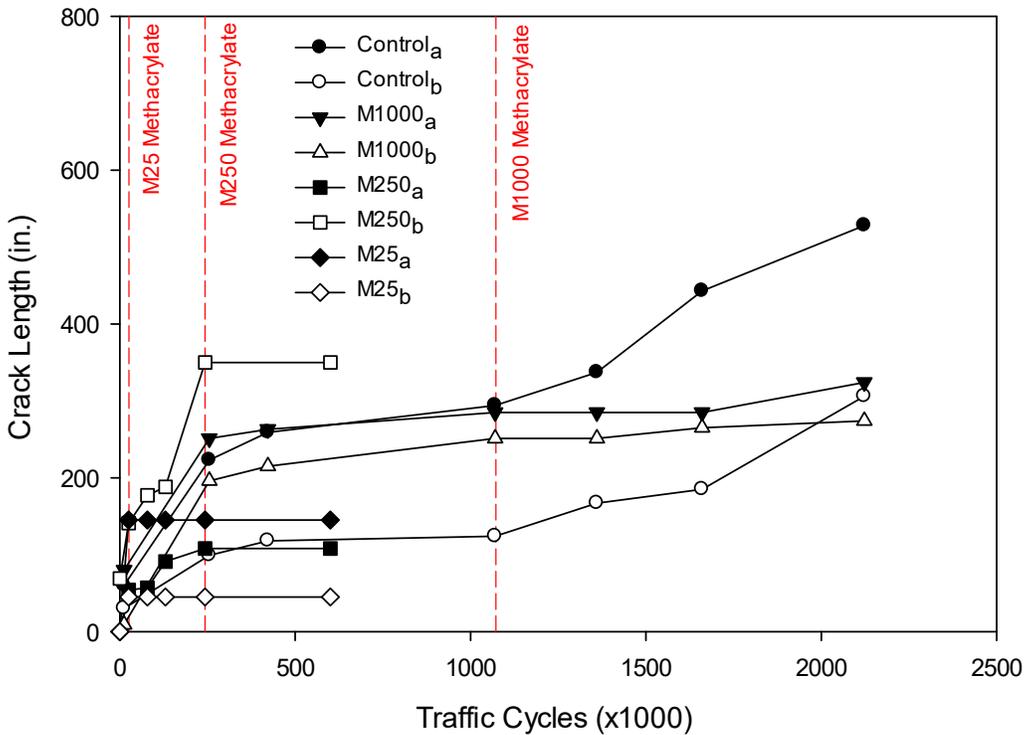
Figure 43: Top crack length for both panel sets.

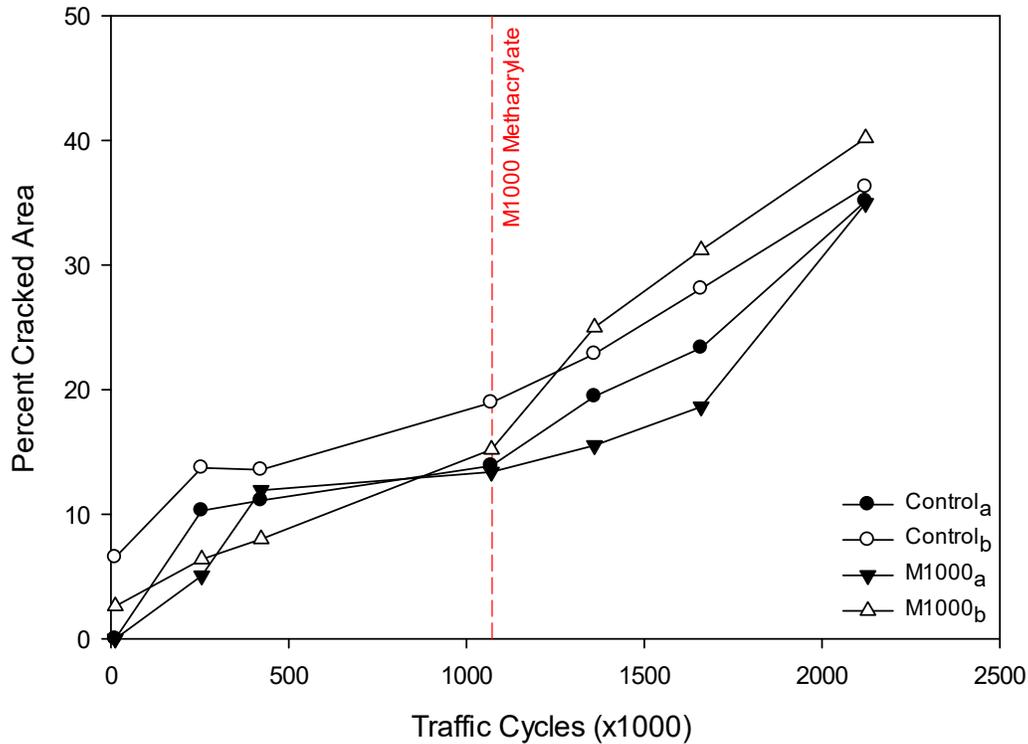
Figure 44: Percent bottom cracking in Panel Set 1.

Cracking in the bottom surfaces of the test panels generally developed as cycling progressed following the pattern described above for top surface cracking, with the notable exception that its progression was not affected by the application of HMWM to the top surface of the panels. In the case of Panel Set 1, and referring to Figure 44, the three stages of crack progression described previously in the top surfaces of the panels is clearly evident in the bottom surfaces, i.e., a period of initial crack development through 250,000 load cycles, followed by a stable period with little change in cracking extent through 1,000,000 load cycles, and concluding with a period of resumed crack growth from 1,000,000 to 2,000,000 load cycles. Unlike the top surface, however, in which cracking was arrested at 1,000,000 load cycles in the panels that were treated with HMWM, cracking resumed at a similar accelerated rate on the bottom surface of all the panels (untreated and treated, alike) through 2,000,000 load cycles, reaching a relatively common extent approaching 40 percent of the panel area.

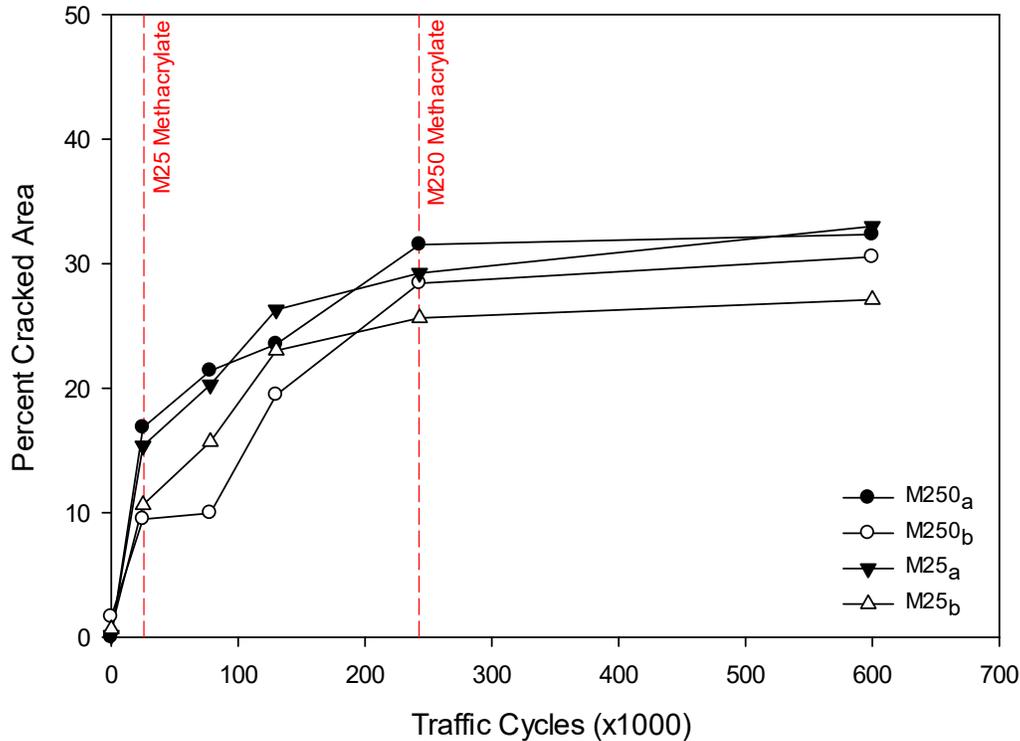
Figure 45: Percent bottom cracking in Panel Set 2.

Crack surveys of the bottom surfaces of Panel Set 2 (summarized in Figure 45) indicate that the second set of panels experienced approximately twice the bottom surface cracking distress (quantified in percent cracked area) as was seen in Panel Set 1 at 600,000 load cycles. As previously discussed, this difference in amount of cracking possibly can be attributed to differences in the concretes used in constructing the two sets of panels. As in the case of Panel Set 1, the progression of bottom cracking was unaffected by HMWM treatment of the top surface, as can particularly be seen in the similarity in cracked condition in all four panels at 250,000 cycles of applied load, while two of these panels were treated at 25,000 cycles of applied load (M25_a and M 25_b).

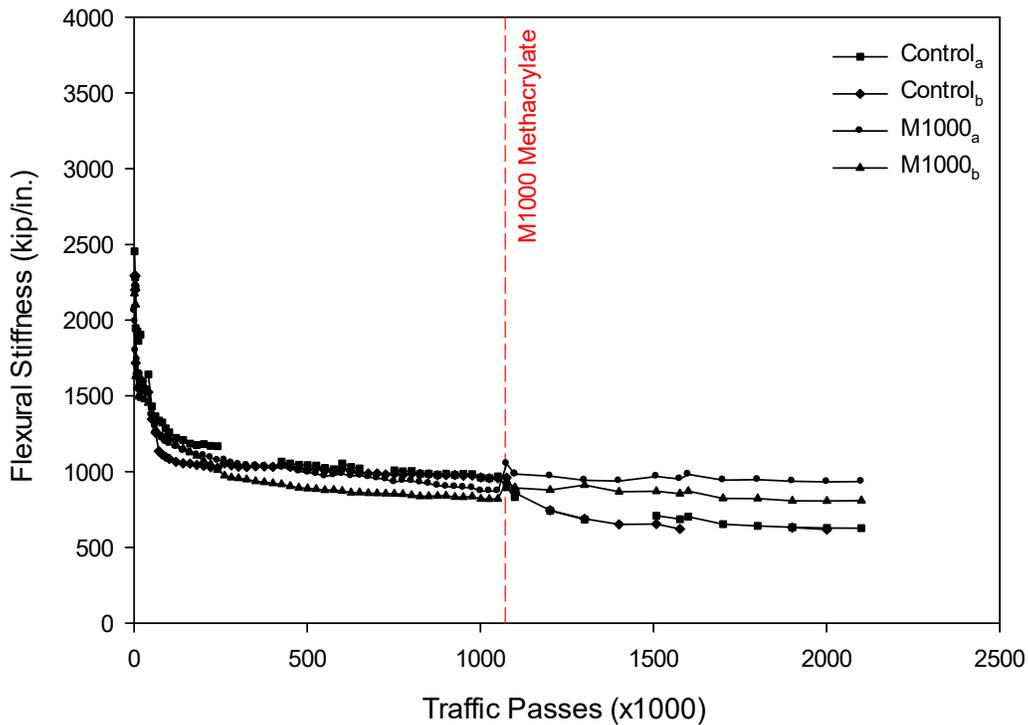
Figure 46: Flexural stiffness of Panel Set 1 based on center-point displacements.

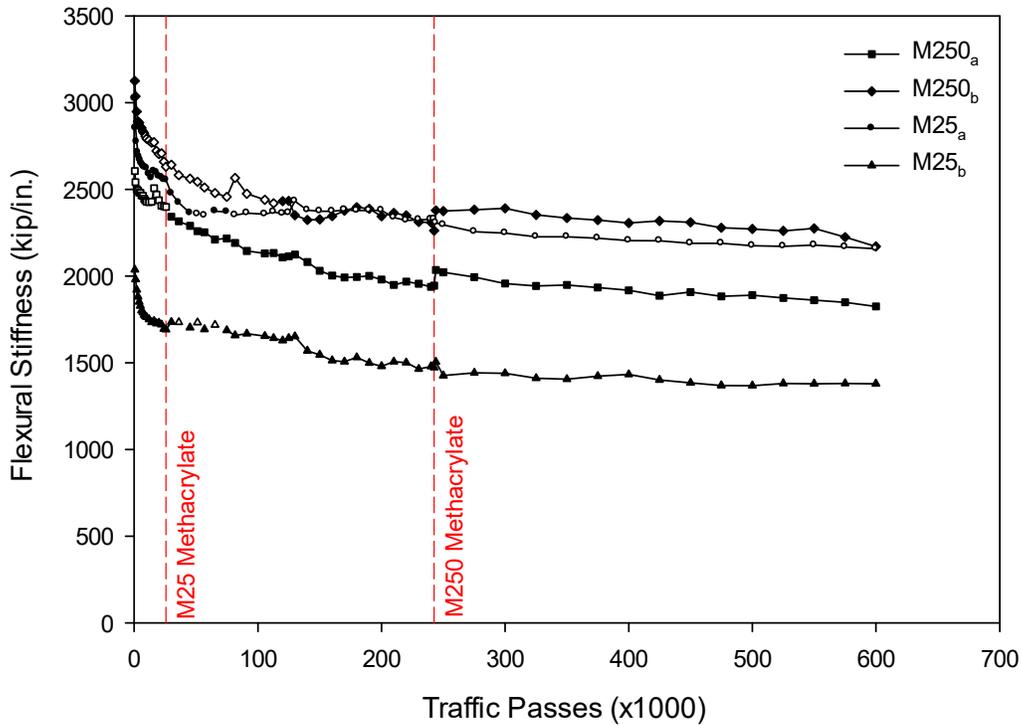
Figure 51: Average flexural stiffness of Panel Set 2.

problems; “open” data markers in the averaged stiffness results (Figure 48 and Figure 51) indicate cycling intervals in which the response has been estimated based on data available just from either the center-point or quarter-point location. A simple elastic analysis of a homogeneous plate of the test slab dimensions and materials with simply supported and clamped edges would have an apparent center-point load/deflection stiffness of approximately 1600 kips/in. and 3500 kips/in., respectively. Referring to Figure 46 and Figure 49, the corresponding initial stiffnesses of the test panels ranged from about 1600 to 2500 kips/in. Thus, based on this simple analysis, the longitudinal edges offer intermediate fixity relative to the simple and fully clamped cases.

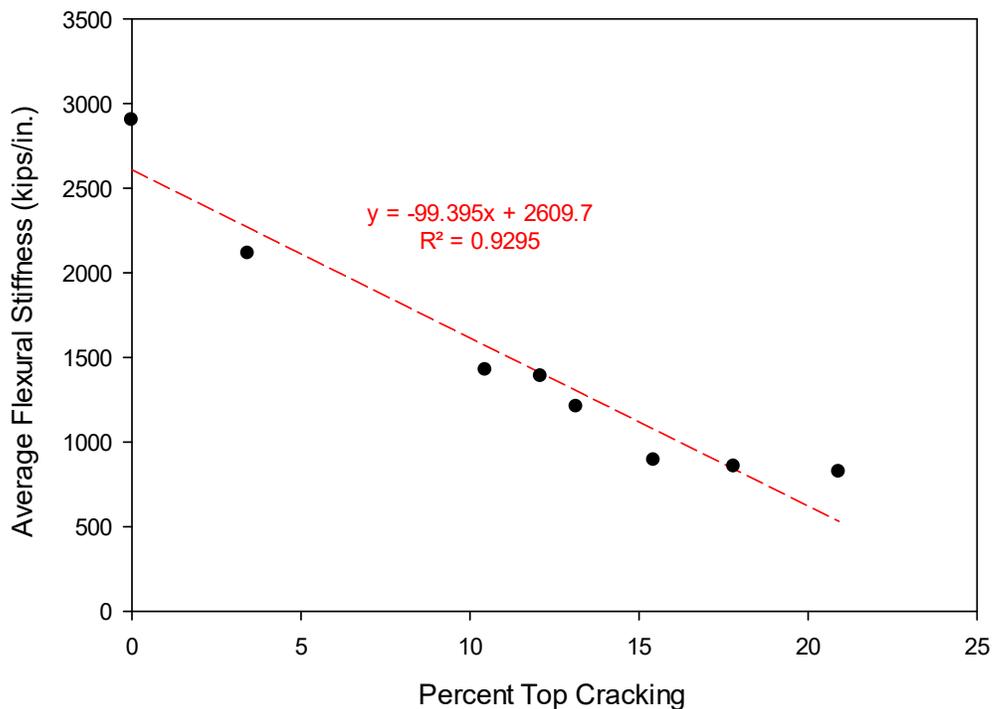
Figure 54: Average flexural stiffness as a function of top cracking for the Control test panels.

Figure 54. Reference “original” stiffness values were actually taken as the stiffness at approximately 70,000 cycles of applied load, at and after which much of the localized variability in the earlier calculated stiffness values was no longer present. Referring to Figure 54, changes in stiffness well represent accumulated cracking in the top surface of the test slabs over the range of top surface distress generated in this program. The correlation coefficient between these two parameters was 93 percent, indicating that average flexural stiffness possibly can be reasonably used to infer distress condition in deck slabs, at least through 10 to 20 percent cracked area. That being said, and recognizing the limited amount of data used in generating the relationship portrayed in Figure 54, the stiffness could be becoming insensitive to further accumulated distress above 15 percent cracked area.

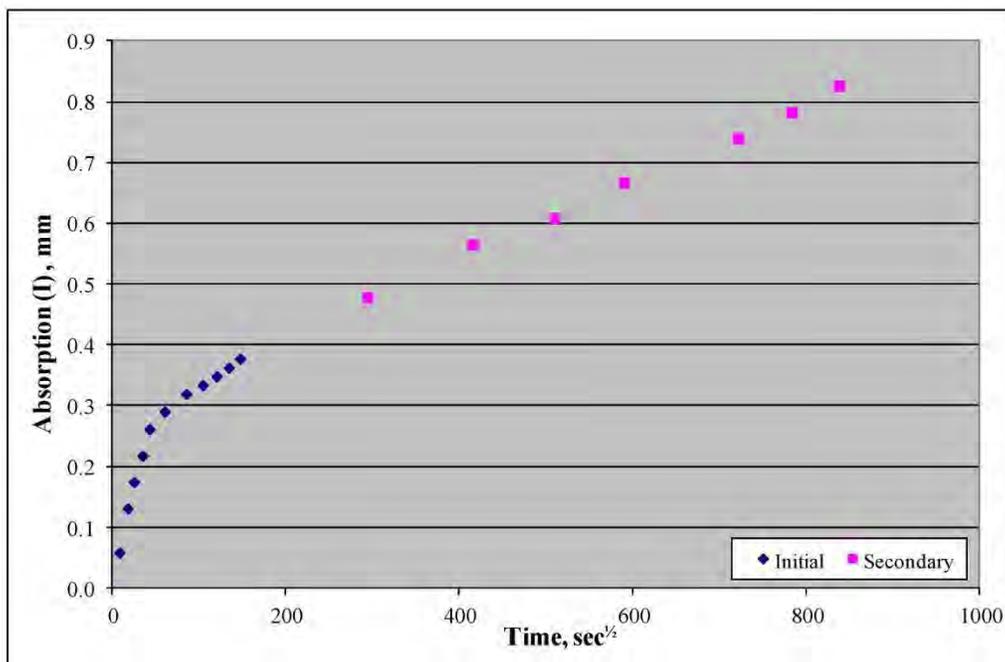
Sample: B1 – Untreated Uncracked		Test Date: June 24, 2013
Diameter: 93.7 mm	Exposed Area: 6896 mm ²	Thickness: 51.8 mm
Conditioned Mass: 811.9g		Post-sealed Mass: 817.0g

Initial Rate of Absorption: 56.8×10^{-4} mm/ \sqrt{s} (first 30 min) [†]	Correlation Coefficient = 0.923 [†]
Secondary Rate of Absorption: 6.2×10^{-4} mm/ \sqrt{s}	Correlation Coefficient = 0.999

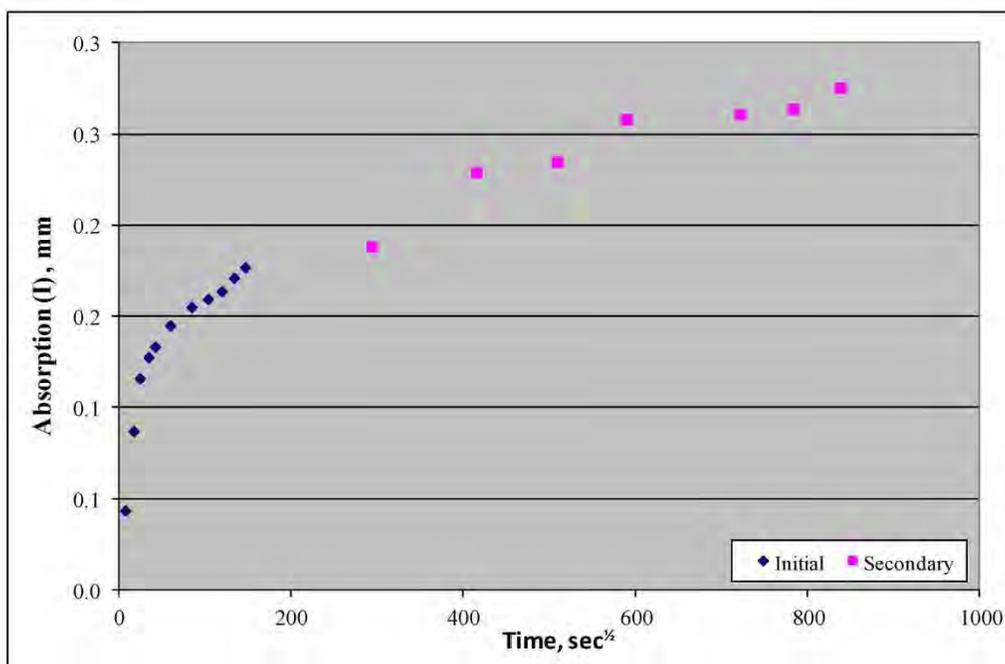
Sample: B2 - Control		Test Date: June 24, 2013
Diameter: 93.7 mm	Exposed Area: 6896 mm ²	Thickness: 52.6 mm
Conditioned Mass: 828.7g		Post-sealed Mass: 834.3g

Initial Rate of Absorption: 4.3×10^{-4} mm/ \sqrt{s} (first 10 min) [†]	Correlation Coefficient = 0.873 [†]
Secondary Rate of Absorption: 1.4×10^{-4} mm/ \sqrt{s}	Correlation Coefficient = 0.946 [†]

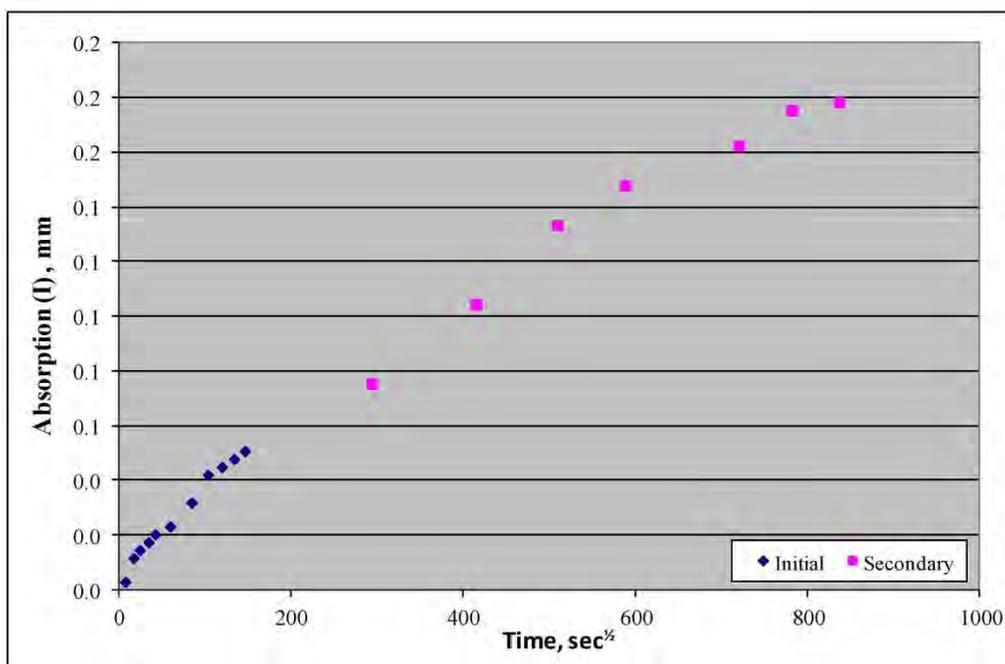
Sample: B3 – Treated Uncracked		Test Date: June 24, 2013
Diameter: 93.7 mm	Exposed Area: 6896 mm ²	Thickness: 51.2 mm
Conditioned Mass: 821.6g		Post-sealed Mass: 826.3g

Initial Rate of Absorption: 3.3×10^{-4} mm/ \sqrt{s}	Correlation Coefficient = 0.991
Secondary Rate of Absorption: 1.9×10^{-4} mm/ \sqrt{s}	Correlation Coefficient = 0.983

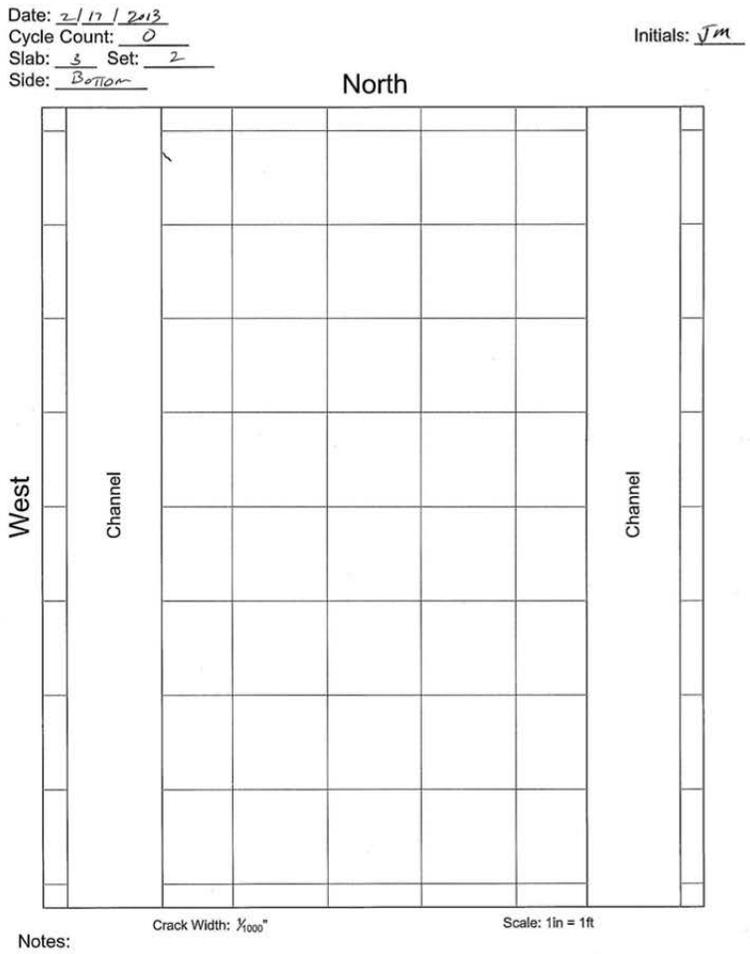
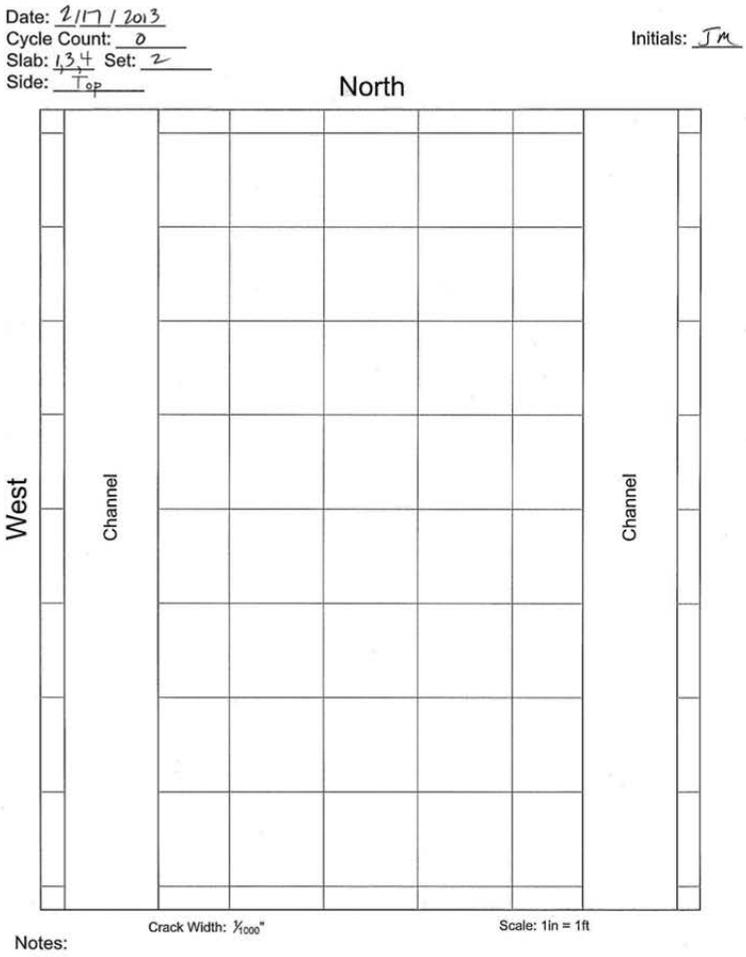
Figure F-1: Crack maps, M25_a test panel, 0 traffic cycles.

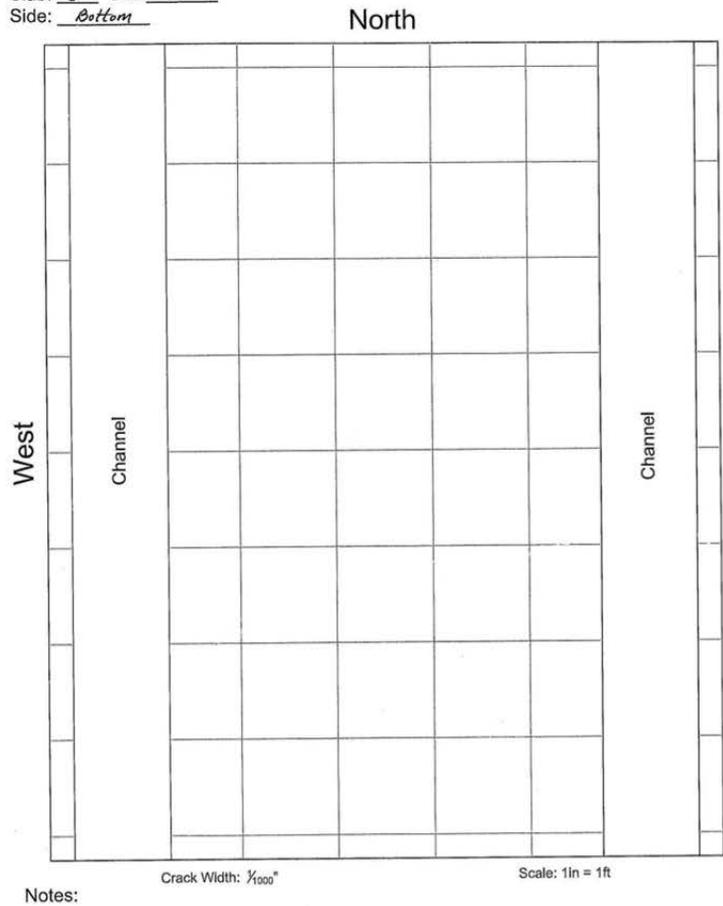
Figure F-26: Crack maps, M1000_a test panel, 255,000 traffic cycles.

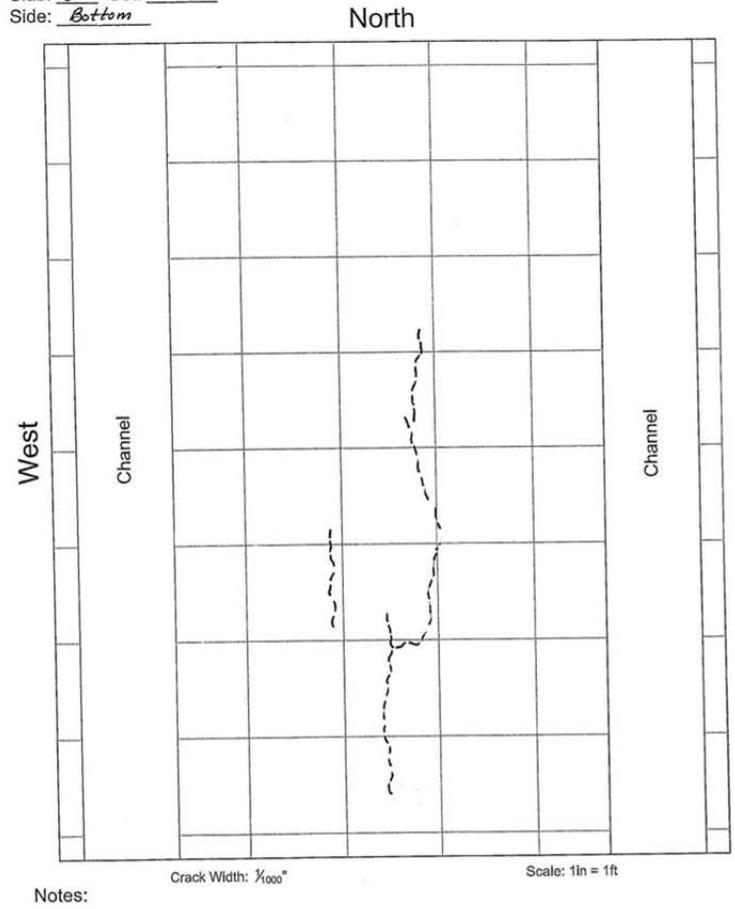
Figure F-27: Crack maps, M1000_a test panel, 422,000 traffic cycles.

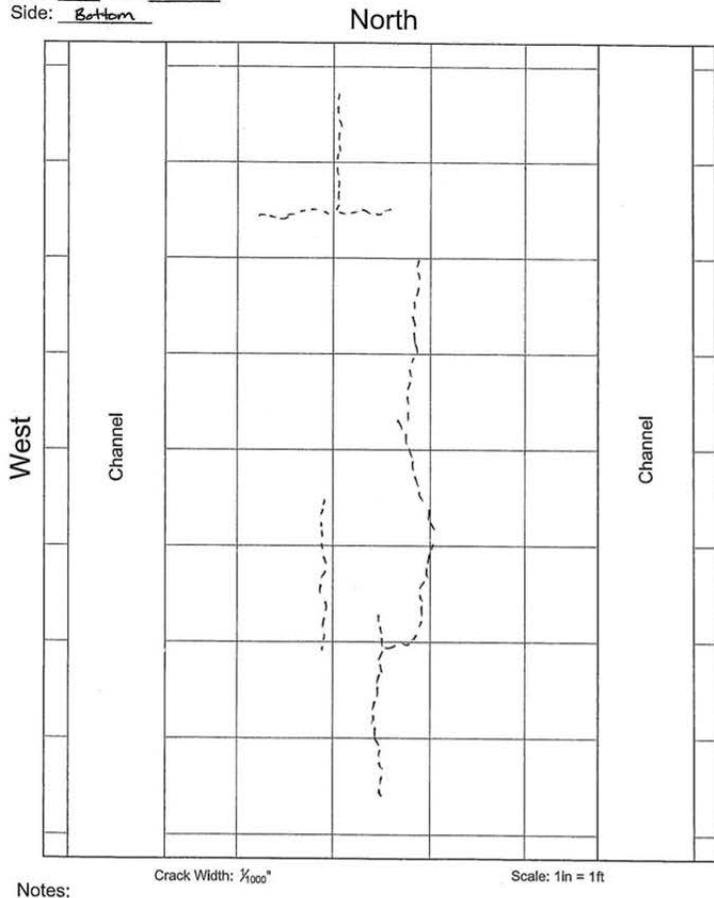
Figure F-28: Crack maps, M1000_a test panel, 1,071,820 traffic cycles.

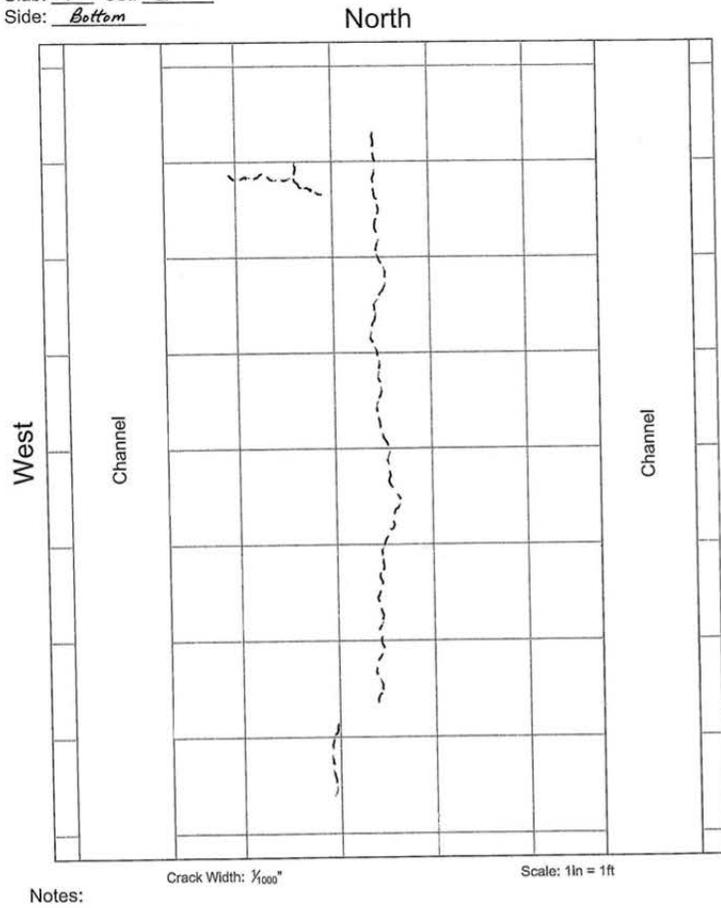
Figure F-34: Crack maps, M1000, test panel, 422,000 traffic cycles.

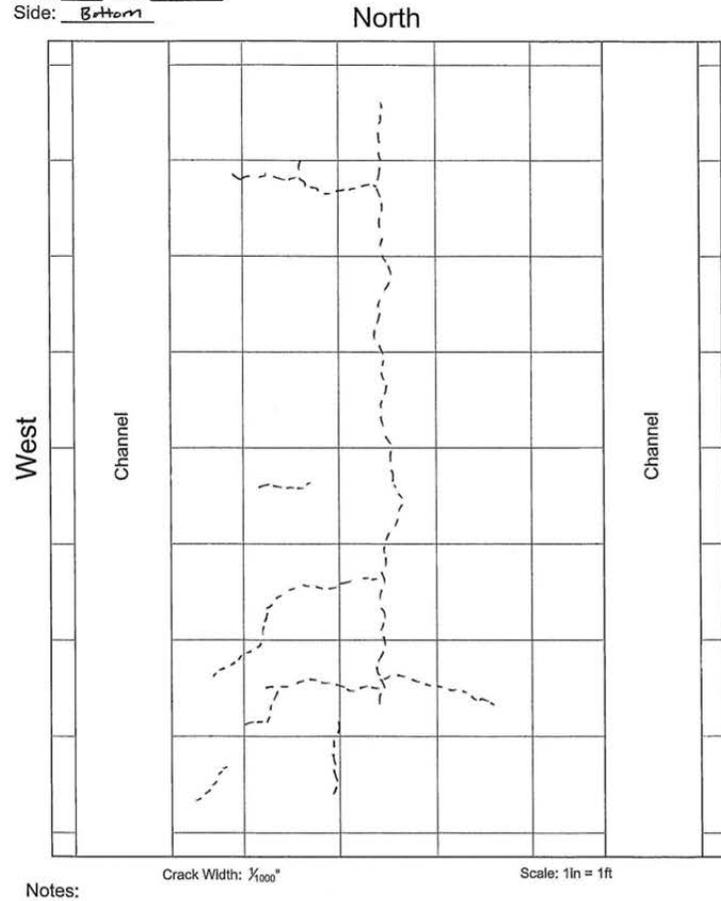
Figure F-35: Crack maps, M1000, test panel, 1,071,820 traffic cycles.

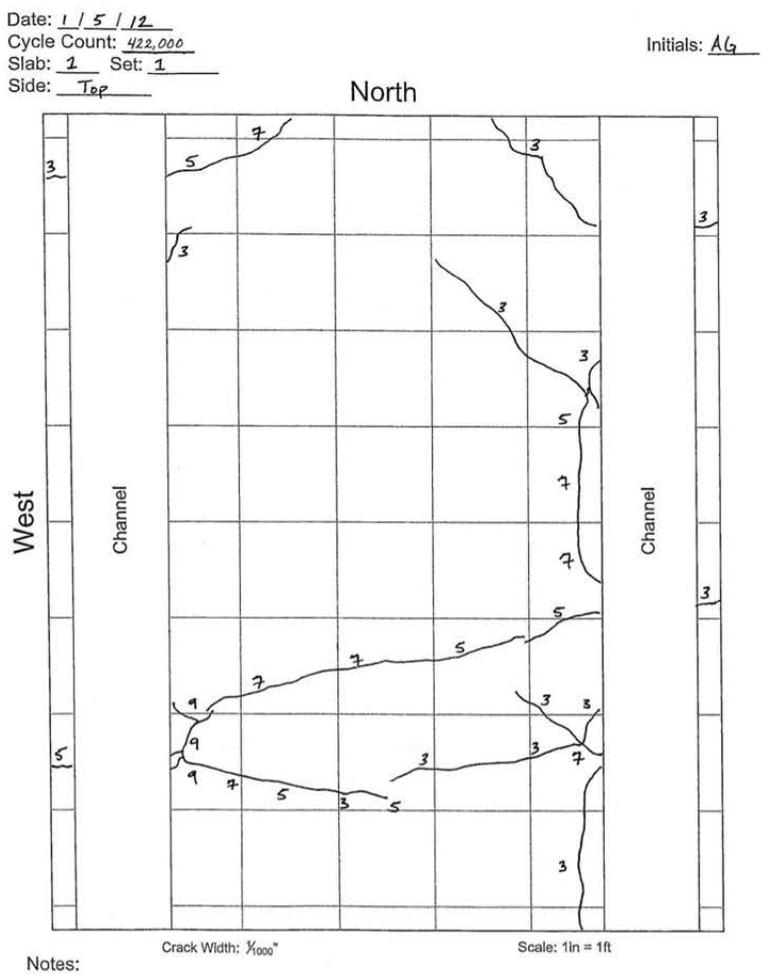
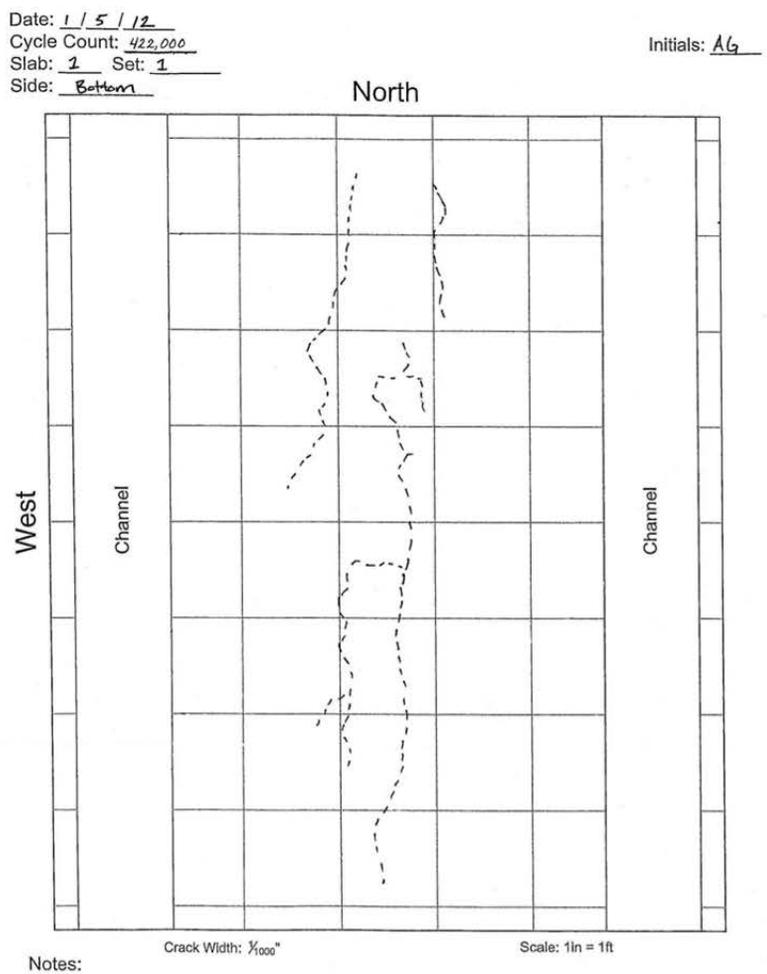
Figure F-42: Crack maps, Control_g test panel, 1,071,820 traffic cycles.

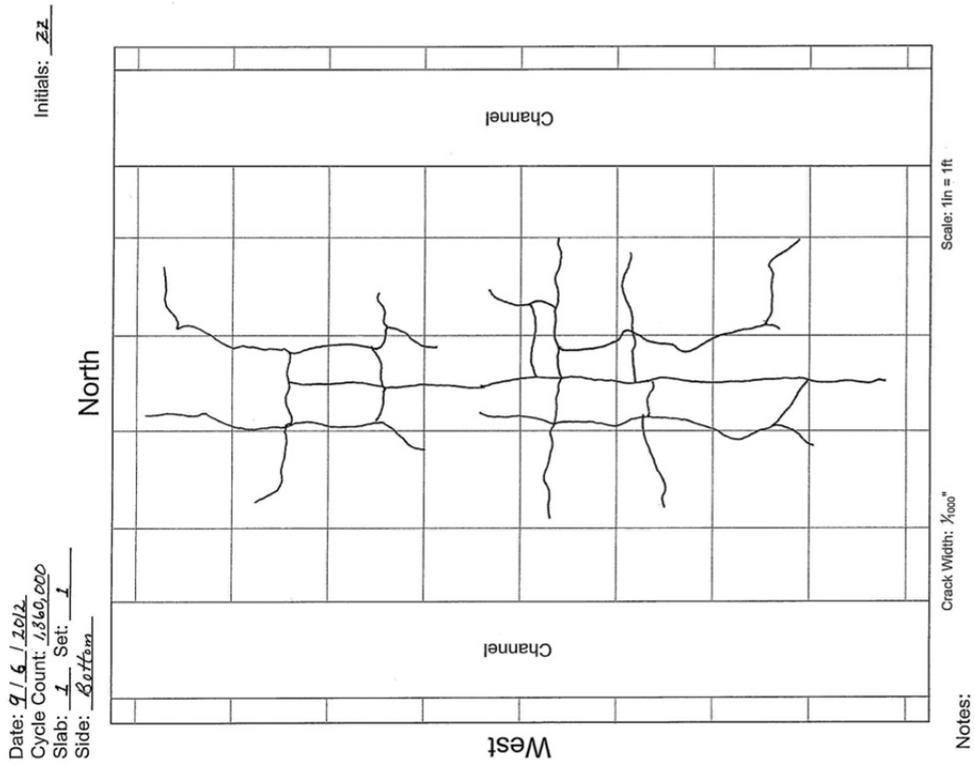
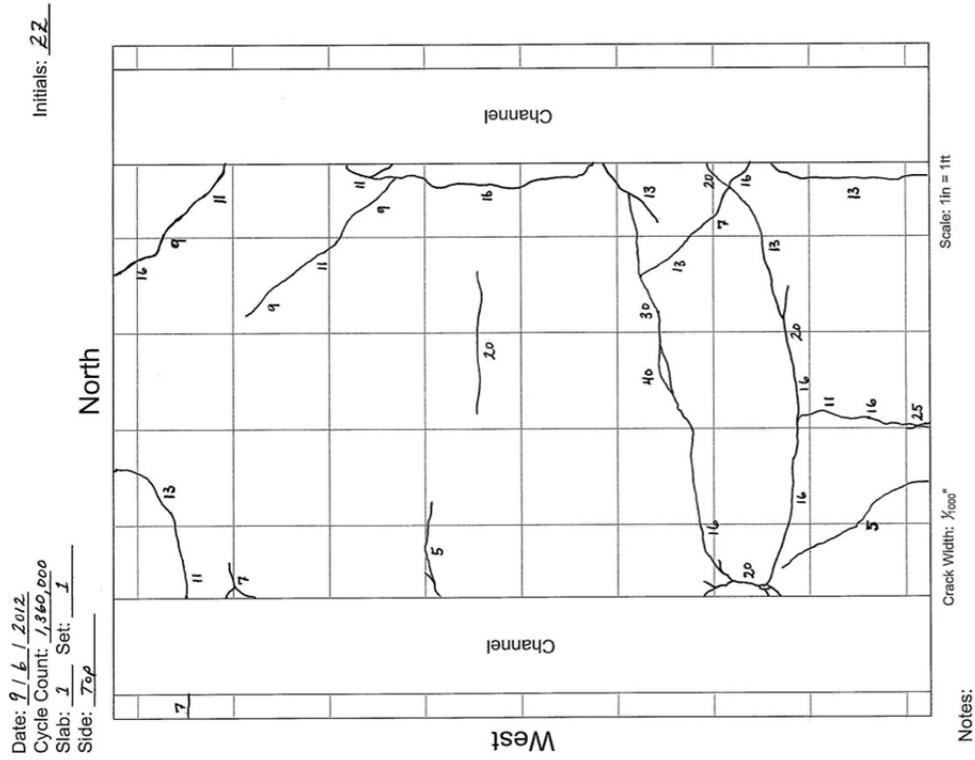
Figure F-43: Crack maps, Control_a test panel, 1,360,000 traffic cycles.

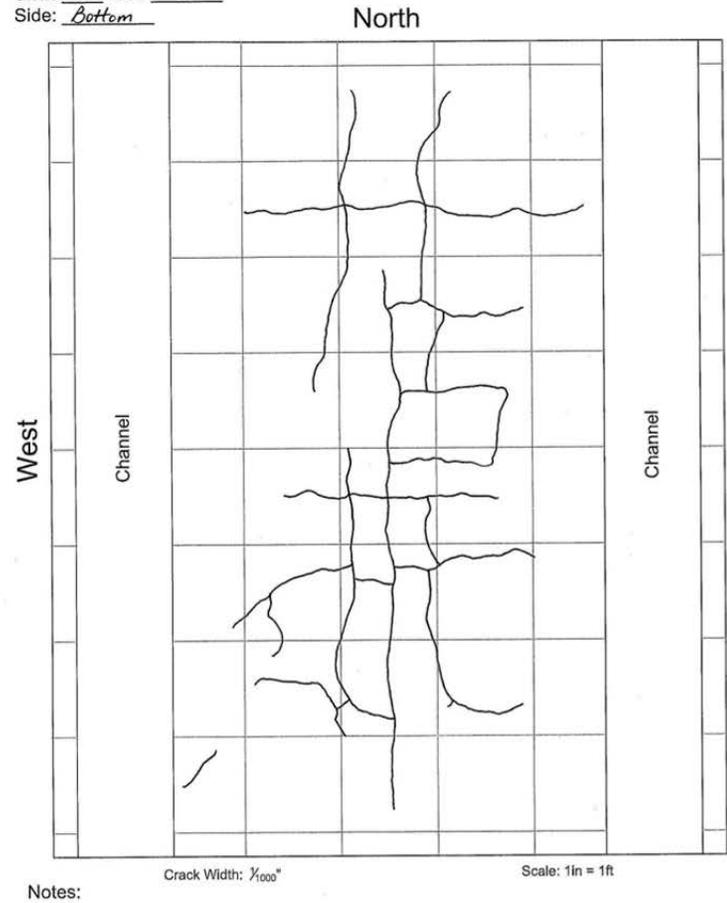
Figure F-45: Crack maps, M1000_a test panel, 2,122,978 traffic cycles.

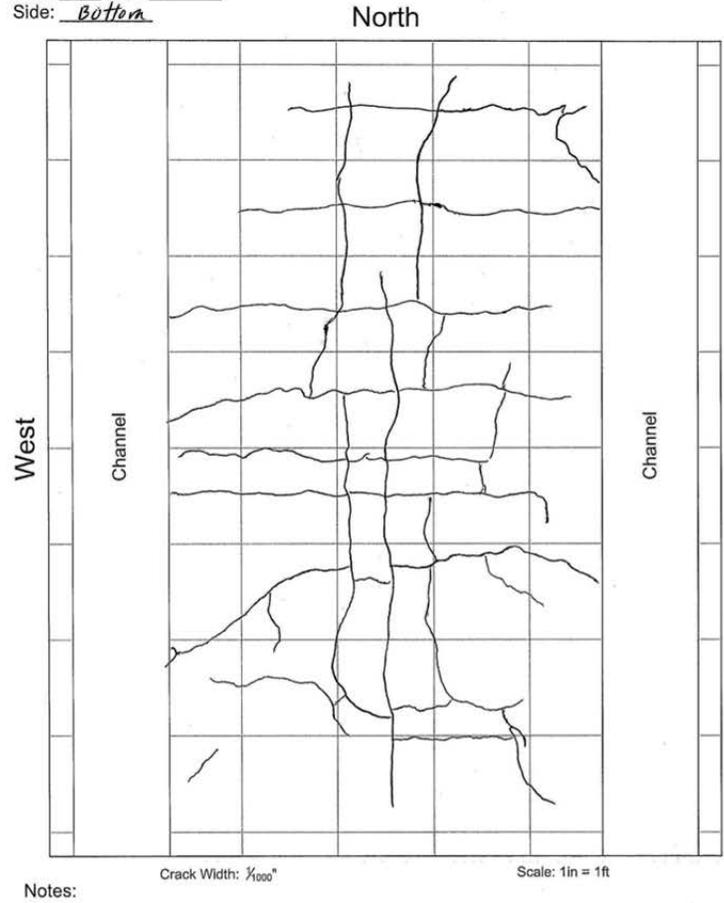
Figure F-46: Crack maps, Control, test panel, 12,000 traffic cycles.

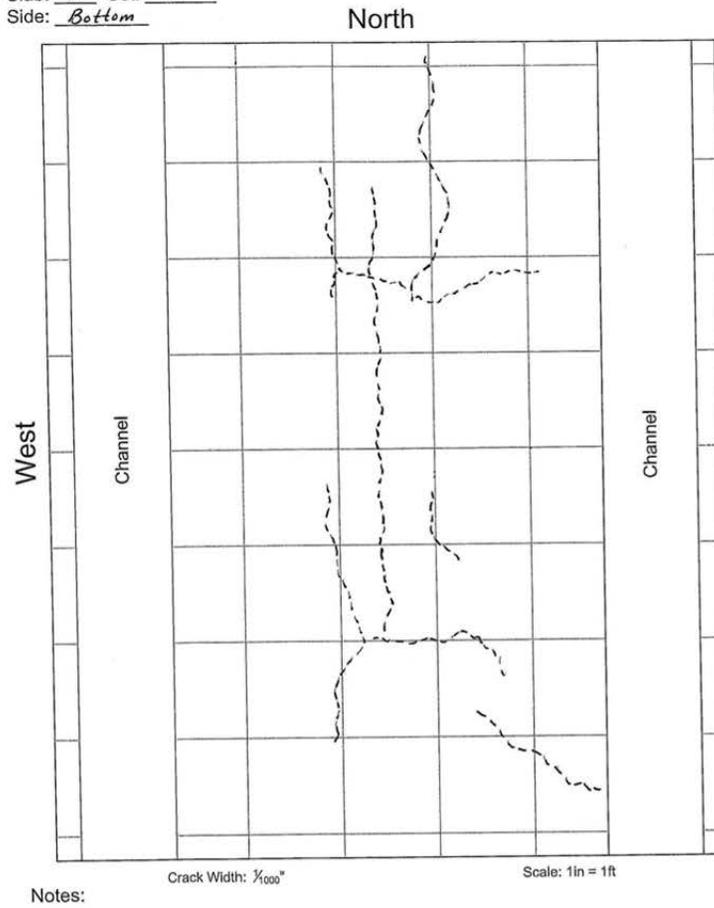
Figure F-48: Crack maps, Control, test panel, 422,000 traffic cycles.

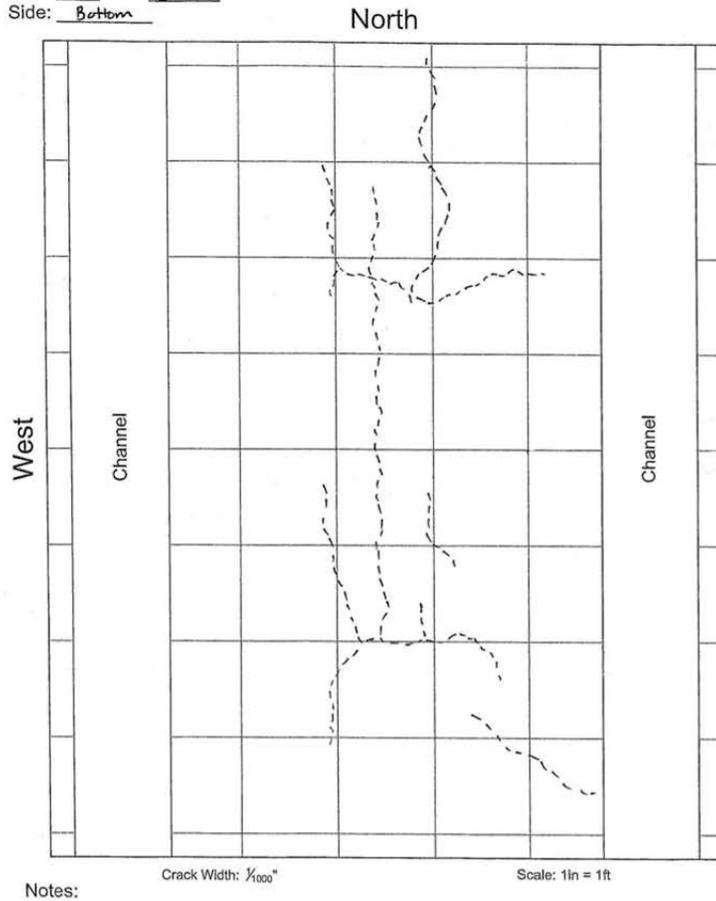
Figure F-49: Crack maps, Control₆ test panel, 1,071,820 traffic cycles.

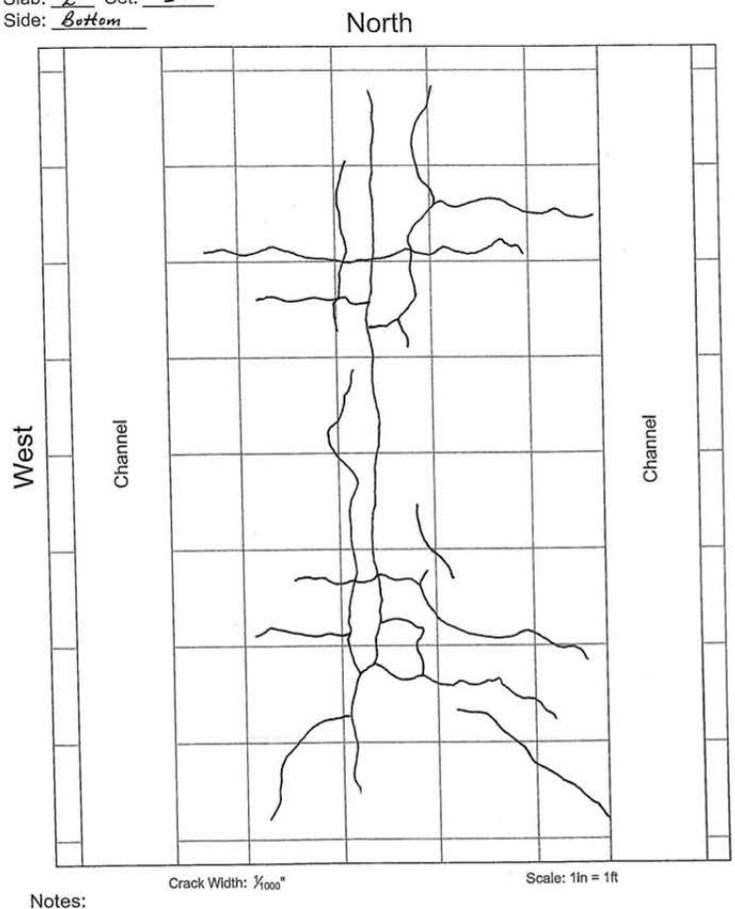
Figure F-51: Crack maps, Control₆ test panel, 1,660,000 traffic cycles.
