1. REPORT NUMBER CA13-2090	2. GOVERNMENT ASSOCIATION NUMBER	3. RECIPIENT'S CATALOG NUMBER
4. TITLE AND SUBTITLE Evaluation of an Animal Warning System Effectiveness - Phase Two		5. REPORT DATE June 2012

Evaluation of an Animal Warning System Effectiveness Phase Two - Final Report

**California PATH Research Report
UCB-ITS-PRR-2012-12**

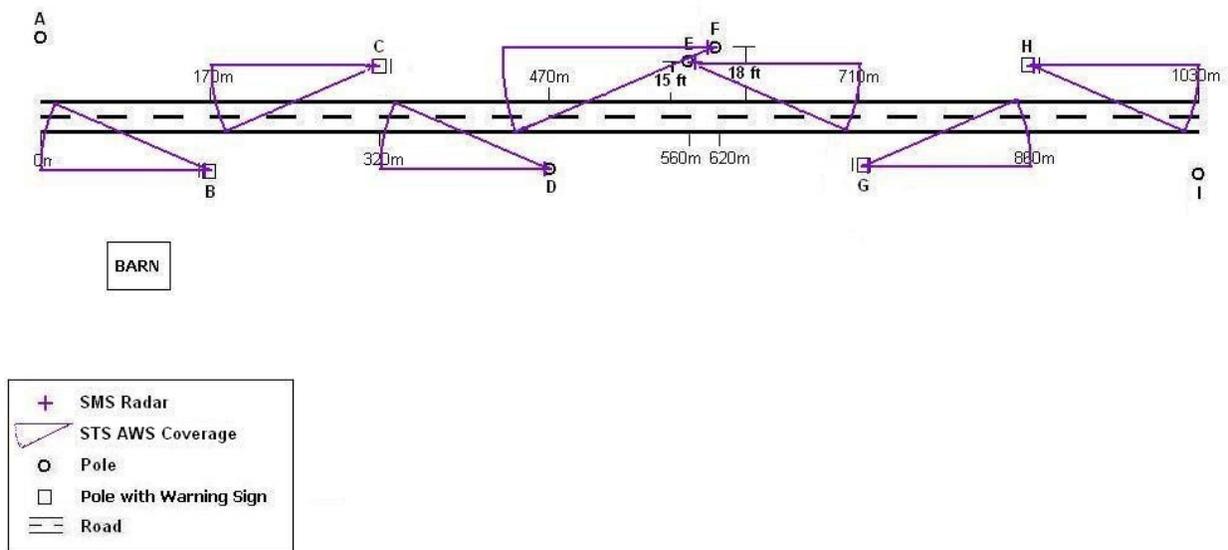
Figure 3.1: A Diagram of SMS Radar Layout.

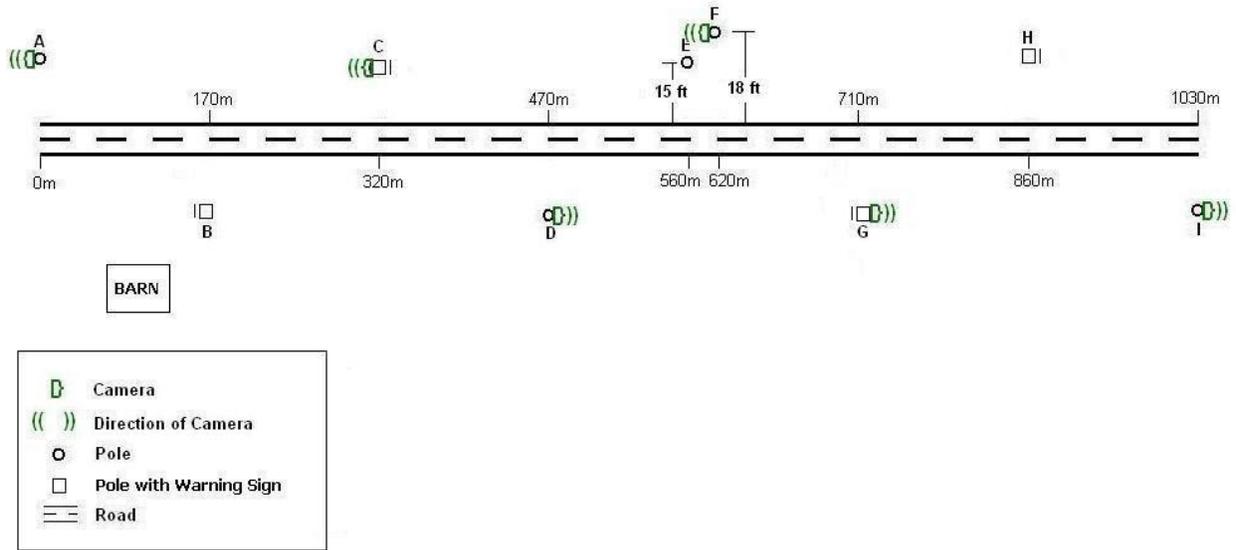
Figure 3.2: A Diagram of Omcon Video Cameras Layout.

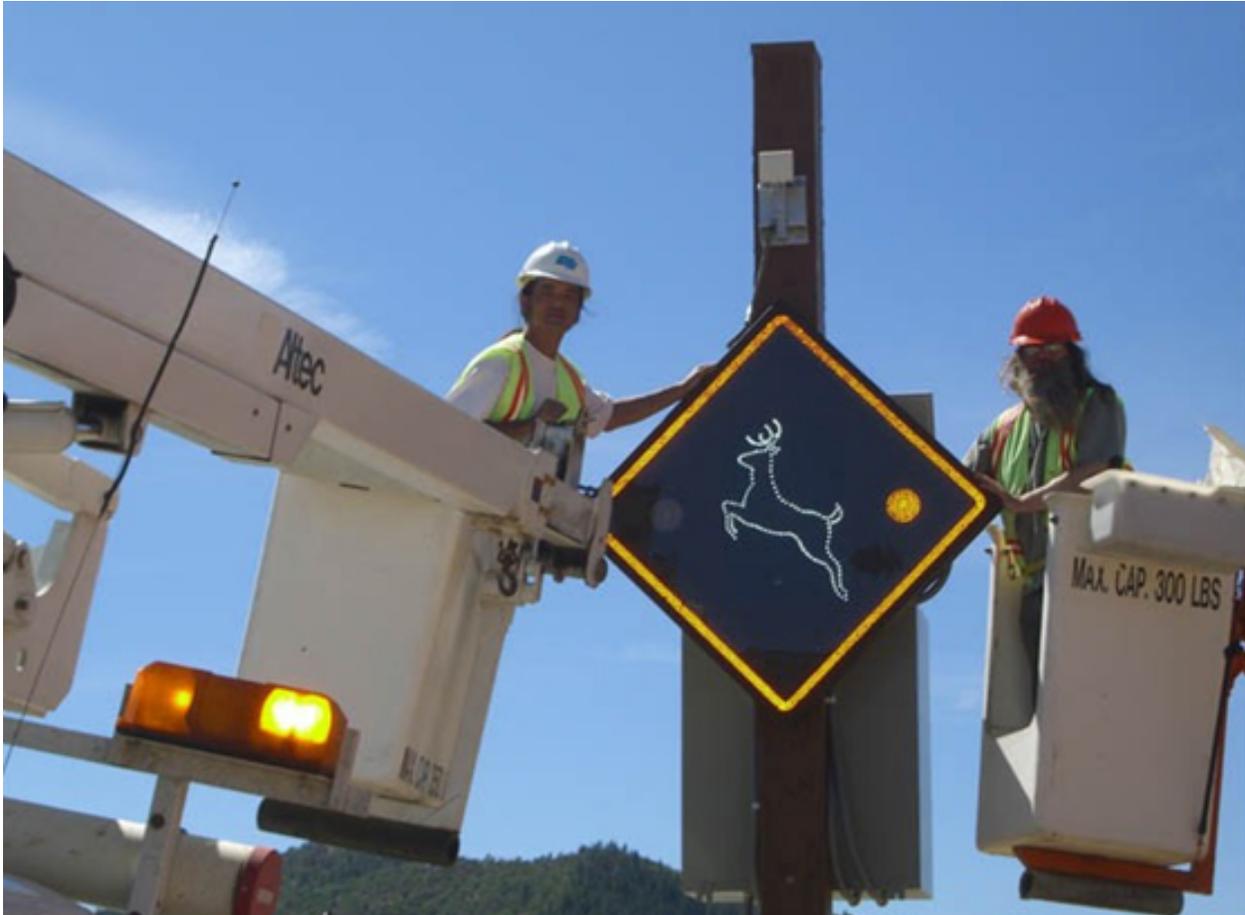
The four animal warning signs were designed and manufactured by Electro-Tech. Two animal warning signs (see Figure 3.3) were installed for each road direction: on Poles B and G on one direction and poles H and C on the other direction of diagram 5 above. The acceptance tests were done by PATH staff on location.

Figure 3.3: Installation of an Animal Warning Sign.

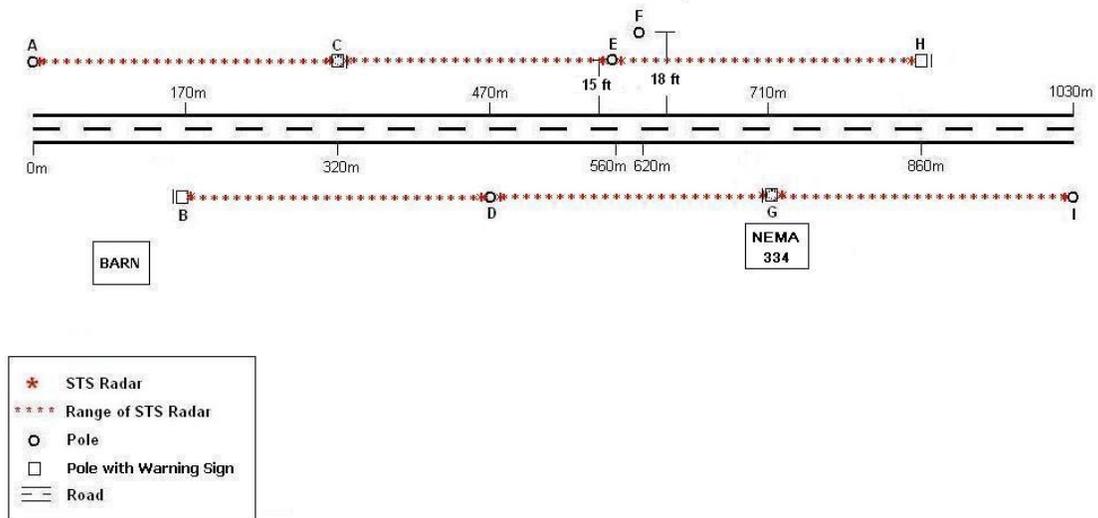
Figure 3.4: A Diagram of RADS System Layout.

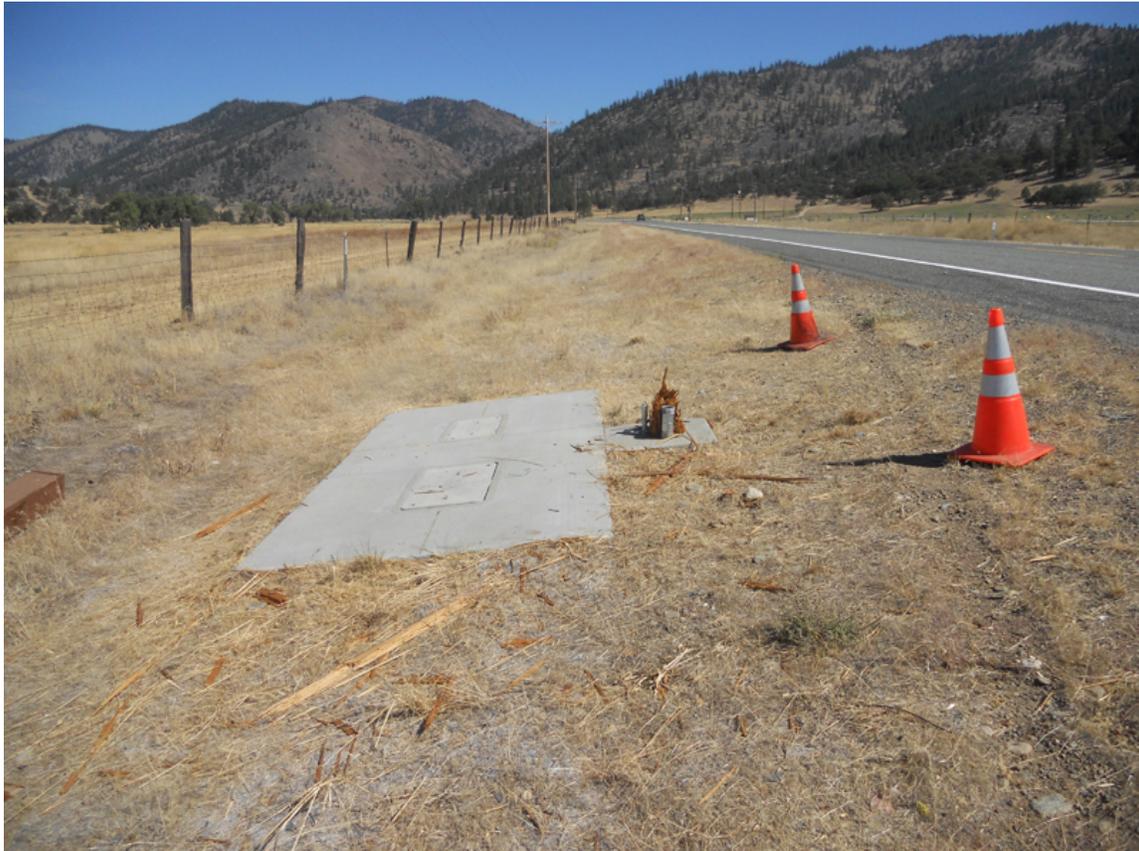
On July 16, 2011, Pole H was hit by a car and fell on the ground. The equipment on Pole H included one SMS radar head, one animal warning sign, one STS animal detection transmitter, one NEMA box, one network switch, one power supply, and one circuit breaker that controls the power to Poles H and I. With the support from Caltrans D2, Pole H was re-installed, and broken parts including the power supply, the network switch, and the circuit breaker were replaced. However, a new STS transmitter could not be procured. The original inventor of the device and the company that currently owns it are in an intellectual property conflict, and a replacement could not be procured.

Figure 3.6: Pole H after Being Struck and Removed.

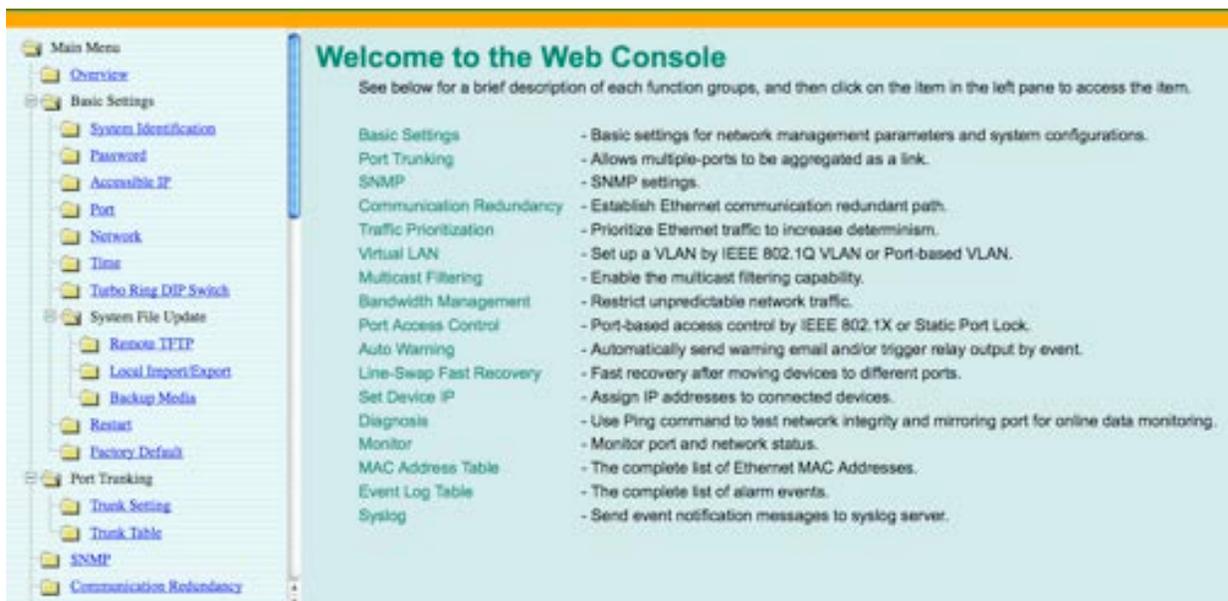
Managed network switches were chosen when the project's network infrastructure was designed. Managed network switches provide a lot of diagnostic information that is not typically available in non-managed network switches, as can be seen in Figure 4.1.

Figure 4.1: Switch Management Menu.

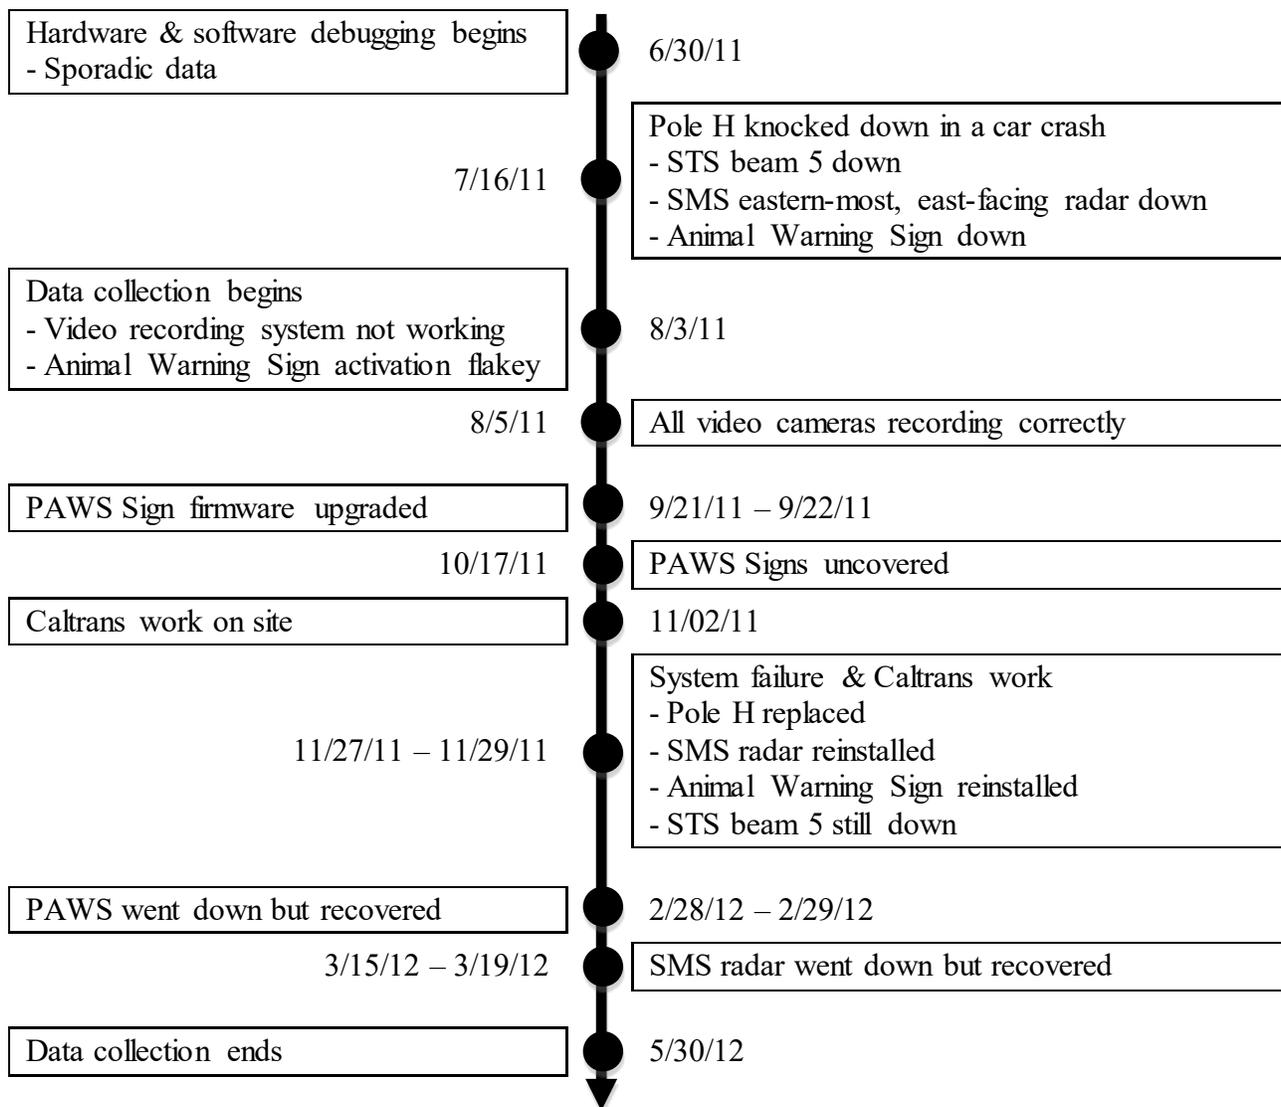
The California PATH Animal Warning System (PAWS) data collection, as analyzed in this report, officially began on August 3, 2011 and officially ended on May 30, 2012, resulting in approximately 10 months and 1 TB of engineering and video data. The system was operational 24/7, and in the time period covered by this report, only 11 days of data was discarded due to system failures or work being performed on the test site. Figure 5.1 below depicts a brief timeline of data collection period and system functionality during this phase of the project.

Figure 5.1. Data collection timeline.

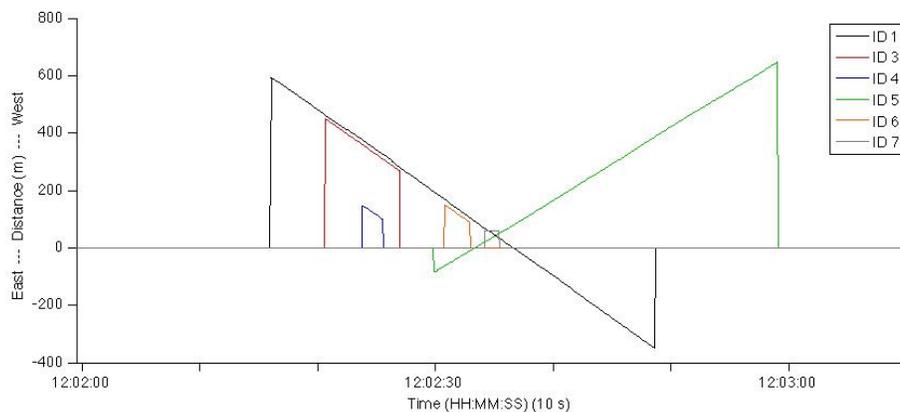
Similarly target ID 7 appeared right as the two vehicles passed each other, indicating a ghost reflection generated by the crossing of the vehicles. After some investigation, target 4 was a spurious target generated by a bug in the SMS radar system. It seemed to occur frequently at the same location when tracking some eastbound vehicles. The high frequency of ghost targets was likely due to the fact that there was very little overlap in the coverage of the 7 SMS radar heads. While this allowed the system to cover the entire 1070 m test site, it also degraded the target recognition when transitioning between radar heads. Fortunately, most of the false targets only appeared in the data for about 10 seconds or less, allowing them to be filtered out by a simple time-based filter.

Figure 5.2: SMS radar spurious target filtering.

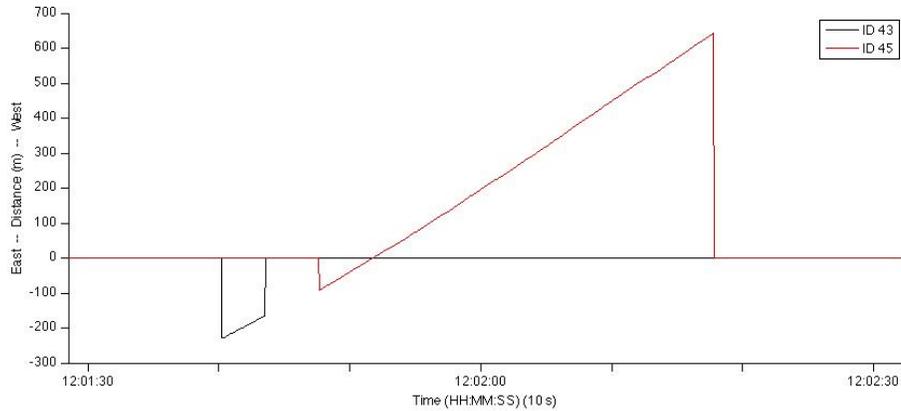
A similar pattern was sometimes seen for eastbound vehicles entering the test site at the limits of the radar's detection range on the west side of the test zone (although less frequently than for westbound vehicles). The time-based filter used to reduce the number of false targets also filtered out the first segment of the data in these cases where a target was acquired briefly, lost, and then reacquired with a different target ID. Thus, in the demonstrated case, the data shown for target ID 43 was discarded, and the analysis was only based on the data shown for target ID 45.

Figure 5.3: Westbound vehicle target loss and reassignment.

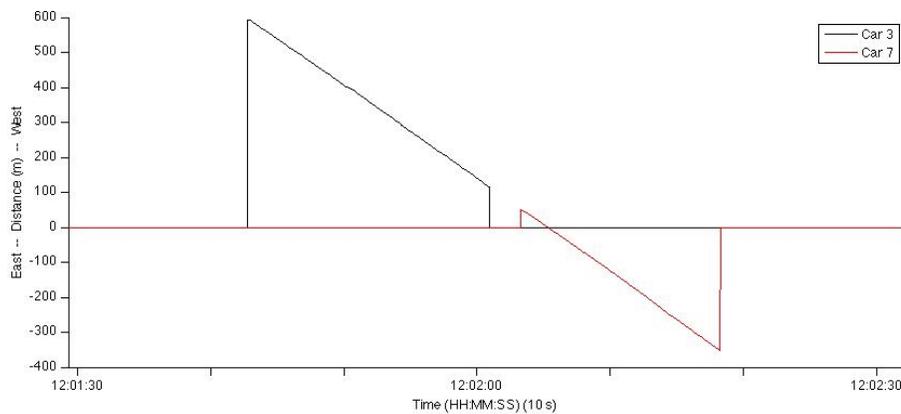
The third and final problem with the SMS data for which a filter was derived was localized to eastbound vehicles. As shown in Figure 5.4, target IDs 3 and 7 was actually the same vehicle, verified by video. The SMS radar system, as implemented at the test site, had a tendency to lose the tracking of eastbound vehicles as they transitioned from one radar head to the next, crossing through Y-values between 100 and 50 m. This particular pattern occurred quite frequently, and a filter was written to merge the two tracks and interpolate over the missing data. A similar pattern was not seen with westbound vehicles.

Figure 5.4: Eastbound vehicle target loss and reassignment.

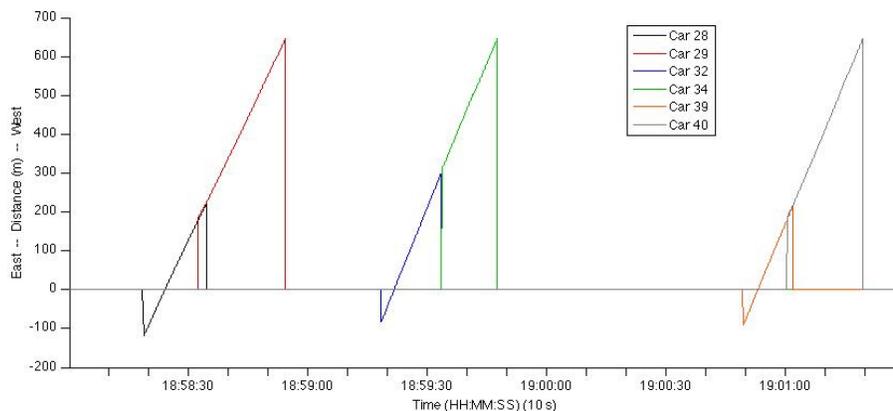
Unfortunately, the pattern shown in Figure 5.5 was more challenging to filter out than it would appear. Based on an analysis of the video, sometimes, this could be due to a vehicle towing a trailer, but sometimes there really were two vehicles that were very closely spaced. Additionally, there were issues with vehicles turning off or onto the main road, or pulling off to the side of the road. Attempts to handle the case of a target vehicle switching ID with some overlap between the two IDs could not be perfected in the time-frame of this project. For as many of the cases as were handled correctly, a similar amount of cases were generated where vehicle tracks were incorrectly merged.

Figure 5.5: SMS radar over-counting the number of vehicles.

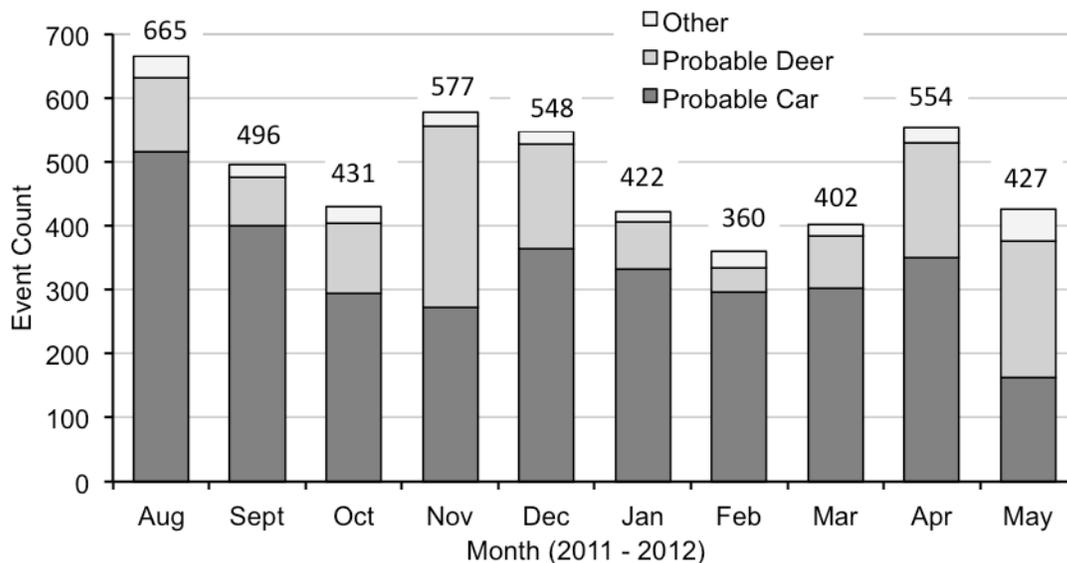
As shown in Figure 6.1, the total number of PAWS events varied from as high as 665 in August to as low as 360 in February. Approximately 67.4 percent or 3292 of the events were labeled as most likely being triggered by turning vehicles, while 27.4 percent or 1335 cases were labeled as probable deer or other wildlife. This averaged to 11.4 car events and 4.6 wildlife events being generated each day. Interestingly, the ratio between the number of car events and the number of wildlife events did not remain constant each month. The highest number of car-generated events occurred in August (516) and September (400). From October to April, the number of car-generated events averaged between 10 and 11 per day, while August and September average 17.8 and 14.2 car-generated events per day. Mostly likely, this activity corresponded to increased farming and harvesting activity.

Figure 6.1: PAWS events by month.

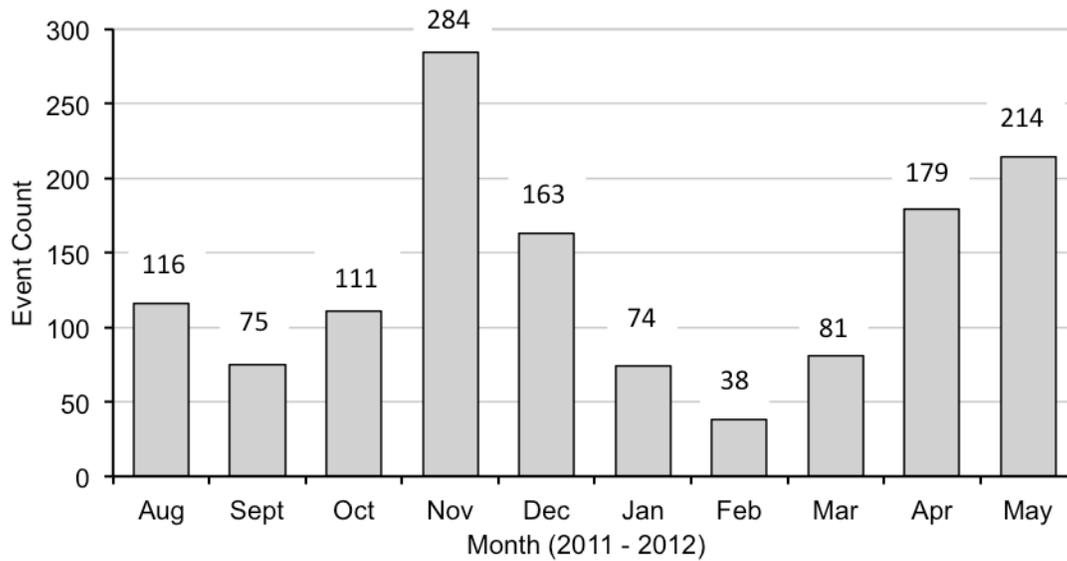
As shown in Figure 6.2, the number of wildlife-triggered events also varied by month with increased activity seen in November, December, April, and May. Wildlife related PAWS events peaked at a rate of 10.5 per day in November, and averaged between 5 and 7 per day in November, April and May. The pattern shown in Figure 6.2 actually matches typically described deer activity patterns. Increased deer activity is usually seen during late fall mating season, October through December, and again during the spring, April and May. Overall, the monthly patterns seen for both cars-generated and wildlife-generated events generally match expectations.

Figure 6.2: PAWS events most probably related to wildlife activity.

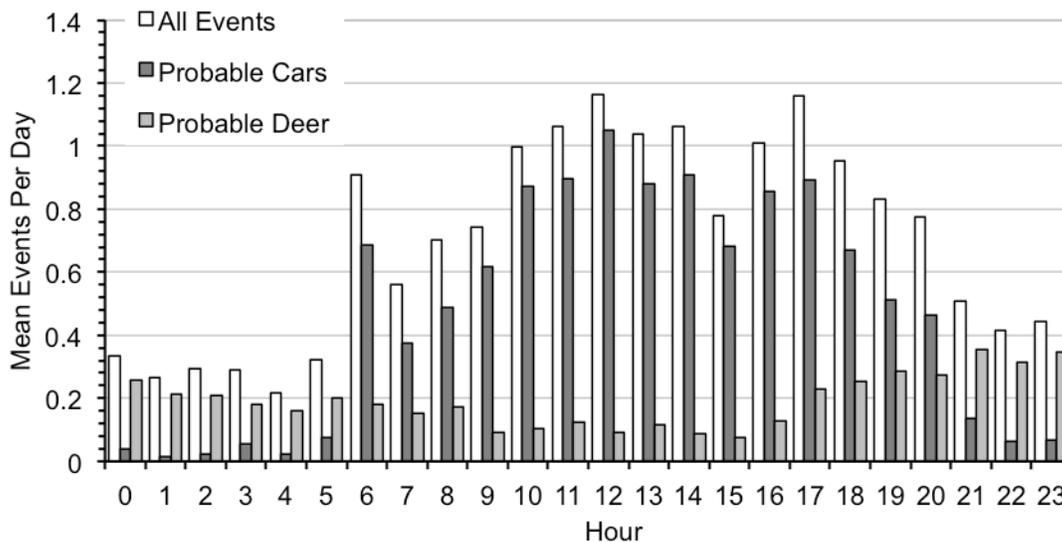
The pattern of PAWS events per hour, shown in Figure 6.4, also corresponds with expectations. PAWS events that were likely triggered by turning vehicles were mostly clustered during the daytime hours of 6 AM to 8 PM. PAWS events that were suspected of being due to wildlife activity were more frequently noted from about 4 PM until midnight, when animals are known to be most active. From about 10 AM until about 6 PM, there was almost one event per hour per day. Between 10 PM and 6 AM, there was only a mean of 0.33 events per hour per day, or put another way, during any given night, there was only about a 33 percent chance of an event in any given hour.

Figure 6.4: PAWS events by hour.

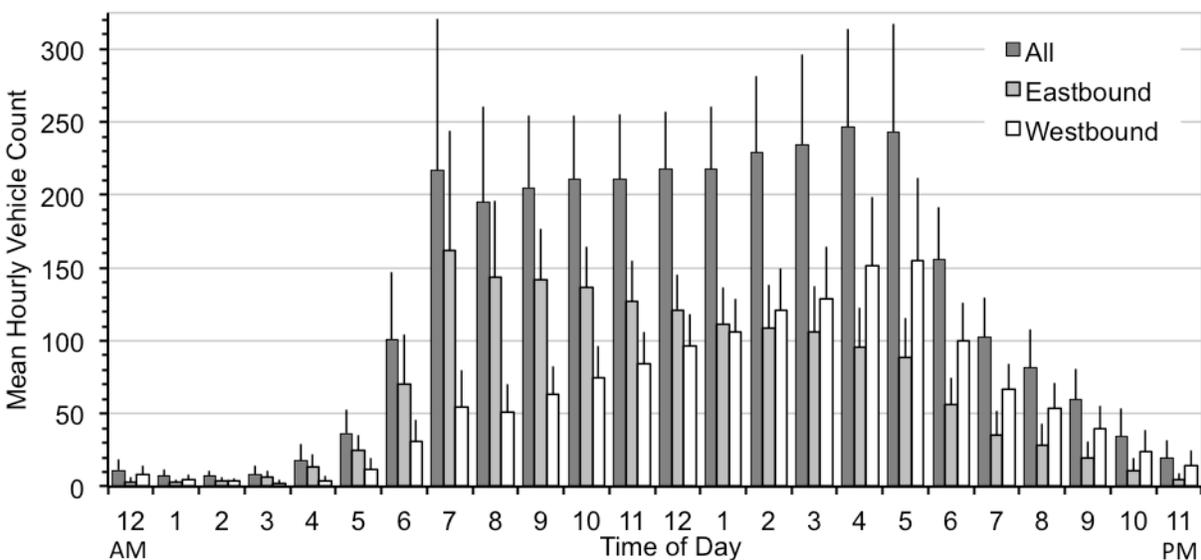
Figure 6.8 provides the most descriptive picture of the travel patterns in both directions along the test site. From 11:00 PM to 5:00 AM, the mean hourly traffic ranged from 7 to 18 cars per hour. The peak morning hour from 7:00 AM to 8:00 AM averaged 216 vehicles per hour, and the peak evening hours from 4:00 PM to 6:00 PM averaged about 245 vehicles per hour. Morning and afternoon traffic remained relatively consistent ranging from 195 to 235 vehicles per hour. Traffic fell sharply after 6:00 PM from 155 vehicles per hour to around 35 vehicles per hour by 10:00 PM.

Figure 6.8: Mean hourly vehicle count.

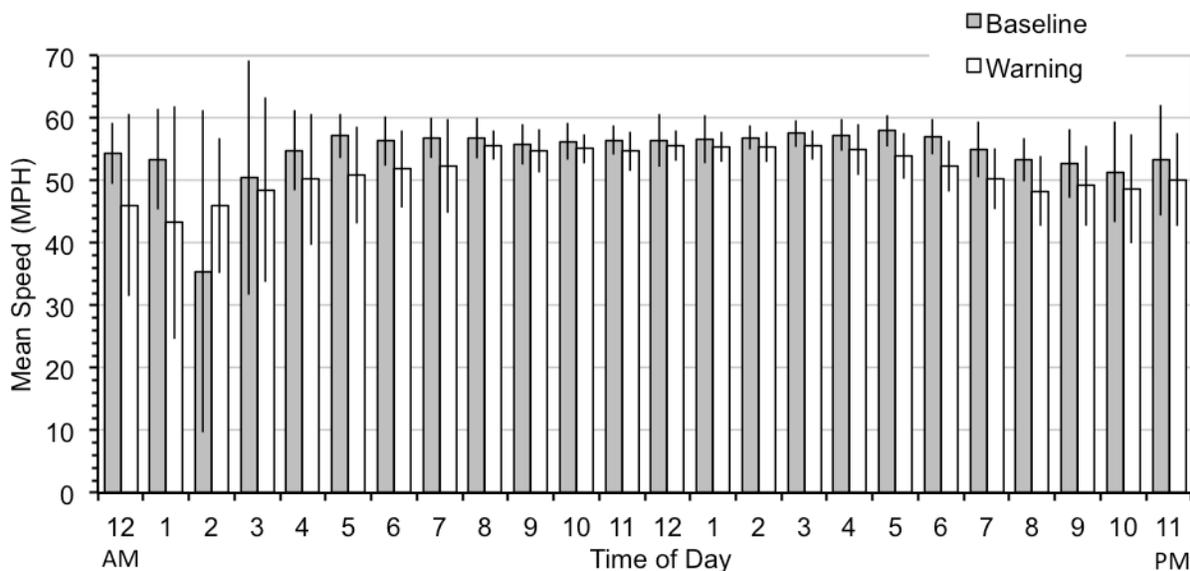
The mean speed during baseline PAWS events (when the animal warning signs were covered) was 56.2 mph (SD 4.4), and the mean speed during PAWS events when the signs were visible to the drivers was 53.1 mph (SD 6.1), suggesting that overall, there was a 3.1 mph drop in the mean vehicle speed when the animal warning signs were illuminated. Furthermore, the interaction between warning presence and time of day is shown in Figure 6.13. This interaction implied that the reduction in mean vehicle speed when the animal warning signs were illuminated was greater in the evenings and overnight, than during the day. This pattern might be explained by driver expectation. If drivers felt that activations during the daytime hours were more likely to be caused by human activity (turning vehicles), while evening and night activations would be more likely to be caused by wildlife, then the drivers might have slowed down more during the evening and night hours than during the daytime hours.

Figure 6.13: Mean speed during PAWS events by hour and by animal warning sign presence.

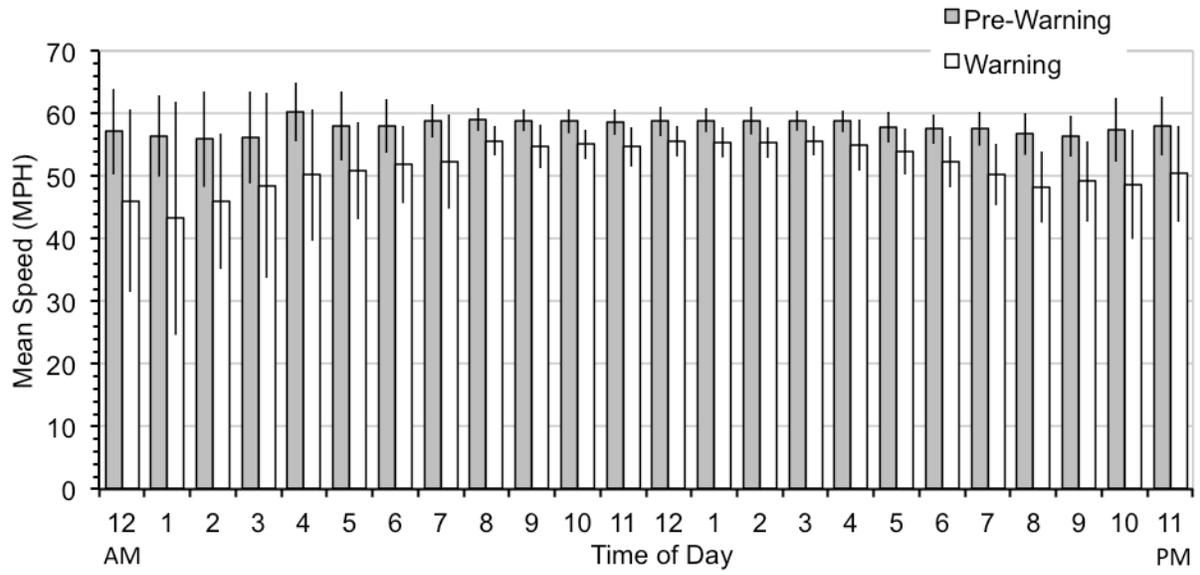
The interaction between warning presence and hour of the day was also significant, and this interaction is shown in Figure 6.17. Similar to the previous analysis using a different measure of the baseline, this interaction shows that the reduction in mean vehicle speed when the animal warning signs were illuminated was greater in the evenings and overnight, than during the day. From 8:00 AM to 6:00 PM, vehicle speeds were reduced by an average of 3.6 mph when the warning signs were illuminated, while from 6:00 PM to 8:00 AM, vehicle speeds were reduced by an average of 8.3 mph.

Figure 6.17: Mean speed by hour and warning presence using pre-warning as baseline.

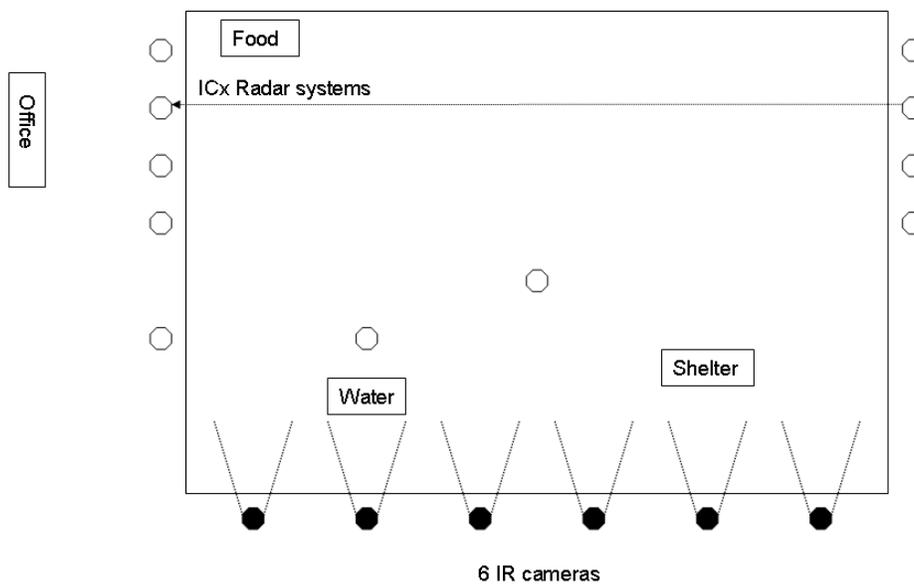
Figure 4.2. Test-bed design including an animal enclosure, the animal detection system tested for this project (open circles represent poles on which sensors can be attached), the six infra-red (IR) cameras aimed at the enclosure from the side (solid circles), and the office with data recording equipment. The arrow shows the direction towards which the transmitter is pointed.

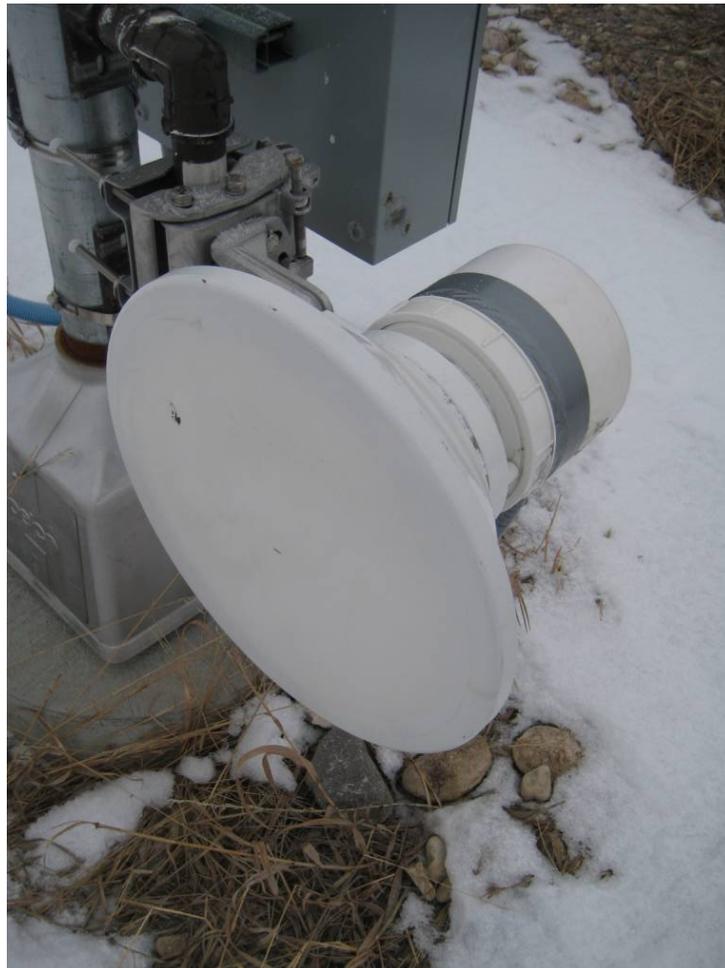
Figure 4.5. The receiver of the third generation break-the-beam system manufactured by ICx Radar Systems. Note: the transmitter looks similar to the receiver.

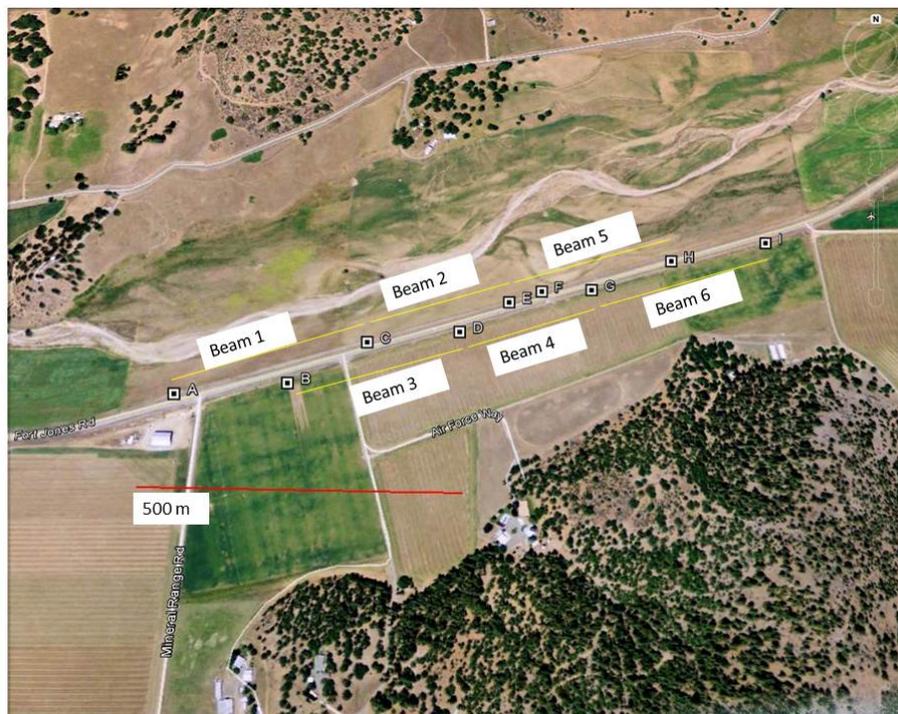
Figure 6.1. Layout of the animal detection system along SR 3 near Ft Jones, CA. Letters indicate poles, numbers and yellow lines indicate beams.

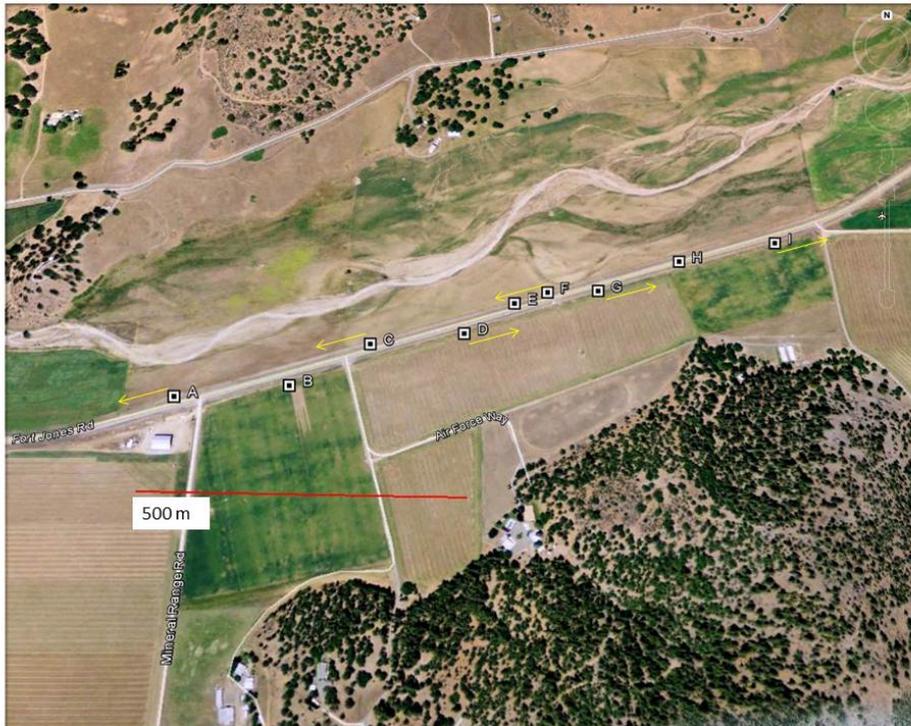
Figure 6.2. The location and direction (yellow arrows) of the video cameras associated with the animal detection system along SR 3 near Ft Jones, CA.
