1. REPORT NO. FHWA/CA08-0287	2. GOVERNMENT ACCESSION NO.	3. RECIPIENT'S CATALOG NO.	
4. TITLE AND SUBTITLE COMPLIANCE CRASH TESTING OF A TYPE 60K TERMINUS		5. REPORT DATE December 2008

Compliance Crash Testing Of The Type 60K Terminus

Final Report

Report No. CA08-0287

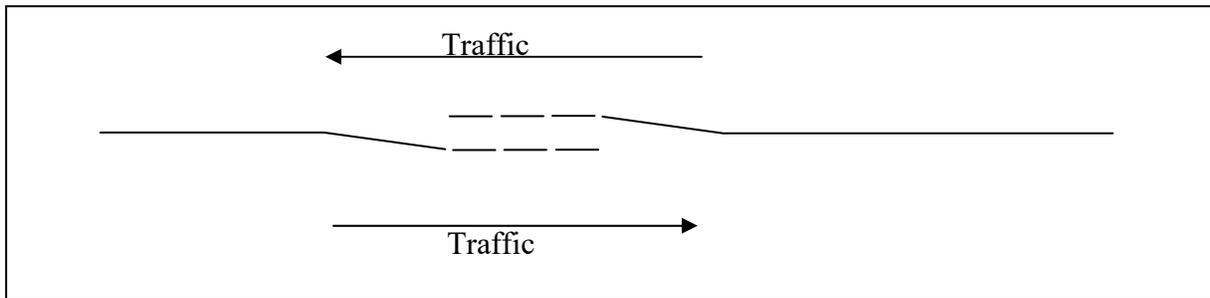
Figure 1-1 – Example Use of Type 60K Terminus

The California Department of Transportation (Caltrans) recently approved a new portable concrete barrier, the Type 60k, for use in semi-permanent applications. Type 60K installations are normally secured at their ends by pinned connections to permanent Type 60 concrete median barriers. This serves to prevent any significant lateral movement of the segments during redirective vehicle impacts under TL-3 conditions. However, recent developments have led to a need for terminating a run of Type 60K barrier segments without attaching the end segment to a permanent concrete barrier. An example of such a configuration is shown in the drawing below.

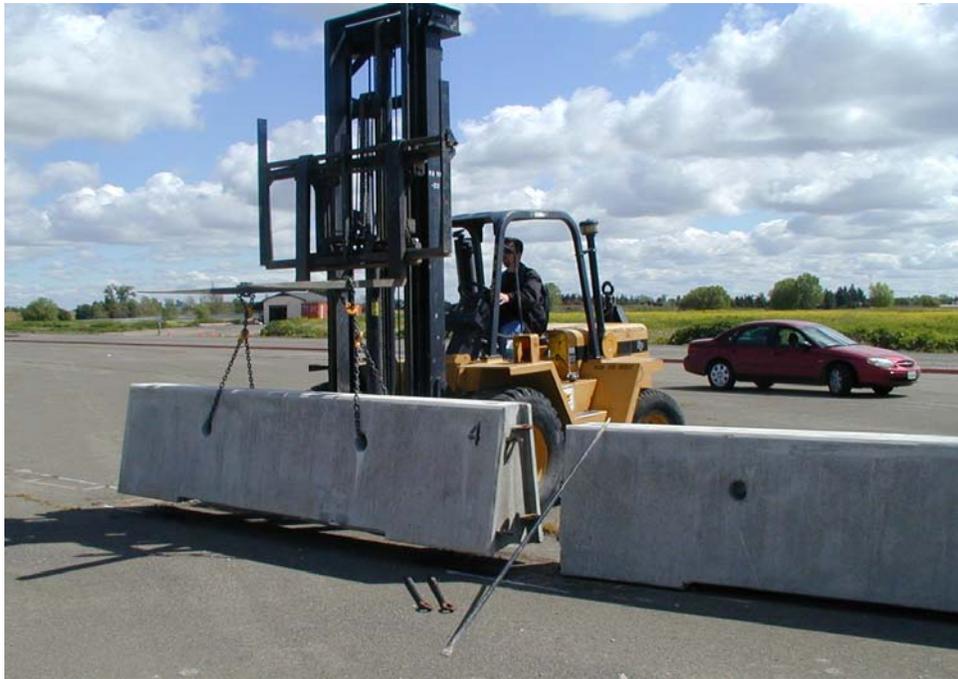
Figure 2-1 – Barrier Placement

A total of nine segments of Type 60K barrier were used to construct the barrier. The barriers were put in place via a 10-kip, side-shifting forklift. 31.8-mm x 760-mm pins were used to connect the segments to each other.

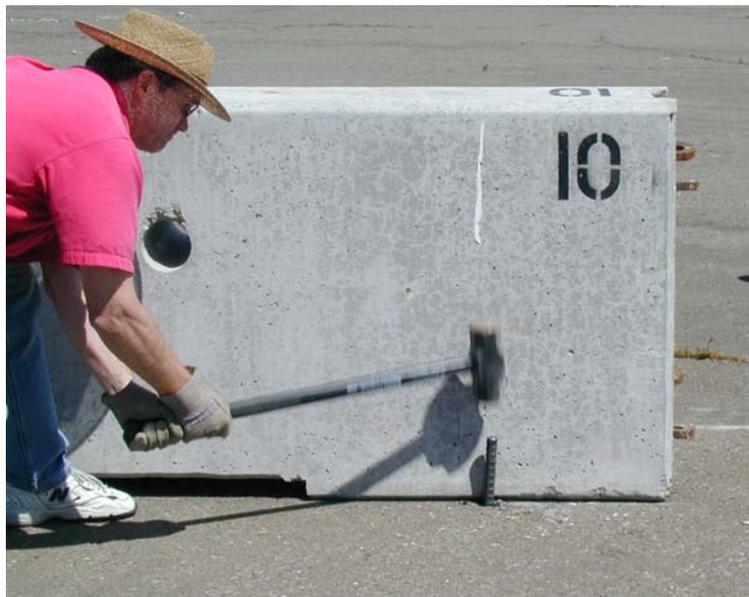
Figure 2-2 – Stake Installation

Segments 8 and 9 were the only segments that were laterally restrained through the use of 25-mm X 1000-mm stakes. The stakes were placed 425 mm from the joints of each of the ends of segments 8 and 9 for a total of 4 stakes. Both a jackhammer with a stake-driver and a sledge hammer were used to drive the stakes. The top 100 mm of each was left above grade.

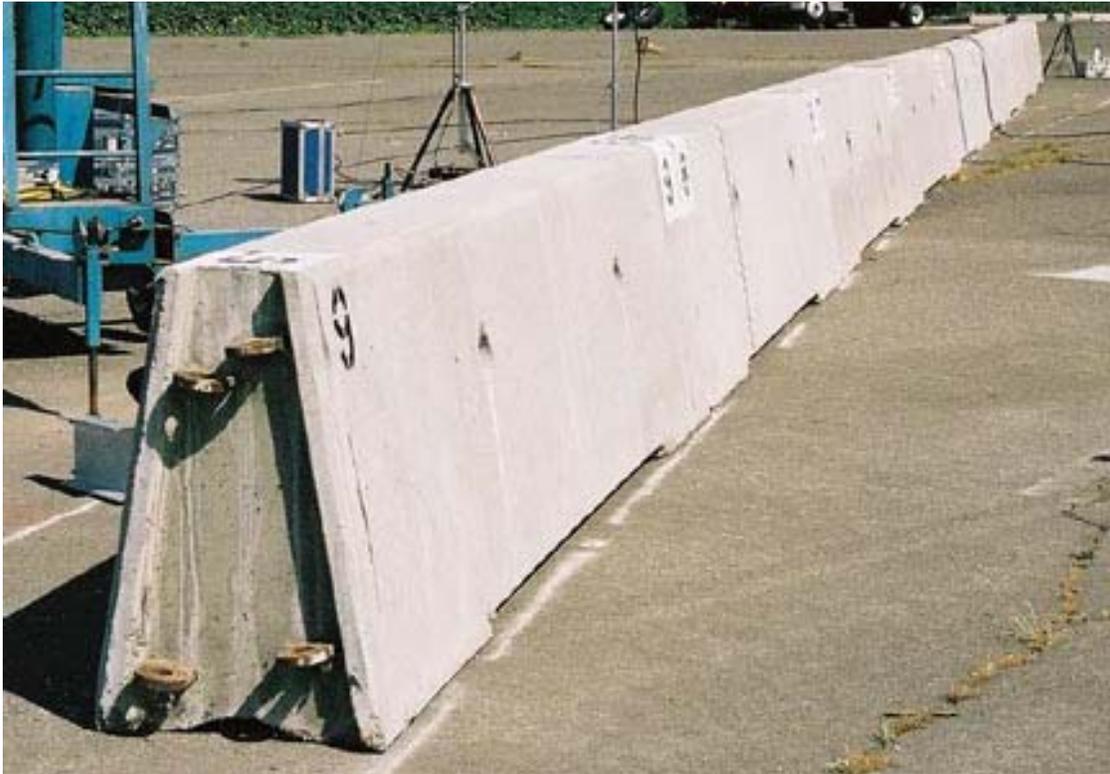
Figure 2-3 – Barrier Alignment

The final test condition of the barrier appeared smooth and flat on the impact side.

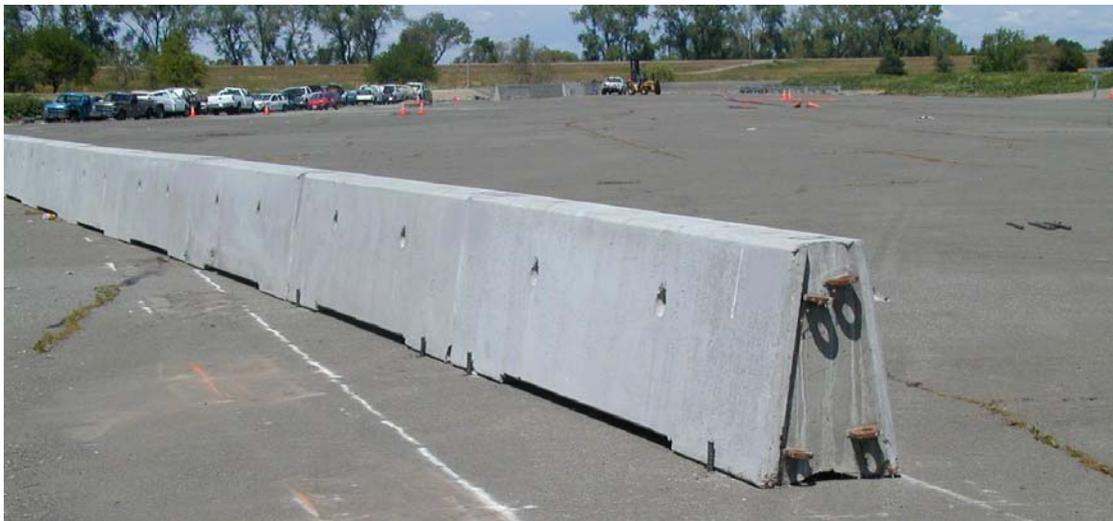
Figure 2-4 – Backside of Completed Barrier with Stakes

The backside of the barrier was also smooth except for the 4 stakes that had been placed for lateral restraint.

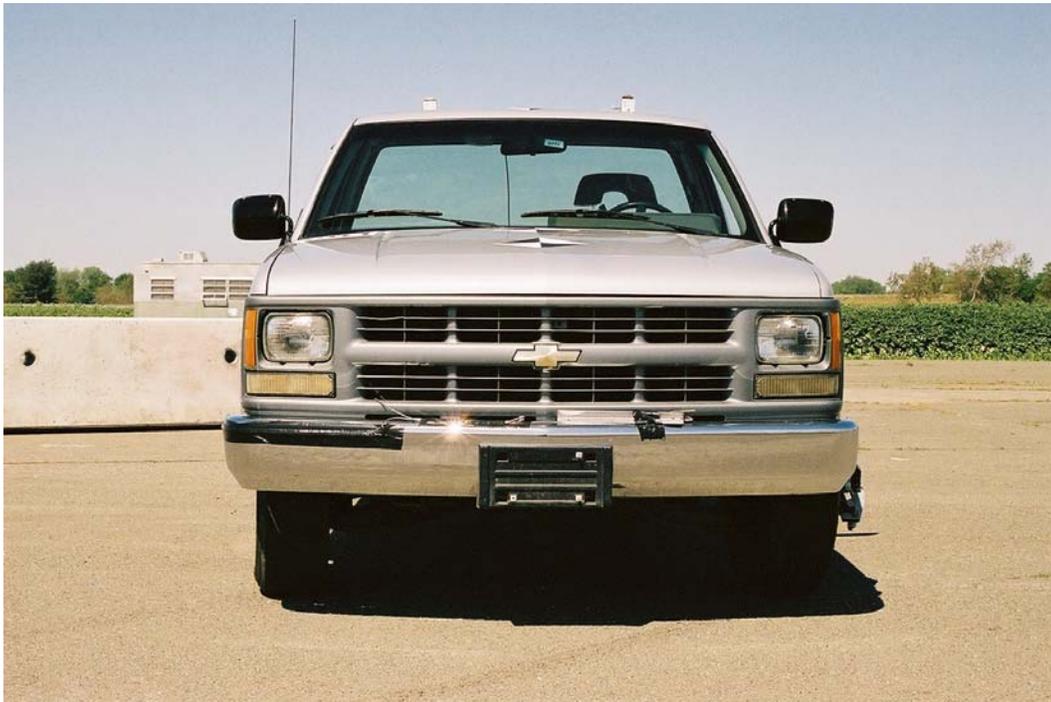
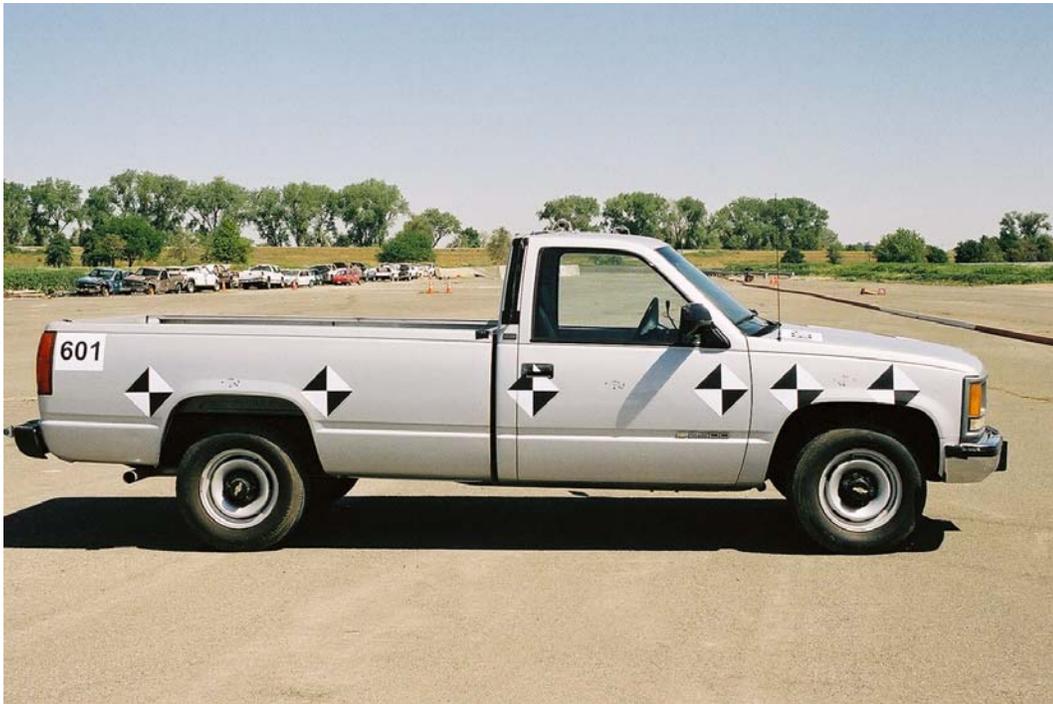
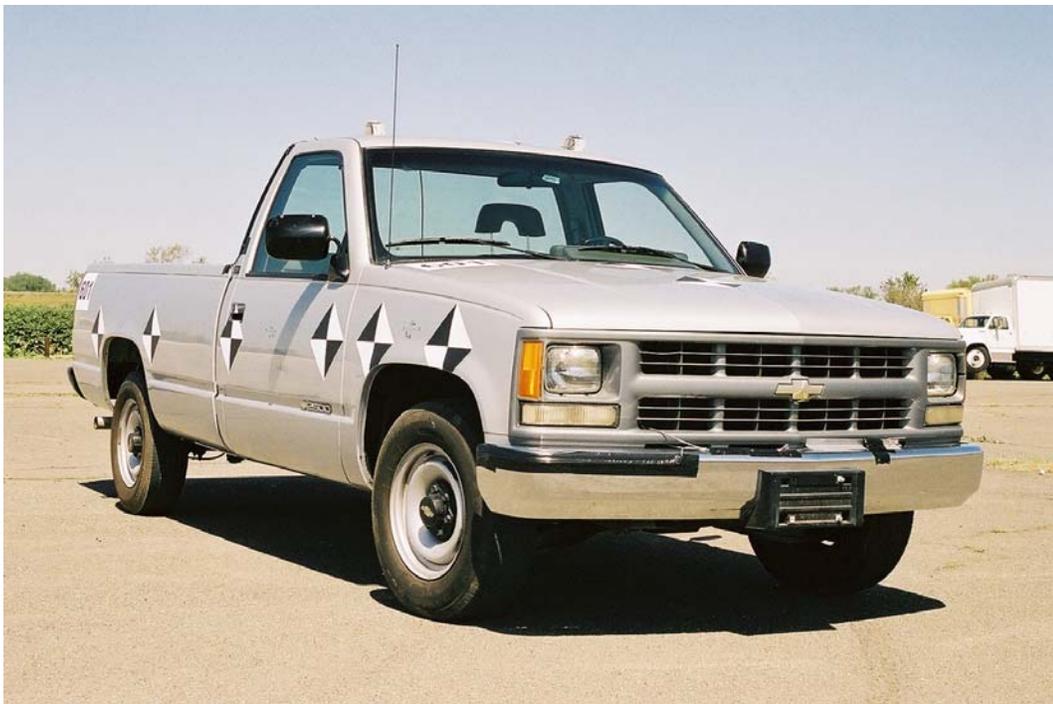
The test vehicle complied with NCHRP Report 350 criteria. The vehicle was in good condition, free of major body damage and was not missing any structural parts. It had standard equipment and a front-mounted engine (see Table 6-1). The vehicle inertial mass was within recommended limits (see Table 2-1). Pictures of the test vehicle prior to impact are included in Figure 2-5 through Figure 2-7.

Figure 2-5 – Front of Test Vehicle Prior to Impact

Figure 2-6 – Right Side of Test Vehicle prior to Impact

Figure 2-7 – Front Right Corner of Test Vehicle prior to Impact

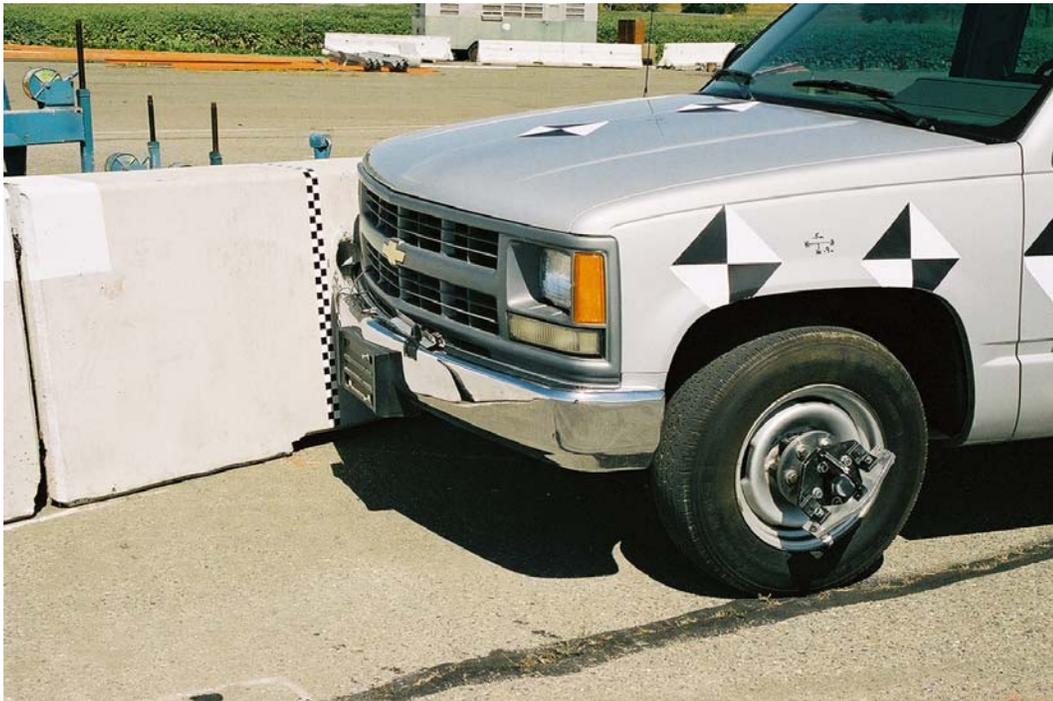
Figure 2-8 – Intended Impact Point

The vehicle impact speed and angle were 100.3 km/h and 24.0 degrees, respectively. Impact occurred at approximately 1000 mm upstream of the joint 8-9 (i.e., the joint between segments 8 and 9). (See Figure 2-8 for an illustration of the intended impact point.) The maximum joint deflection occurred at joint 8-9 at 0.346 seconds after impact. There were no visible signs of snagging and the vehicle was smoothly redirected. The vehicle hood overrode barrier, penetrating the barrier face by approximately 300 mm. The brakes were applied 0.73 seconds after impact.

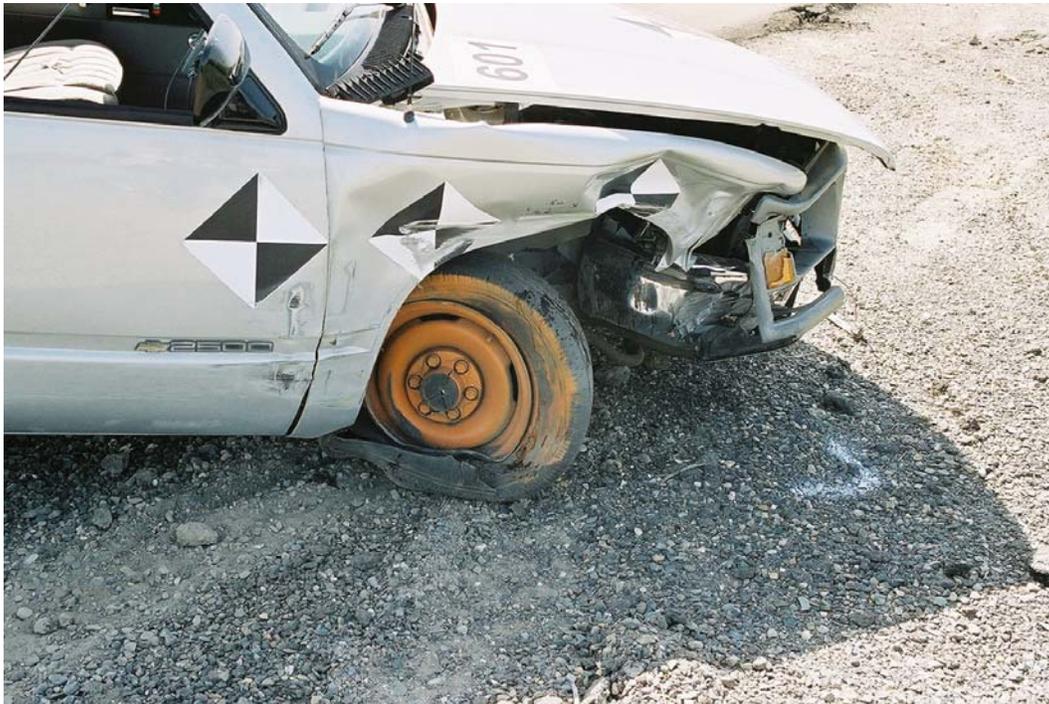
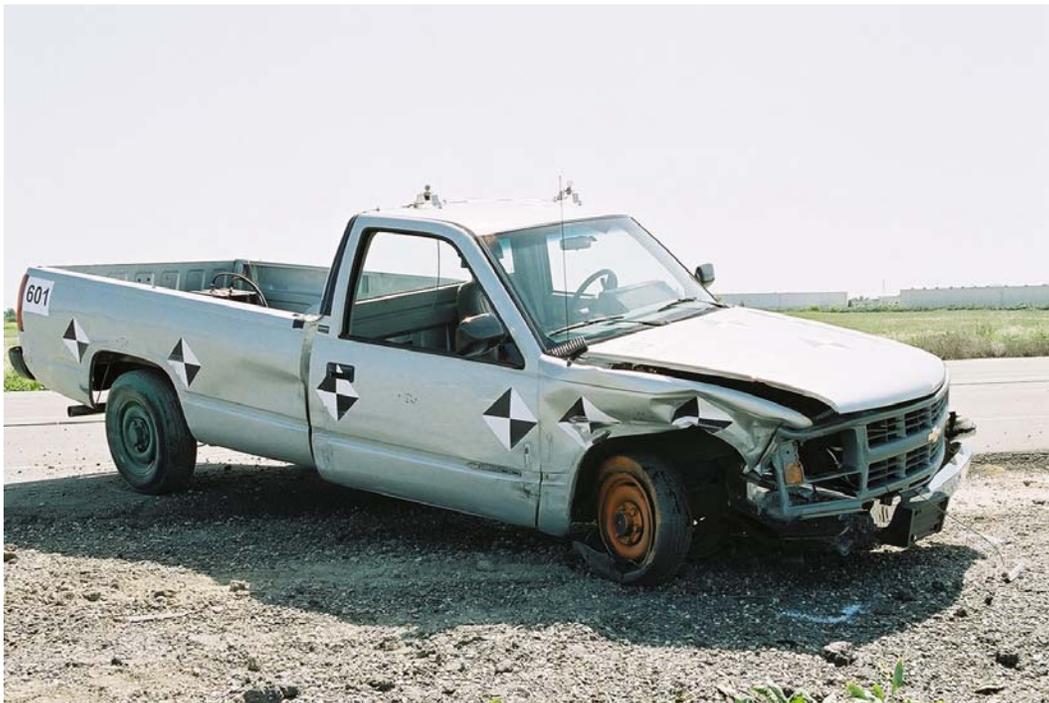
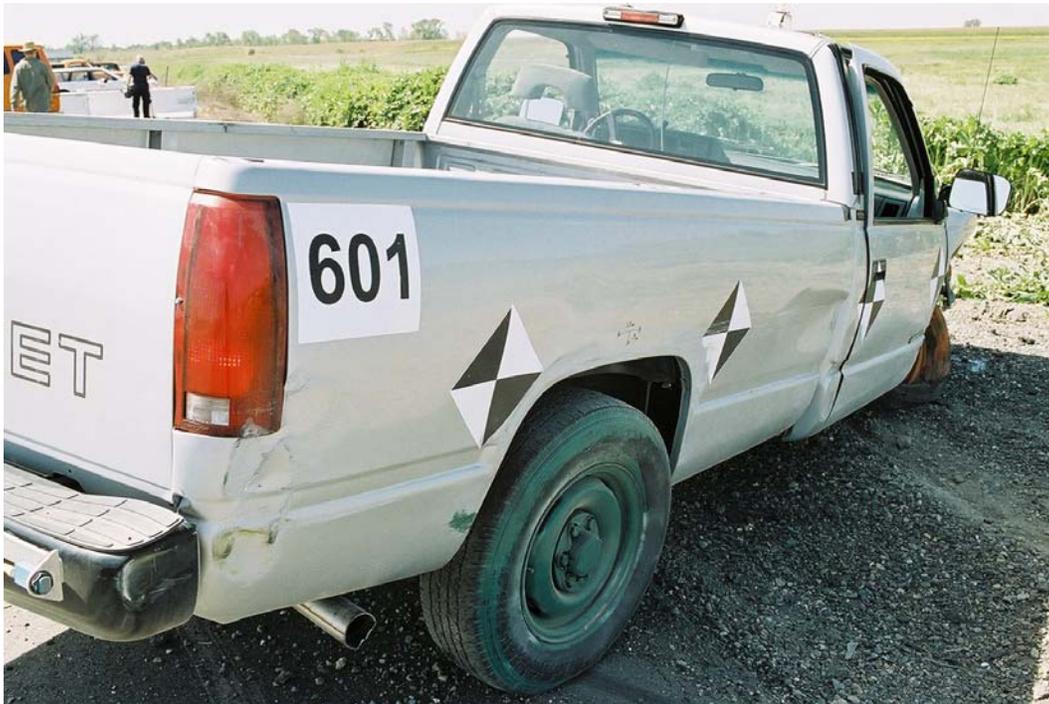
Most of the damage to the vehicle was on the front half of the right side. The right third of the bumper was pushed back into the front right wheel well. The front tire was torn, but still on the rim. The wheel was pushed back about 450 mm. The right side of the bed was dented near the cab and near the taillight.

Figure 2-9 – Front Wheel of Test Vehicle Post-Impact

Figure 2-10 – Front Right Corner of Test Vehicle Post-Impact

Figure 2-11 – Rear Right Side of Test Vehicle Post-Impact

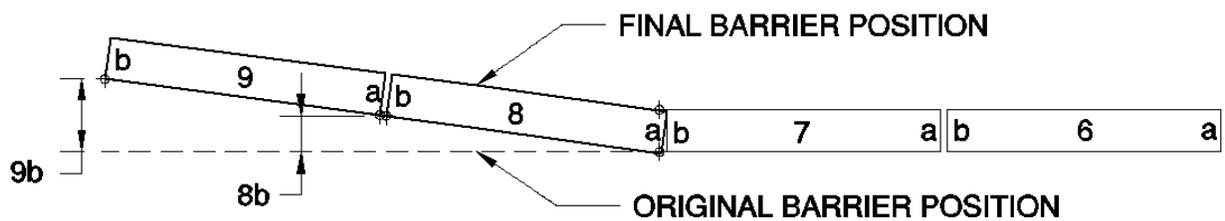
Figure 2-12 – Permanent Deflection Drawing

Damage to the barrier was limited to barrier deflection, bending of the connecting pins and bending to the lateral retention stakes. Barrier deflections are shown in Figure 2-12. There was only minor scraping on the face of the barrier. Barrier damage is shown in Figure 2-13 through Figure 2-16.

Joint	7a	7b	8a	8b	9a	9b
Lateral Deflection (mm)	0	5	15	555	565	1060

Repair to the barrier would require replacing the pins and realigning the last few barrier segments with new lateral retention stakes where necessary.

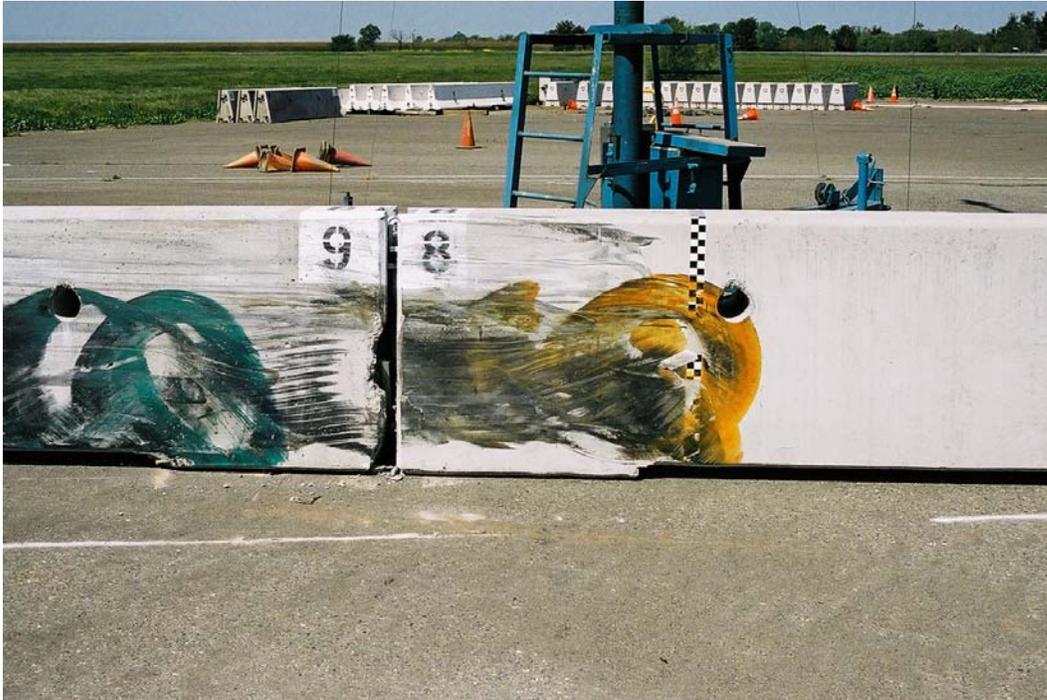
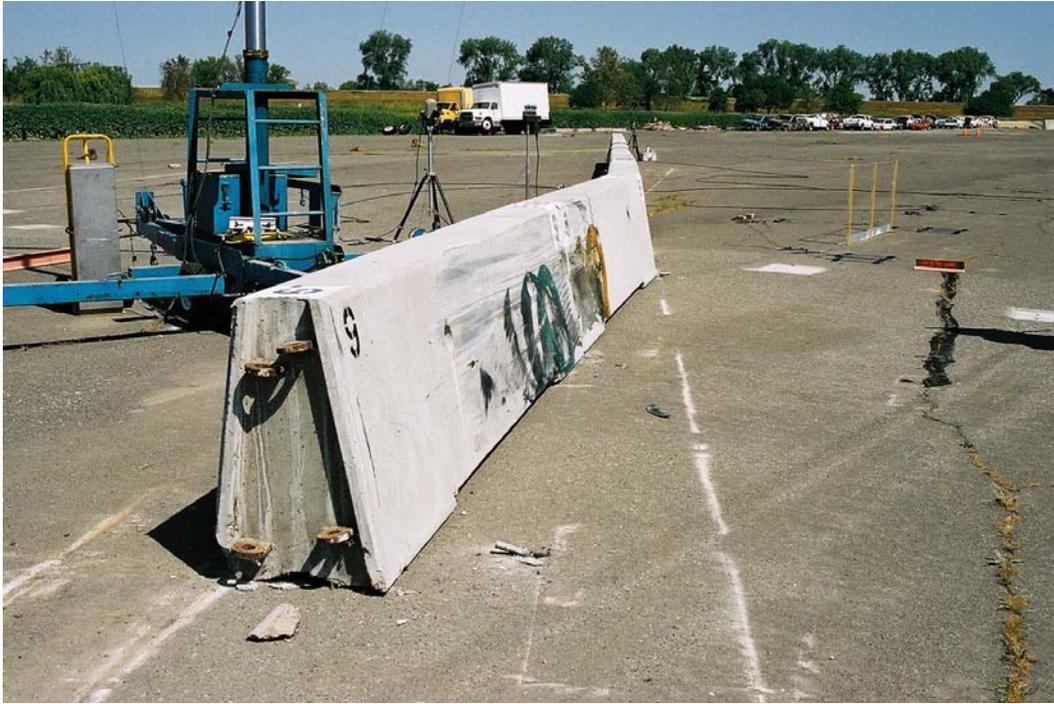
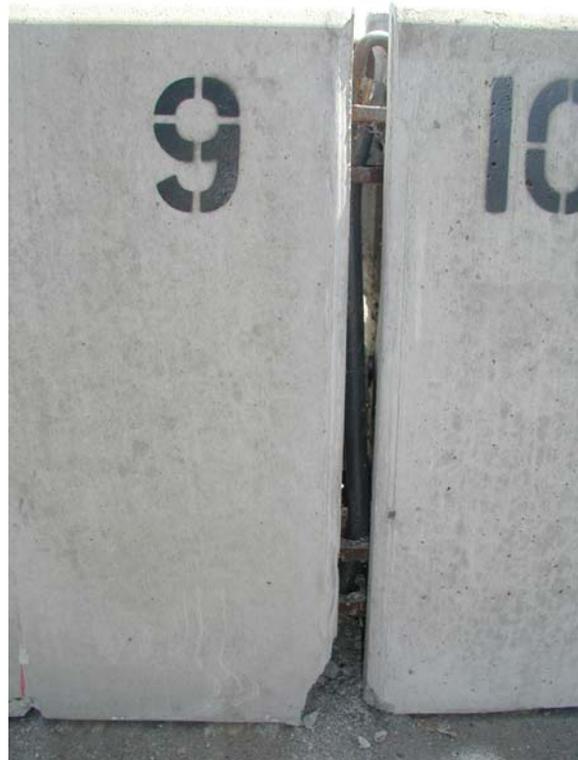
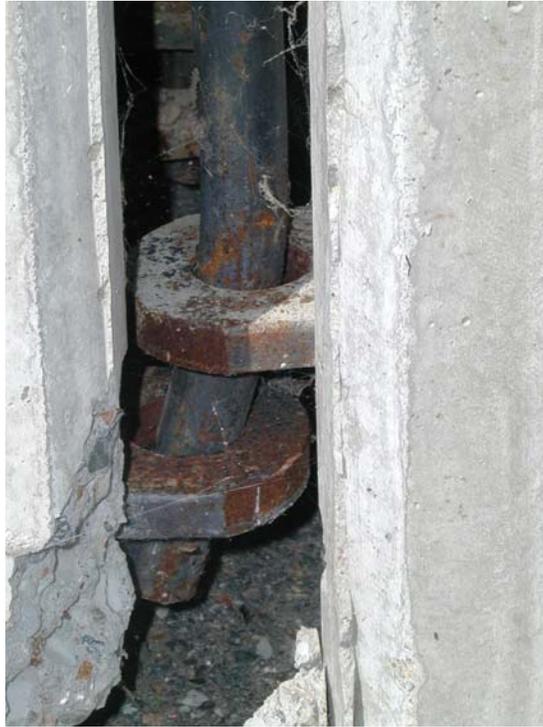
Figure 2-13 – Barrier Damage near the Impact Point

Figure 2-14 – Permanent Deflection

Figure 2-15 – Backside of Joint 8-9 showing Minor Concrete Spalling and Bent Pin (mislabeled)

Figure 2-16 – Close-up of Bent Pin at Joint 8-9

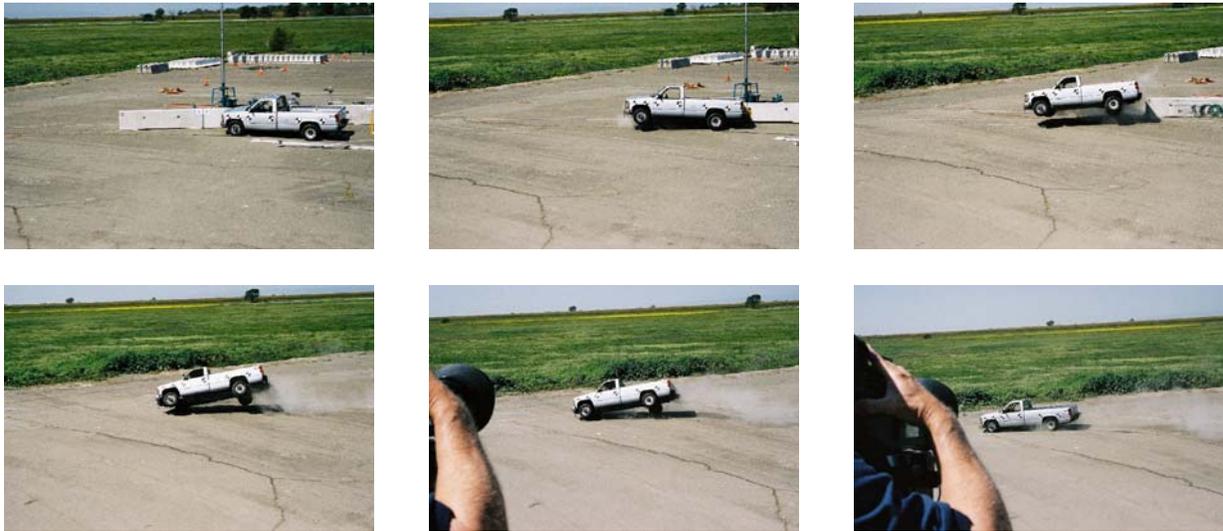
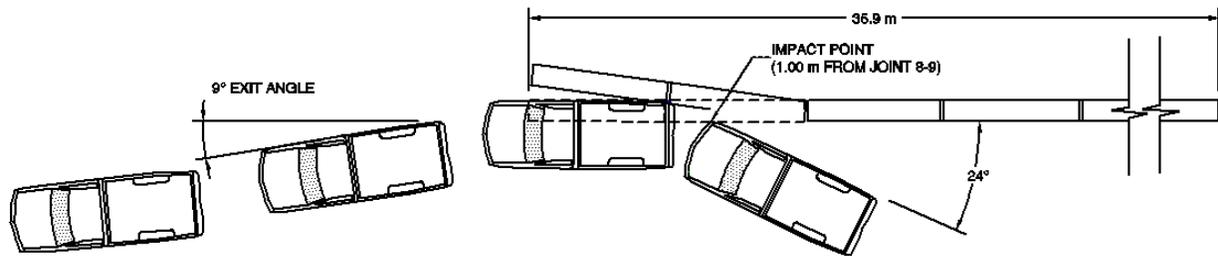
Figure 2-17 – Test 601 Data Summary Sheet

Impact Sequence Drawing

Name 60K Terminus
 Installation Length 36.0 m
 Description 9 segments of 60K barrier, on an AC base with 4 25-mm by 1000-mm stakes on the last two barriers

Velocity 100.3 km/h
 Angle 24.0°
 Impact Severity 125.8 kJ

Barrier damage was limited to deflection and bent connecting pins. There was only minor scraping on the face of the barrier. Repair to the barrier would require replacing the pins and realigning the last few barrier segments with new lateral retention stakes where necessary.

Maximum Roll Angle 26.88°
 Maximum Pitch Angle 8.70°
 Maximum Yaw Angle -39.99°

<i>Occupant Risk Values</i>	<i>Longitudinal</i>	<i>Lateral</i>
Occupant Impact Velocity	4.75 m/s	-6.40 m/s
Ridedown Acceleration	-7.35 g	12.85 g

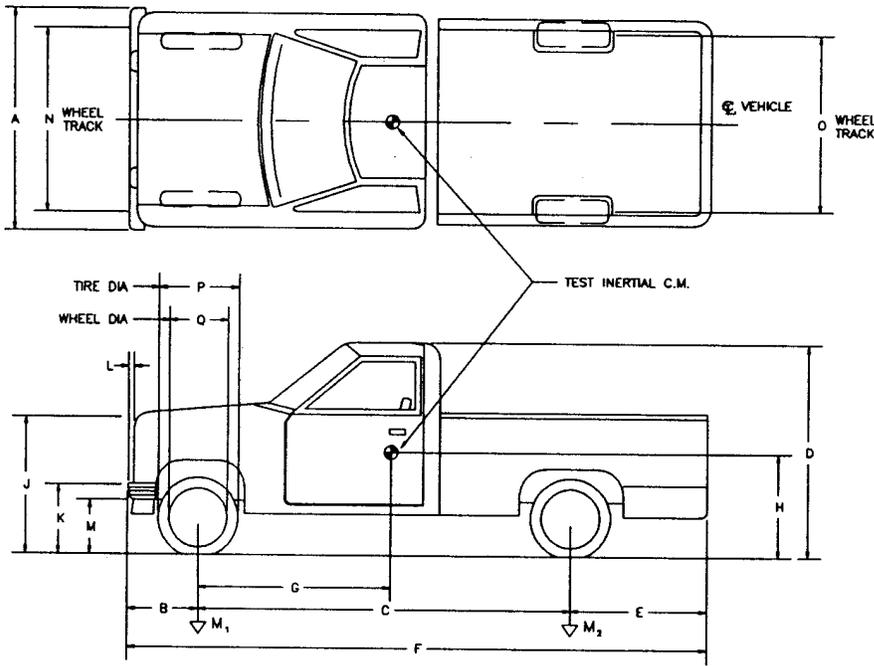
DATE: 4/23/02 TEST NO: 601 VIN NO: 1GCFC2444R2263338 MAKE: Chevy
 MODEL: 2500 Pick-Up YEAR: 1994 ODOMETER: 24637.4 (MI) TIRE SIZE: LT255/75R16
 TIRE INFLATION PRESSURE: 55 (PSI)
 MASS DISTRIBUTION (kg) LF 547.0 RF 539.0 LR 438.0 RR 436.0

DESCRIBE ANY DAMAGE TO VEHICLE PRIOR TO TEST: There was a small dent in the driver's side door.

ENGINE TYPE: Gas V8
 ENGINE CID: 305
 TRANSMISSION TYPE:
 AUTO
 MANUAL
 OPTIONAL EQUIPMENT:
 AC

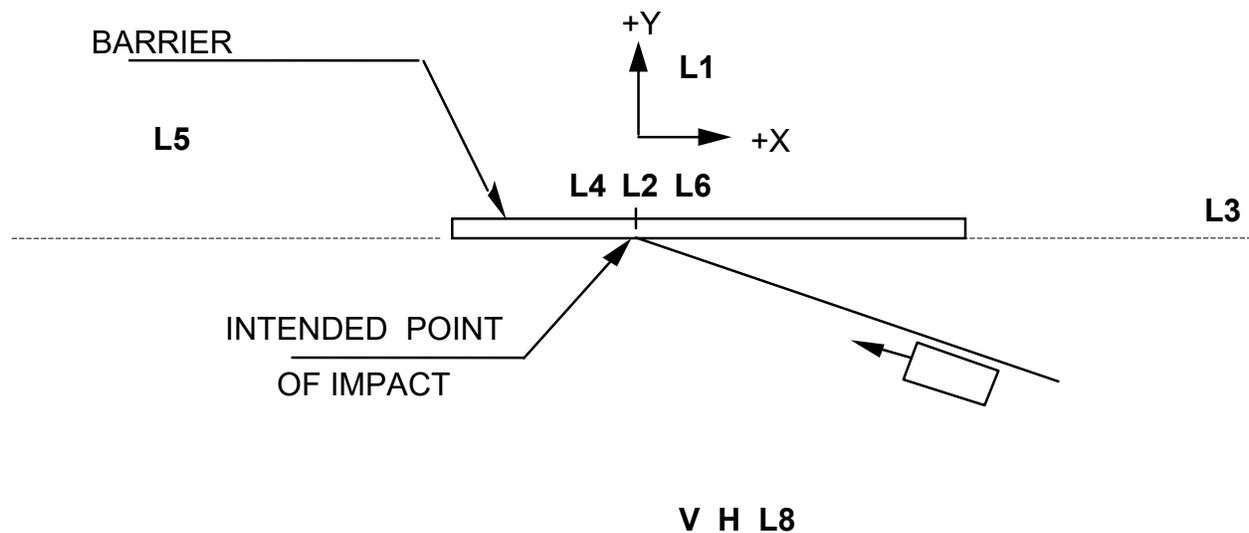
Figure 6-1 – Camera Locations

Typical Coordinates, m						
Camera Label	Film Size (mm)	Camera Type	Rate: (fr./sec.)	Test 601		
				X*	Y*	Z*
L1	16	LOCAM 1		5.4	2.4	1.4
L2	16	LOCAM 2	404.8	0	0	9.1
L3	16	LOCAM 3	400	33.4	-0.21	1.4
L4	16	LOCAM 4	400	-0.61	0	9.1
L5	16	LOCAM 5	400	-80.9	-.08	1.4
L6	16	LOCAM 6	400	0.61	0	9.1
L8	16	LOCAM 8	405.1	1.6	-26.0	1.4
V	1.27	SONY BETACAM	30	-2.4	-26.3	4.5
H	35	HULCHER	40	-1.1	-26.8	4.5

Note: Camera location measurements were approximated and are typical for all crash tests involved in this report.
*X, Y and Z distances are relative to the impact point.

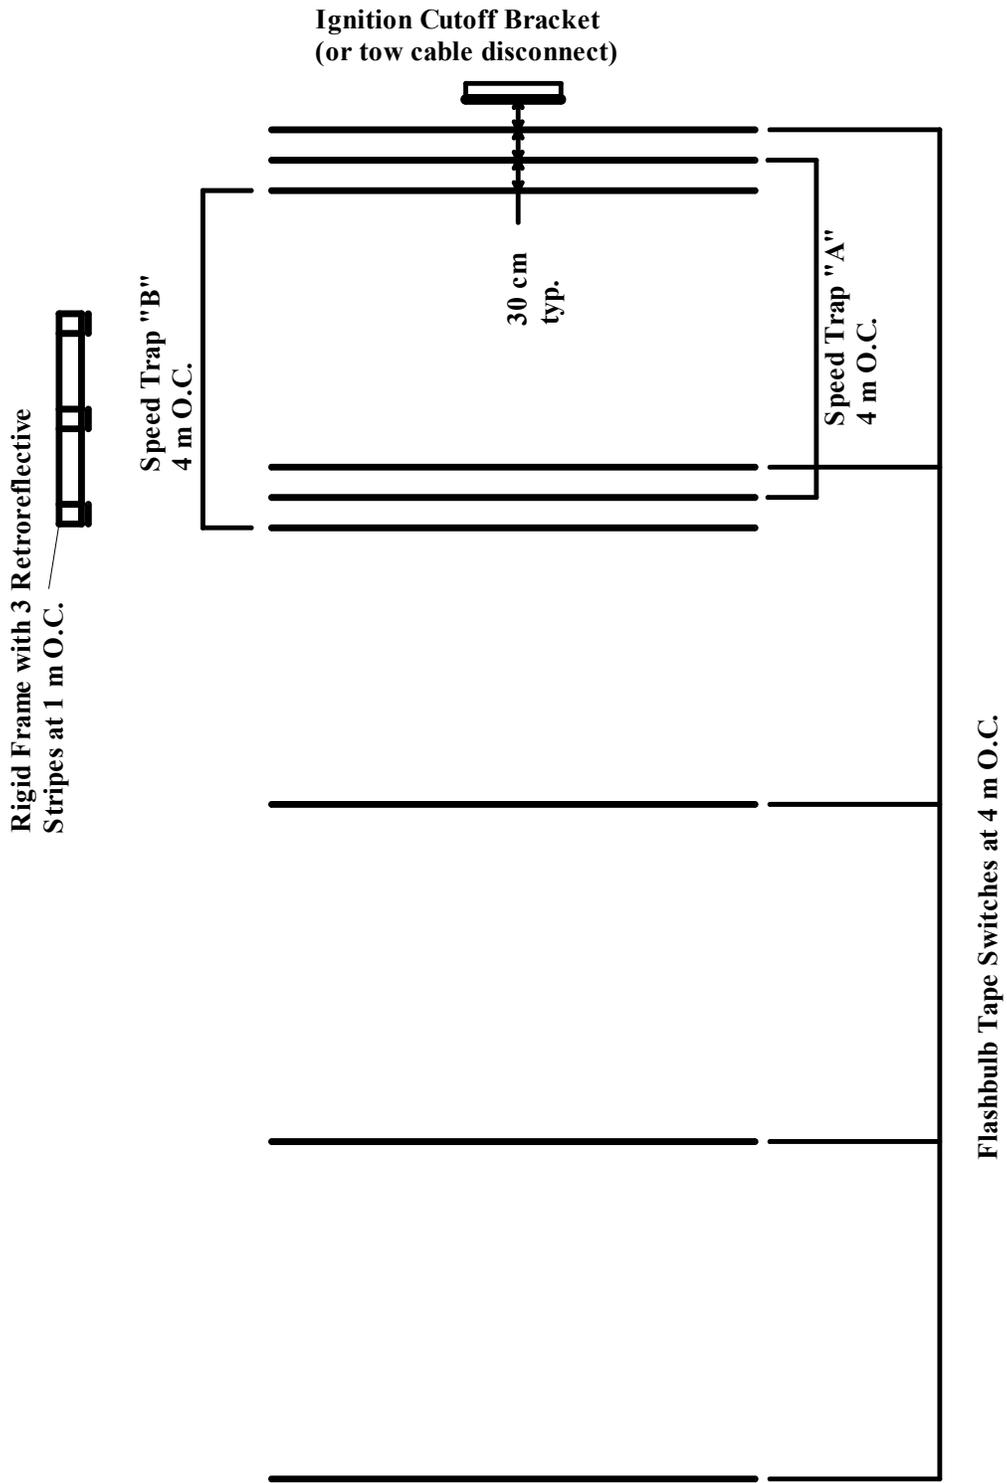
Figure 6-2 – Event Switch Layout

- 3) Five tape switches, placed at 4-m intervals, were attached to the ground near the barrier and were perpendicular to the path of the test vehicle. Flashbulbs were activated sequentially when the tires of the test vehicle rolled over the tape switches. The flashbulb stand was placed in view of the cameras. The flashbulbs were used to correlate the cameras with the impact events and to calculate the impact speed independent of the electronic speed trap. The tape switch layout is shown in Figure 6-2.

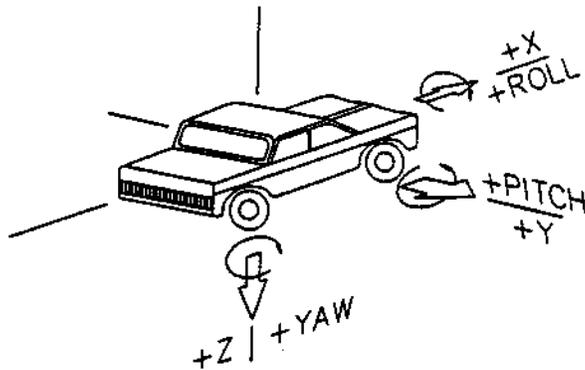
Figure 6-3 – Vehicle Accelerometer Sign Convention

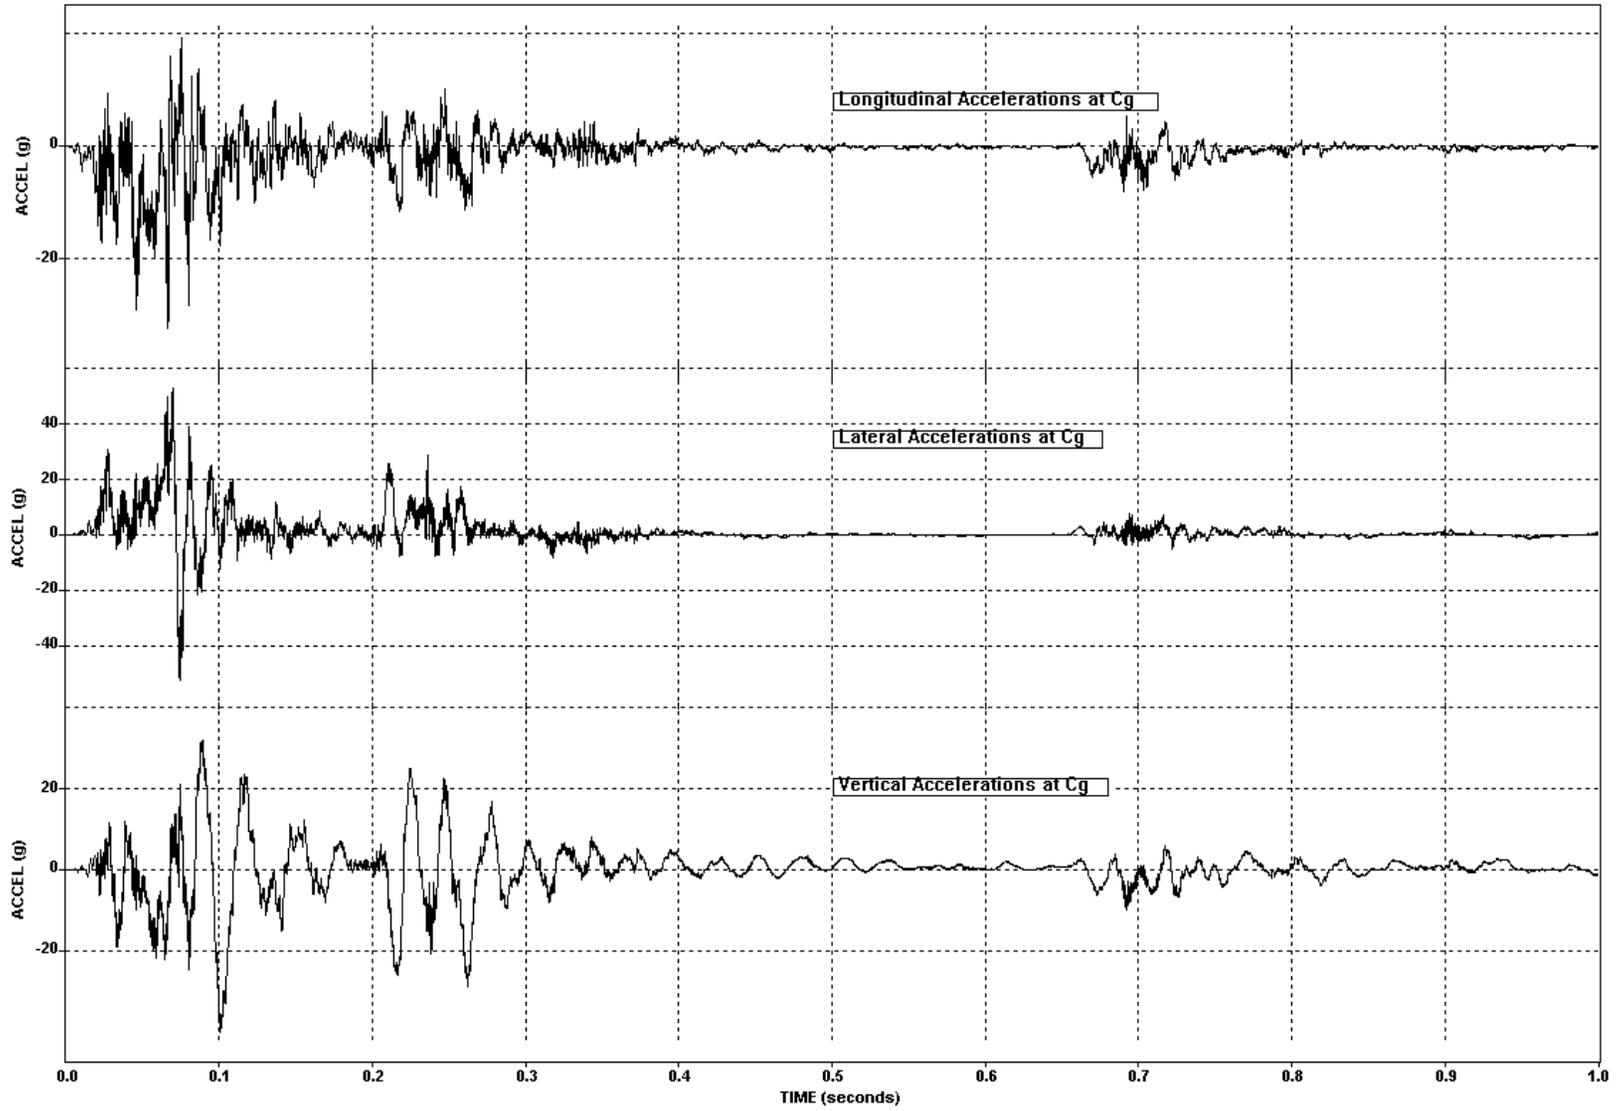
Figure 6-4 – Test 601 Vehicle Accelerations -Vs- Time

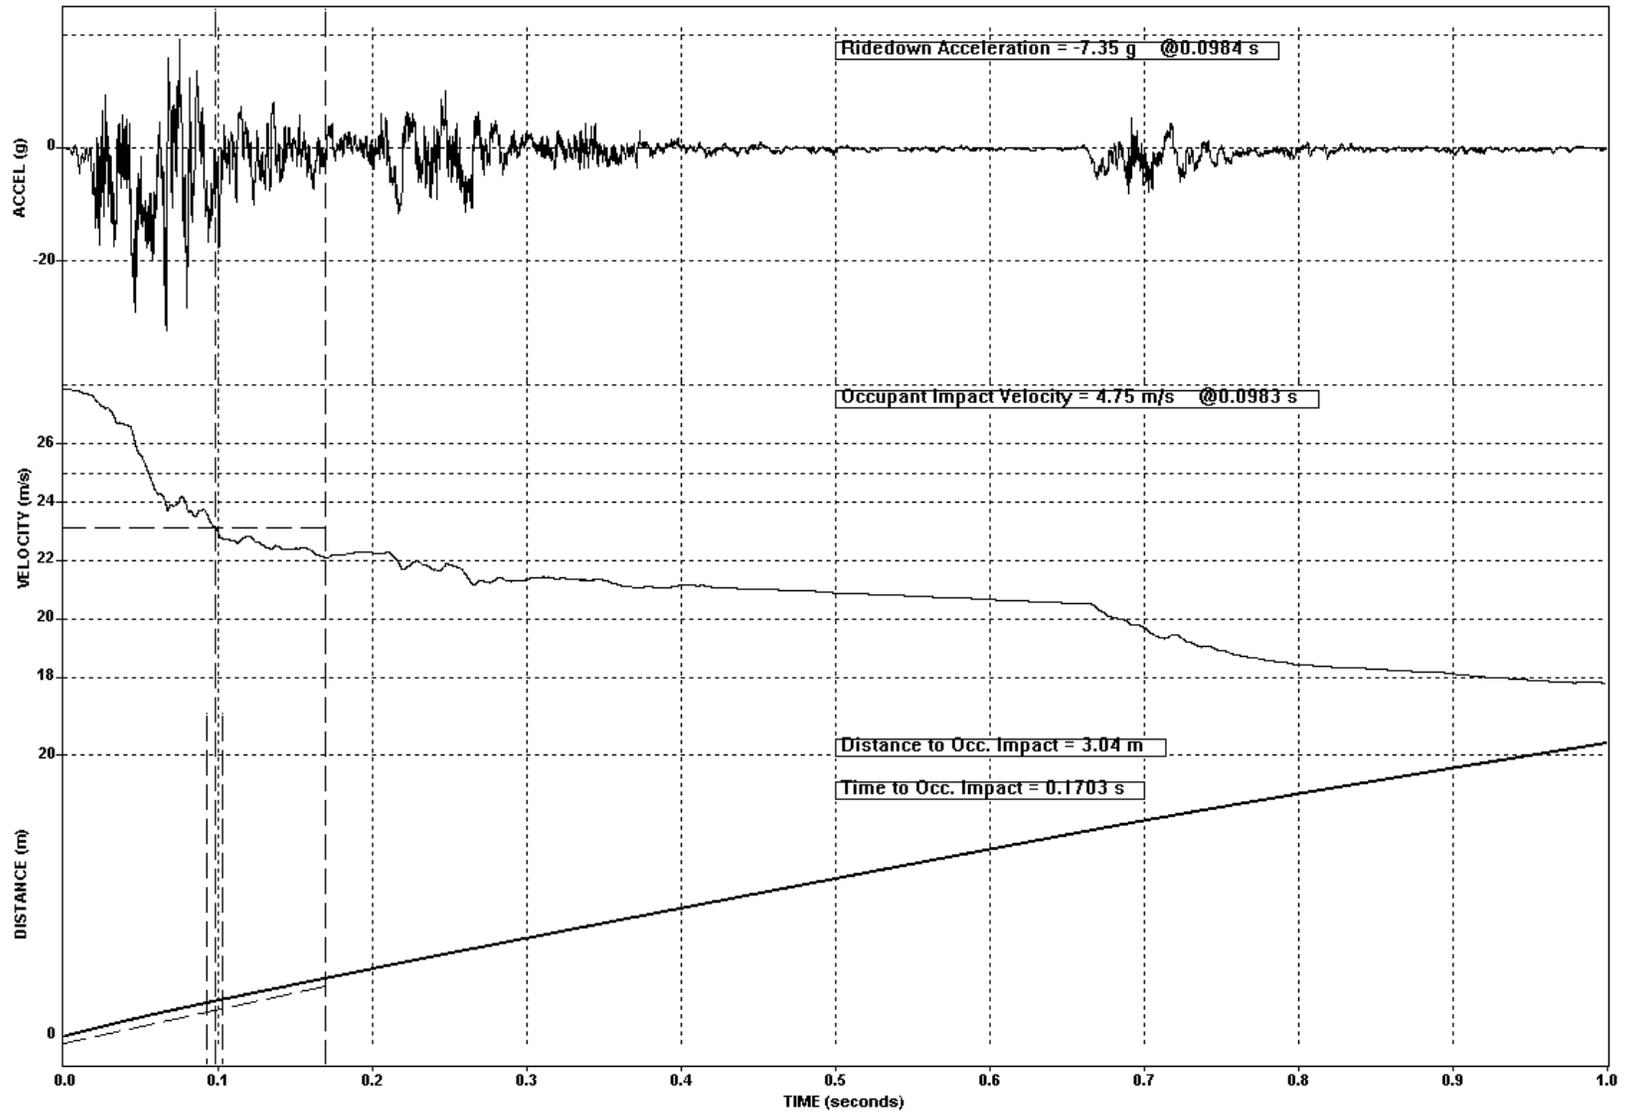
Figure 6-5 – Test 601 Vehicle Longitudinal Acceleration, Velocity and Distance -Vs- Time

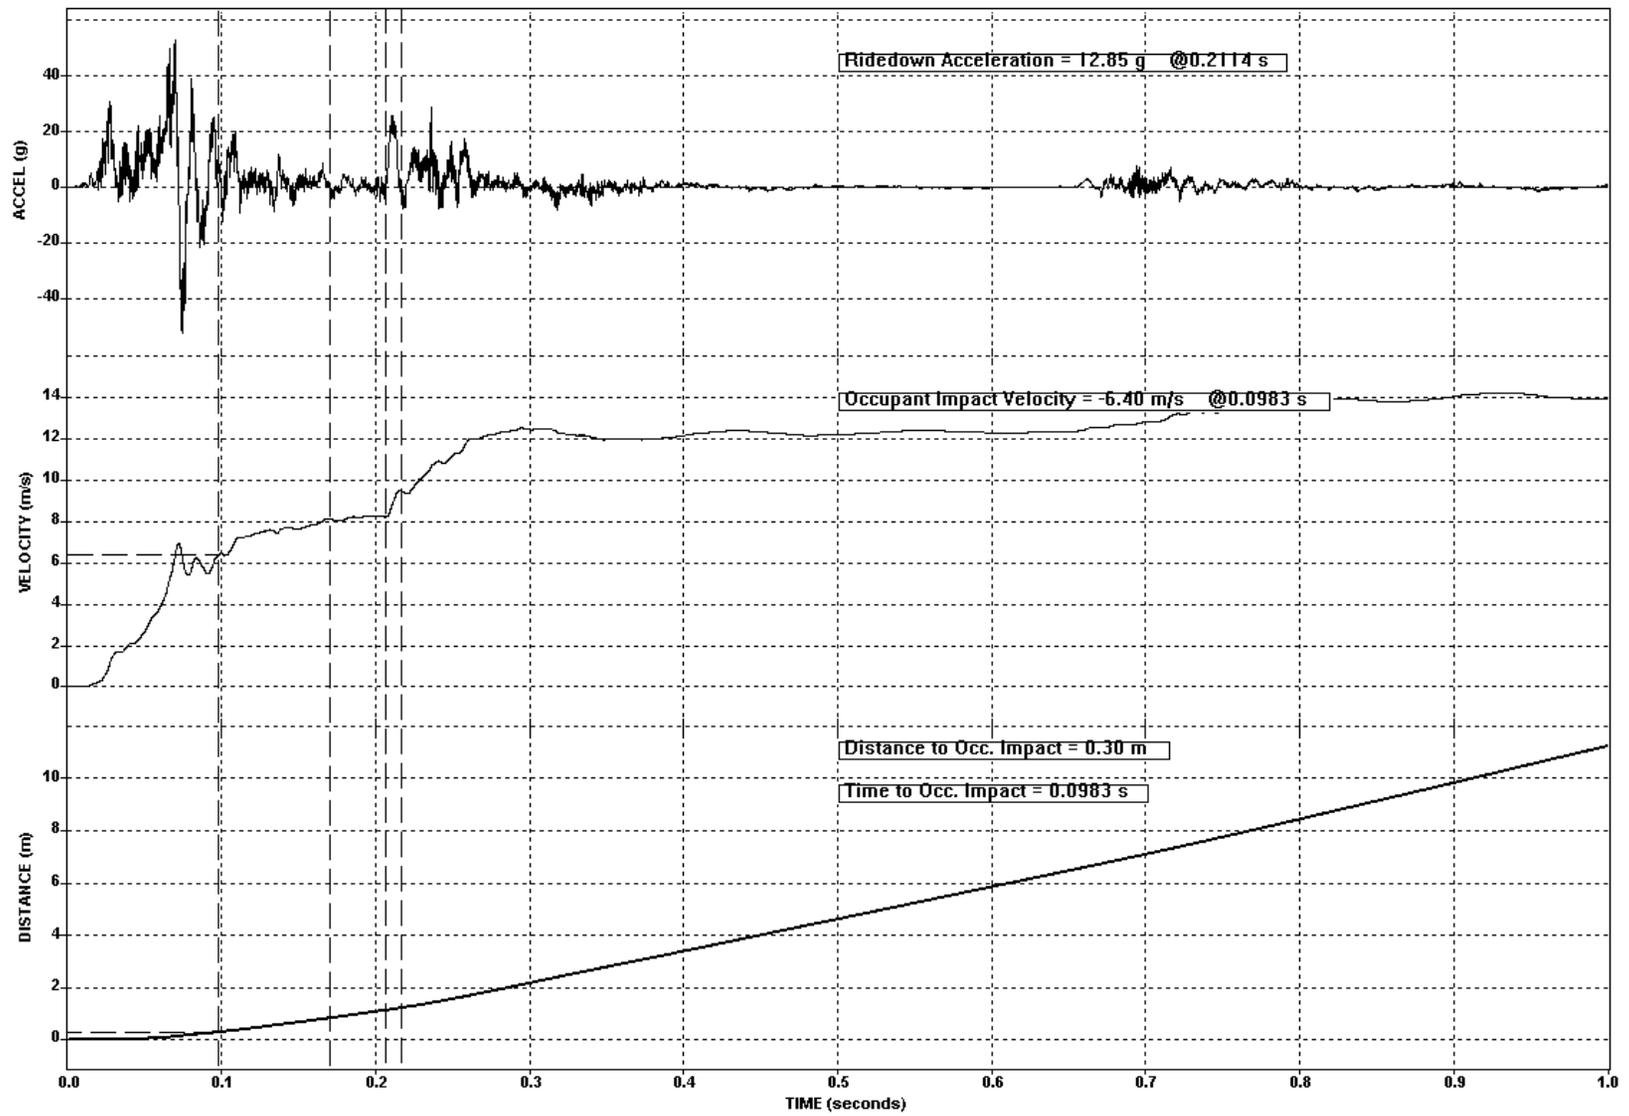
Figure 6-6 – Test 601 Vehicle Lateral Acceleration, Velocity and Distance -Vs- Time
