1. REPORT NO. FHWA/CA08-0287	2. GOVERNMENT ACCESSION NO.	3. RECIPIENT'S CATALOG NO.	
4. TITLE AND SUBTITLE COMPLIANCE CRASH TESTING OF A TYPE 60K TERMINUS		5. REPORT DATE December 2008

Compliance Crash Testing Of The Type 60K Terminus

Final Report

Report No. CA08-0287

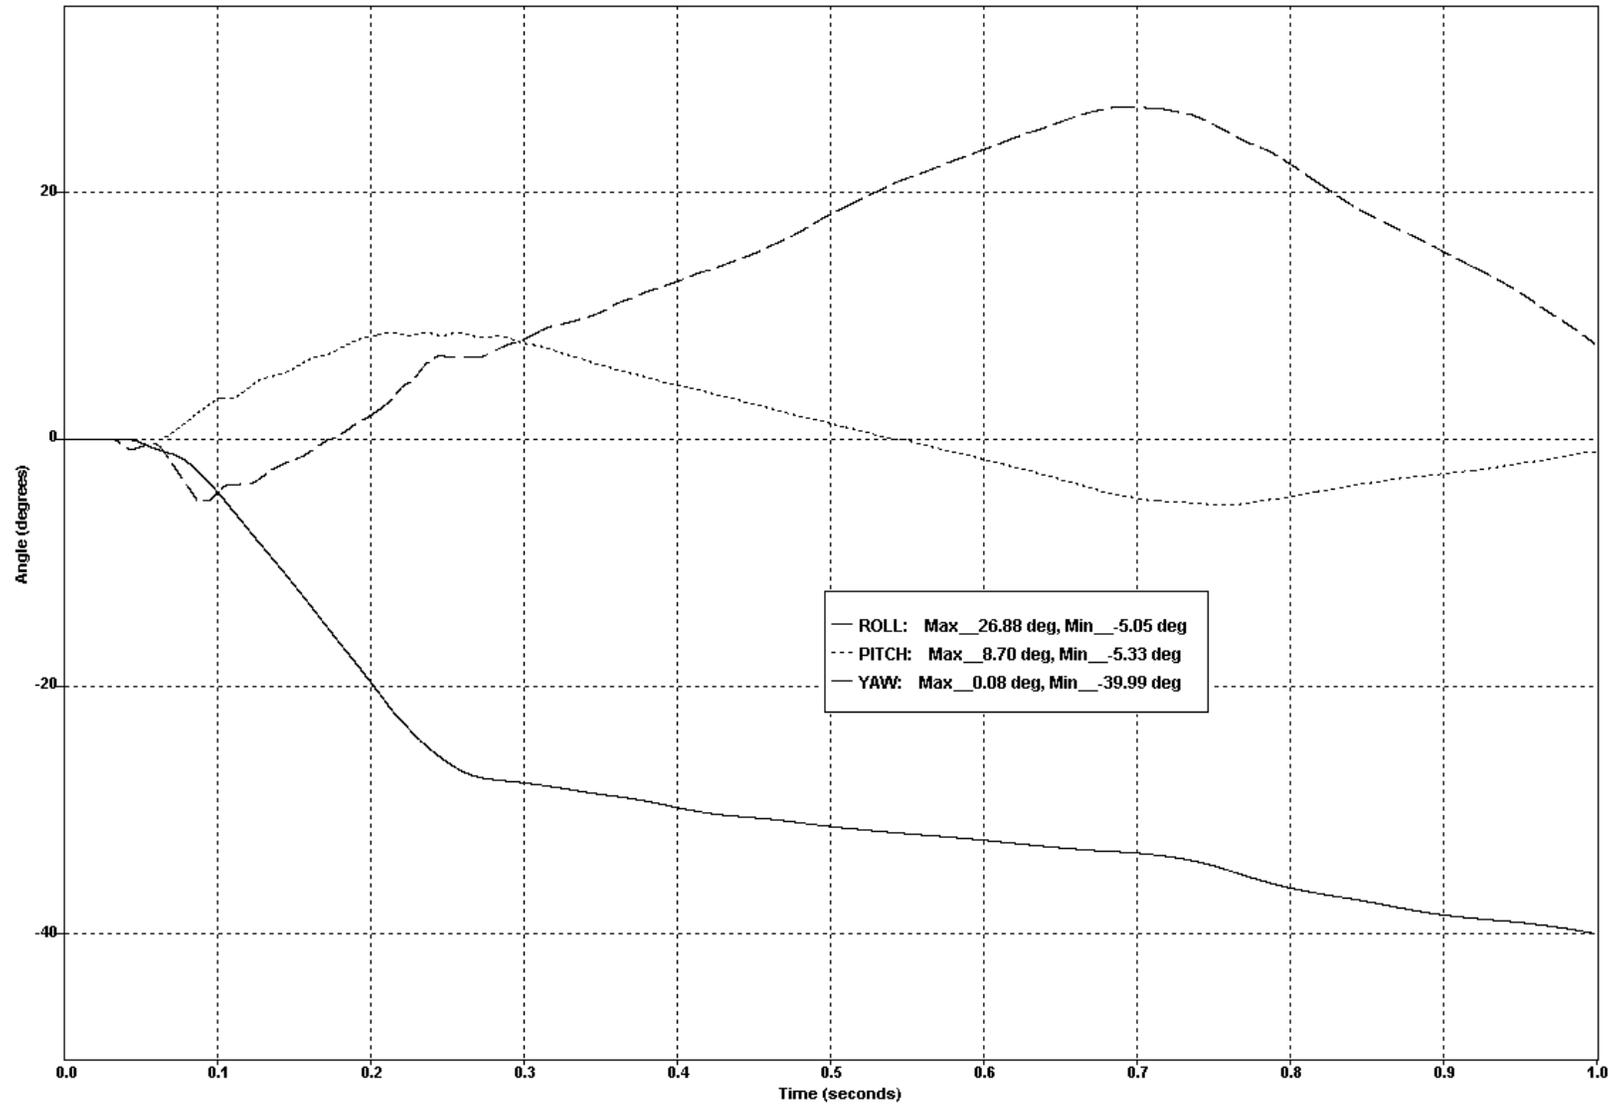
Figure 6-7 – Test 601 Vehicle Roll, Pitch and Yaw -Vs- Time

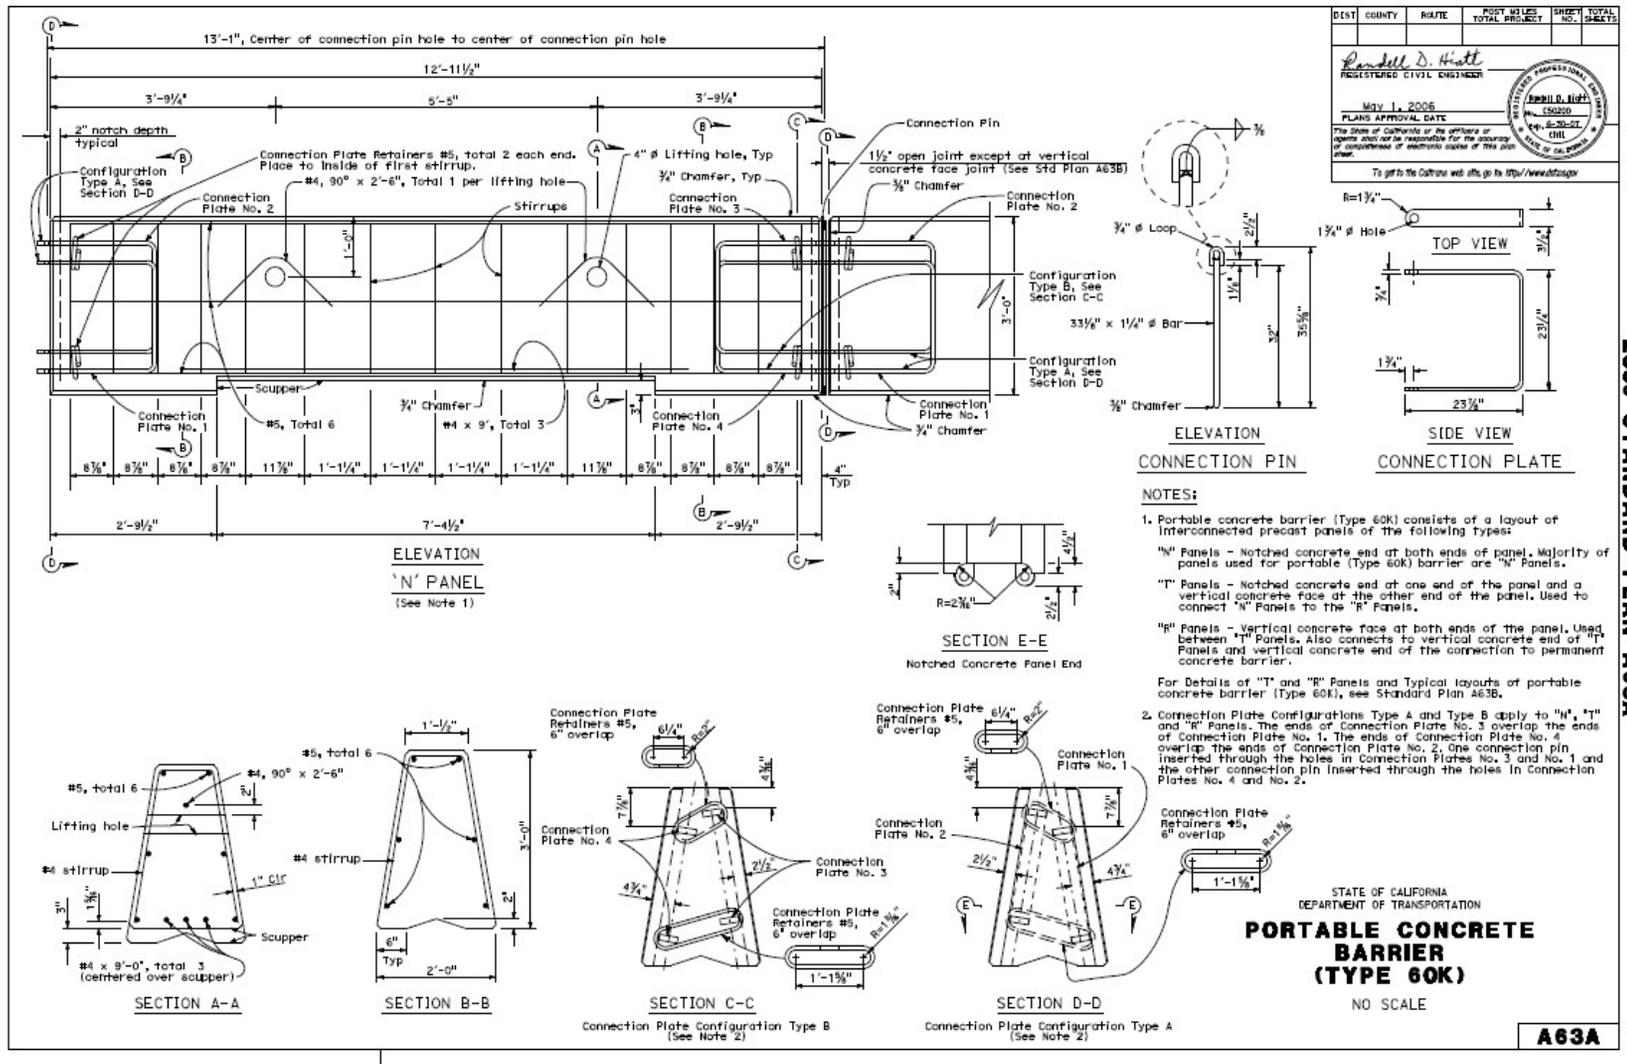
Figure 6-8 – Type 60 Standard Plan

2006 STANDARD PLAN A63A
