| 4. TITLE AND SUBTITLE<br><b>INVESTIGATION OF THE CRASHWORTHINESS OF<br/>BARRIER MOUNTED HARDWARE:<br/>BARRIER MOUNTED SIGN AND SIGNPOST</b> | | 5. REPORT DATE<br><br><b>June 2011</b> | |
| 16. ABSTRACT<br><b>This test was conducted to investigate the crash-worthiness of a popular saddle style mount used on many concrete barriers in California. A 46-m (150-ft) section of Caltrans Type 60 concrete median barrier (previously approved) had two aluminum signs with a 101.6-mm (4-in) outside diameter steel support post mounted onto it for the purpose of investigating the affect the signpost has on a ¾-ton pick-up truck impacting the barrier. The parameters and conditions used for this test are in compliance with NCHRP Report 350, Test 3-31. This particular method of mounting the signpost to the barrier was selected for testing because it is commonly used throughout California's highway system.</b><br><br><b>The test involved a 1993 Chevy Cheyenne pick-up truck impacting the combination barrier and sign support at an angle of 25.5° and a velocity of 99.1 km/h (61.6 mph). The barrier redirected the vehicle, but the impact with the barrier created a high risk to its occupants and possibly

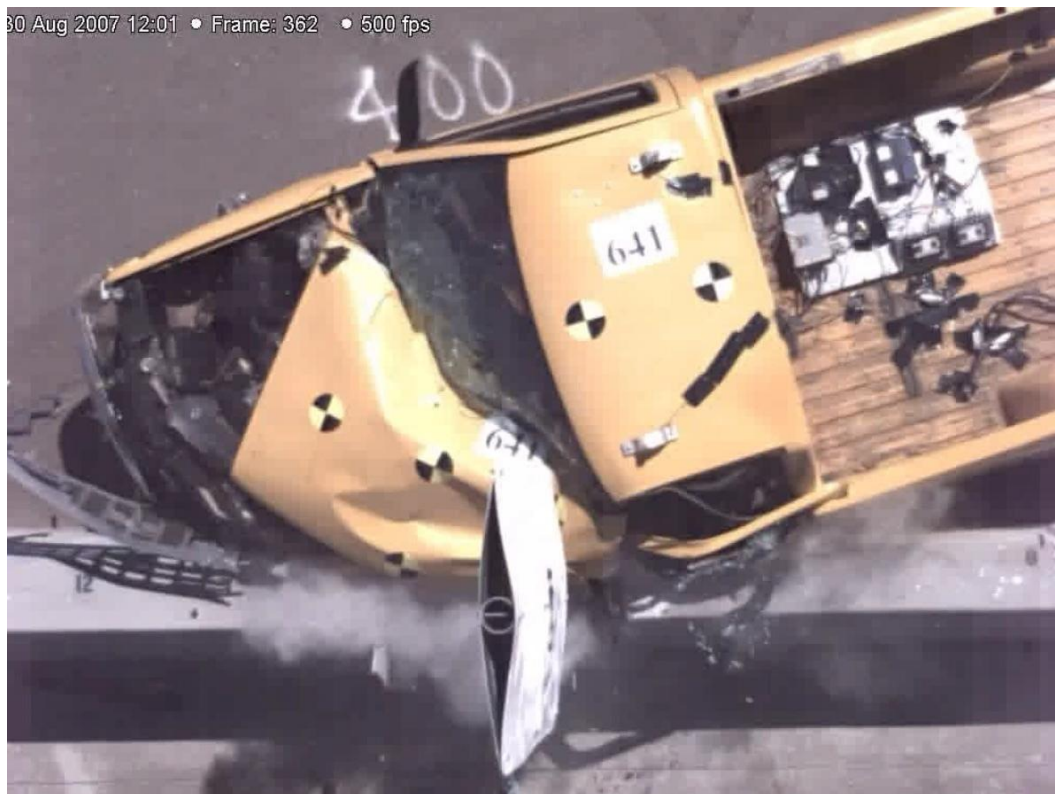
Figure 2-7 Vehicle Impacting Signpost and Barrier

The vehicle was parallel and had full contact with the barrier at 0.254 seconds after impact. Also, the front grill had completely broken away from the vehicle and was thrown along the top of the barrier. The brake flash bulb located on the top of the vehicle triggered at 0.284\*seconds after impact and occurred while the vehicle was fully airborne. The vehicle lost contact with the barrier at 0.414 seconds. At 0.634 seconds all four of the vehicle's tires were in contact with the ground. The grill of the vehicle crossed to other side of the barrier at 1.184 seconds. The final resting place of the grill was in the opposing traffic side of the barrier. The vehicle came to rest at 3.064 seconds after the impact.

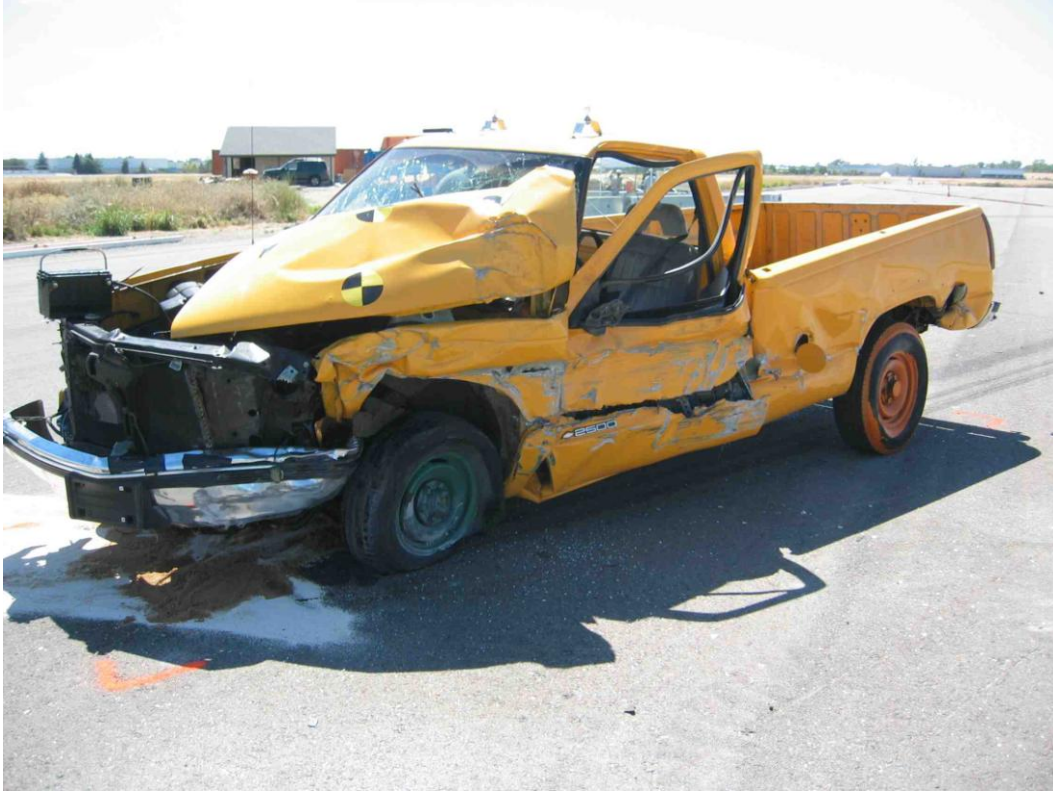
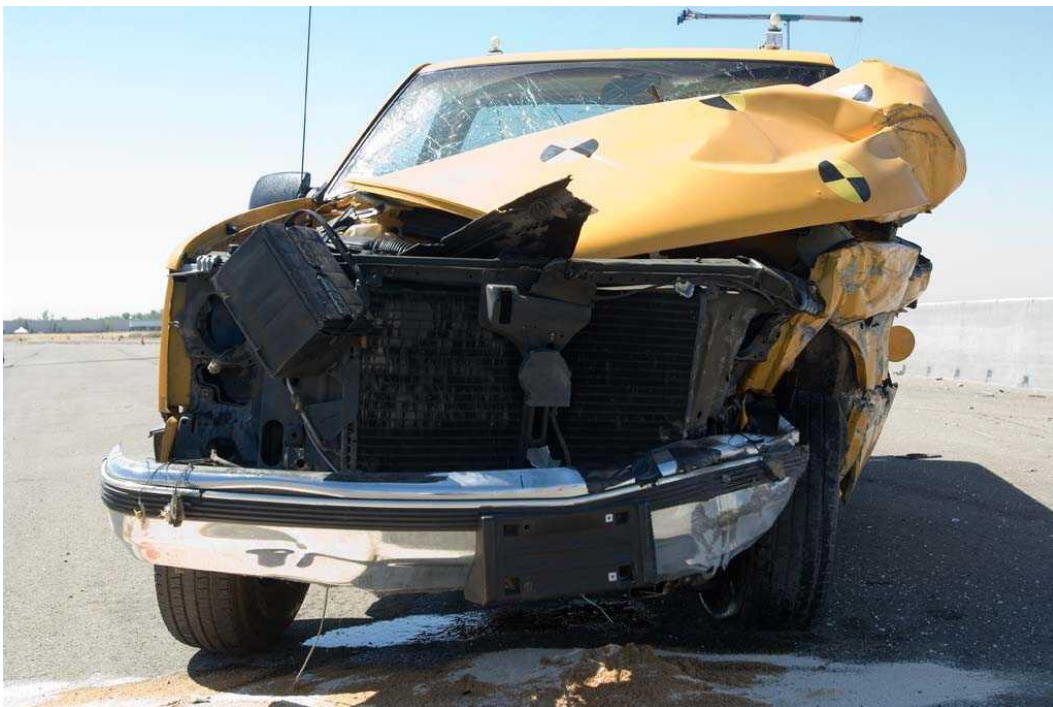
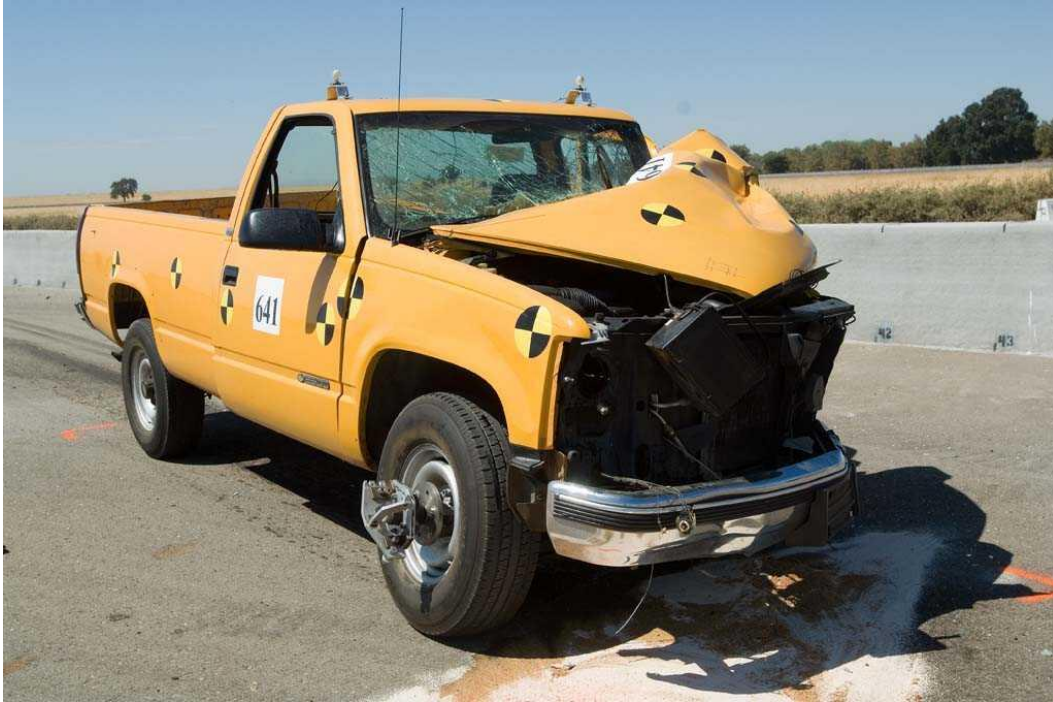
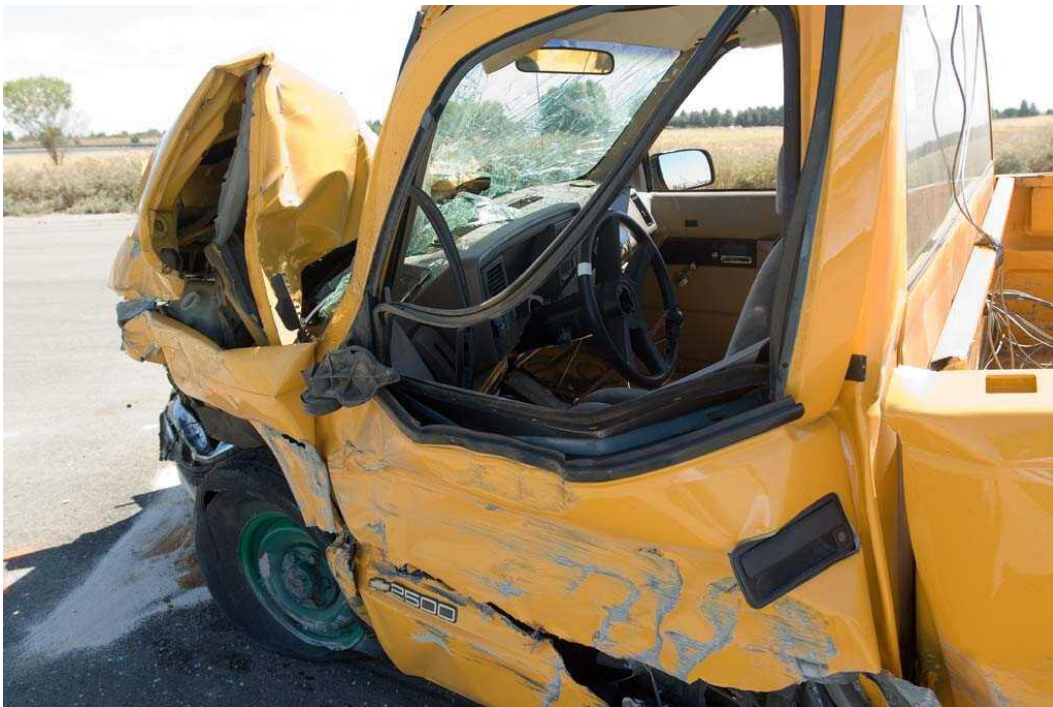
Figure 2-8 Vehicle After Test (1)

Figure 2-9 Vehicle After Test (2)

Figure 2-10 Vehicle After Test (3)

Figure 2-11 Vehicle After Test (4)

The driver's side front quarter of the vehicle sustained significant damage in the initial impact with the barrier. The amount of damage increased as the hood impacted the signpost. The front left wheel was pushed backward 340 mm (13.4 in) from its initial location. The hood penetrated the windshield by 250 mm (9.8 in) measured from the bottom center of the windshield to the resting place of the hood. The vehicle's battery had been thrown out of the engine compartment but was still held in place by the negative terminal cable. The top of the driver side door had buckled outward from the vehicle's frame. The jagged slice down the side of the vehicle caused by the signpost bolts is due to the sustained contact with the barrier. Inspection of the occupant compartment revealed that the dashboard was pushed back 202 mm (8.0 in) toward the driver. The driver side had a peak loss of 98 mm (4.0 in) measured between the bottom of the dashboard and the floorboard.

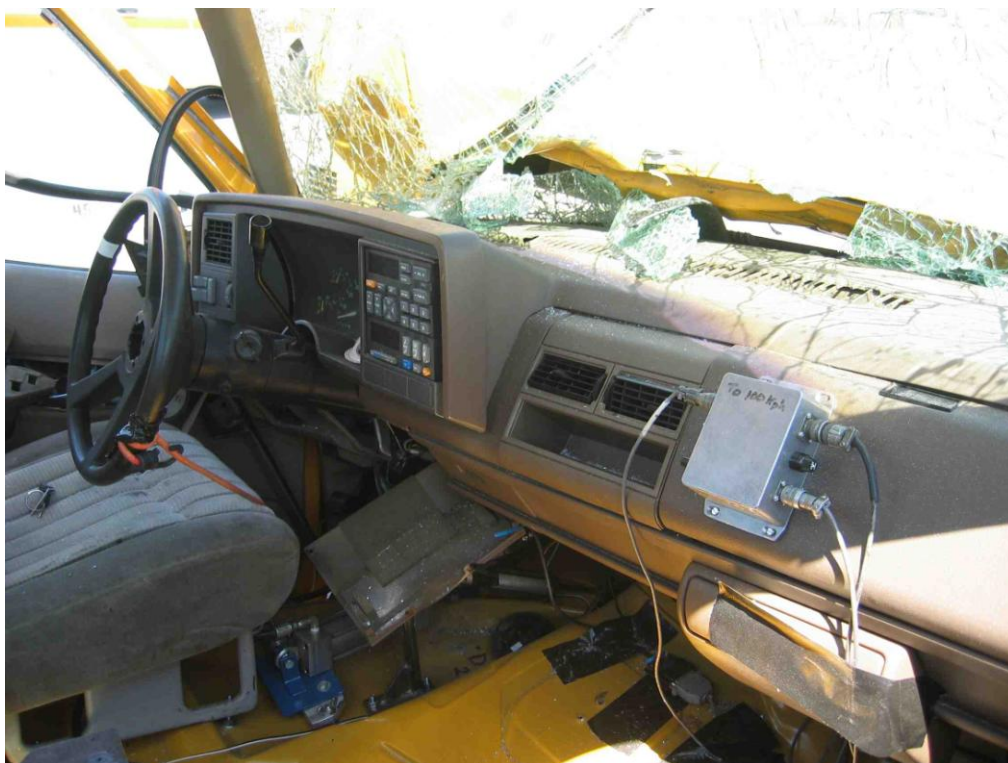
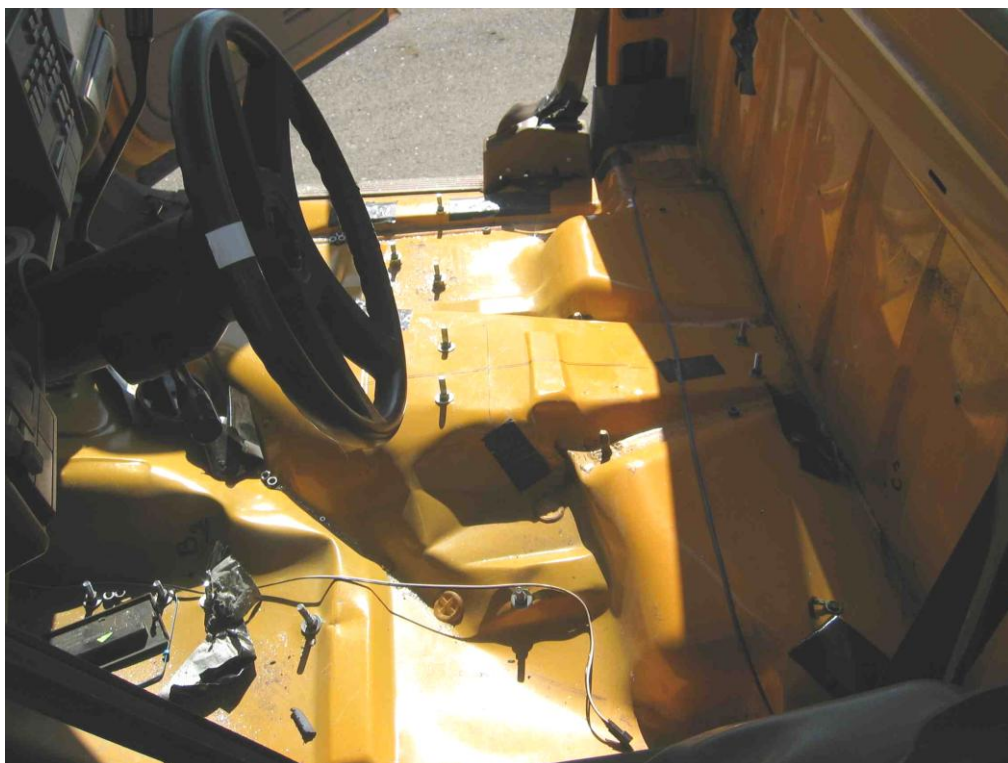
Figure 2-12 Vehicle After Test Internal (1)

Figure 2-13 Vehicle After Test Internal (2)

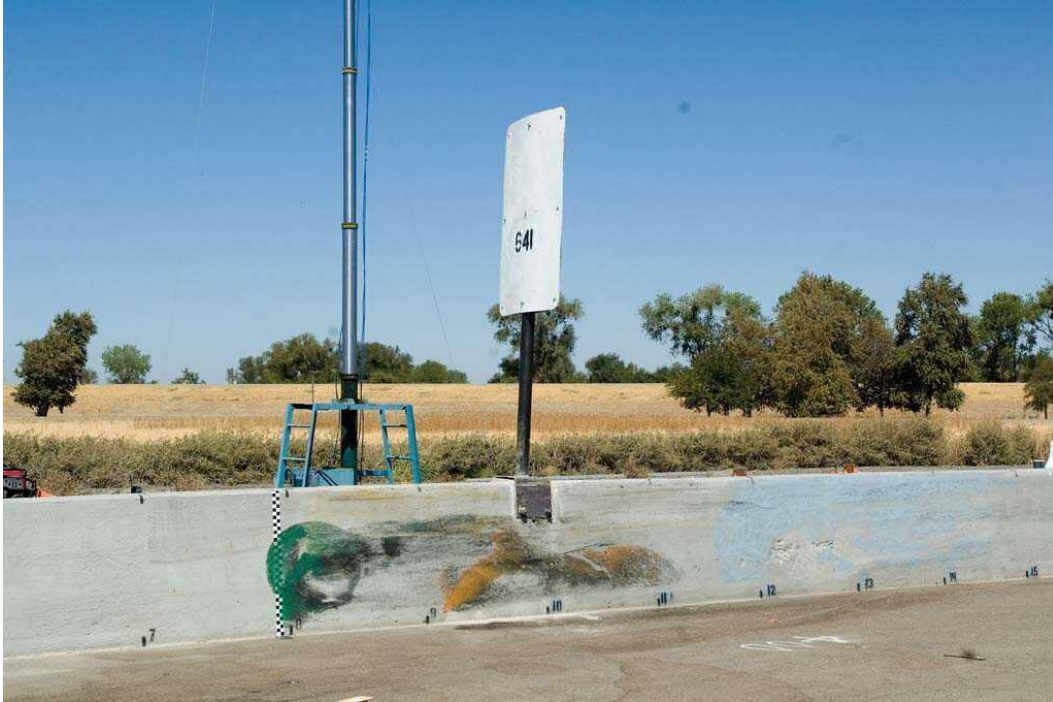
Figure 2-16 Impact Area After Test

There was only cosmetic damage to the barrier. The signpost saddle was pushed 19 mm (0.75 in) downstream and the two bolts were also bent slightly downstream. The sign pole had a dynamic deflection of 10.6° and a static deflection of 3.4° leaning downstream of impact.

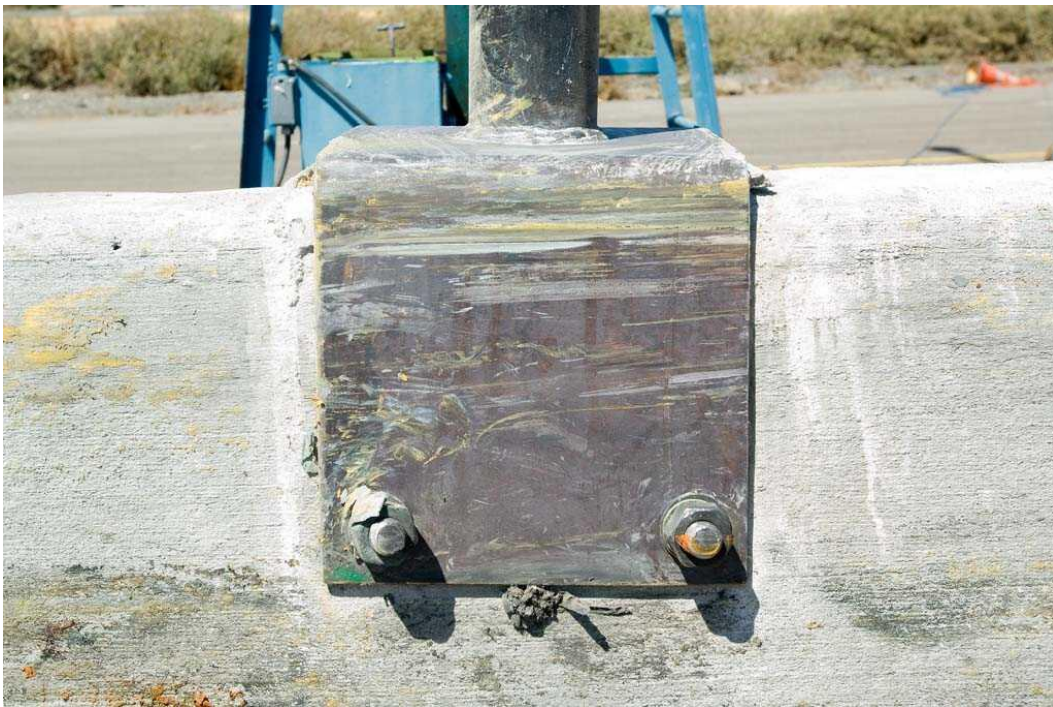
Figure 2-17 Signpost Saddle After Test

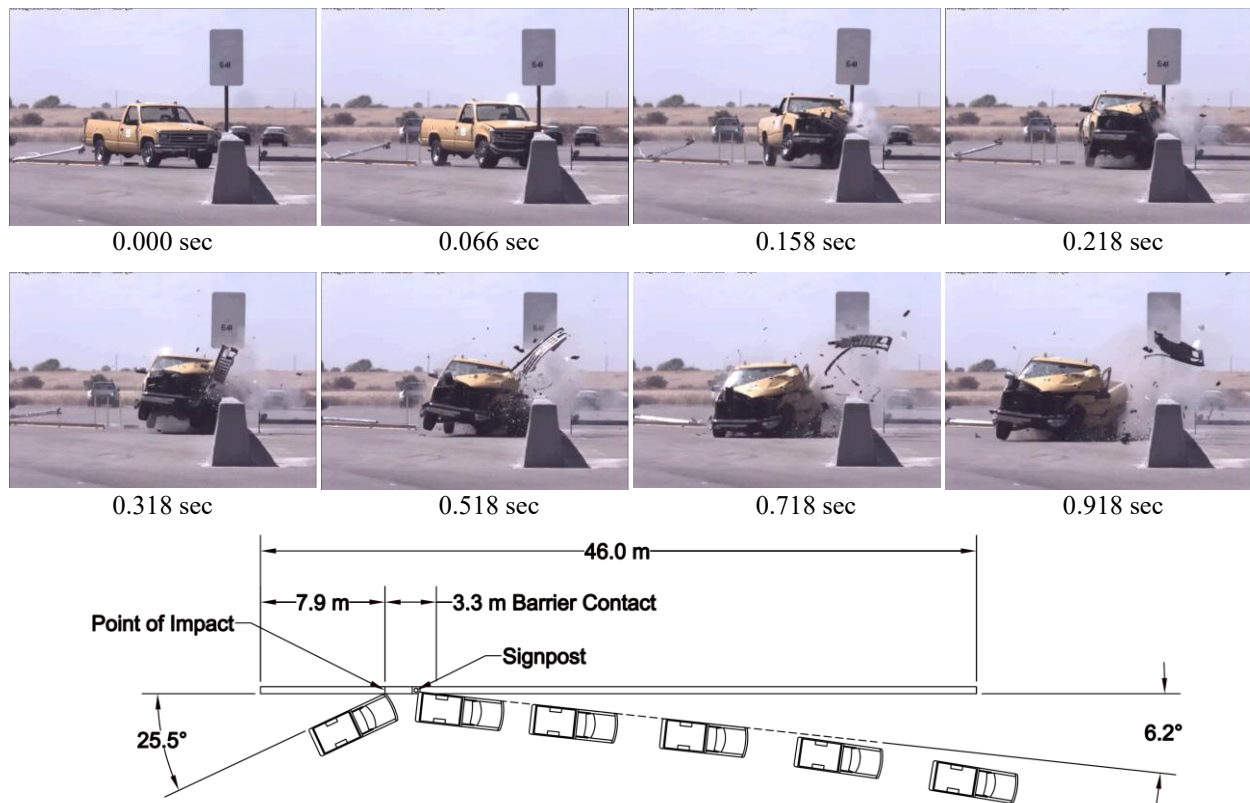
Figure 2-18 Test SS641 – Impact Sequence and Diagram

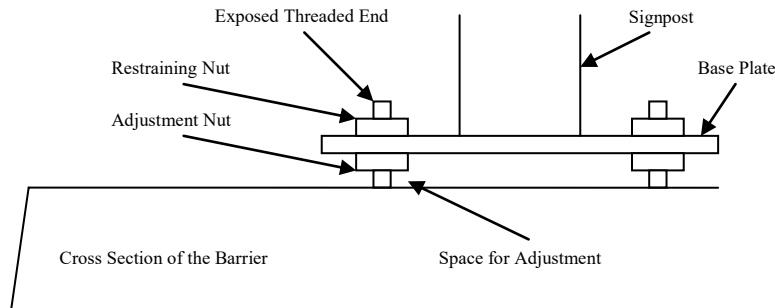
The height of the Type 60 barrier can be increased from the standard 36 inch (910 mm) height to 46 inches (1170 mm) using a 4:1 slope. The 4:1 slope is the same that is used to transition between the Type 742 Concrete Bridge Barriers and three beam guardrail in Caltrans 2006 Standard Plan B11-57. The addition of 10 inches (254 mm) to the height of the barrier will prevent the hood of a standard pick-up truck from hitting the signpost during an impact. The signpost can be mounted to the barrier with the use of a mounting plate, see Figure 4-1.

Figure 4-1 Example of the Mounting Plate with Adjustment Bolts

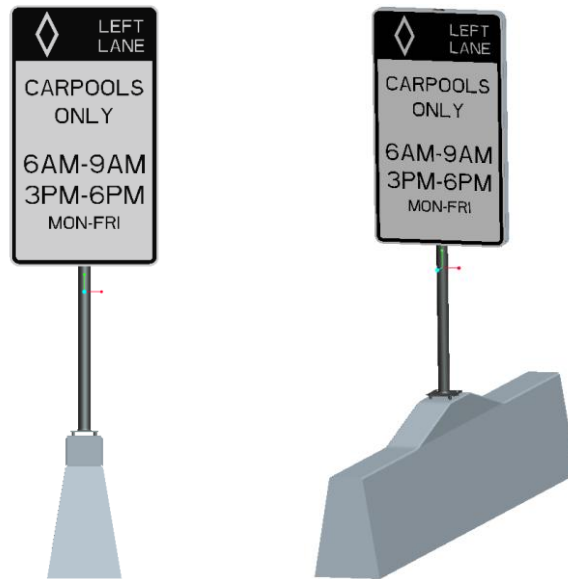
The 46-inch (1170-mm) height is based on the 2009 “Manual for Assessing Safety Hardware” (MASH) criteria that will be replacing the NCHRP Report 350 criteria. The “MASH” pickup has a height of 42 inches (1070 mm) from the ground up to the start of the front edge of the hood while the “Report 350” pickup has a height of 38 inches (970 mm) measured from the same points. The other difference between the two pickups is that the shape of the “Report 350” pickup’s hood is more of a square shape, while the shape of the “MASH” pickup’s hood is like an isosceles trapezoid with the narrow end at the front of the vehicle. At the time this report was written, the Roadside Safety Research Group did not have any videos of crash tests of the “MASH” pickup impacting the Type 60 barrier. Therefore, it is hard to say how far the hood will override the barrier during an impact. Though the “MASH” pickup is higher it may not override as much as the “Report 350” pickup because of the shape of the hood. It was decided the height of the “MASH” pickup would be used in this recommendation as the most severe case because there was not any information on how far it would override in an impact.

Figure 4-2 Example of Raised Type 60 Barrier

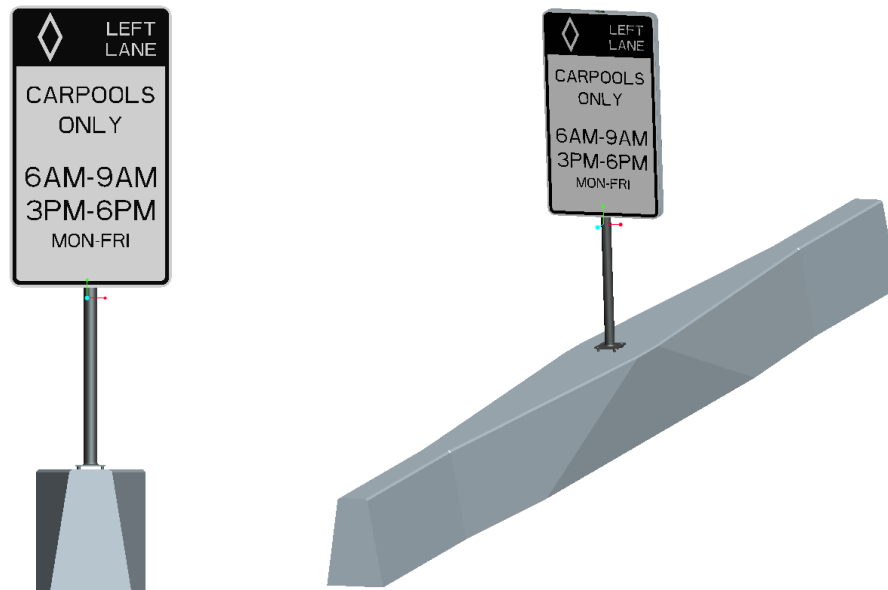
The width of the Type 60 barrier can be increased so that the top and bottom of the barrier has a width of 34 inches (864 mm). The width of the barrier can be increased with a 20:1 slope on each side of the barrier. The 20:1 slope is the same that is used in the Caltrans 2006 Standard Plan A76C for transitions between the Type 60 and the Type 60E Concrete Barriers. The 34-inch (864 mm) width provides a 15 inch (381 mm) set back between the top corner of the barrier and the edge of the signpost. The 15 inches should help to minimize the potential for hood-snagging, but would not eliminate it completely. Also, a mounting plate will need to be used to mount the signpost to the barrier. Depending on the need for adjustment nuts under the mounting plate, the set back may need to be between the edge of the bolts to the face of the barrier if the height of the treaded end extends past one inch (25.4 mm) from the top of the

barrier. This will also increase the width of the barrier. Another option could be to create a recess in the barrier that the mounting plate can fit into that will keep the mounting bolts from impacting the vehicle's hood.

Figure 4-3 Example of the Widened Type 60 Barrier

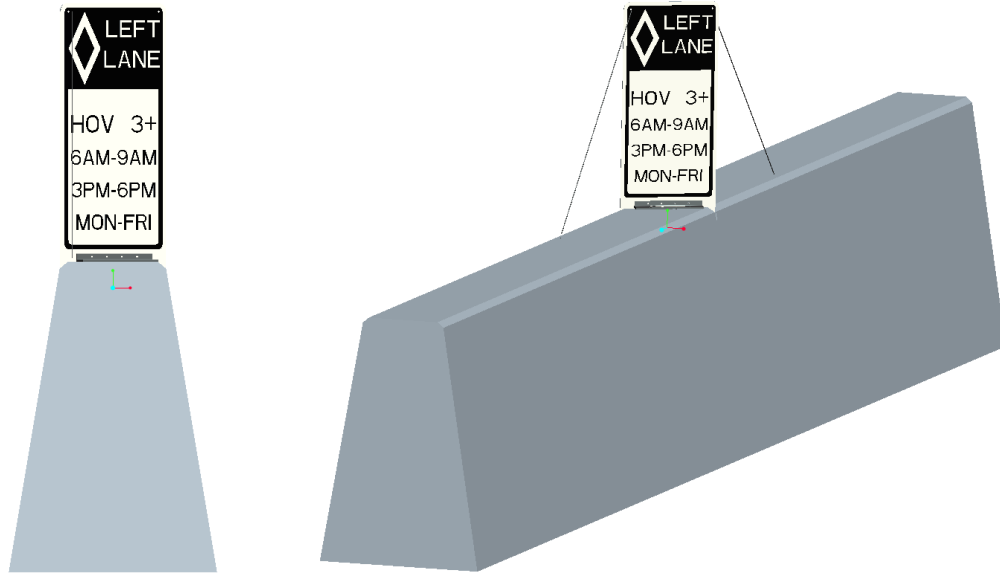
As a future project for retrofitting existing locations where signposts are mounted onto median barriers, the signpost could be removed and the sign mounted directly to the barrier. This could be accomplished by cutting a groove at an angle in the top of the barrier. A new sign will have to be developed that can be placed inside the groove. Along with the groove, brackets on the front and back face of the sign can be used to hold the sign in place. Tie down cables can be used to help restrain the sign and keep vibrations to a minimum. The cables can also act as tethers in the event of an impact. See Figure 4-4 for an example of this concept. Further research will need to be conducted to find what angles will provide the best visibility for the motorist, how these angles will affect the reflective surface of the sign at night, and the crashworthiness of the concept.

Figure 4-4 Example of a Sign Mounted Directly to the Barrier

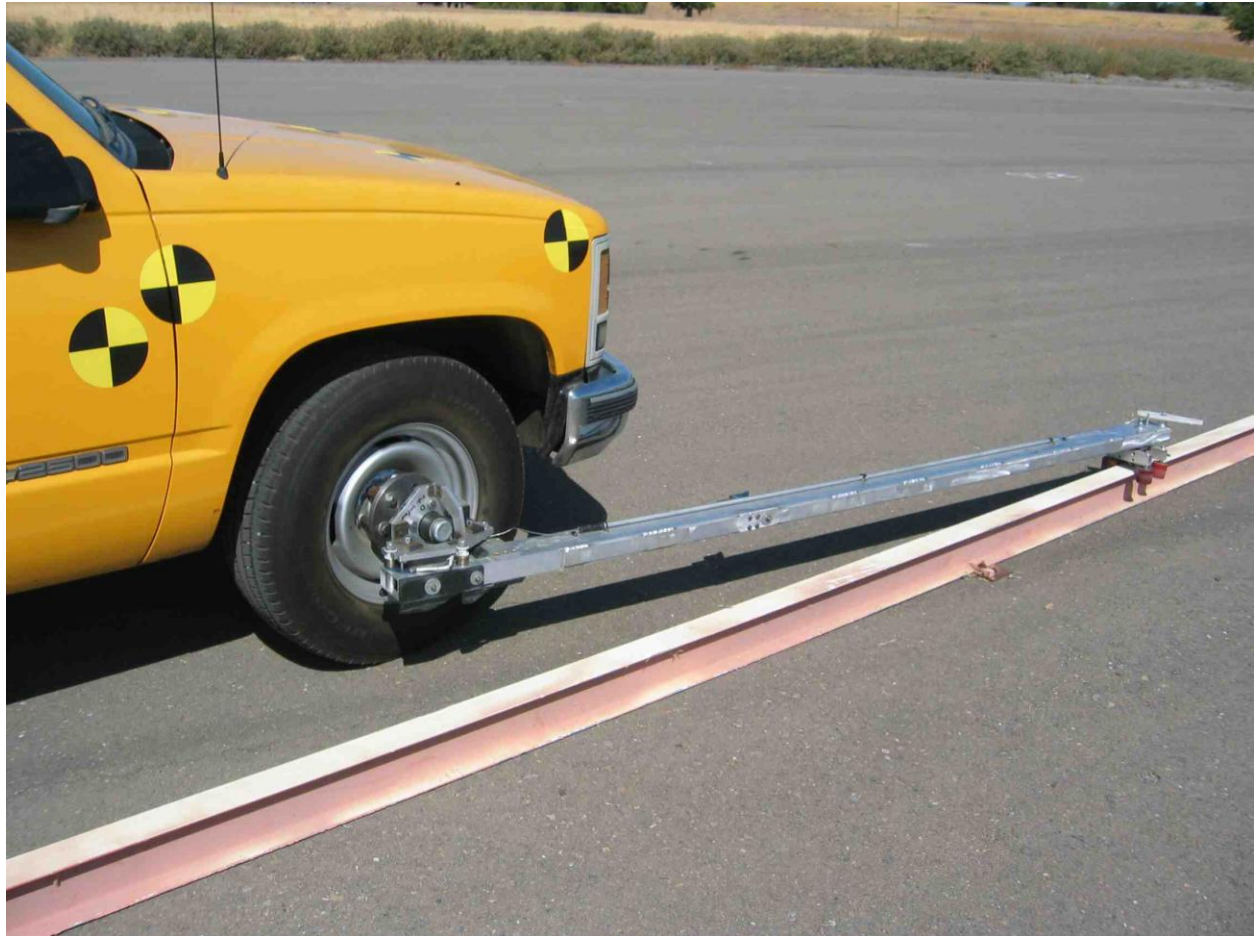
A rail guidance system directed the vehicle into the barrier. The guidance rail, anchored at 3.8-m (12.5-ft) intervals along its length, was used to guide a mechanical arm that is attached to the front passenger side wheel of the vehicle (Figure 7-1). A 10-mm (0.375-in) nylon rope was used to trigger the release mechanism on the guidance arm, thereby releasing the vehicle from the guidance system before impact.

Figure 7-1 Test Vehicle Guidance System

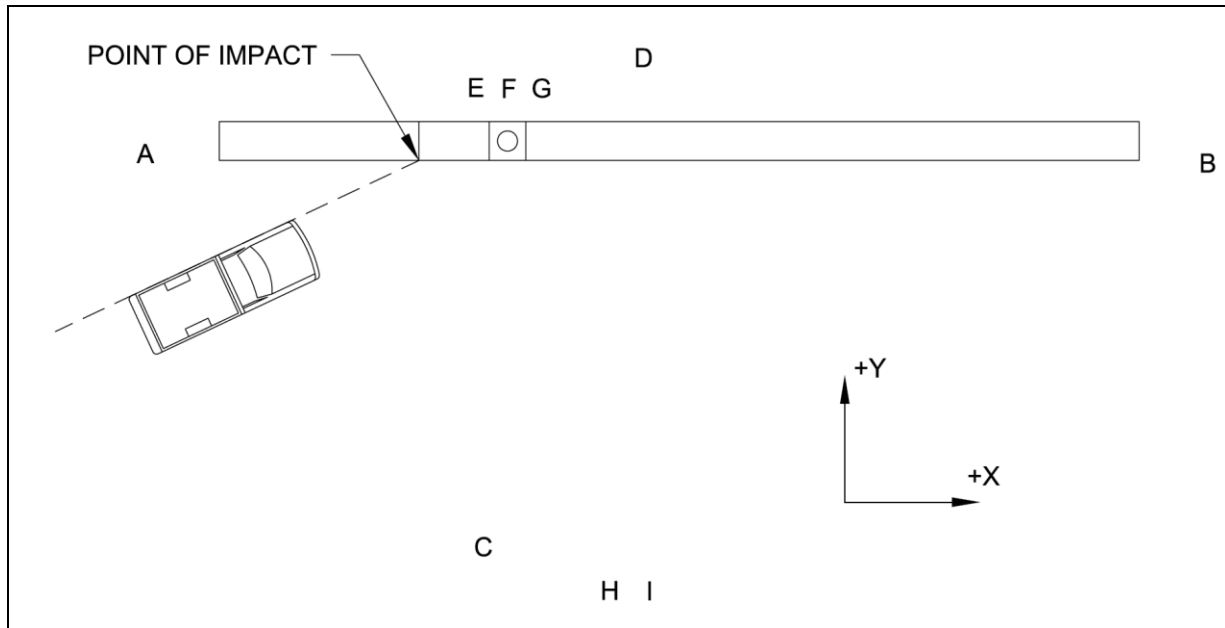
Figure 7-2 Camera Locations (Not to Scale)

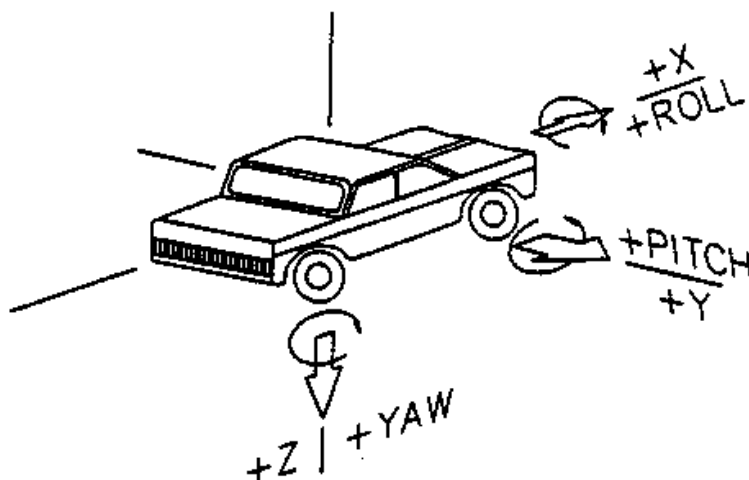
Figure 7-3 Vehicle Accelerometer Sign Convention

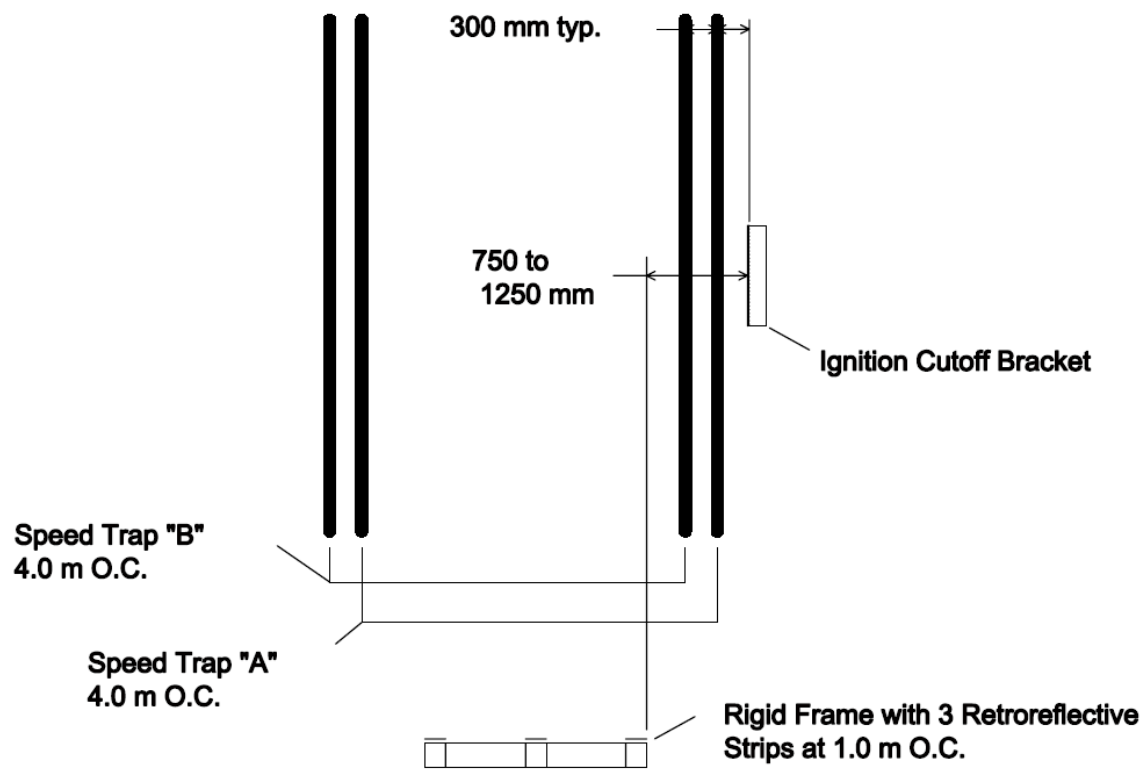
Figure 7-4 Event Switch Layout

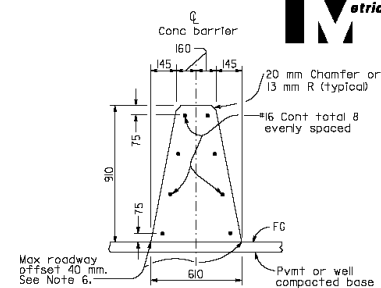
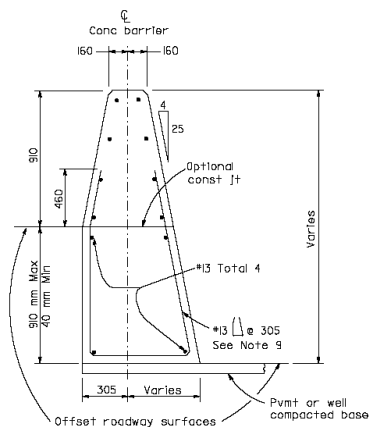
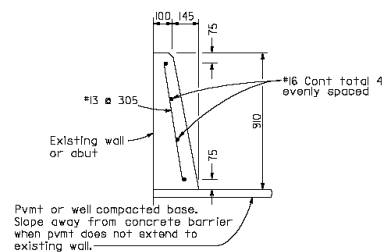
Figure 7-5 Standard Plan for Type 60 Barrier

**CONCRETE BARRIER TYPE 60A**  
Details similar to Type 60 except as noted.

**CONCRETE BARRIER TYPE 60**

**CONCRETE BARRIER TYPE 60C**  
Details similar to Type 60 except as noted. Concrete barrier end anchor when necessary.

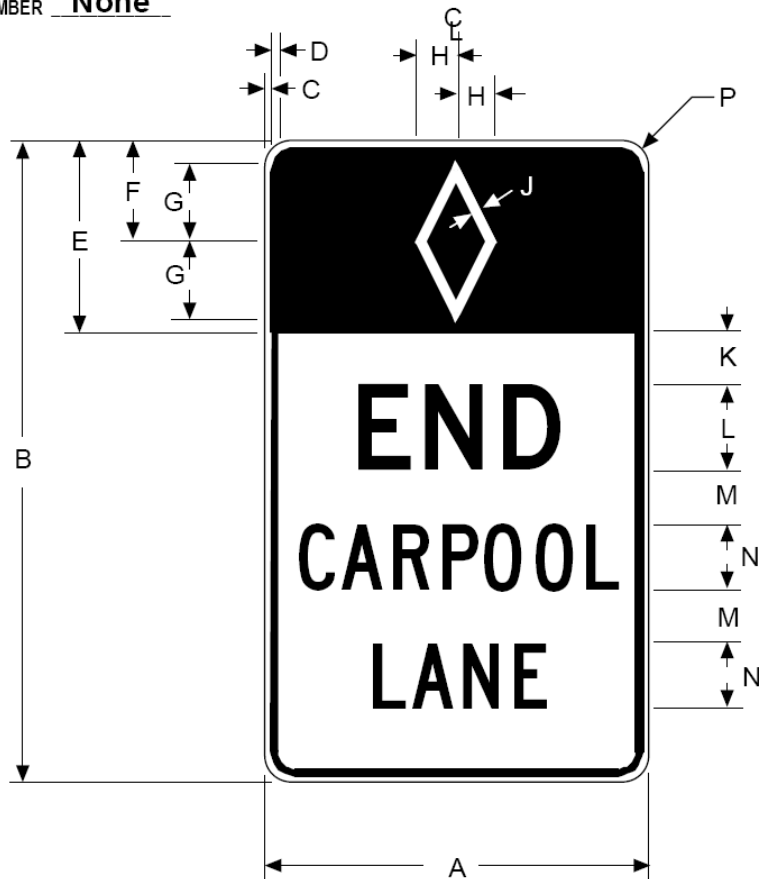
MUTCD NUMBER NoneCODE R84-1

mounted to the barrier with two 25-mm (1.0-in) bolts. The general shape of the signs was designed using the Caltrans standard plan for HOV sign R84-1 (CA) (Figure 7-8). The sign configuration used two 914-mm (36.0-in) by 1524-mm (60.0-in) panels placed back to back, negating the need for braces. A local contractor, National Concrete Cutting, was hired to use a coring drill to core two 32-mm (1.25-in) horizontal holes into the type 60 barrier. The impact point was then marked two meters upstream from the center of the signpost assembly.
