Compliance Crash Testing of K-Rail Used in Semi-permanent Installations

October 1999

**COMPLIANCE CRASH TESTING OF K-RAIL USED IN
SEMI-PERMANENT INSTALLATIONS**

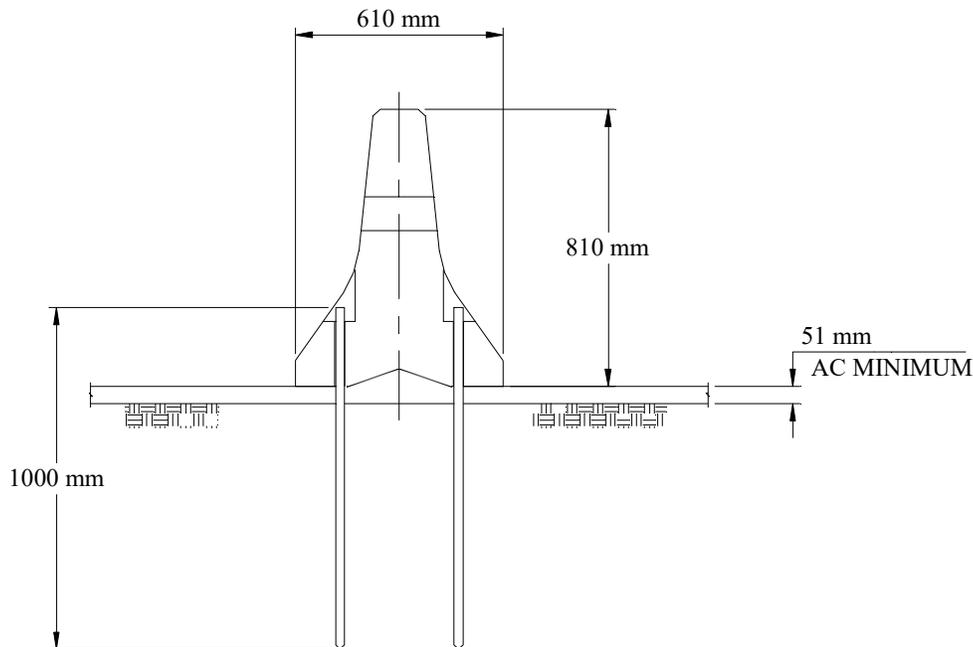
Figure 2-1 - Cross Section of Planned Test Barrier

Refer to Standard Plans July 1997 for
Dimensions, page 132 SECTIONS A-A, B-B.

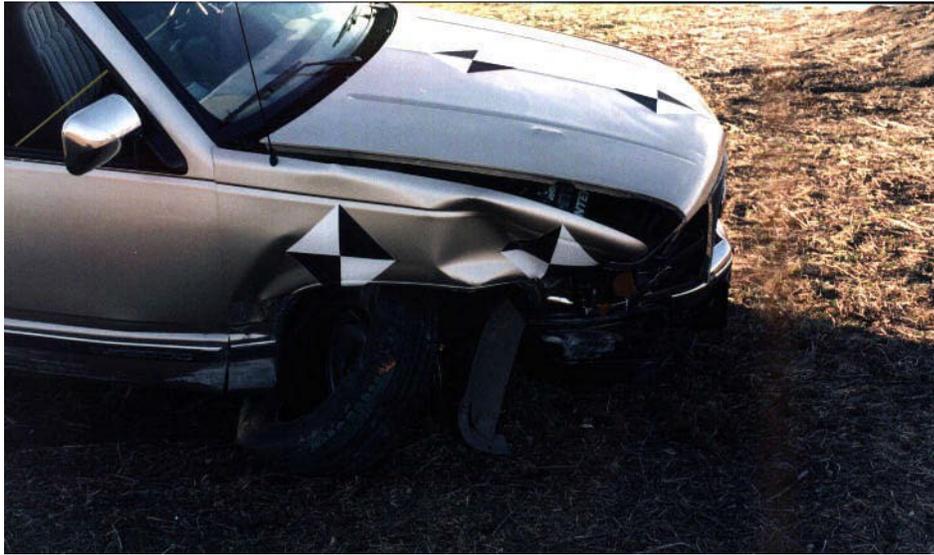
Figure 2-10 - Front Impact Side of Vehicle

Most of the damage to the vehicle was confined to right front corner. The right front tire was separated from the wheel. The right front fender and bumper were crushed (Figure 2-10). The tie-rod was broken, but the left front wheel could still be controlled by the steering wheel. There were scuff marks and scratches along the entire right side of the vehicle. The left rear wheel sustained minor damage, but the tire was still inflated.

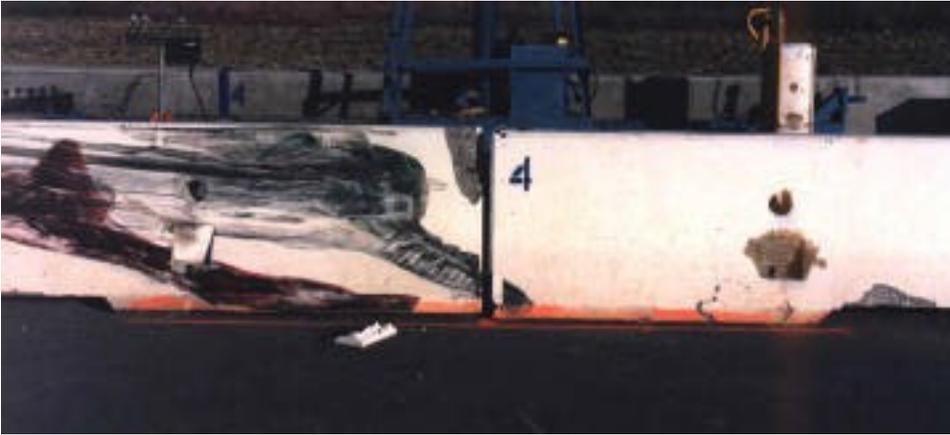
Figure 2-11 - Post Impact View of Barrier

Damage to the barrier was minimal (Figure 2-11 through Figure 2-15). The connecting pin-and-loop at joint 4-5 bent enough that it caused minor spalling and the pin had to be cut before the barrier could be moved. The maximum lateral displacement measured at the top of the barrier was 260 mm during impact. There was also some minor spalling of anchor stakes in segments 4 and 6.

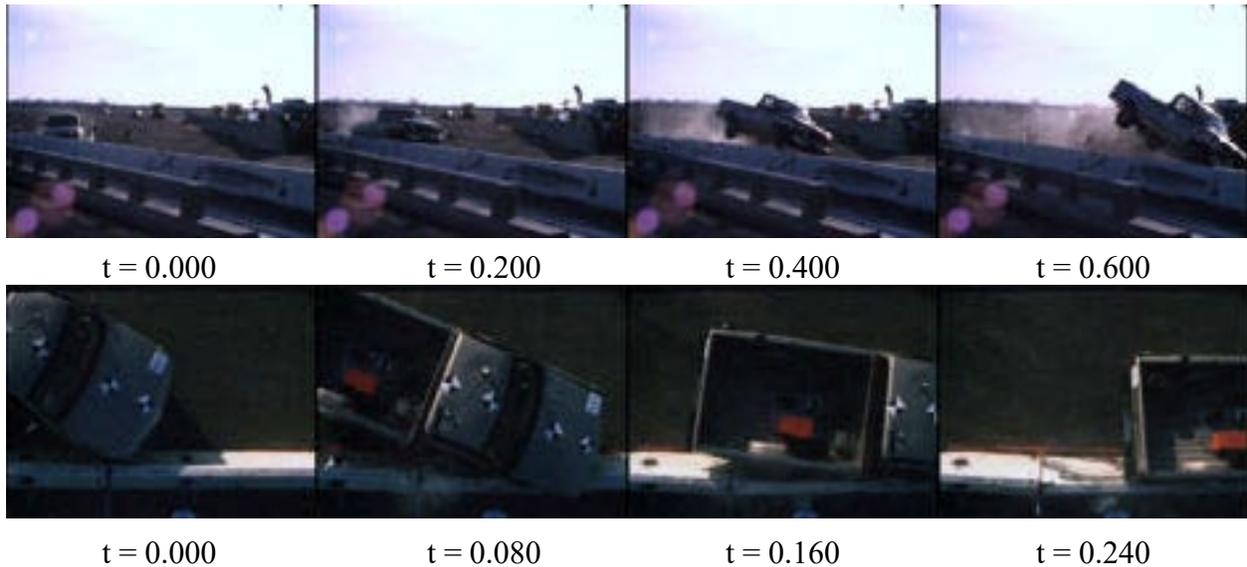
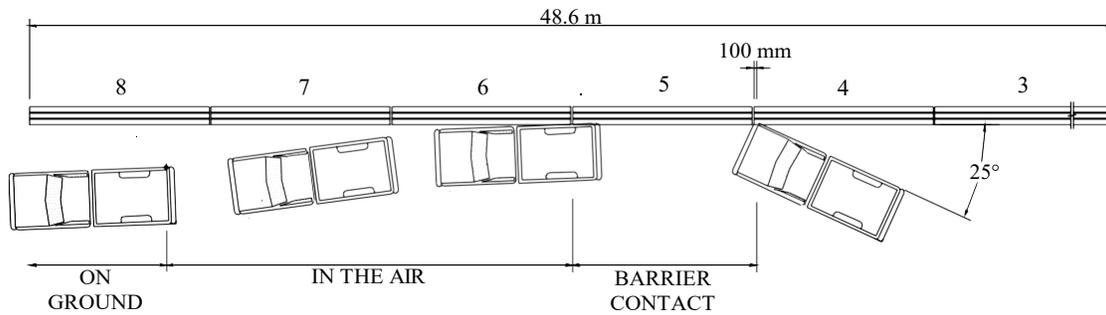
Figure 2-16 - Test 551 Data Summary Sheet

Spalling at the pin-and-loop
 connection at point of
 impact, also at some of the
 anchor stakes. Superficial
 scuffing

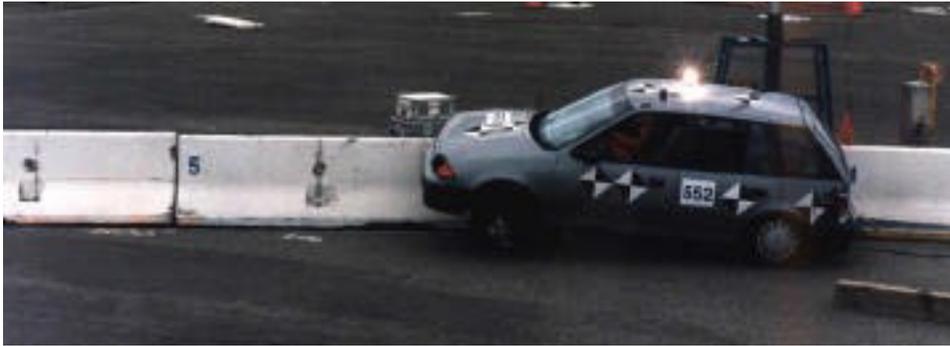
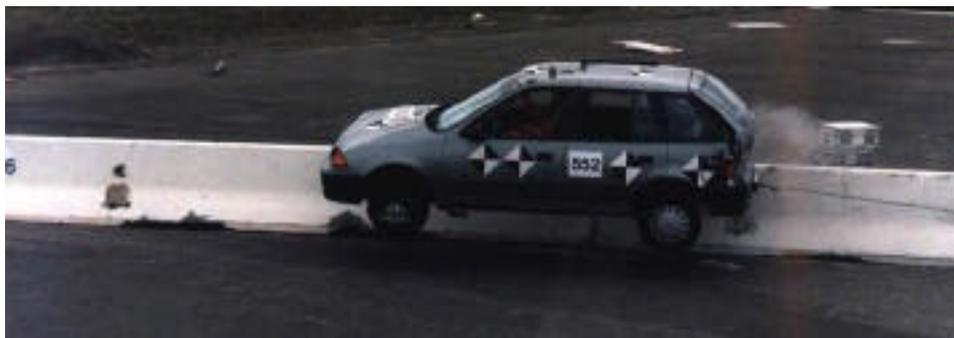
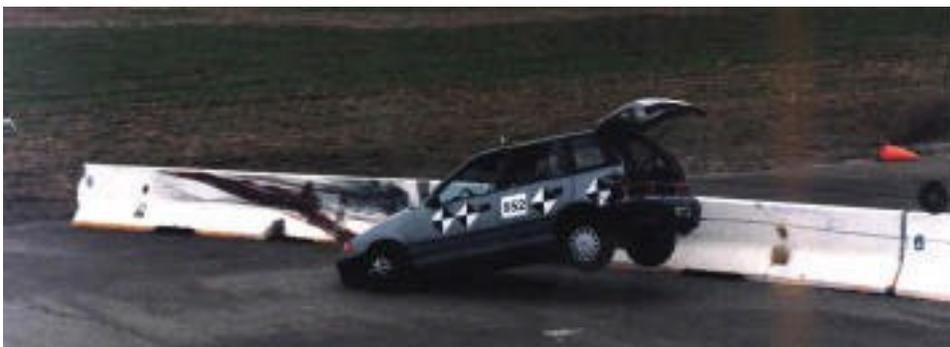
Figure 2-21 -
Vehicle 552
Impacting Barrier

Figure 2-22 -
Vehicle 552 Exiting
Barrier

Figure 2-23 -
Vehicle 552
Landing Upright
and Stable

The vehicle impact speed and angle were 101.7 km/h and 20 degrees, respectively. Impact occurred at the joint between the fourth and fifth segments (see Figure 2-17). Within the first 3 m of barrier contact, the vehicle rotated 20 degrees to the left, the rear hatch opened up and all four wheels left the ground. Contact with the barrier continued for about 8 m while the vehicle rose. The vehicle stayed level while rising to an ultimate height of 630 mm. The vehicle came back down 15 m downstream of the impact point (see Figure 2-21 through Figure 2-23).

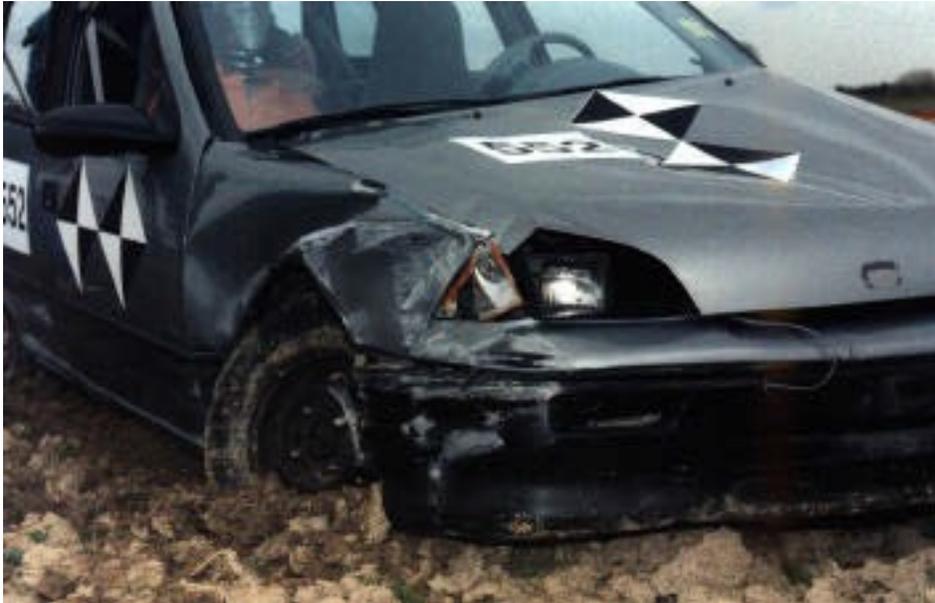
Figure 2-24 -Front View of Vehicle Impact Damage

As in Test 551, most of the damage to the vehicle was confined to the right front corner. The right 300 mm of the bumper was slightly pushed into the fender panel and the fender had considerable sheet metal damage. The parking light was broken. The right wheel assembly was pushed back and to the left, with the bottom of the wheel canted outward (see Figure 2-24 and Figure 2-25).

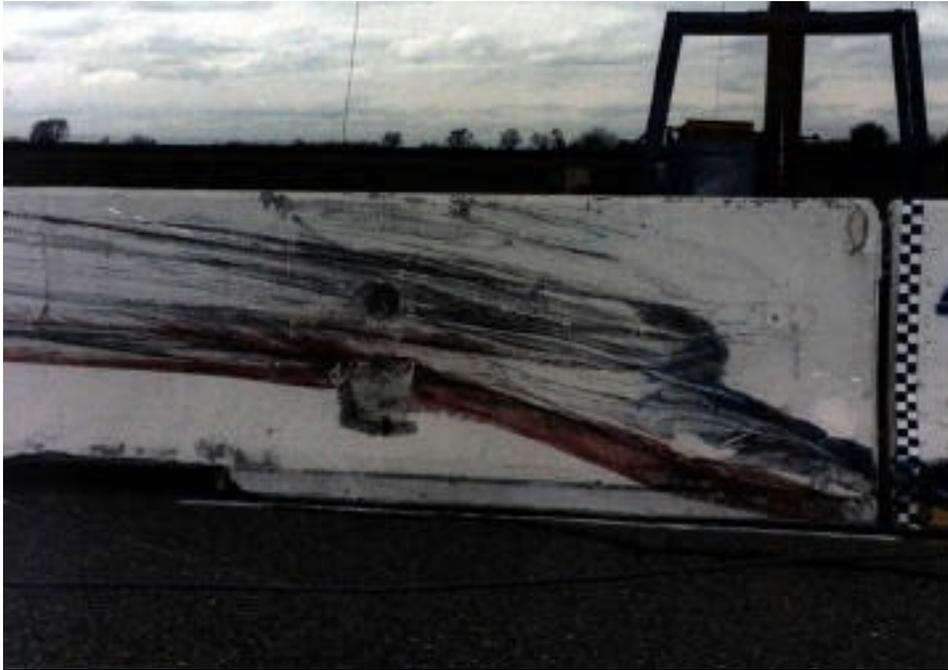
Figure 2-26 - Test
552 Barrier
Scuffing

Damage occurred only on the front of the barrier. Vehicle contact was limited to segments 4 and 5, where the barrier received superficial scuffing (see Figure 2-27). The K-rail cracked around several of the stake holes, but they all retained their integrity. The barrier rotated back approximately 30 mm during impact, but righted itself as the vehicle lost contact with the barrier.

Segment 4 had a permanent deformation of 25 mm, with the front edge of the barrier raised about 10 mm. The loop connections did not incur any damage.

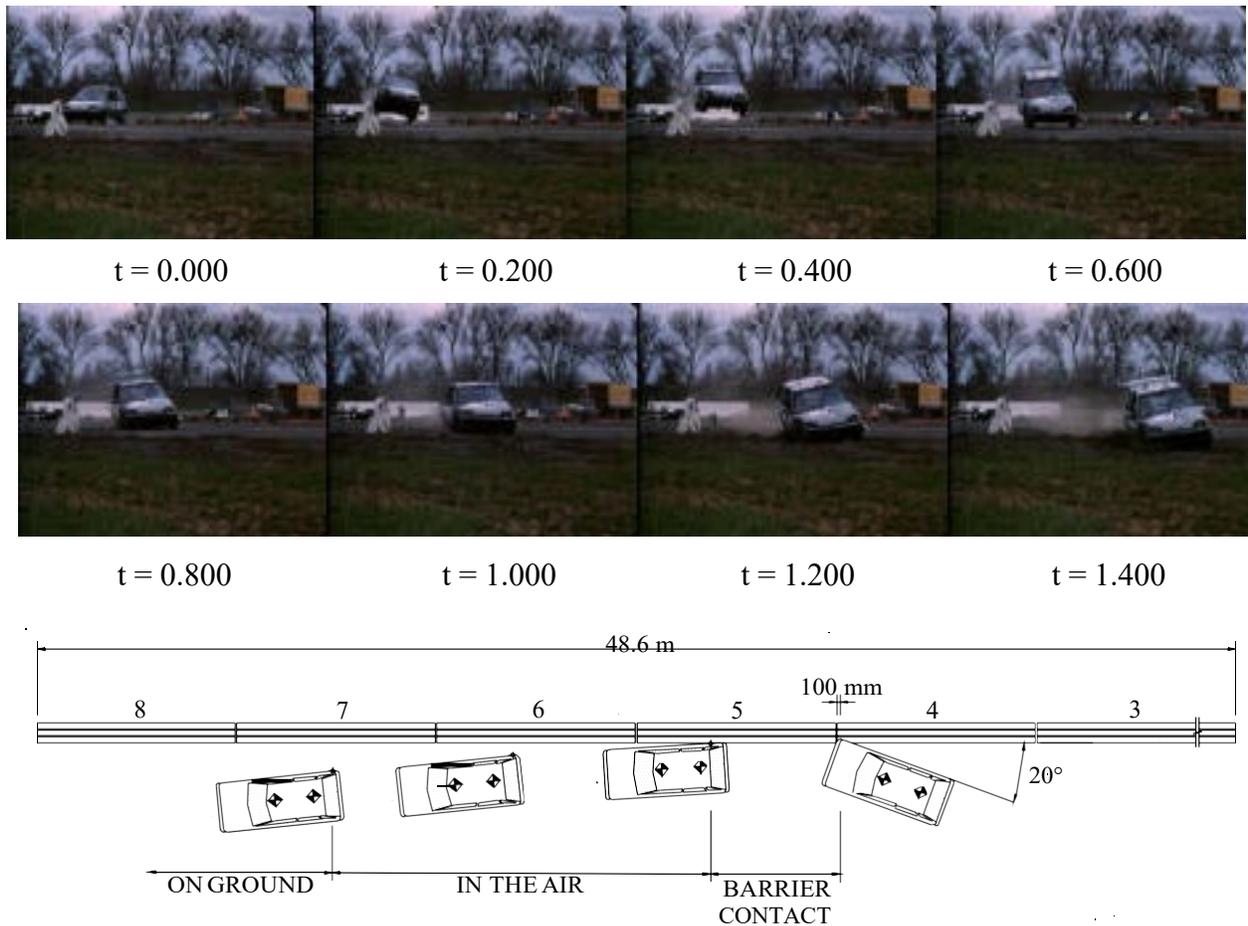
Figure 2-27 - Test 552 Data Summary Sheet

Barrier Damage: Superficial scuffing.

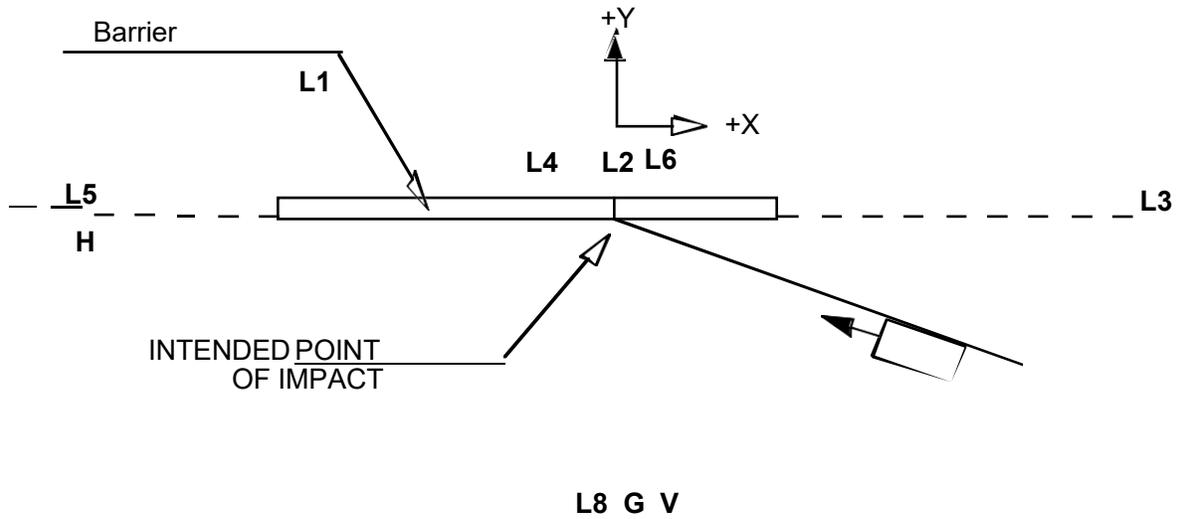
Figure 6-1 - Camera Locations

All of these cameras were mounted on tripods except the three that were mounted on a 10.7 m-high tower directly over the impact point on the test barrier.

A video camera and a 16-mm film camera were turned on by hand and used for panning during the test. Switches on a console trailer near the impact area remotely triggered all other cameras. Both the vehicle and barrier were photographed before and after impact with a normal-speed movie camera, a beta video camera and a color still camera. A film report of this project has been assembled using edited portions of the crash testing coverage.

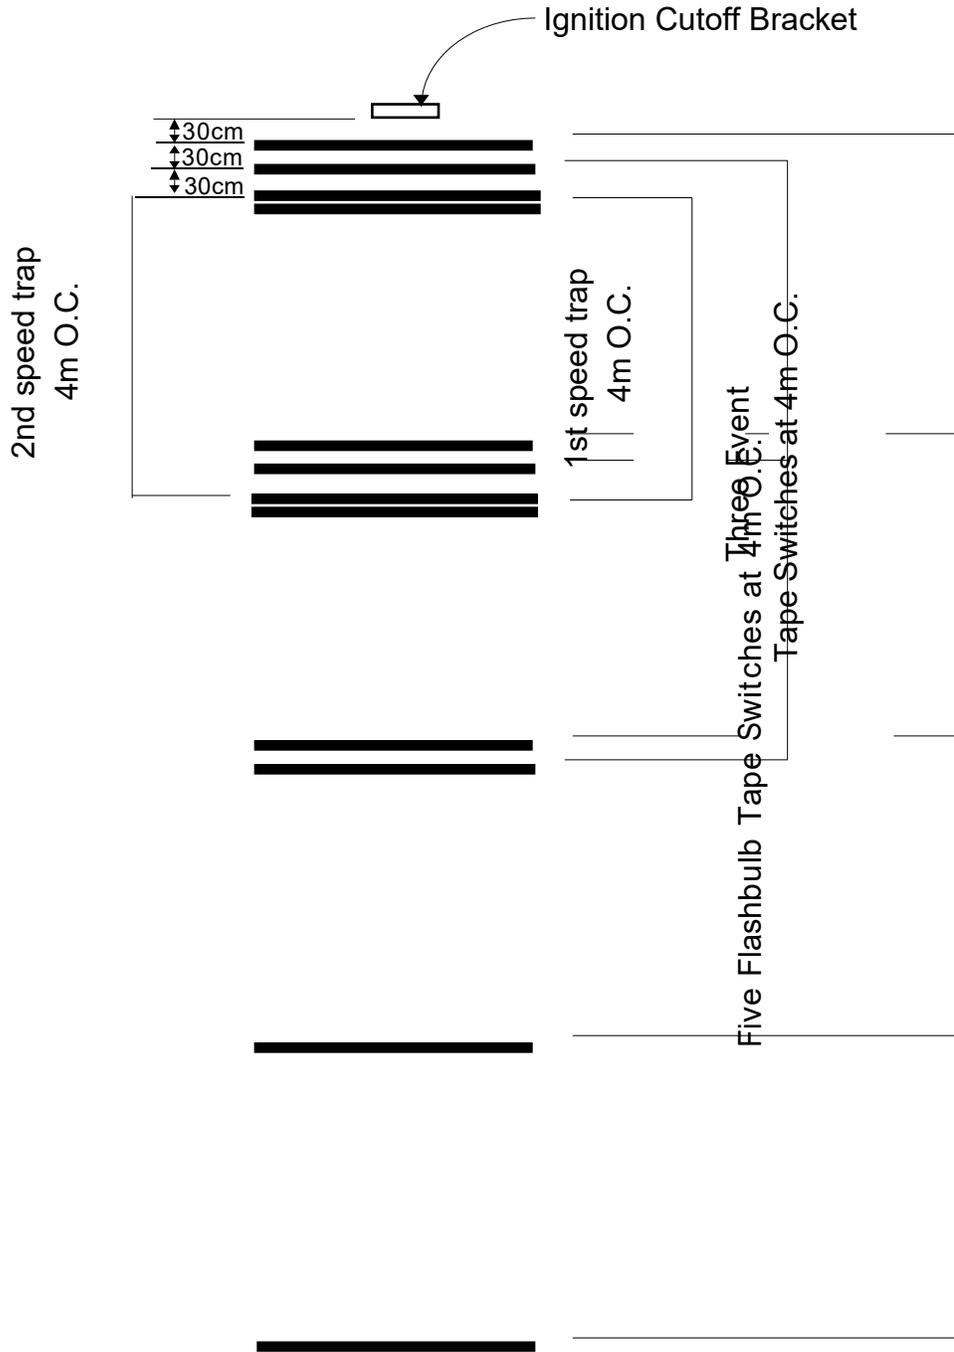
Figure 6-2 - Tape Switch Layout

3) Five tape switches, placed at 4-m intervals, were attached to the ground near the barrier and were perpendicular to the path of the test vehicle. Flash bulbs were activated sequentially when the tires of the test vehicle rolled over the tape switches. The flashbulb stand was placed in view of most of the cameras. The flashing bulbs were used to correlate the cameras with the impact events and to calculate the impact speed independent of the electronic speed trap. The tape switch layout is shown in Figure 6-2.

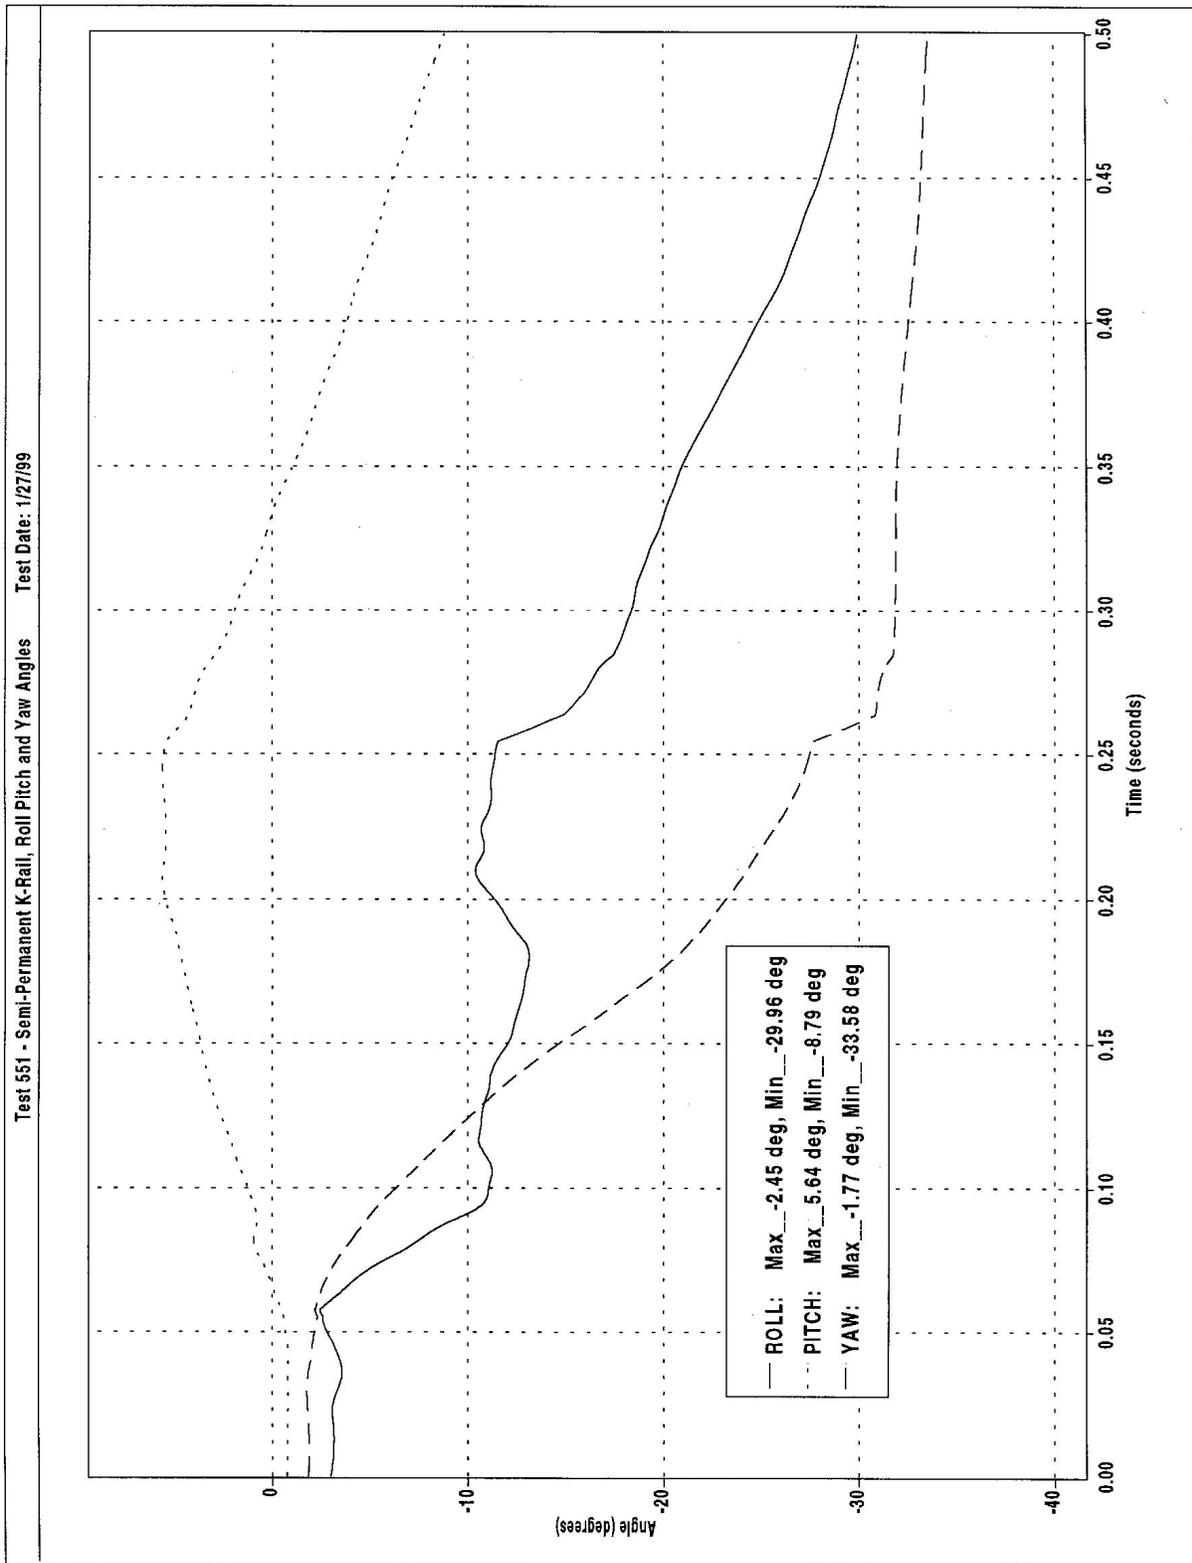
Figure 6-7 - Test 551 Vehicle Roll, Pitch and Yaw -Vs- Time

The rate gyro data for tests 551 and 552 recorded with multiple spikes due to loose wiring. The spikes are reflected in the plots. After test 551 was completed a failed attempt to correct the wiring was made, after test 552 the wiring was corrected.
