1. REPORT NO. CA10-0645	2. GOVERNMENT ACCESSION NO.	3. RECIPIENT'S CATALOG NO.
4. TITLE AND SUBTITLE DEVELOPMENT AND TESTING OF A LOW-PROFILE BARRIER		5. REPORT DATE <p style="text-align: center;">April 2012</p>

DEVELOPMENT AND TESTING OF A LOW-PROFILE BARRIER

**DEVELOPMENT AND TESTING OF A
LOW-PROFILE BARRIER**

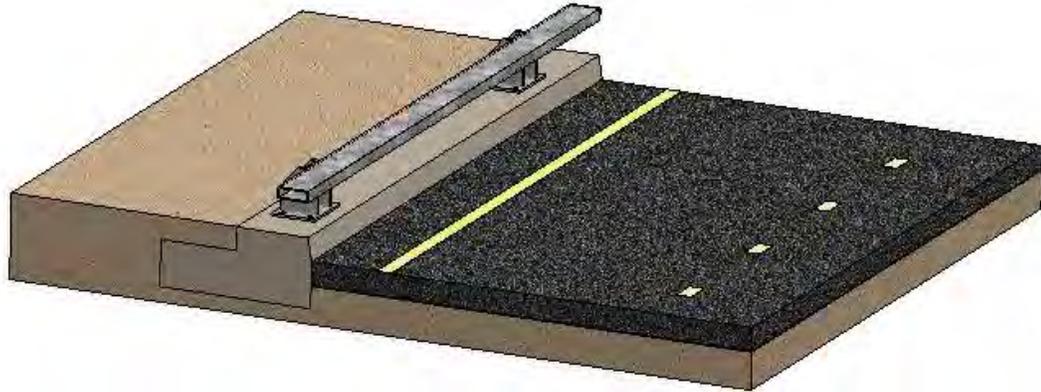
Figure 1-1. Computer Generated Barrier Design Concept

The barrier design concept is shown in Figure 1-1. The total height of the barrier is 18 inches measured from the ground with posts spaced at 10 feet apart. Regarding aesthetics, the leading request is for openings in the barrier, which would provide a less monolithic and more see-through appearance.

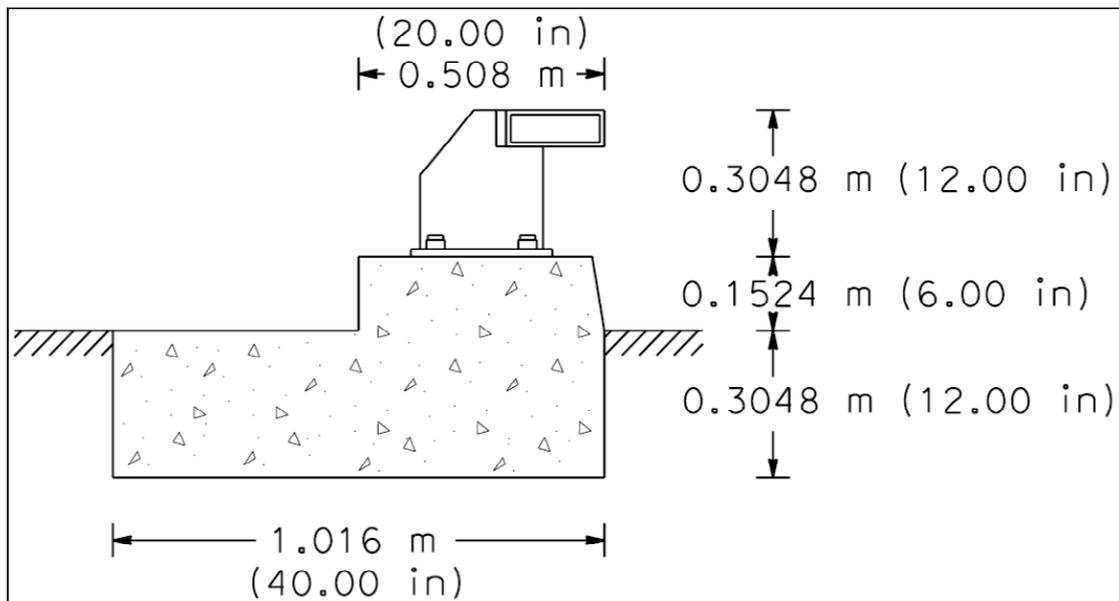
Figure 2-1. Low-Profile Barrier Cross-Section

A cross-section of the barrier is shown in Figure 2-1.

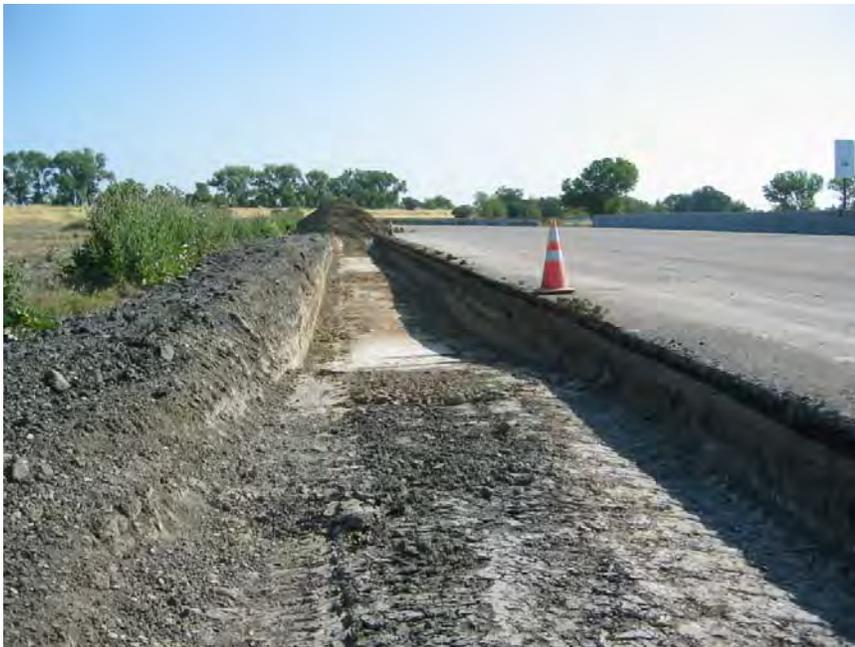
Figure 2-2. Excavation of Existing Soil

The low-profile barrier test article was constructed at the Caltrans Dynamic Test Facility. The test article was 30.48 m (100 feet) long with a nominal height of 0.4572 m (18 inches). It consisted of a 0.305 m (12 inch) deep foundation, a 0.105 m (6 inch) curb, with nine 0.305 m (12 inch) posts spaced at 3.048 m (10 feet) on center, and a 3x8x3/8 inch structural steel rail. In order to validate a LS-DYNA computer model, it was necessary that the low-profile barrier footing was built in a uniform soil bed to get a homogeneous soil reaction. Because existing soils were non-homogeneous due to an assortment of previous projects at the construction location, a 2.44 x 0.61 x 30.48 meter (8 x 2 x 100 feet) soil bed was excavated then backfilled with soil from a local gravel provider (Cascade Rock, Inc.). The soil analysis of the fill soil was completed by the Caltrans Geotechnical Lab and classified as fine sandy silt. At a 90% relative compaction and an optimum moisture content of 12.3%, the maximum dry density was 114.6 pcf¹.

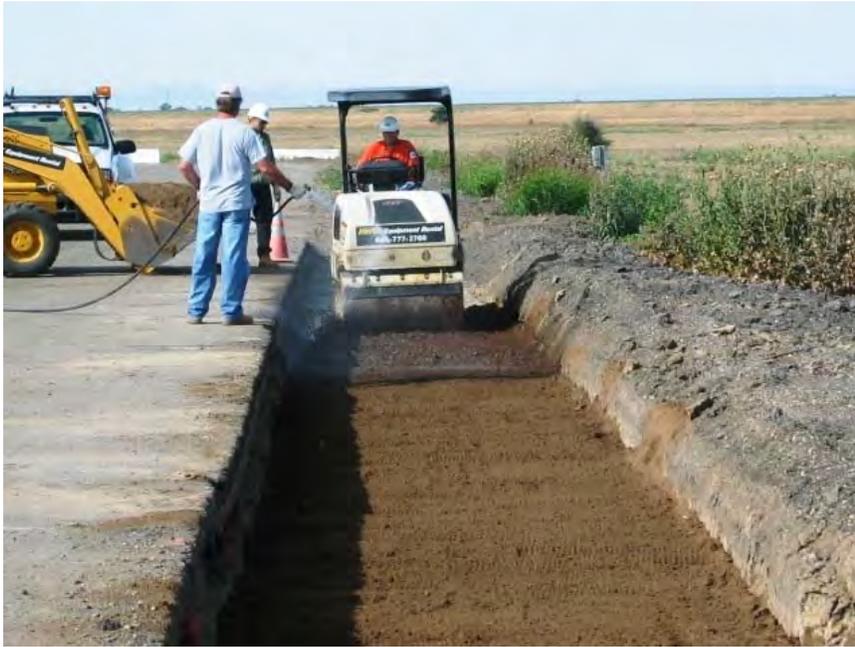
Figure 2-3. Soil Compaction of Fill Soil in 4 to 6 Inch Lifts

Once the excavation was complete, the bed was filled with soil, 0.1016 to 0.1524 meters (4 to 6 inches) per lift. Each lift was moisture-conditioned and compacted using a vibratory roller.

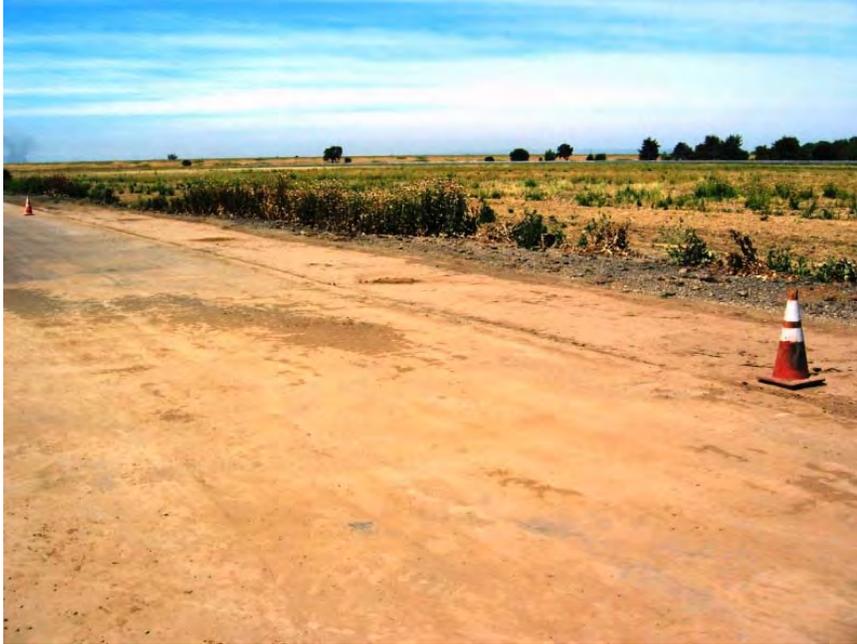
Figure 2-4. Completed Soil Bed (between cones)

Once the bed was completely filled and compacted, a nuclear gauge was used to test the compaction. The minimum relative compaction required was 90% under Caltrans 2006 Standard Specifications. A 93% relative compaction was achieved with a density of 122.4 pcf.

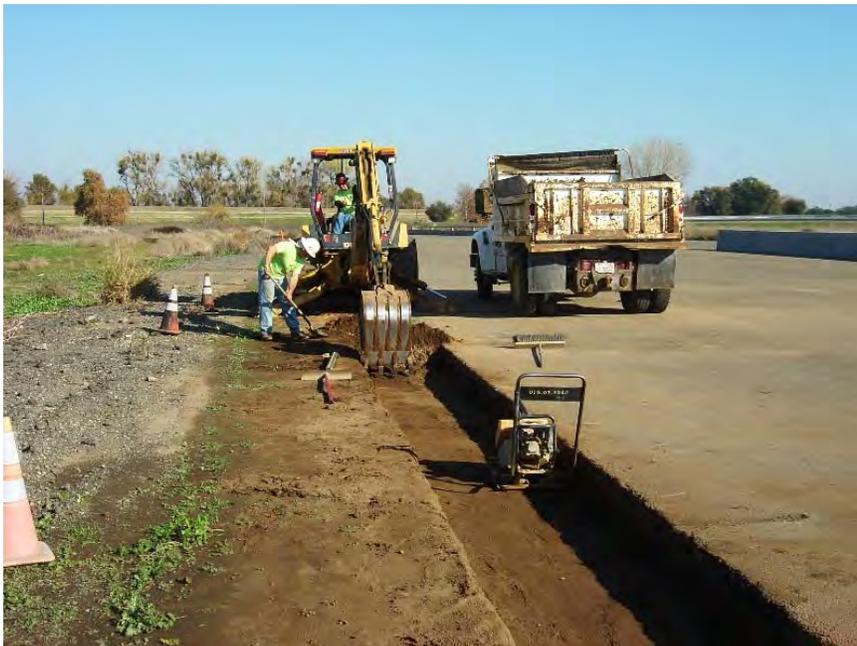
Figure 2-5. Excavation for Barrier Installation

The low-profile barrier was constructed and installed in two phases: pouring of the footing and attachment of the rail. The soil was re-excavated 1.016 x 0.3048 x 30.48 meters (3.3 x 1 x 100 feet) to install the footing of the barrier. The footing and the curb were constructed in a single pour.

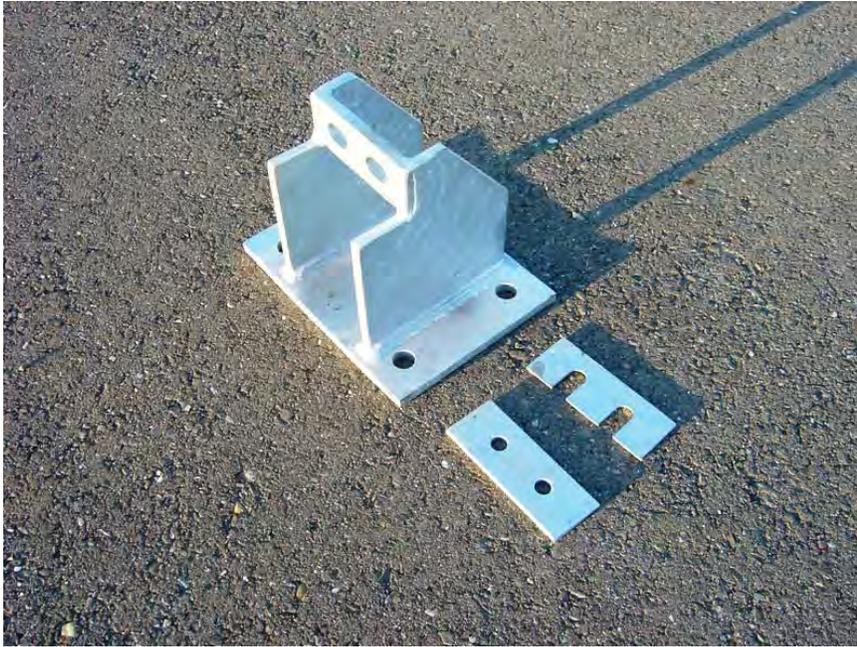
Figure 2-6. Post, Plate, and Shim

The footing was 30.48 m (100 feet) long and had 9 posts spaced 3.048 m (10 feet) on center. The rail came in 4 pieces and spanned 30.48 m (100 feet).

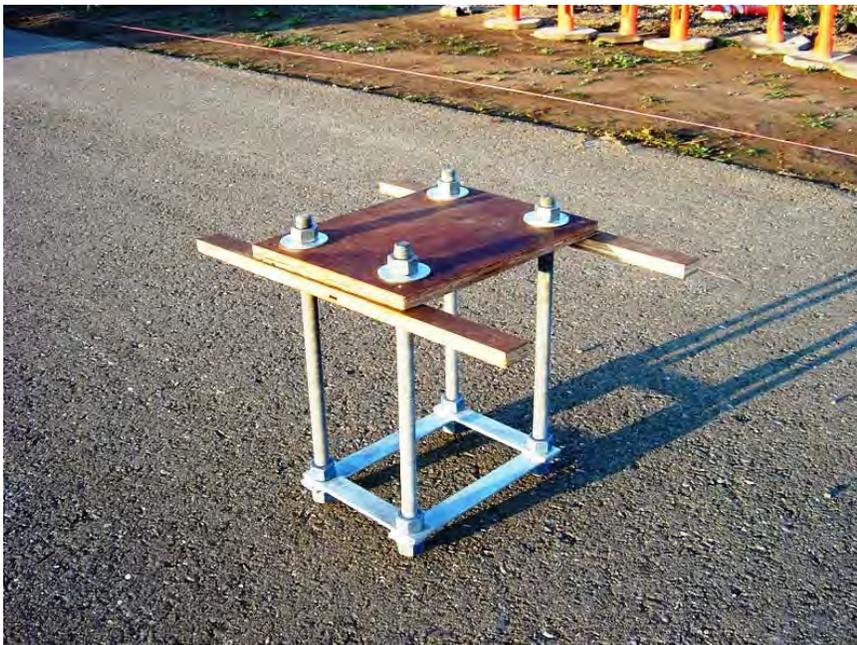
Figure 2-7. Post Anchor Setup

Once the formwork for the footing was complete, the reinforcing steel and anchor bolts were position and tied in. Concrete was then poured into the formwork while being consolidated with a concrete vibrator. All exposed steel components were galvanized from the manufacturer prior to installation. The footing was placed on December 4, 2009. The posts and rails were installed on December 15, 2009.

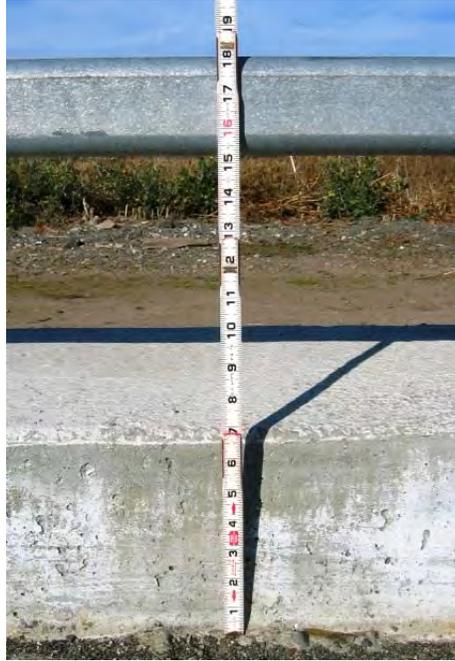
Figure 2-9. Height of Low-Profile Barrier

Because the adjacent pavement elevation varied along the length of the low-profile barrier, the as-built height of the barrier ranged from 0.4572 to 0.4826 meters (18 to 19 inches).

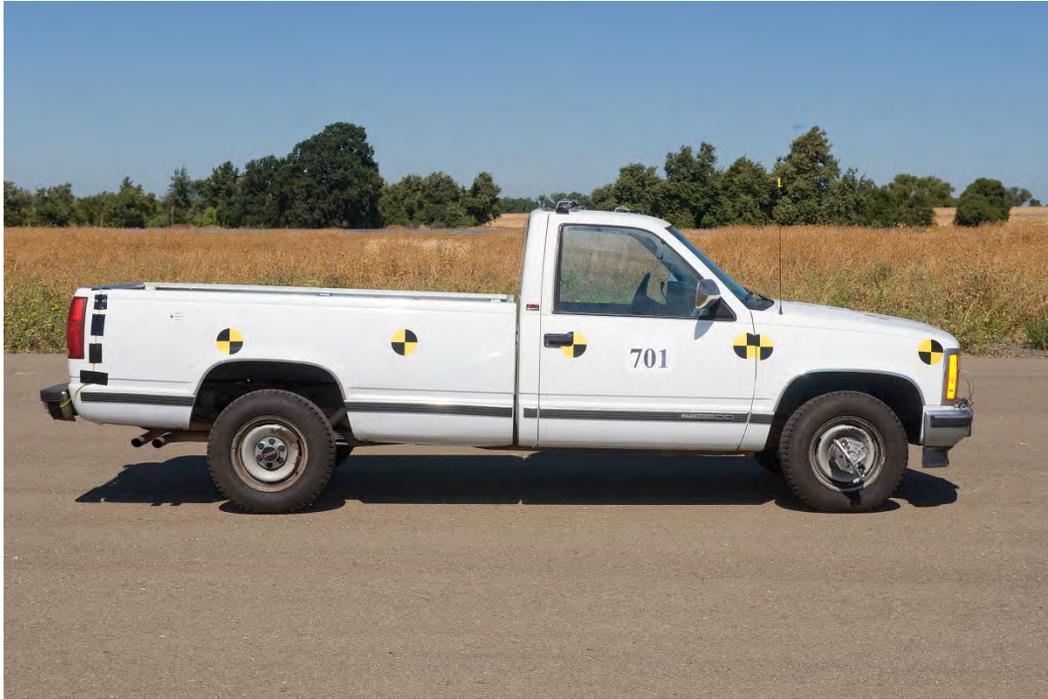
Figure 2-10. Test 701 Pickup Truck (Side)

The test vehicles complied with NCHRP Report 350 requirements. The vehicles, a 1990 GMC Sierra 2500 (Test 701) and a 1995 Geo Metro (Test 702) were in good condition. Both were free of major body damage and were not missing structural parts. They both had standard equipment. The inertial mass of the truck and small car were 1960.5 kg and 832 kg, respectively. Both vehicles were within the recommended mass limits of NCHRP Report 350 for each type of vehicle. To achieve the desired impact speed, the pickup truck was self-powered while the Geo Metro was towed by another vehicle. The Geo Metro was connected to a Ford F-350 Dually using a steel cable and towed to the target impact speed. A speed-control device limited the acceleration of both vehicles once the target impact speed had been reached. The speed control device was installed in the GMC truck and on the tow vehicle for the Geo Metro. For both vehicles, steering was accomplished by means of a guidance rail anchored to the ground and a guide arm attached to the vehicle wheel hub. Remote braking was possible at any time during the test via radio control. The vehicles were released from the guidance rail a short distance before impact. Shortly before impact, the pickup truck ignition was turned off while the tow cable was released from the metro. Photos of the test vehicles are shown in Figures 2-10 to 2-15.

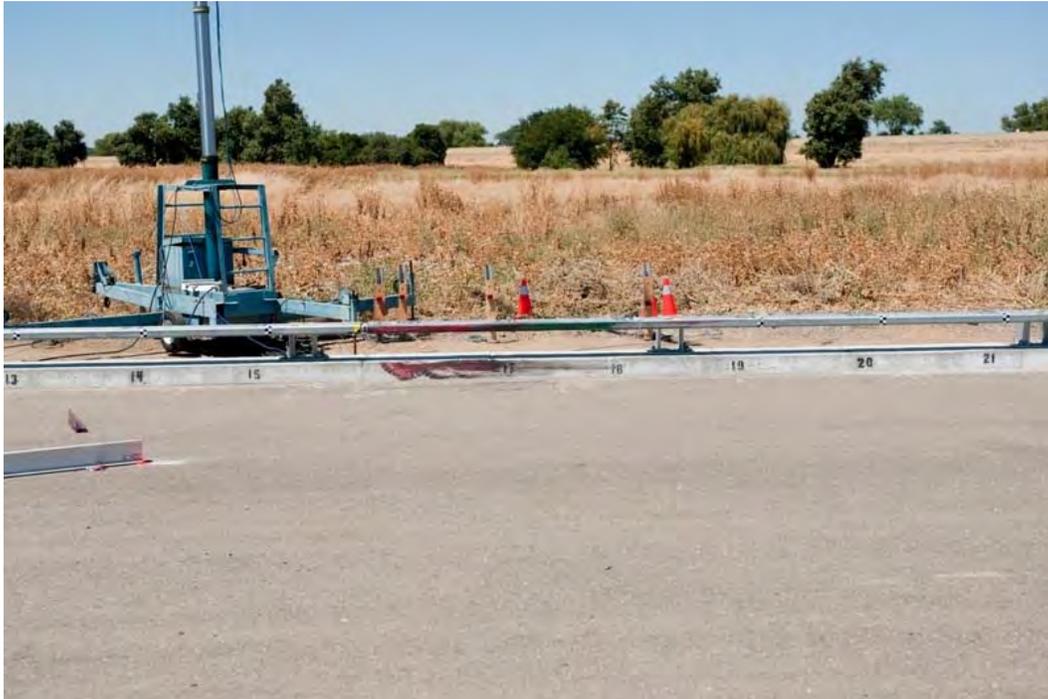
Figure 3-1. Test 701 Barrier Post Impact

There was minimal damage to the barrier. Stringpots and angular rate sensors were used to measure the displacements and rotations of the barrier for Test 701. The maximum permanent deflections for rail and the footing were 9.823 mm and 0.408 mm. See Section 8-6 in the Appendix for stringpot and rate gyro data. Damage to the barrier was considered cosmetic and would not have required field repairs.

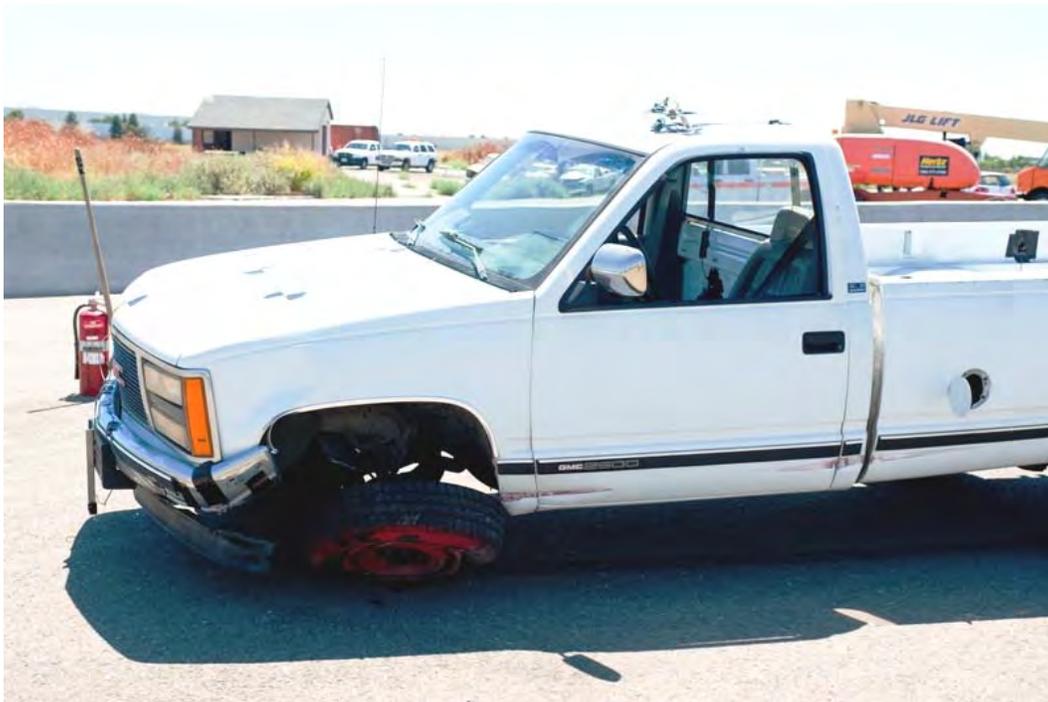
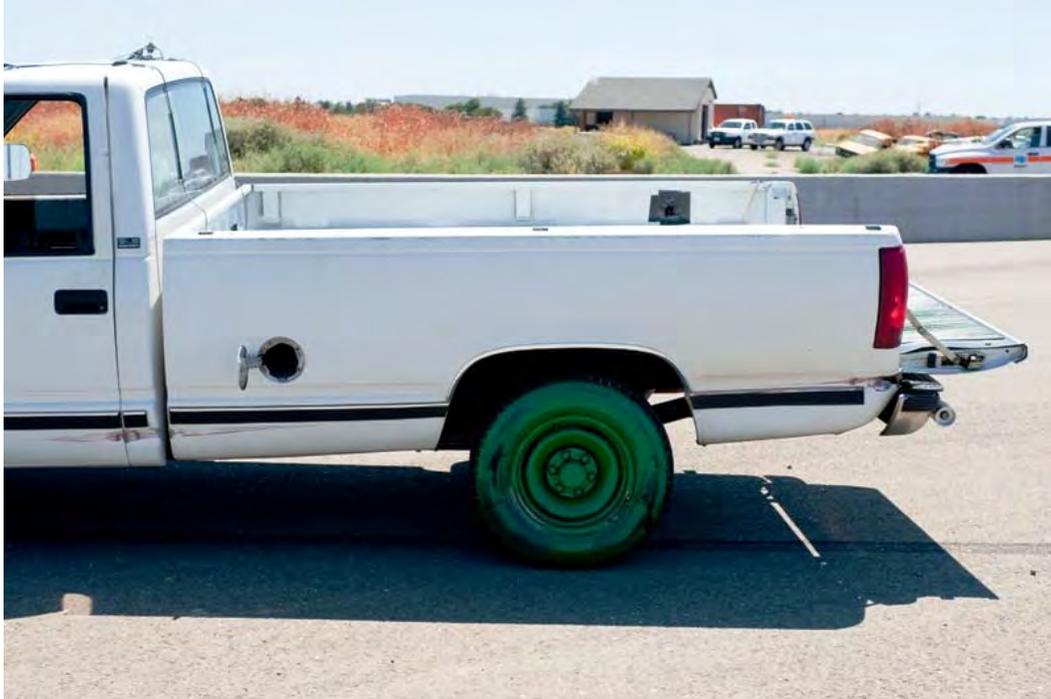
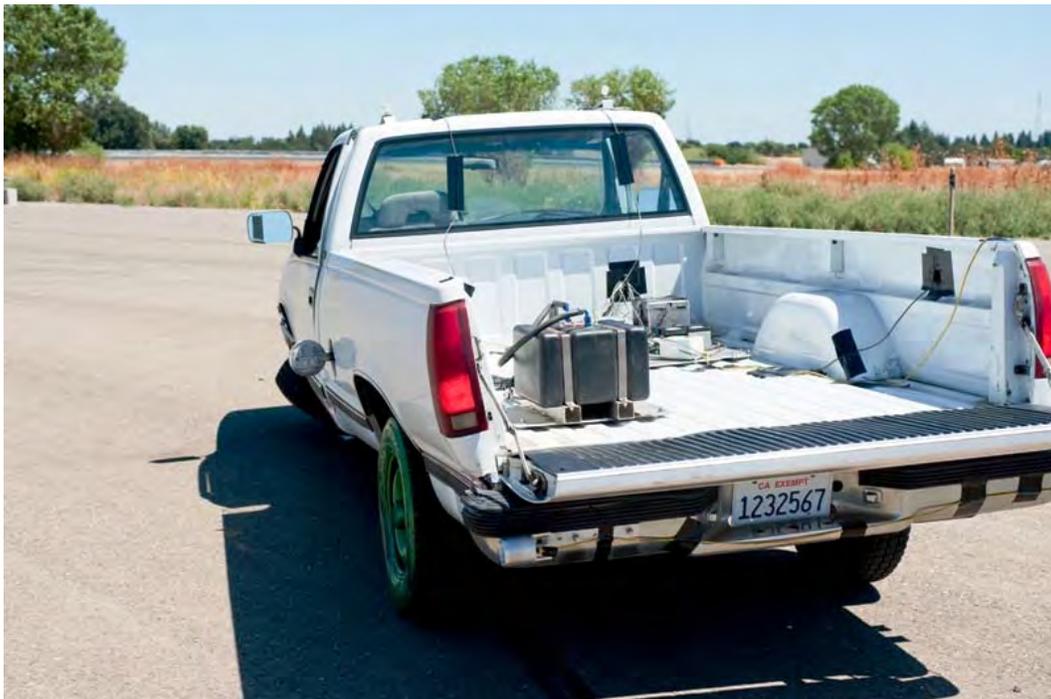
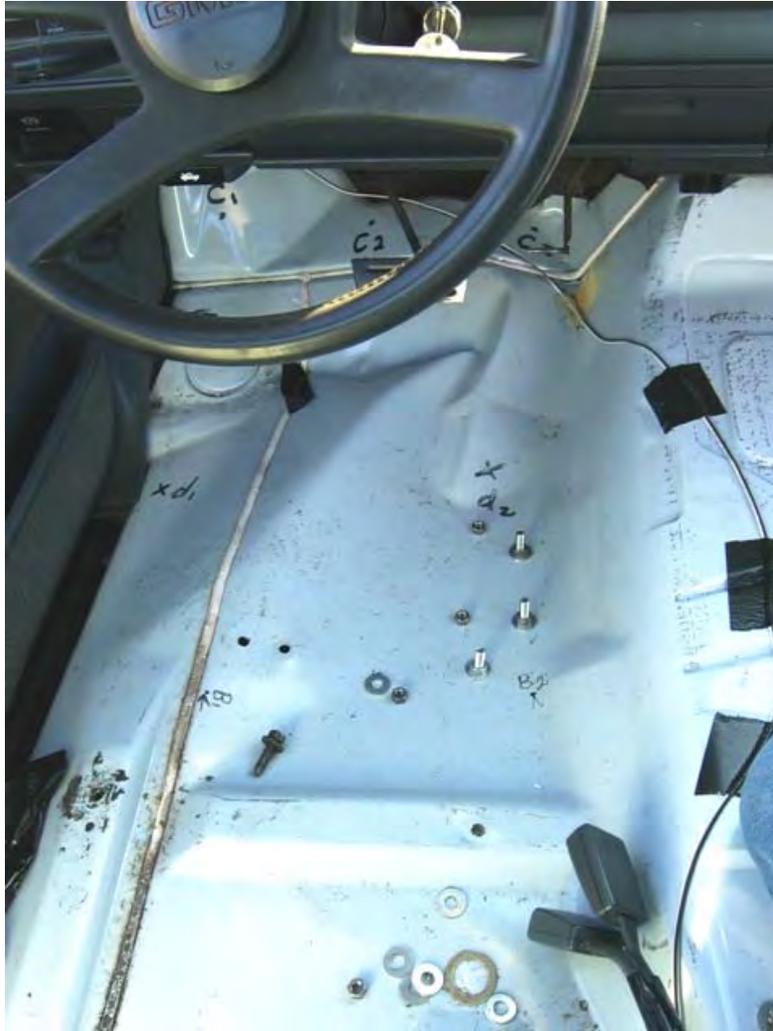
The front left corner and wheel of the test vehicle sustained most of the damage. Additional damage also occurred to the floorboard and side of the vehicle as it scraped the barrier when redirected. The front left tire was flat and the wheel assembly came loose from the ball-joint. The front left bumper was bent in and up towards the left fender when it made contact with the barrier rail. The wheel assembly was pushed back into the wheel well, eliminating the ability to steer the vehicle after impact. See Figures 3-4 to 3-7 for pictures of the truck vehicle damage. The floorboard buckled due to the tire being pushed back in the wheel well. The maximum floorboard deformation was 45 mm, located just right of the center on the driver's floor (see Figure 3-7).

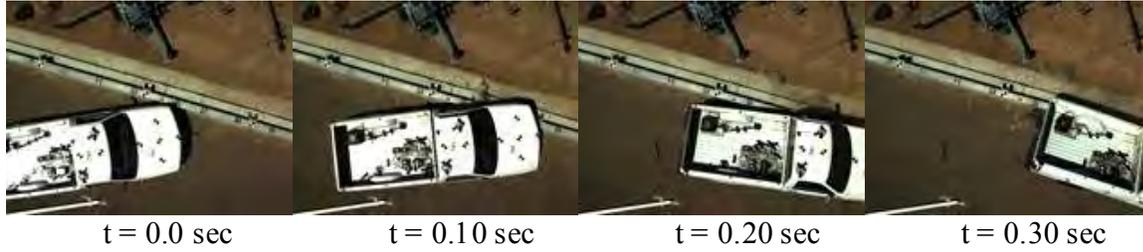
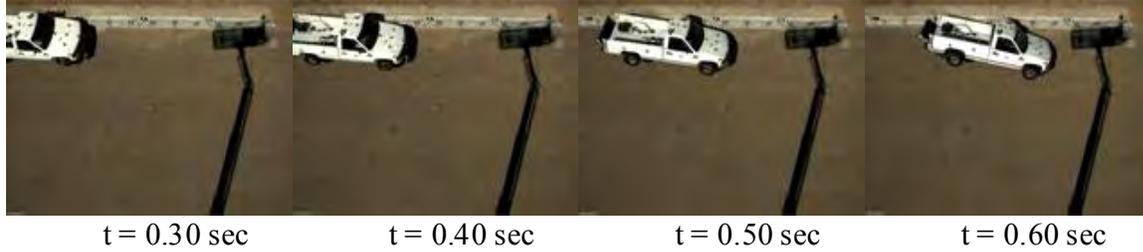
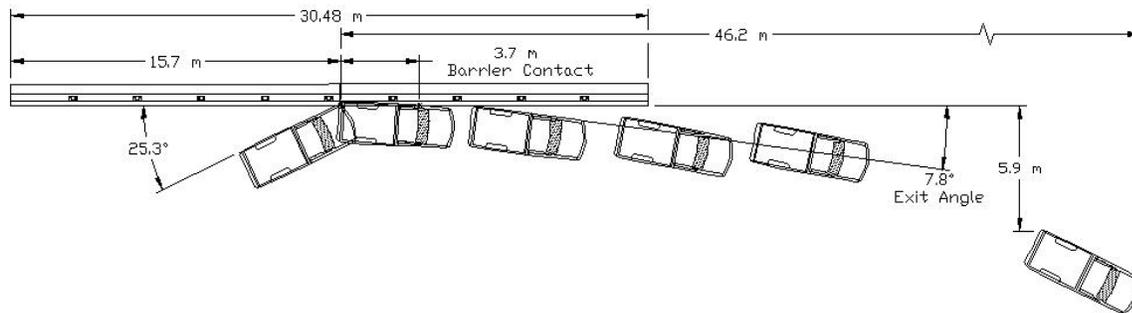
Figure 3-8. Test 701 Data Summary Sheet

The deflection of the rail and footing was 9.823 mm and 0.408 mm. Damage to the barrier was minimal and considered cosmetic.

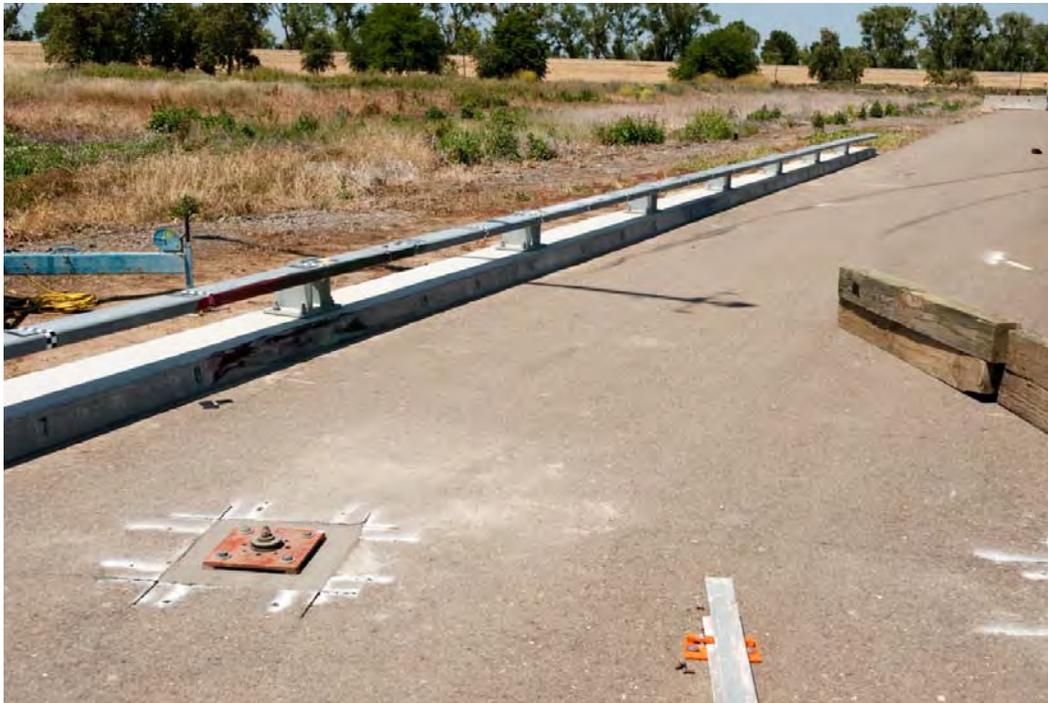
Figure 3-9. Test 702 Barrier Post Impact

There was no discernable permanent deflection of the barrier. Damage to the barrier was considered cosmetic and would not have required field repairs.

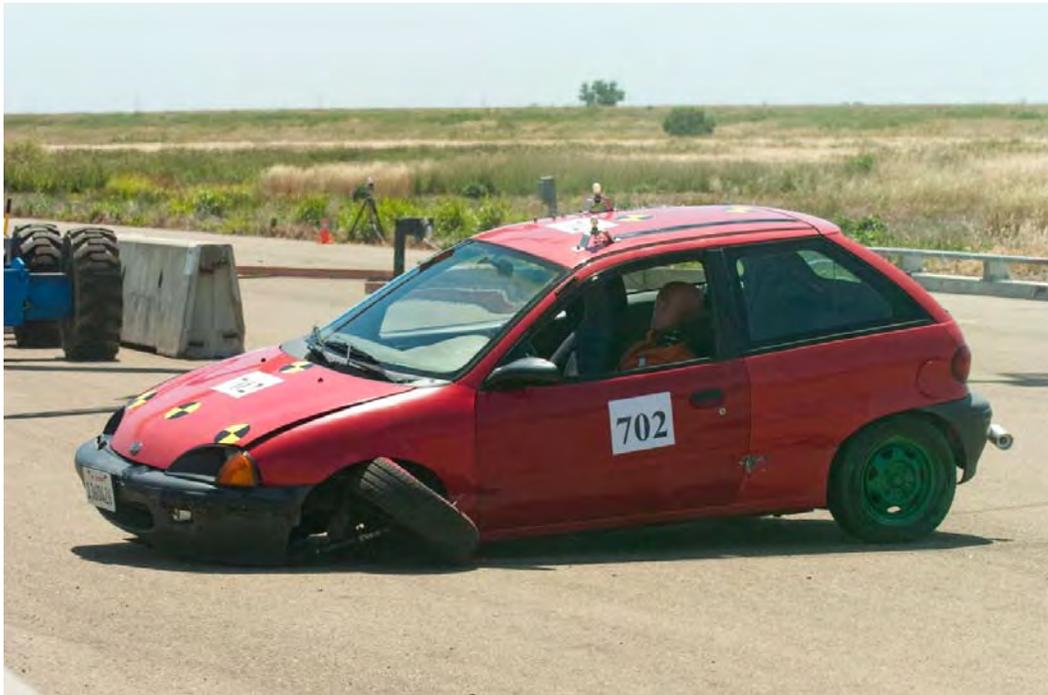
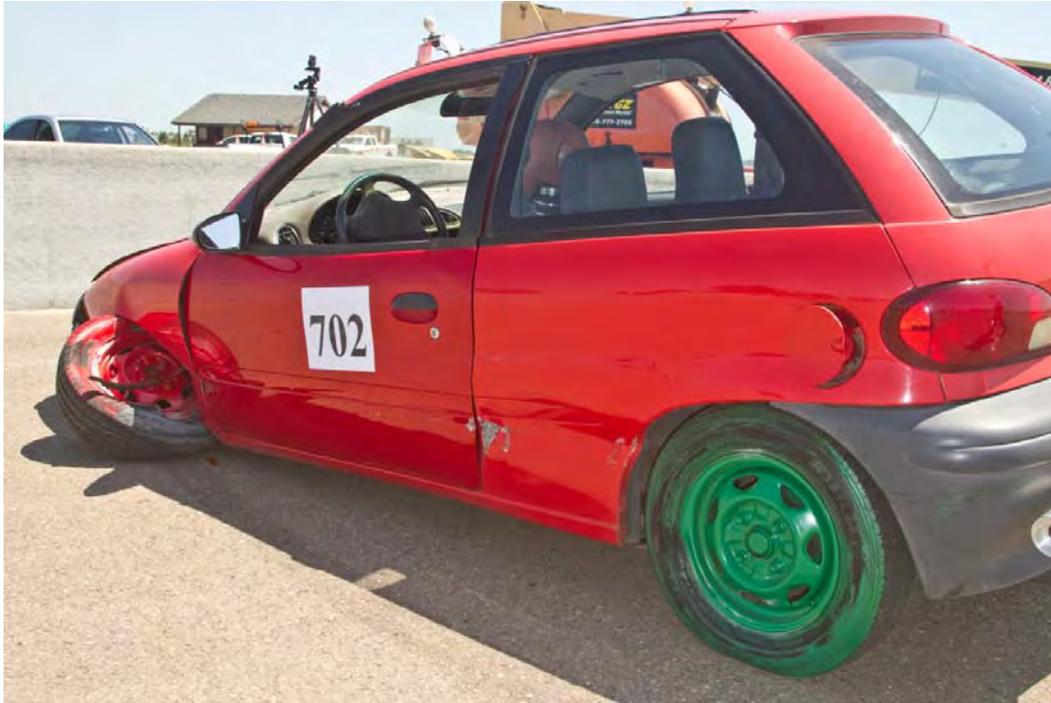
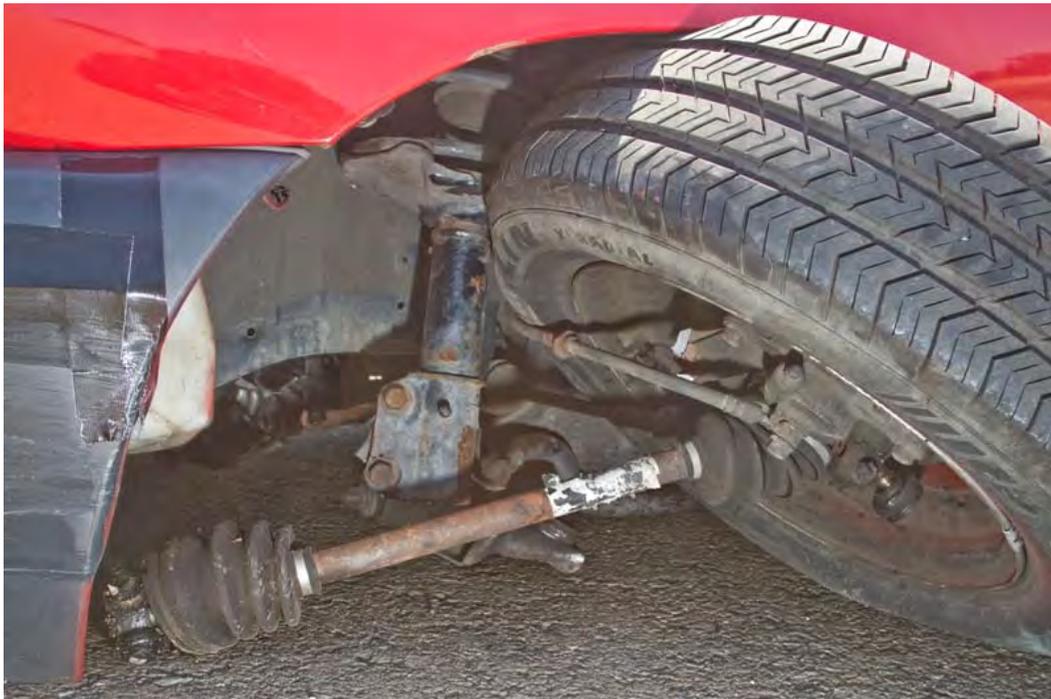
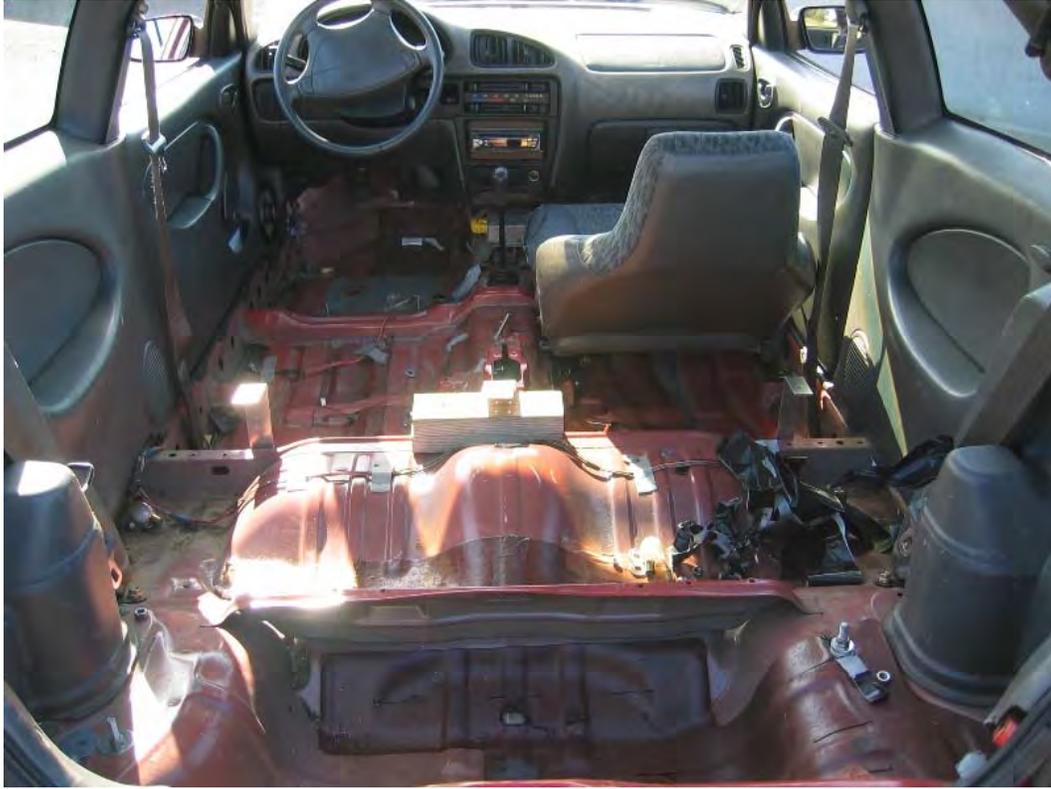
The front left wheel absorbed most of the impact. The rim was bent during impact causing the tire to deflate. The wheel well of the test vehicle sustained most of the damage. Additional damage also occurred to the side of the vehicle as it scraped the barrier when redirected. The CV axle and strut broke, eliminating the ability to steer the vehicle after impact. Refer to Figures 3-12 to 3-15 for pictures of vehicle damage. Since the front left wheel took most of the impact, there was no distinguishable damage to the floorboard (see Figure 3-15).

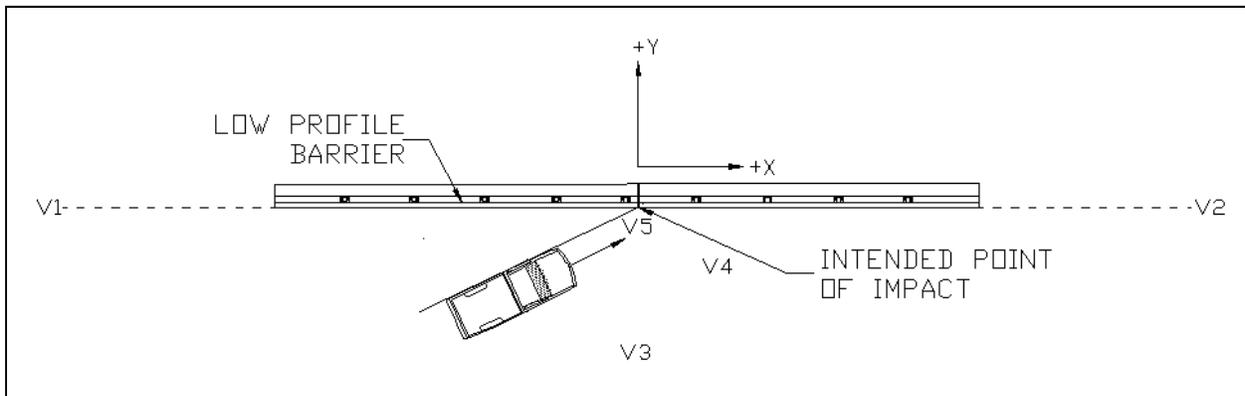
Figure 8-1. Test 701 Camera Locations

Several high-speed video cameras recorded the impact during the tests. The high-speed video frame rates were set to 500 frames per second. The types of cameras and their locations are shown in Figures 8-1 to 8-2 and Tables 8-3 to 8-4. The origin of the coordinates is at the intended point of impact.

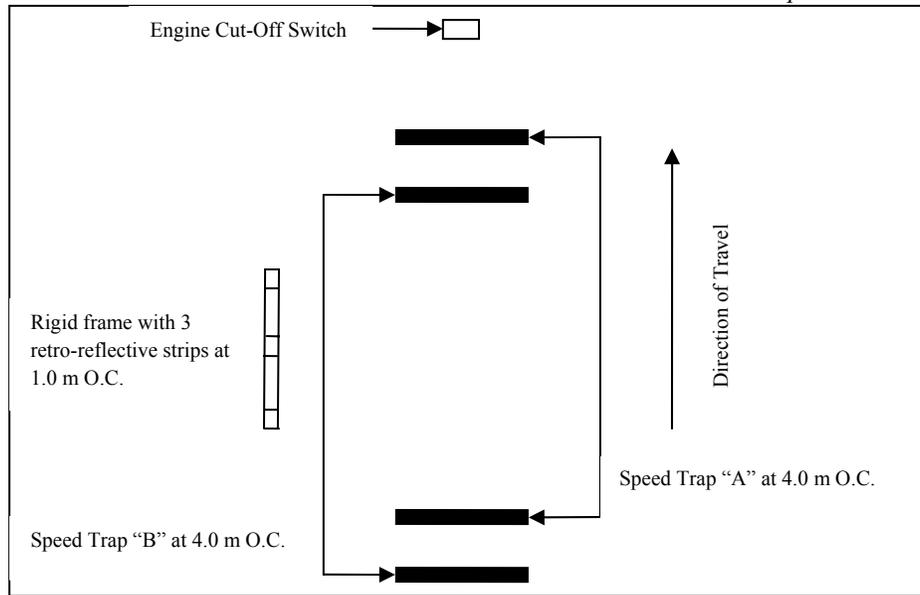
Figure 8-4. Tape Switch Layout

A rigid stand with three retro-reflective 90° polarizing tape strips was placed on the ground near the test article and alongside the path of the test vehicle. The strips were spaced at carefully measured intervals of 1000 mm. The test vehicle had an onboard optical sensor that produced sequential impulses or “event blips” as the vehicle passed the reflective tape strips. The event blips were recorded concurrently with the accelerometer signals on the TDR, serving as “event markers”. The impact velocity of the vehicle could be determined from these sensor impulses, the data record time, and the known distance between the tape strips. A pressure sensitive tape switch on the front bumper of the vehicle closed at the instant of impact and triggered two events: 1) “event marker” was added to the recorded data, and 2) a flashbulb mounted on the top of the vehicle was activated. Two sets of pressure activated tape switches, connected to a speed trap, were placed 4 m apart just upstream of the test article specifically to establish the impact speed of the test vehicle. The layout for all of the pressure sensitive tape switches and reflective tape is shown in Figure 8-4.
