1. REPORT NO. CA10-0645	2. GOVERNMENT ACCESSION NO.	3. RECIPIENT'S CATALOG NO.
4. TITLE AND SUBTITLE DEVELOPMENT AND TESTING OF A LOW-PROFILE BARRIER		5. REPORT DATE <p style="text-align: center;">April 2012</p>

DEVELOPMENT AND TESTING OF A LOW-PROFILE BARRIER

**DEVELOPMENT AND TESTING OF A
LOW-PROFILE BARRIER**

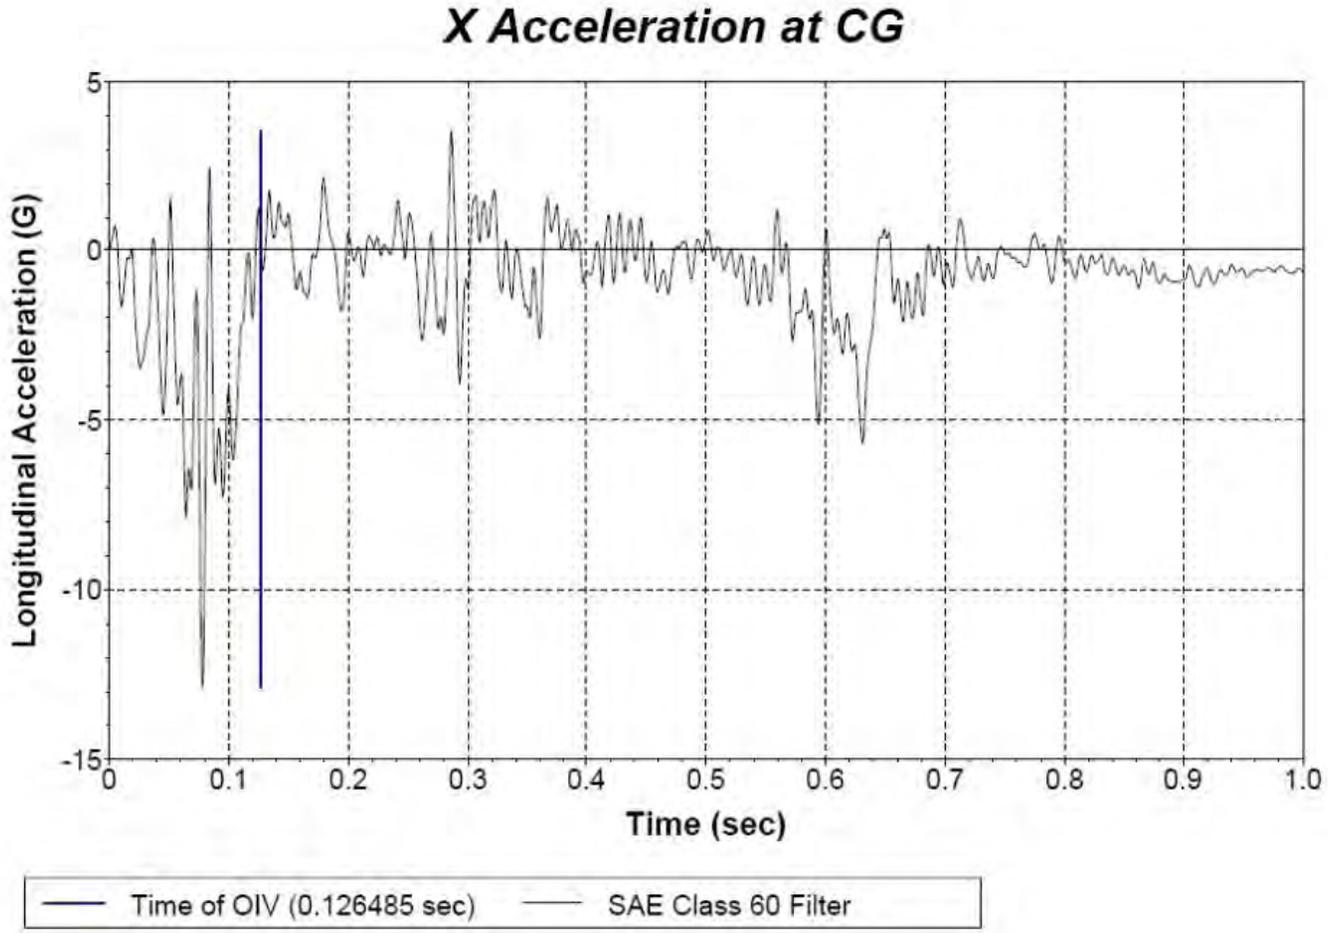
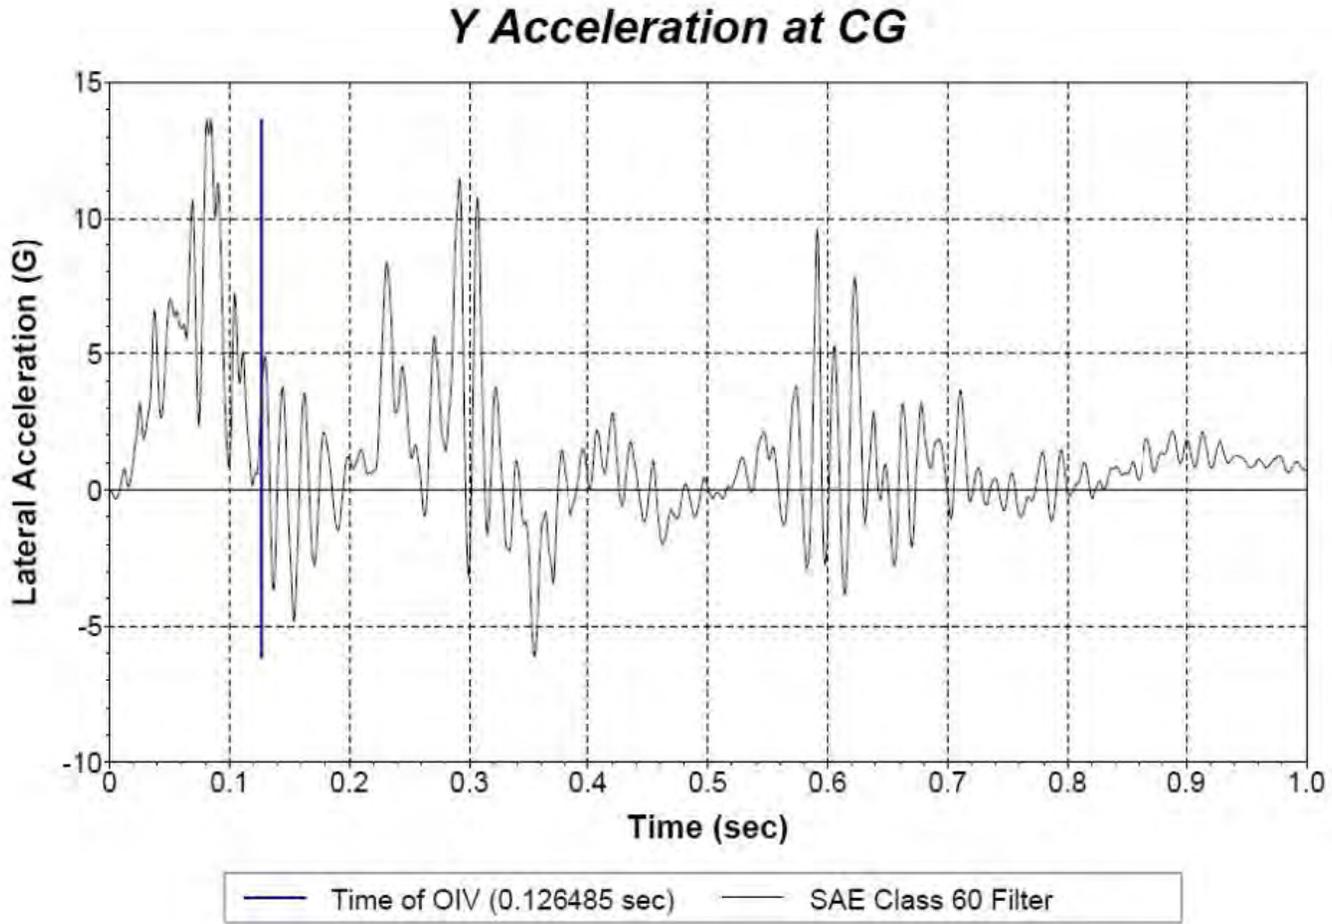
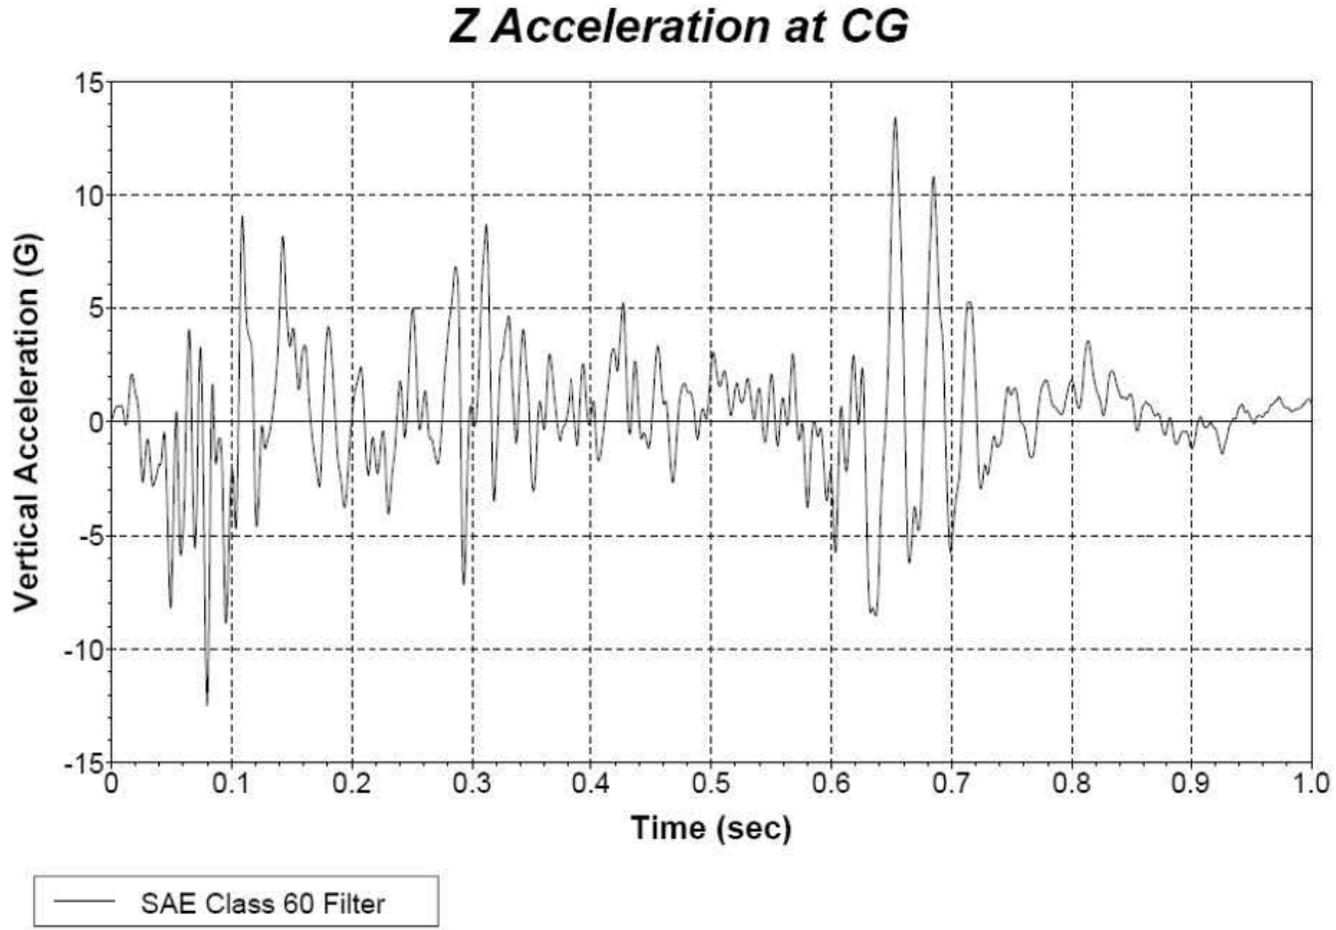
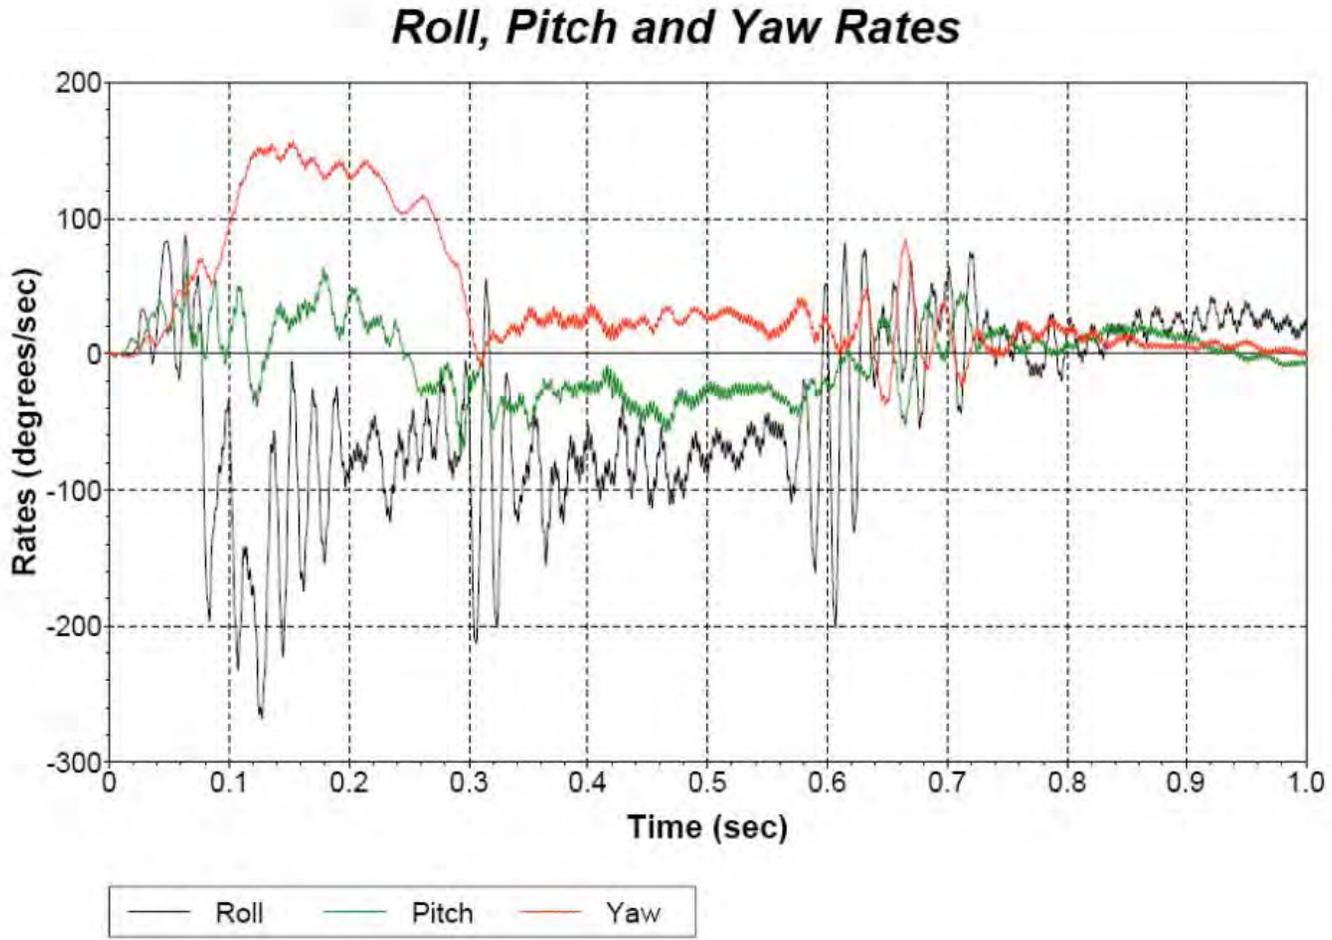
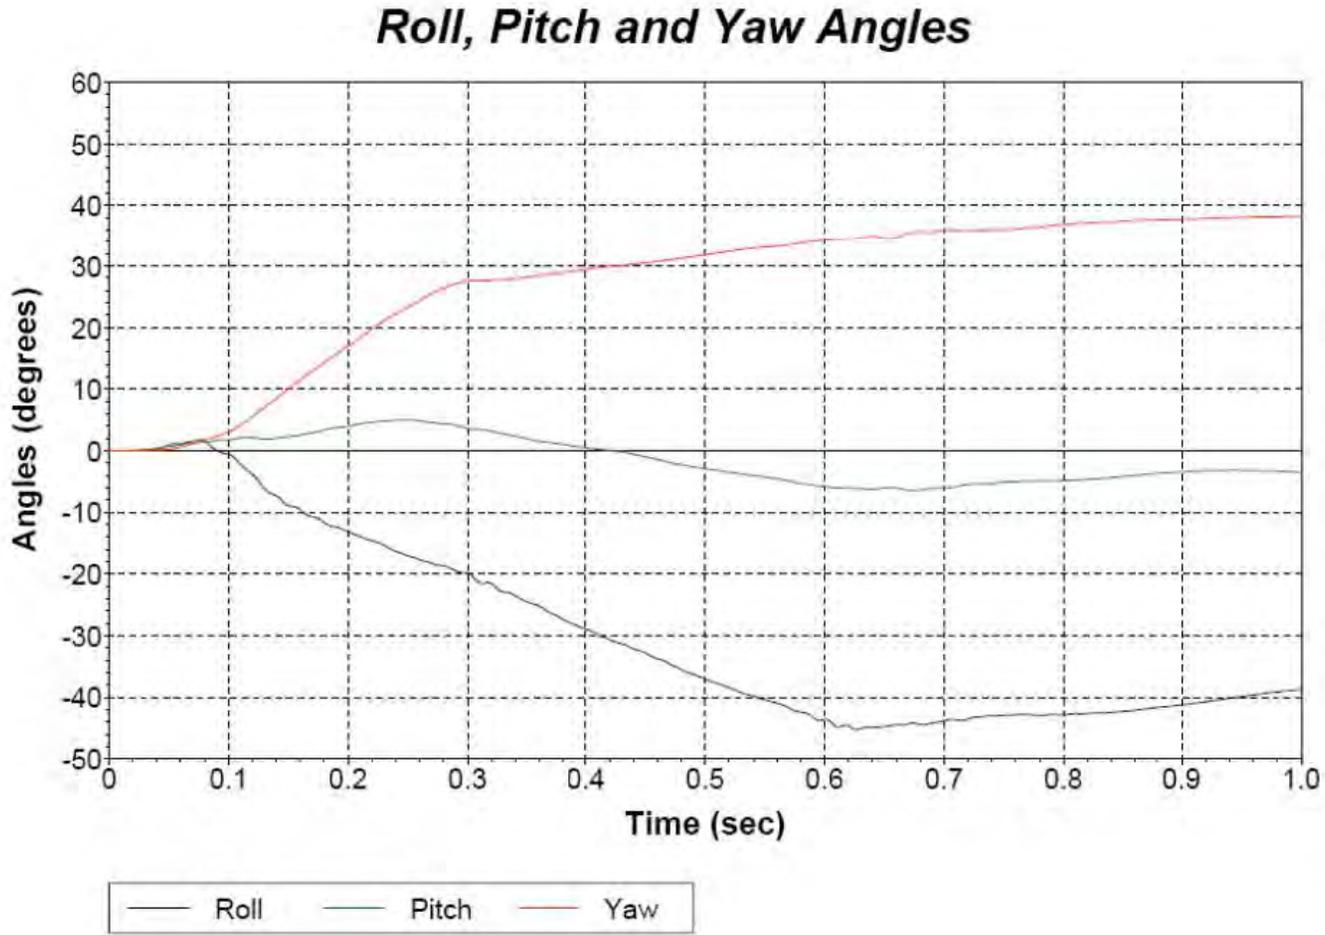
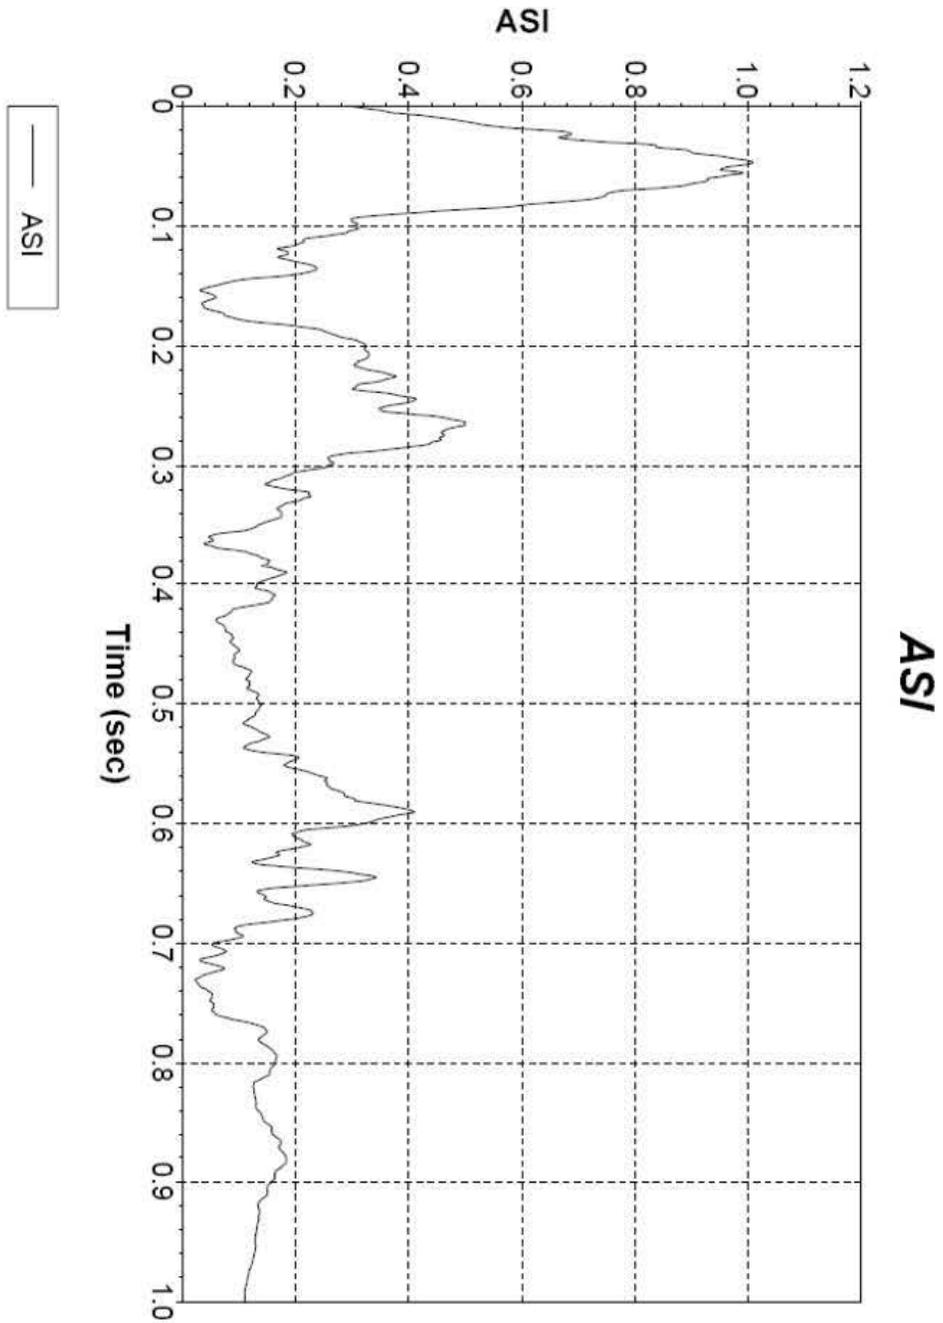
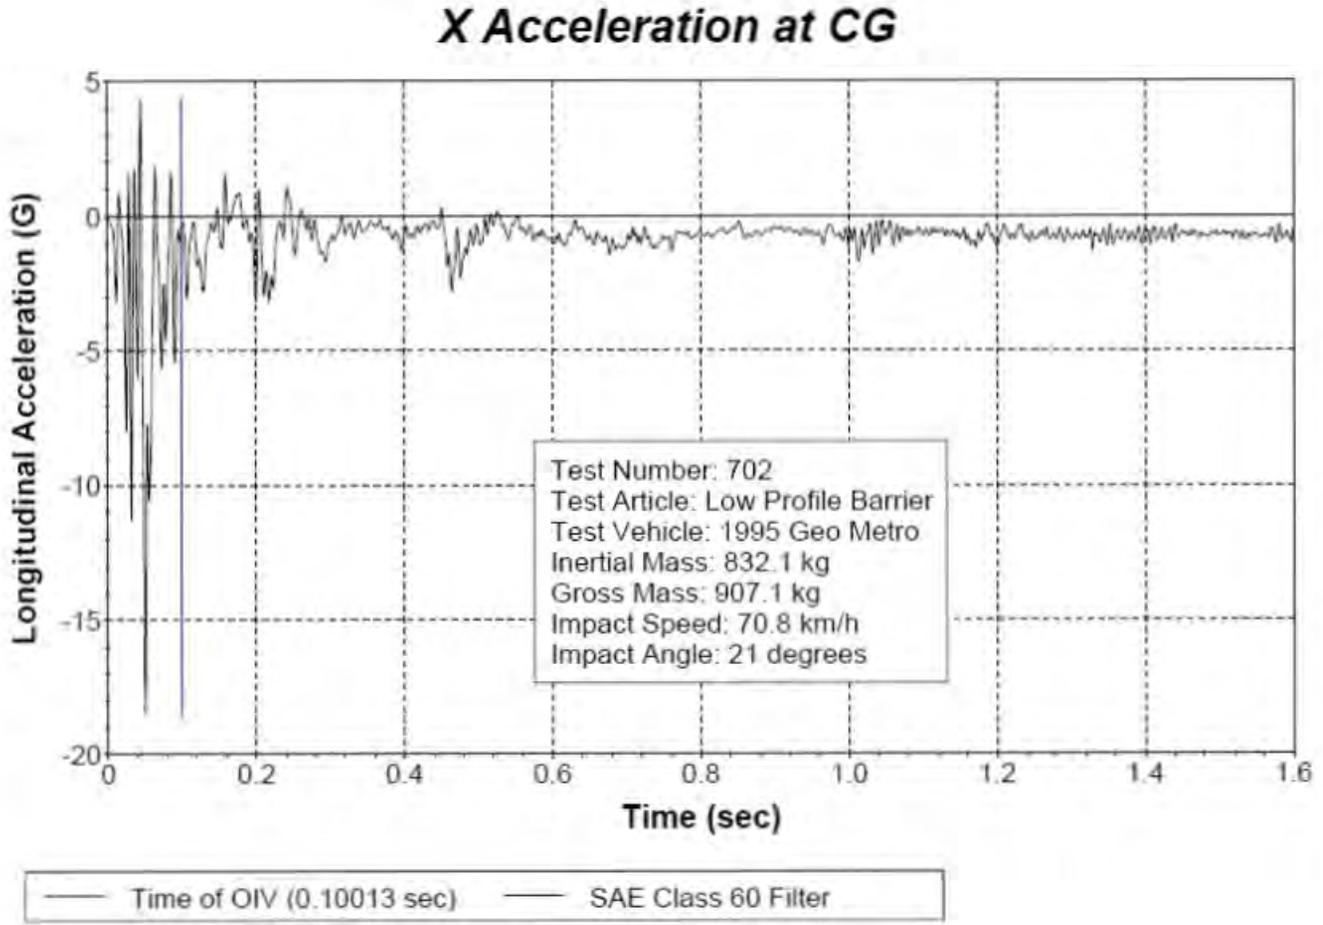
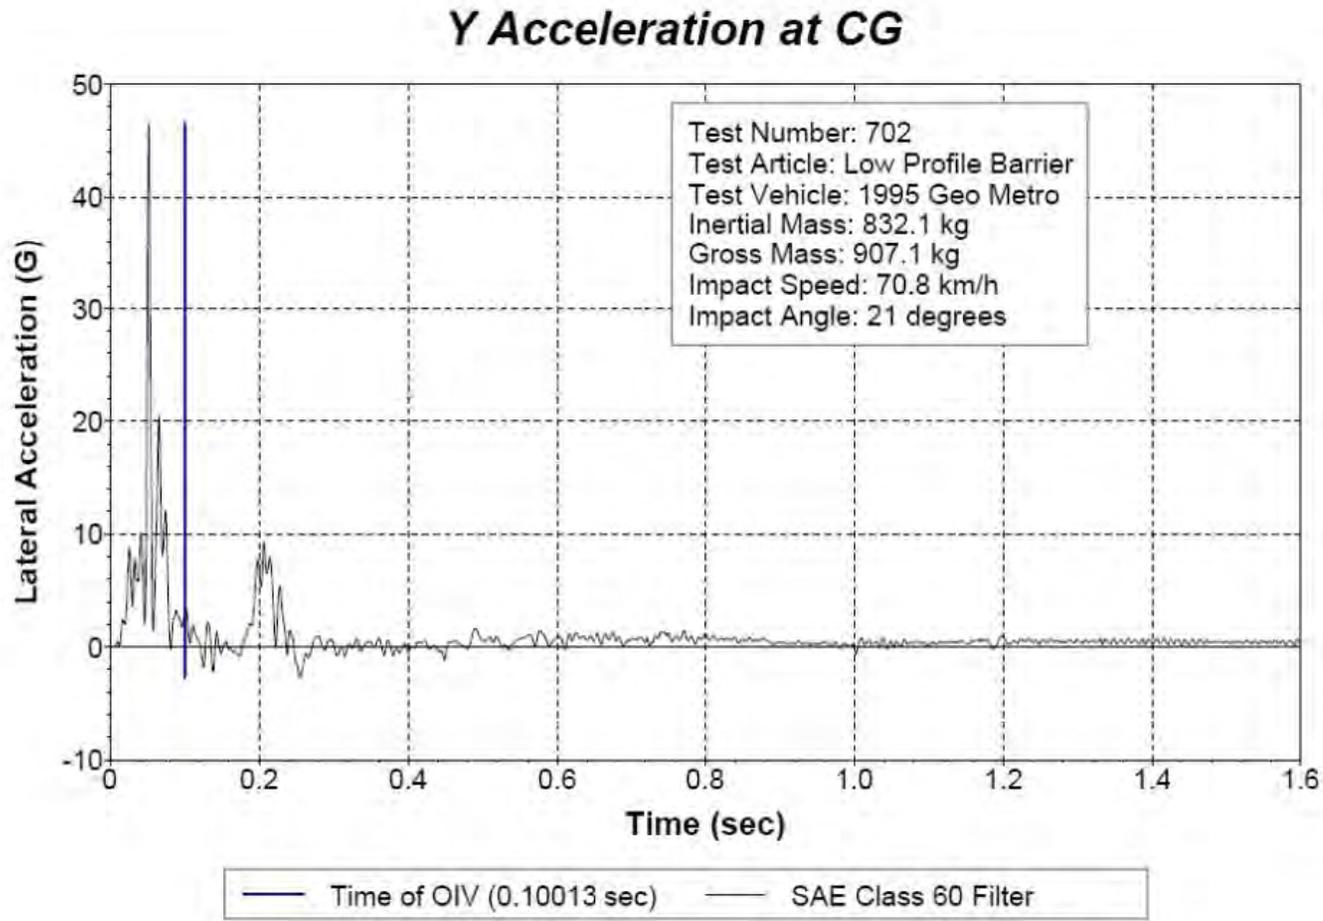
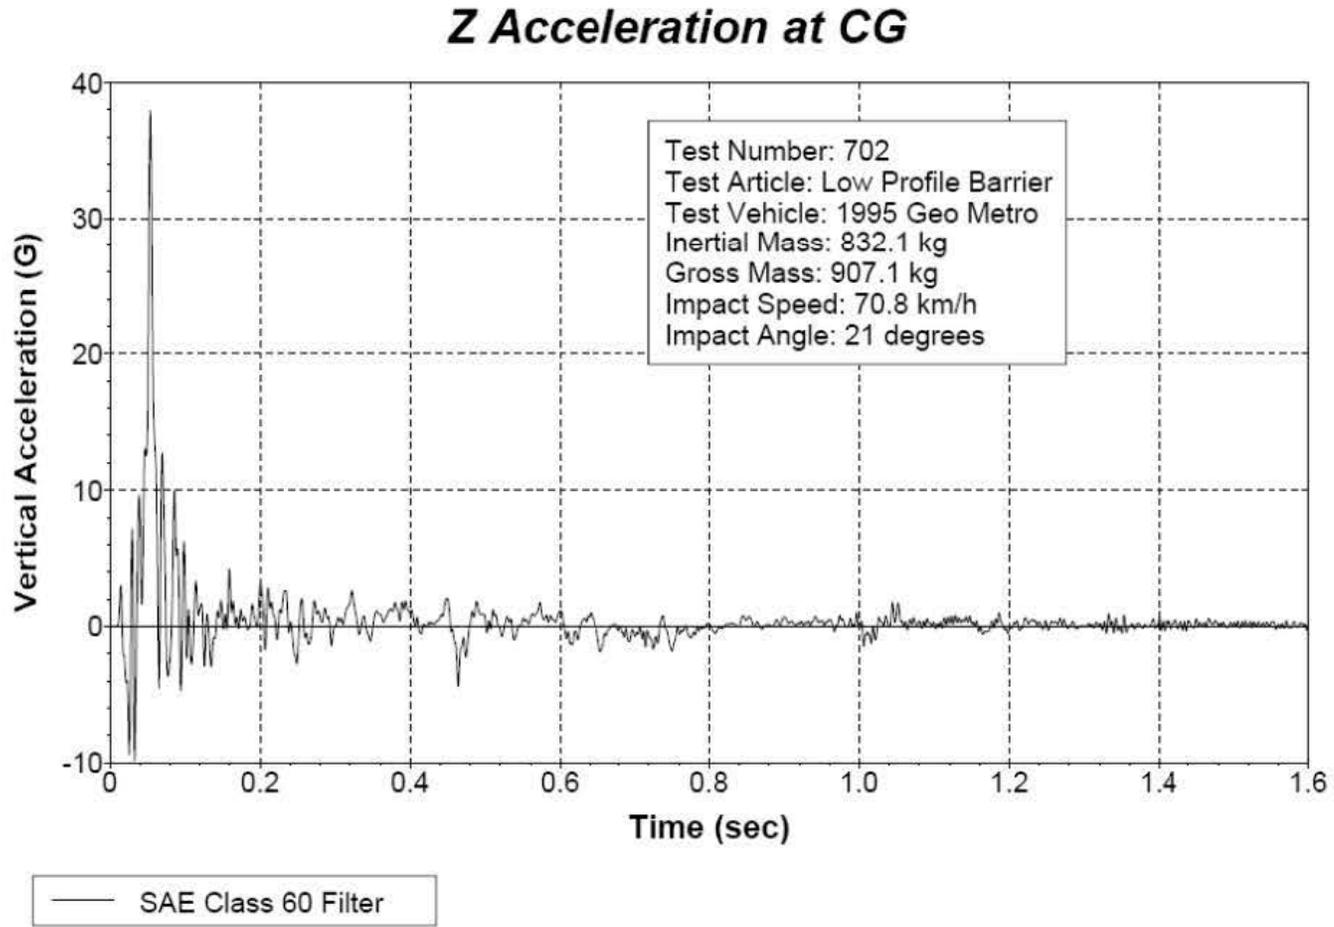
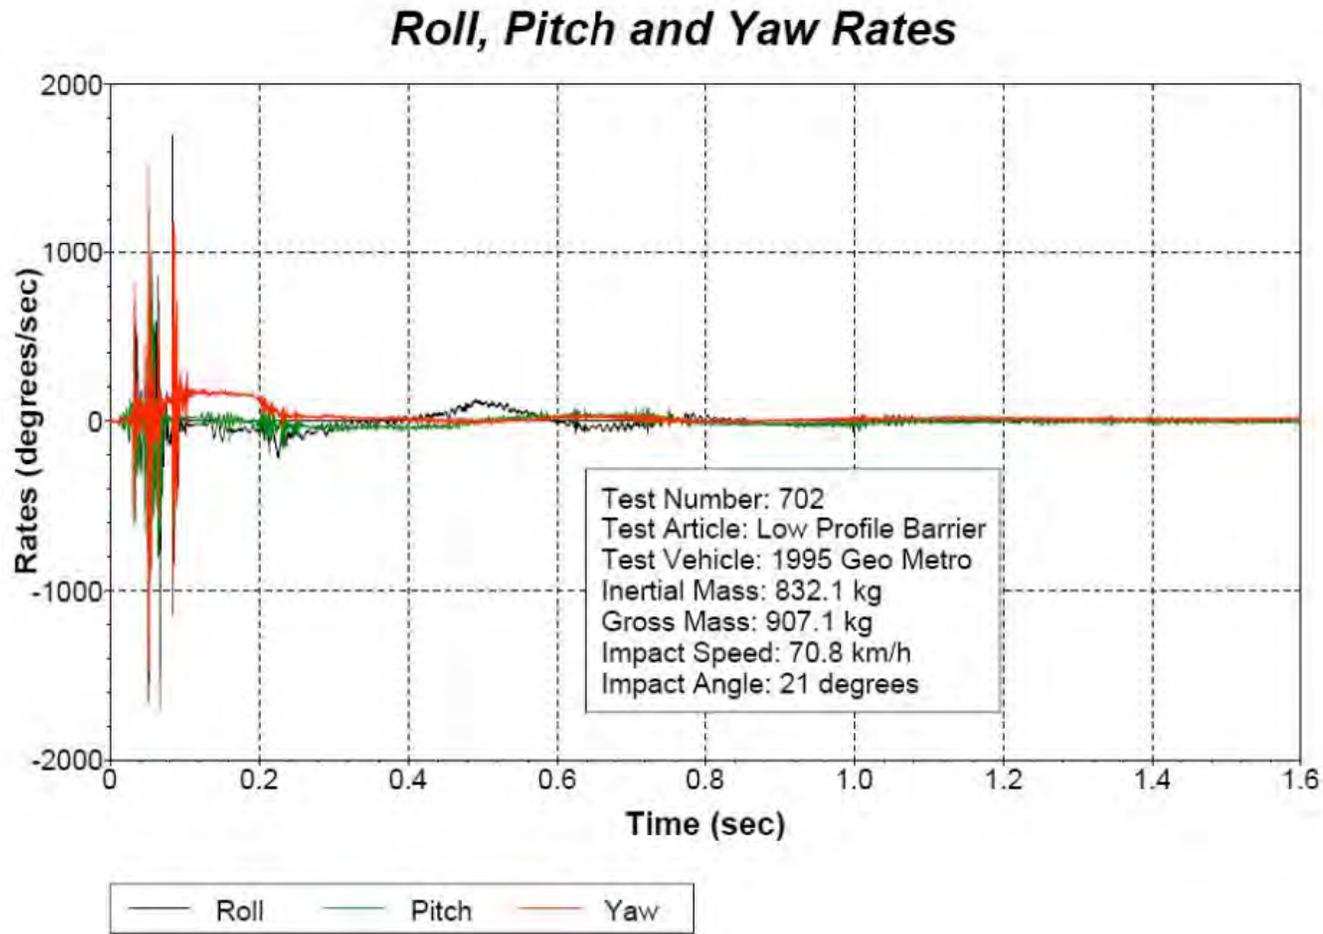
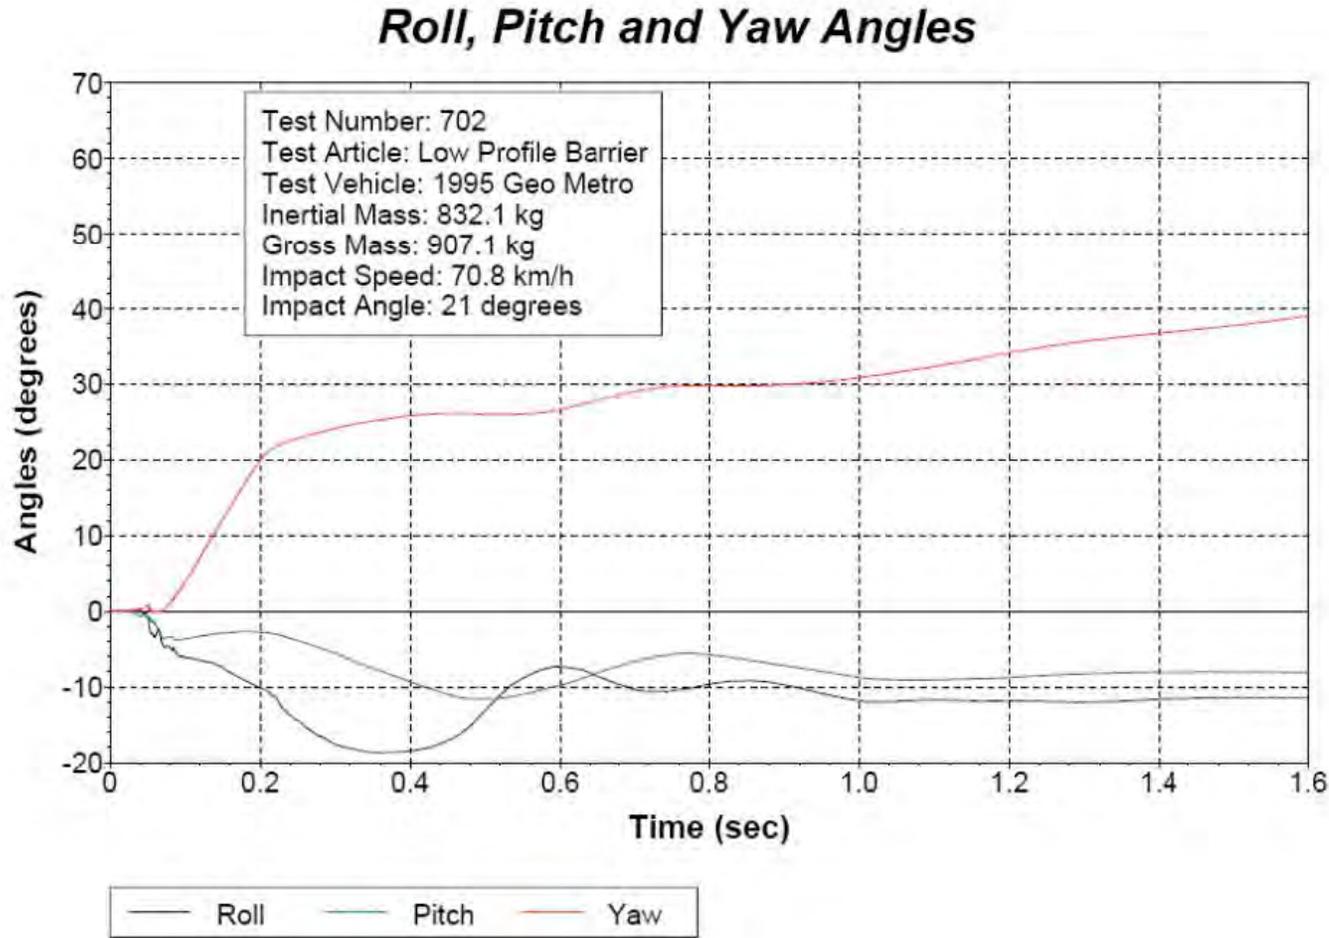
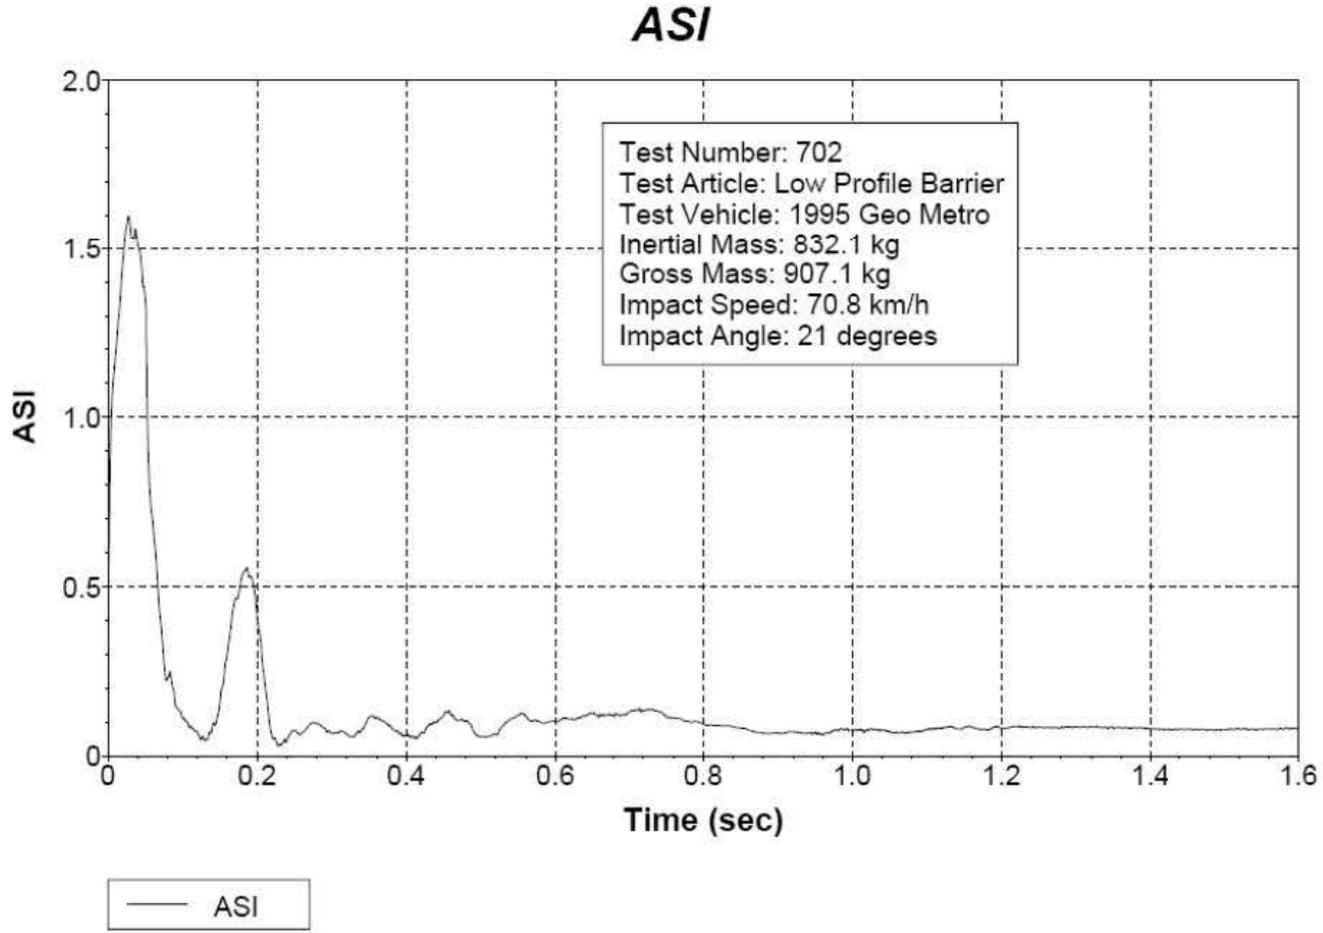
The data curves are shown in Figure 8-5 through 8-16 include the accelerometer and angular rate sensor records from the test vehicles. They also show the velocity and displacement curves for the longitudinal and lateral components. These plots are required to calculate the occupant impact velocity defined in NCHRP Report 350. All data were analyzed using TRAP.

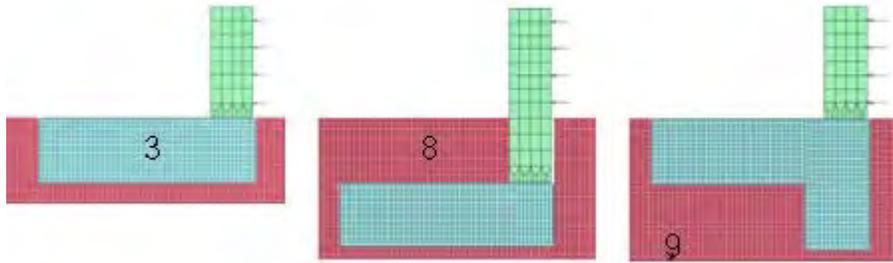
Figure 8-17. Cross-Sections 3, 8, and 9

The next step after calibrating the soil model was to determine the most effective foundation cross-section in resisting vehicle impacts. A parametric design study of various cross-sections of the foundation was performed using LS-DYNA to determine effective sizes and geometries. Ten different foundation cross-sections were modeled. The parametric study narrowed the selection of the cross-sections down to sections 3, 8, 9. (See Figure 8-17)

Although the L-shape keyed foundation (cross-section 9) was the most resistant to impacts, the decision was made to use cross-section 3 since it was easier to construct and yielded similar results. (*ARA Caltrans Barrier Report, April 21, 2008*)

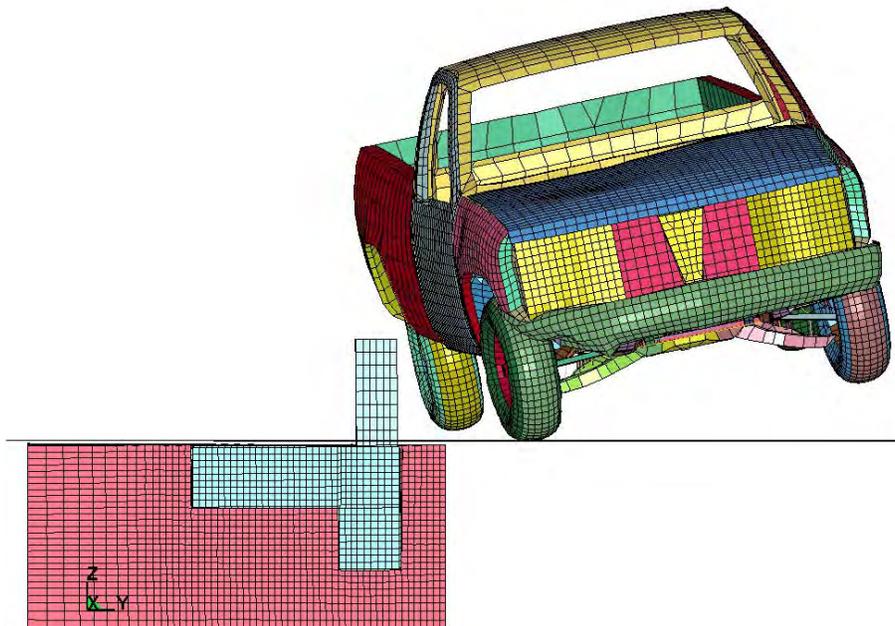
Figure 8-18. C2500 Pickup Impact on Cross-Section 9

The full length rigid barrier impact with a C2500 pickup was completed on cross-section 9. (See Figure 8-18) The 3-dimensional simulation of section 9 yielded deflections that were lower than the 2-dimensional parametric cases.

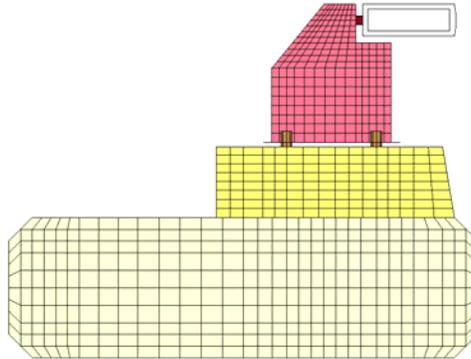
Figure 8-19. Cross-Section 3 foundation with Low-Profile Barrier Installed

During the second quarter of the project, the crash test simulations (in 3-dimensions) were conducted with two soil extremes. The low-profile barrier is installed on the cross-section 3 foundation for the full crash test simulations. (See Figure 8-19)

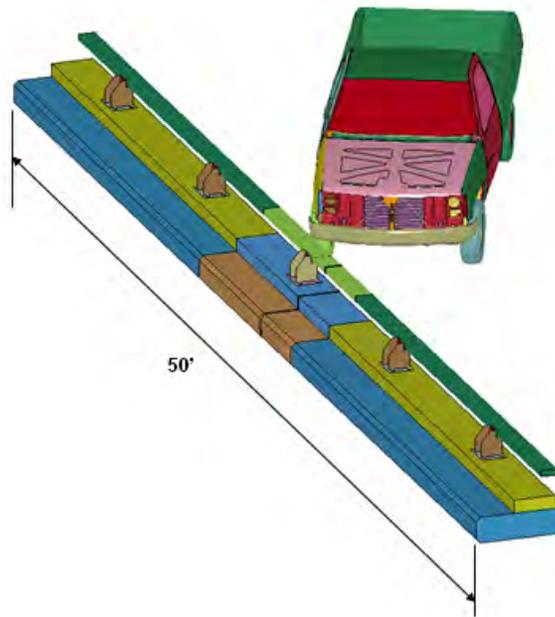
Figure 8-20. 50 Feet Long Test Section

The low-profile barrier model was impacted by the pickup truck in weak soil (loose sand) and in rigid soil to evaluate deflections and foundation strength. Only 50 feet of the low-profile barrier was modeled to reduce computation time although a 100 feet long test section was later built and crash tested to validate the simulation. (See Figure 8-20)

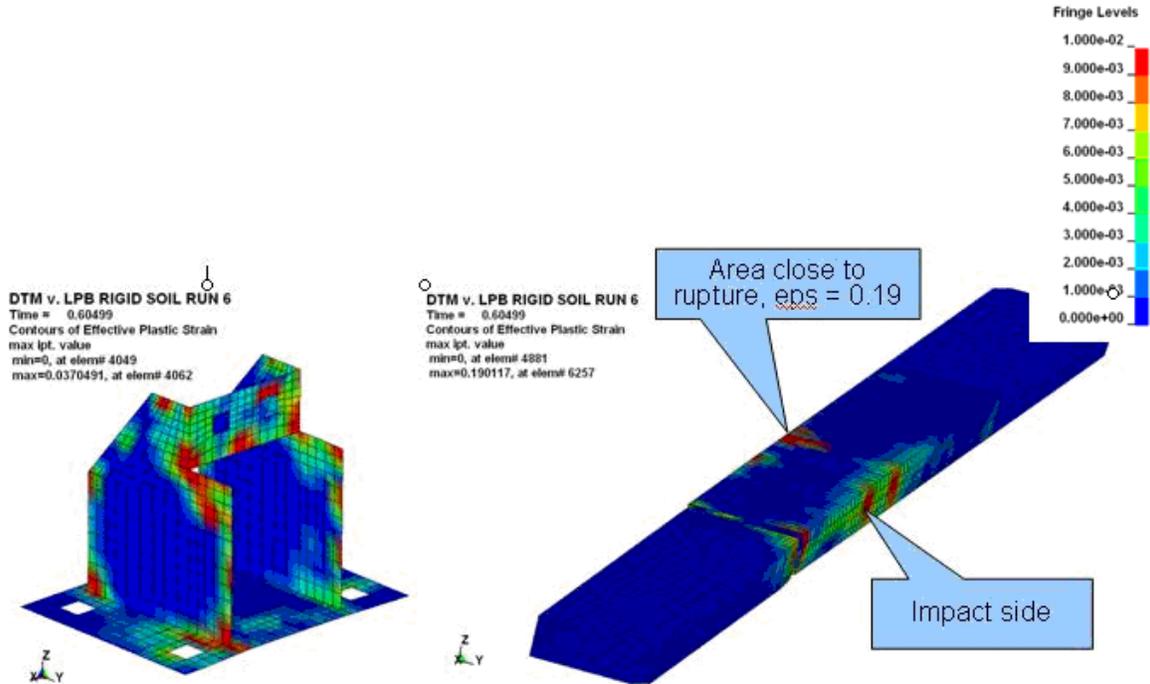
Figure 8-21. Impact side and Area close to rupture

The rigid soil test simulation concluded that the low-profile barrier structure met the evaluation criteria. The mounting bolts for the posts and rail sections were able to carry the loads sufficiently. However, subsequent impacts in the same location could cause steel parts to rupture and possibly fail at the anchor and rail bolts, which would require repair or replacement. (See Figure 8-21)

The steel parts deformed plastically but not enough to cause snagging or pocketing concerns for subsequent impacts. However, the high rail strains at the center post from the splice bending needed to be strengthened or redesigned.

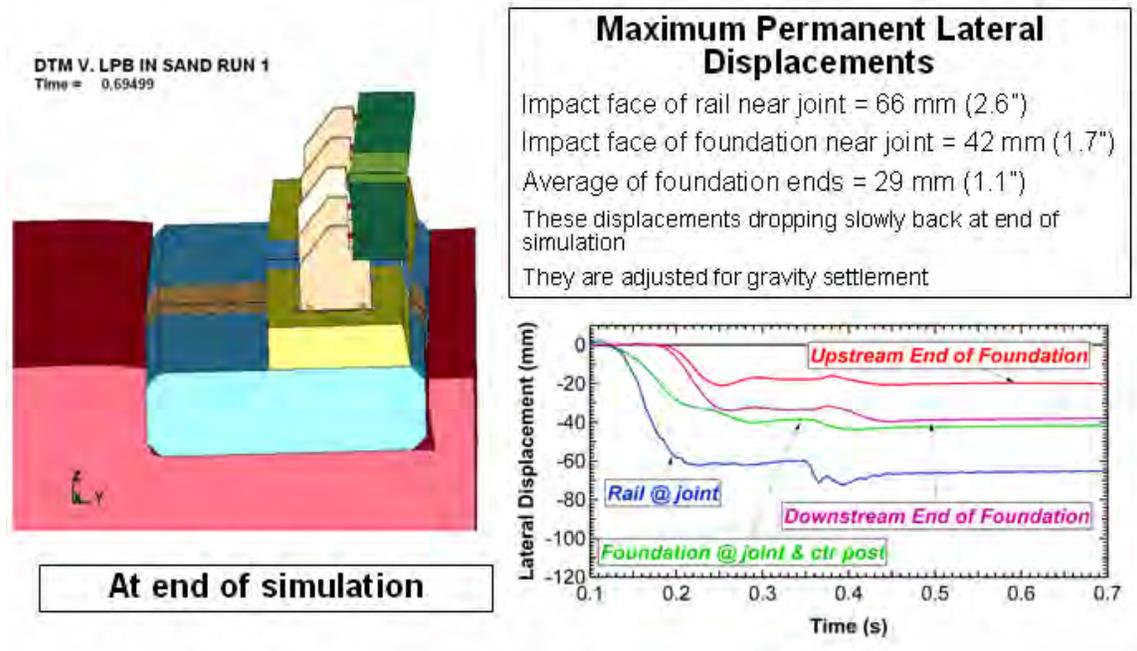
Figure 8-22. Maximum Permanent Lateral Displacements

The vehicle was redirected and did not roll, snag, or pocket. The lateral occupant impact velocity (OIV) was 5.03 m/s. The longitudinal OIV was 4.3 m/s. The preferred value in *NCHRP Report 350* is 9 m/s. The lateral and longitudinal ridedown accelerations were 8.2 g and 5.1 g. The preferred value is 15 g. The maximum lateral permanent rail deflection was 66 mm. (See Figure 8-22) (*ARA Caltrans Barrier Report, July 24, 2008*)

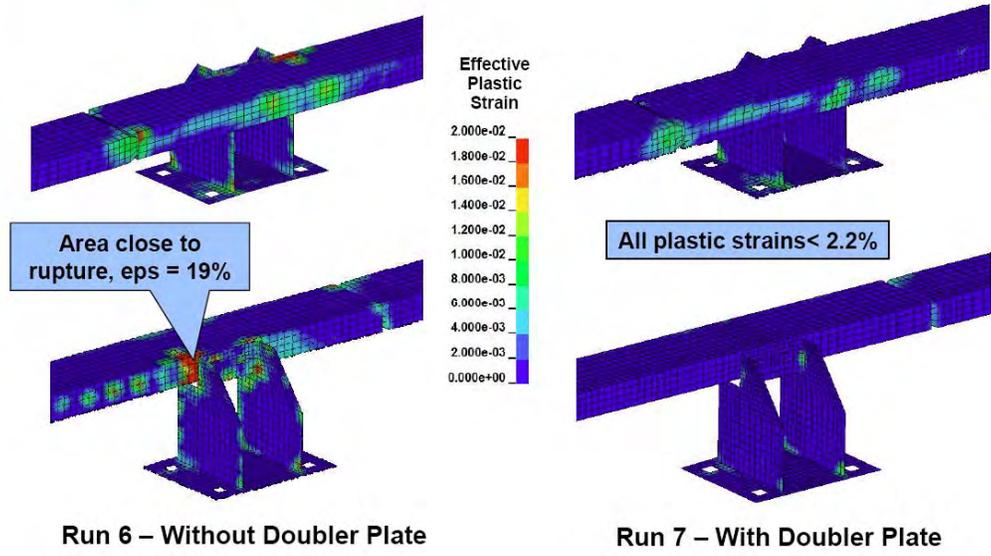
Figure 8-23. Plastic Strains at Post

The focus of the work for the last quarter was on crash simulation at the post and at the mid-span of low-profile barrier with the modifications to the rail post connection and anchor bolts strengths. Both the rigid and weak soil cases were simulated. The rail post connection was reinforced with double plate and higher strength bolts were use. For the rigid soil simulation, the addition of the double plate greatly reduced the peak plastic strains seen in the rail when impacted at the post (19% to 2.2% plastic strain for impact at the post). (See Figure 8-23)

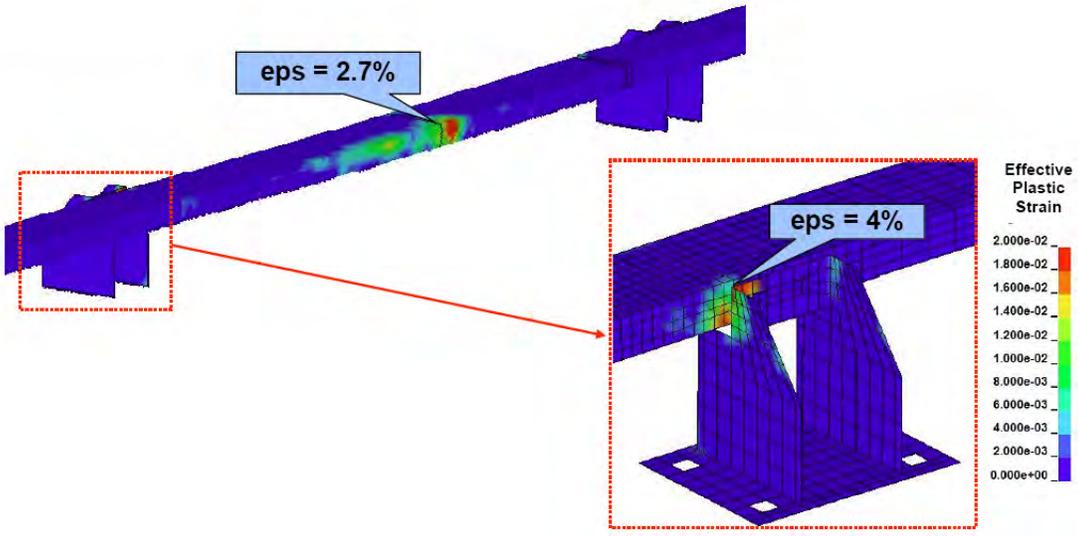
Figure 8-24. Plastic Strains at Mid-Span

The largest plastic strains were seen in the upper corner of the downstream post for the mid-span impact (4% plastic strain). (See Figure 8-24)

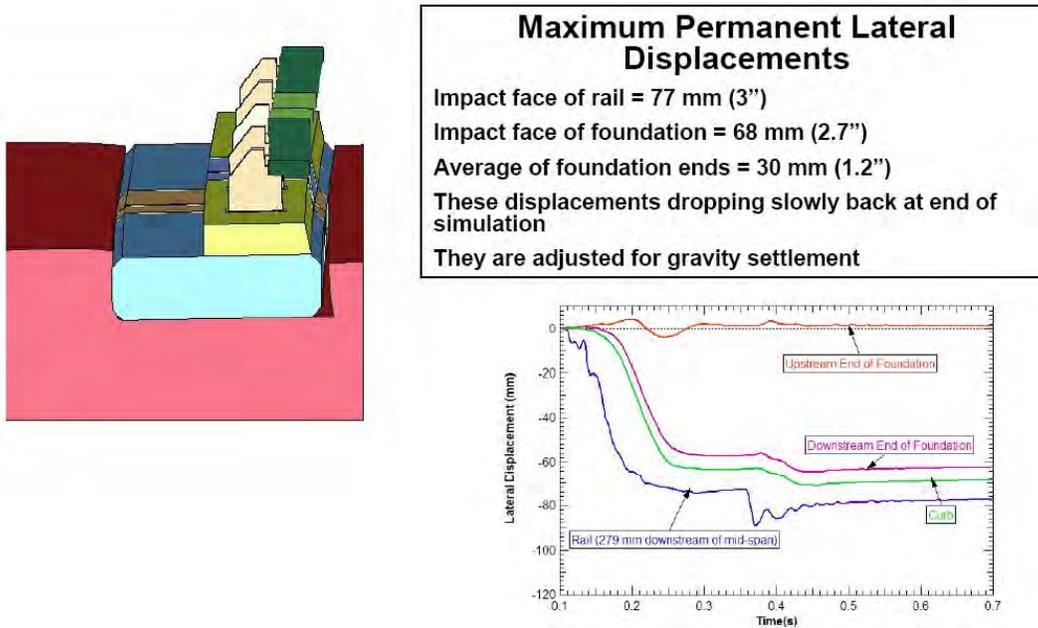
Figure 8-25. Maximum Permanent Lateral Displacements

mm from the impact at the post (66 mm to 77 mm lateral deflection). (See Figure 8-25) (ARA Caltrans Barrier Report, October 16, 2008)
