1. REPORT NO. CA10-0645	2. GOVERNMENT ACCESSION NO.	3. RECIPIENT'S CATALOG NO.
4. TITLE AND SUBTITLE DEVELOPMENT AND TESTING OF A LOW-PROFILE BARRIER		5. REPORT DATE <p style="text-align: center;">April 2012</p>

DEVELOPMENT AND TESTING OF A LOW-PROFILE BARRIER

**DEVELOPMENT AND TESTING OF A
LOW-PROFILE BARRIER**

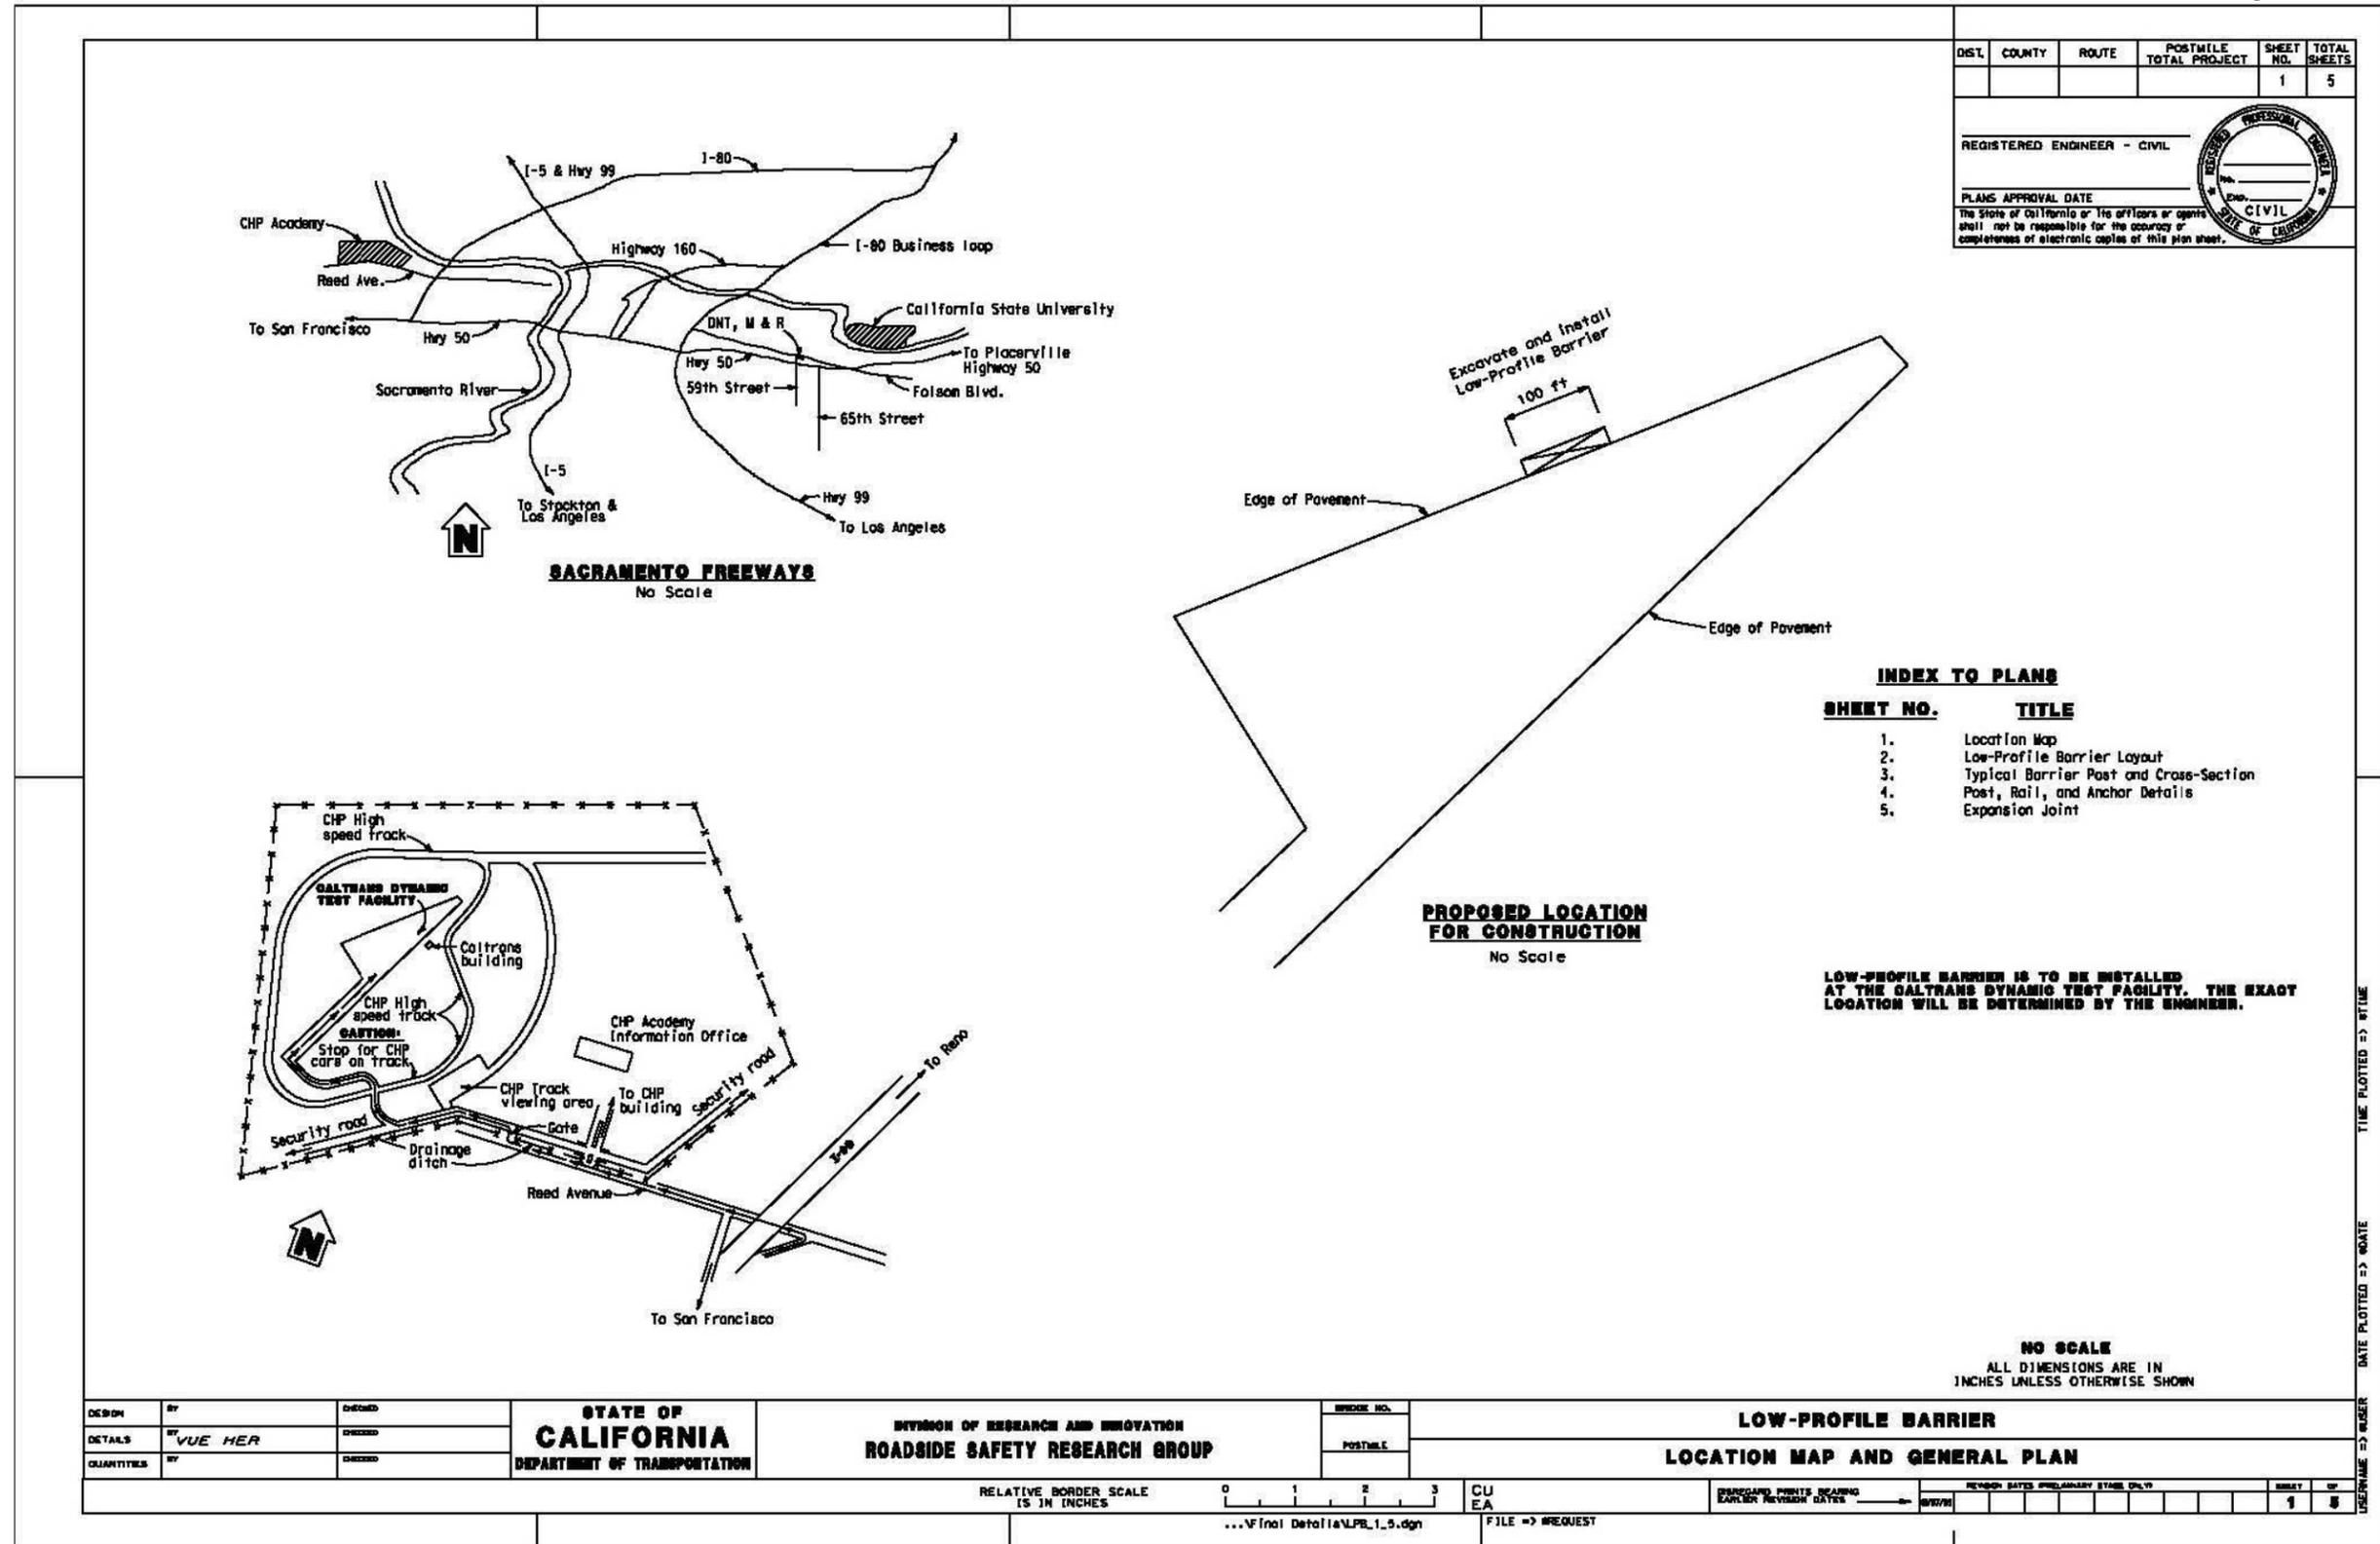
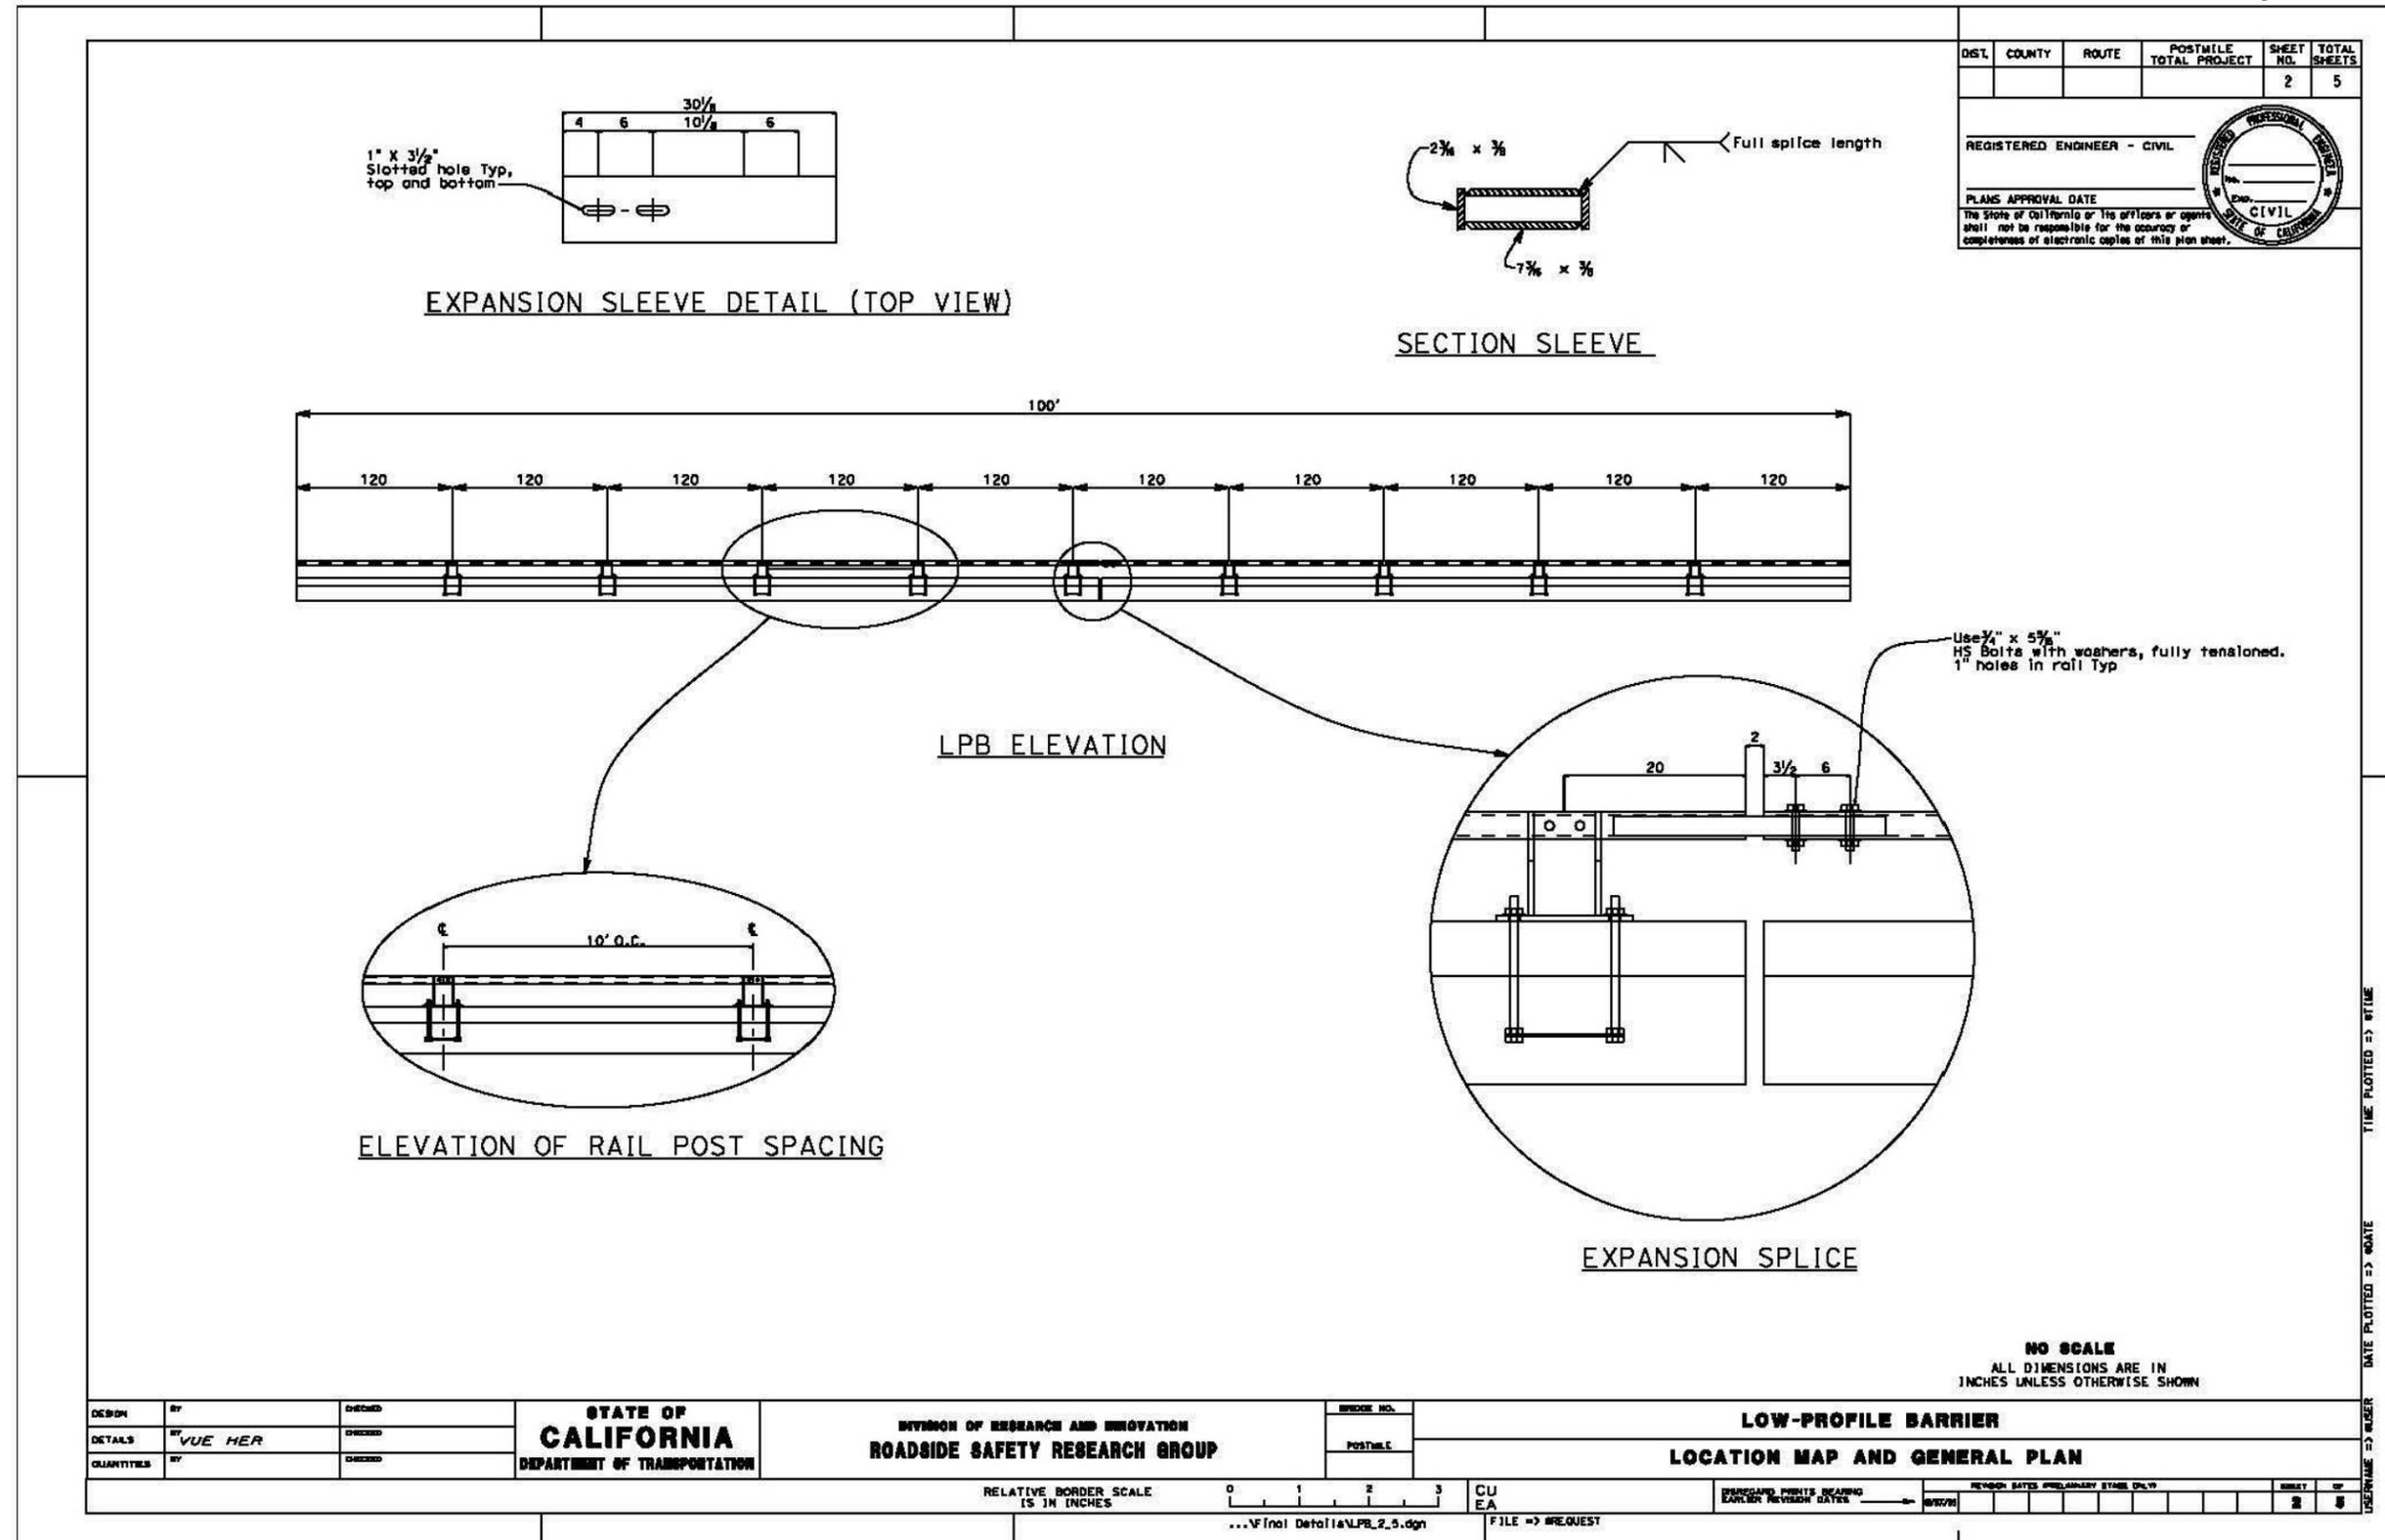
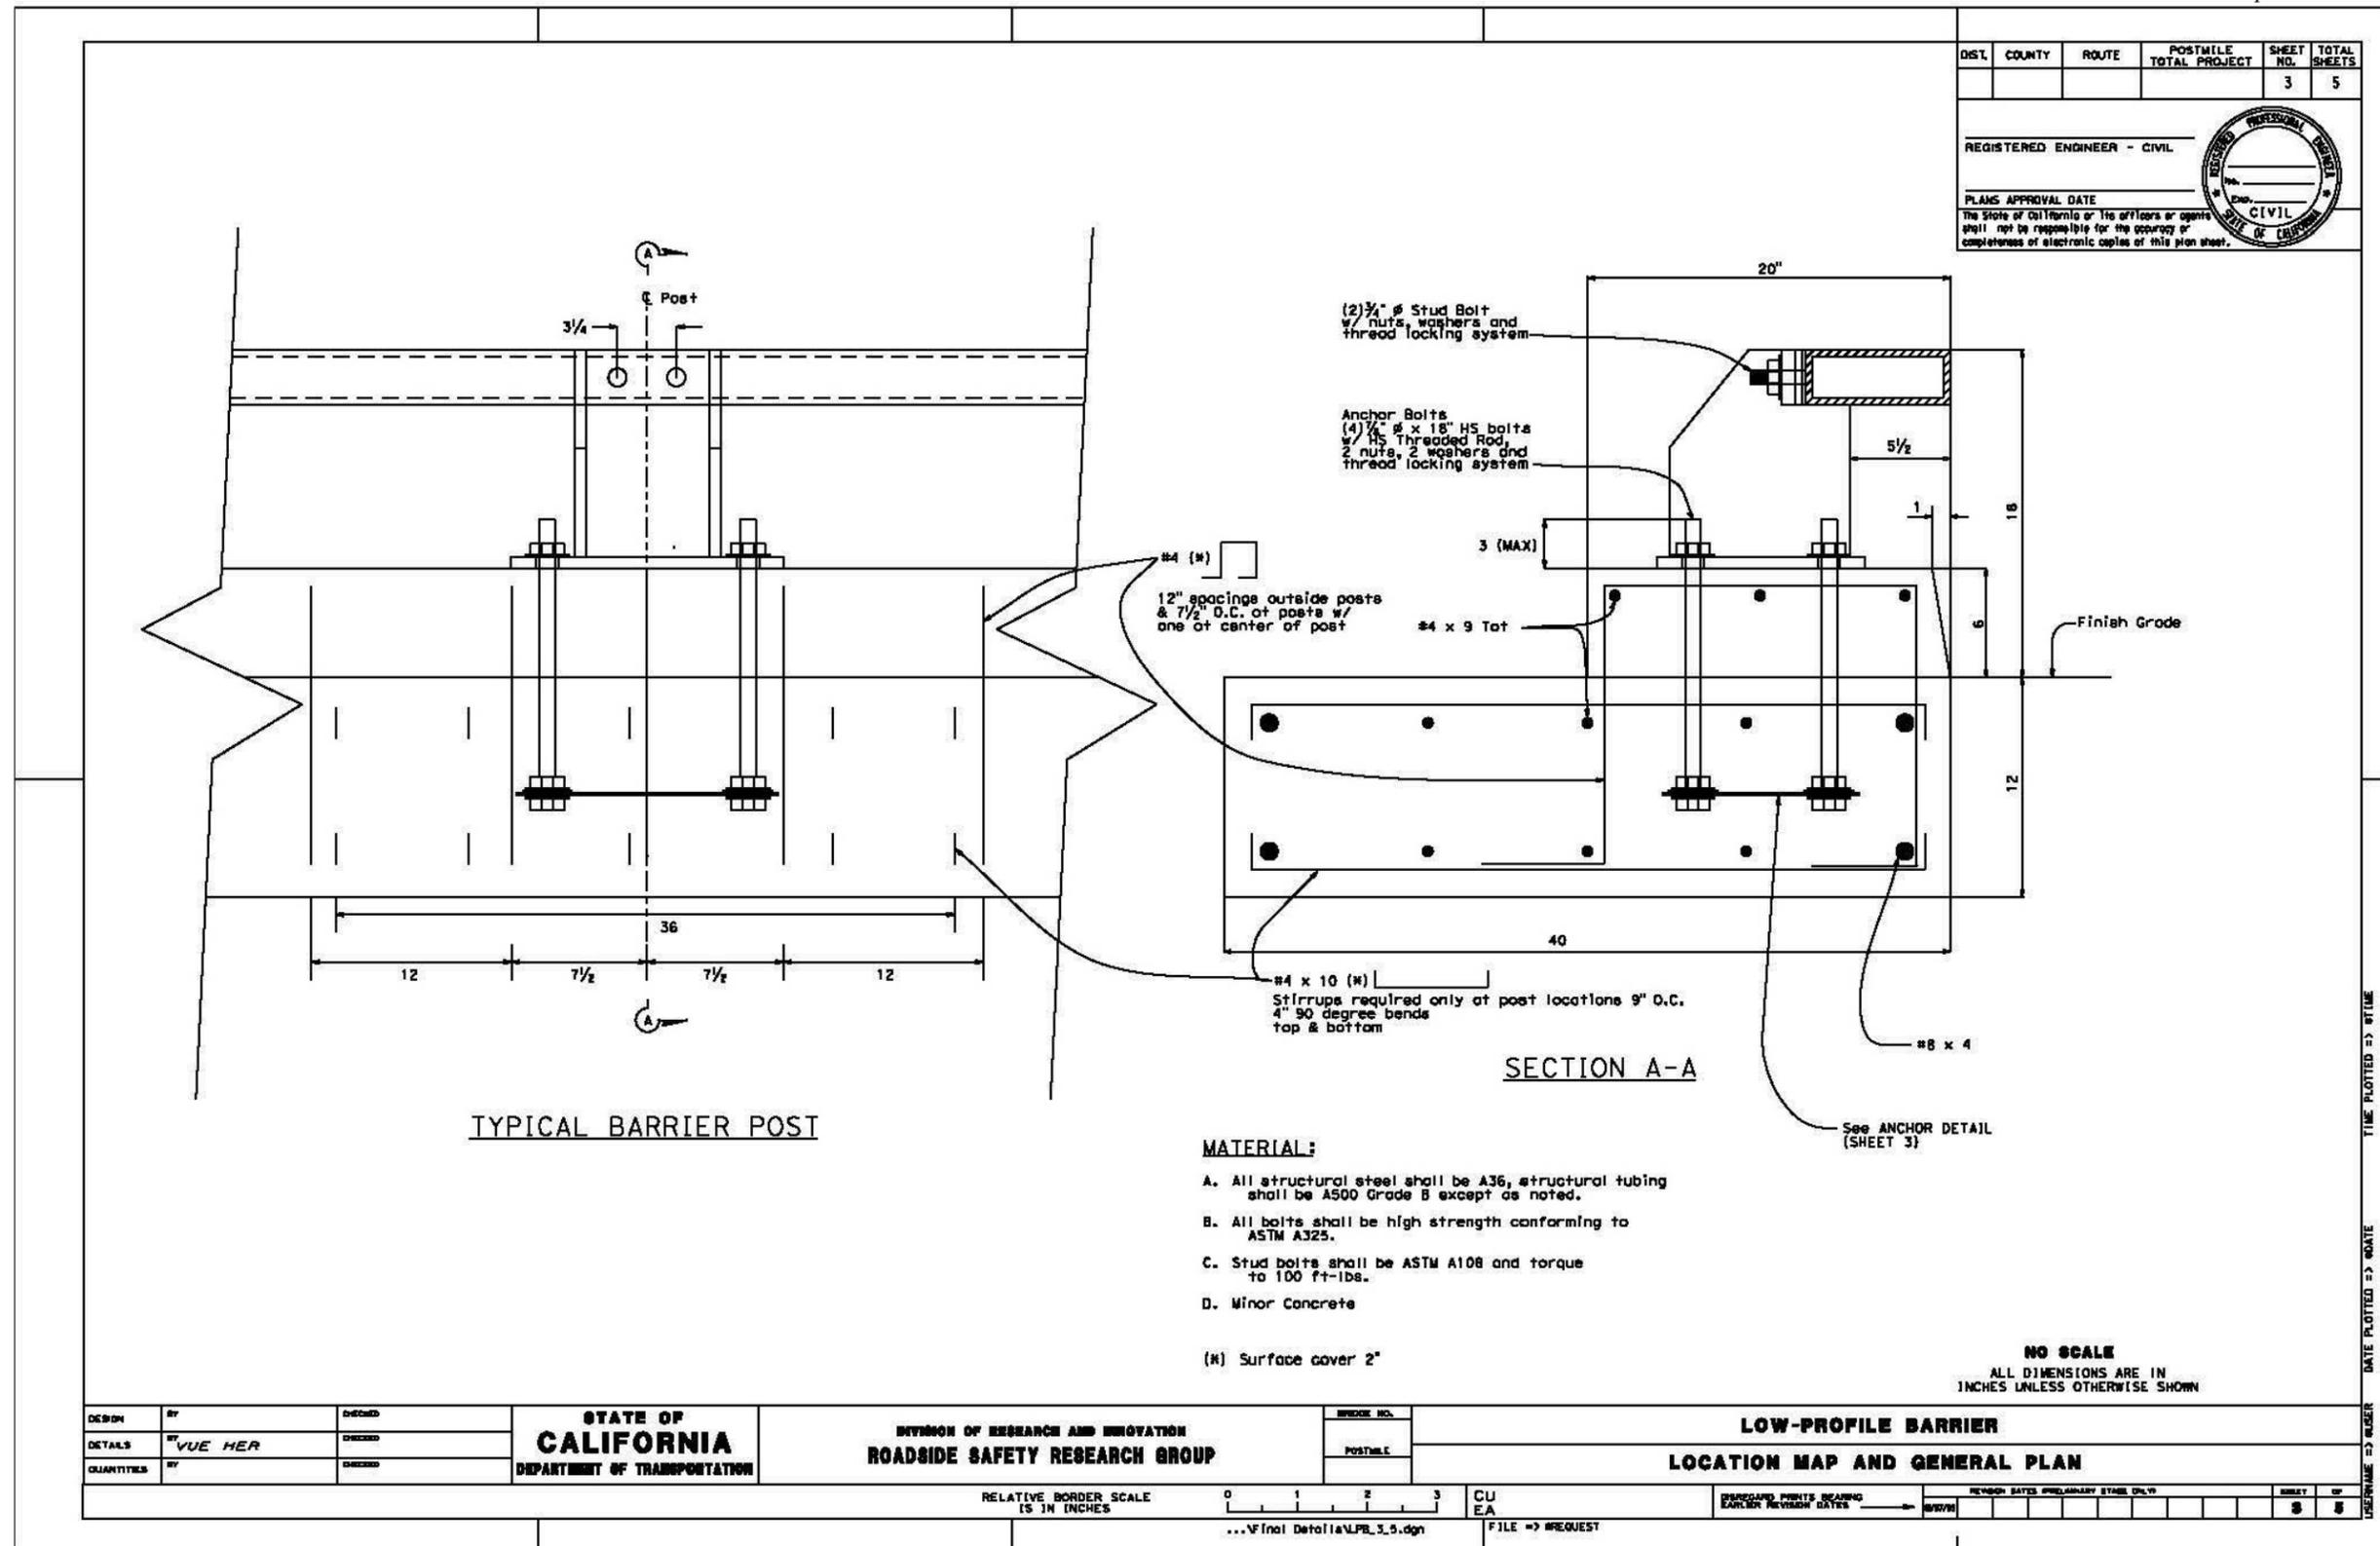
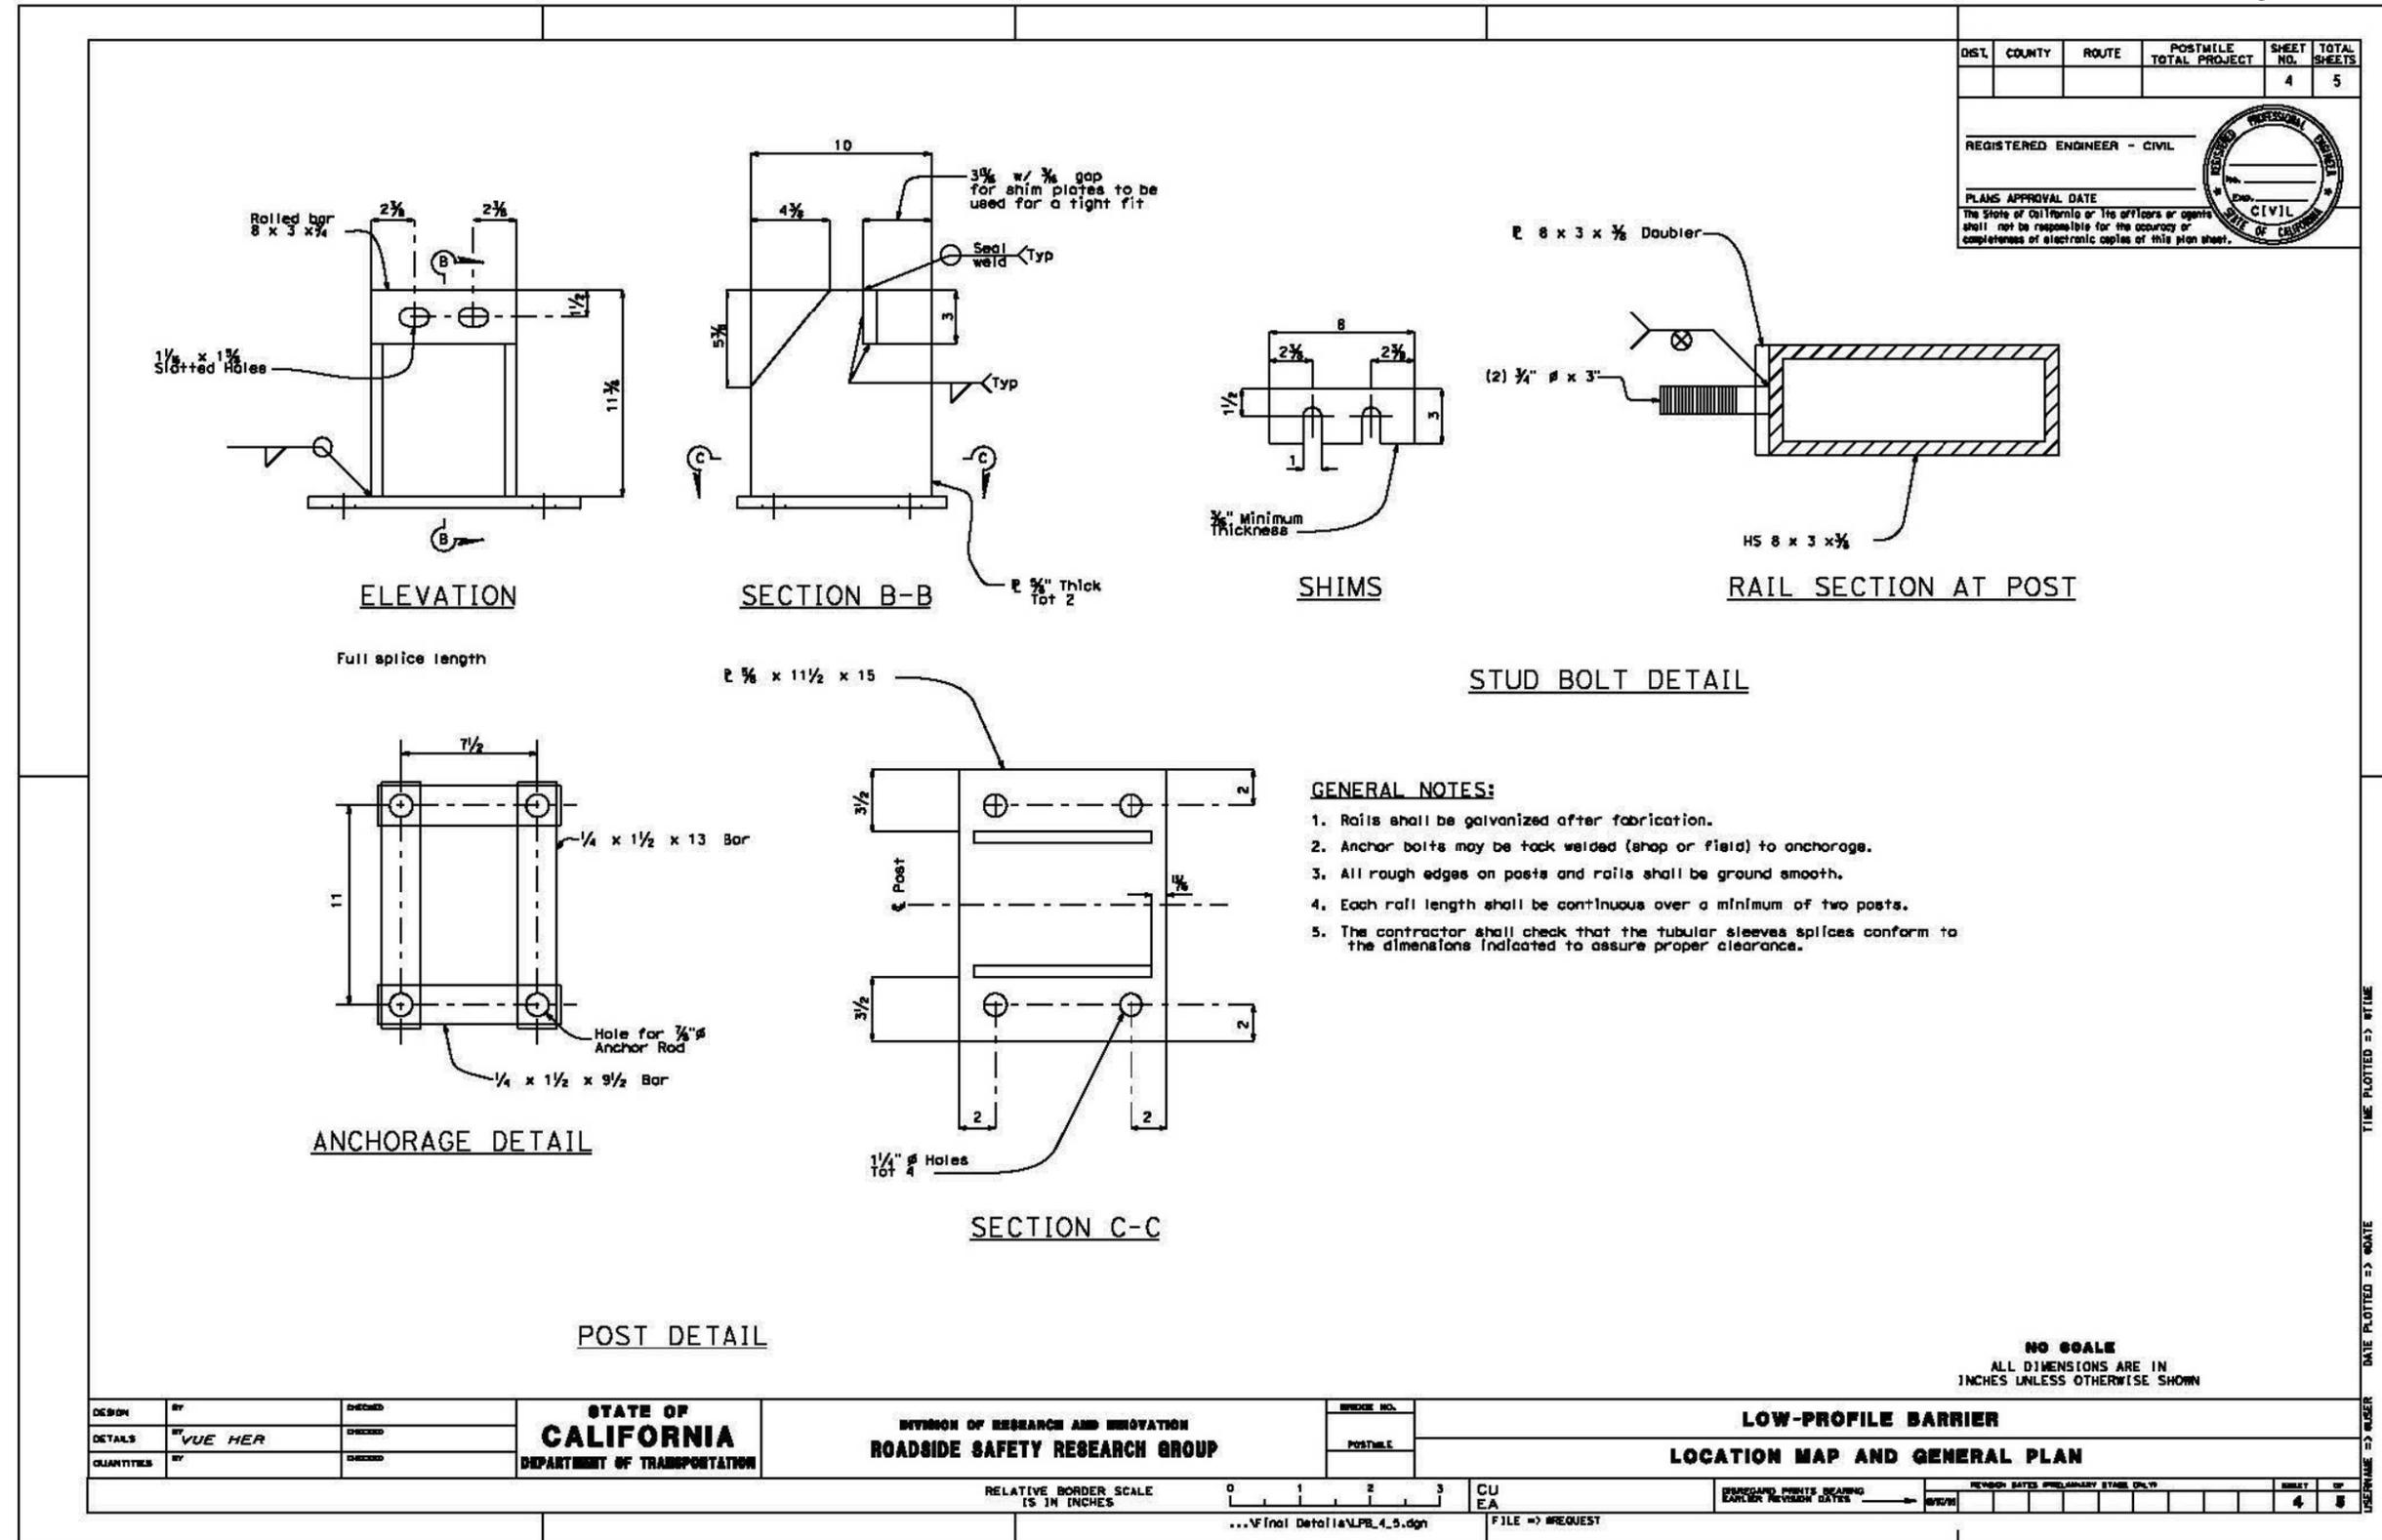
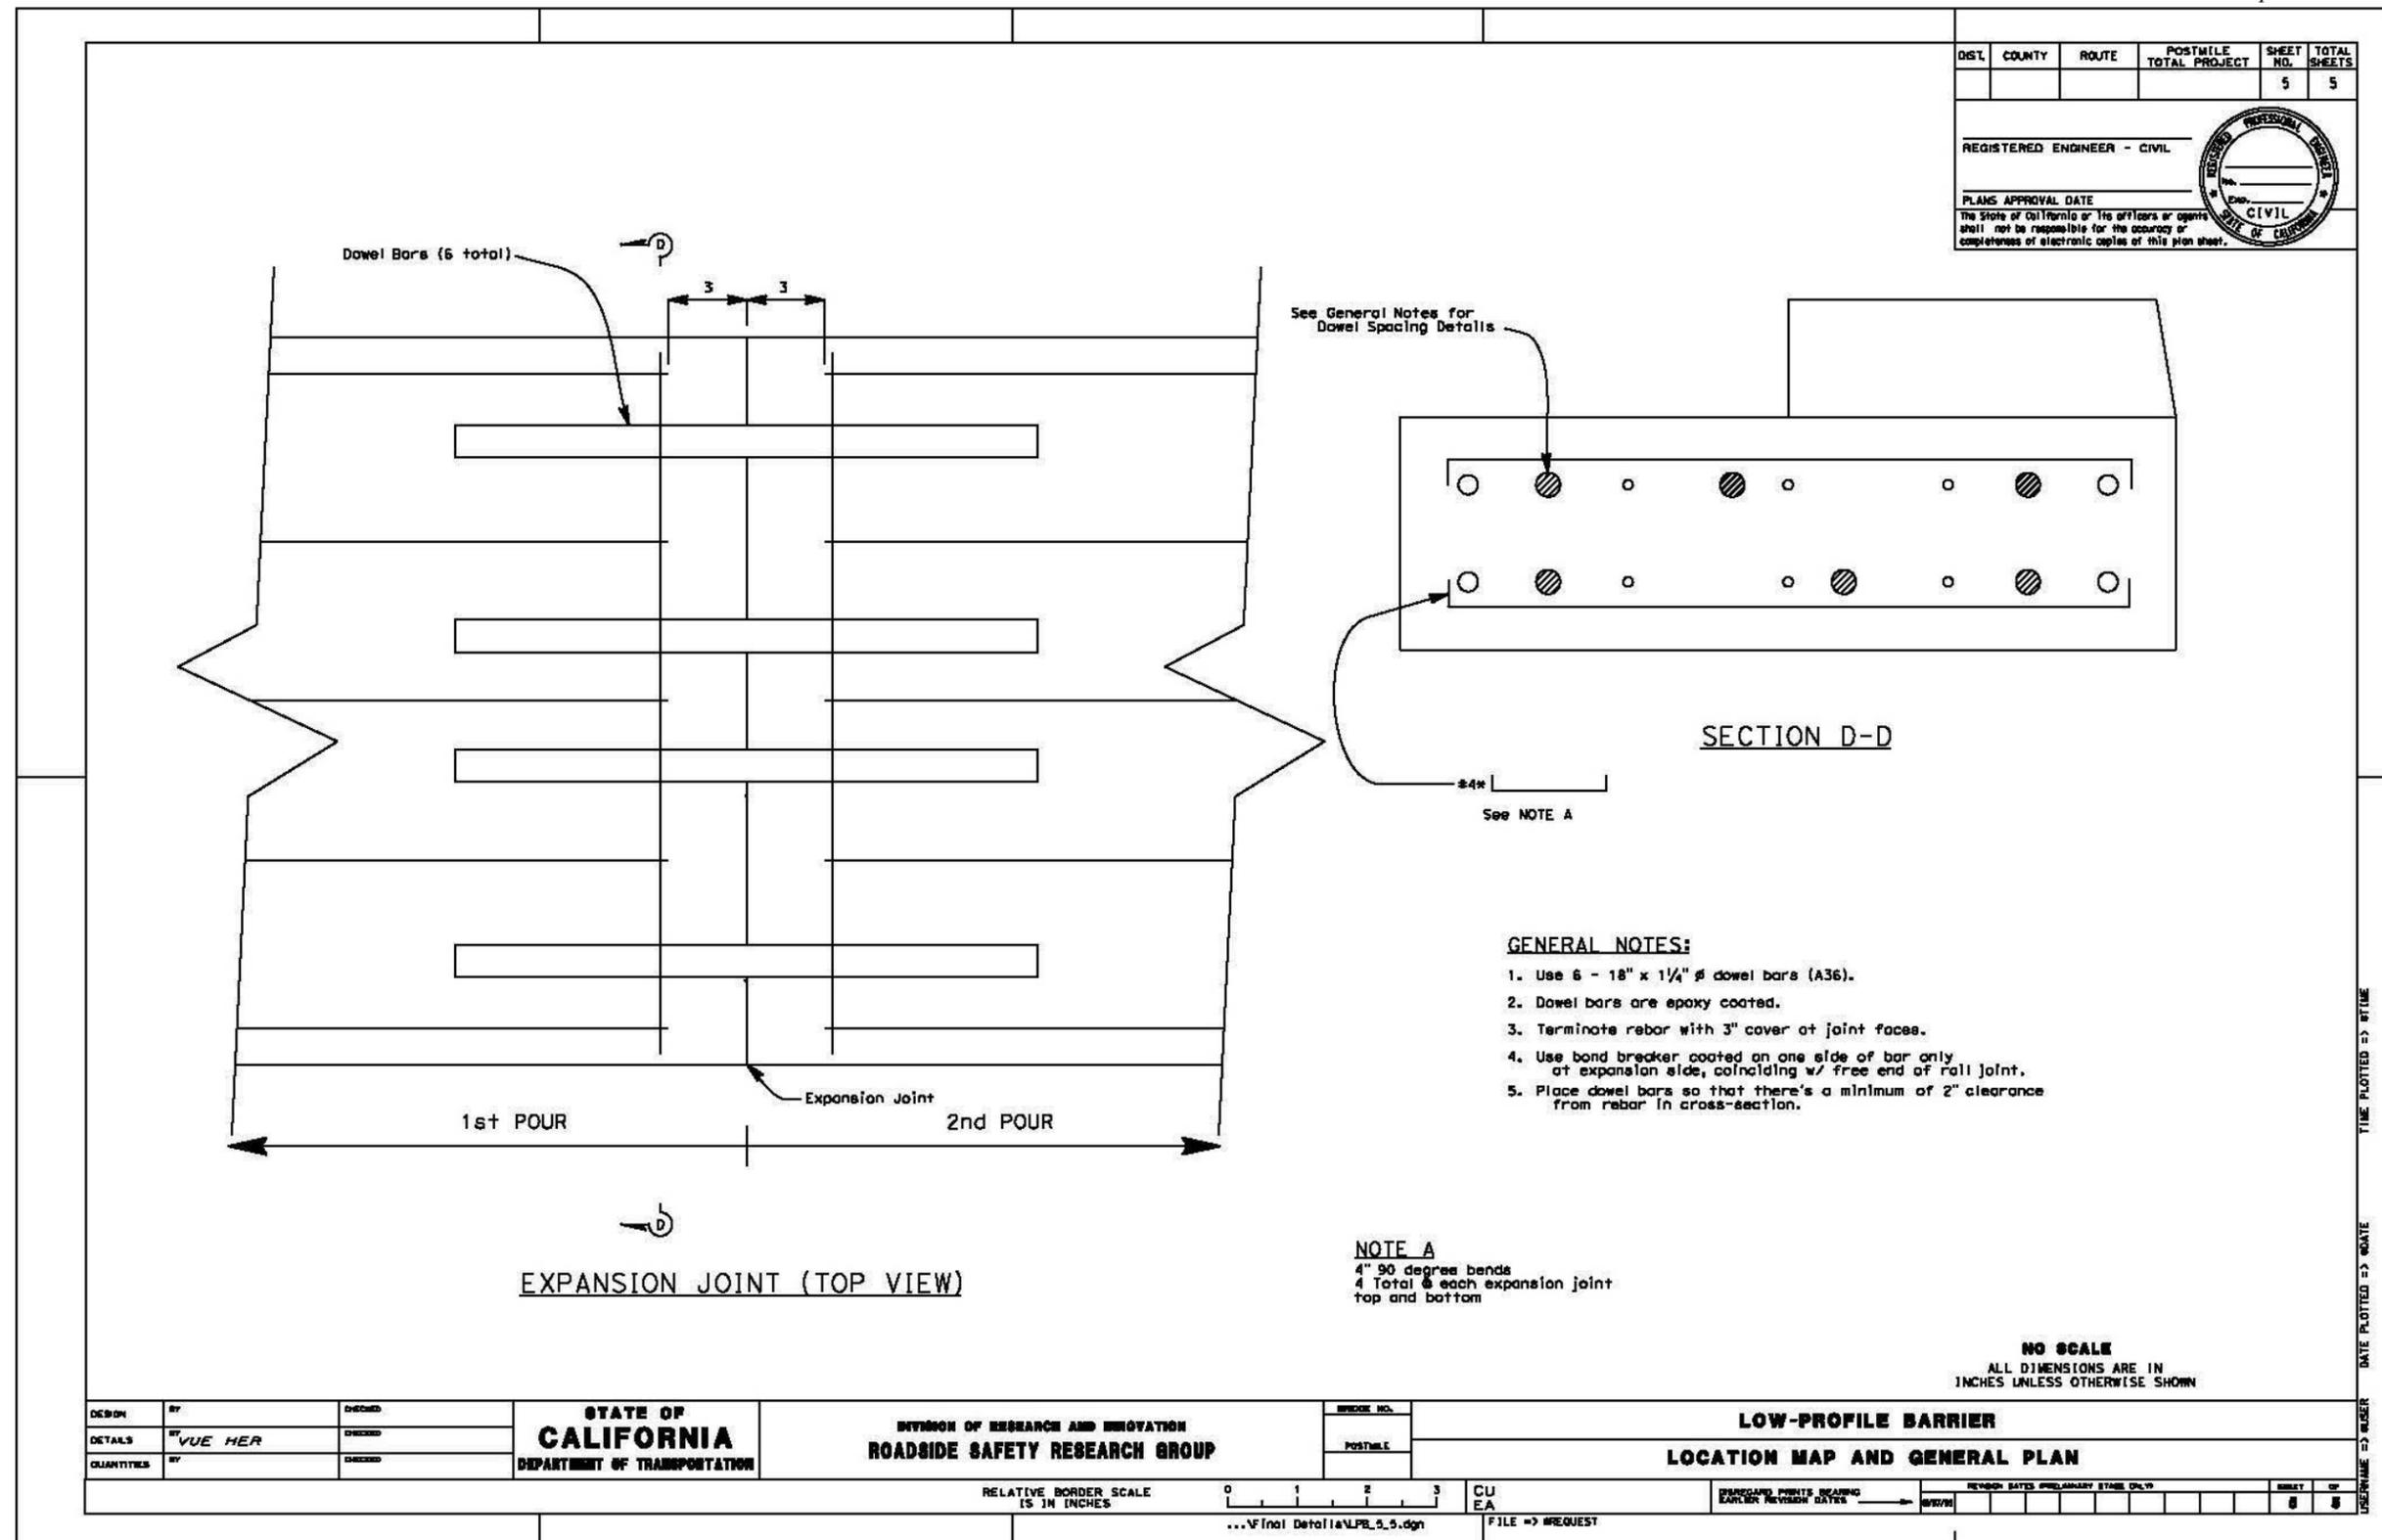
The following details in Figure 8-28 to 8-32 are for the tested barrier only.
