1. Report No. CA13-1723	2. Government Access No.	3. Recipient's Catalog No.	
4. Title and Subtitle Investigation of Methacrylate Rehabilitation Strategy to Extend the Service Life of Concrete Bridge Decks		5. Report Date September 2013

INVESTIGATION OF METHACRYLATE REHABILITATION STRATEGY TO EXTEND THE SERVICE LIFE OF CONCRETE BRIDGE DECKS

Final Project Report

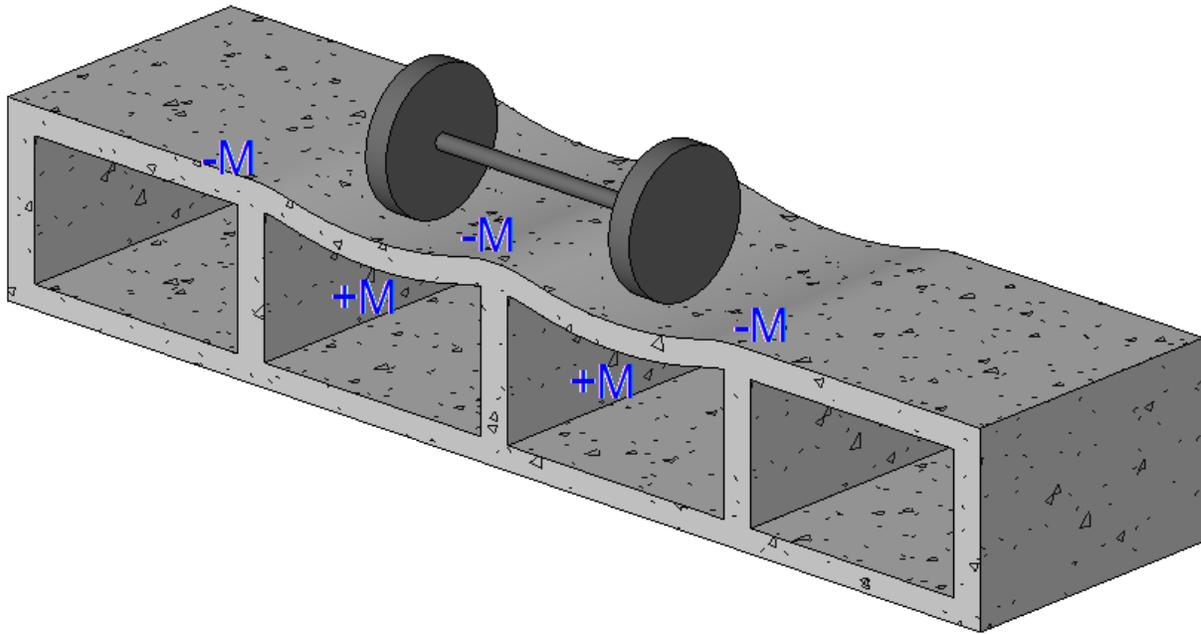
Figure 8: Idealized moment behavior of the deck in the transverse direction.

The plan geometry and support conditions for the test panels were specifically determined based on matching the local transverse flexural stresses in the panel with those experienced in an actual bridge deck. Note that these local stress excursions in the transverse direction under each passing wheel load were judged to be more critical in the fatigue performance of the deck than the global longitudinal stress excursions generated by transmitting vehicle loads longitudinally to the bridge supports. Simply stated, these local transverse stresses consist of tensile stresses in the top of the deck over the webs of the box girders (negative moment) and compressive stresses in the top surface of the deck between webs (positive moment), as shown in Figure 8.

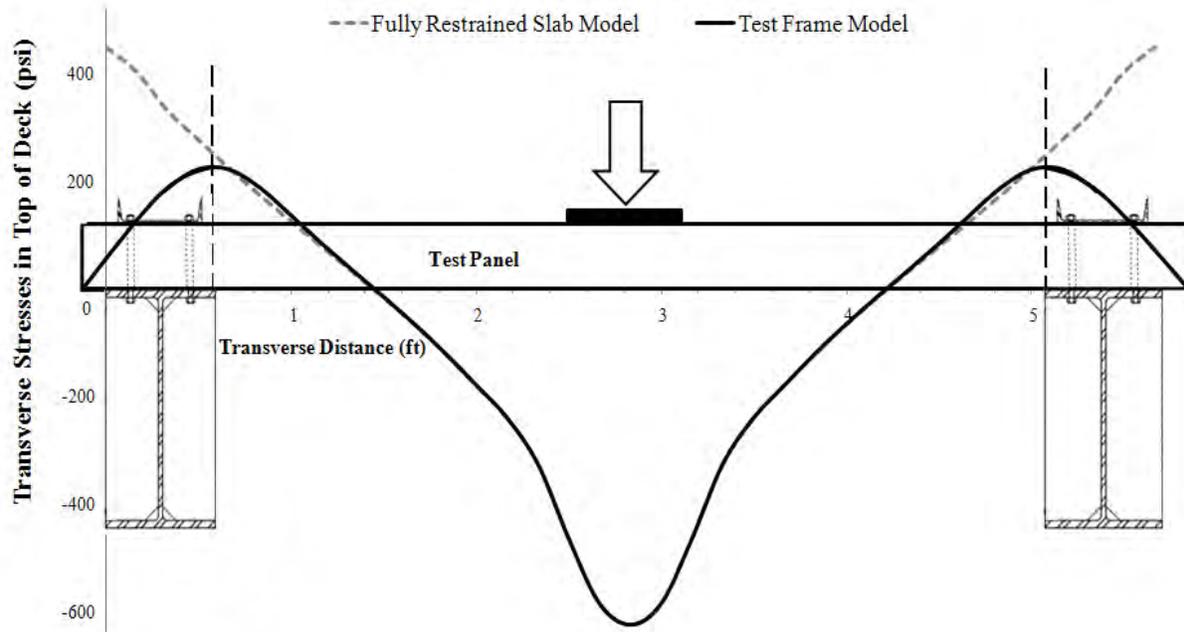
Figure 19: Comparison of transverse stresses in the top of the deck for the fully-restrained slab model and rest frame model.

In designing the reaction frame, multiple finite element analyses were done of the complete test setup (i.e., the reaction frame, clamping system and test panels) to confirm that the stresses generated in the test panels would be consistent with their required fixed edge support condition in the transverse direction (Gilbert, 2011). Linear elastic ANSYS analyses were done using an applied patch load of 15 kips. The initial frame design, for example, did not include web stiffeners for the longitudinal support beams. Subsequent finite element analyses revealed that these beams twisted when load was applied to the test panel, reducing the negative moment at the clamped edges of the panel and increasing the positive moment at the center of the panel. To address this problem, various web stiffener arrangements were analytically investigated iterating on stiffener size and spacing until the observed transverse stresses in the test panel were close in magnitude to those analytically predicted for a panel with perfectly fixed longitudinal edges (see Figure 19).

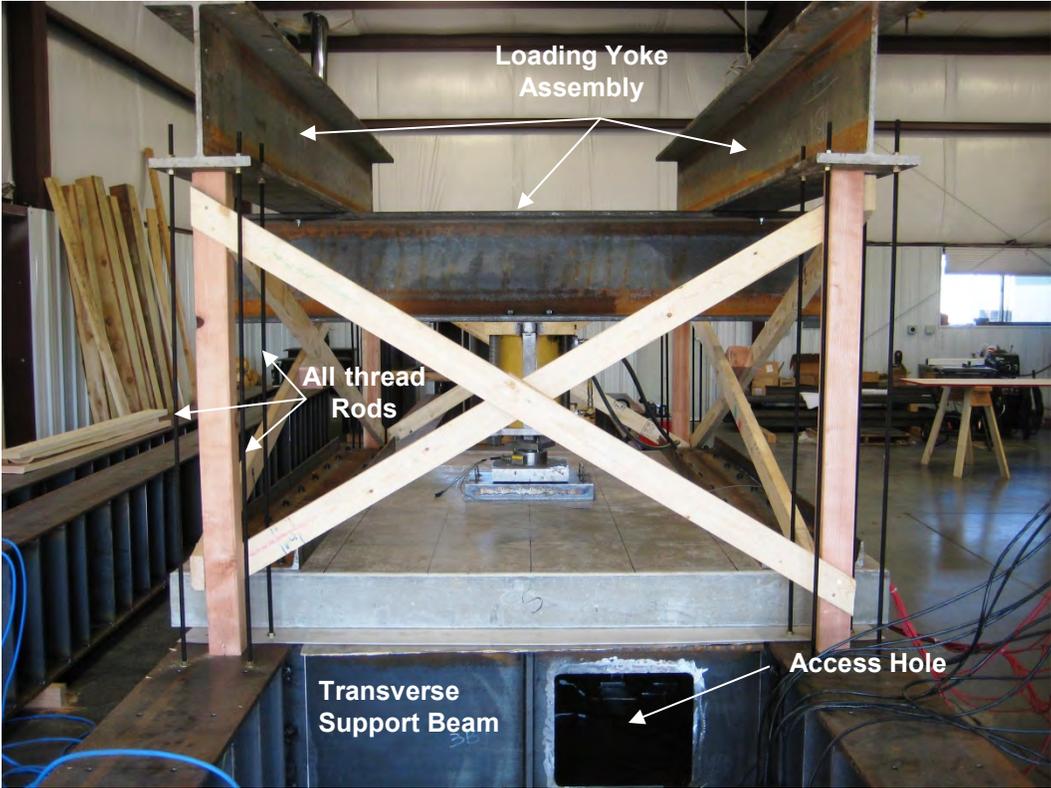
Figure 20: End view of static load test setup.

A further verification of the performance of the reaction frame was conducted by physically loading to failure a single test panel mounted in one of the interior bays of the frame (Figure 20 and Figure 21). The specific specimen used in this test had the same geometry and reinforcing arrangement as the already described fatigue test specimens, with a 28-day concrete strength of 7,618 psi (8,040 psi on the day it was tested). The panel was clamped in the reaction frame using the procedure outlined above. Load was applied using a 2.5-inch thick A-36 steel loading plate with a contact area of 12 x 20 inches (representing a dual truck tire assembly).

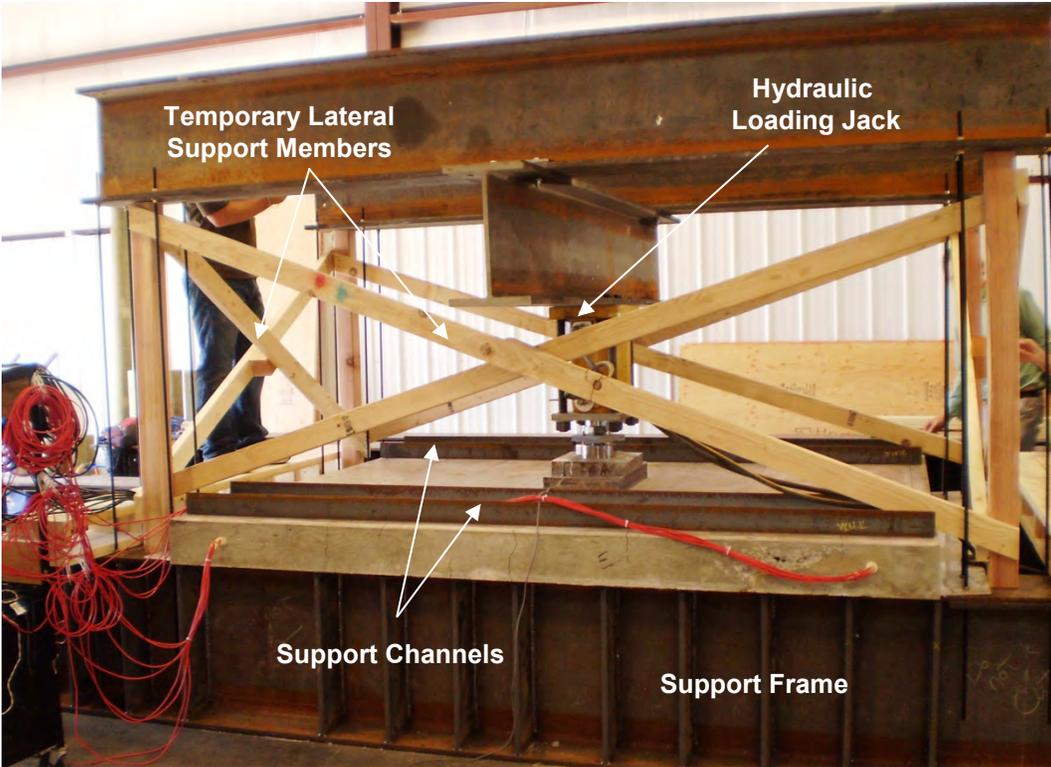
Figure 21: Side view of static load test setup.

Internal strain measurements made in the transverse direction of the panel during this test confirmed that the reaction frame offered a high degree of rotational fixity along the longitudinal edges of the slab (Gilbert, 2011). The strains measured near the clamped edges were tensile in the top of the deck and compressive in the bottom (negative moment) for loads up to 75 kips. Furthermore, the measured strains closely matched those obtained in an FE analysis of the slab in which full rotation and translation restraint was assumed along the longitudinal edges. A tensile strain of 30 microstrain and a compressive strain of 37 microstrain were recorded in the static load test, while the ANSYS model with ideally clamped edges experienced a tensile strain of 35 microstrain, and a compressive strain of 46 micro-strain. These tensile and compressive strains were higher than the experimental results by only 17 and 23 percent, respectively. Finally, the observed crack patterns in the test slab were also consistent with the expected distribution of stresses, that is, all of the top surface cracks initiated in the expected tension zone along the face of the supports, and bottom surface cracks were concentrated in the expected tension zone directly under the applied load.

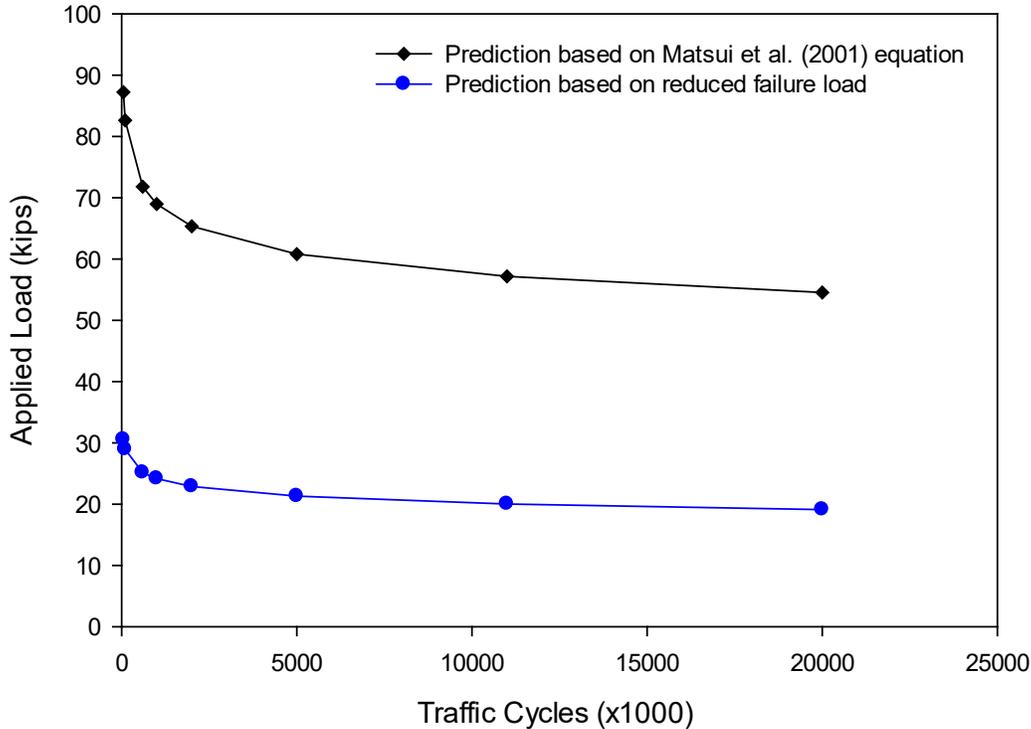
Figure 22: Predicted fatigue life of test panels as a function of applied load.

Another important task prior to initiating the trafficking of the test panels was to estimate the number of traffic cycles that would be needed to produce the degree of deck deterioration needed in this study. This degree of deterioration was defined as the maximum level of distress at which an HMWM treatment would still be used as a rehabilitation treatment. Thus, for the test panel configuration defined above, an effort was made to predict the magnitude and number of load cycles that would be required to reach this deteriorated condition. These predictions were made generally following the form of fatigue life prediction equation previously introduced by Matsui et al. (2001), in which the number of load cycles to failure was expressed as a function of the applied load normalized by the ultimate capacity of the deck slab (Equation 1). This equation was first evaluated with failure being defined as a complete loss of structural load carrying capacity. The failure capacity of a typical slab was established in a previously described test by Gilbert (2011) to be 192 kips (with the failure mechanism being punching shear). This value was adjusted for relative concrete strength (the concrete in the Gilbert slab had an unconfined compression strength of 8,040 psi, compared to a target concrete strength in these test panels of 4,000 psi) and was then used for the normalizing value, P_s , in Equation 1. The resulting fatigue life curve is presented in Figure 22 (upper curve in this figure). Notably, across a range of possibly reasonable magnitudes for the rolling wheel load of 15 to 25 kips, the predicted fatigue life was effectively infinite.

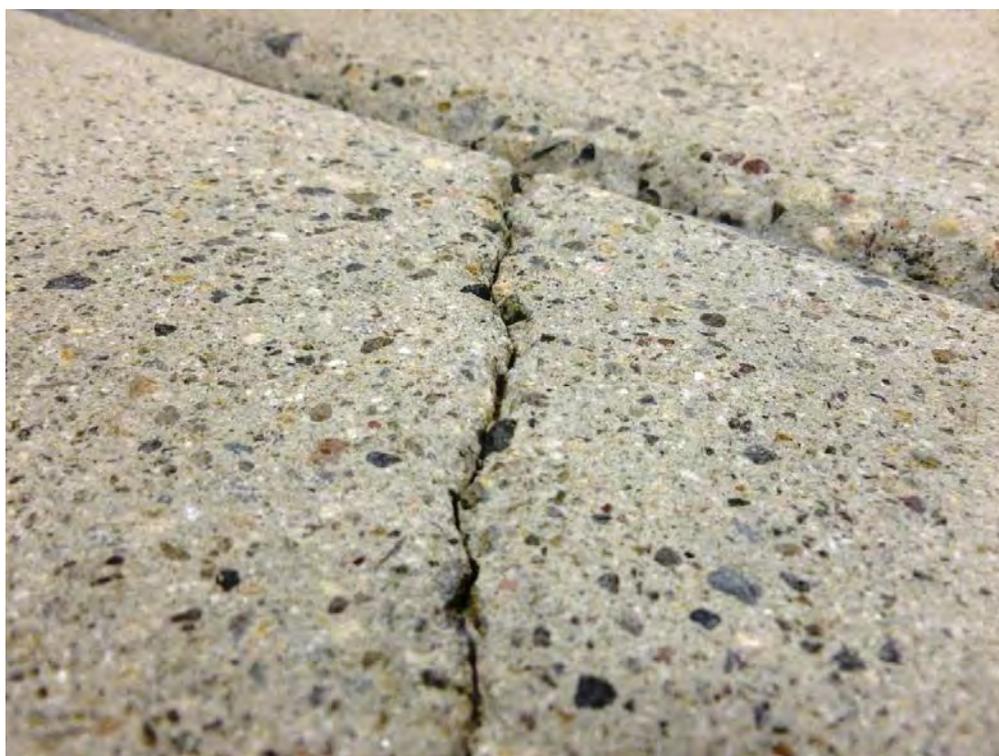
Figure 32: Crack in deck surface after shot blasting.

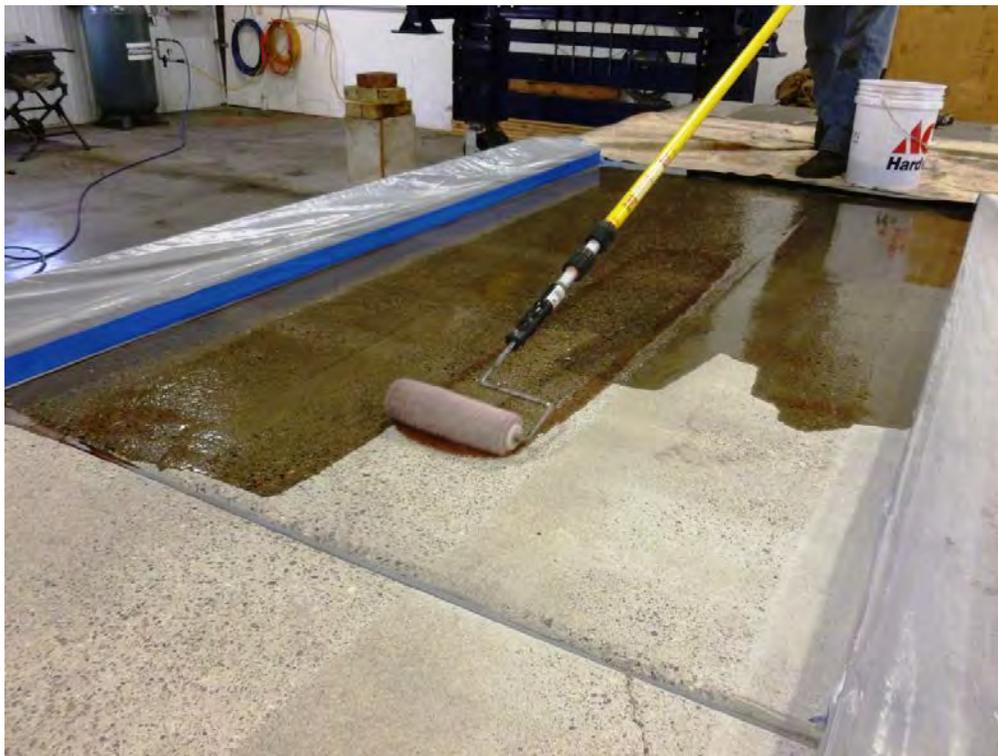
Figure 33: Application of HMWM surface treatment.

Subsequent to surface preparation, the KBP 204 (HMWM) was mixed in accordance with Kwik Bond product specifications and applied with a ½-inch nap paint roller (Figure 33). Excess material was rolled to the end of the slab and soaked up or deposited in a trough formed between adjacent test panels. Because cracked areas tended to soak up more methacrylate, special attention was paid to these areas to ensure adequate HMWM was present to fill the cracks prior to curing. The sealer cured for several days before trafficking was resumed. Friction enhancing sand was not added to the surface prior to curing as additional traction was deemed unnecessary in this application, and it was thought that this sand would obscure detection of surface distresses in the deck. A close-up photo of a crack filled with methacrylate is shown in Figure 34.

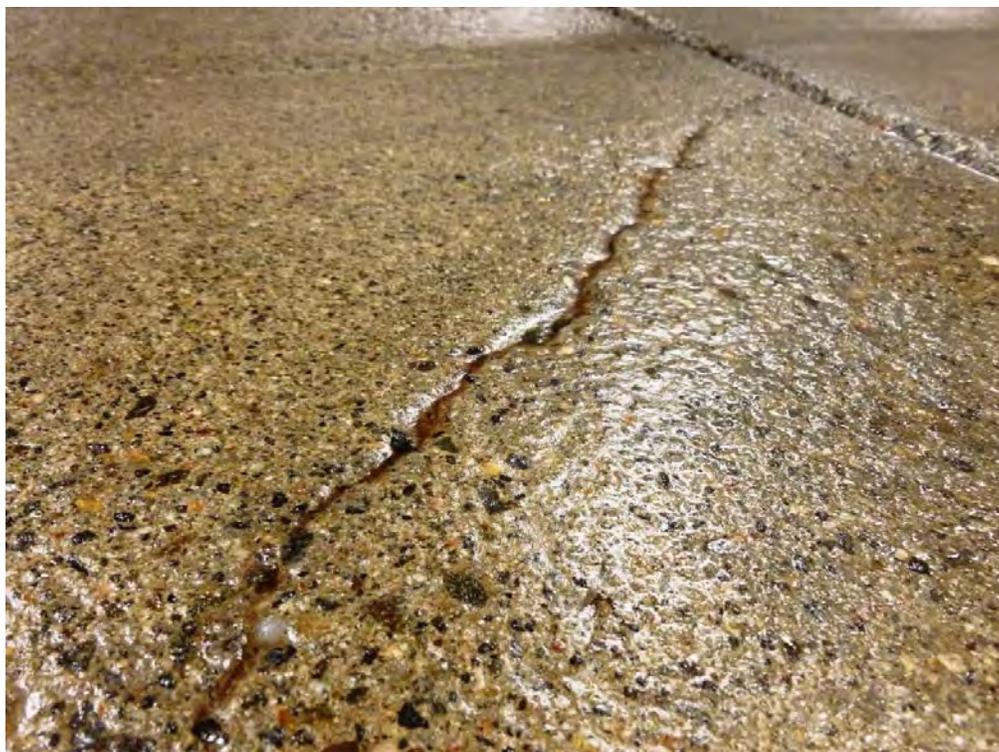
Figure 34: Close-up of methacrylate-filled crack.

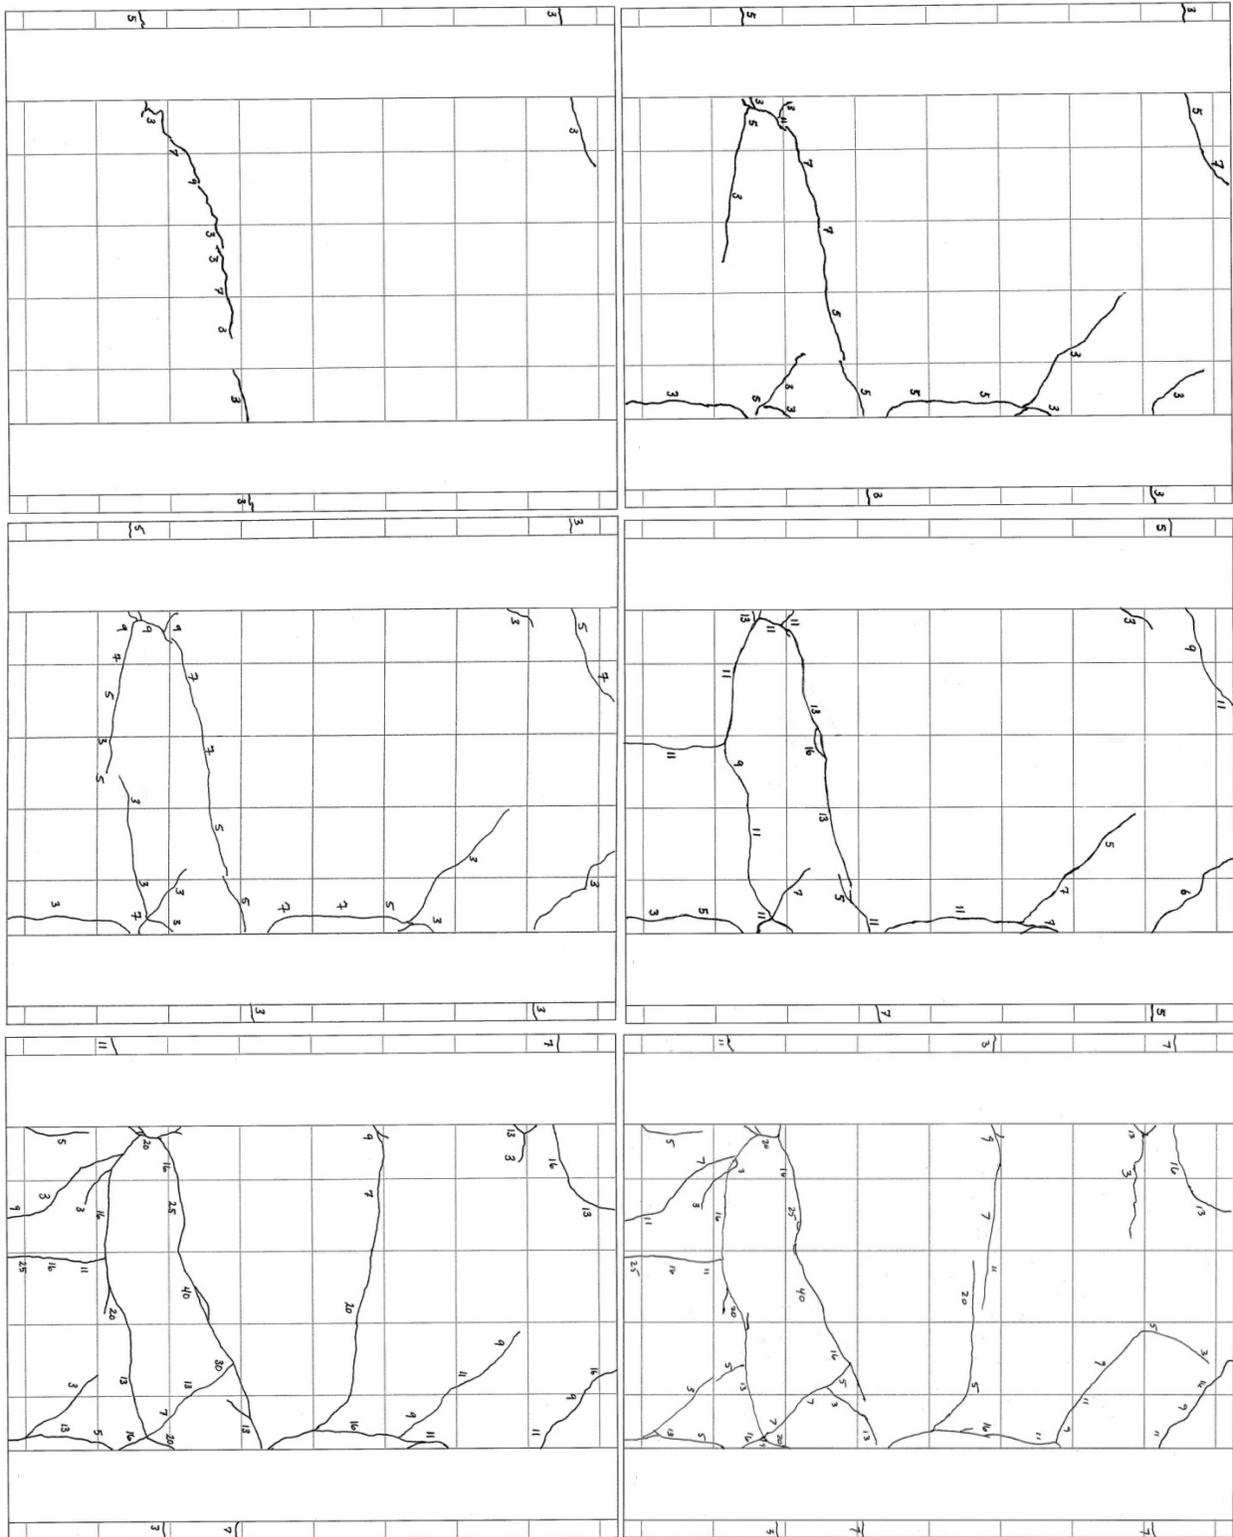
Figure 35: Top cracking in Control_a test panel at various traffic levels.

A typical set of crack maps as a function of cycles of applied load is presented in Figure 35 and Figure 36 for top surface and bottom surface cracking, respectively (test panel Control_a is shown). Cracking in the top surfaces of the panels occurred in many of the specimens by 12,000 to 25,000 load cycles (refer to Figure 35a). This distress often consisted of a single crack along the longitudinal edge of the panel indicative of negative transverse moment, and a few relatively “random” oriented skew and transverse cracks. By the second set of inspections (after 255,000 and 78,000 cycles of applied load, respectively, for panel set one and two), all panels exhibited cracking in their top surfaces. This cracking generally consisted of one or two longitudinal cracks along one or both edges of the panel, and some diagonal cracks across the corners, with occasional skew and transverse cracks. Bottom cracking at these same levels of cyclic load (Figure 36, for test panel Control_a) was confined to the center region of panels. Bottom surface cracking consisted initially of a few longitudinal cracks at or near the center of each panel, consistent with the presence of positive transverse bending moment. Cracking in the bottom surface of the decks definitely reflected the layout of the bars in the bottom mat of reinforcing, and initially, in particular, the longitudinal bars in this mat. Note that the cracking in the top surfaces of the decks did not follow the layout of the top mat of reinforcing steel. The top surfaces of the panels also appeared to generally exhibit less cracking than the bottom surfaces (as is borne out in the quantitative crack analysis presented below). This difference in cracking behavior between the top and bottom surfaces of the decks is believed to be due in part to the relative clear cover on the top and bottom mats of reinforcing steel. The top mat had 2 inches of clear cover, versus 1 inch for the bottom mat.

In general, as cycling progressed, cracks continued to increase in extent and width in the top surface of the decks (Figure 35), with this cracking being almost completely arrested when a panel received HMWM treatment. Early crack widths, i.e., at the time of the second set of crack inspections, were typically in the range of only 0.003 to 0.007 inches. At the conclusion of testing of Panel Set 1, cracks in the top surface of the untreated panels (i.e., test panels Control_a and Control_b) generally were in the range of 0.016 to 0.020 inches wide, with a maximum width of 0.040 inches. A typical longitudinal crack along a clamped edge is shown in Figure 37 (edge of M1000_a test panel at approximately 1,000,000 load cycles). Note the maximum crack width in each panel at the time the HMWM treatment was applied was previously reported in Table 3.

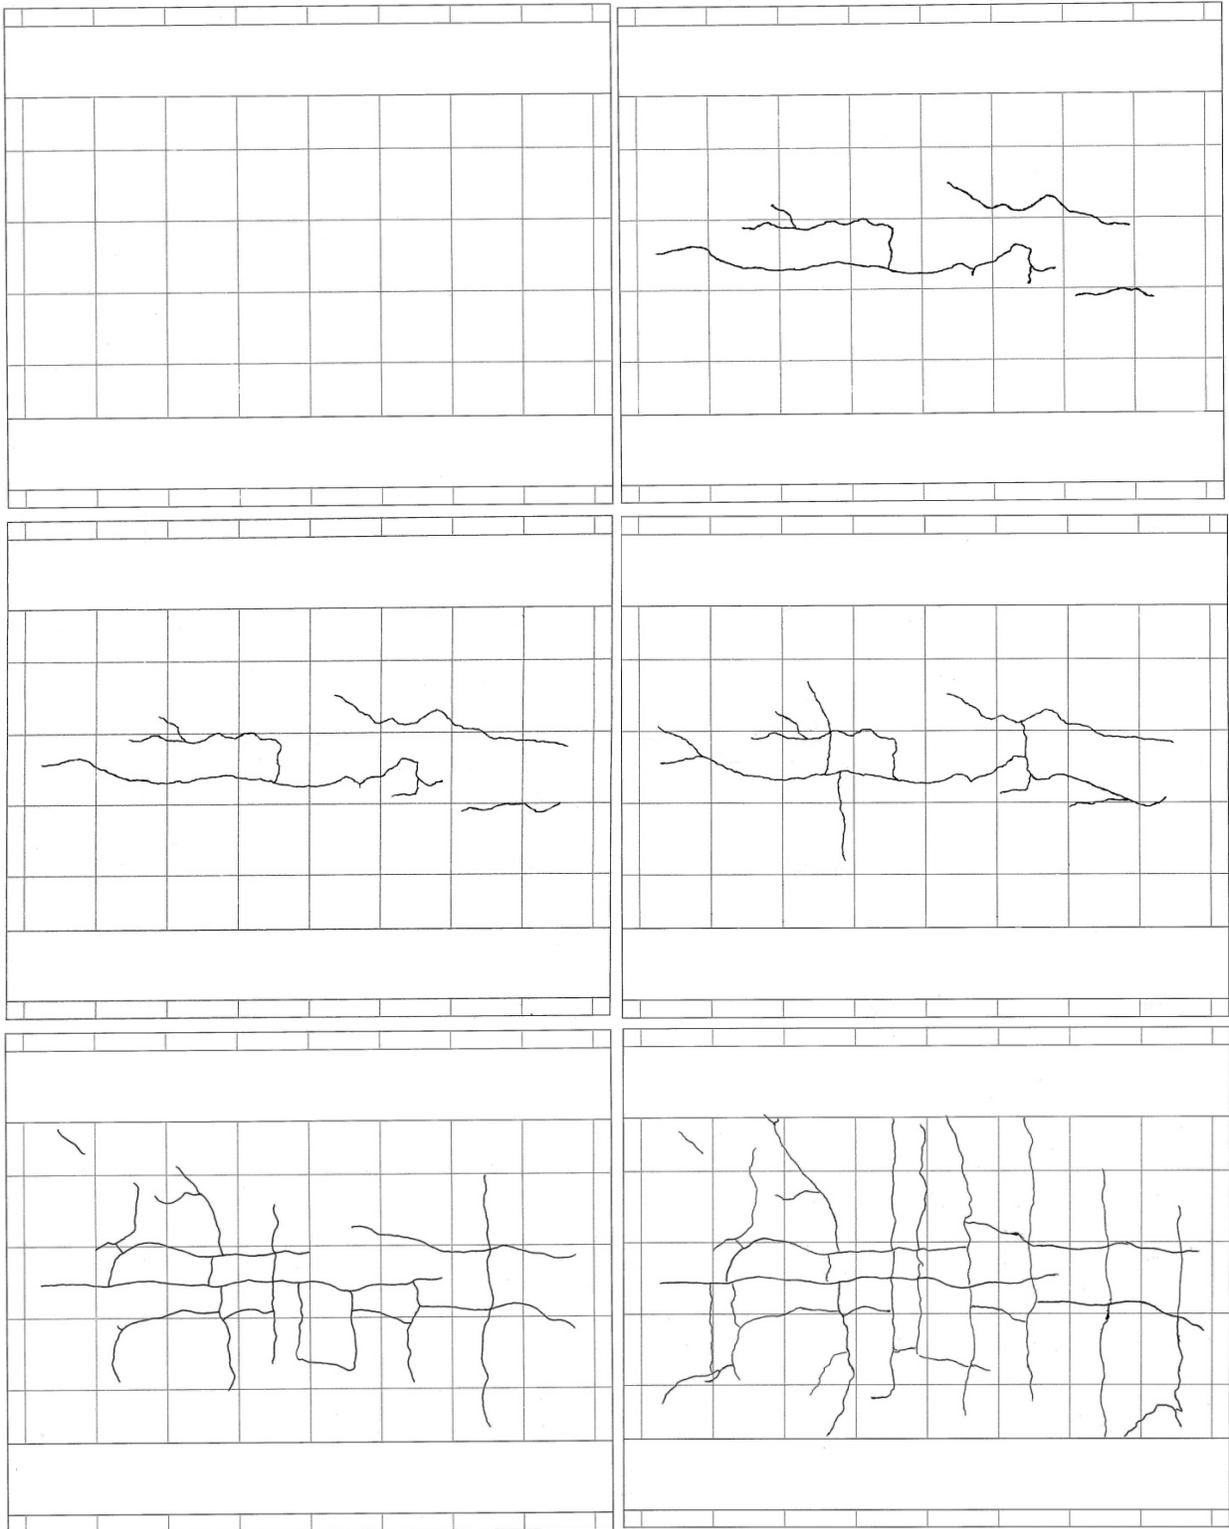
Figure 36: Bottom cracking in Control_a test panel at various traffic levels.

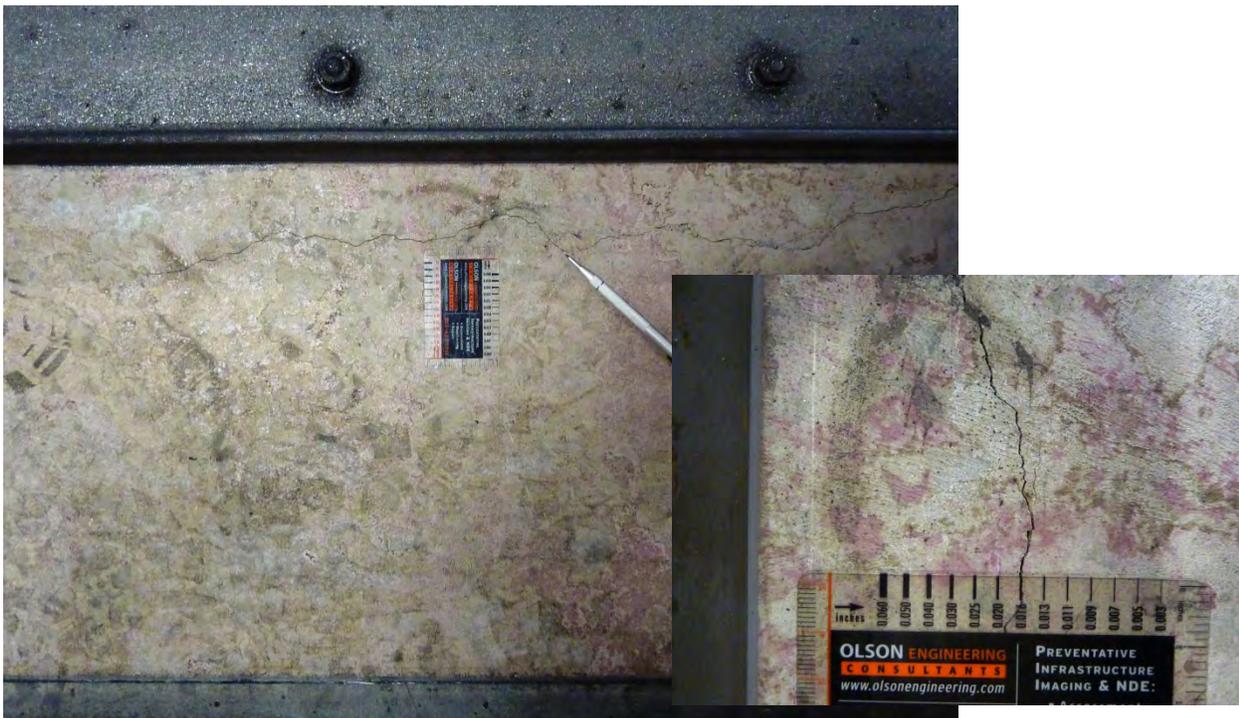
Figure 37: Longitudinal crack in top surface.

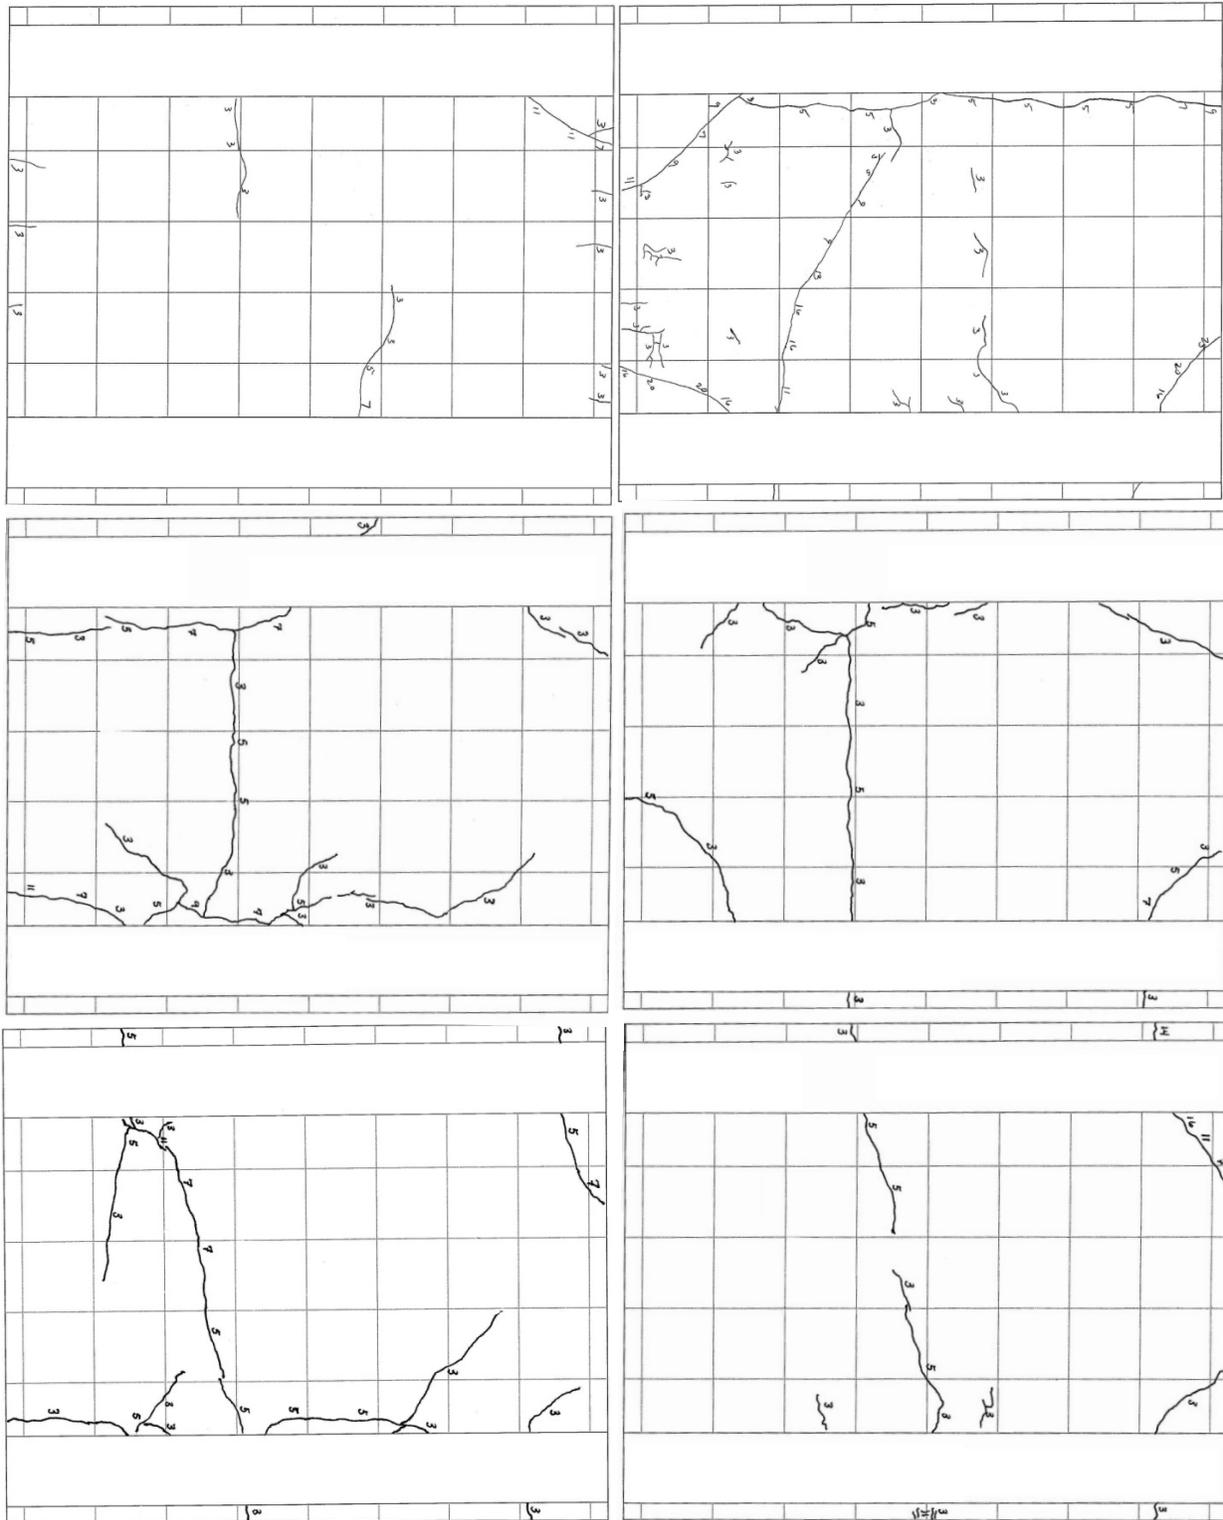
Figure 38: Top cracking in all test panels at about 250,000 traffic passes.

Relative to comparative performance between panels, all panels were expected to exhibit similar top surface distress as cycling proceeded until any given panel received HMWM treatment. An excellent opportunity to make such a comparison was after approximately 250,000 load cycles, as six of the eight panels were still untreated at this point, and crack assessments were done on all panels at about this same level of trafficking. The cracking distress in the top surface of these six panels at approximately 250,000 load cycles is presented in Figure 38. Panels M250_b, M1000_a, M1000_b and Control_a exhibited similar crack patterns, as did panels M250_a and Control_b. The difference in the response between these two groups of panels is the presence of longitudinal cracks in the former panels along at least one clamped edge of the panel, while such cracks are absent in the latter panels. The absence of such cracks in Panels M250_a and Control_b could have resulted from differences in the degree of clamping provided by the support frame for these panels, although an associated decrease in the stiffness of these panels was not observed (see stiffness results presented in the subsequent sections below). In the case of panel M250_a, the HMWM was applied at 250,000 load cycles, arresting any further crack development. In the case of panel Control_b, limited longitudinal cracks did develop along the clamped panel edges after 1,360,000 cycles of applied load.

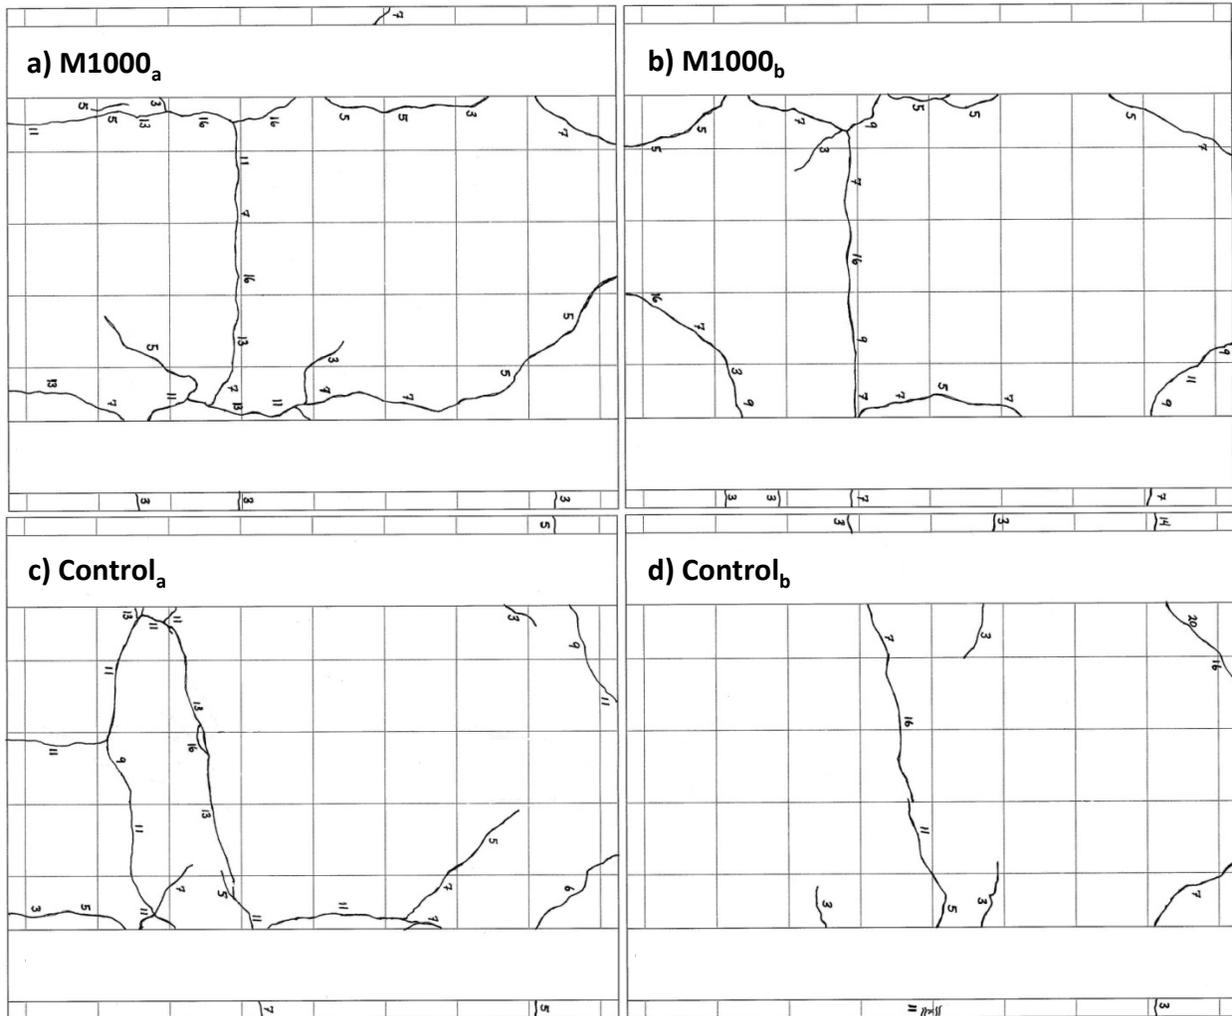
Figure 39: Top cracking in M1000 and Control test panels at 1,071,820 traffic passes.

The expected similarity in the distress generated in similarly configured and loaded test panels could also be evaluated using the condition of the slabs in Panel Set 1 at approximately 1,000,000 load cycles, as no treatments were applied to any of these slabs prior to this point. Crack maps of the top surfaces of the four panels comprising this set of panels at approximately 1,000,000 load cycles are presented in Figure 39. Once again, the crack patterns in slabs Control_a, M1000_a and M1000_b are similar in nature, while panel Control_b continued to manifest no longitudinal cracks.

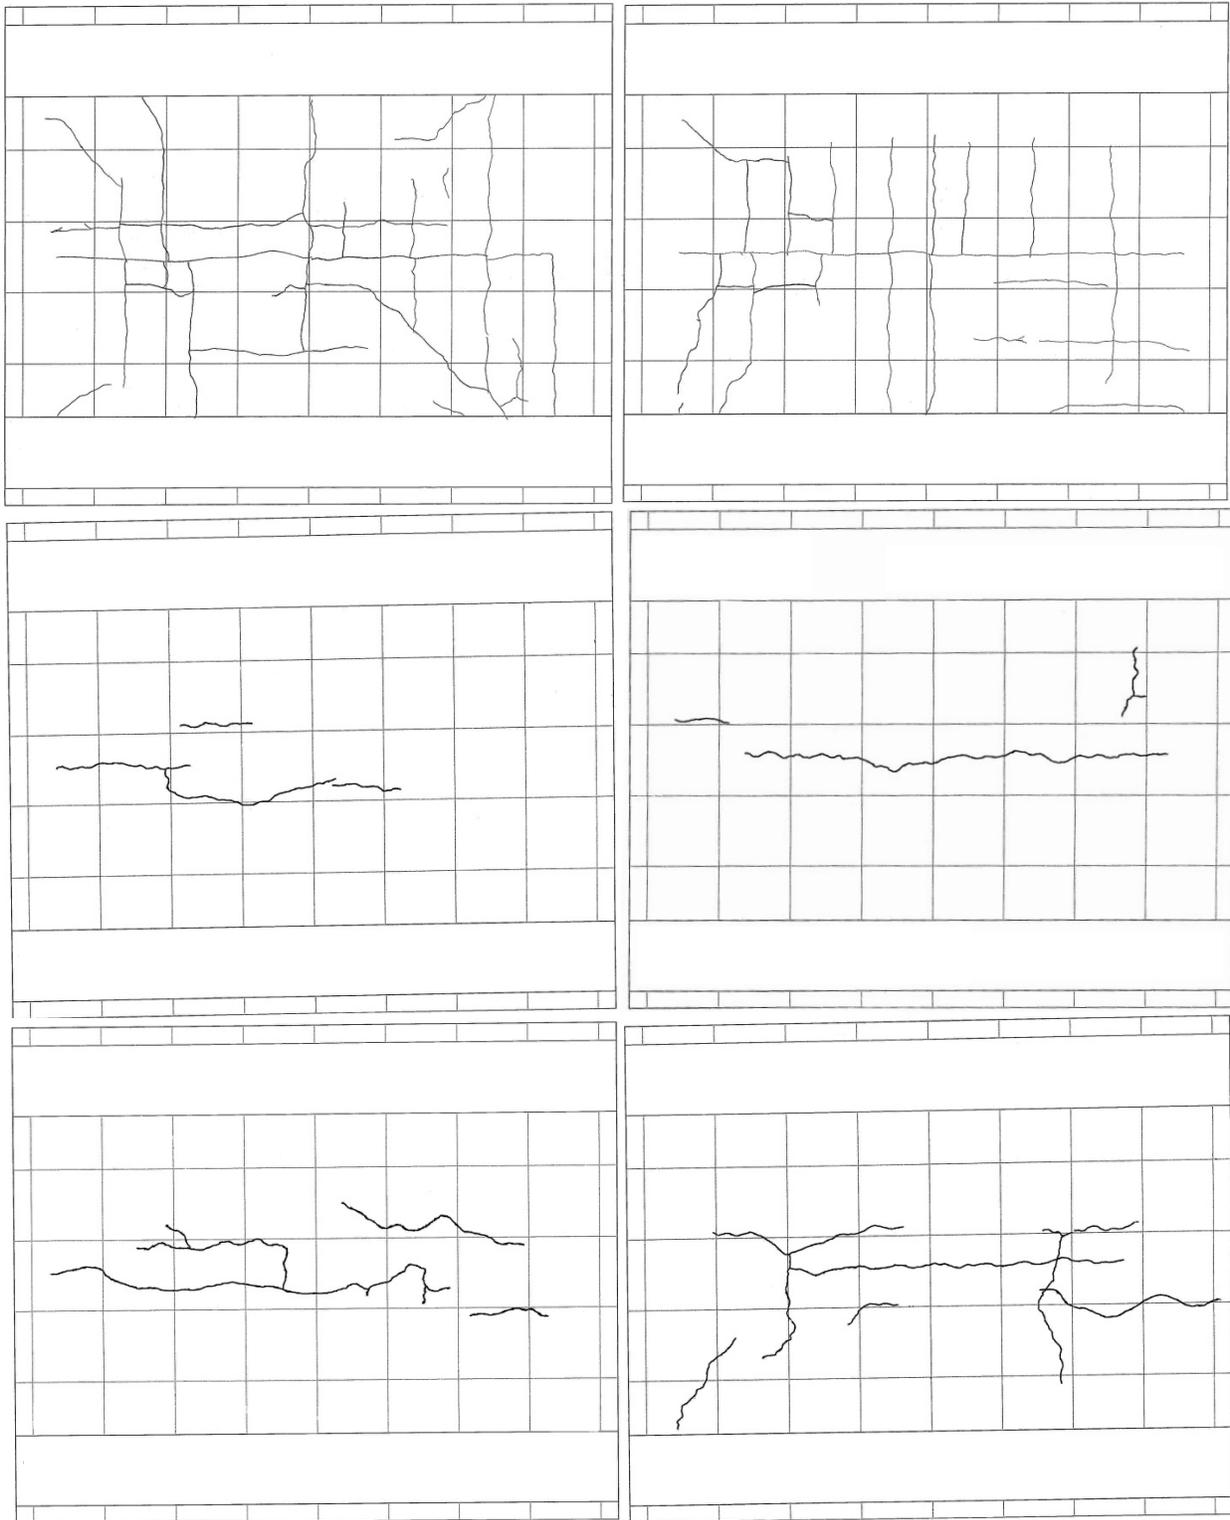
Figure 40: Bottom cracking in M250, M1000 and Control test panels at 250,000 load cycles.

A comparative analysis of the cracking in the bottom surfaces of similarly configured panels was also possible at about 250,000 and 1,000,000 cycles of applied load. The bottom cracking in the six similarly configured panels available for this comparison at approximately 250,000 cycles of applied load (panels M250_a, M250_b, M1000_a, M1000_b, Control_a and Control_b) are shown in Figure 40. Considering the information presented in Figure 40, it is apparent panels M250_a and M250_b from Panel Set 2 exhibit more extensive bottom cracking than the other panels. Looking further, it was found that bottom cracking across all the panels in Set 2 was noticeably more

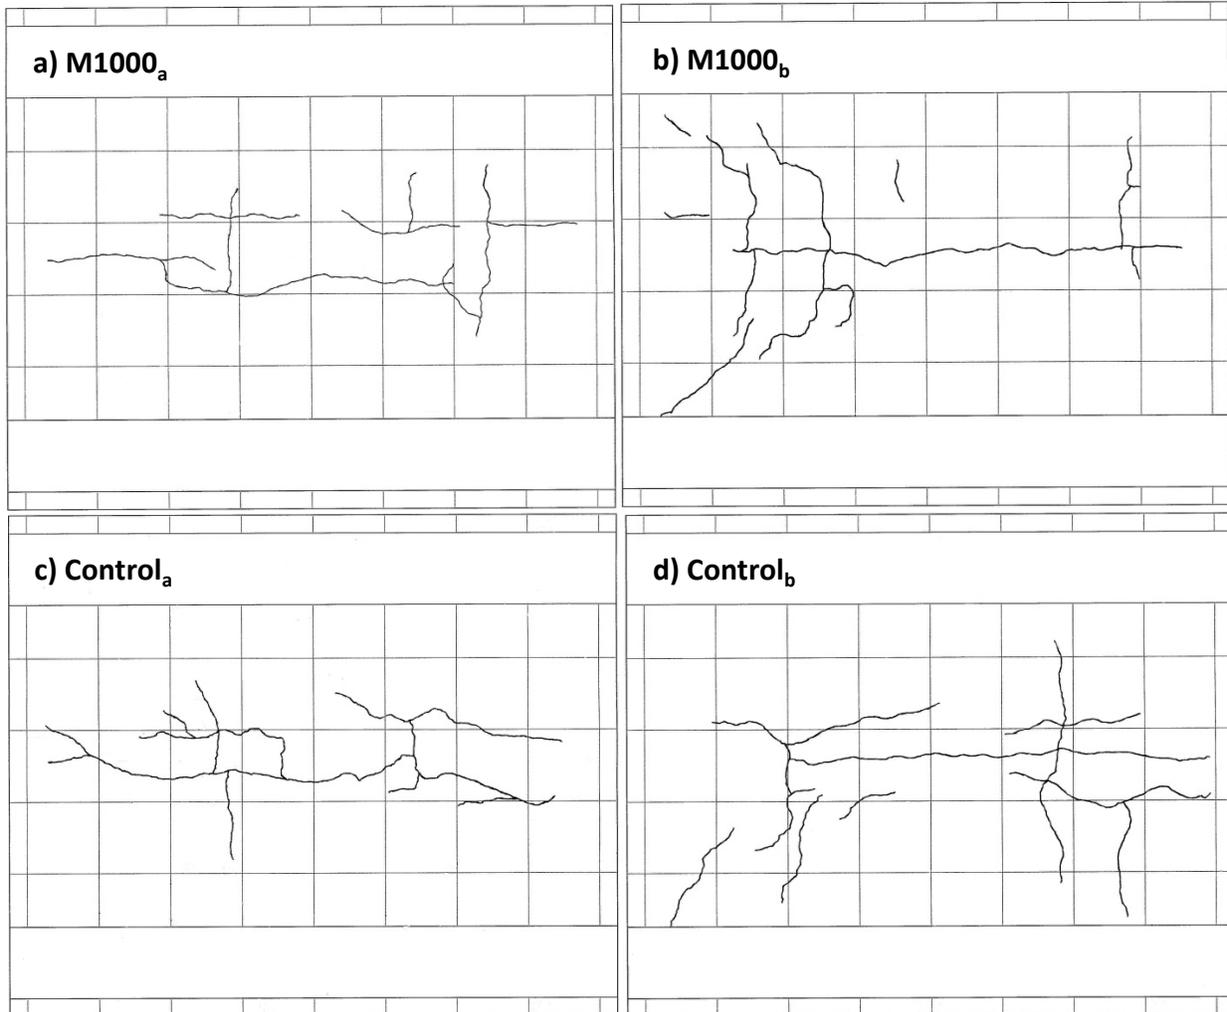
Figure 41: Bottom cracking in M1000 and Control test panels at 1,071,820 traffic passes.

Bottom cracking in the four slabs in Panel Set 1 at 1,071,820 cycles of applied load are shown in Figure 41. At this cycle point the most extensive bottom cracking continued to be seen in panel Control_b, with the least bottom cracking in panel M1000_a (closely followed by Control_a).

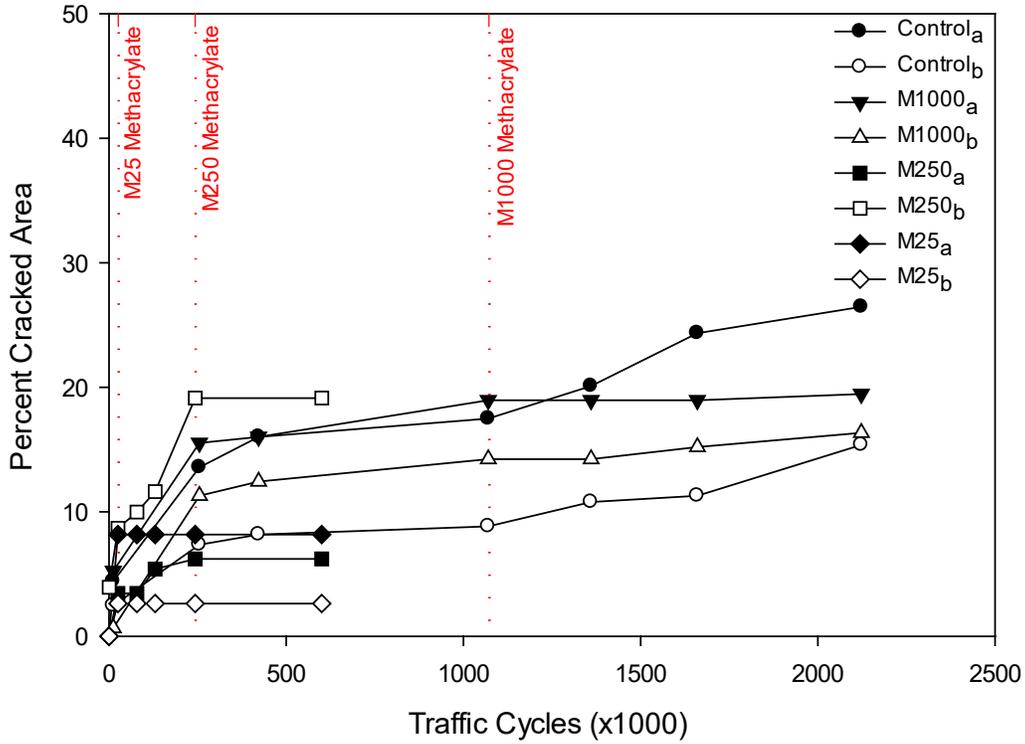
Figure 42: Percent top cracking for both panel sets.

Referring to Figure 42, and considering first the behavior of Panel Set 1 (M1000_a, M1000_b, Control_a and Control_b), top surface cracking increased relatively rapidly up to the 255,000 inspection point, variously reaching approximately 10 to 20 percent of the area. Between 255,000 and 1,000,000 load cycles, distress in the top surface continued to increase, but at a much more moderate rate. Between 1,000,000 and 2,000,000 load cycles, considering just the untreated control panels, cracking again progressed at a more accelerated rate. At the conclusion of testing, the percent cracked top area of the Control panels ranged from 15 to 18 percent.

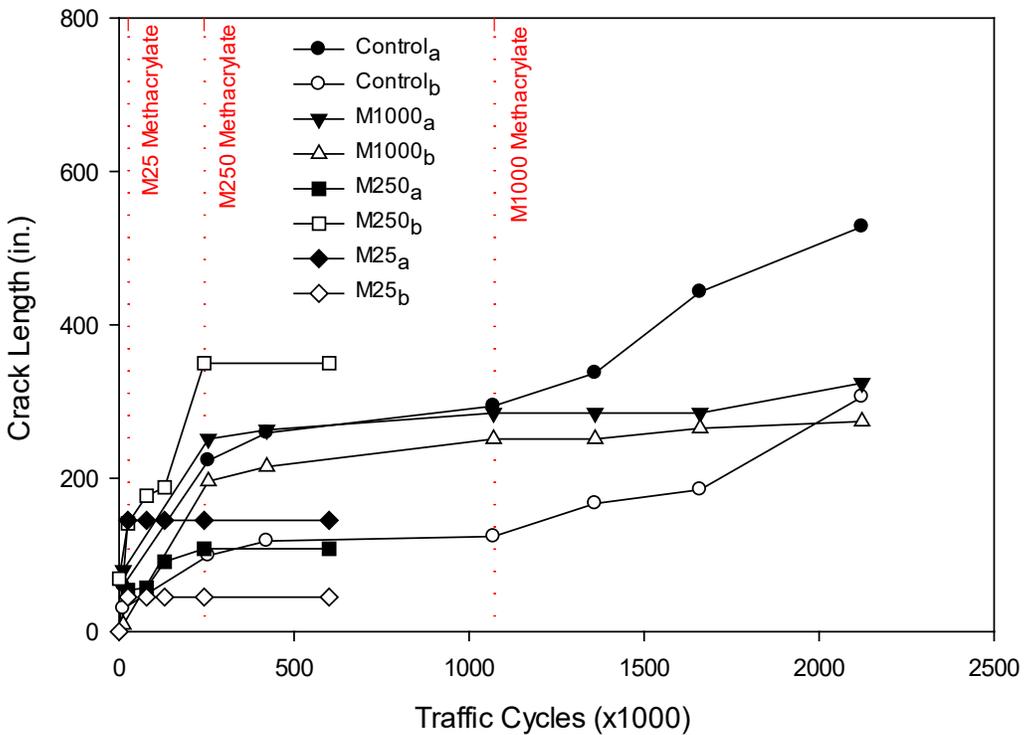
Figure 43: Top crack length for both panel sets.
