1. Report No. CA13-1723	2. Government Access No.	3. Recipient's Catalog No.	
4. Title and Subtitle Investigation of Methacrylate Rehabilitation Strategy to Extend the Service Life of Concrete Bridge Decks		5. Report Date September 2013

INVESTIGATION OF METHACRYLATE REHABILITATION STRATEGY TO EXTEND THE SERVICE LIFE OF CONCRETE BRIDGE DECKS

Final Project Report

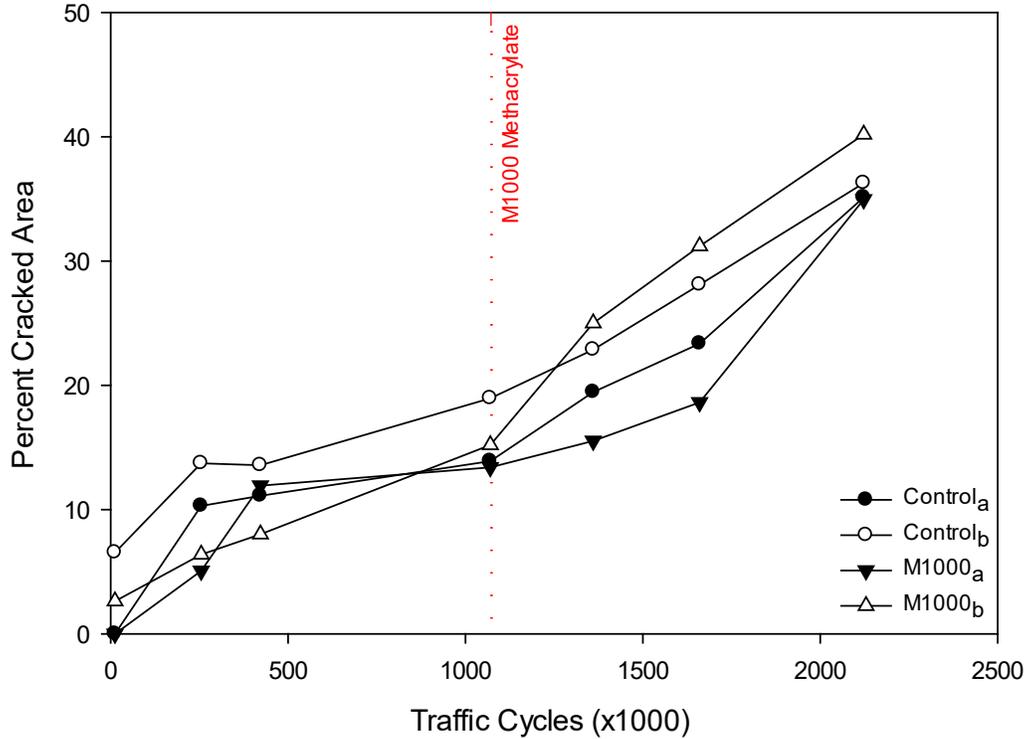
Figure 44: Percent bottom cracking in Panel Set 1.

Cracking in the bottom surfaces of the test panels generally developed as cycling progressed following the pattern described above for top surface cracking, with the notable exception that its progression was not affected by the application of HMWM to the top surface of the panels. In the case of Panel Set 1, and referring to Figure 44, the three stages of crack progression described previously in the top surfaces of the panels is clearly evident in the bottom surfaces, i.e., a period of initial crack development through 250,000 load cycles, followed by a stable period with little change in cracking extent through 1,000,000 load cycles, and concluding with a period of resumed crack growth from 1,000,000 to 2,000,000 load cycles. Unlike the top surface, however, in which cracking was arrested at 1,000,000 load cycles in the panels that were treated with HMWM, cracking resumed at a similar accelerated rate on the bottom surface of all the panels (untreated and treated, alike) through 2,000,000 load cycles, reaching a relatively common extent approaching 40 percent of the panel area.

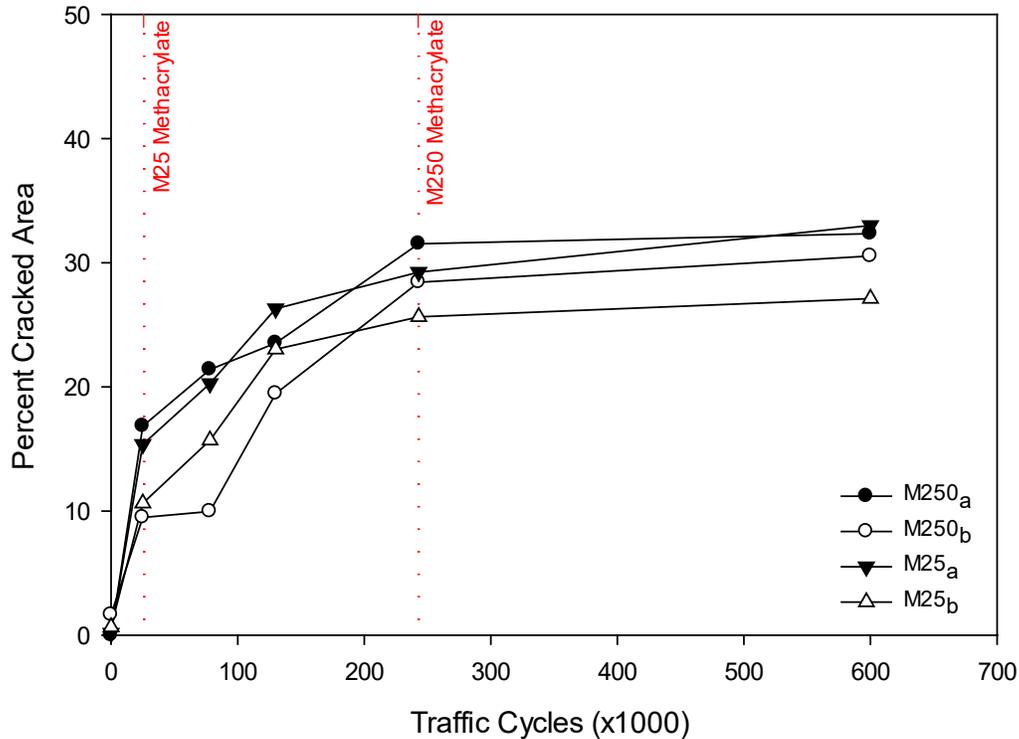
Figure 45: Percent bottom cracking in Panel Set 2.

Crack surveys of the bottom surfaces of Panel Set 2 (summarized in Figure 45) indicate that the second set of panels experienced approximately twice the bottom surface cracking distress (quantified in percent cracked area) as was seen in Panel Set 1 at 600,000 load cycles. As previously discussed, this difference in amount of cracking possibly can be attributed to differences in the concretes used in constructing the two sets of panels. As in the case of Panel Set 1, the progression of bottom cracking was unaffected by HMWM treatment of the top surface, as can particularly be seen in the similarity in cracked condition in all four panels at 250,000 cycles of applied load, while two of these panels were treated at 25,000 cycles of applied load (M25_a and M 25_b).
