Results from Visual Inspection and Laboratory Testing for ASR in Existing Concrete Cores from Bridges and Pavements in California

Partnered Pavement Research Center (PPRC) Strategic Plan Project Task 3.34:
Improved Screening Tests for ASR

1. REPORT NUMBER UCPRC-RR-2015-07	2. GOVERNMENT ASSOCIATION NUMBER	3. RECIPIENT'S CATALOG NUMBER
4. TITLE AND SUBTITLE Results from Visual Inspection and Laboratory Testing for ASR in Existing Concrete Cores from Bridges and Pavements in California		5. REPORT PUBLICATION DATE March 2017

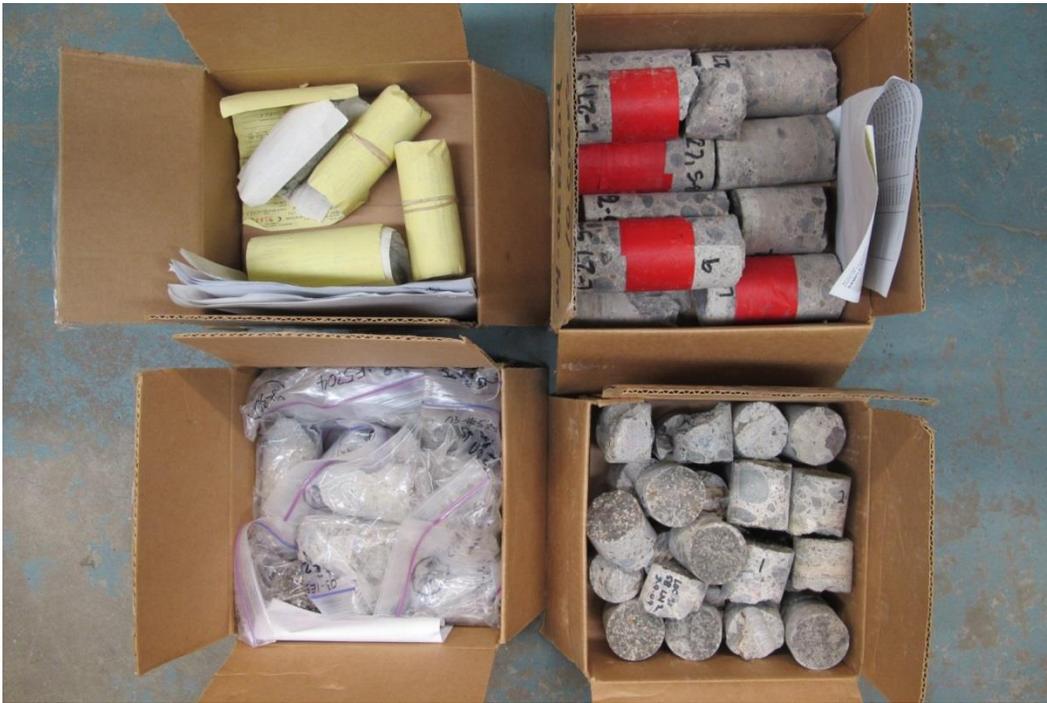
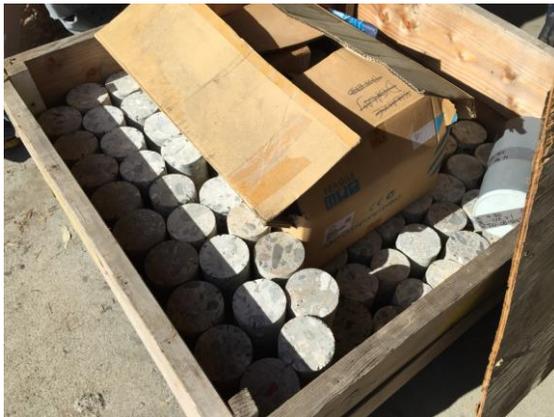
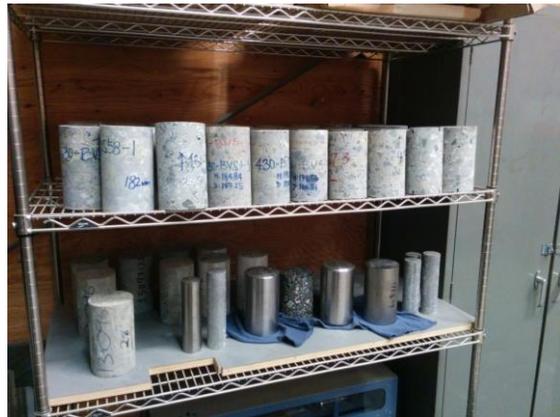
Figure 2.1: Pavement cores, including 150 cores that had been soaked in lime water for CTE testing.

The 265 pavement cores (Figure 2.1), of which 131 had been soaked briefly in lime water for the CTE testing, and 311 bridge cores were prepared for examination for ASR. For this investigation the petrographic consultant advised selecting bridge cores that had a minimum length of 3 inches (75 mm), so that the required amount of surface area for the examination on each would be available, and a preferred length of 4 inches (100 mm); this resulted in the selection of 102 cores to process before the examination (Figure 2.2). The pavement cores had sufficient surface area for examination because of their greater width (4 inches [102 mm]) and length.

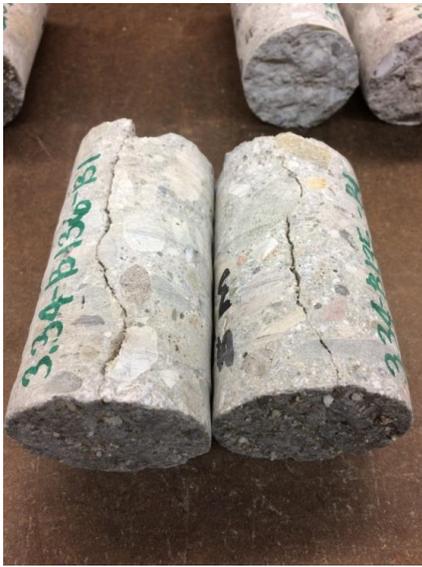
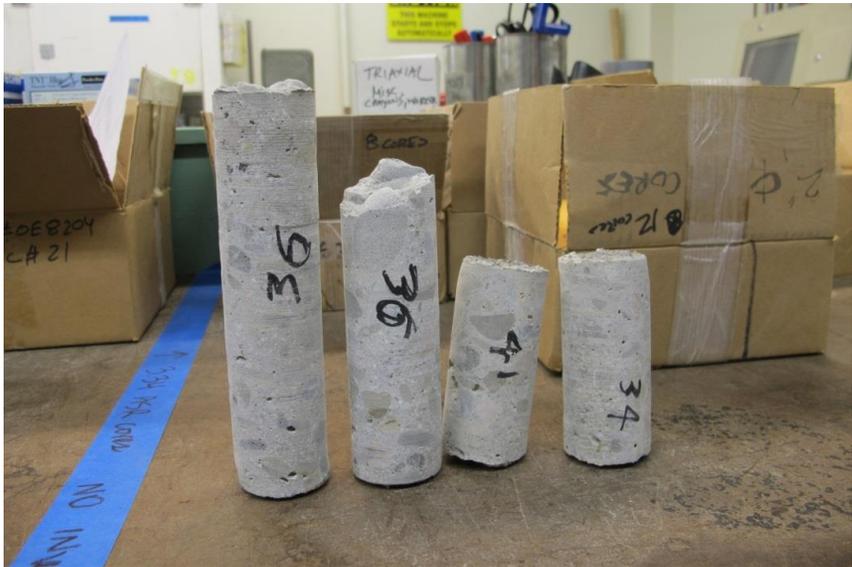
Figure 2.2: Bridge cores; cores equal to or longer than 3 inches were used for ASR visual inspection.

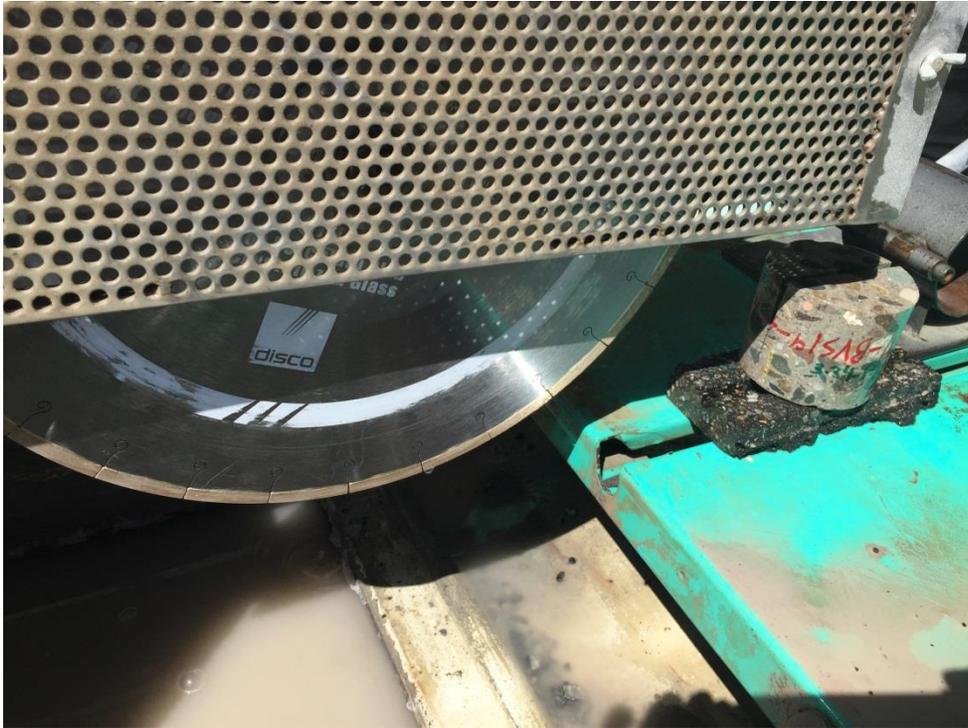
Figure 2.7: J-slot continuous diamond blades for concrete core cutting.

After the cores were inventoried and measured, they were cut for testing and examination. As shown in Figure 2.7, the cores were cut using J-slot continuous diamond blades, which are commonly used to cut marble and tile.

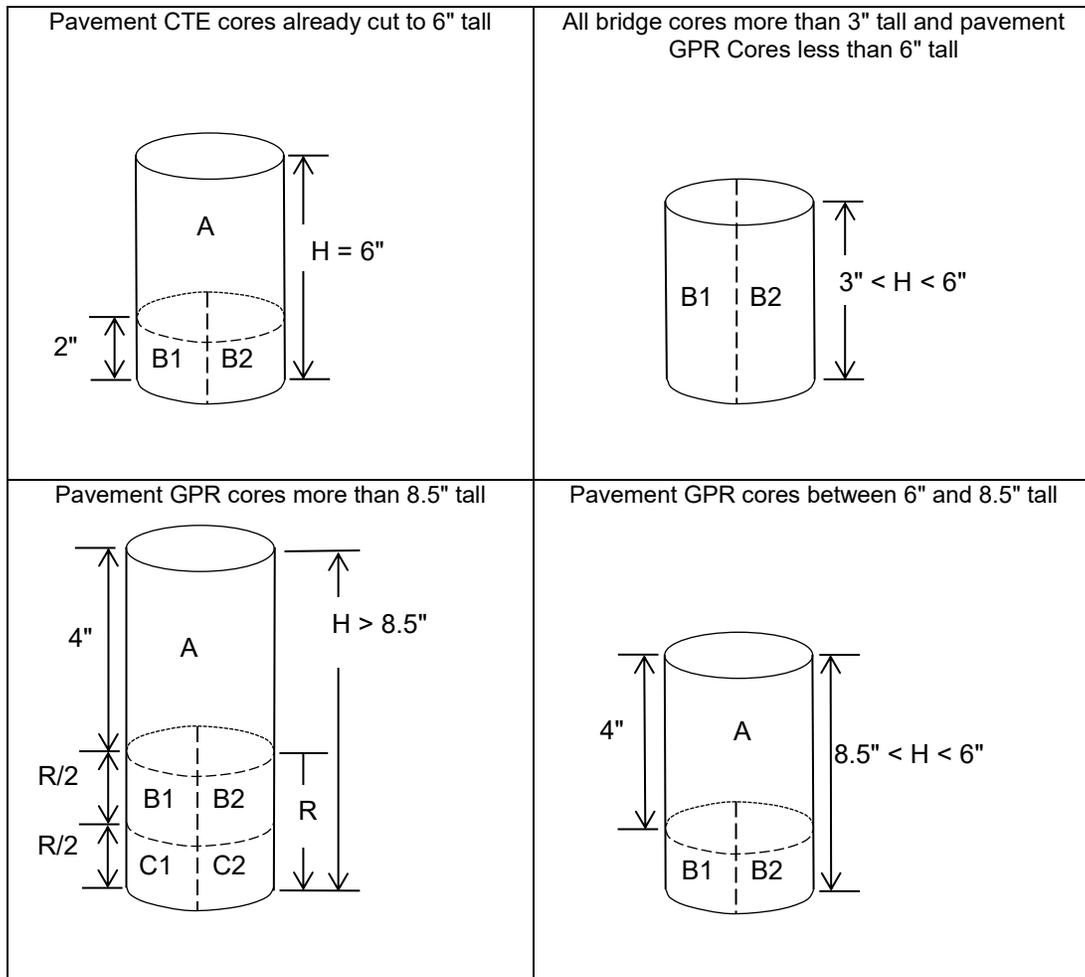
- Pavement CTE cores were 6 inches tall exactly, cut for previous testing.
- Bridge cores and pavement cores from the GPR study were separated by height to determine how to cut them: between 3 and 6 inches, between 6 and 8.5 inches, and greater than 8.5 inches.

Figure 2.8: Cutting plan for pavement cores.

All the pavement cores used for CTE testing had been cut to a length of 6 inches (152 mm), but the pavement cores and bridge cores from the GPR study were of varying lengths. For this study, bridge cores that were equal to or longer than 3 inches were cut vertically into two parts for the ASR visual inspection (Figure 2.8 and Figure 2.9).

Pavement cores shorter than 6 inches (152 mm) were cut vertically, splitting them into two parts for visual inspection for ASR. Pavement cores between 6 inches (152 mm) and 8.5 inches (216 mm) long were cut twice, once for strength testing and once for visual inspection. First, a horizontal cut was made 4 inches (102 mm) from the top of the core, and this 4 inch core was used for strength testing; on pavement cores that had been less than 8.5 inches long, the remaining bottom piece of the original core (if it was not less than 2 inches long) was then cut down the middle vertically for ASR visual inspection. On pavement cores longer than 8.5 inches (216 mm), the bottom piece was cut horizontally again into two short cylinders not less than 2 inches (51 mm) long; each of these was then cut vertically in half for ASR visual inspection.

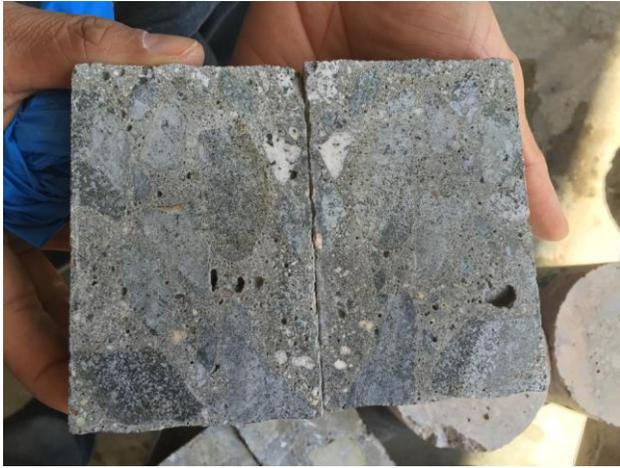
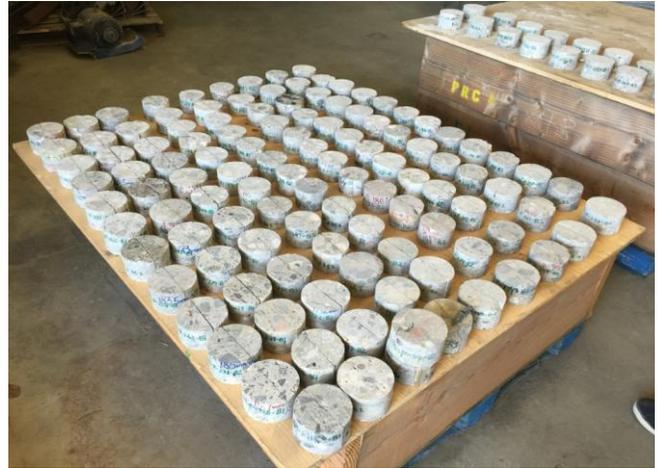
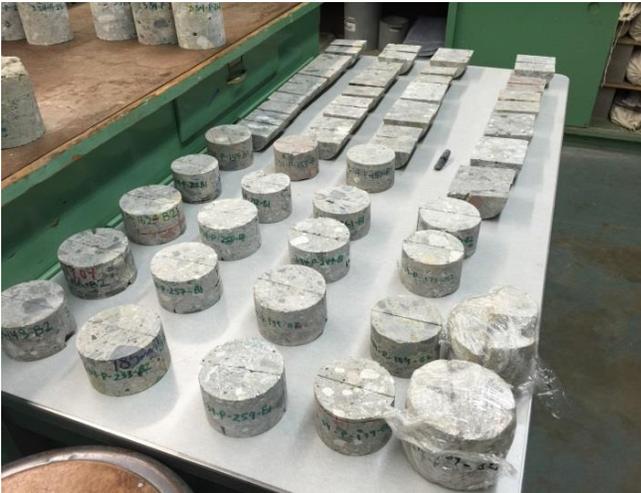
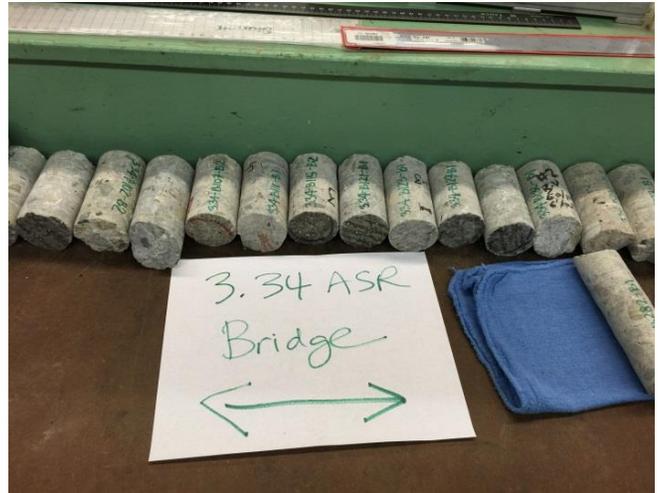
Figure 2.9: Concrete cores for visual inspection.

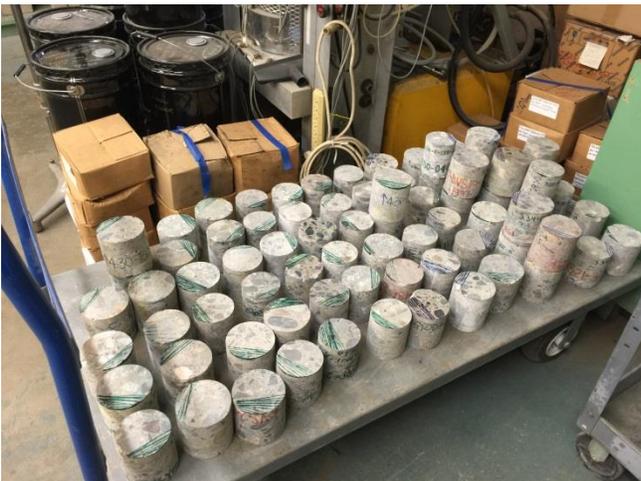
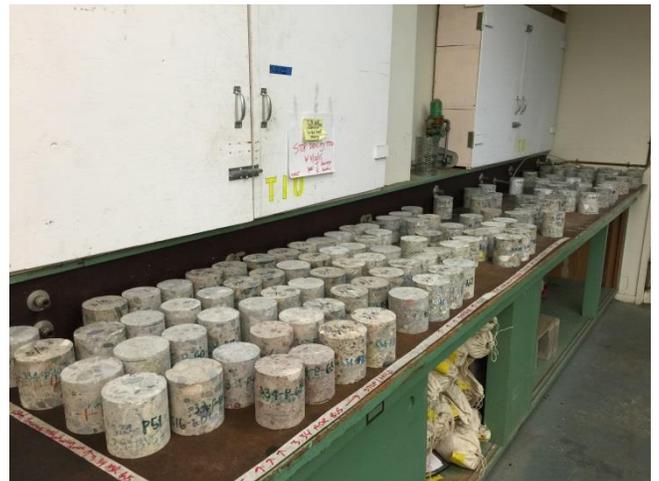
Figure 2.10: Concrete pavement cores after cutting and leveling for strength testing.

Pavement core pieces cut for strength testing were ground to ensure that the top and bottom surfaces were parallel to each other and perpendicular to the core sides (Figure 2.10). All the bridge cores were too small for strength testing.

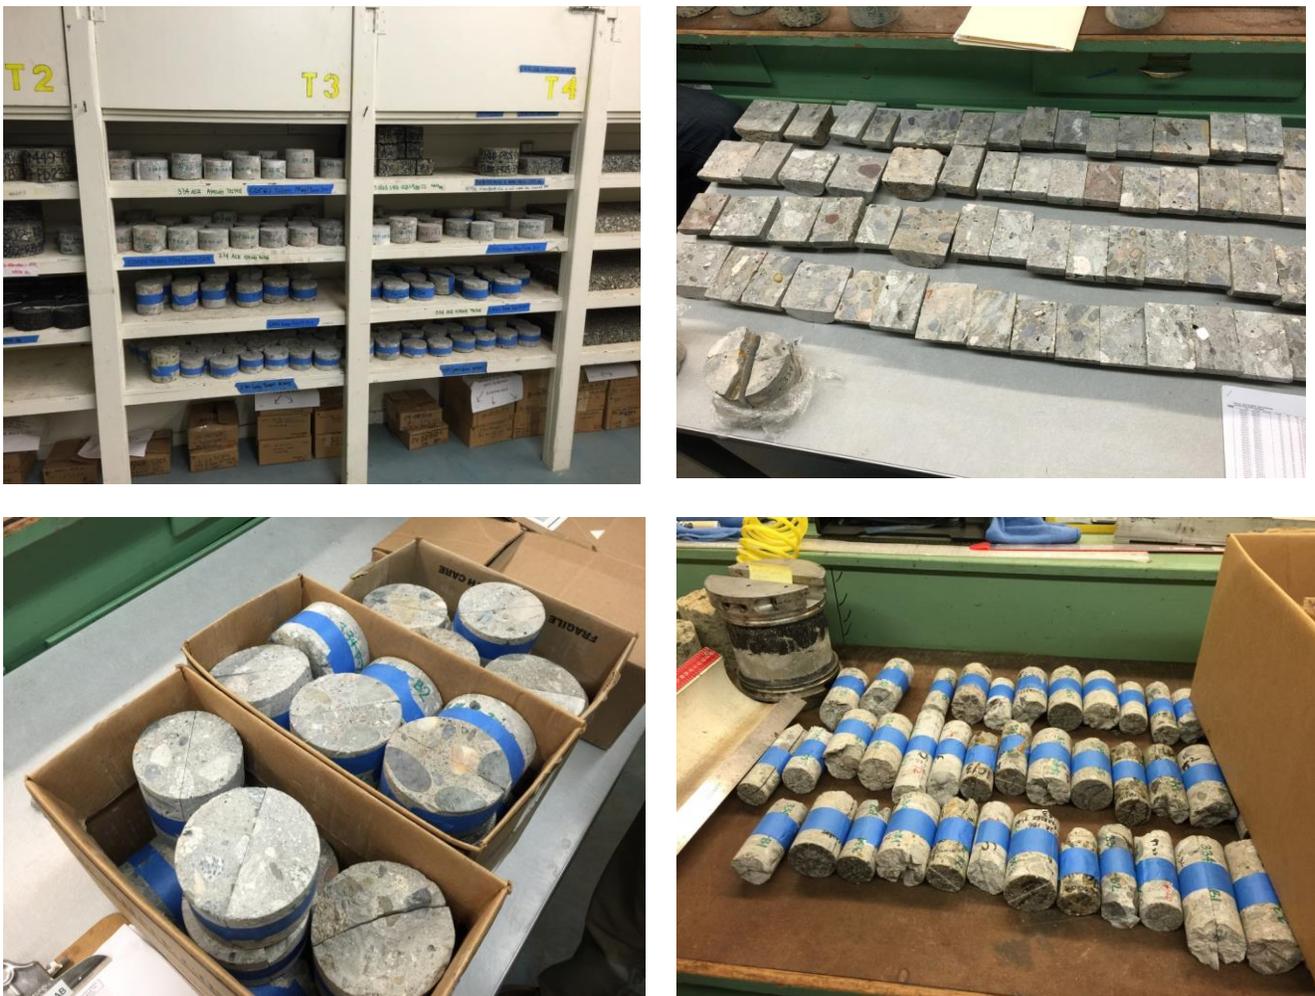
Figure 3.1: Pavement and bridge cores after cutting for visual inspection.

A total of 259 pavement core samples (multiple pieces for most pavement cores) and 80 bridge core samples (Figure 3.1) were visually inspected by the primary petrographer.

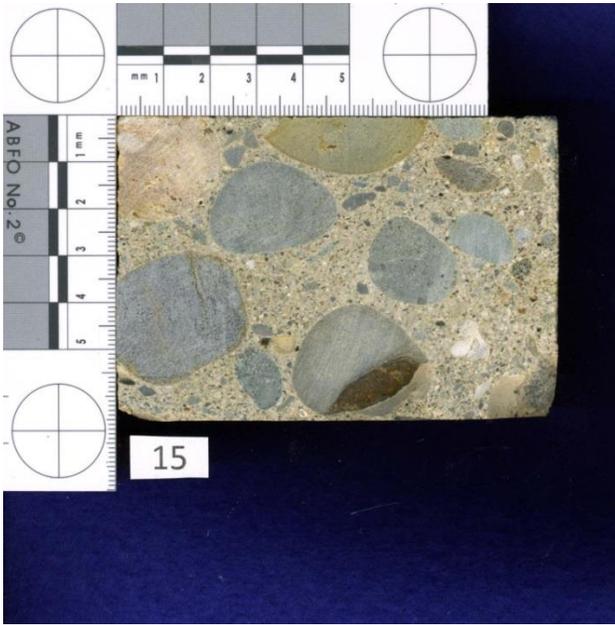
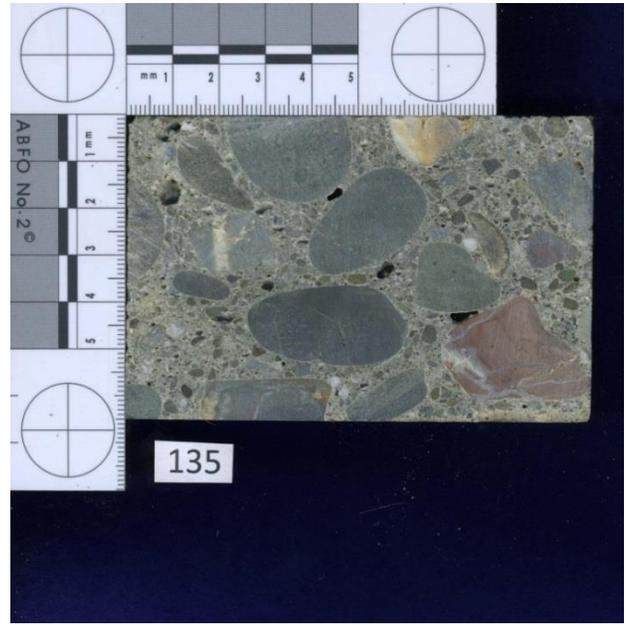
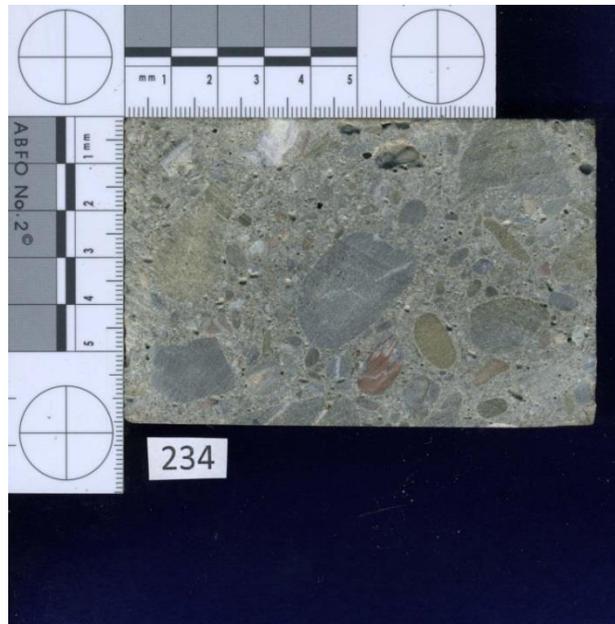
Figure 3.3: Example scans of the cut surfaces of three pavement cores.

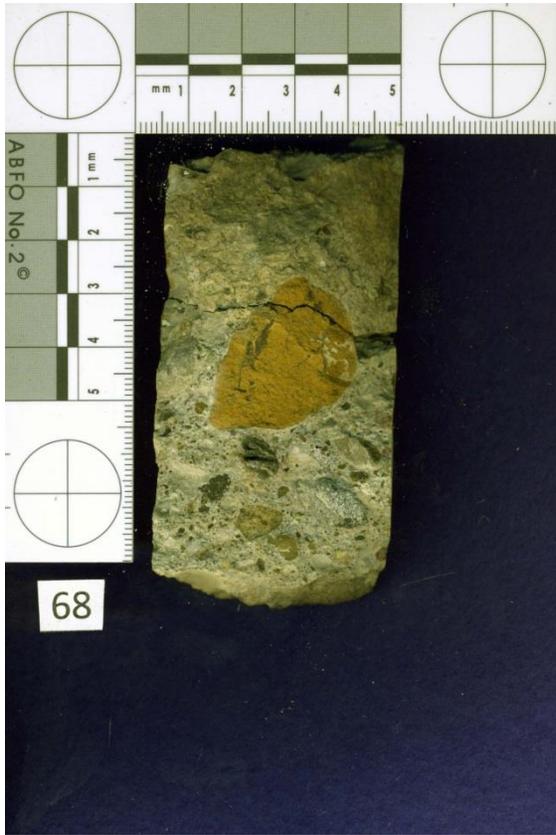
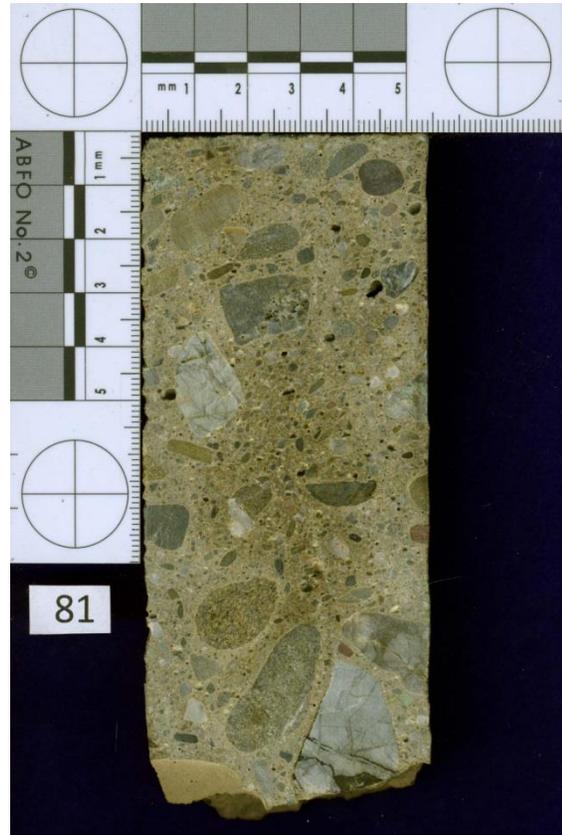
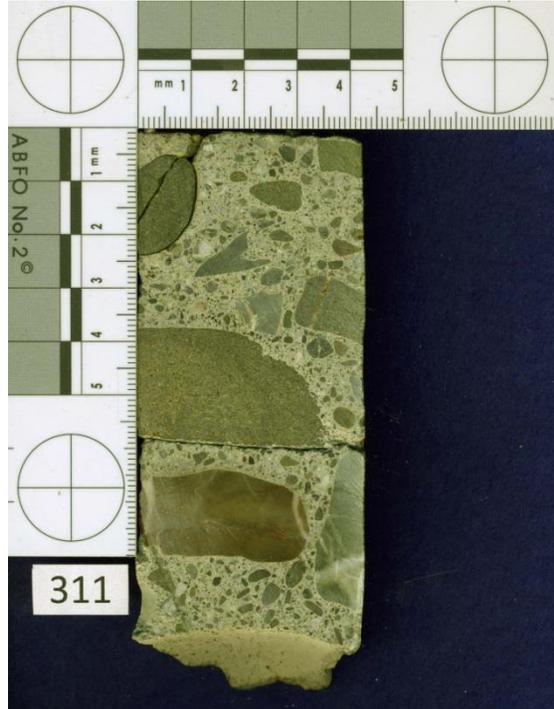
Figure 3.4: Example scans of the cut surfaces of three bridge cores.

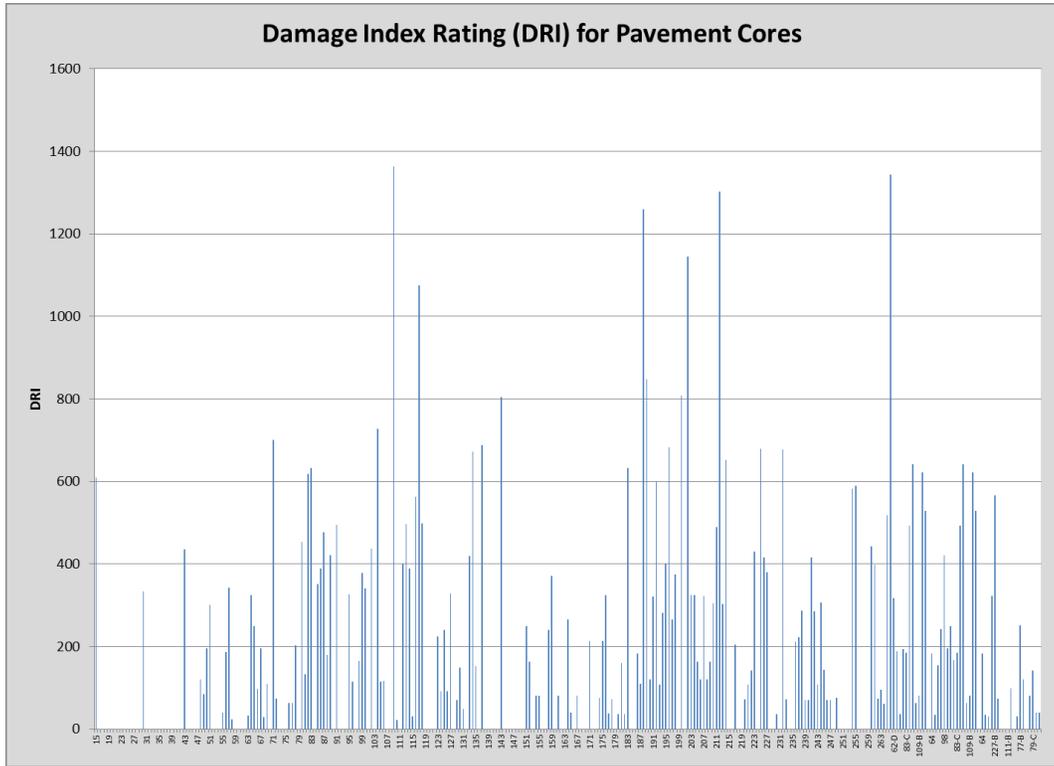
Figure 3.6: DRI of pavement cores, by core number.

The results of the visual inspection for pavement cores using the DRI method are presented in Figure 3.6 through Figure 3.8, organized respectively by core number, frequency of DRI result, and DRI cumulative distribution. Most of the pavement cores inspected showed DRI numbers less than 1,000 (ASR not likely according to the criteria shown in Section 3.2), with a DRI around 200 being the approximate median, as can be seen in Figure 3.8. A few cores had DRI values between 1,000 and 2,000 (ASR possible) but, as noted, none of the pavement cores inspected showed DRI results larger than 2,000 (ASR probable).

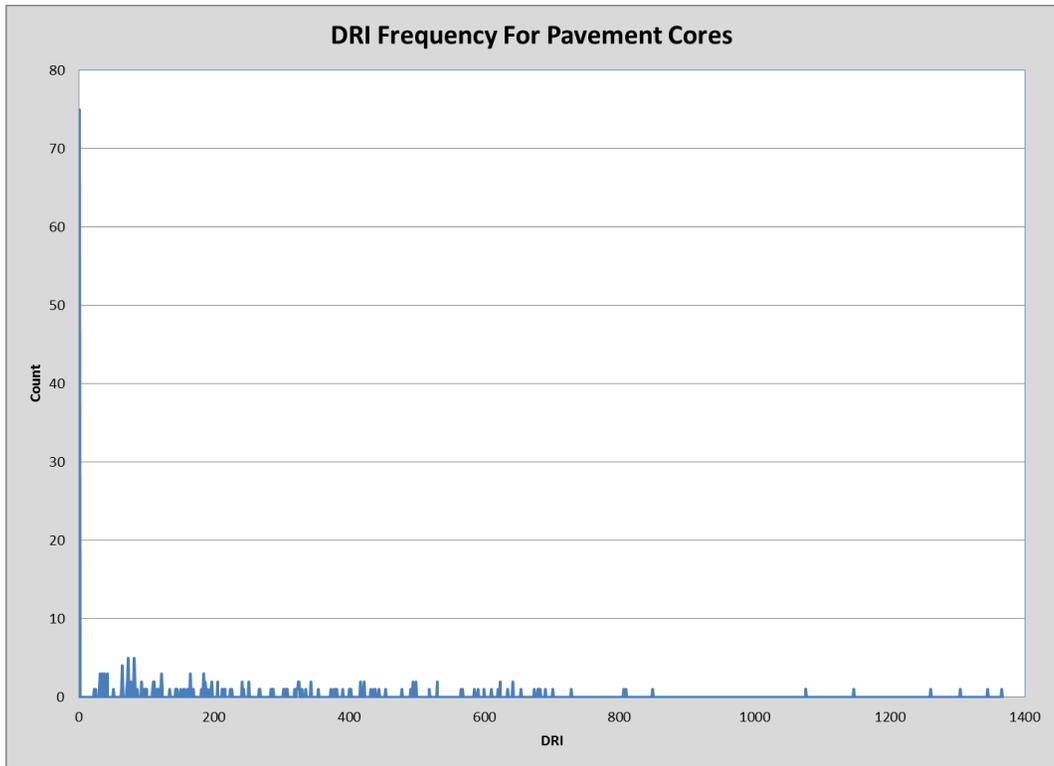
Figure 3.7: DRI of pavement cores, frequency chart.

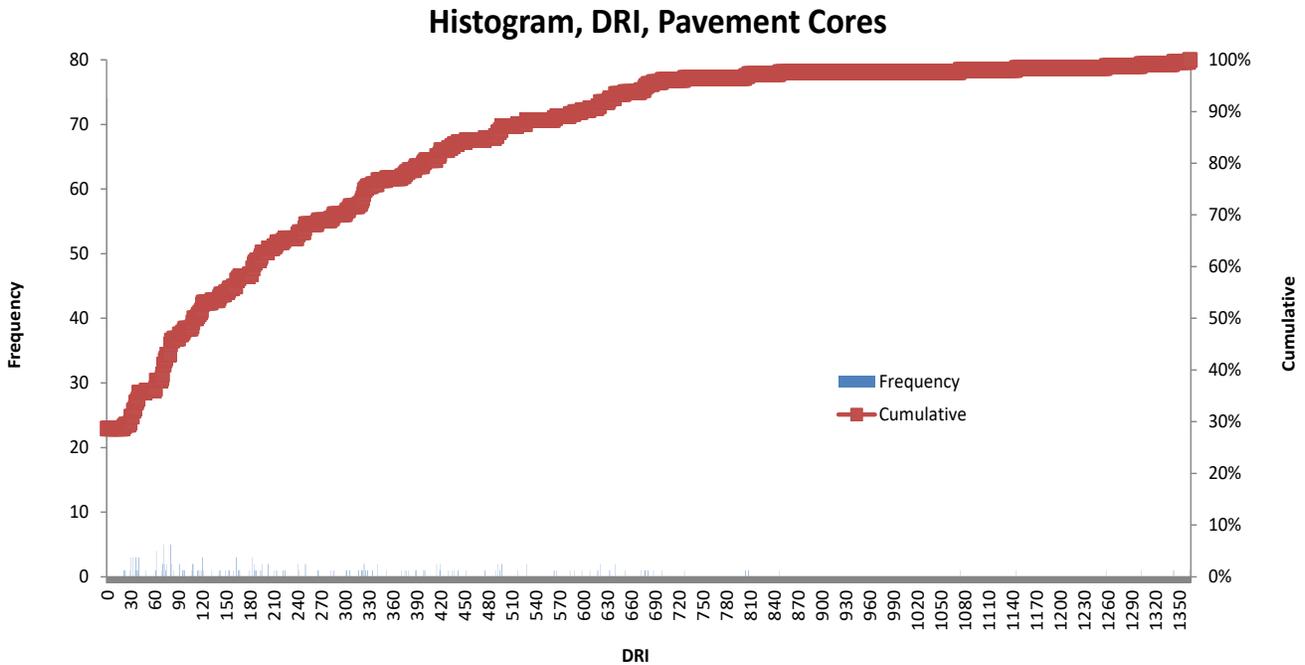
Figure 3.8: DRI of pavement cores, cumulative distribution chart.

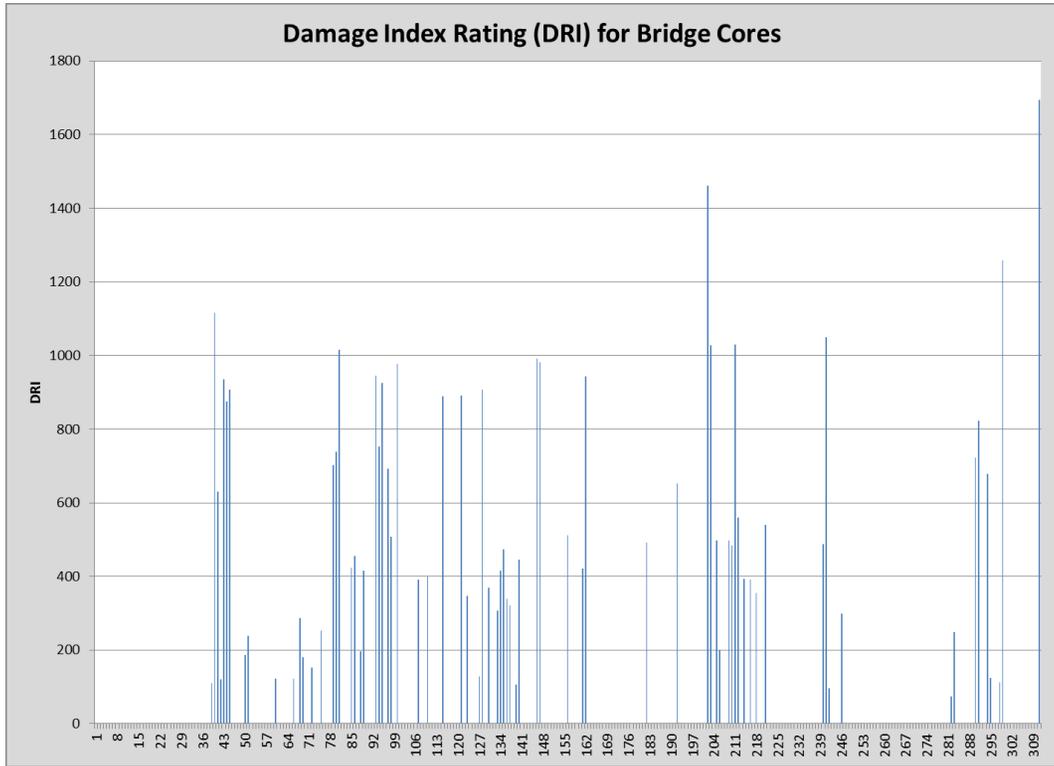
Figure 3.9: DRI of bridge cores, by core number.

The results of visual inspection for the bridge cores using the DRI method are presented in Figure 3.9 through Figure 3.11, organized respectively by core number, frequency of DRI result, and DRI cumulative distribution. As with the pavement cores, most of the bridge cores inspected had DRI results less than 1,000 (ASR not likely, according to the established criteria), and the median DRI result was approximately 500, as shown in Figure 3.11. Very few of the bridge cores had DRI results between 1,000 and 2,000 (ASR possible), and none of them had DRI results greater than 2,000 (ASR probable).

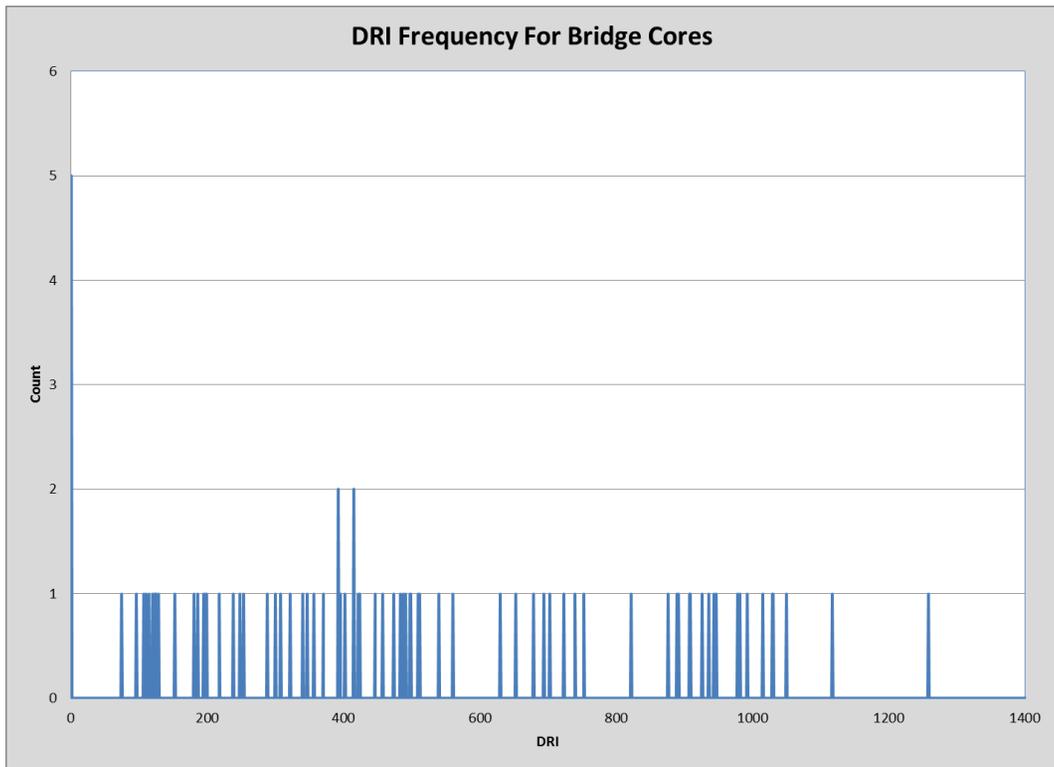
Figure 3.10: DRI of bridge cores, frequency chart.

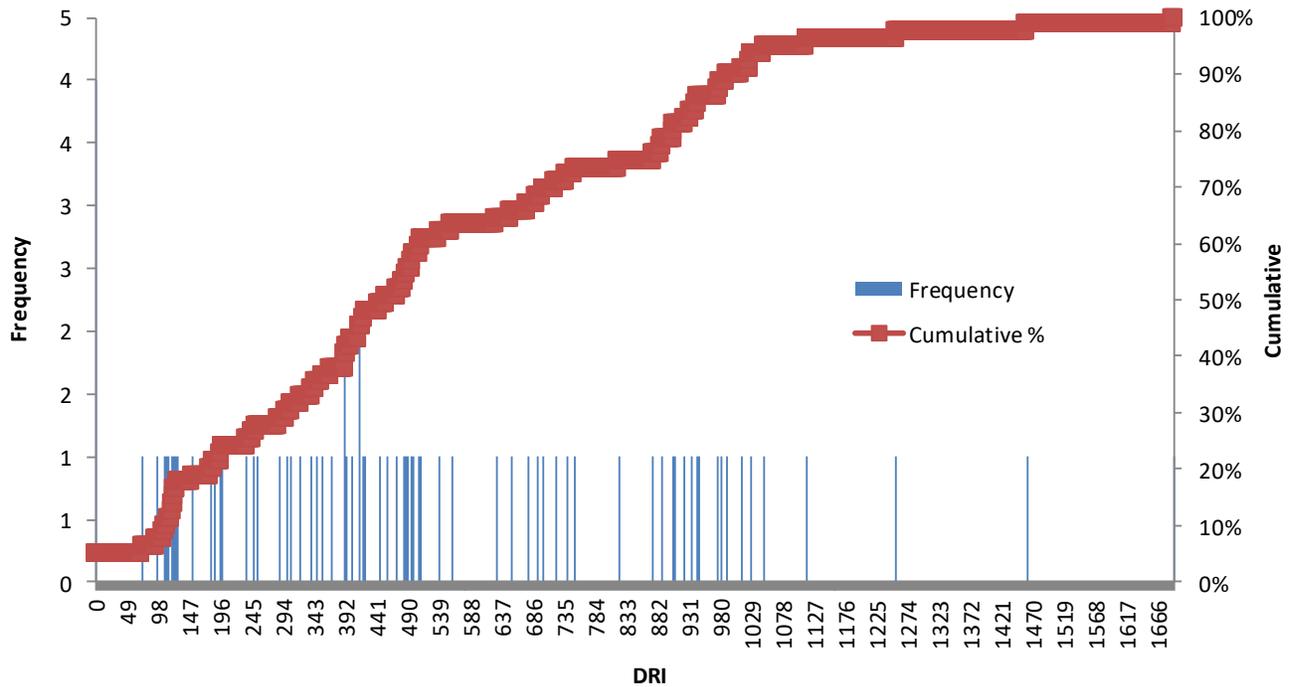
Figure 3.11: DRI of bridge cores, cumulative distribution chart.

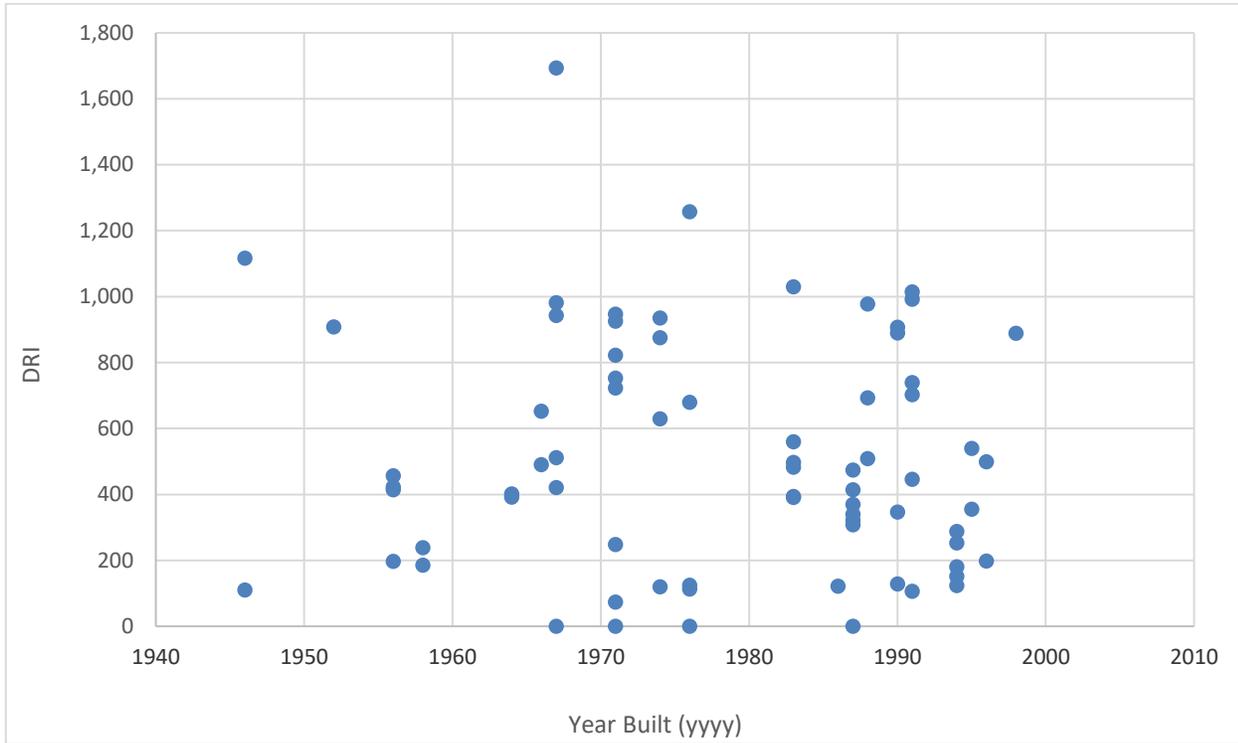
Figure 3.12: Damage Rating Index versus year of construction for bridge cores.

The year of construction of each of the bridge cores was compared with the Damage Rating Index for each of the 259 cores for which a construction year was found in the bridge logs, as shown in Figure 3.12. The data indicate that there is almost no trend between the ages of the cores, which ranged from 17 to 69 years old at time of visual inspection, and DRI. This should have been sufficient time for even the youngest cores to begin to manifest ASR if the reaction was occurring.

There were 26 cores taken from bridges built after 1995, approximately the time when changes in specifications to reduce the risk of ASR were implemented. There was no apparent difference in DRI values for bridges built before and after 1995.

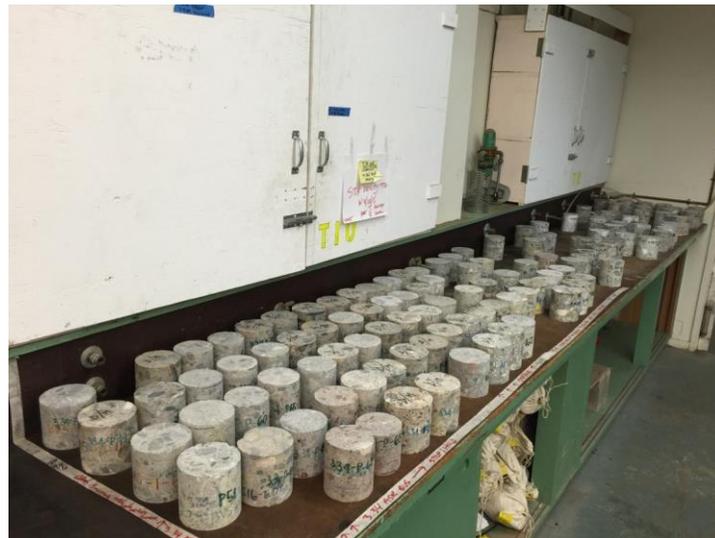
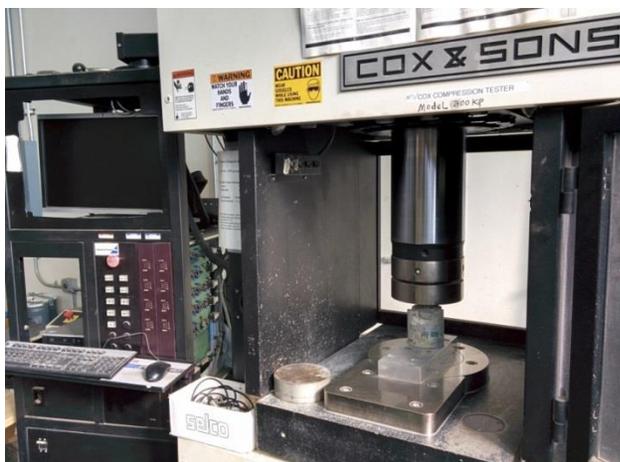
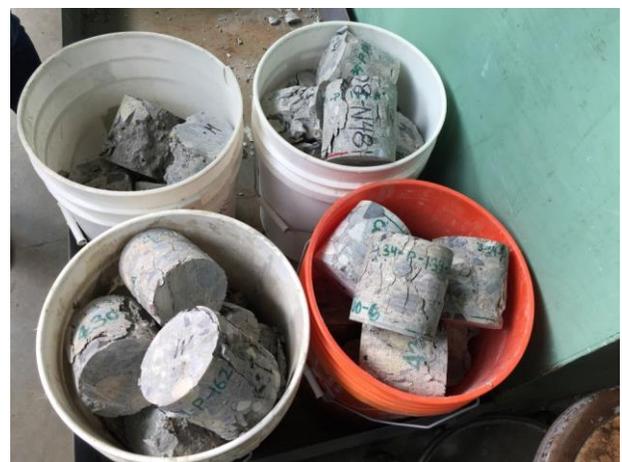
Figure 4.1: Pavement cores and strength testing.

In Task 3 of this project, 206 of the pavement cores were subjected to compressive strength testing (Figure 4.1) following ASTM C39/C39M-14a (Standard Test Method for Compressive Strength of Cylindrical Concrete Specimens) to help assess the condition of the concrete. Low strength due to microcracking is a potential indicator of ASR damage. The density of the pavement cores used for strength testing was also measured following ASTM C642-13 (Standard Test Method for Density, Absorption, and Voids in Hardened Concrete) to help determine whether any low strength values were attributable to low-density aggregate or high voids contents. The compressive strengths were also compared with those expected for concrete pavement strength based on data provided by the Caltrans Office of Structural Materials.

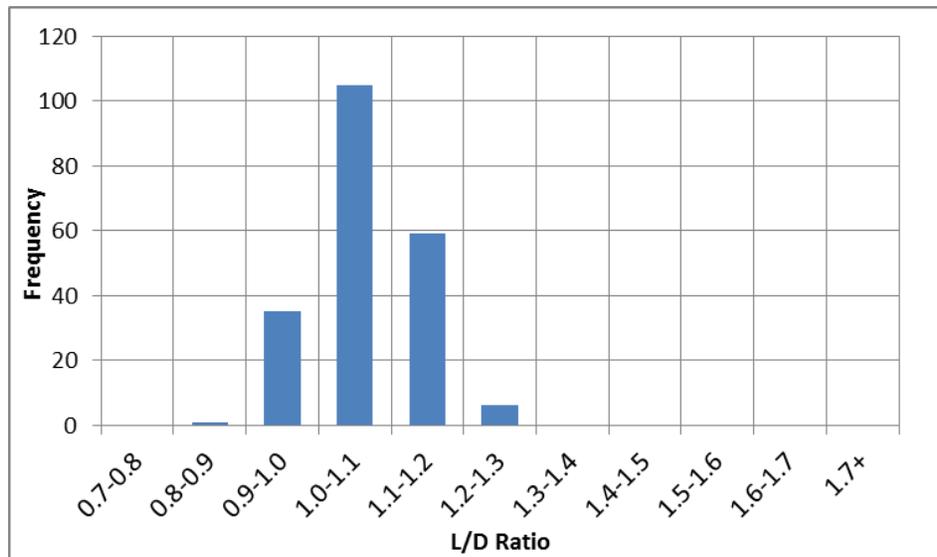
Figure 4.2: Frequency of length-to-diameter ratio (LDR) of pavement cores.

The length-to-diameter ratio (LDR) of the pavement cores in ASTM C39/C39M was used to adjust the strength values from cores of different lengths in order to produce approximately comparable values. The LDR values are presented in Figure 4.2. Most of the LDR values for the pavement cores ranged from 1.0 to 1.2, smaller than the standard LDR of 2.0. The correction factor curve of LDR for the pavement cores is shown in Figure 4.3, using a four-step linear interpretation from the LDR correction factor given in ASTM C39/C39M. The density of the pavement cores for strength testing was measured using the total air mass and the total volume of each core.

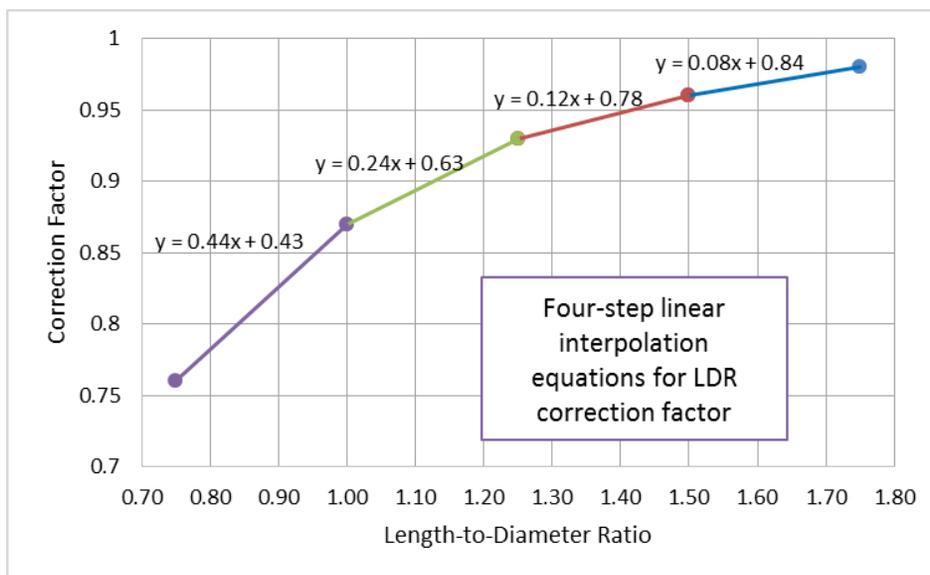
Figure 4.3: Length-to-diameter ratio (LDR) correction factor.

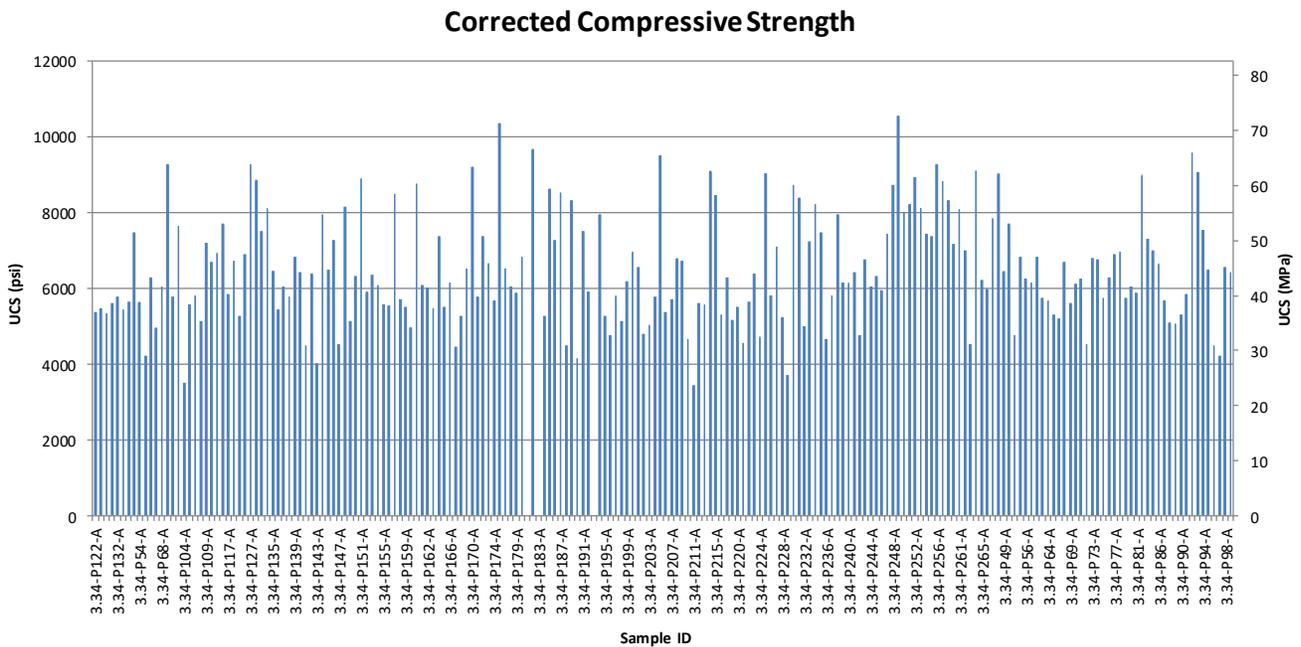
Figure 4.4: Corrected unconfined compressive strength of pavement cores, organized by core number.

The LDR corrected unconfined compressive strengths (UCS) of the pavement cores are presented in Figure 4.4 and Figure 4.5, plotted by core number and grouped into a histogram, respectively. Most of the pavement cores tested had UCS results less than 8,700 psi (60 MPa) while a small number had results between 8,700 and 11,600 psi (60 MPa and 80 MPa). None of the pavement cores tested had UCS results greater than 11,600 psi. The median UCS result was approximately 6,090 psi (42 MPa). These results were considered to be within the range of long-term strengths expected of PCC pavements by experienced Caltrans materials engineers.

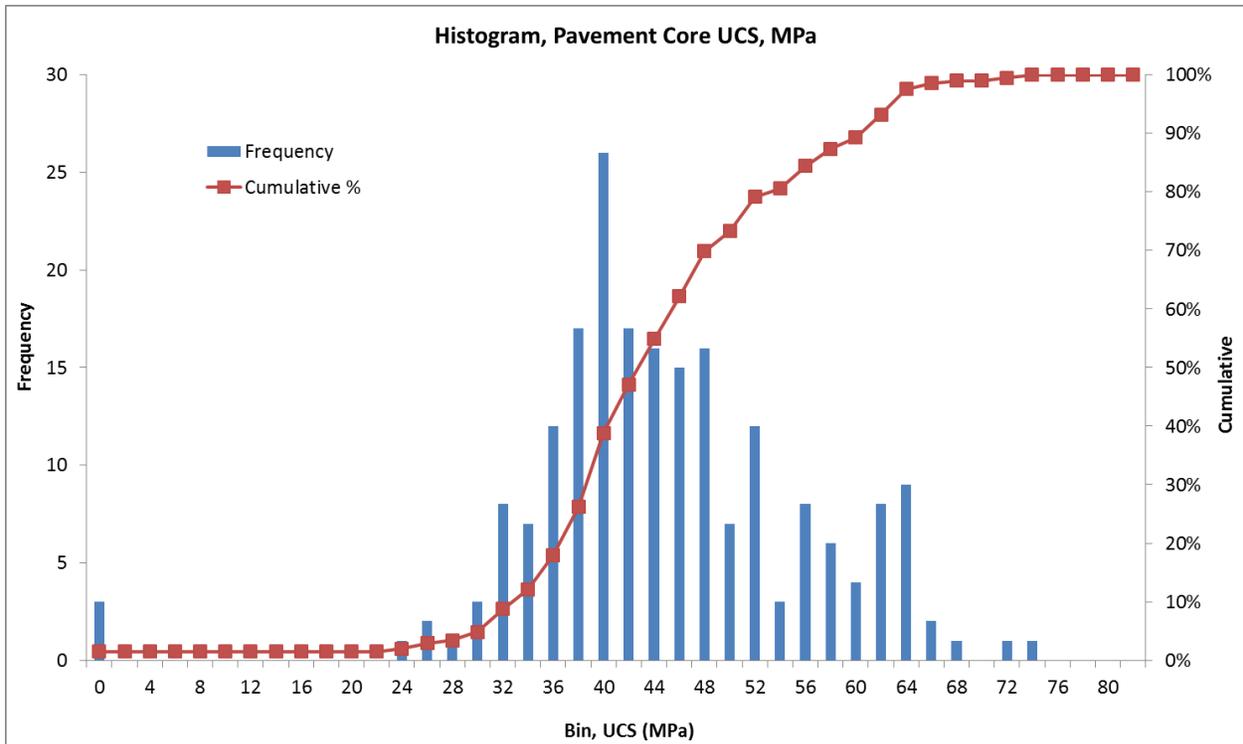
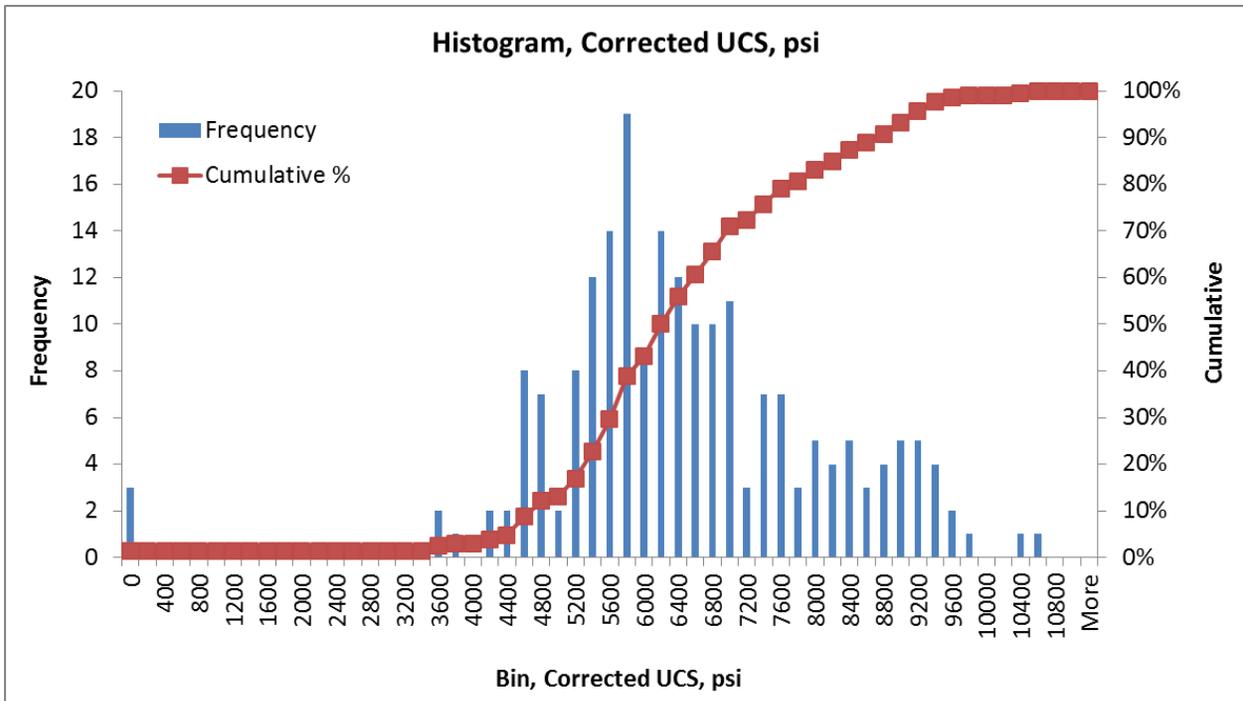
Figure 4.5: Corrected unconfined compressive strength of pavement cores, histogram chart (metric and US units).
