Results from Visual Inspection and Laboratory Testing for ASR in Existing Concrete Cores from Bridges and Pavements in California

Partnered Pavement Research Center (PPRC) Strategic Plan Project Task 3.34:
Improved Screening Tests for ASR

1. REPORT NUMBER UCPRC-RR-2015-07	2. GOVERNMENT ASSOCIATION NUMBER	3. RECIPIENT'S CATALOG NUMBER
4. TITLE AND SUBTITLE Results from Visual Inspection and Laboratory Testing for ASR in Existing Concrete Cores from Bridges and Pavements in California		5. REPORT PUBLICATION DATE March 2017

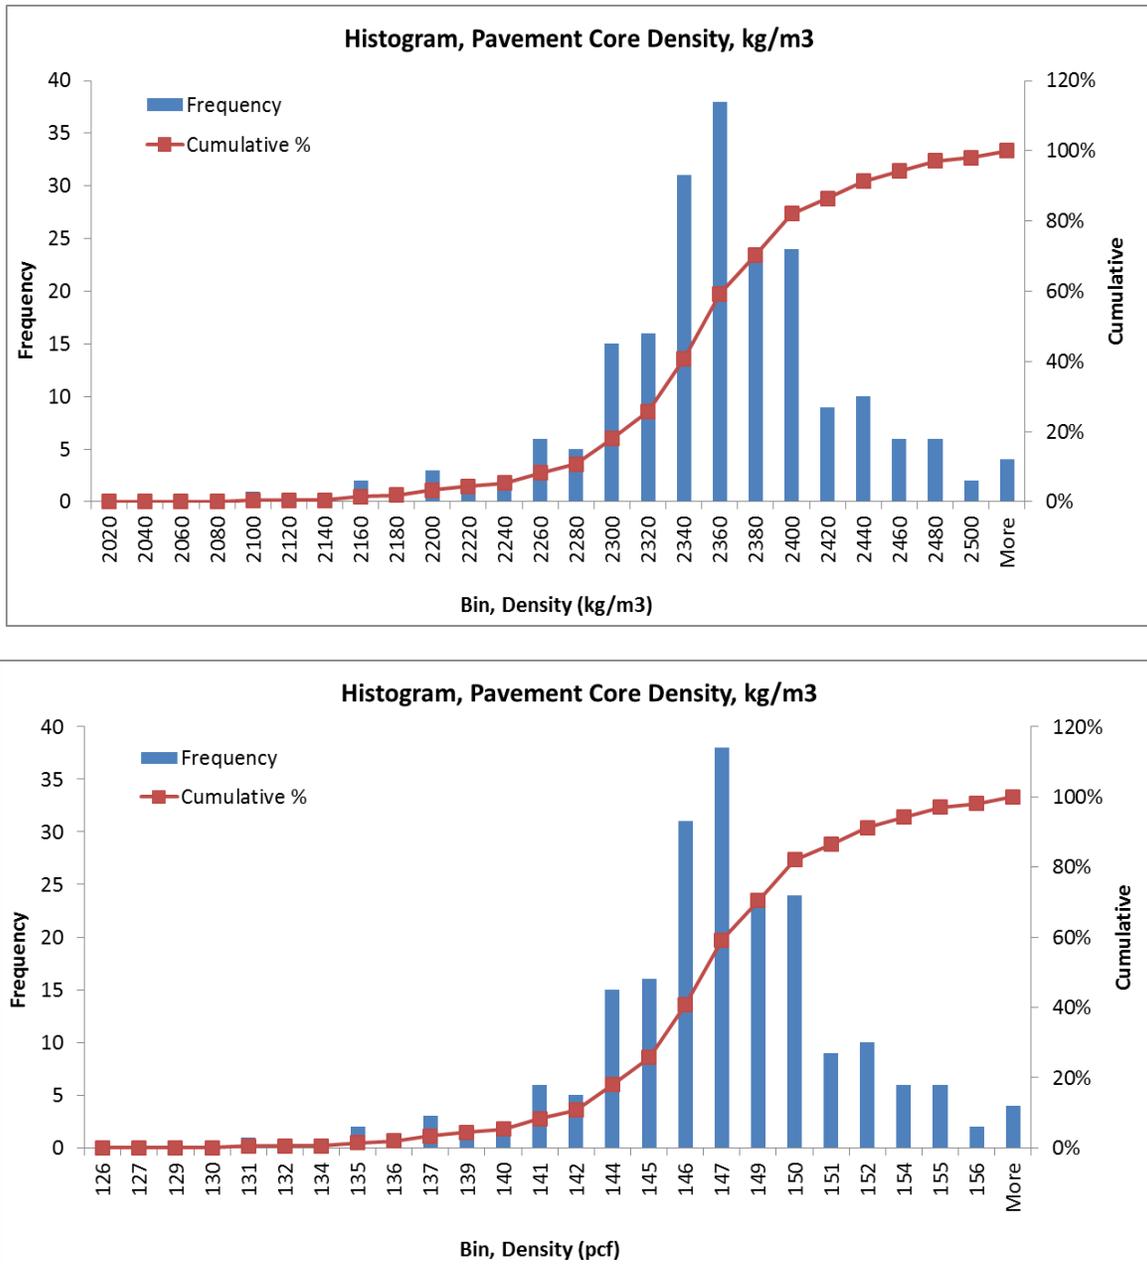
Figure 4.6: Density of pavement cores, histogram chart (metric and US units).

The densities (air mass/volume) of the pavement cores tested are presented in Figure 4.6 with histogram plots. Most of the pavement cores tested had densities less than 156 pcf (2,500 kg/m³) and the median UCS result was approximately 147 pcf (2,350 kg/m³). Density is primarily controlled by the density of the aggregates used in the concrete. These results were considered to be within the range of densities expected of PCC pavements by experienced Caltrans materials engineers.

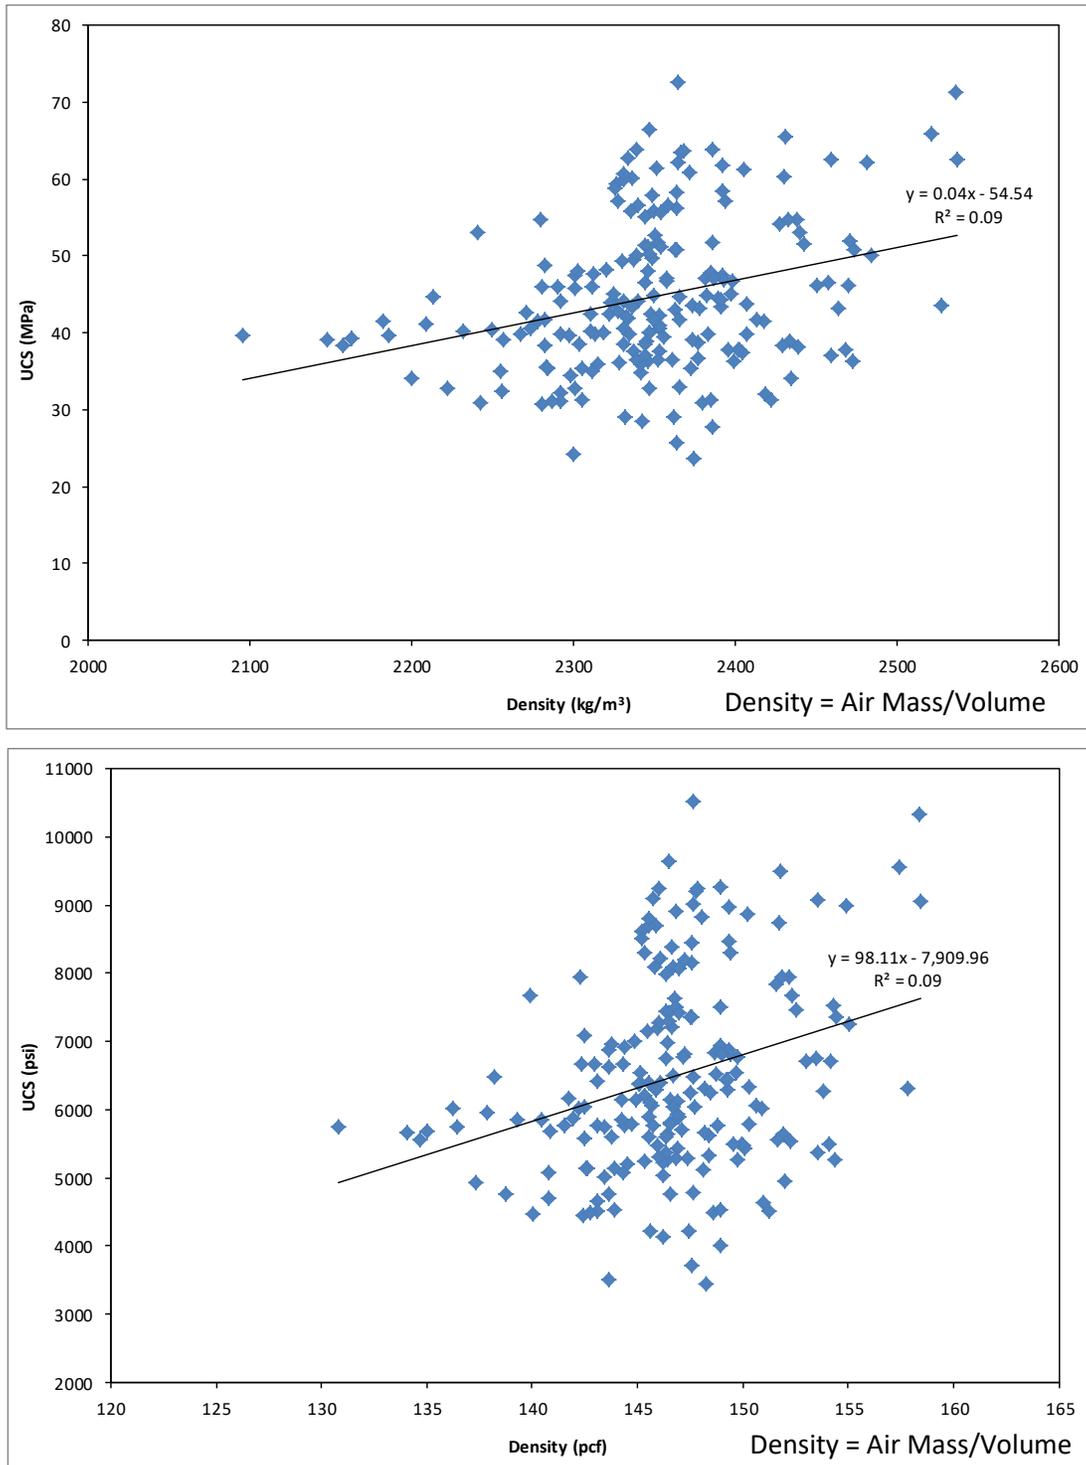
Figure 4.7: Strength versus density of pavement cores (metric and US units).

Comparison of the results of the UCS and density tests for the pavement cores are presented in Figure 4.7. It can be seen that there is no significant correlation between the UCS values and densities of the pavement cores tested, although the UCS strengths generally increase with the density.

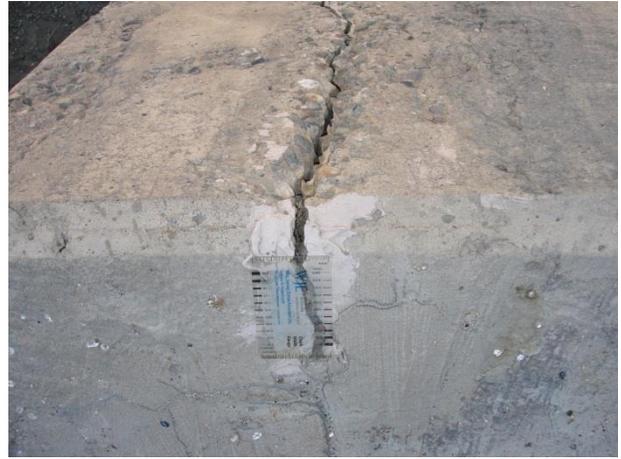
Figure A.2: Example photos showing some of the common petrographic features of ASR.

gel, and voids lined or filled with gel. Each feature should be given a weighing factor based on its association to ASR. Photos in Figure A.2 show some of the common petrographic features of ASR. The weighted features should be summed and normalized to the area examined, which will give a Damage Rating Index (DRI) value for the core slice. Additional information should be gathered regarding the presence of reacted aggregate (but not showing signs of distress), the presence of secondary mineral deposits other than ASR gel, and the physical characteristics of the concrete, such as consolidation and segregation.

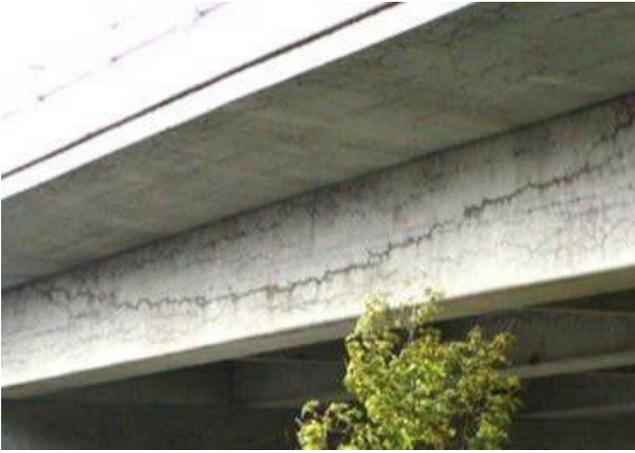
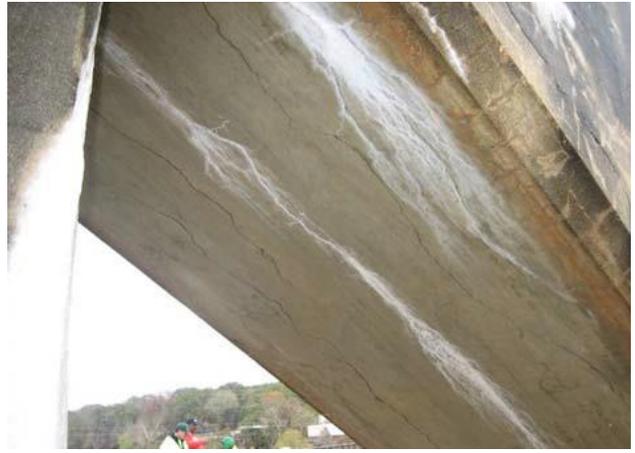
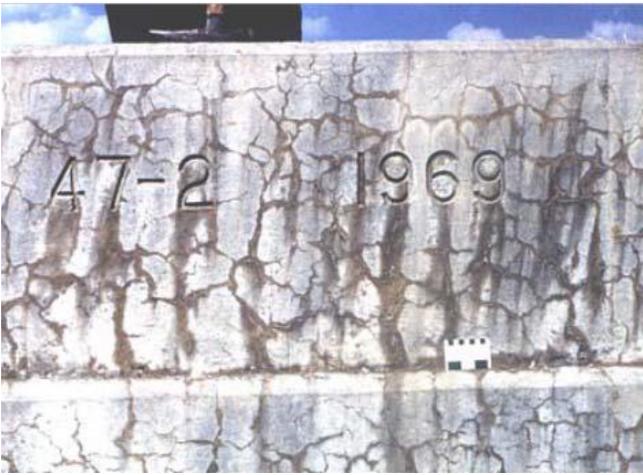
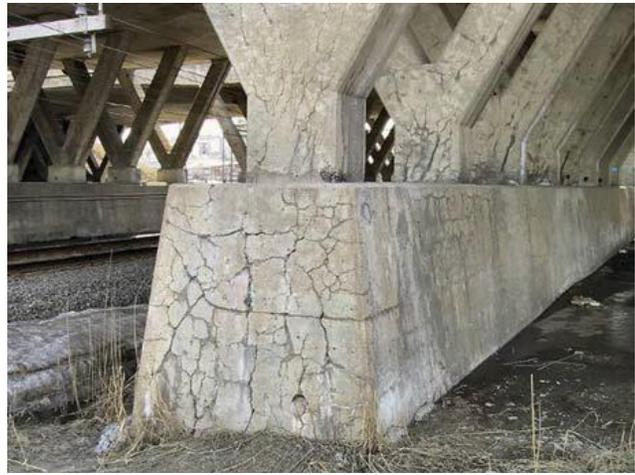
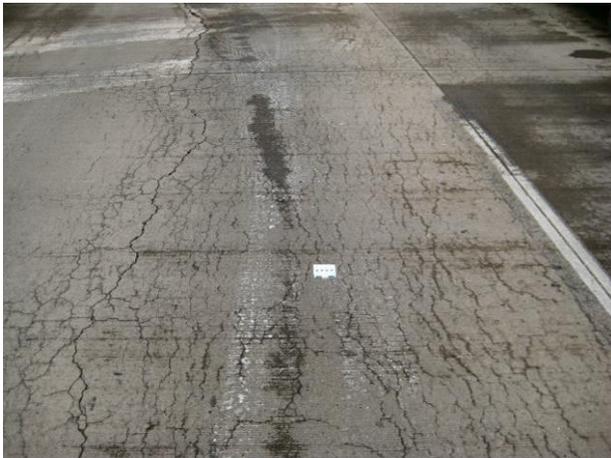
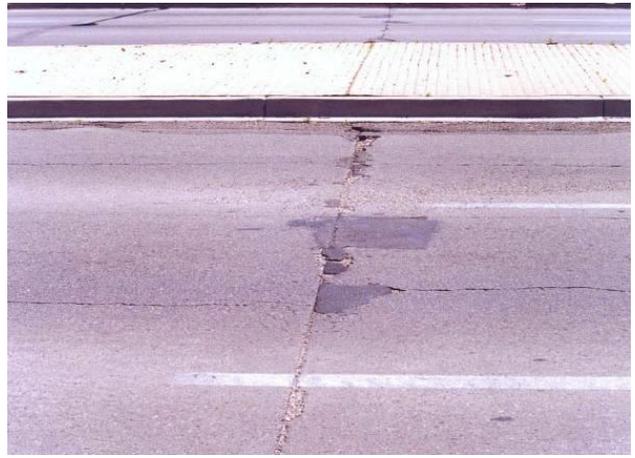
Figure A.2: Example photos showing some of the common petrographic features of ASR (*cont'd*).

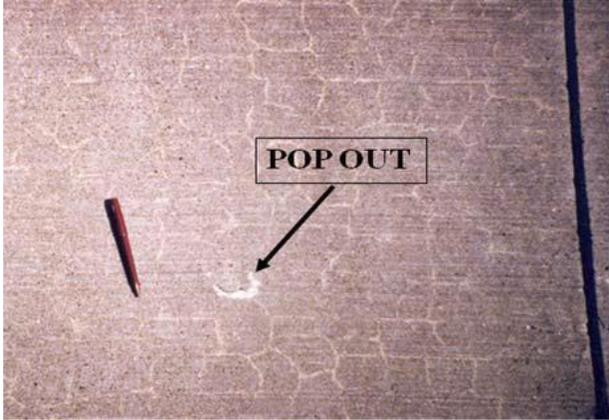
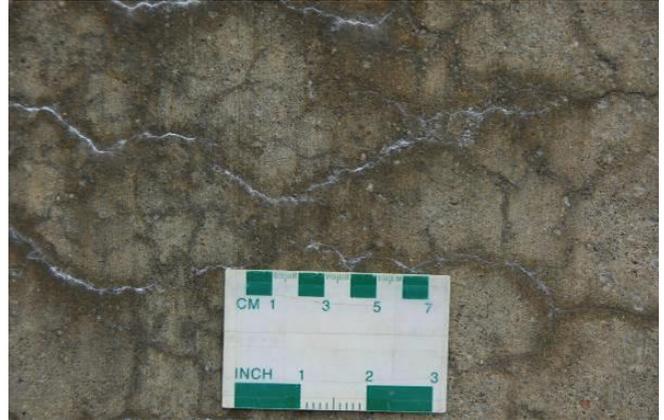
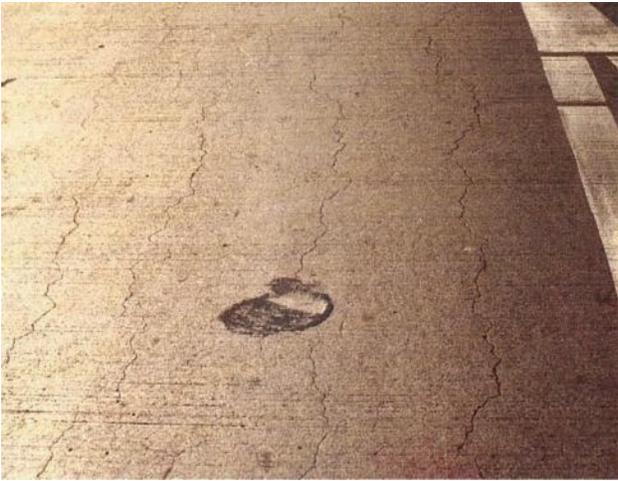
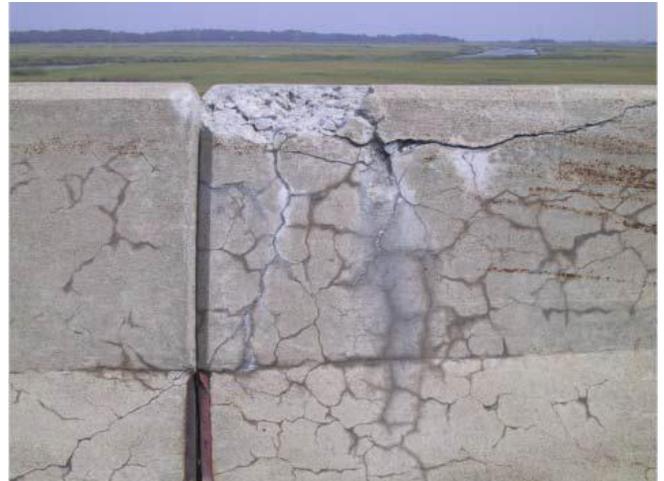
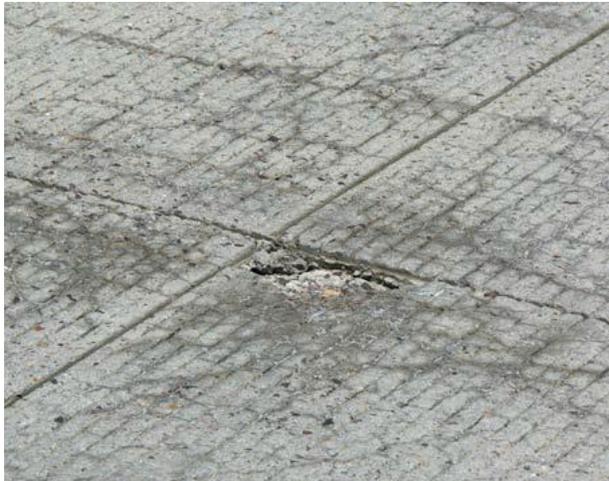
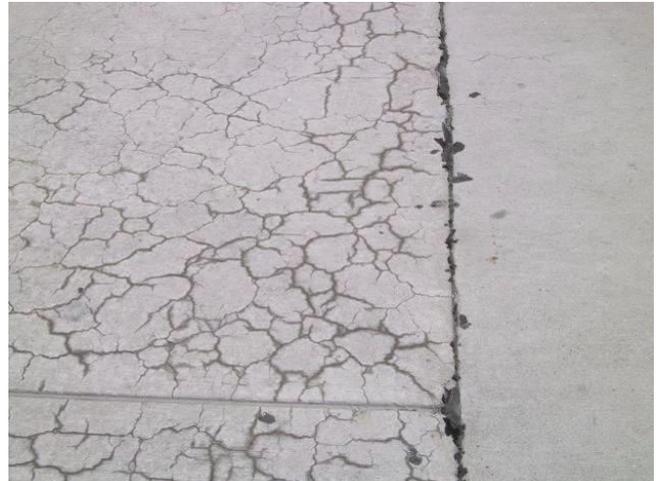
Figure A.2. Example photos showing some of the common petrographic features of ASR (*cont'd*).
(Some of the photos are from the reference: Thomas, M.D.A., B. Fournier, and K.J. Folliard. *Alkali-aggregate Reactivity (AAR) Facts Book*. No. FHWA-HIF-13-019. 2013.)
